Gray Cottage

Sagamore Hill National Historic Site
Oyster Bay, New York

HISTORIC STRUCTURE REPORT

**James J. Lee III
Architectural Conservator
Historic Architecture Program
Northeast Region, National Park Service
Lowell, Massachusetts**

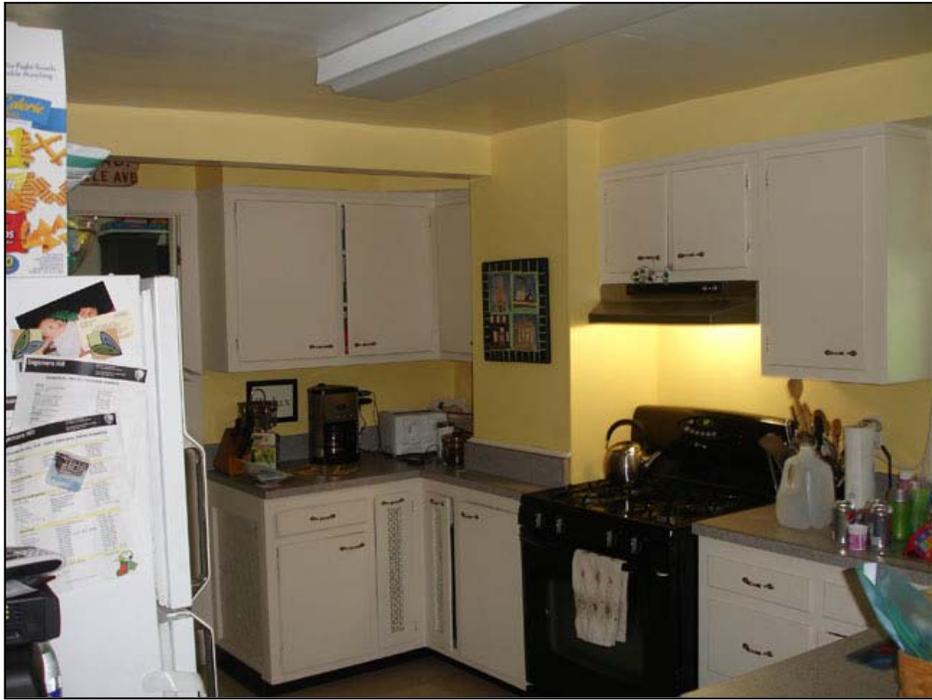
Figure 47. Gray Cottage, Room 103, kitchen, north and east elevations, 2009.

The layout of the kitchen is depicted in the current plans of Gray Cottage (fig. 44), and most of the built-in elements appear to date from the 1964 renovations. Base cabinets are installed along the north, east, and west walls and at the south end of the west wall (fig. 47). The base cabinets are constructed with plywood and have plywood doors with brass handles and small butt hinges. The narrower doors in the northeast corner and at the south end are constructed with screened panels within stile and rail frames. Similar screened panels were installed at the west ends of the north and south base cabinets. At the south end of the west-wall cabinets is curved open shelving. Formica countertops with a Formica backsplash are installed on top of the base cabinets. In the northwest corner of the room is a more recently installed countertop with a dishwasher stored beneath it. Upper cabinets are installed above the countertops except for the sections in the southeast corner near the window openings. The upper cabinets were also constructed with plywood. The upper cabinets along the west wall have glass doors and curved open shelves in the south corner. The tops of the upper cabinets are constructed with a molded trim with a fillet-and-cavetto profile. The upper cabinets do not extend to the ceiling, and the gap to the ceiling is in-filled with gypsum board.

The walls of the kitchen are currently painted bright yellow and the ceiling is painted white (fig. 47). The woodwork in Room 103, including the wooden elements of the window openings, is painted white. The door in D104 has a clear resinous finish.

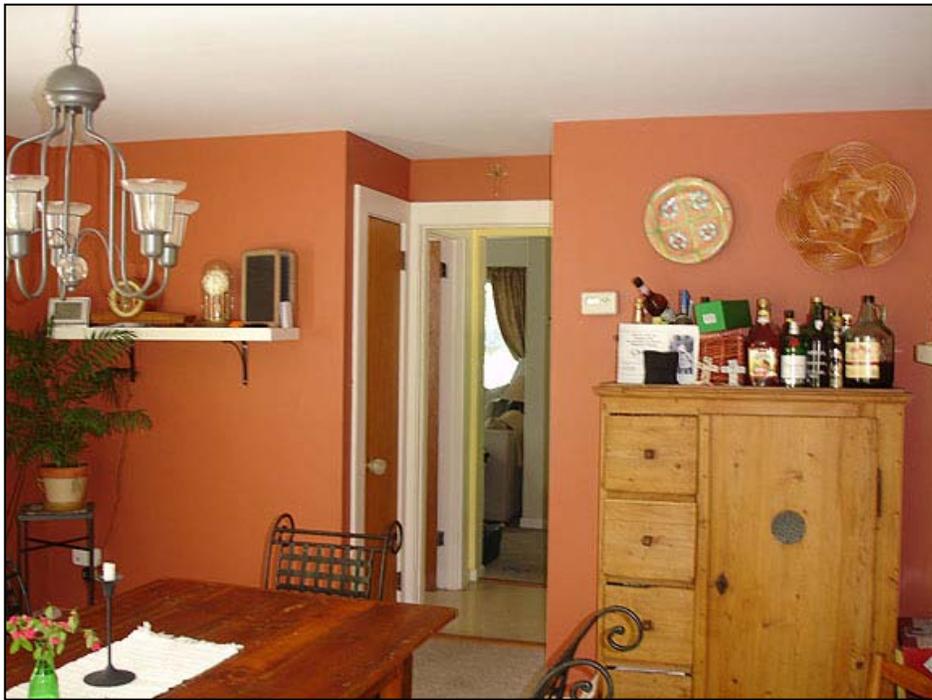
Figure 48. Gray Cottage, Room 105, dining room, north elevation, 2009.

Room 105 is a large rectangular room that occupies most of the south ell. The room is accessed from Room 104 and has a small closet west of the doorway (fig. 48). Room 105 is currently used as a dining room.

The walls in Room 105 are currently painted a red-orange color that approximates terracotta clay (fig. 48). The ceiling is painted white and the trim is painted white. The closet door has a clear resinous finish.

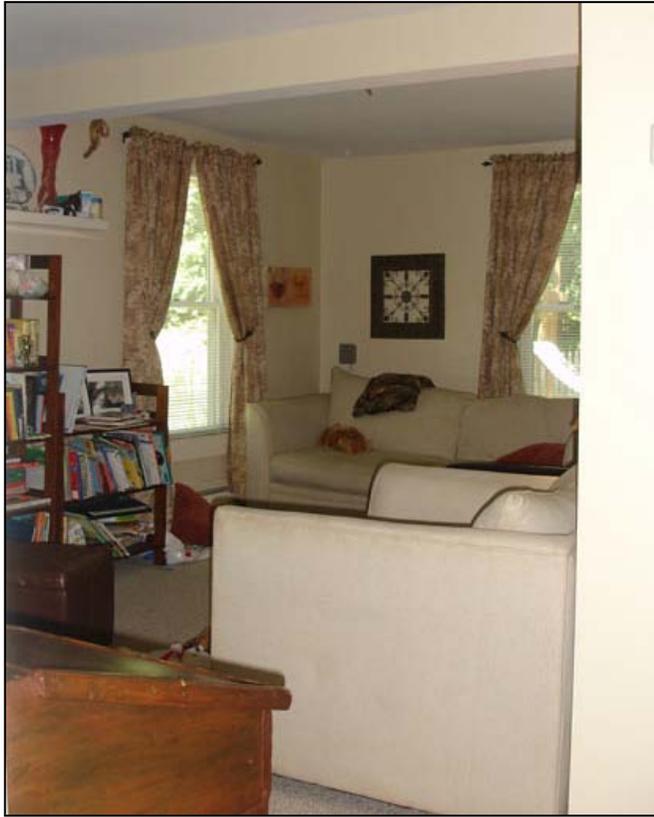
Figure 49. Gray Cottage, Room 107, living room, north and west elevations, 2009.

Room 107 is a large room that occupies the west half of the main block. The room plan is rectangular with jogs at the north and south ends of the east wall (fig. 49). The room has an exterior doorway and has access to Rooms 102 and 104, as well as the staircase to the second story. Room 107 is the largest room in the building and is currently used as the living room.

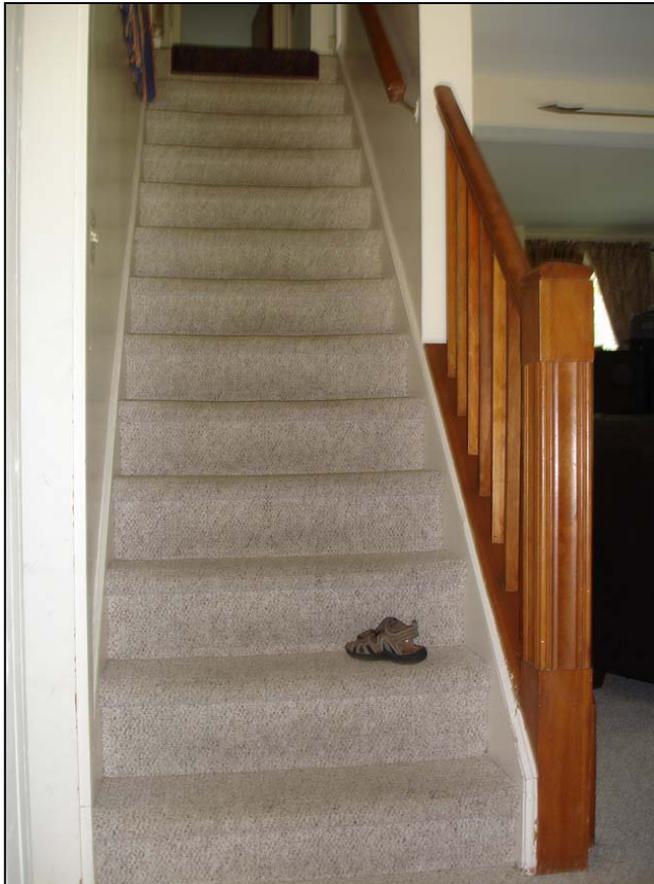
Figure 50. Gray Cottage, Room 107 staircase to second story, 2009.

The staircase to the second story begins near the northeast corner of Room 107 opposite the front entry doorway (D102). It is a closed-stringer staircase with 9-inch treads and 8-inch risers that are covered with wall-to-wall carpet. The west side of the staircase is open at the first story and has a wooden balustrade (fig. 50). The rest of the staircase is enclosed with gypsum-board walls and ceiling. The wooden balustrade is constructed with a molded handrail, a square newel post with molded sides and edges, and 1¼-by-¾-inch square-edged balusters. A wooden handrail is fastened to the west wall and continues from the balustrade to the second-story hallway. Both sides of the staircase are trimmed with raked baseboards with an applied molding along the top edge.

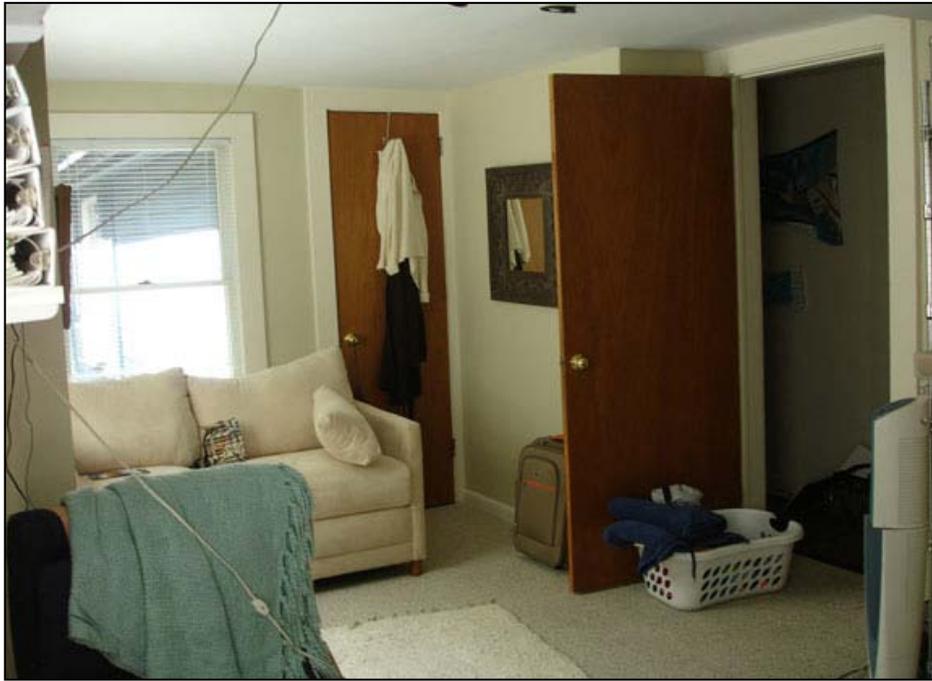
Figure 51. Gray Cottage, Room 202, south and west elevations, 2009.

The east bedroom (Room 202) is a rectangular room on the east side of the main block. The chimney stack is located near the center of the east wall. There is a jog in the southwest corner of the room that corresponds to the hallway linen closet. A large closet is located near the southwest corner of the room (fig. 51). That closet extends into the ell of the building.

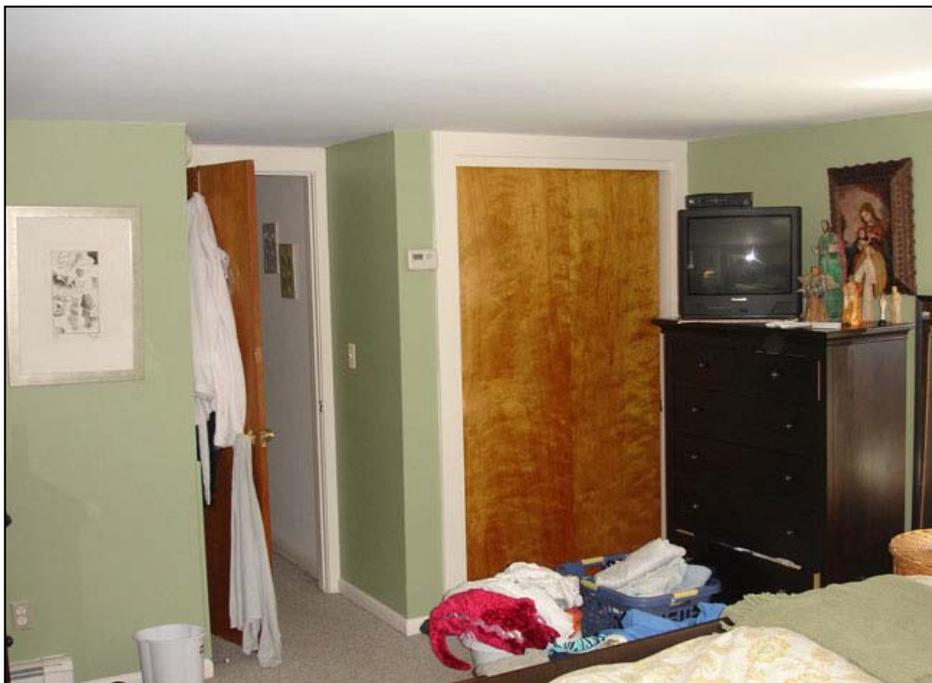
Figure 52. Gray Cottage, Room 203, north elevation, 2009.

The doorway to Room 203 opens into a short passageway that is flanked on the west by the bathroom wall and on the east by the bedroom closet (fig. 52). Beyond the passage, Room 203 is a rectangular room that occupies most of the second story of the ell.

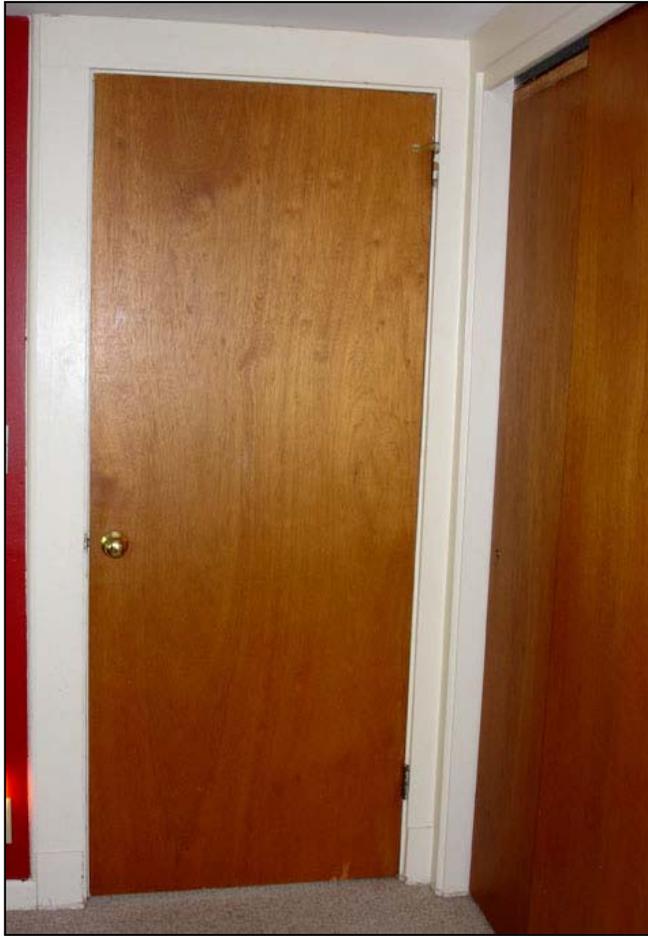
Figure 53. Gray Cottage, Room 205, D204 depicting historic trim and replacement door, 2009.

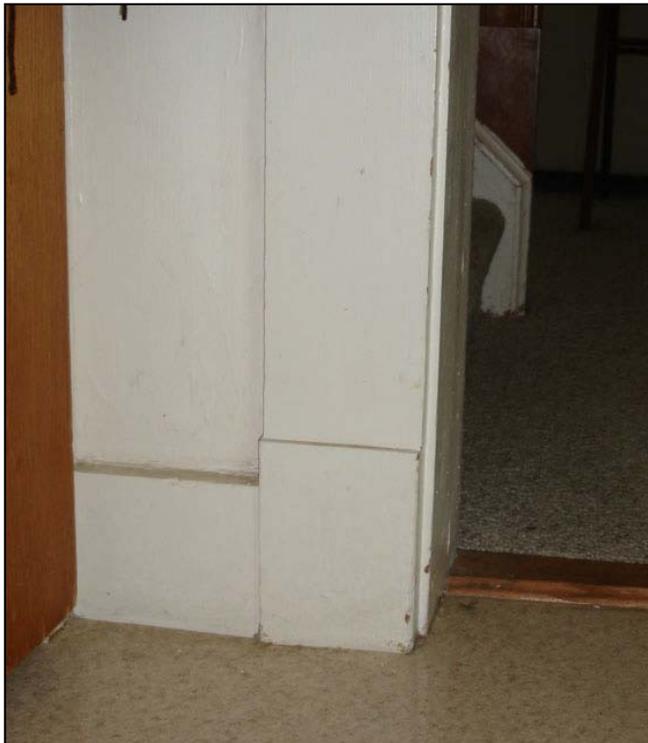
Figure 54. Gray Cottage, Room 101, D105 historic trim with plinth block at base, 2009.

This small room contains three doorways. D105, leading to the living room, has a $\frac{3}{4}$ -inch-wide flat casing with a rectangular plinth block at the base (fig. 54). The north side casing is only 2 inches wide and abuts the north wall of the room. Currently D105 has no door. The extant elements of D105 indicated that it was one of the historic doorways.

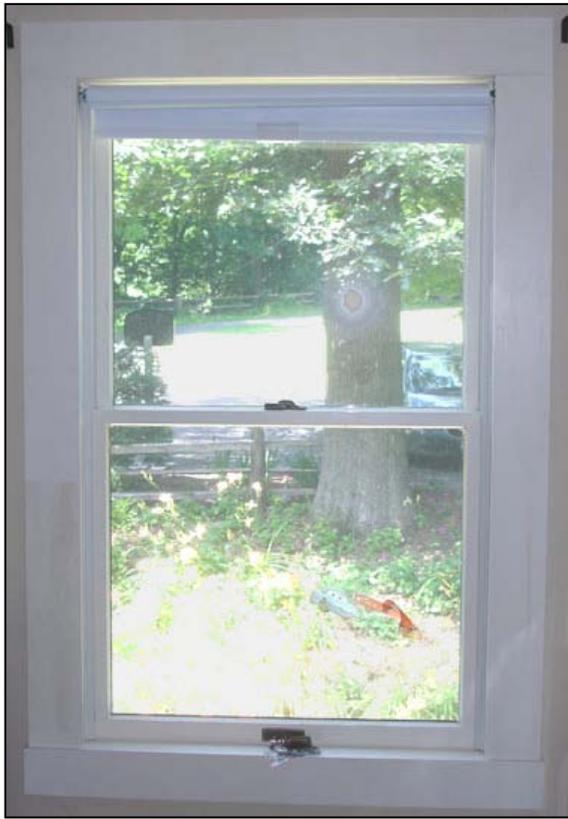
Figure 55. Gray Cottage, Room 205, W211 depicting typical interior elements and replacement sashes, 2009.

Room 102 has a window opening on the north elevation (W101) and the east elevation (W102). The windows are trimmed with flat 4¾-inch-wide boards that surround the entire opening including the windowsills, which only project slightly beyond the plane of the other casings. As previously described, the window openings have one-over-one replacement sashes. The interior of the sashes are wooden with grommets for snap-in muntins. The interior elements of these two windows are typical of the window openings at Gray Cottage (fig. 55).

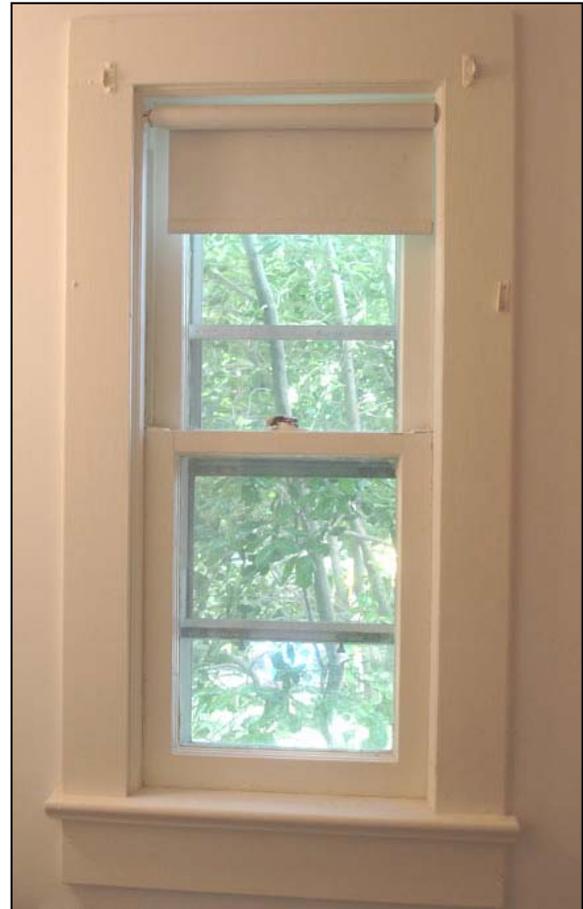
Figure 56. Gray Cottage, Room 106, W108 depicting elements typical of bathroom window openings, 2009.

The half-bathroom has a narrow window opening (W108, fig. 56) with double-hung, one-over-one wooden sashes. The stiles and rails of both sashes have an elongated quarter-round bead-and-fillet profile. The sashes are secured with a spring sash lock that is mounted on the top rail of the lower sash and hooks onto a catch on the bottom rail of the upper sash. Window W108 has molded window stops and 3½-inch-wide casings and head. It has a 3-inch molded windowsill with a 3½-inch-wide apron below that.

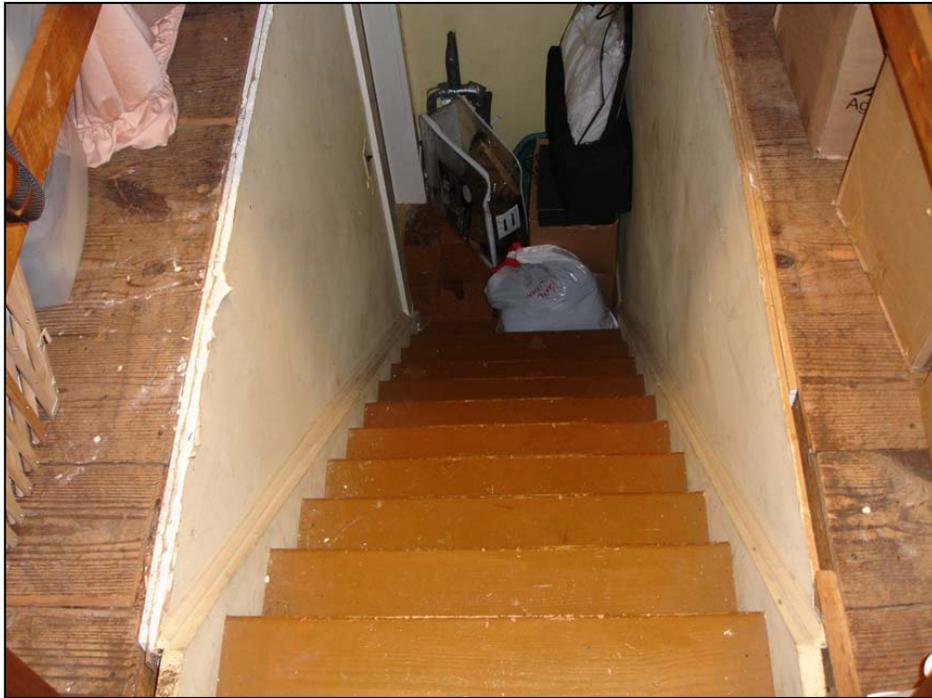
Figure 57. Gray Cottage, attic staircase added in 1964, 2009.

The attic is unfinished except for the staircase walls and trim, which are painted yellow, and the treads, which are painted brown. There were remnants of kraft paper on the gable ends that was apparently used in the original construction. There is some evidence of yellow paint in the sash-unit jambs and sills, but the interiors of the sashes are not painted.

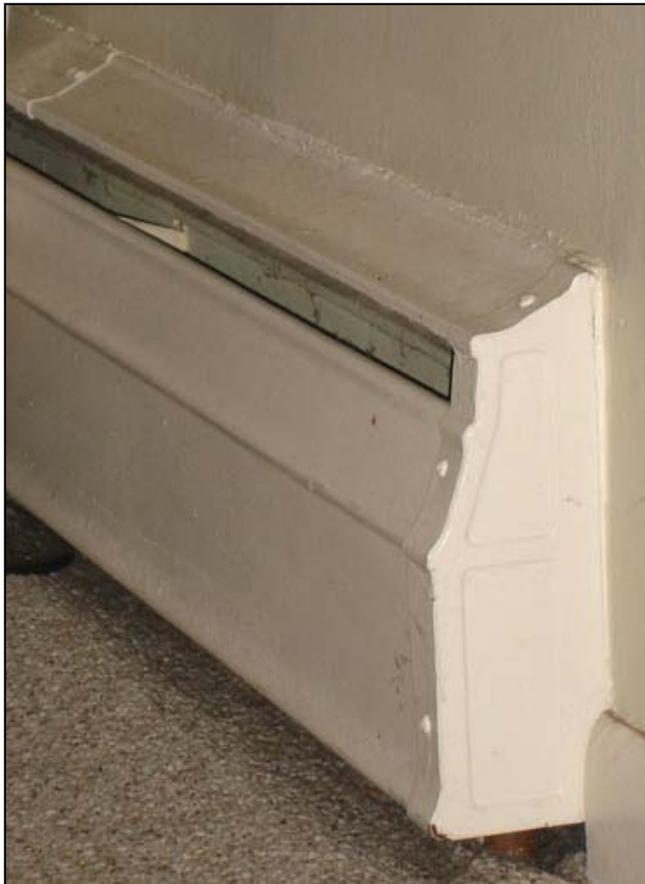
Figure 58 . Gray Cottage, baseboard radiator added by the TRA in 1956, 2009.

The baseboard radiator installed in Room 102 is typical of the older-style baseboard units in the building that were previously described (fig. 58, see previous section "Alterations"). The baseboard radiators with the decorative metal panels are installed on the north and east walls of Room 102, and are typically installed along the outside walls. This type of baseboard was observed throughout the main block of Gray Cottage and was evidently installed when the TRA renovated the building in the 1950s.

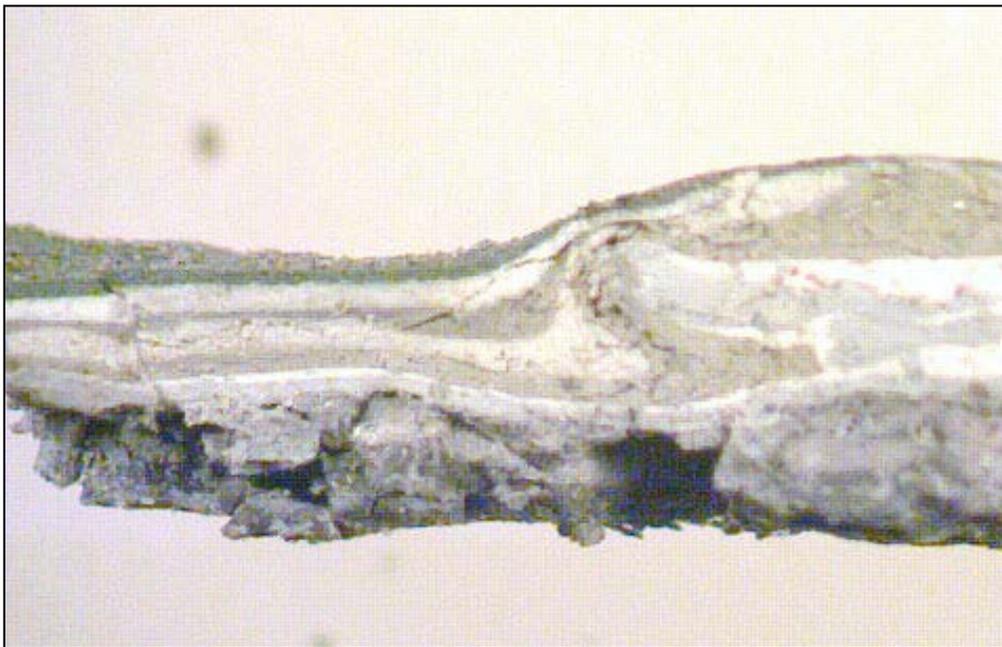
N5 (gray)

Figure 59. Gray Cottage, paint sample from horizontal drop siding (P016).

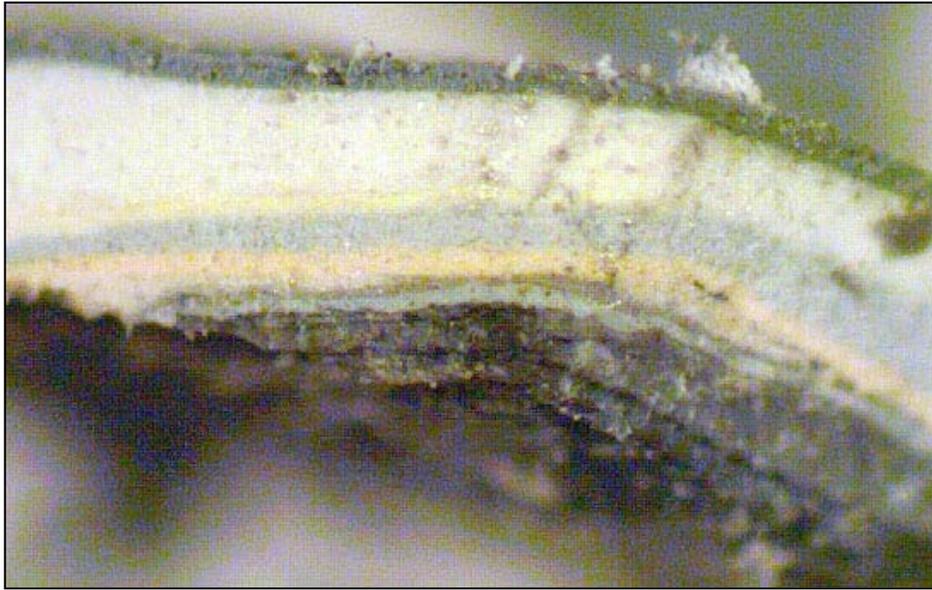
Figure 61. Gray Cottage, fascia below cornice (P026).

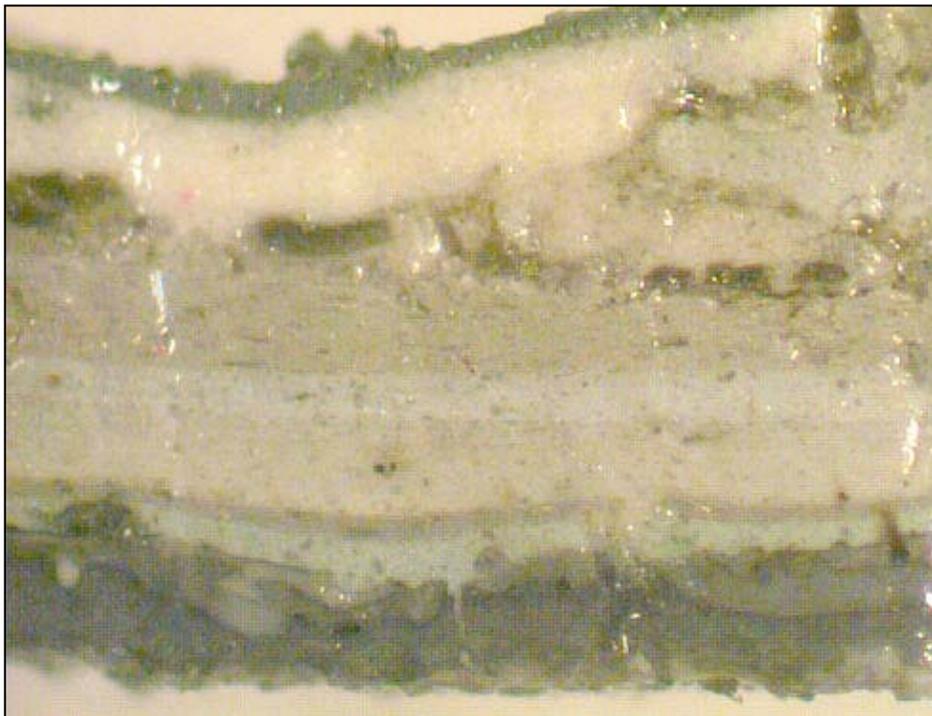
Figure 62. Gray Cottage, northeast corner board (P028).

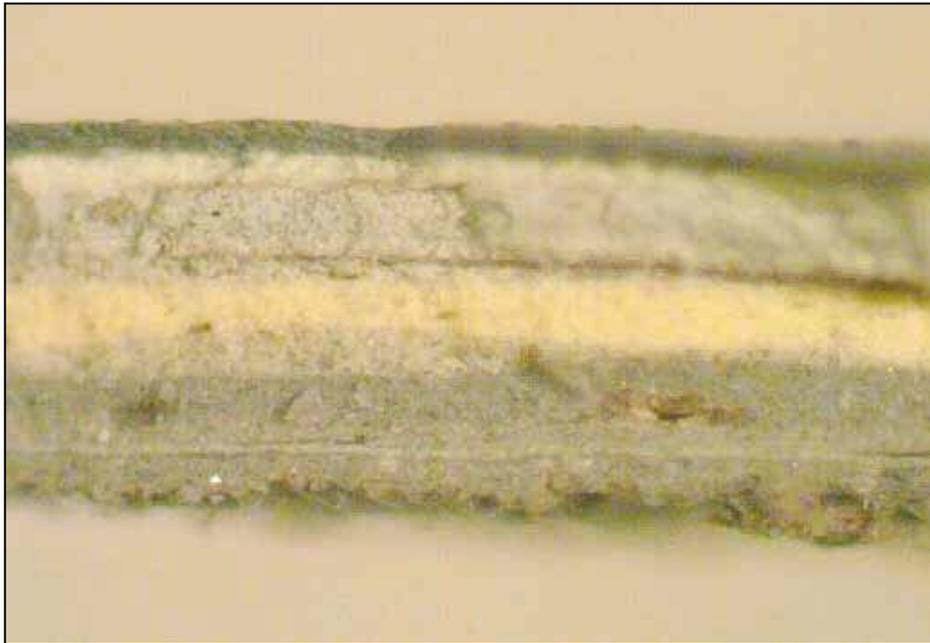
Figure 63. Gray Cottage, front porch, north-elevation siding (P023).

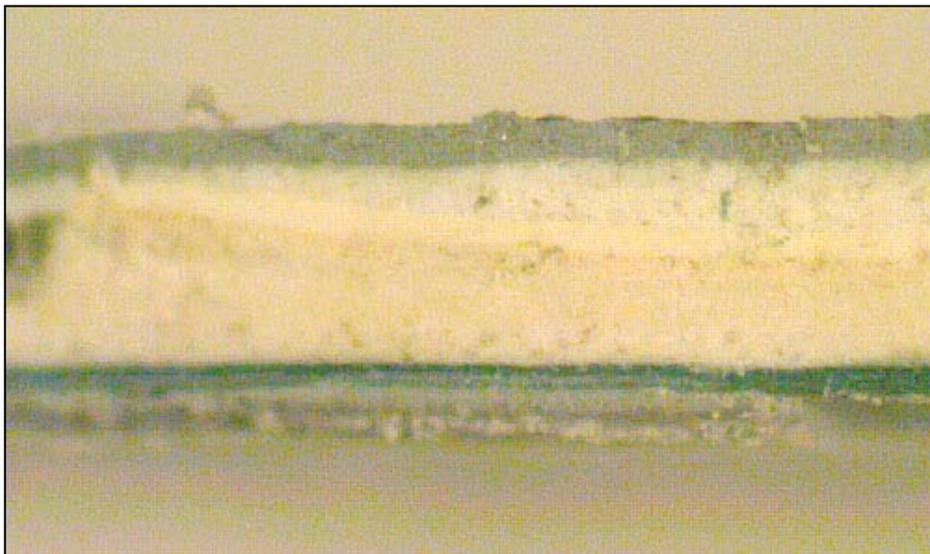
Figure 64. Gray Cottage, front porch, east- elevation window trim (P025).
