ARCHAEOLOGICAL EXCAVATION AT
EL MORRO, SAN JUAN, PUERTO RICO

by
HALE G. SMITH

Work Done Under National Park Service
Contract Number 14-10-0131-745, 1961

NOTES IN ANTHROPOLOGY
Volume 6, 1962

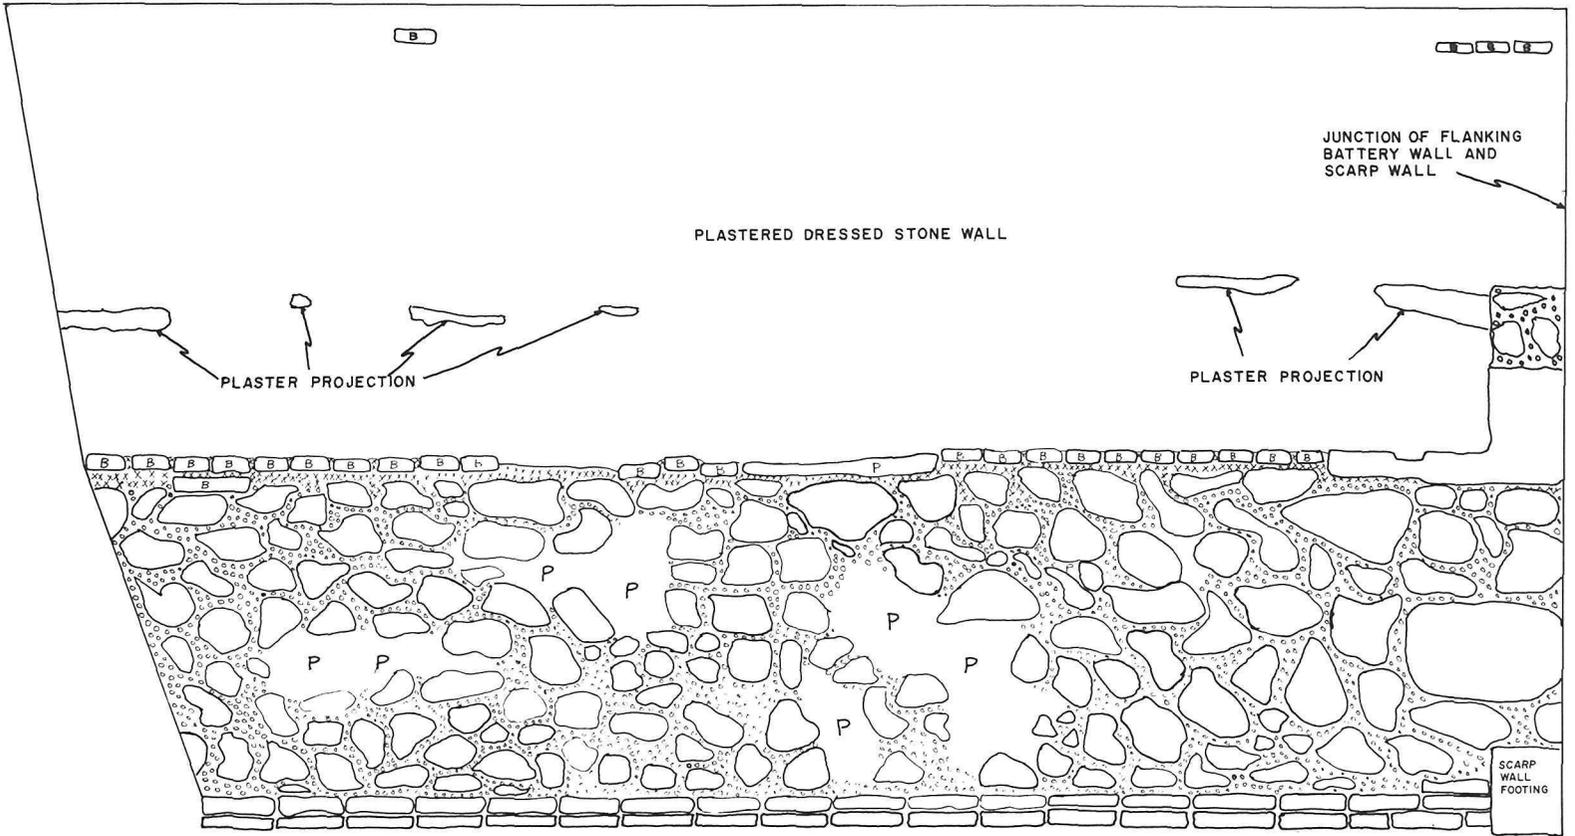
0.00 1.00 Figure 10

FLANKING BATTERY WALL OF THE AUSTRIA BASTION

The excavation along the flanking battery wall carried down to 10.60 feet, or to a relative elevation of 89.40 feet (Fig. 10, Pl. 3). The original ground level had been smoothed and a prepared "floor" was present. This "floor" was made of mortar, sandstone chips and clay. The "floor" was four-tenths

The rough stone mamposteria wall was 4.90 feet high and had a batter of two-tenths of a foot in four feet. This wall was originally plastered with a very poor grade of plaster. The plaster, at time of excavation, was very soft and only occurred in small areas having been worn off or having fallen off most of the wall. This wall was capped with brick set in a very hard mortar. The bricks were laid with their longest diameter at right angles to the wall. The mamposteria wall was outset from eight-tenths of a foot to nine-tenths of a foot from the dressed-stone wall with batter and extended under it for an unknown distance (Fig. 10, Pls. 3, 4).

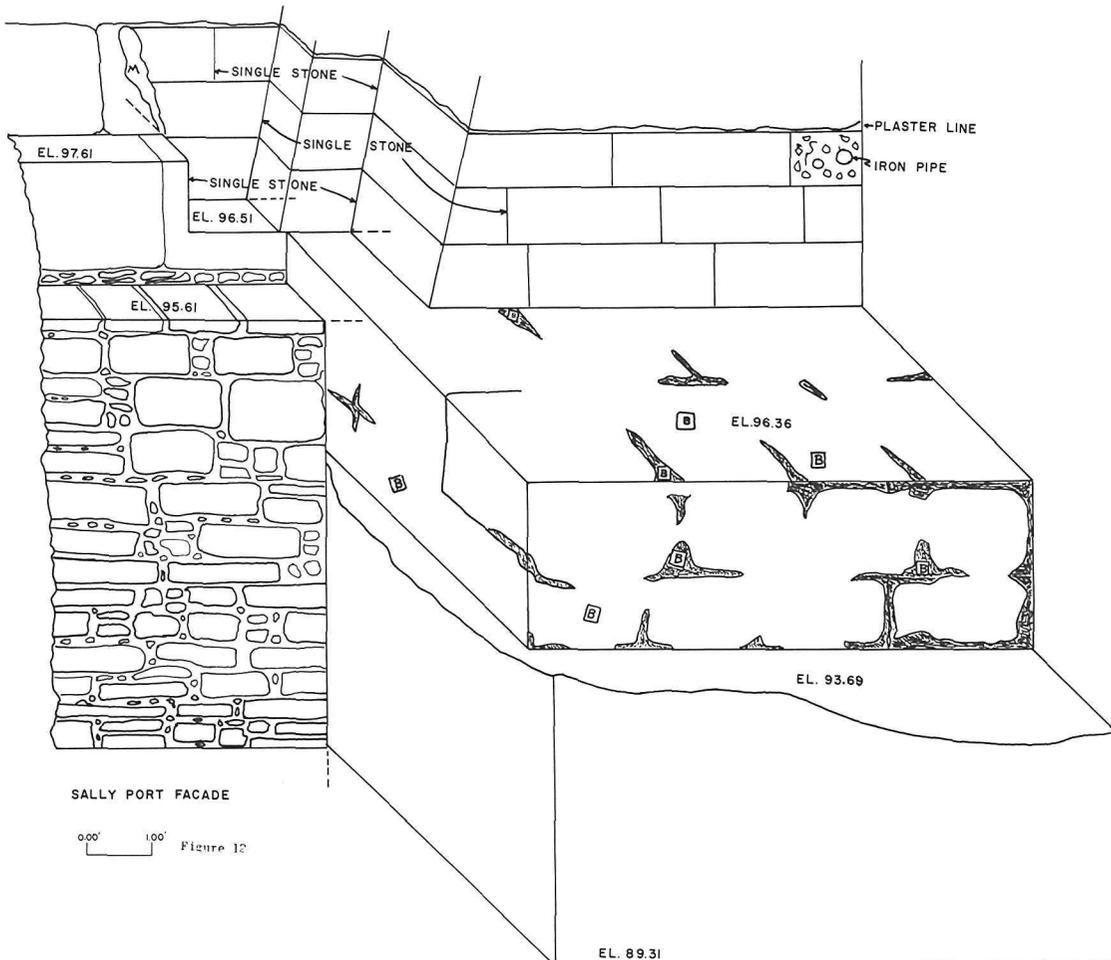
0.00 100' Figure 12

SALLY PORT FACADE

surface. The ledge formed by this step varied in width from four-tenths of a foot to one and eighty-five-hundredths of a foot. The step became wider as it approached the moat bridge pier to which it was joined (Fig. 12).

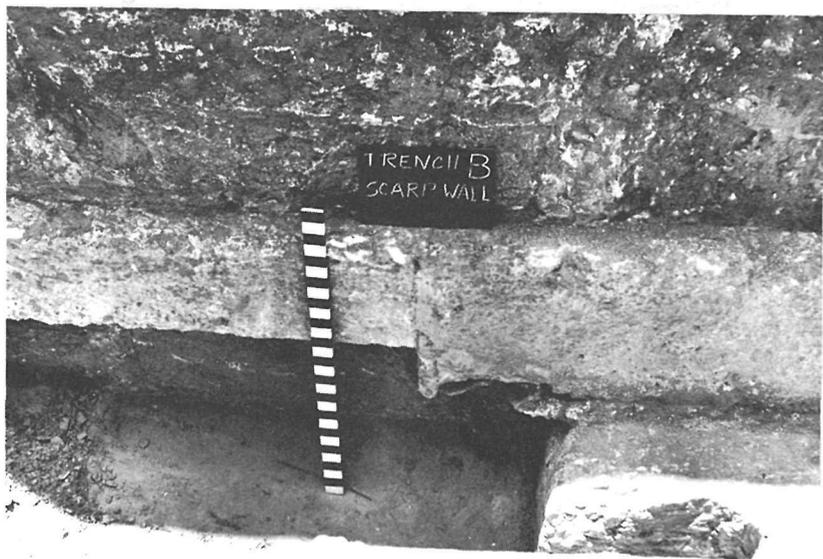
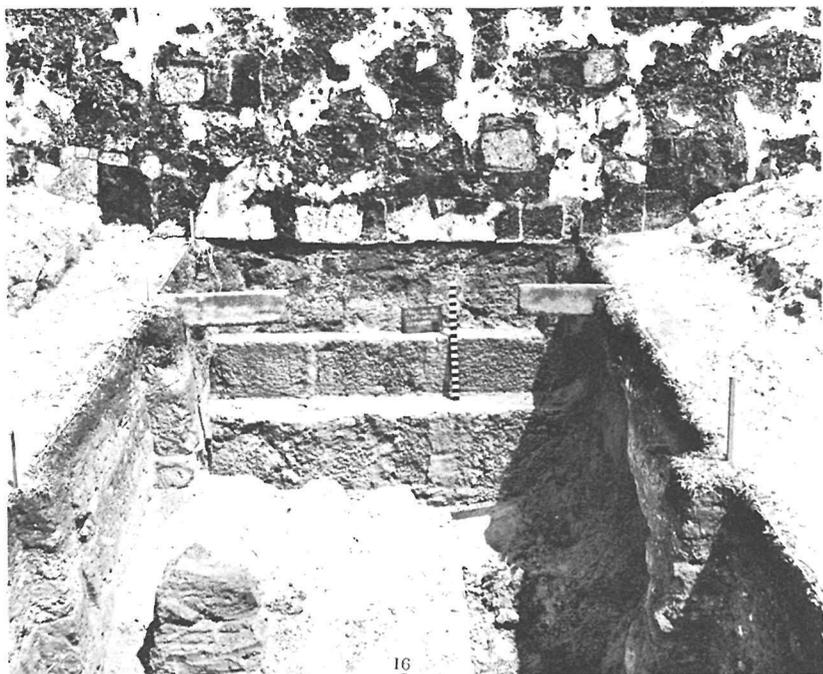
1. ABOVE: MOAT, TRENCH B, SCARP WALL SHOWING JUNCTION OF BELTING AND DRESSED STONE FOOTING.
 2. BELOW: MOAT, TRENCH A, SCARP WALL AND DRESSED STONE FOOTING. MARKED SCALE IS SET ON MAMPOSTERIA WALL.

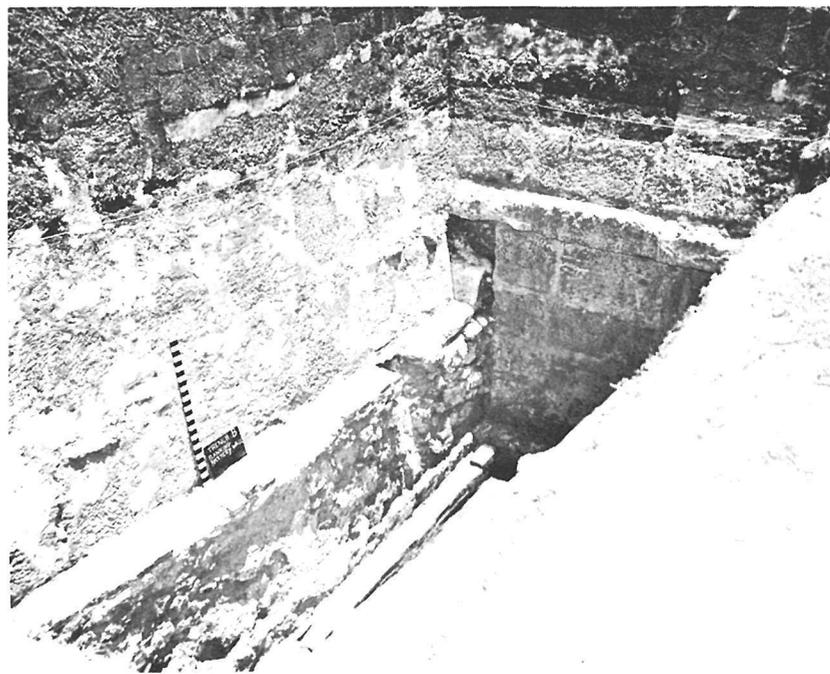
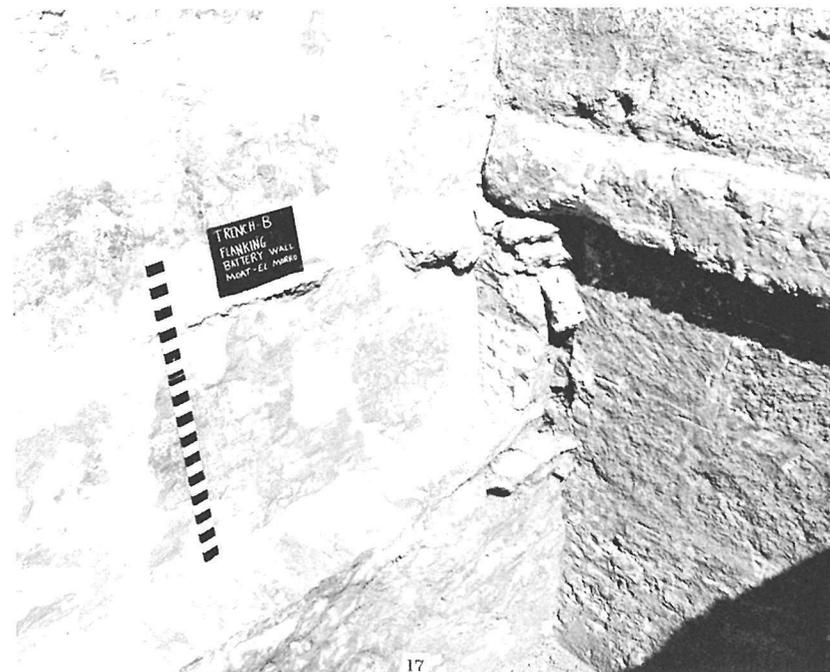
3. ABOVE: MOAT, TRENCH B, CORNER OF FLANKING BATTERY WALL AND SCARP WALL.
 4. BELOW: MOAT, TRENCH B, CORNER FLANKING BATTERY WALL AND SCARP WALL.

The vertical wall butted against the dressed stone mamposteria (Pl. 4). The belting butted against the dressed stone footing above the mamposteria. The dressed stone that the belting butted into was four feet long and under this stone the mamposteria had been cut back (northward) one and three-hundredths of a foot in order to receive the vertical stone wall (Fig. 9).

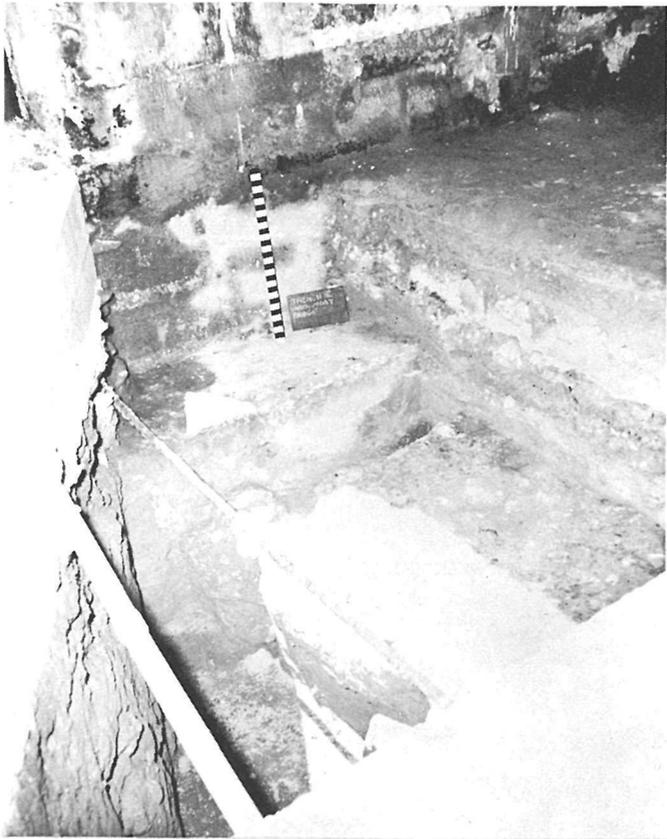
5. MOAT, TRENCH E, SCALE IS STANDING ON MOAT BRIDGE FOOTING. TRIANGULAR AREA IN FOREGROUND IS A SIDEWALK. THE AREA BETWEEN THESE FEATURES IS REMAINS OF EARLIER MOAT CAUSEWAY OR FORMER BRIDGE PIER FOOTING.

Trench E: This trench was located under the moat bridge in the archway adjacent to the drawbridge span. At an elevation of 96.49 feet the top of the footing for the drawbridge pier was encountered. The elevation of the top of the sally port footing and the top of the drawbridge pier footing only varied twenty-three hundredths of a foot (Fig. 14, Pl. 5).

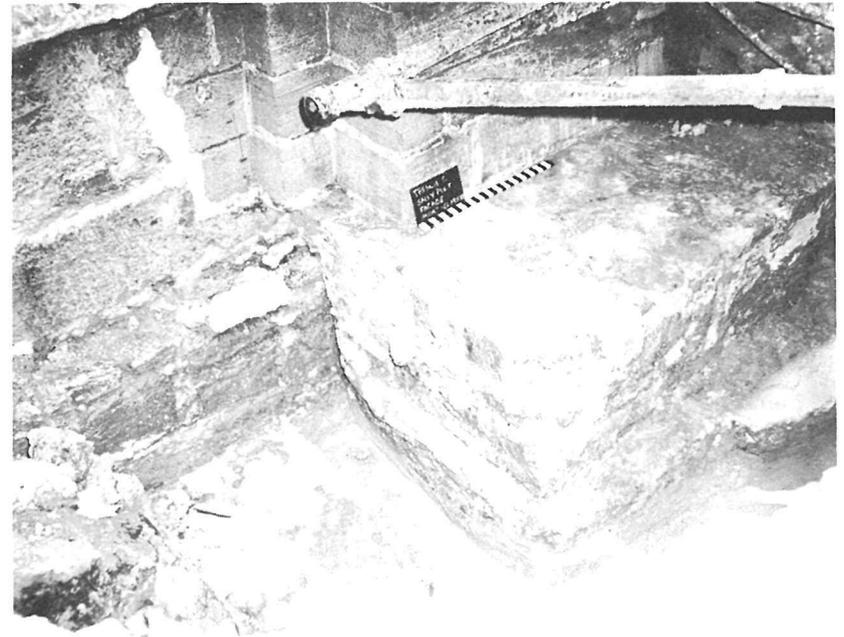
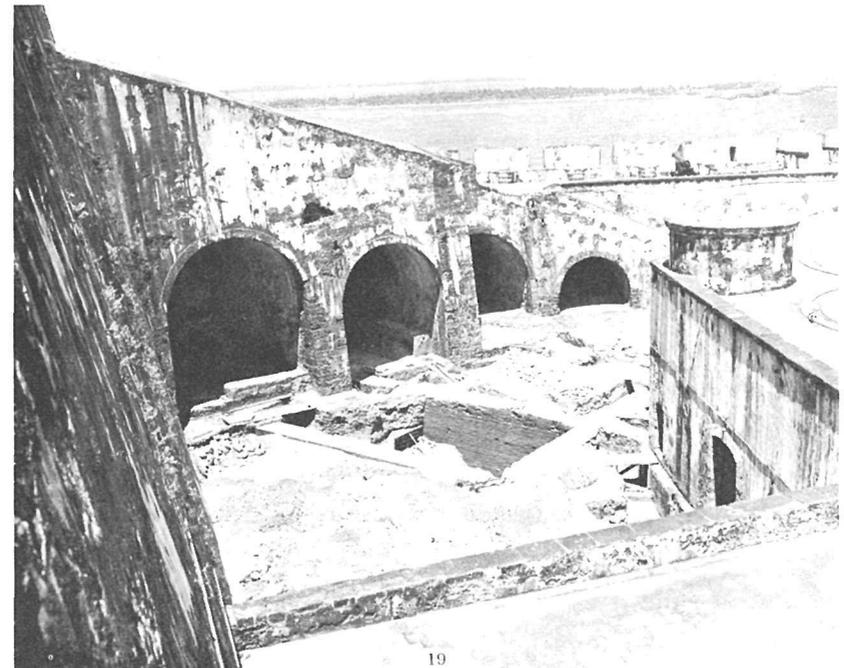
6. ABOVE: MOAT, TRENCH C, SALLY PORT FOOTING AND TO LEFT THE DRESSED STONE SCARP WALL FOOTING THAT HAS CUT AWAY TO RECEIVE THE SALLY PORT FACADE KEYING STONES.
7. BELOW: KITCHEN AREA, SHOWING VAULTS UNDEE RAMP. VAULTS FROM LEFT TO RIGHT: LATRINE, KITCHEN, VAULT 3 AND VAULT 4.

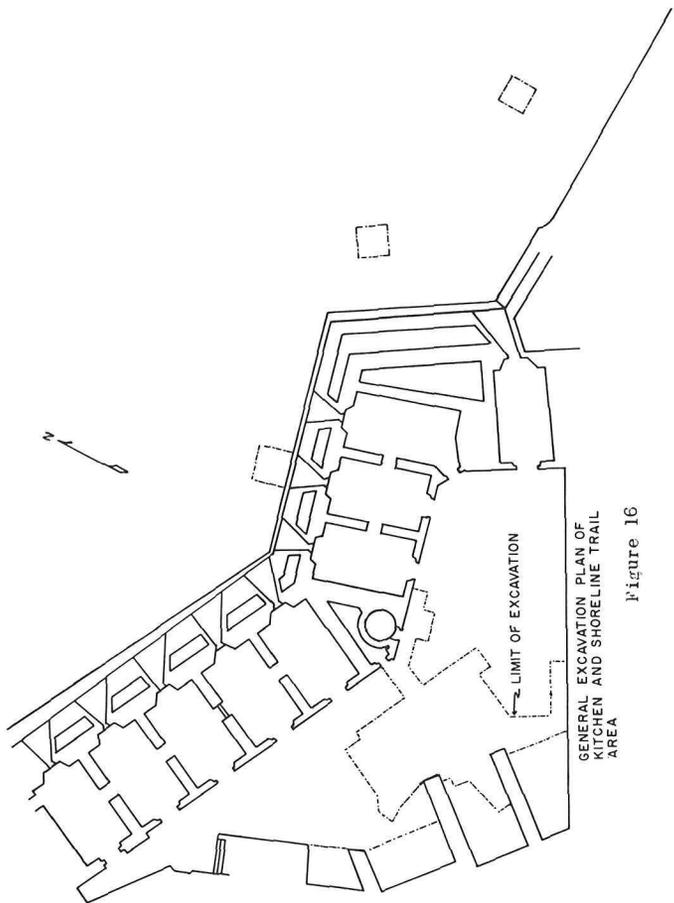
Figure 16
GENERAL EXCAVATION PLAN OF
KITCHEN AND SHORELINE TRAIL
AREA

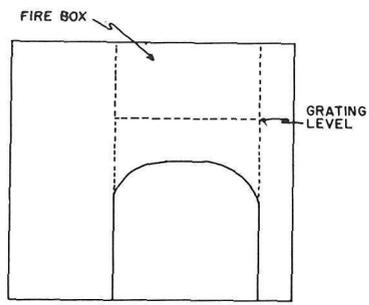
FRONT ELEVATION OF FORGE Figure 20
VAULT 3

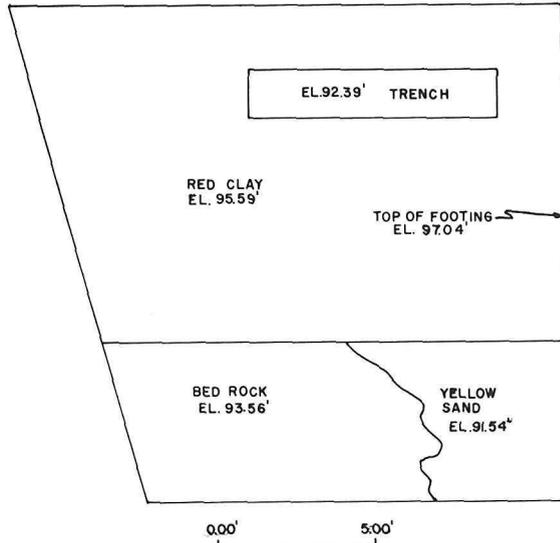
FLOOR PLAN VAULT 4 Figure 21

Vault 4: The only feature that was found in Vault 4 was a trench seven feet by two, and three and two-tenths deep. This trench was located two feet from the back wall and two feet from the north wall of the vault (Pl. 18, Fig. 21).

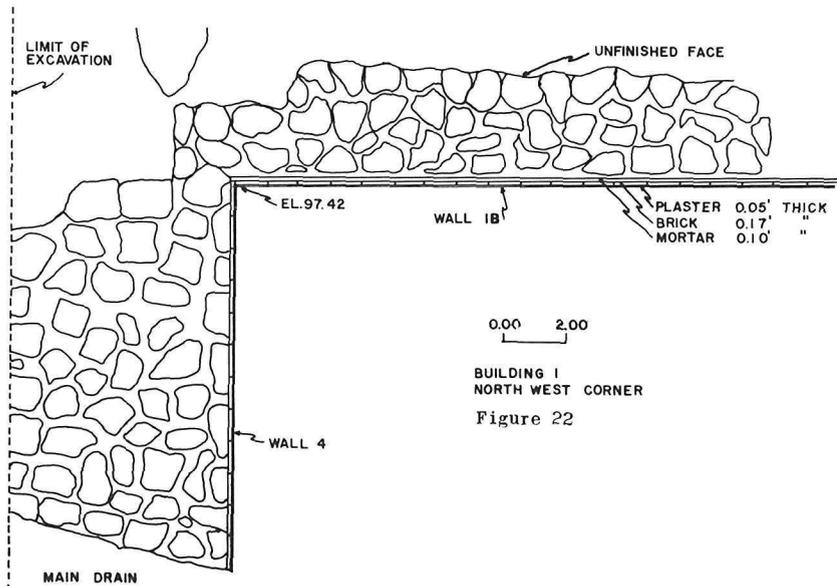
BUILDING 1
NORTH WEST CORNER
Figure 22

structure. The inside east-west dimension was 43.80 feet and the north-south dimension was 39.40 feet. The east-west outside dimension is unknown due to the fact that wall 4 extended beyond the limits of the excavation (Pl. 13, Fig. 22). When excavation was discontinued wall 4 was seven feet wide. The north-south outside dimension of building 1 was 51 feet. The top of the walls of building 1 were from ninety-one-hundredths of a foot to two and two-tenths of a foot below datum.

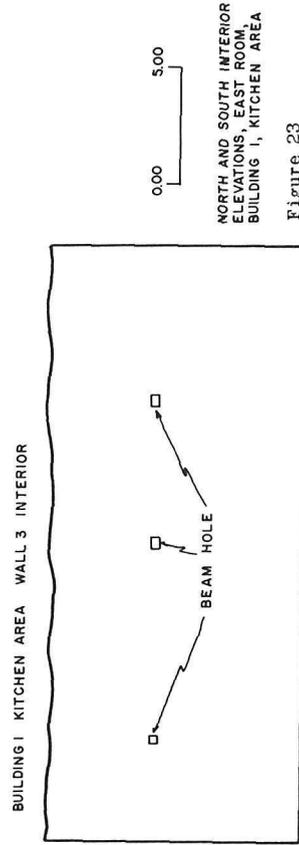
NORTH AND SOUTH INTERIOR
ELEVATIONS, EAST ROOM
BUILDING 1, KITCHEN AREA
Figure 23

The rectilinear openings had been filled with gray clay. It was assumed that these openings were placed here originally in order that wooden racks of one type or another could have been constructed. Either after construction or later it was decided to do away with this feature so the holes were plugged (Pl. 16, Figs. 23, 24).

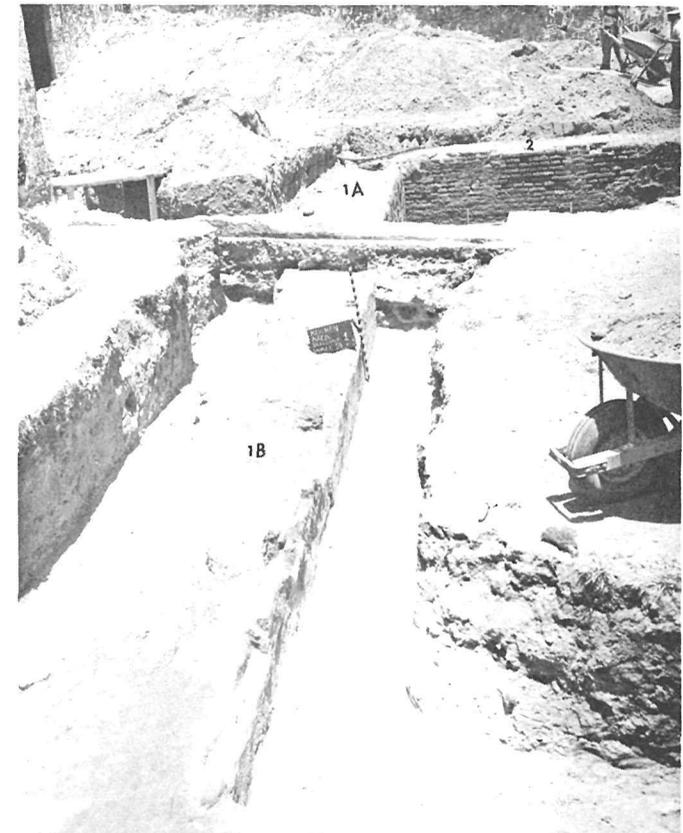
14. KITCHEN AREA, BUILDING 1, WALL 1B. INTERIOR FACED WITH BRICK.

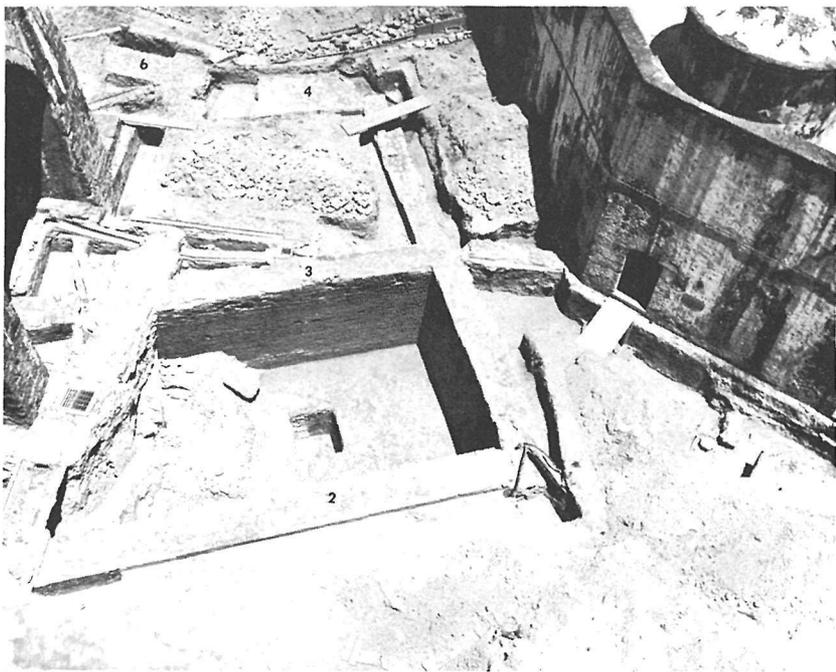
17. ABOVE: KITCHEN AREA, BUILDING 1;
16. BELOW: KITCHEN AREA, BUILDING 1, WALL 2.

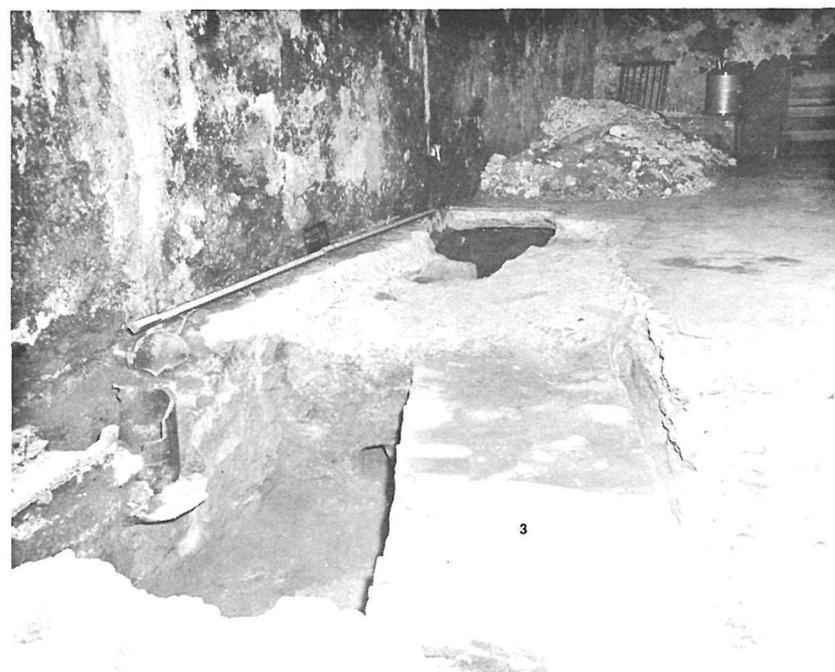
18. ABOVE: KITCHEN, WALL 3;
18. BELOW: KITCHEN AREA, WALL 4.

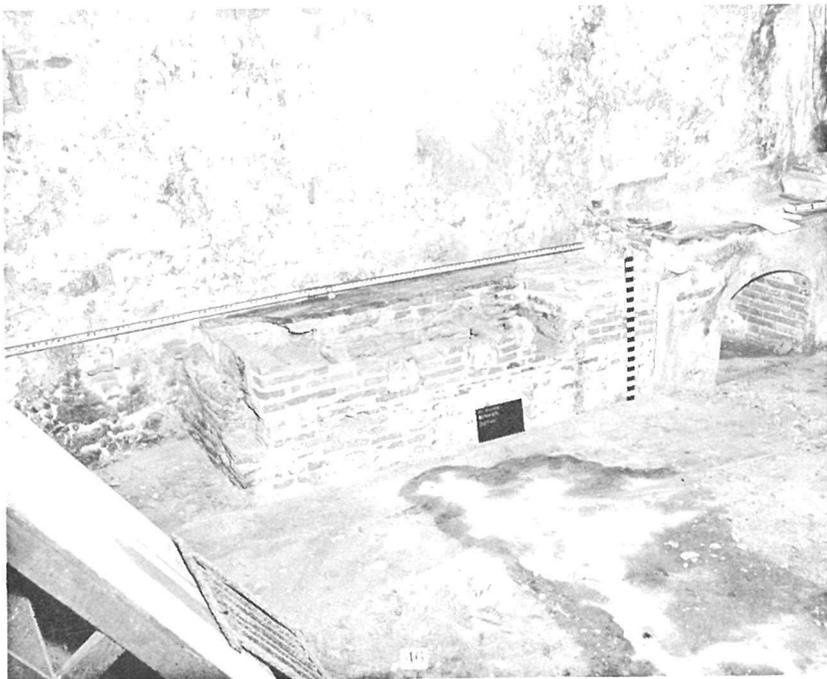
19. ABOVE: KITCHEN AREA, VAULT 3 SHOWING DOOR.
 20. BELOW: KITCHEN STOVE.

The cement was removed revealing a structure made of brick. The firebox area was plastered. Iron straps were placed at irregular intervals six-tenths of a foot above the firebox base. These straps were not of uniform width and varied from fifteen-hundredths of a foot to twenty-five-hundredths of a foot in width (Pl. 20, Fig. 31).

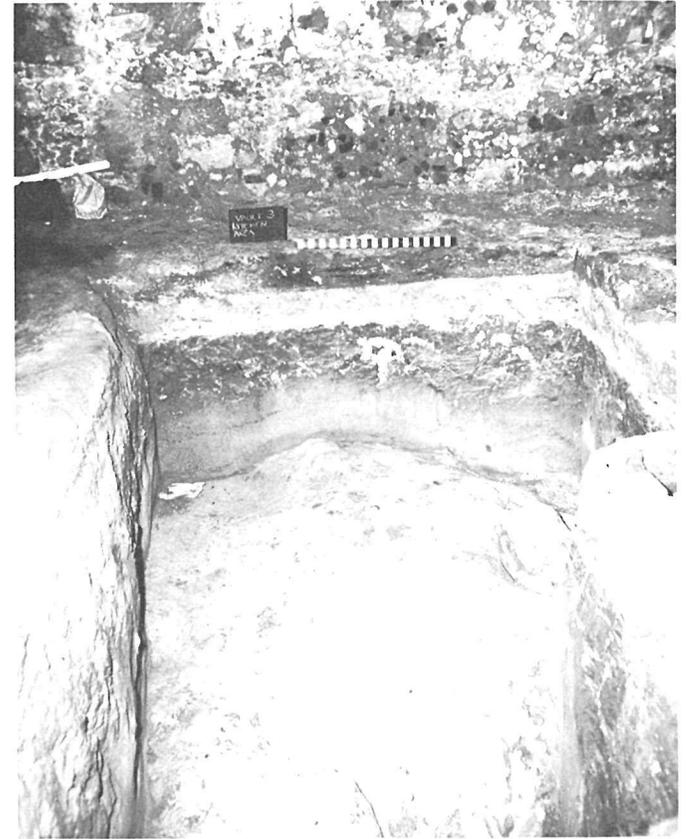
21. KITCHEN AREA, VAULT 3 SHOWING BUDDOCK.

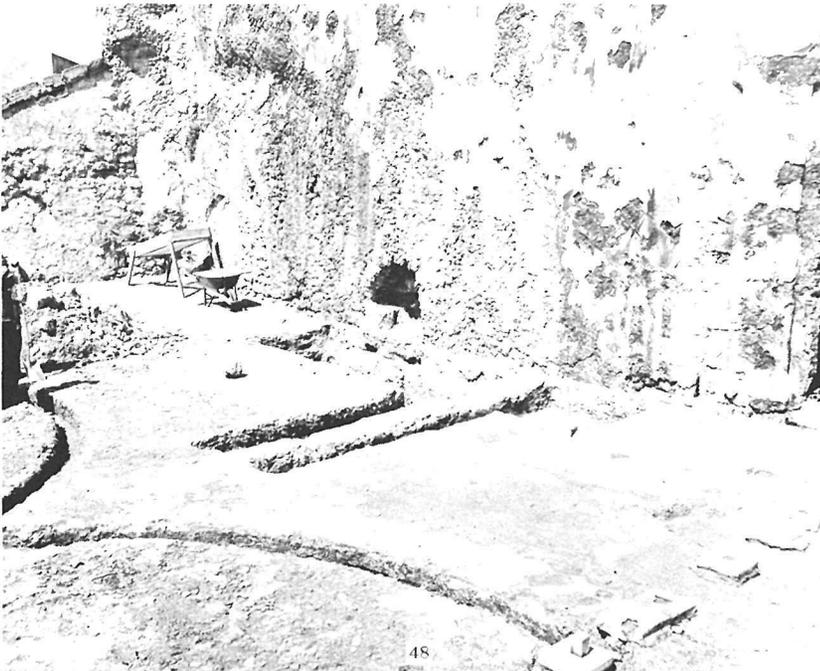
22. ABOVE: KITCHEN AREA, CASEMATE FOOTING.
23. BELOW: WATER BATTERY, GENERAL VIEW LOOKING NORTHEAST.

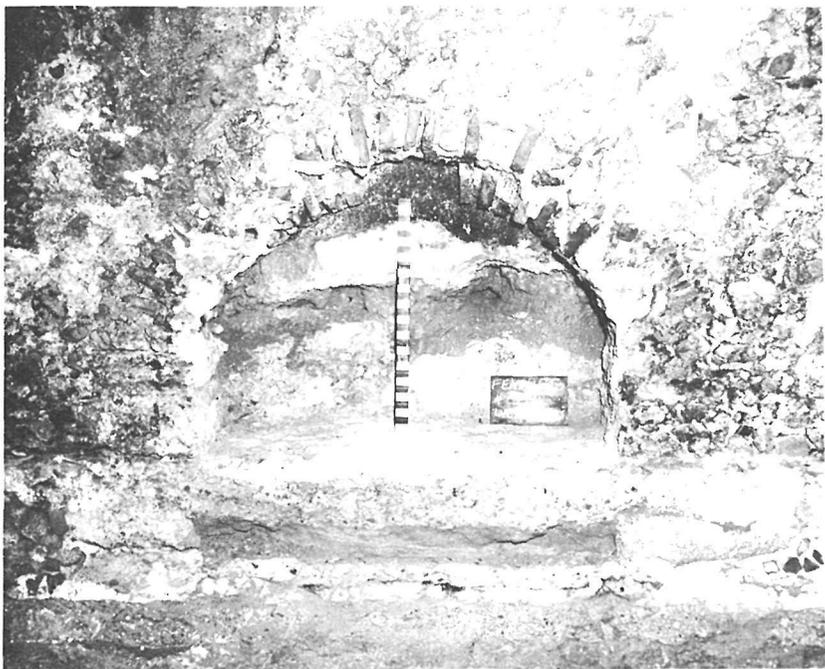
59. ABOVE: WATER BATTERY NICHE AFTER PARTIALLY CLEANED BUT BEFORE REMOVAL OF FLOOR 1.
 26. BELOW: WATER BATTERY, HOT SHOT OVEN.

The wall niche, Feature 3, (Pl. 25) was located in the east wall of the Water Battery twenty-three feet south of the northeastern corner of the Water Battery. The existing evidence at time of excavation, that indicated a niche was present, included a brick arch and an opening one foot by two feet. At one time the niche had been completely sealed with masonry composed of brick fragments and rough and dressed stones of various sizes. The mortar to seal the niche was of the same consistency as that used for floor A. It was noted that the top of the arch was smoke blackened.

Floor A, in the niche, was removed and remains of an iron plate were found on top of floor B1. The function of the niche is unknown.

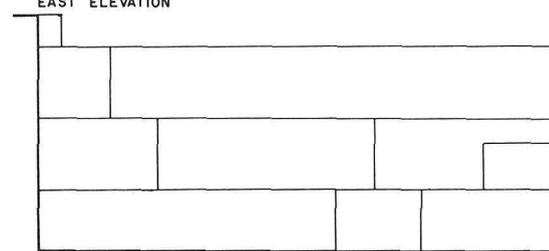
Figure 29

WATER BATTERY PARAPET SECTION

NORTH PROFILE

Parapet Wall: The parapet wall at the time of excavation was faced with cement one-tenth of a foot thick. The thickness of this cement covering varied from place to place by five-hundredths of a foot. It was decided that an examination of a cross section of this wall might give information that would be of value for interpreting the development of the Water Battery. An eleven foot section, twenty-three feet from the southwest corner of the Water Battery was opened (Fig. 29).

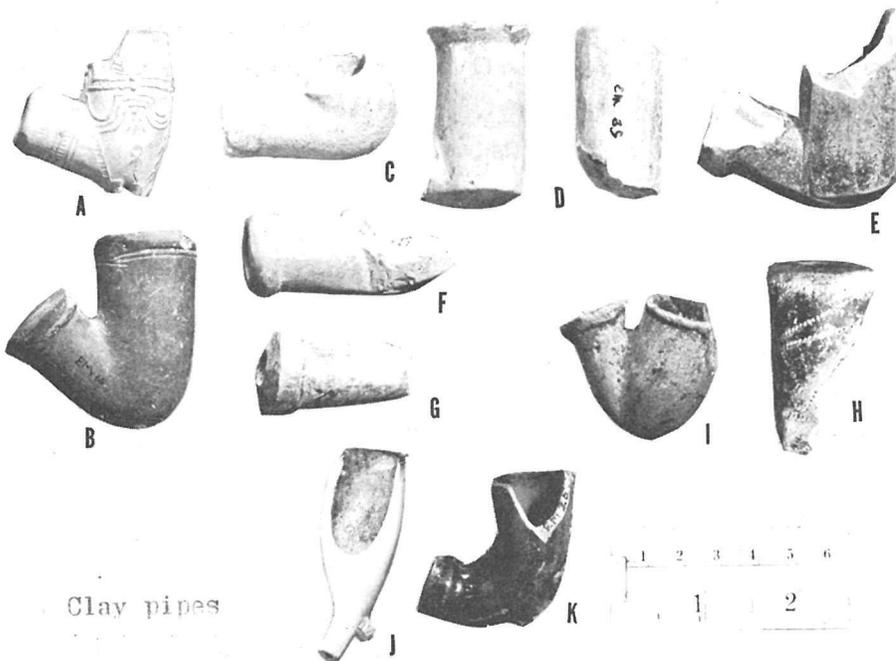
Plate 29

Clay pipes

Pipes: There were very few kaolin pipe bowls and stems found. In the moat area seven stem fragments and one green glazed kaolin pipe bowl were found (Pl. 29, K). A nineteenth century kaolin pipe occurred that has a bas-relief geometric design covering the bowl (Pl. 29, A). This pipe was buff in color.

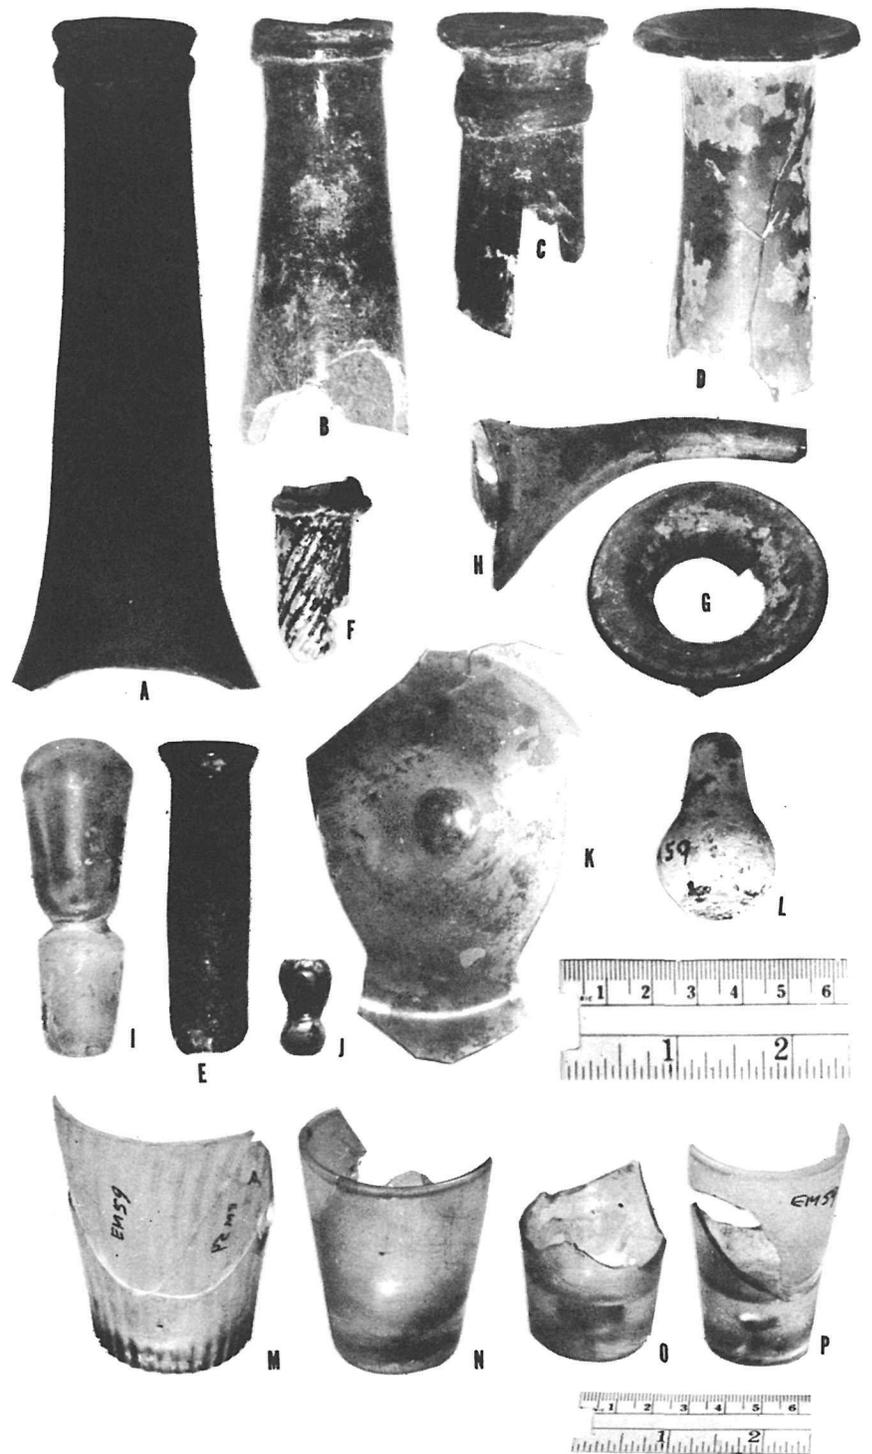
Plate 30

Glass: A-F: Bottle necks, G: Bottle lip, H: Piston, I, J: Bottle stoppers, K: Bottle kickup, L: "Tear glass", M-P: Tumblers.

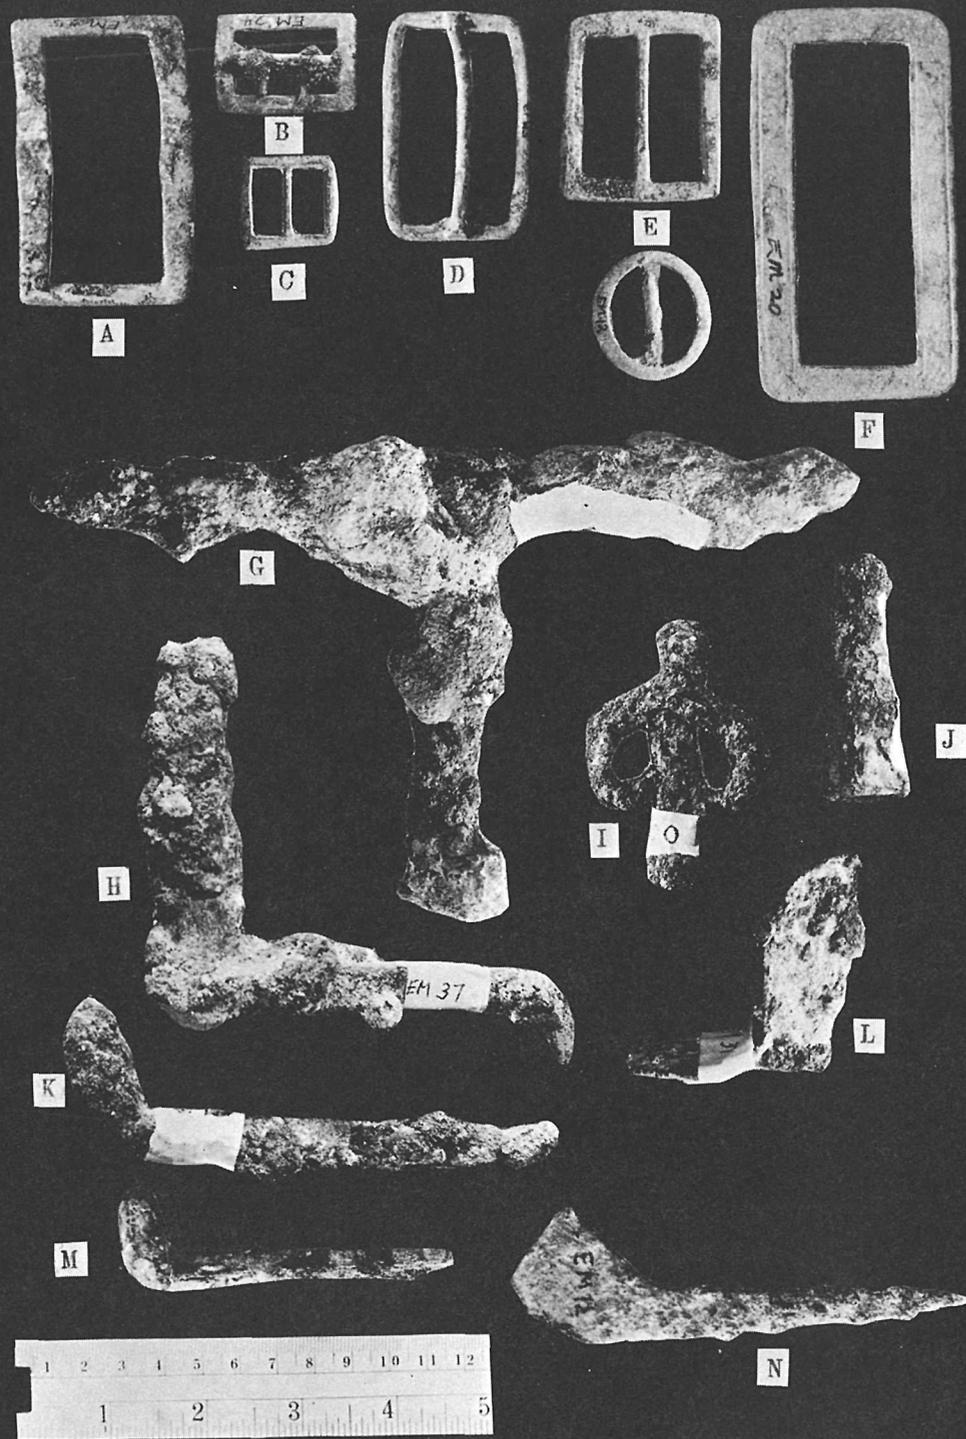
Plate 31

Brass: A-F: Brass buckles, Iron: G. Slide bolt, H: Pintel, I, K, M, N: Unknown function, J: Chape, L: Frizzen.

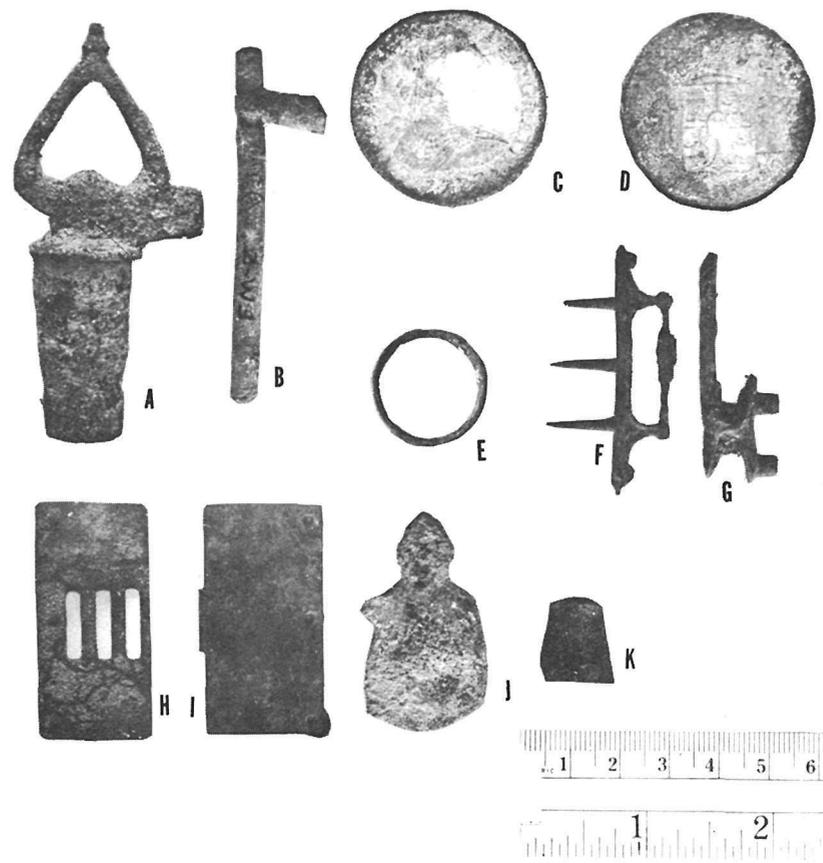
Plate 32

A: Brass spigot, B: Fuselighter, C, D: Silver pesos, E: Brass ring, F: Brass clip, G: Brass belt holder, H, I: Belt clasp, J: Brass ornamental object, K: Thimble.

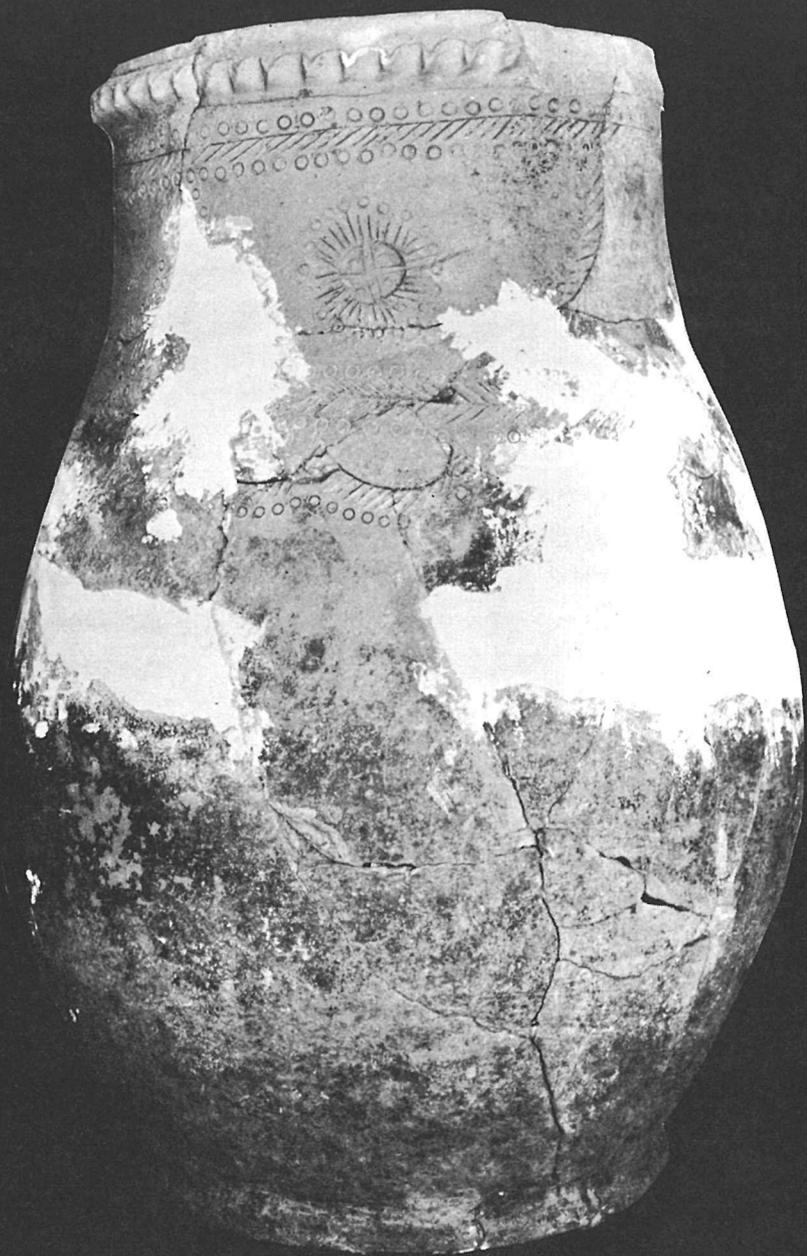
Plate 33

Ceramic vessel of unknown origin found in kitchen courtyard area. Height 22.5 inches, greatest diameter 14.5 inches.

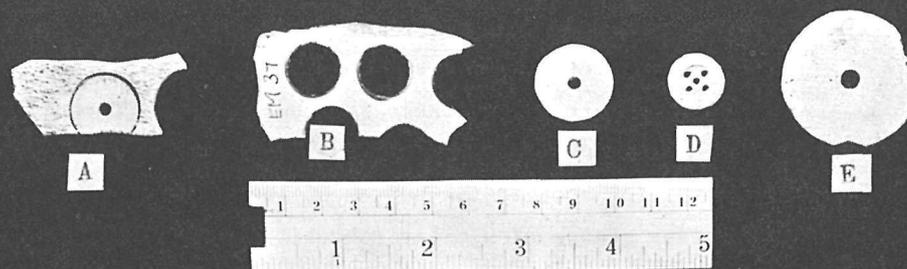
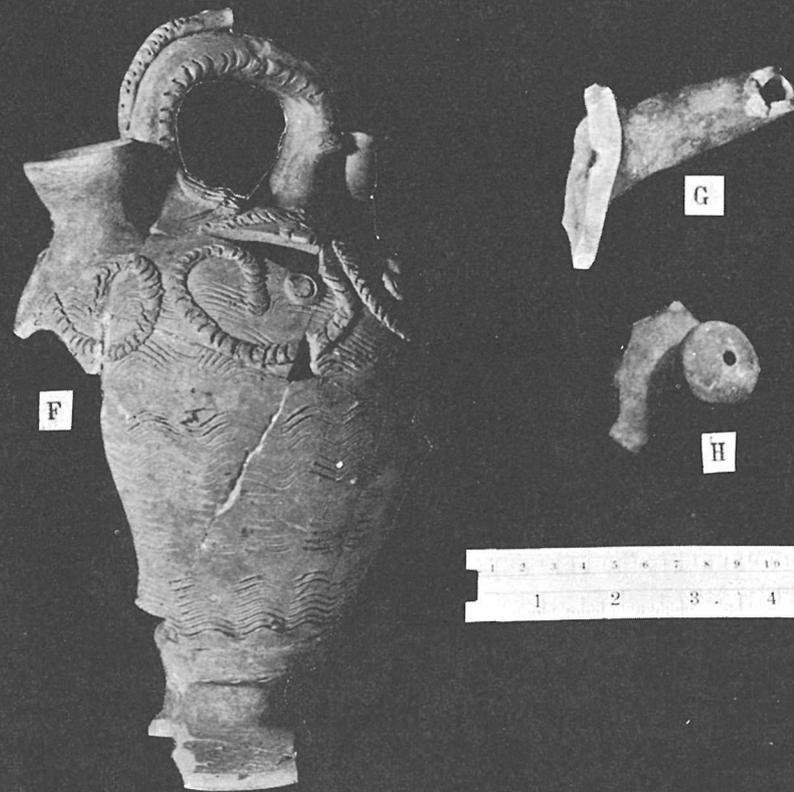
Plate 34

Bone: A,B: Button blanks, C-E: Buttons, Gray Earthenware: F: Botijo, G-H: Pistons of botijo.

Gray Earthenware: A hard, fine paste ware that is unslipped and unglazed. Most of the sherds are plain but some have incised geometric decorations and/or appliqued strips that are incised or punctated. On the interior throw marks are present. The forms found include botijo and small mouthed jars.
