**WEIR FARM
HISTORIC STRUCTURES REPORT**

**Weir Farm National Historic Site
Wilton, Connecticut**

Burlingham Complex

1995

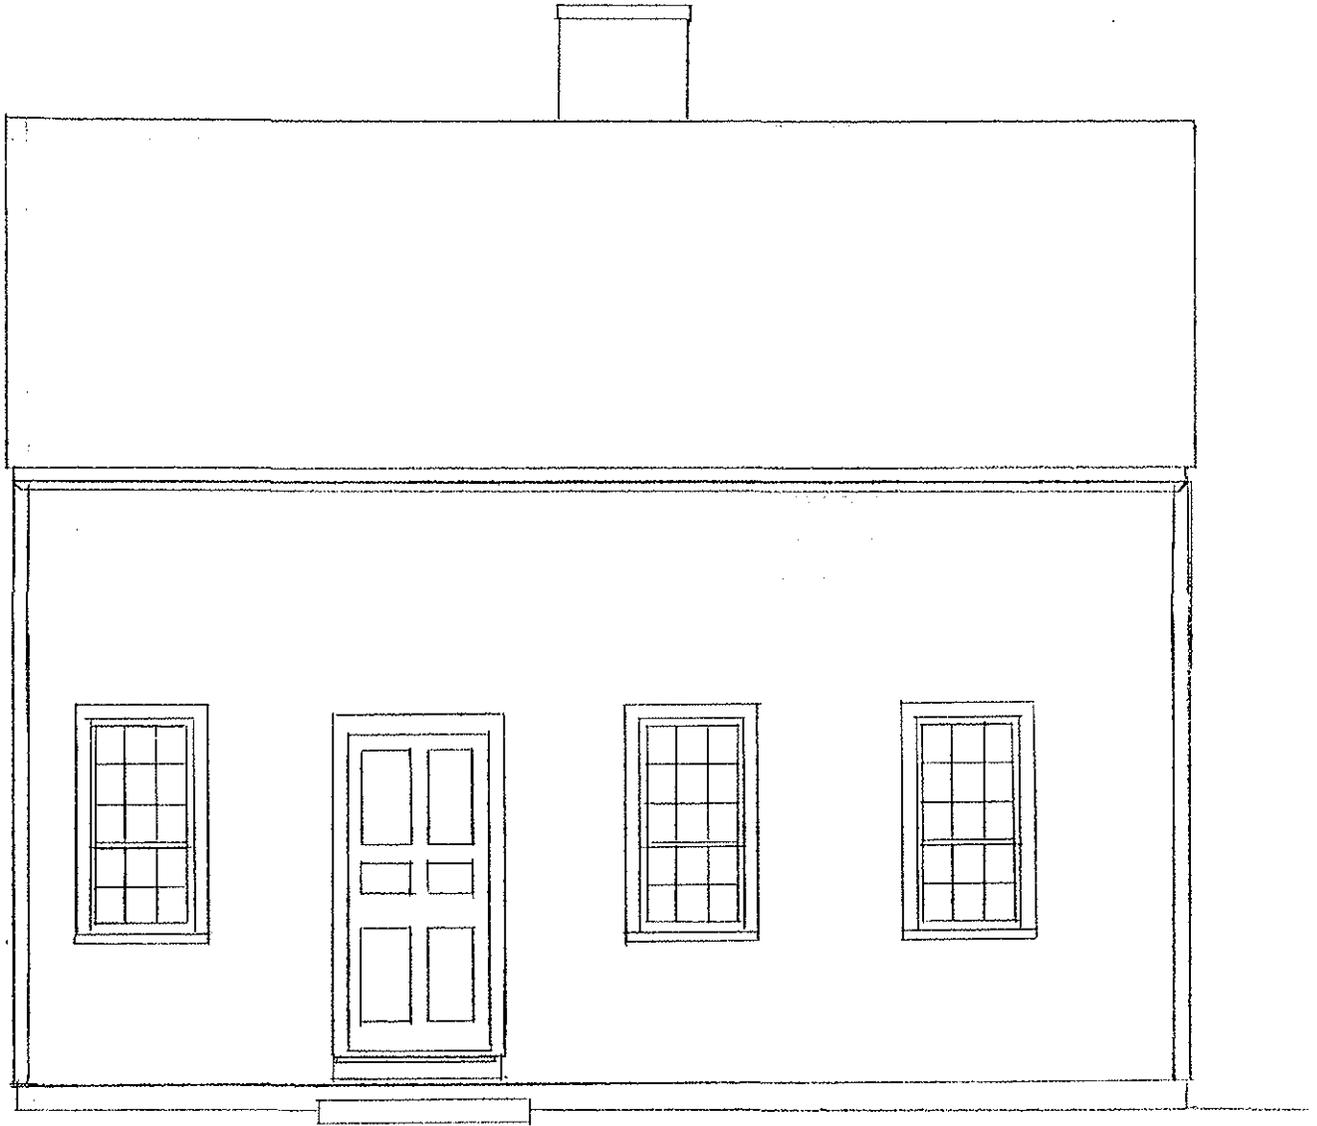
Figure 1. Webb-Burlingham House,
Conjectured Circa-1775 East Facade.

The original east facade (fig. 1) was four bays wide, not the five bays that it is today. Three sash windows were located on the first story in three of the bays, and there was probably a doorway

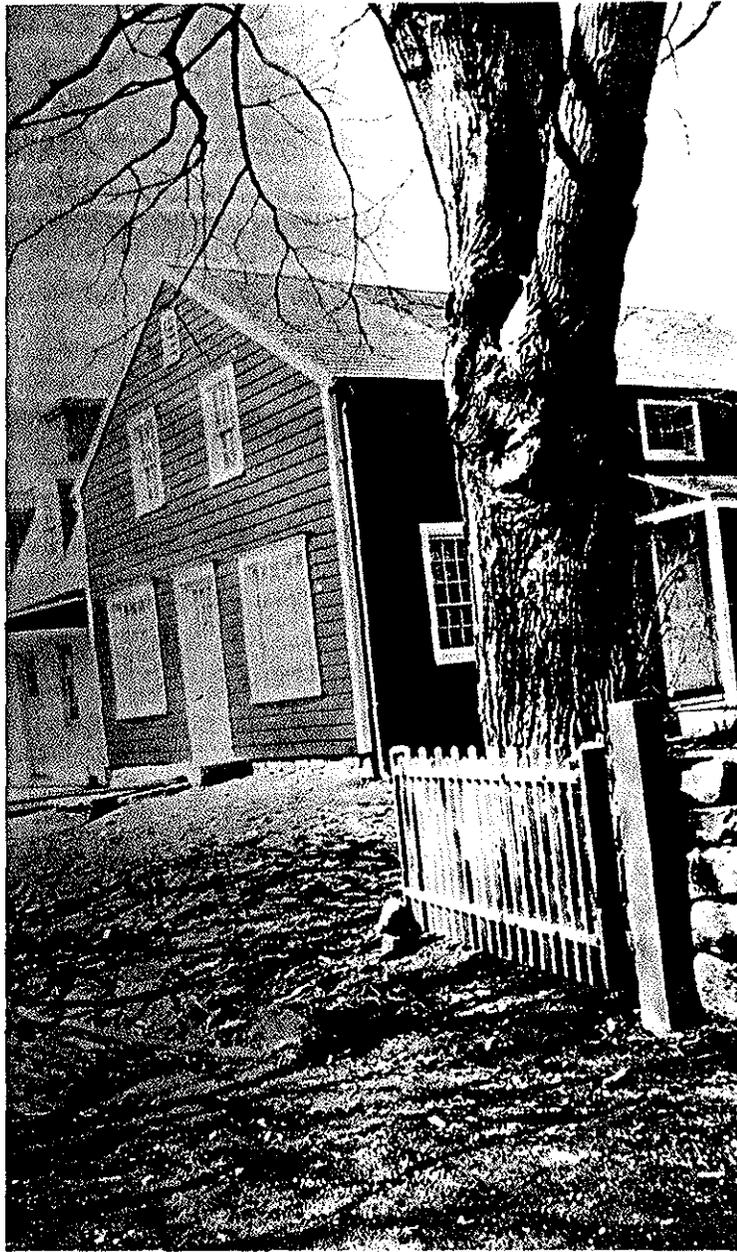
Figure 2. Webb-Burlingham House, Main House,
East Facade and West Wall (circa 1933).

the surround, if only by a few years. A photograph thought to date to circa 1932 shows the east entrance with the extant door but with a plain surround.²⁰ The view also shows that the entrance had a covered porch with a shed roof and wooden stoop, both of which were removed in 1938 (fig. 2).

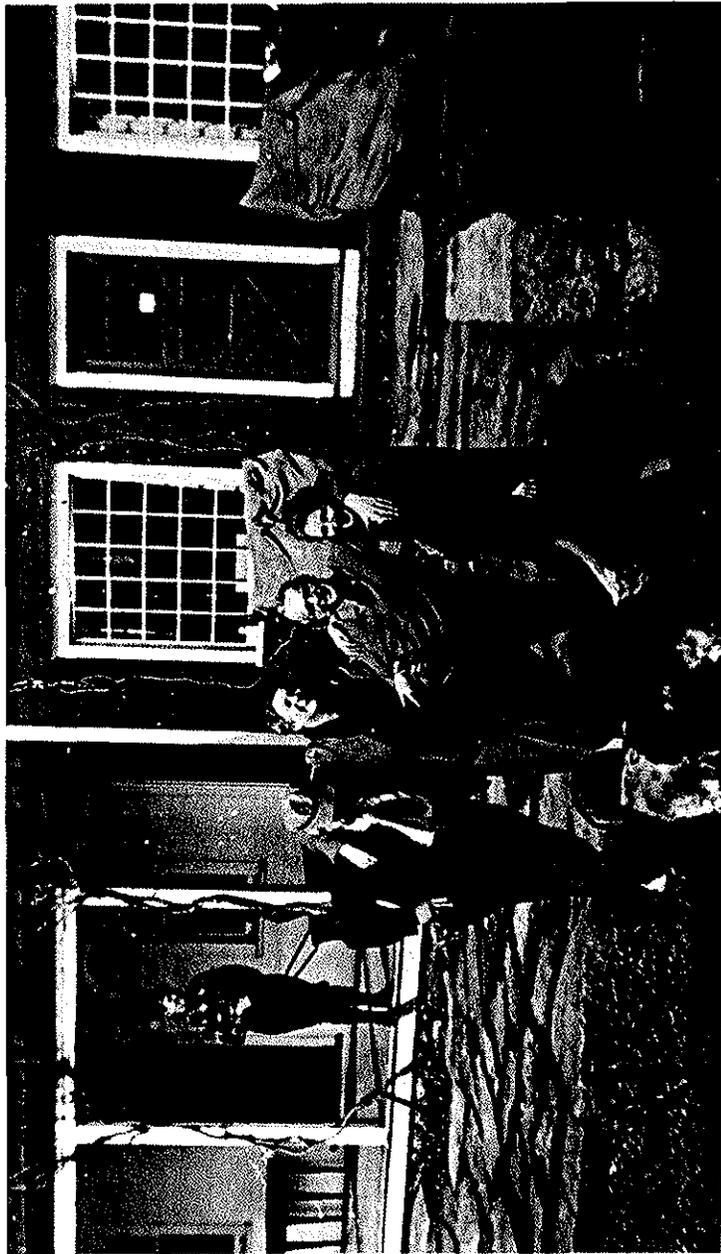
Figure 3. Webb-Burlingham House, South Aspect,
Main House and Dining Room Ell (pre-1947).

Photographs from the mid-1930s show that the exterior appearance of the south and west walls of the kitchen ell has changed since it was first built (figs. 4, 6, & 9-11). Figures 3, 5 and 9 show that the first-story south wall originally had two small 6-pane windows. A trellis is set against the wall shaded by a rustic pergola. The rear (west) wall of the kitchen ell can be seen in the background in figure 10, taken before 1940.¹⁷ The rear porch and upper-story windows are visible and appear much as they do today. A back doorway, which is extant, was located under the rear porch. A post blocks the view of the porch door in the photograph, but the steps lead up to the same point as they do today, and the interior paint stratigraphy of the door is

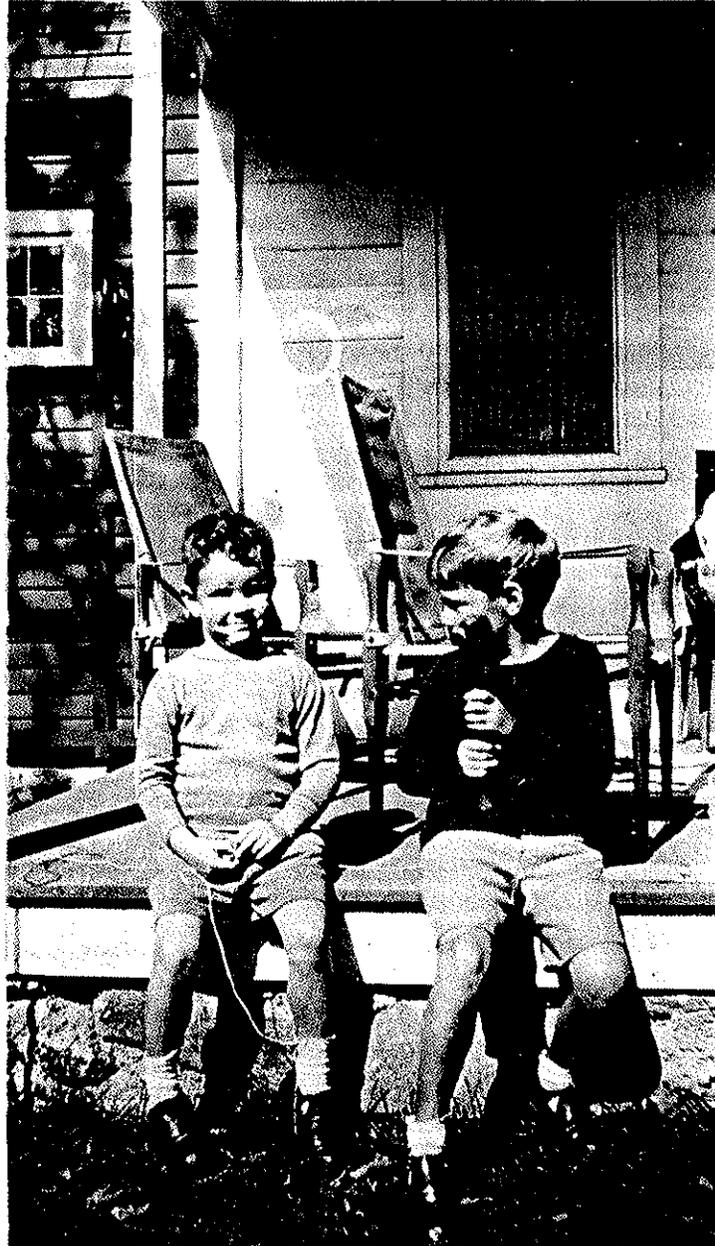
Figure 4. Webb-Burlingham House, South Porch (Circa 1933).

The extant dining room ell and the south porch can be seen in photographs of the house dating to circa 1933-1935 (figs. 4-6). The ell appears to have been built at the same time as the south addition to the main house. This is also evident in a shared basement foundation wall that, from the ell side, is continuous along the main house and the south addition. The ell was joined to

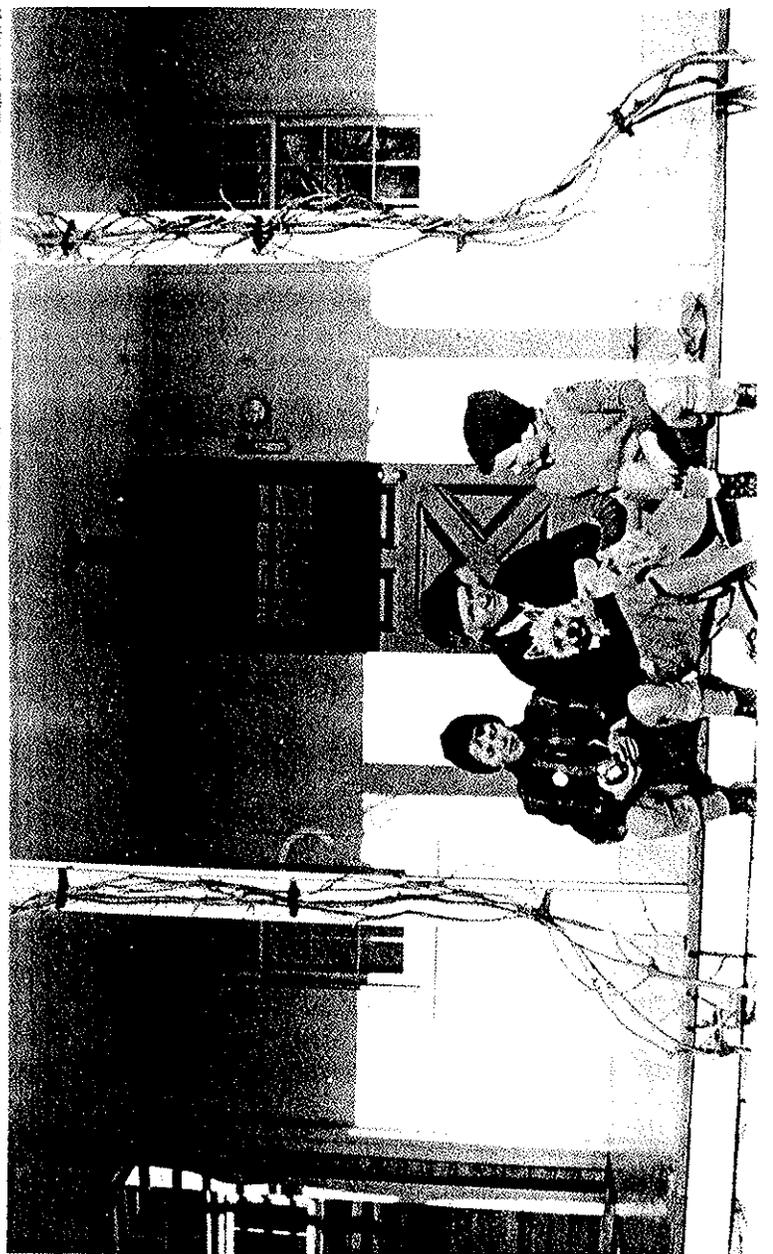
Figure 5. Webb-Burlingham House, South Wall Dining Room Ell (Circa 1937).

The south porch was built at the same time as the dining room ell. Analysis of mortar samples taken from the porch foundation shows that they are the same as mortar samples taken from the ell foundation, and paint histories of the porch elements match those of features on the ell's south wall. Burlingham family photographs from the mid-1930's show the porch as it appears today, with screens in place and vines growing up the posts in the summer months (figs. 5 & 6). The porch protected the entire south wall of

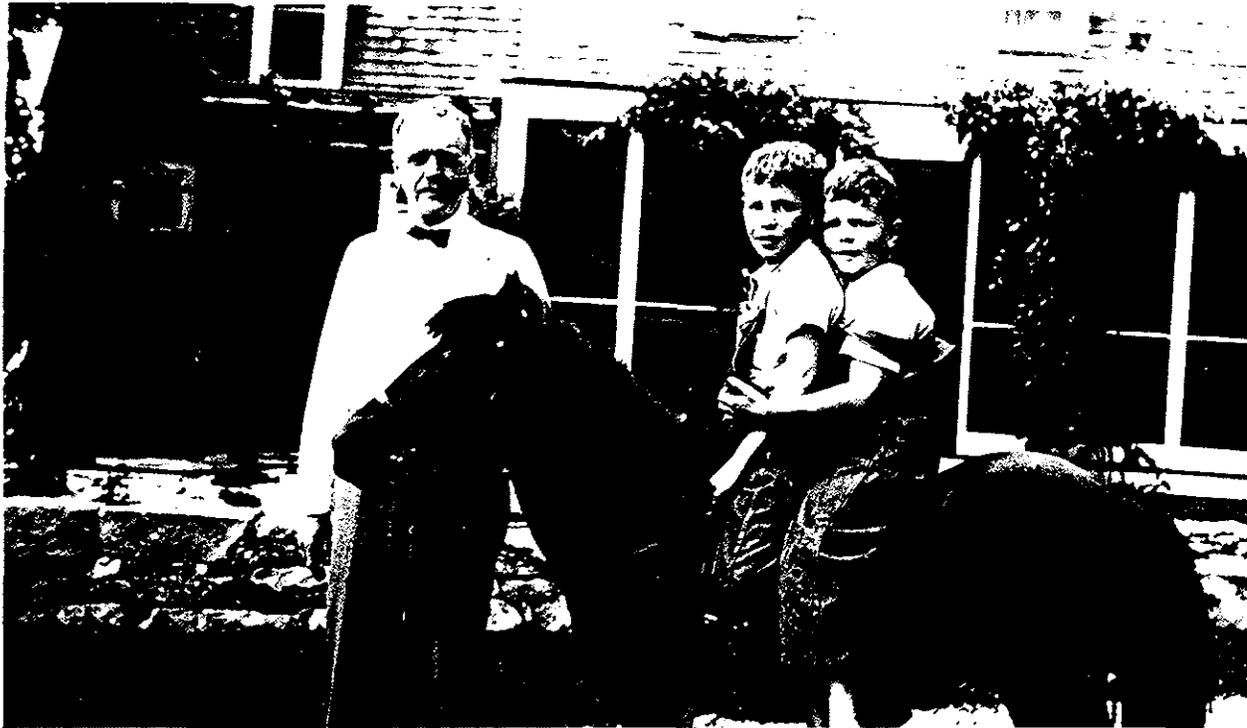
Figure 6. Webb-Burlingham House, South Aspect,
Dining Room and Kitchen Ells with Screened South Porch (Circa 1937).

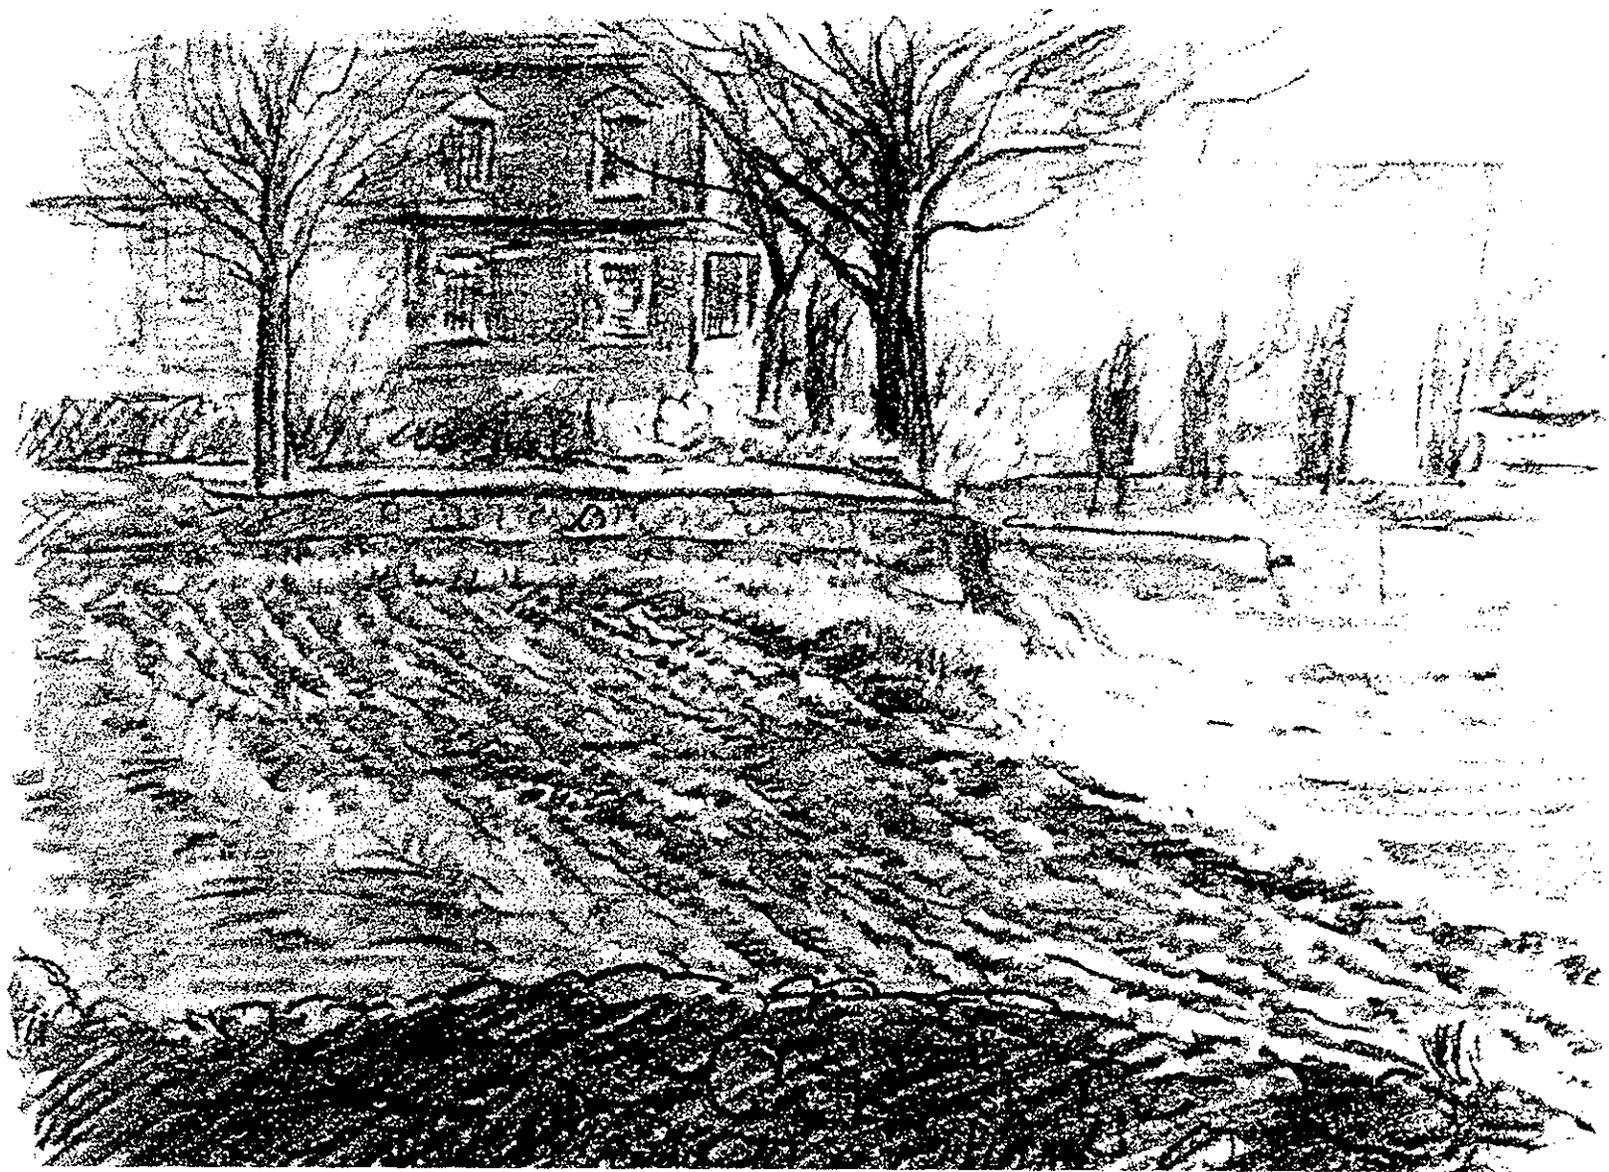
Figure 7. Mahonri Young, *Plowed Garden* (1939), Showing North Aspect of Webb-Burlingham House.

There are no known circa-1930's photographs of the north wall of the dining room ell, but there are two Mahonri Young drawings of the north side of the kitchen and dining room ells that date to 1939 and circa 1942 (figs. 7 & 8). From the drawings it can be seen that the dining room ell's original appearance has not changed, with the main feature at the first story the extant bay with tripartite windows. The foundation for this bay is integral with the rest of the ell foundation wall, and is thus known to be original to the ell. This is confirmed by analysis of the paint on the sashes and surrounds of the bay and basement windows, which shows stratigraphies similar or identical to those on circa-1932 features on the ell's south wall.

There were also originally two gable dormers on the lower north slope of the dining room ell's gambrel roof. These dormers appear in Young's drawings, and are identical to the extant dormers on the ell's south roof slope. There was also originally a doorway

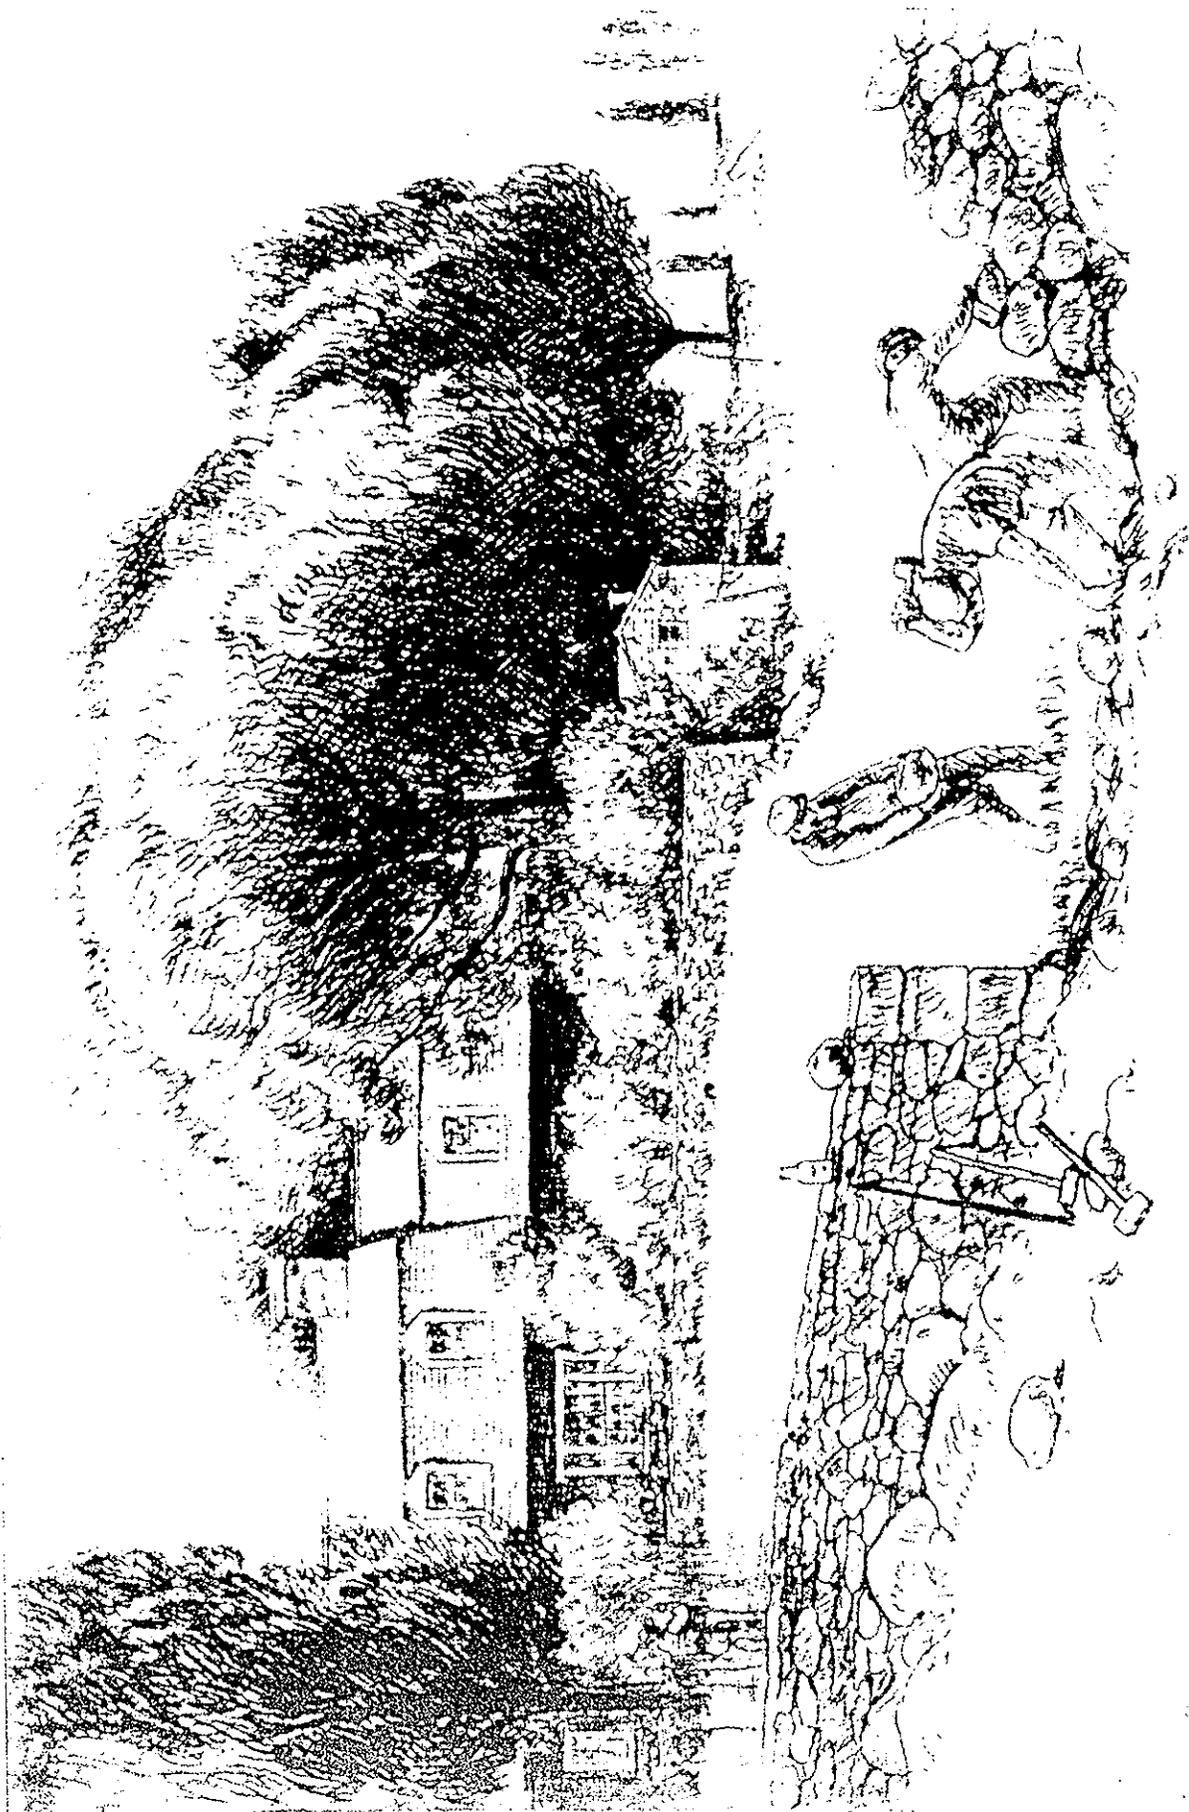
Figure 8. Mahonri Young, Joe Knoche Builds a Wall (Circa 1942), Showing North Aspect of Webb-Burlingham House and Burlingham Tool House.

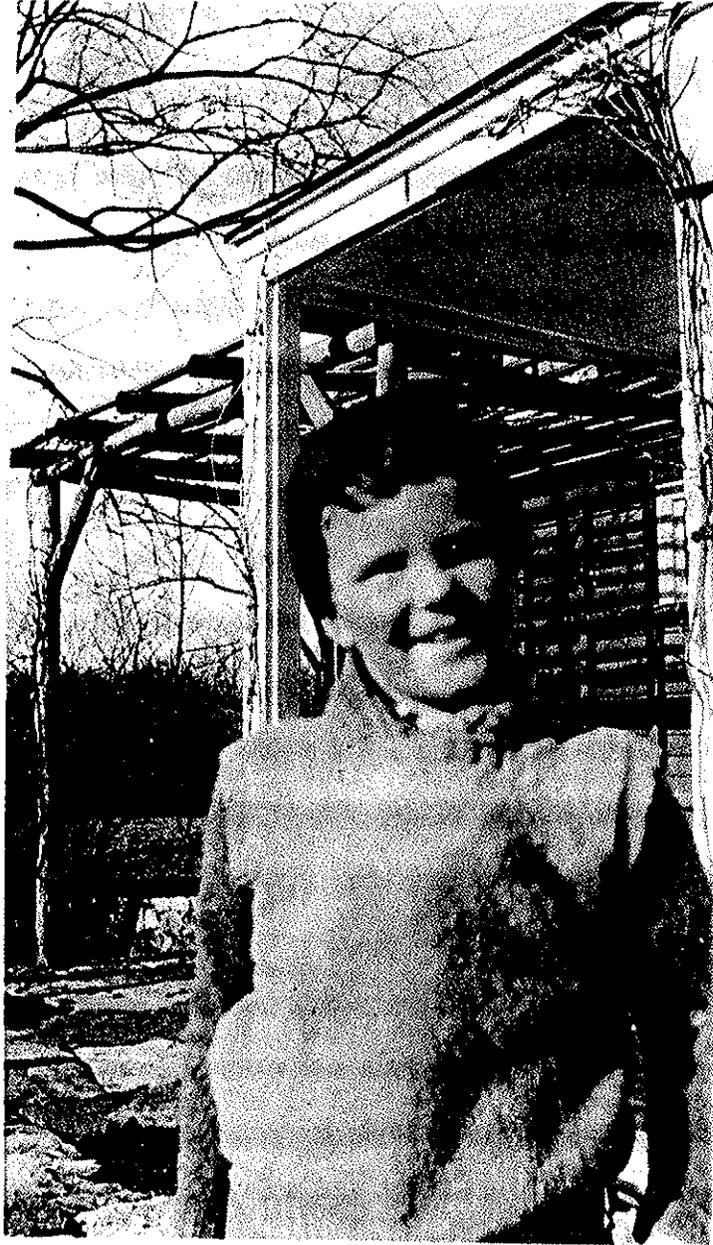
Figure 9. Webb-Burlingham House, South Wall,
Kitchen Ell and Pergola (circa 1937).

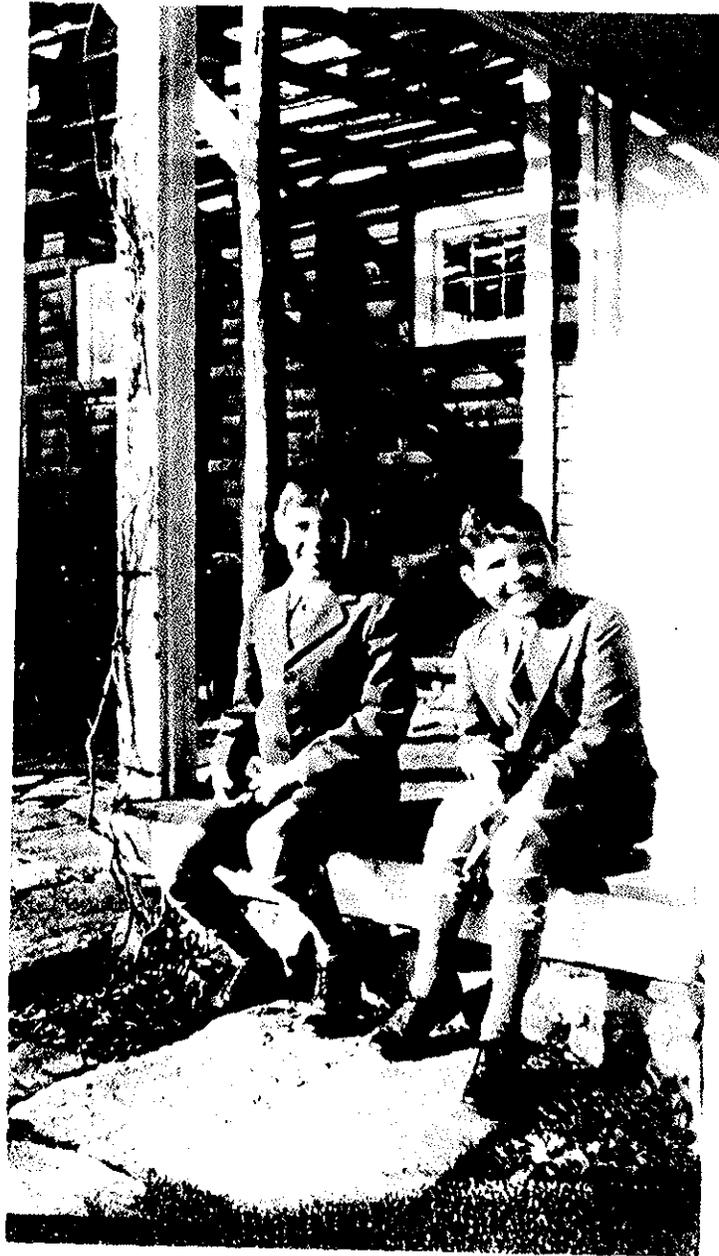
Figure 10. Webb-Burlingham House, South Aspect,
Kitchen Ell and South Porch (Circa 1937).

Notations on plans for a 1938 greenhouse built on the south kitchen wall (see following section) indicate that the greenhouse used the extant stone terrace for its foundation and flooring. This terrace is thought to have been installed sometime after 1932. A family photograph shows Cora Burlingham's two sons, Charlie and Bill, sitting on the edge of the south porch in front of the kitchen and dining room ells. Charlie is approximately 3 to 4 years old in the photo, which would date it to circa 1933-1934. Both boys' feet are resting on grass where the terrace would exist (fig. 3). A later photograph, taken before the 1938 greenhouse was installed, shows the (somewhat older) boys in a similar pose, with their feet resting on the terrace stone (fig. 10).

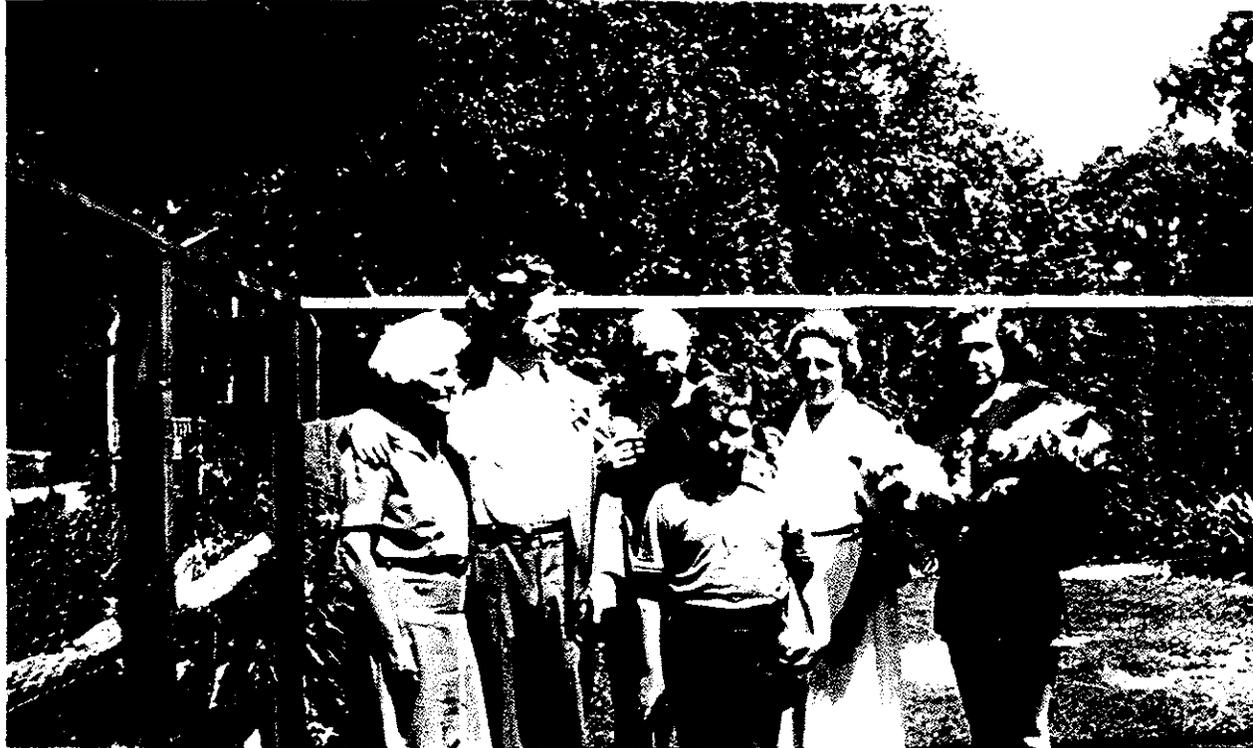
Figure 11. Webb-Burlingham House, Dog Pen West of House,
Exterior West Wall of Kitchen Ell in Rear Left (Pre-1940).

Surviving plans by Nelson Breed document that the first floor interior of the kitchen ell was gutted and completely remodeled in 1948.²¹ This renovation impacted the exterior appearance of the first story by changing the size and arrangements of windows. The 6-light single-sash windows on the south wall that can be seen in the circa-1935 historic photographs and on Breed's plans for the 1938 greenhouse were replaced by six-over-six double-hung sashes. Analysis of the paint on the interior of the kitchen windows indicates that these double-hung sashes were part of the original 1932 kitchen. They were probably the two sashes that can be seen in the pre-1940 photograph of the rear of the house (fig. 11) and were moved to the south wall when a large sliding window was

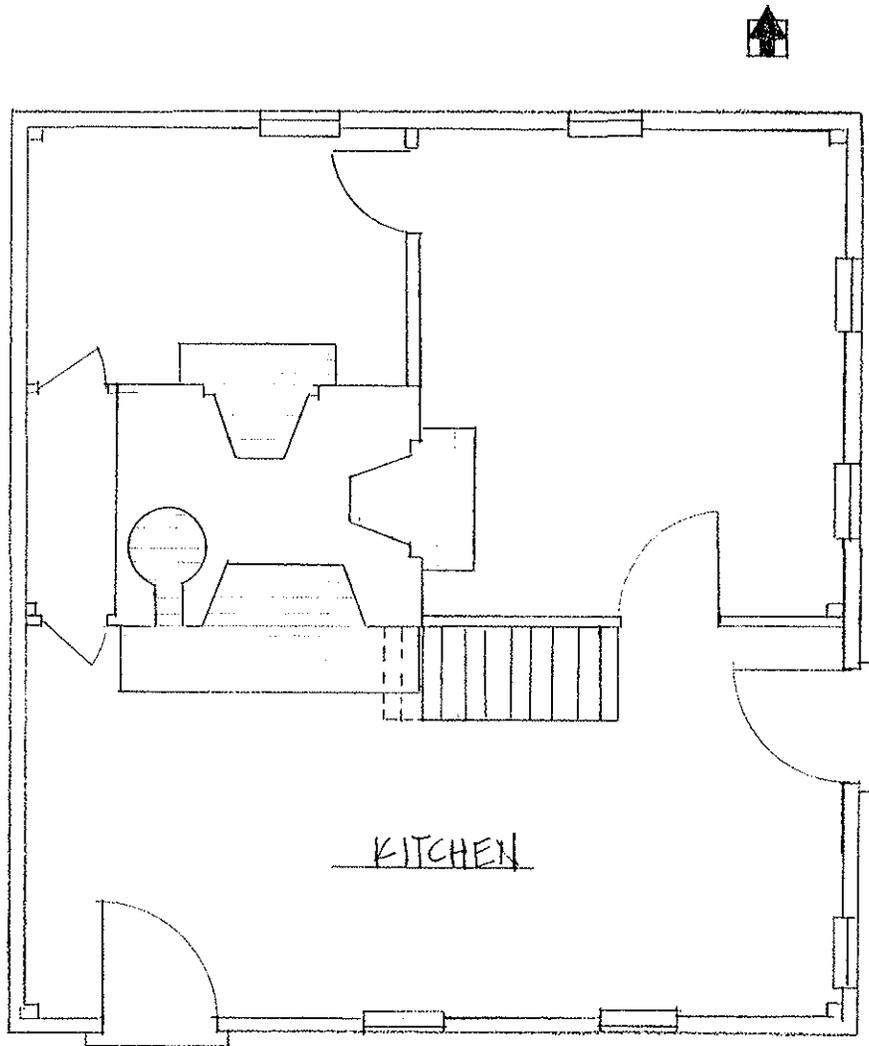
Figure 14. Webb-Burlingham House,
Conjectured Circa-1775 First-Floor Plan.

The ridge pole of the original roof of the house ran parallel to the road, as was typical in 18th century vernacular Connecticut houses.²⁴ On the first floor, the placement of the chimney stack slightly off-center and behind the ridge line indicates that, although circulation in the original house revolved around the chimney mass, the house did not have the center chimney plan that was more common for the region. The house was built as a one-and-a-half story structure, in which one would usually find either an entry and a second-floor staircase in front of the chimney stack, or (less frequently) an entry in front of the chimney with the stairs behind. Apparently the original Webb-Burlingham house had no such entry or staircase. As can be seen in the conjectured plan

(fig. 14), the chimney stack was placed off-center front-to-rear. The area to the front of the chimney stack was too large to have been used for an entry alone or even for the entry and staircase typical of 18th century Connecticut houses. In addition, a fireplace was located on the front face of the stack, and analysis of the mortar in its extant firebox in the current study indicates that this is an original feature of the house. The area at the rear of the stack was too narrow to accommodate a staircase.

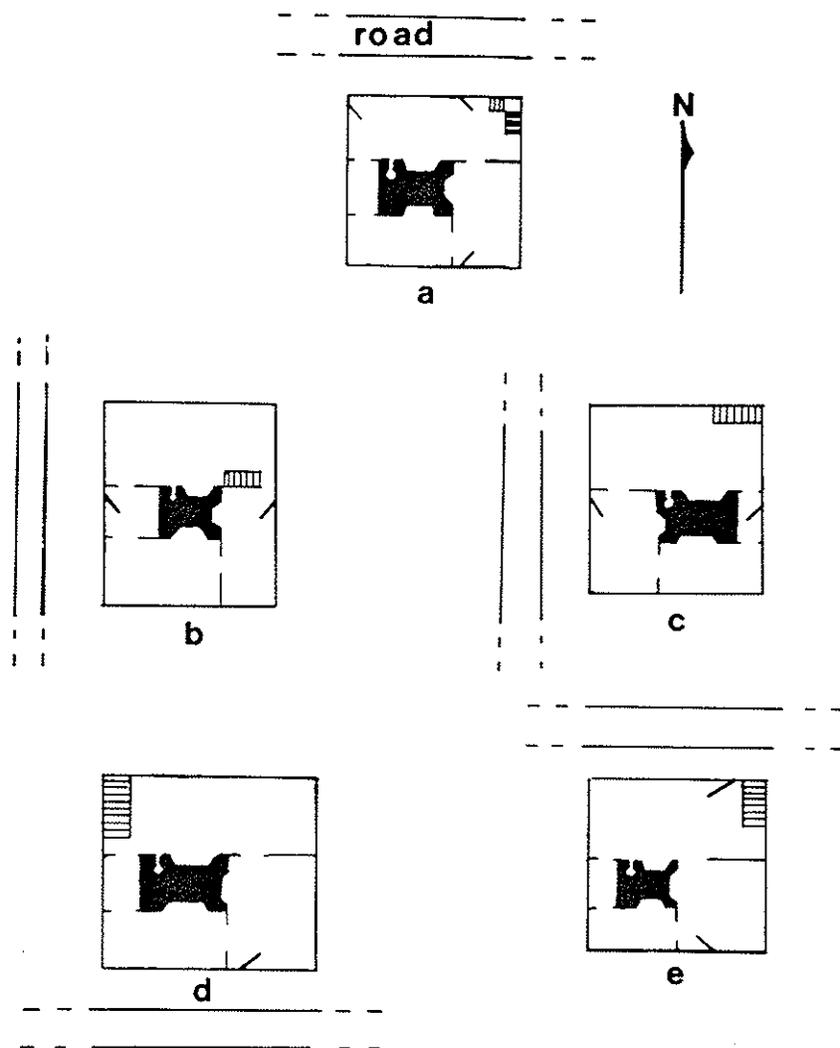
Figure 15. Reconstructed Plans of the Five Hemenway-Plan Houses.

Fig. 4. Reconstructed plans of the five Hemenway-plan houses located: (a) Bixby house, (b) Aaron Gates house, (c) Joseph Underwood house, (d) Amos Hemenway house, (e) Joab Holland house. Not to scale. (Drawing, Nora Pat Small)

been previously recorded".²⁵ Each of these houses (called the "Hemenway houses") had the ridge pole parallel to the road, and an interior arrangement of three rooms of unequal size with a small passage at one end of the slightly off-center chimney (fig. 15). The main difference between these houses and the original Webb-Burlingham house was that in the Hemenway houses the kitchen was located on the north side, and the two smaller rooms on the south.²⁶ The existence of this house plan type in central Massachusetts beginning a decade after the conjectured construction date for the Webb-Burlingham house suggests a common source for this previously-unrecorded building tradition.

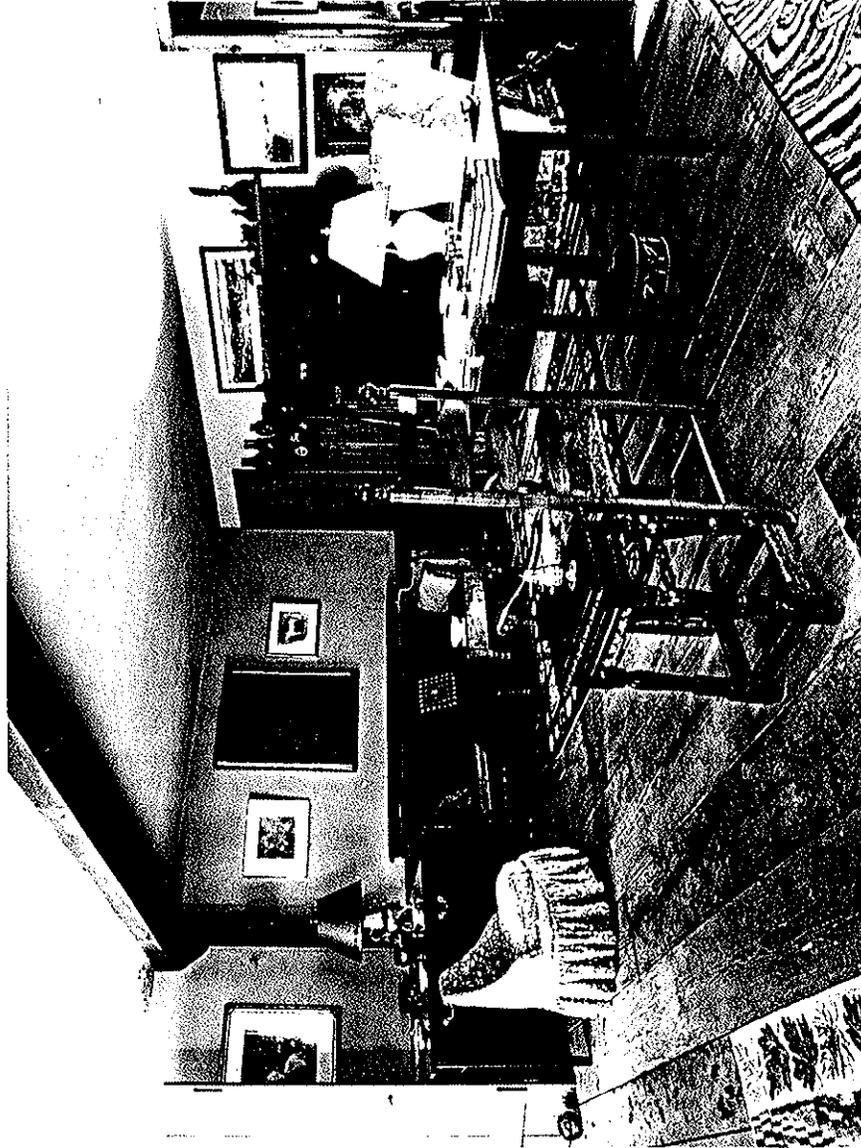
Figure 16. Webb-Burlingham House Living Room (Room 108), Looking Northwest (circa 1940s).

The first phase of the circa-1932 remodeling of the Webb-Burlingham house made by the Burlinghams shortly after Cora Burlingham took possession of the property was the extension of the main house by 8 feet to the south. This work resulted in a larger living room on the south end of the first floor (fig. 16), and the creation of a master suite on the south end of the second floor. The hopper windows on the east wall of the new master bedroom and the northeast bedroom were probably installed at this time. These rooms are essentially unchanged from circa 1932 to today (see section PHYSICAL DESCRIPTION - INTERIOR ELEMENTS, following).

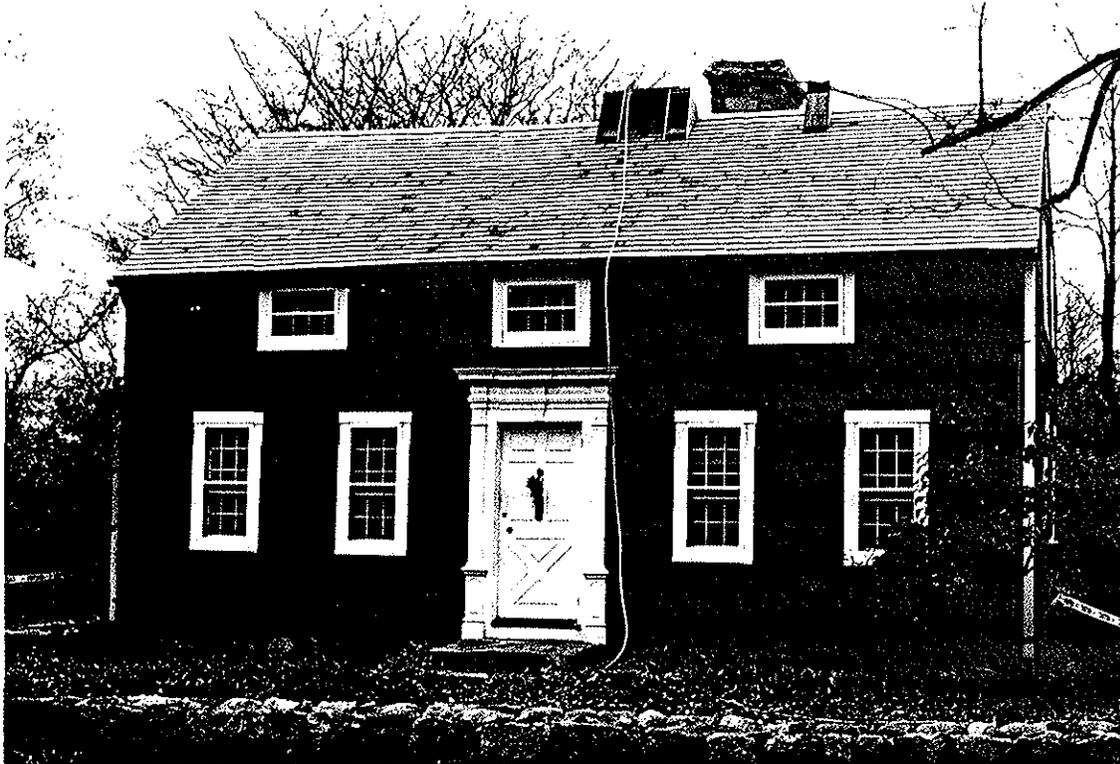
Figure 17. Webb-Burlingham House, Main House East Facade (1994).

The Webb-Burlingham house (fig. 17) is located on the west side of Nod Hill Road, and consists of the main house, which is set back approximately 20 feet from the road, and two ells extending from the main house in a line to the west. The main, or front, portion of the house is a rectangular, gable-roof, wood-frame structure measuring 32 feet 6 inches wide by 22 feet 6 inches deep and 1 1/2 stories high. It is set on a fieldstone foundation, and has a wood-shingle gable roof, with a stone chimney located off-center behind (west of) the ridge line. An unpaved driveway, which parallels the south side of the house, leads down from the road to the outbuildings to the west.

The front of the main house faces Nod Hill Road to the east. The east (front) facade is five bays wide, with two sash windows symmetrically placed on either side of a center entrance doorway at the first story, and three hopper windows tucked up under the eaves at the upper half-story (fig. 17).⁴⁶ A basement window is located in the foundation wall to the south of the doorway.

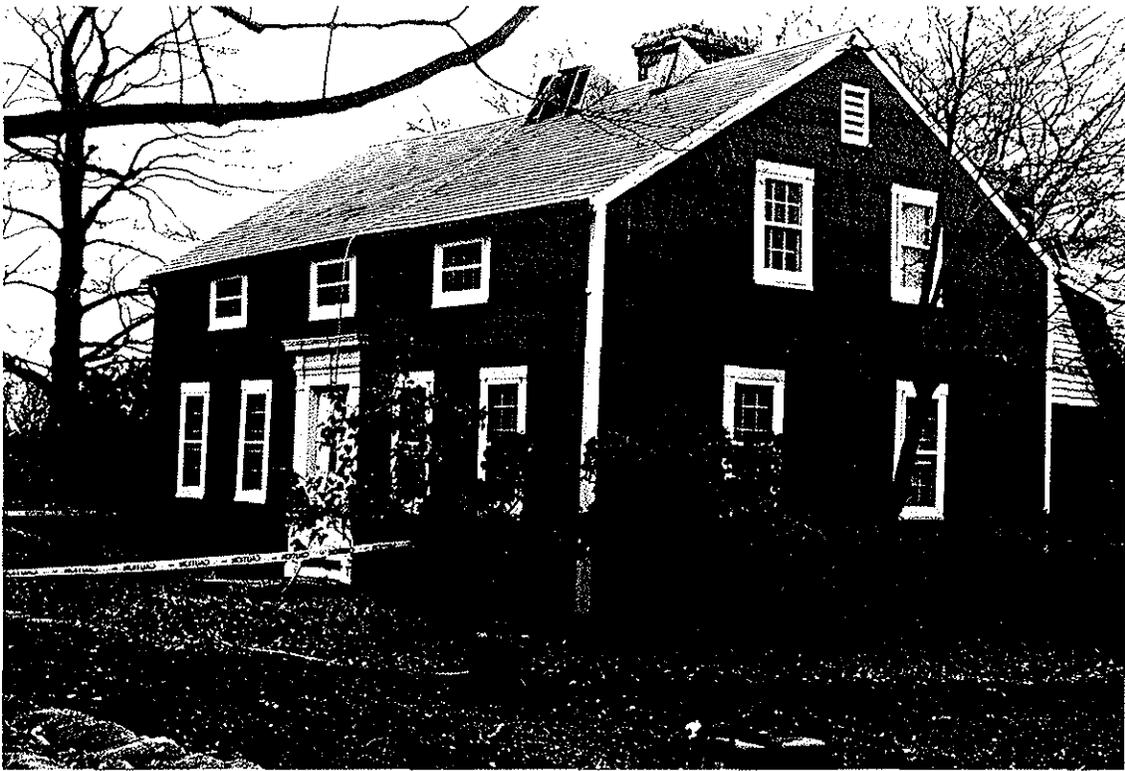
Figure 18. Webb-Burlingham House,
Main House East Facade and North Wall (1993).

The **north gable end** of the main house has one basement window, four sash windows (two at the first-story level and two at the upper-story level) and an attic vent under the gable (**fig. 18**). The **south gable end** has two fixed bow windows flanking a center doorway with a half-glass dutch door, two sash windows at the upper level, and an attic vent under the gable (**fig. 19**).

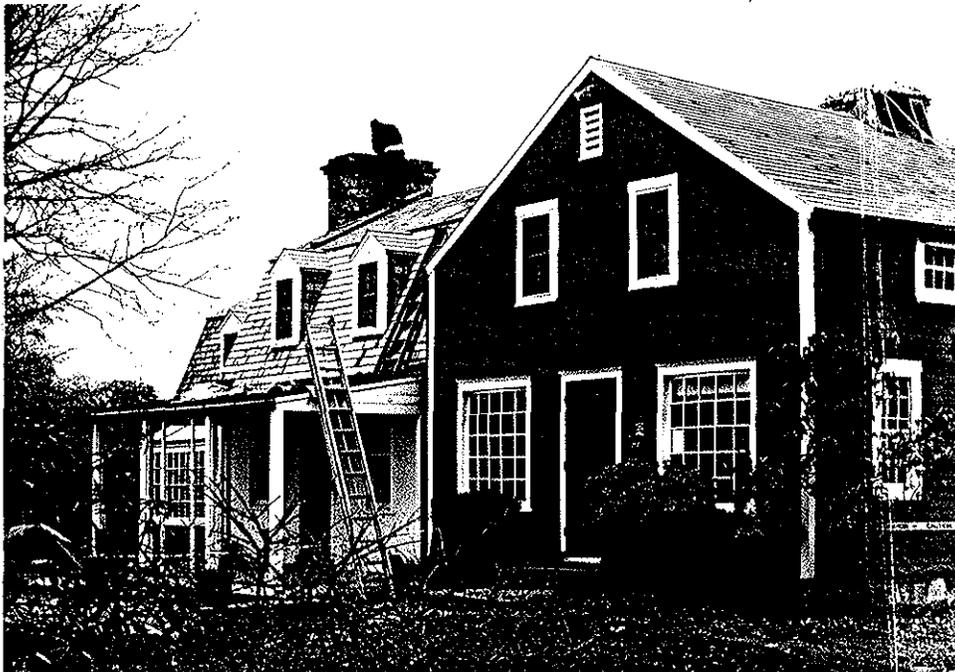
Figure 19. Webb-Burlingham House, Main House and
Dining Room Ell, South Aspect (1993).

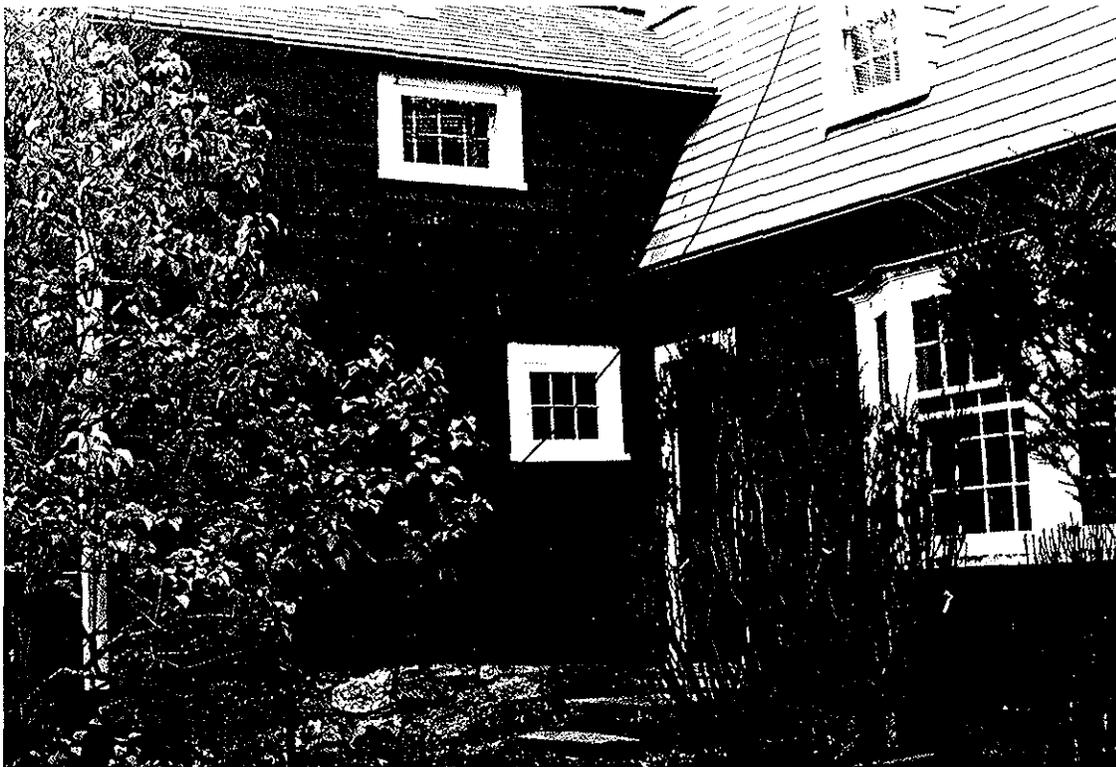
Figure 20. Webb-Burlingham House, Main House and Dining Room Ell, West and North Walls (1993).

The **rear (west) wall** of the house is interrupted at its south end by an ell. A small **casement** window has been installed on the upper story at the extreme south end of the wall under the eaves where the ell's gambrel roof intersects with the main house roof. The north end of the west wall has a small casement window on the first story near the ell, and a hopper window centered on the exposed wall at the upper story (**fig. 20**).

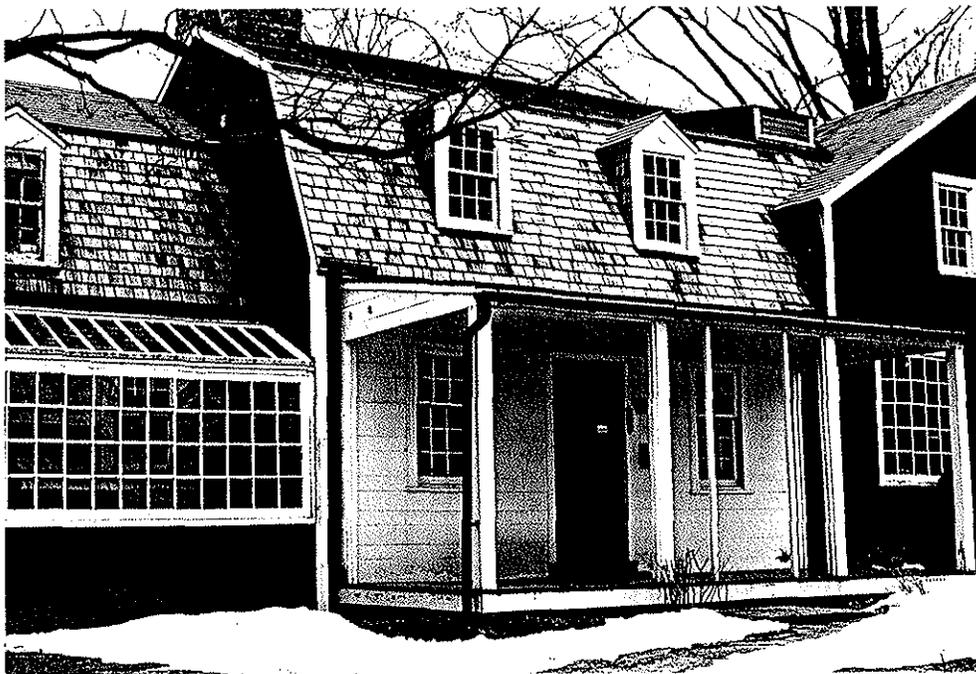
Figure 21. Webb-Burlingham House, Dining Room Ell, South Wall (1993).

Two wood-frame ells are located in a line to the west of the main house. The first of the ells (the "dining room ell") is connected to the south end of the west wall of the main house. The ell measures 22 feet wide by approximately 17 feet deep, and is 1 1/2 stories high. It is set on a fieldstone foundation, and has a wood-shingle gambrel roof with a stone chimney at its west end (**fig. 21**).

The dining room ell's **south wall** is recessed from the south wall of the main house, and in turn projects from the kitchen ell south wall to its west (**fig. 21**). The dining room ell's south wall has a center doorway with a half-glass door that is flanked by two
