**WEIR FARM
HISTORIC STRUCTURES REPORT**

**Weir Farm National Historic Site
Wilton, Connecticut**

Burlingham Complex

1995

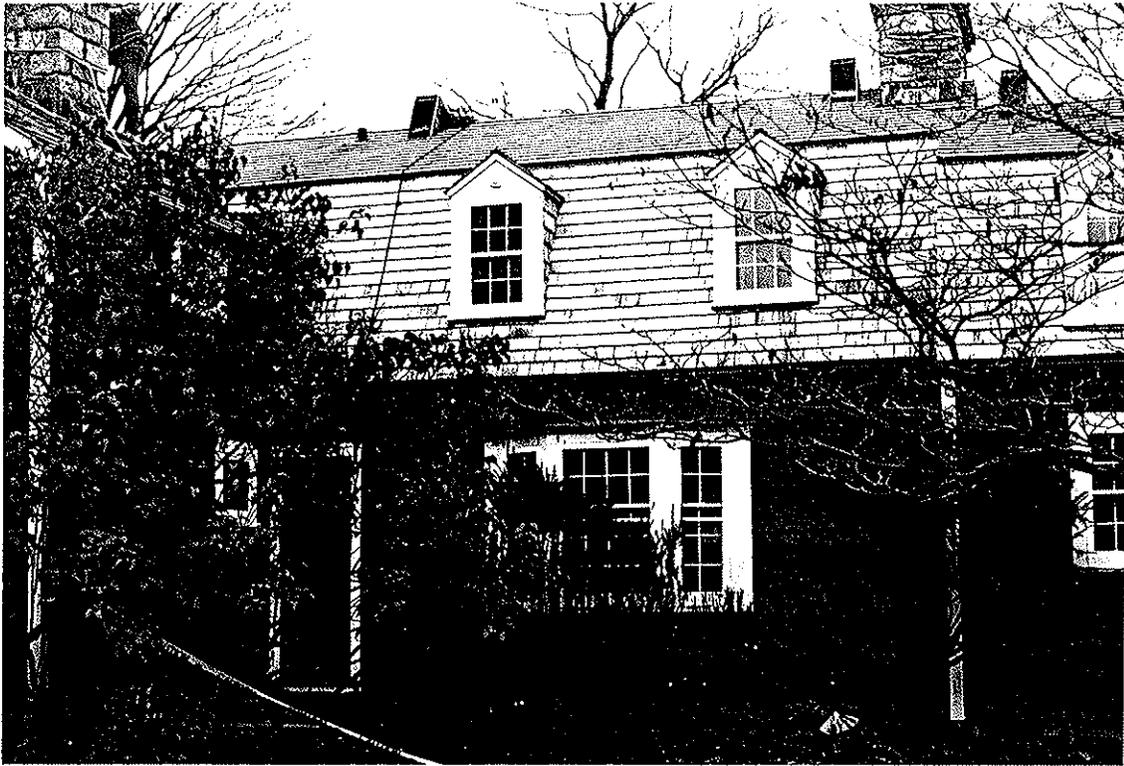
Figure 22. Webb-Burlingham House, Dining Room Ell, North Wall (1993).

The dining room ell's north wall is recessed from the north wall of the kitchen ell to the west. A doorway is located at its east end at the junction with the west wall of the main house. This doorway is fitted with a half-glass door and is approached using two steps made from granite slabs. A bay with three windows is centered on the wall (fig. 22), and one basement window is located in the bay foundation. Two dormers pierce the lower north slope of the ell's gambrel roof.

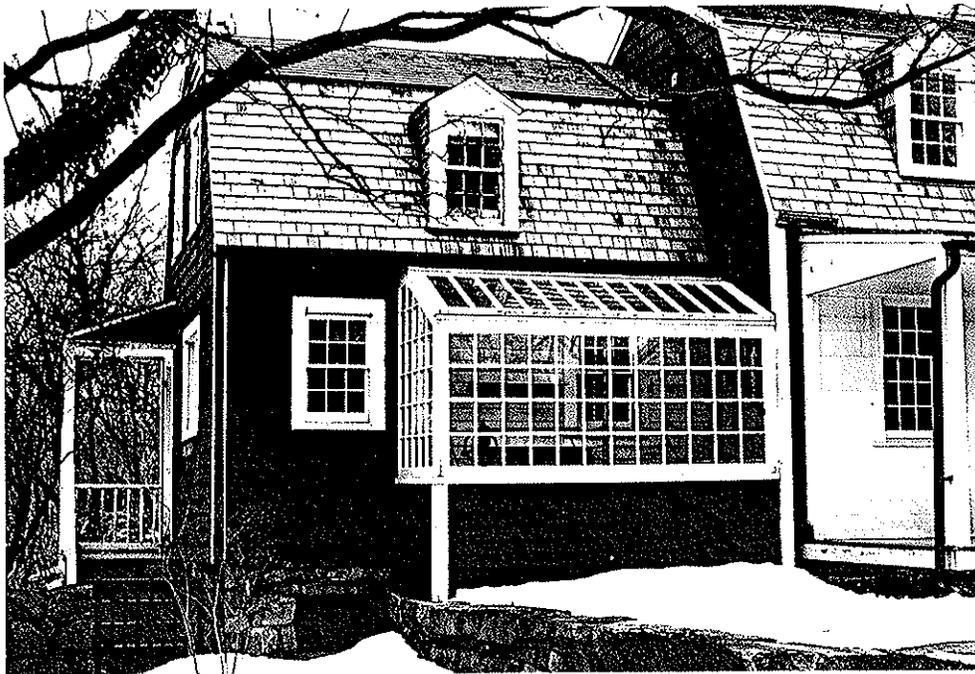
Figure 23. Webb-Burlingham House, Kitchen Ell, South Wall (1993).

The second of the two ells ("the kitchen ell") is connected to the west wall of the dining room ell (fig. 23). The kitchen ell measures 16 feet 6 inches wide by 18 feet deep and is 1 1/2 stories

One of the first-story windows on the south wall of the kitchen ell opens into the interior of a **greenhouse** that is located in the recess at the intersection of the dining room ell and the kitchen ell (**fig. 23**). The greenhouse, which rests on the retaining wall and the stone terrace, is glazed on the upper half of its south and west walls and on its shed roof.

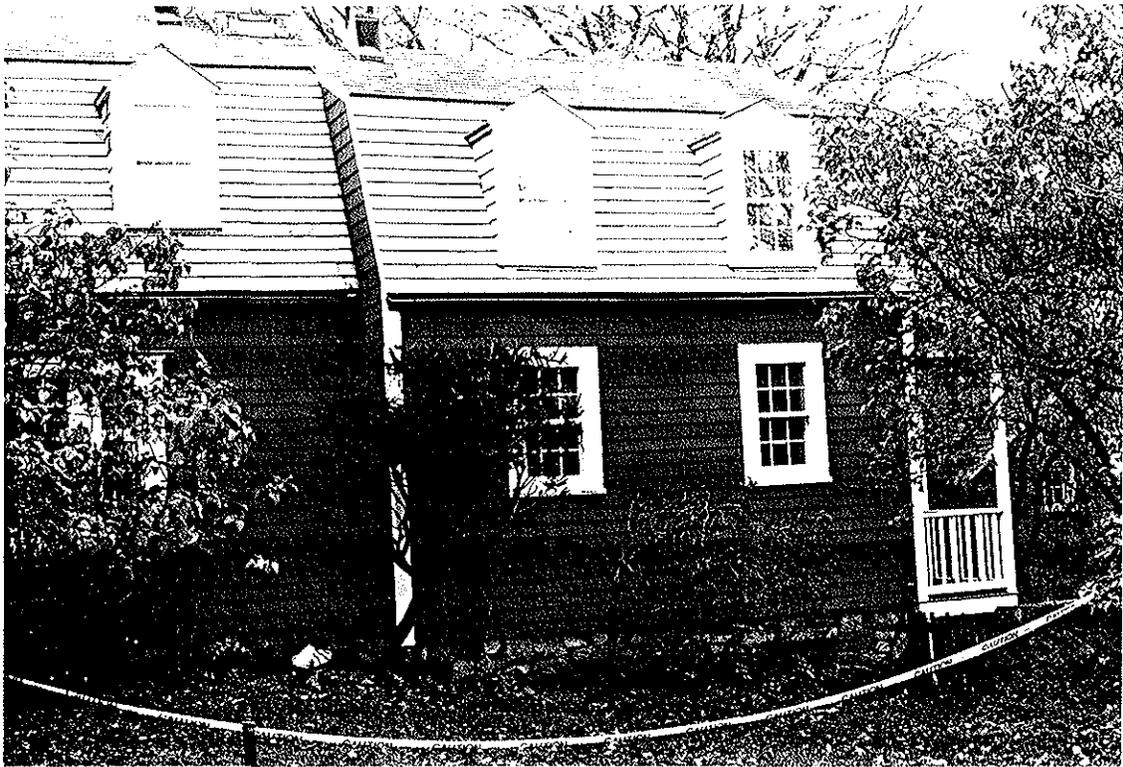
Figure 24. Webb-Burlingham House, Kitchen Ell, North Wall (1993).

The **north wall** of the kitchen ell projects from the north wall of the dining room ell. There are two sash windows on the first story, two dormer windows on the lower north slope of the gambrel roof, and a basement window at the west end of the foundation wall (**fig. 24**). A short **east wall** projects from the north wall of the dining room ell.

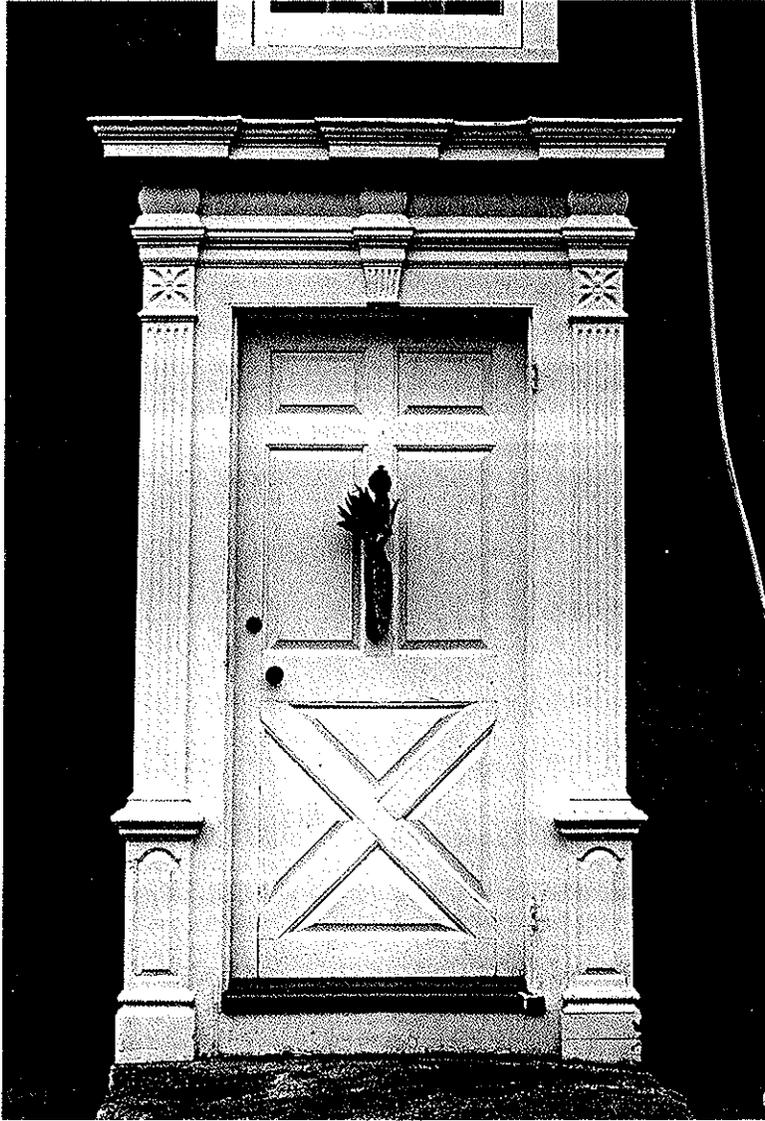
Figure 26. Webb-Burlingham House, Main House
East Facade, Main Entrance (D103) (1993).

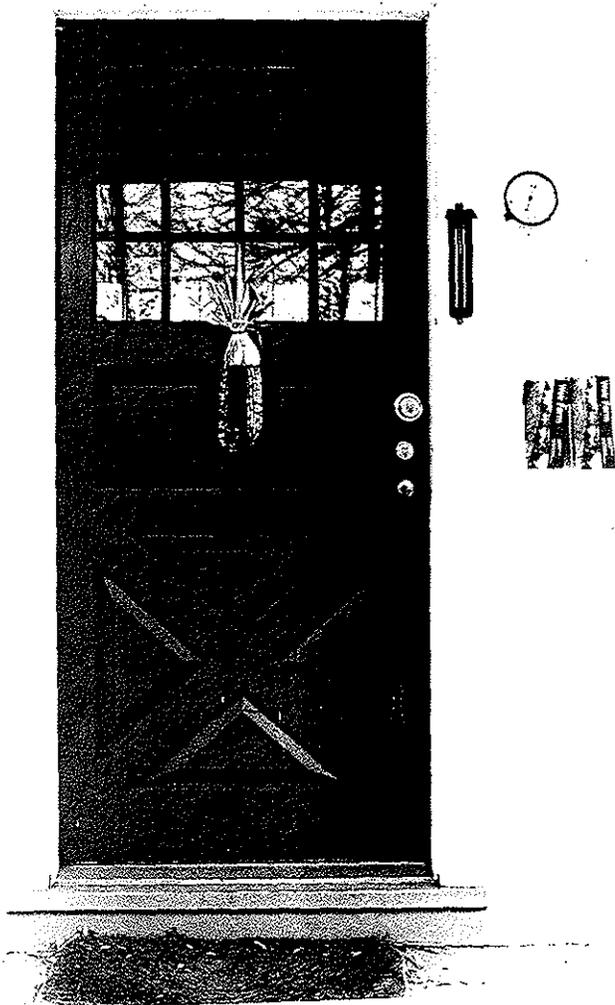
Figure 27. Webb-Burlingham House, Dining Room E11 South Wall, Doorway D101 (1993).

There are two doorways along the south aspect of the house. A circa-1932 doorway with a half-glass door is centered on the south wall of the dining room ell. This doorway is approached from the south porch, and opens into the dining room (D101 - fig. 27), and measures 3 feet wide by 6 feet 7 1/2 inches high. The door in the opening has a cross panel on its lower third, two small square panels in the middle, and 12 lights on the top third of the door. There is a 2-inch-wide brass knob and plate, original to the door, and two recently-installed dead-bolt locks. The doorway has a plain 4-inch-wide surround with a quarter-round molding cornice.

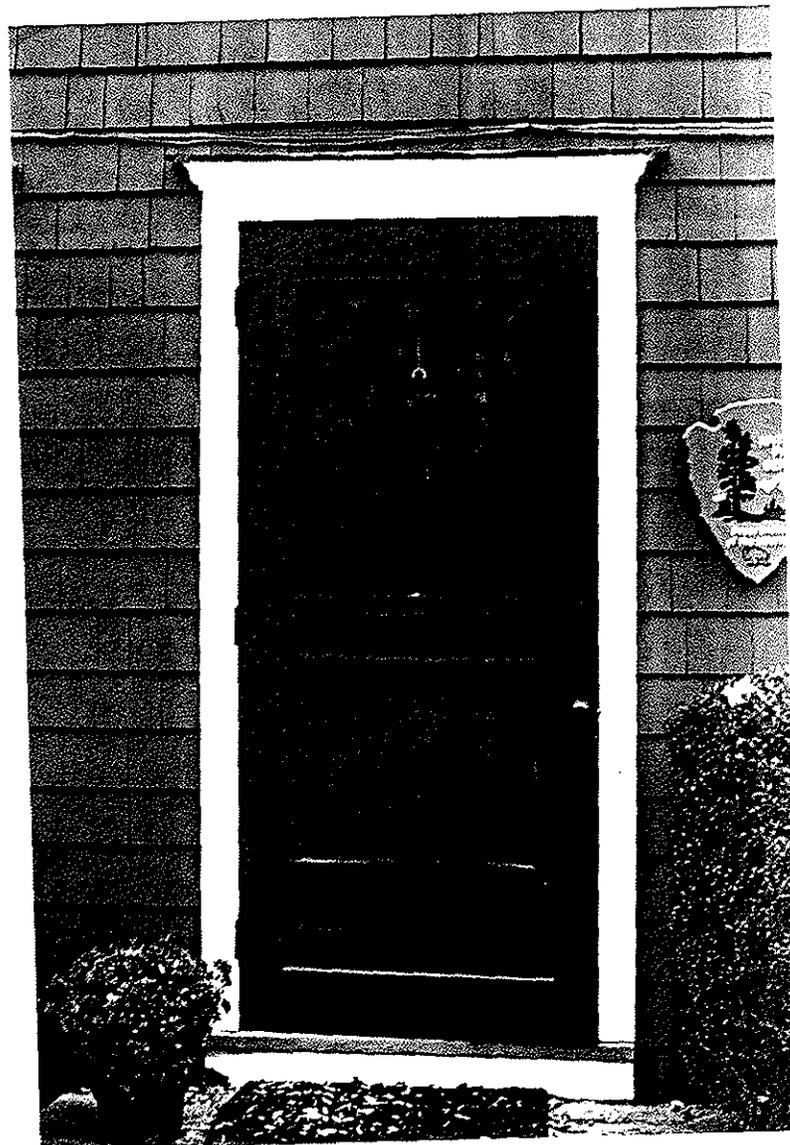
Figure 28. Webb-Burlingham House, Main House South Wall, Doorway D102 (1993).

The second doorway on the south aspect of the house is a circa-1932 doorway that is centered on the south wall of the main house (D102 - fig. 28). This doorway is approached via two steps composed of large granite slabs, and opens into the living room. The opening measures 3 feet wide by 6 feet 7 1/2 inches high, and

has a half-glass dutch door with a cross-panel on the bottom half and a glazed upper half with 9 lights. The opening is fitted with a screen door (D102a). The door and screen door have 2-inch-wide brass knobs and plates that are original to both doors. The main door has a recently installed brass dead-bolt lock. The doorway has a plain 4-inch-wide surround, with a slightly more elaborate ogee cornice than on D101.

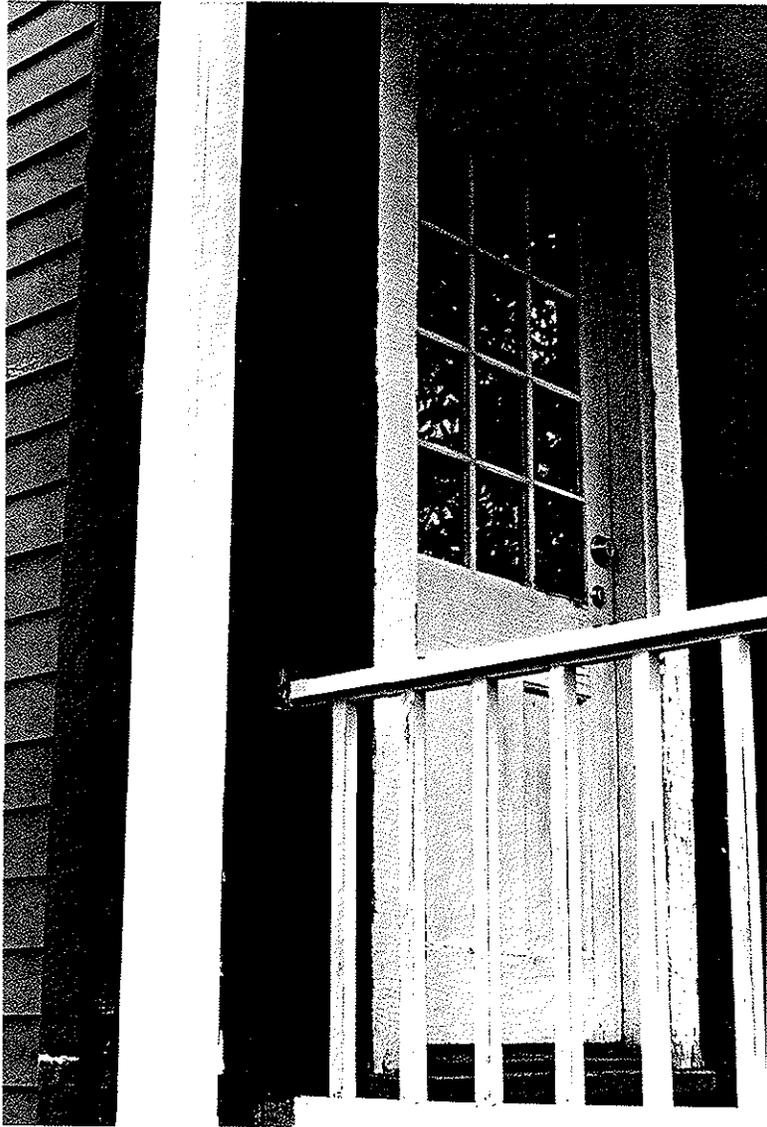
Figure 29. Webb-Burlingham House, Kitchen
E11 West Wall, Doorway D105 (1993).

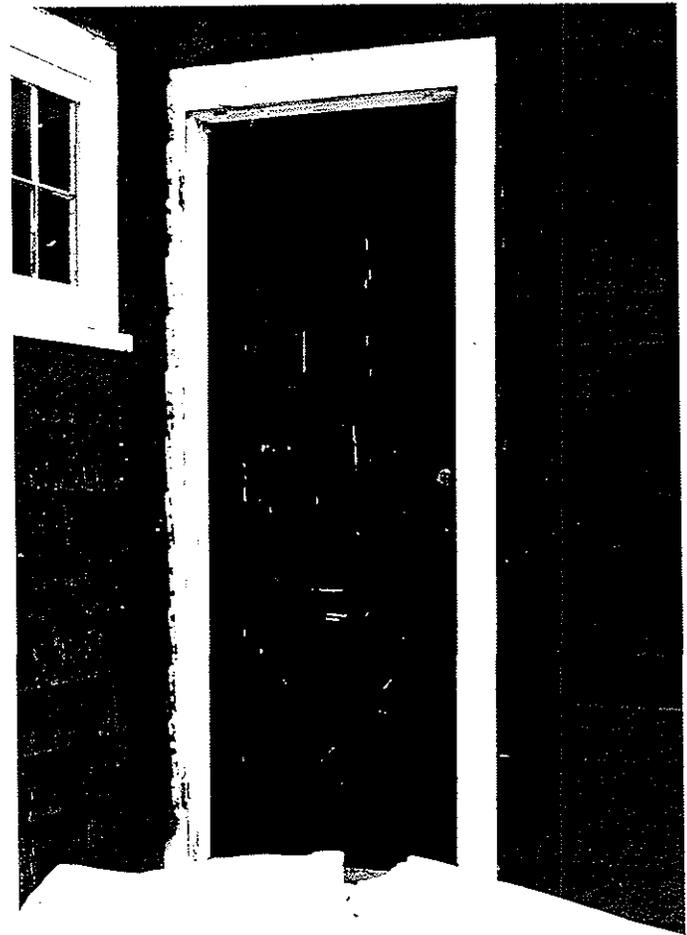
Figure 30. Webb-Burlingham House, Dining
Room E11 North Wall, Doorway D104 (1993).

There is one doorway on the north side of the house, located at the east end of the dining room ell (D104). This doorway, which dates to the circa-1932 construction of the ell, opens into the back hall and is approached by two steps composed of large granite

blocks (fig. 30). The doorway measures 2 feet 6 inches wide by 6 feet 7 1/2 inches high, and has a half-glass door that has a cross-panel on the bottom of the door, two rectangular panels in the middle, and 9 lights on the top third of the door. The door has retained its original, 2-inch-wide brass knob and plate. The opening has a plain surround that is 4 inches wide on the right side and top, and 2 inches wide on the left of the opening where it butts up against the west wall of the main house.

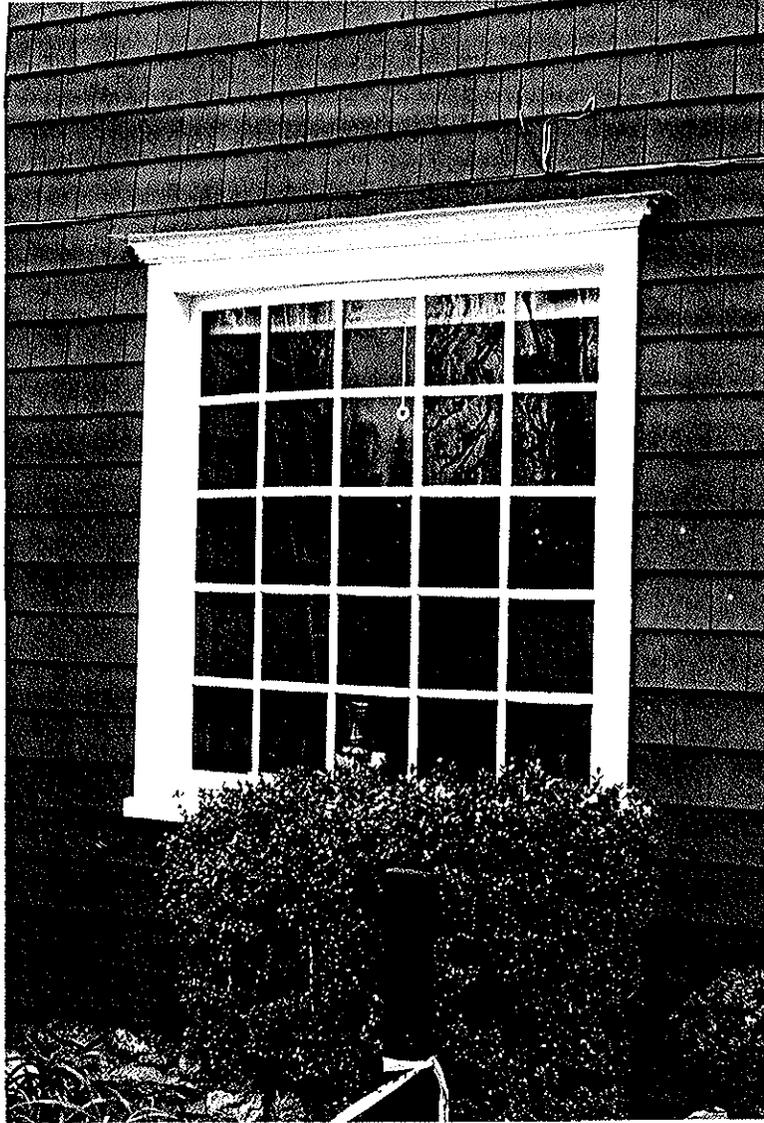
Figure 31. Webb-Burlingham House, Main House
South Wall, Window W107 (1993).

There are four circa-1932 windows on the south wall of the main house, two on the first story and two on the upper level. The two windows on the **first story** (W107 & W108) are bow windows that flank the center entrance (fig. 31). Each window measures 54 inches wide by 57 3/4 inches high, and has a fixed convex sash with 25 lights (five-over-five). Each is trimmed with a 3 1/2-inch wide plain surround with the same ogee cornice found on doorway D102.

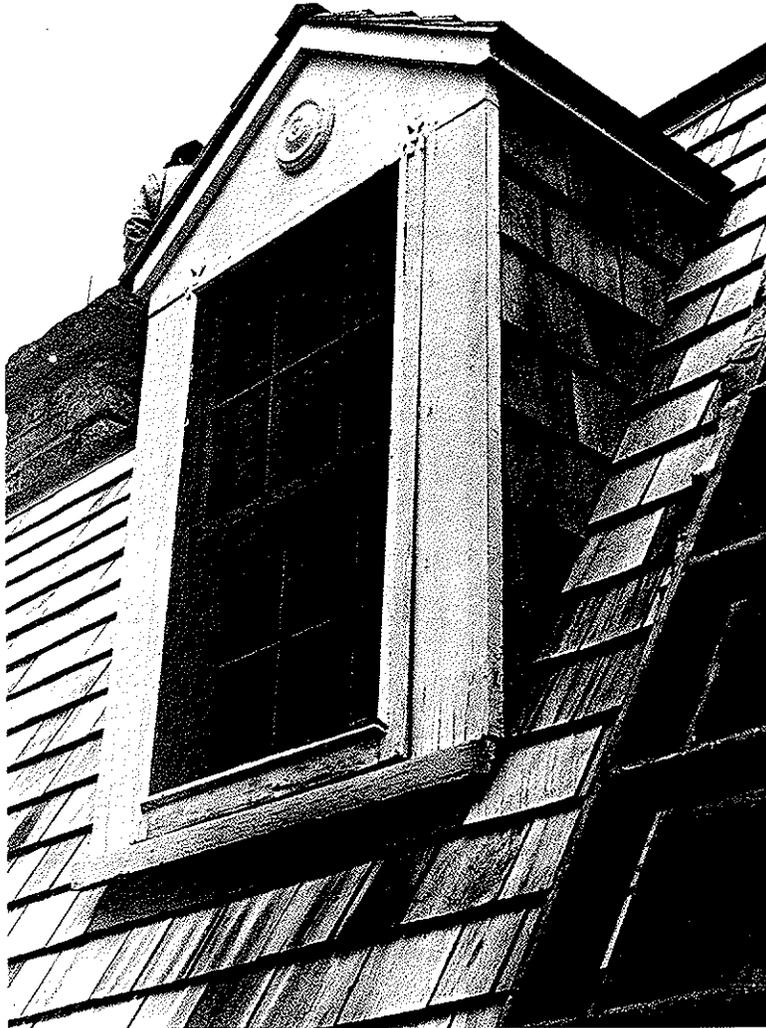
Figure 32. Webb-Burlingham House, Dining Room E11 South Wall, Dormer Window W203 (1993).

The two dormer windows are located at the **upper story** on the lower south slope of the ell's gambrel roof (W202 & W203 - fig. 32). The dormers have gable roofs and shingled cheeks. Each dormer window has a double-hung sash with 12 lights that measures 24 inches wide by 40 1/2 inches high. The window is trimmed with a plain 6-inch-wide surround, and a raised wooden circular medallion or patera is centered on each dormer pediment.

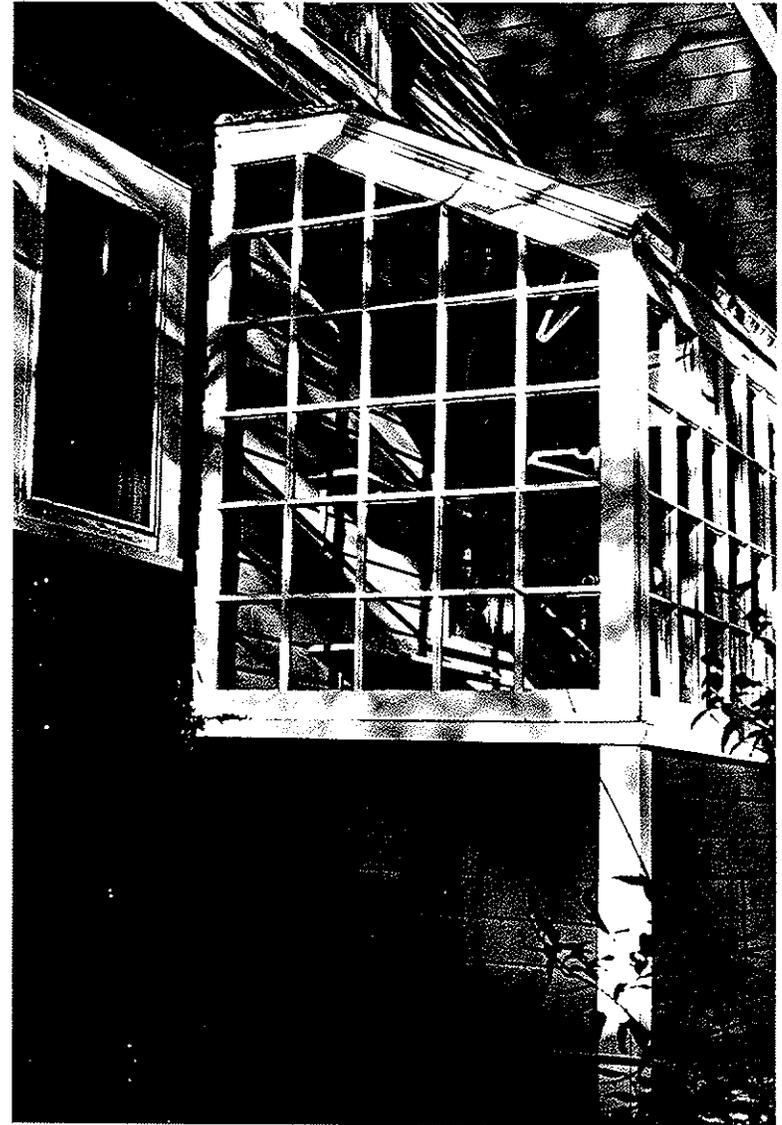
Figure 33. Webb-Burlingham House, Greenhouse West Wall (1993).

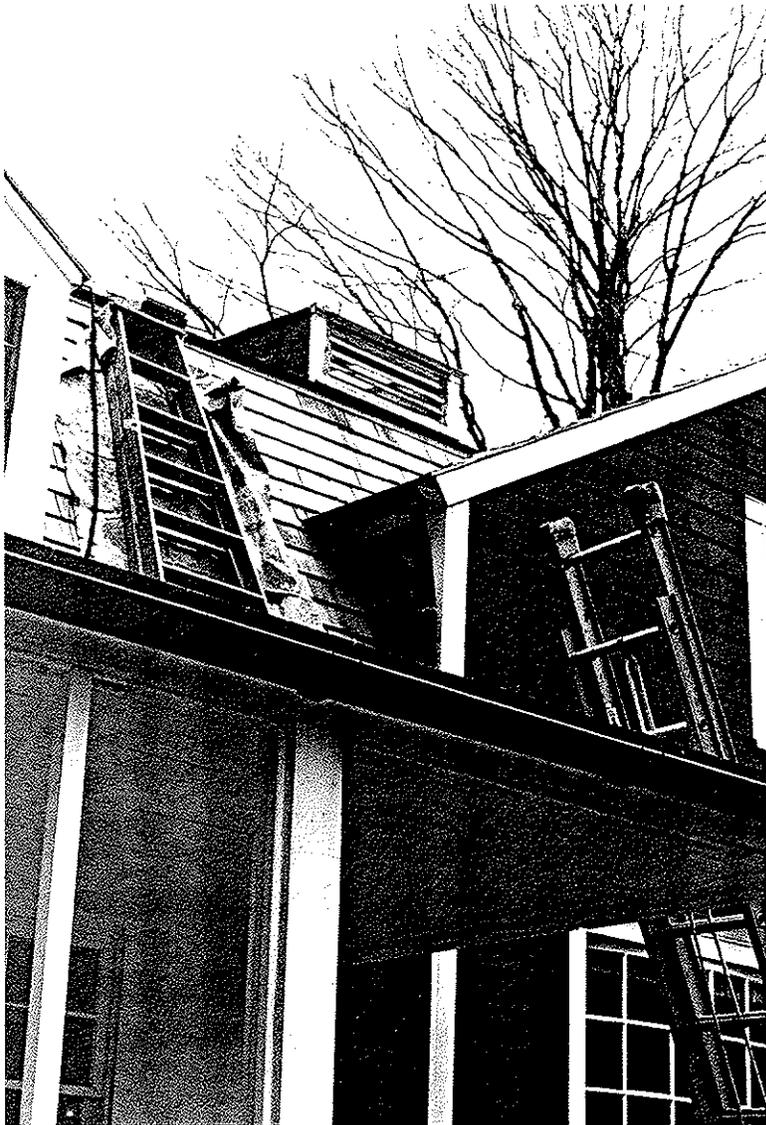
Figure 34. Webb-Burlingham House, South Aspect, Junction of Dining Room Ell Roof (1993).

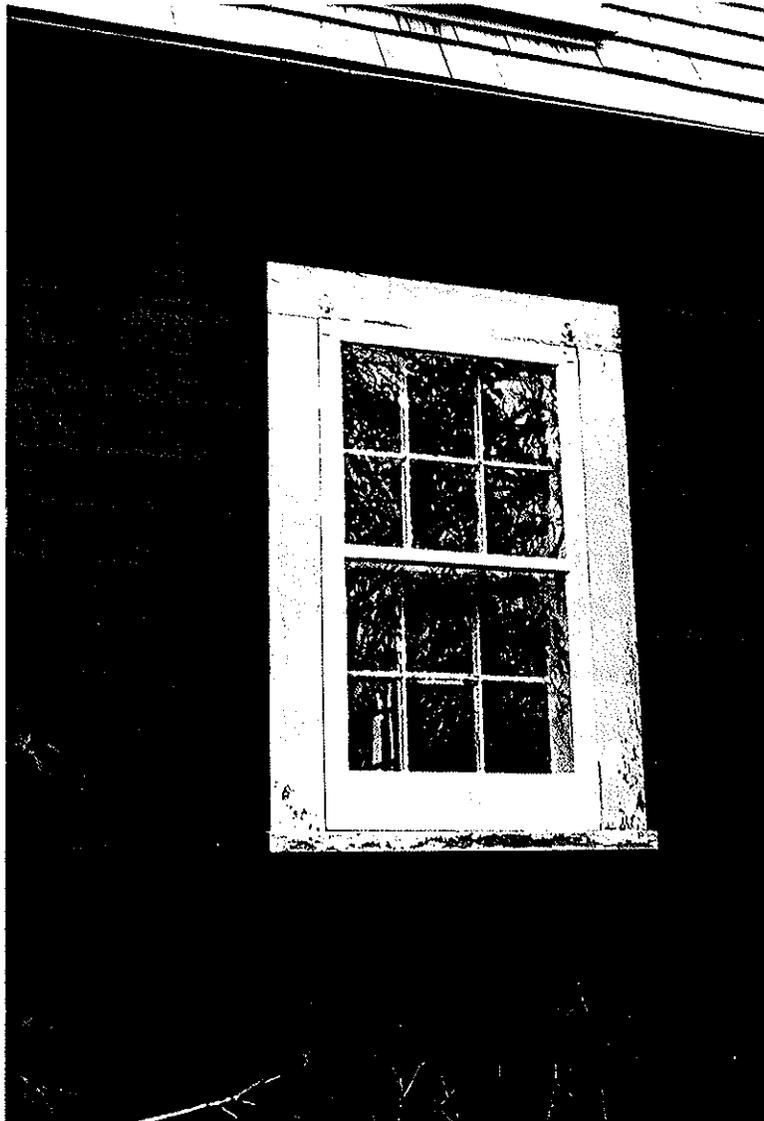
Figure 36. Webb-Burlingham House, Kitchen
E11 North Wall, Window W118 (1993).

Each of the two sash windows on the **first story** (W117 & W118) measures 24 inches wide by 40 1/2 inches high, has a double-hung sash with 12 lights (twelve-over-twelve), and a plain 4 1/2-inch-wide surround (fig. 36).

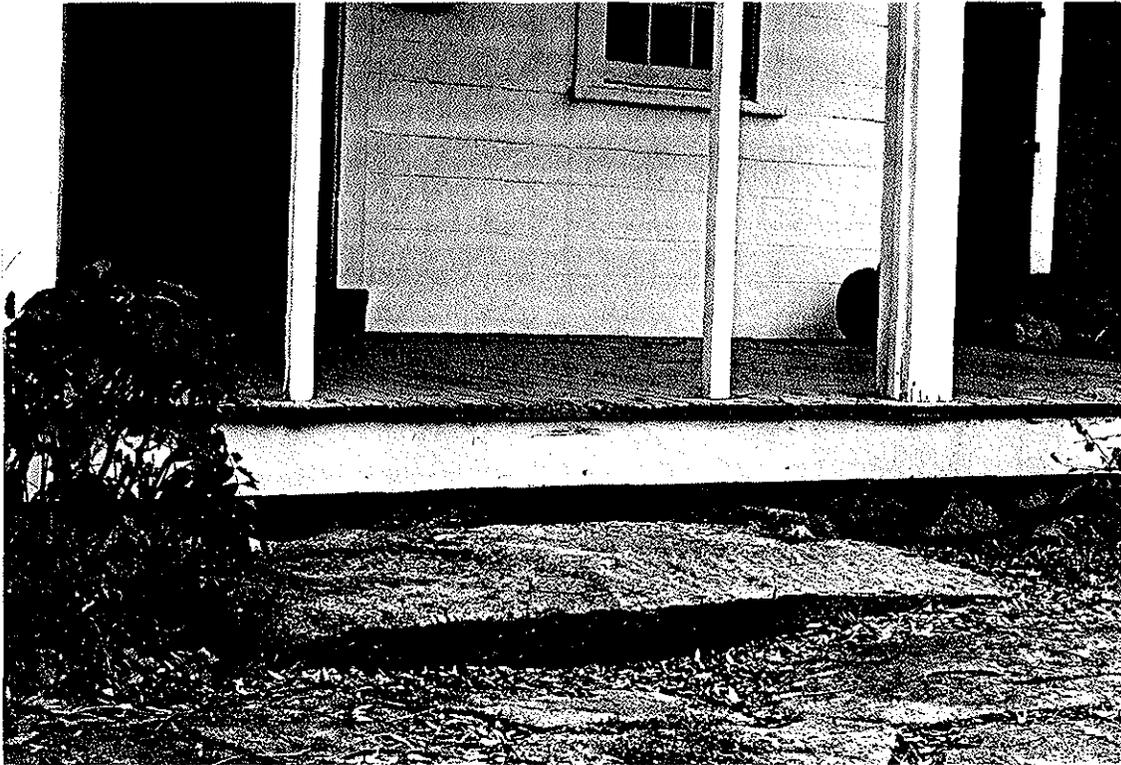
Figure 37. Webb-Burlingham House,
Dining Room Ell, South Porch Foundation (1993).

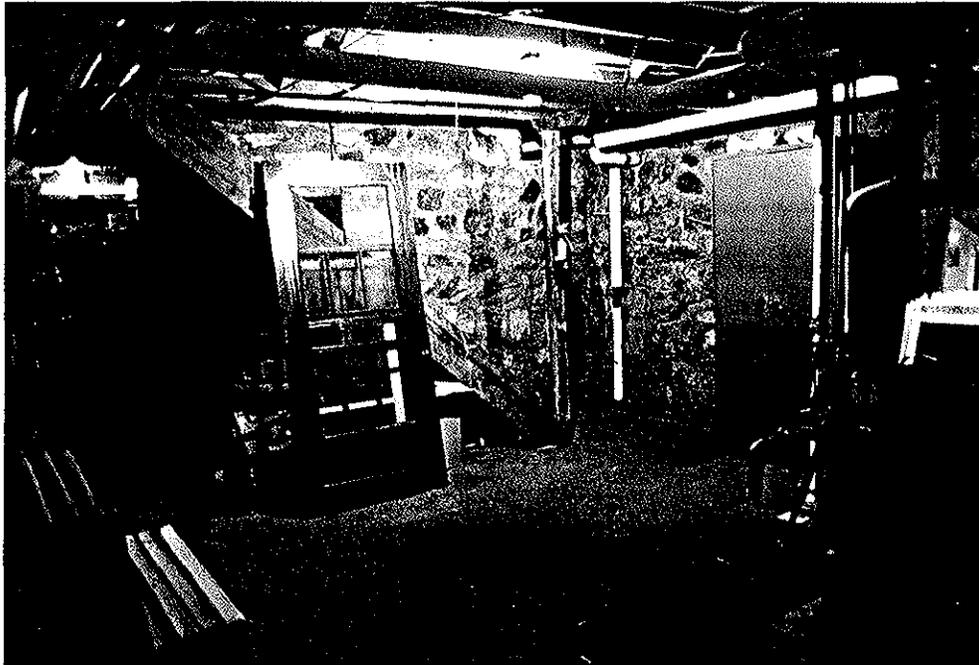
Figure 38. Webb-Burlingham House, Room 001 - Basement, Looking East (1994).

The staircase from the first floor is located along the east wall of the dining room basement, and runs from the north down to the southeast corner of the room. The staircase has an open-stair construction with no handrail (fig. 38)

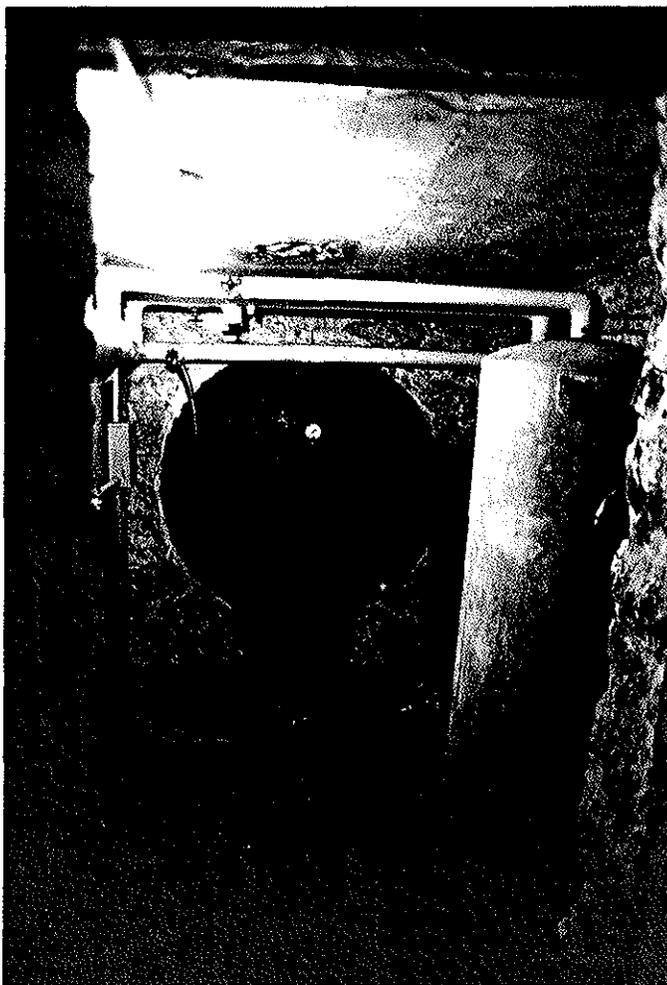
Figure 39. Webb-Burlingham House, Room 001 - Basement, North Wall, Pump Room (1994).

A pump room is located off the northwest corner of the basement (fig. 39). The room is constructed of fieldstone walls

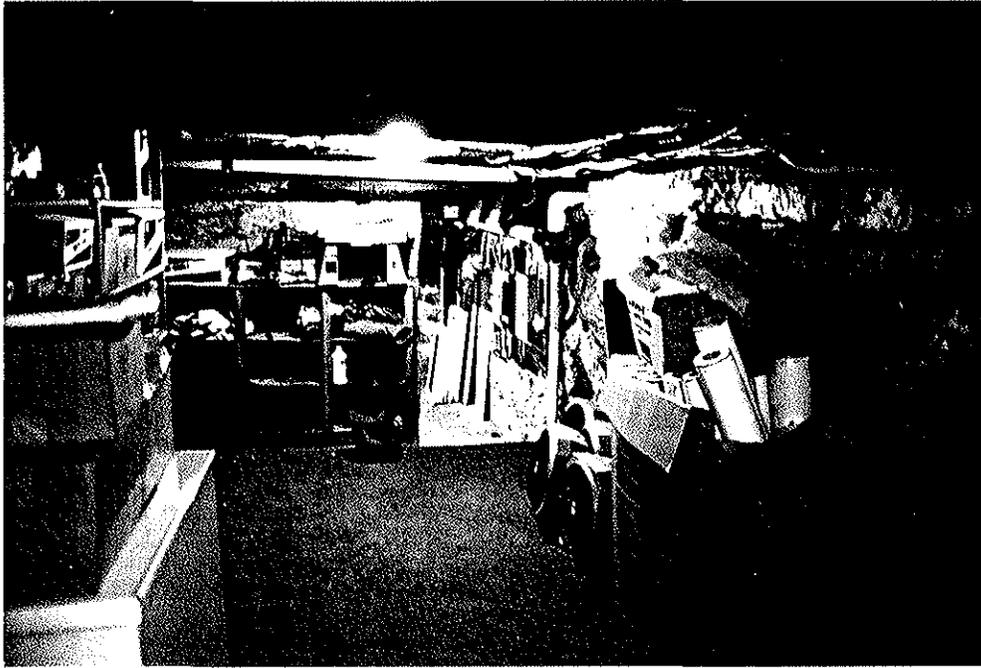
Figure 40. Webb-Burlingham House, Room 003 - Cellar, Looking West (1994).

A cellar and a crawlspace that were part of the original circa-1775 house are located on either side and in front of the original chimney foundation mass. The cellar (R003) occupies the south side of the chimney (fig. 40) and is located under what used to be the kitchen and is now part of the living room. The crawlspace (R004) is located under the original chambers, now the

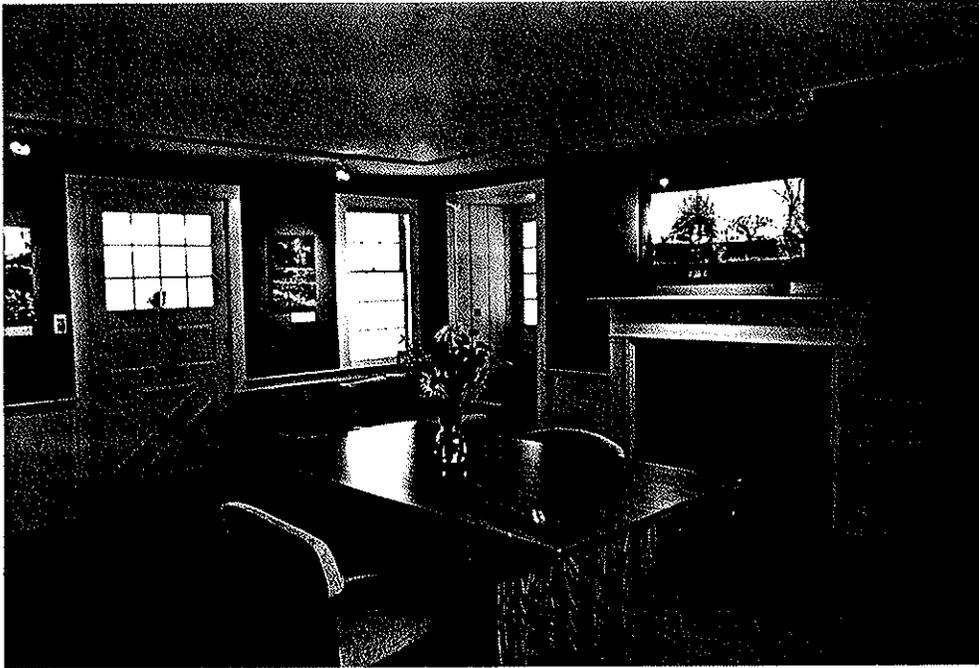
Figure 42. Webb-Burlingham House,
Room 102 - Dining Room, Looking Southwest (1994).

The dining room occupies most of the first floor of the dining room ell that was built circa-1932 (figs. 42 & 43). The room is located in the center of the east/west axis of the house, and measures approximately 15 feet wide by 18 feet deep. Two steps lead down from the stairhall and living room to the east, and the kitchen is located to the west. All features in the room, except

There are five doorways in the dining room. An exterior entrance doorway (D101) is centered on the south wall of the room (**fig. 42**). This opening is fitted with a half-glass door.

A fireplace is centered on the west wall of the dining room. The opening measures 3 feet wide by 2 feet 10 inches high. The firebox, which is 1 foot 6 inches deep, is constructed of red brick that has been painted black, and has a stone floor. The fireplace has a stone hearth that measures 4 feet 4 inches at its widest point and 2 feet 3 inches at its deepest. It is composed of a rectangle made up of two large pieces of granite, with a semi-circle extending into the room composed of three pieces of granite. The fireplace has a Colonial Revival style mantel that measures 6 feet 5 inches long and 4 feet 4 inches high (fig. 42).

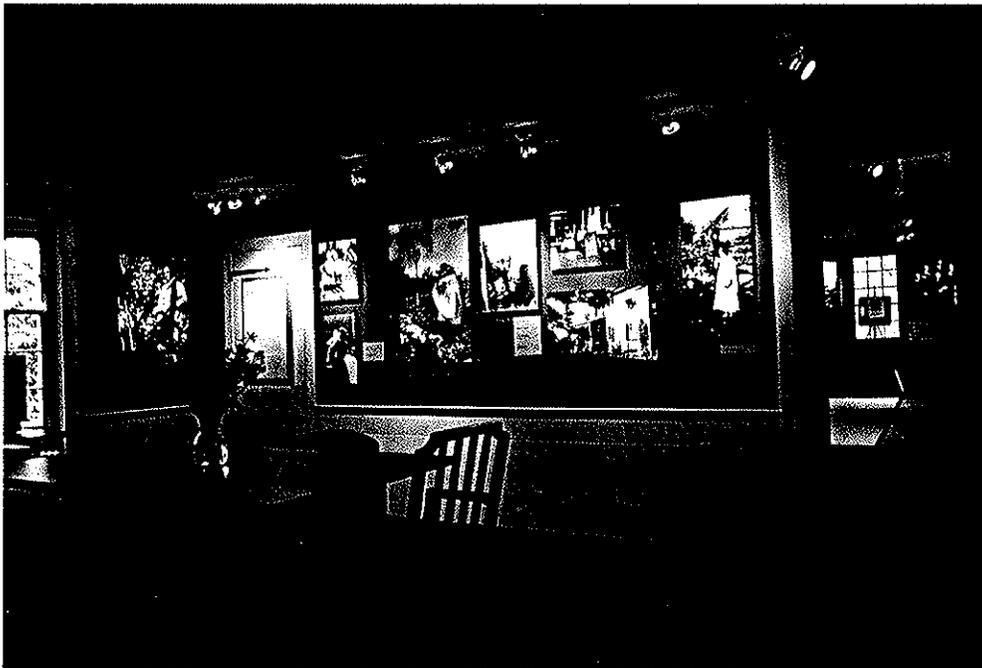
Figure 43. Webb-Burlingham House,
Room 102 - Dining Room, Looking Northeast (1994).

Two doorways are located on the east wall of the room: one at the south end of the wall (D109), which leads from the stair landing and has no door; and a second located at the north end of the wall (D108) that opens into a back hall (**fig. 43**). Doorway D108 measures 2 feet 6 inches wide by 6 feet 5 1/2 inches high, and is fitted with a door constructed of tongue-and-groove pine boards approximately 11 inches wide each. These boards are mounted vertically using two horizontal pine boards as support on the back hall side of the door. This is the standard-style door used throughout the house, and replicates what are thought to be original

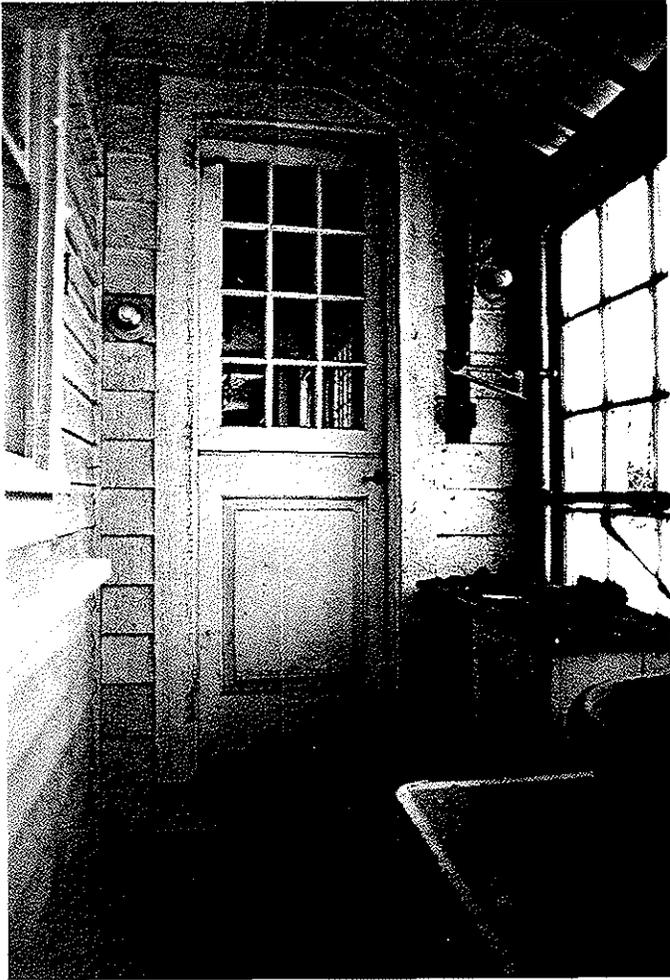
Figure 45. Webb-Burlingham House,
Room 103 - Greenhouse, Looking East (1994).

The greenhouse is located on the south exterior wall of the kitchen ell (figs. 45 & 46). It was designed by F. Nelson Breed and was constructed in 1938, approximately five years after the kitchen and dining room ells were built. The room measures 10 feet long by 4 feet wide. The only entrance into the greenhouse is on the west wall from the dining room. There is a step down from the doorway to a 3-foot-square wood platform, and another step down from the platform to a stone floor.

east wall and leading from the dining room (see subsection "Doorways" in section "Room 102 - Dining Room, above). The door has a brass hand latch, and hardware for a non-extant screen door is mounted on the surround (fig. 45).

A small cupboard with a sink is located on the platform level at the east end of the south wall of the greenhouse (fig. 45). Two-foot-deep potting counters line the remainder of the south wall and the west wall (fig. 46). The counters are composed of spaced 4-inch boards with 6-inch-high sides, over a frame that is supported by 1 1/2-inch steel pipe.

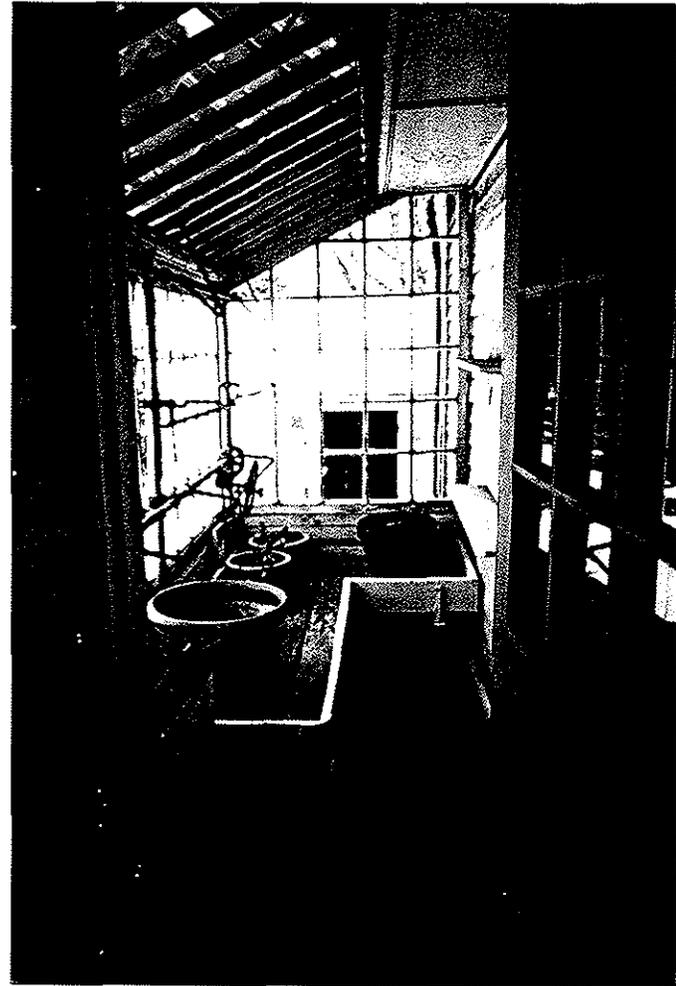
Figure 46. Webb-Burlingham House,
Room 103 - Greenhouse, Looking West (1994).

The upper half of the west and south walls of the greenhouse are fully glazed (fig. 46).

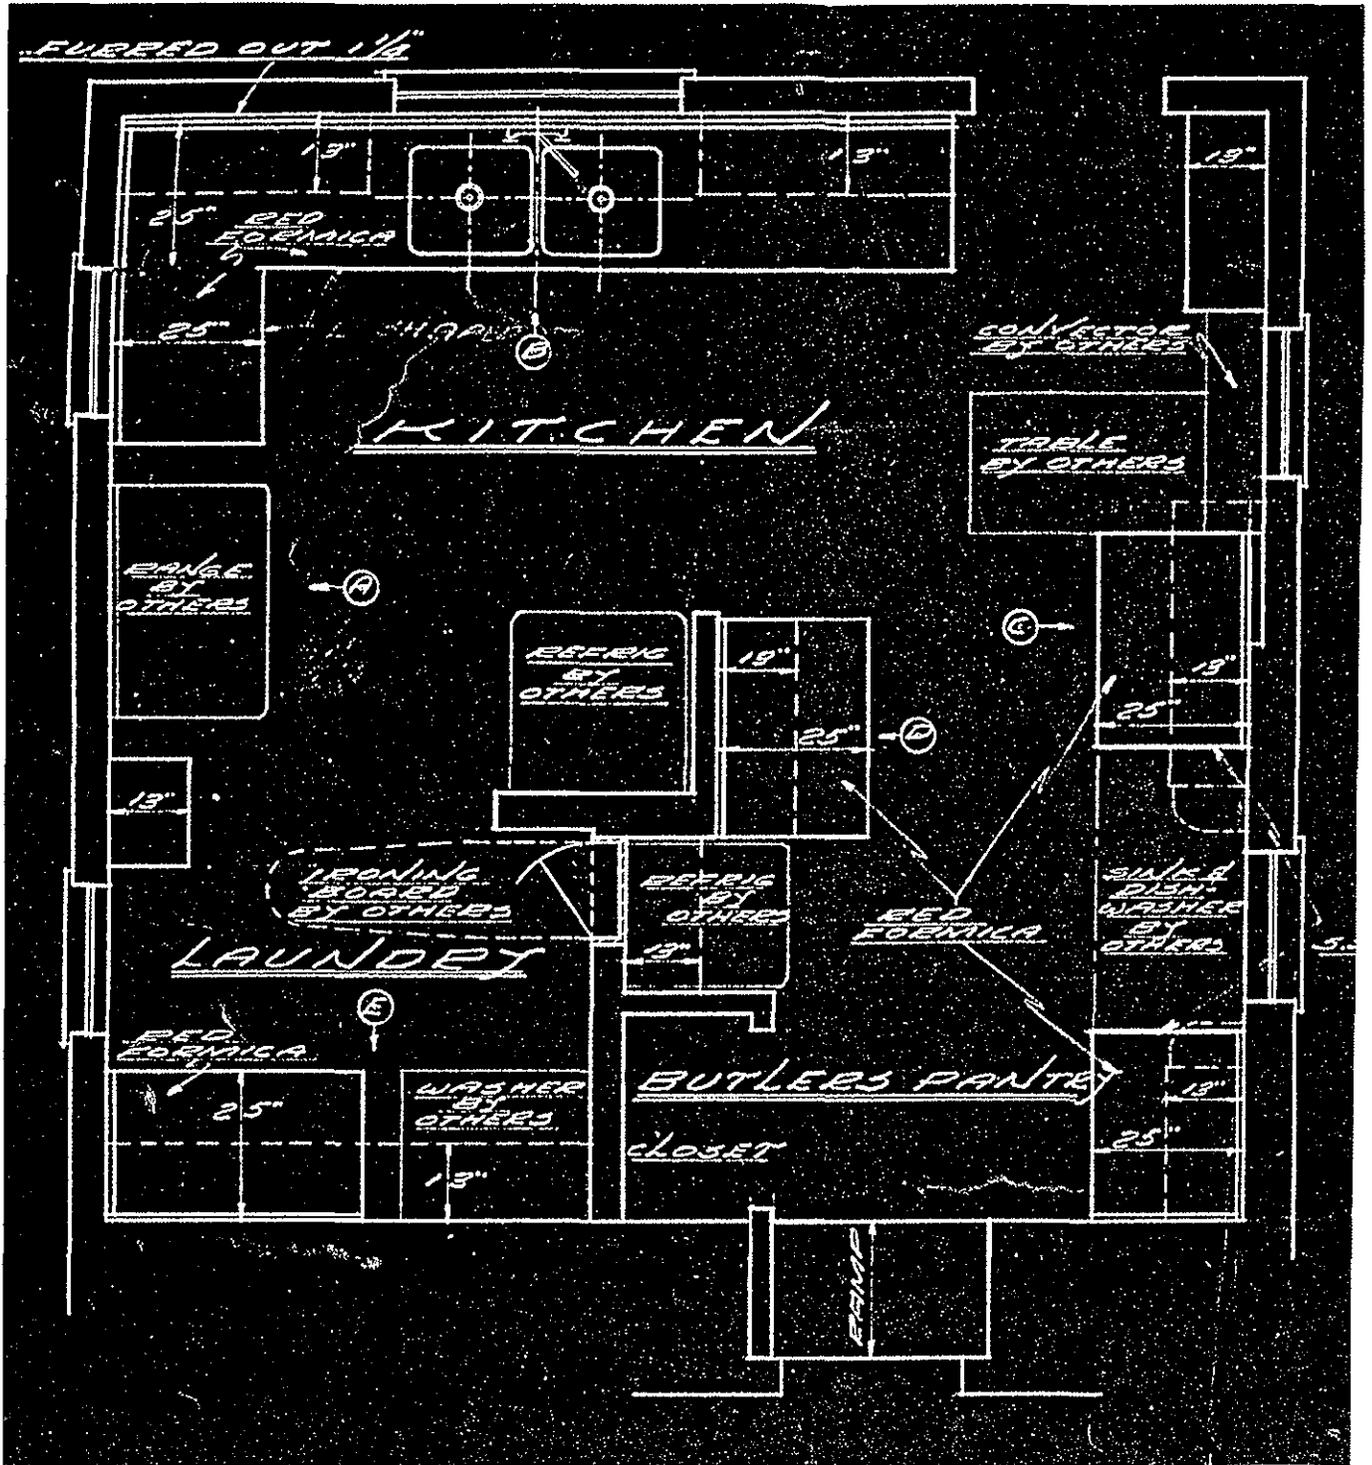
Figure 47. Portion of Drawing of Altered Kitchen Layout for Webb-Burlingham House Dated 11/7/47, Marked "Approved as Noted - F. N. Breed - 11/25/47".

The kitchen is divided into three areas around an east/west partition that runs from the east wall to the center of the room, as can be seen on F. Nelson Breed's 1947-1948 plans (fig. 46a).⁵¹ The first area is on the north side of the room and is referred to on the plans as the butler's pantry (fig. 47). Doorway D107 from the dining room, on the pantry's east wall, is the only interior access to the kitchen. The butler's pantry contains a closet, cupboards, sink, dishwasher, and spaces for a refrigerator and a table. The west side of the room is the cooking and preparation

White enamel wall and floor cabinets line the walls of all three areas of the kitchen (fig. 46a). The cabinets have red formica counters and are trimmed with chrome.

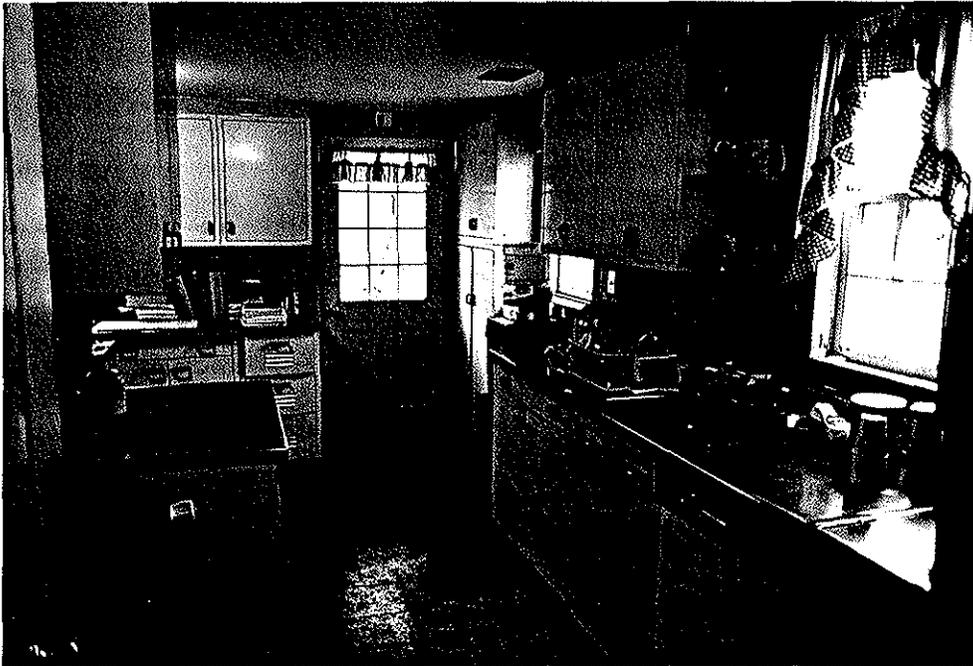
Figure 48. Webb-Burlingham House, Room 104 - Kitchen,
Looking West, Butler's Pantry (1994).

area, in which is found additional cupboards, a second sink, and a stovetop and ovens (fig. 48). The southeast corner of the room is referred to on Breed's plans as the laundry area, and contains cupboards, a pull-down ironing board, and space for a washing machine (fig. 49).

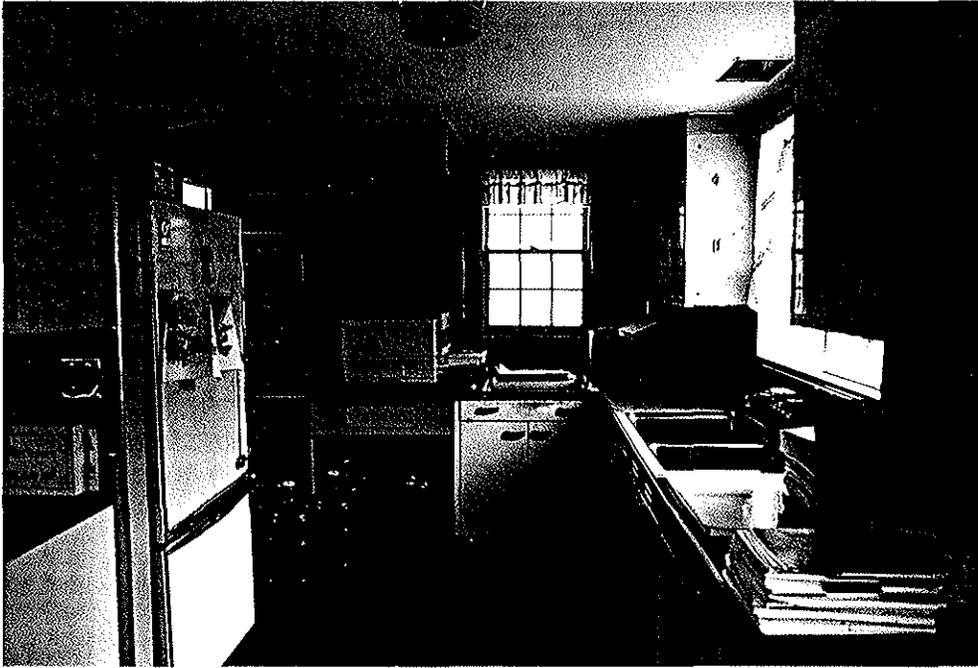
Figure 49. Webb-Burlingham House, Room 104 - Kitchen,
Looking South, Kitchen Area (1994).
