**WEIR FARM
HISTORIC STRUCTURES REPORT**

**Weir Farm National Historic Site
Wilton, Connecticut**

Burlingham Complex

1995

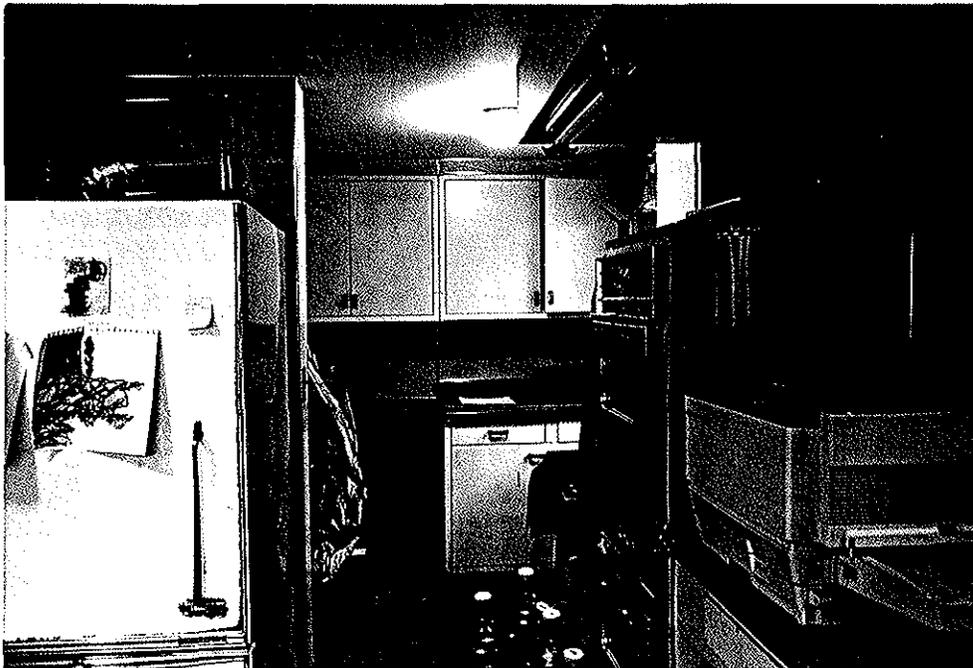
Figure 50. Webb-Burlingham House, Room 104 - Kitchen,
Looking East, Laundry Area (1994).

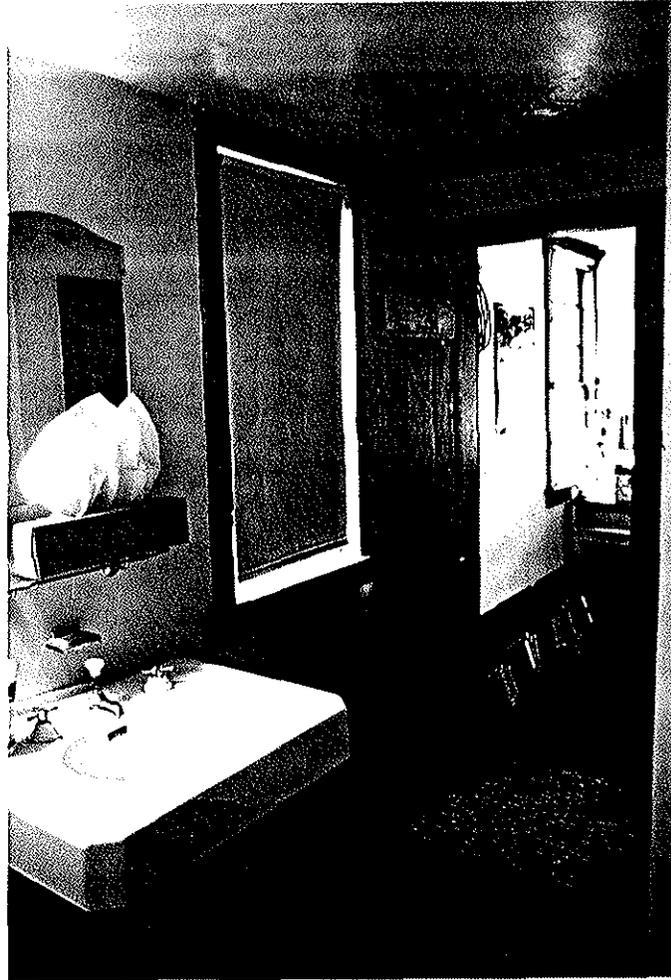
Figure 51. Webb-Burlingham House,
Room 106 - Bathroom, Looking East (1994).

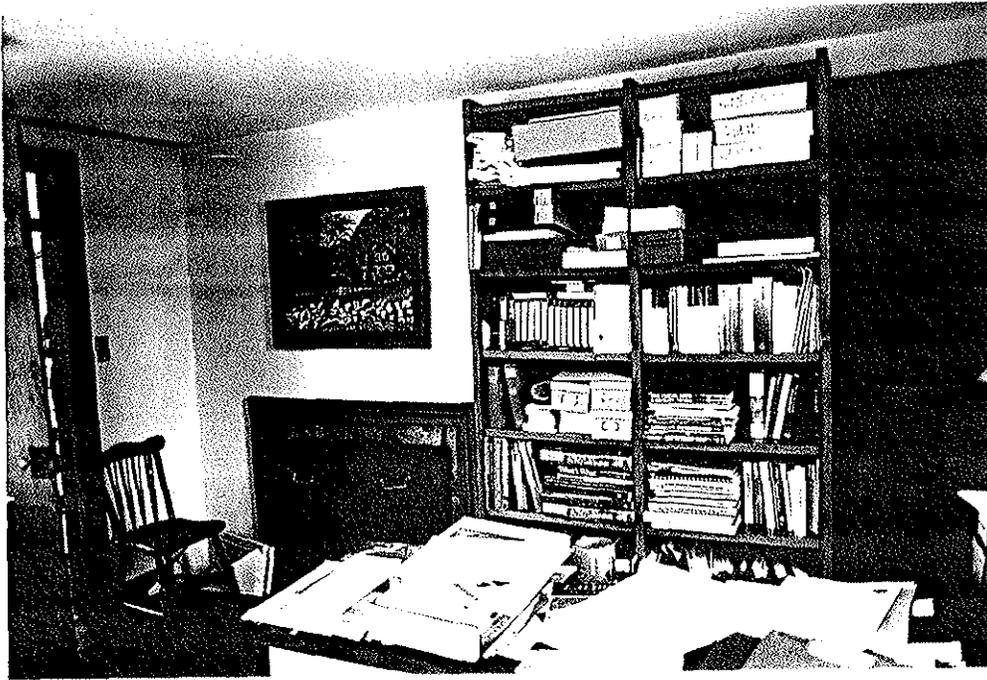
Figure 52. Webb-Burlingham House,
Room 107 - Study, West Wall (1994).

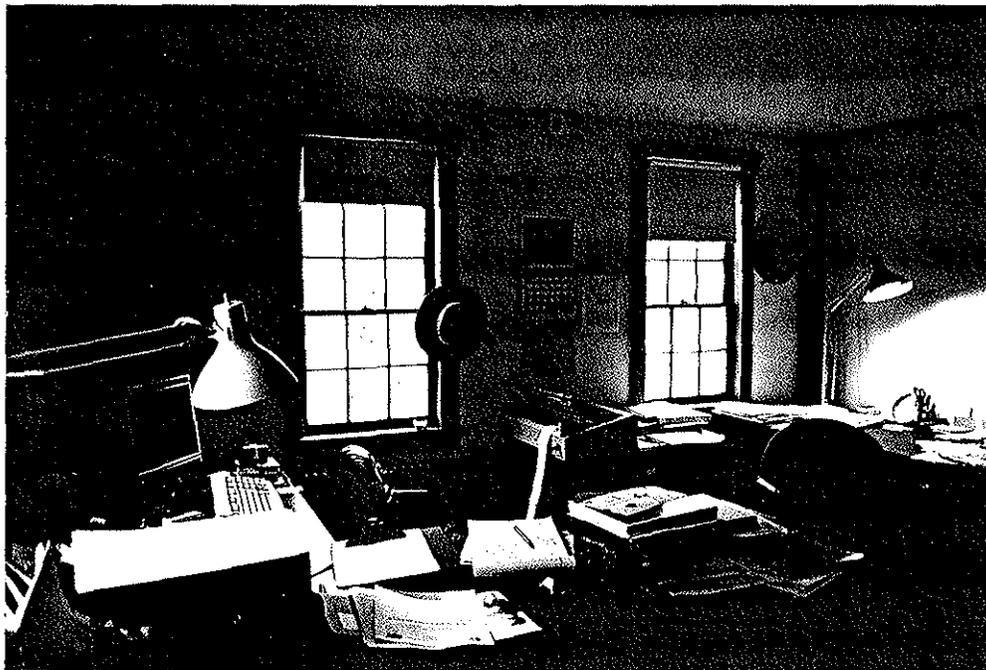
Figure 53. Webb-Burlingham House,
Room 107 - Study, East Wall (1994).

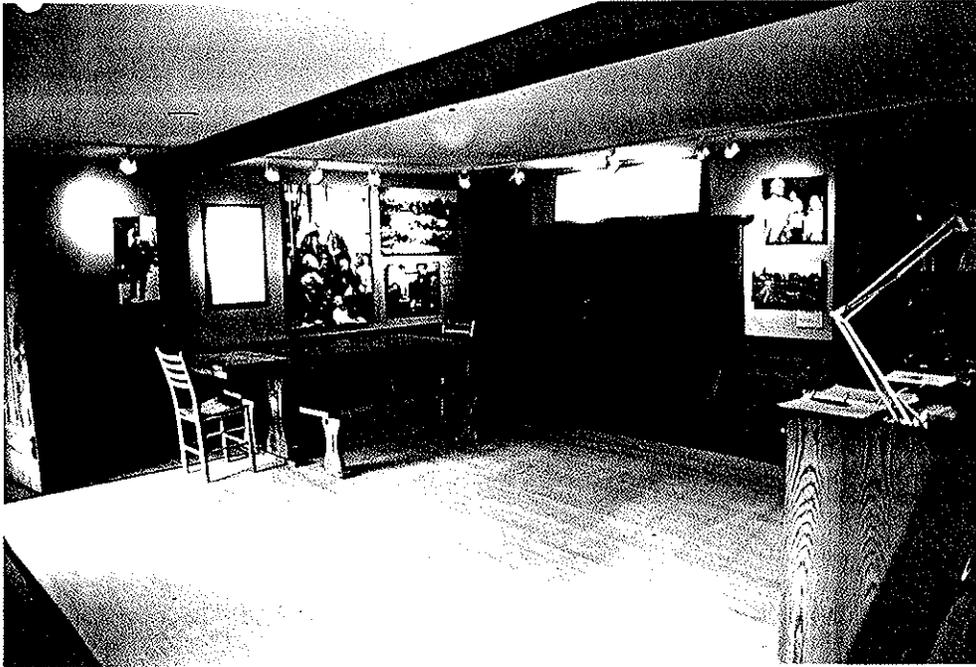
Figure 54. Webb-Burlingham House,
Room 108 - Living Room, Looking Northwest (1994).

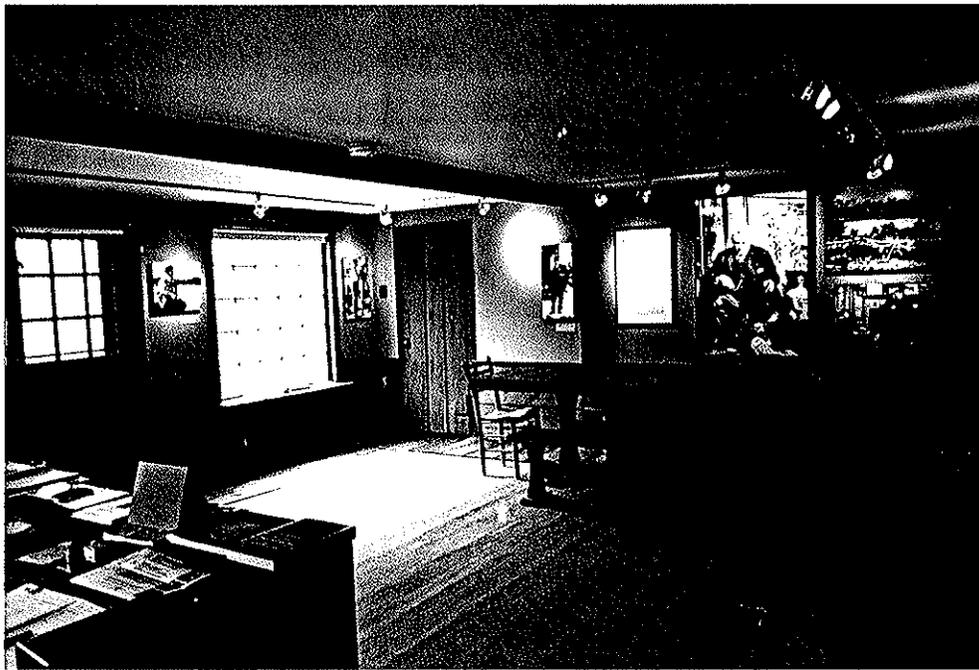
Figure 55. Webb-Burlingham House,
Room 108 - Living Room, Looking Southwest (1994).

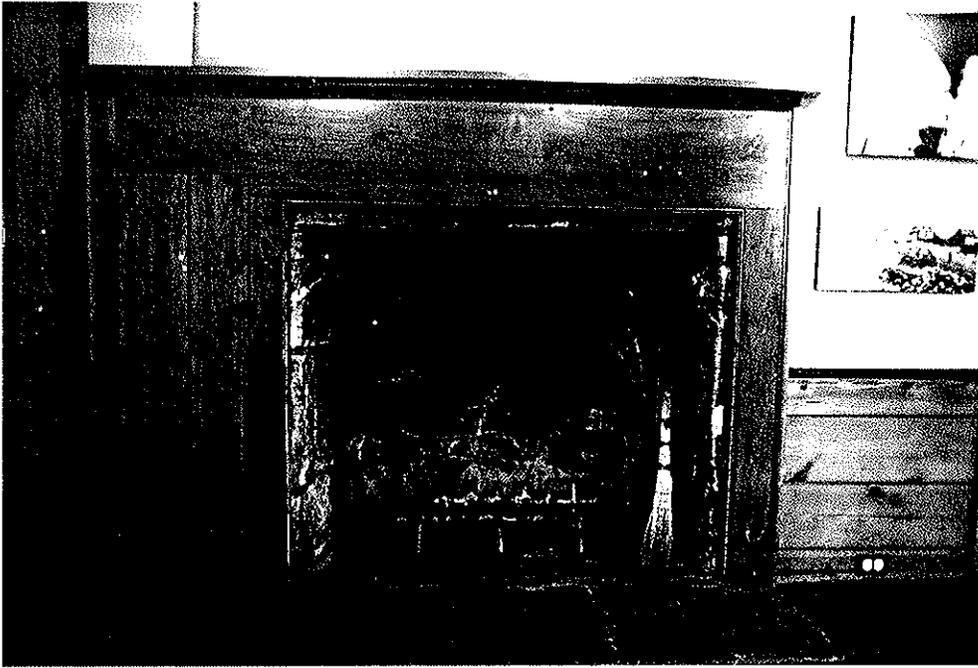
Figure 56. Webb-Burlingham House, Room 108 -
Living Room, North Wall Fireplace (1994).

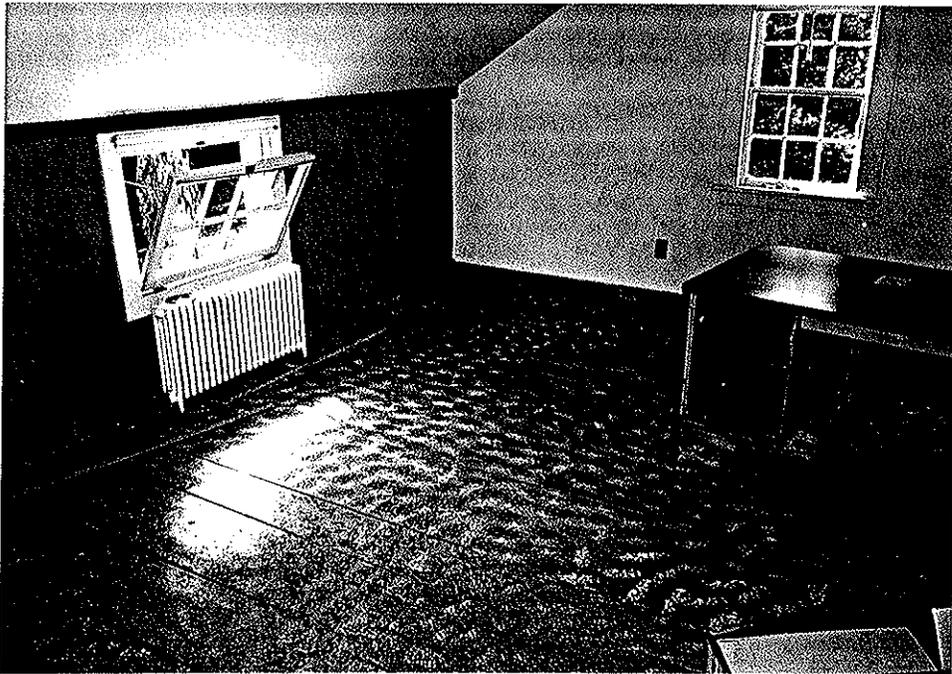
Figure 57. Webb-Burlingham House, Room 210 -
Master Bedroom, Floor With Decorative "Scrambled" Painting (1992).

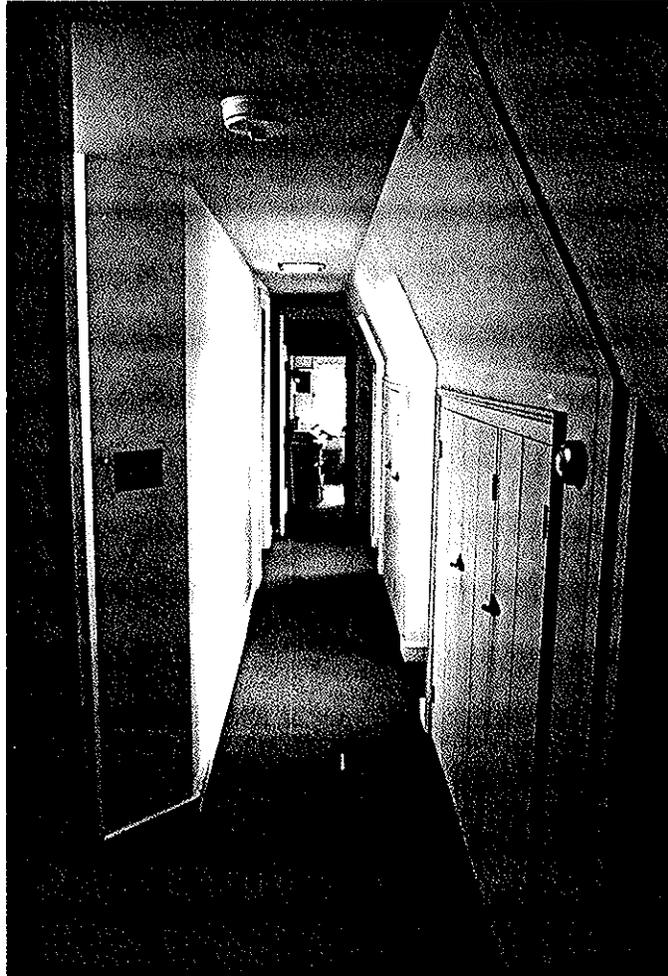
Figure 58. Webb-Burlingham House,
Room 201 - Center Hall, Looking West (1994).

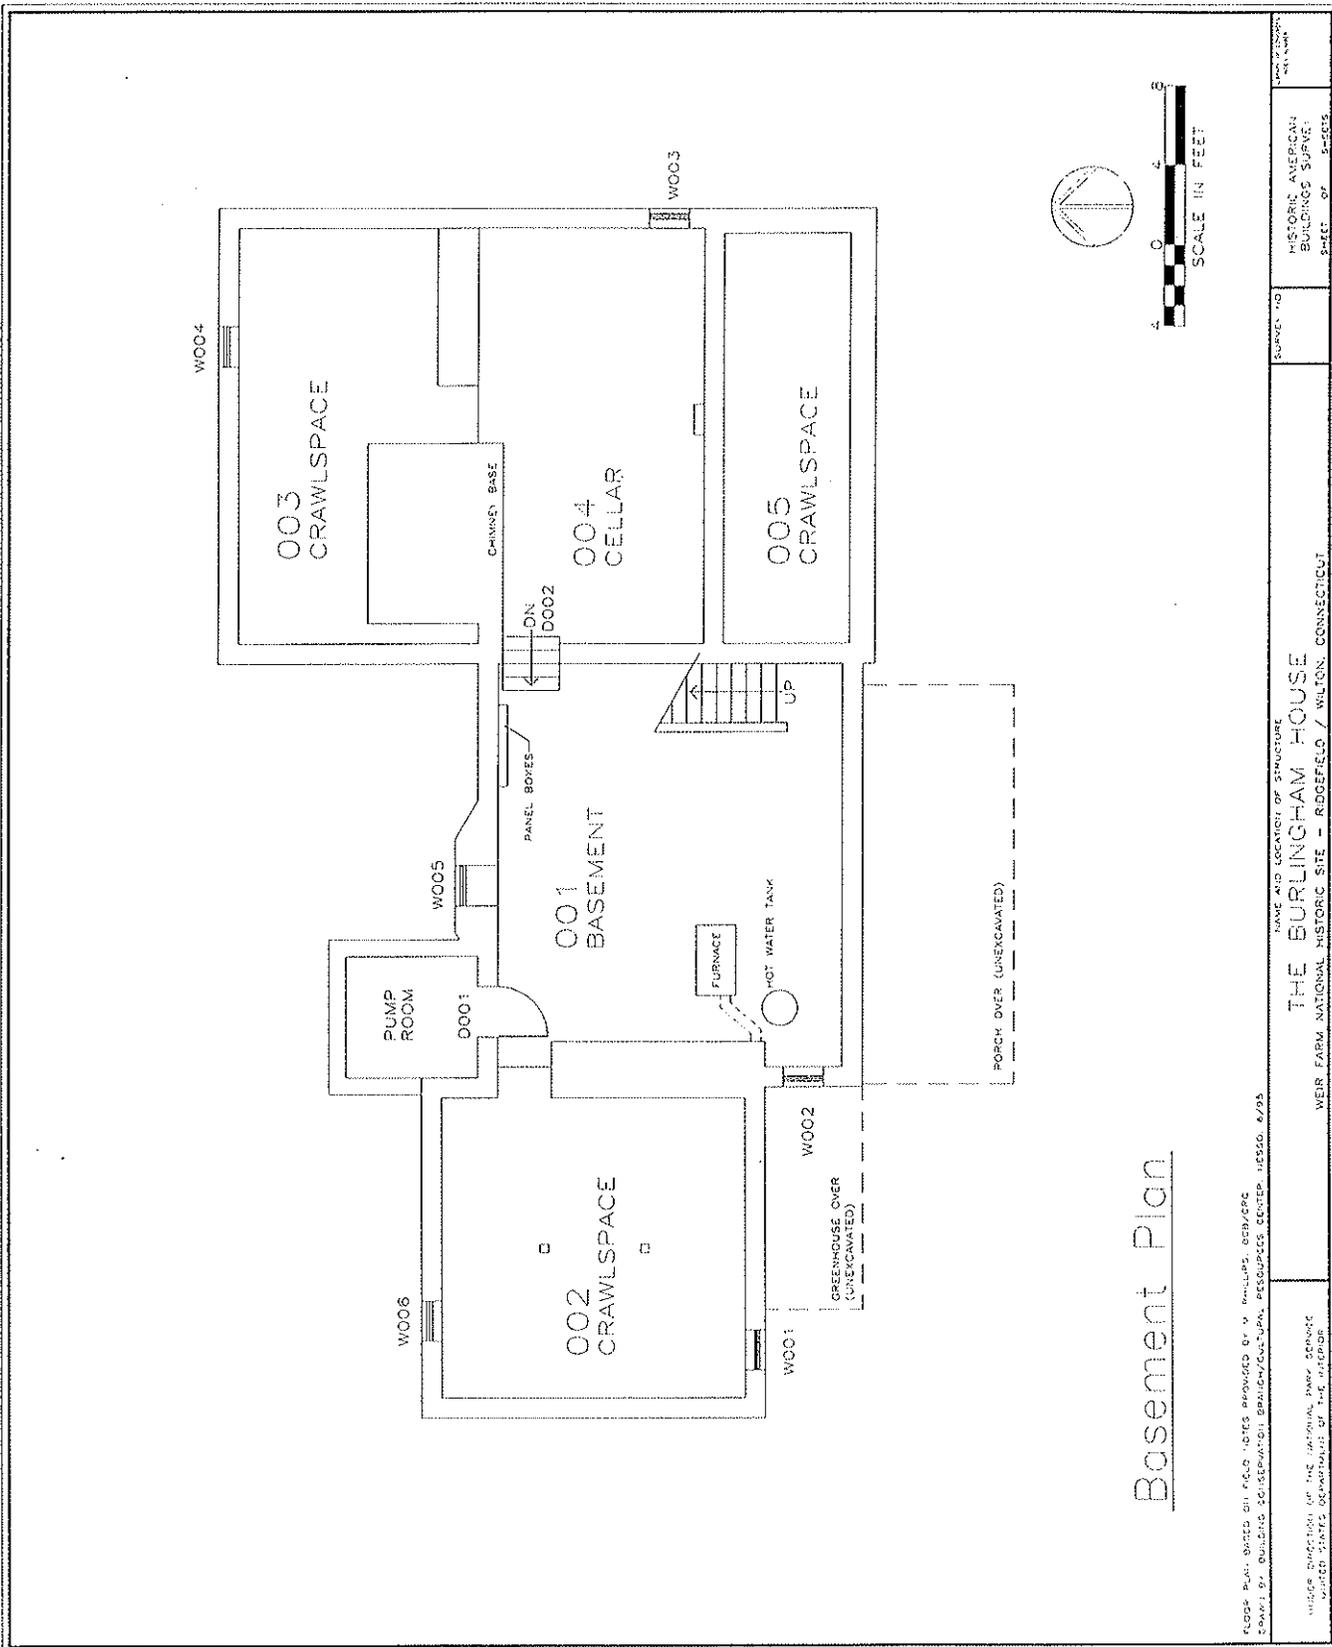
Basement Plan

FLOOR PLAN, BASED ON FIELD NOTES PROVIDED BY W. PHILLIPS, ARCHITECT
 DRAWN BY: BUREAU OF HISTORIC ARCHITECTURE, NATIONAL HISTORIC LANDMARKS CENTER, WASHINGTON, D.C.

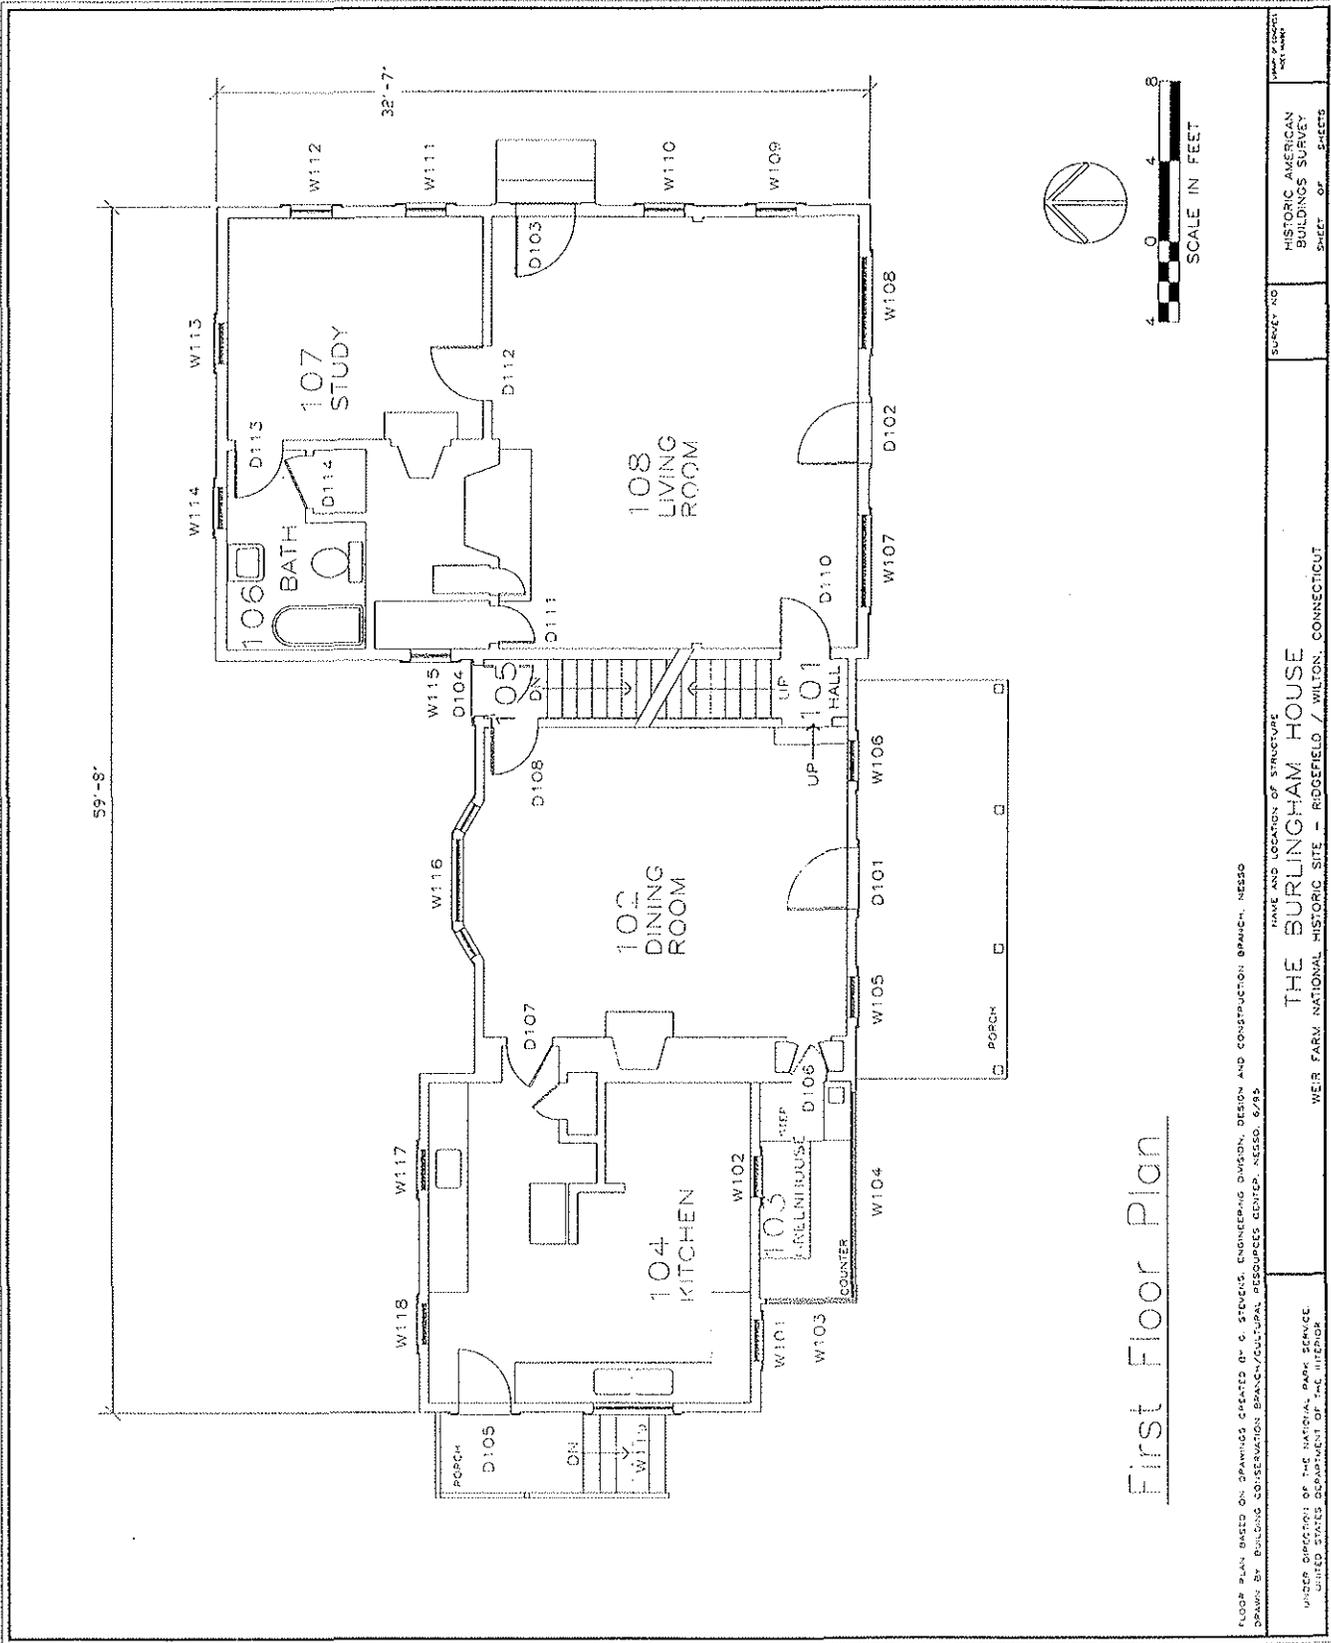
First Floor Plan

FLOOR PLAN BASED ON DRAWINGS CREATED BY G. STEVENS, ENGINEERING DIVISION, DESIGN AND CONSTRUCTION BRANCH, NESCO
 DRAWN BY BUILDING CONSERVATION BRANCH/CULTURAL RESOURCES CENTER, NESCO, 6/89

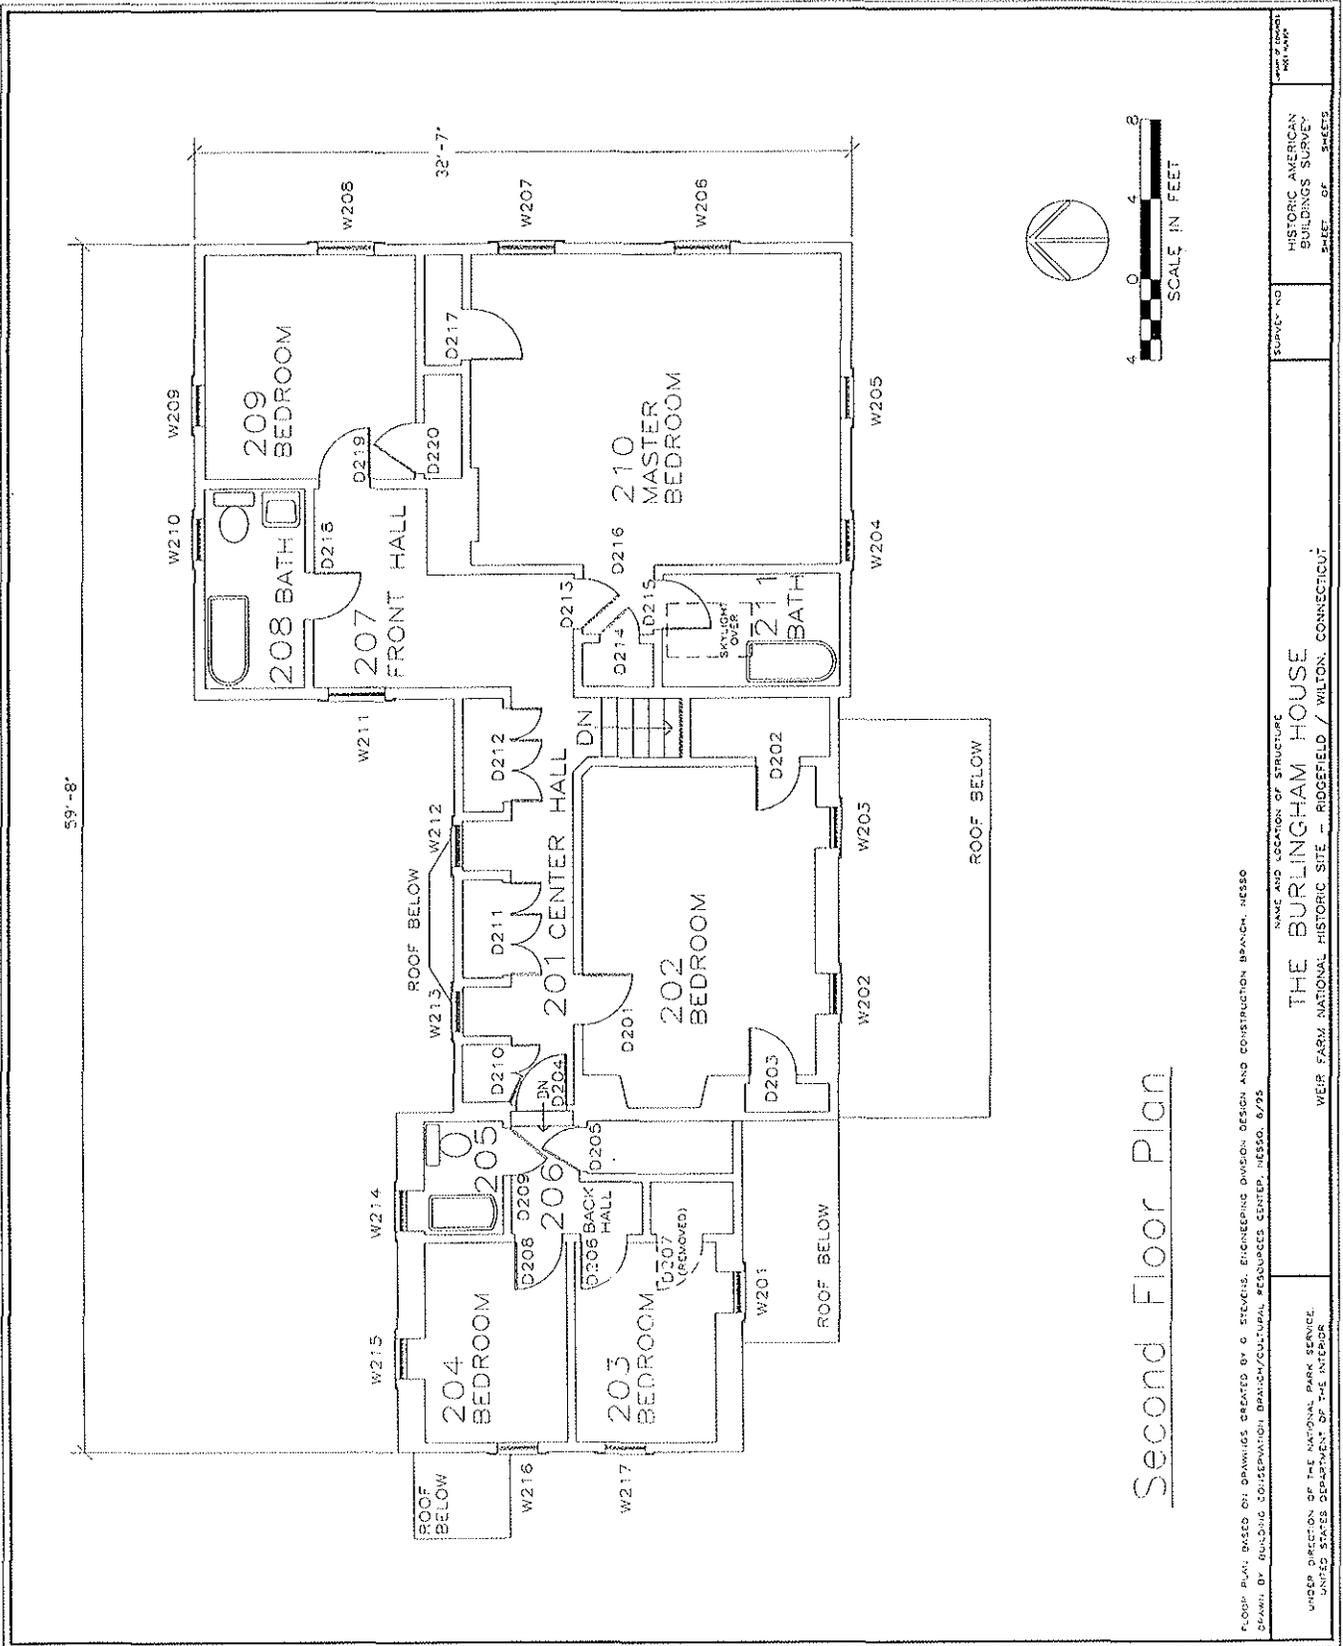
Second Floor Plan

FLOOR PLAN BASED ON DRAWINGS CREATED BY G. STEVENS, ENGINEERING DIVISION, DESIGN AND CONSTRUCTION BRANCH, NCSBO
 DRAWN BY: BUILDING CONSERVATION BRANCH/CULTURAL RESOURCES CENTER, NCSBO, 6/75
