Whiskeytown Visitor Center VOLUME 2

HISTORIC STRUCTURE REPORT | AUGUST 2022

II: Appendices

Appendix A: Original As Built Drawings

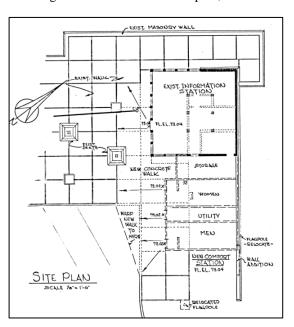
Images 13 and 14: Site Plan as designed in 1965, and with restroom addition in 1983.

⁵ See images 13 and 14.

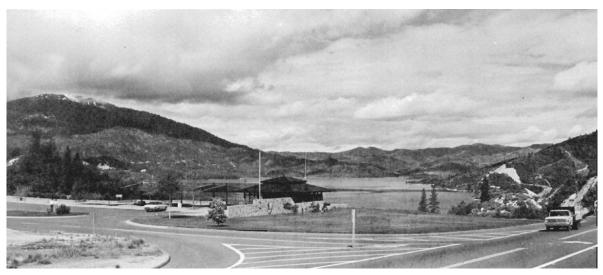
Image 15: Visitor Center Site circa 1972. Note the historic location of the flagpole and NPS arrowhead on the stonewall. Image looking west. Source: National Park Service, *Master Plan for Whiskeytown National Recreation Area*, Denver Service Center.

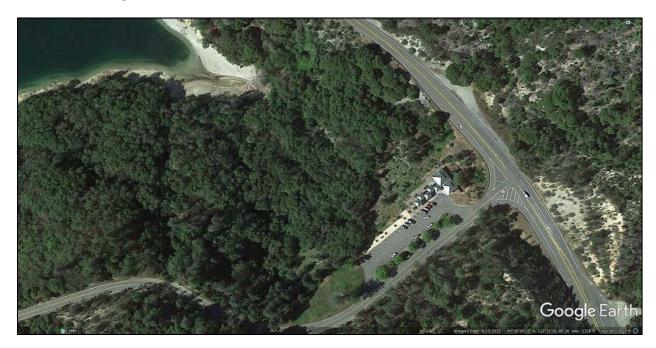
Image 16: Ariel view of the Whiskeytown Visitor Center Site, April 15, 2015. Image courtesy of Google Earth.

A canopy of five connecting, staggered hipped roofs resting on centered square metal posts provides shade to visitors. Custom wrap-around wood slat benches are situated around two of the canopy supports. The interlocking canopy connects to the northwest corner of the front façade of the main block, providing a covered entry into the building. The smaller, single hipped roofs of the canopy echo the motif of the main structure down the courtyard, connecting the site as a single unit (see image 16).

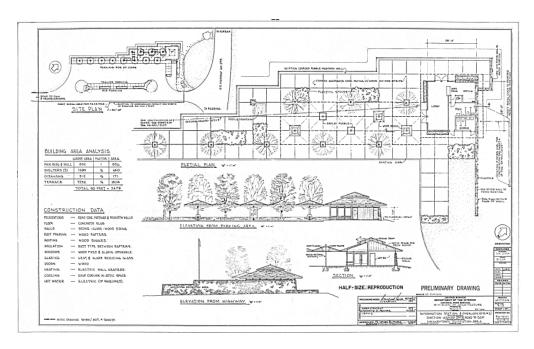
Image 17: Preliminary Drawing. RM Smith, NPS WODC RA-WHI 3018c, 1963.

design was accented by trees, and all of it maintained a low enough profile not to overwhelm the view of the lake and surrounding landscape. (see images 17 and 18). Everything from the parking lot to the building was designed to engage the visitor, and offer a sense of place among the natural resources of the newly established Whiskeytown National Recreation Area. ¹²

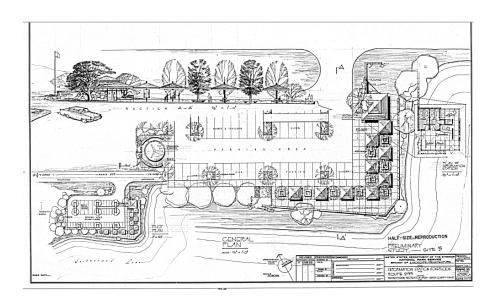
Image 18: Preliminary Study of the Whiskeytown Visitor Center. NPS WODC Drawing RA-WHI 3018A, 1963.

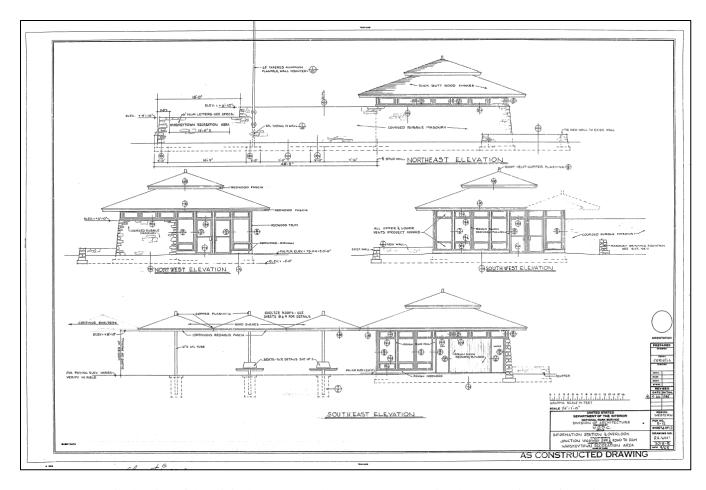
Image 19: As-Built drawing of the original structure and canopy. Source: National Park Service, "Information Station and Overlook" RA-WHI Architectural Drawing. As Constructed Drawing, September 1965.

Wide eaves extend from the low-pitched hipped roof, which is covered in green enameled standing-seam metal. A second hip rises above the first allowing for attic ventilation (see images 19 and 21). A copper clad plumbing vent pierces the peak, and is designed to match the steel post protrusion on the courtyard shelters. Currently, the building's HVAC unit is installed on the western slope, and series of solar panels are attached to the south slope.

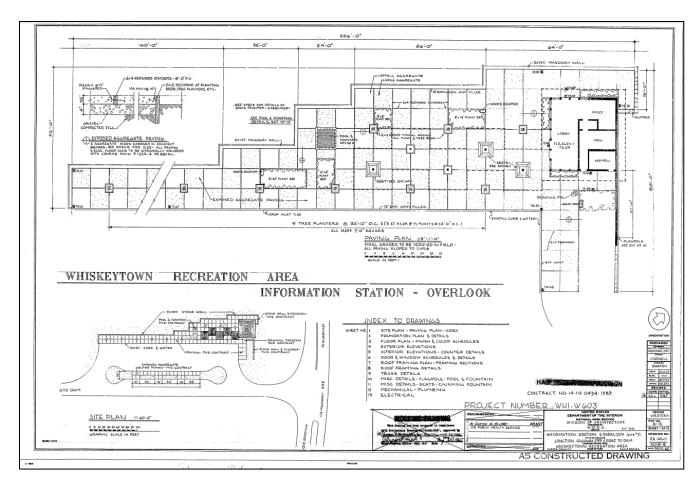
Image 20: Site-Plan for the Whiskeytown Visitor Center. Source: Smith, et al, *Information Station and Overlook*, As Constructed Drawing, NPS RA- WHI 3018B, 1965.

passenger vehicle spots are located along the courtyard curb. The parking configuration, traffic flow, and landscaping appear to match the original design of the site (see images 20 and 25).

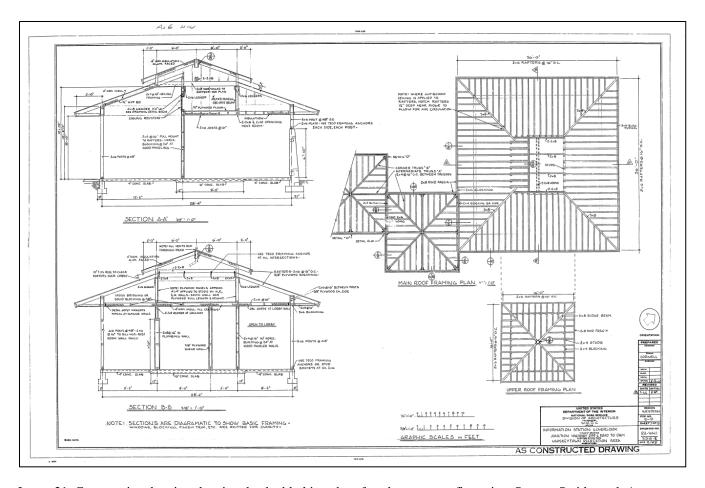
Image 21: Construction drawing showing the double-hipped roof, and canopy configuration. Source: Smith, et al, As Constructed Drawing, NPS RA- WHI 3018B, 1965.

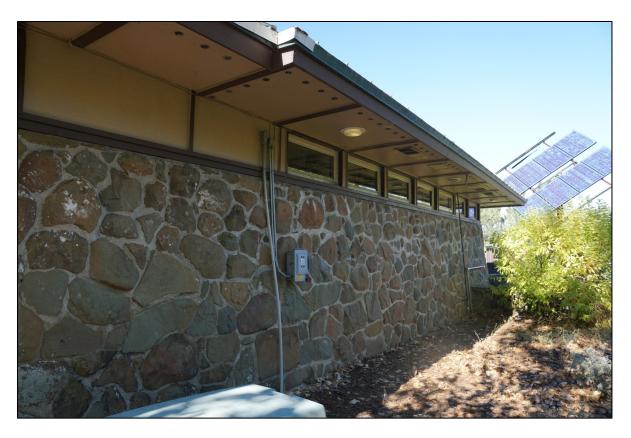
Image 22: Rear wall showing mortared stone work and pole mounted solar panel in the northwest corner. Photo by Ashley Phillips, 2016.

The Visitor Center site has been altered since its original construction. The building was originally a small 812 square-foot structure that contained a public lobby, men's and women's restrooms, and an office (See image 11).² Changes to the main structure include replacement of thick cedar shakes with a green standing seam roof in 2006 and the installation of solar panels in 2001.³ An AC unit was also installed on the west slope at an unknown date (the unit was previously located in the attic space). In 2009, the original medium-bronze anodized aluminum windows were replaced with low-e white vinyl sash. The historic double door replacement with windows on the west elevation, and reduction to a single swinging door on the south, may have been done during the same project as the window replacement. The interior layout was opened up and reconfigured when the restrooms and office were relocated in an addition in the 1980s. The space now functions as a large public lobby. The current exhibit displays and information booth were added during the remodel, and are not historic (see images 11 and 12). The courtyard remains relatively intact, with a few reversible changes: At an unknown date, the fountain was repurposed as a planter, seven Sycamore (possibly Liquid Amber) trees that were historically planted in an alternating pattern around the courtyard, juxtaposing the staggered hipped roofs, were removed, and their 18" planting squares filled in with concrete. ⁵ An additional four Oak trees and Red Bud shrubs were replanted and 4500 square feet of concrete path leading from the courtyard towards the south were replaced in 2014 using the same design as the original, but with a modern concrete mix that doesn't quite match the historic (see image 24). The Kentucky Bluegrass and Meadow Fescue turf lawn behind the building was replaced with a native plant garden in 2000; the welcome sign was installed in 2000; the split-rail fence, propane tank, and radio station solar panels were installed sometime in the 2000's as well (see images 22, 29, and

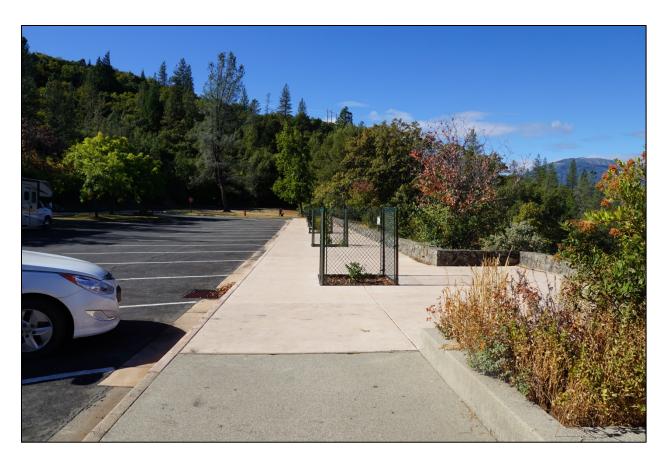
Image 24: Looking south down the courtyard. Newly planted trees and replaced concrete are visible. Photo by Ashley Phillips, 2016.

the visitor center and steps-in until it straightens out down a concrete path that terminates at a picnic table and trailhead leading down to the lake. Four newly planted trees in temporary chain-link cages line the middle of the concrete path (see image 24). A set of non-historic bear-proof recycling and trash receptacles is located near the curb on the north end of the terrace; another set is located by the canopy and is flanked by a pair of modern green banner posts (see image 32). A series of exhibit and interpretive tools of unknown dates are dispersed throughout the courtyard. A large map and fee station are installed under the canopy, and a coinoperated telescope, an often photographed wood "Whiskeytown Lake" sign, and numerous interpretive panels are located along the stone wall overlooking the lake. Interpretive panels, although not included in the original design drawings, are essential elements to a Mission 66 visitor center, and are a character-defining feature at Whiskeytown.

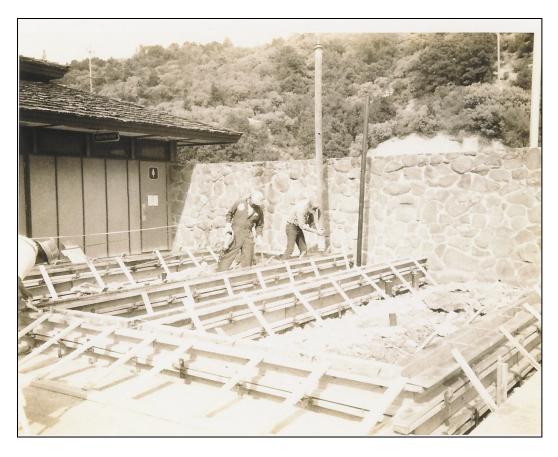
Image 26: 1980s removal of historic flagpole, and construction of restroom addition. Phot courtesy of Whiskeytown National Recreation Area.

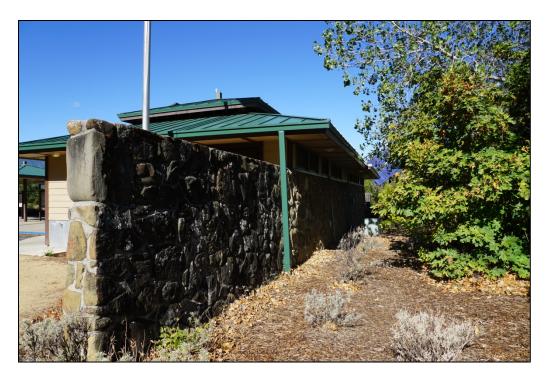
$Image\ 27: Stone\ wall\ extension\ beyond\ addition.\ Differentiation\ in\ stone\ color\ is\ visible.\ Photo\ by\ Ashley\ Phillips,\ 2016$

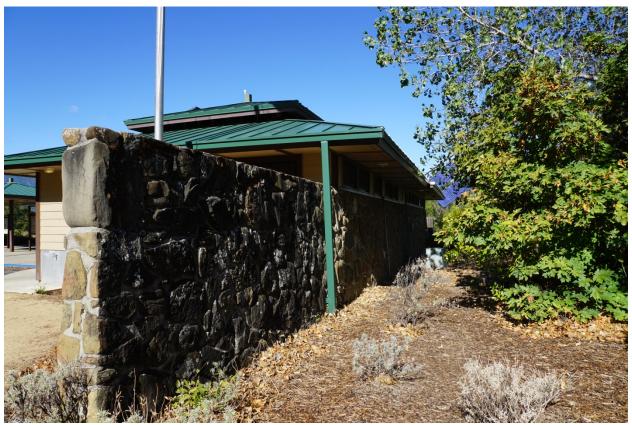
Image 33: Stone wall on northeast corner. Darker stone on non-historic portion is visible. Image looking west. Photo by Ashley Phillips.

30). None of these changes detract from the significance or integrity of the structure, and much of the historic fabric remains including the concrete courtyard with raised planters and unique hipped-roof canopy, native stone walls on both the building and surrounding the courtyard, redwood trim and fascia, window wall, and outdoor seats. The 756 square foot restroom addition nearly doubles the size of the original structure, yet is clearly differentiated as contemporary, and is respectful and compatible with the original structure. It shares the same roof design, wide eaves, rectangular windows, and minimal ornamentation. Its construction did not destroy existing historic fabric, instead the addition incorporated the existing free-standing stone wall, and built a new free-standing elongation that is differentiated by the use of slightly darker stones (See image 33).

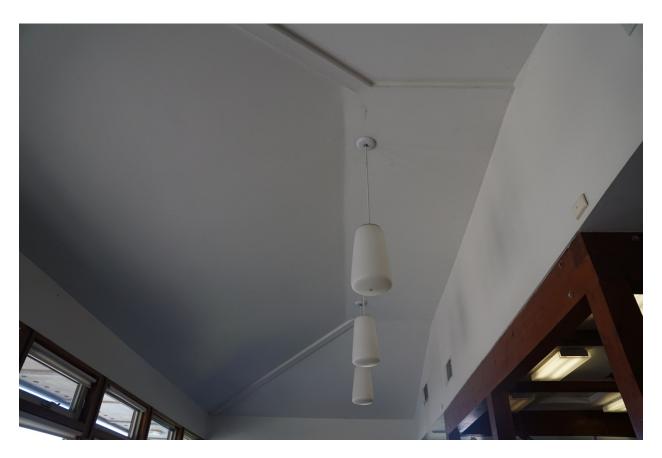
Image 34: Vaulted ceiling in the lobby. Image looking west. Photo by Ashley Phillips.

The interior space of the main block was remodeled following the construction of the addition in 1984. The space is essentially an open lobby with an information booth in the center. Custom-made exhibit displays are situated along the back, north wall, with merchandise cases and displays occupying the rest of the room (see images 8-10). A narrow administrative office and storage room located in the addition is accessible via a door in the northeast corner of the lobby. The front lobby area features a vaulted ceiling, mirroring the hipped roof form visible from the exterior (see image 34). Low-pile carpet covers the floors throughout the main structure.
