CULTURAL LANDSCAPE REPORT

KENNECOTT MILL TOWN

WRANGELL-ST. ELIAS
NATIONAL PARK AND PRESERVE
ALASKA

2001

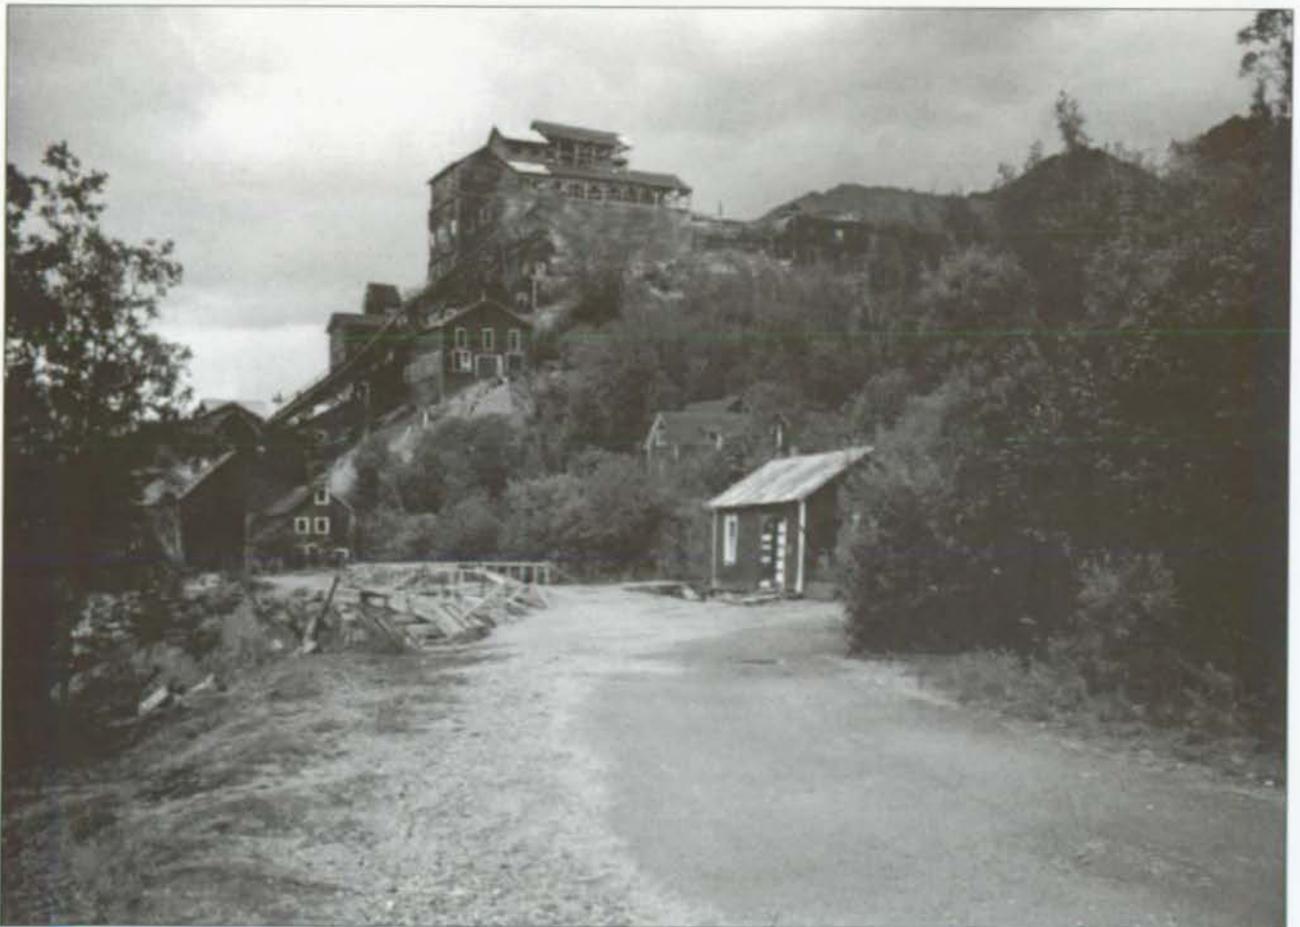
Figure 1. View north from the entry road to the lower Kennecott mill town, part of the National Historic Landmark District. (NPS park files, WRST, 1997.)

In June 1998, the National Park Service (NPS) acquired the land, mineral rights, and associated holdings of the Kennecott Copper Mines in south-central Alaska.¹ Located in the center of Wrangell-St. Elias National Park and Preserve, the area is a designated National Historic Landmark (NHL) District, encompassing 7,700 acres of public and private lands. The 2,839 acres purchased by the NPS includes property and structures in the historic mill town (figure 1), which was the center of operations between 1901–1938.

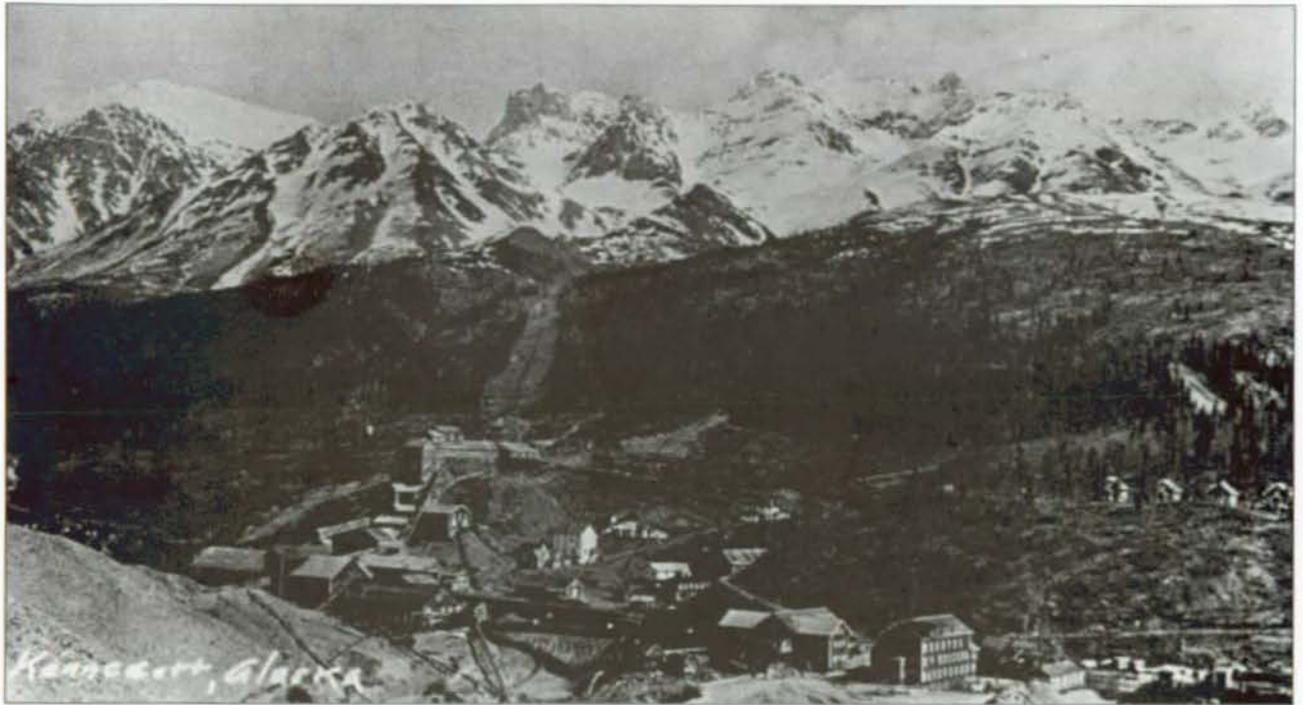
Figure 2. View of Kennecott, circa 1930, showing cleared vegetation, roads and trails, concentration mill, support structures, cottages, flumes, crib dam, and tramway up the hill. (Evonne Sullivan, park files, WRST.)

Throughout the 1910s and 1920s, the mines continued to expand with new discoveries and increased investment (figure 2). Substantial facilities and infrastructure were established to advance the work and support the work force. Individual mine sites were self-sufficient camps, with structures for operating

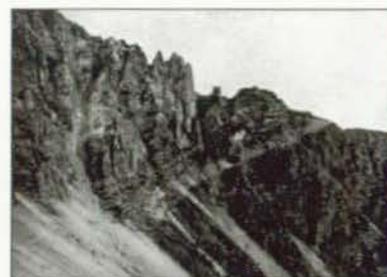
Figure 5. Location of the Bonanza claim, circa 1903. The rich chalcocite ore body is visible as the diagonal striations oriented toward the upper right of the photograph. (Mendenhall, 1905.)

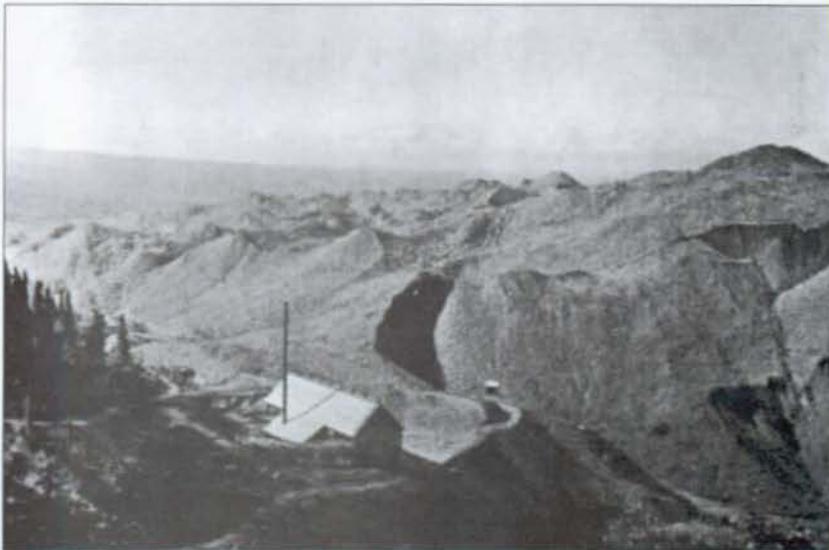
Figure 8. Kenecott mill town, circa 1908. View looking south with the sawmill in the foreground. (Photo courtesy of the Anchorage Museum of History and Art.)

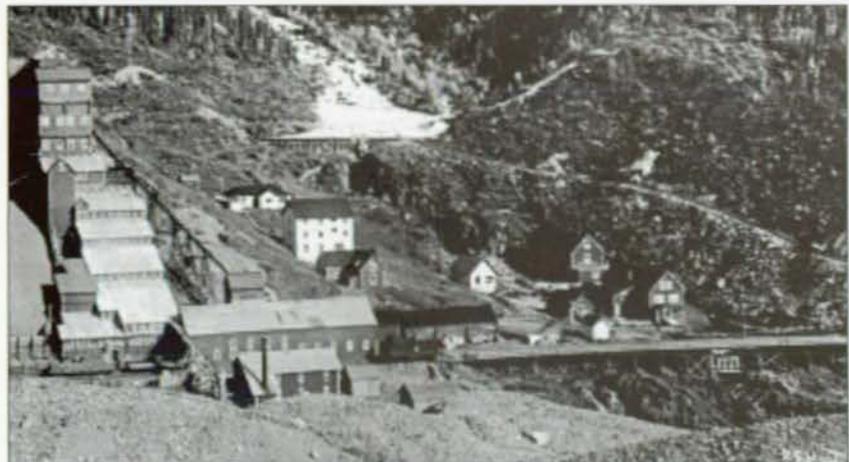
Figure 12a. Panaroma of Lower Kennecott mill town, circa 1913. (Mears Collection, Rasmuson Library, University of Alaska, Fairbanks Alaska.)

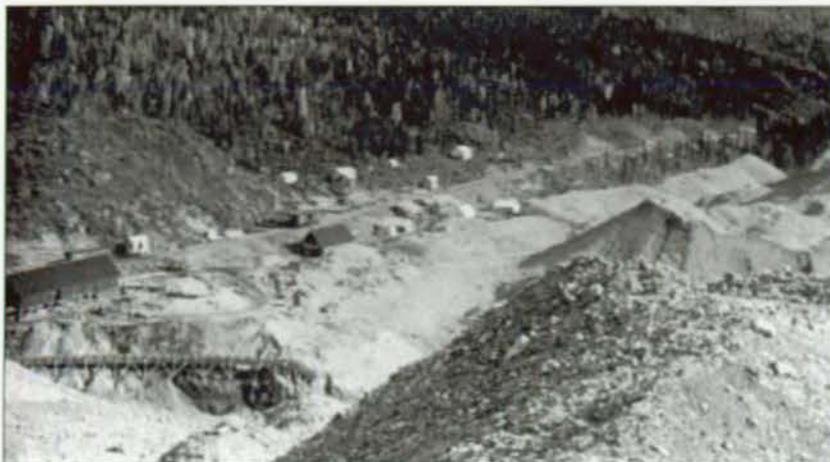
Figure 12b. Panorama of Lower Kennecott mill town, circa 1913. (Mears Collection, Rasmuson Library, University of Alaska, Fairbanks Alaska.)

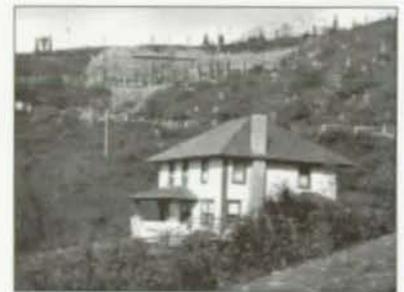
Figure 14. Built in 1916, Stephen Birch’s residence was situated near the Bonanza Mine ore bin and Jumbo aerial tramway tower, visible in the background. Photograph circa 1919. (USGS photo library, Moffit 754.)

Developments in 1916 also included substantial improvements to staff and managerial residences. Immediately north of the National Creek dam, a two-story residence built for manager Stephen Birch (painted white) sat perched on the rise of the slope, affording views to the concentrator, other National Creek structures, and the glacial moraine beyond (figure 14). Because Birch’s residence occupied the space once used for the community garden, management allocated space for a new garden, measuring 100 feet by 160 feet, on the north side of the National Creek dam reservoir. New accommodations for staff were constructed at the north and south ends of the mill town. At the north end, three cottages were constructed next to the power plant alongside those built the previous year. Due to the steep drop-off on the west side of the rail grade, these cottages included lined basements and catwalks connected each cottage with a privy.⁷⁶ Toward the south end of the mill town an apartment house containing five, four-room apartments and farther south, four, six-room cottages

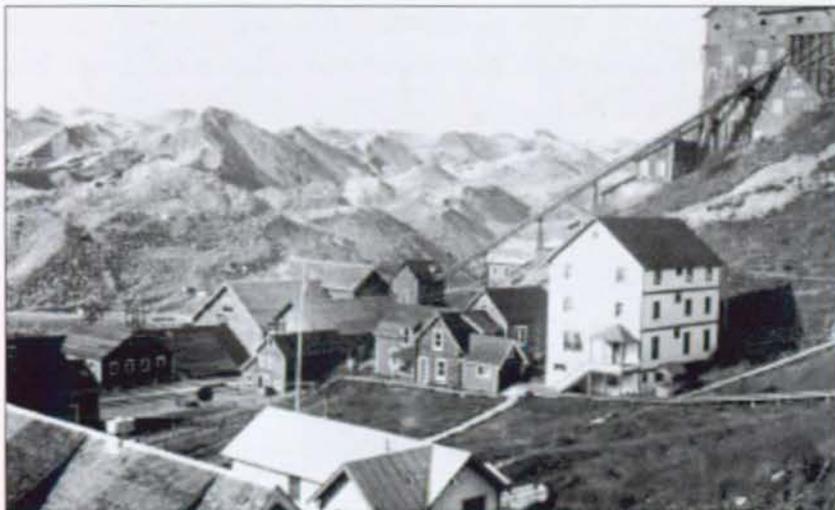
Figure 15. Administrative center of Kennecott showing the mill and industrial buildings, hospital (center foreground), staff house (right), and manager's office (center). Note the well, flagpole, picket fence, and boardwalks (center foreground). Photograph circa 1919. (USGS Photo Library, Moffit 753.)

Improvements at the mill town also continued. The powerhouse received an extension to accommodate a diesel engine and additions were made to the east side of the hospital. Both bunkhouses on National Creek were renovated to accommodate more workers (figure 15).⁹¹ The second bunkhouse (circa 1910) included a toilet, shower and laundry facilities, a poolroom, reading room, and locker room.

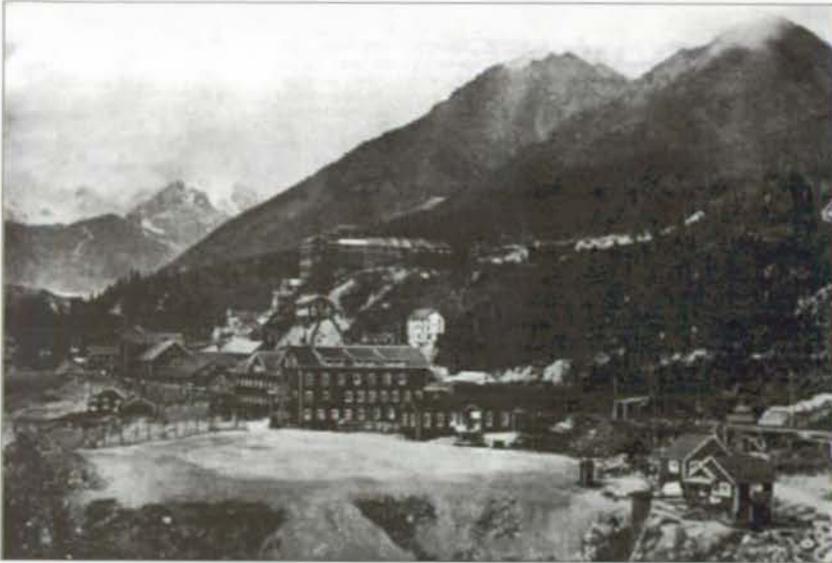
Figure 16. Kennecott mill complex in 1925. West bunkhouse is at center with the schoolhouse and baseball field in front. (Photo courtesy of the Alaska Suite Library.)

between the recreation hall and barn, and north of the recreation hall (for a coal bunker). The company also constructed two garage facilities south of the dairy barn. Lumber storage areas occupied space near the railroad, including areas between the apartment block and schoolhouse south of the recreation hall and east of the upper mill complex. Facilities for workers that were constructed by 1925 included a bathhouse east of the company store, two cottages north of the recreation hall, and a tent cottage at the south end of the complex (figure 16).

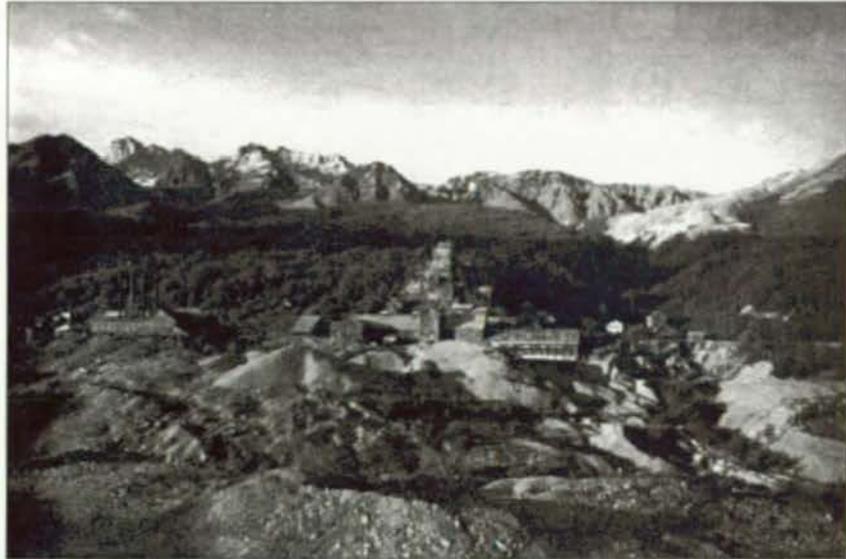
Figure 18. Kennecott mill complex, 1985.
(Historic American Engineering Record,
Jet Lowe.)

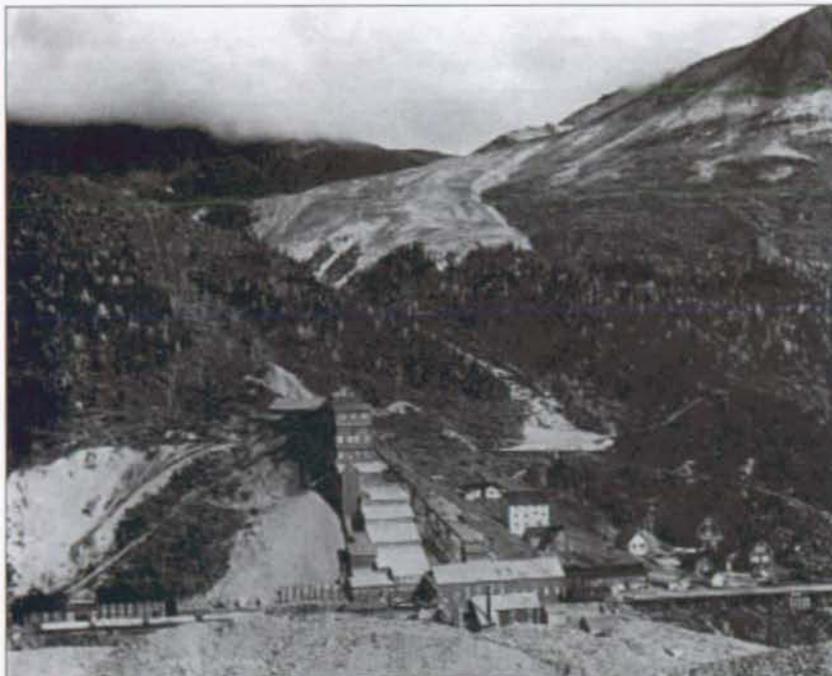
Figure 21. Kennecott, circa 1913, showing cleared vegetation, the complex of administration structures, and the concentration mill, tramway, crib dam, and railway along the bottom of the photograph. (Mears Collection, Rasmuson Library, University of Alaska, Fairbanks, Alaska.)

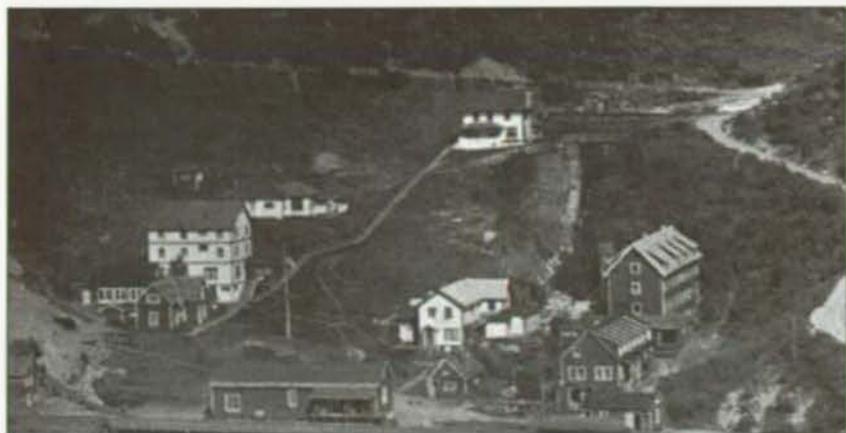
Figure 23. View of administrative core showing boardwalks, flag pole, and primary structures, including the manager's house, staff housing, hospital, and barracks buildings. Photograph circa 1930. (Evoenne Sullivan, photo files, WRST.)

Occupying the central area within the mill town, the manager's office and residence, the staff house, hospital, bunkhouses, assay shed, and community garden compose the administrative core (figure 23). Individual buildings were larger and more stylized than in other areas of the town. The manager's residence reflected a hierarchy and social status typical of other company towns. Constructed in 1916, the manager's house was a two-story structure, painted white, and sited on the highest portion of the mill town. Circulation through this area was somewhat formalized along boardwalks that linked key buildings stepping down the valley from the crib dam along National Creek and ending at the rail-

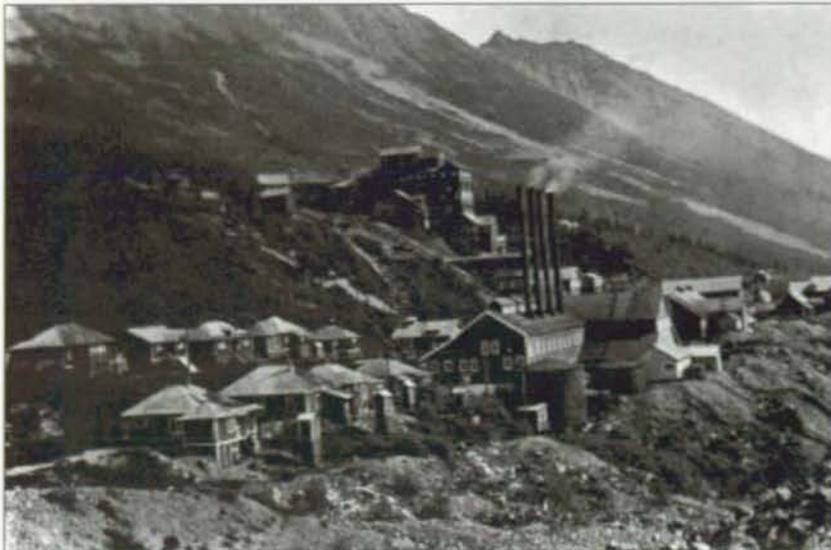
Figure 24. View of cottages in the north end of the mill town, circa 1930. (Jim McGavock, photo files, WRST.)

Two functionally related clusters of cottages and residential structures on the north and south sides of the mill town made up the housing core (figure 24). North of the concentrator, four individual cottages were constructed between 1908–1915 on the east side of the railroad tracks. These cottages were the first constructed in the mill town and they provided housing for families. As the town expanded between 1915–1938, four more cottages were built directly west. These cottages included lined basements and catwalks to individual privies. Collectively, these structures defined the northern edge of the mill town. Also during this period, seven cottages making up “Silk Stocking Row” were built on the hill south of the crib dam. These residences also had several associated out-buildings, including garages, chicken coops, outhouses, and gardens.

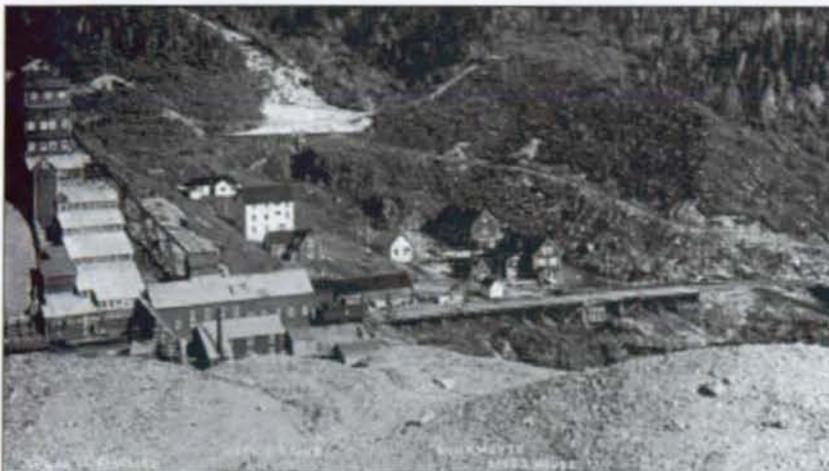
Figure 25. Railroad trestle through the mill town was the primary link to outside markets and supplies. Note the wagon road extending up the hill, south of the bunkhouse buildings. Photograph circa 1913. (Mears Collection, Rasmuson Library, University of Alaska, Fairbanks, Alaska.)

Between 1908–1915, core circulation systems were established that would influence virtually all future development at Kennecott. Key to this circulation system was the rail line connecting the mill town with Cordova, about 196 miles away (figure 25). In 1908, the Copper River and Northwest Railway crossed the Copper River at Flag Point near Cordova. After many physical and political obstacles, the railroad finally reached the Kennecott mines in the spring of 1911.

The track entered the site from the south on an alignment just east of the existing wagon road. Extending north, the track crossed National Creek on a 256-foot trestle bridge and ended at the ore bins at the base of the concentration mill. Completion of the railroad had a dramatic effect on construction at Kennecott. First, it provided a reliable source of supplies and a transportation system for the ore. Second, the railroad established a strong linear framework for both the structural and functional development of the mill town.

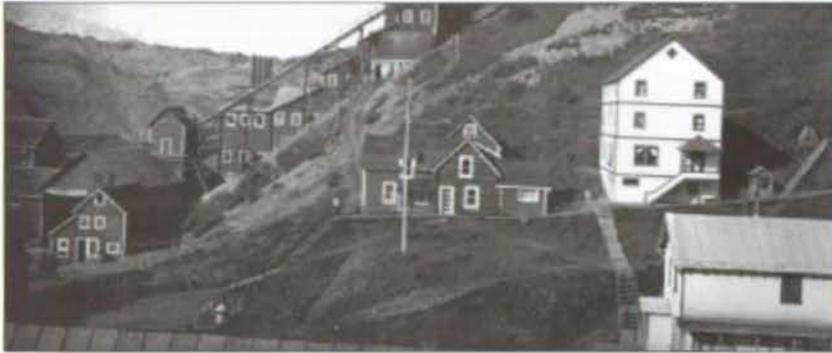
Figure 26. Wood boardwalks and foot paths through the administrative area of the mill town, linking primary buildings, circa 1919. (Photo courtesy of F.H. Moffit, USGS.)

Also during this period, wood plank boardwalks were constructed, linking primary residential structures (cottages and staff quarters) and service buildings (the hospital, manager's office, and assay office). While these boardwalks primarily served a functional purpose, they also served to formalize footpaths and provided some sense of domesticity in an otherwise industrial landscape (figure 26). In contrast, the paths between the industrial buildings were based on need and function, were informal in character, and did not follow straight lines and sharp angles.

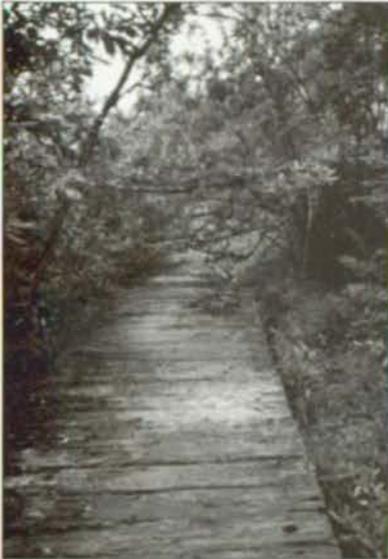
Figure 27. Remnant boardwalk section in front of cottages along the north end of the mill town. (NPS, photo file, WRST, 1997.)

features contribute as remnant features of circulation. These include the segment of boardwalk in front of cottages 13a–e, a portion of stairways, railing, and boardwalk in the National Creek area and below Silk Stocking Row (figure 27).

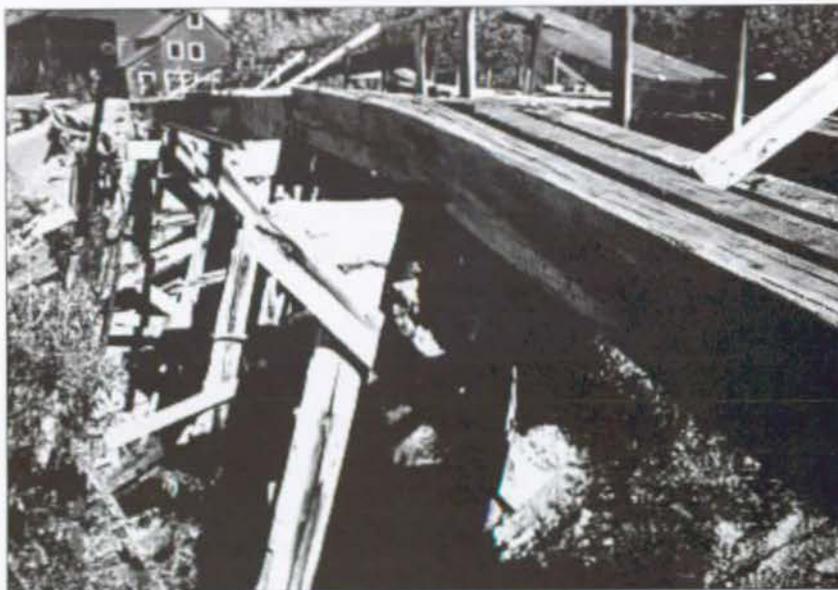
Figure 29. Railroad trestle structure as it looks today. (NPS, photo file, WRST, 1998.)

The Copper River and Northwest Railway reached Kennecott from the Port of Cordova in 1911. The rail line entered the mill town from the south, crossing a 250-foot trestle and terminating at the concentrator (figure 29). The railway and associated trestle became the dominant circulation structure in the town, defining the overall industrial infrastructure and building complex. The trestle originally served two pairs of tracks, one pair on the west and one on the east. The rail bed was constructed of pressure-treated beams, cribbing, and railroad ties. The posts supporting the bed structure are a combination of pressure-treated round poles and untreated spruce trees.

The railroad trestle is an important historic structure and although it is in poor condition, is still an important contributing feature of the Kennecott mill town.

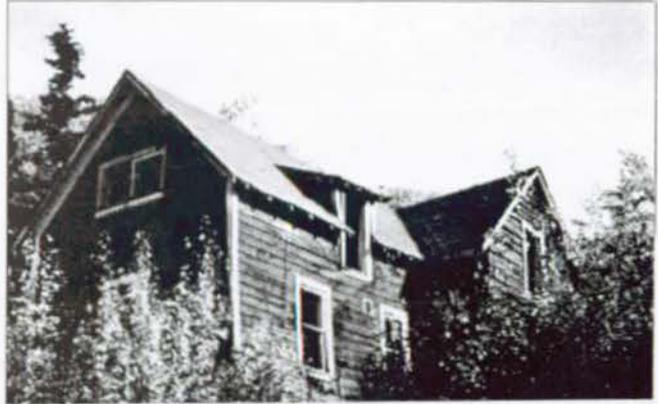
Figure 31. Manager's office, 1998. (NPS photo file, WRST.)

Description: Built in stages, the original portion of the manager's office is a one-and-a-half-story, saddle-notched log structure with sill log foundation. The main door and two windows are on the south façade. One-over-one, double-hung windows are in the gable end above the first floor. An addition is set back on the west side of the log structure and has a roof line running perpendicular to the original roof. A small one-story office wing was also constructed on the east side. And on the rear of the log structure, a large two-story wing was constructed.

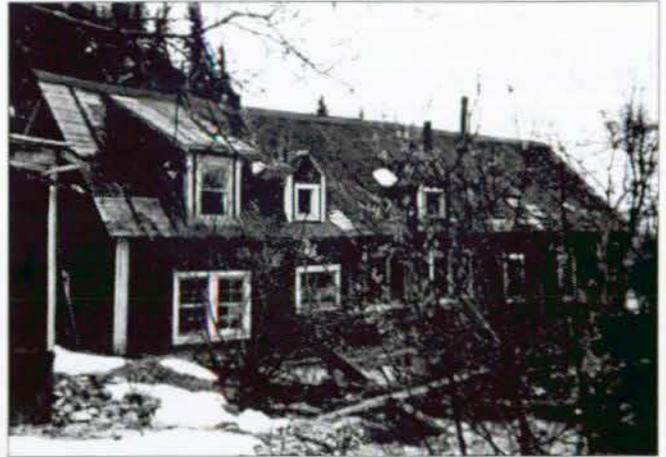
Figure 34. Bunkhouse along National Creek. (NPS photo file, WRST, 1998.)

Description: Sited along National Creek, this bunkhouse is a rectangular, one-and-a-half-story structure with a gable roof, and shed roof dormer on the south side. Two gable roof dormers provide additional light and space to the north and south side rooms. A shed-roofed porch is on the south side of the building, extending the length of the structure. The boardwalk on the north side of the building has been buried by flood rubble. Gable and verge overhangs are detailed with a narrow fascia board.

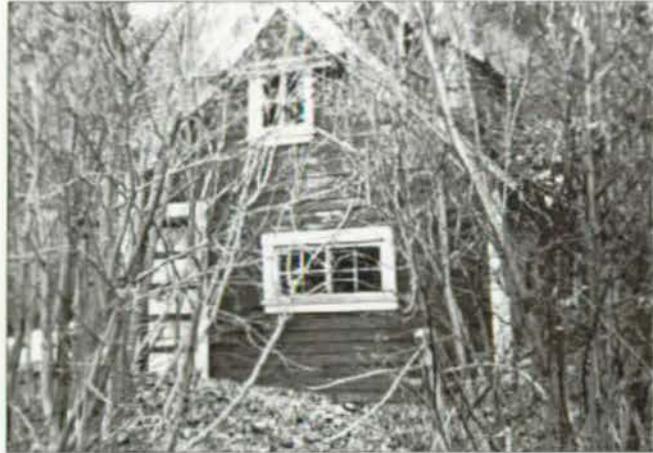
Figure 35. West façade of the assay office. (NPS photo file, WRST, 1998.)

Description: The assay office is a small, one-story, wood frame structure, located east of National Creek. Primarily a functional structure, there are few decorative features. Four-over-four, double-hung windows are located to provide light for interior work areas. A louvered ridge cupola provides ventilation to the attic.

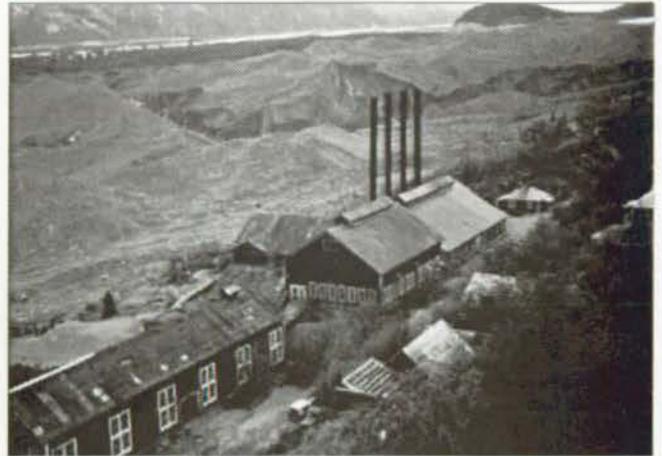
Figure 36. View northwest toward the power plant with four smokestacks. (NPS, photo file, WRST, 1998.)

Description: Characterized by four towering smoke stacks and constructed in three phases, the power plant is a three-story structure located north of the concentration mill on the west side of the railroad corridor. The south portion of the structure has a sheet metal gable roof and tall, nine-over-nine, double-hung windows. Paneled doors provide access to the south platform and front entrance of the structure. The north side of the building has an addition that includes a lower story with a central doorway and six-over-six, double-hung windows. A three-story west wing extends downhill from the rear of the south portion of the structure. One-story shed roofs flank this wing.

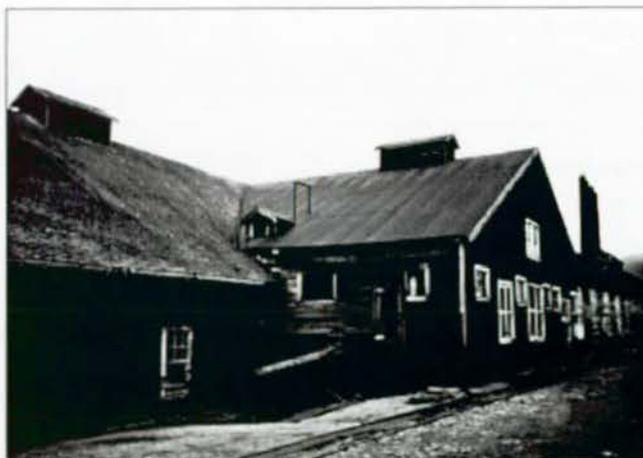
Figure 37. Leaching plant, east elevation. (NPS photo file, WRST, 1998.)

Description: The leaching plant is on the west side of the railroad bed, north of National Creek. A one-and-a-half story, wood frame structure with a basement opening to the rear (west) grade, the building is utilitarian in nature. Having little ornamentation, the plant is characterized by varying rooflines reflecting periods of growth and development in the mining operations in Kennecott. The original portion of the structure (now collapsed) contains the leaching tanks and is one story below grade, with a central gabled wing extending to the roadway. Six-over-six, double-hung windows are common on the first floor, and six light windows are on the second floor. A two-story addition on the north end of the structure has a central pavilion, with double doors opening toward a loading dock at the side elevation.

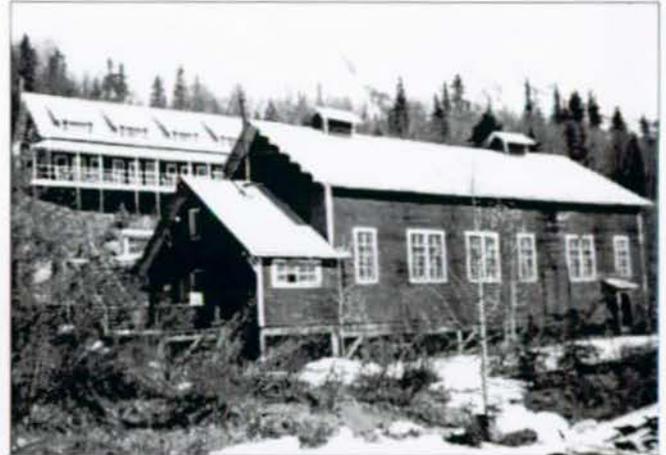
Figure 38. Recreation hall, west elevation. (NPS photo file, WRST, 1991.)

Description: The recreation hall is located on the west side of the railroad corridor south of National Creek. A two-story, balloon frame structure, the hall is rectangular in shape and set on 6x6 wood post foundations. Two louvered cupolas provide ventilation at the ridge of the gable roof. Windows are four-over-four, double-hung sash.

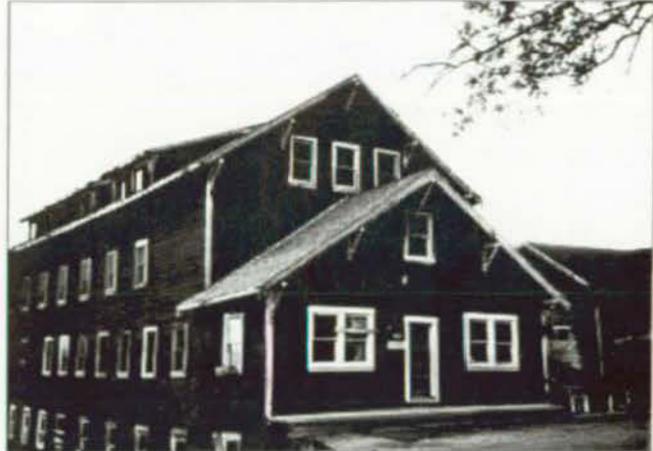
Figure 39. West bunkhouse. (NPS photo file, WRST, 1998.)

Description: The west bunkhouse is a rectangular, balloon-frame, four-story structure, oriented perpendicular to the west side of the main road, south of National Creek. The foundation is wood post on pier. There is a gable roof over the structure with three dormers on each side of the gable. Windows are double-hung single light sashes. The ground floor is approximately nine feet below the grade of the railroad line, with timber cribbing retaining the adjacent bank.

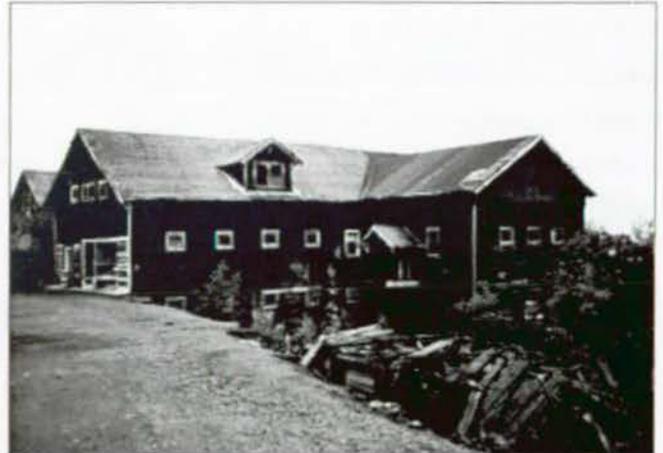
Figure 40. View southward to the store and warehouse. (NPS photo file, 1998.)

Description: One-and-a-half story, T-shaped, wood commercial building with gabled store facade and recessed entrance with bracketed verge overhangs, exposed eave rafter ends, and double-hung and fixed sash. Catwalks extend to the warehouse entrances on each side wing of the rear warehouse structure. Gable roof porches are at each entry above a full-height basement containing additional storage rooms. A receiving area, complete with a conveyor, is located on the west half of the structure.

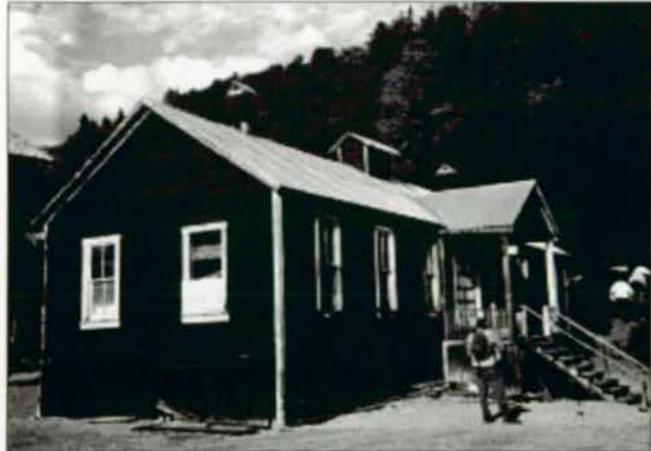
Figure 41. View eastward toward the schoolhouse. (NPS photo file, 1998.)

Description: The schoolhouse is a rectangular, wood frame, gable roofed structure, located on the west side of the main road into the mill town. Four-over-four and two-over-two, double-hung windows are on the north and south facades. A central louvered cupola is located on the ridge of the gable, which is flanked by two small chimneys. Grounds surrounding the structure were used for sporting activities and recreation.

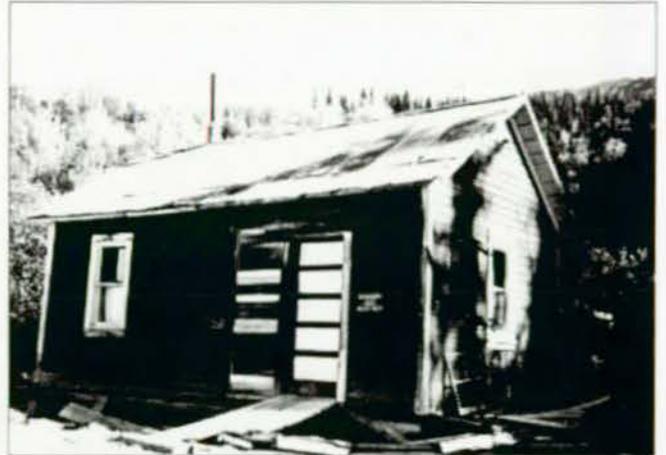
Figure 42. The station house, or depot, was constructed between 1910-1912. (NPS photo file, WRST, 1998.)

Description: Sited next to the rail bed, the station house is a small, one-story wood frame structure on post and sill foundation. The entrance vestibule has a shed roof and the windows are four-over-four, double-hung. A wood decking wraps around the north, west, and south sides of the building.

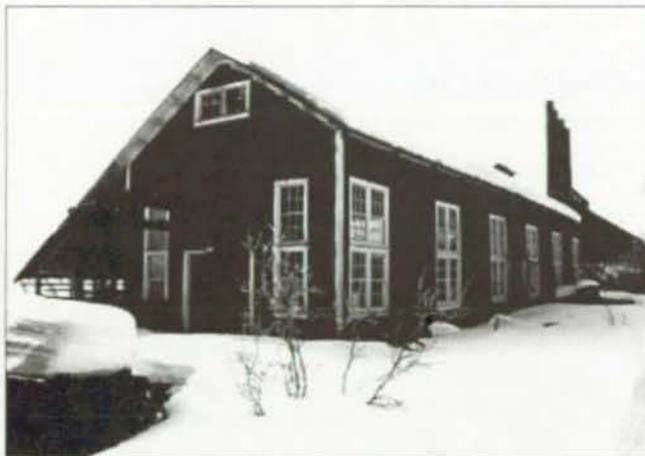
*Figure 43. View northwest to the machine shop, constructed in 1916.
(NPS photo file, WRST, 1998.)*

Description: The machine shop is located on the west side of the main road, north of the leaching plant and south of the power plant. Rectangular in plan, the wood frame structure has six front bays of six-over-six, double-hung sash. The front elevation faces east and is parallel to the main road. The roof is gabled in three sections: aluminum to the south, and center and tarpaper on the north section. Large double doors are set in the south, east, and north sides of the structure. An overhead hoist enters the building above a door on the south end of the structure. The grade falls away to the west, with storage for machinery, tools, fittings, and gears stored under the building.

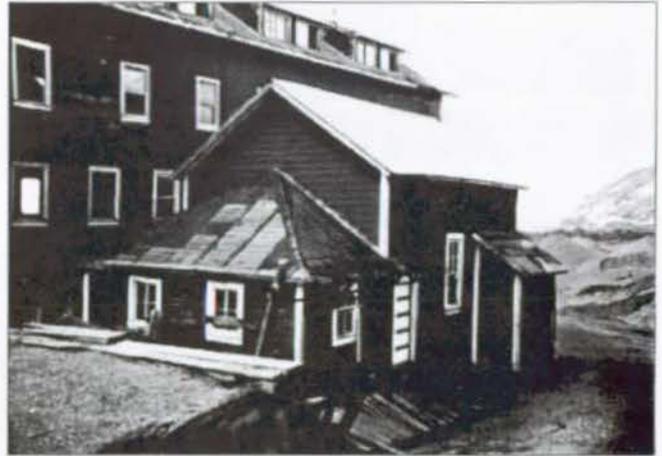
Figure 44. View westward to the refrigerator plant or meat cooler. (NPS photo file, WRST, 1998)

Description: The refrigerator plant is sited between the bunkhouse and the store and warehouse on the west side of the main road. Timber cribbing retains the railroad right of way, which is approximately seven feet above the level grade of the structure. Rectangular in shape, this structure is built around a large walk-in refrigerator. An exterior meat hoist extends around the front, above a platform and into the building above the main entry. Four-over-four, double-hung windows provide light into the refrigerator compartment.

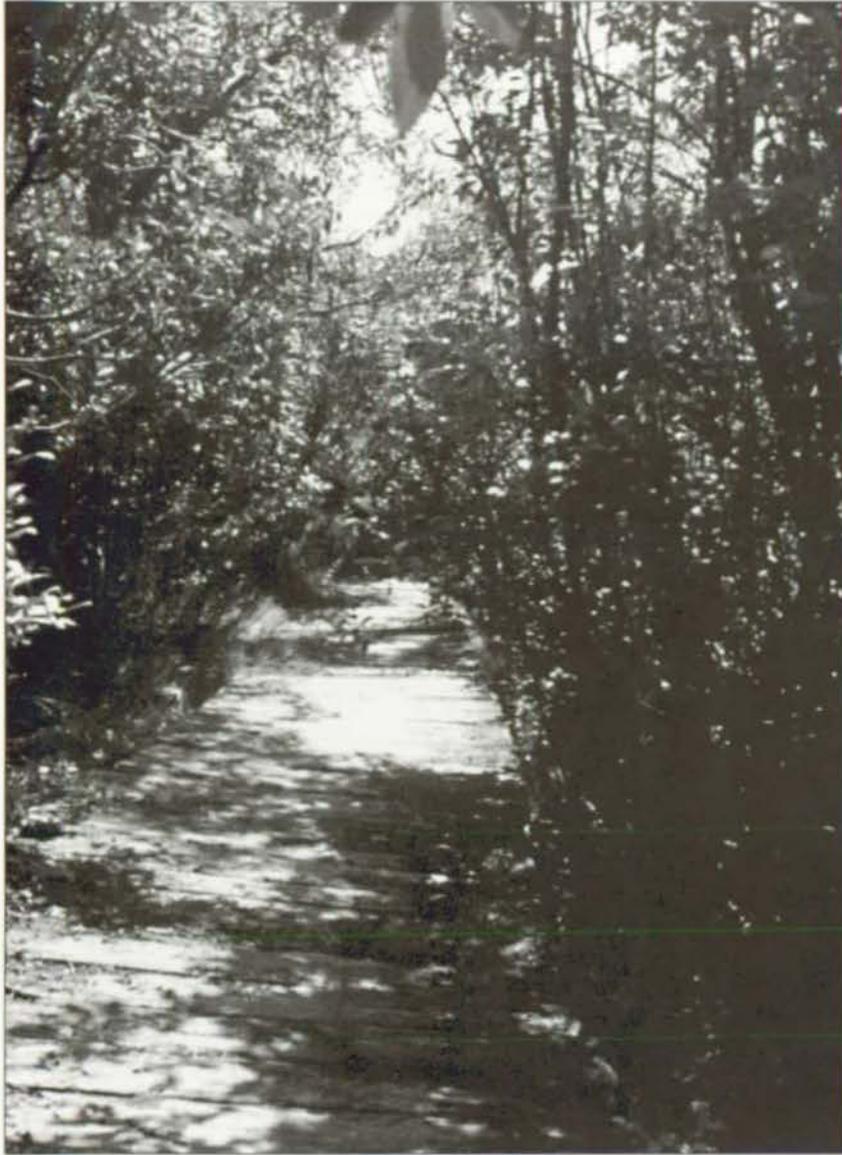
Figure 48. Boardwalk in front of staff cottage north of power plant and east of rail grade. (NPS photo file, WRST.)

The five cottages in the east row are set back from the rail grade and are currently obscured by vegetation (post-1938). Vegetation also obscures an access road to the rear of the cottages and evidence of Kennecott-era vegetable gardens. An extant boardwalk west of the cottages continues to define pedestrian circulation. A utilidor—conveying water, steam, and sewer pipes to the cottages—runs west of the boardwalk (figure 48). Firehouses are located south of structures 13a and 13d.

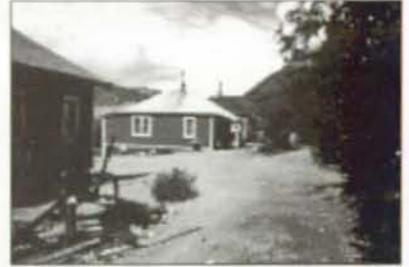
Figure 49. Restored staff cottage (13f) north of the power plant. (NPS photo file, WRST.)

The west row of four cottages fronts the rail grade (figure 49). Constructed on a hillside, these cottages include lined basements. Historically, catwalks extended from the rail grade level to privies west of the cottages. Two privies from this system are currently extant. The rail grade separating the rows of cottages continued north as a wagon road to the Erie Mine, with a spur leading around the eastern extent of the mill town. Both roads are extant, although the route to Erie Mine eventually narrows to a walking trail.

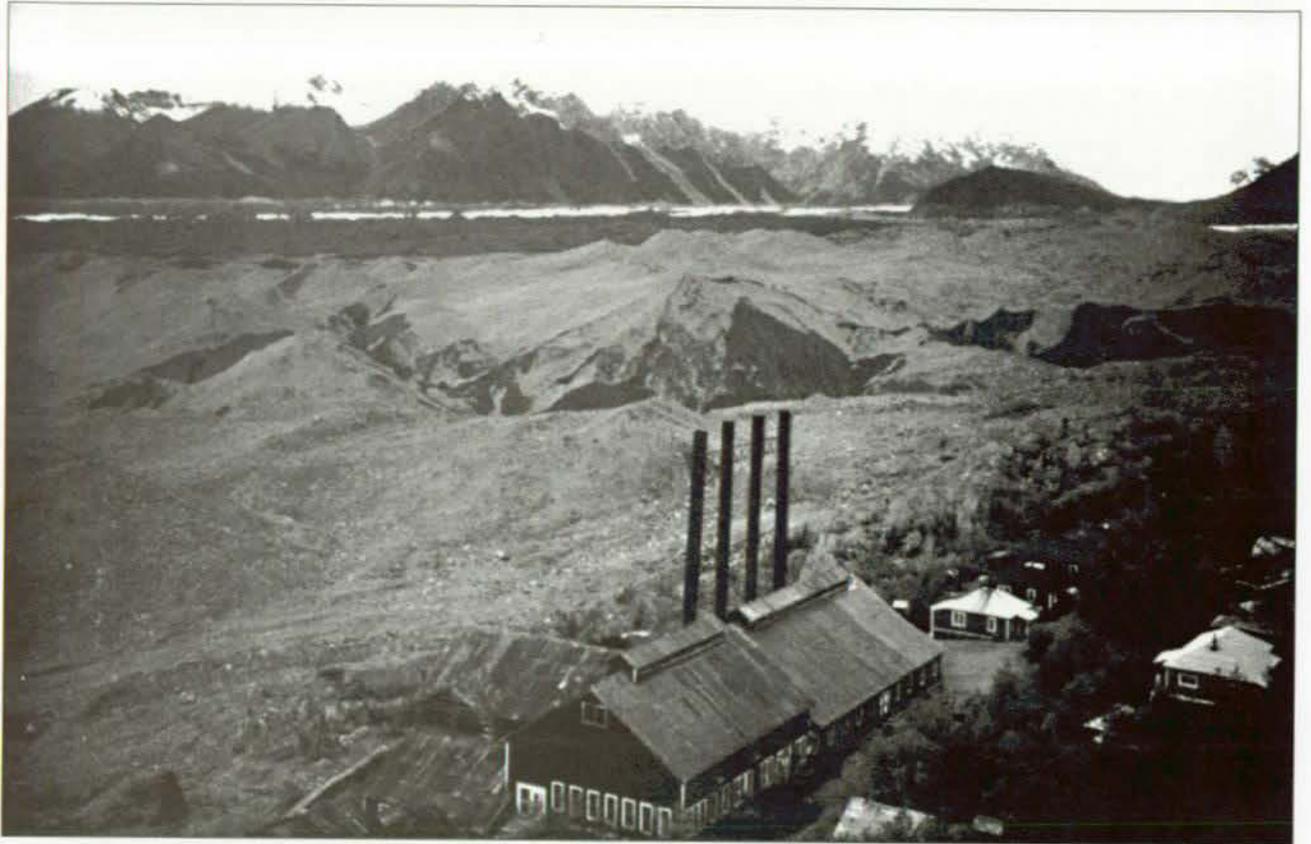
Figure 52. View north from tram terminus over section 2. Power plant (9) on left, and staff cottages in middle distance. (NPS photo file, WRST.)

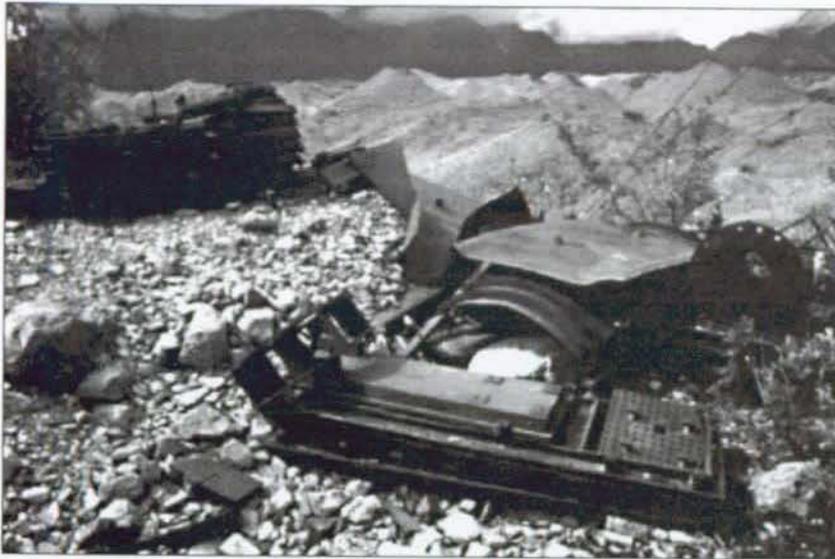
Figure 54. Power plant fixtures, including furnace latches and braces (background), stacked during asbestos removal in 1995. View looking south. (MTU field documentation, 1997.)

Immediately south of the oil house are stacks of furnace latches, braces, metal plate, and ceramic blocks (a, b, d). These artifacts derive from the powerhouse, perhaps salvaged by the company after the 1924 power plant fire (figure 54). The remnants of a boardwalk lie between the power plant and oil house. A second boardwalk, farther south connected the power plant with the machine shop dump (figure 55). Extensive dumps (k, l) west of the terrace scarp contain predominantly industrial and construction-related materials (barrels, concrete, and firebricks), although domestic artifacts are also present.

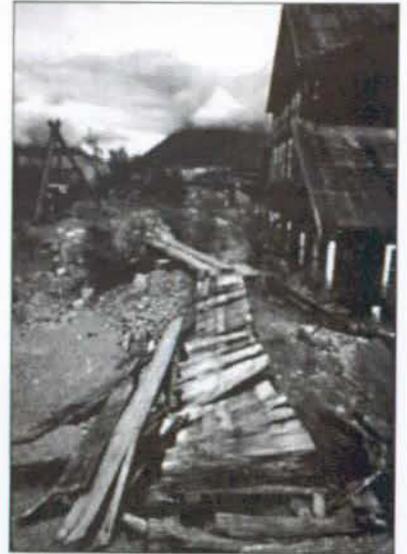
Figure 55. View north at boardwalk connecting between power plant (right) to machine shop dump. Trig post (middle left) marked the upper terminus of a stub tram bringing sand up from the glacial moraine. (MTU field documentation, 1997.)

Kennecott did not use the slope between the terrace and glacial moraine solely for waste disposal. A small wood crib (g) probably housed the hoist for a stub tram that brought sand from the glacial moraine to the power plant. (The sand likely found use for construction and blacksmithing activities at the concentrator and mines). This structure has moved approximately 80 feet down the slope from its original location. A wooden trig post (f) at the top of the terrace functioned as the upper terminus for the tram.

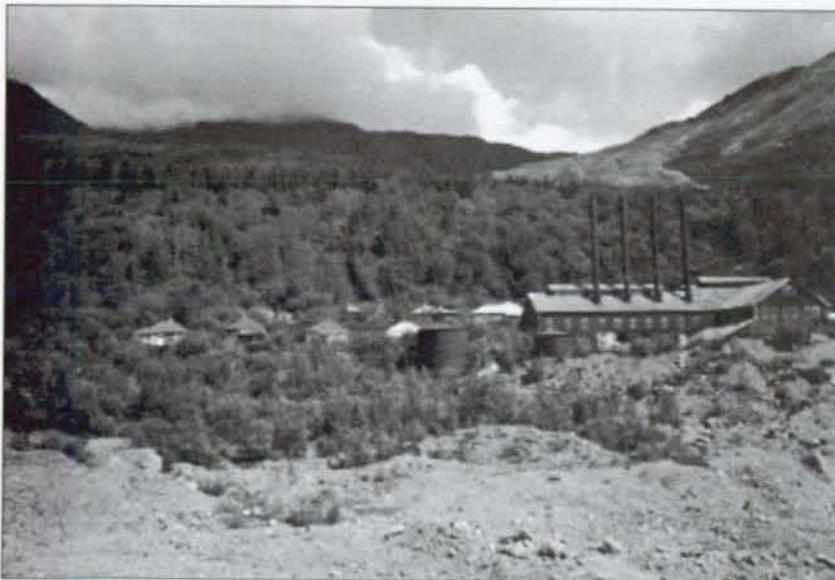
Figure 56. West side of the power plant (9), looking toward the oil tanks and platforms. (NPS photo file, WRST.)

An oil intake platform (i) and two other decks are the only features east of the power plant (figure 56). The oil intake platform suffered heavy damage during 1995 asbestos removal procedures. The two decks likely served as temporary storage for machinery loaded off the railroad.

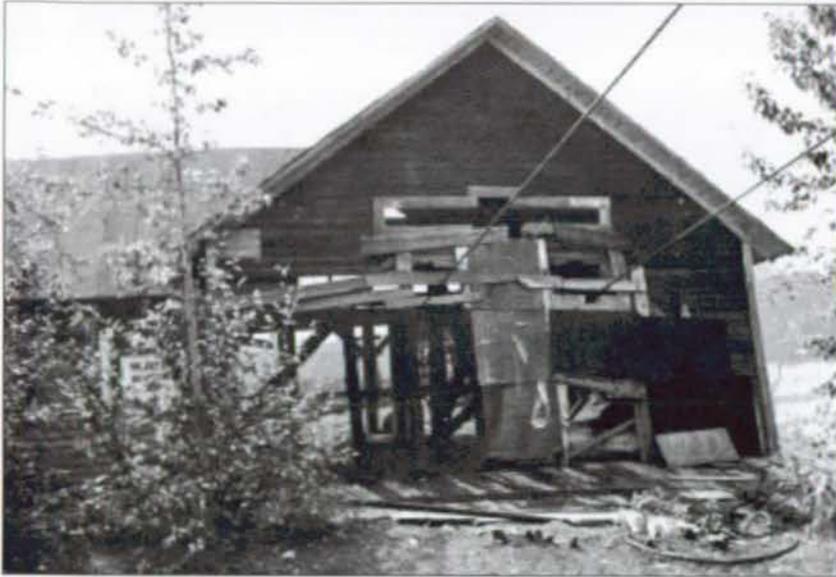
Figure 62. Tram terminus (2) for the Jumbo Mine aerial tramway. (NPS photo file, WRST.)

Description: The concentrator tram terminus (2) extends west from the top of a hill scarp above the rail grade. Decks around the concentrator, as well as their contents, are for the most part well preserved (see c and d, and figure 62). Together with the track incline system connecting the tram terminus with the crushing unit of the concentration mill and machine shop, these features illustrate the system by which concentrator machinery was installed, repaired, and temporarily stored.

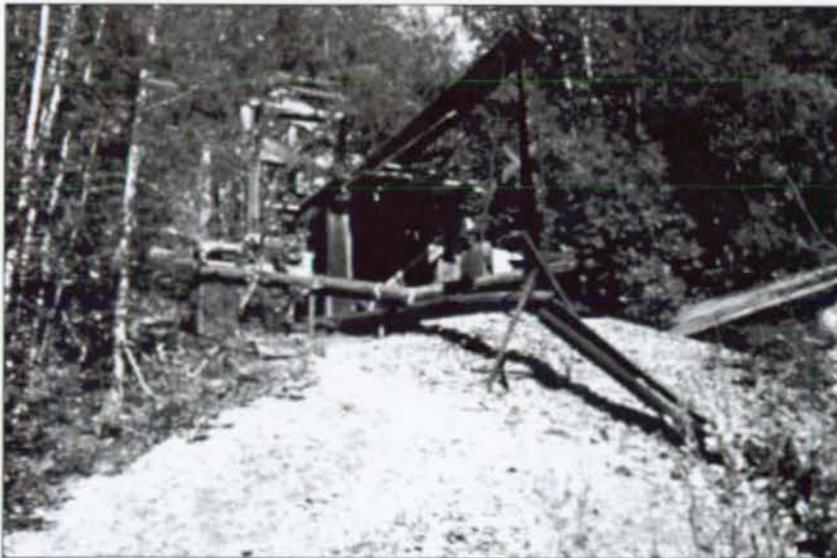
Figure 63. Wrangell Consolidated operations (64). View northeast from tailings toward shaking and crushing machinery. A shed (63) once behind the manager's house, circa 1910, is at middle right. (MTU field documentation, 1997.)

During the 1960s, Consolidated Wrangell operated a concentration mill southeast of the tram terminus (figure 63). Remains of Wrangell workings include an ore chute, storage basin, conveyor, crushing machinery, and a storage shed (63, 64). Tailings from Wrangell operations were directed west of the crushing machinery. This eventually covered areas formerly occupied by the manager's residence and staff office building (removed 5–10 years prior), two sites having potential archeological value.
