CULTURAL LANDSCAPE REPORT

KENNECOTT MILL TOWN

WRANGELL-ST. ELIAS
NATIONAL PARK AND PRESERVE
ALASKA

2001

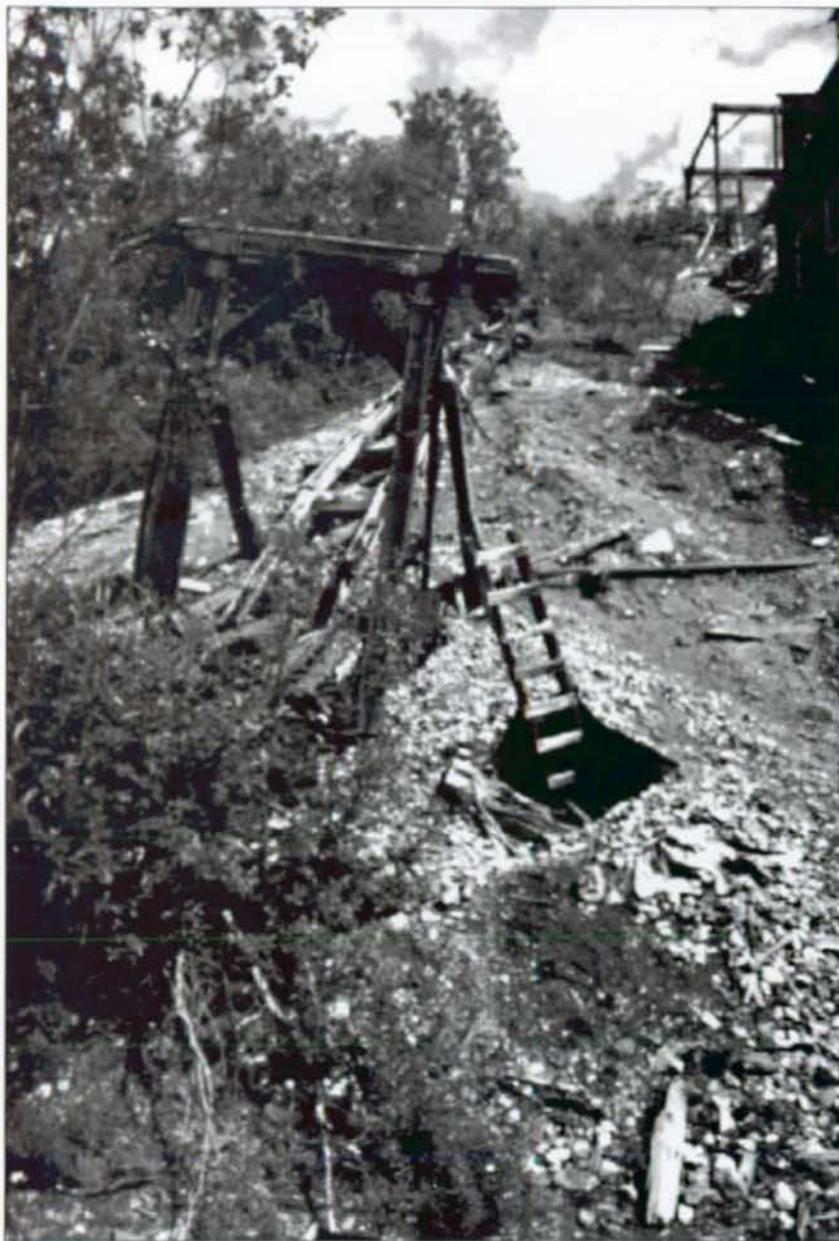
Figure 65. Drawbridge of service tram between tram terminus (2) and machine shop (36). (MTU field documentation, 1997.)

remain, powered a drawbridge that raised and lowered the tracks of a service tram line between the concentrator and machine shop (also see Section 5b, o).

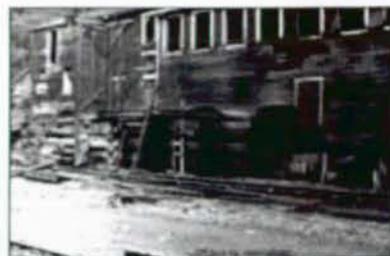
Figure 66. West wall of concentration mill (3) showing three generations of foundation cribbing. (MTU field documentation, 1997.)

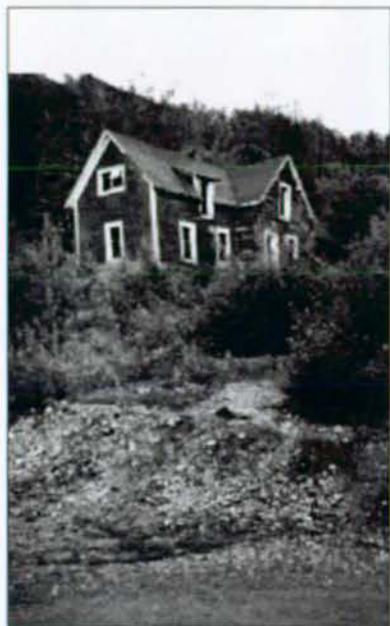
Figure 67. Manager's office building. Vegetation between the building and the tram terminus (upper left) occurred after Kennecott's closure. (NPS photo file, WRST.)

Although the rail grade provided general access to the concentration mill, boardwalks indicate pedestrian circulation traversed the hillside. A boardwalk between the manager's office (1) and the concentrator is the only substantial survival of a once well-defined pedestrian circulation in the National Creek area (figure 67).

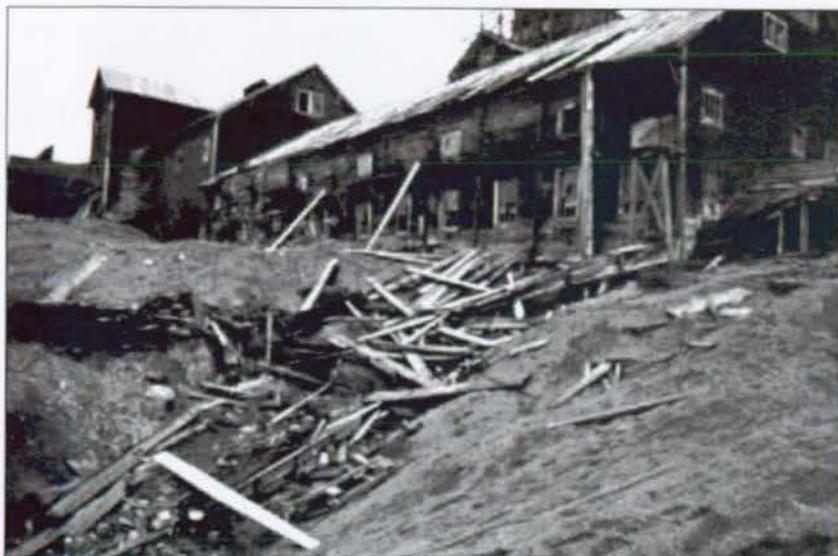
Figure 70. Ammonia leaching plant (15), looking northeast. Flumes and pipes for waste removal in foreground. (MTU field documentation, 1997.)

Flumes and pipes south and west of the leaching plant directed both tailings and wastewater toward National Creek. A cluster of flumes (l) extended from the southwest corner of the leaching plant (figure 70). The southern part of the leaching plant sustained significant damage during the flooding of National

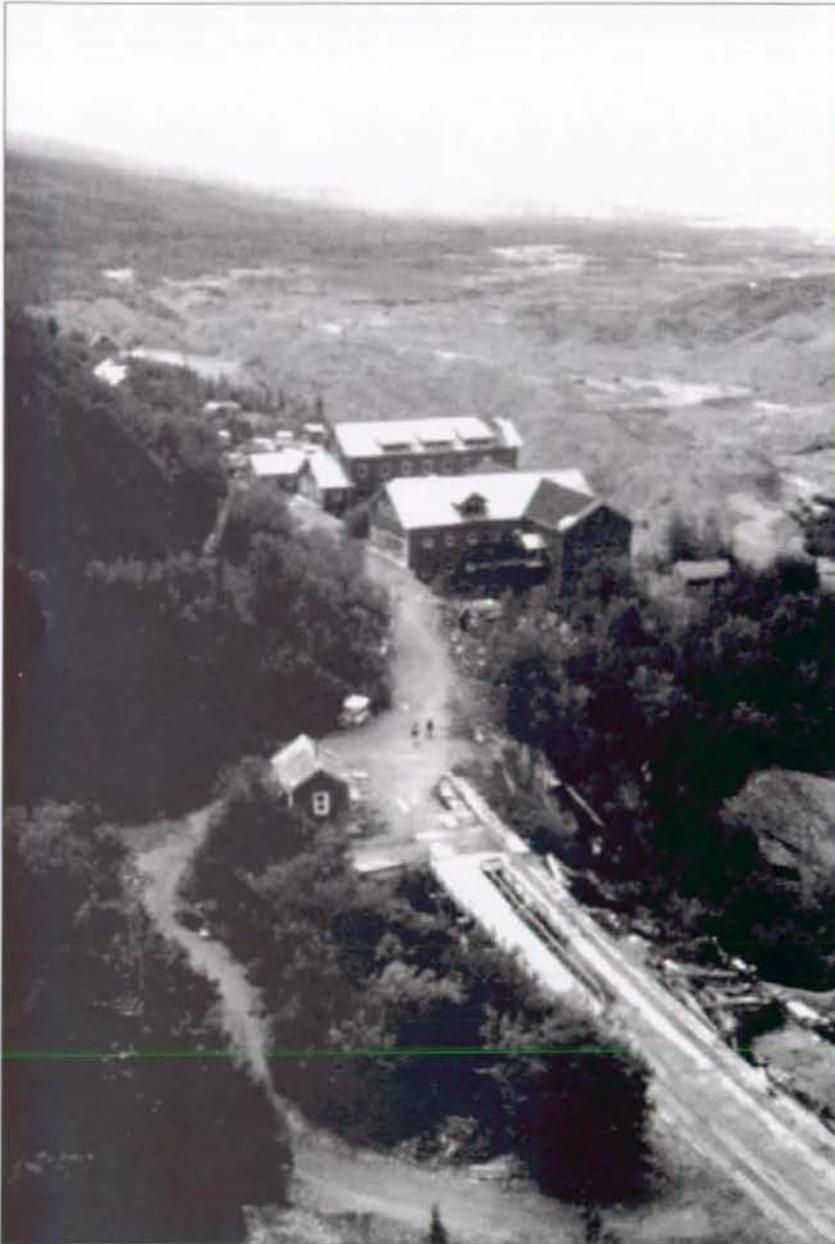
Figure 72. View of south mill town from tram terminus (2). Rail bridge (50) and depot (34) in foreground, store (19) and west bunkhouse (20) in background. (MTU field documentation, 1997.)

Description: This area contains five extant buildings clustered around National Creek. A rail bridge (50) and a vehicle road currently access the west portion of this area (figure 72). This area provided accommodations for workers (5, 7), medical services (14), storage (g), transportation and administration (34), and metallurgical testing (8).

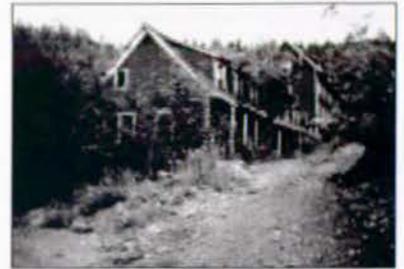
Figure 73. View east with 1908 bunkhouse (5) in foreground and 1910 bunkhouse (7) in background. The road is on the right is built on gravel brought in during the 1980 and 1983 National Creek floods. (NPS photo file, WRST.)

example, are almost entirely absent (with exception of a small area abutting the west side of the hospital). Floods likely removed a storage shed that had been located south of the 1908 bunkhouse (5) (figure 73). A firehouse (h) abutting the west side of this bunkhouse is still extant, but at least two others were once in the area (between the two bunkhouses and north of the assay shed).

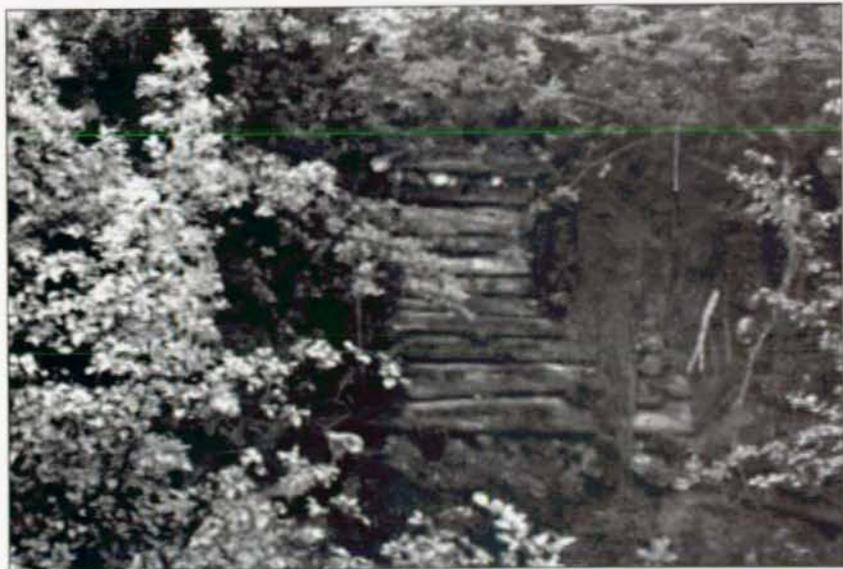
Figure 75. Detail of west face of National Creek Dam (33), built circa 1911. (NPS photo file, WRST.)

In spite of major breaches in 1980 and 1983, the National Creek Dam (33) retains a high level of structural integrity (figure 75). Cribbing, facing boards and a spillway are extant.

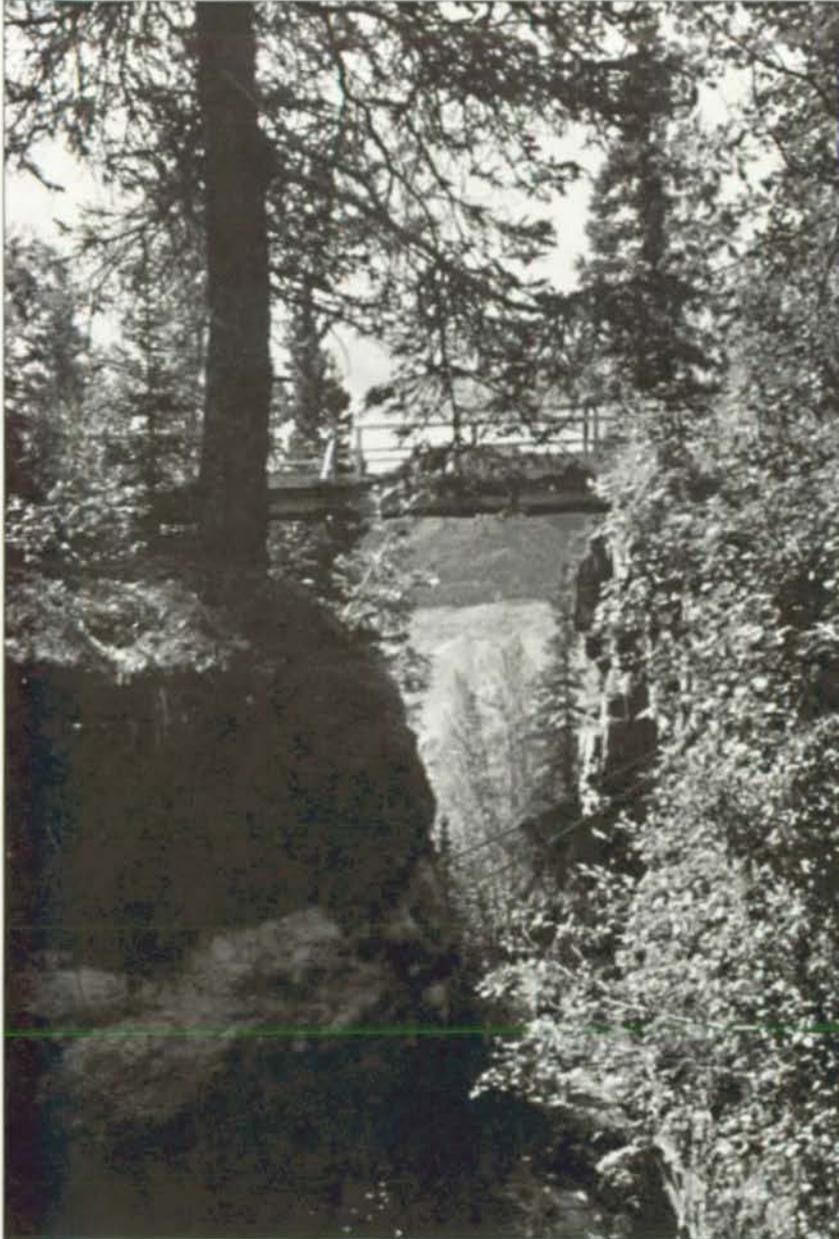
Figure 76. Footbridge over National Creek, west of dam. View looking west. (NPS photo file, WRST.)

Other structures in the area are not well preserved. A storage shed northeast of the dam (62) has collapsed entirely. A footbridge (e) across National Creek, west of the crib dam, is in need of repair and boardwalks on both sides of the footbridge are poorly preserved (figures 76 and 77).

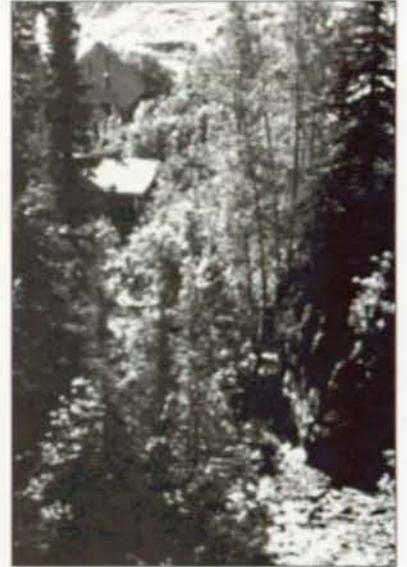
Figure 77. Looking west from footbridge over National Creek. Central mill town bunkhouses (5, 7) can be seen in the background. Vegetation has grown since Kennecott's closure. (MTU field documentation, 1997.)

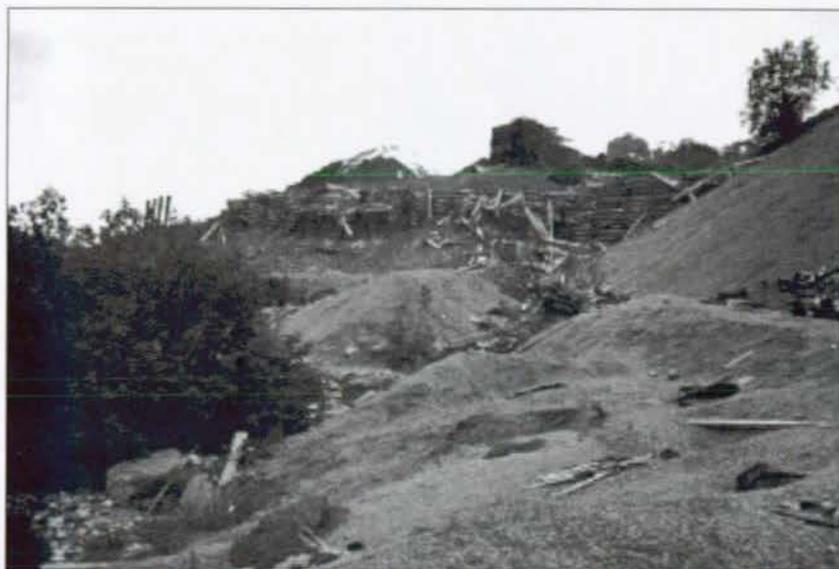
Figure 80. Tailings cribbing (45) looking northeast. (NPS photo file, WRST.)

Flooding of National Creek in 1980 and 1983 damaged the north section of the crib and carried off a substantial portion of the stored tailings (figure 80). Floods additionally undermined and removed numerous waste water pipes. Pipe and flume sections are found west of the rail bridge (a), on the west face of the crib dam, and approximately 50 feet northeast of the dam. The orientation of several pipe sections undoubtedly differs from original positions.

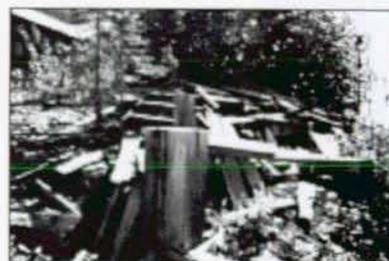
Figure 81. Looking southeast toward laundry remains, including corner post (center) and rock wall (left). Warehouse (19) appears in upper left. (MTU field documentation, 1997.)

A terrace southeast of the tailings dam extended along the southern extent of the mill town and provided space for the construction of mill facilities (see Sections 10–13). Remains of a company laundry (built by 1925) occupy the north-west corner of the terrace (figure 81). This one-story, wood frame structure has entirely collapsed (apparently destroyed as a potential hazard in the late 1970s),

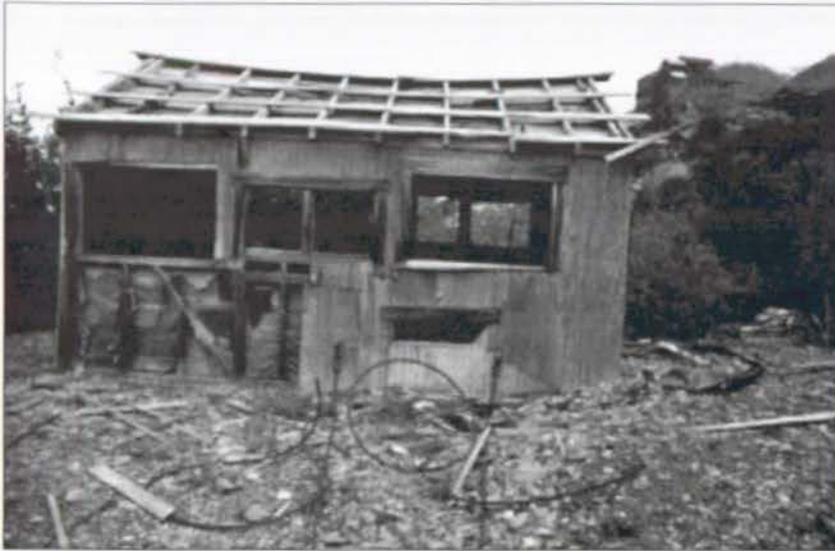
Figure 83. Detail of hoist house (44), looking north. Concentration mill in background. (MTU field documentation, 1997.)

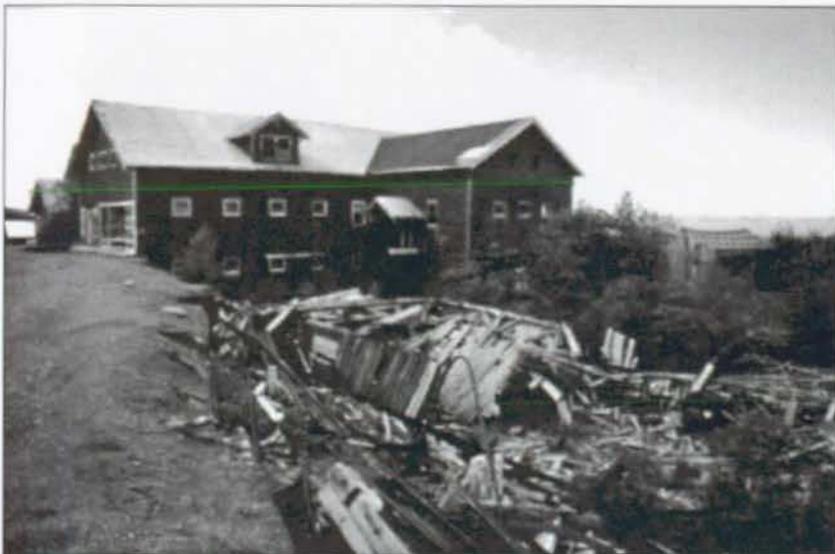
Figure 84. View south toward store and warehouse (19). Remains of carpentry shop (6) in foreground. Hoist house (44) appears at right background. (MTU field documentation, 1997.)

The carpentry building north of the warehouse has almost entirely collapsed (figure 84). Of the few wall sections remaining, all lack stability. Some standing walls may belong to the paint shop (51) or to a later extension of the carpentry. Artifacts in the wood scatter include a workbench (a), an edging machine (c), and flywheels (e and f), and clearly relate to work activities in the shop.

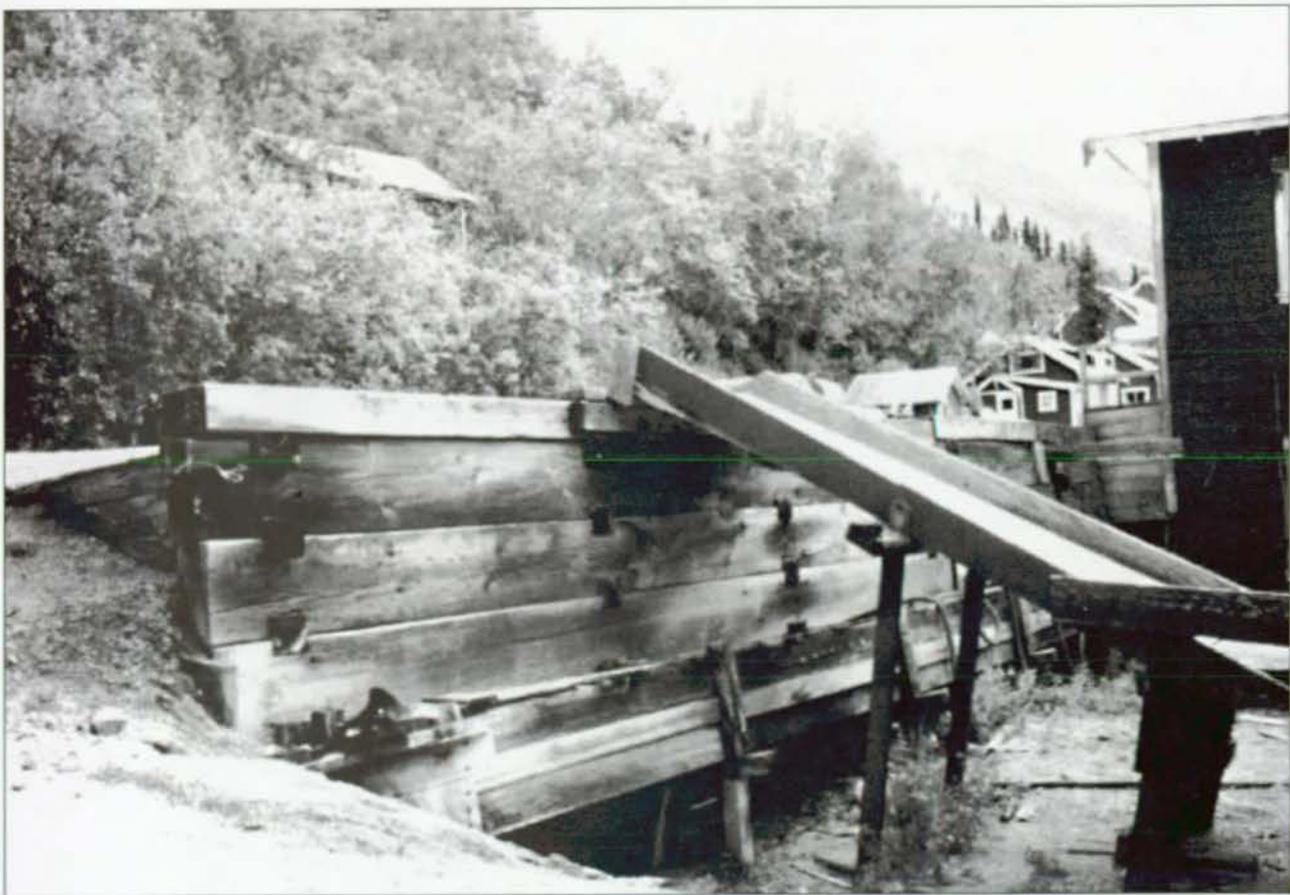
Figure 86. Retaining wall and covered utilidor east of the refrigeration plant (48). View looking southeast. (NPS photo file, WRST.)

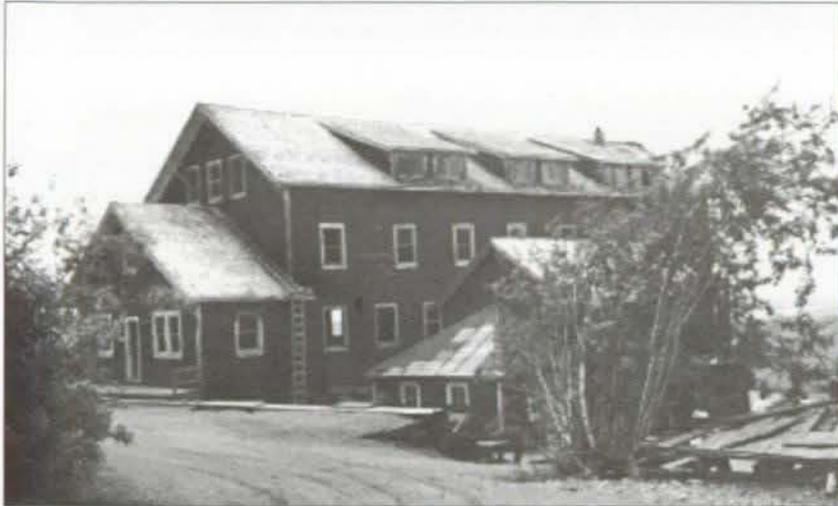
Figure 87. View showing refrigeration plant (48) with west bunkhouse (20) in background. (NPS photo file, WRST.)

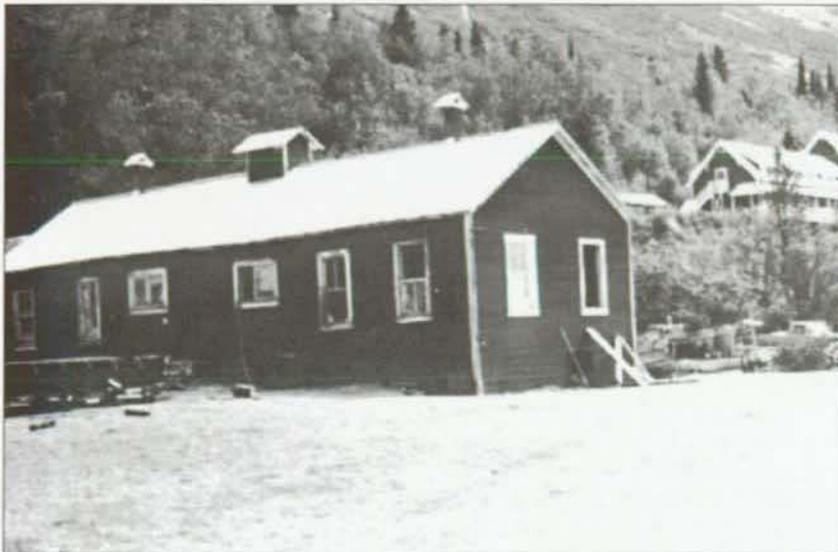
Figure 88. Looking southeast toward the schoolhouse (23). Conveyor and remains of handball court can be seen in center left. (NPS photo file, WRST.)

court (brought in but not adopted in 1995 as a means to back-fill the leaching plant floor with tailings) is anomalous to designated equipment areas during the concentrator's operation.

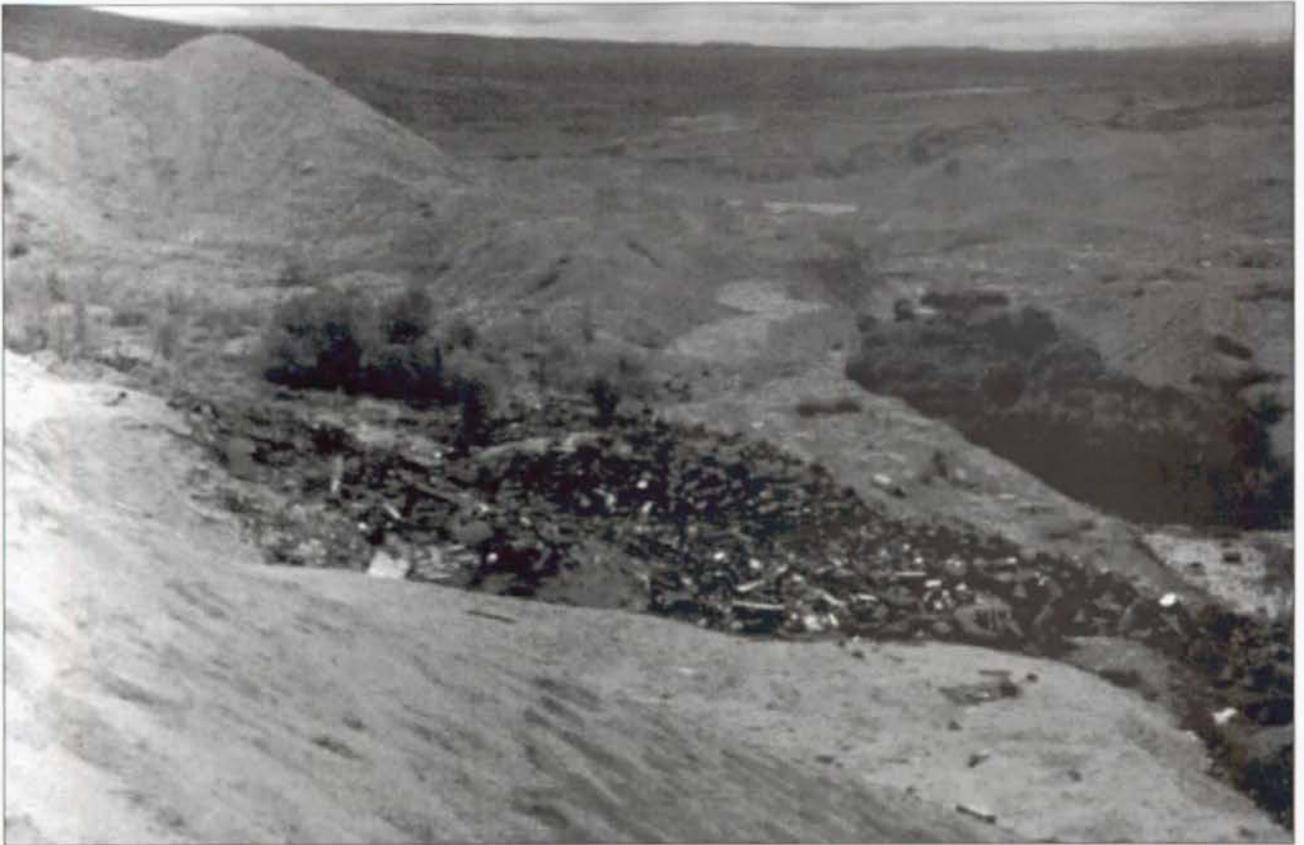
Figure 90. Main domestic dump viewed from tailings terrace. View looking south. (MTU field documentation, 1997.)

During Kennecott's operation, the western edge of the rail grade terrace included a fire station, framing platform, and areas for wood and pipe storage. While no remnants of these activities are extant, the area may retain some archeological integrity (potentially revealing decking foundations and pipeline to the fire station). A large dump (e) located at the bottom of the terrace scarp includes ceramics, glassware, and food ways (figure 90). In excess of 28,000 square feet,

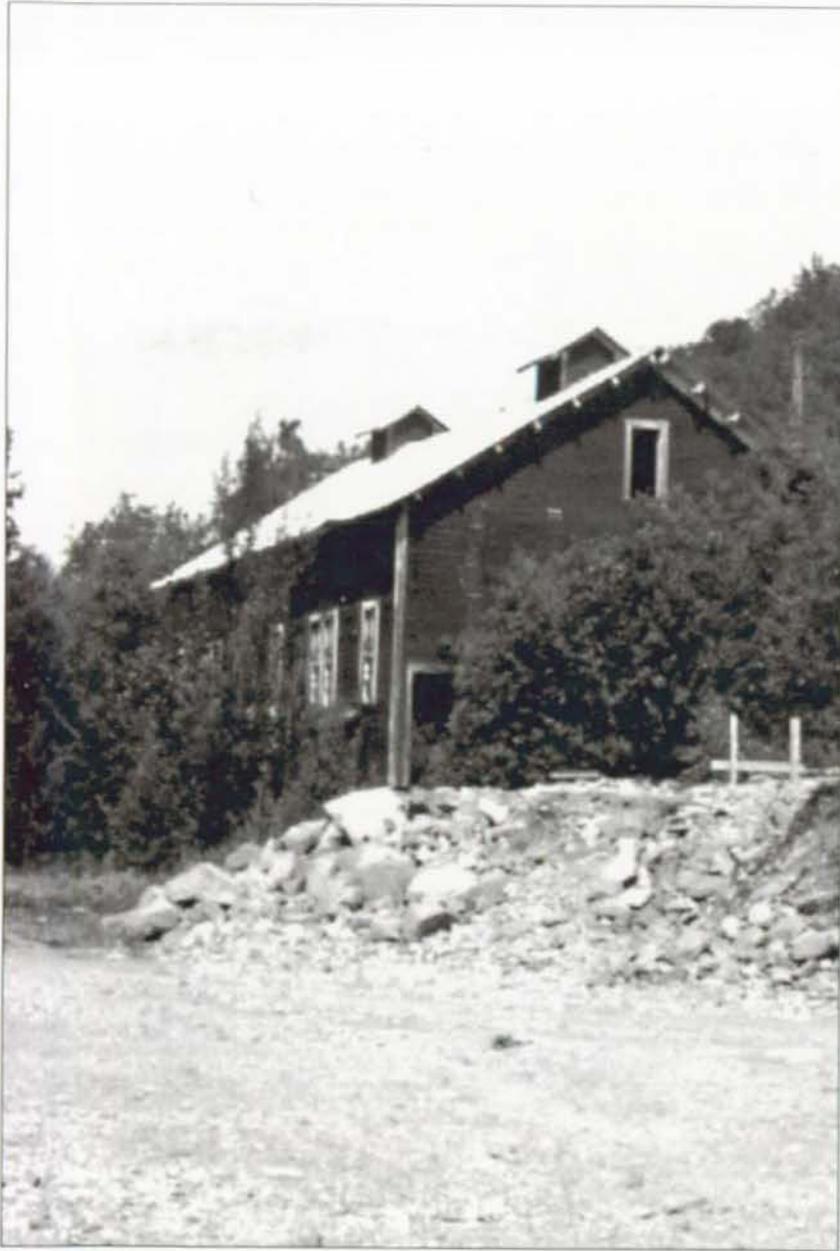
Figure 92. Looking north from the old wagon road toward the recreation hall (18). Landscaping (foreground) derives from the construction of a commercial facility in the south mill town. (MTU field documentation, 1997.)

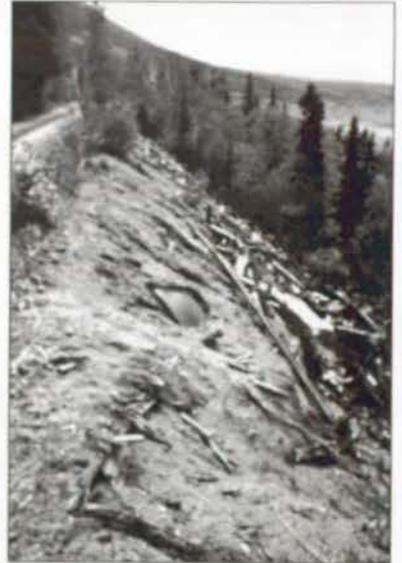
Figure 93. Industrial dump located at south entrance to the mill town. View southeast with rail grade at left. (MTU field documentation, 1997.)

A dispersed dump, containing both modern and Kennecott-era materials, extends north of the dairy barn. A second and more concentrated refuse dump west of the rail grade at the southern extent of the mill town primarily contains industrial artifacts (such as link belts, screens, and machinery). This area is less disturbed by modern refuse and retains high archeological significance (figure 93). Isolated artifacts located in the scrub between the cottage (26) and the former wagon road includes a concrete mixer, washer, and water heater. These were, in all likelihood, used during Kennecott's operation.

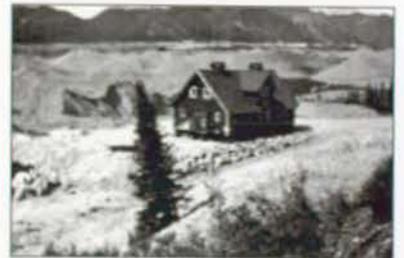
Figure 94. Looking northwest toward the dairy barn (28). Landscaping around the barn is a recent disturbance. (MTU field documentation, 1997.)

Numerous modifications occurred in this area after the closure of Kennecott. A modern road between the northern cottage and recent commercial facility provides vehicle access from the rail grade to the former McCarthy wagon road. Recent landscaping around the dairy barn has destroyed its surrounding context (figure 94). Decking extending east from the dairy barn to the rail grade is no longer present.

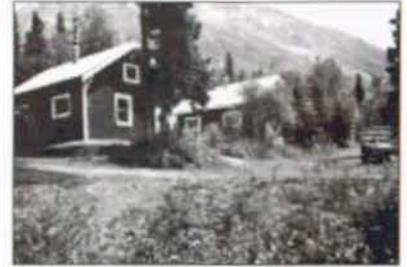
Figure 96. South cluster of cottages built in 1916 on Silk Stocking Loop road. (NPS photo file, WRST.)

The southern cluster, built in 1916, includes a row of three, freestanding wood frame cottages (30 a–c, figure 96). The cottages sit to the east of Silk Stocking Loop. Two collapsed chicken coops (31 a–b) are located west of the cottages on the other side of the dirt road. A utilidor carried water and steam lines to a firehouse between the chicken coops. Utility lines were not conveyed into the cottages and privies were built to the rear.

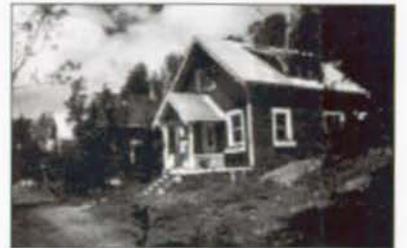
Figure 97. North cluster of cottages (32 b–d) built in 1918 on Silk Stocking Loop road. (NPS photo file, WRST.)

In 1918, the company constructed a second cluster of four cottages (32 a–d) 300 feet north of the first group (figure 97). Although of similar design and orderliness to the southern cluster, the northern cottages were fitted with water, steam, and sewage lines. Remnants of the utilidor between the west bunkhouse (20) and cottage 32d are found down the hillside. It is likely that the firehouse, water, and steam lines conveyed to the southern cluster of cottages occurred during the construction of the 1918 cottages. Pipes between the building clusters follow the west side of Silk Stocking Loop. A collapsed garage (72)

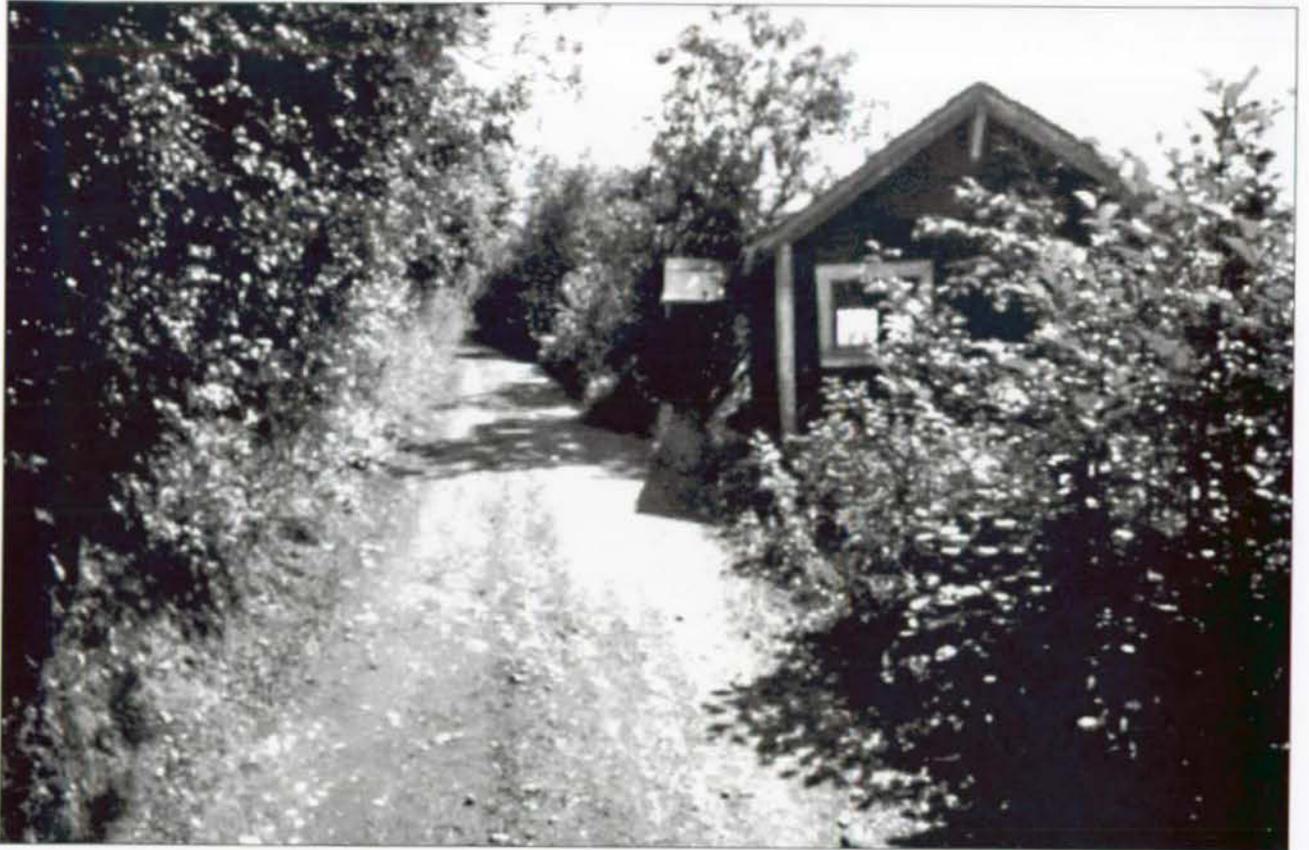
Figure 99. Bathhouse (47) seen from Silk Stocking Loop road, looking southeast. (MTU field documentation, 1997.)

Description: This section of the mill town predominantly served storage and transportation functions. Structures positioned close to the rail grade included a tool shed (46), oil storage building, and open-air lumber storage. Although the tool shed remains intact, a small wood scatter and leveled ground testify to the presence of the one-story oil warehouse to the south. Artifacts in the vicinity, including pipe bends, relate to the tool shed. Extant decking south of the oil storage building contains gears, sections of pipe, and corrugated iron. The latter likely derived from the roof of the oil storage building or an abutting shed. An extant bathhouse, southwest and up the hillside from the deck, probably served families living in the south mill town not connected to a water supply (figure 99).

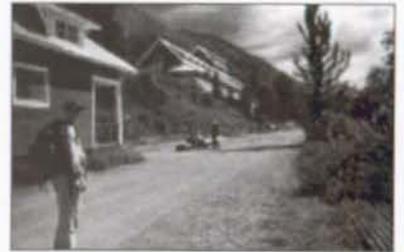
Figure 101. Looking south along rail grade in south mill town area. The cottage (29 c) in foreground was moved during renovations of the Kennicott Glacier Lodge (17) seen in the background. (NPS photo file, WRST.)

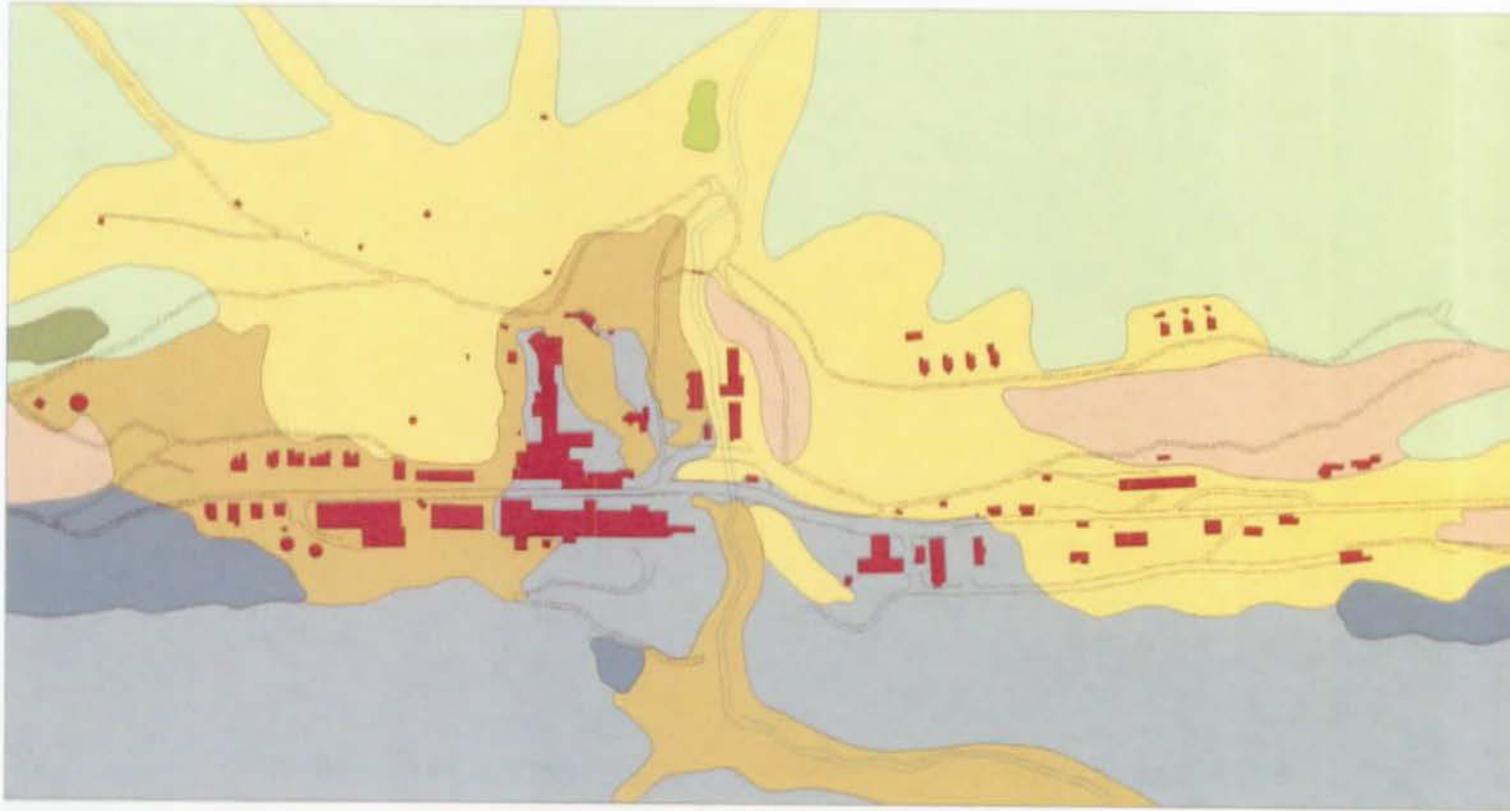
Existing Conditions
Vegetation Documentation
for Cultural Landscape Report:
Kennecott Townsite, 1998

- Vegetation Types**
- III.B.1.a. Seral Herbs
 - II.B.2.a Open Tall Willow Shrub
 - I.A.2.e. Open White Spruce Forest
 - I.A.1.j. Closed White Spruce Forest
 - II.B.1.d. Closed Tall Alder-Willow Shrub
 - II.B.2.d. Open Tall Alder-Willow Shrub
 - II.B.2.e. Open Tall Birch-Willow Shrub

There is more total vegetation cover today than at any time since the start of the mining era. This is due primarily to the ongoing retreat of the Kennicott Glacier and the consequent colonization of its abandoned lateral moraines. Virtually all of the land cleared during the mining era has revegetated to some degree, and most roadways and trails have either disappeared or become narrow paths through a tunnel of encroaching alder and willow. With the exception of privately-owned property (the Kennicott Glacier Lodge, Silk Stocking

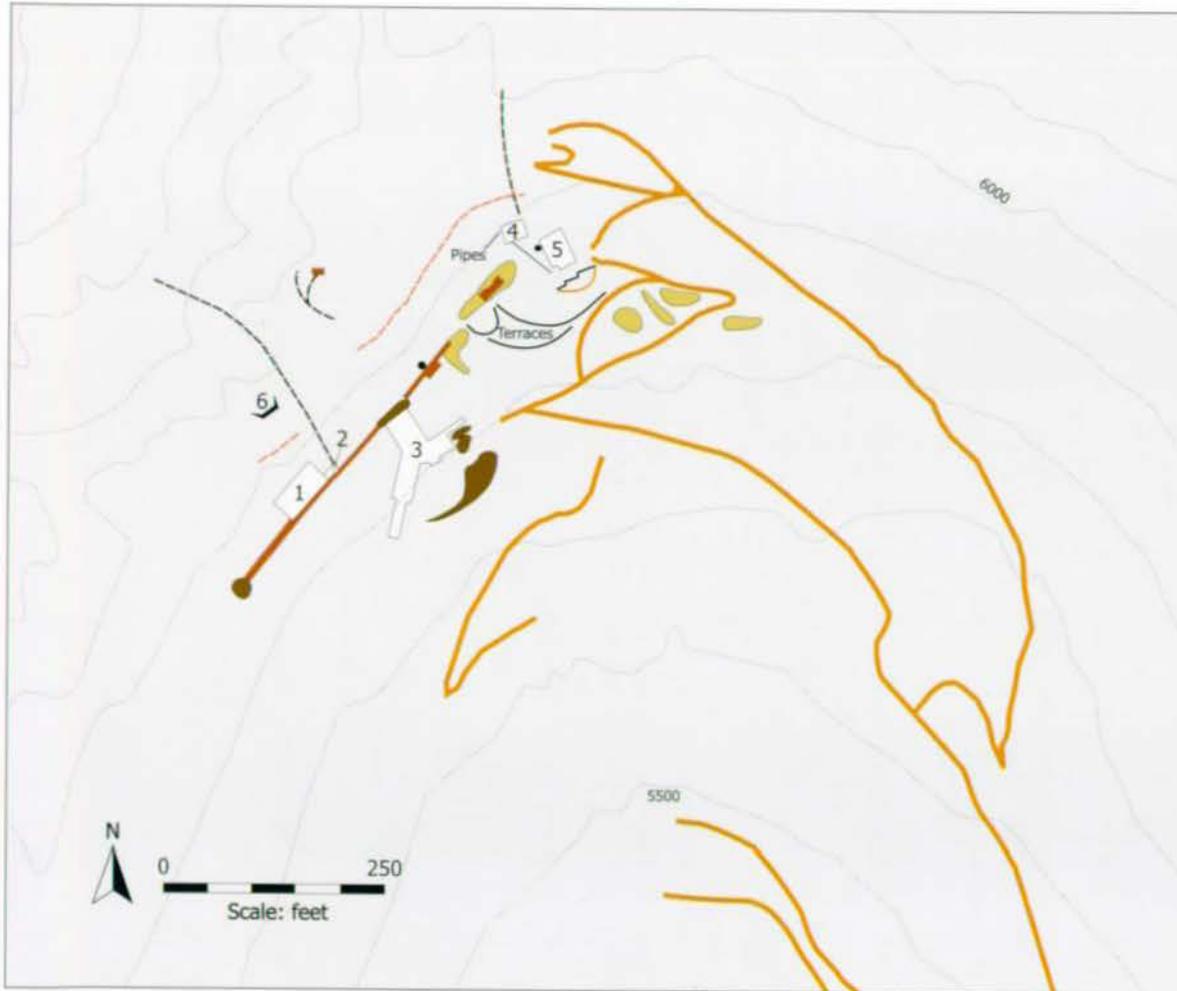
Bonanza Mine
Existing Conditions

- Adit
- Wood Scatter
- Dump
- Decking
- Telephone Line (fallen)
- Cable
- Trail

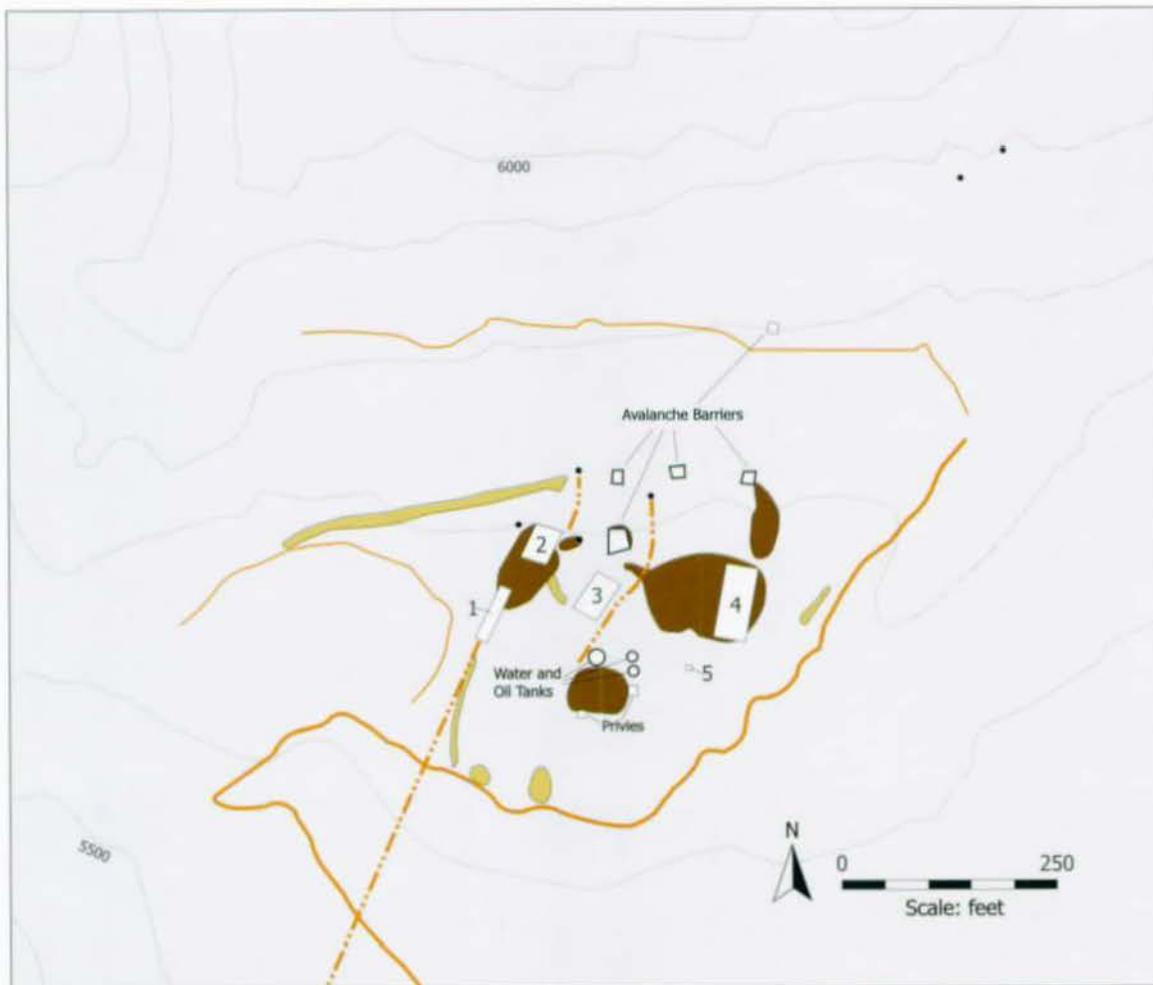
Jumbo Mine
Existing Conditions

- Adit
- Wood Scatter
- Dump
- Tramway
- Trail

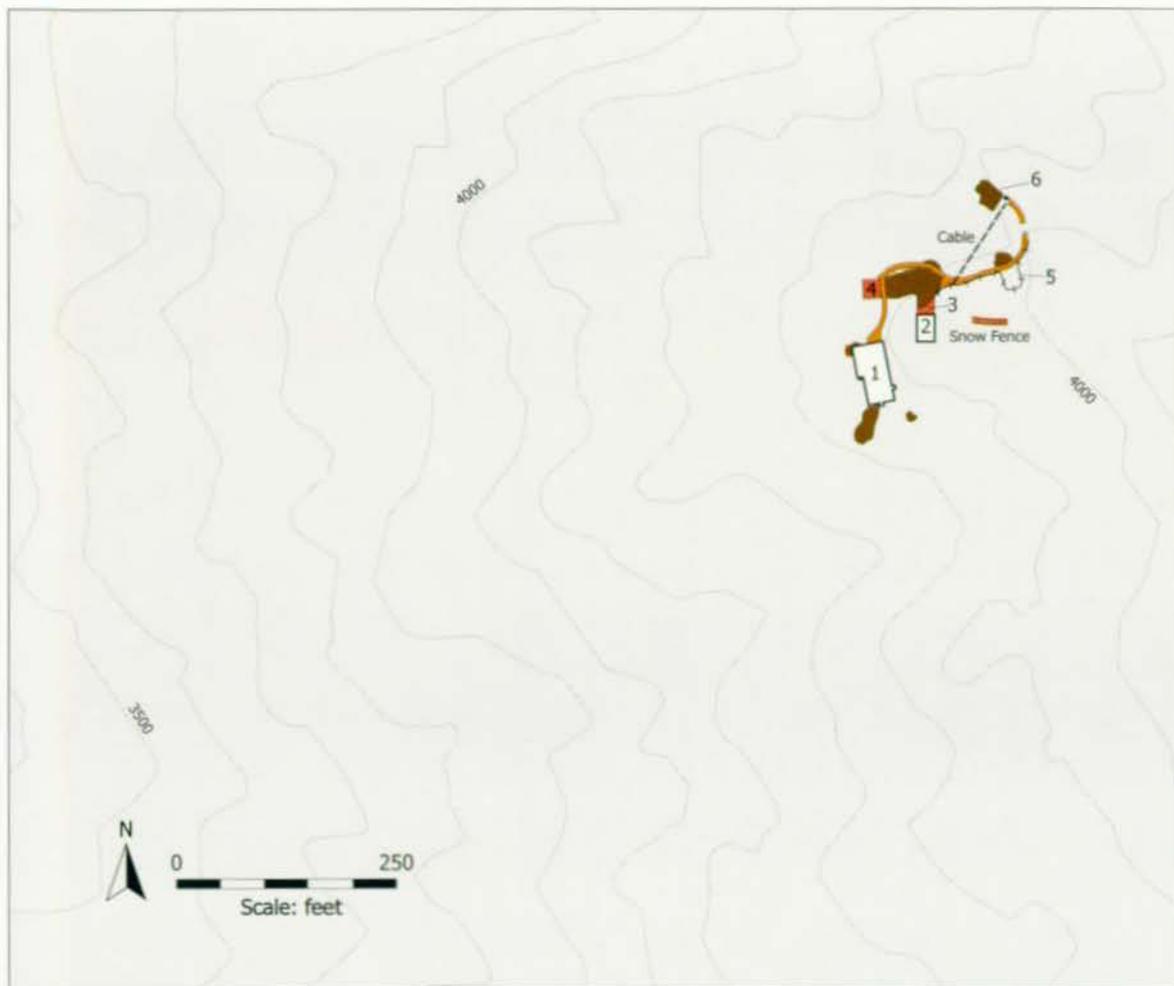
Erie Mine
Existing Conditions

- Ruin
- Adit
- Wood Scatter
- Trail
- Scarp

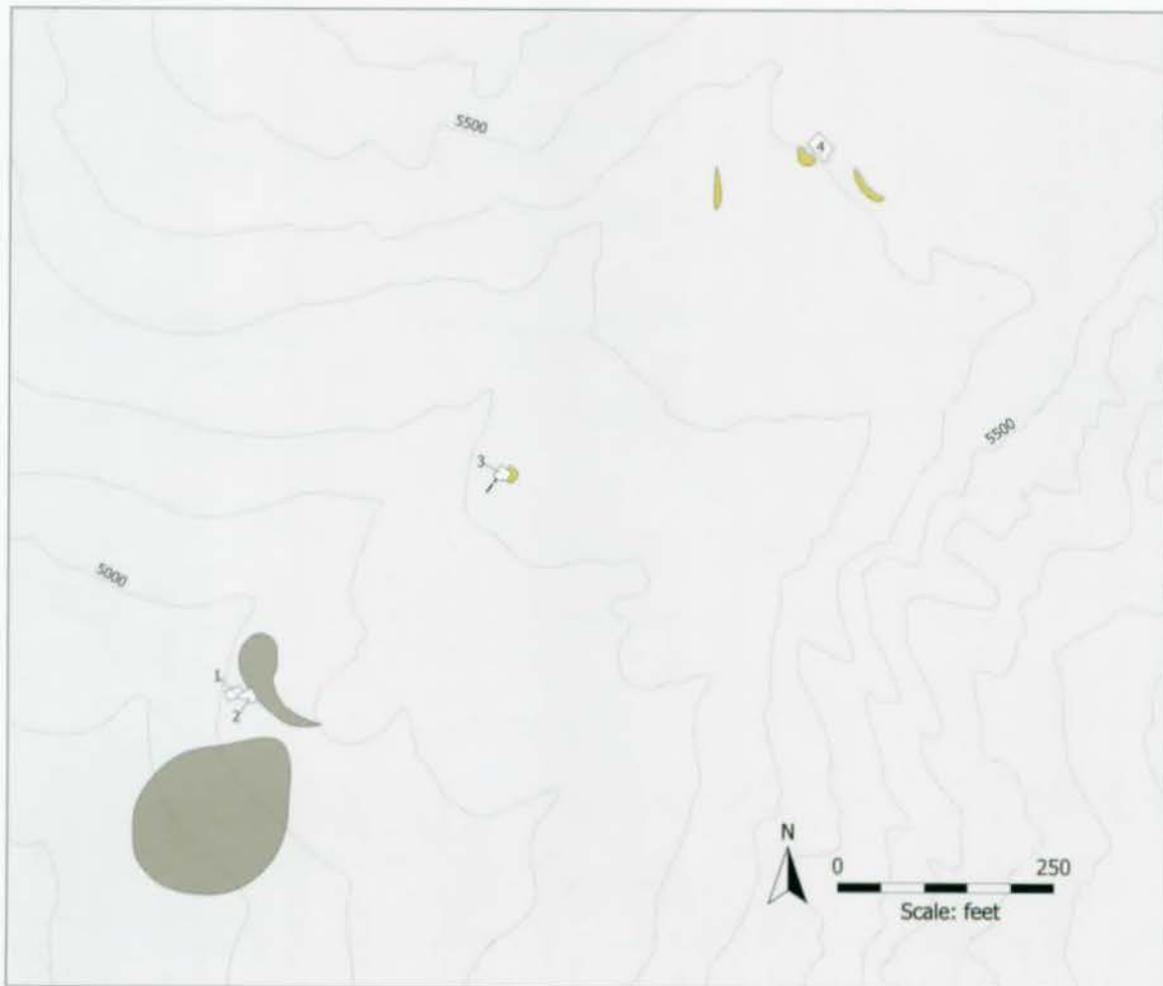
Glacier Mine
Existing Conditions

- Dump
- Tailing
- Cable
