ARCHEOLOGICAL INVENTORY AND EVALUATION AT THE CARRIGAN AND BURCH PROPERTIES, LINCOLN HOME NATIONAL HISTORIC SITE, SPRINGFIELD ILLINOIS

BY
JANIS L. DIAL-JONES

Midwest Archeological Center
Technical Report 125

NATIONAL PARK SERVICE
Midwest Archeological Center

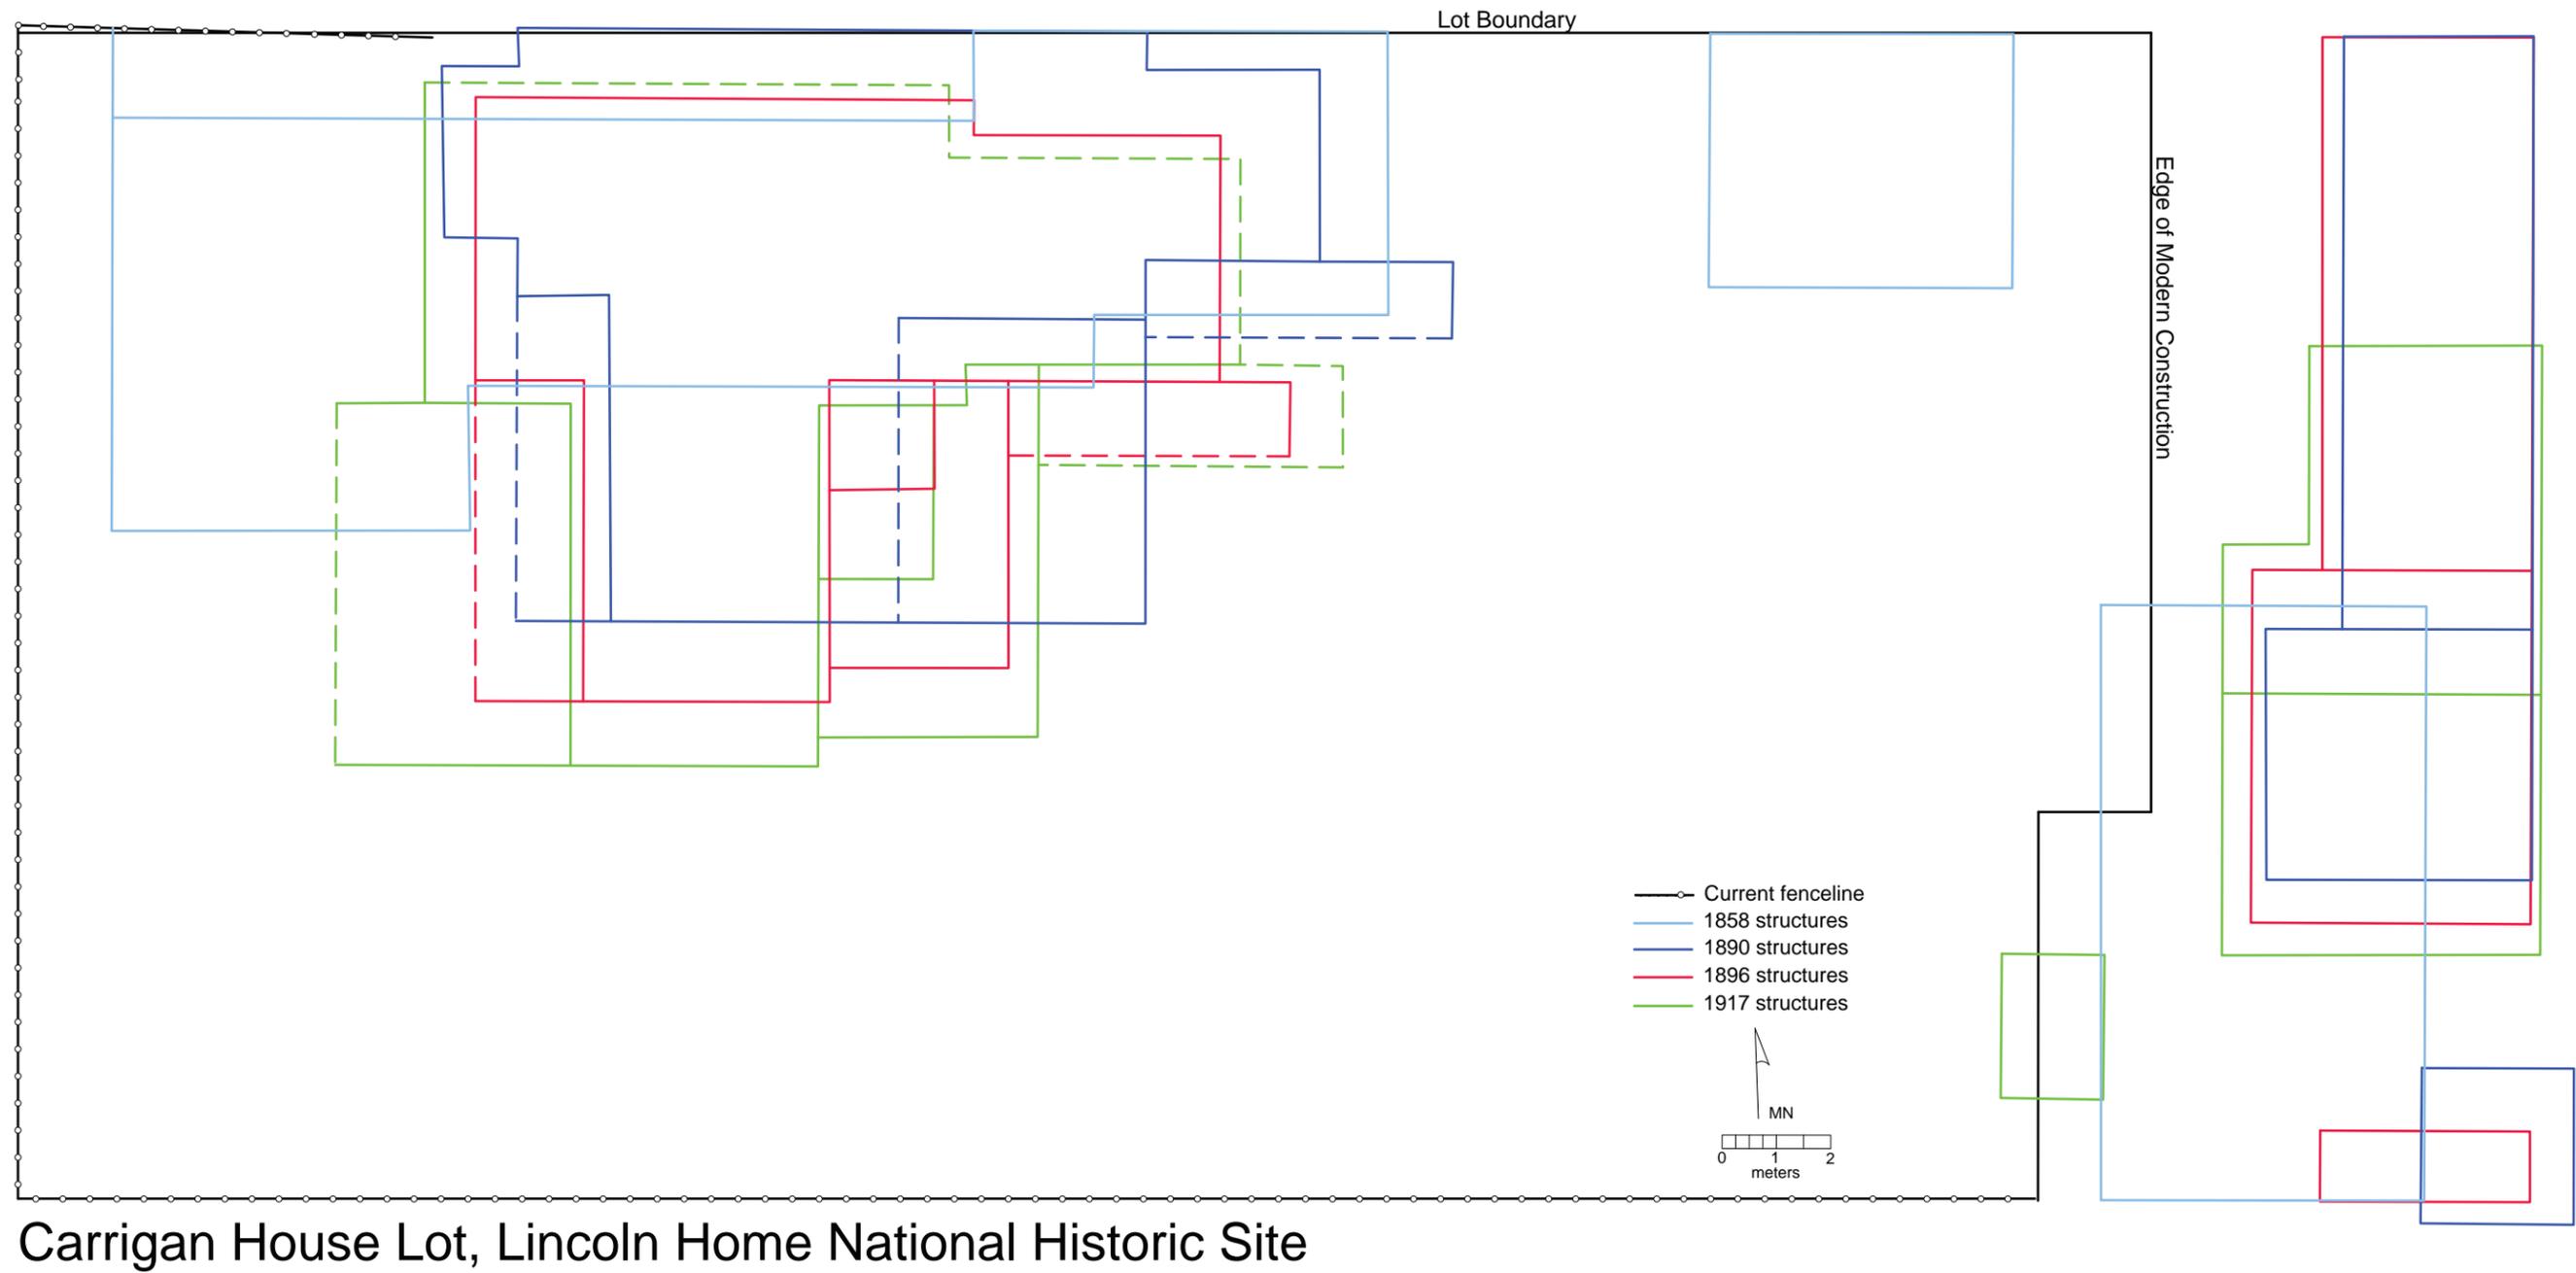
Figure 2. Plan view of the Carrigan property with the locations of structures that formerly stood on the property as depicted on several historic maps.

The locations of early structures on the Carrigan property depicted on several historic maps are presented in Figure 2 as a composite of several overlays. The structures present on the property in 1858 included the Carrigan house itself, a small outbuilding behind the house that was built along the north property line, and a barn in the southeast corner of the lot (Sides 1858). The structures mapped in 1890, 1896, and 1917 reflect the later Irwin house and its associated outbuildings (Sanborn-Perris Map and Publishing Company 1890; Sanborn Map and Publishing Company 1896, 1917). All of the plan maps of the Carrigan property prepared for the current archeological project showing the locations of the archeological features identified in 2005 and 2006 and other relevant information are presented consecutively as Figures 2 through 12 for ease in reference, although discussions of the individual plan maps are dispersed throughout the report.

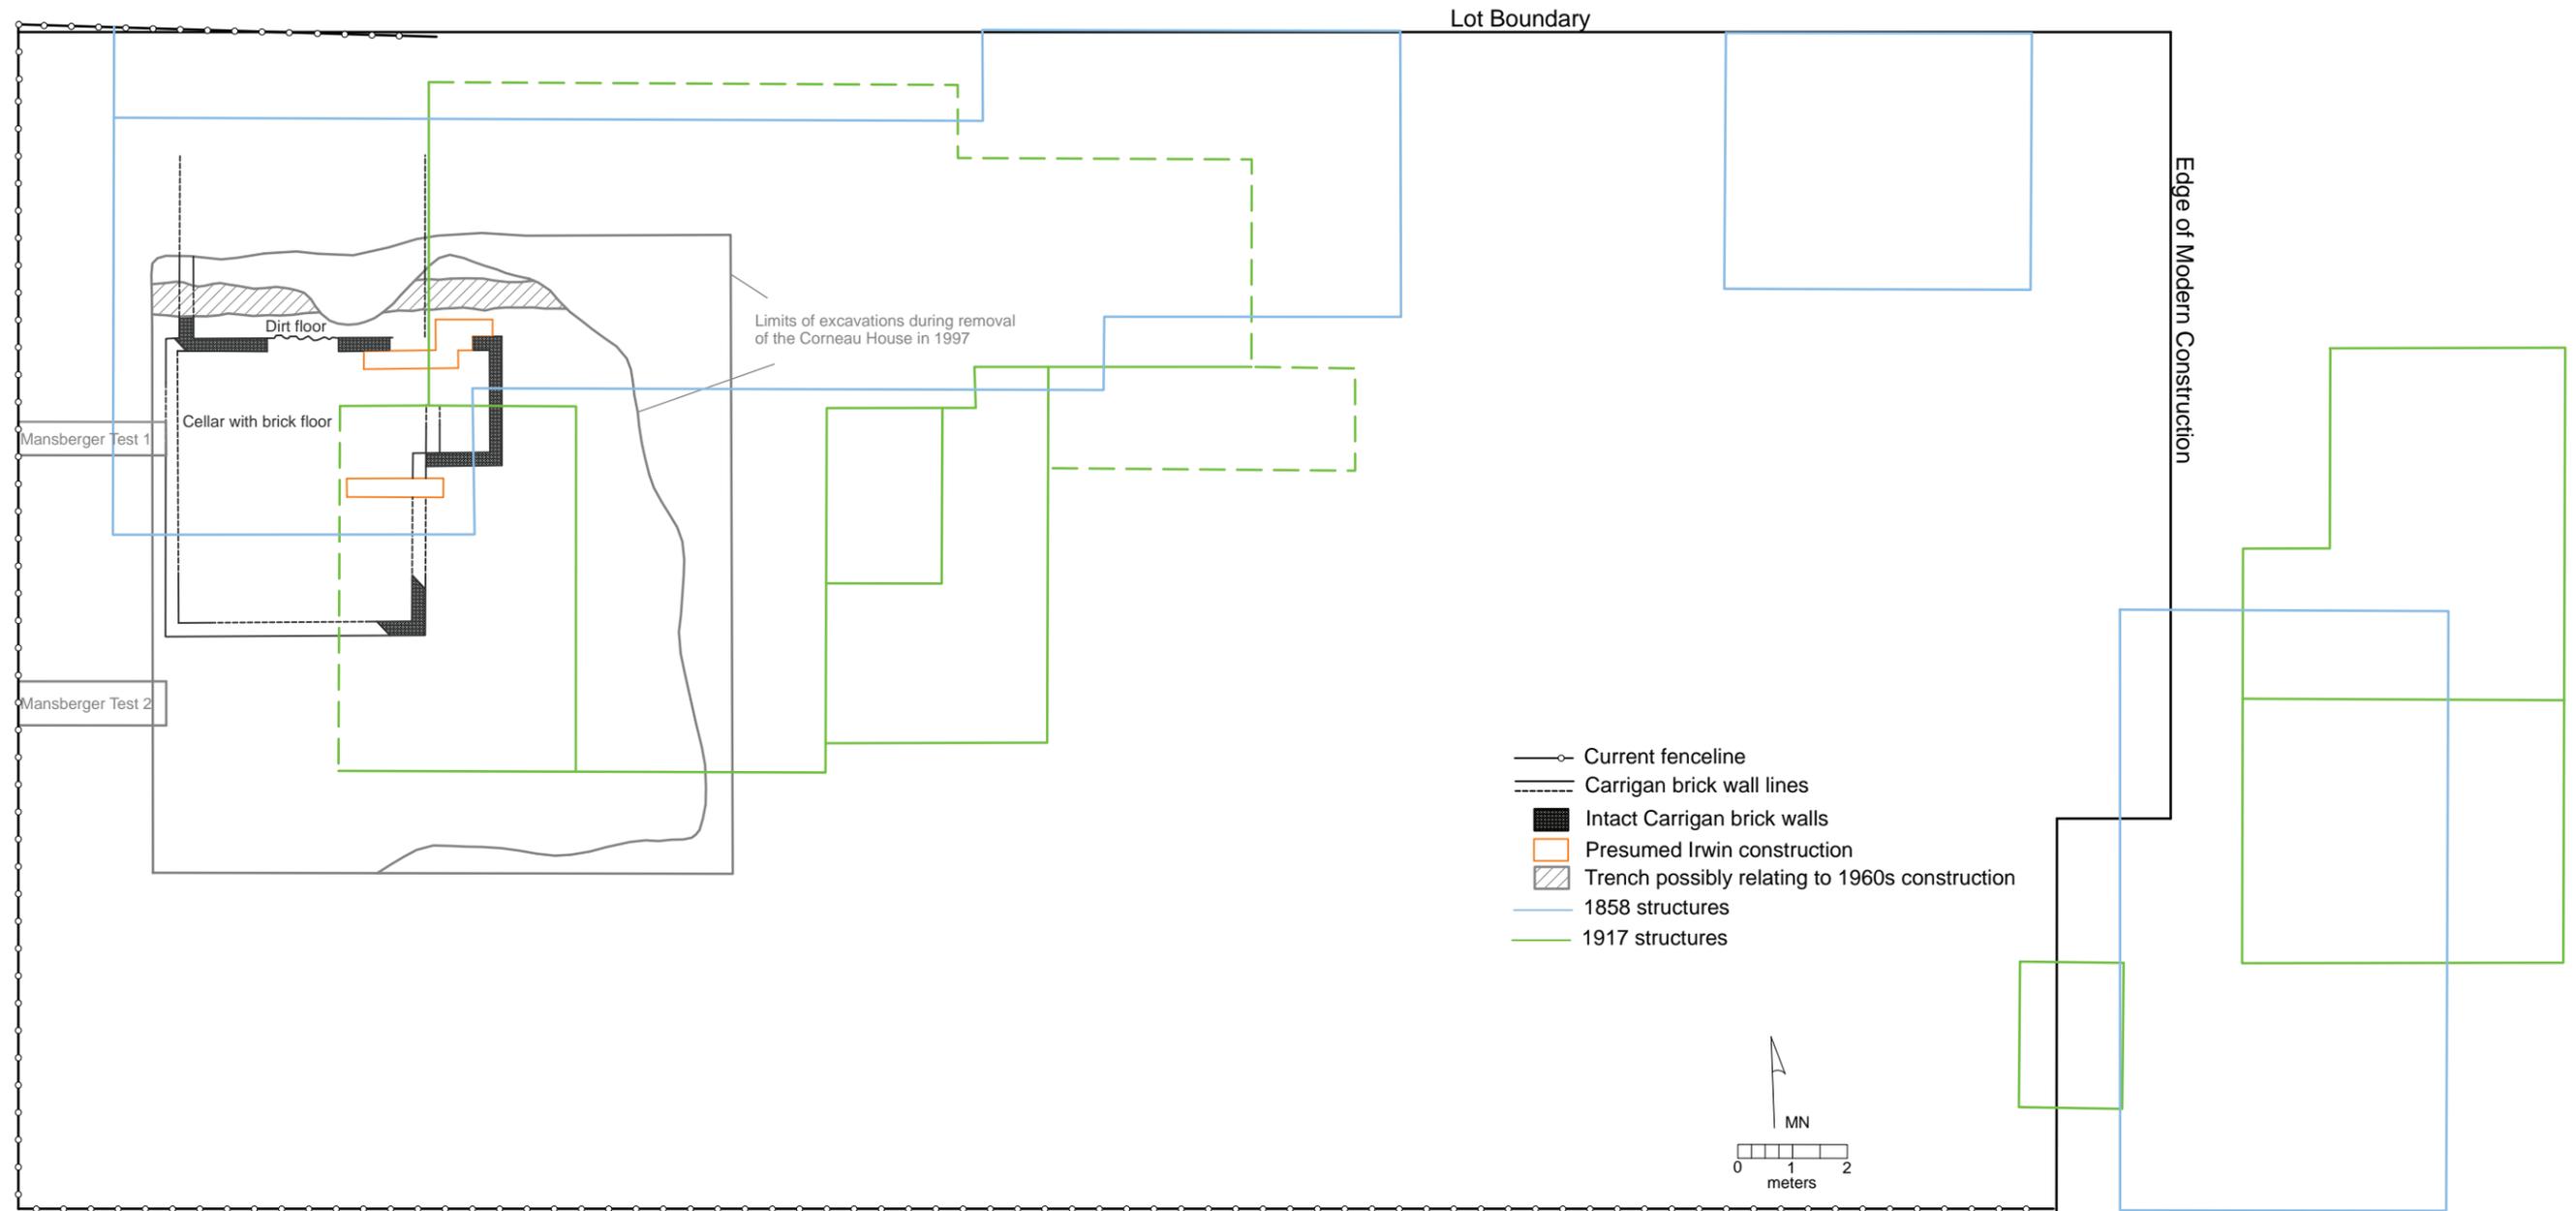
Figure 3. Plan view of the Carrigan property with archeological features relating to the Carrigan and Irwin houses exposed by Mansberger in 1997 during removal of the Corneau house.

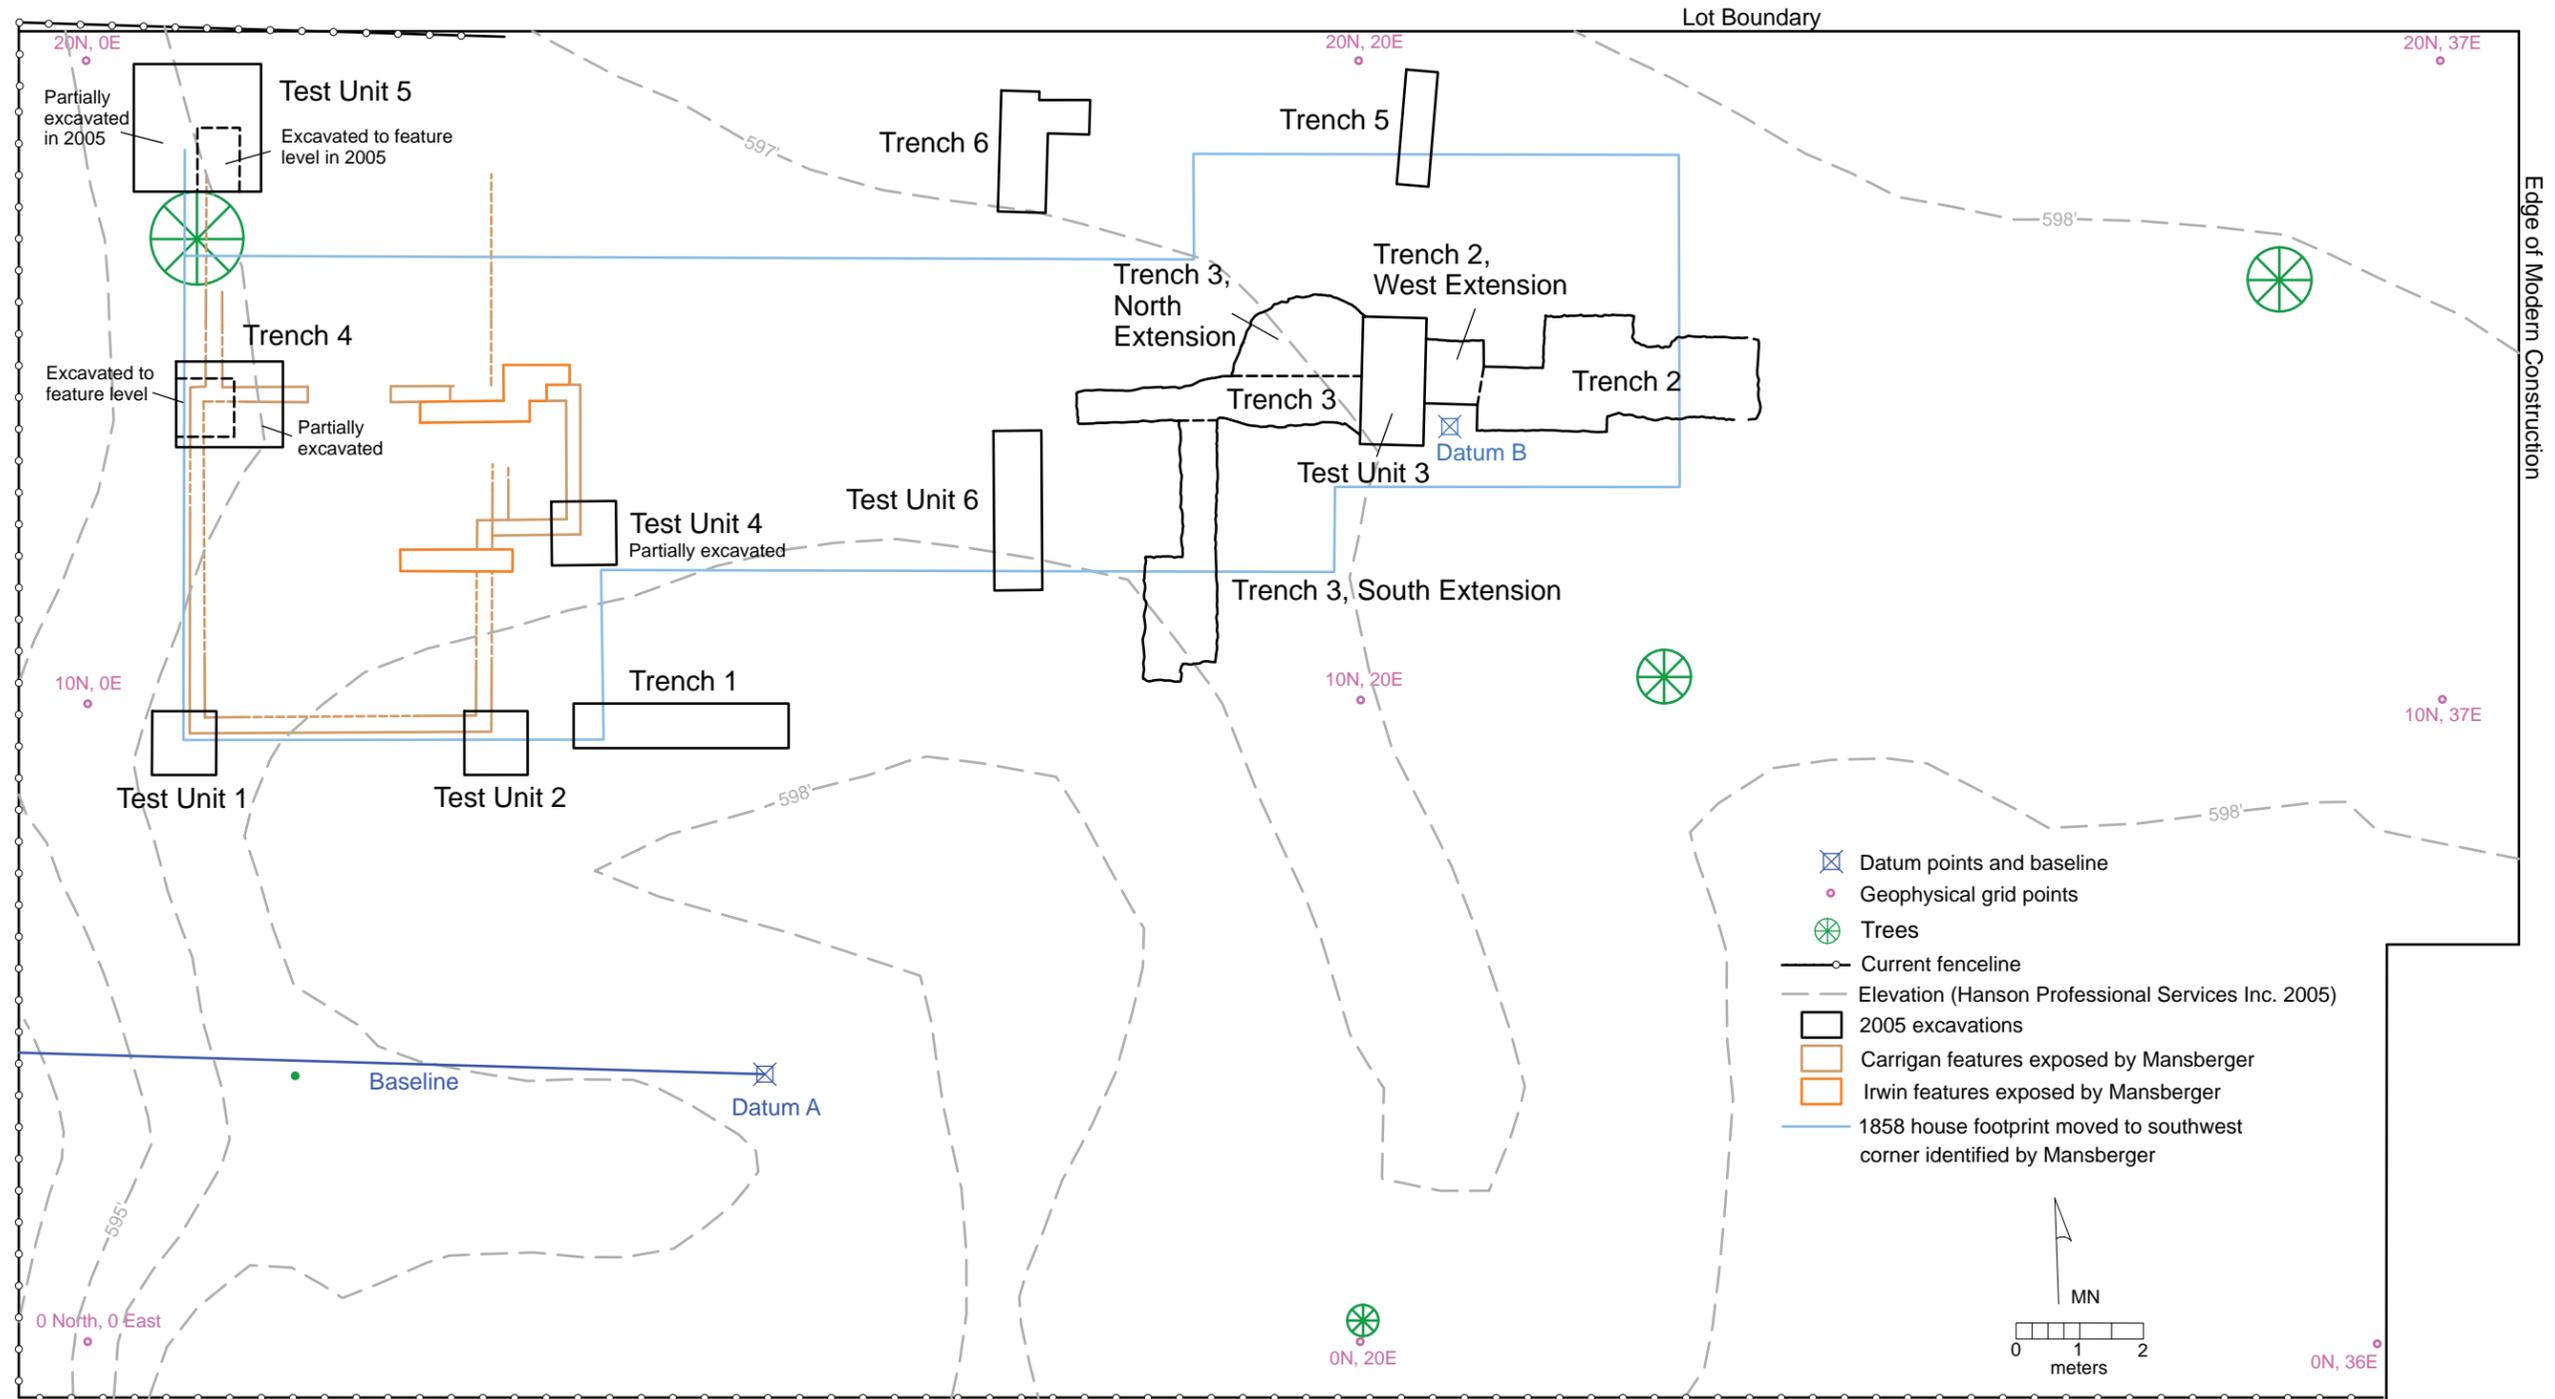
Figure 4. Plan view of the Carrigan property with references for the 2005 archeological field methodology.

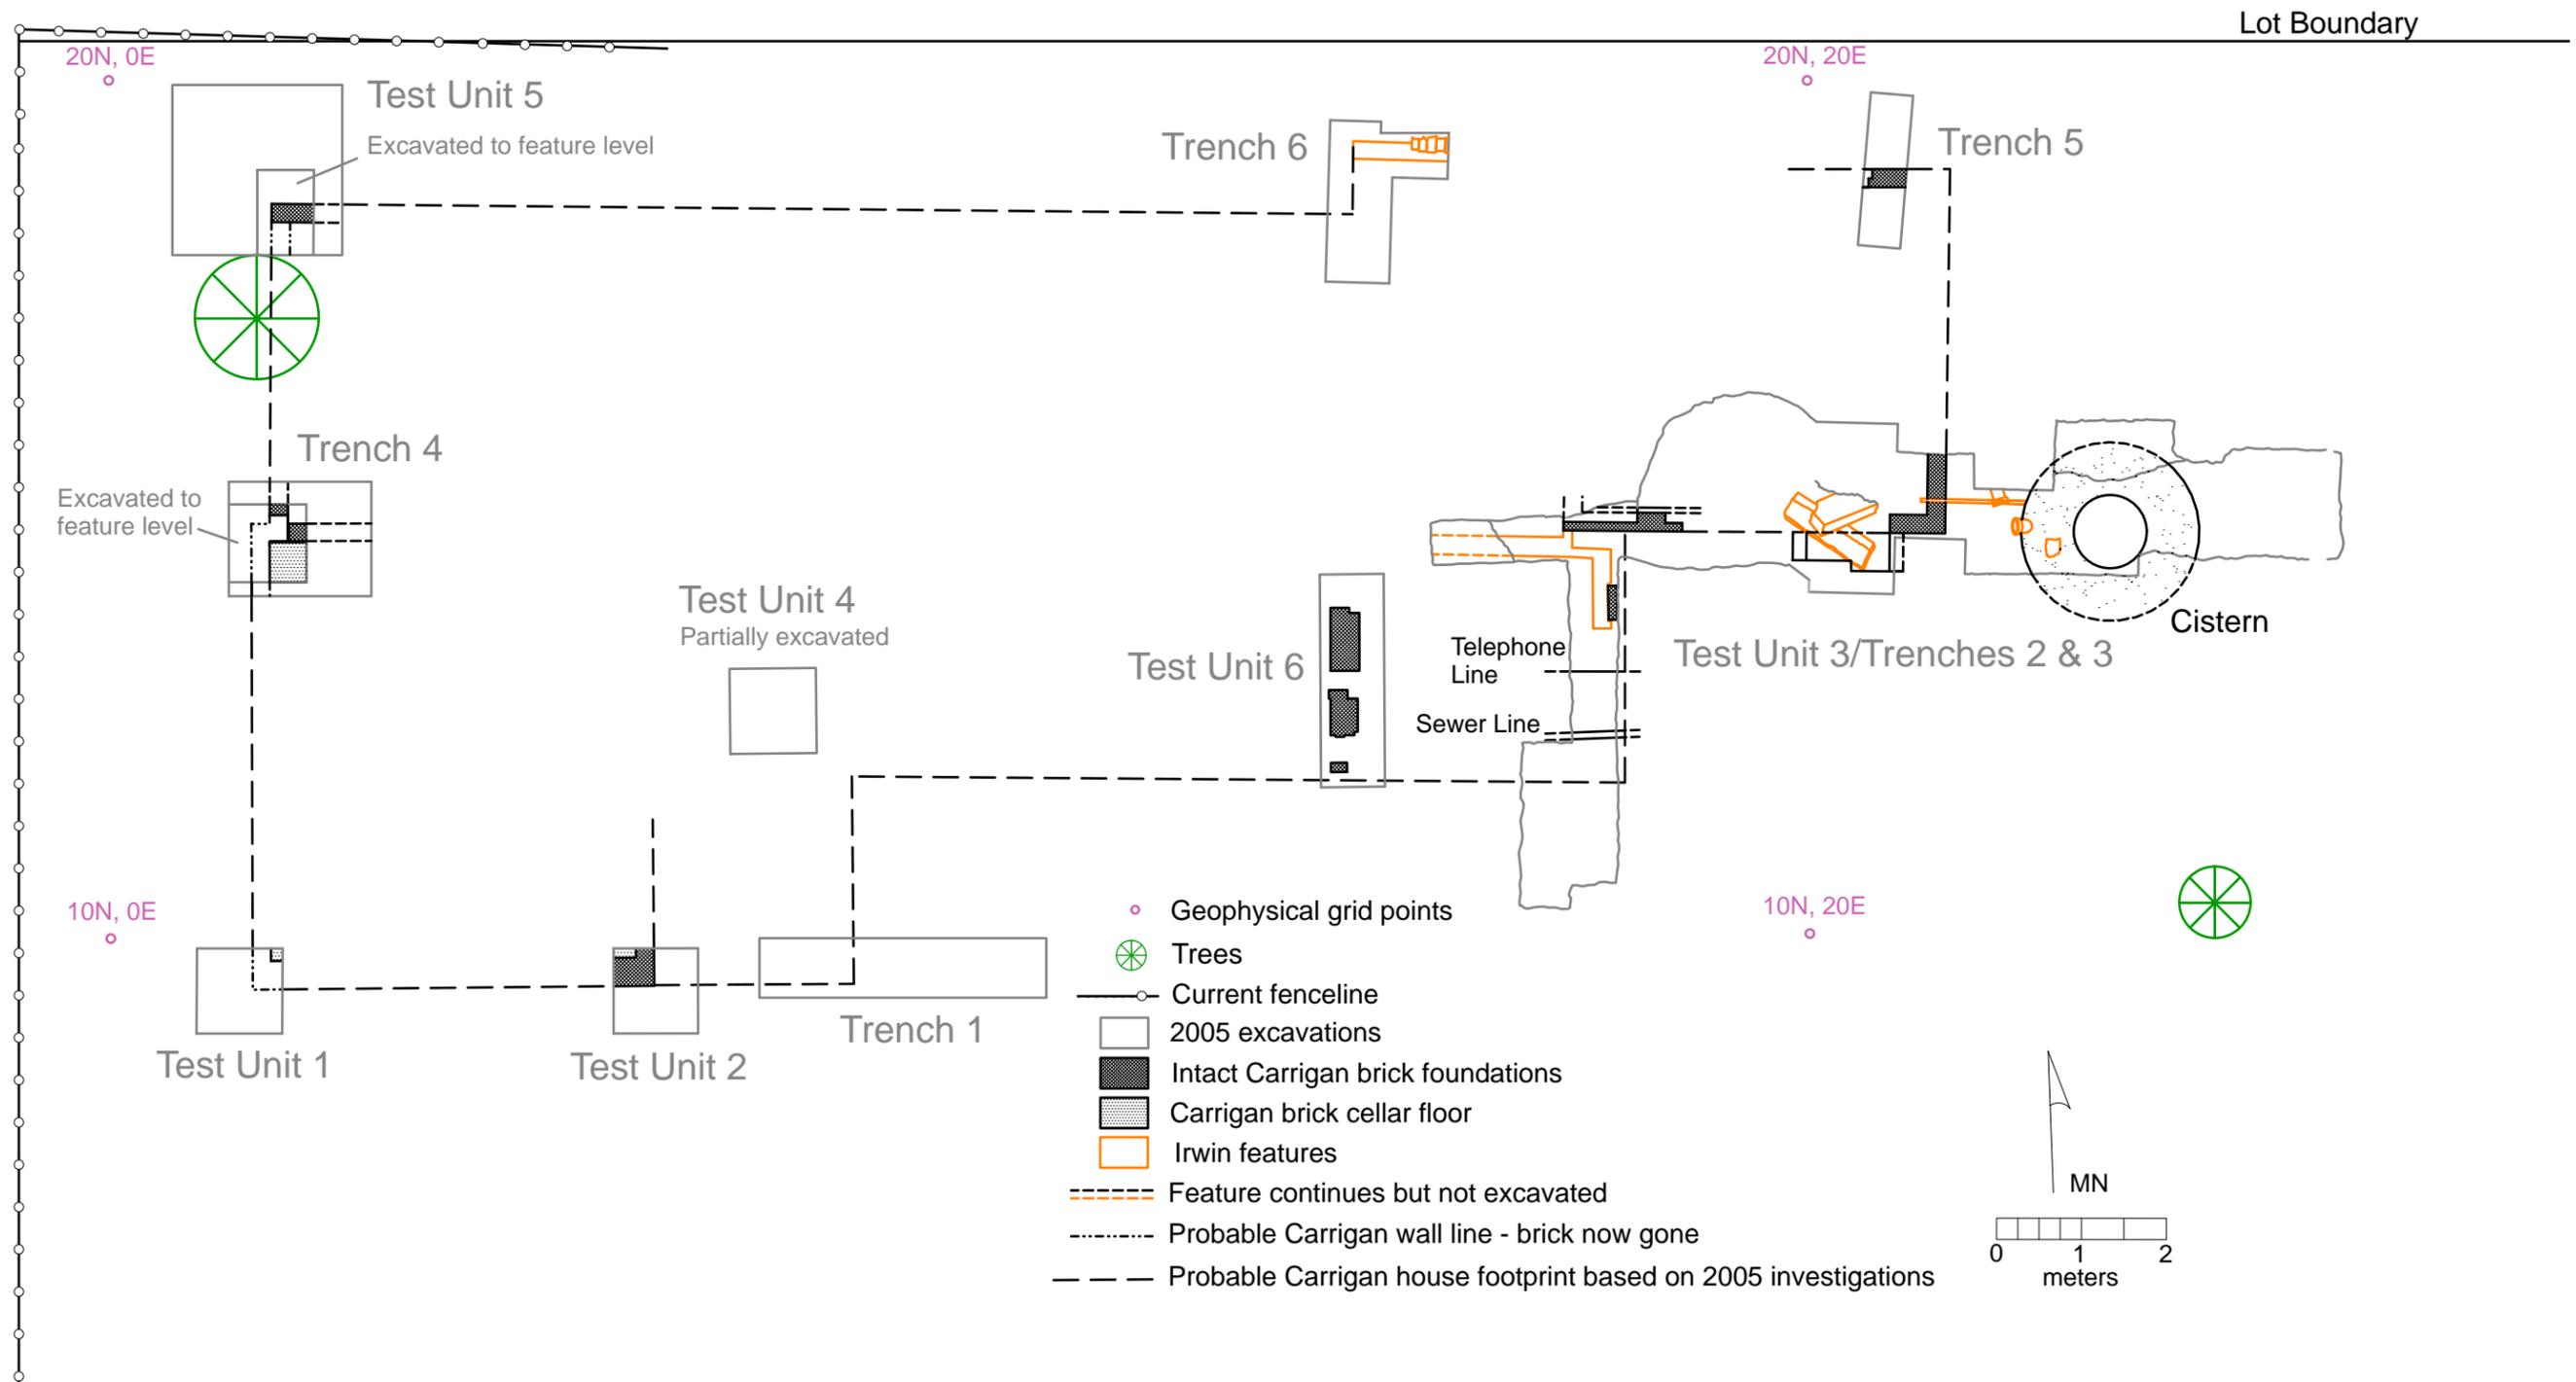
Figure 5. Plan view of the Carrigan property with archeological features relating to the Carrigan and Irwin houses identified in 2005.

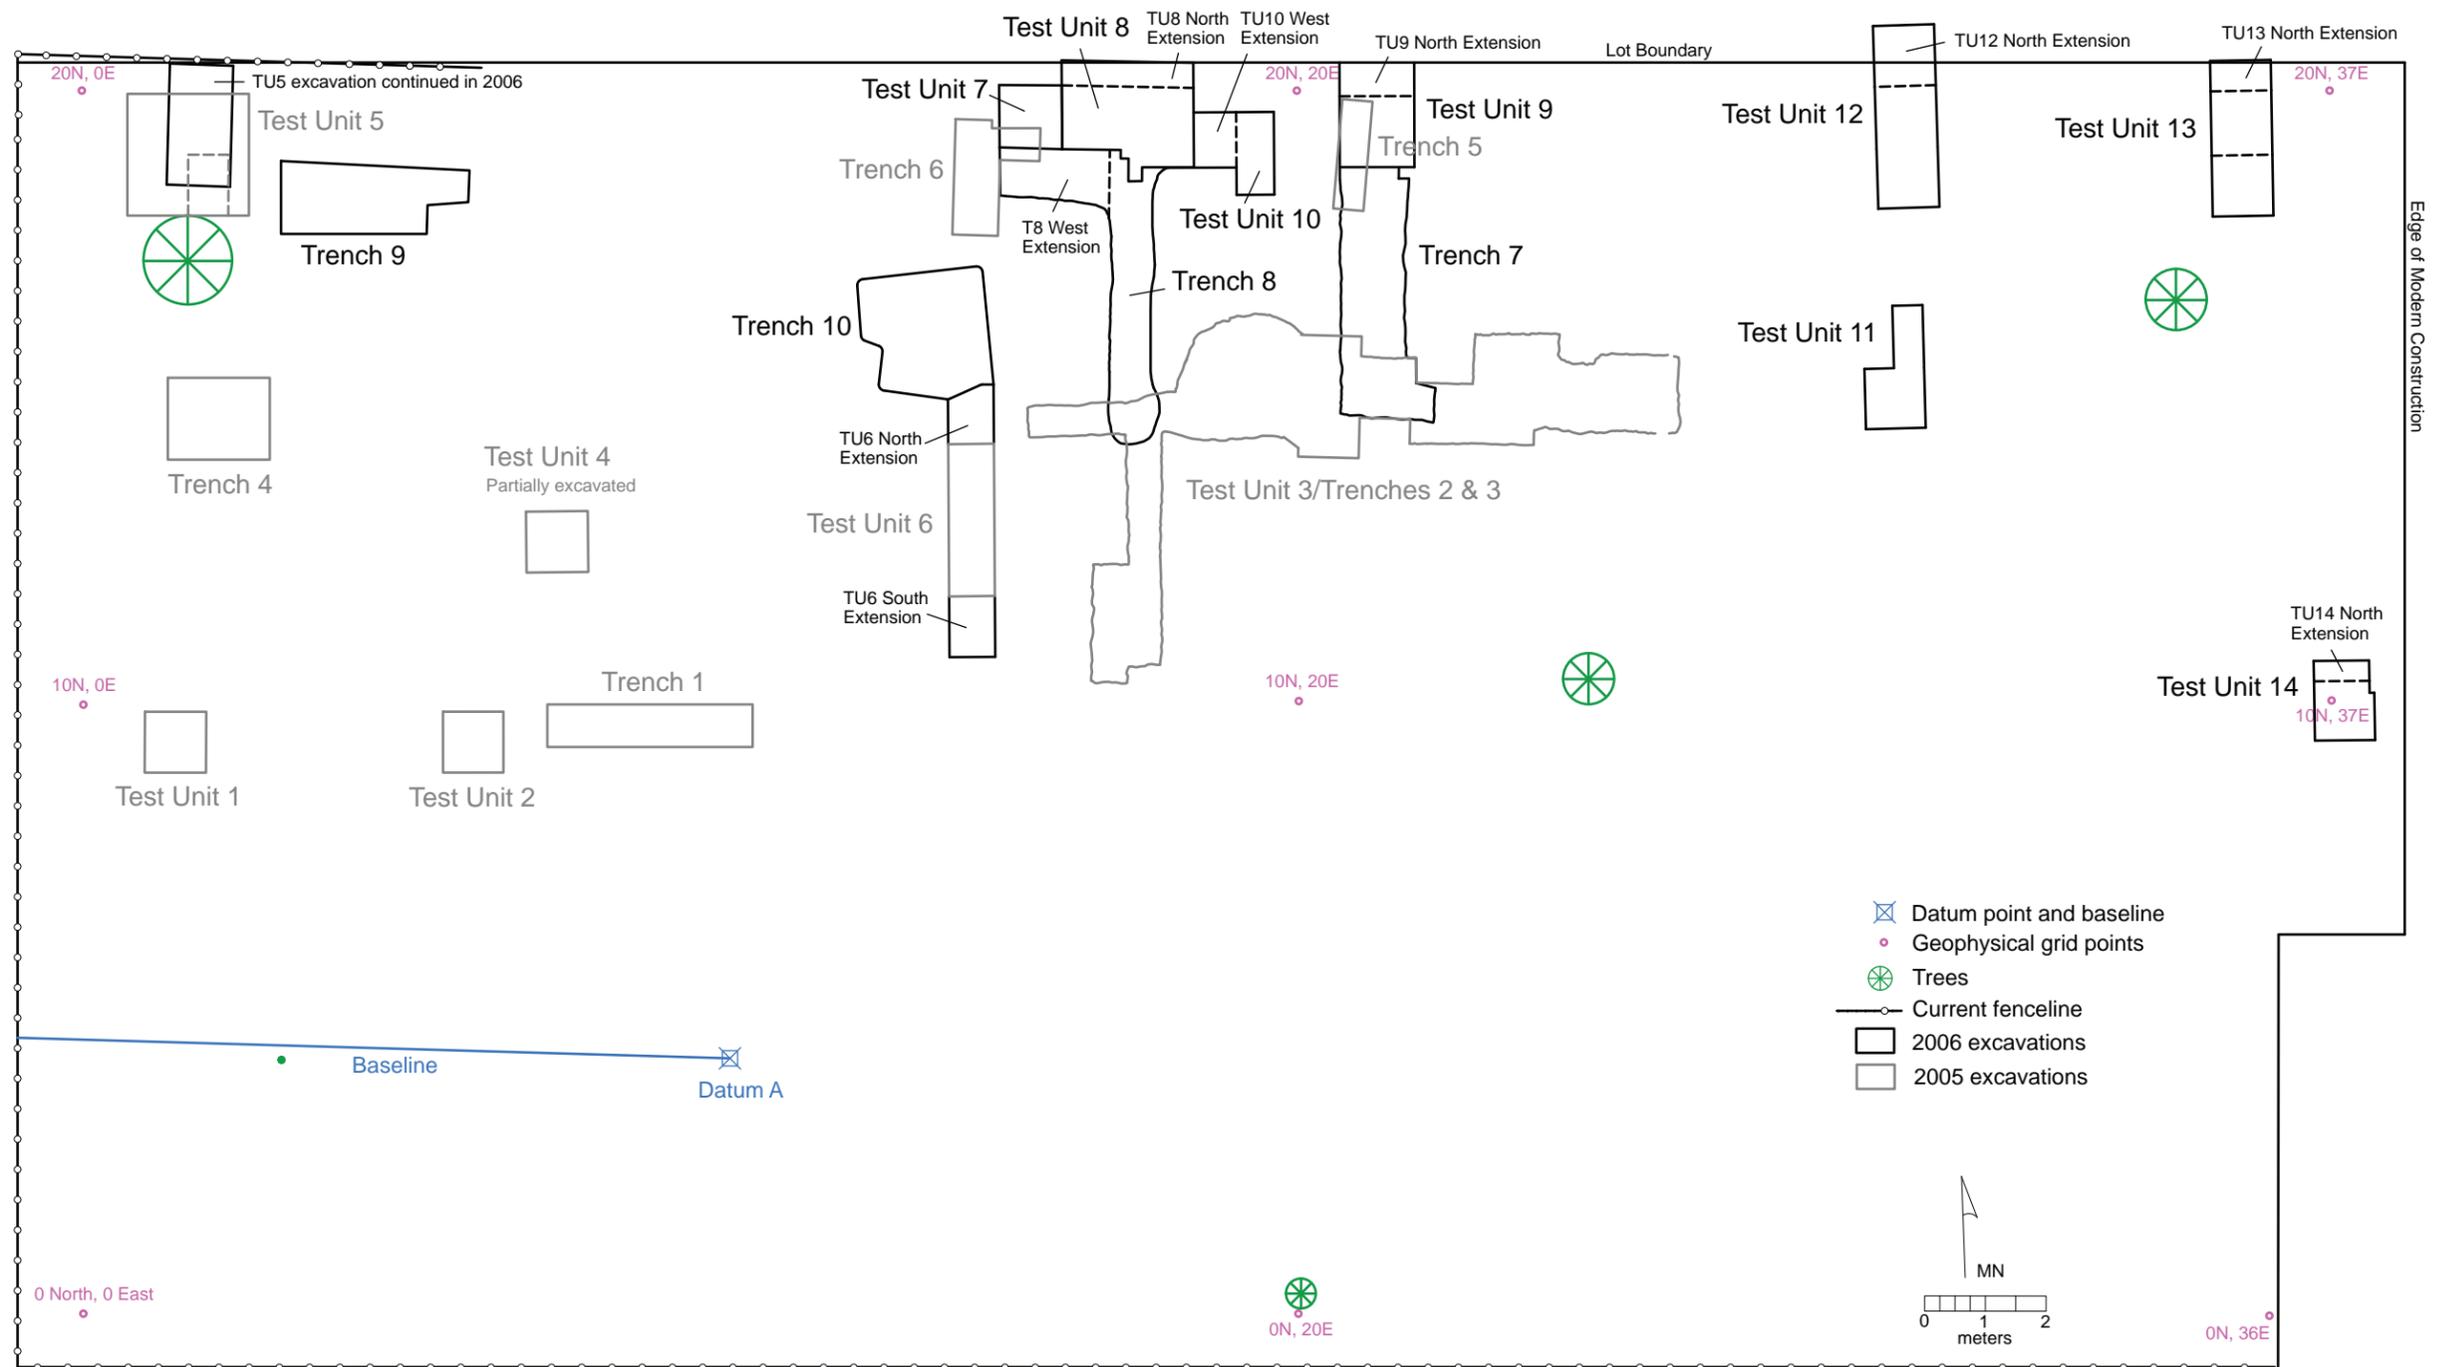
Figure 6. Plan view of the Carrigan property with references for the 2006 archeological field methodology.

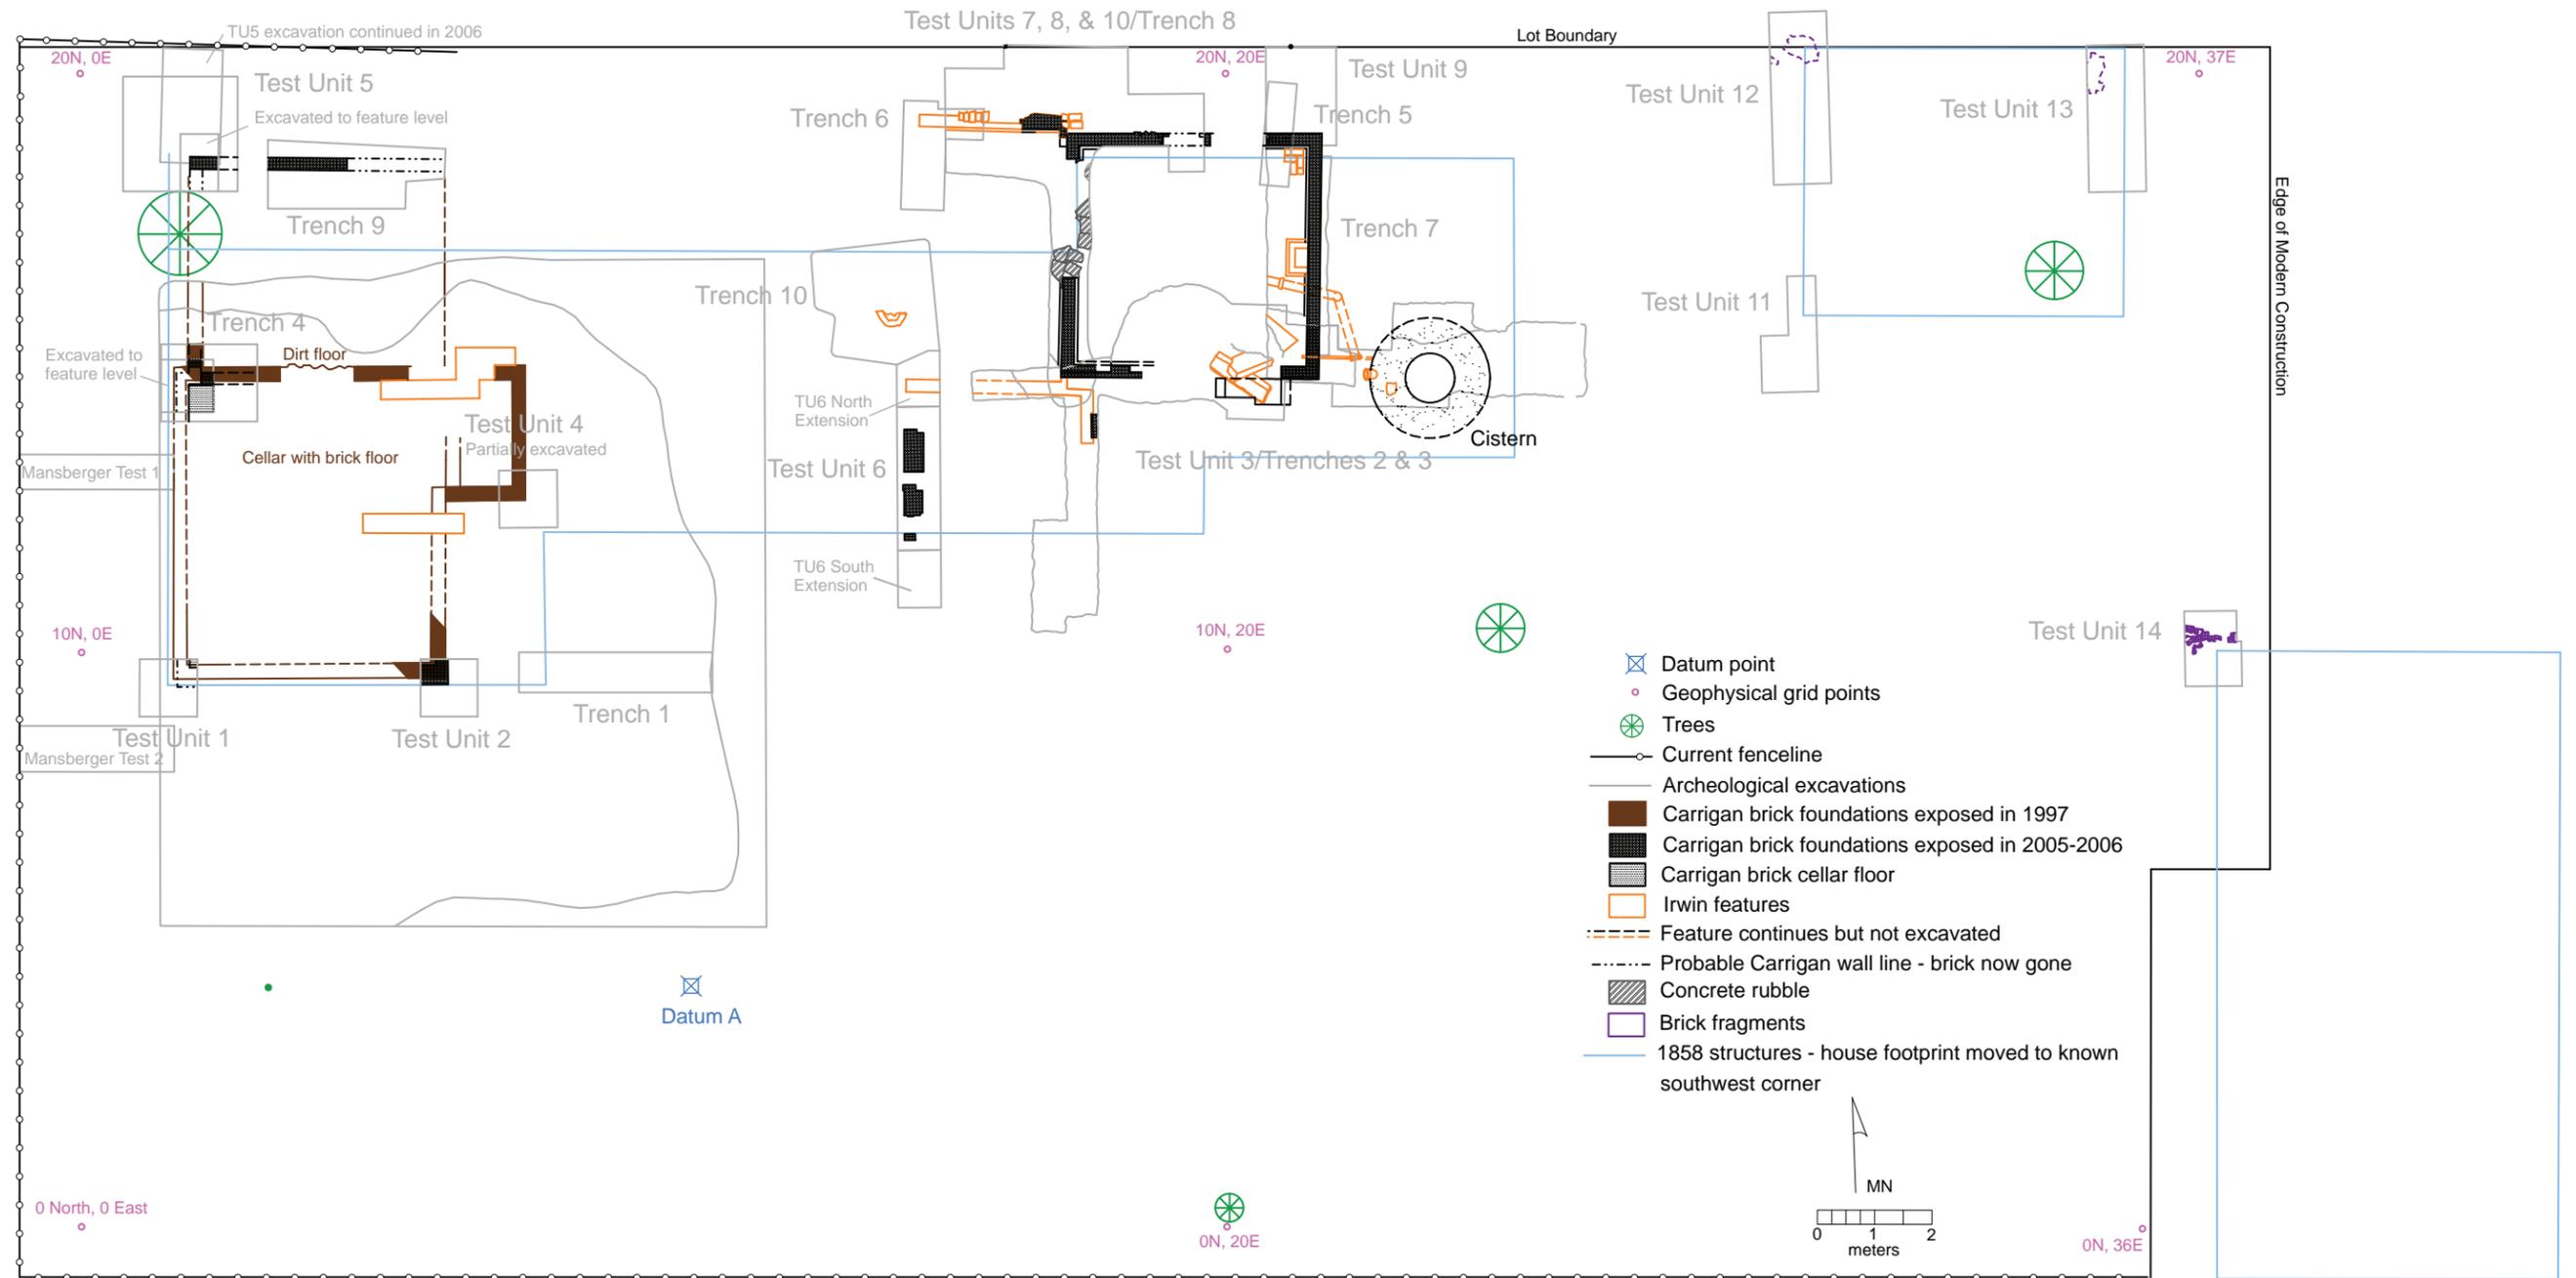
Figure 7. Plan view of the Carrigan property with archeological features identified in 1997, 2005, and 2006 relative to the locations of the Carrigan house and outbuildings as depicted in 1858.
