ARCHEOLOGICAL INVENTORY AND EVALUATION AT THE CARRIGAN AND BURCH PROPERTIES, LINCOLN HOME NATIONAL HISTORIC SITE, SPRINGFIELD ILLINOIS

BY
JANIS L. DIAL-JONES

Midwest Archeological Center
Technical Report 125

NATIONAL PARK SERVICE
Midwest Archeological Center

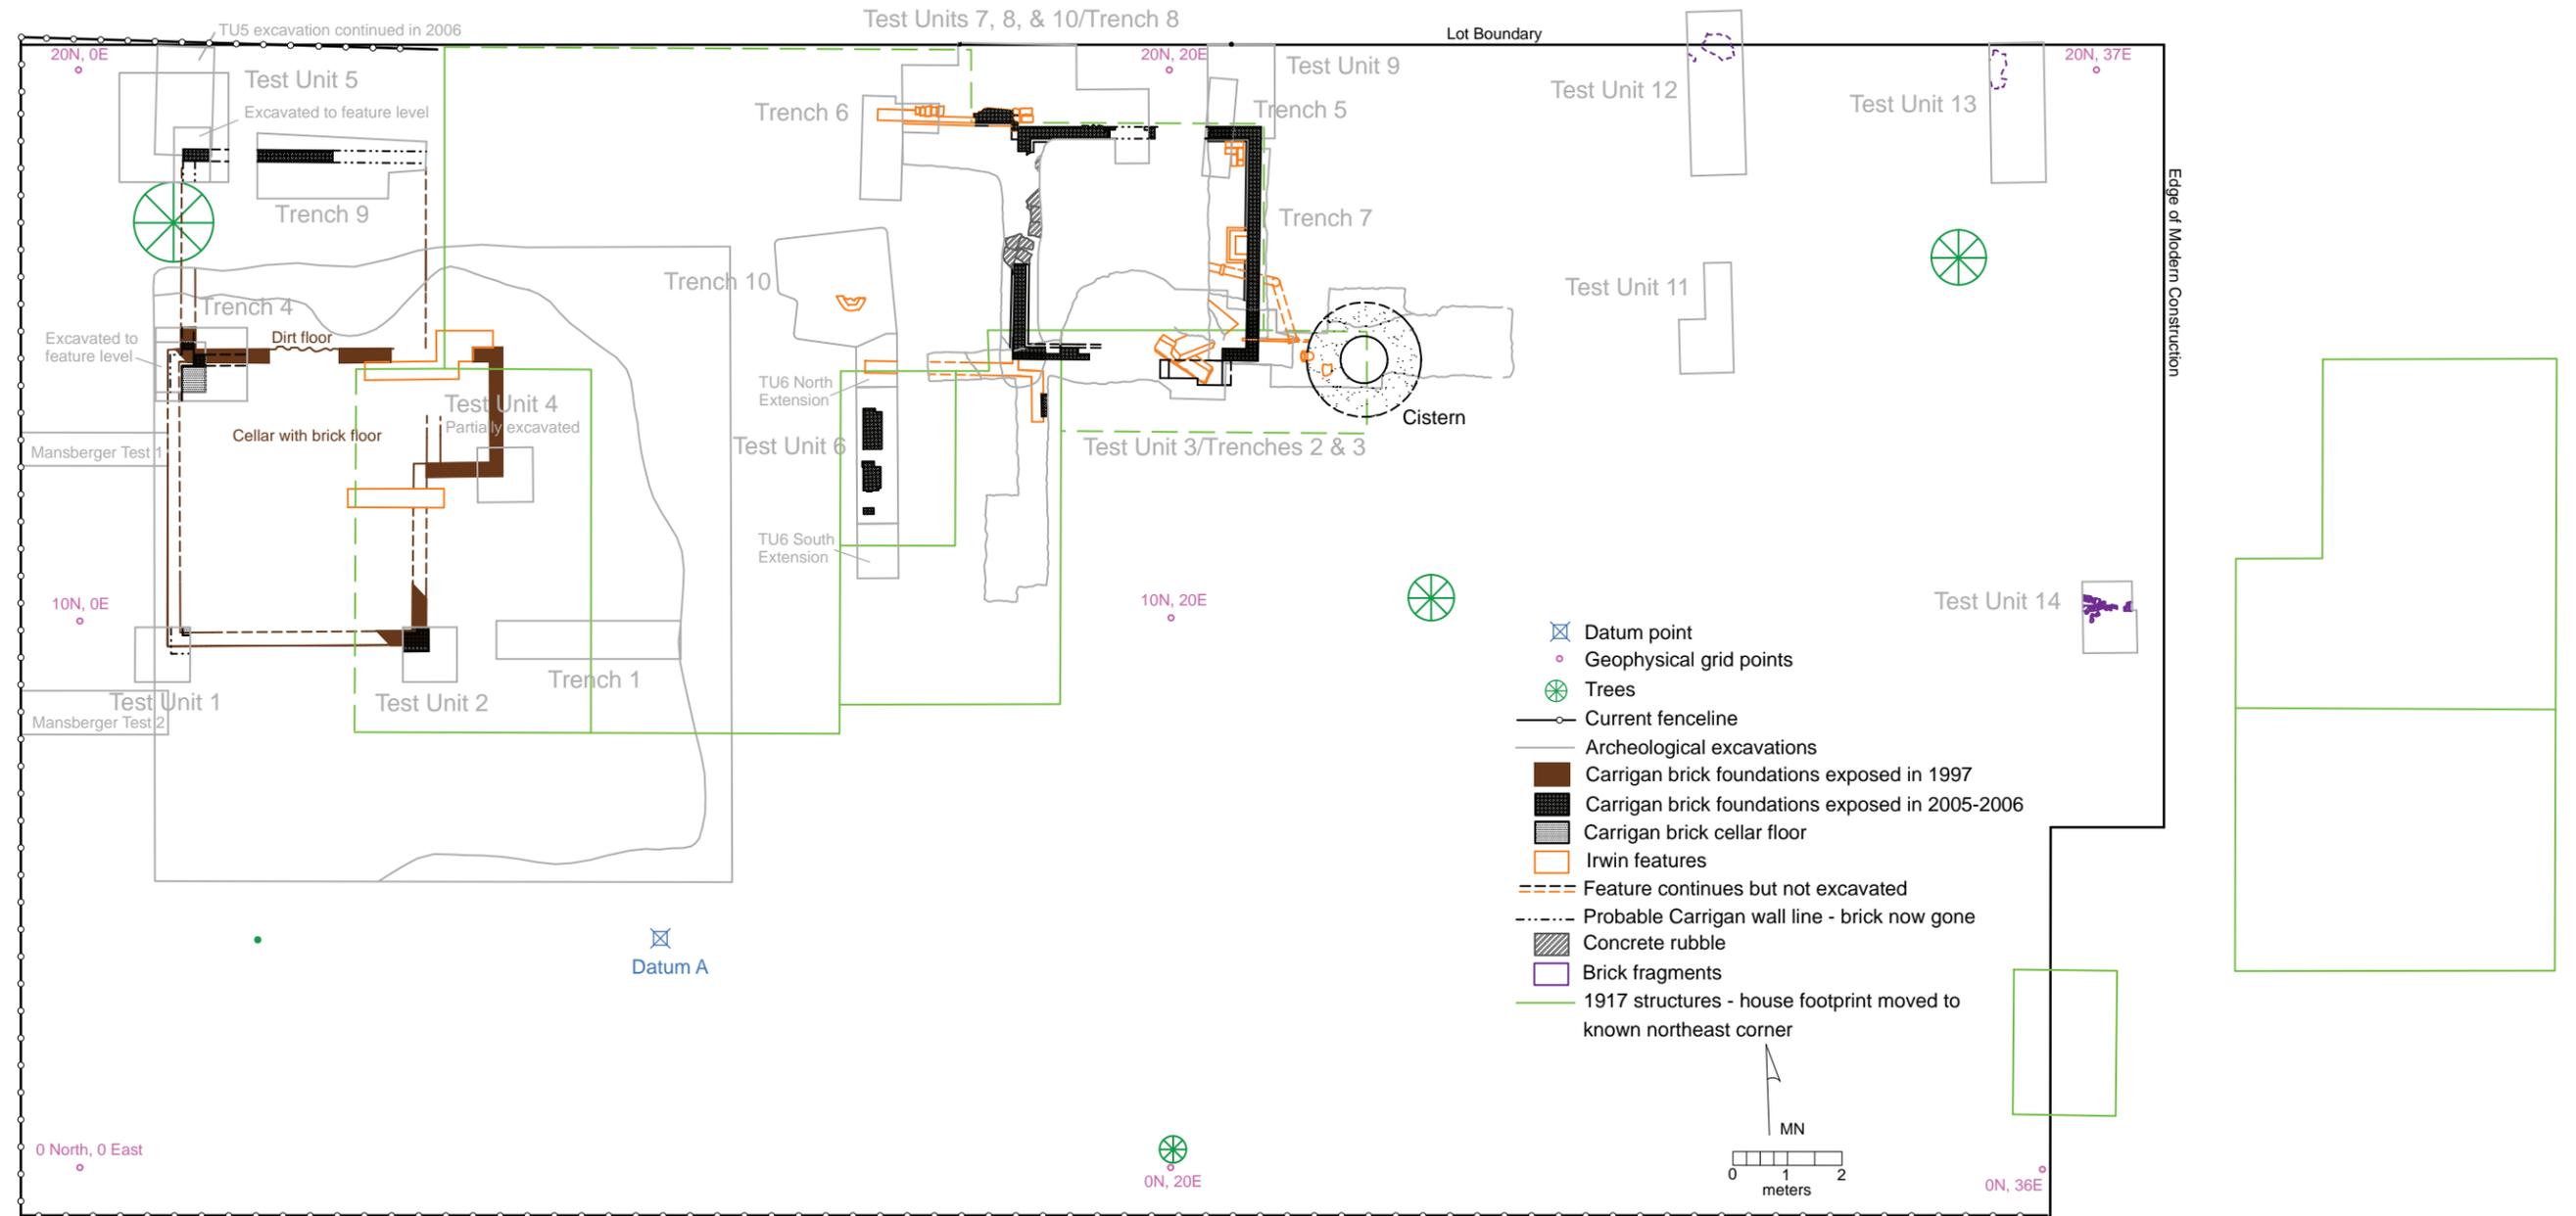
Figure 8. Plan view of the Carrigan property with archeological features identified in 1997, 2005, and 2006 relative to the locations of the Irwin house and outbuildings as depicted in 1917.

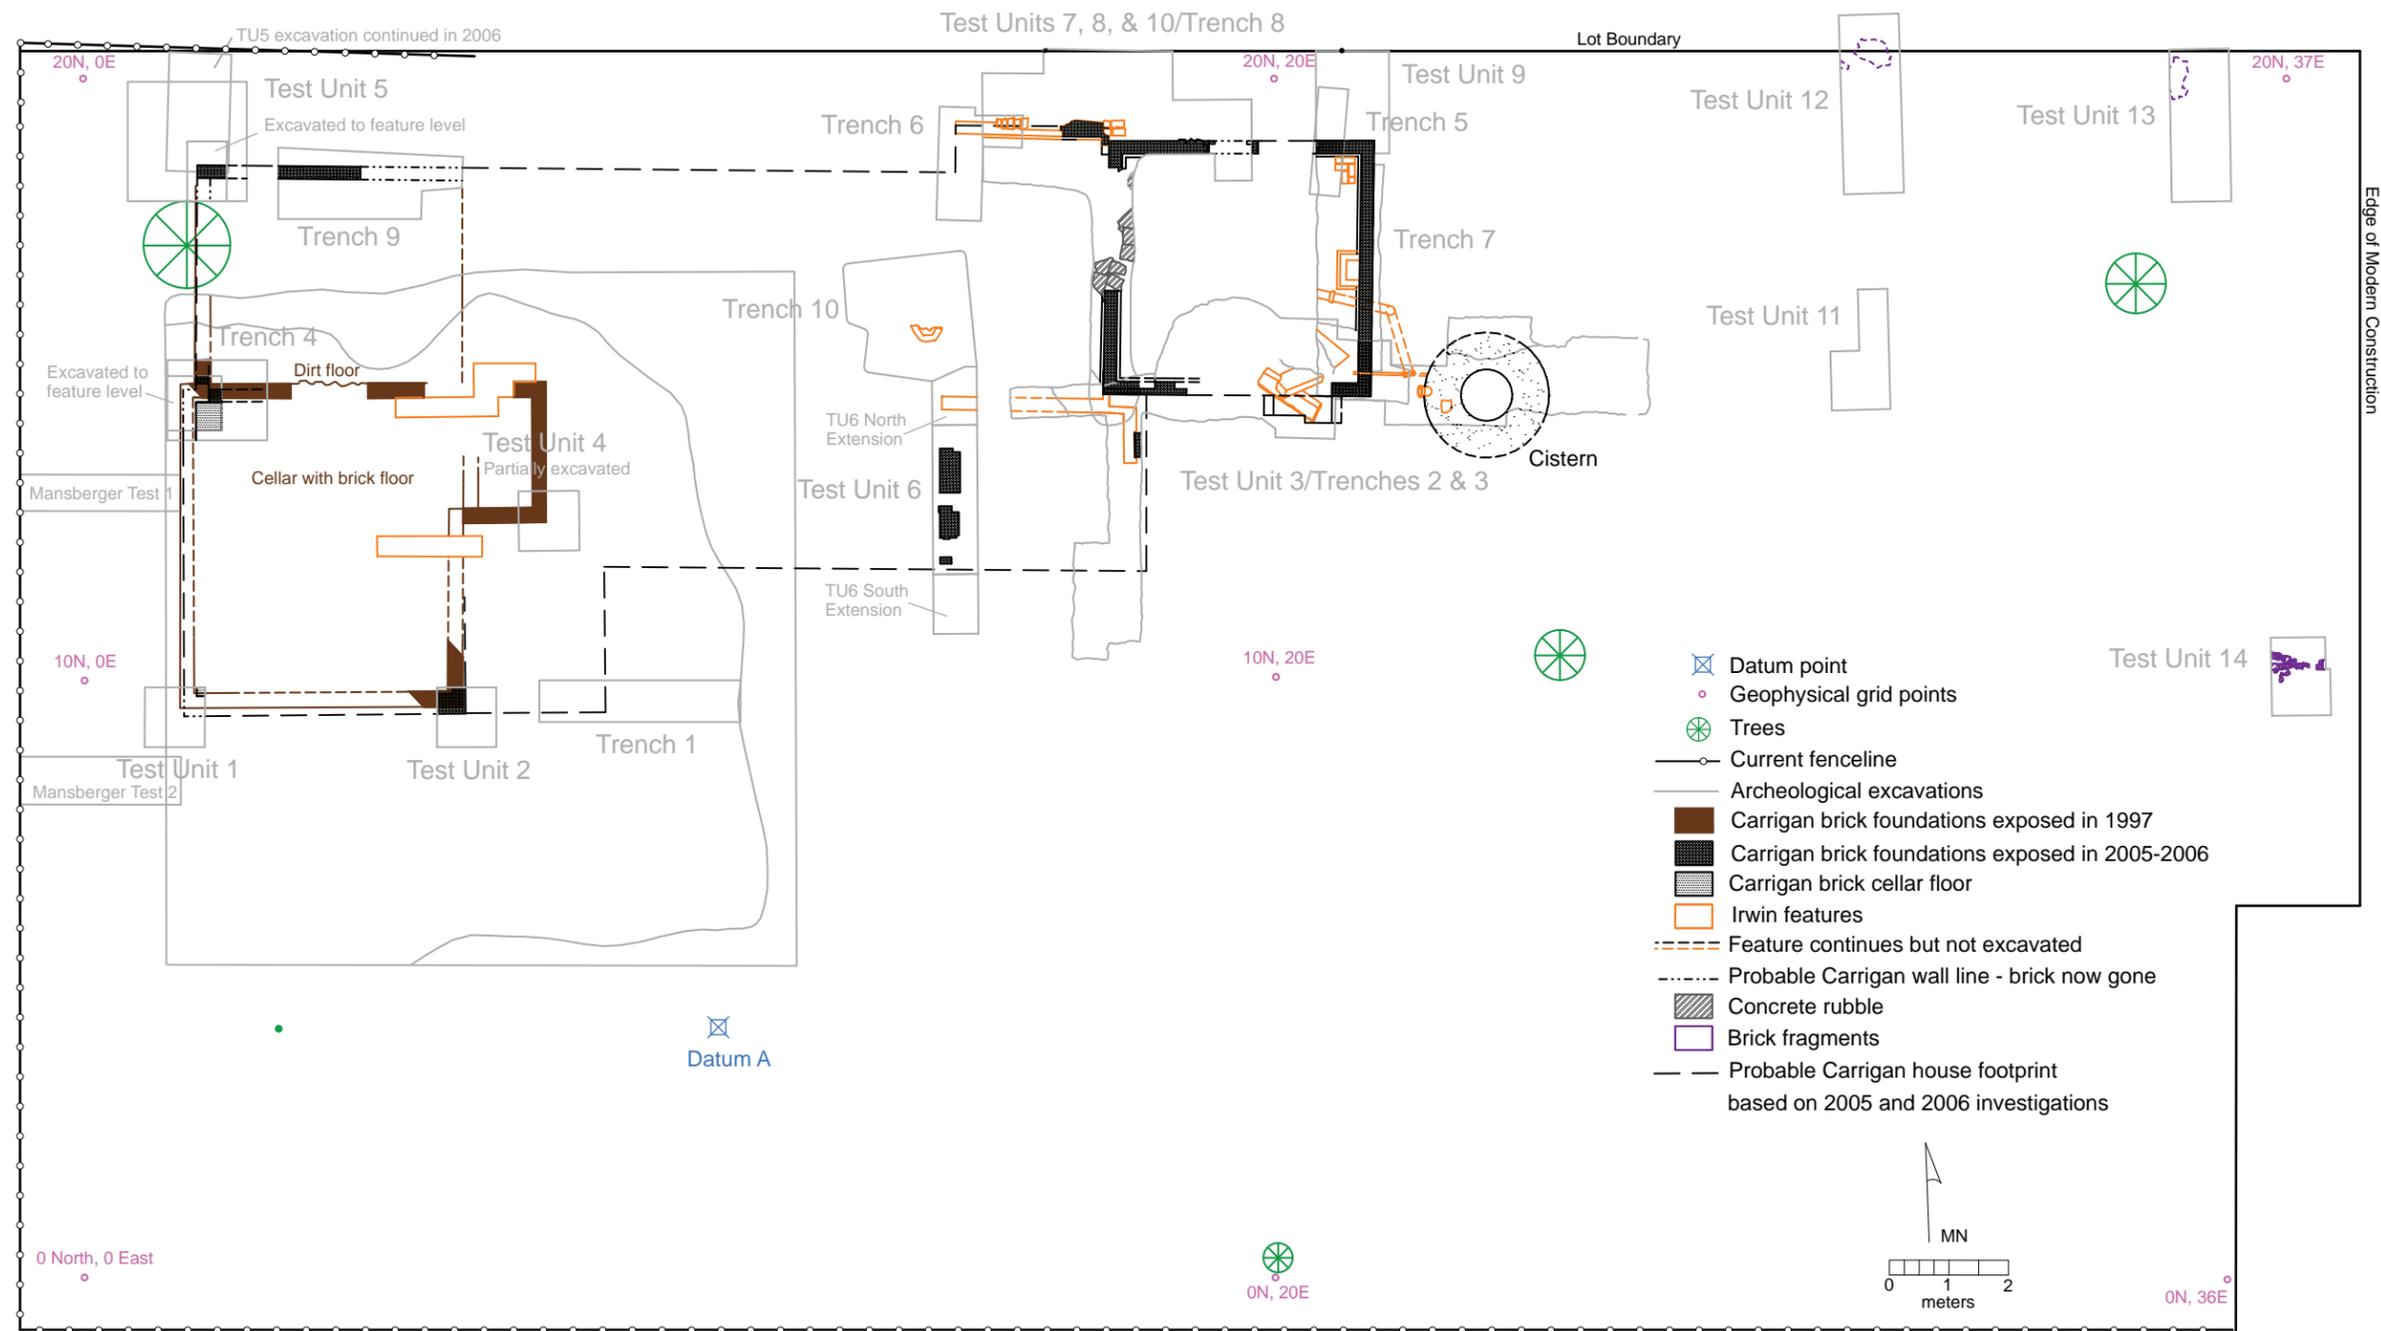
Figure 9. Plan view of the Carrigan property with the probable footprint of the Carrigan house based on the archeological features identified in 1997, 2005, and 2006.

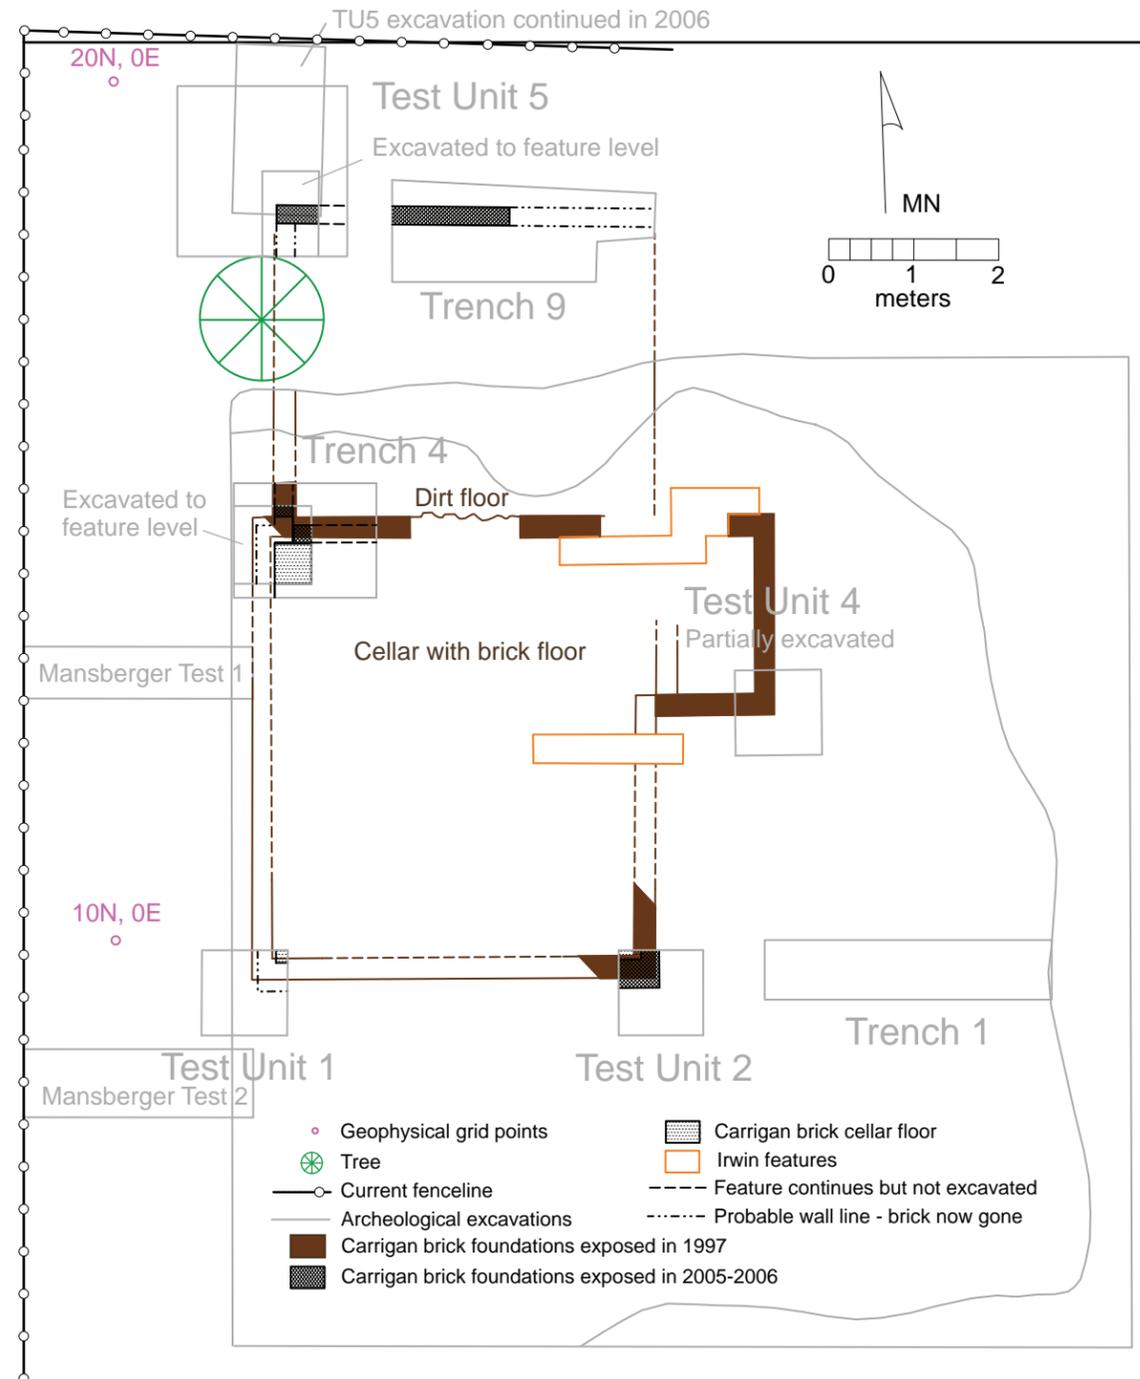
Figure 10. Closeup plan view of archaeological features identified at the front of the Carrigan property.

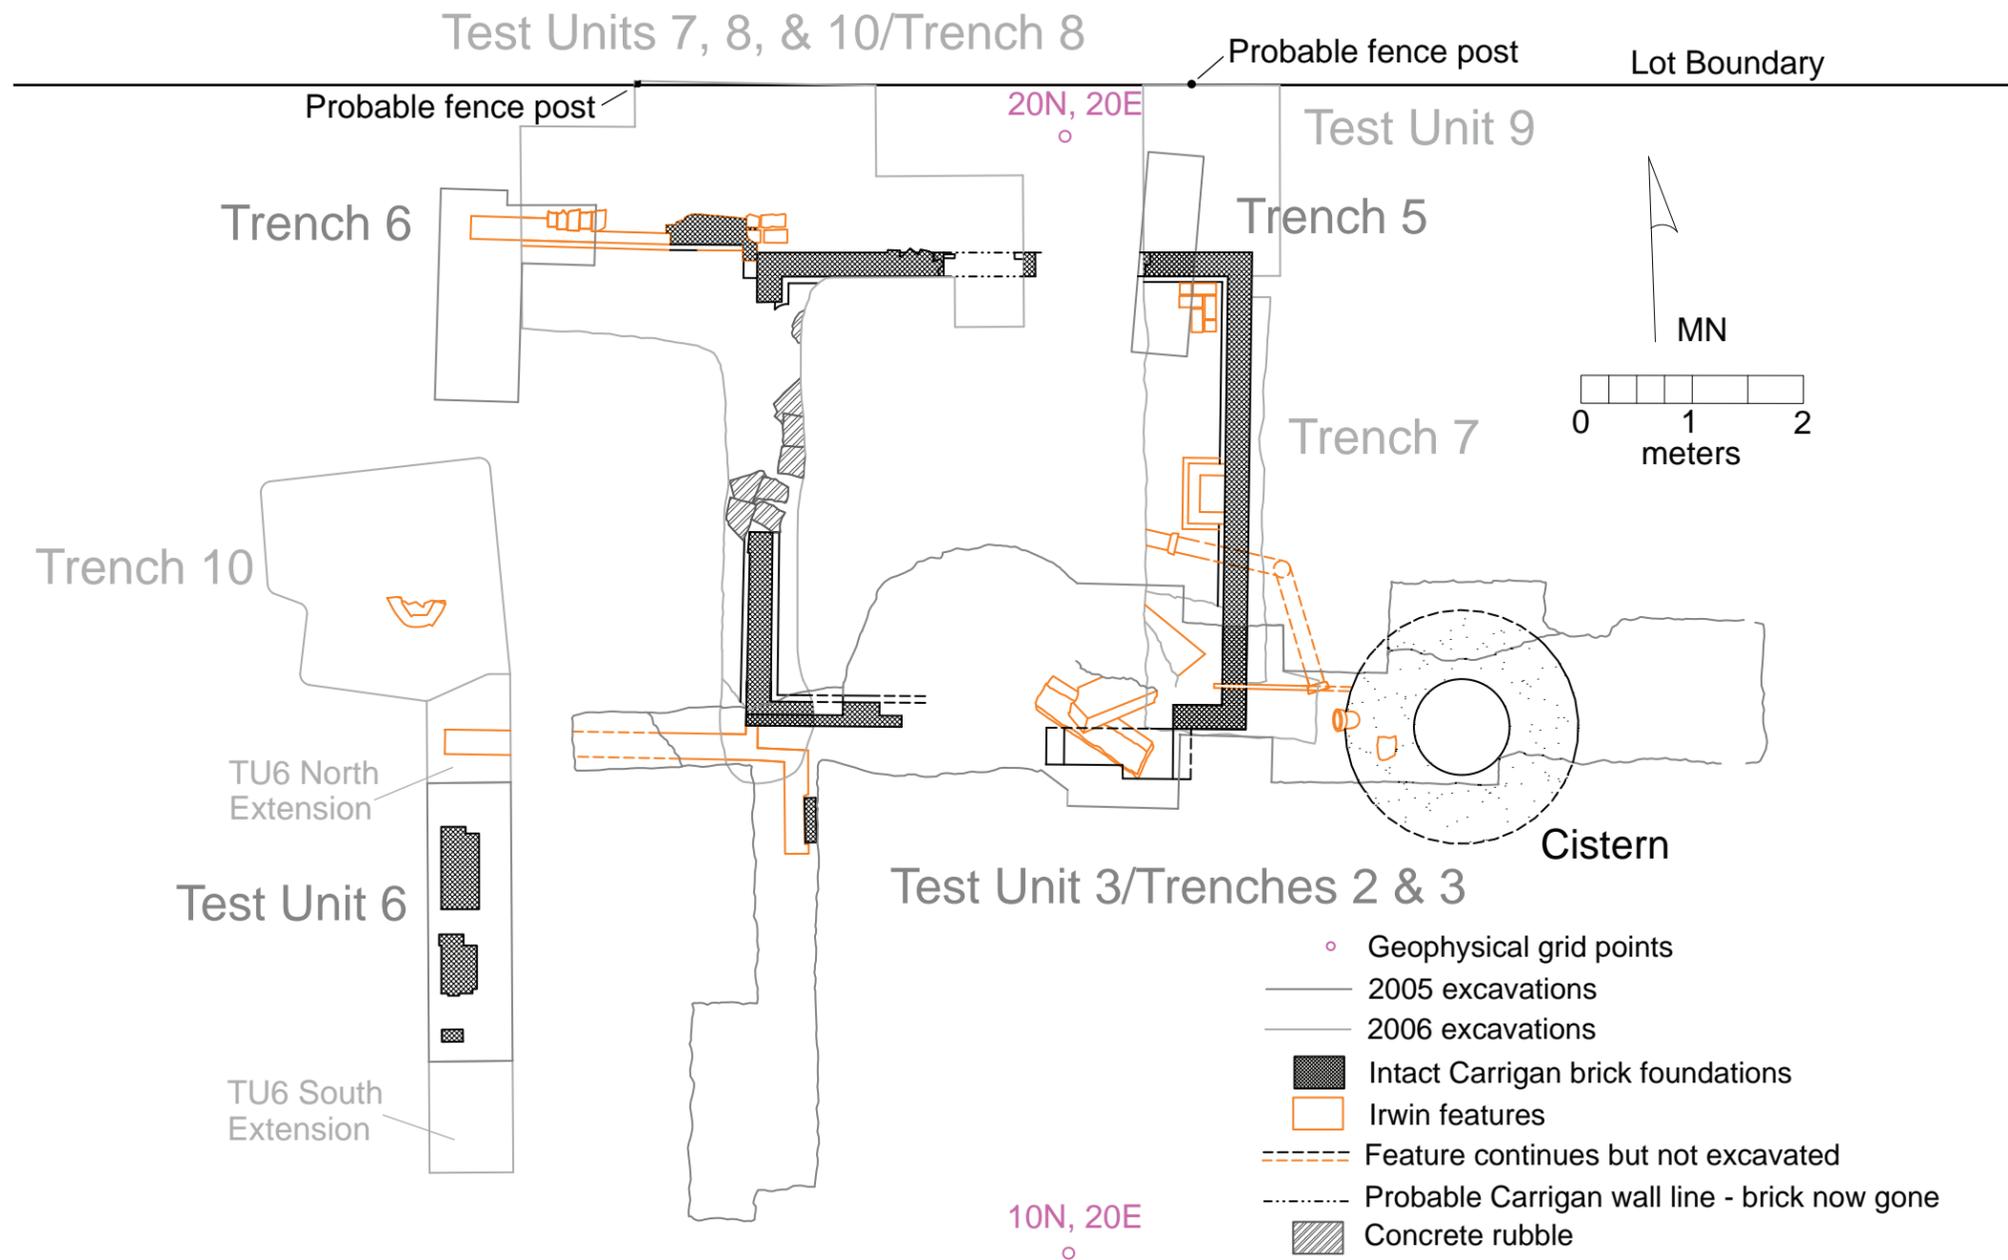
Figure 11. Closeup plan view of archeological features identified in the middle of the Carrigan property that relate to the back sections of the Carrigan and Irwin houses.

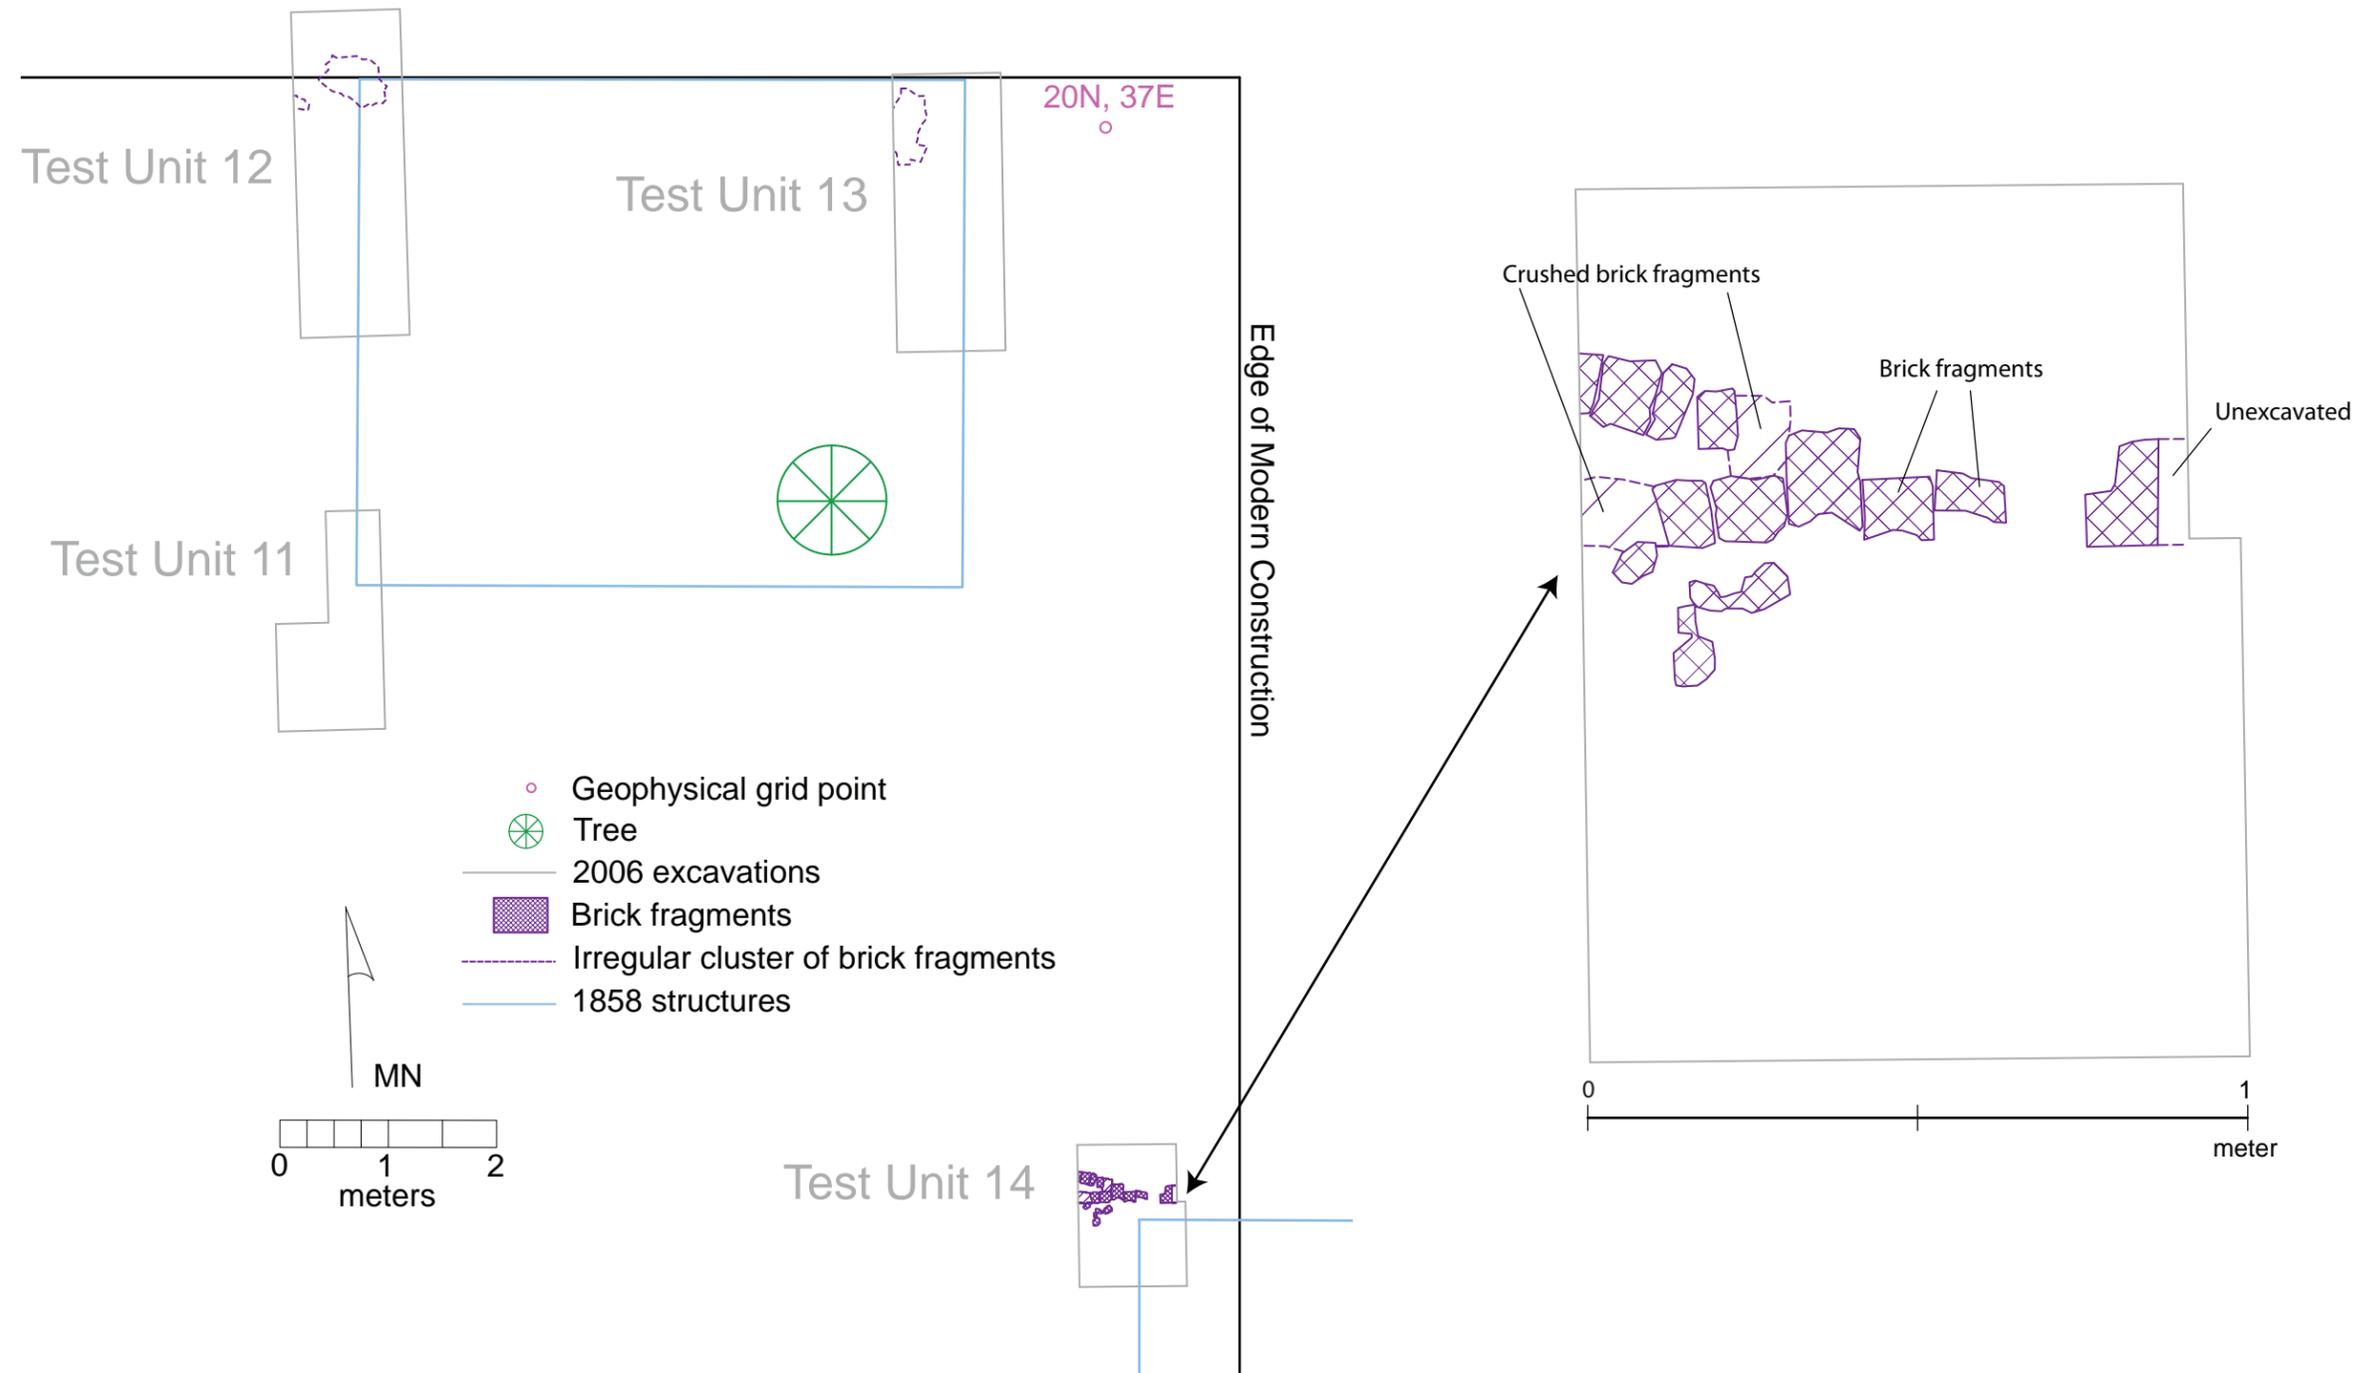
Figure 12. Closeup plan view of archeological features identified toward the back of the Carrigan property.

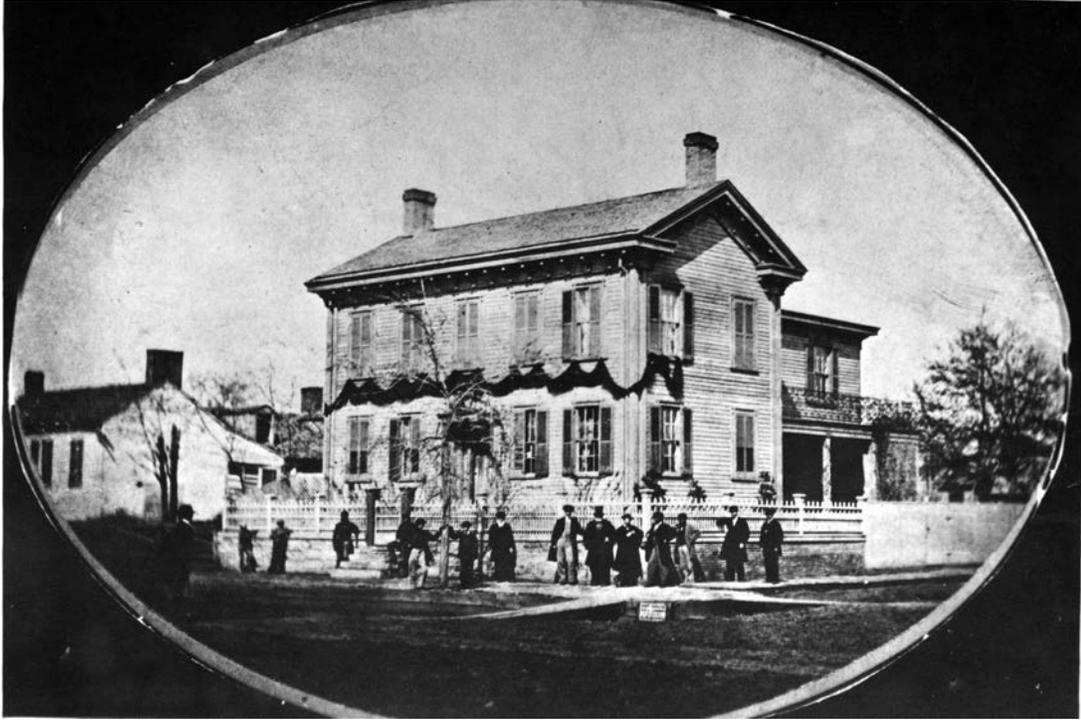
Figure 13. Photograph of the Carrigan house immediately left of the Lincoln Home, taken in the 1860s (Courtesy of the Sangamon Valley Collection at Lincoln Library).

Photographs of the Lincoln Home taken over the years frequently included a partial view of the Carrigan house and the later Irwin house. The Carrigan HSR includes a discussion of a number of those photographs, focusing on architectural details that can be discerned from the photos, the types and location of fencing, and landscaping of the property. Several photographs showing the houses that stood on the Carrigan property over the years are reproduced in this report as Figures 13-19. The photograph reproduced as Figure 13 was taken in the 1860s and shows the Carrigan

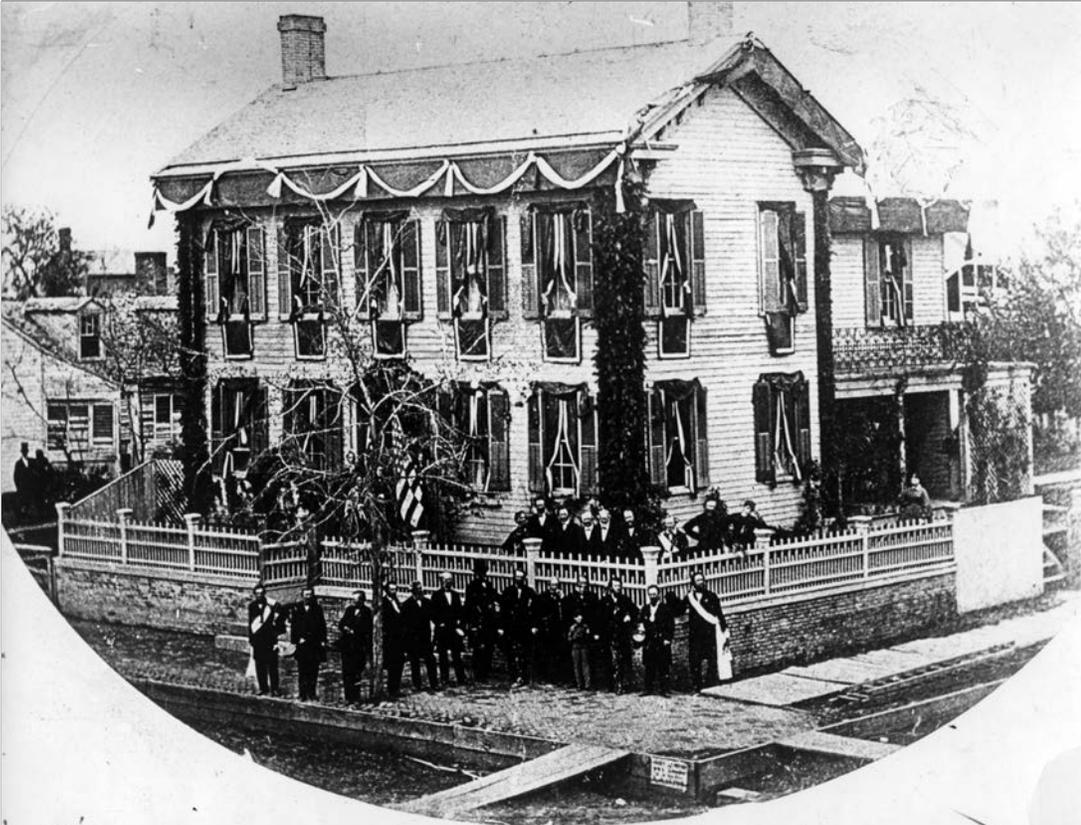
Figure 14. Photograph of the Carrigan house left of the Lincoln Home, taken in 1865 (Courtesy of the Sangamon Valley Collection at Lincoln Library).

Figure 14 is a photograph taken in 1865 that again shows the porch that extended from the back of the front section of the Carrigan house. It appears that the porch continued in an L shape along the south side of the ell, as louvered porch lattice is visible there as well. A chimney is visible toward the back of the house, immediately behind a second dormer on the ell. Figure 15 is a digitally-enhanced portion of a photograph taken in 1867 showing the front of the Carrigan house and the two chimneys that stood along the north and south walls of that section of the house. The photograph reproduced as Figure 16 was taken in the 1870s and shows the Carrigan house visible through the trees left of the Lincoln Home.

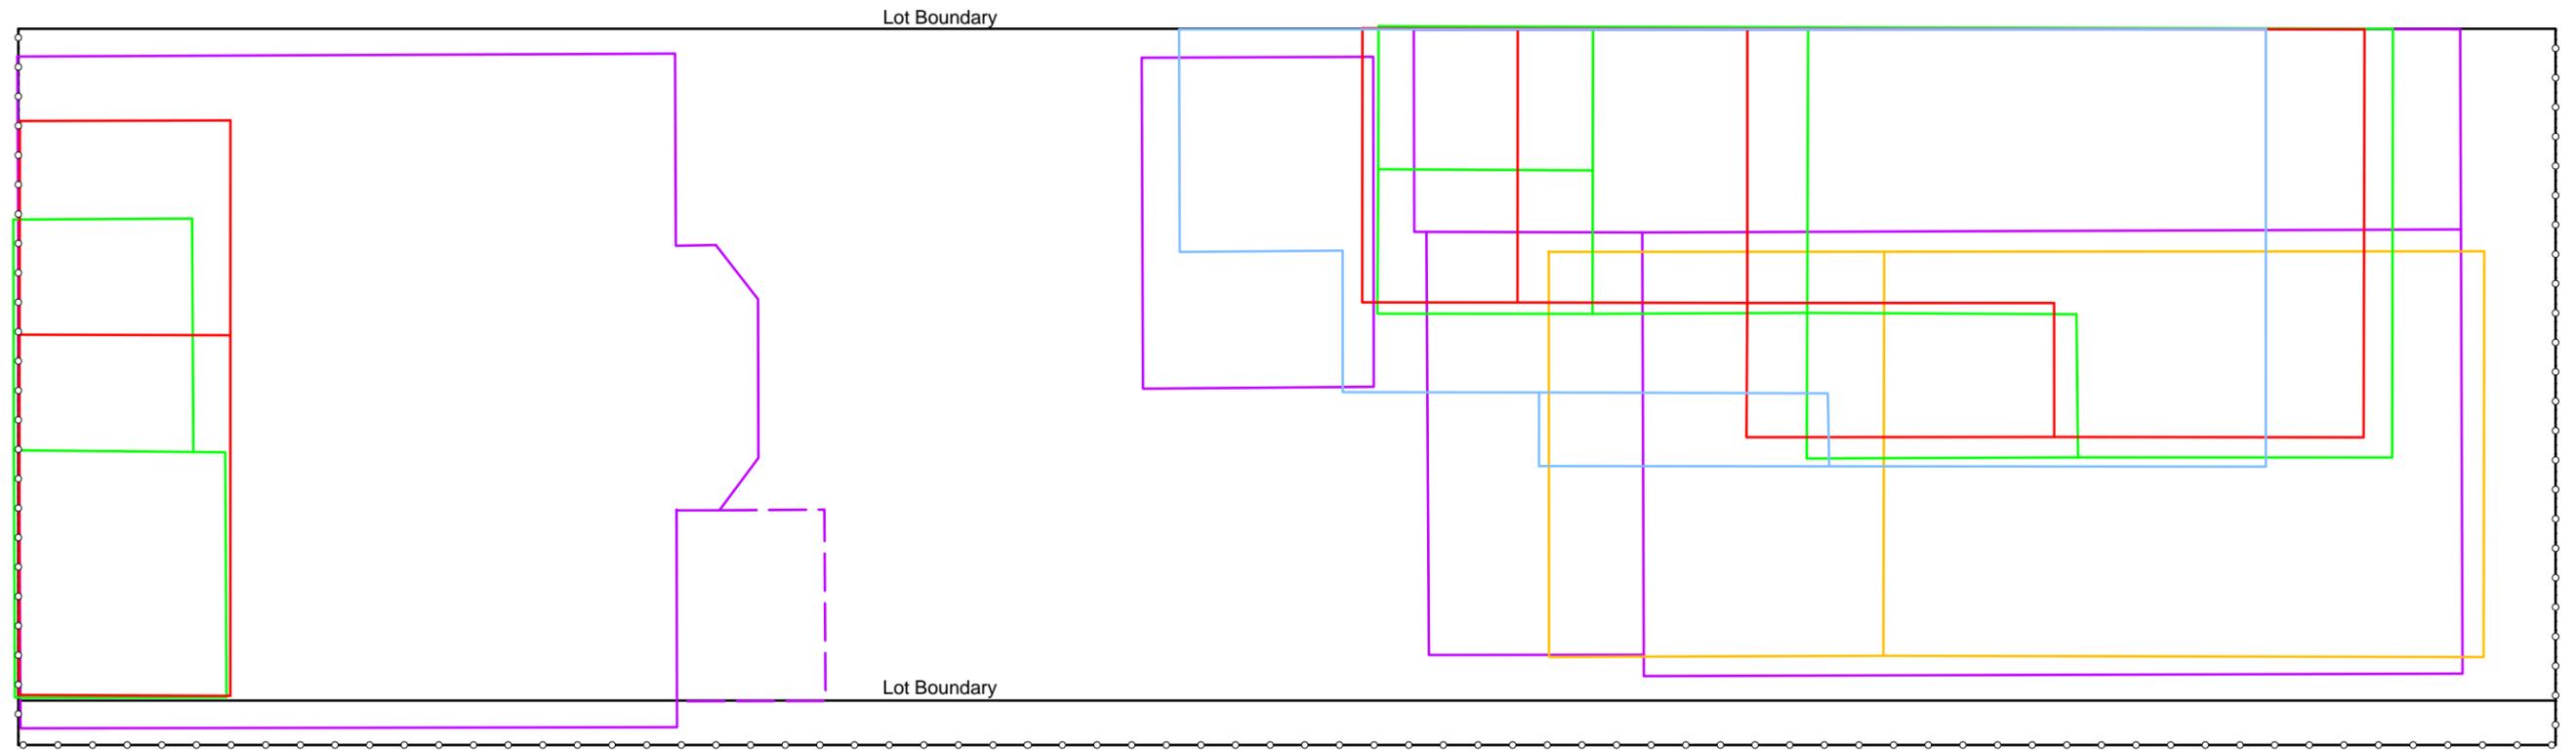
Figure 23. Plan view of the Burch property with the locations of structures that formerly stood on the property as depicted on several historic maps.

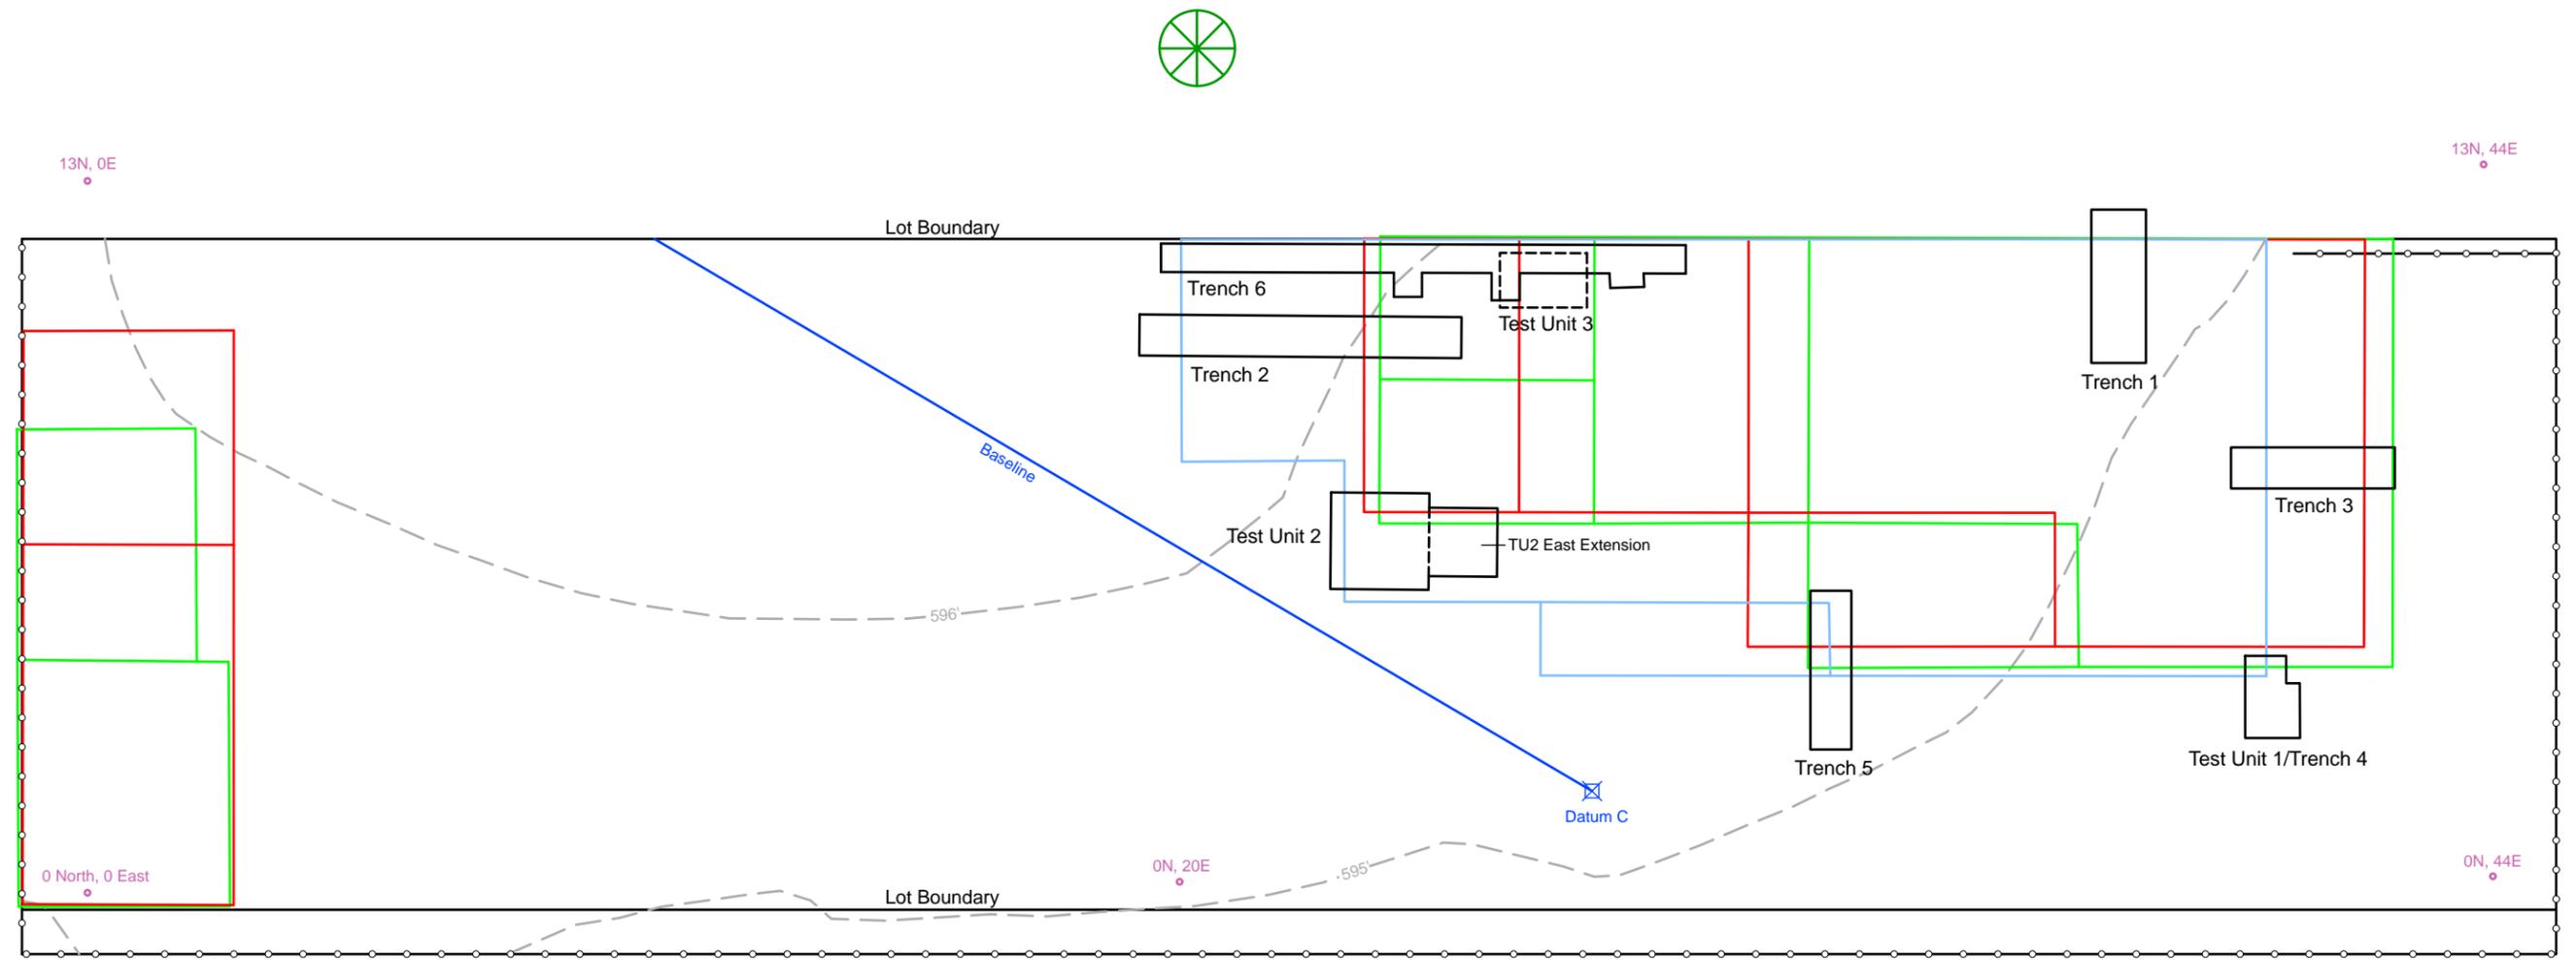
Figure 24. Plan view of the Burch property with references for the 2005 archeological field methodology.

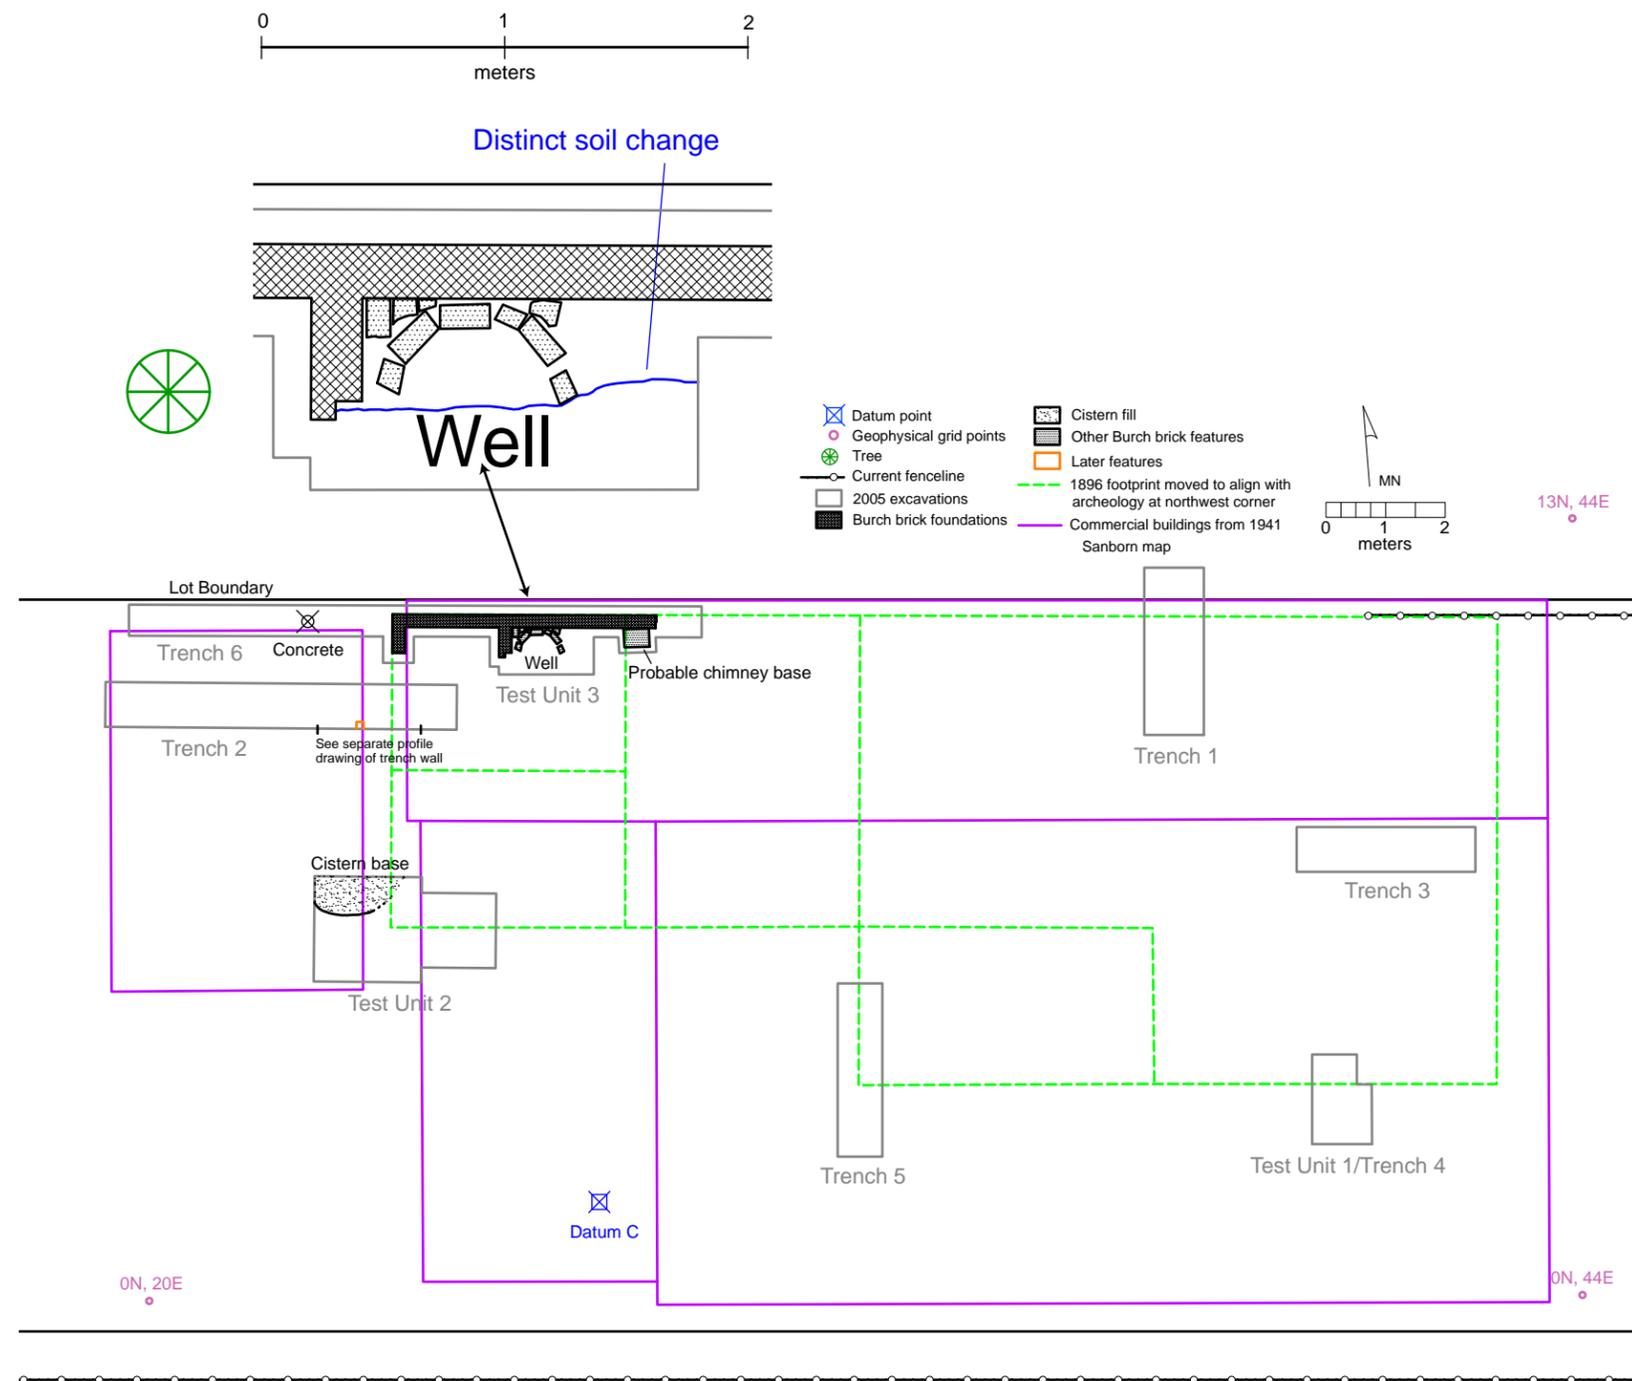
Figure 25. Plan view of the Burch property with archeological features identified in 2005.
