ARCHEOLOGICAL INVENTORY AND EVALUATION AT THE CARRIGAN AND BURCH PROPERTIES, LINCOLN HOME NATIONAL HISTORIC SITE, SPRINGFIELD ILLINOIS

BY
JANIS L. DIAL-JONES

Midwest Archeological Center
Technical Report 125

NATIONAL PARK SERVICE
Midwest Archeological Center

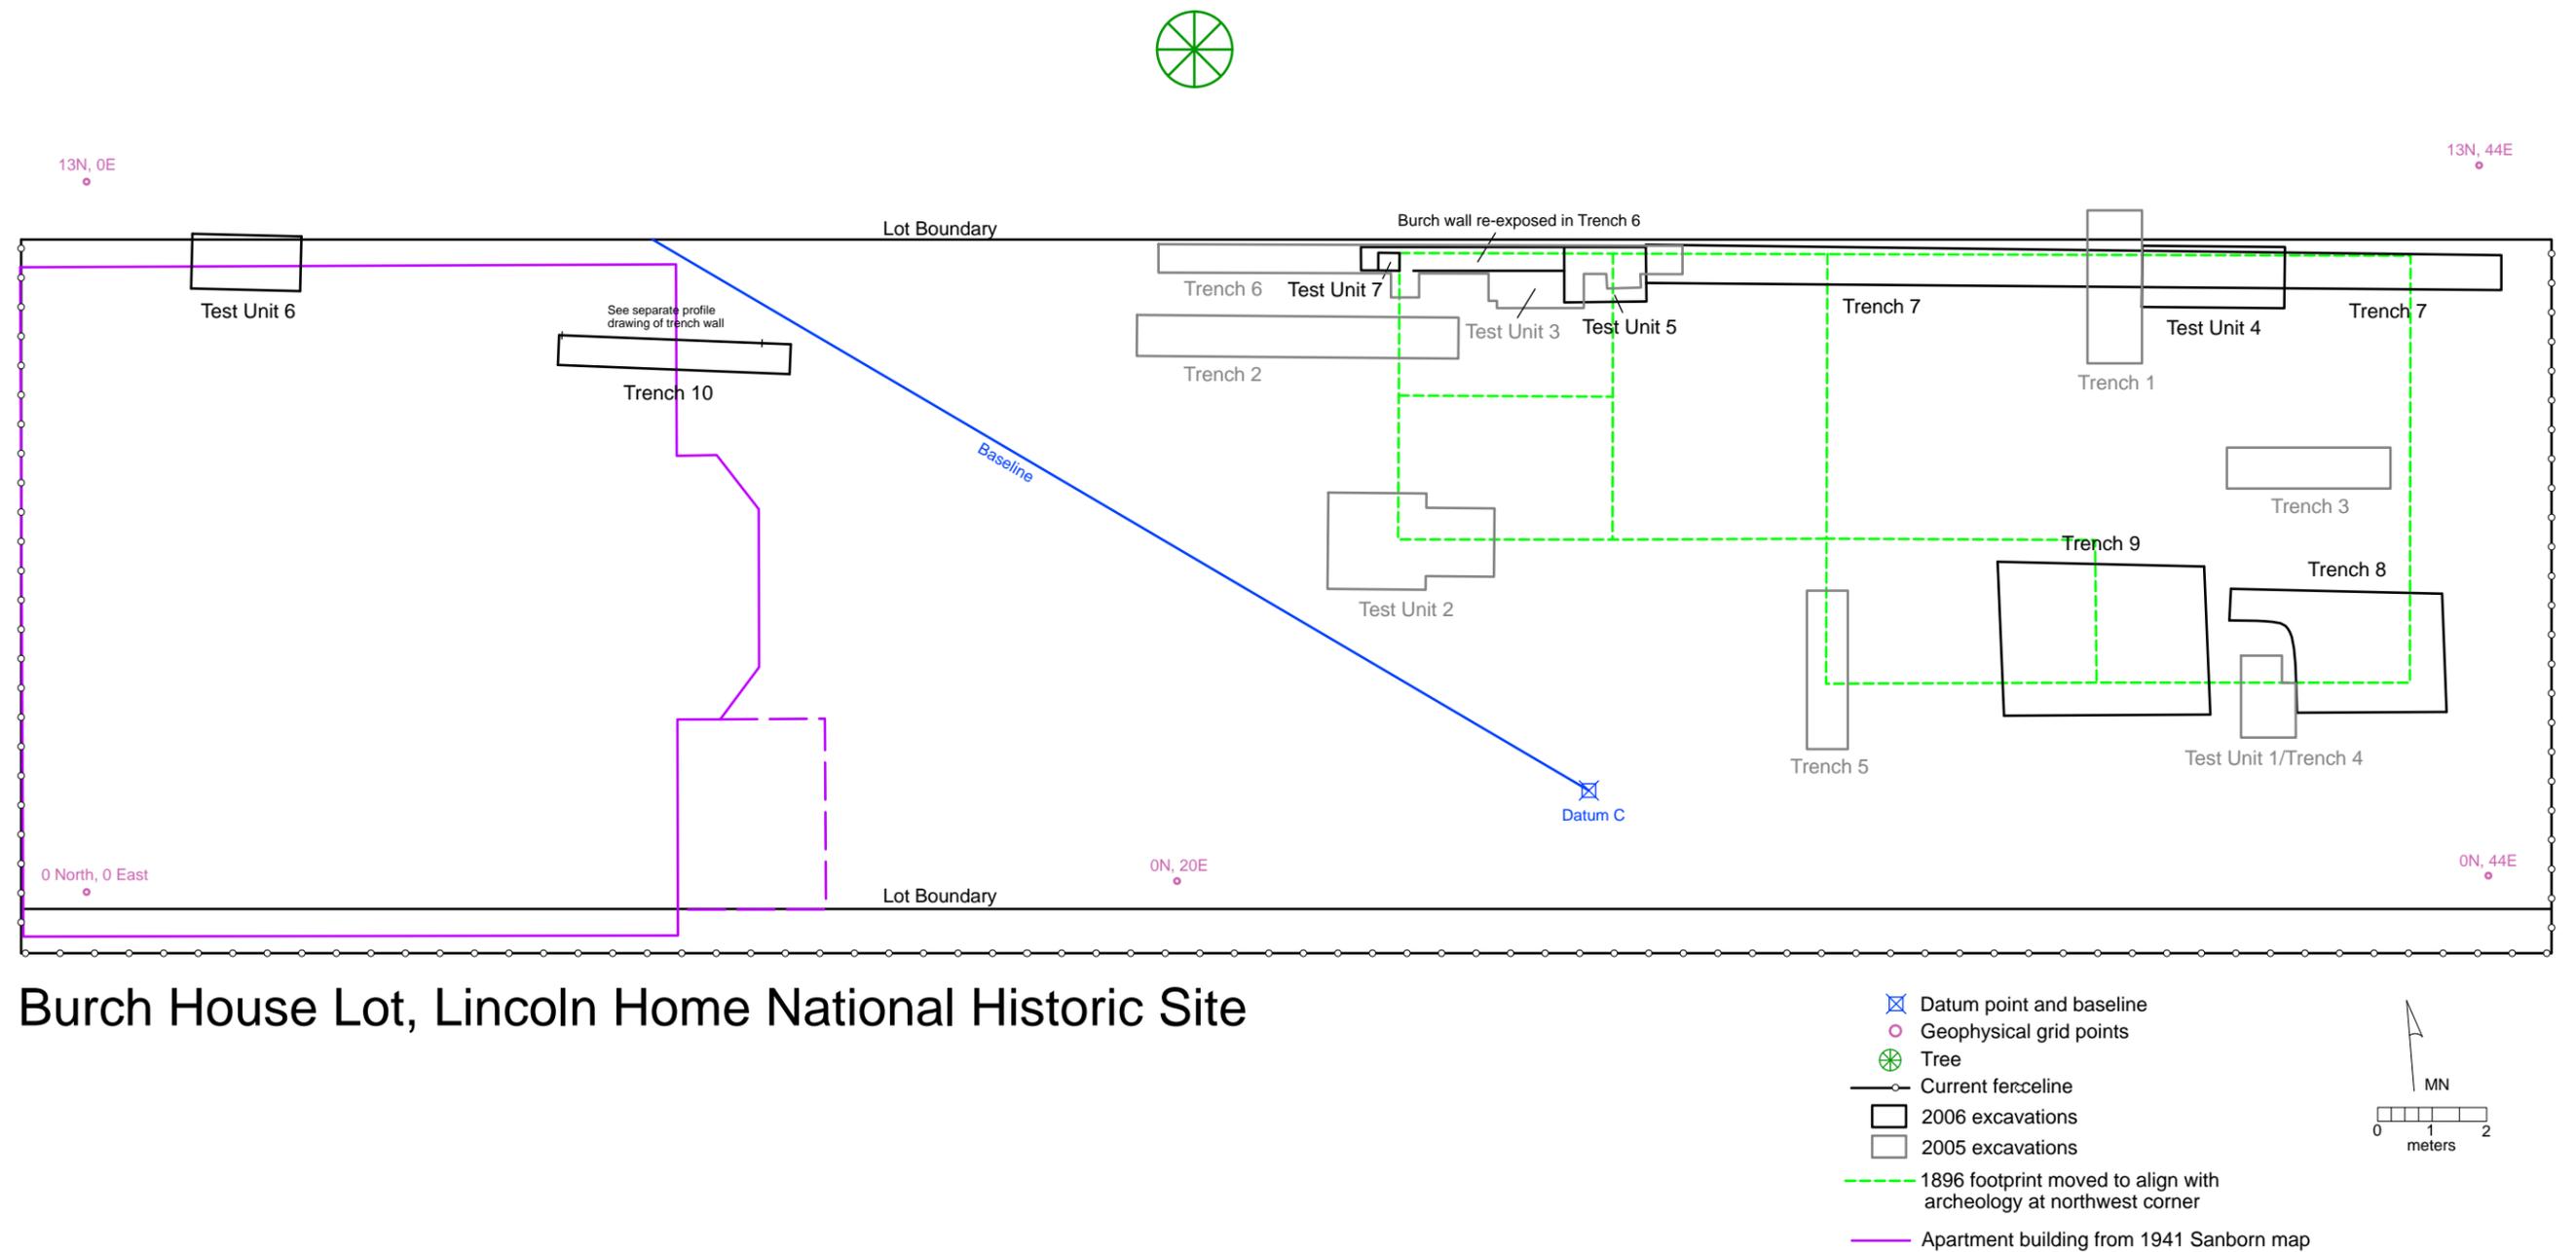
Figure 26. Plan view of the Burch property with references for the 2006 archeological field methodology.

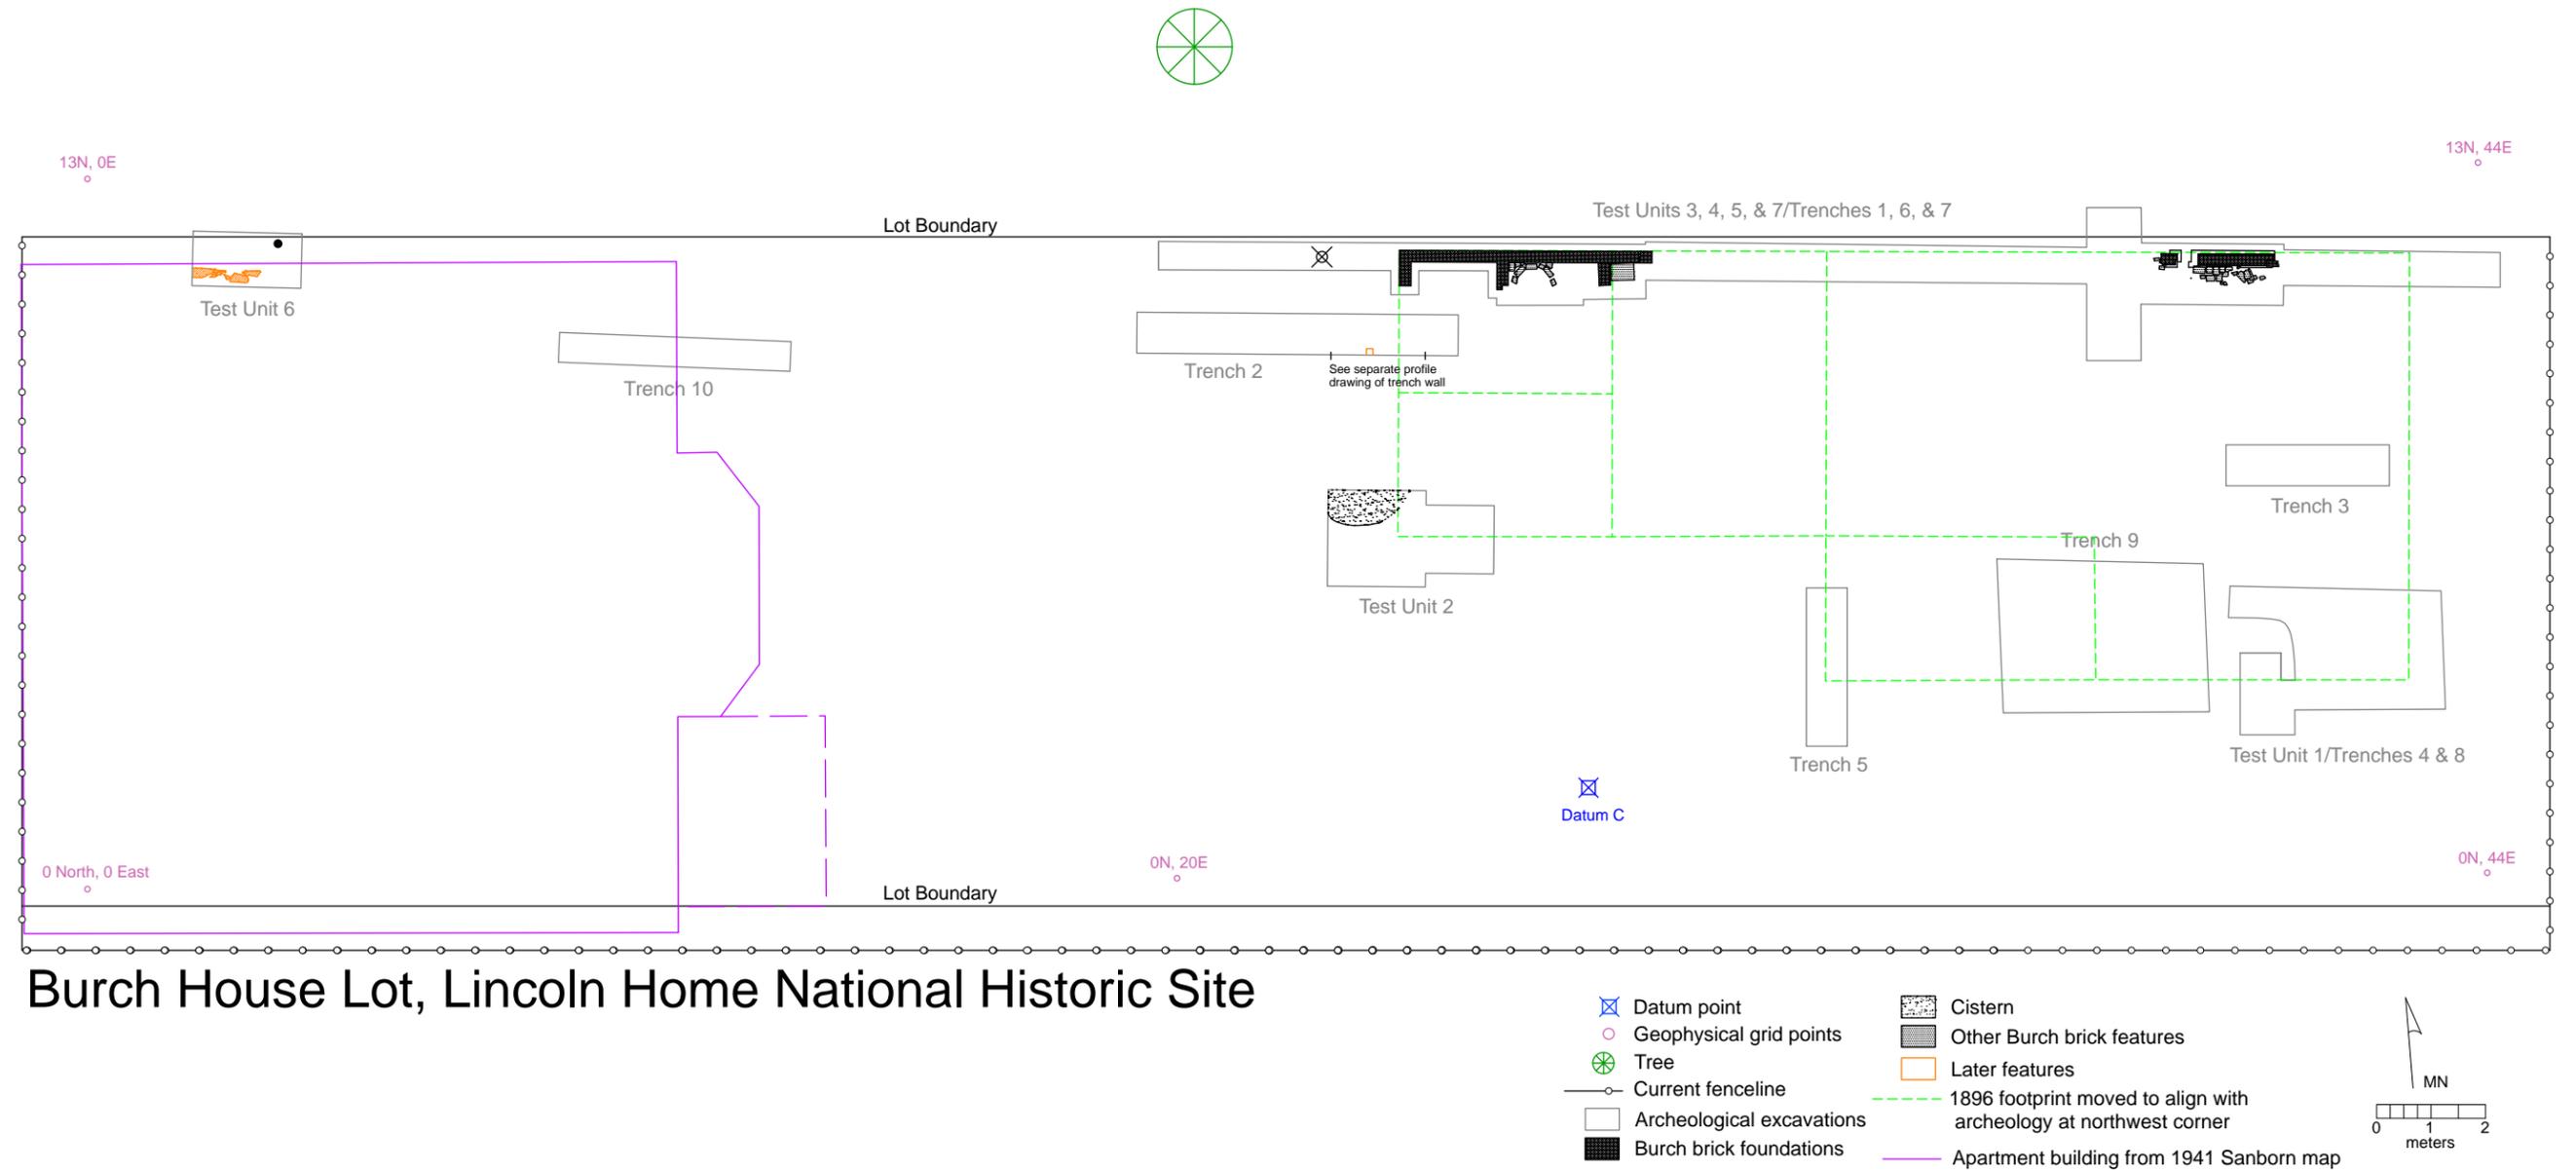
Figure 27. Plan view of the Burch property with archeological features identified in 2005 and 2006.

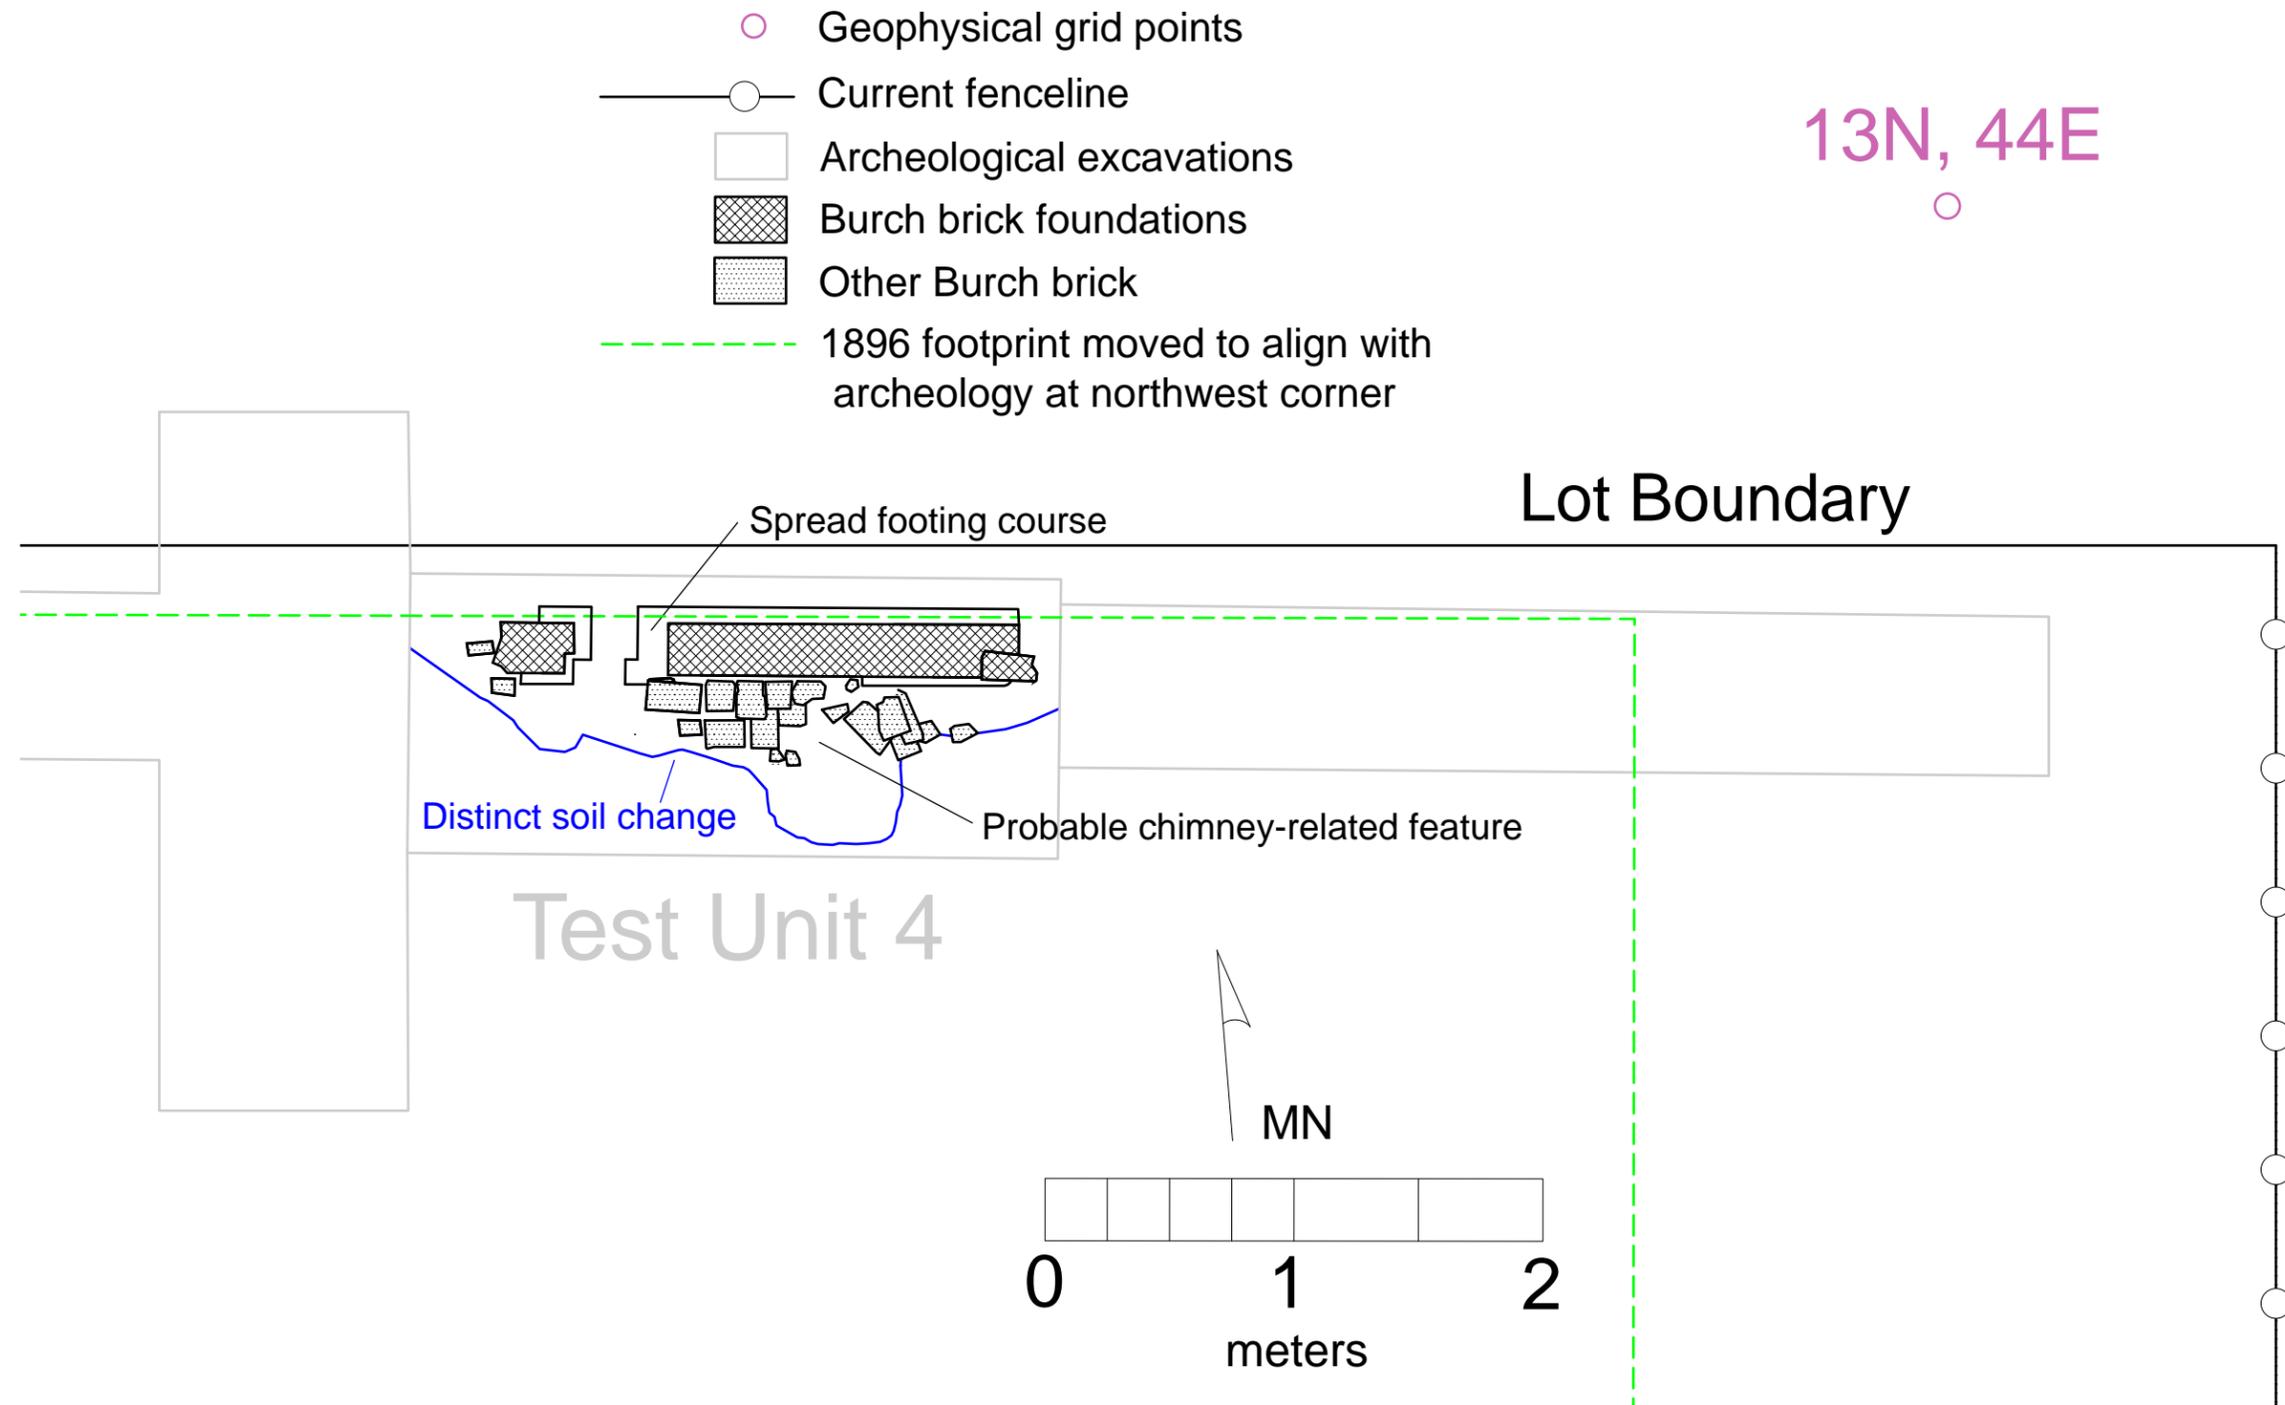
Figure 28. Closeup plan view of archeological features identified at the front of the Burch property.

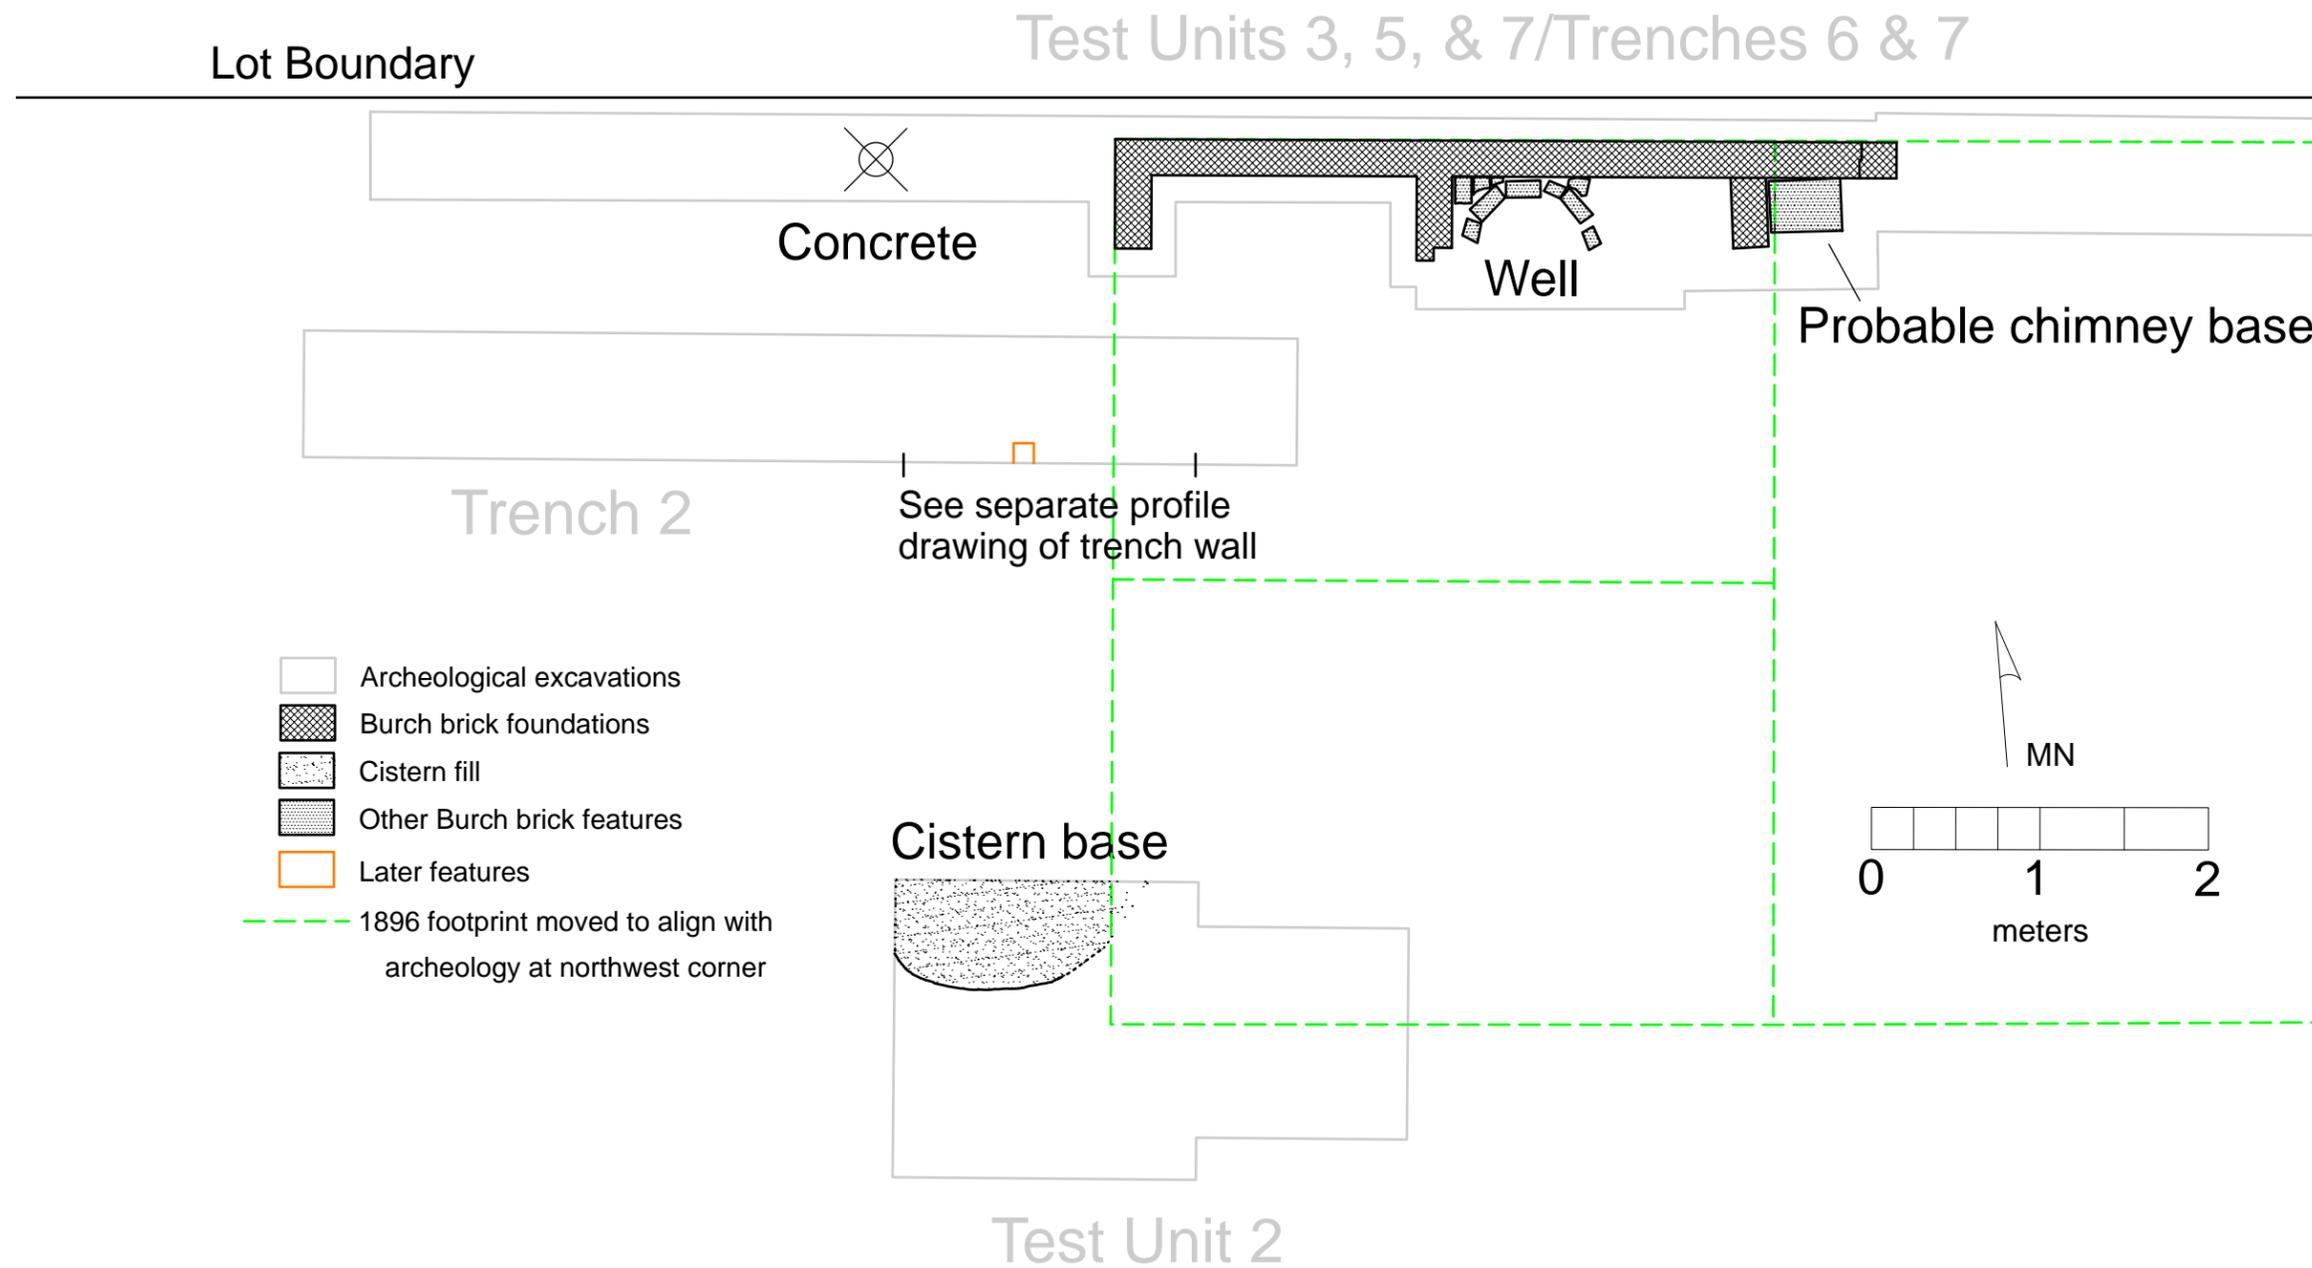
Figure 29. Closeup plan view of archeological features identified in the middle of the Burch property that relate to the back section of the Burch house.

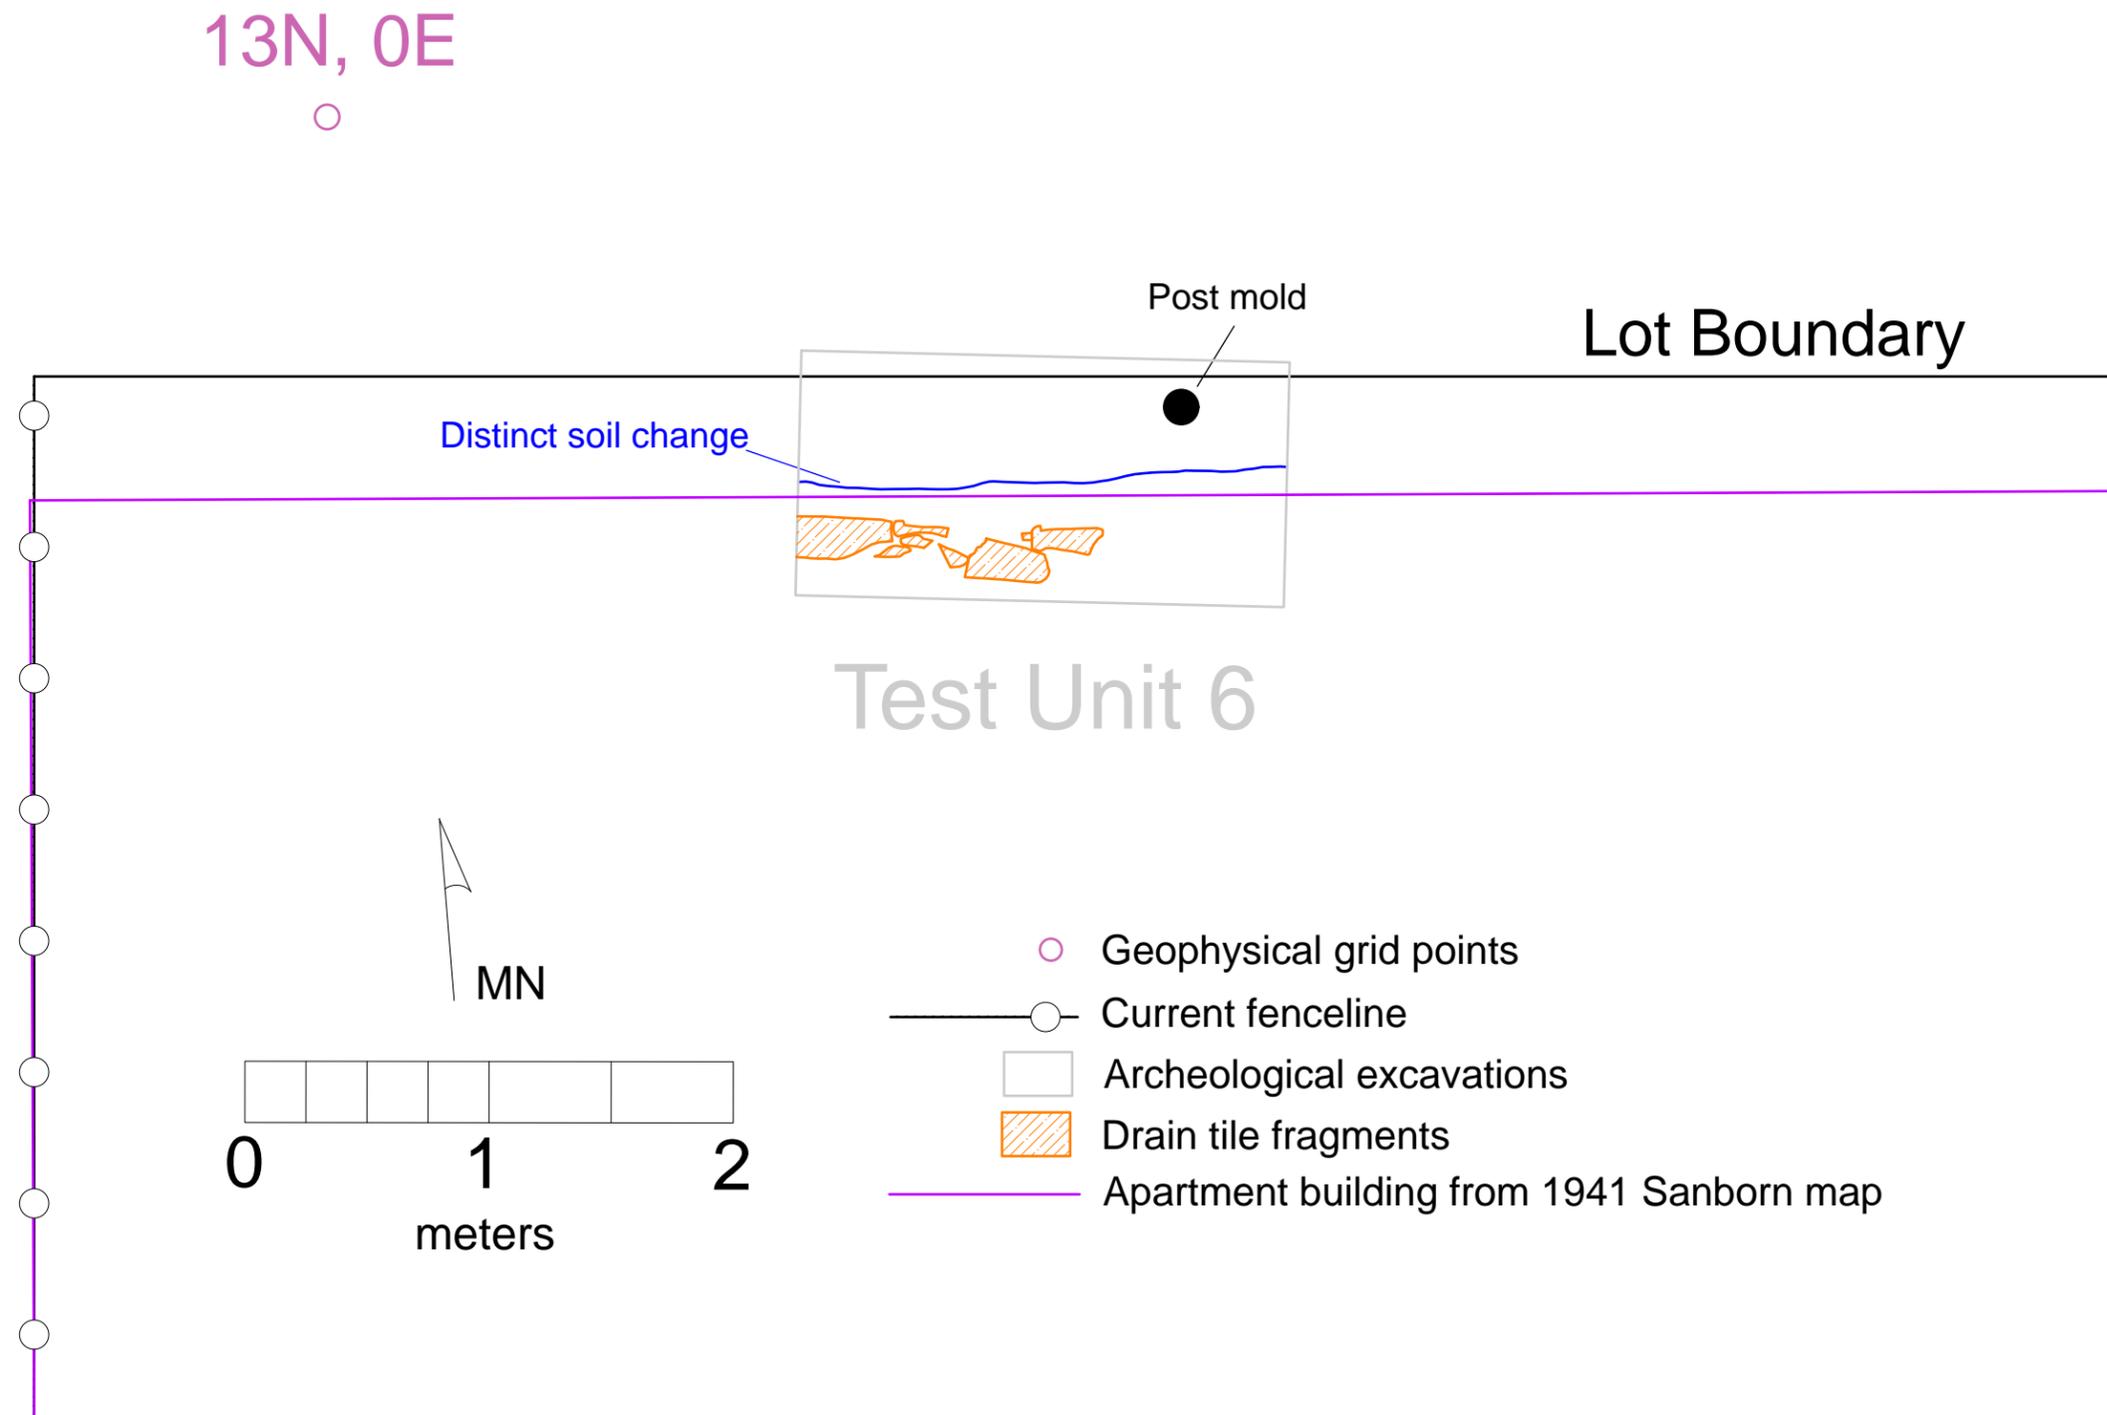
Figure 30. Closeup plan view of archeological features identified at the back of the Burch property.

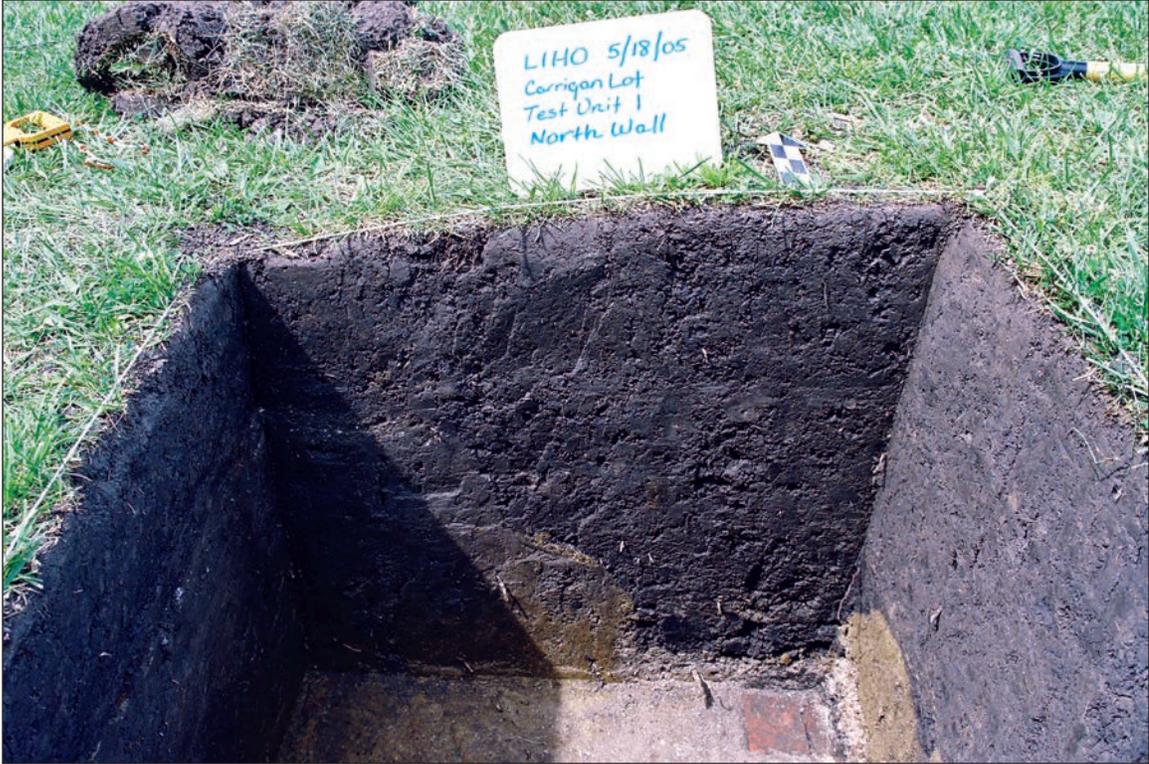
Figure 31. Carrigan lot, Test Unit 1, north unit wall profile showing the bottom of the builders trench for the Carrigan house foundation, now gone, and the southwest corner of the brick cellar floor.

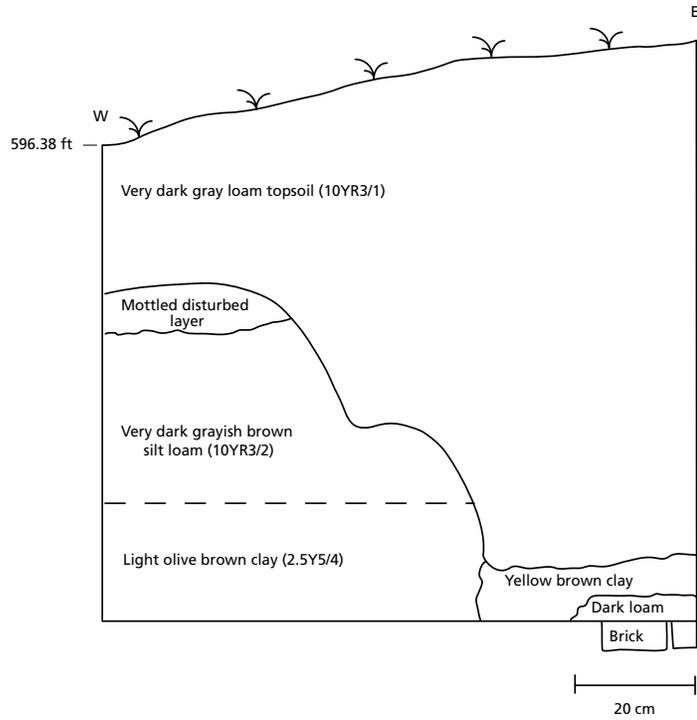
Figure 32. Carrigan lot, Test Unit 1, north unit wall profile drawing.

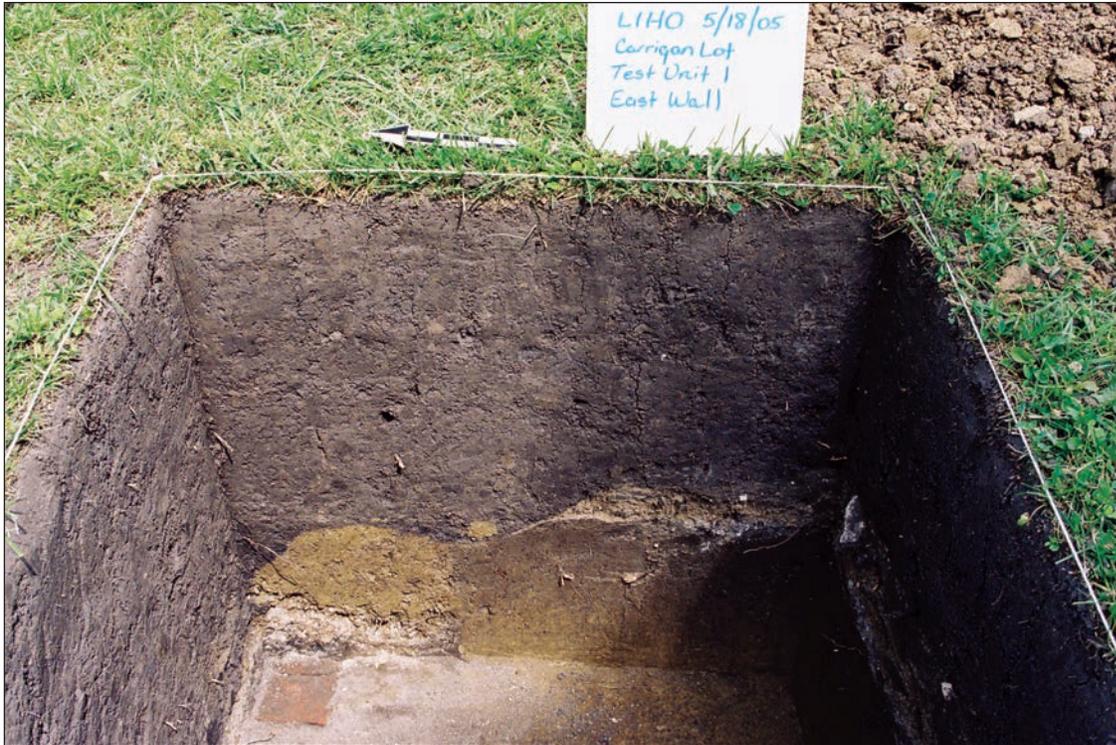
Figure 33. Carrigan lot, Test Unit 1, east unit wall profile showing the bottom of the builders trench for the Carrigan house foundation, now gone, and the southwest corner of the brick cellar floor.

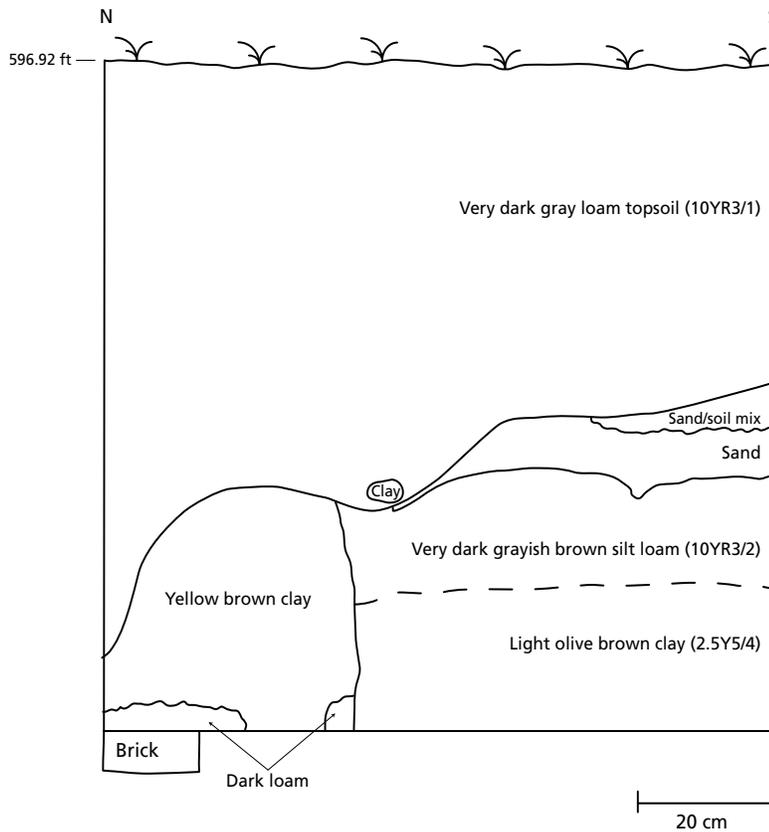
Figure 34. Carrigan lot, Test Unit 1, east unit wall profile drawing.

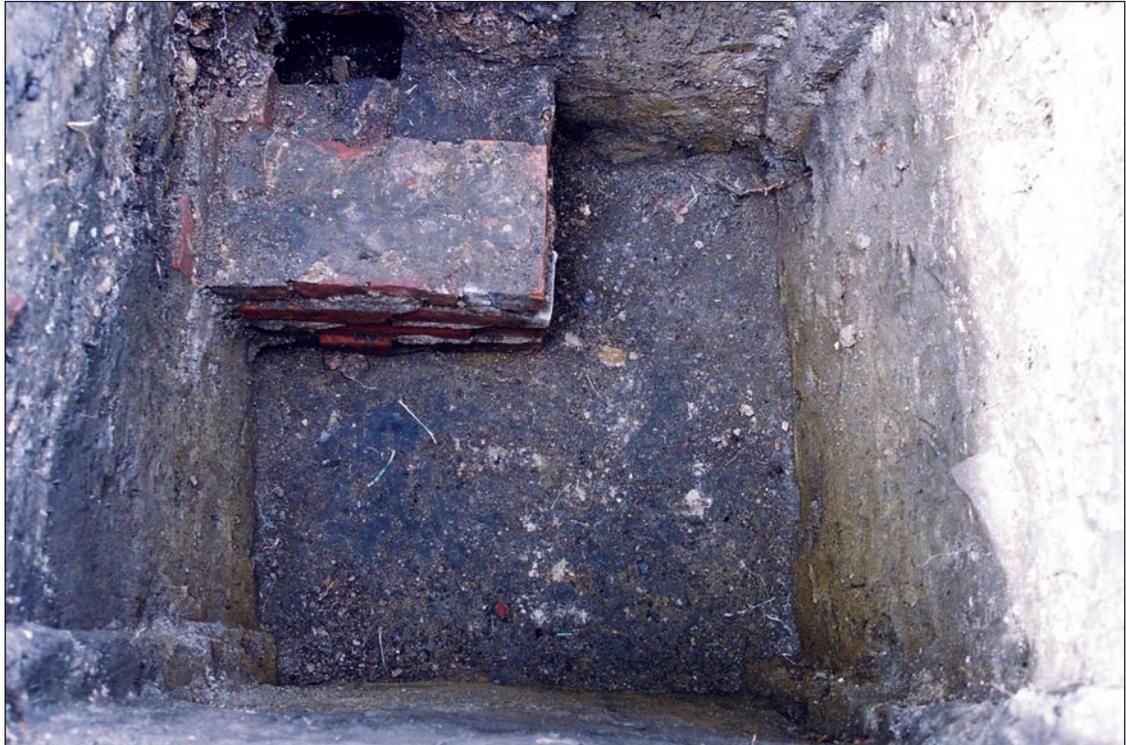
Figure 35. Carrigan lot, southeast corner of the foundation for the front section of the Carrigan house, seen at the bottom of Test Unit 2.

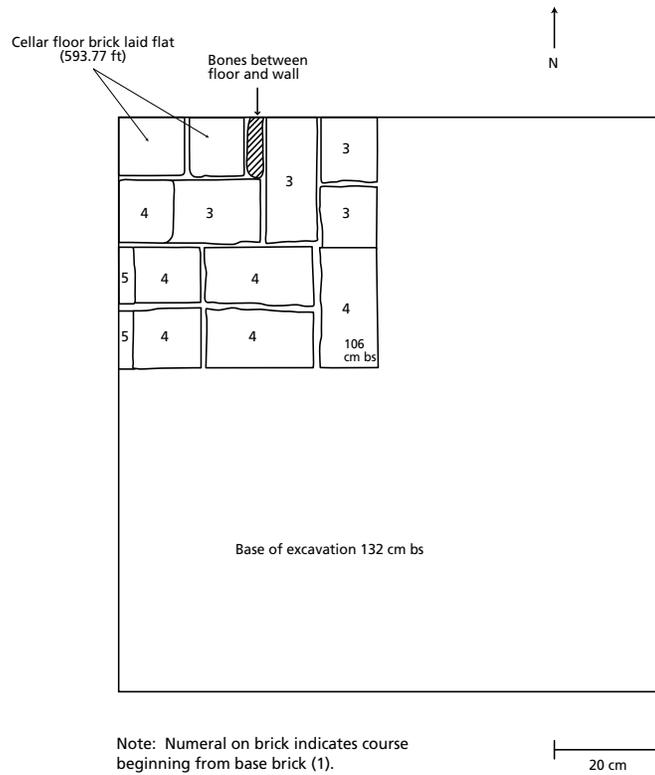
Figure 36. Carrigan lot, Test Unit 2, plan view of the southeast corner of the brick foundation for the front section of the Carrigan house.

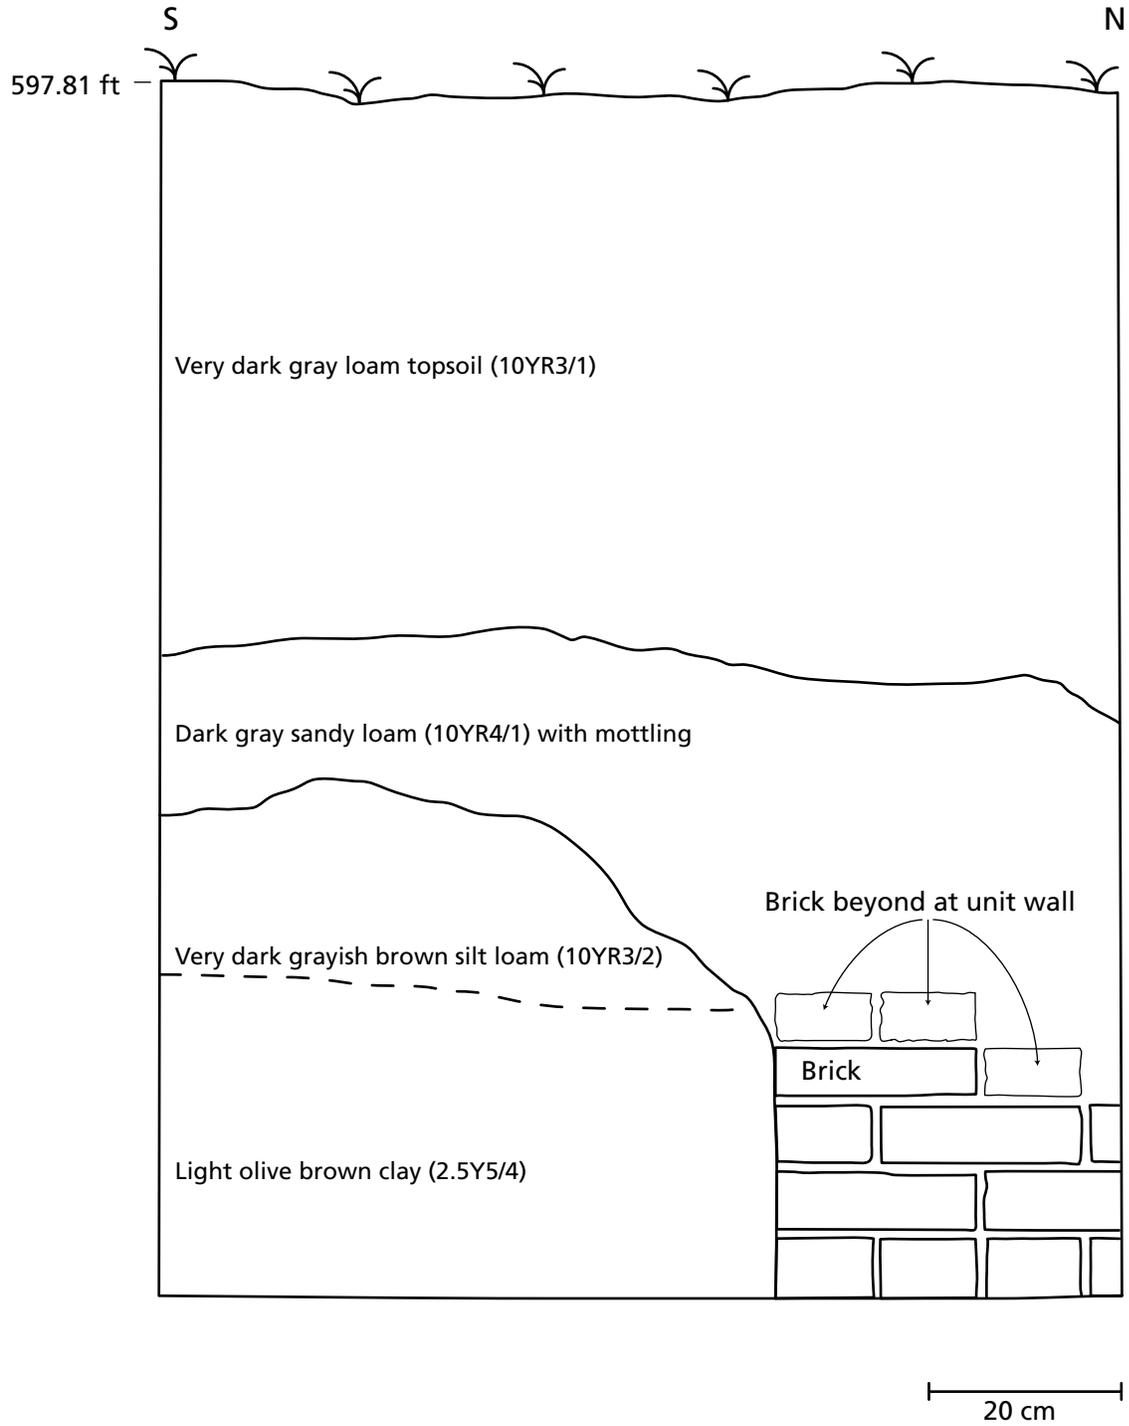
Figure 37. Carrigan lot, Test Unit 2, west unit wall profile drawing.

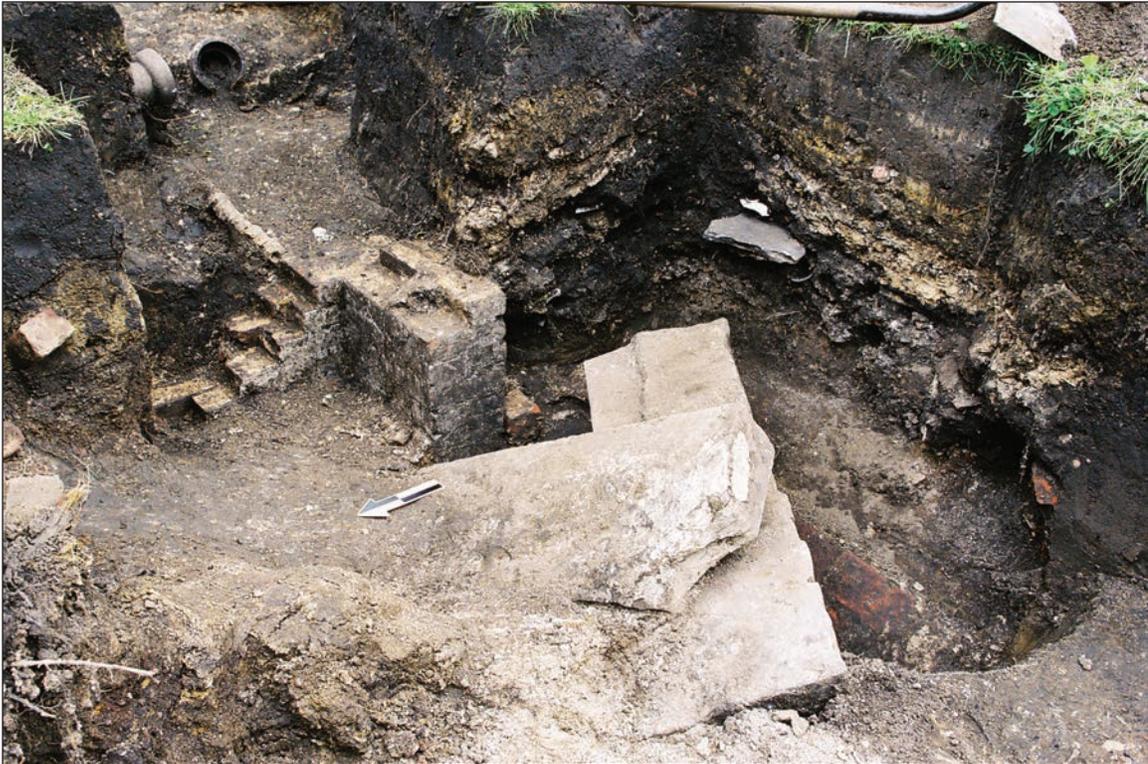
Figure 38. Carrigan lot, Test Unit 3/Trench 2, view southeast to remains of the southeast corner of the Carrigan/Irwin house (brick foundation at left center in photo), back cellar entry features, and stoneware drain tile and iron pipe extending from the cistern.

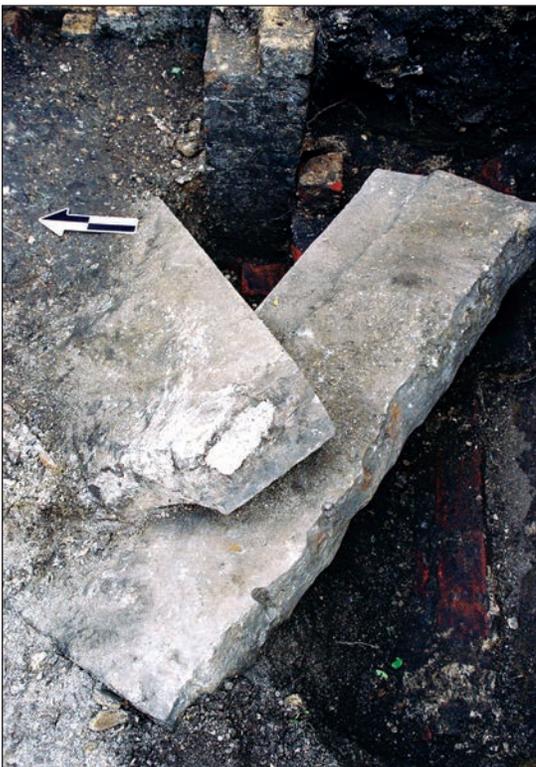
Figure 39. Carrigan lot, Test Unit 3/ Trenches 2 and 3, view east to back cellar entry features including the finished east jamb for the cellar entryway (top center), two displaced dressed stones, sloped brick paving (bottom right extending under a stone), and the remnants of brick cheek walls (bottom right and to right of jamb).
