ARCHEOLOGICAL INVENTORY AND EVALUATION AT THE CARRIGAN AND BURCH PROPERTIES, LINCOLN HOME NATIONAL HISTORIC SITE, SPRINGFIELD ILLINOIS

BY
JANIS L. DIAL-JONES

Midwest Archeological Center
Technical Report 125

NATIONAL PARK SERVICE
Midwest Archeological Center

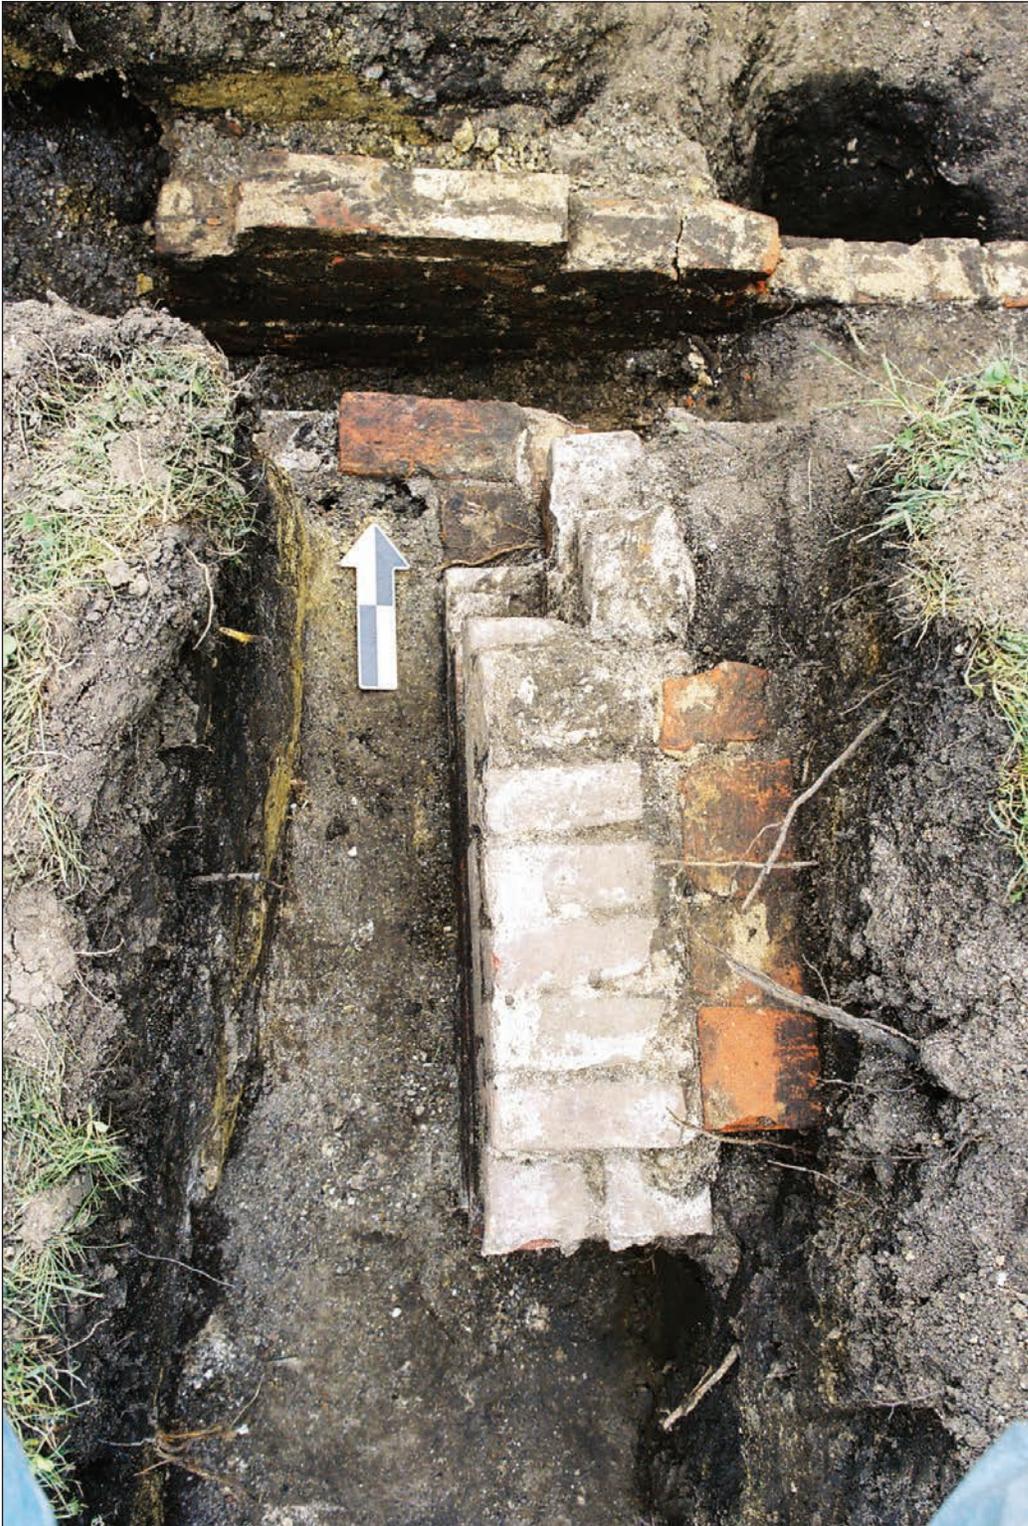
Figure 40. Carrigan lot, Trench 3, structural remains including the southwest corner of the Carrigan back addition (top left) and Carrigan foundation, an Irwin house wall (center), and four Carrigan half-bricks (along right side of Irwin wall).

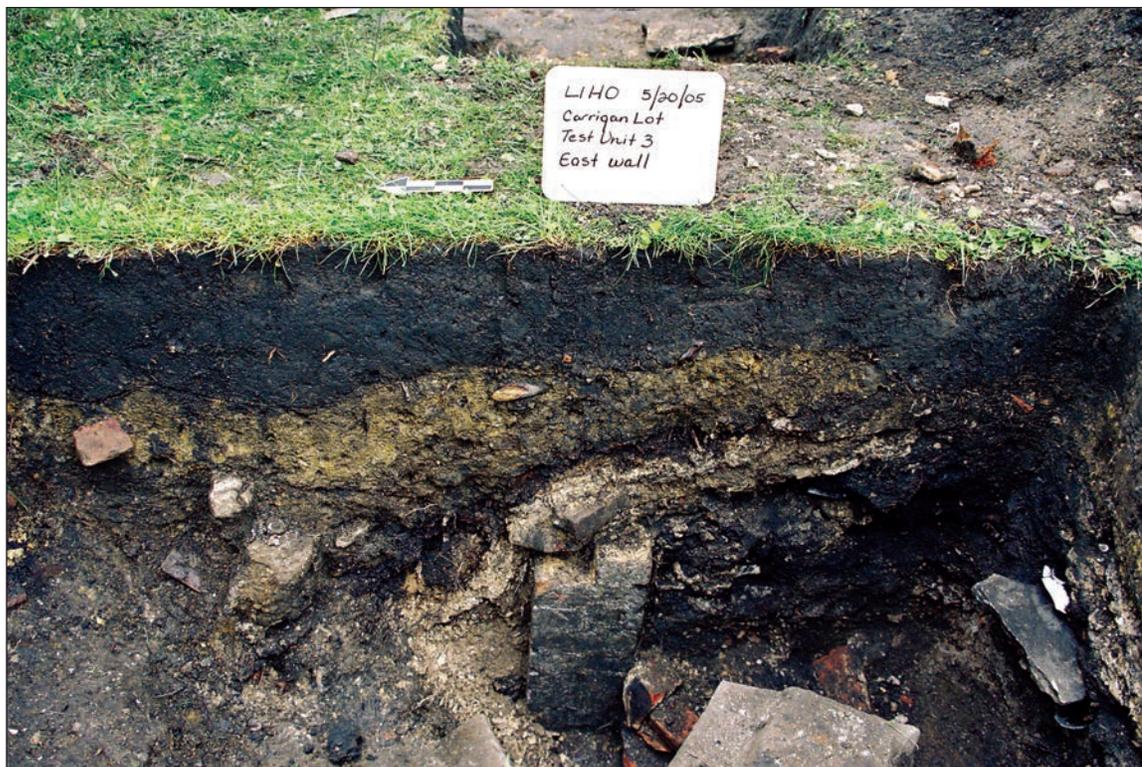
Figure 41. Carrigan lot, Test Unit 3, east unit wall profile showing the east jamb of the back cellar entryway (bottom center) and fill stratigraphy.

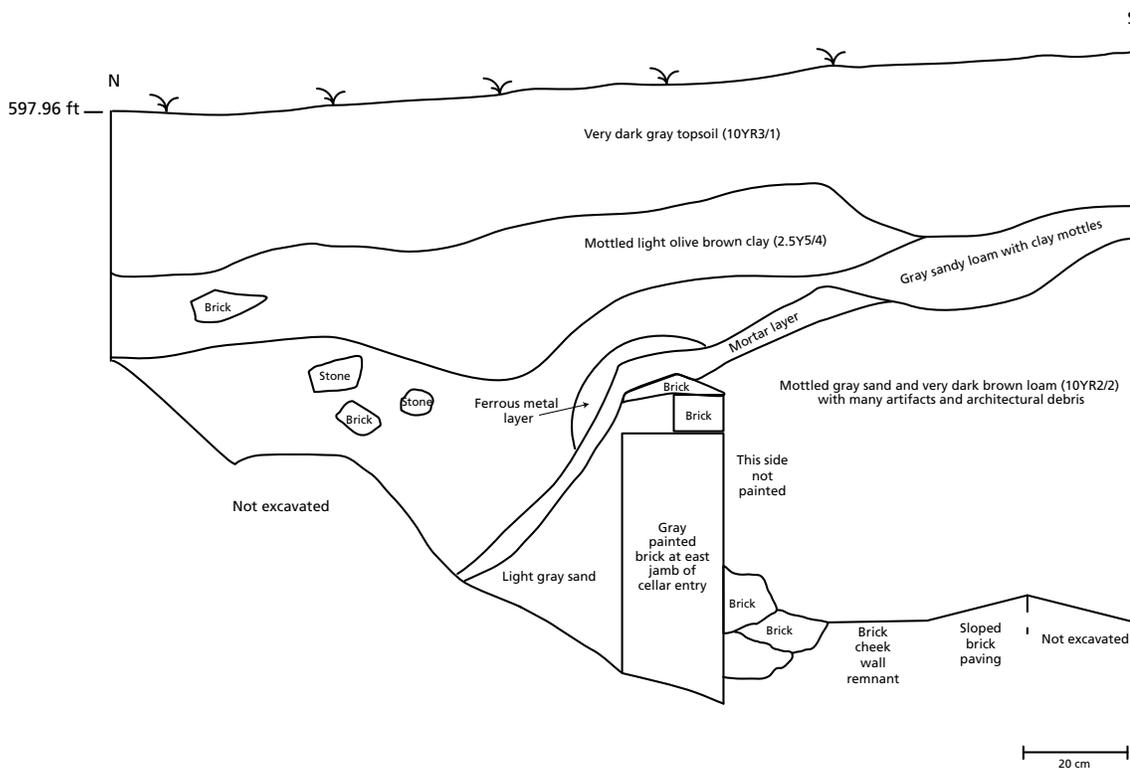
Figure 42. Carrigan lot, Test Unit 3, east unit wall profile drawing.

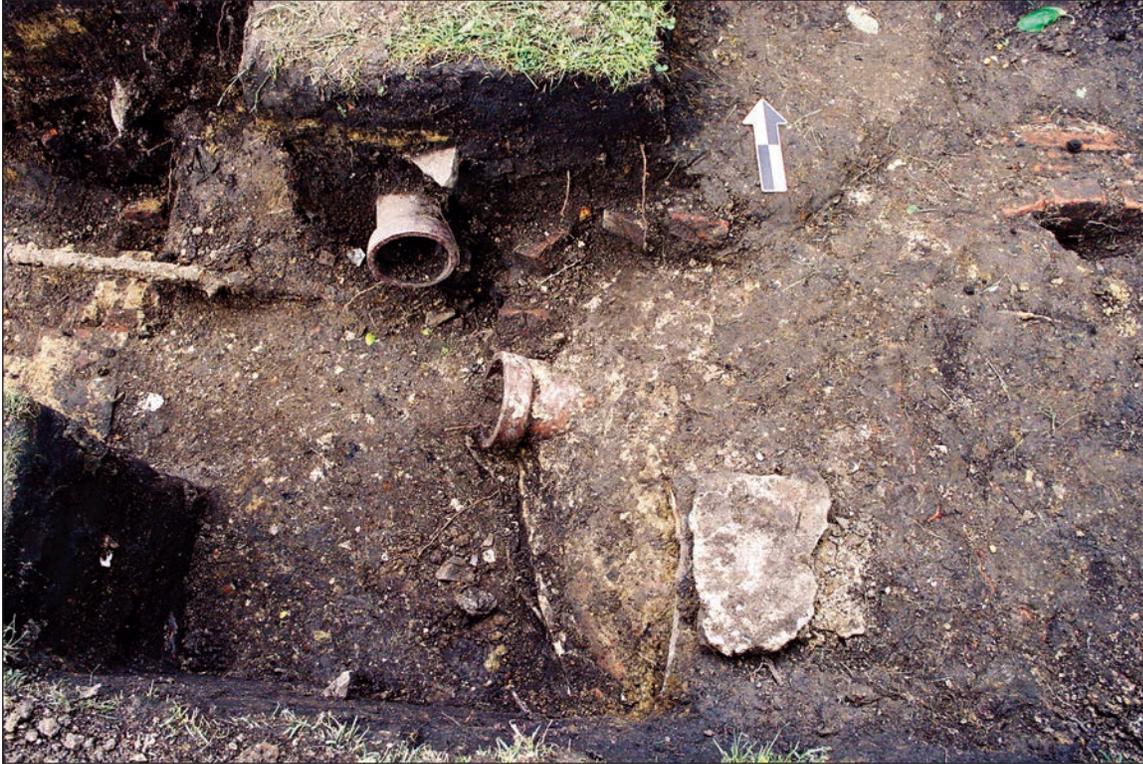
Figure 43. Carrigan lot, Trench 2, cistern-related features including the cistern cap (right half of photo), stoneware drain tile, iron pipe, and limestone mortared to top of cistern.

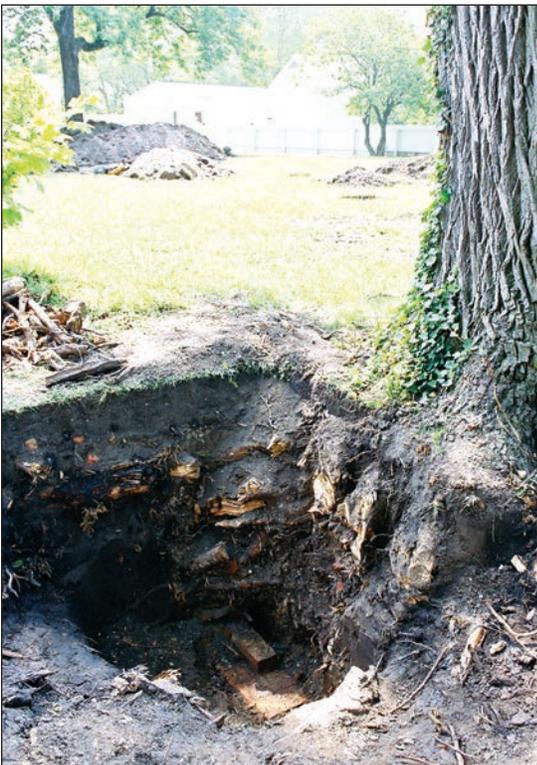
Figure 44. Carrigan lot, view southeast across Test Unit 5 excavated in 2005, with the northwest corner of the Carrigan house foundation exposed in the bottom of the unit.

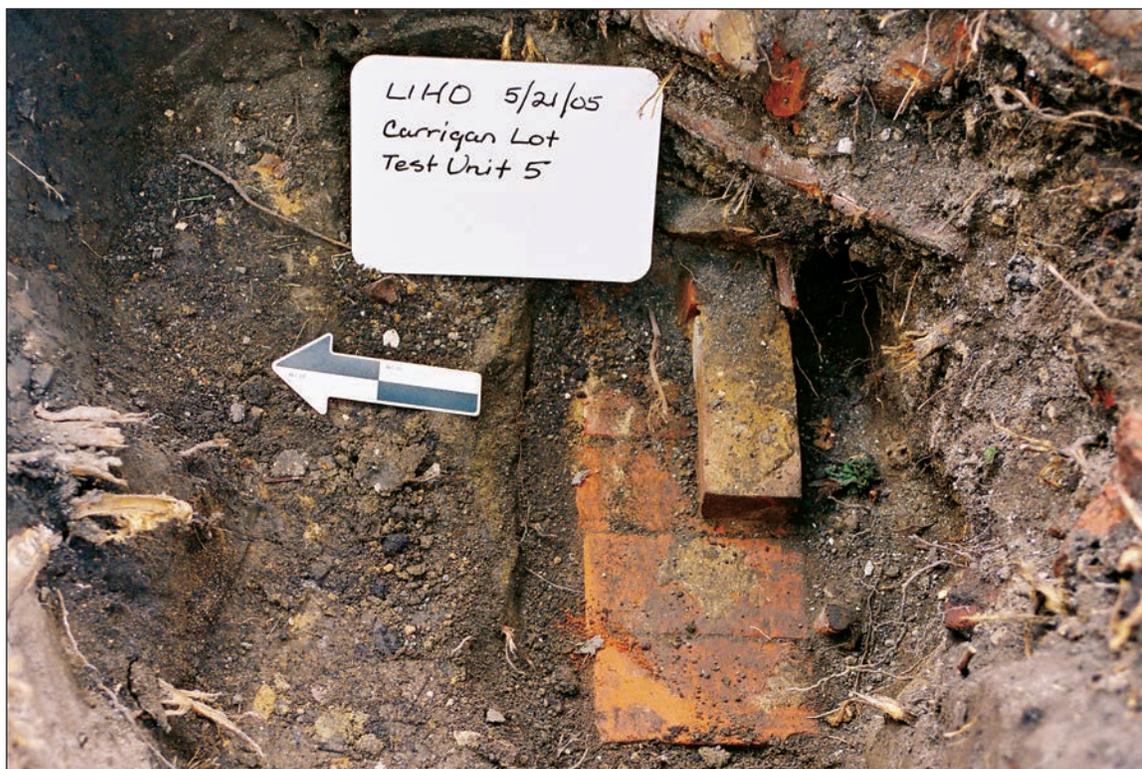
Figure 45. Carrigan lot, Test Unit 5, closeup of bottom two courses of brick at the northwest corner of the Carrigan house.

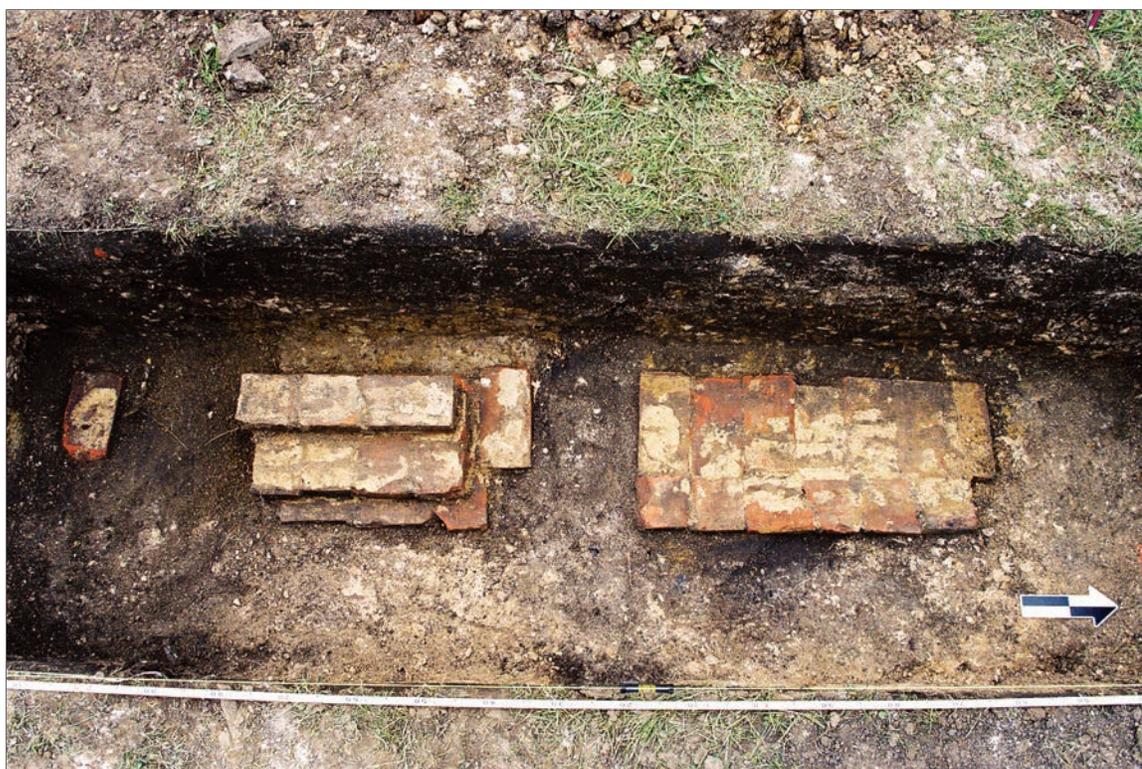
Figure 46. Carrigan lot, Test Unit 6, brick alignment interpreted as the remains of a porch support.

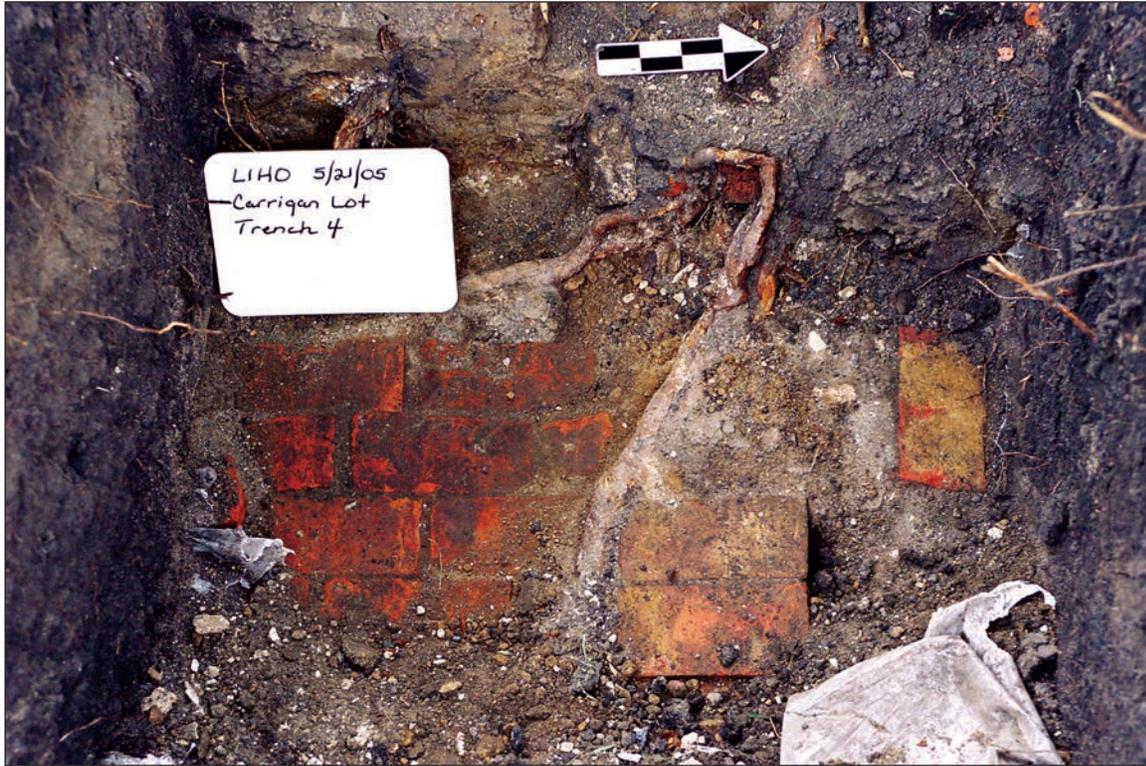
Figure 47. Carrigan lot, Trench 4, brick cellar floor (left) and brick foundation remains (right) at a jog in the front (west) wall of the Carrigan house.

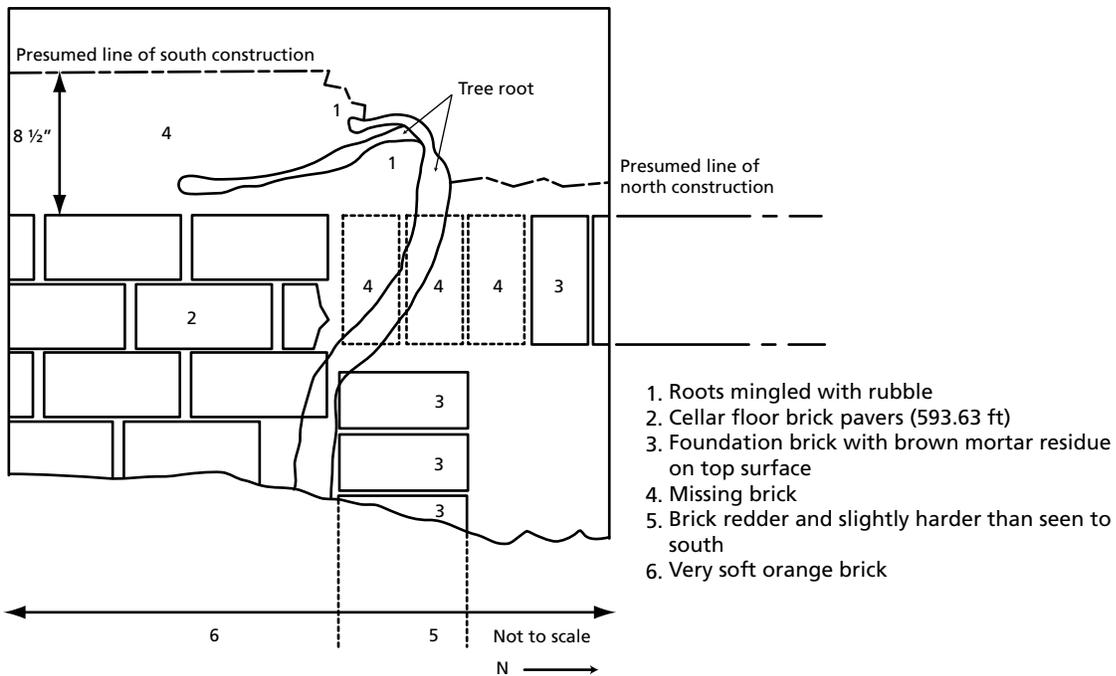
Figure 48. Carrigan lot, Trench 4, schematic drawing of the jog in the front (west) wall of the Carrigan house at approximately 1 meter below the present ground surface.

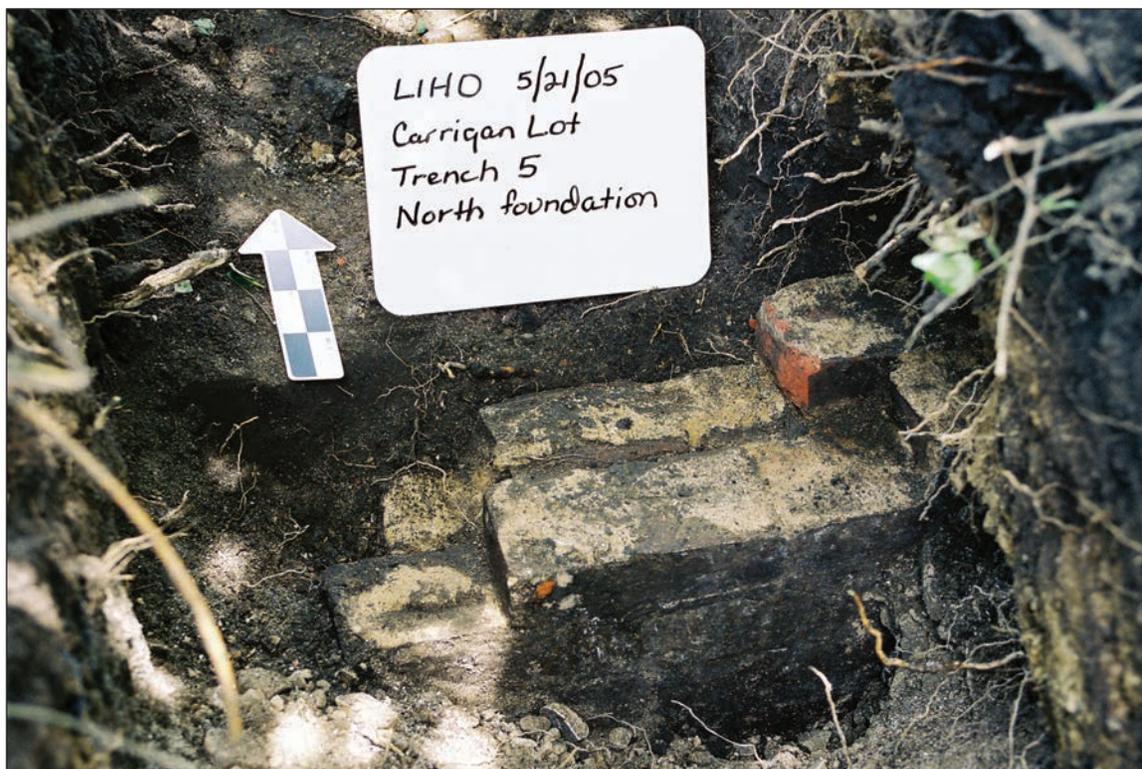
Figure 49. Carrigan lot, Trench 5, north foundation wall of the Carrigan house.

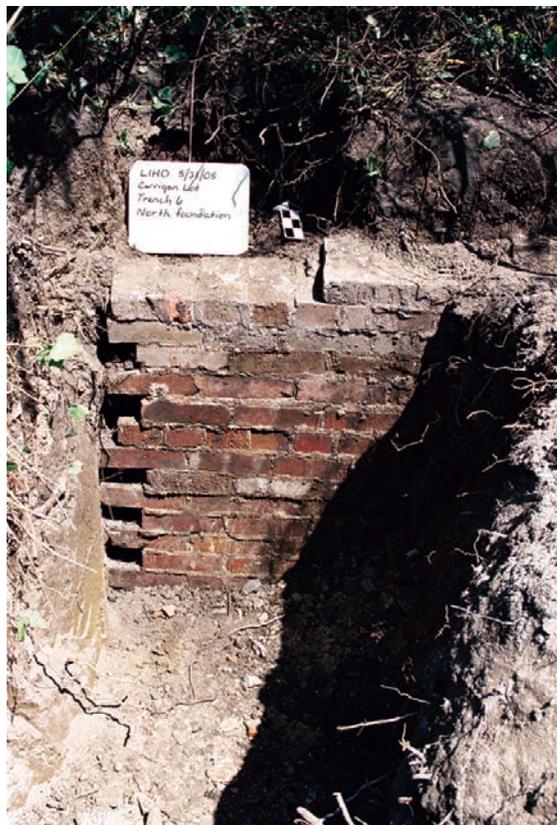
Figure 50. Carrigan lot, Trench 6, north foundation of the Irwin house.

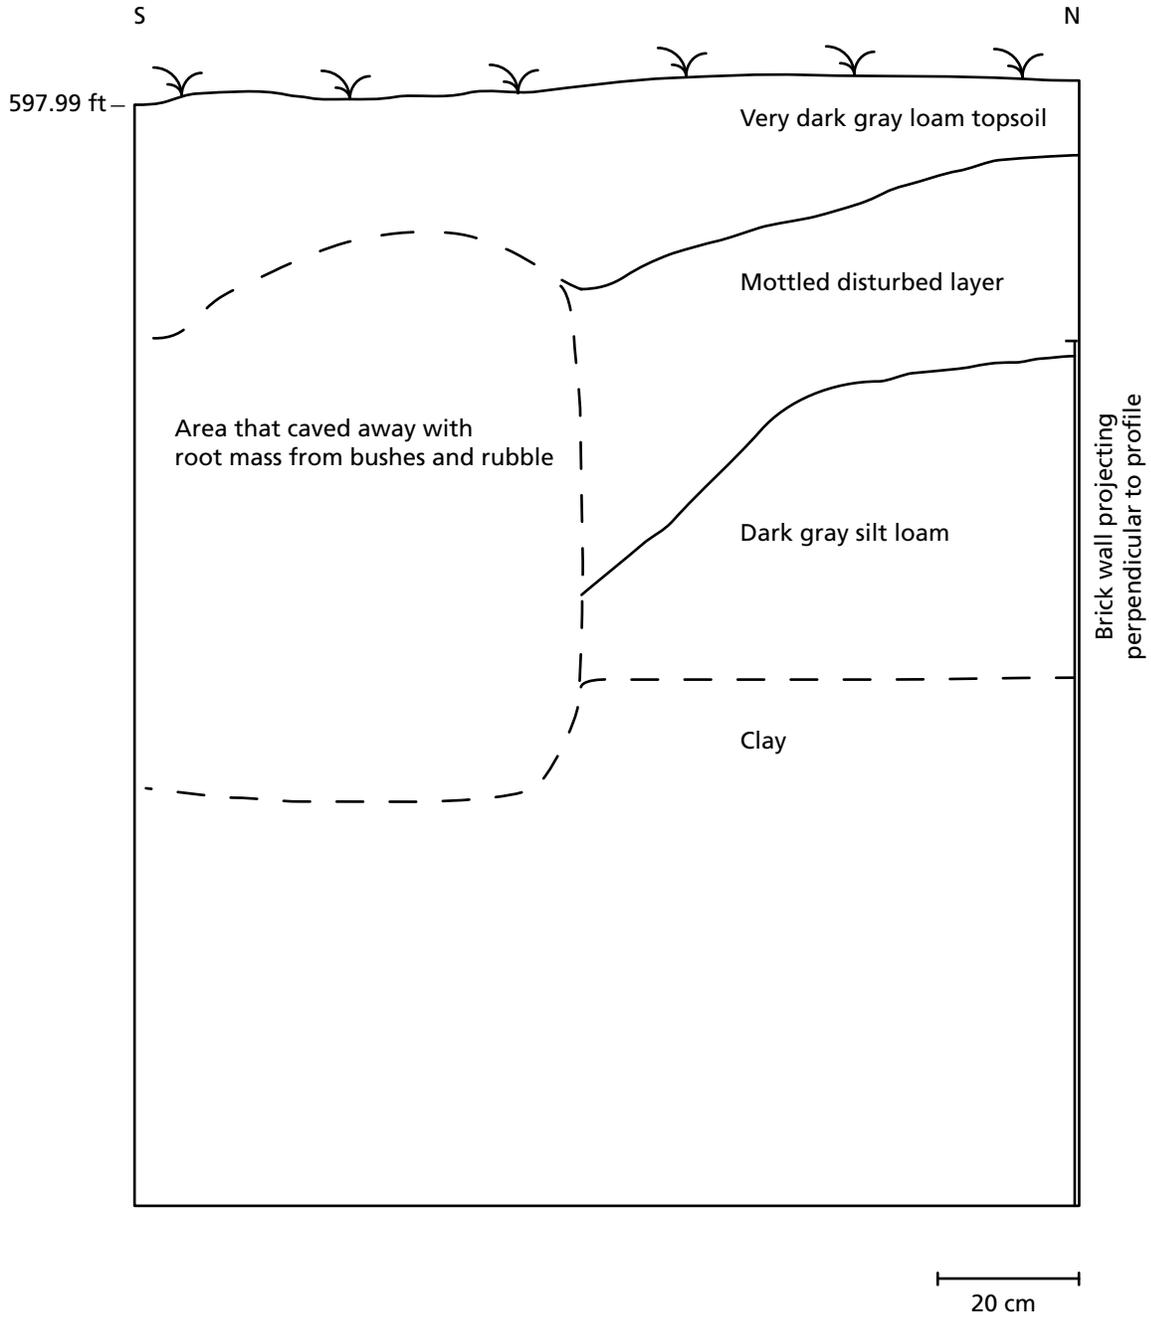
Figure 51. Carrigan lot, Trench 6, west unit wall profile drawing.

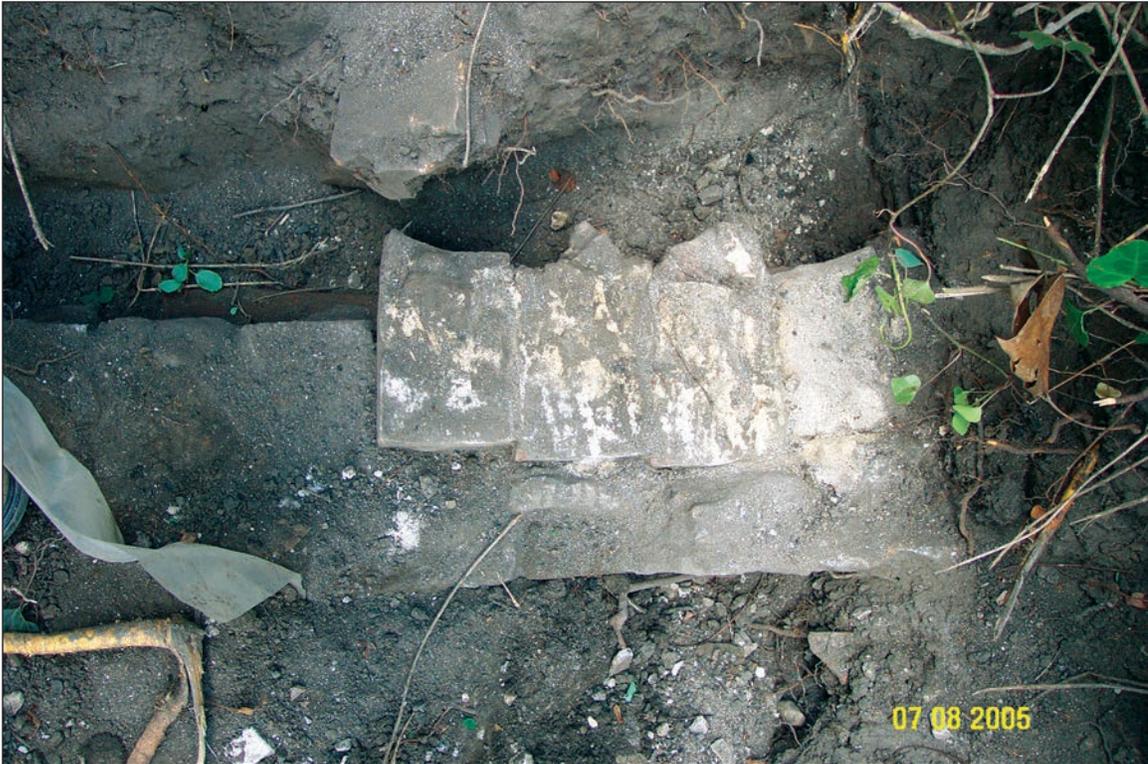
Figure 52. Carrigan lot, Trench 6, rough arc of Carrigan brick atop a north Irwin foundation wall.

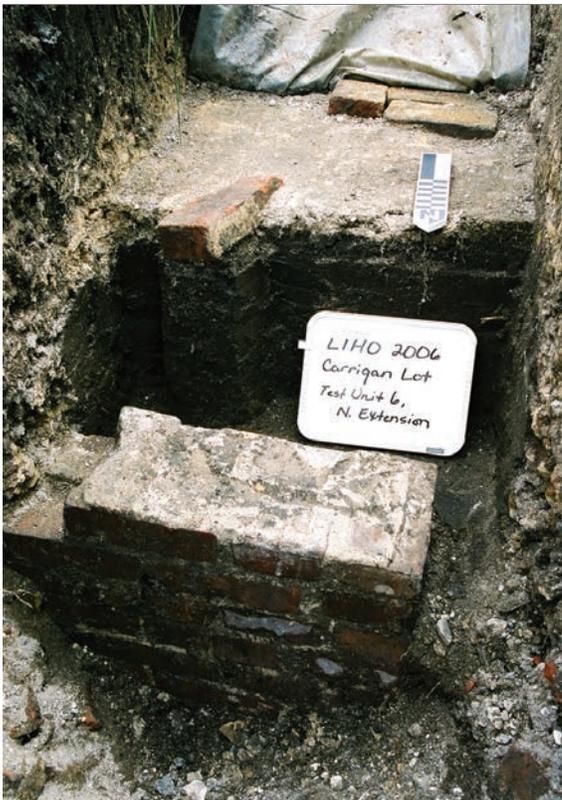
Figure 53. Carrigan lot, Test Unit 6, North Extension, view south to a section of the Irwin house foundation. An intact brick alignment interpreted as a Carrigan porch support structure is visible at the upper right in photo, partially covered with plastic laid in 2005.

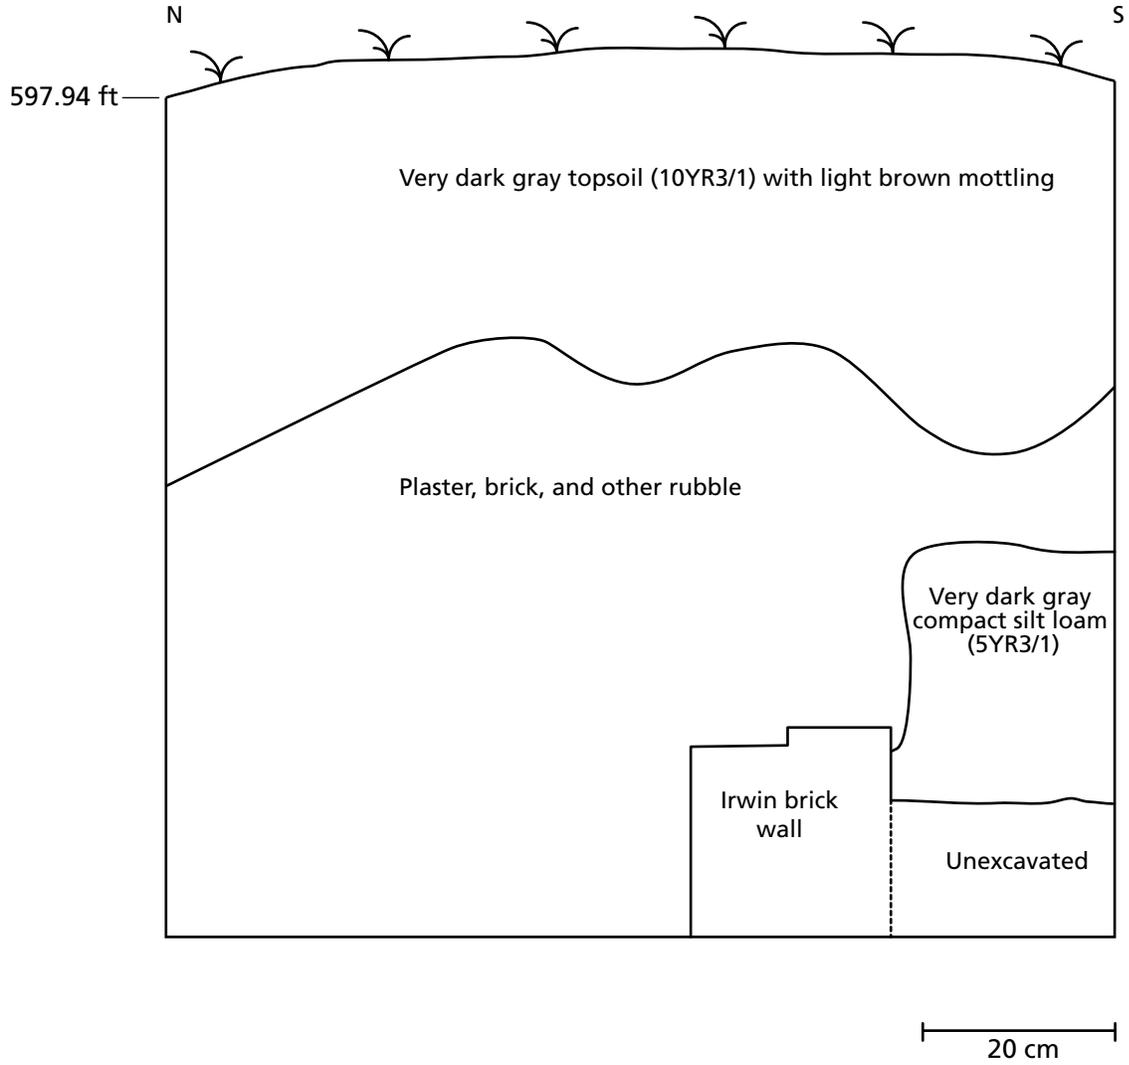
Figure 54. Carrigan lot, Test Unit 6, North Extension, east unit wall profile drawing.

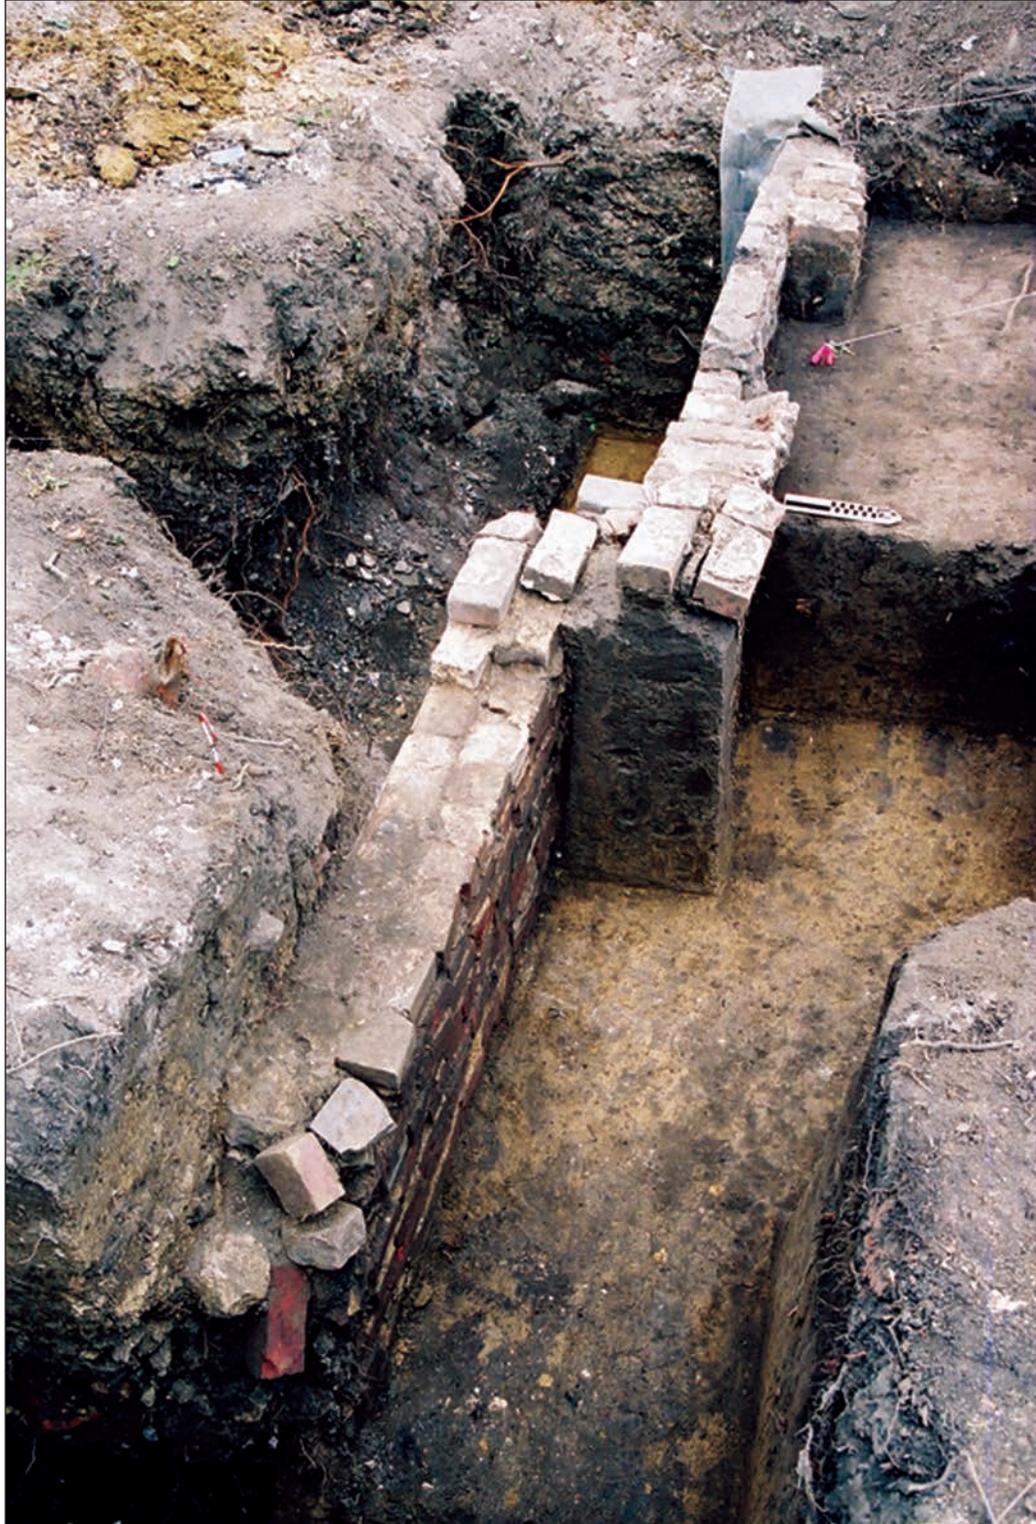
Figure 55. Carrigan lot, Test Units 7, 8, and 10 West Extension (right in photo) and Trench 8 (left), north foundation wall of the Carrigan back addition (bottom) and north foundation wall of the ell with arc of Carrigan brick (top). A possible four-brick pier is located immediately outside (right of) the juncture of the back addition and the ell.

The Poston brick portion of the wall had been toothed into the Carrigan portion of the wall, but was angled 3-degrees farther toward the north (Figure 11 and 62). The eastern end of this patch was a single wythe, and the western end was two wythe. The arc of Carrigan-era brick described above was mortared to the top of this section of the wall (Figures 55 and 56). Overall, this section displayed sloppy workmanship.

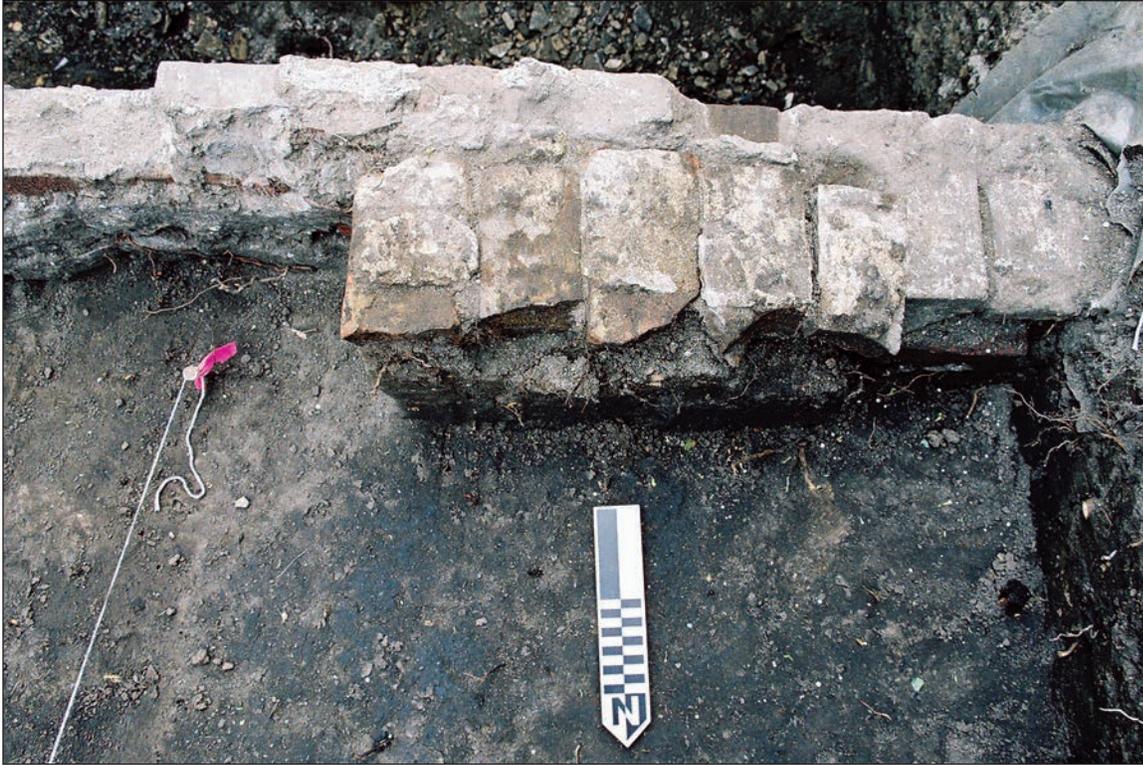
Figure 56. Carrigan lot, Test Unit 7, view south to the arc of Carrigan-era brick mortared to the north Irwin house foundation.

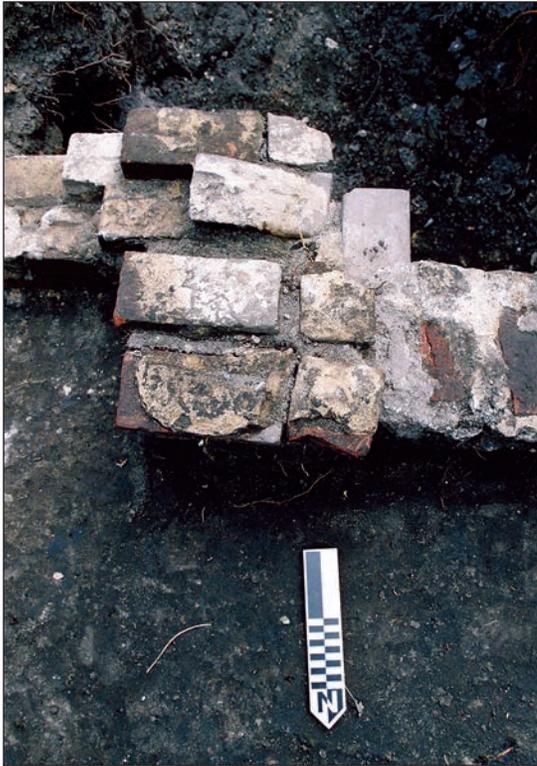
Figure 57. Carrigan lot, Test Unit 8, view south to the juncture of the back addition (top left) and the ell (middle right), and a possible four-brick pier (center) immediately outside the foundation.

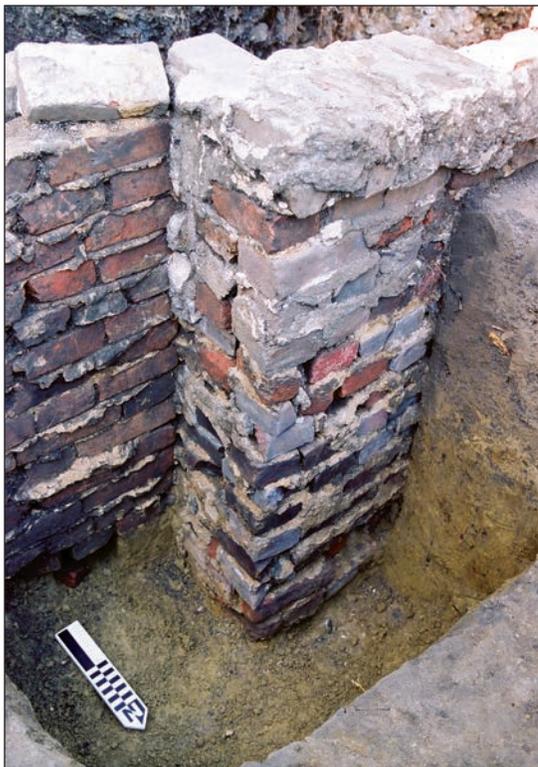
Figure 58. Carrigan lot, Test Unit 8, view southwest to the exterior face of the north foundation at the intersection of the back addition (left) and the ell (center and right). The possible brick pier was removed in the process of exposing this face of the wall.

construction of those walls more closely (Figure 58). The remains of a possible fence post were also identified along the north lot line at the northwest corner of Test Unit 8.

When a section of the exterior (north) face of that foundation wall was exposed (Figure 58), it was found that the footing was spread to the interior only and the narrow gap behind that brick was filled against the builders trench with irregular brick rubble with no projection outside the exterior face of the wall, possible done to simplify construction as there would have been no need to backfill above an outside spread footing. The top of the footing at the northwest interior corner of the back addition lay at an elevation of 594.09 ft, again similar to the top of footing elsewhere around the back cellar (see discussion of Trench 7, and the elevation of the footing in the southwest corner of the back cellar above).

North foundation wall of the ell – The portion of the north ell foundation exposed in 2006 included an original Carrigan section that had been extensively reworked during the Irwin house period, and a section that was constructed partly of Poston bricks (dating to 1916 or later) set in very hard gray mortar containing Portland cement that appeared to represent a foundation repair made fairly late in the Irwin house period (Figures 11 and 62). In the original Carrigan section, the old soft brick had been laid in a medium brown sand-lime mortar in a common bond pattern. However, this section had been reworked at a later date, as it also included a few dense machine-made bricks (unmarked), and the top two remaining courses of brick were set in a white sand-lime mortar, similar to the top two remaining courses in the north addition wall. A single-wythe pilaster extended south from the east end of the wall that also included a mix of the early soft and dense machine-made brick set in light brown mortar (Figures 60 and 61). The top three courses of the pilaster appeared to be laid in Portland cement mortar, and some of the lower courses had been shallowly repointed with Portland cement mortar over the brown sand-lime mortar. The pilaster was well-toothed to the main wall. When the exterior (north) face of this section of the wall was exposed, it was found to exhibit the same non-standard construction methods as the north wall of the Carrigan addition (Figure 58). Both brown mortar and white mortar were visible on the exterior face, both applied carelessly.

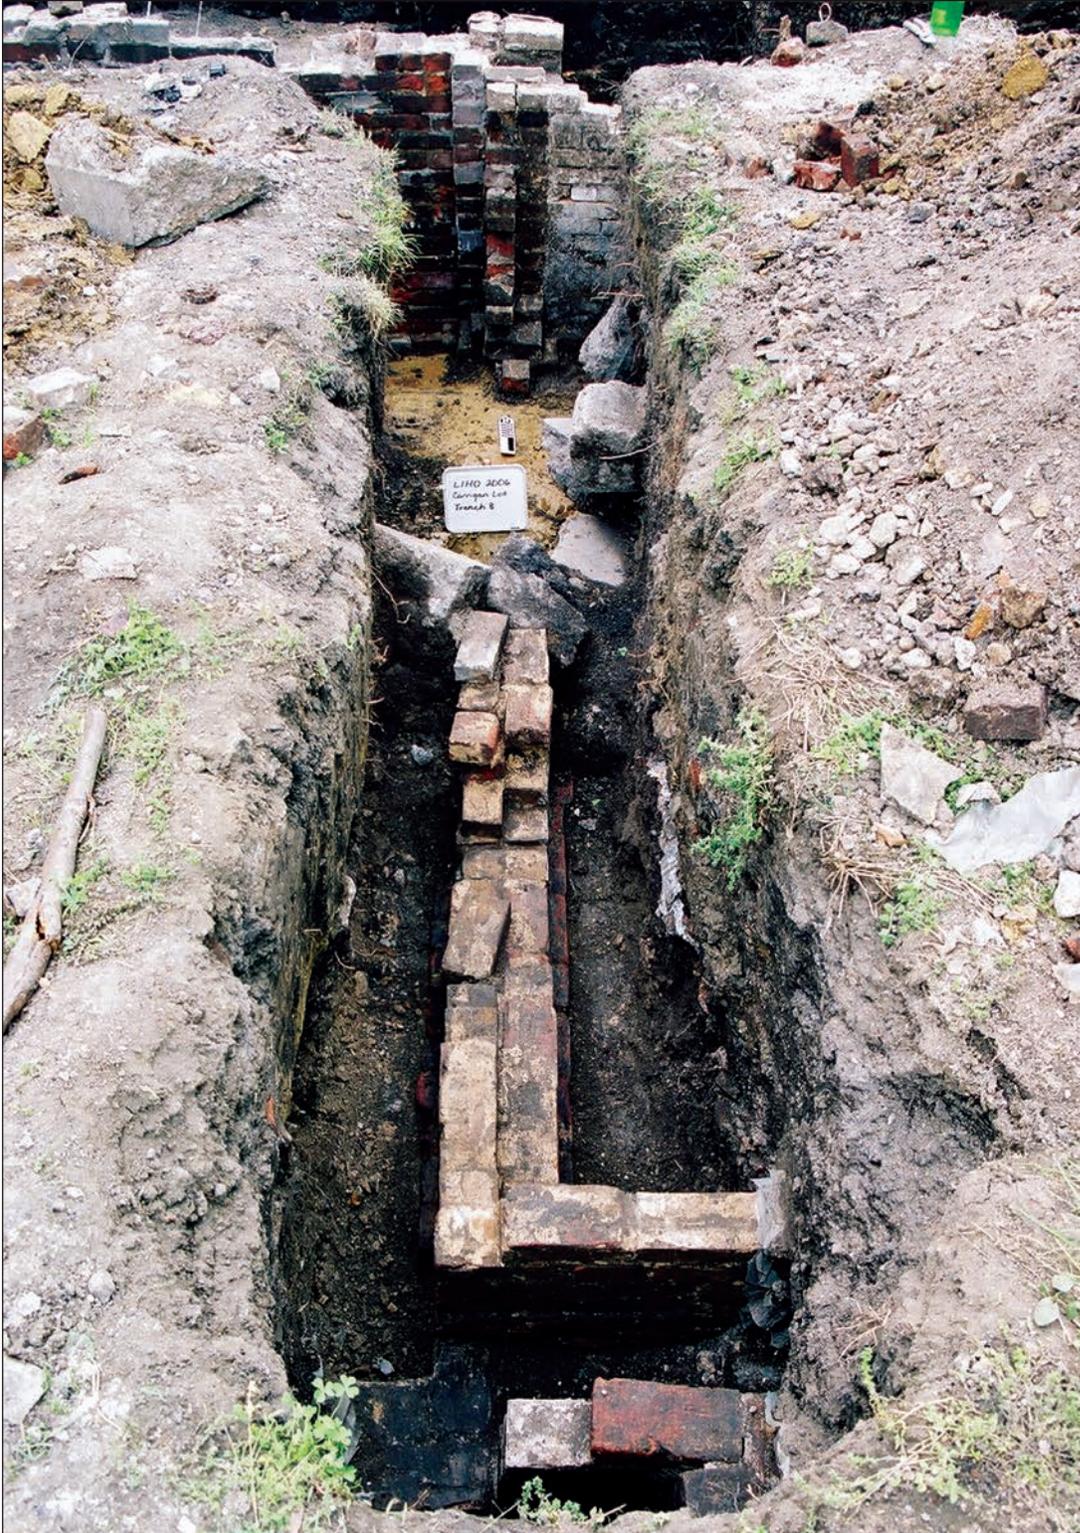
Figure 59. Carrigan lot, Trench 8, view north to the remains of the west foundation wall of the Carrigan back addition including the southwest corner of the back addition (lower center), a possible cellar entryway partially blocked by broken concrete fill, and northwest corner at the juncture with the ell (top center). The remains of Irwin construction are visible at the bottom of the photo.

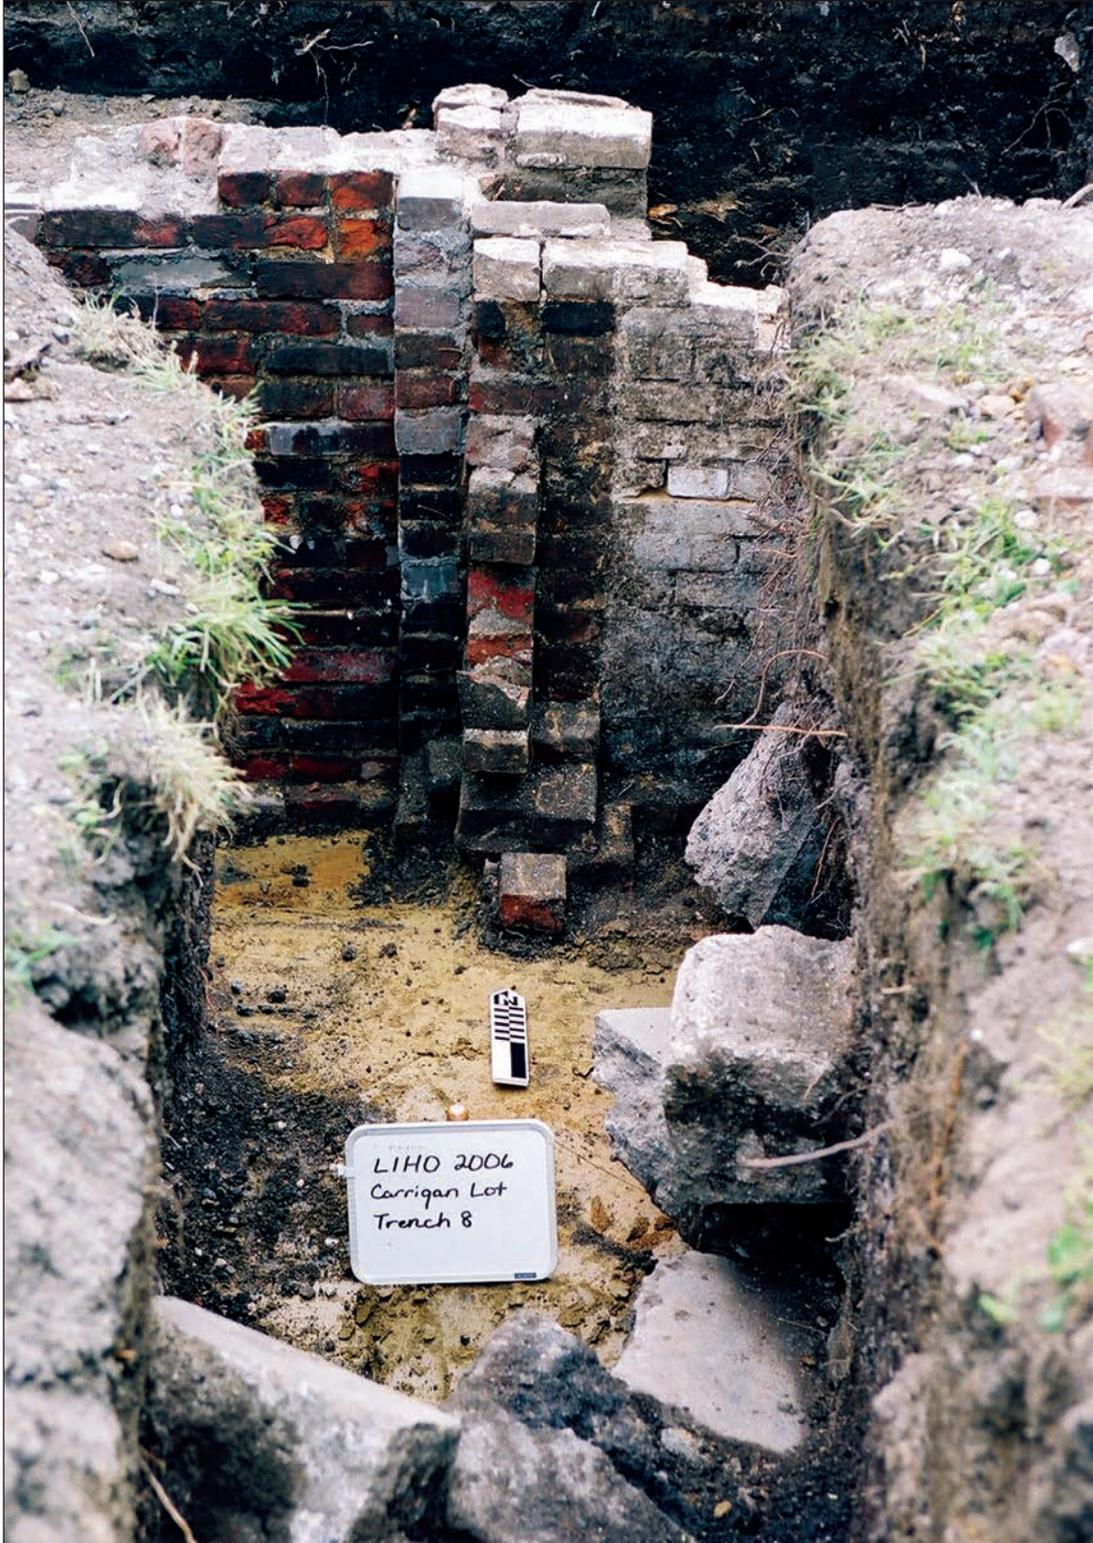
Figure 60. Carrigan lot, Trench 8, view north to closeup of the interior face of the north foundation at the juncture of the back addition and ell. Of the three vertical brick stacks/wythe in the center of the photo, the right two were part of the west wall of the back addition, and the left one served as a pilaster for the ell foundation wall. The possible brick pier lies above and immediately outside the remains of the north foundation at top center in photo.

The northwest corner of the addition was intact, but only a very short section of the west wall directly south of that corner was present, the end of which had been roughly dismantled/demolished with broken and missing bricks (Figures 60 and 61).
