ARCHEOLOGICAL INVENTORY AND EVALUATION AT THE CARRIGAN AND BURCH PROPERTIES, LINCOLN HOME NATIONAL HISTORIC SITE, SPRINGFIELD ILLINOIS

BY
JANIS L. DIAL-JONES

Midwest Archeological Center
Technical Report 125

NATIONAL PARK SERVICE
Midwest Archeological Center

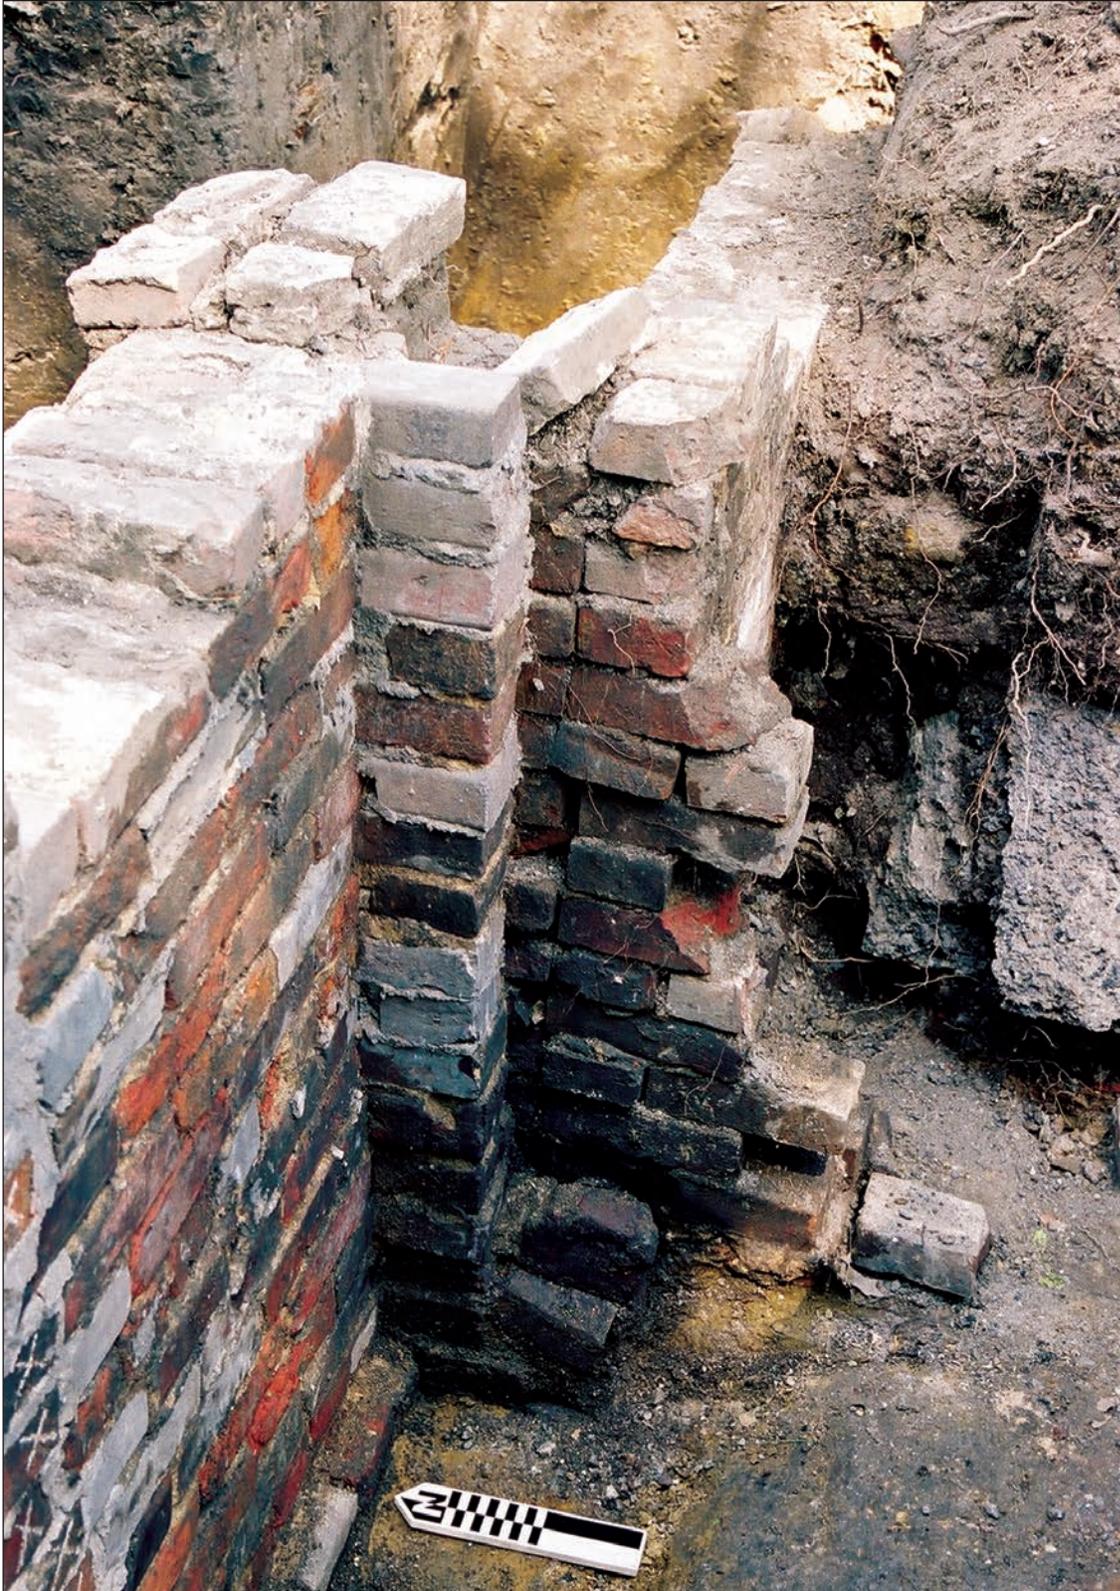
Figure 61. Carrigan lot, Trench 8, view northeast to closeup of the interior face of the north foundation at the juncture of the back addition and ell, including the ell wall with pilaster (left), and damaged remains of the west wall of the back addition (right). The possible brick pier lies at upper left.

The northwest corner of the addition was intact, but only a very short section of the west wall directly south of that corner was present, the end of which had been roughly dismantled/demolished with broken and missing bricks (Figures 60 and 61).

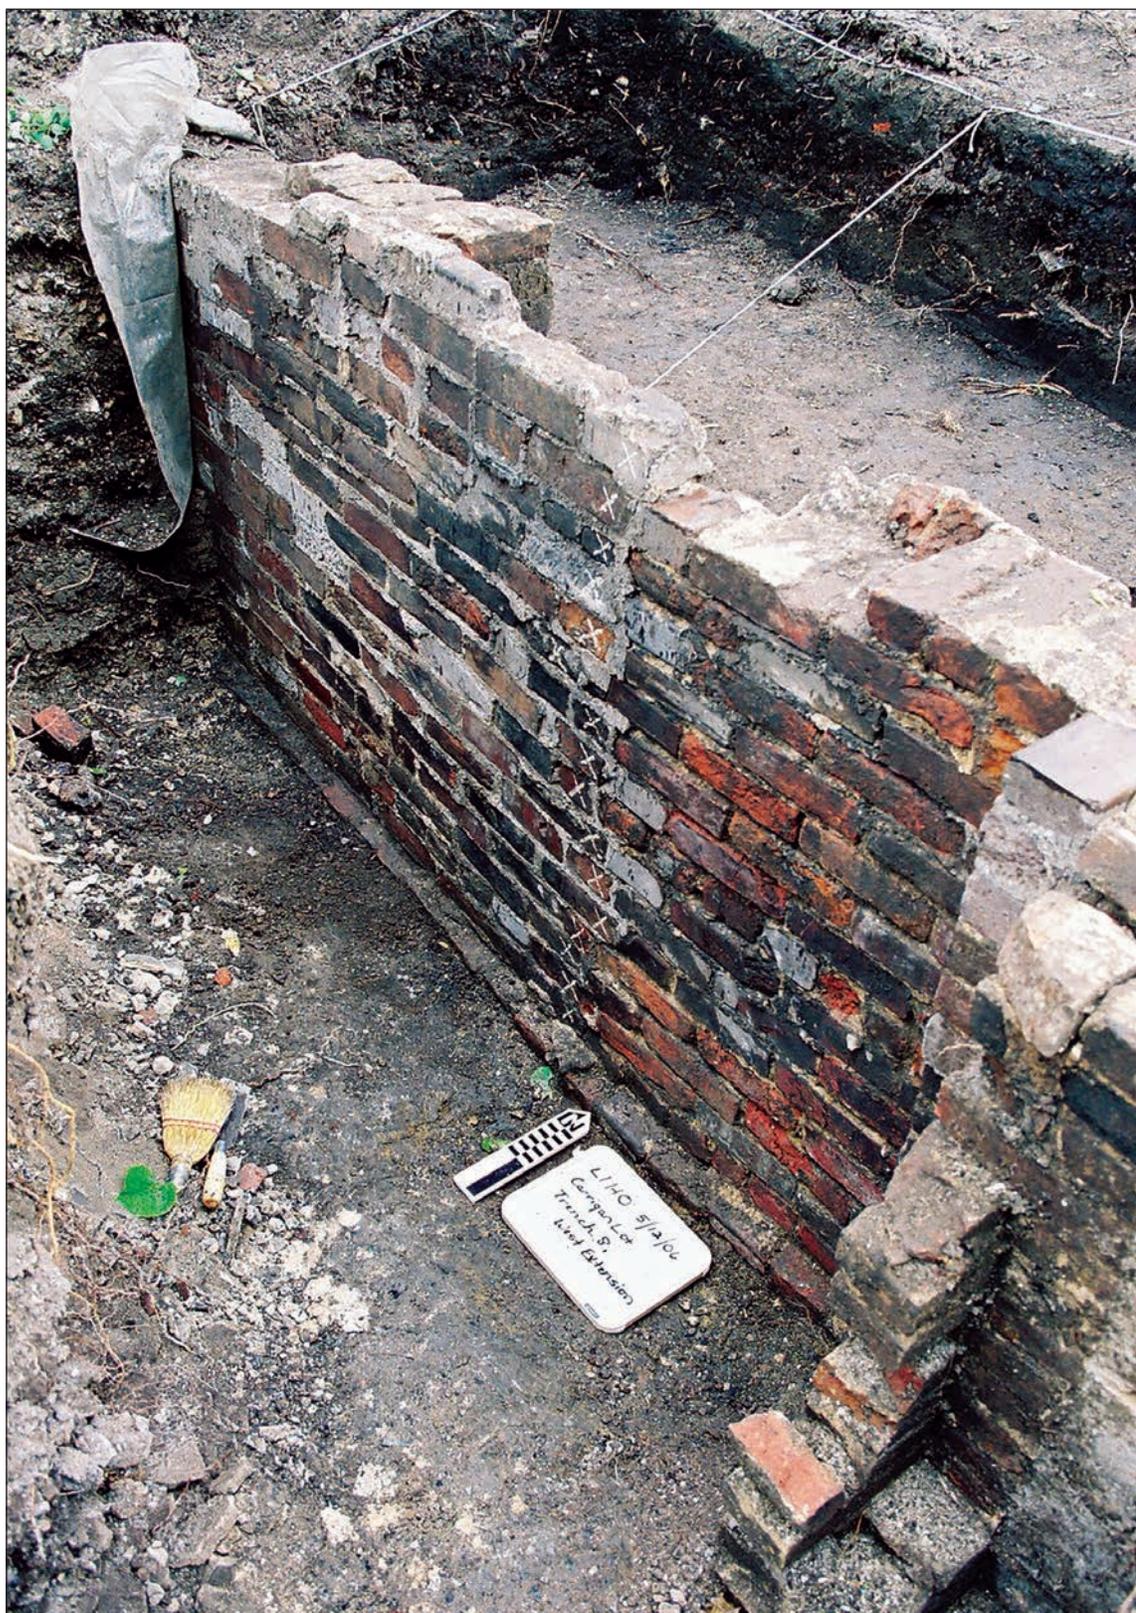
Figure 62. Carrigan lot, Trench 8 West Extension, view northwest to the interior face of the north foundation wall of the ell. The late Irwin section of the wall begins at the bricks marked with an X and extends to the left. The original Carrigan section is right of the Irwin section.

Trench 8 was extended west along the interior face of the north foundation wall of the ell to the edge of the Trench 6 excavation from 2005. That wall clearly defined another cellar that was located at the back of the ell. The wall included an original Carrigan section that had been extensively reworked during the Irwin house period, and a section that was constructed partly of Poston bricks (dating to 1916 or later) and mortar containing Portland cement that appeared to represent a foundation patch or repair made fairly late in the Irwin house period (Figure 62). The western end of that patch was exposed in 2005 within Trench 6.

The Poston brick portion of the wall had been toothed into the Carrigan portion of the wall, but was angled 3-degrees farther toward the north (Figure 11 and 62). The eastern end of this patch was a single wythe, and the western end was two wythe. The arc of Carrigan-era brick described above was mortared to the top of this section of the wall (Figures 55 and 56). Overall, this section displayed sloppy workmanship.

This entire foundation wall had a two-inch spread footing on the interior side (Figure 62). The two footing bricks at the east end of the wall below the original Carrigan section had been replaced with later bricks. The top of the footing lay at an elevation of 593.56 ft, which was approximately 5-6 inches deeper than the footing in the back addition.

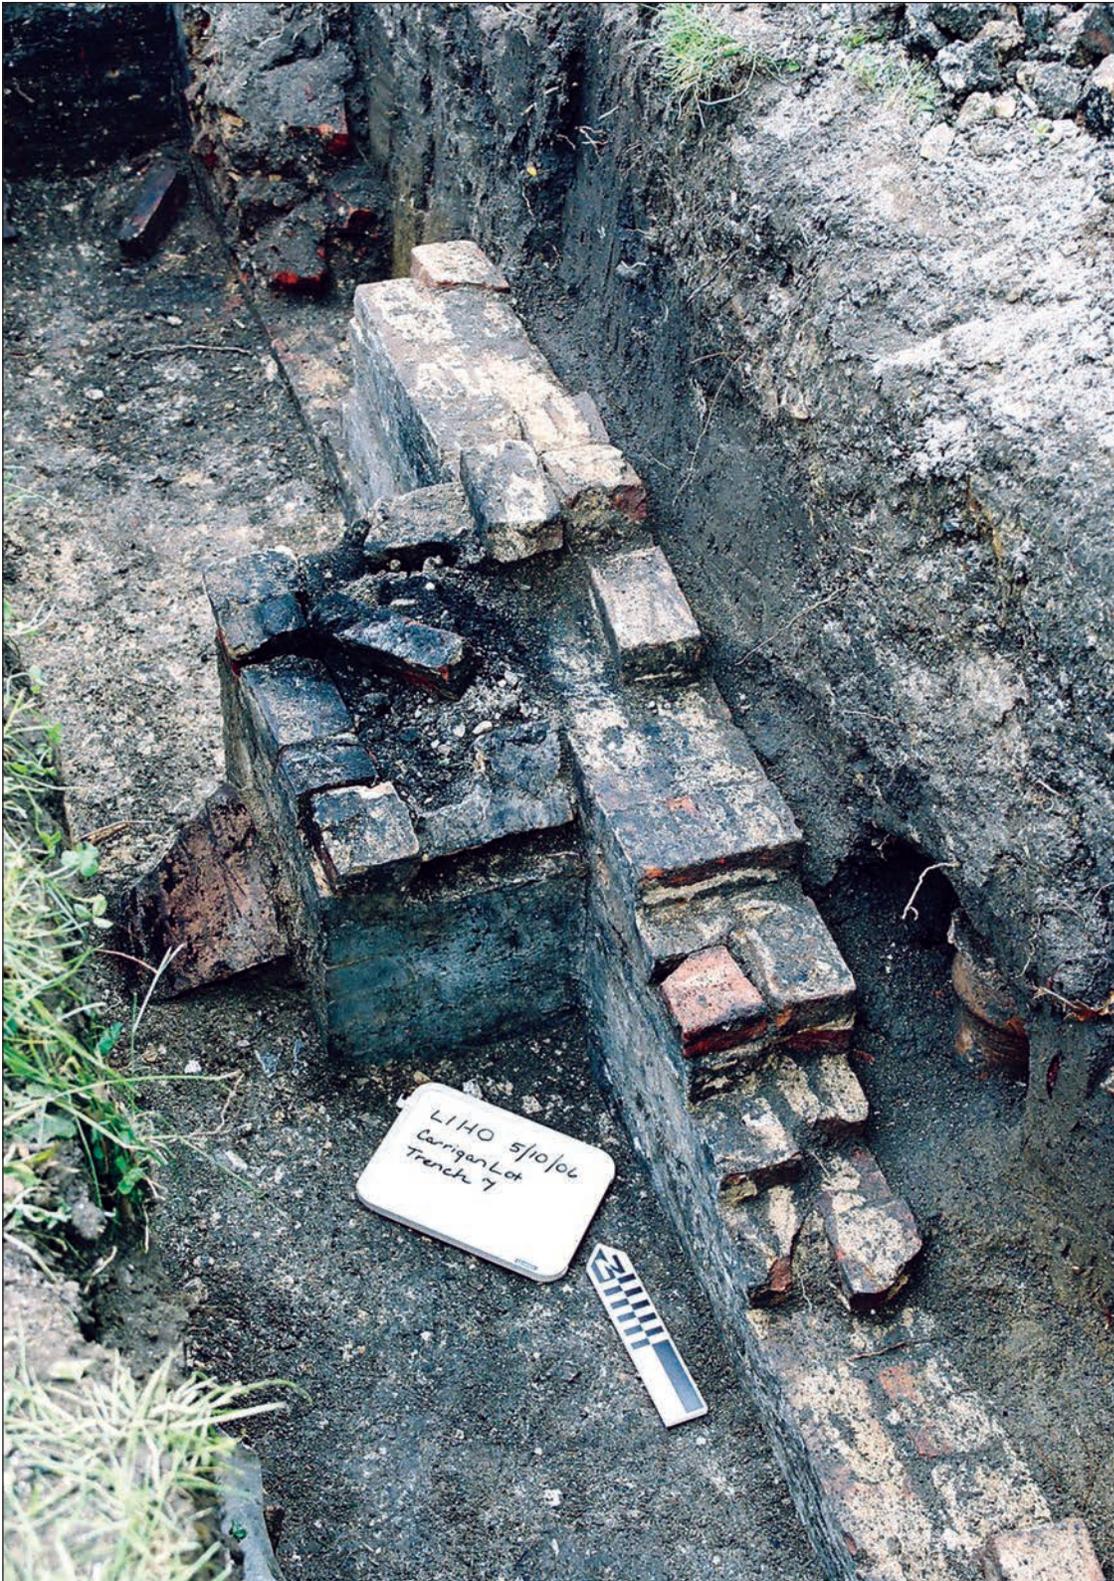
Figure 63. Carrigan lot, Trench 7, view northeast to the remains of the back (east) wall of the back addition to the Carrigan house, and the base of an early Irwin house chimney stack when first exposed.

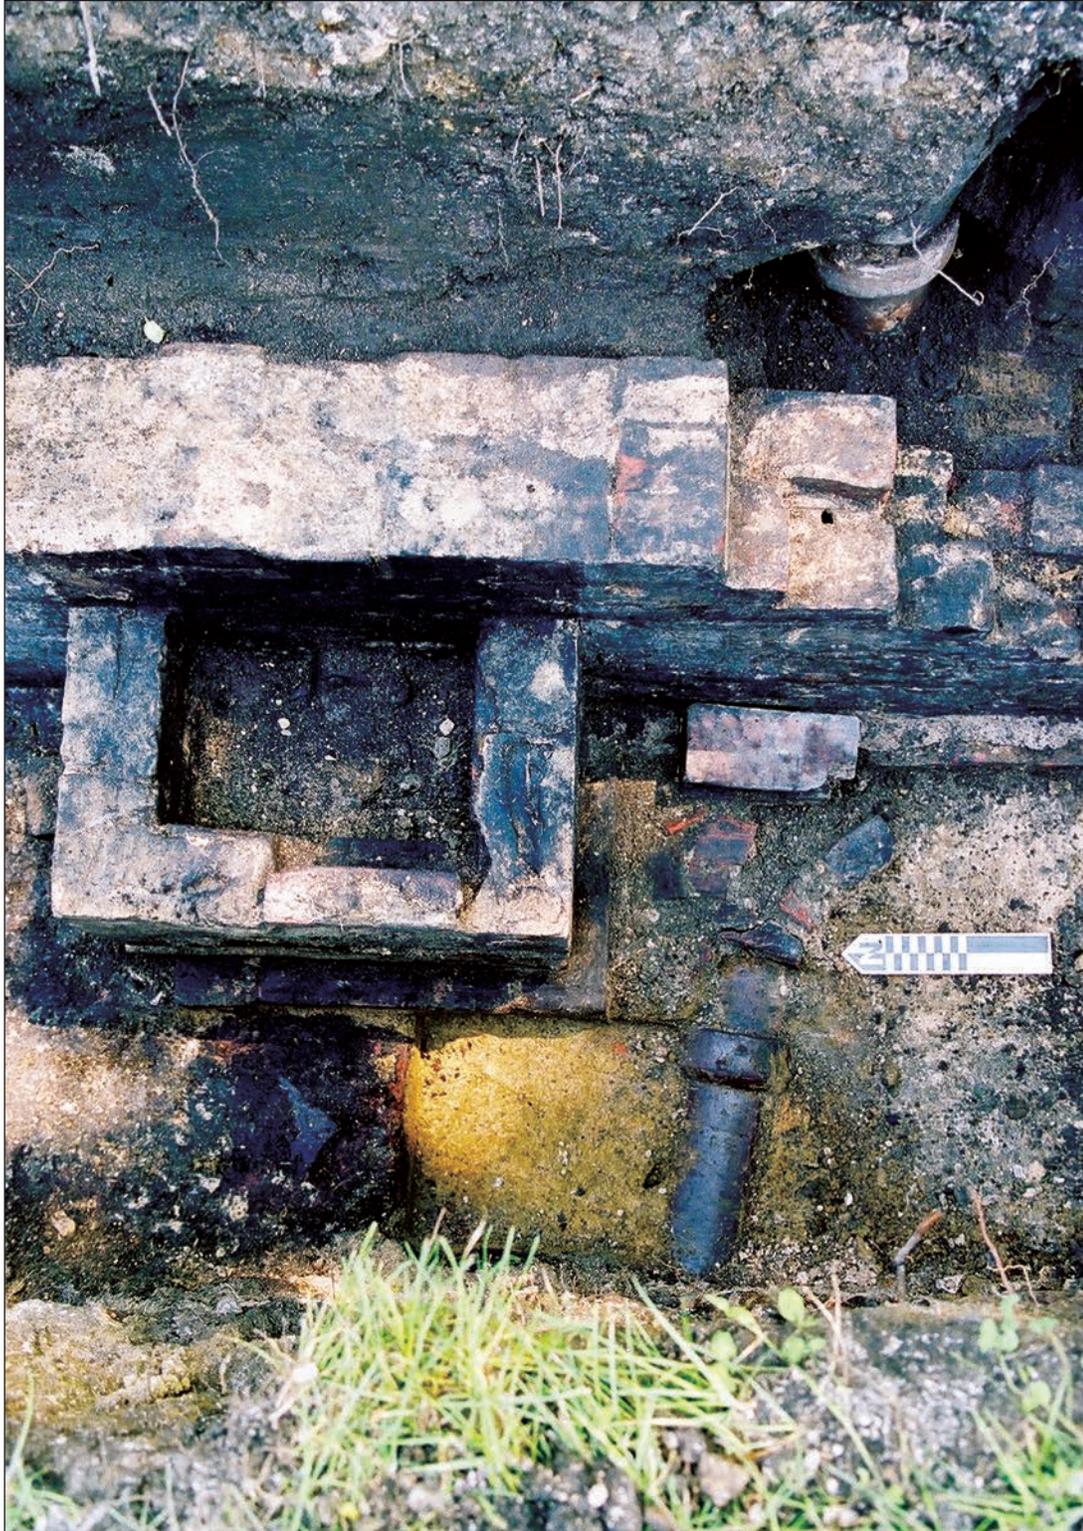
Figure 64. Carrigan lot, Trench 7, remains of the back (east) wall of the back addition to the Carrigan house, the base of an early Irwin house chimney stack after three courses were removed (sleeper brick in west wall may have served as cleanout port), stoneware drain tile extending from the cistern (vertical section outside the wall at upper right, and horizontal section set below cellar floor at lower right), and pressed brick atop displaced footing.

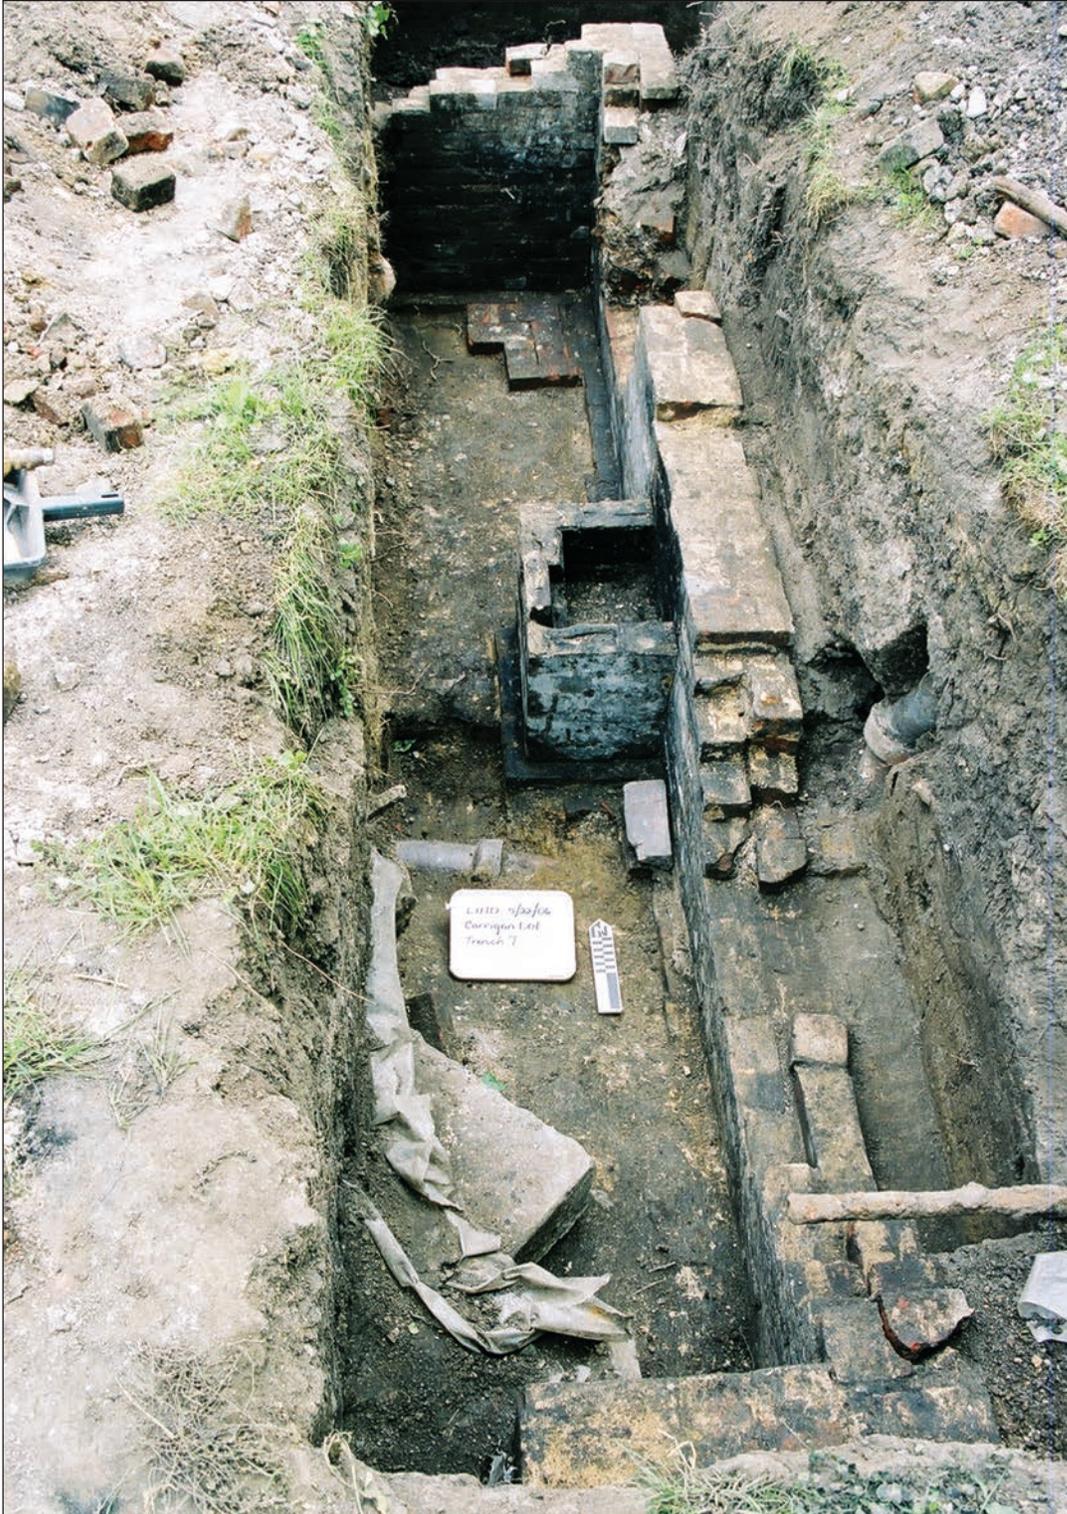
Figure 65. Carrigan lot, Trench 7, view north to the remains of the back (east) wall of the back addition to the Carrigan house (northeast corner at top of photo, east cellar entry jamb at bottom center), the base of an early Irwin house chimney stack, stoneware drain tile extending from the cistern, steel pipe from the cistern, partially exposed dressed stone in cellar fill, and brick support pad at northeast corner of cellar floor.

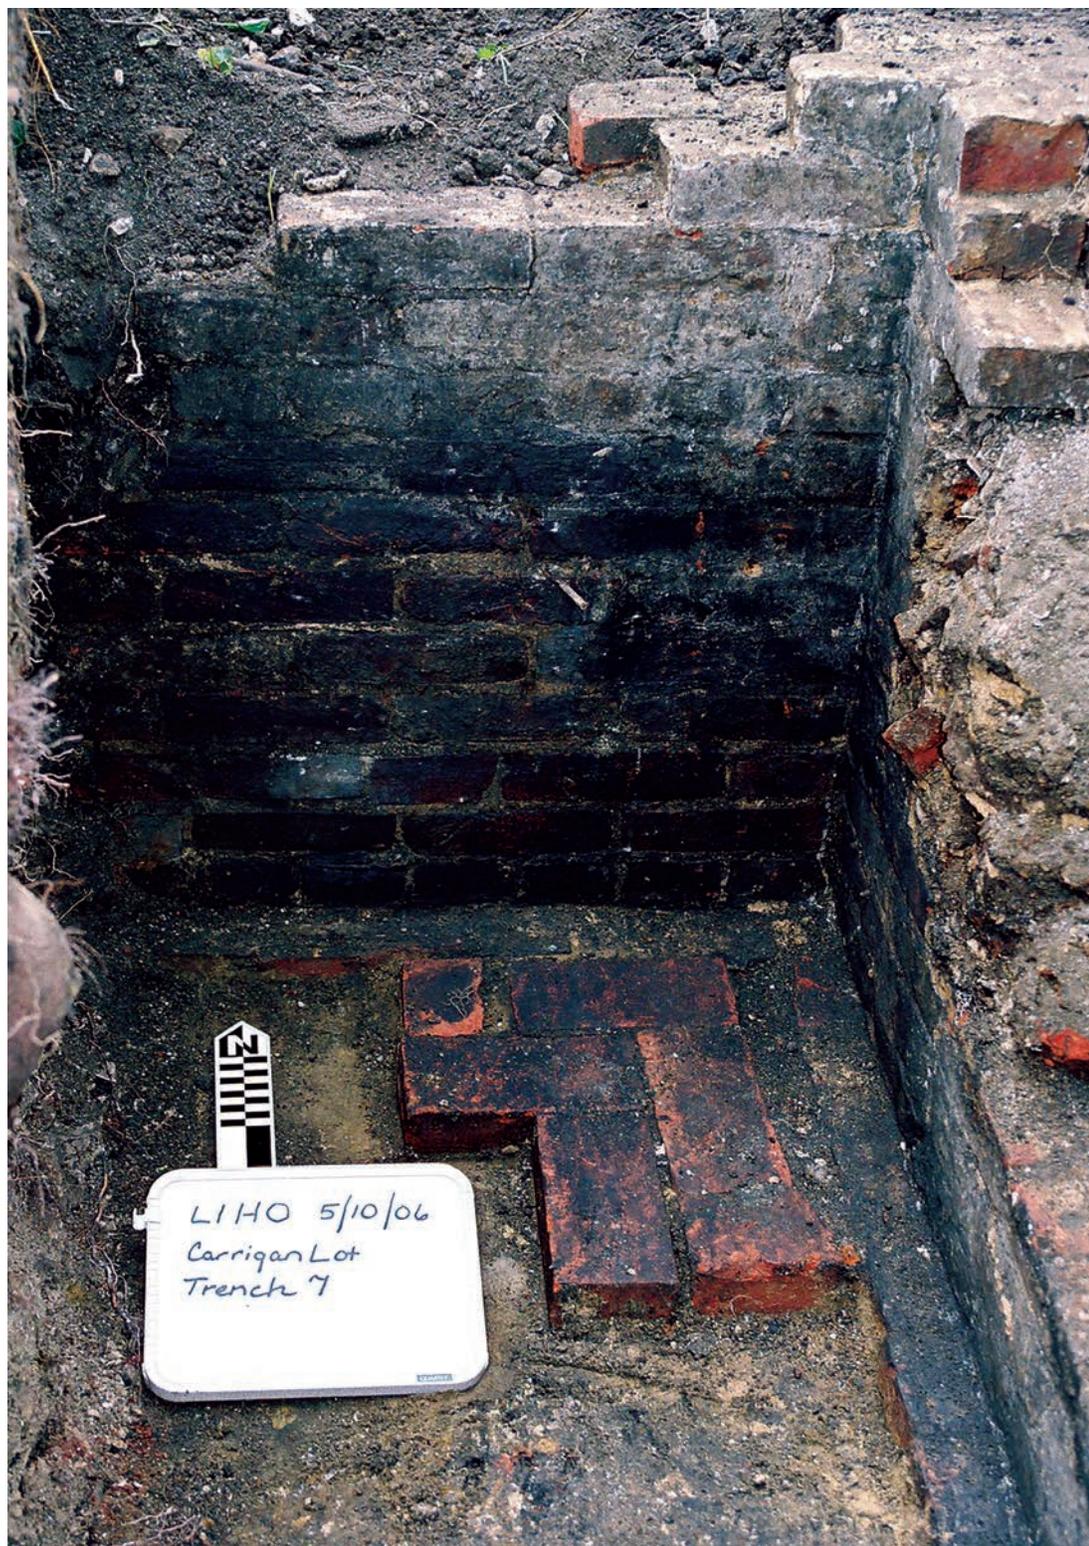
Figure 66. Carrigan lot, Trench 7, brick support pad at the northeast corner of the back cellar floor.

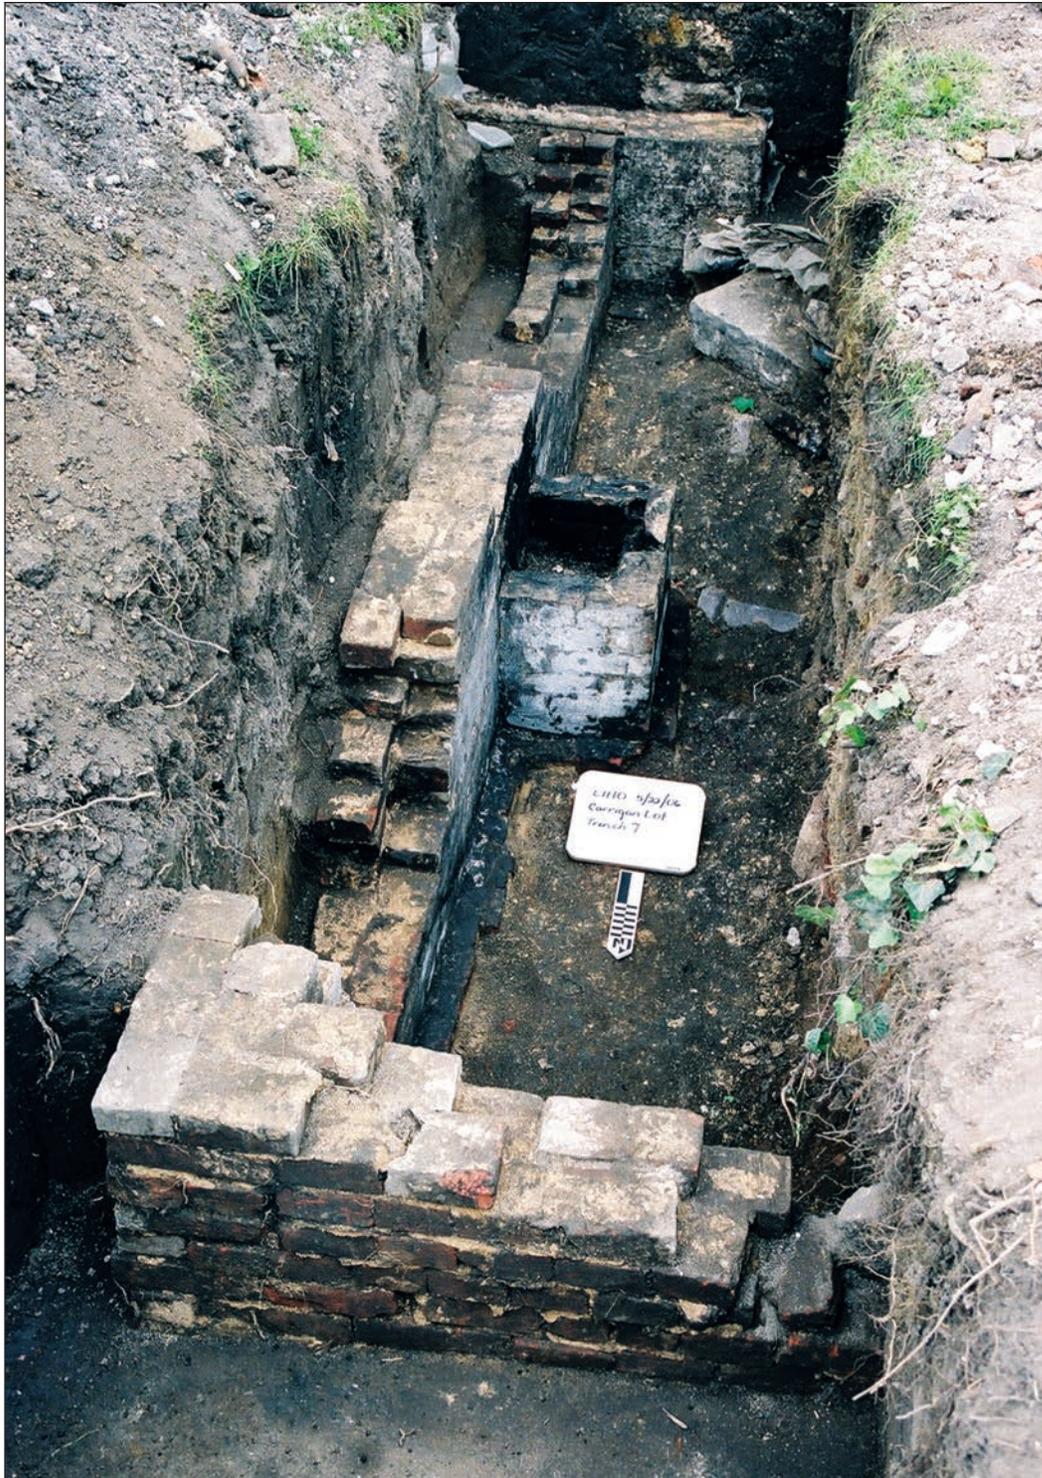
Figure 67. Carrigan lot, Trench 7, view south to the remains of the back (east) wall of the back addition to the Carrigan house (northeast corner at lower left, southeast corner at top center, and east cellar entry jamb at top right), the base of an early Irwin house chimney stack, stoneware drain tile under the cellar floor, steel pipe from the cistern, and partially exposed dressed stone in cellar fill.

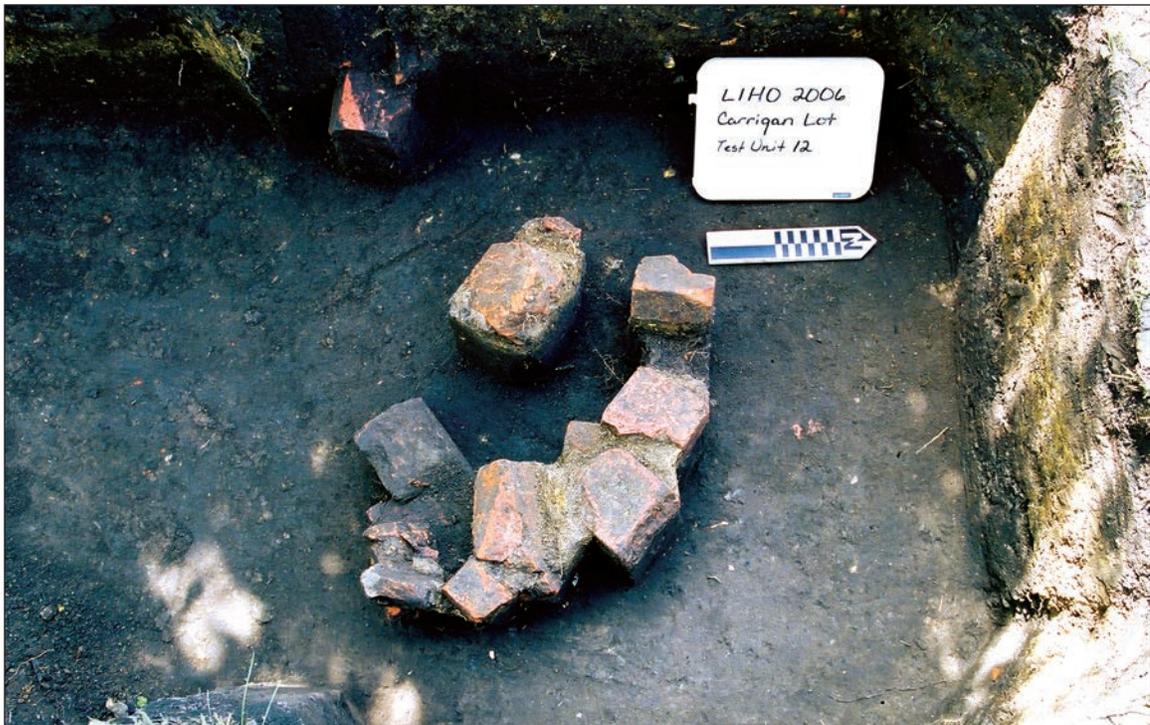
Figure 68. Carrigan lot, Test Unit 12, North Extension, view west to an irregular cluster of brick fragments exposed at the projected location of the northwest corner of the small Carrigan outbuilding that stood along the north lot line.

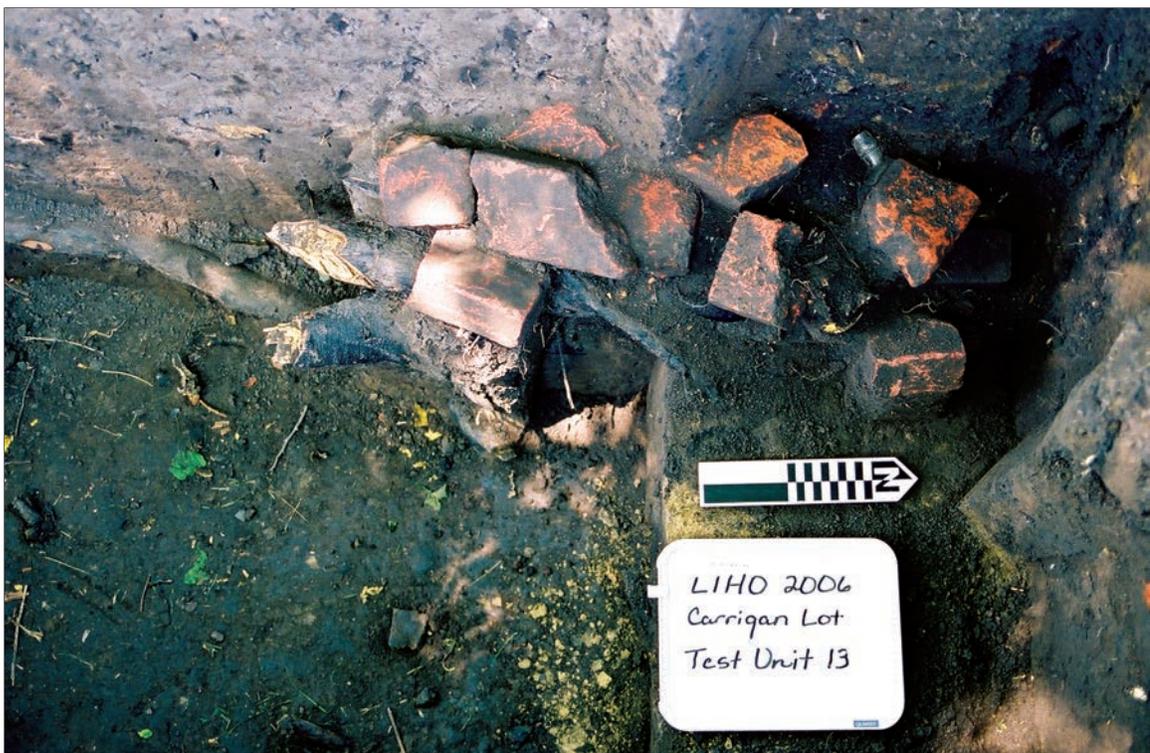
Figure 69. Carrigan lot, Test Unit 13, view west to a jumble of brick fragments identified fairly near the projected location of the northeast corner of the small Carrigan outbuilding that stood along the north lot line. Part of the neck and finish of a glass shoofly flask are visible extending from beneath a brick fragment in the upper right of the photo. The flask likely dates after 1880.

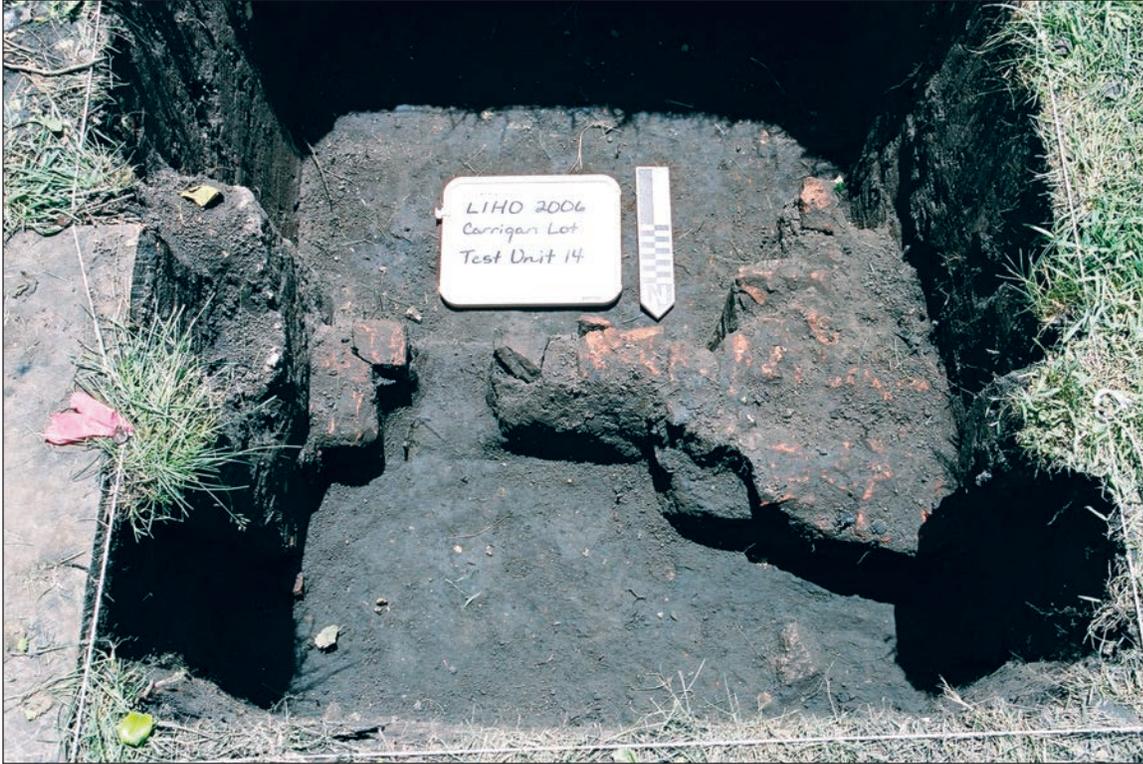
Figure 70. Carrigan lot, Test Unit 14, view south to a partial alignment of brick fragments exposed near the projected location of the northwest corner of the Carrigan era barn. A wooden step outside the modern building at the rear of the property is visible at the left.

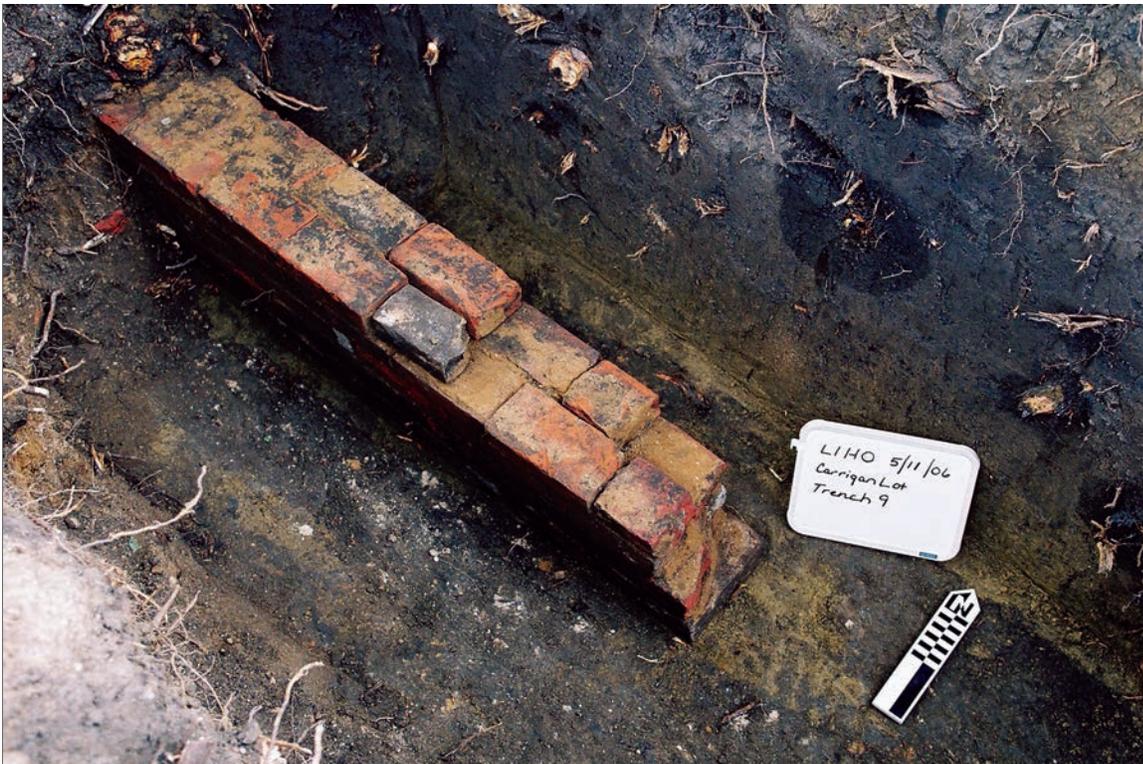
Figure 71. Carrigan lot, Trench 9, remains of the north foundation wall for the front section of the Carrigan house.

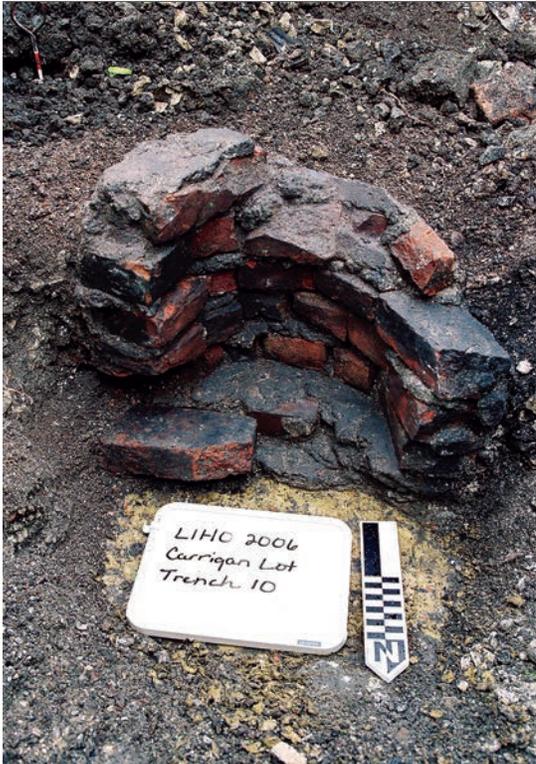
Figure 72. Carrigan lot, Trench 10, small partial ring of brick standing on a brick pad that is thought to represent a furnace-related feature of the Irwin house.

The feature itself had been constructed on a level clay floor and was composed of hard-fired brick and mortar (Figure 72). Five courses of brick were represented in the partial ring. The top of the brick base lay at an elevation of 593.59 ft, very similar in depth to the top of the brick footing for the north foundation wall of the ell exposed in Trench 8 (593.56 ft), both of which were probably set directly on the clay floor of the same cellar space. Large chunks of coal were also observed in the rubble fill immediately around the feature.

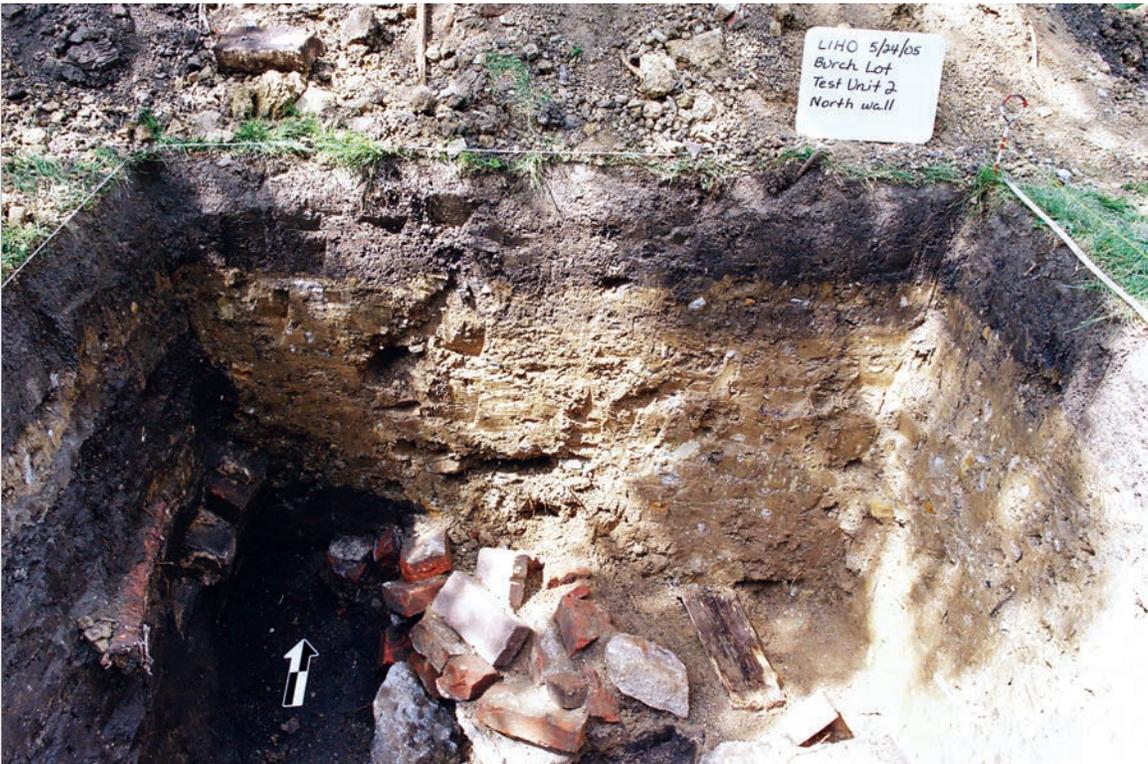
Figure 73. Burch lot, Test Unit 2, north unit wall profile showing yellow brown clay fill beneath the topsoil and sloping up to the west (left in photo). Remnants of a brick cistern cap are visible at lower left beneath a large tree root, with black cistern fill below. The pile of bricks at the bottom center of photo lie atop more cistern fill.

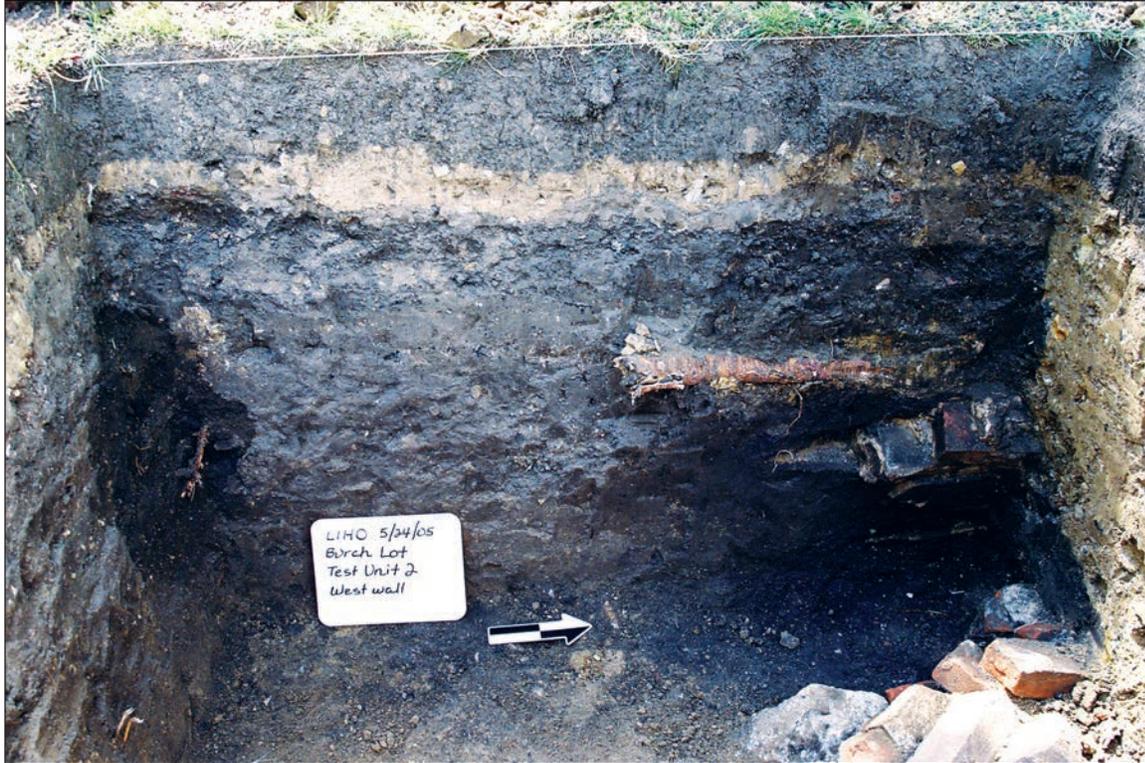
Figure 74. Burch lot, Test Unit 2, west unit wall profile showing the thin layer of yellow brown clay fill beneath the topsoil with brown silt loam below. Remnants of a brick cistern cap, mortar lining, and black cistern fill are at lower right in photo.

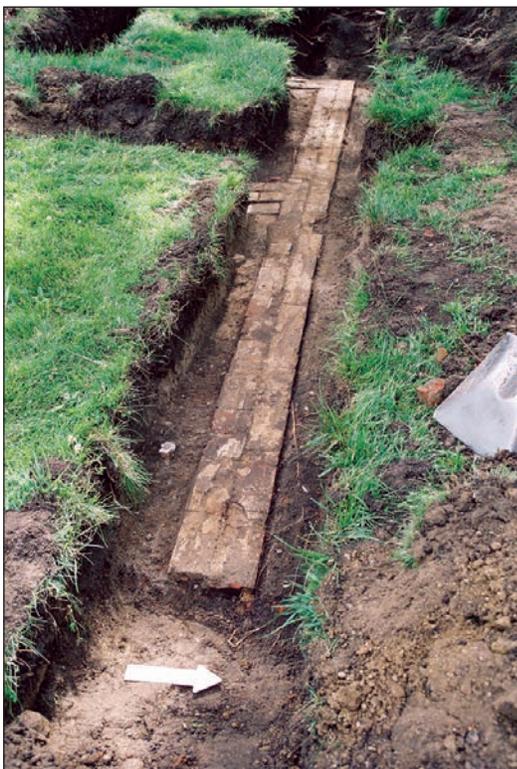
Figure 75. Burch lot, Trench 6, view southwest to remains of the north foundation of the Burch house with the northwest corner of the house at top center in photo.

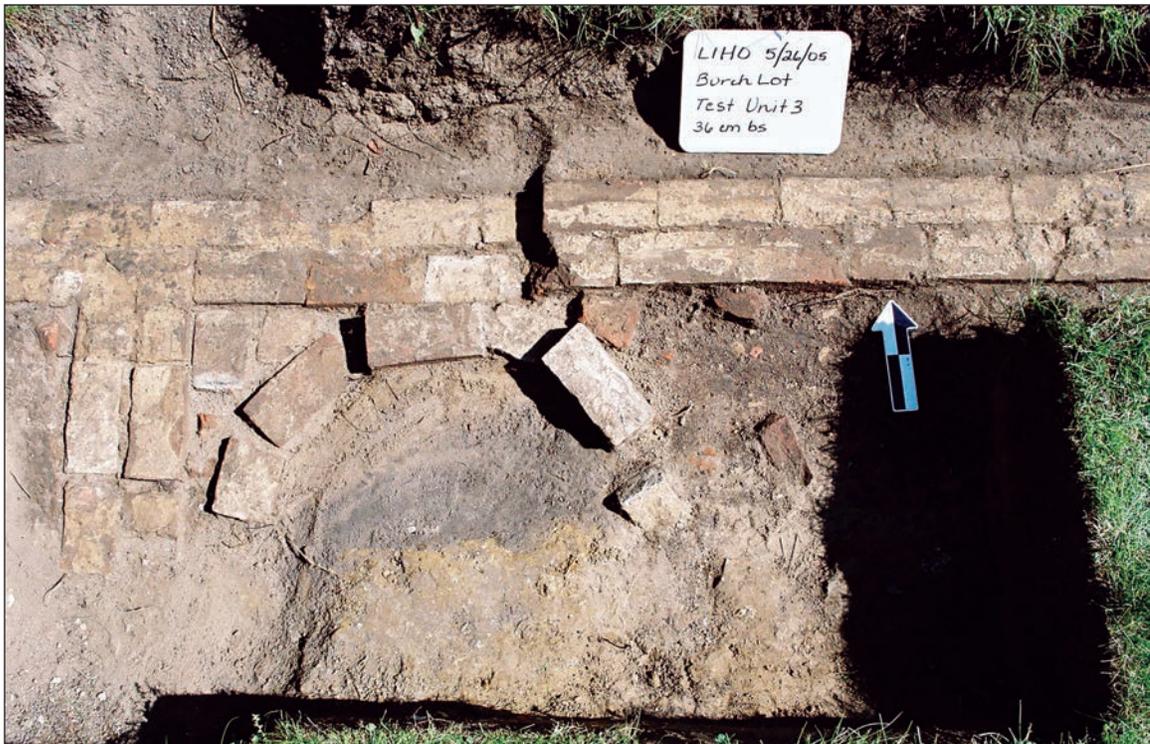
Figure 76. Burch lot, Test Unit 3, view north to the remains of an interior well along the north wall of the Burch house foundation. An interior wall of the house is immediately west (left) of the well. The small spaces between the walls and the well structure were filled with additional bricks. A marked soil change extended roughly east-west across the unit along the south edge of the well feature.

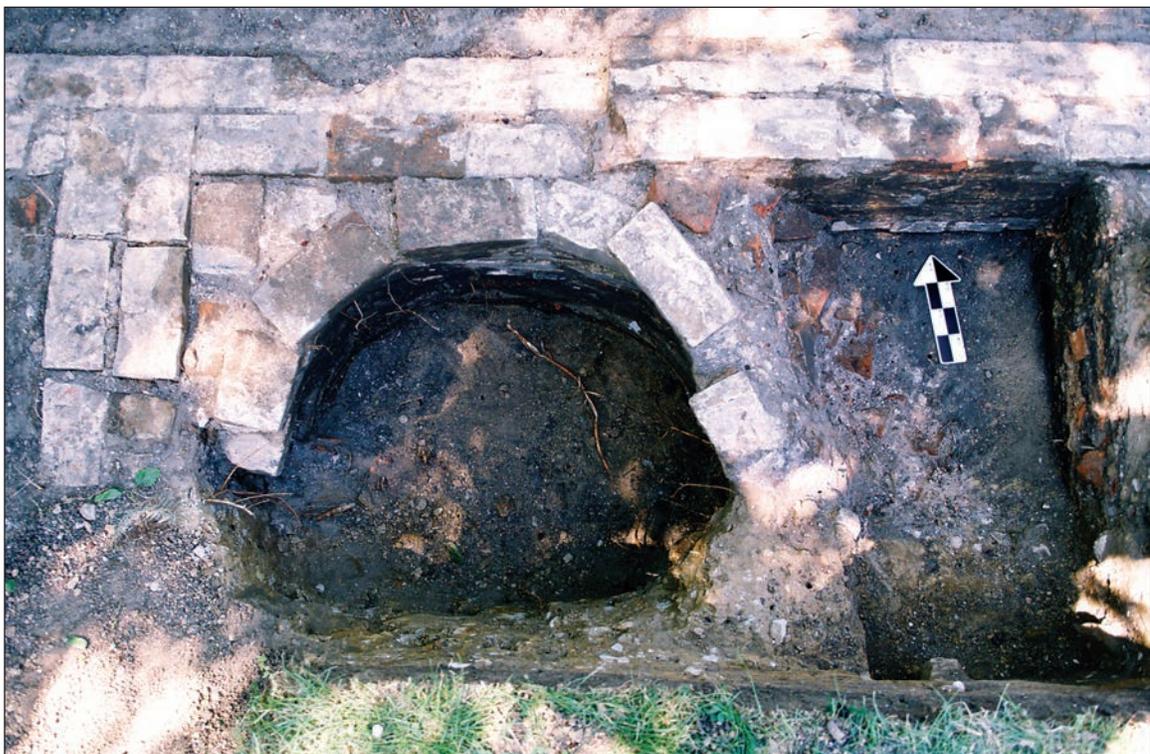
Figure 77. Burch lot, Test Unit 3, view north to the remains of the interior well along the north wall of the Burch house foundation after partial excavation.
