ARCHEOLOGICAL INVENTORY AND EVALUATION AT THE CARRIGAN AND BURCH PROPERTIES, LINCOLN HOME NATIONAL HISTORIC SITE, SPRINGFIELD ILLINOIS

BY
JANIS L. DIAL-JONES

Midwest Archeological Center
Technical Report 125

NATIONAL PARK SERVICE
Midwest Archeological Center

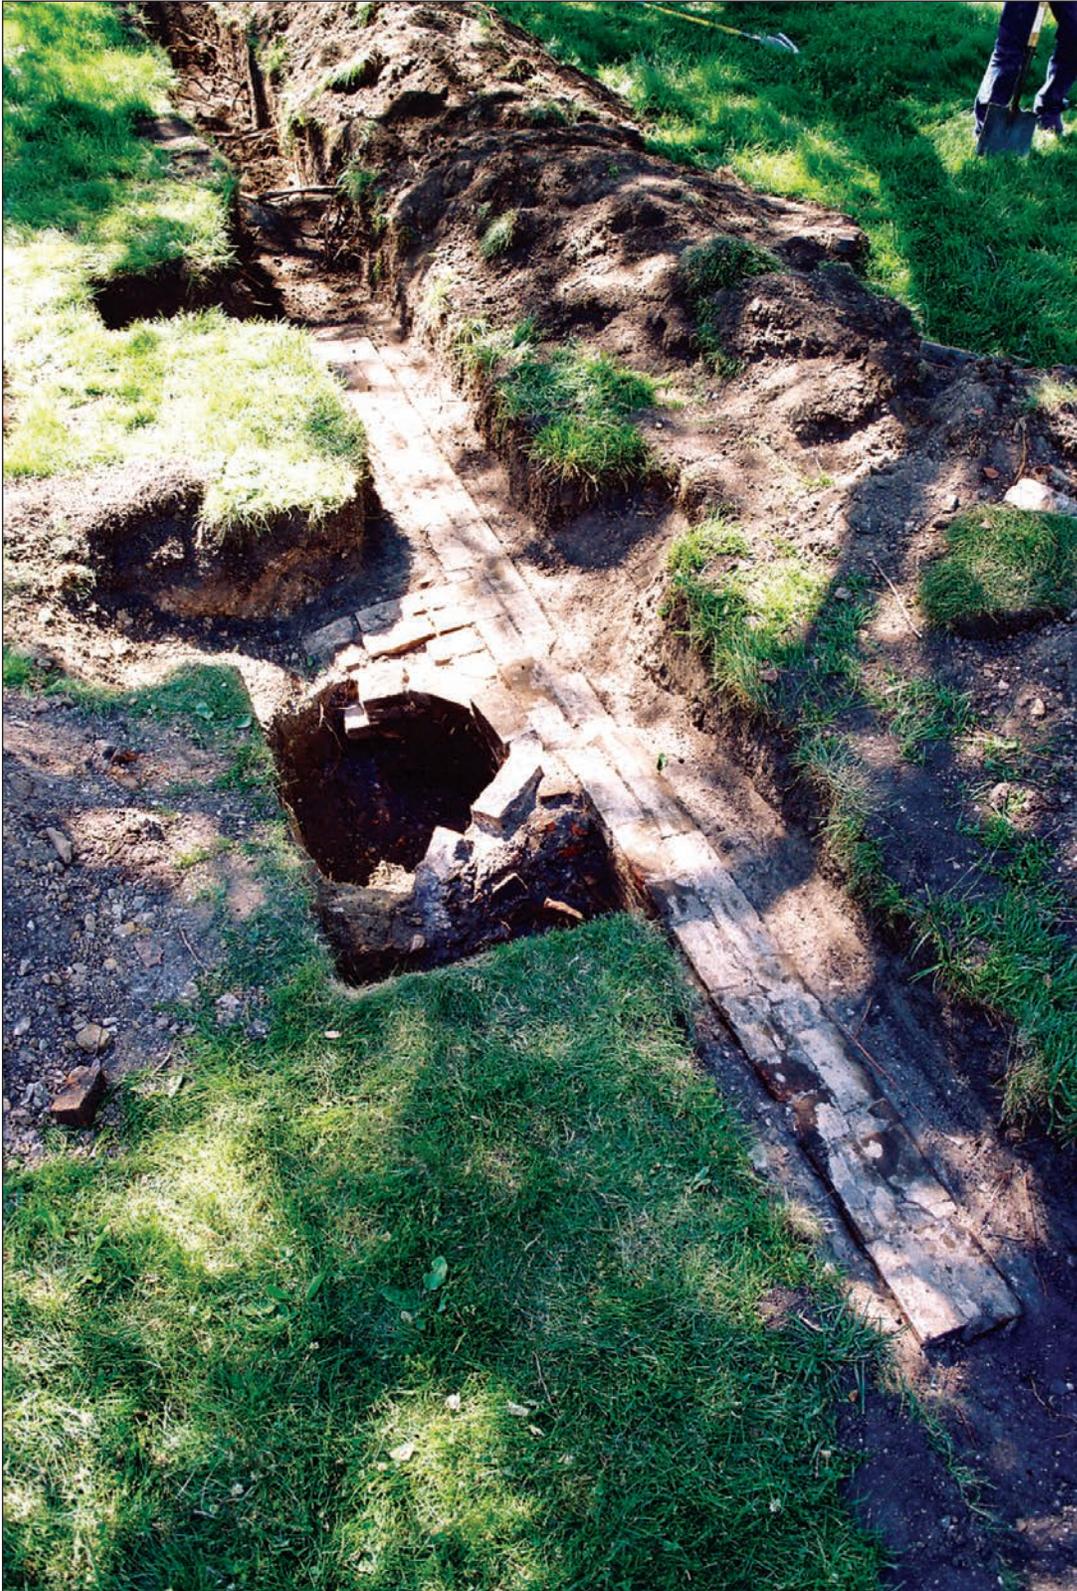
Figure 78. Burch lot, Trench 6 and Test Unit 3, view northwest to remains of the north foundation of the Burch house, an interior wall intersection with the north foundation, and an interior well.

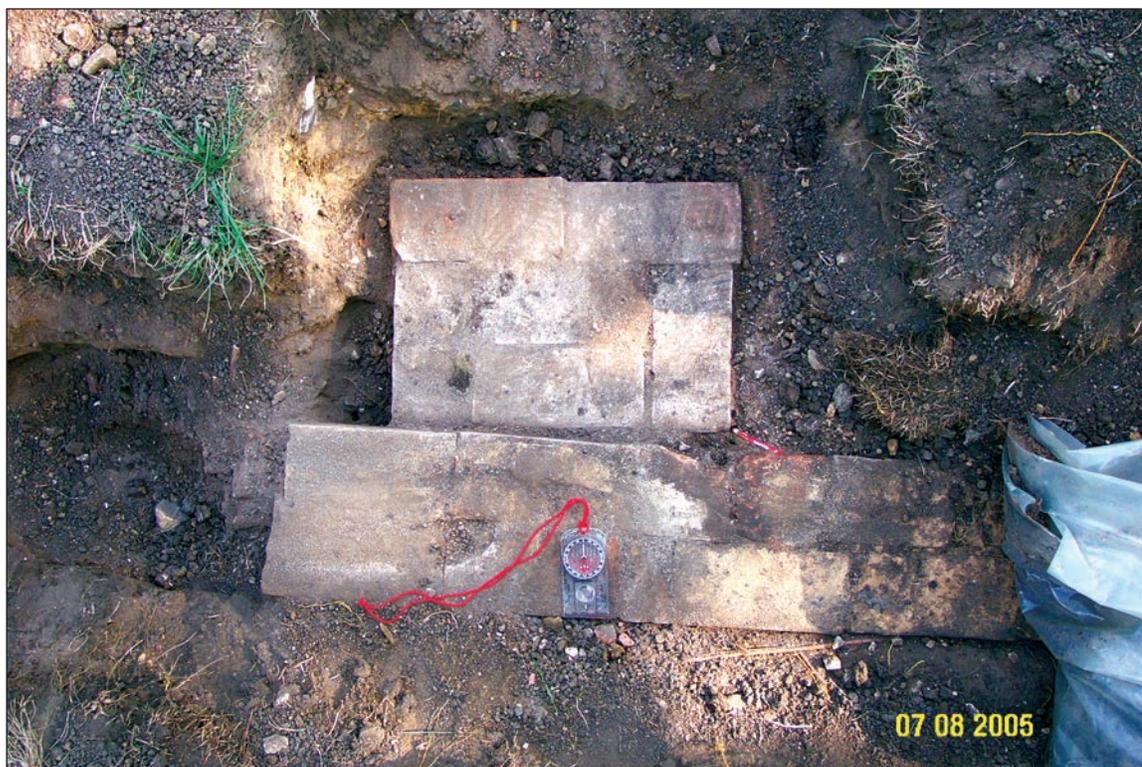
Figure 79. Burch lot, east end of Trench 6, view south to a probable chimney base along the interior face of the north foundation of the Burch house.

The excavation of Trench 6 was begun along the north lot line in the area of a ground penetrating radar anomaly at geophysical survey grid coordinates 11-13N, 26E (DeVore 2005:36 Figure 24). An intact section of the Burch house foundation was identified at that location at a depth of only 31 cm below the present ground surface, so that the trench was extended to both the east and west to continue exposing the foundation (Figures 24 and 25). Since this discovery was made late in the afternoon on the second-to-last day of the project in May 2005, very little time remained to investigate it. Only the top of the foundation was exposed for most of its length, which was sufficient to identify the northwest corner at the back of the house, one interior wall intersection, and part of an interior brick-lined well that butted against the north foundation wall immediately east of that wall intersection (Figures 75-78). Test Unit 3 was opened to investigate the well and measured 1 m north-south x 1.6 m east-west. In July 2005, a probable chimney base was also discovered along the foundation while the author and O'Bright were collecting a brick sample (Figure 79). The layout of those

Probable chimney base – A brick footing pad was identified along the interior face of the north foundation wall that probably served as the base for a chimney (Figure 79). The pad measured 12 ¼ inches north-south x 16 ½-17 inches east-west. While it

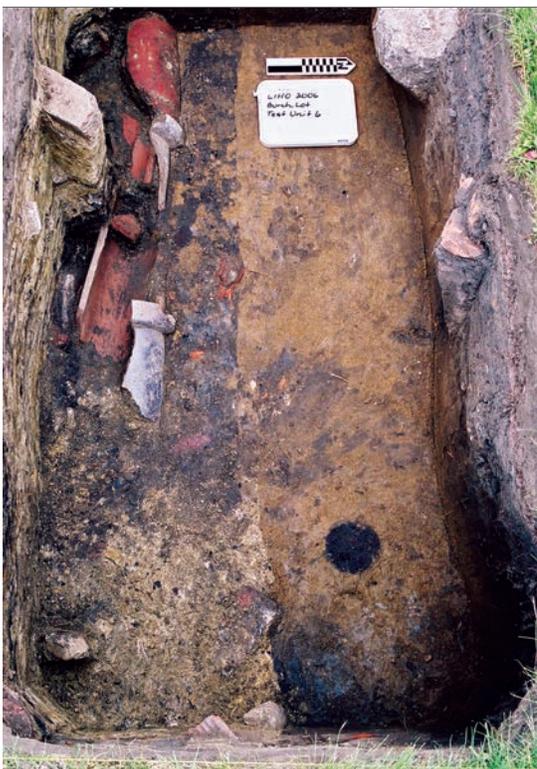
Figure 83. Burch lot, Test Unit 6, east unit wall profile showing yellow and white clay fill in the area where a twentieth century apartment building stood. The base of a post hole stain is also visible in the floor of the unit (lower left in photo).

The topsoil within Test Unit 6 was variable in depth and extended 20-45 cm below the present ground surface. An irregular band of yellow and white clay was first exposed at a depth of 35 cm below the ground surface running east-west across the unit. At 45 cm below the ground surface, fill in the southern half of the unit consisted almost entirely of yellow and white clay with a few lenses of dark soil. That clay deposit continued downward to the base of excavation in the southeast quarter of Test Unit 6 at 90 cm below the ground surface (Figure 83) and down to 58-80 cm below the ground surface in the southwest quarter of the unit. The clay deposit was thus coincident with the documented location of the apartment building (Figures 30 and 84). It would seem to represent fill that was brought to the site after the apartment house was demolished/removed in a sequence of events similar to that which apparently occurred following the demolition/removal of the commercial building on the front half of the property.
