**Archeological Investigations for the Barn Relocation
at Ulysses S. Grant National Historic Site,
St. Louis, Missouri**

By
Douglas D. Scott

Midwest Archeological Center
Technical Report No. 78

2002

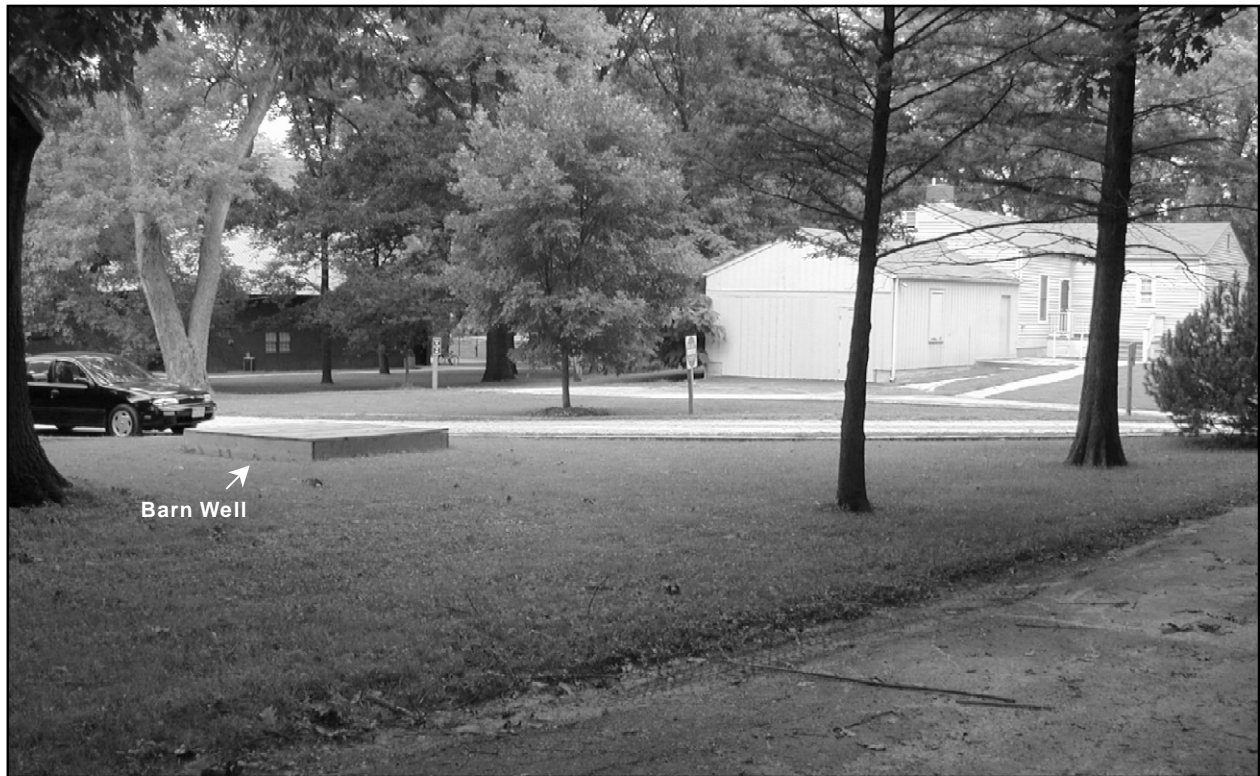
Figure 4. The proposed barn relocation site, looking architectural northwest. The Barn Well (HS-9) is in the foreground and the Cottage is in the background.

The Cottage, also known as the caretaker's house and currently serving as the park administrative headquarters (Figures 3 and 4), was constructed about 1914 (O'Bright:1999:7.7). It is a bungalow with

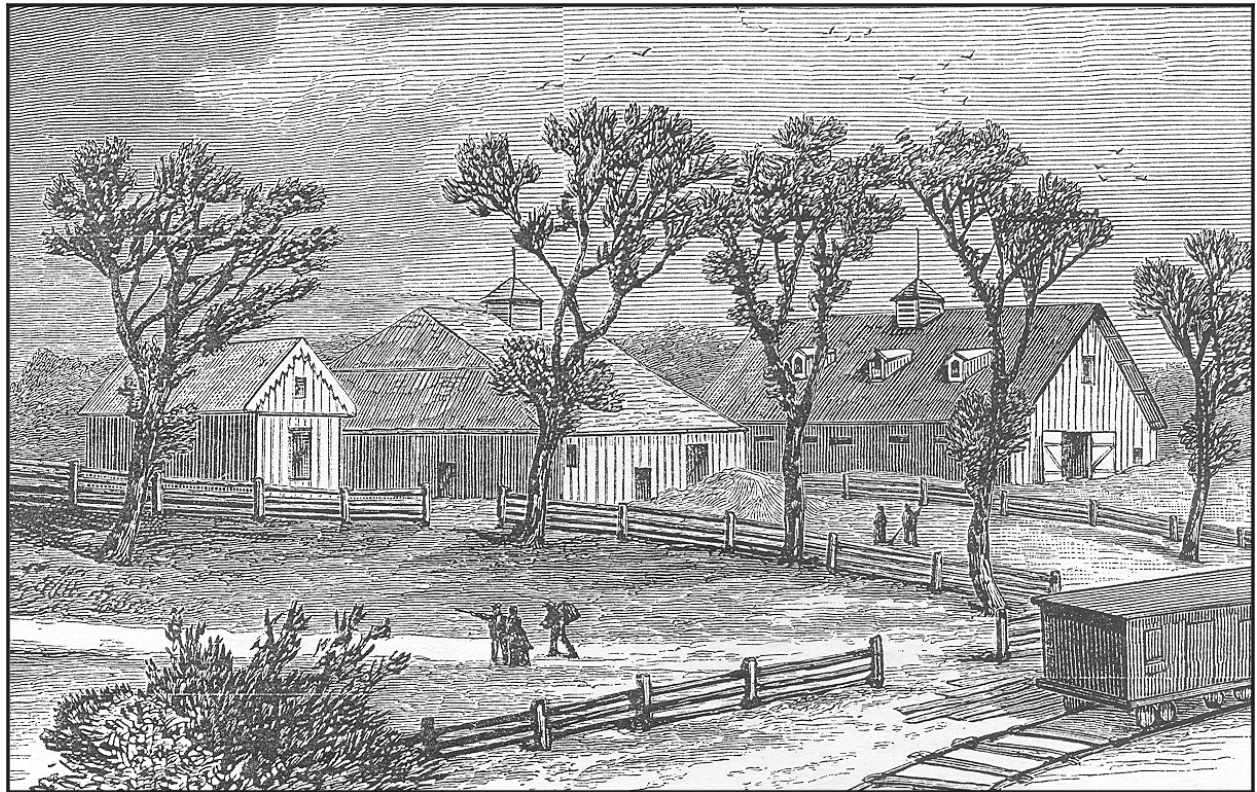
Figure 5. The October 16, 1875, issue of *Frank Leslie's Illustrated Newspaper* depicts from right to left the original location of the Grant Barn, the hipped-roof cow barn, and the shed.

The Barn (HS-3), which currently houses the visitor contact station and library, was constructed for Ulysses Grant in the late 1860s as a horse stable and barn (O'Bright 1999:4.12–4.14). The Barn (Figure 5) originally stood well south of the Cottage, near what is now a cul-de-sac. A brick-lined Barn Well (HS-9) was located nearby (Figure 3). The Barn was moved to its present location in 1962 to allow for better use of the adjacent housing development. The Barn is scheduled to be moved, once again, to a site now occupied by the Cottage. The Barn will be further adaptively restored to become the visitor contact station and interpretive center for the park.

The Cottage is believed to sit on the location of a hipped-roof cow barn. Little is known about the cow barn. Only two references to it are known, and one engraving (Figure 5) shows it as part of the background. O'Bright (1999:7.9–7.10) believes the cow barn predates construction of HS-3, the Grant Barn. The earliest known reference to the cow barn is found in an 1818 letter from Ann Lucas Hunt (O'Bright 1999:7.10) to her father "... a new hewn log Barn 26 feet by 20' with sheds all around, 14 feet wide...". The other possible reference is in an 1846 real estate sale advertisement. The advertisement mentions a large stable among the structures included on the property.

The only known depiction of the cow barn is an engraving of White Haven published on October 16, 1875, in *Frank Leslie's Illustrated Newspaper* (Figure 5). It shows a hipped-roofed structure with what may be vertical log walls. Two doors and a window are depicted on the west façade and a single door can be seen on the north façade. A cupola tops the structure's roof. The pitch of the roof and lines in the engraving suggest that the north side had shed-like extensions along that face.

The 1875 *Frank Leslie's Illustrated Newspaper* engraving shows a small building immediately north of the cow barn (Figure 5). Its function is unknown, but its configuration is very similar to the Chicken House, which may have been moved to its present location many years ago. The site of this shed is very near and most likely under the current Cottage site.

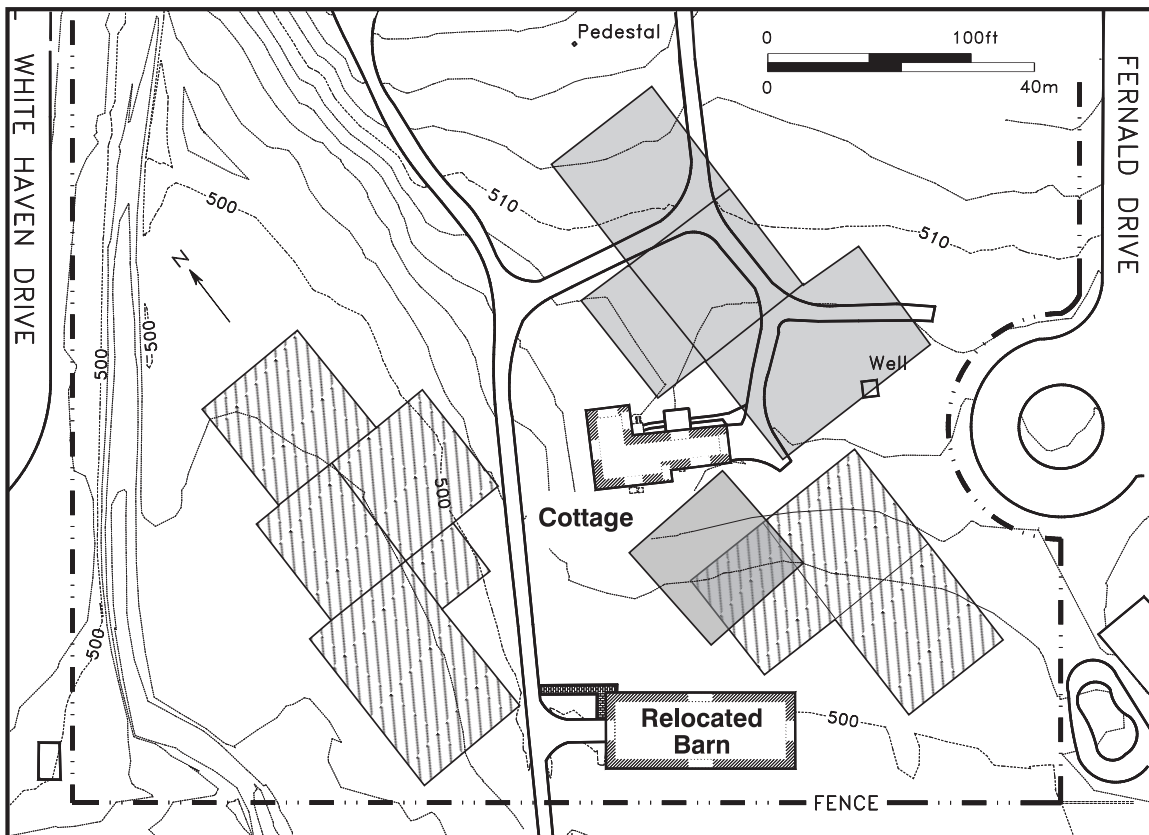
Figure 7. The 1991 remote sensing grids and shovel test grids (hatched) relative to the 2000 remote sensing and shovel test grids (shaded).

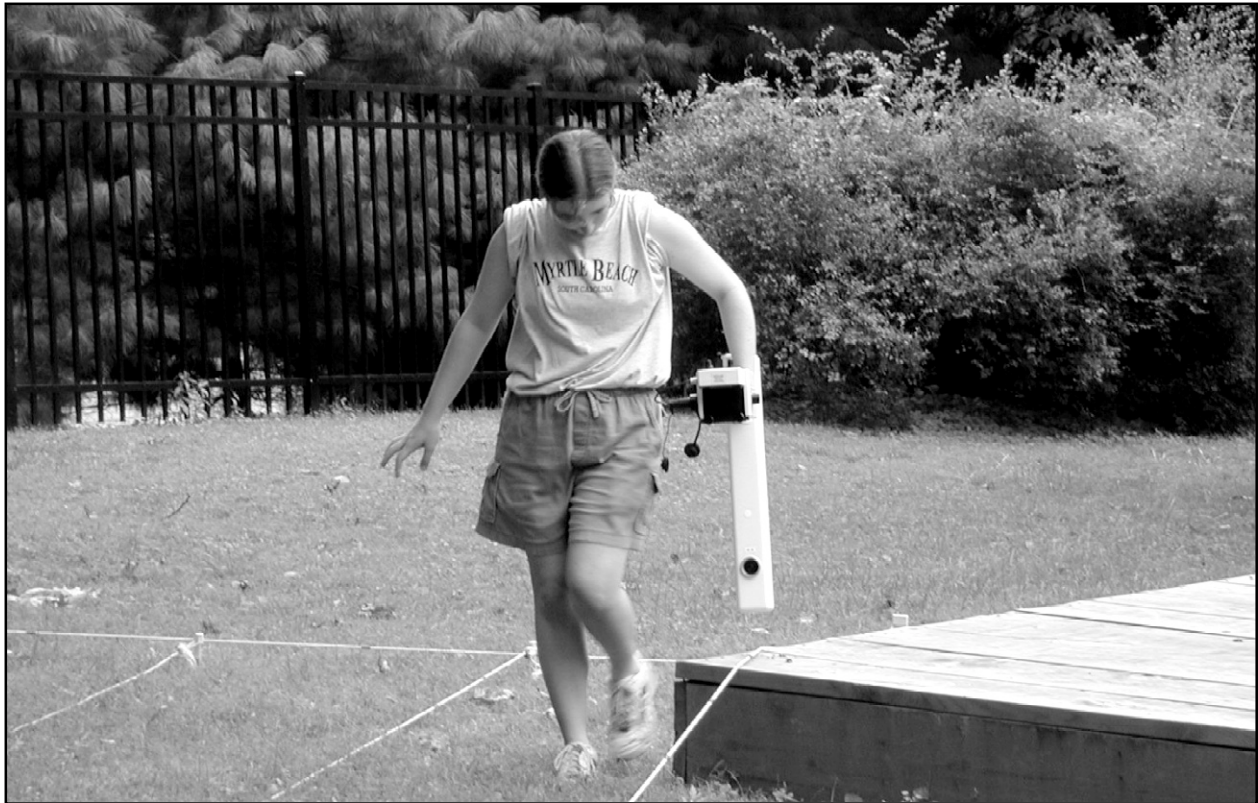
Figure 8. Anne Kern beginning a transect with the Geonics fluxgate magnetometer near the Barn Well (HS-9).

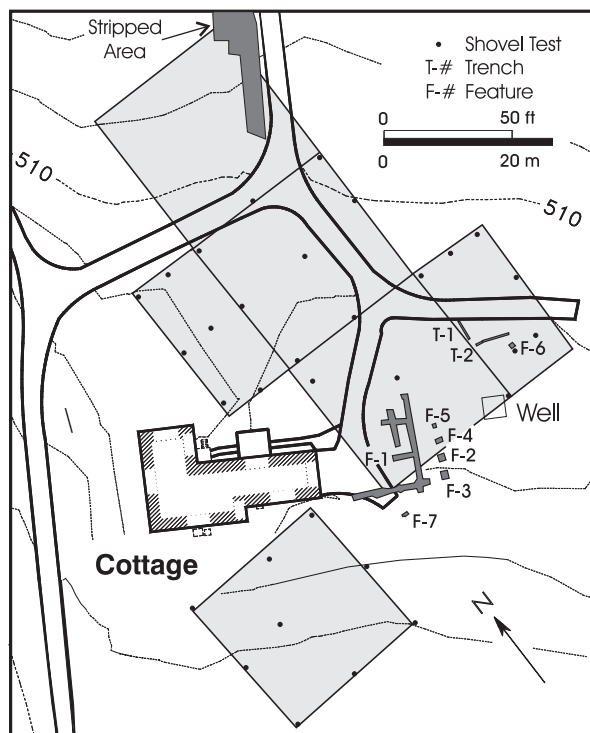
Figure 9. Locations of shovel tests, test trenches, and features in Grids 1–6.

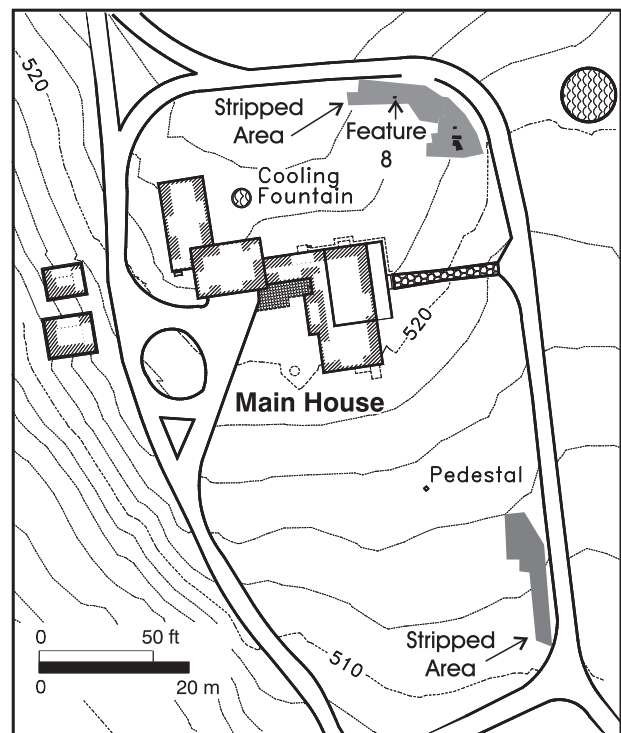
Figure 10. Areas mechanically stripped in an attempt to locate fence posts or post molds.

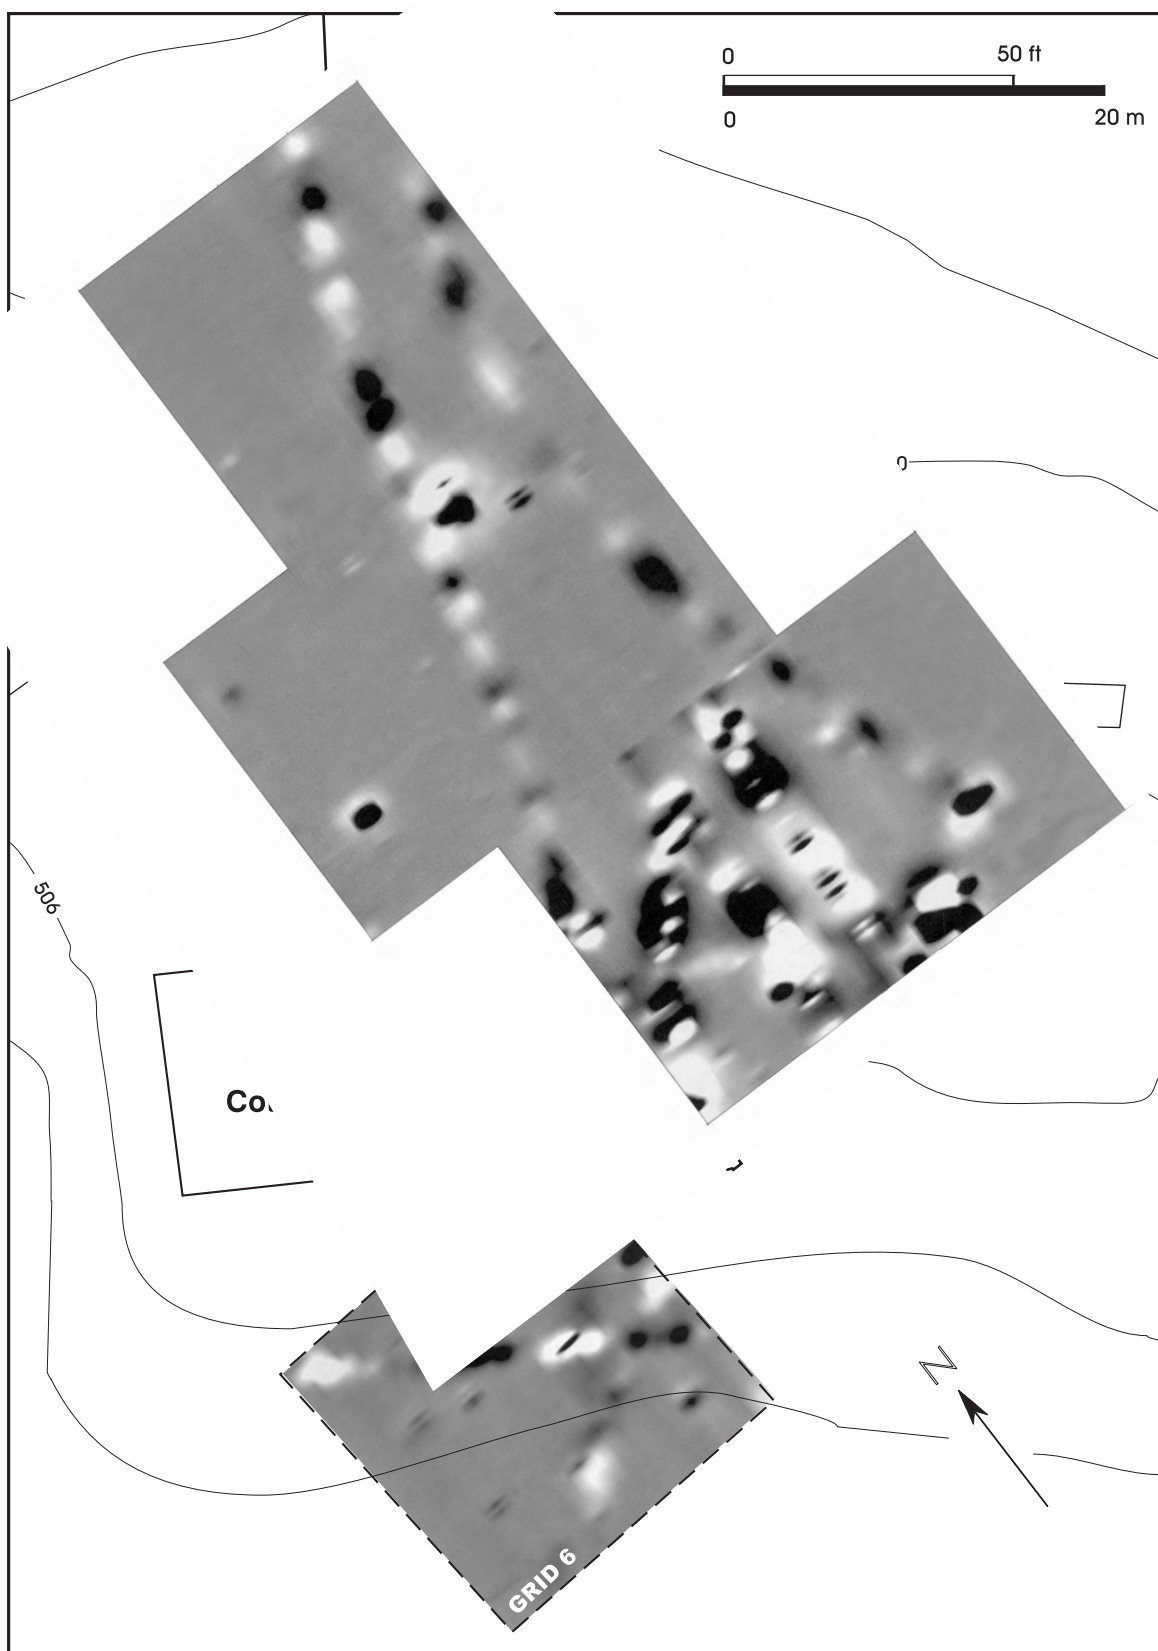
Figure 11. Magnetic anomalies in Grids 1–6 (grayscale) and current site features and roads. The intense anomalies in Grid 1 are iron rebar pins in the wood edging around the traffic island. The linear anomaly in Grids 2–4 is a modern water line, but the linear anomaly in Grid 5 is unidentified. The linear anomaly in Grid 6 is a footpath.

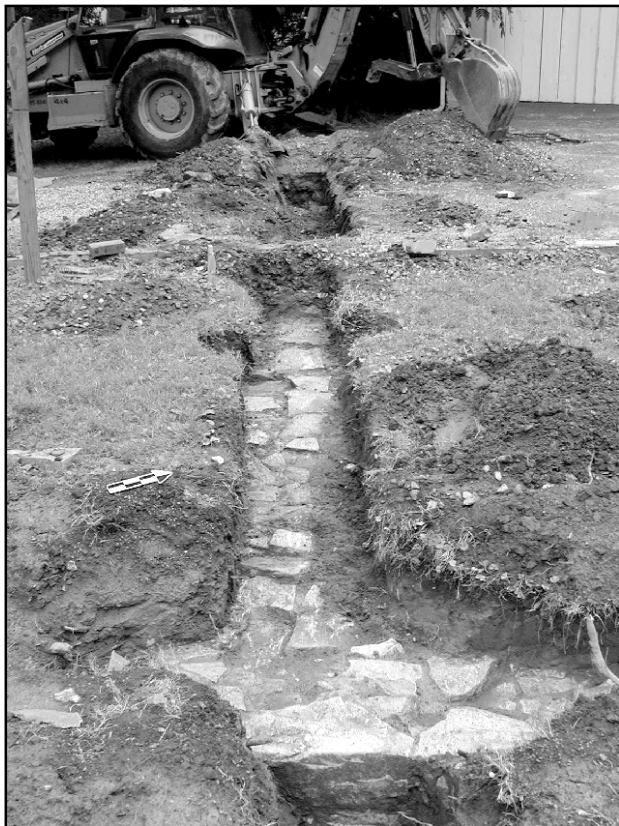
Figure 12. The west wall of Feature 1, looking architectural north; arrow points to magnetic north.

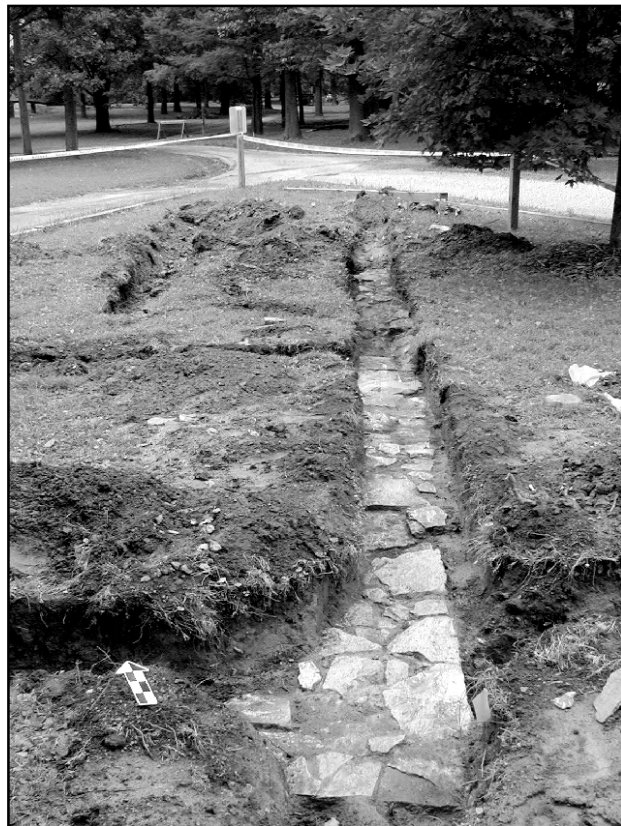
Figure 13. The south wall of Feature 1, looking architectural east; arrow points to magnetic north.

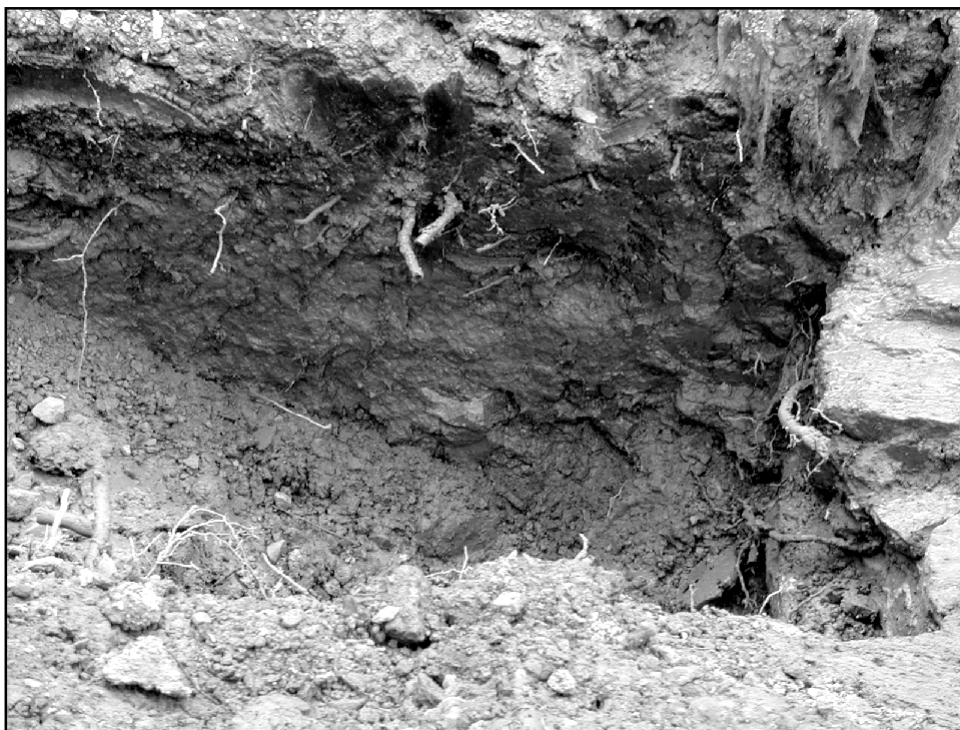
Figure 14. A 20th-century pit cut through the west wall of Feature 1, looking architectural north.

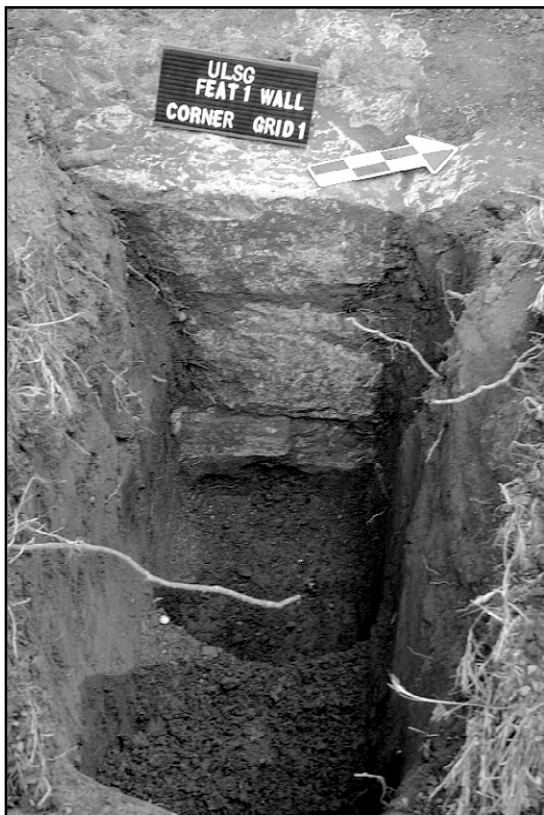
Figure 15. Remaining foundation thickness at the southwest corner of Feature 1, looking architectural north; arrow points to magnetic north.

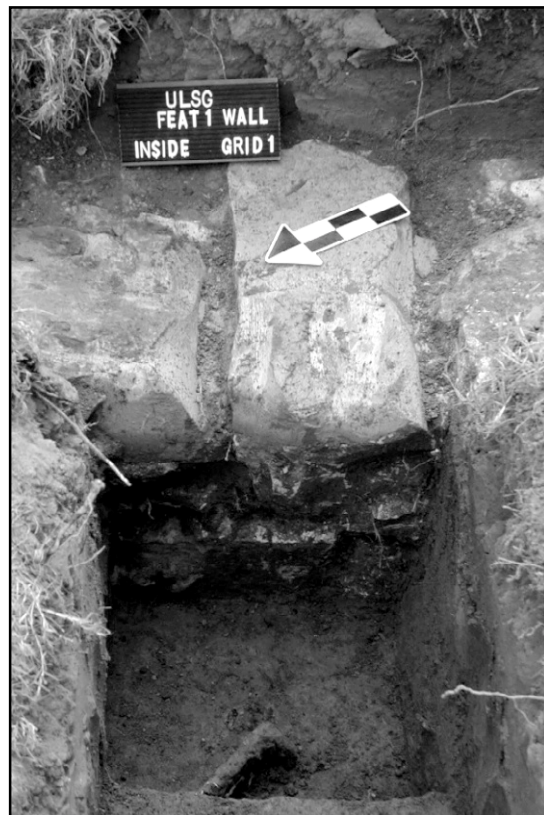
Figure 16. Remaining foundation thickness of Feature 1 on the interior of the south wall, looking architectural south; arrow points to magnetic north.

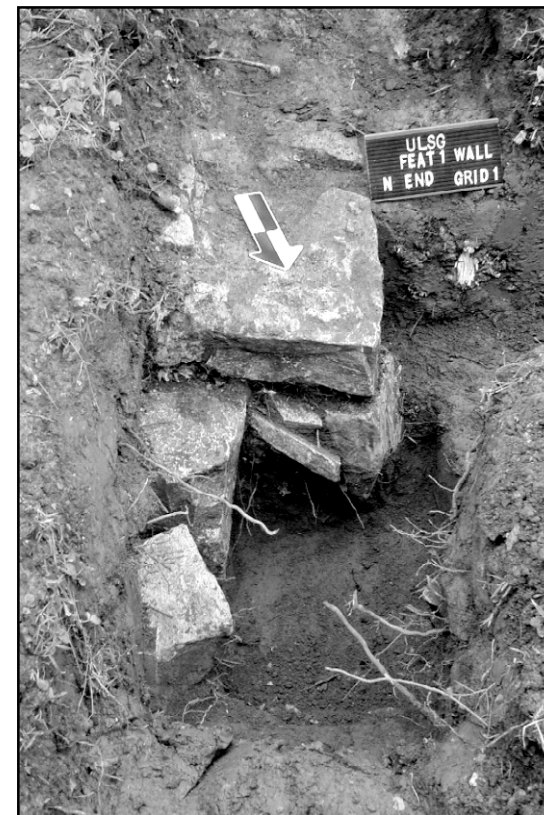
Figure 17. The broken foundation wall of Feature 1 at its eastern end, looking architectural west; arrow points to magnetic north.

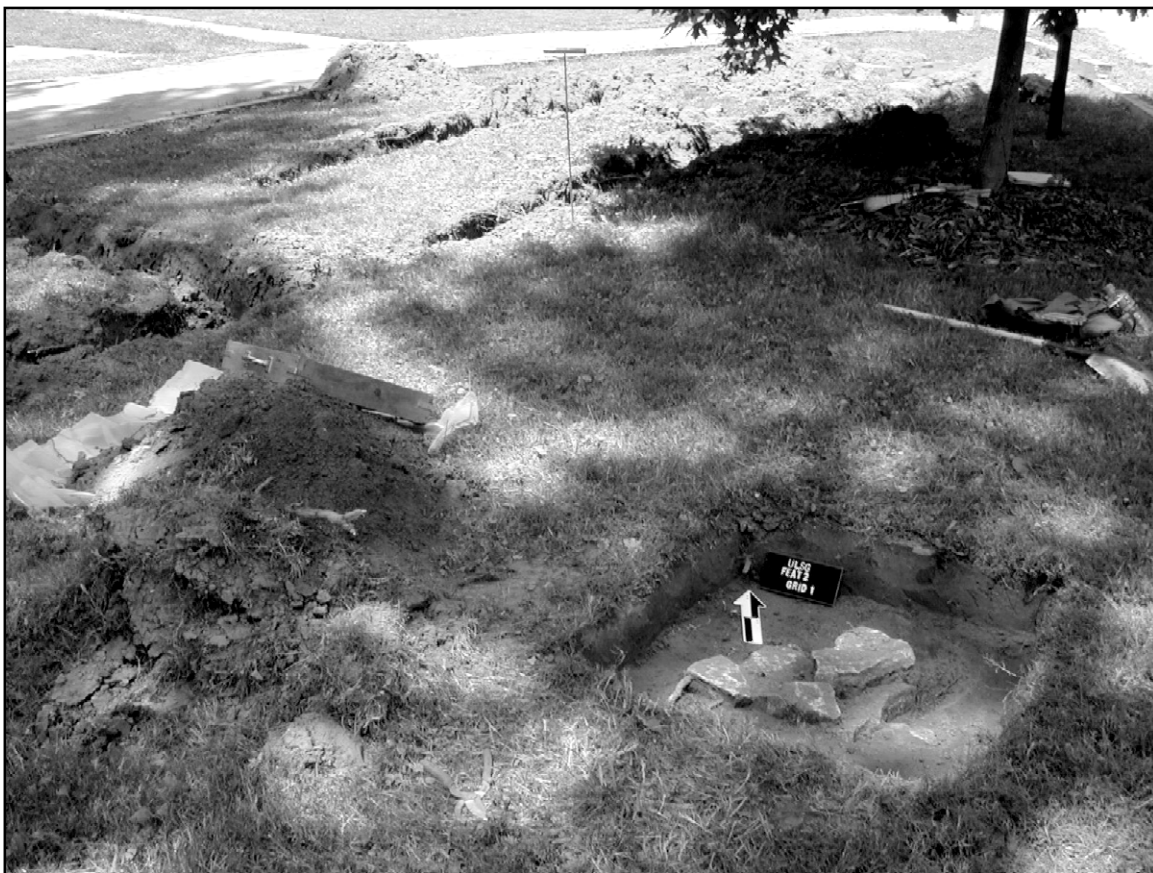
Figure 18. Feature 2, the footings or pier to a structure associated with Feature 1, looking architectural east; arrow points to magnetic north.

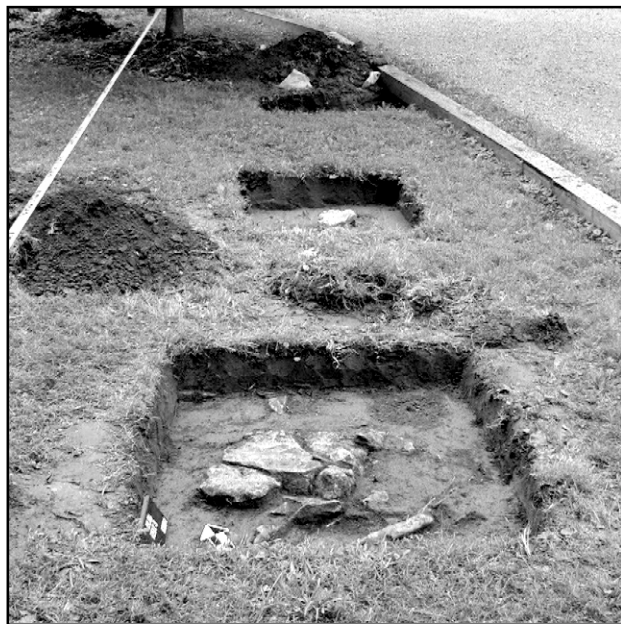
Figure 19. Features 3, 4, and 5, footings or piers to a structure or shed associated with Feature 1, looking architectural east; arrow points to magnetic north.

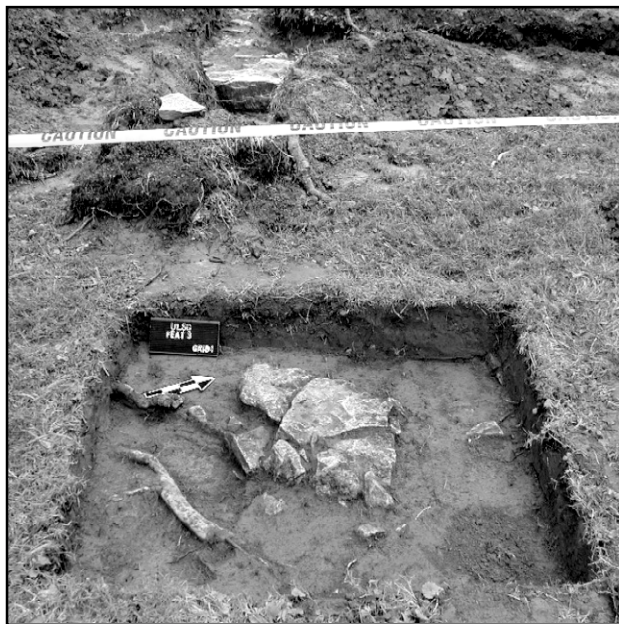
Figure 20. Feature 3, a footing or pier associated with the Feature 1 foundation, looking architectural north; arrow points to magnetic north.

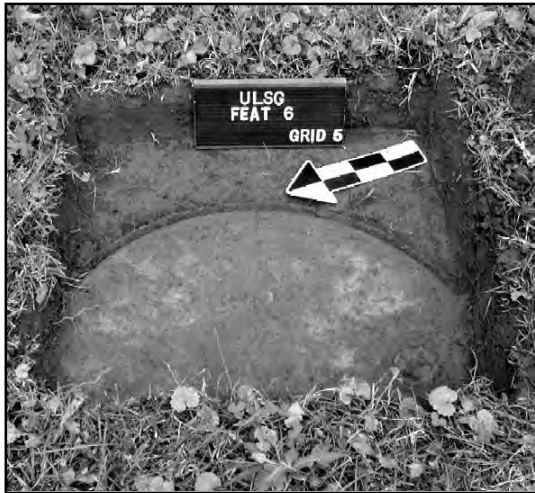
Figure 21. Feature 6, a 20th-century 55-gallon drum lid, looking architectural south; arrow points to magnetic north.

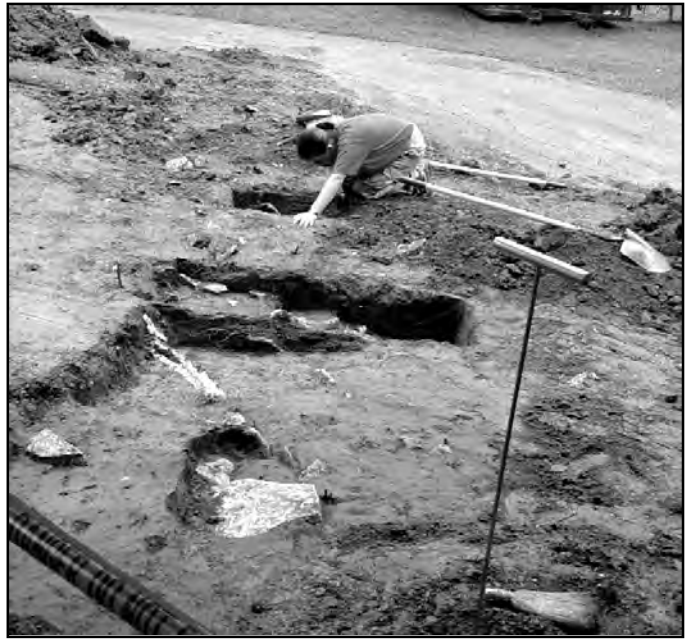
Figure 22. Mechanical stripping and testing along the fence line east of the Cottage.

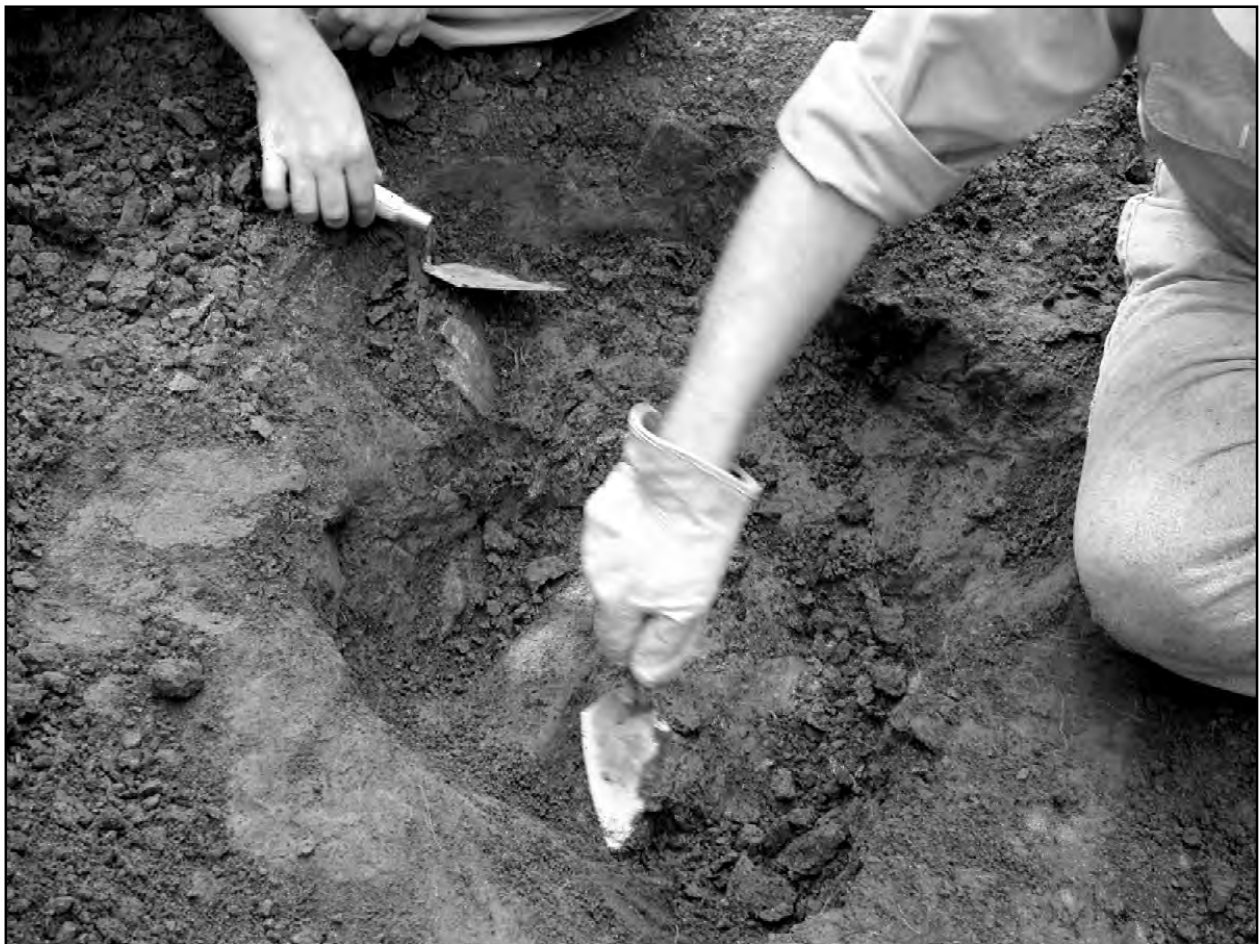
Figure 23. Feature 8, a 20th-century burn pit, under excavation, looking architectural north.
