AFRICAN MEETING HOUSE

**Boston African American
National Historic Site**

Historic Structure Report

THE AFRICAN MEETING HOUSE
HISTORIC STRUCTURE REPORT

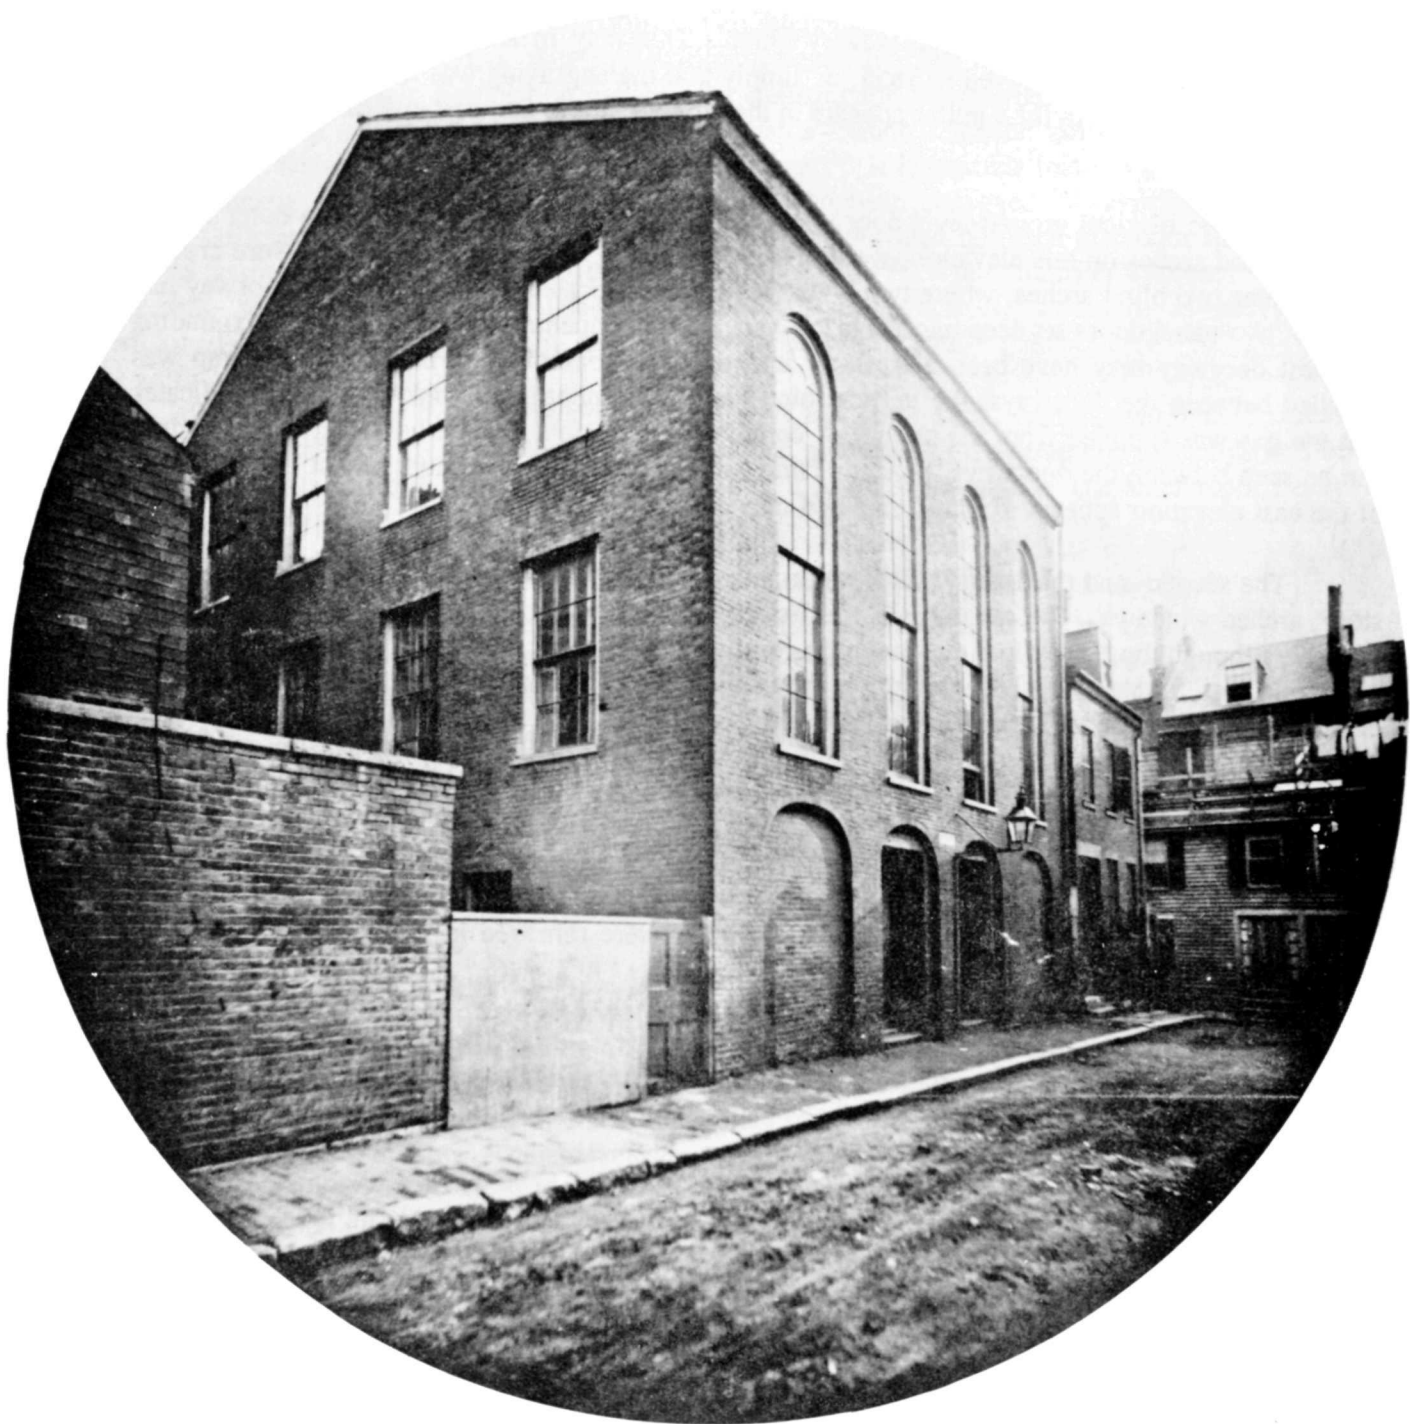
Figure 5. First Independent Baptist Church (circa 1860).

The Hawes photograph, compared with the engraving of 1843, shows that while some original (1806) architectural elements remained unchanged in 1855, a large number of them were altered. For example, the cornice seen in the 1843 engraving is projecting and elaborate, while the one seen in the ca.-1860 photograph is very plain. This may mean that the 1806 cornice was constructed of wood and removed in 1855, or simply that the engraving was inaccurate in depicting the cornice. A downspout for a gutter appears in the photograph, at the west end of the north (front) elevation.

on the south elevation, where 1806 window openings were bricked up in 1855, when the other windows were being lengthened. Comparison of the 1843 engraving (fig. 2) and the ca.-1860 photograph (fig. 5) confirms the fact that the 1806 windows were shorter.

The 1806 windows on the second and third stories of the north elevation resembled those of the other three elevations. This is clear from comparison of figures 2 and 5, and from the altered brickwork around the lower ends of one of these windows' jambs, visible inside the building beneath the present east stairway.

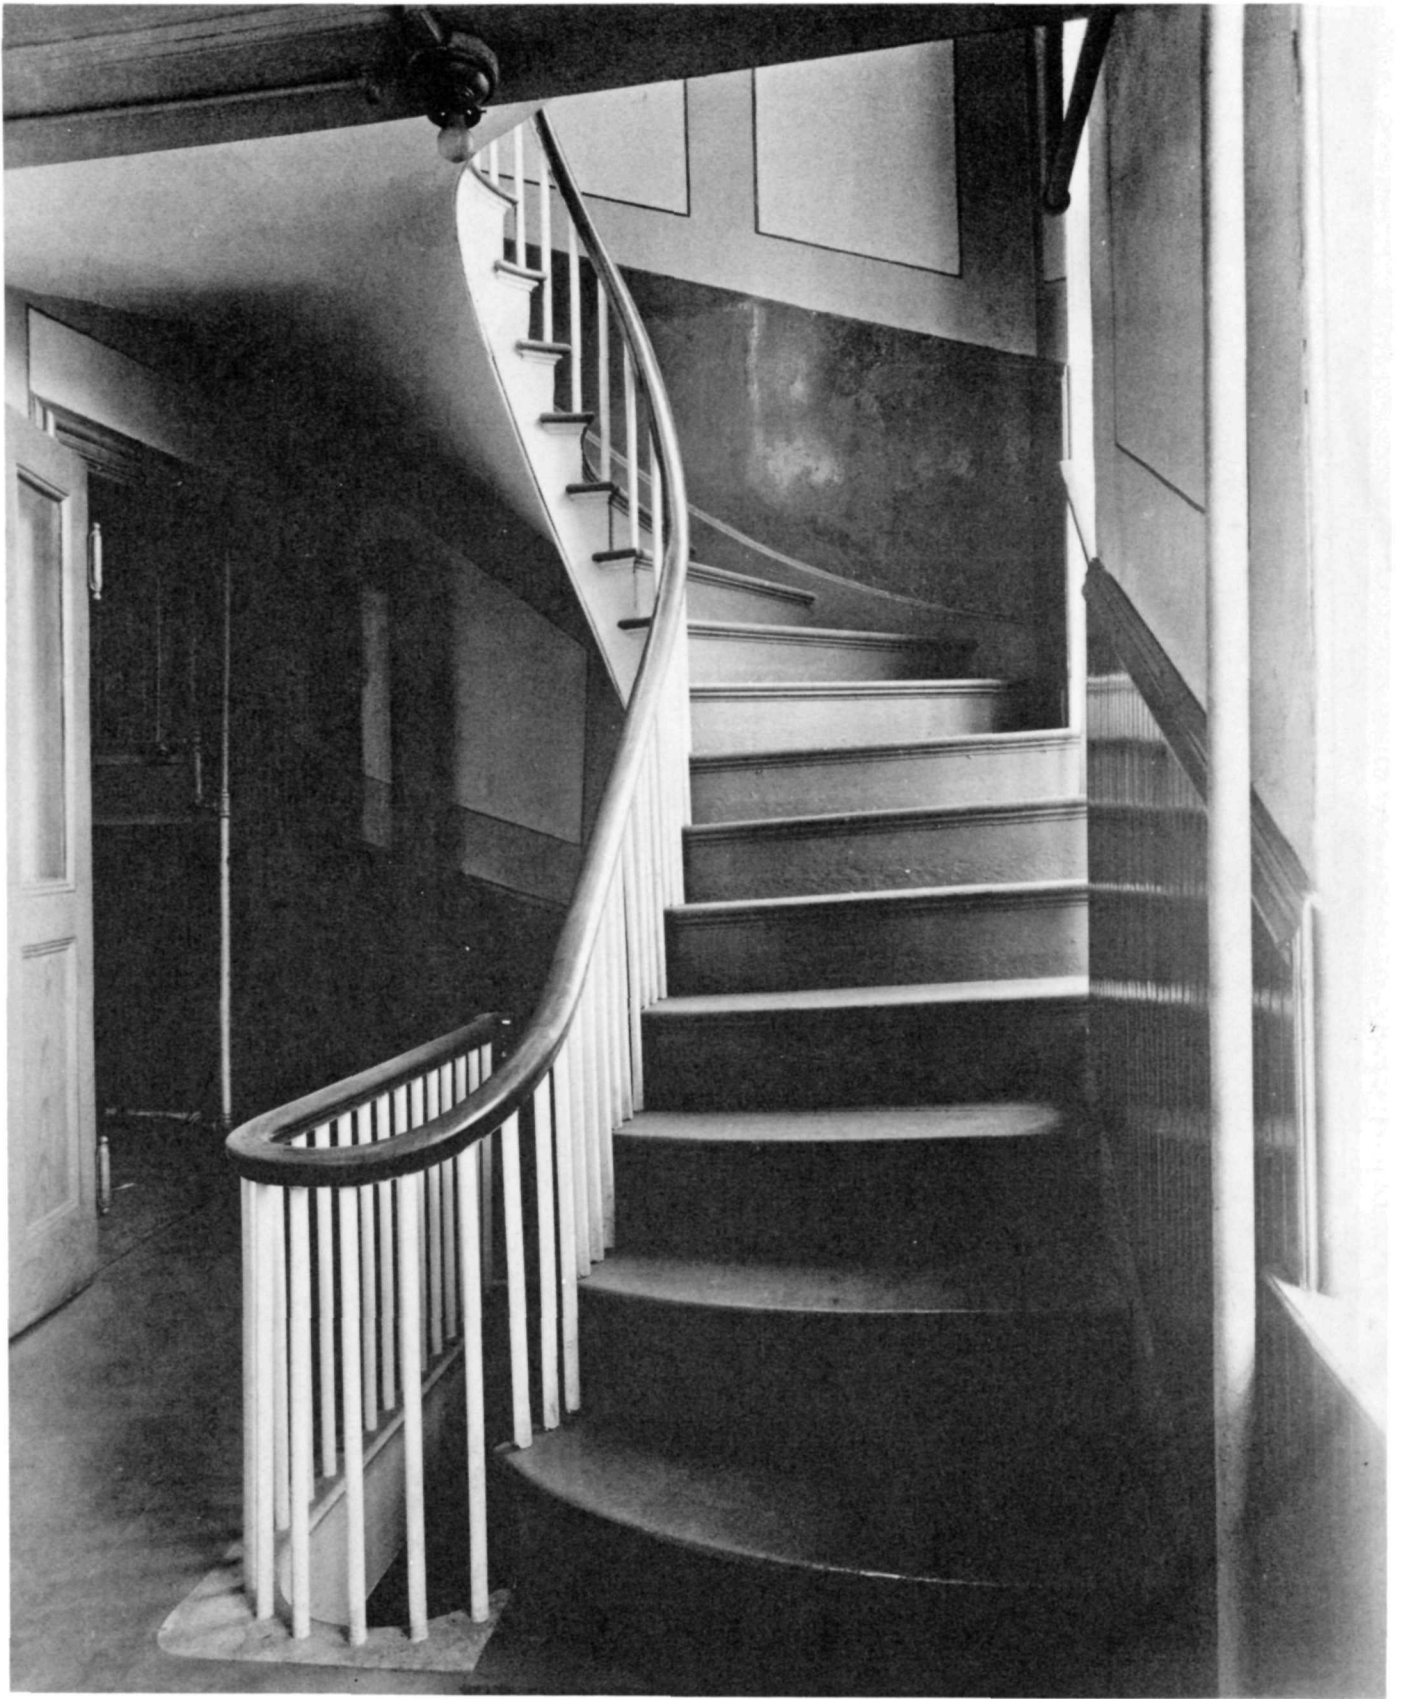
Figure 11. Interior of Synagogue, West Gallery Stair (1937).

The foyer ceiling in 1855 would have been the soffits of the east and west stairways to the gallery, and the soffit of the north-wall section of gallery. The HABS photographs show that the soffits of the stairways were plastered (fig. 11), and suggest that the soffit of the north-wall section of gallery also was plastered (fig. 15).

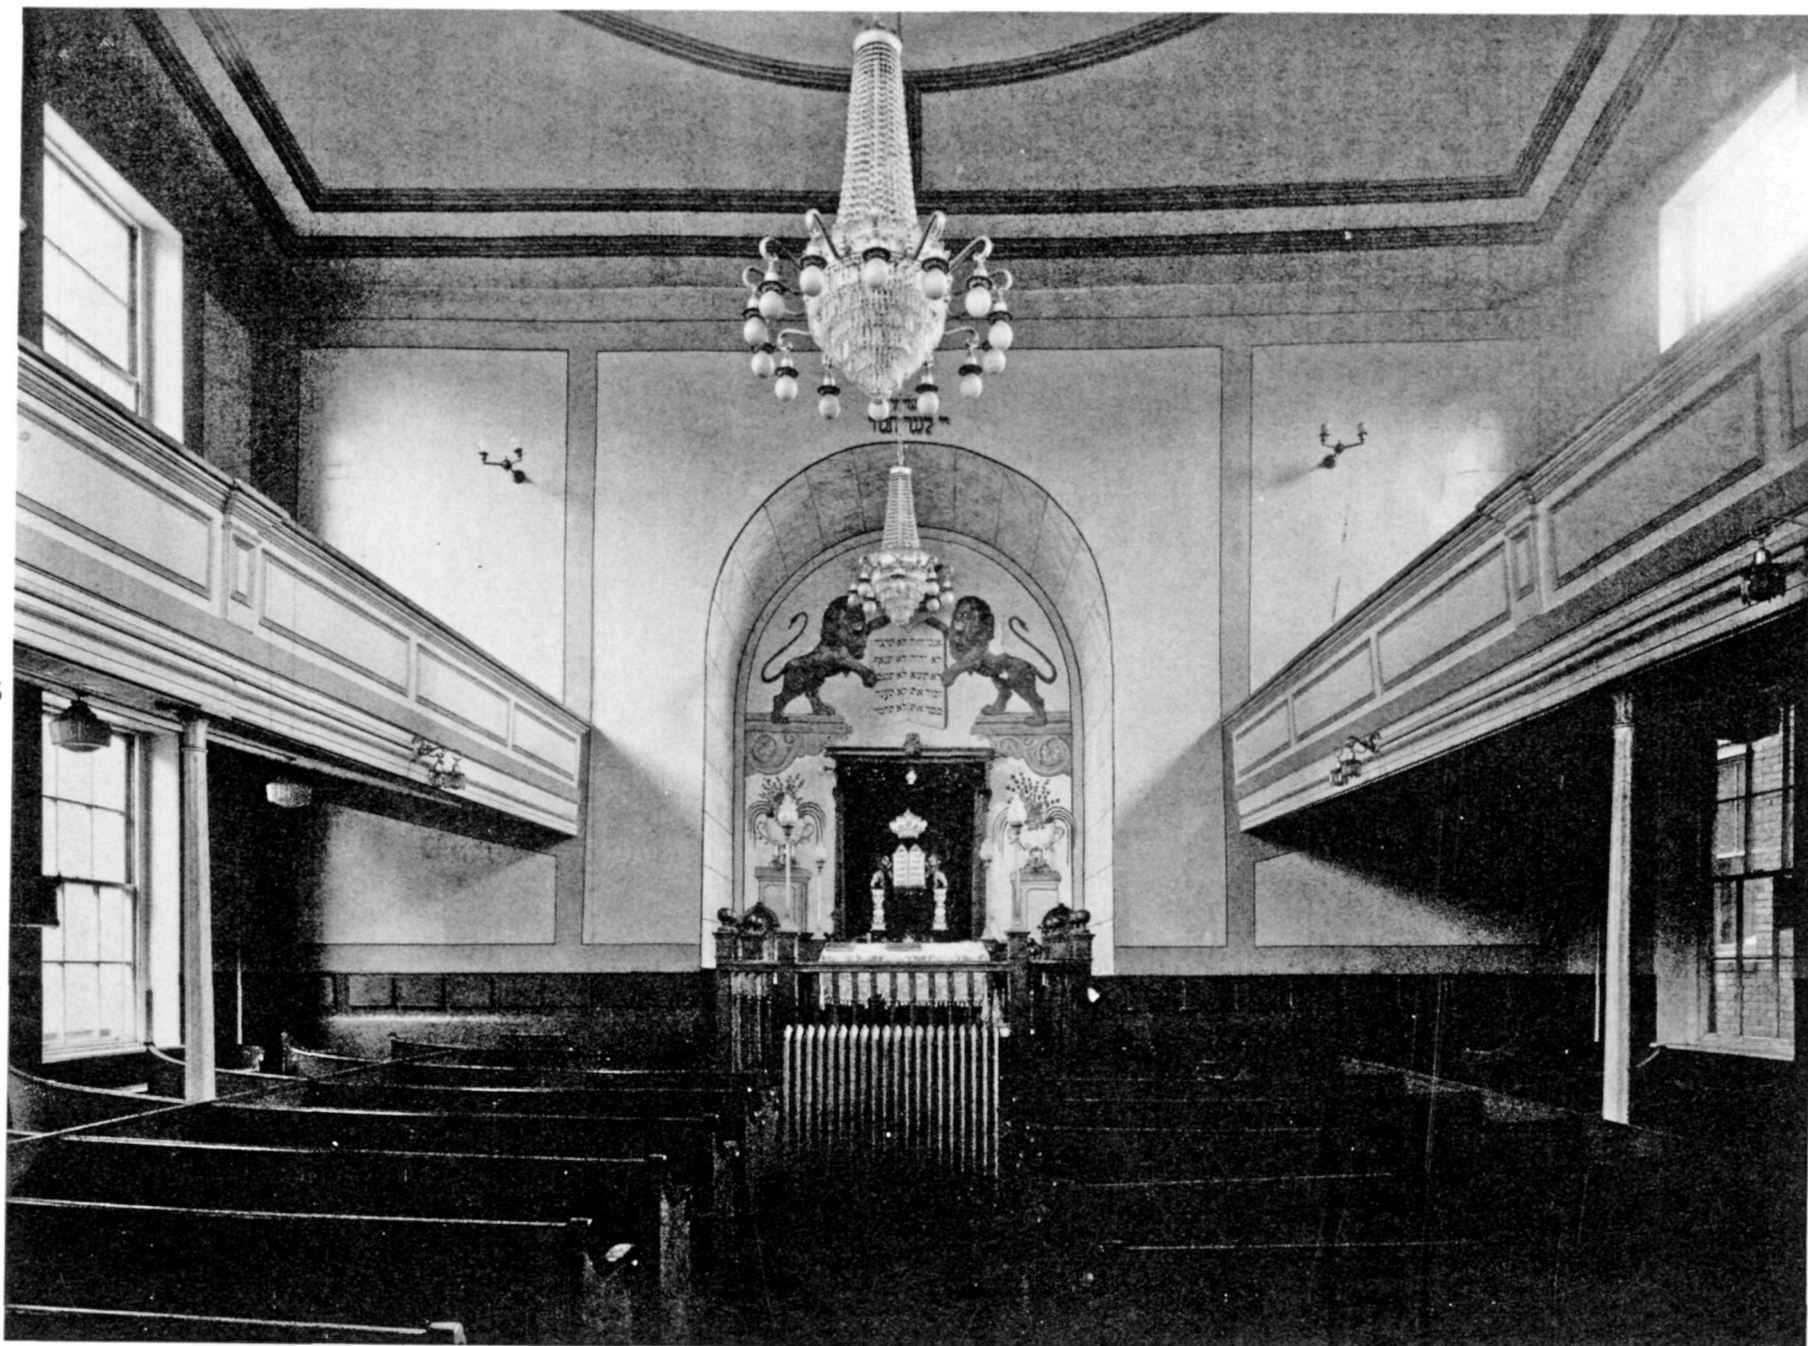
Figure 12. Interior of Synagogue, South Wall of Sanctuary and Gallery (1937).

The three doorways in the north partition wall have been discussed previously in connection with the foyer. A fourth doorway may have been located in the west wall of the apse. Although this conjectured doorway had been removed by the time the 1937 HABS photographs were taken (fig. 12), the south exterior wall of the building shows evidence of a possible exterior stairway and protective roof.

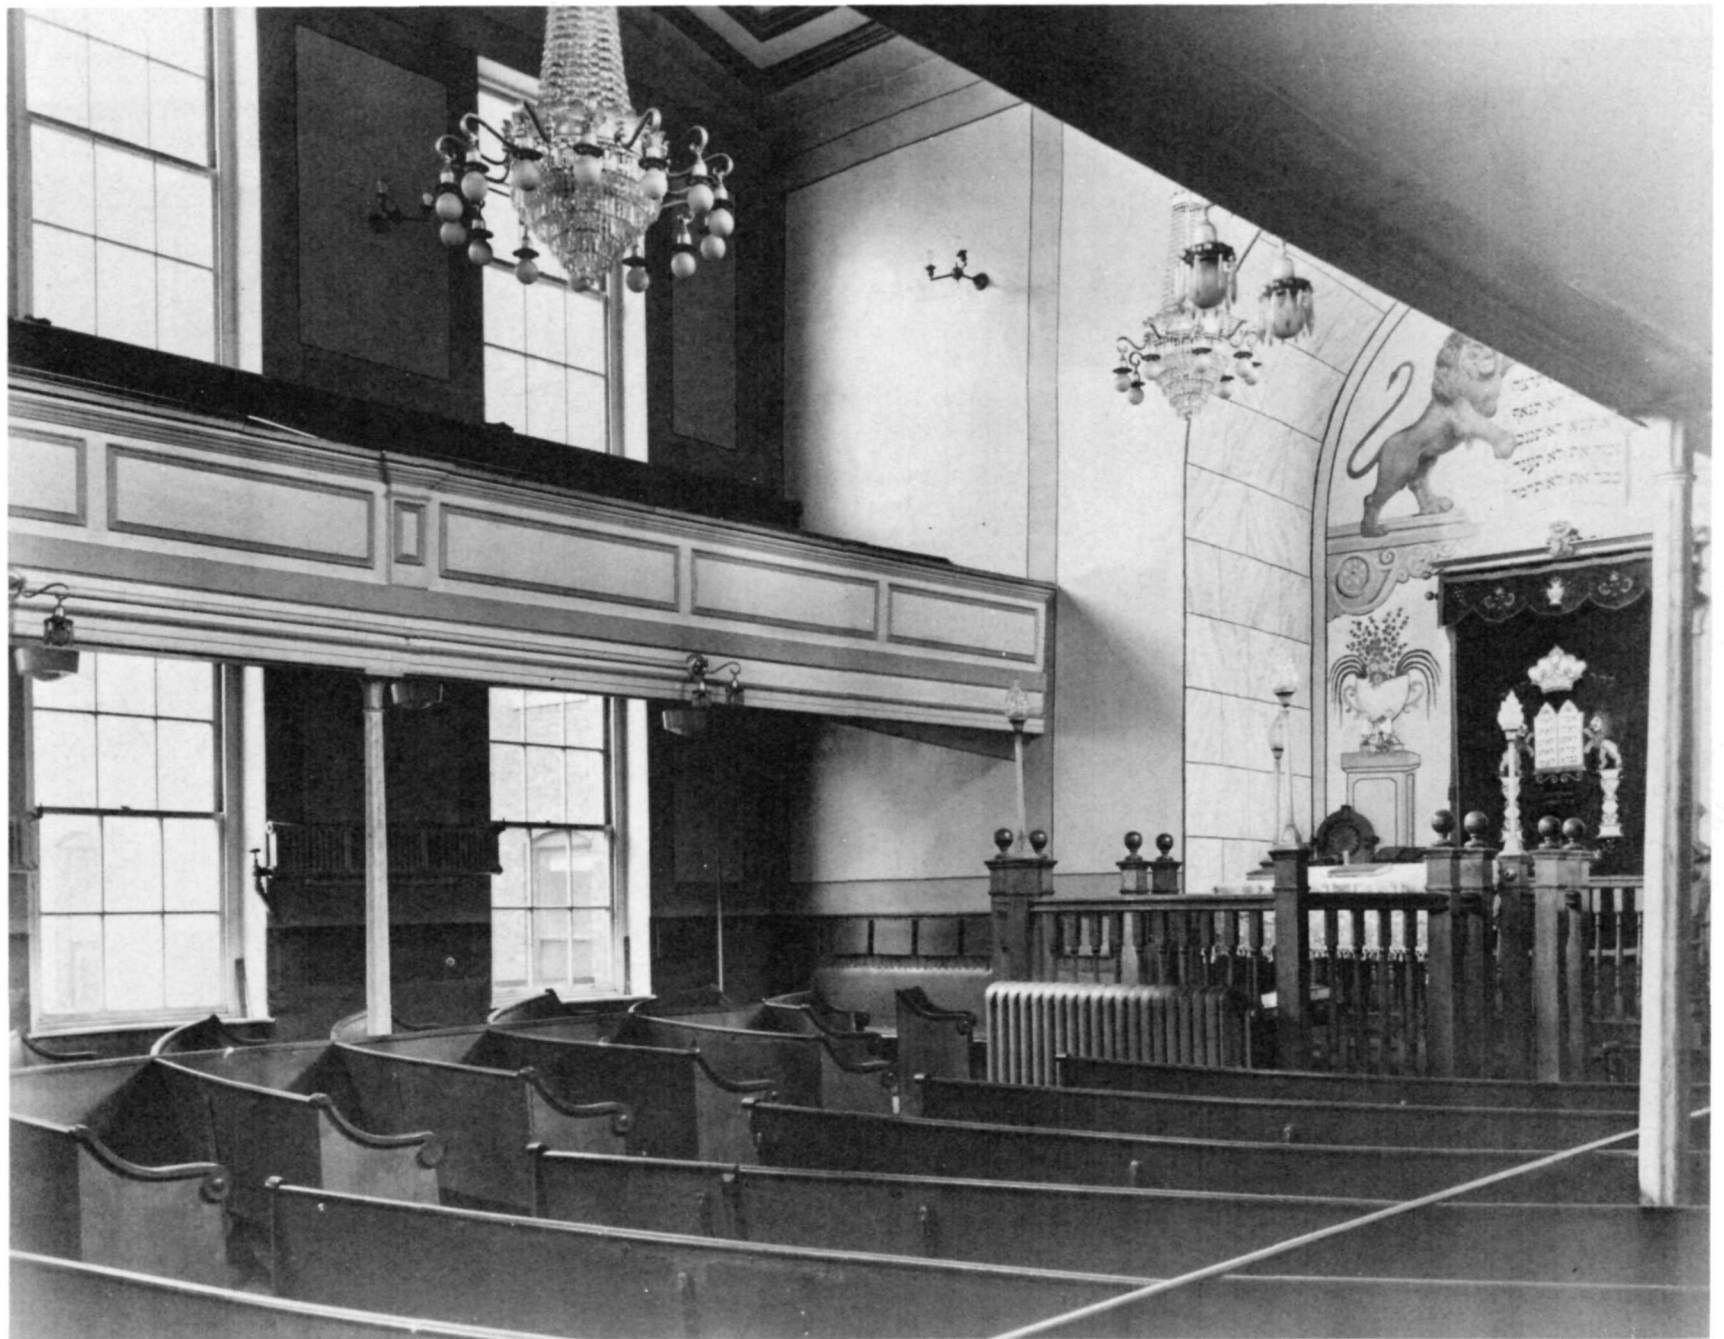
Figure 13. Interior of Synagogue, Southeast Corner of Sanctuary and Gallery (1937).

Evidence of these fixtures may be seen in the 1937 HABS photographs of the sanctuary (figs. 13-14). Also, extant holes in the sides of the east and west gallery beams probably accommodated the gas-supply pipes for these fixtures. Unfortunately, it is not possible to verify the period of the fixtures on the front of the gallery balustrade, since all associated woodwork and paint was removed in 1975. If these fixtures postdated 1855, they were probably installed at the same time as the post-1880 gaslight fixtures on the east and west walls.

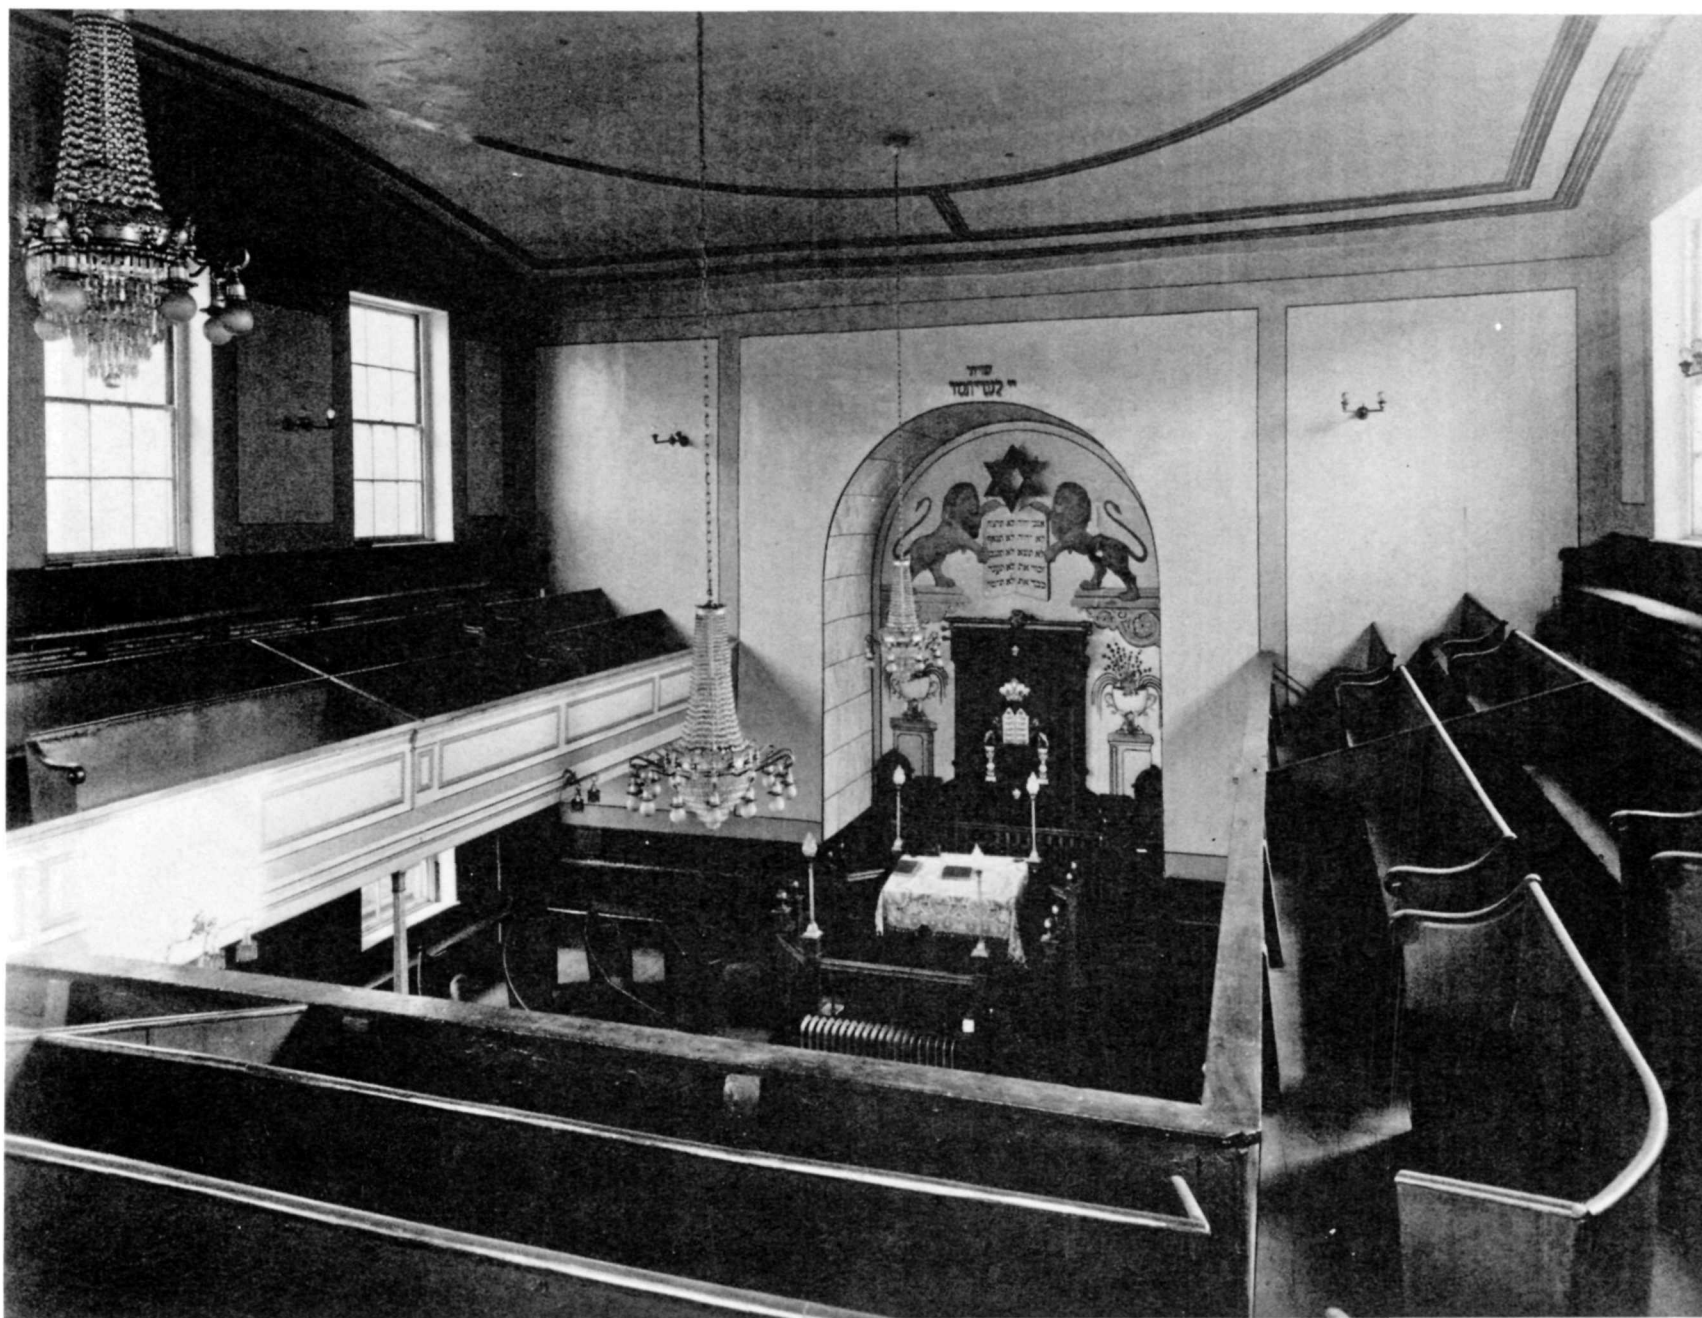
Figure 16. Interior of Synagogue, Southeast Corner of Sanctuary and Gallery (1937).

- Reinstall arched plaster ceiling.
- Reconstruct trap door in northwest corner, as seen in figure 17.
- Rebuild the ceiling of the 1975 apse, such that it displays the barrel-arch form seen in figure 16.

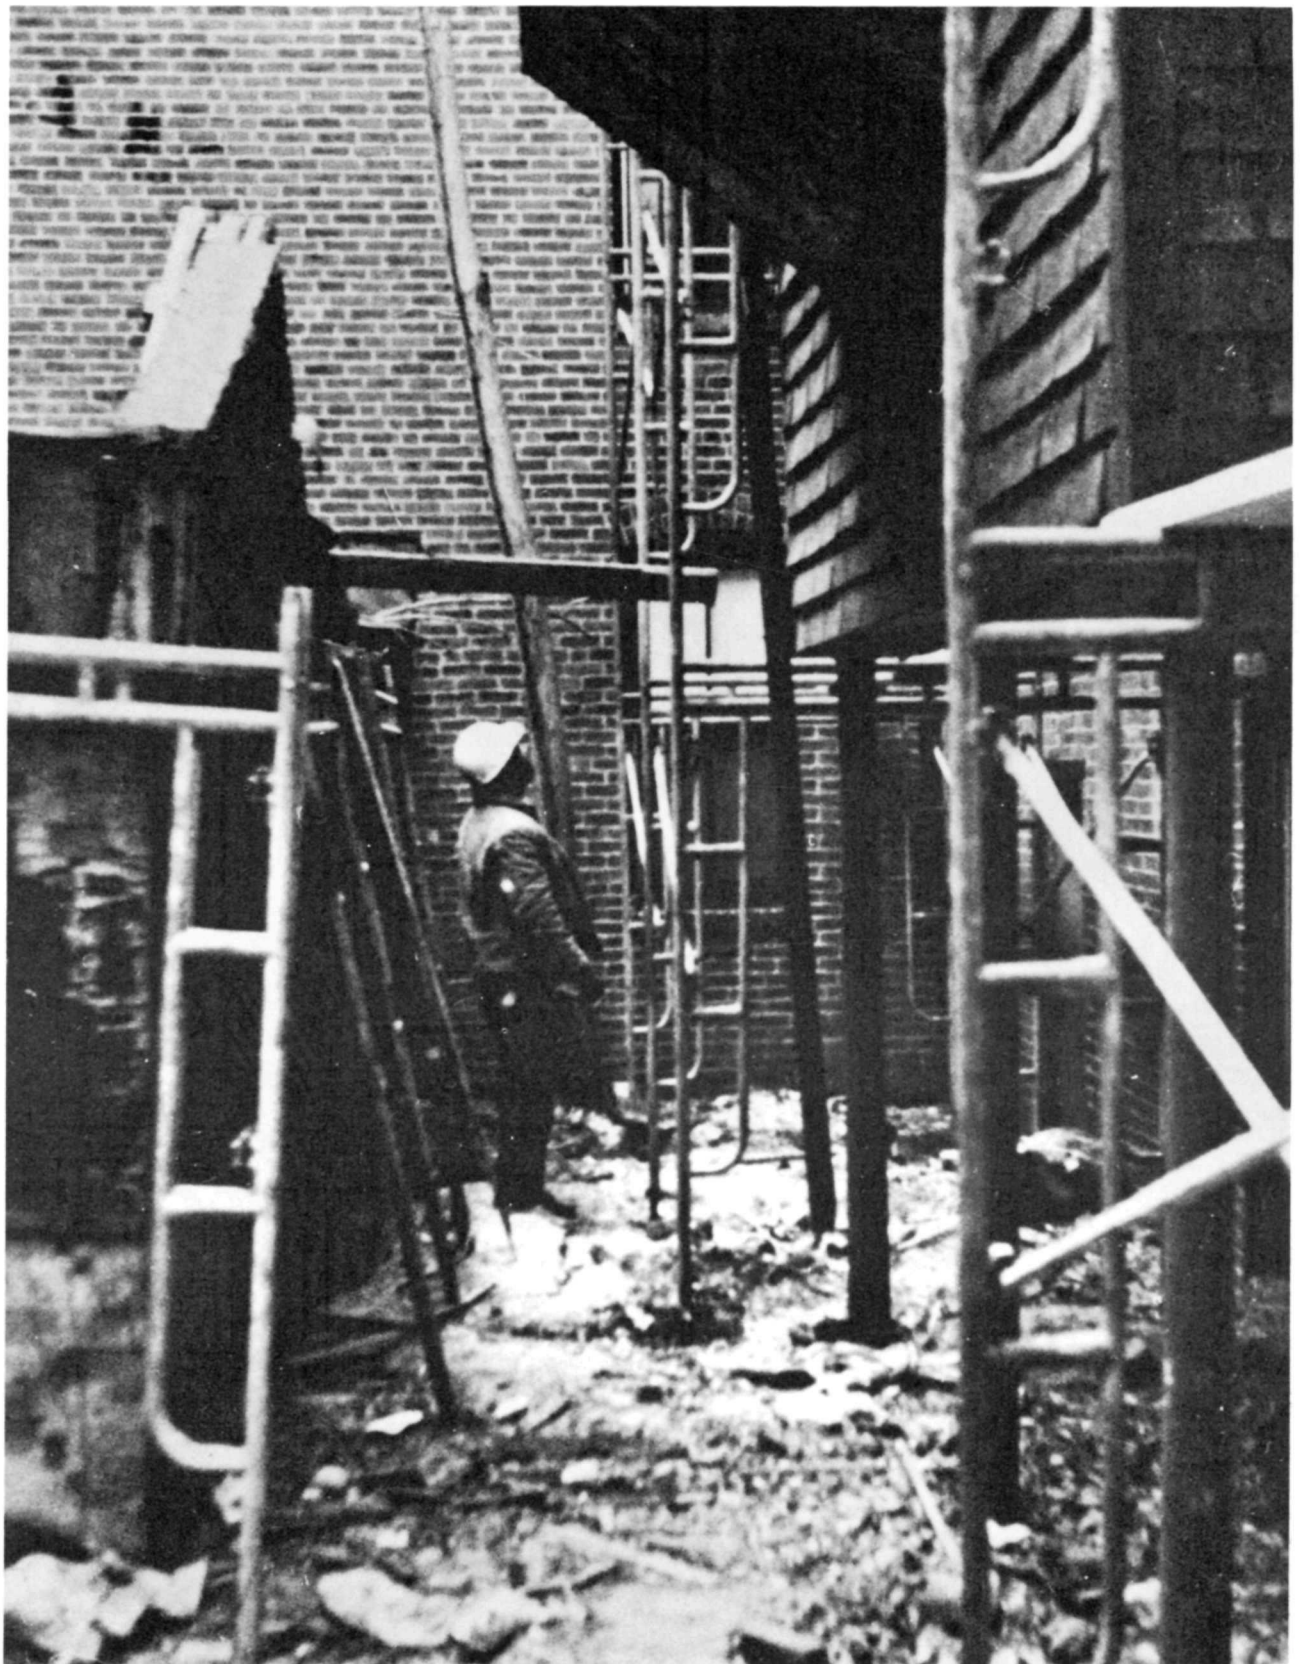
Figure 27. Exterior View of Apse (1973).

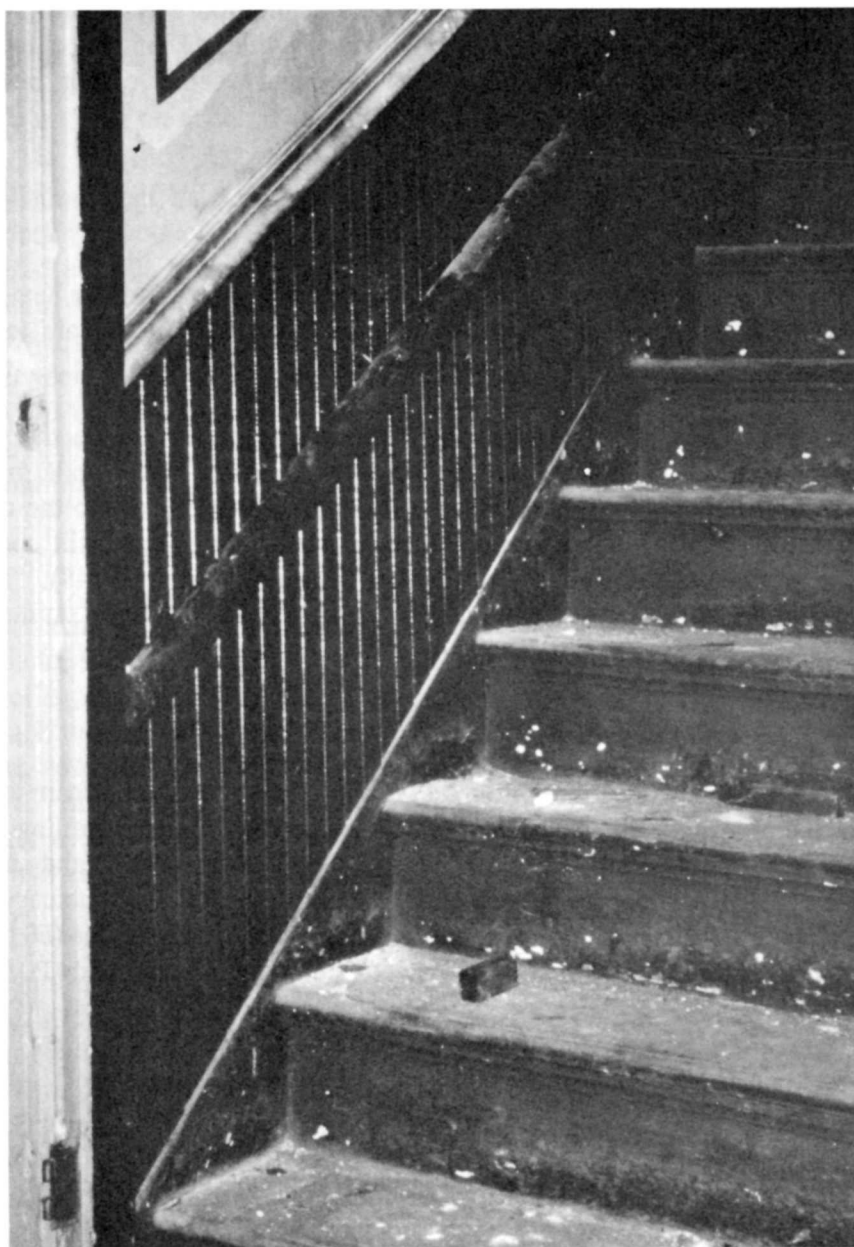
Figure 31. Entry, East Sanctuary-Stair Doorway (1975).

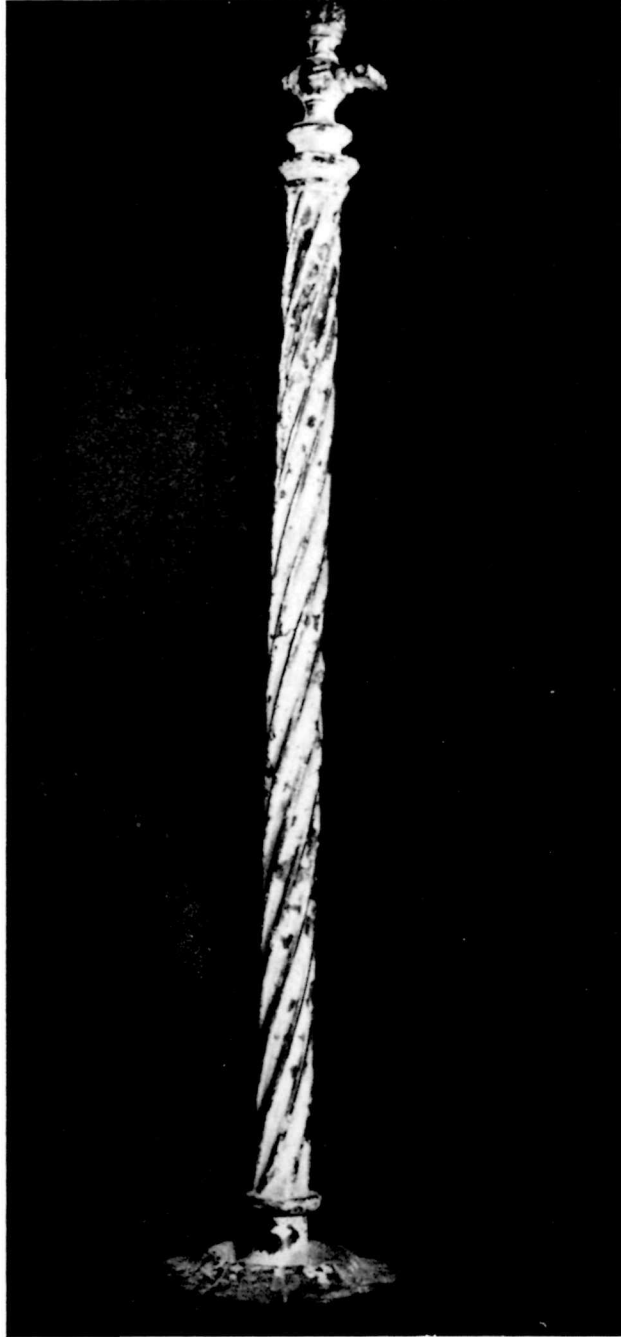
Figure 37. Early Gaslight Fixture Found During 1975 Archeological Work.

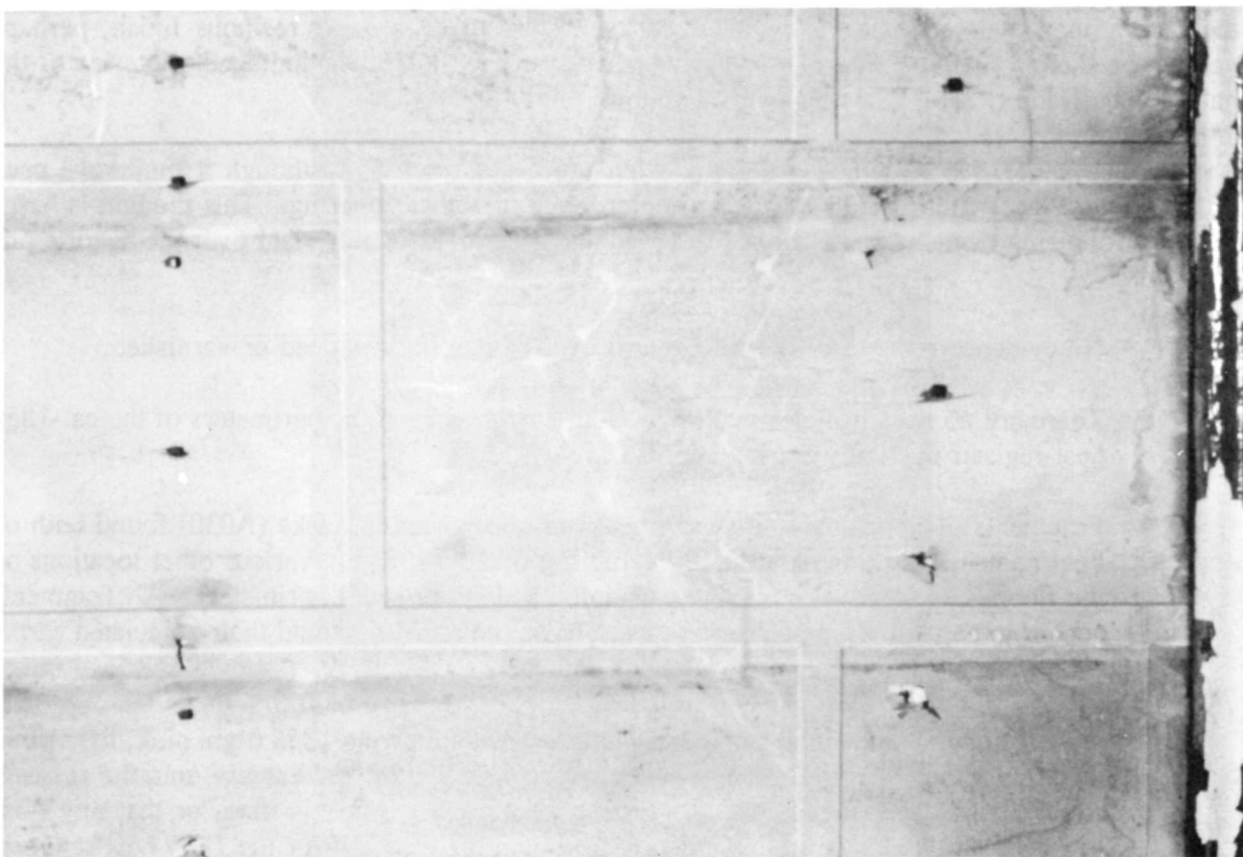
Figure 38. Sanctuary, 1855 Wallpaper.

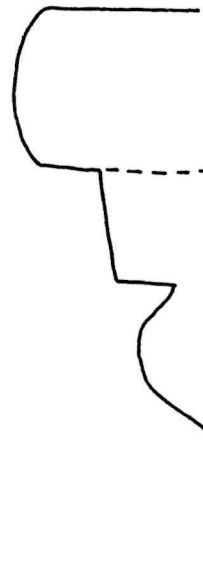
Figure 43. Examples of Post-1880 Molding Profiles
Found at the African Meeting House.

WAINSCOT TOP MOLDING,
SOUTH WALL SANCTUARY

W-102 SILL,
BASEMENT

DOORWAY MOLDING, SOUTH
PARTITION WALL, FOYER

- Doorway D102 was converted to a window (P209-211).
- Some windows were altered: some jamb and sill boards were replaced (P052, 054; figure 43, middle); two-over-two sashes were installed (P051, P059, P062, P067, P069); W-101 was reduced in size (P024, M057); W-112 received a new frame and sashes (M008).
- The wooden post—presumably dating to 1806 and retained in 1855—that supported the cut in the middle sanctuary-floor girt was removed; a wooden beam was presumably introduced to compensate, spanning the two 1855 columns, which were plastered (P143, M040).
- Gas lighting was installed (A001).
- Toilets were possibly installed at the north end (a sewer system was extant by 1909, because repairs were recorded as being made then).

- The south-wall niches were closed with framing and plaster; the 1806/1855 wainscot on this wall was removed, and was replaced with new wainscot (fig. 43, top; P122-123).
