MOLOKA'I LIGHT STATION HISTORIC RESOURCES REPORT

by William Chapman

Kalaupapa National Historical Park
Moloka'i, Hawai'i
November, 2001

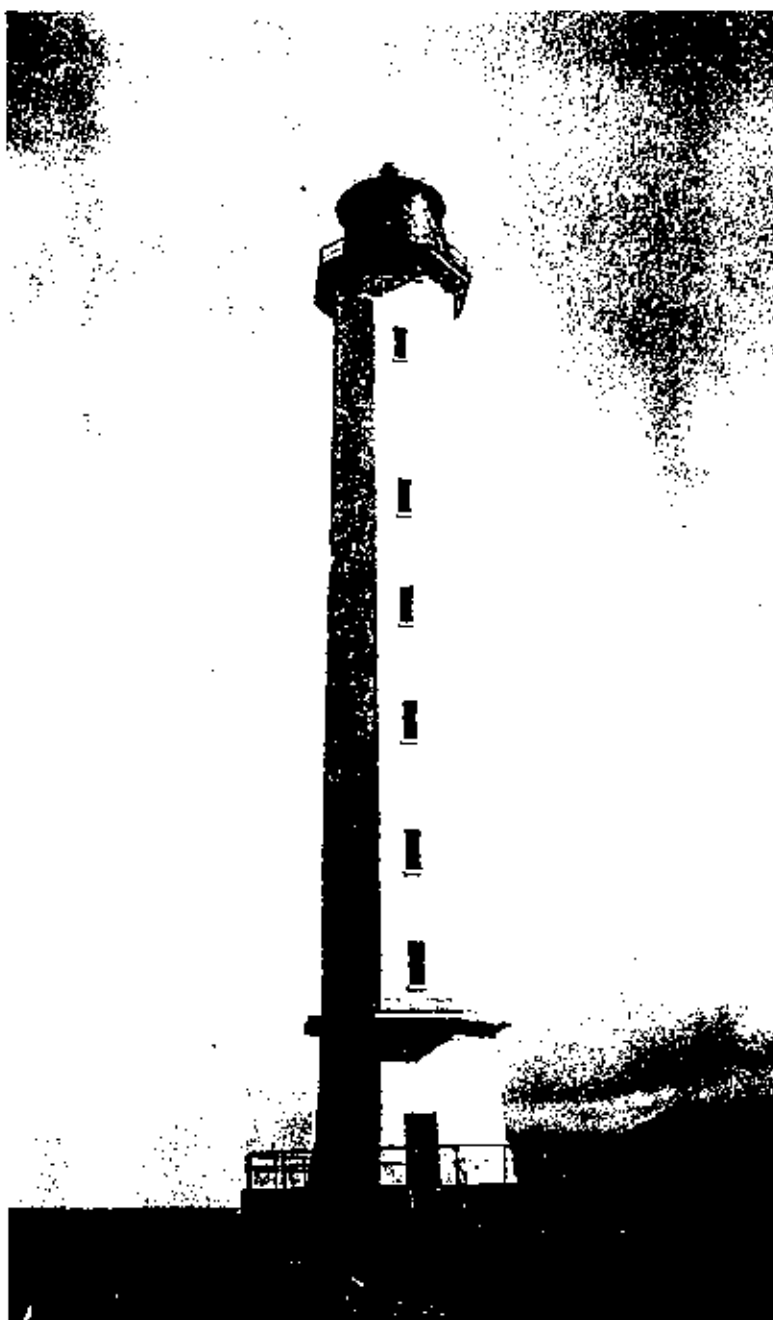
Figure 5. Completed tower, Postcard, Kalaupapa Lighthouse, Moloka'i, ca. 1910. Bishop Museum Archives, negative number CP 73604.

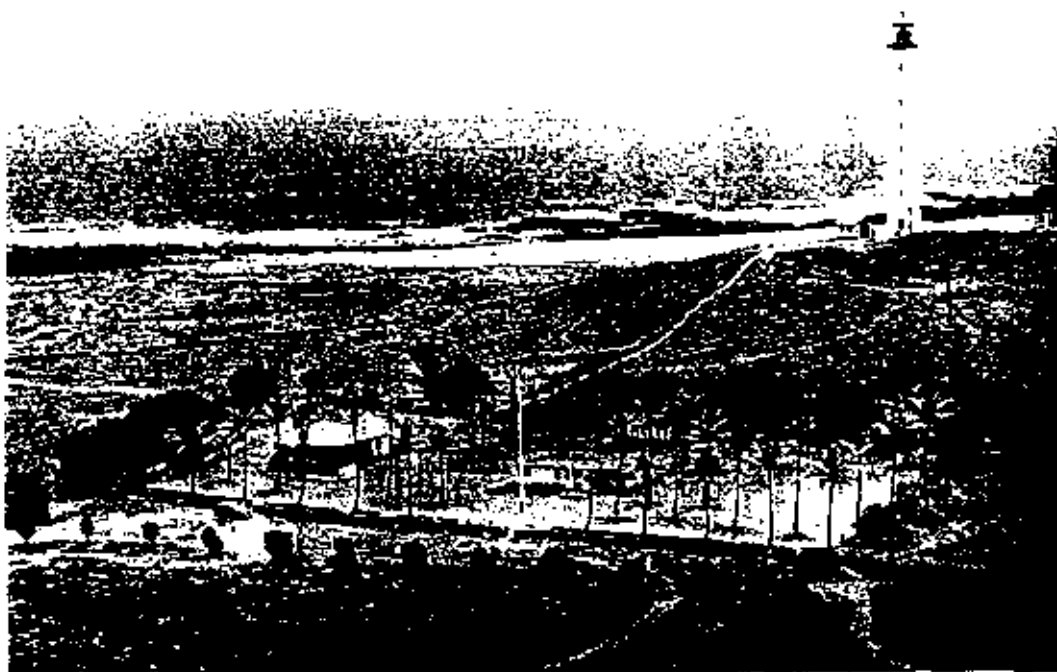
Figure 10. Aerial view, Keeper's compound and light station, 1956. U.S. Coast Guard Archives, Honolulu, Hawai'i.

By 1956, the Moloka'i Light Station had evolved to a new point of "maturity." In overall

appearance and in terms of its components it approached closely to what still remains on the site. Significant changes included the demolition of the last of the two wood keepers' residences (demolished in 1950 and 1952, respectively), a small addition to the small, wood-frame wash house (built in 1909; added to in 1951), and completion of the rectangular, flat-roofed, masonry house within the residential compound (1950). Significant features of the 1920s and 1930s were in place: the powerhouse (1934), the concrete walkway (1929), and the frame garage (ca. 1920). The trees and plants introduced in the 1910s and 1920s had reached maturity. The site was well maintained, with immaculate lawns and neatly trimmed hedges and foundation shrubs. It still conveyed aspects of its historic, 1909 origins and announced the new period of modernization under the U.S. Coast Guard Service.

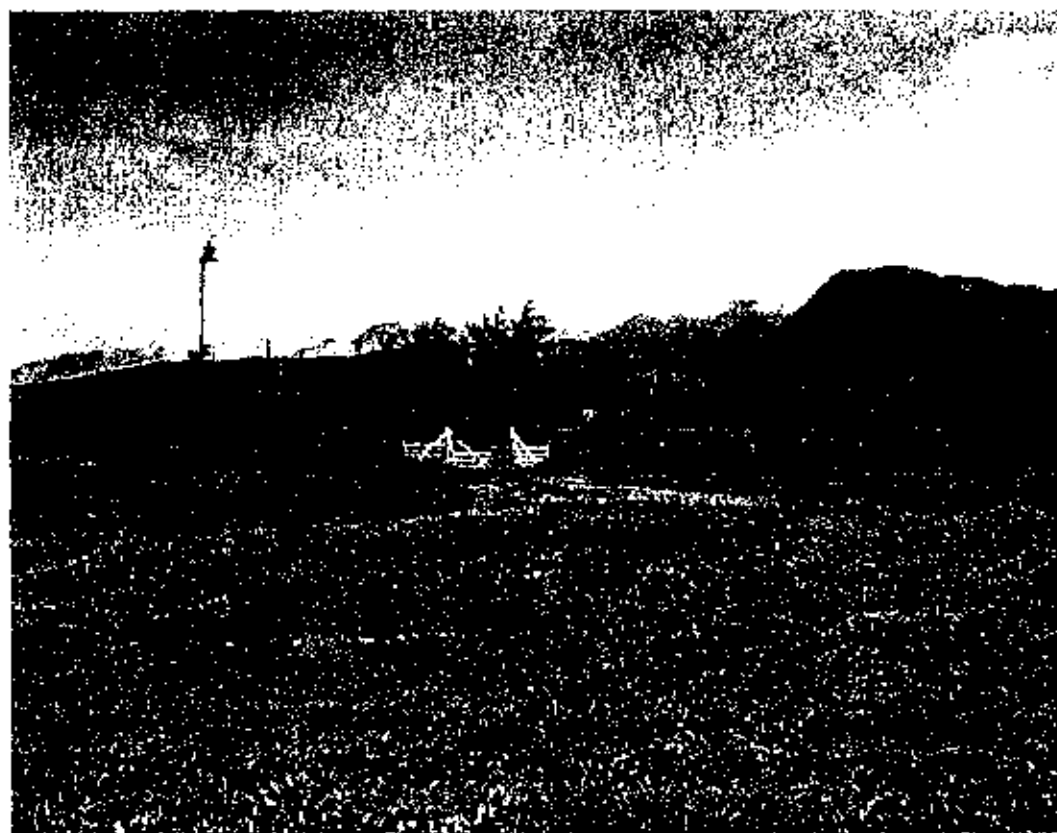
Figure 13. Kalaupapa Lighthouse, Kalaupapa, Moloka'i, Hawai'i, March 1974.
Bishop Museum Archives, John C. Wright, negative number H 107, 223 - frame 48.

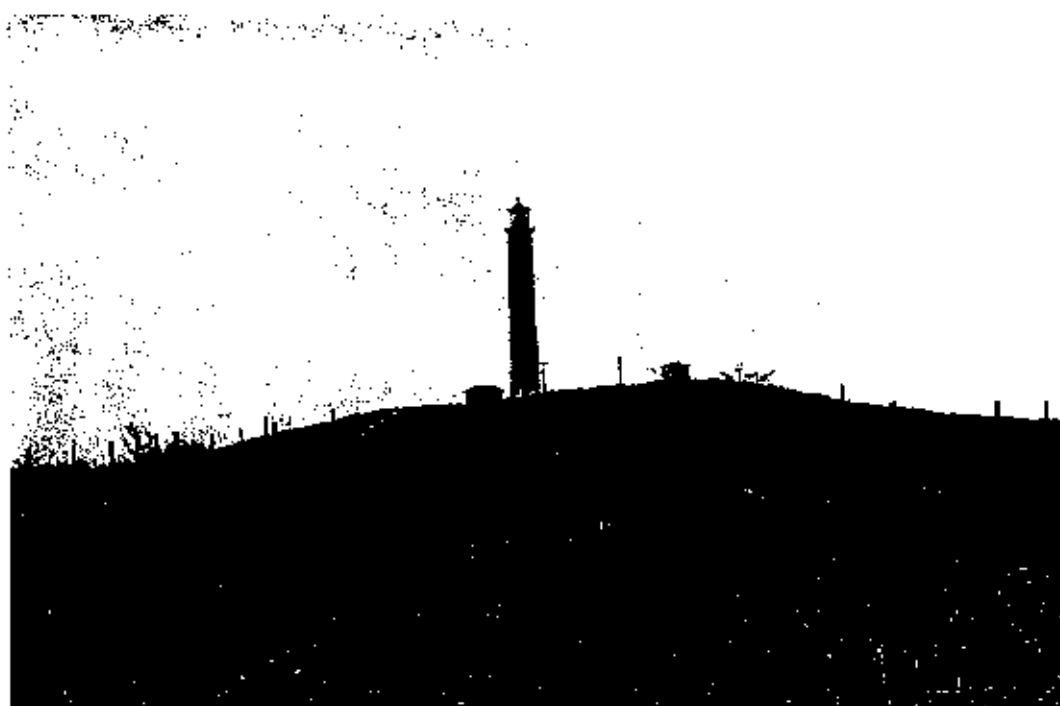
Figure 14. Kalaupapa Lighthouse, Moloka'i, Hawai'i, June 1978, Bishop Museum Archives, negative number I 114, 812 - frame 16.

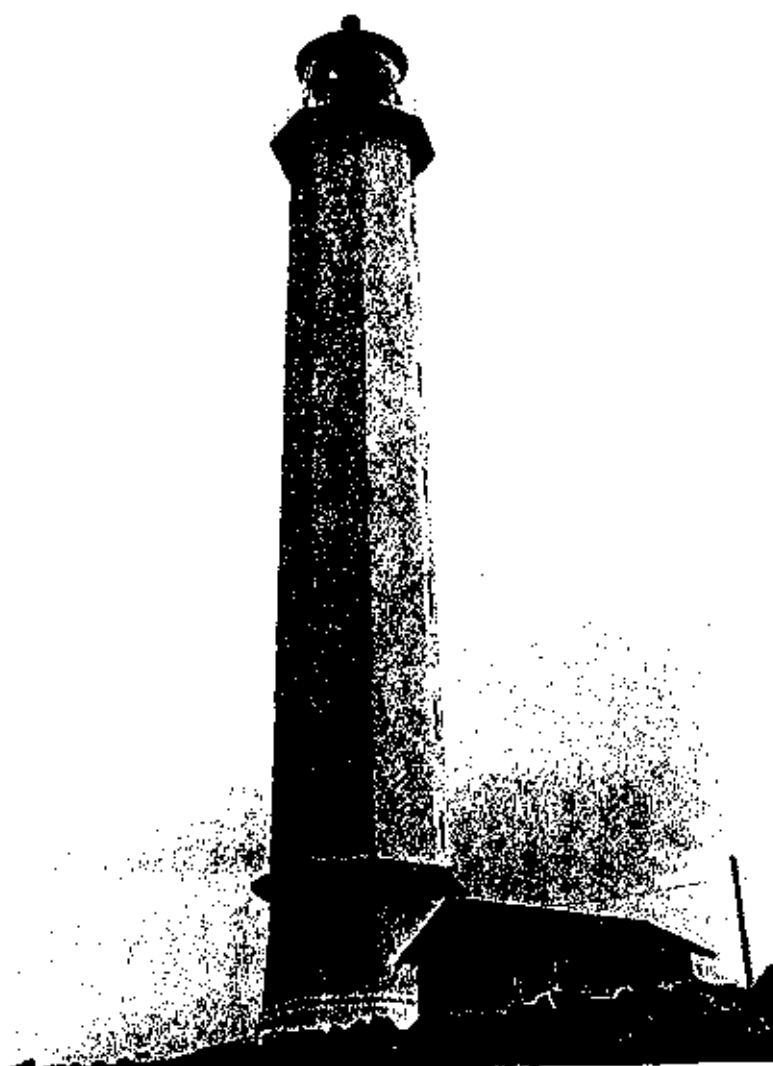
Figure 15. View of Moloka'i Lighthouse, from the northeast,
1985, U.S. Coast Guard Archives, Honolulu, Hawai'i.

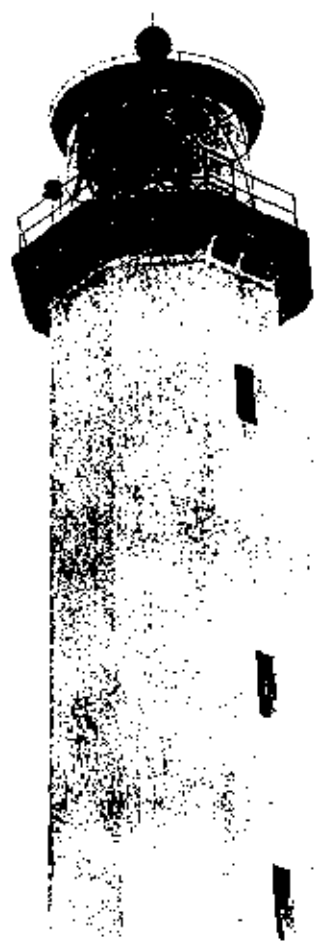
Figure 17. Detail of tower and lantern, from northwest,
1985, U.S. Coast Guard Archives, Honolulu, Hawai'i.

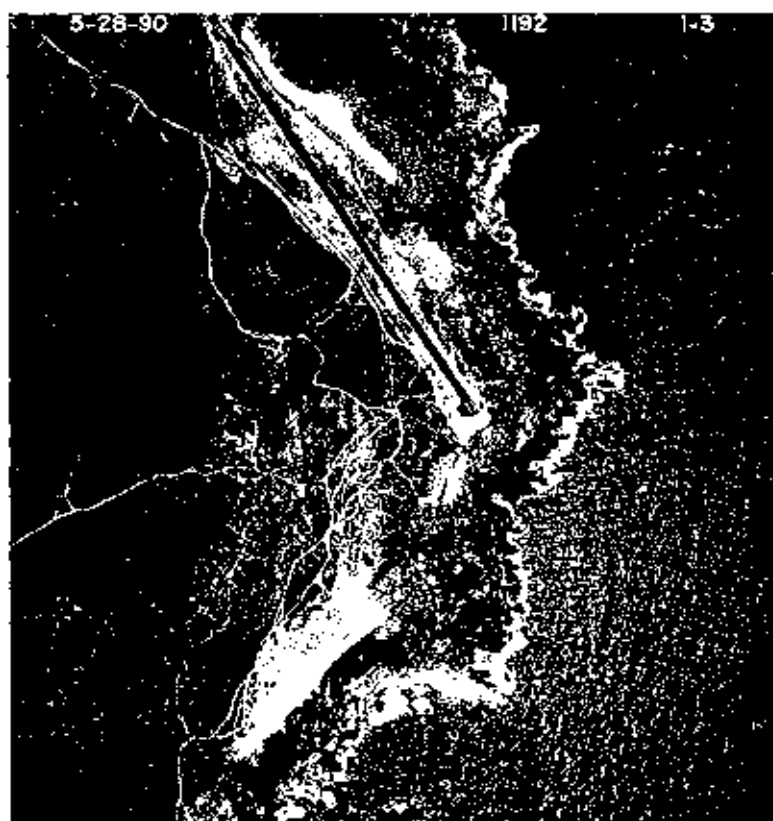
Figure 20. Air Survey Hawaii, Aerial view, Molokai Light Station, May 28, 1990, Kalaupapa National Historical Park, Kalaupapa, Hawai'i.

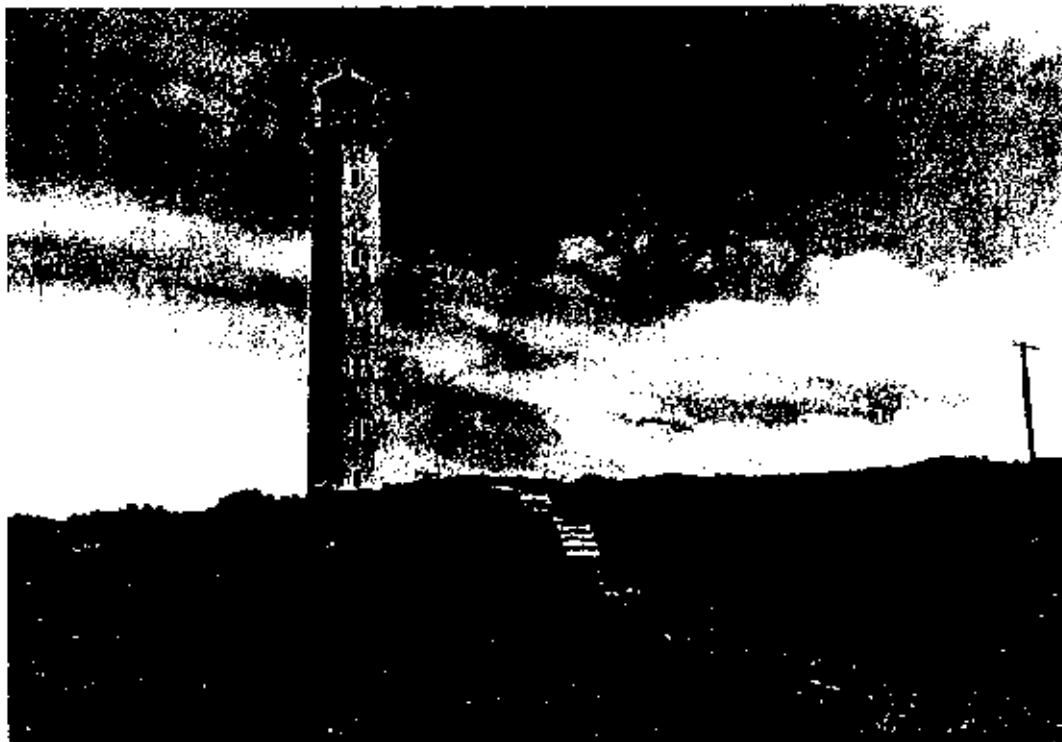
Figure 24. Lighthouse tower (Feature 1) and concrete sidewalk (Feature 2), from northeast, September, 1999. Photograph: William Chapman.

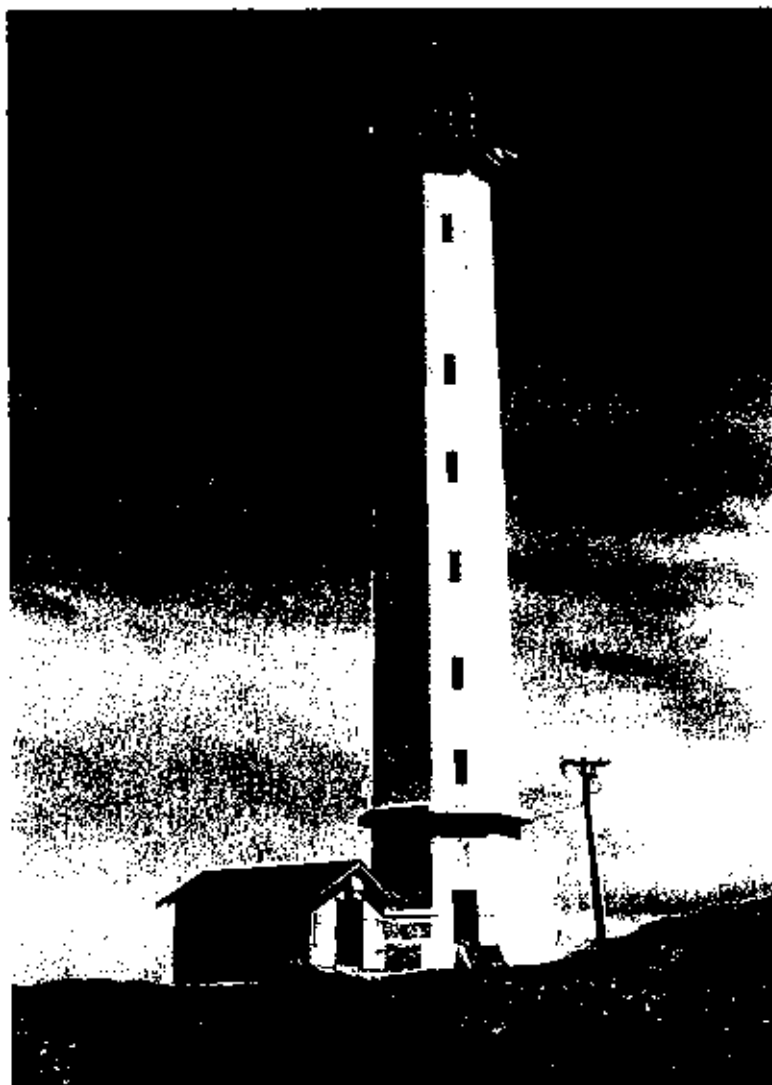
Figure 25. Lighthouse base and tower (Feature 1), with wood-frame powerhouse (Feature 12), from northeast, September, 1999. Photograph: William Chapman.

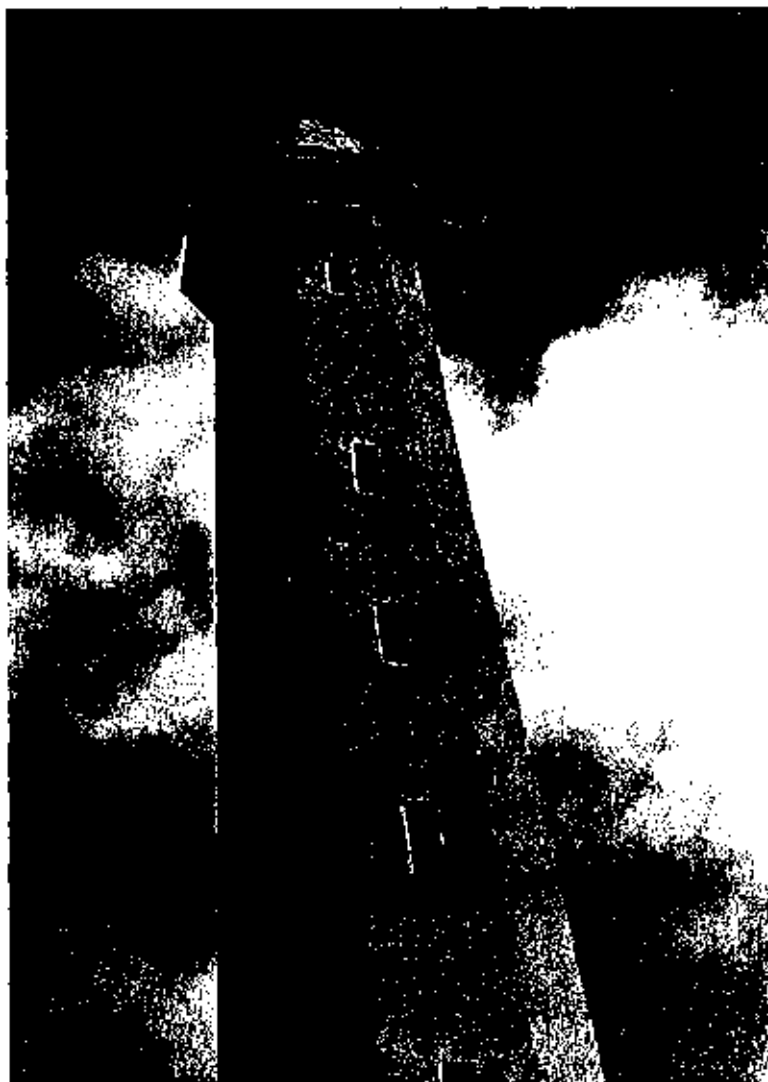
**Figure 27. Lighthouse tower (Feature 1), view from west,
September, 1999. Photograph: William Chapman.**

The upper-most floors of the tower consist of a cast iron platform, resting on 6-in steel I-beams, historically designed to carry the weight of the lens and lens pedestal; and a second, lighter metal floor at the lens level. (This floor was elevated a few inches in 1986, when the older mercury vat system was eliminated and the Fresnel lens was removed to be replaced by a modern, electrical signal.) The area between the upper-most floor and the cast iron platform was known historically as the watchroom. Access to the watchroom was via a circular, iron staircase. Access to the upper most lantern room required (and still requires) a fixed iron ladder.

A 32-ft long, 18-in wide weight shaft descends from the watchroom level to the level of the third concrete landing. This shaft contained the counterweights — actually steel drums, measuring about 2 ½ ft in length and 1 ft in diameter — used historically to move the lens in its chariot or channel while activated. Operated manually, the weights linked via a system of cables and pulleys to the gear mechanism operating the revolving light. The movement of the drums was translated to

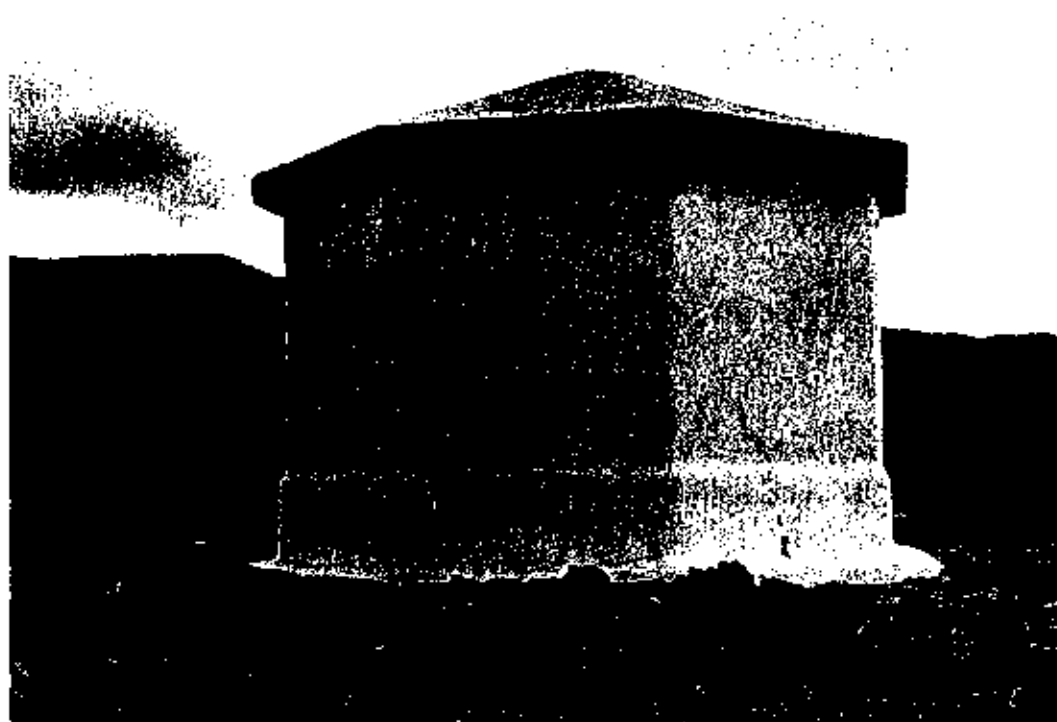
Figure 33. Octagonal, reinforced-concrete water-storage tank (Feature 3), view from north, September, 1999. Photograph: William Chapman.

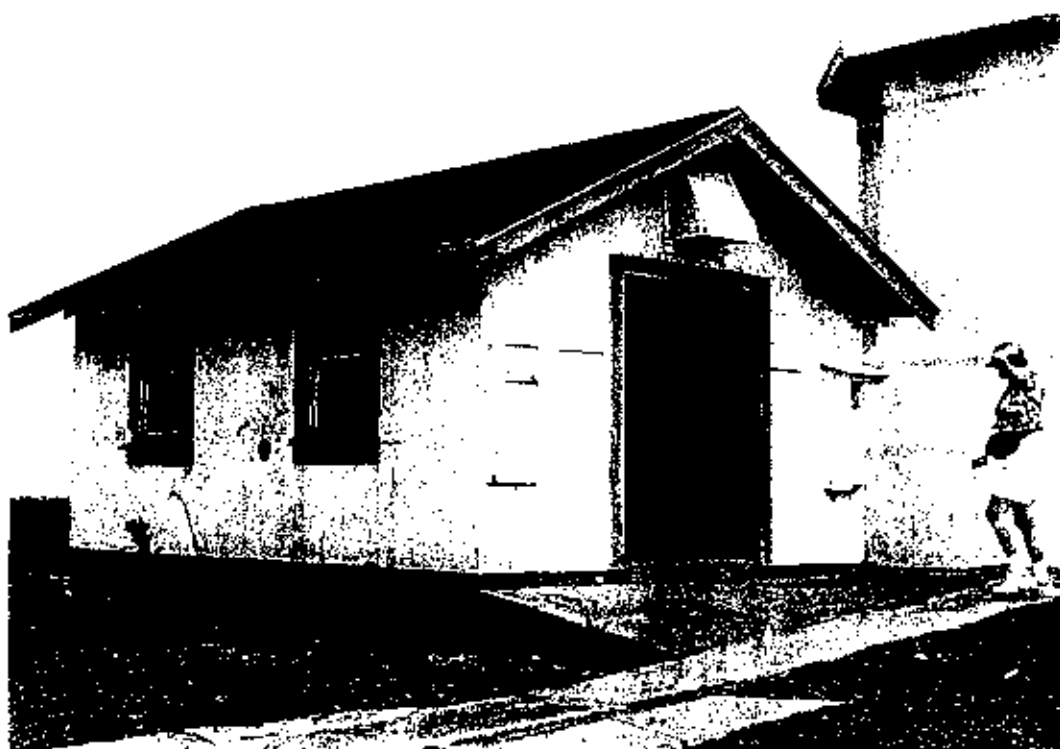
Figure 34. Wood-frame powerhouse (Feature 4), view from west, September, 1999.
Photograph: William Chapman.

The small building is of frame construction, the frame consisting of true 2 x 4 in members, with the upright posts (studs) set about 3 ft on center. There is a horizontal member at about three ft above grade; also a 4 x 4 in sill and top plate. The structure is braced in the corners by 2 x 4 in diagonal members, which interlock with the supporting studs. The structure is attached by metal bolts to the reinforced concrete floor and foundation.

The exterior of the building is clad with 6 in (actually 5 ½ in) vertical siding. The cladding is exposed on the interior. The boards are tongue-and-groove Douglas fir, of the type common in Hawai'i during this period.

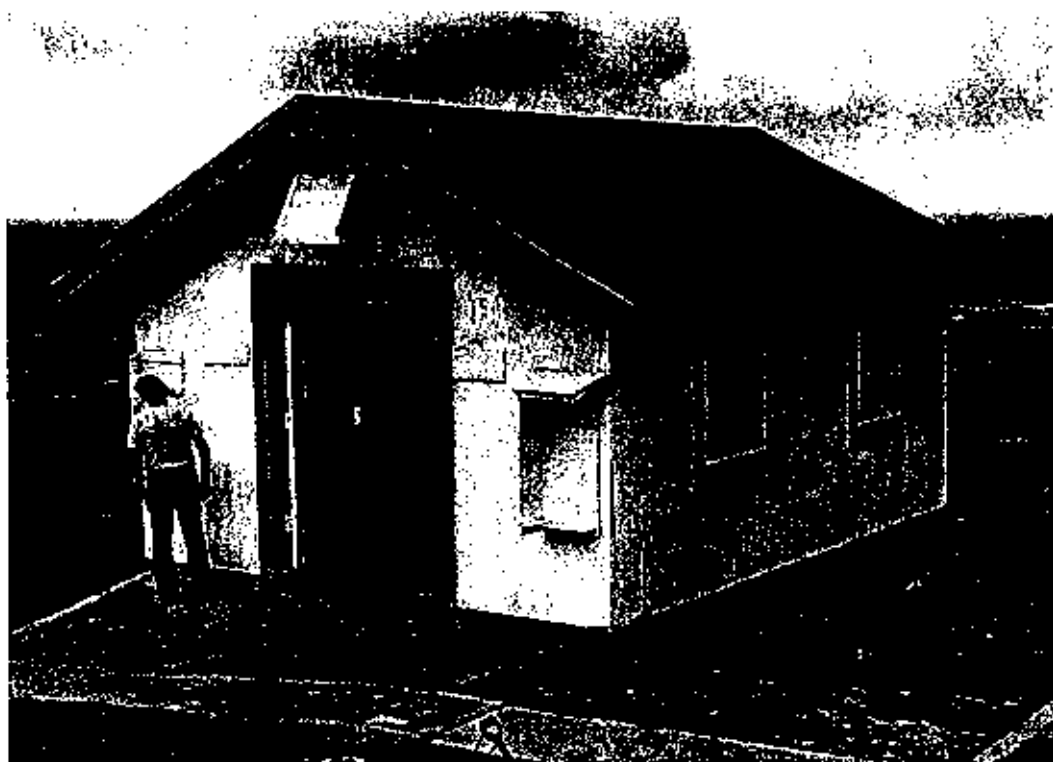
Figure 35. Wood-frame powerhouse (Feature 4), view from southwest.
Photograph: William Chapman.

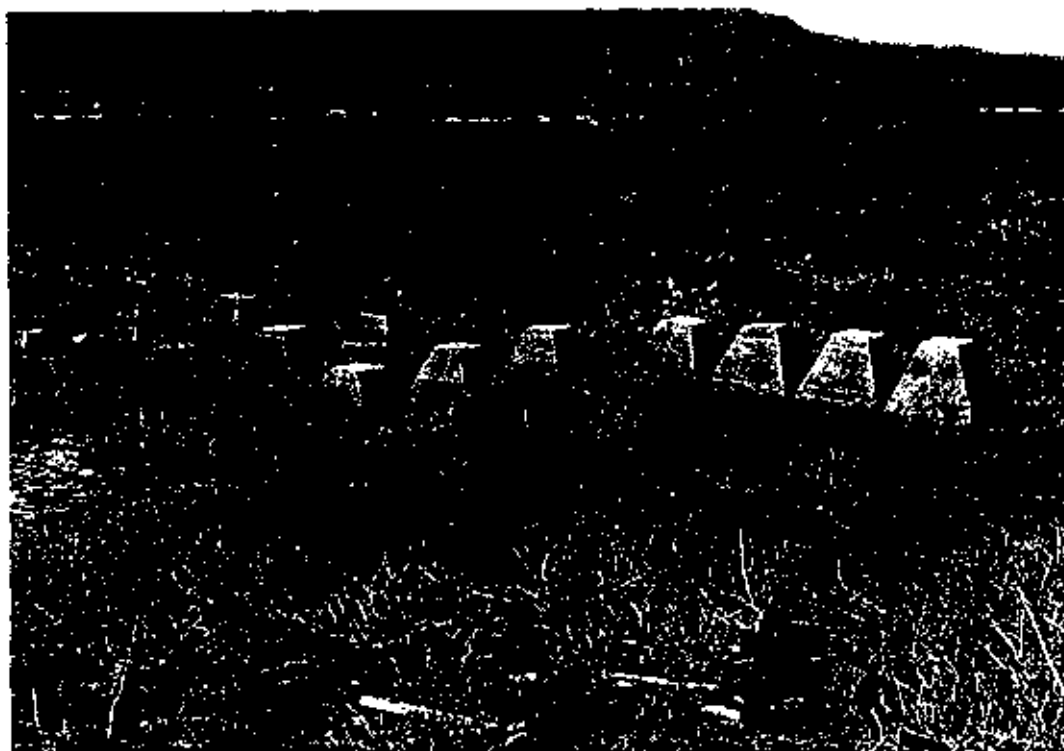
Figure 37. Concrete pier supports for former oil-drum loading ramp (Feature 6), from northeast, September, 1999. Photograph: William Chapman.

A plan of ca. 1950 indicates a broad "I"-shaped structure, with the stem pointing to the southeast. This plan and the present configuration of the piers and other remaining elements suggest that the ramp was inclined on the south side, and that the ramp led to a wood platform on the north.

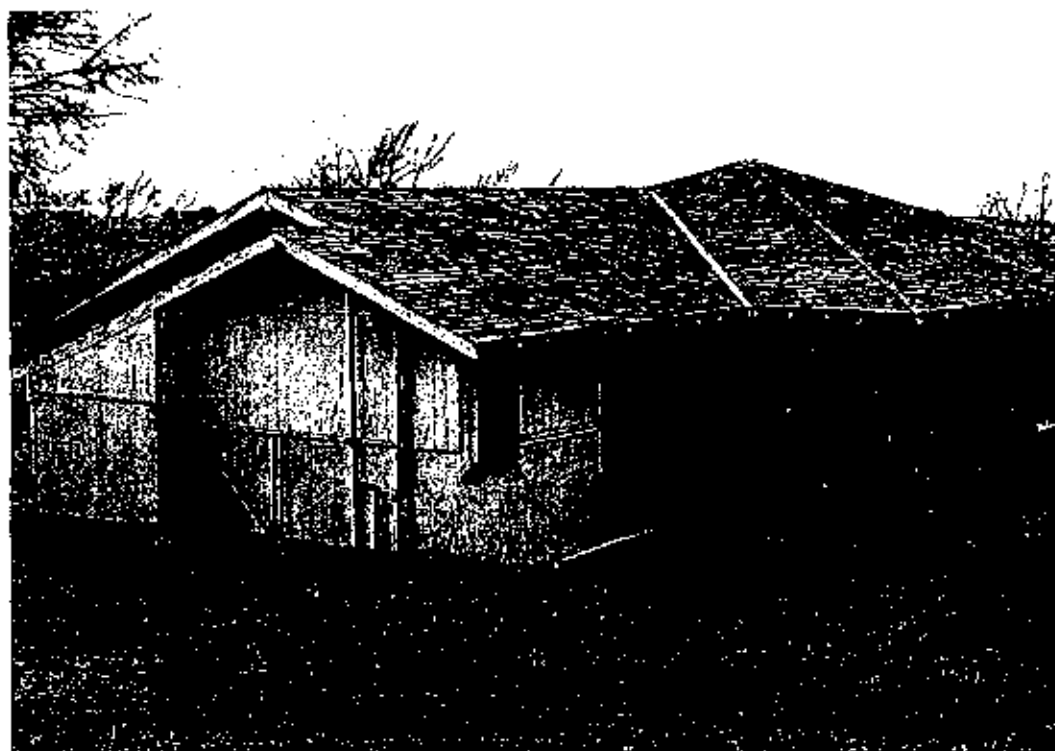
Figure 40. Stone, Principal Keeper's Residence (Feature 7), from east/northeast, September, 1999, Photograph: William Chapman.

a recessed porch, on the west, and a smaller, wood-frame ell across the rear of the building, on the east. Overall dimensions for the hipped roof, one-story house are 30 ft by 30 ft for the stone section and 20 ft 5 in by 22 ft for the wood-frame ell. A small shed addition, measuring about 8 by 3 ft, projects from the southeast corner of the ell.

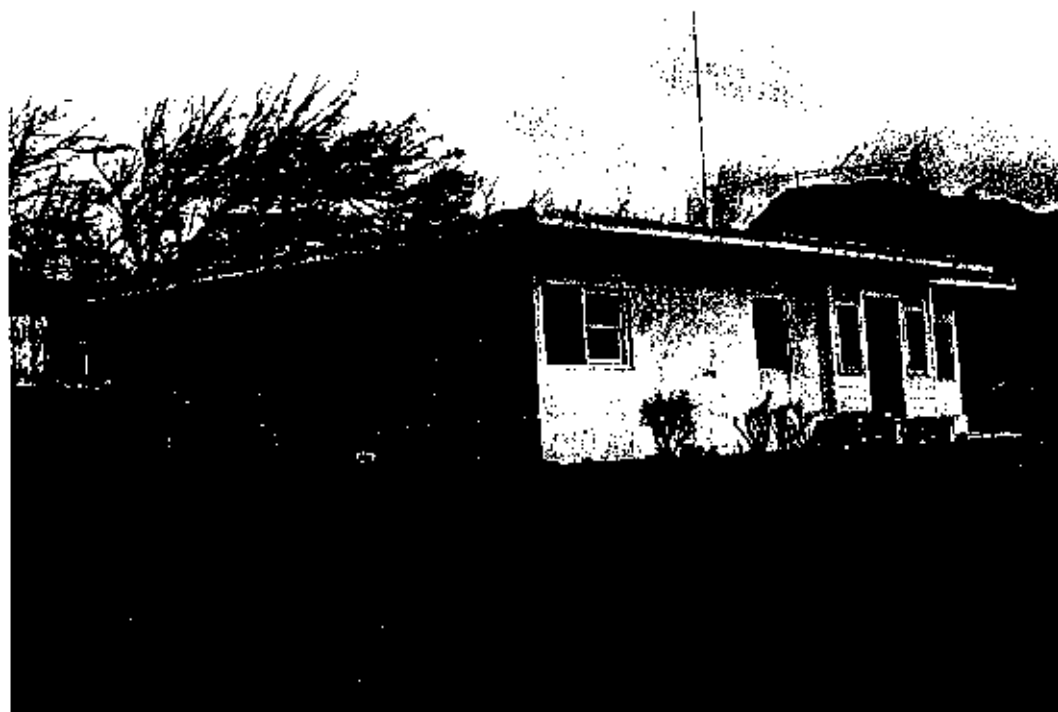
Figure 41. First Assistant Keeper's Residence, later Keeper's Residence (Feature 8), view from northwest, September, 1999. Photograph: William Chapman.

The First Assistant Keeper's Residence is a one-story, concrete-block, flat-roofed building located in the near middle of the historic keepers' compound. Measuring about 30 by 46 ft overall, the house sits on slightly sloping land, which rises toward the rear of the building. Extremely

utilitarian in style, the walls consist of white-painted, and unembellished concrete blocks sitting on a poured concrete foundation. The roof, which is constructed with wood rafters, is cantilevered about 3 ft from the surface of the wall. The eaves are boxed, with a fascia of about 6 in in width running around the building on all sides. The ends of the 2 x 6-in rafters are visible in the soffits. The edges of the roof have 3-in metal flashing; the roof covering is rolled roofing (asphalt), colored a bright white.

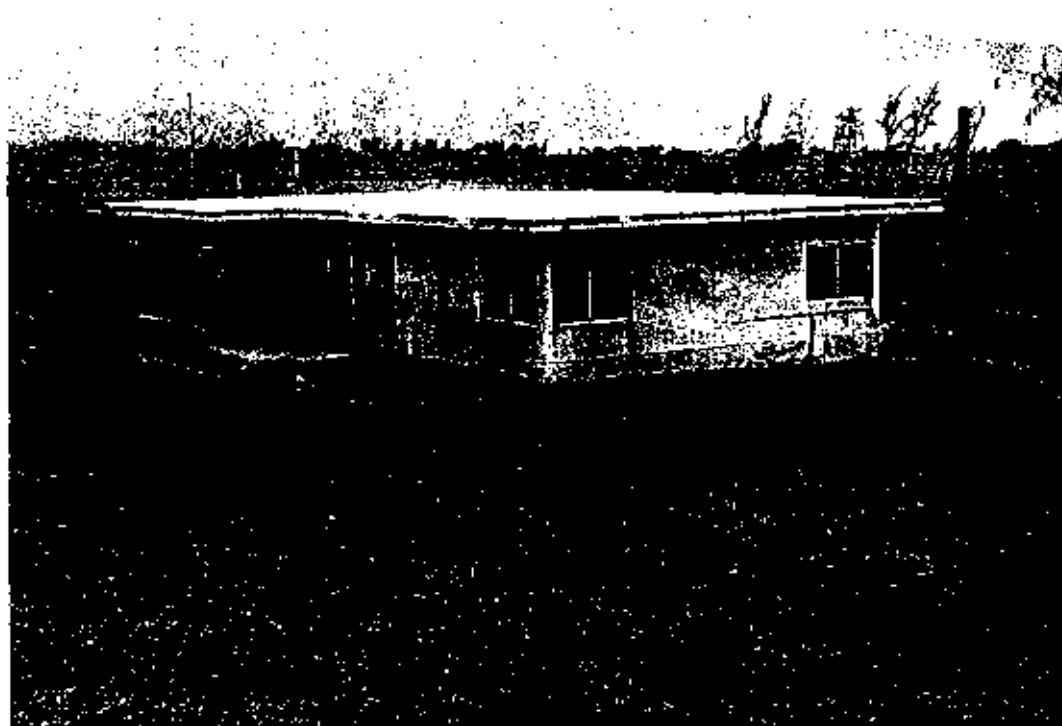
Figure 42. First Assistant Keeper's Residence, later Keeper's Residence (Feature 8), view from northeast, September, 1999. Photograph: William Chapman.

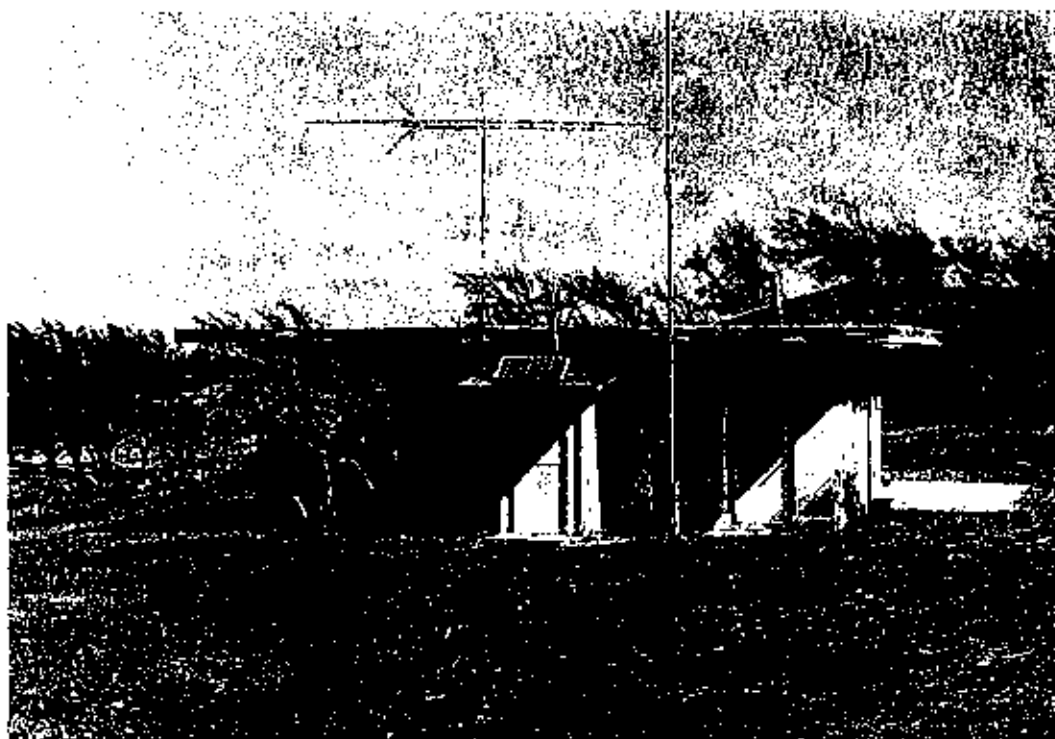
Figure 43. First Assistant Keeper's Residence, later Keeper's Residence (Feature 8), view from south, September, 1999, Photograph: William Chapman.

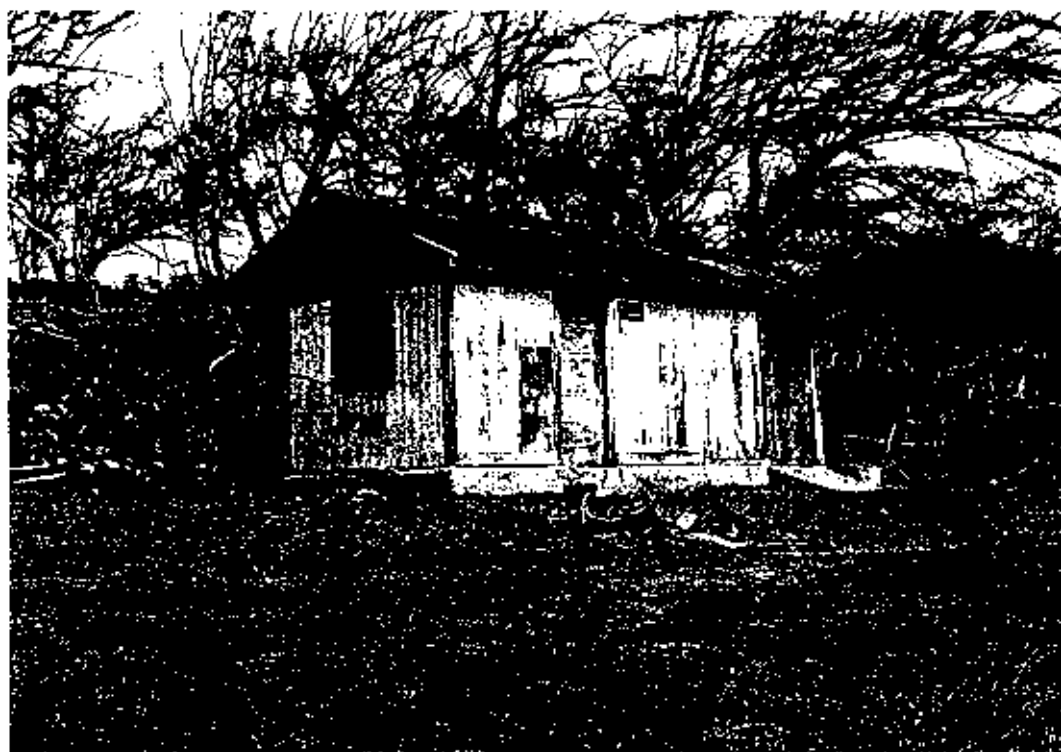
Figure 45. Wash house/Storage shed (Feature 9), view from northwest, September, 1999. Photograph: William Chapman.

The present building is a one-story frame structure, measuring 20 by 9 ½ ft. Constructed of 5-in wide tongue-and-groove vertical boards, with some interior framing members, on the north and of a mixture of 7-in wide vertical and 6-in wide horizontal siding on the later south addition, the structure sits on a poured, reinforced concrete slab, which projects about 2 in from the face of the building. Built on a slight slope, the concrete base extends about 12 in above grade on the west side,

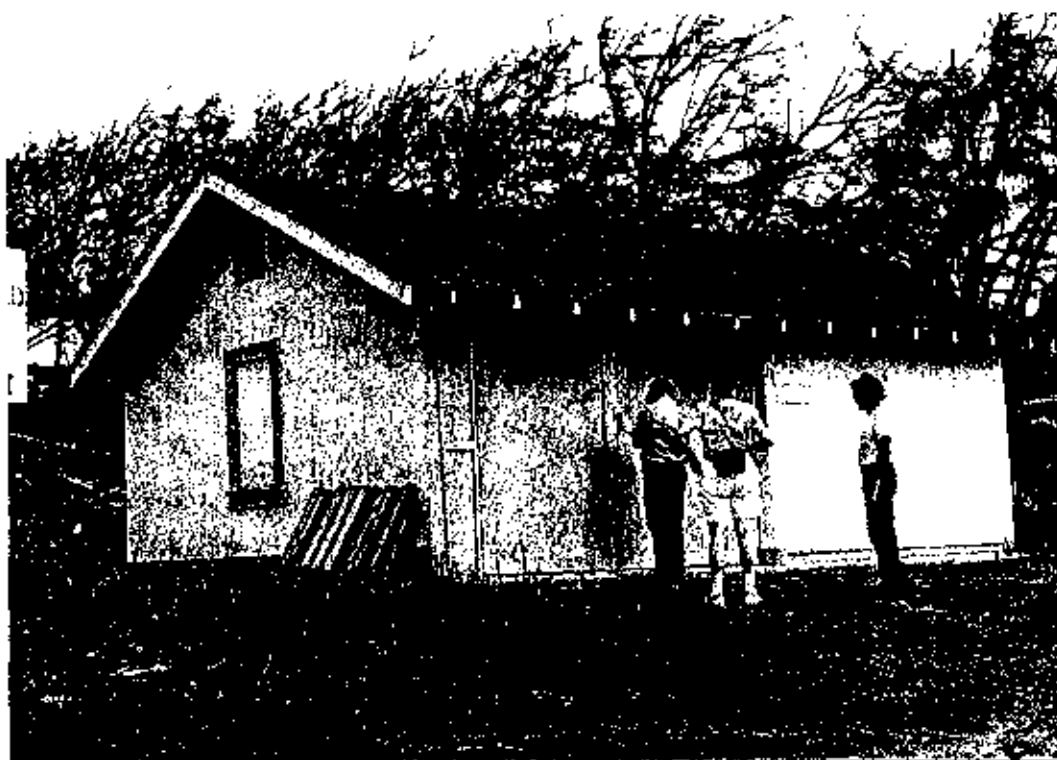
Figure 46. Wood-frame garage (Feature 10), from northwest, September, 1999.
Photograph: William Chapman.

The simple, rectangular structure measures 17 ft 3 in by 25 ft 2 in. It is oriented roughly north and south, following the longitudinal ridge of the gabled-roof. Placed on a concrete foundation and slab, which extends 14 in above grade on the west and 6 in above grade on the east, the building has a simple 2 x 4-in frame construction and is sheathed in 5-in wide tongue-and-groove vertical boards.

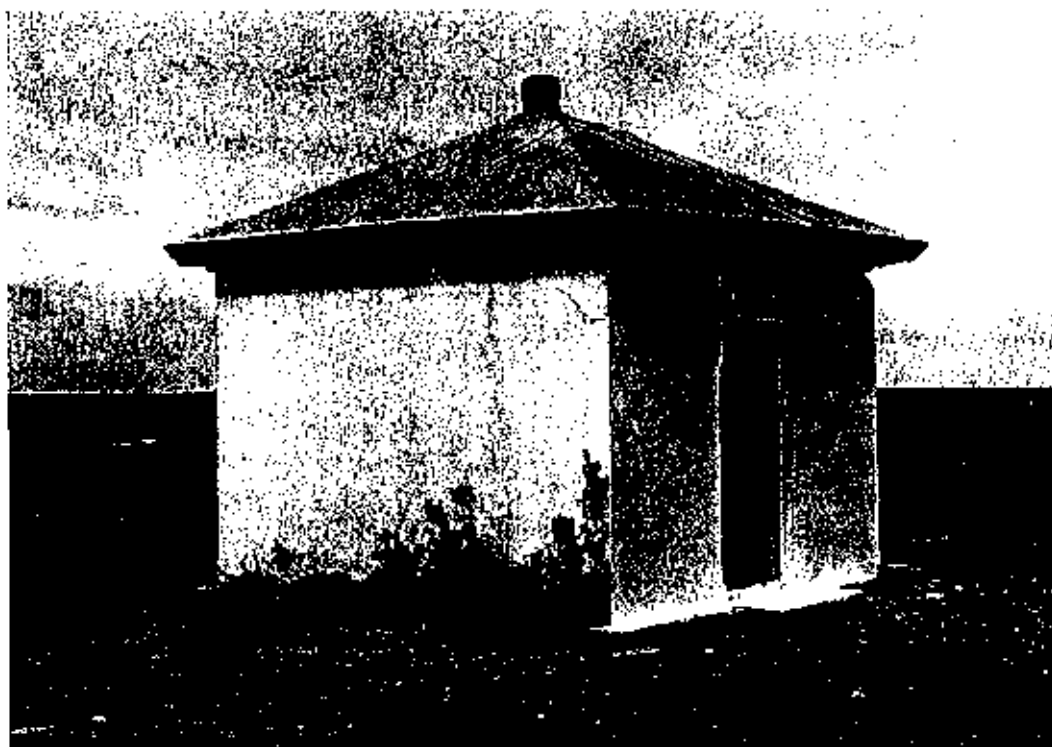
Figure 48. Oil-storage building (Feature 11), view from south, September, 1999.
Photograph: William Chapman.

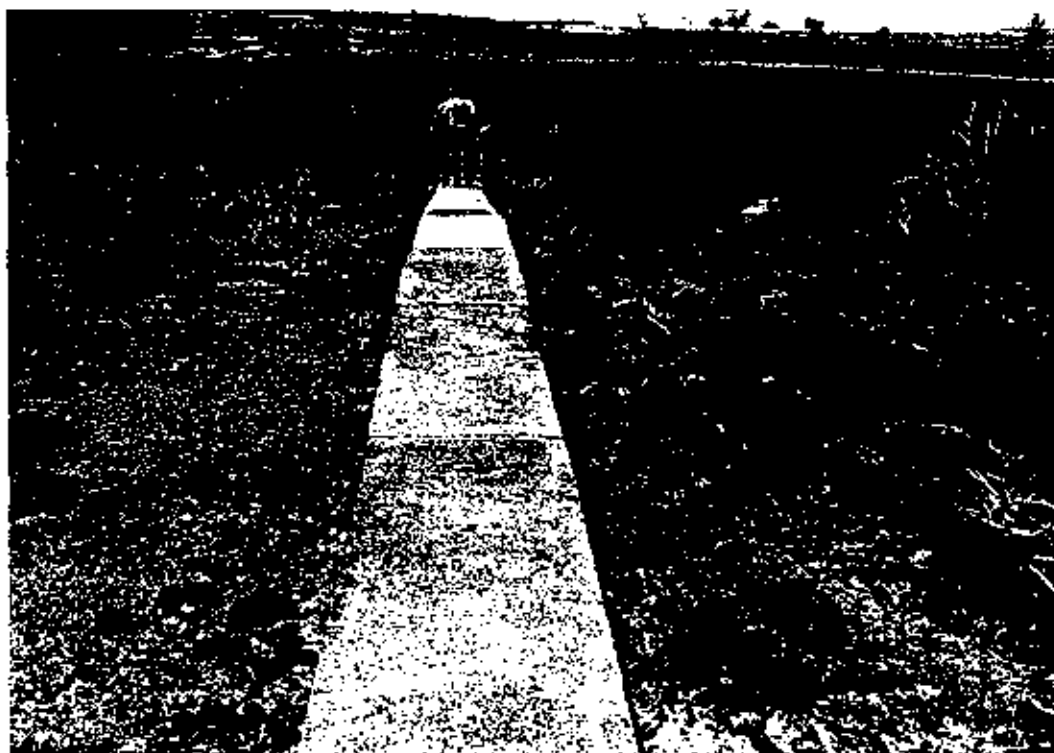
**Figure 50. Concrete sidewalk (Feature 12) from southeast, September, 1999.
Photograph: William Chapman.**

The concrete walkway served as a means of communication between the keepers' compound and the lighthouse tower. Before its construction keepers relied on unpaved paths to carry out their duties. The walk is 450 ft long, beginning at the edge of the keepers' compound and ending at the steps to the lighthouse tower. It travels in a east-southeasterly direction for a distance of 250 ft, then turns eastward for 150 ft, then southeastward for the remaining 50 ft. Divided into 10 ft sections and 32 in wide, the walk is broken by six sets of steps. The first of these is a single step, the next 2 steps, the next 5 steps, the next 4 steps, the next 2 steps, and the last, near the top, 1 step again. Each of the steps is about 6-7 in high and 1 ft deep.

concrete walkway in its middle. Total dimensions are about 8 by 4 ft, not including the 32-in wide walkway.

The concrete has a 3-in smooth edge on four sides of each section. Overall the walkway is in good condition, with some minor settlement and tilting along its course.

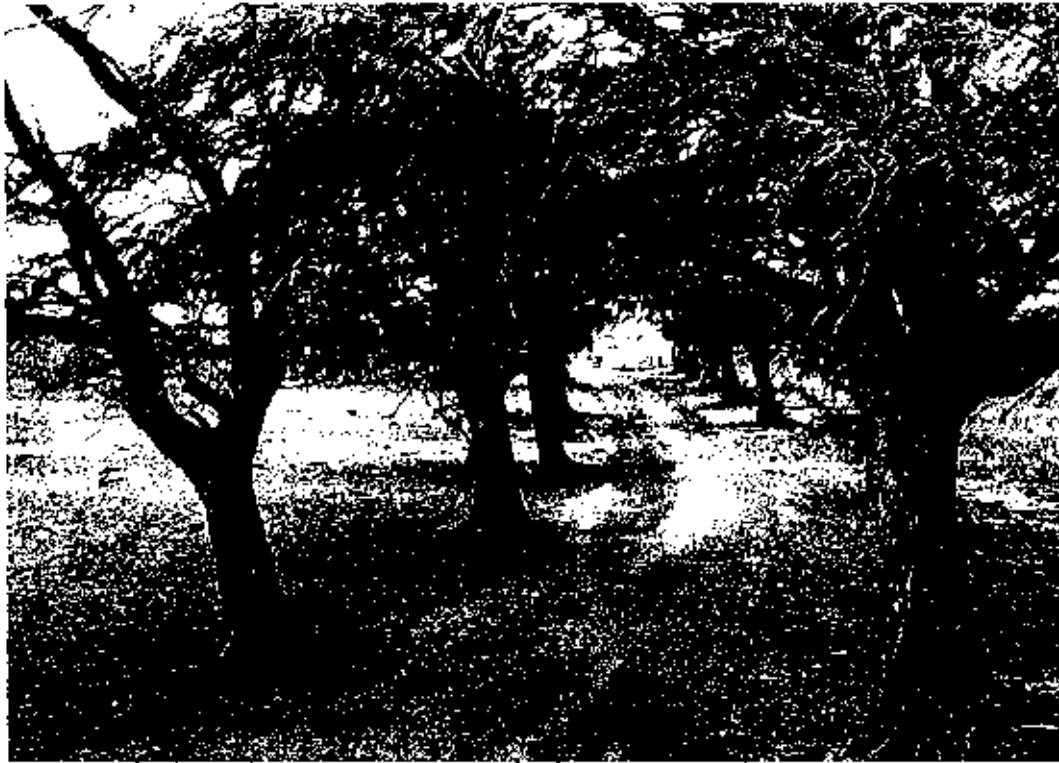
Figure 51. Principal access road and Ironwood trees (Features 13 and 19), view looking west/northwest, September, 1999. Photograph: William Chapman.

The road as nominated to the National Register extends from the northwest edge of the plot in a southeasterly direction, then curves toward the south in a wide arc ending at a point in front of and parallel to the west wall of the keepers' compound for a distance of about 700 ft. Just to the north and west of the keepers' compound the road splits, with one branch going eastward toward the lighthouse tower, then southward to the rear of the keepers' compound.

The road is gravel surfaced and graded. It appears to follow its historic route.
