**Subject:** Altering the Character of Historically Finished Interiors

- Applicable Standards:**
2. Retention of Historic Character
  5. Preservation of Distinctive Features, Finishes and Craftsmanship
  6. Repair/Replacement of Deteriorated or Missing Features Based on Evidence

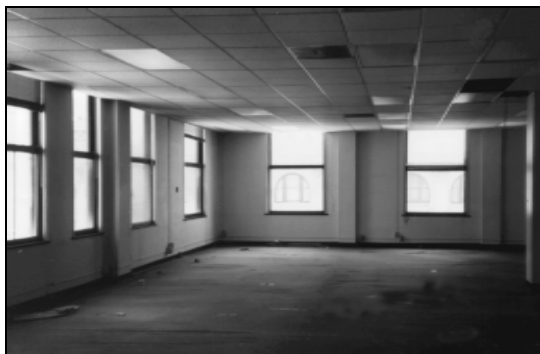
*LEFT: Previously installed suspended ceiling.*

**Application I (*Incompatible Treatment*):** Many historic office buildings, particularly those built for speculative reasons, undergo many interior changes as new tenants or owners change and update these buildings. The addition of suspended ceilings, as shown in this 1980s remodel of a 1915 office building, has been a common treatment ever since new forced air-conditioning systems began to be installed. Commonly, the original plaster ceiling finish in these buildings was installed using wood or metal lath fastened directly to the underside of the floor structure. The addition of a new suspended ceiling is frequently used to conceal the often bulky and complicated new systems and to provide a continuous, finished ceiling. Unfortunately, the new ceilings are not always installed in a manner that respects the historic character of the space.

When a previously installed suspended ceiling is removed as part of a rehabilitation project, the owner must either restore the original ceiling finish, or install a new ceiling that is compatible with the historic character of the building. The removal of a non-historic feature without appropriate replacement of the feature does not meet the Standards, especially in cases where the element or feature removed helps to define the original character of the space. After rehabilitation, the interior space shown in the 1915 structure illustrates the drastic change in character the space has undergone by exposing the underside of the upper floor structure and leaving the new systems exposed. Even though the original windows and historic plaster finish along the perimeter walls are still there, the character of the new interior is in contrast with the character of this historic office building which features a classically detailed masonry exterior. To meet the Standards, a new finished ceiling concealing the structural system would have to be added and the ductwork installed either above the new ceiling, or within a new soffit.

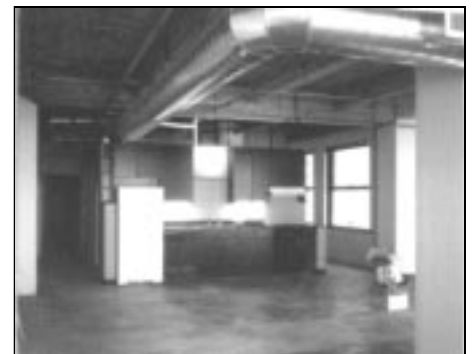
*RIGHT: Photo of another area in the same building after rehabilitation. Notice how the exposed concrete floors further add to the “warehouse loft” appearance.*
