THE FORTIFICATIONS OF SAN JUAN NATIONAL HISTORIC SITE

HISTORIC STRUCTURE REPORT

El Fuerte de San Cristóbal

1991

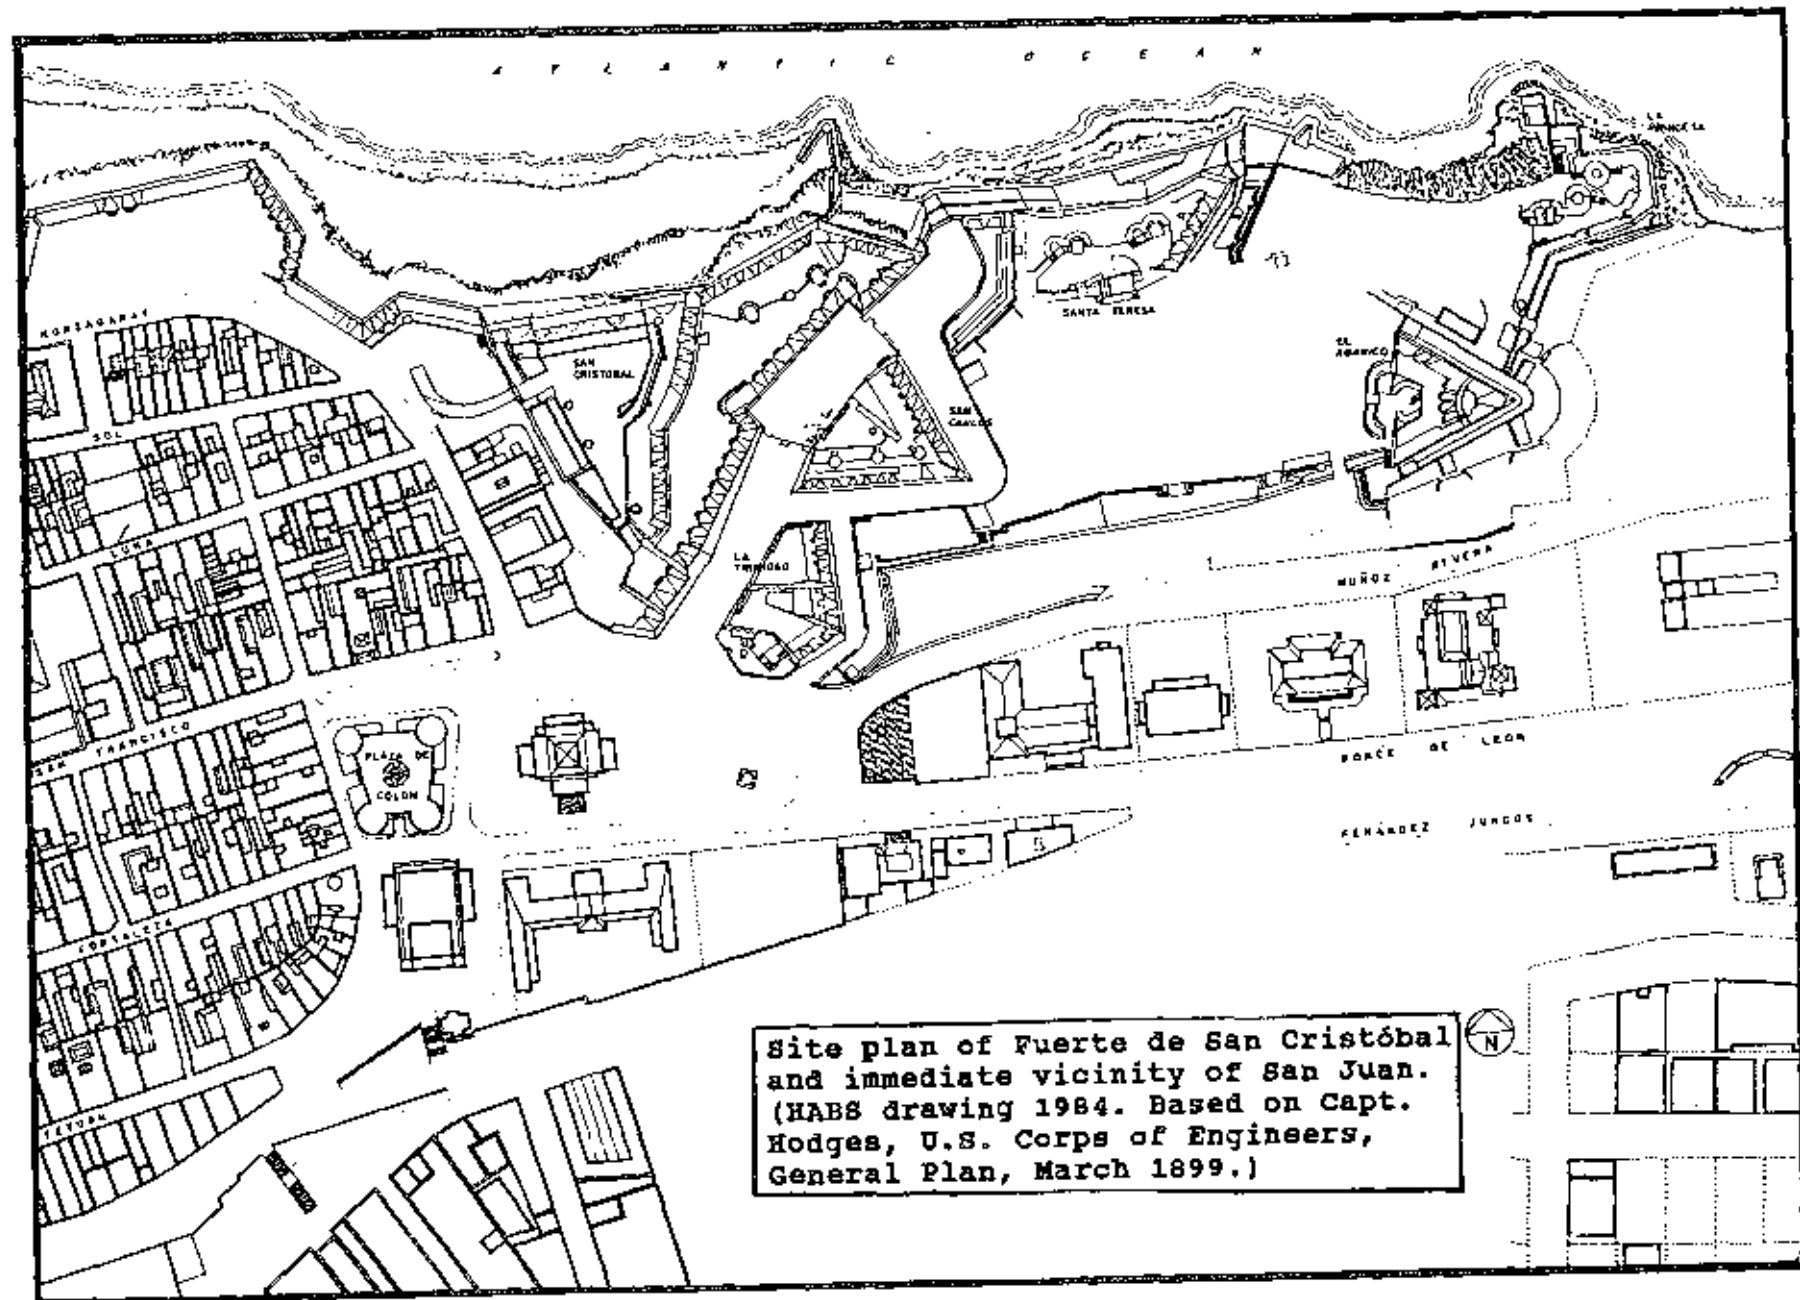
Site plan of Fuerte de San Cristóbal and immediate vicinity of San Juan. (HABS drawing 1984. Based on Capt. Hodges, U.S. Corps of Engineers, General Plan, March 1899.)

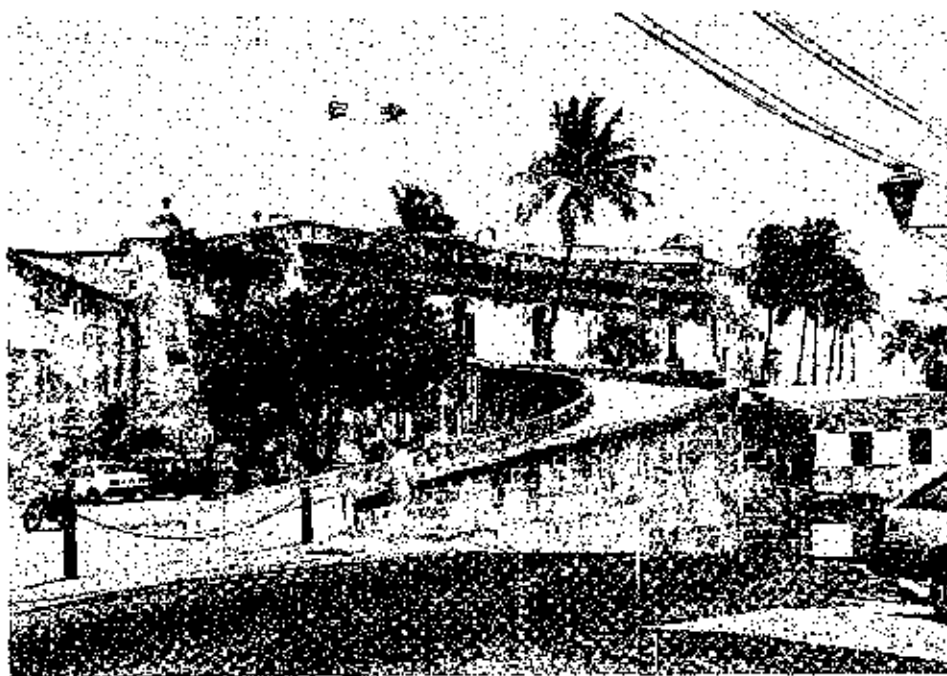
1.1. Main Gate and entrance ramp to San Cristóbal. (Photo by CPR, 1986.)

The main section of the fort of San Cristóbal is accessed by a long, curved, gently sloping ramp and its associated Main, or Principal Gate located at the west wall (fig. 1.1). The flat area on the north side of the ramp is utilized as a parking lot, bounded on the north by a modern brick retaining wall containing remnants of the original parapet wall. Remnants of an earlier low brick retaining wall survive directly in front of the west wall. The area on the south side of the ramp is a grassy strip bounded on the east by the cistern arcade below the Officers' Quarters and on the south by quarters 208 and 209. One of Old San Juan's main streets, Calle Norzagaray, runs perpendicular to the Main Gate's ramp on a north/south axis west of the entrance.

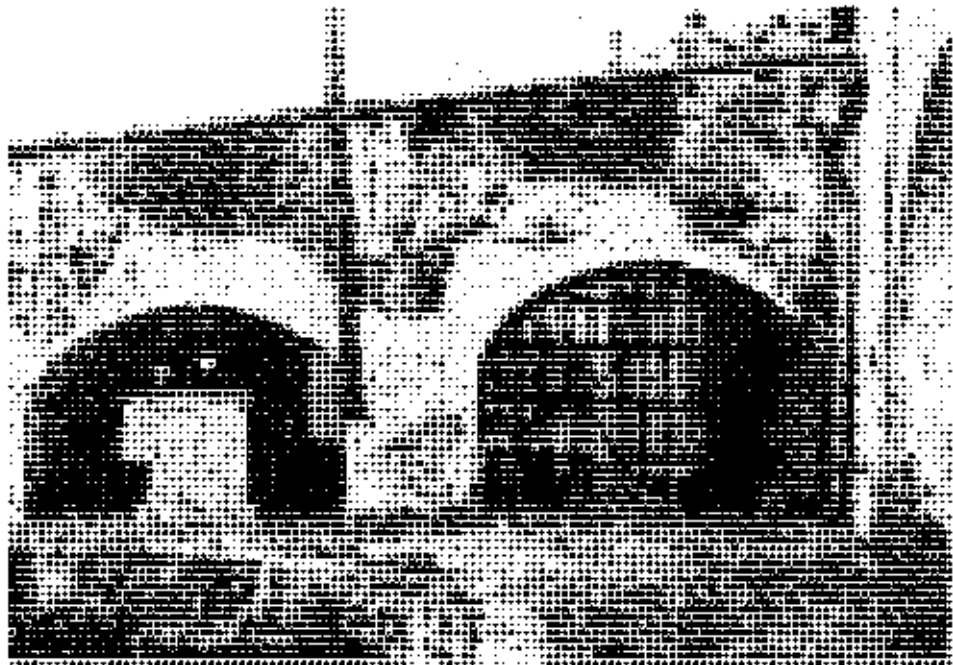
Figure 1.3. Two elliptical barrel vaults punctured on the north and east faces. Photo by Mrs. L. H. L.

of the ramp are two elliptical brick barrel vaults (Nos. 1 and 2). The western vault (No. 2) is now infilled on the north face (fig. 1.3). This rubble infill has in turn been punctured by a large rectangular opening and two smaller openings to the west. The east vault (No. 1) is larger and only

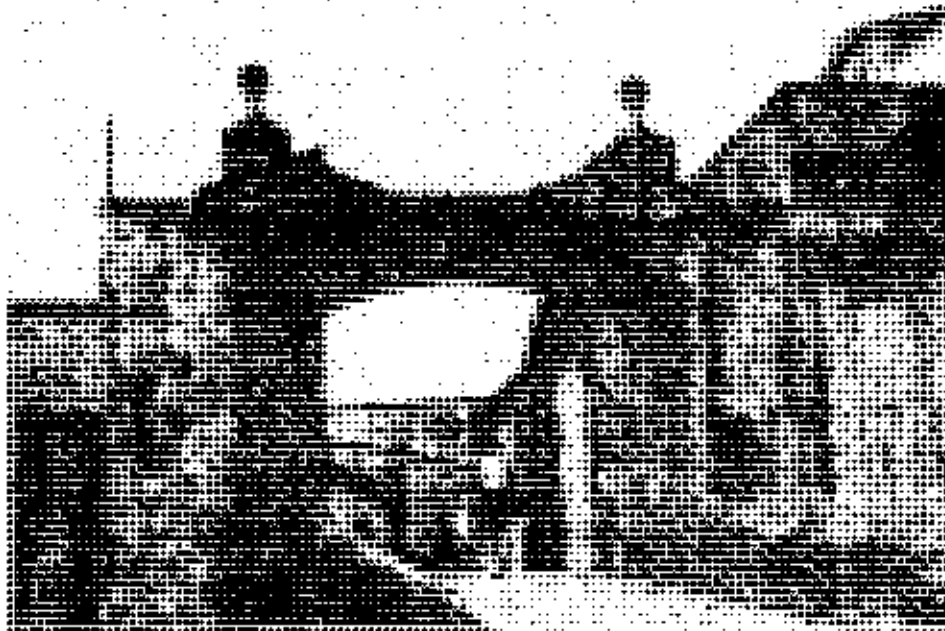
Figure 1.4. East elevation of Main Gate to San Cristóbal. (Photo by CPR, 1986.)

The portal of the Main Gate (fig. 1.4, 1.5, 1.6) is architecturally the most elaborate of the present gateways and is distinguished by a Tuscan order frontispiece. The segmental arched entryway is flanked by single pilasters supporting a full entablature surmounted by a broken pediment with pedestaled finials. On the frieze, centered above the entryway, is a carved scallop shell. Decorative carving is also found in the lobed ball finials rising above the broken pediment on a delicate neck and cushioned base supports. The frontispiece is of ashlar and appears to have been carved in place judging from the extension of the blocks into the coursed rubble walls to the north and south, and the close

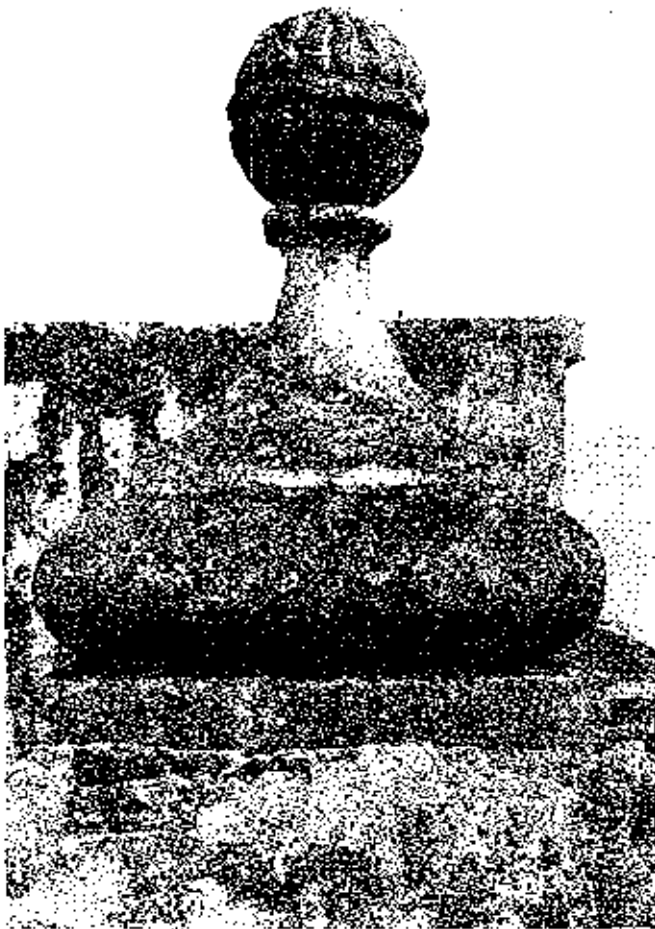
Figure 1.6. Carved finial on Main Gate's post. (Photo by CFR, 1986.)

The finial assemblies are carved from a single piece of stone and rest on stuccoed brick pedestals. The stone work of the front (west) elevation carries to approximately half the depth of the gate. The soffit reveals the interface of the front stone masonry with the stuccoed brick construction of the rear elevation.

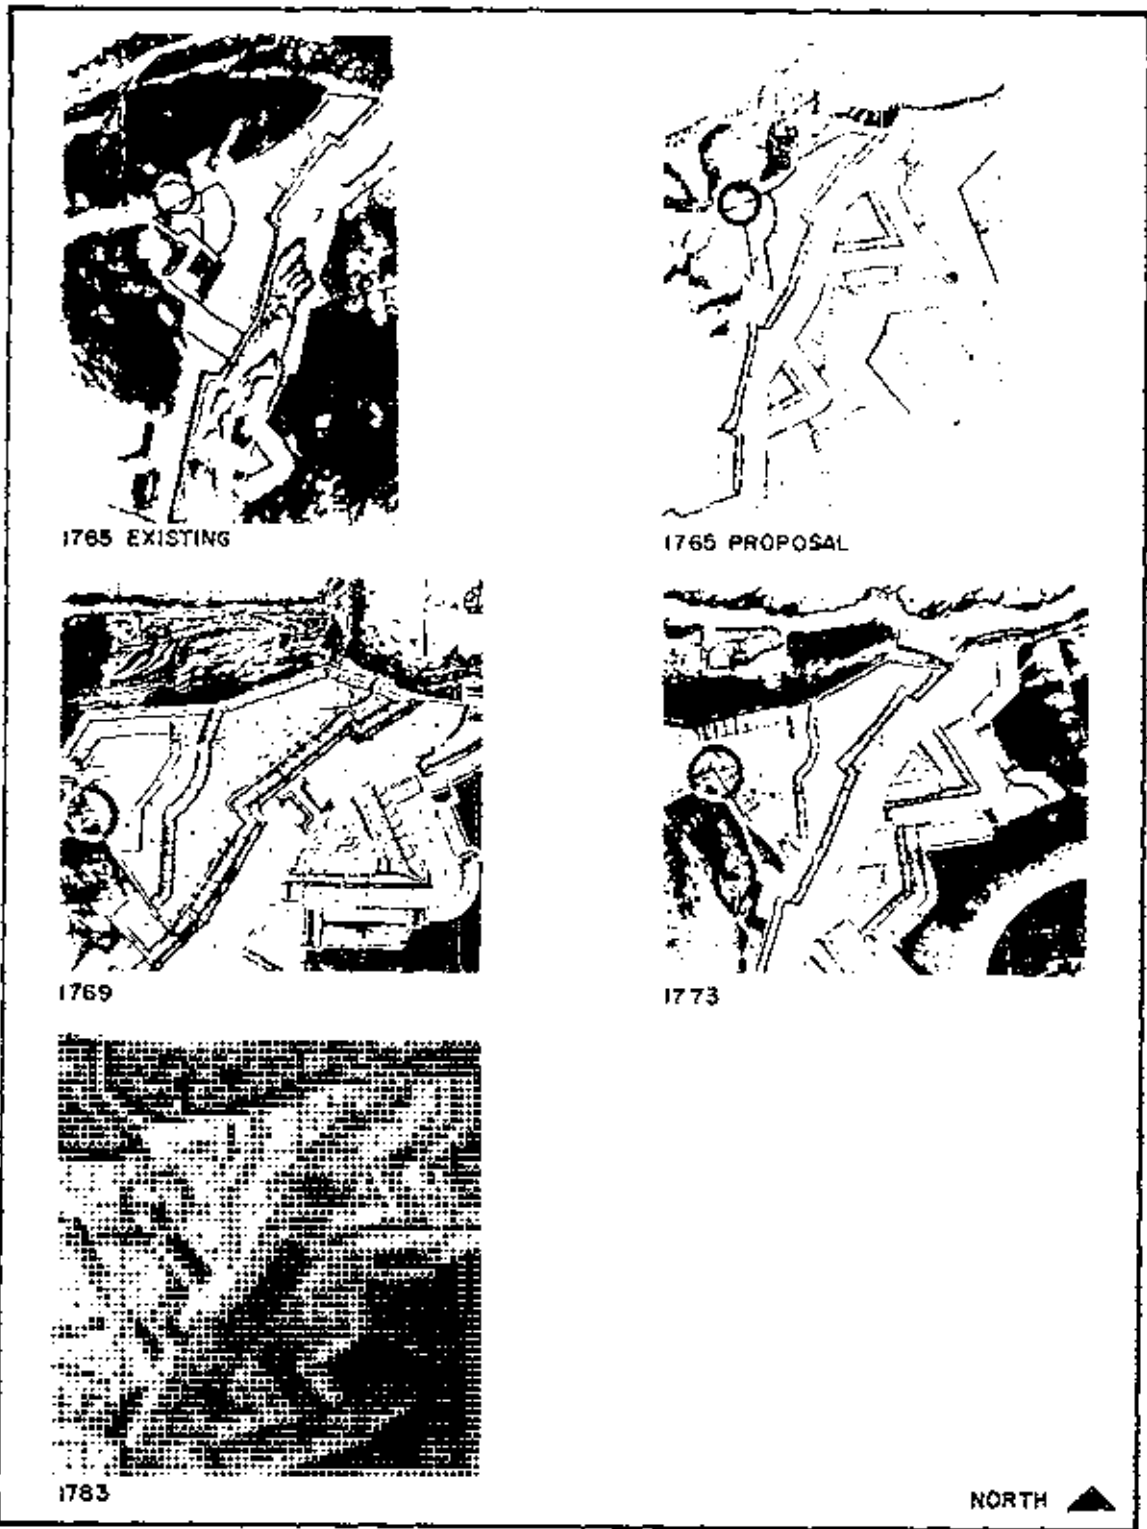
Figure 1.7. Early plans of San Cristóbal. Orientation of main entrance circled.

Both O'Daly's existing conditions and proposed modernization plans of 1765 for San Cristóbal indicated that the principal entrance to San Cristóbal was situated on the north. However, by 1769 he had relocated the entrance. The 1769 plan showed a broad straight-run ramp and two post gate on the west on axis with the three proposed cisterns below the Plaza de Armas. O'Daly's plan of 1773 retained this location even though the cisterns were redesigned and oriented on an east-west axis. Mestre's plan, and the associated copy drawings of 1783, located the west gate and ramp in their present location just north of the 1774 block of the Officers' Quarters, though the straight configuration of the ramp curved in a northerly direction. (See fig. 1.7 for details on all the above-mentioned plans.)

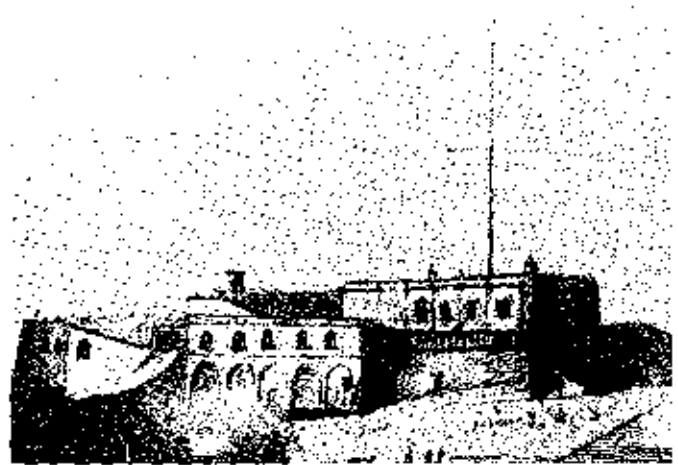
Figure 1.10. Detail of sketch by August Plee, ca. 1821, showing east elevation of San Cristóbal.

The first known representation of the pedimented gate appeared in a sketch by August Plee⁴ executed in ca. 1821 (fig. 1.10).⁴ During the early-nineteenth century, repairs were made to the ramp (1829), and in 1832 a temporary structure was installed atop the pediment.⁵ Known as a "telegraph", this wooden structure supported flags, fireworks, and other ceremonial regalia commemorating the birth of Isabel the Second. The evidence for this framework can still be

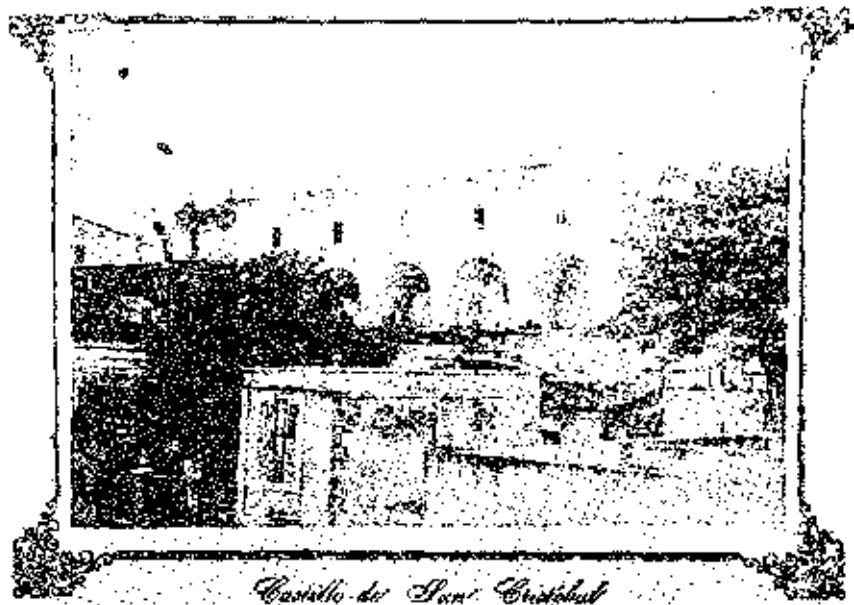
Figure 1.12. Early view of Officers' Quarter showing west elevation including a portion of Main Gate, ca. 1885-1900. (San Juan NHS Archives.)

Photographic views of the Main Gate and Entrance Ramp from 1884-1912 showed few alterations from 1861. (See fig. 1.12, 1.13.) By this time the secondary picket gate and buttressed posts were removed as well as many of the lower ramp posts. Only the picket fence at the base of the ramp was retained, though in an altered form. The two lower

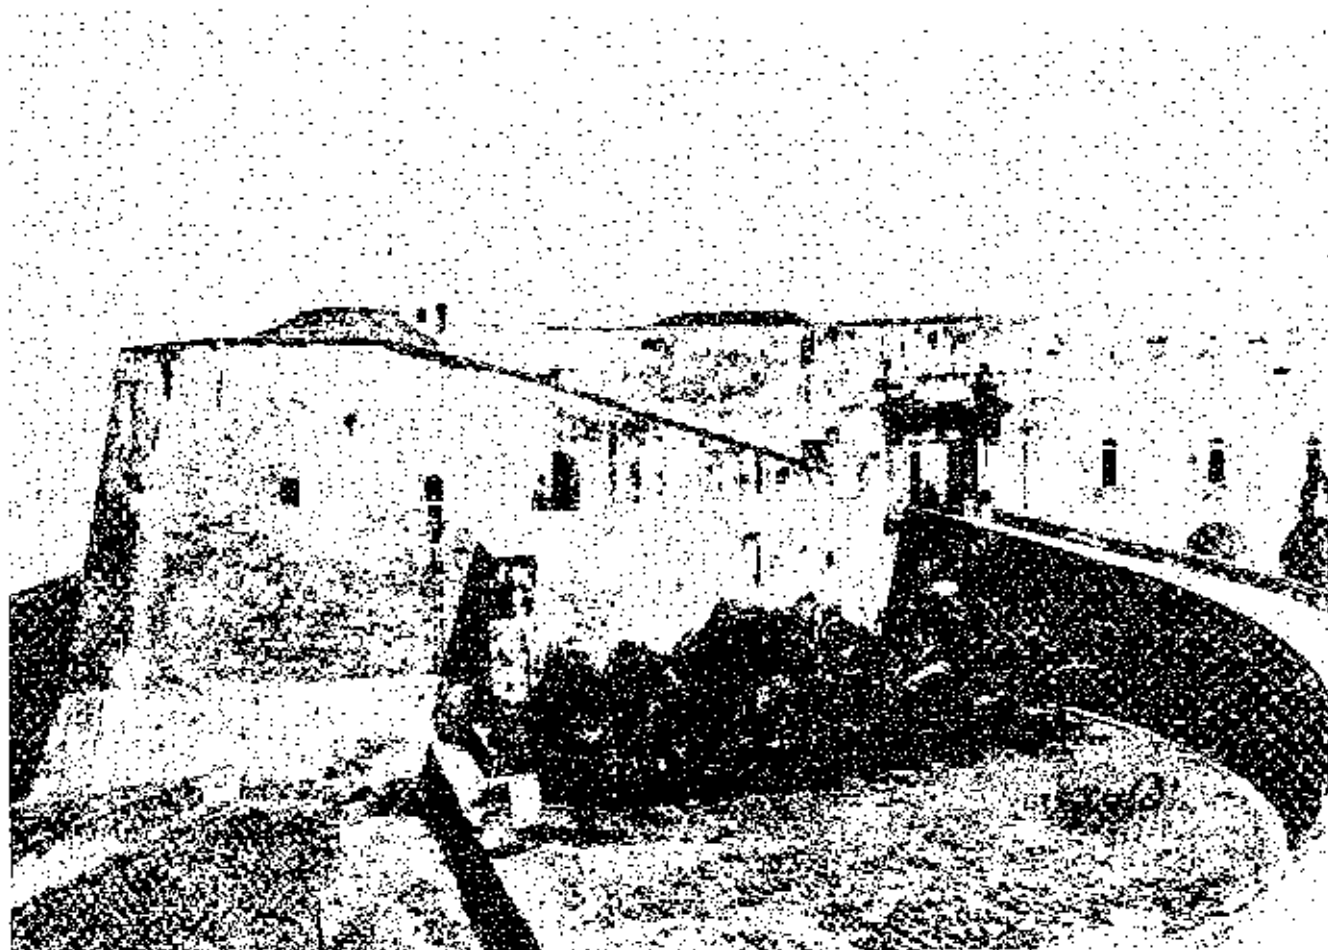
Figure 1.13. West elevation of North Casemates and Main Gate, ca. 1899-1912. (Photo, San Juan NHS Archives.)

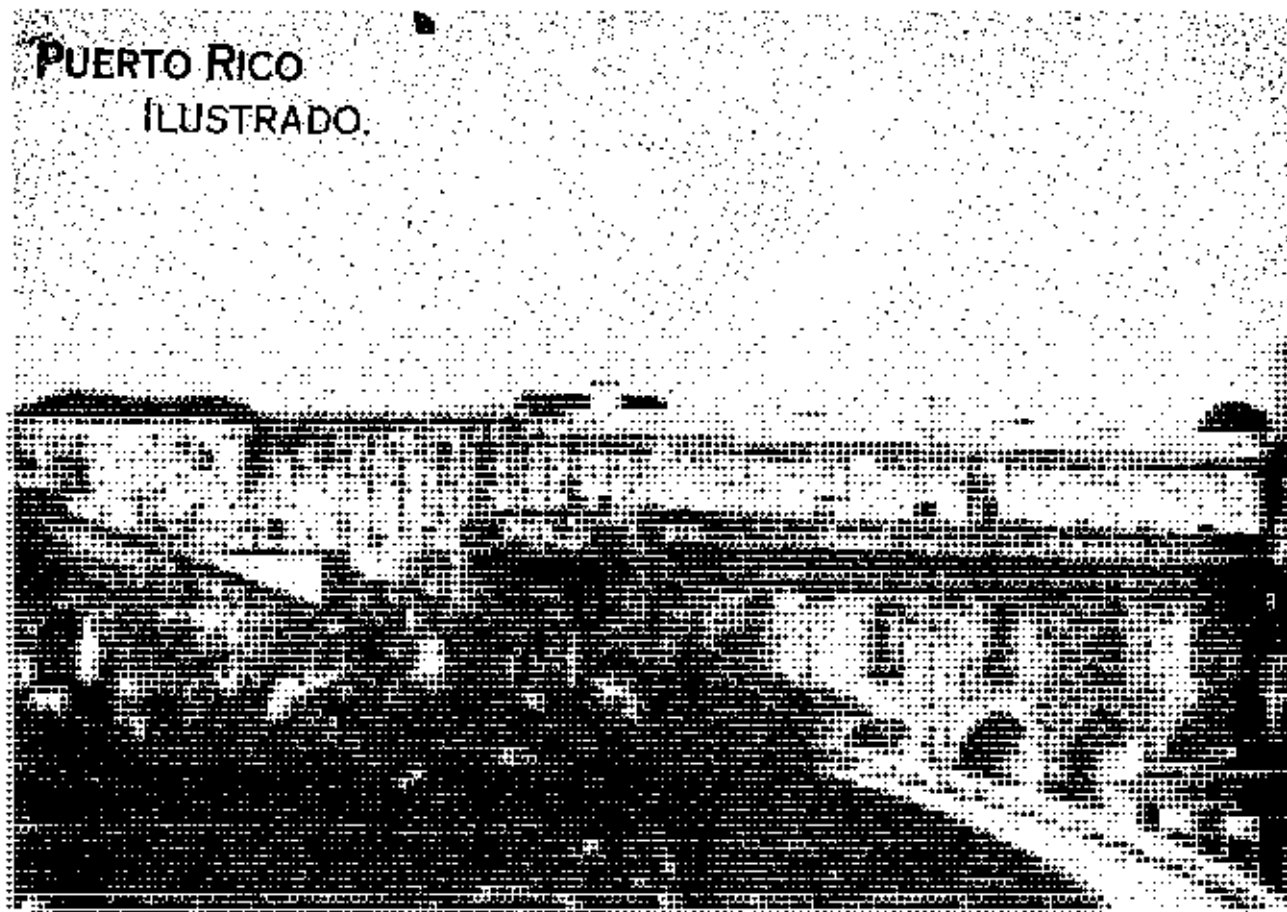
Figure 1.14. Photograph from the *Cronica*, August 12, 1912, showing west elevation of the fort. (San Juan NBS Archives.)

posts were now fitted with a new gate and capped with four cannonballs. The north quadrant adjacent to the ramp was clearly planted during this time with trees and possibly crops. By 1904 a temporary shed structure was constructed adjacent to the ramp's eastern arch on the south side. Also around this time, the floor of the ramp appears to have been resurfaced (1901). Documents record at least three repavings, the earliest being done in 1901. At that time the ramp was described as being "in bad condition due to traffic picking out the concrete of which it is composed".⁷ Also in 1901, side gutters were installed and a wooden rail fence, presumably to keep animals out of the fort garden, was erected within the north quadrant. A photograph from 1912 (fig. 1.14) indicated that by this time, the ramp's picket fence was replaced, the

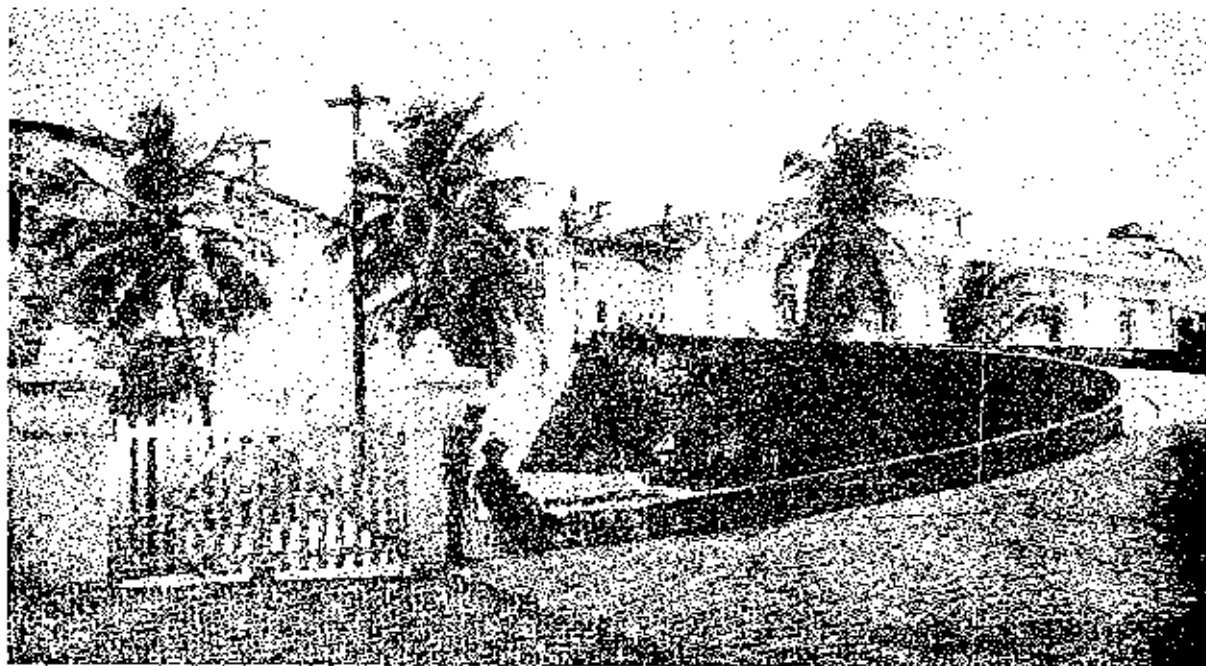
Figure 1.15. View of entrance ramp and Main Gate, ca. 1939. (HABS negative 181.178.)

A brick retaining wall fitted with a reconstructed cast stone sentry box (1939-40) was built to the north of the enlarged parking area. Photographs of 1938-40 (fig. 1.15) indicated that the slatted wooden transom and solid wooden gate of the Main Gate were removed by this time.¹⁰ The north face of the eastern arch (No. 2) beneath the ramp also appeared closed off, possibly infilled along with the south face in 1861.

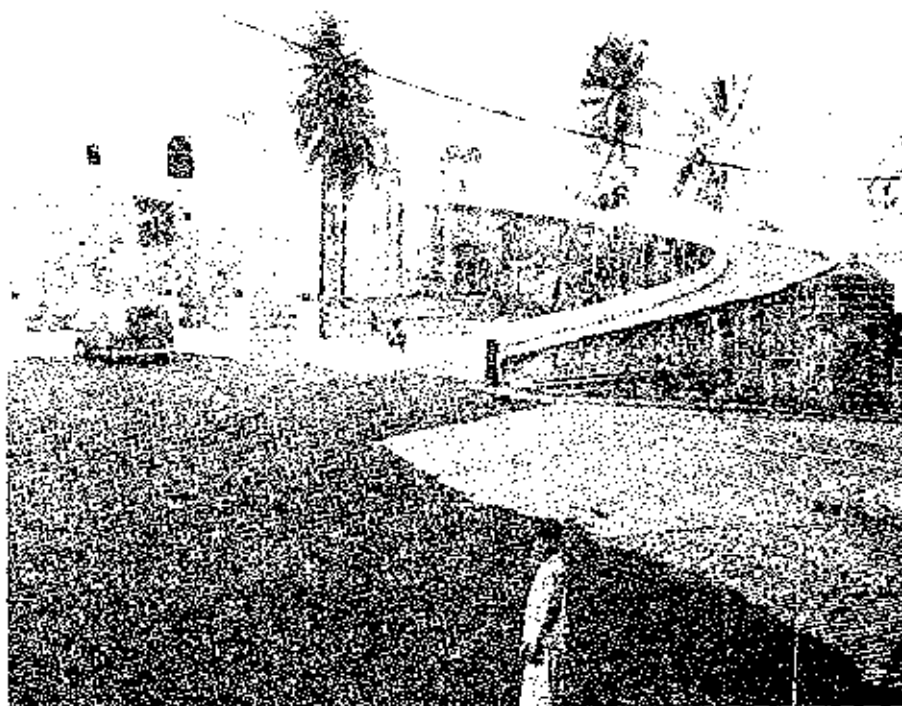
Figure 1.16. View of entrance ramp and Main Gate. HABS photo by Jack Boucher, January 1960.

Photographs from the 1960s provide the first views of the altered ramp, the modified section of which appeared to have been scored in an imitation of the ramp's earlier finish. On the south face of the ramp the truncated remains of the original ramp were left in place. It is likely that at this time, the recessed water channels along the parapet walls were infilled, levelling them with the ramps' central portion and altering water flow and drainage systems. Also visible in photographs were modifications to the gate posts at the bottom of the ramp (now topped with a single cannon ball). They were moved some 90 degrees to the east. A new asphalt parking lot was created in the north quadrant by filling the terreplein of the area. A new retaining wall terminated the newly repaved ramp. The Main Gate was fitted with a modern chain link gate (fig. 1.16).¹¹

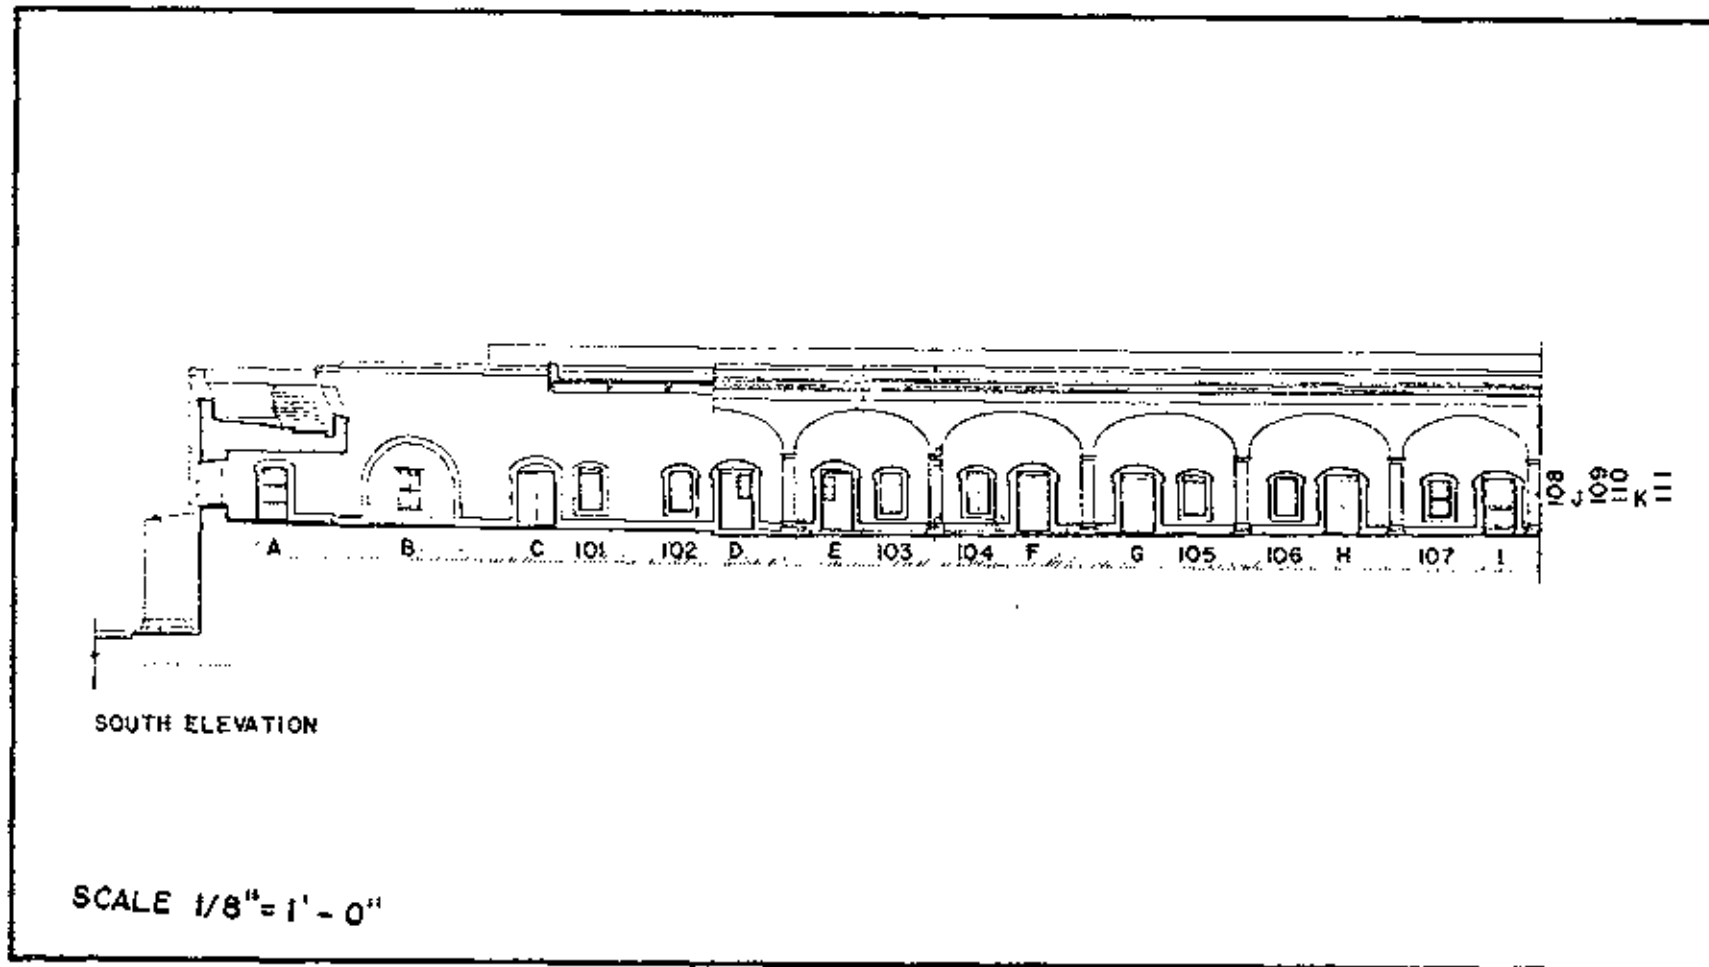
Figure 2.1. South elevation of North Casemates with window and door openings labeled, as drawn by KABS (1963) and annotated by Jana Gross (1989).

The main portion of the south elevation (fig. 2.1) is characterized by a regular arrangement of doors and windows. Doors D and E seem to be original and have an upper, adjustable, louvered opening. The door reproduction hardware is modern. Door architraves match those of window openings 101 through 107.

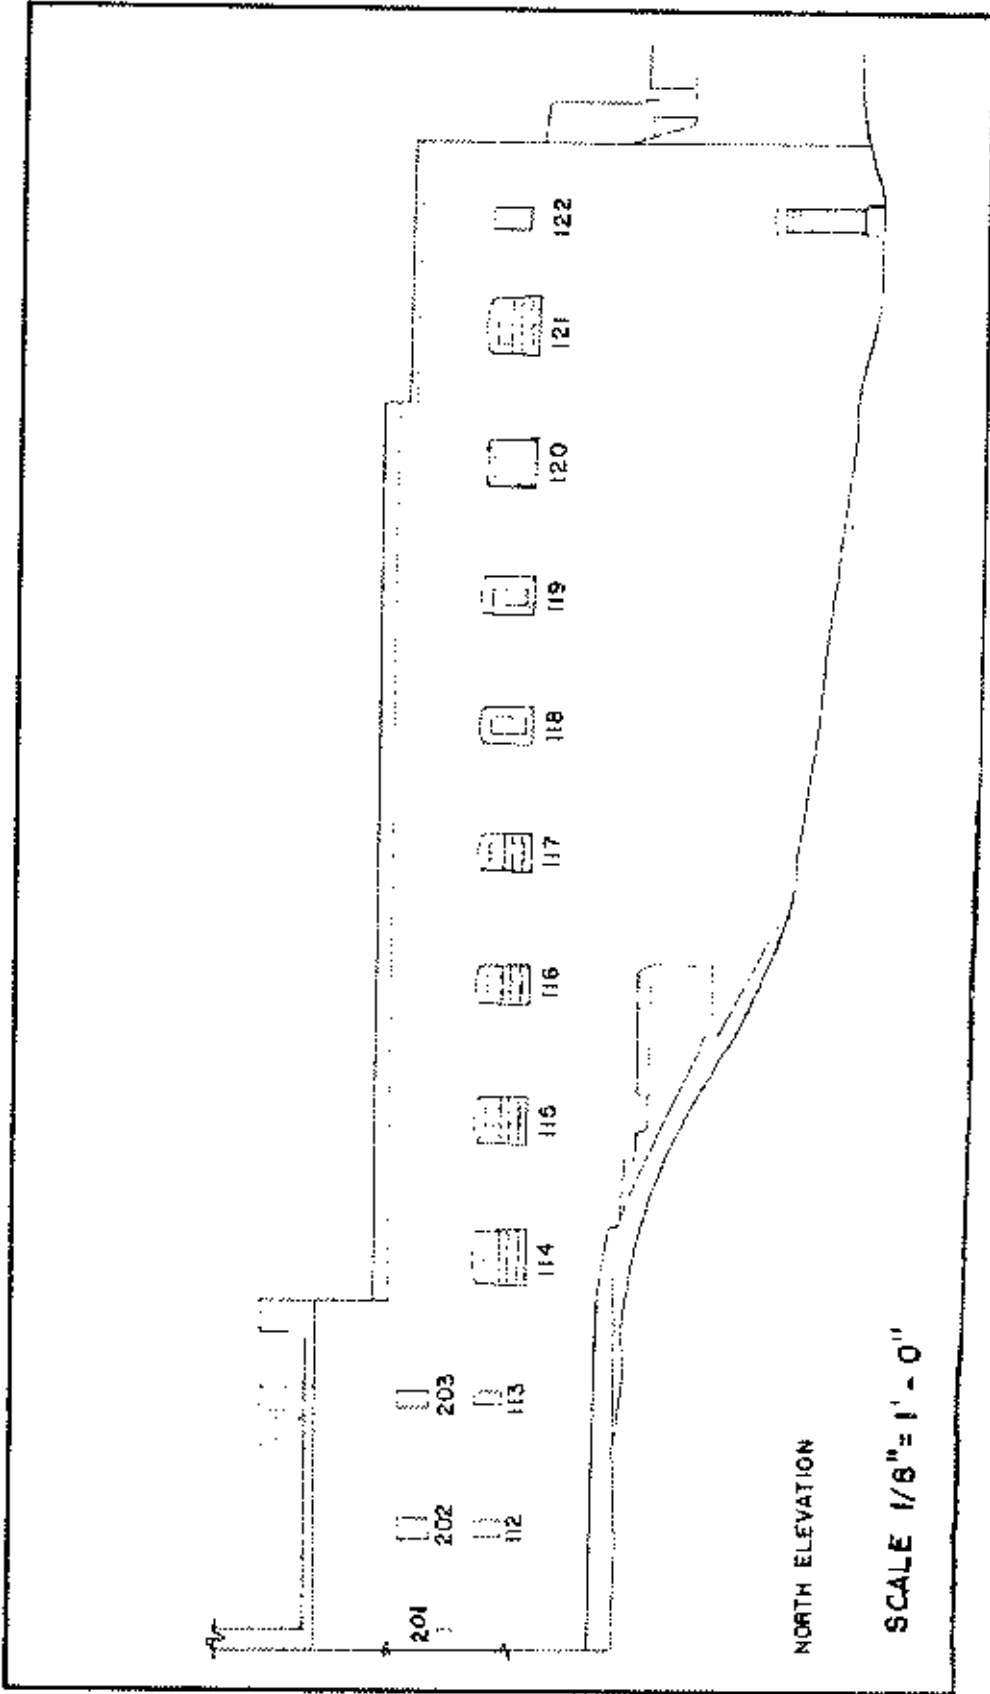
Figure 2.2. North elevation of North Casemates with window openings labeled as drawn by HABS (1963) and annotated by Jan Gross (1989).

The north wall (fig. 2.2) is one of the most impressive features of San Cristóbal. Extending a distance of over 208 feet, the battered wall rises to a height of 49 feet at the northeast and 79 feet at the northwest corner. Its sloping parapet is stepped up to protect its double gun emplacement. Almost the entire wall is of uniformly dimensioned ashlar.

Fourteen window openings pierce the north elevation (fig. 2.2). Proceeding left to right, CM-10 and CM-11 contain four unusual window openings (112, 113, 202, and 203). They are splayed and have stepped, stuccoed sills with reproduction wood interior shutters. Window 201 is a narrow vertical slit. This opening allows for the constant ventilation of the easterly stairway. CM-2 through CM-9 contain windows 114 through 121. All are splayed, like an embrasure, and have wide sloping sills. Segmental arches, sandstone voussoirs and quoins extend down to the sill level of each window opening. Although none of the original shutters remain, most openings have reproduction, interior wood shutters with modern hardware.

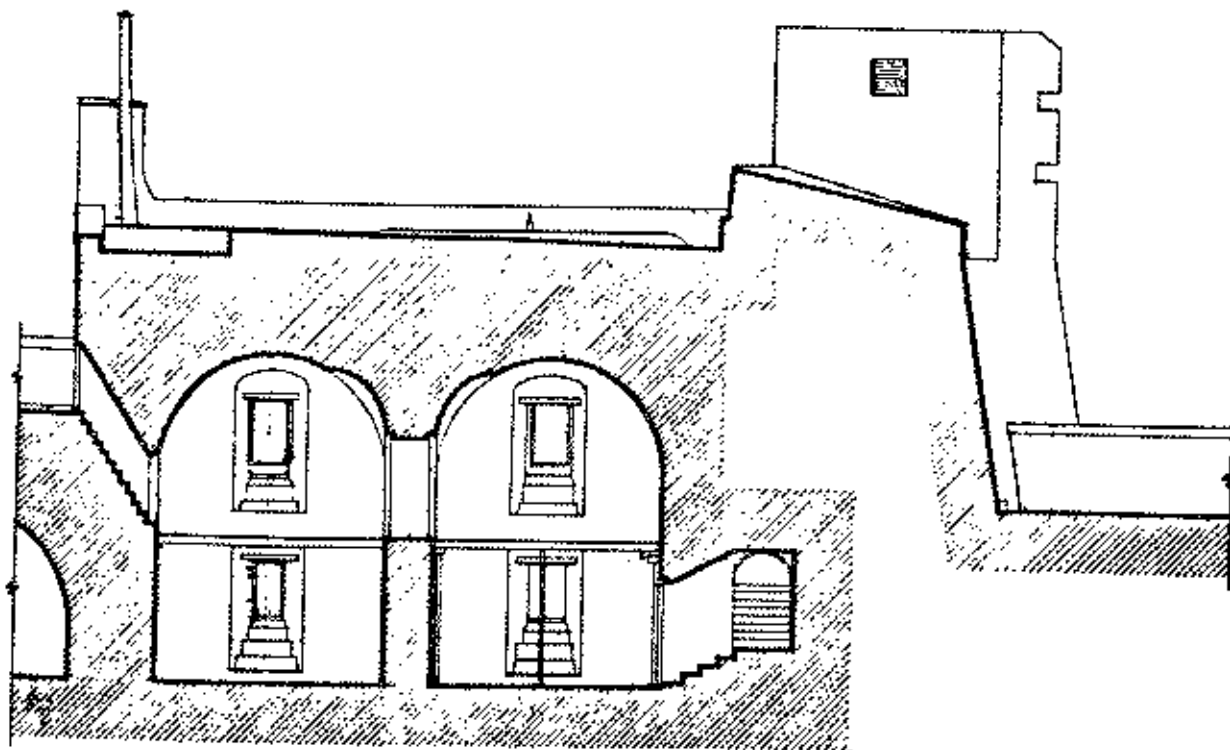
SCALE 1/8" = 1' - 0"

Figure 2.3. Section of North Casemates looking north and showing the two-story magazines. Drawn by HABS (1963) and annotated by Jana Gross (1989).

The casemates on the north side of the Plaza de Armas were built in two stages: the first in ca. 1768-1771 and the second in ca. 1774-1785. Comprising the oldest part were the two magazines in two levels located on the east end (fig. 2.3) that functioned as powder magazines. They were known in the eighteenth century as the vaults for reposito de polvora (storage for powder). Their roof terreplein became the north end of the enlarged caballero. Three years after the completion of the magazines, a one-story extension to the west was begun. This addition included nine vaults, a terreplein above, and an access ramp at the far west end. Housed therein were quarters, kitchen, and latrine. The vaults were then referred to as bovedas á prueba (proofed vaults), generally assumed to mean bomb-proof vaults. The terreplein above was called the bateria (battery). Both old and new sections were built under the direction of Engineers Thomas O'Daly and Juan Francisco Mestre. No part of the structures had yet been conceived in the original modernization plans for San Cristóbal in 1765. The first known documented record is dated 1769.

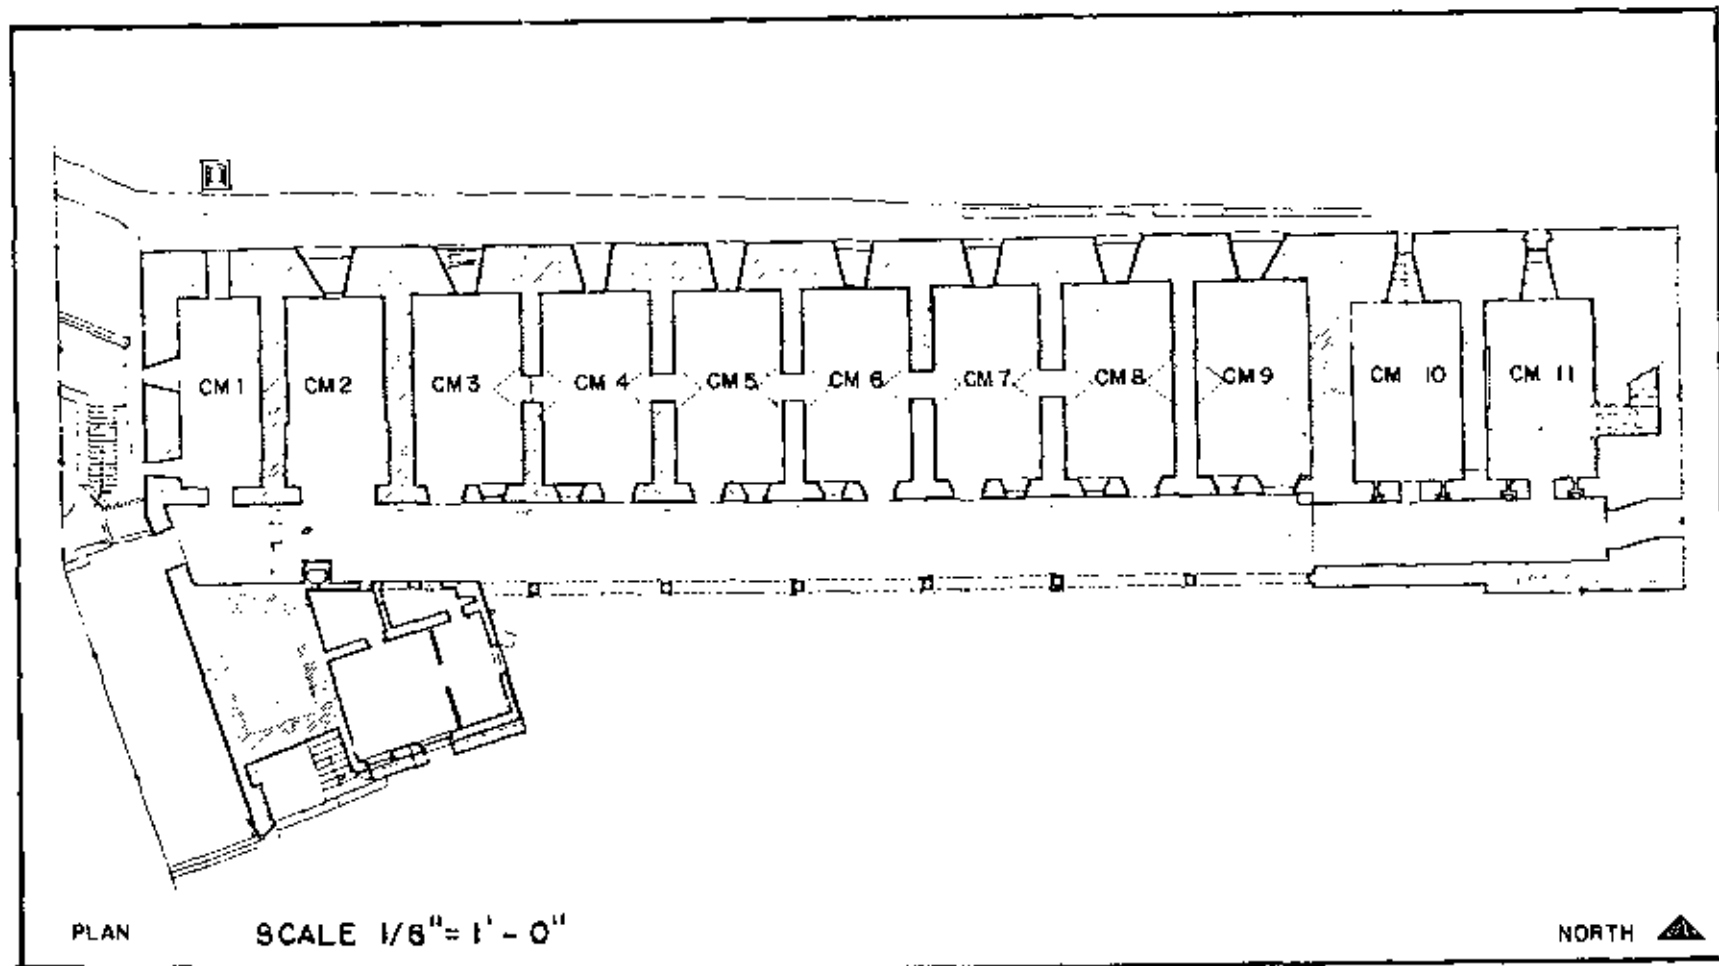
Figure 2.4. First floor plan of North Casemates with casemates labeled. Guardhouse in lower left. Drawn by HABS (1962) and annotated by Jan Gross (1989).

For clarification during this discussion, the casemates and magazines have been. Beginning with the far west casemate, the one-story vaults have been assigned numbers 1 through 9, and the two-story powder magazines numbers 10 and 11. (This numbering system corresponds to one devised and implemented by HABS in 1963.) Vaults will be referred to in an abbreviated form using "CM" to denote casemate. Dates mentioned in this section will be cited in the following structural evolution section. (See fig. 2.4.)

The floor plan (fig. 2.4) of the North Casemates is long and narrow. All of the eleven casemates are rectangular in plan. CM-1 through CM-9 have twentieth century cement flooring. The first floor of CM-10 and CM-11, and the east and west stairways are also covered with cement. The steep narrow west stairway in CM-10 is unused. Modern plywood doors with padlocks secure both ends of this stairway. The treads are laid with brick but the overall construction is of brick rubble, covered with white plaster.

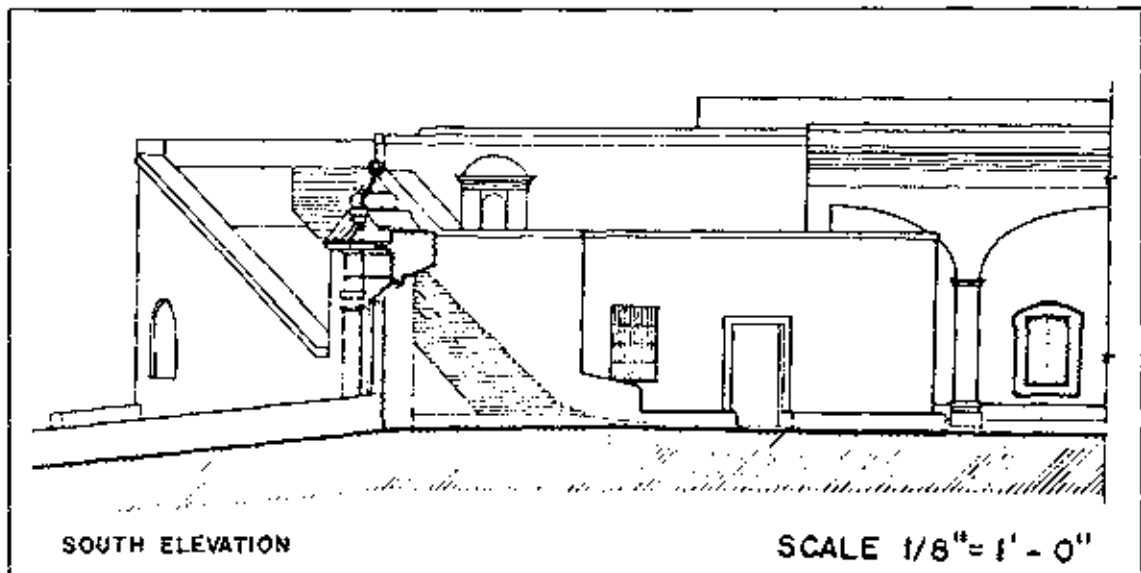
Figure 2.5. South elevation of North Casemates showing ramp to upper terreplein. Drawing by HABS (1963).

The terreplein of the North Casemates is accessible by a short but steep ramp at the western end (fig. 2.5). This ramp separates the Guardhouse from the Main Gate of San Cristóbal. Two gun emplacements are distinctly marked on the terreplein. They consist of two semi-circular tracks of stone pavers laid flush and an iron mount bolted to the terreplein. The floor

The west ramp (fig. 2.5) dates from the late eighteenth century. It has steps of varying sizes adjacent to the east cheek wall and slopes down in a southerly direction. The floor of the ramp has a hormigón surface broken up in regular intervals by five horizontal bands. These are made of rectangular, flat, stone laid flush with the hormigón. A six foot wide stairway adjoins the right cheek wall. Risers and treads are of varying dimensions and are paved with bricks laid in mortar.
