THE FORTIFICATIONS OF SAN JUAN NATIONAL HISTORIC SITE

HISTORIC STRUCTURE REPORT

El Fuerte de San Cristóbal

1991

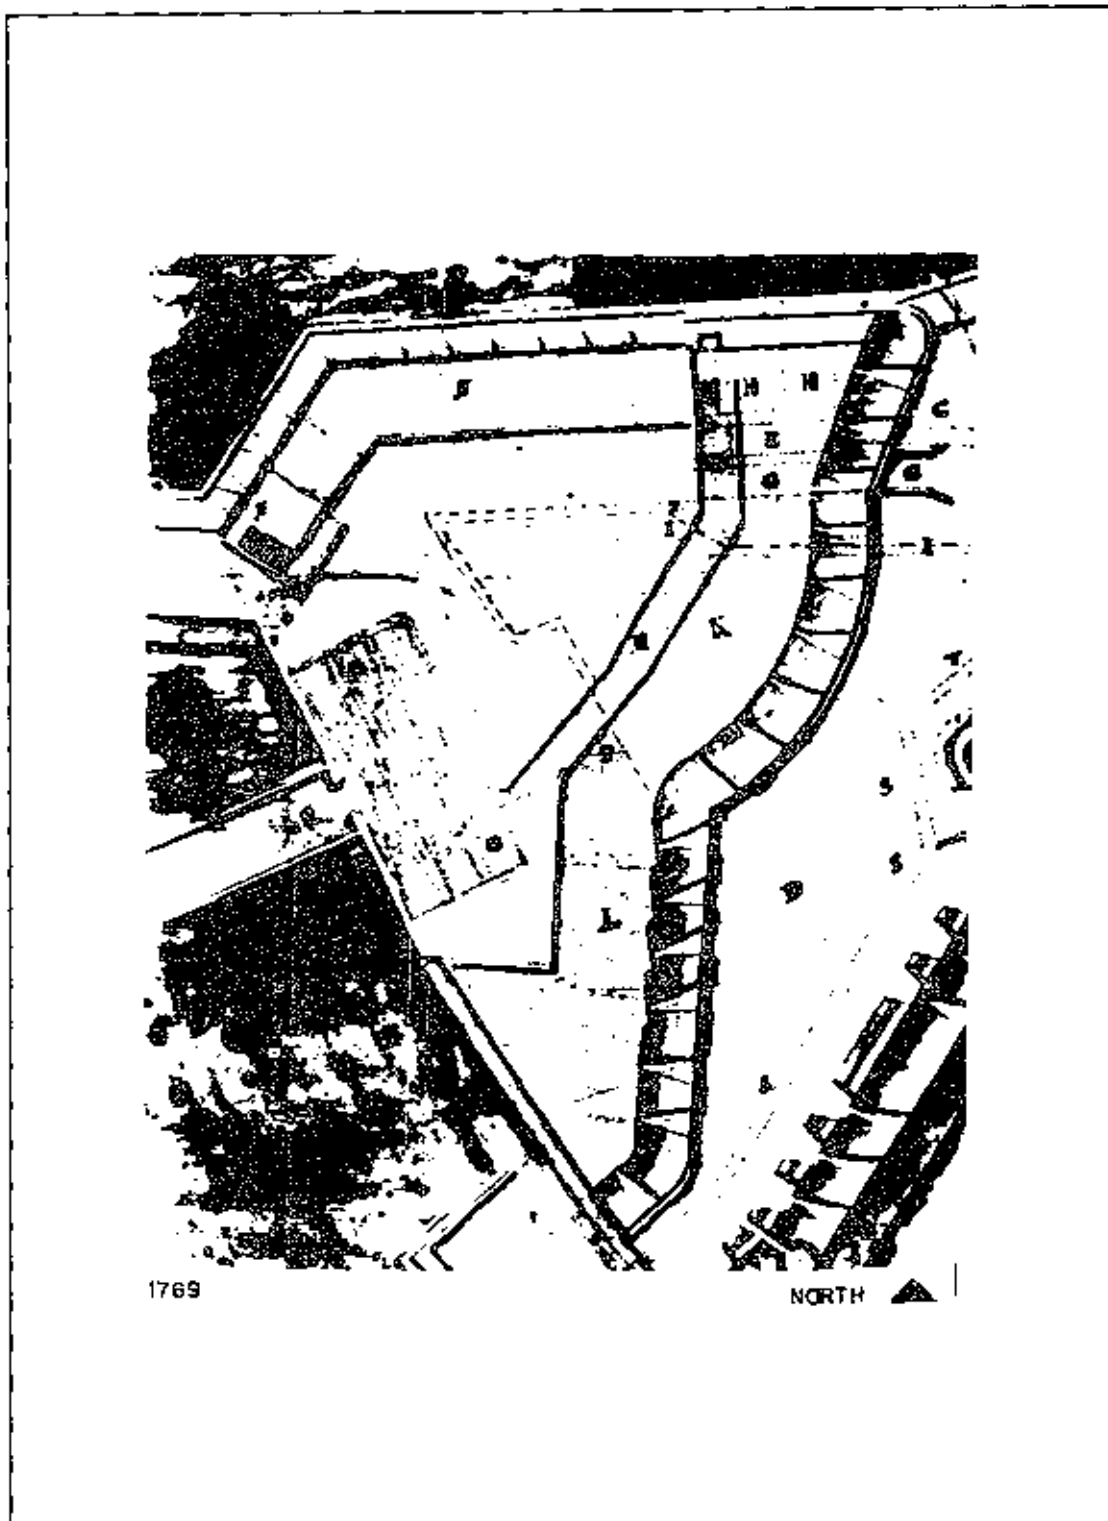
Figure 2.8. Detail of Thomas O'Daly's January 15, 1769 proposed construction plan showing the location of North Casemates labeled "N". (San Juan NHS Archives.)

Construction of the two story powder magazines was well underway by January 15, 1769, based on Thomas O'Daly's plan (fig. 2.8). This plan labeled the vaults "H" and described them as: "Two magazines [almacenes] for storage of powder; they lack vaults."¹ This has been interpreted to mean that the foundations and the first story had been completed and were lacking only the second story vaults.² The magazines were shown situated at the edge of the north cliff. Immediately adjacent on the east side was the newly-widened flank of the North Bastion. To the south was communication gallery "E" (Tunnel 2) also built at this time. The second story vaults were completed sometime before March 1771.³ El Caballero was subsequently raised to match the height of the new magazines.⁴ The terreplein of the magazines thus became a part of the new enlarged caballero that is discussed at length in Chapter 4.

Work on the one-story addition to the west of the powder magazines did not begin until 1774.⁹ Planning for these vaults, however, commenced five years earlier. The design, as originally conceived by O'Daly in his plan of 1769, differed from that actually built. The proposed structure (fig. 2.8) was not straight, but angled at its west end to enclose the Plaza. Access to the battery above was gained by two flights of stairs positioned at right angles to one another. Inside, the space was divided into seven vaults. On the plan, the proposed structure was labeled "N" and described in the legend as: "Projected battery in extension with seven proofed vaults for magazines or barracks."¹⁰

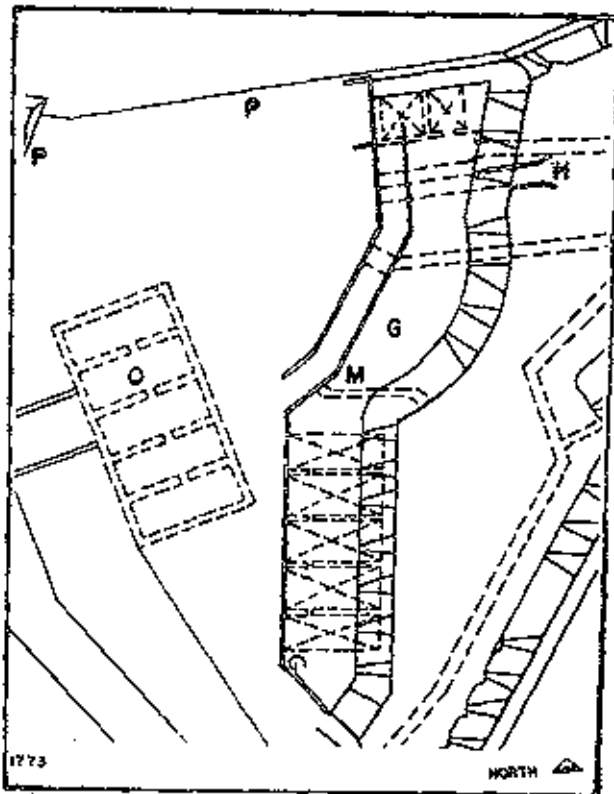
Figure 2.9. Detail of O'Daly's August 8, 1773 proposed construction plan as traced by Jana Gross (1989).

Following their construction, the two-story powder magazines were pictured in O'Daly's 1773 plan of San Cristóbal. (See fig. 2.9.) Here they were labeled "L" and described as, "Proofed storage for powder in two levels."⁷ Whether or not the vaults were used at all times to store powder is questionable. One map, undated but probably delineated sometime between 1769 and 1773, qualified their use for powder storage "during siege times."⁸

The same angled configuration was apparent, although with less detail shown, in O'Daly's general plan dated August 31, 1772.¹² Exactly when this design was revised is not known. Just one year prior to construction, in 1773, O'Daly prepared a plan showing existing conditions (fig. 2.9). Not pictured on the plan was the proposed structure on the north side of the Plaza. Instead, the area was labeled "p" and described in the legend as: "Appropriate space for five proofed vaults and a battery above."¹³

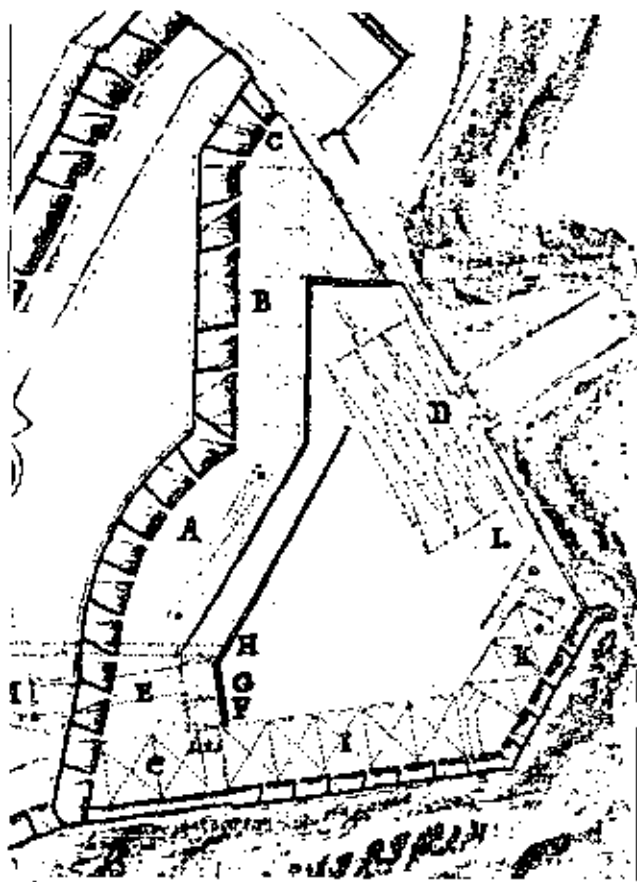
Figure 2.10. Detail of O'Daly's plan showing North Casemates labeled "e", "I", and "K". Ca. 1769.

This layout remained unchanged, but the interior functions were more clearly defined in an undated plan believed to post-date 1769 (fig. 2.10). Here, the north vaults were labeled "I" and the southwest vaults "K," described in the legend as:

- I. Another five [vaults] for quarters.
- K. Two identical [vaults] for kitchens and latrine which serve as a [water] outlet for the upper platform with which they are maintained clean.¹¹

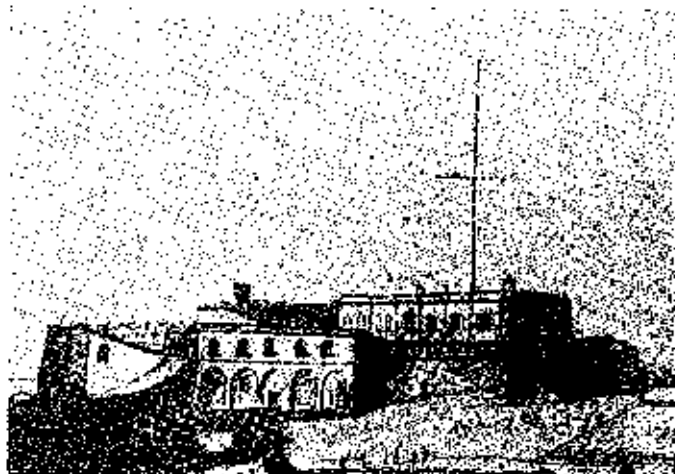
Figure 2.13. Detail of August Plee's sketch of San Cristóbal, east elevation, ca. 1821.

Unlike other areas of San Cristóbal, a surprising amount of information was found on the structure north of the Plaza for this period. This includes a sketch dated ca. 1821 (fig. 2.13) and a description of work done in 1830.

The sketch from ca. 1821 is a view looking from outside San Cristóbal toward the northeast.²⁴ Clearly illustrated were the exterior west wall of the north vaults and the west ramp to the battery. Two window openings were located in the wall of the first vault, identified in the eighteenth-century documents as the latrine. These windows were on the plan of 1783. The sketch, therefore, provides evidence that they were actually constructed. Not visible

on the 1783 plan, but appearing in the sketch, is another large window opening with arched top located in the ramp wall. This opening exists today and was part of the original construction.

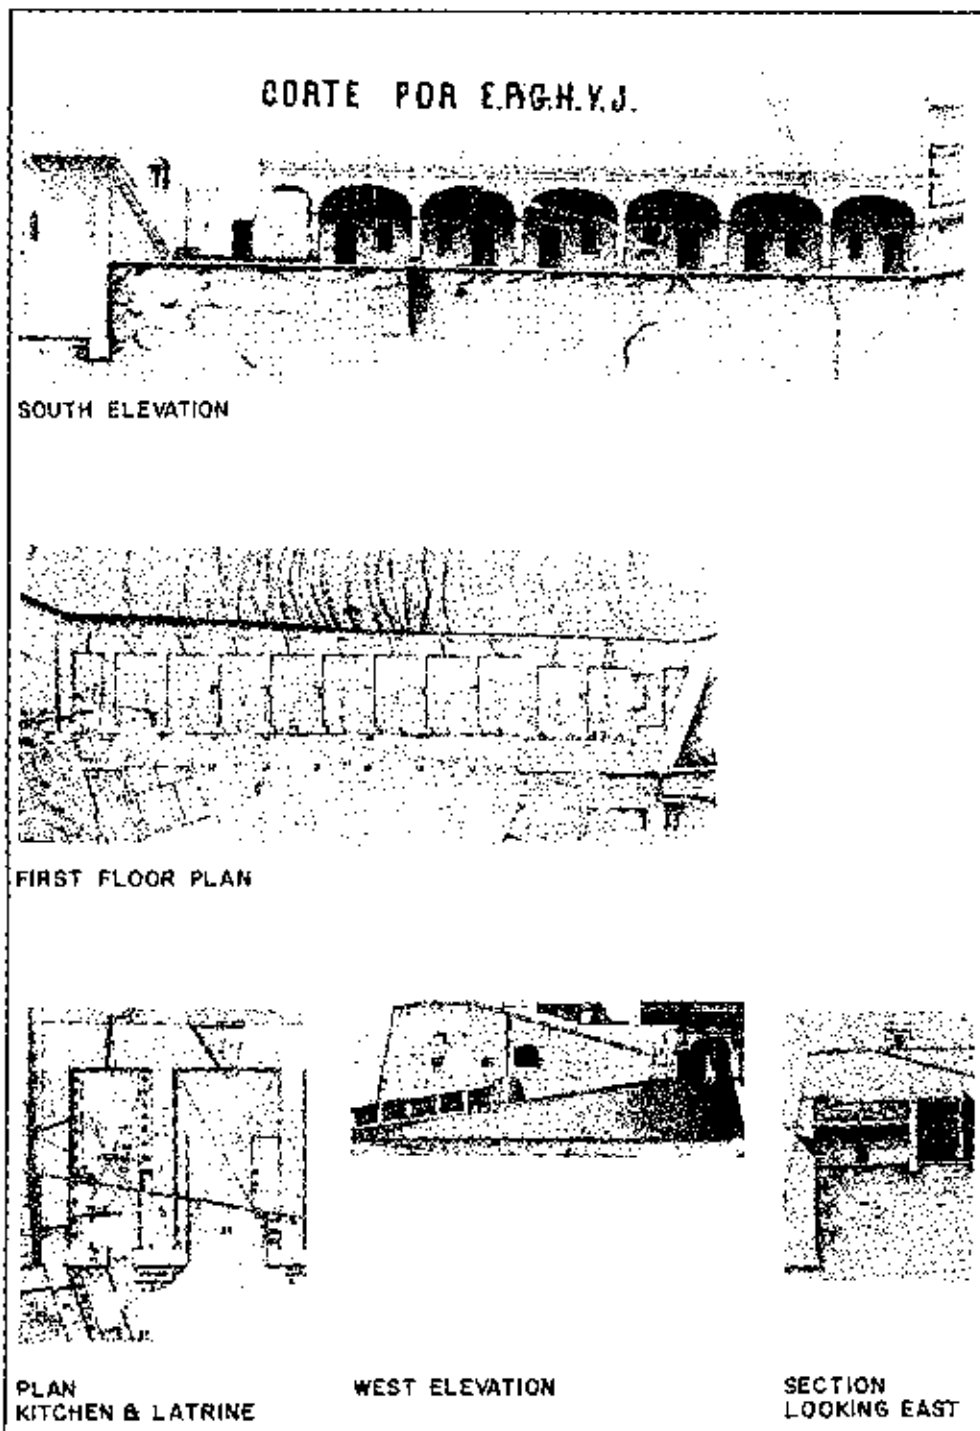
Figure 2.14. Details of 1861 plans and elevation drawings by Manuel Castro showing the North Casemates. (San Juan NHS Archives.)

I, nos. 27-37 for complete set of drawings).³³ Illustrating the powder magazines and north vaults were five drawings: a first floor plan, second floor plan, roof plan, section looking east, and a south elevation. While the intent of these drawings has not been determined (e.g., to record existing conditions or proposed work) they do provide a valuable detailed view of this area and the new loggia (fig. 2.14).

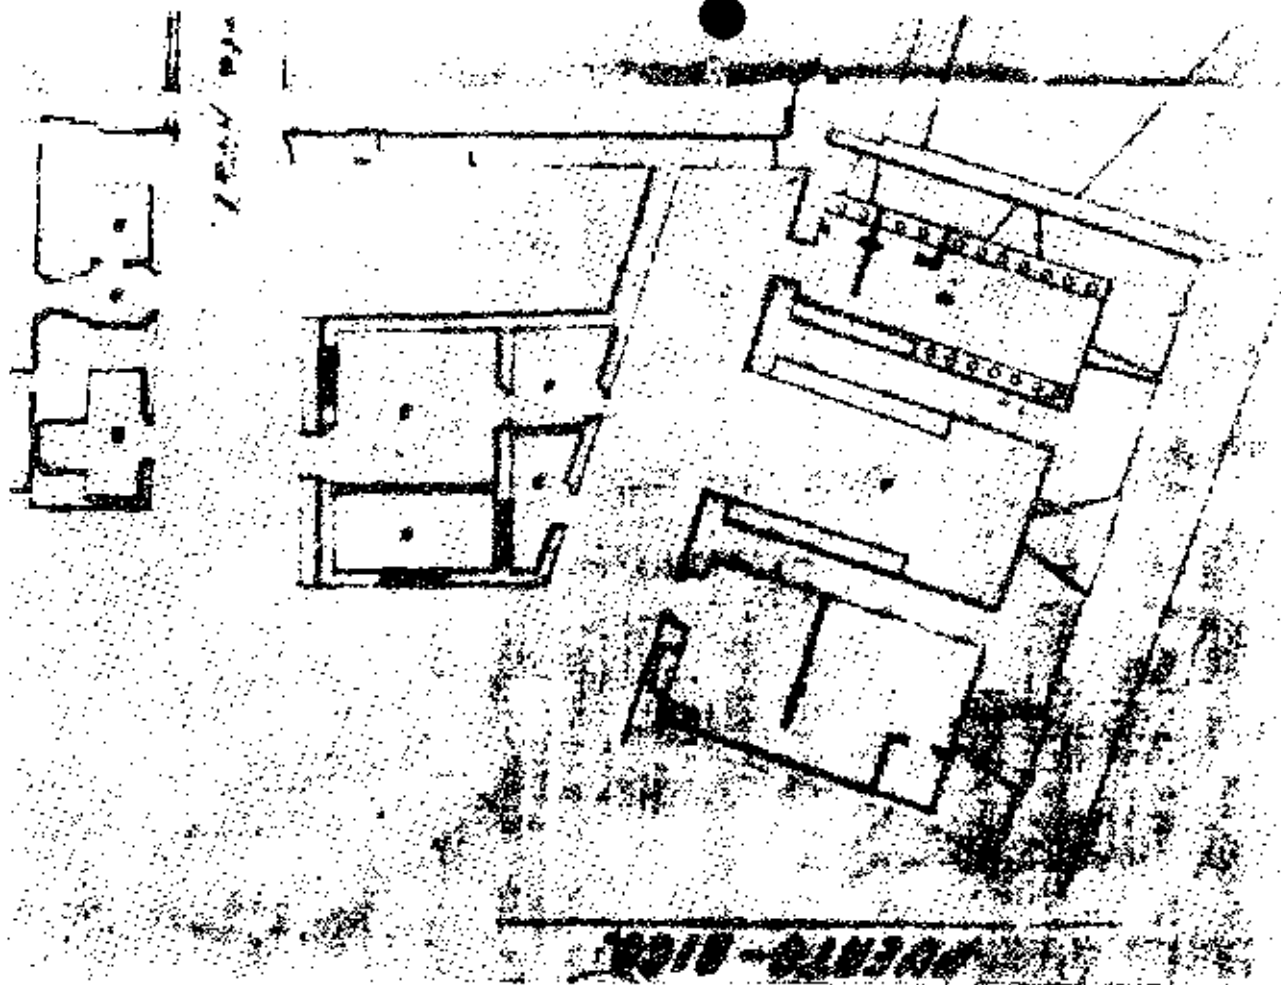
Figure 2.15. Detail of 1868 plan by Leon Castro showing west end of North Casemates. (From HABS negative 181.31.)

Leon de Castro recorded the west side of the Plaza in 1868.³⁴ Included in his plan (fig. 2.15) were the first three (west to east) of the north vaults. CM-1 is labeled "10. Latrines," and CM-2 "9. Kitchen." Although the east wall of the kitchen is only generally detailed, neither vault appears to have changed since 1861. Alterations are evident in other areas. The latrine room outside the original latrine vault was not shown. Also, partition walls have been added in CM-3 to create two rooms and a small closet in the northeast corner. It is not known if these changes were actually existing, or proposed by de Castro in 1868.

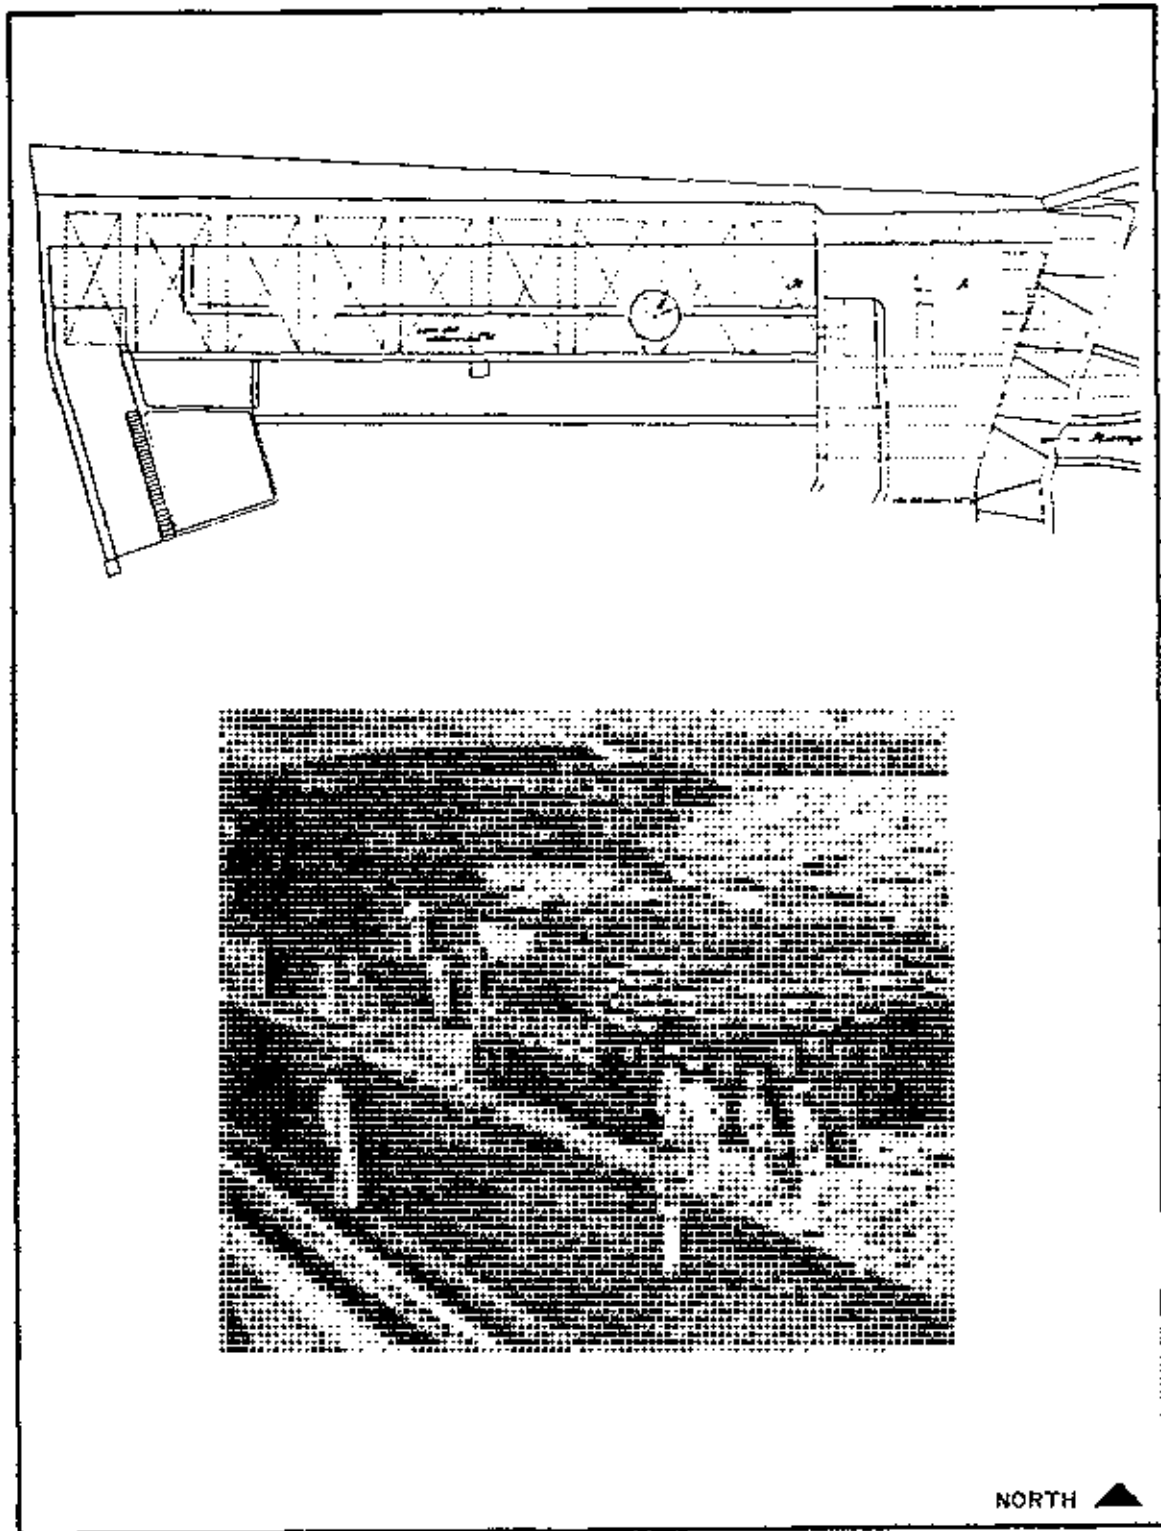
Figure 2.16. Plan and photograph, both dated ca. 1897, showing late-19th century gun emplacements on terreplein of North Casemates. (Plan, San Juan NHS Archives. Photo, *Crónicas de la Guerra*, 1973.)

Following occupation of the American forces in 1898, after the Spanish-American War, an inspection report was prepared on the defenses of San Juan. This report included San Cristóbal.³⁵ On the north side of the Plaza, two 24-cm howitzers were found emplaced on the battery of the single story vaults. Evidence of their exact locations is visible today. Ammunition for these guns was stored in the casemates below and "sent up to the barbette tier through a circular well by means of a small shot crane."³⁶ Precisely where this well was located, and which casemates were employed, as magazines is not known. The north parapet in front of the guns was reinforced with earth and concrete ca. 1897. This reinforcement was illustrated in an early photograph taken before the occupation (fig. 2.16). The emplacement was located on the slope of the parapet and shaped like a gable roof. The gun crews were protected by earthen traverses, also visible in the photograph. One of the traverses was located between the two guns and supported by barrels and sacks. The emplacement on the parapet remained until early in the twentieth century.

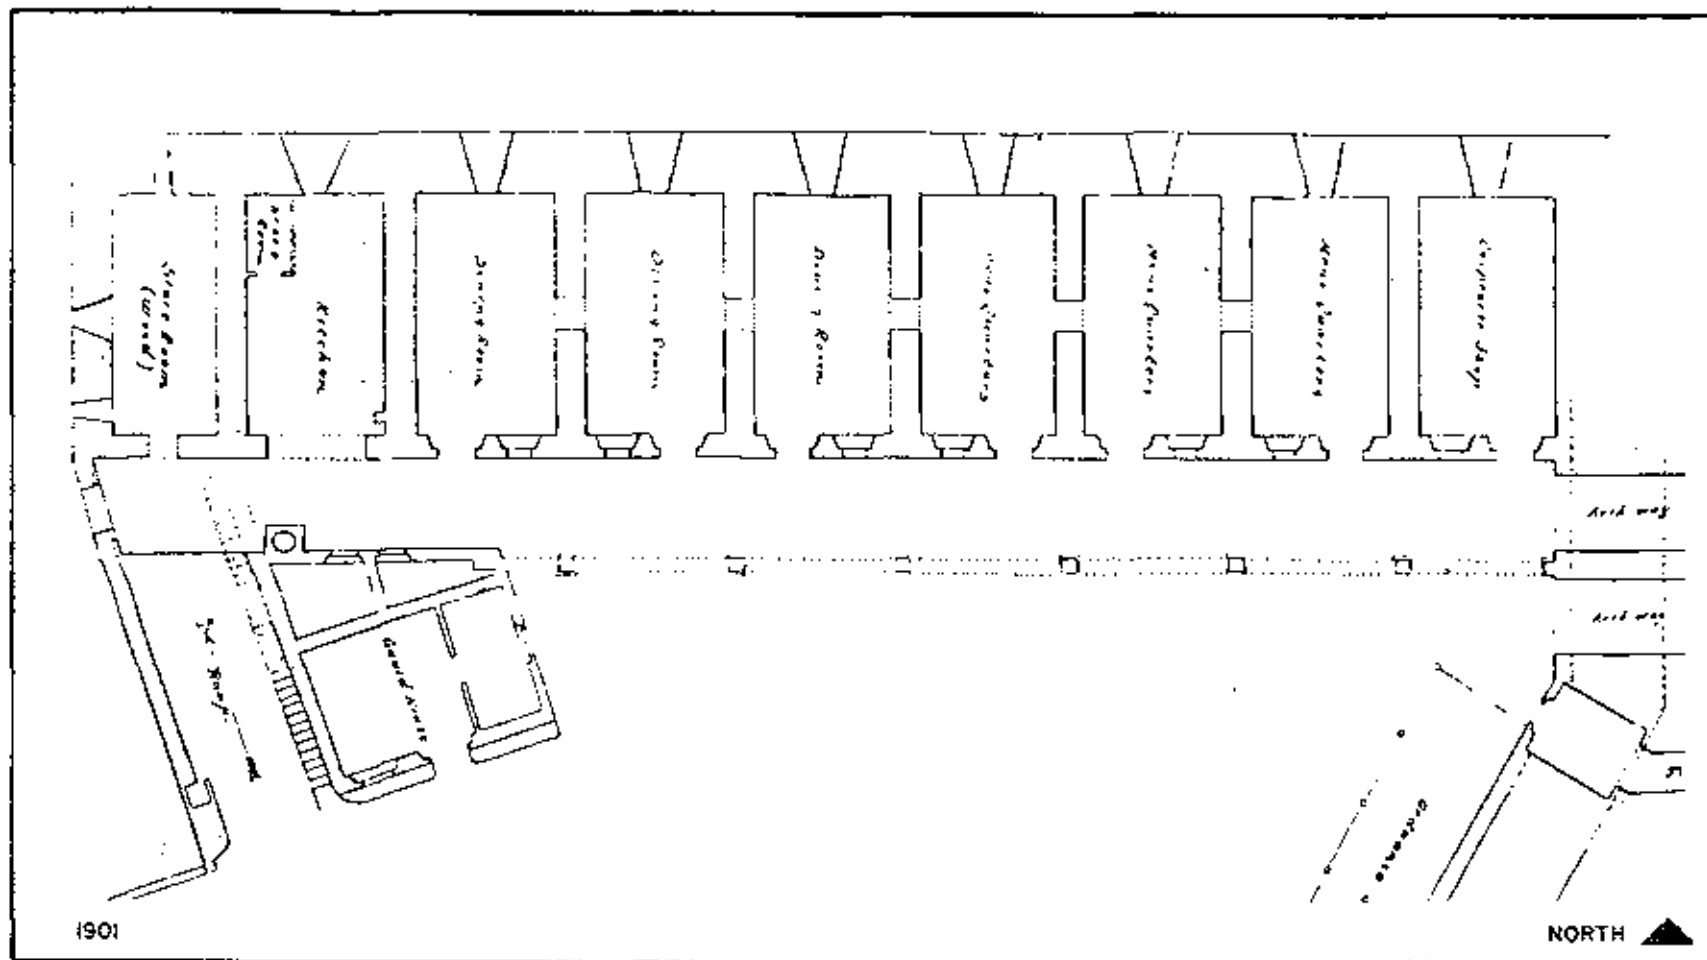
Figure 2.17. Detail of plan by Guy S. Boyce, dated 1901 and titled "Quarters at Fort San Cristóbal" showing North Casemates. (San Juan NMS Archives.)

Whether or not the latrine was still located in CM-1 in October 1898 has not been determined. Assuming it was, it would most likely have been relocated in the spring of 1899 when city water and sewer systems were introduced.³⁸ By December 1899, bathroom facilities for the enlisted men were located in the south wing of the Officer's Quarters. The plan dated February 1901 indicated that the original latrine in the north vaults (CM-1) was then a storeroom for wood (fig. 2.17).³⁹

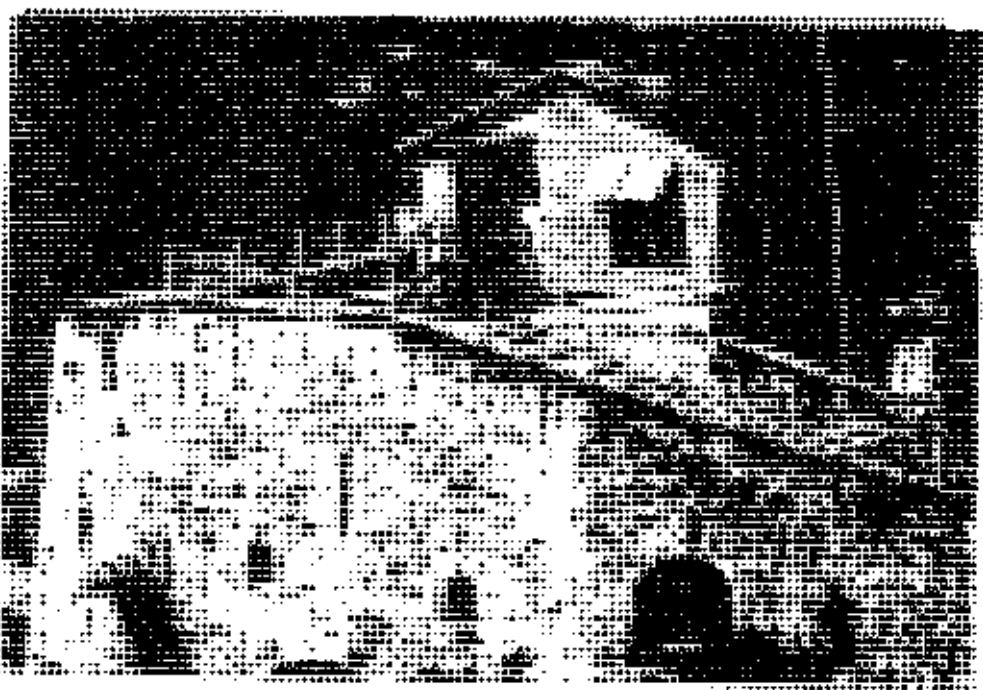
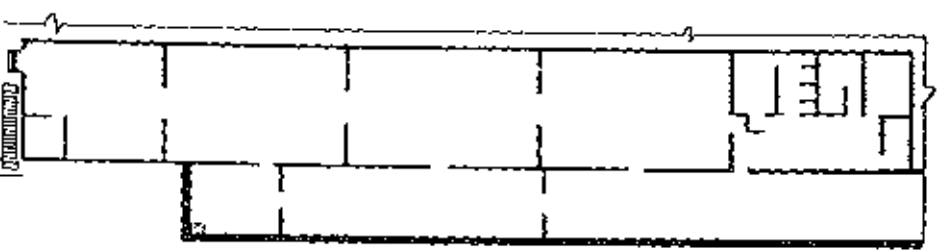
Figure 2.19. Detail photograph and plan showing temporary frame building (1943) on terreplein of North Casemates. (Photo by Rotkin, San Juan NHS Archives. Undated plan, "General Floor Plan San Cristóbal," San Juan NHS Archives.)

One photograph of the northwest facade showed this building to be a long, one-story, gabled-roof structure with board siding (fig. 2.19).

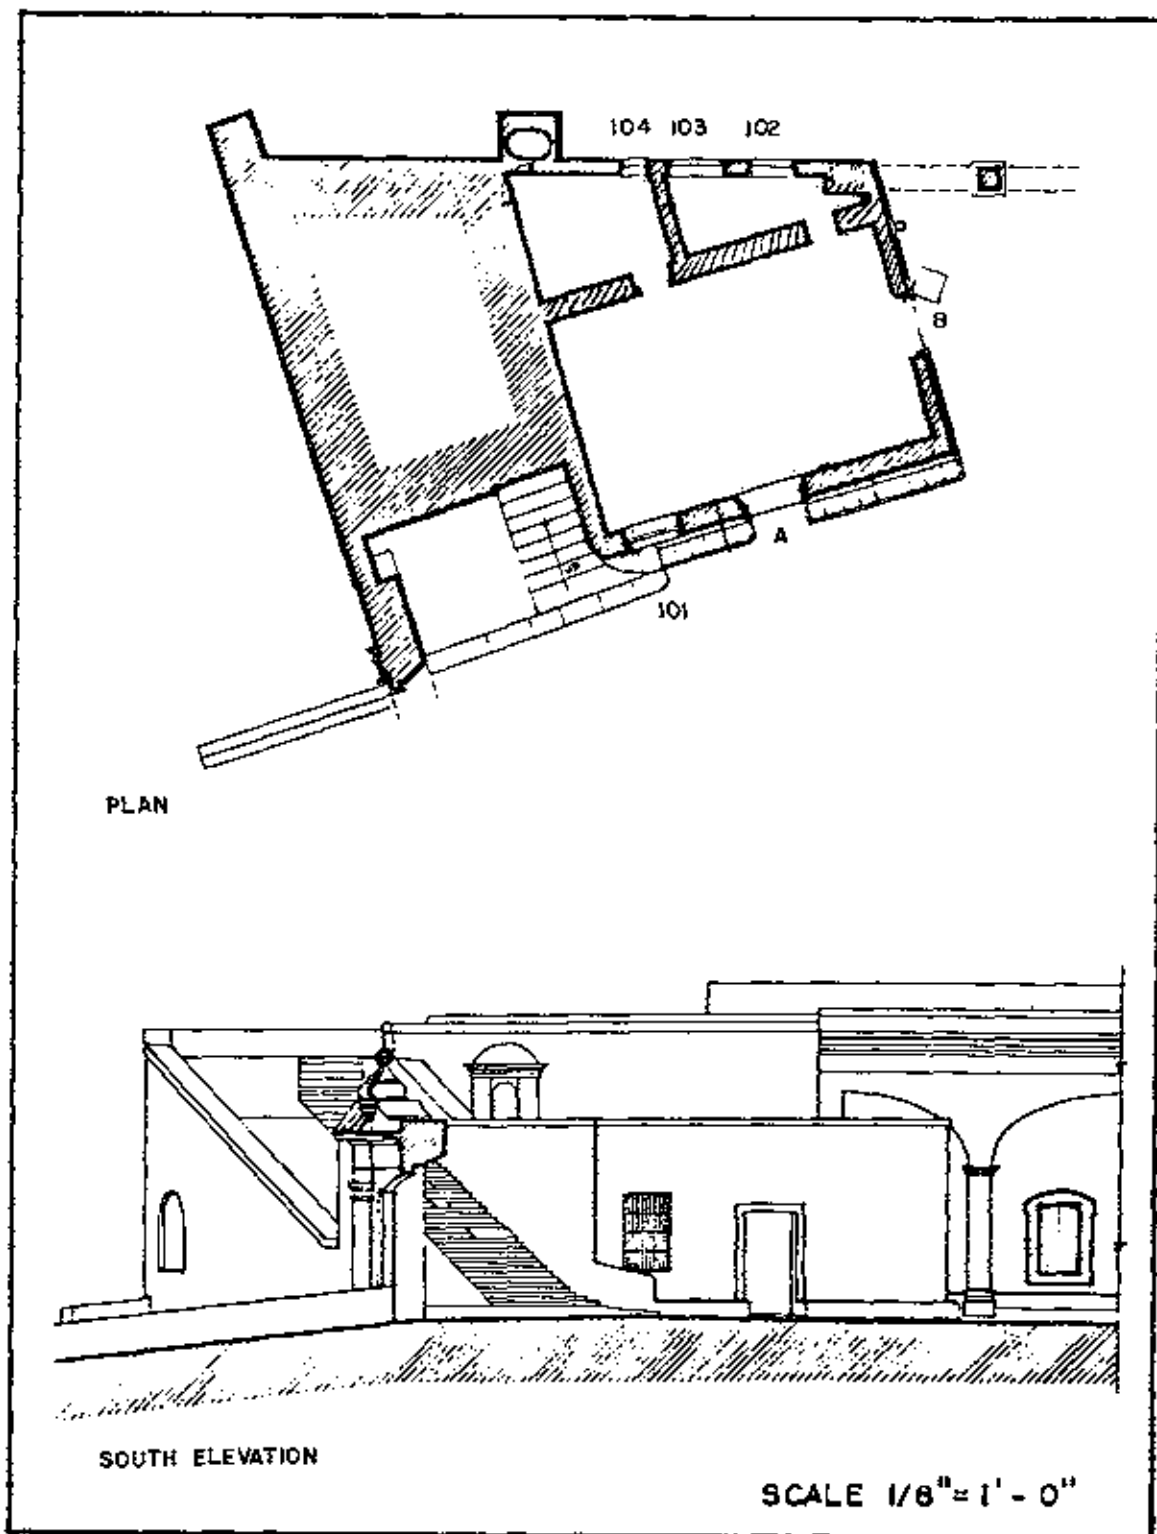
Figure 3.1. Plan and south elevation of Guardhouse with openings labeled. NABS drawings (1963) annotated by Jana Gross (1989).

The Guardhouse, (La Casa de la Guardia or Cuerpo de Guardia de la Tropa), is a distinct component of the North Casemates. It is located at the northwest corner of the Plaza de Armas attached to the small ramp that provides access to the terreplein level of the North Casemates. It is a small plain structure, that is utilitarian in appearance. The Guardhouse is strategically situated on the Plaza so as to control pedestrian access in and out of the fort (fig. 3.1).

The interior of the building is subdivided into three rooms (fig. 3.1). The rooms are plain and have no decorative features or trim. The larger of the three rooms takes up the whole south width of the structure and is currently used as a visitor information area. It also houses the copy of the original 1839 model of San Cristóbal. The floor is covered with modern Portland cement.

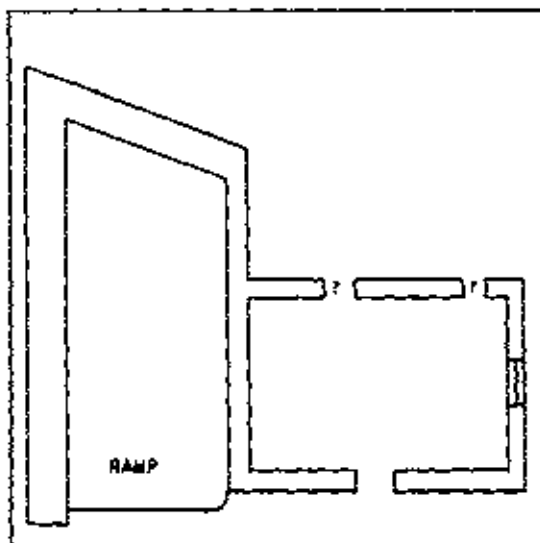
Figure 3.3. Guardhouse floor plan based on 1839 model and drawn by Barbara Yokum, 1986.

The model (fig. 3.3) provides the first evidence of a structure in the location of the present Guardhouse.² Here, the building is rectangular in shape with a flat roof, a doorway in the south facade, and a window opening in the east facade. Openings in the north facade are not apparent. Based on this information, the Guardhouse as we know it today was originally smaller and comprised what is now the large south room. In the model, the exterior walls are a neutral gray color unlike some other structures on the Plaza that are colored yellow.

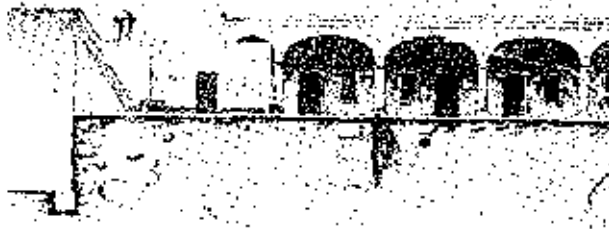
CORTE POR E.F.G.H.Y.J.

Figure 3.4. Detailed views of Guardhouse from the 1861 drawings by Manuel Castro. (San Juan NHS Archives.)

Castro recorded the building in tri-color drawings. Included were a south elevation, a roof plan, and a floor plan. (See fig. 3.4.) These, along with extant building materials examined in 1986, provide a detailed picture of ca. 1861 conditions.

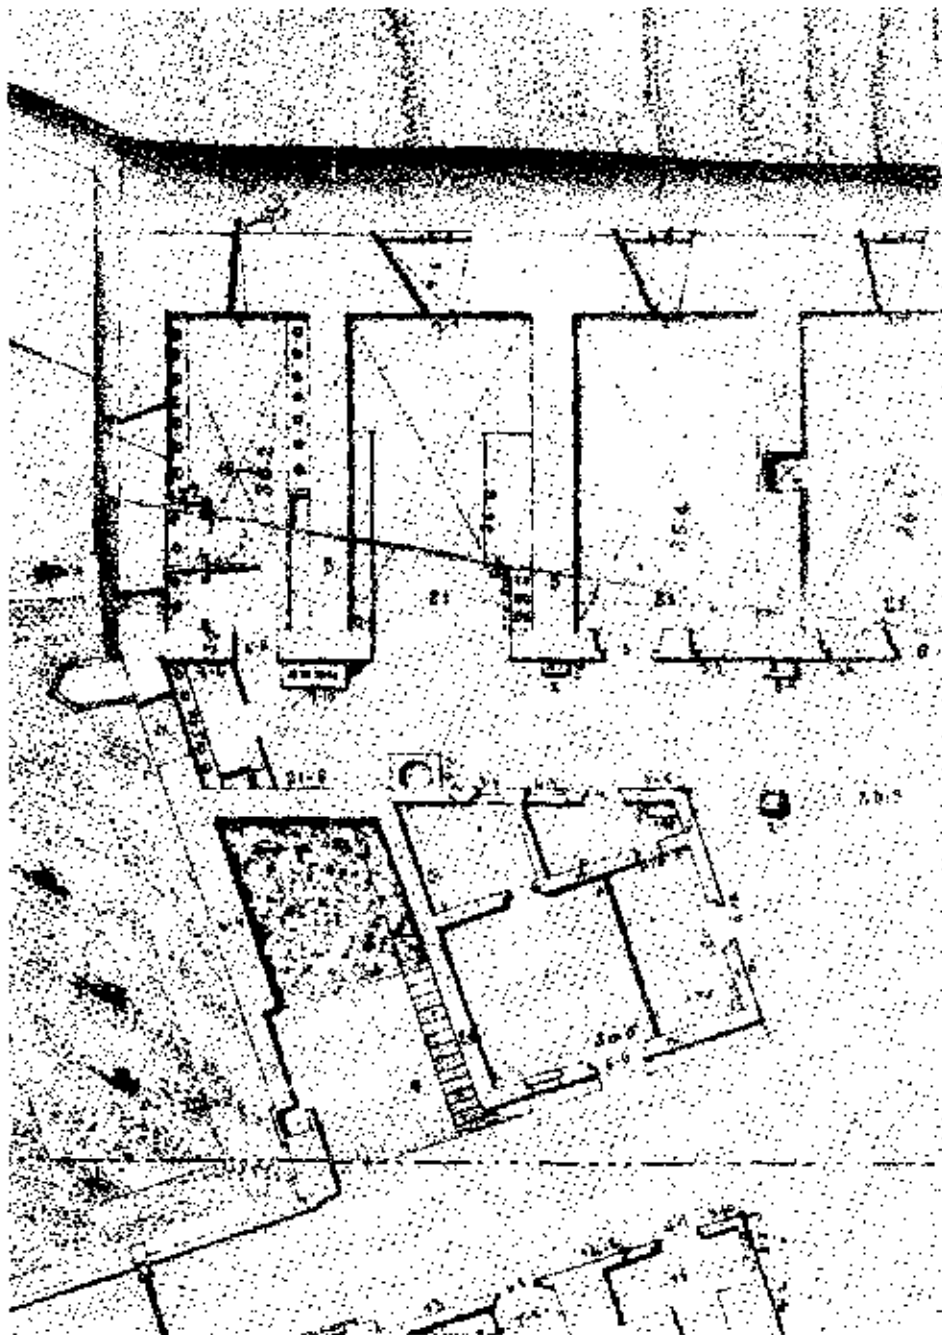
Figure 3.5. Detail of Manuel Castro's plan showing Guardhouse and four western North Casemates. From KABS negative.

In ca. 1861, doorways and windows were located on the south, east, and north facades (fig. 3.5). In the south facade facing the Plaza was a doorway in the middle of the wall and a window to the west side. It is of interest to note that while both doorway and window are illustrated in the plan, only the doorway was shown in the south elevation drawing. This has been attributed to delineator error. In the east facade there was one doorway in the original part of the building. This was enlarged from an early window based on comparison with the 1839 model. On the new north facade, facing the North Casemates, were one doorway and two windows. The doorway was on the east side and flanked by two windows to the west. Remaining physical evidence of old features at these windows helps to further define their early appearance. These are small windows of rectangular shape set horizontally and high up in the wall. Their frames are wood and the larger east window is divided by a central vertical mullion. Early paint on the exterior side of the mullion indicates that the frames were first painted white (in a resinous medium) and later gray. Cutouts in the frames for pintels evidence early shutters that hung on the interior sides of the windows. It is doubtful that vertical bars presently seen in the openings are original. Based on the paint evidence, extant bars appear to be of 20th century vintage.

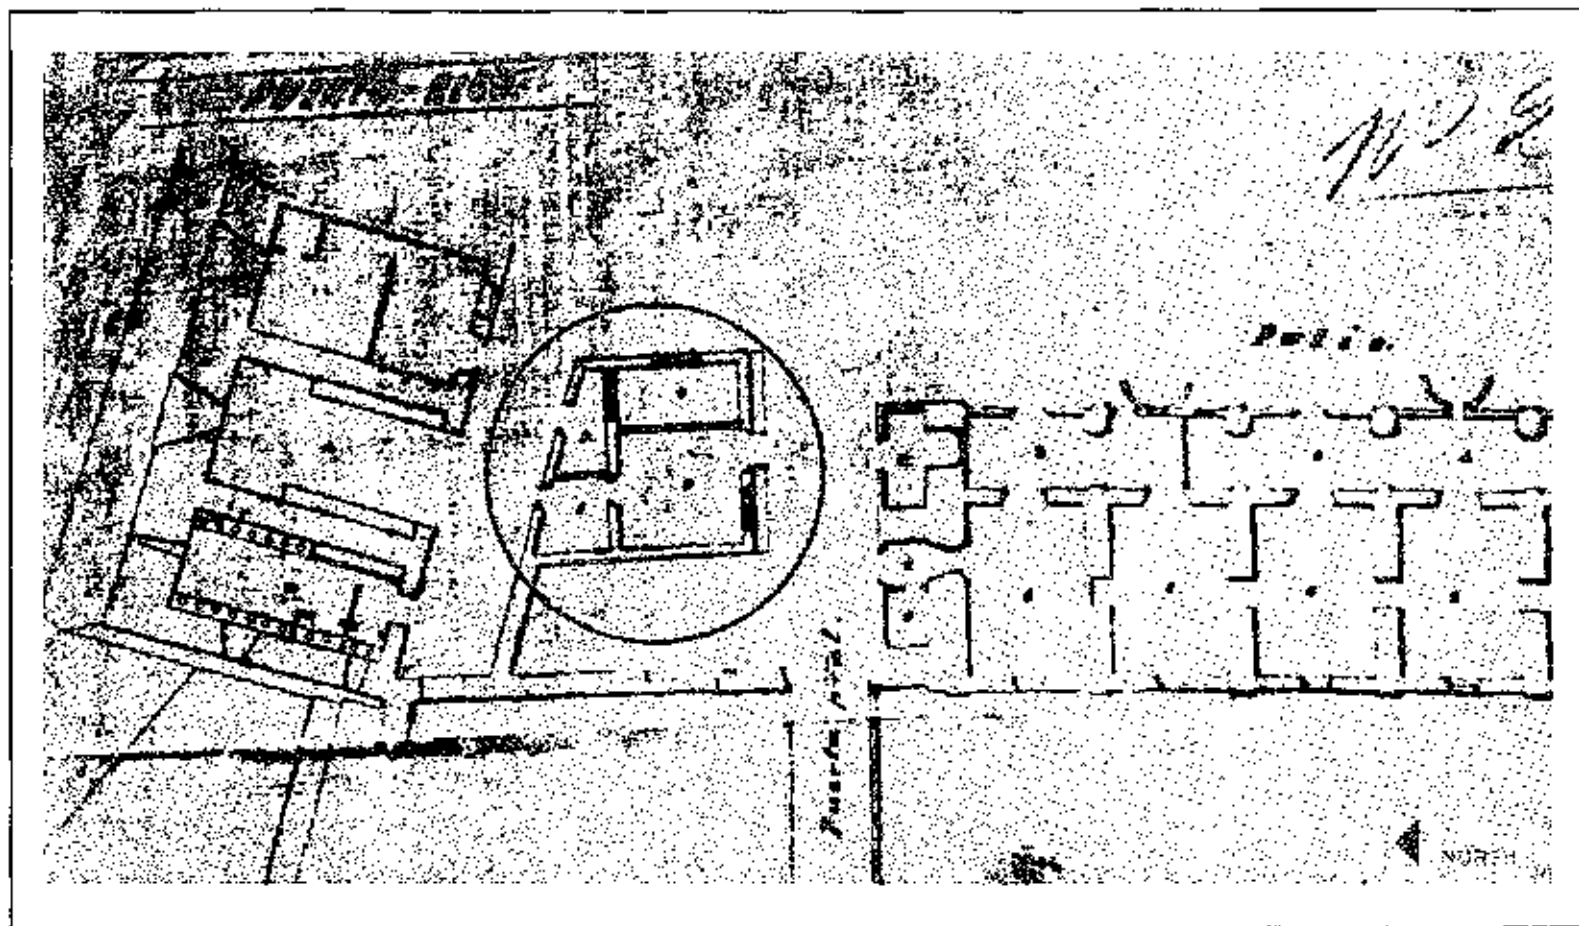
Figure 3.6. Leon Castro's plan with Guardhouse circled, 1868. (HABS negative 181.31.)

In 1868, seven years after Manuel Castro's drawings, a plan was prepared by Leon de Castro. (See fig. 3.6.) For the first known time, the building's four interior rooms were labeled and their functions described in the legend. Unfortunately, the copies of the plan available for this study were of poor quality and illegible. However, a report done in the 1960s did refer to this legend which included the Cuerpo de guardia de la tropa north of the Officer's Quarters.⁴

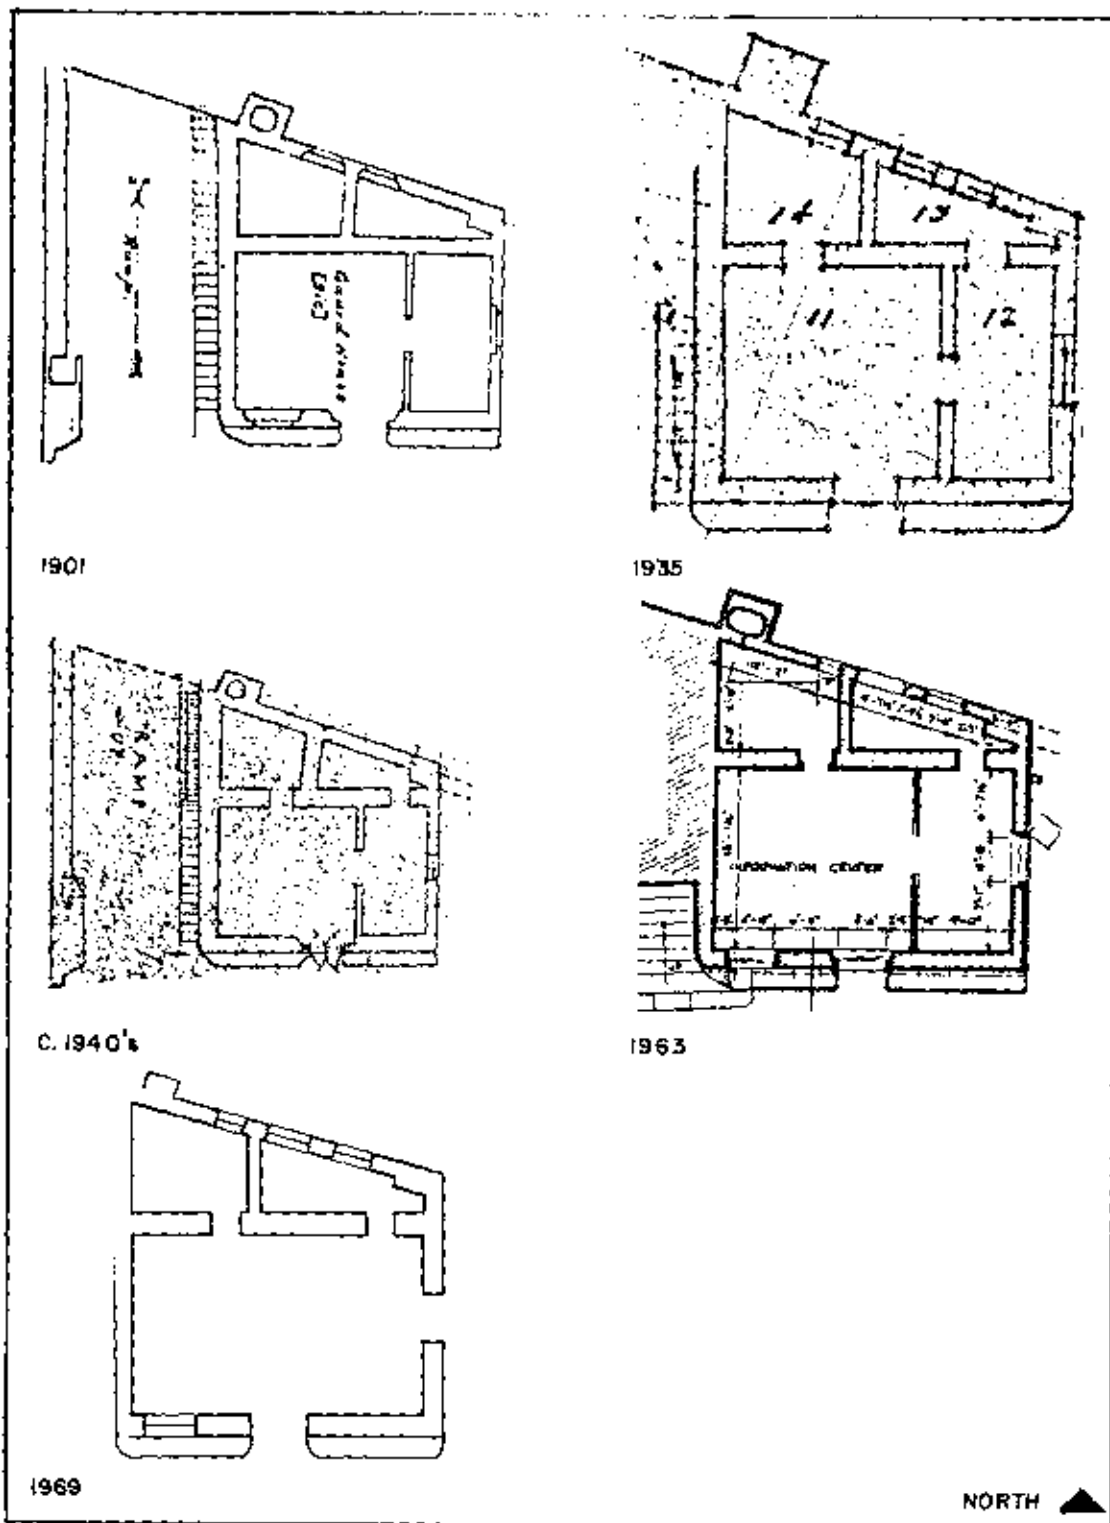
Figure 3.7. Selection of 20th-century plans of Guardhouse showing the evolution of structure's floorplan and fenestration.

During this period, San Cristóbal has been under the jurisdiction of the U. S. Department of the Army (1898-1961), and the NPS (1961 to the present). Both agencies have made repairs and changes to the Guardhouse. Figure 3.7 illustrates the evolution of the Guardhouse plan during the twentieth century.

One year later, on 12 February 1901, the building was illustrated in a plan showing the existing allocation of quarters at San Cristóbal.⁶ The four-room configuration of the structure remained unchanged from the 1860's plans and the southwest room was labeled "Guard House." However, several changes are apparent in the locations of doorways and windows. On the exterior, the doorway in the east facade was shown as a window, and the doorway in the adjacent north facade not shown and presumably blocked up. Inside, a doorway had been added in the partition between the two front rooms. The two doorways formerly connecting the front rooms with the smaller back rooms were also missing, possibly indicating that the back rooms were not in use. Exactly when these changes took place is not clear.

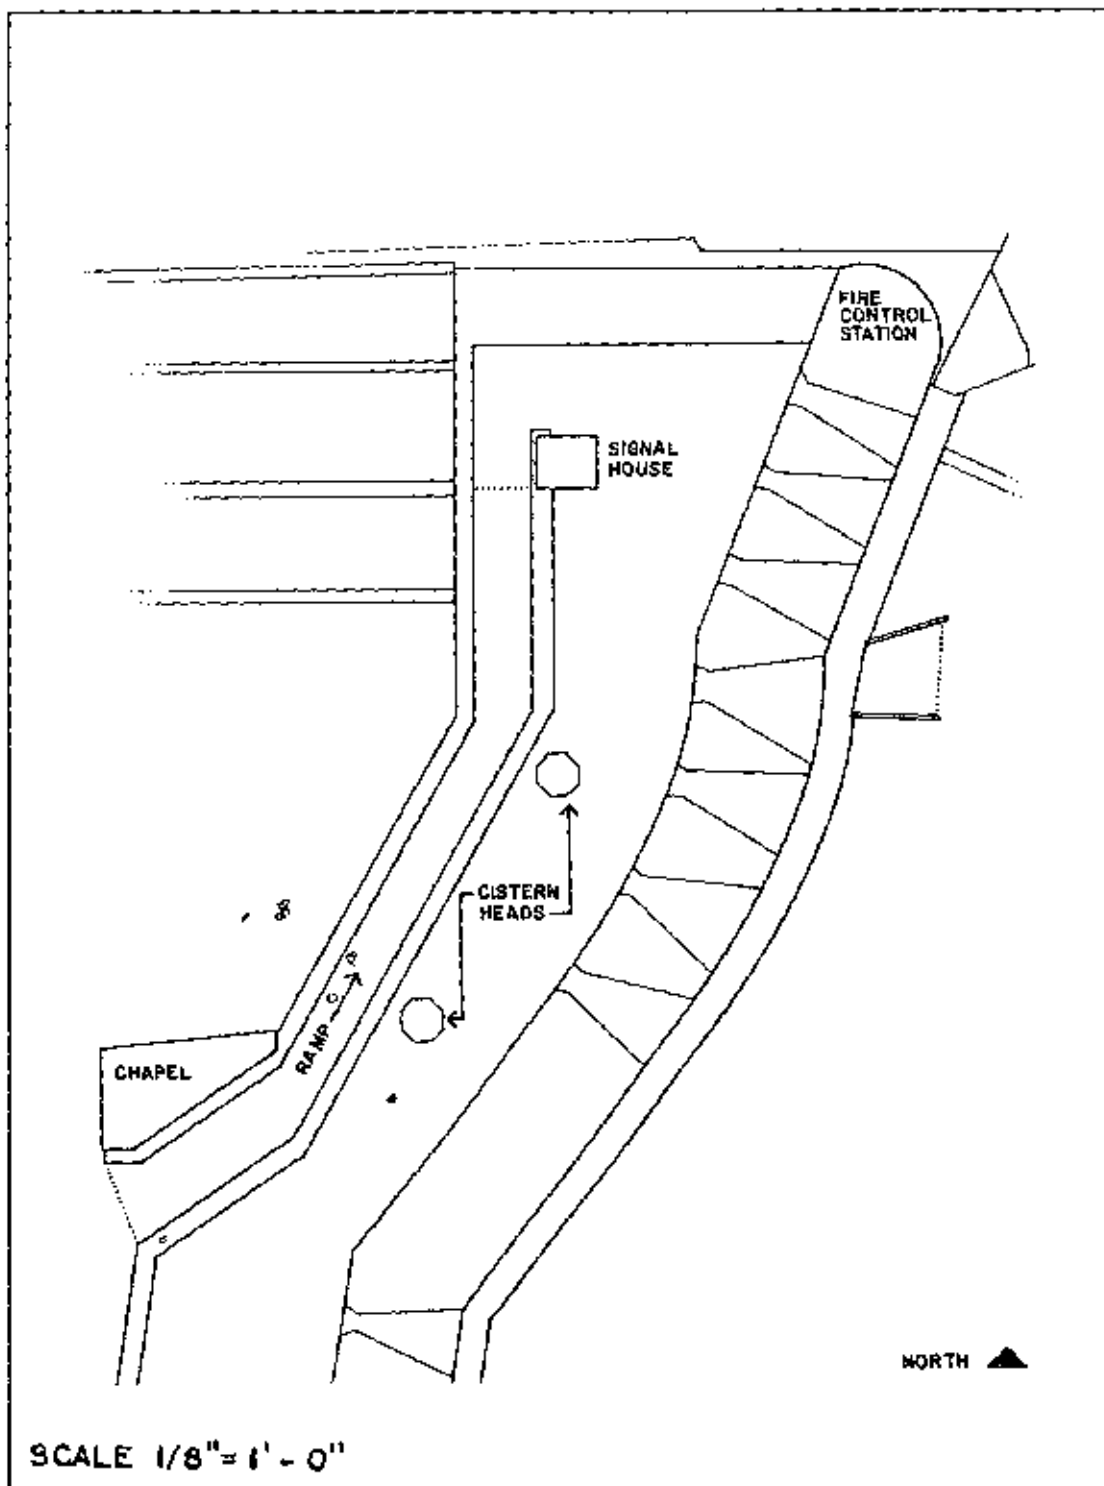
Figure 4.1. Plan of el Caballero showing cistern heads, signal house, World War II fire control station and stair. Drawing by Jana Gross (1989) based on 1970 HABS site plan.

Located on the east side of San Cristóbal's Plaza de Armas, el Caballero extends from north to south to enclose the Plaza. Long and angular, the structure caps a portion of the North Casemates and the whole of the Troops' Quarters. The accompanying ramp to the west gives access to the terreplein. A circular stair and two cistern heads project above the terreplein. El Caballero is the highest structure of San Cristóbal and derives its name (cavalier) by occupying a lofty position. (See figs. 4.1, 4.2 and 4.3.)

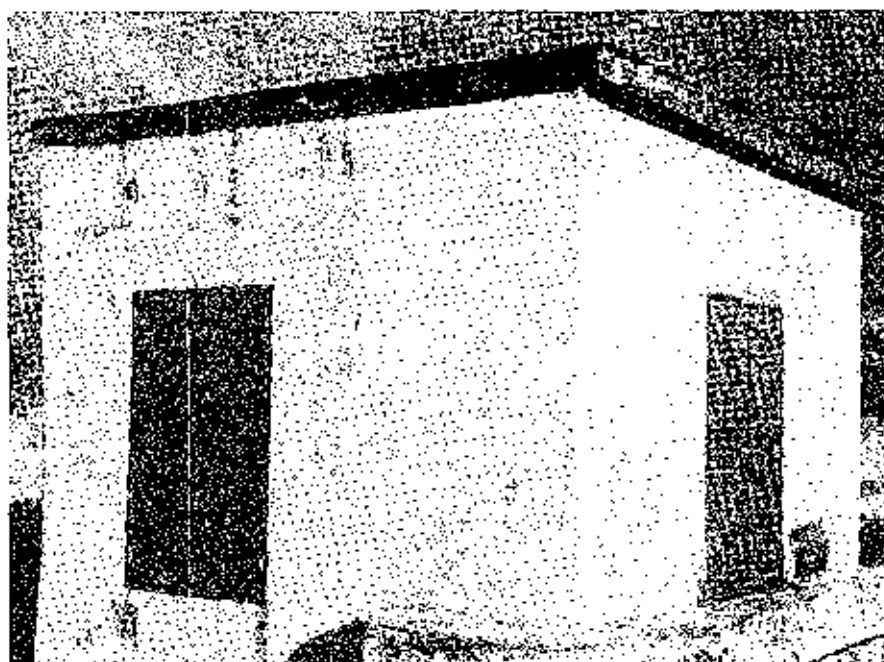
Figure 4.4. East and south elevations of the signal house on el Caballero. Photo by Richard Crisson, 1986.

The signal flag house adjacent to the ramp is of brick or brick-rubble construction with wooden roof joists and a masonry roof (fig. 4.4). Originally it housed the flags hoisted onto the adjacent signal pole to signal incoming ships. It is unused today. The solid wood plank paired shutters of the building's two windows are secured by cross-bars set on angles. The hardware and shutters are modern and sit flush to the outer wall. The south-facing doorway is of similar construction and date. The structure is capped with a simple, flat, projecting cornice. Drips of tar are evidence of a modern bituminous coating on the roof.
