THE FORTIFICATIONS OF SAN JUAN NATIONAL HISTORIC SITE

HISTORIC STRUCTURE REPORT

El Fuerte de San Cristóbal

1991

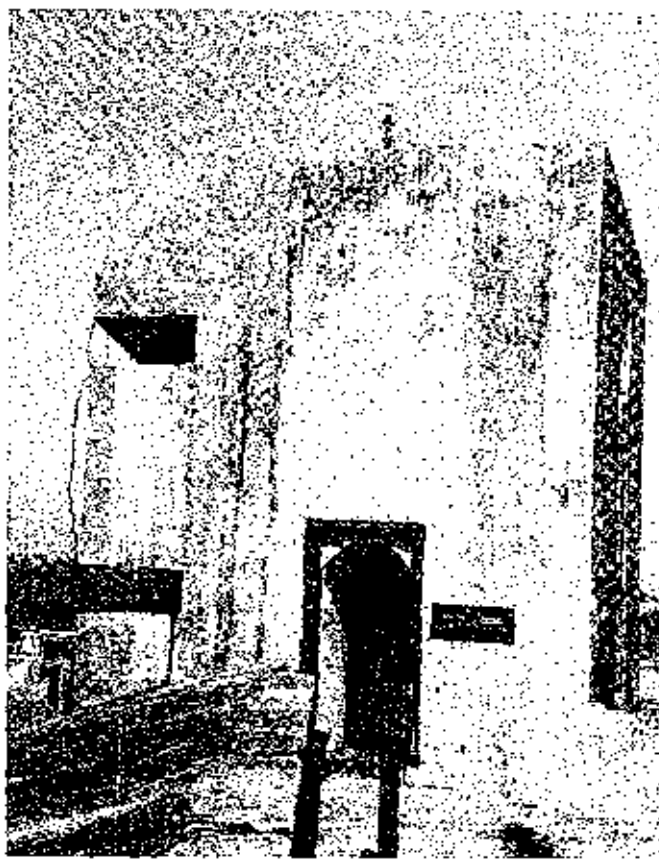
Figure 4.5. North elevation of fire control station on el Caballero. Photo by Richard Crisson, 1986.

The two-story fire control station at the northeast corner, is made of reinforced concrete and dates to 1942 (fig. 4.5). It was an integral element of the 1941 fire control installation for the San Juan harbor defense. It is a rhombus in plan and has a rounded corner. Situated on top of the 1770's parapet, it has long, narrow, horizontal openings for windows on both levels. The windows face north, and are deeply set into the structure to provide wide recessed sills. A window with an inward-opening shutter faces south at the second story. The roof is flat, sloping northward, and has no cornice. Interior conditions were inaccessible due to a "special use permit" between the NPS and San Juan Ports' Authority.

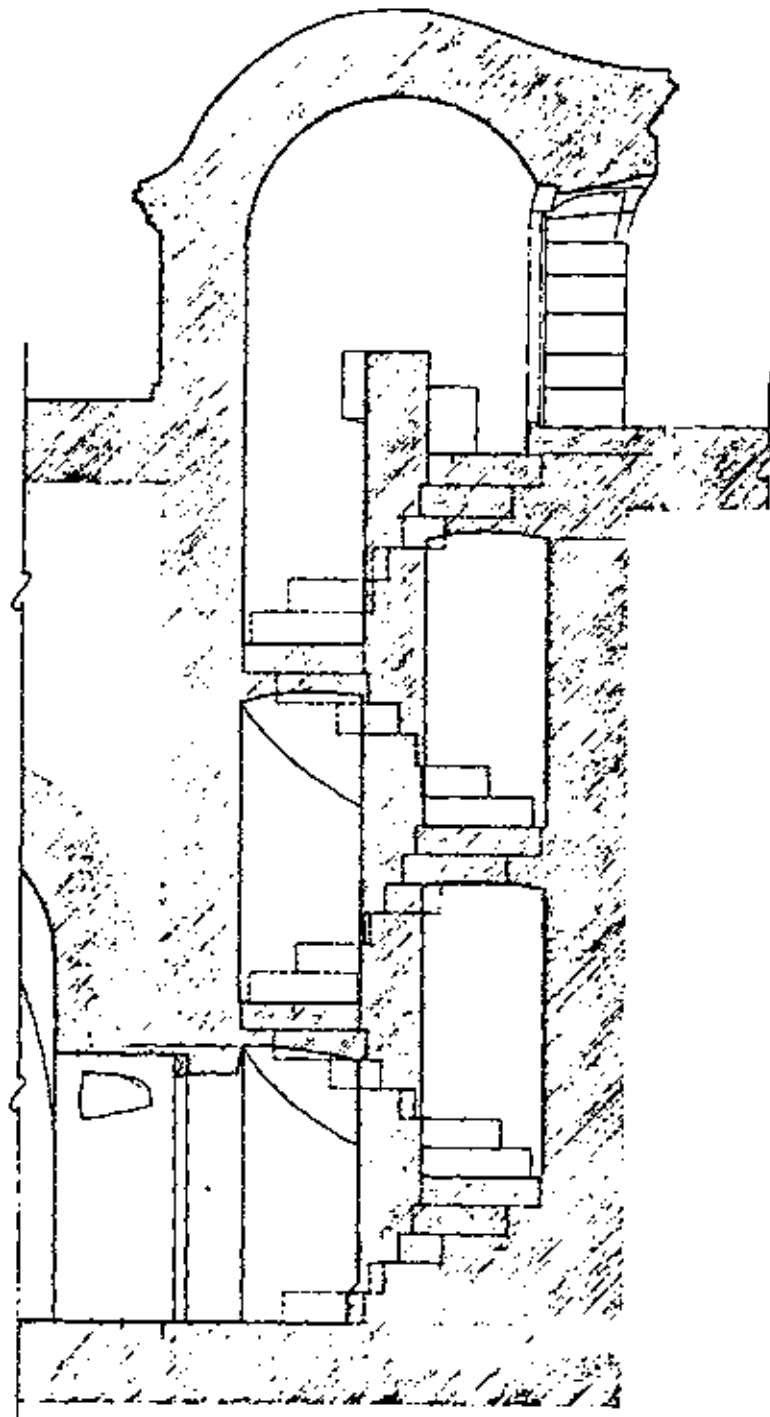
Figure 4.7. Section of spiral staircase. HABS drawing, 1962.

Visible at the southwest corner is the circular stair tower (fig. 4.7). Although its walls are an extension of the lower (Troops' Quarters) wall, the actual 1773 construction of the tower is of brick and stonerubble covered with reddish stucco and re-surfaced with a white stucco. Of note in the stair tower is the use of cut sandstone for the cornice, doorway, and circular window.

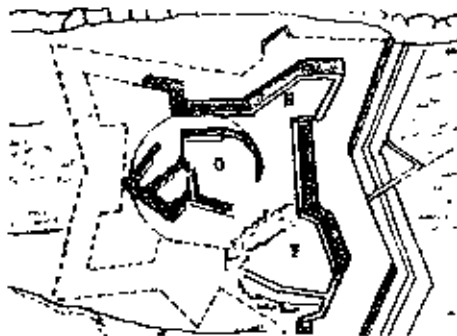
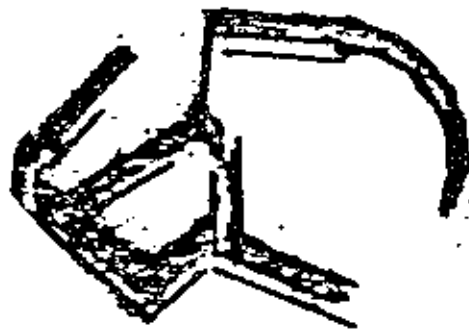
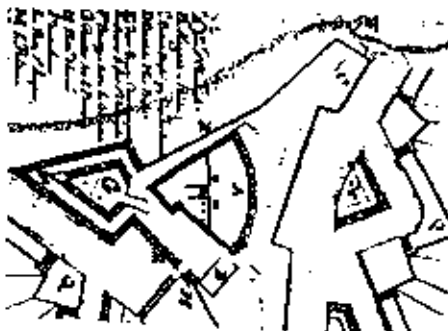
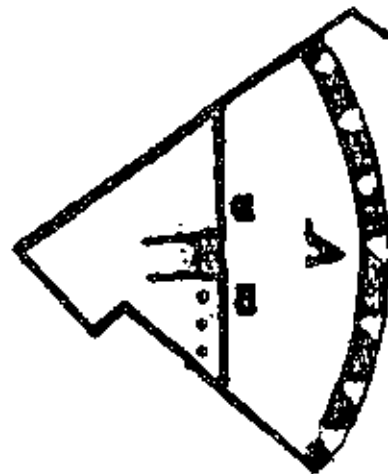
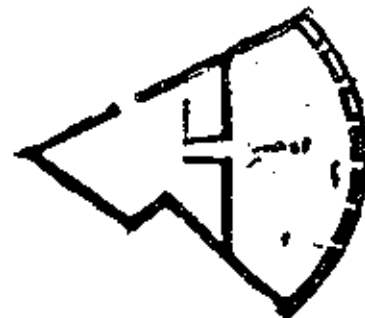
Figure 4.8. Early plans showing el Caballero. Compiled by Barbara Yokum, 1986.

The highest part of San Cristóbal, el Caballero, is also one of its oldest features. The curved east wall appears in the map of 1678 and most likely dates to the original 1634-1644 construction of the fort. It was known in the seventeenth century as la Santísima Trinidad (Most Holy Trinity).¹ In 1702, this feature was labeled in french as "A" emphasizing its importance as the center of the fortification. Not until the eighteenth century was it referred to as el Caballero (the cavalier), meaning a high platform on a bastion. Plans from this period are all included in figure 4.8.

The plan of 1678 was sketched by Engineer Luis Venegas Osorio for the repair and proposed expansion of San Cristóbal. Here la Santísima Trinidad was shown as semi-circular, with a curved wall on its east side. Flanking it to the west was a demi-bastion. No additions were proposed to the feature at this time, although repairs may have been in order. These, unfortunately, were not detailed.

The same basic configuration was shown in the French plan of 1702 by an unknown author.² Two additional details were included; seven embrasures in the semi-circular wall, and a ramp to the west enclosed by the flanking demi-bastion. Different from 1678, was the northwest wall illustrated in 1702 as a straight line. This may have been a proposed alteration as the intent of the 1702 drawing was to record both existing conditions and proposed new work. Alternatively, the 1702 plan may have simply been a more accurate rendition of the existing works.

Engineer Thomas O'Daly also described the cistern in his report on the existing conditions at San Cristóbal in 1765. This he called a "capacious and [bomb] proofed cistern."⁴ Whether or not it then contained water was not noted. O'Daly's plan that accompanied the report showed el Caballero unchanged from the 1702 plan, with seven embrasures to the east and an access ramp to the west. In addition, the

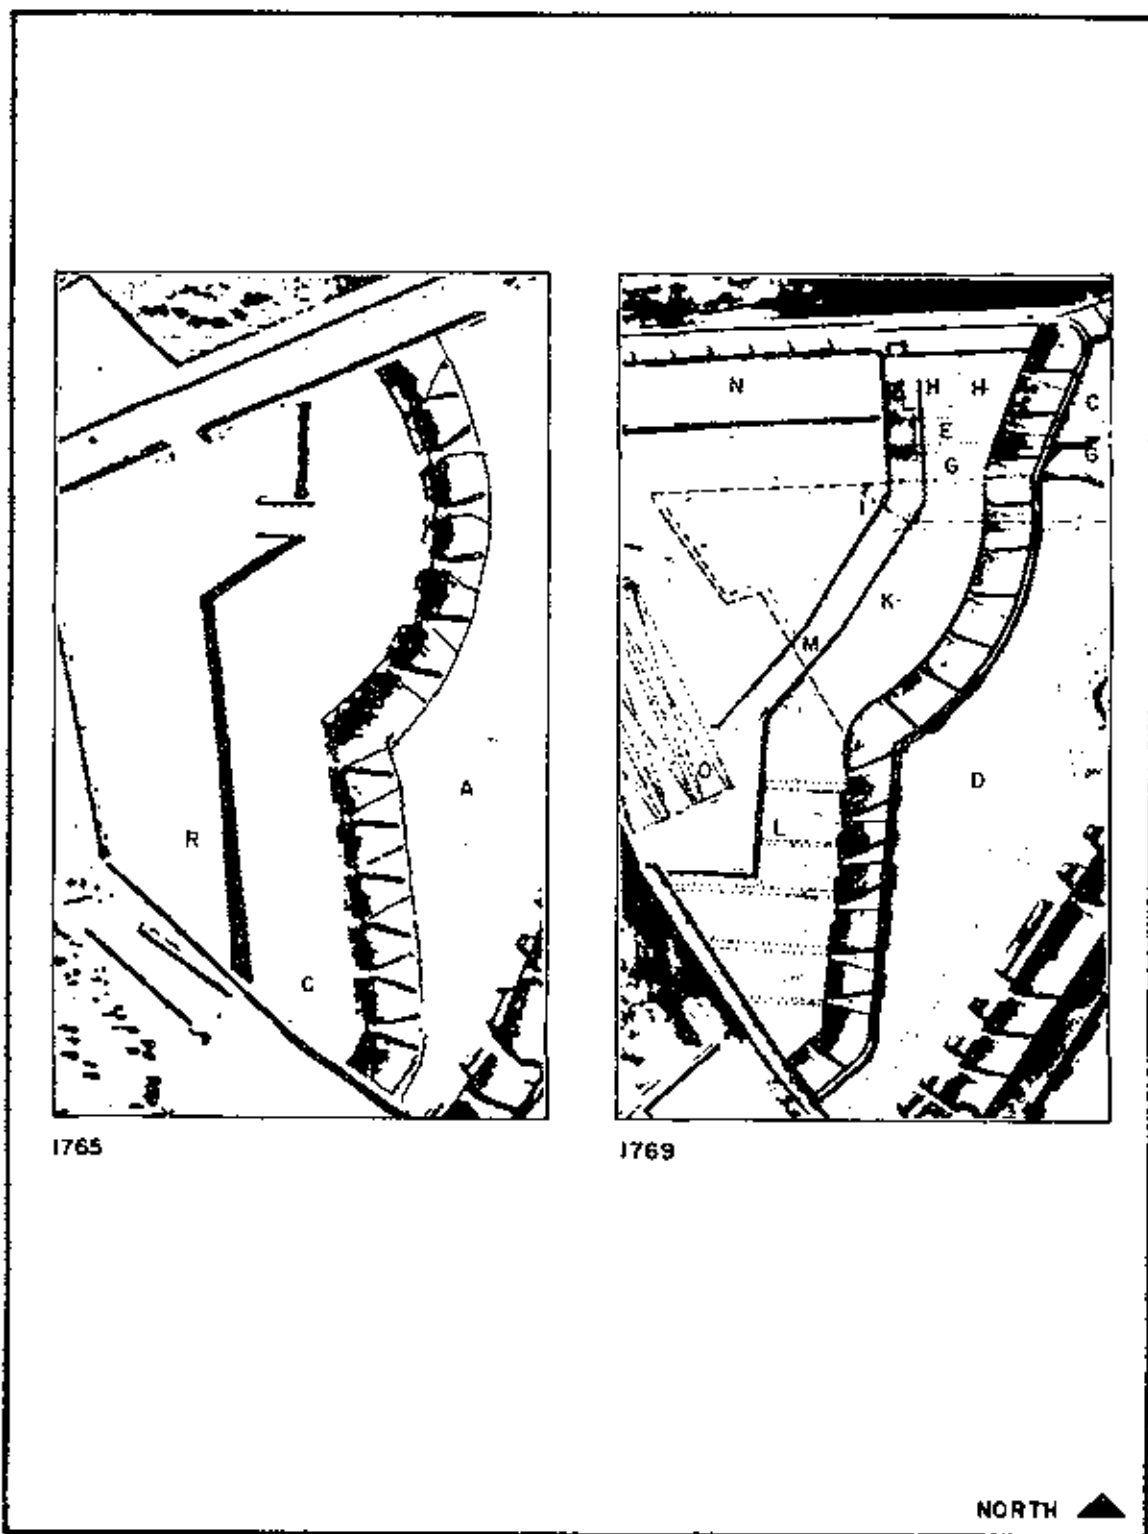
Figure 4.9. Details of two plans by O'Daly showing proposed designs for el Caballero. Note outline of old Caballero indicated on 1769 plan.

The design had changed four years later when O'Daly drew up another plan in 1769 (fig. 4.9) and proposed to raise the platform of the "old" Caballero (K), "6 pies [about 5.58 feet] in order to better dominate the outer works and the terrain in front." This made the old ramp obsolete, so a new ramp was designed along the west side whose purpose was "carrying artillery to el Caballero." Already under construction was a new addition to the north with three embrasures on its east side. Within this addition would be powder magazines, the entrance to Tunnel 1, and Tunnel 3 to the North Bastion (all discussed in later chapters). Still projected to the south was the wing (L) described as the "battery in continuation of the Caballero." The design had changed slightly since 1765, being enlarged southward and having seven embrasures instead of six. Construction, however, had not yet begun.⁶

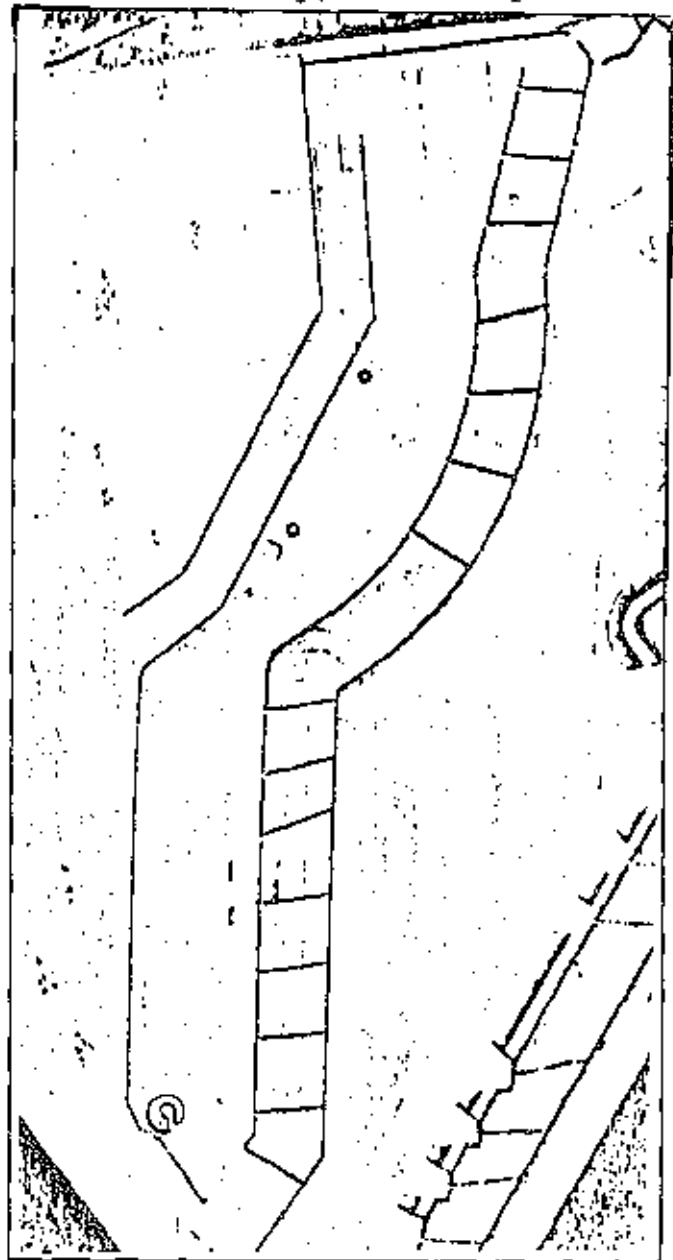
Figure 4.10. Detail of 1773 plan by O'Daly showing modernized el Caballero as built.

The plan (fig. 4.10) illustrated fourteen embrasures in the east parapet wall facing the land approaches. In addition, a large opening faced southeast at the south end of the parapet. This too was apparently a gun position since a later accounting mentioned that el Caballero "can mount 15 cannon." At the southwest corner of the new lengthened platform was a small circular feature. This was the stair tower covering the

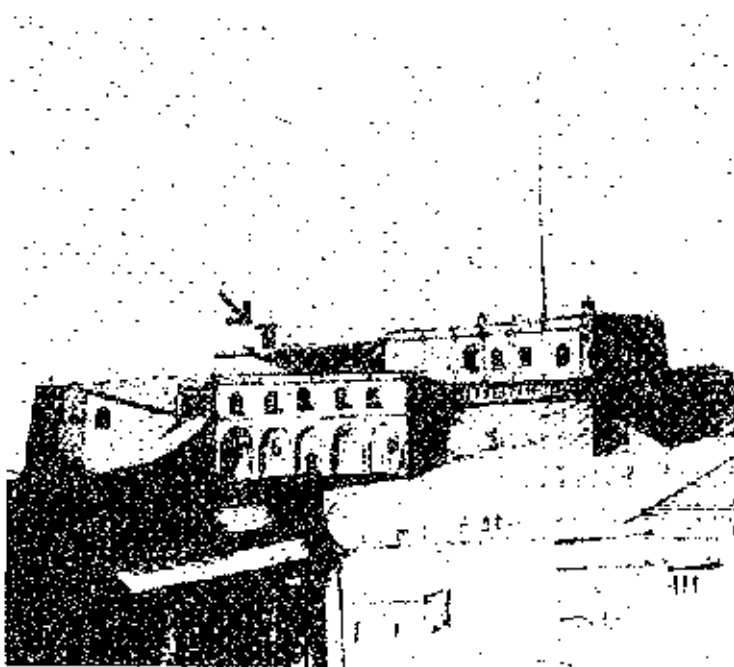
Figure 4.11. Detail of August Pleé sketch, 1821. East elevation. Arrow points to possible signal house on el Caballero.

More than ten years after these repairs were made, the west side of el Caballero was documented in a sketch (fig. 4.11) made of San Cristóbal in 1821.¹¹ Seen for the first time in this sketch is a large signal pole north of the stair tower and a small building in the same approximate location as the signal house today. The design of this small building differs in detail from the existing structure and the rendering of other features is only approximately accurate. Therefore, the

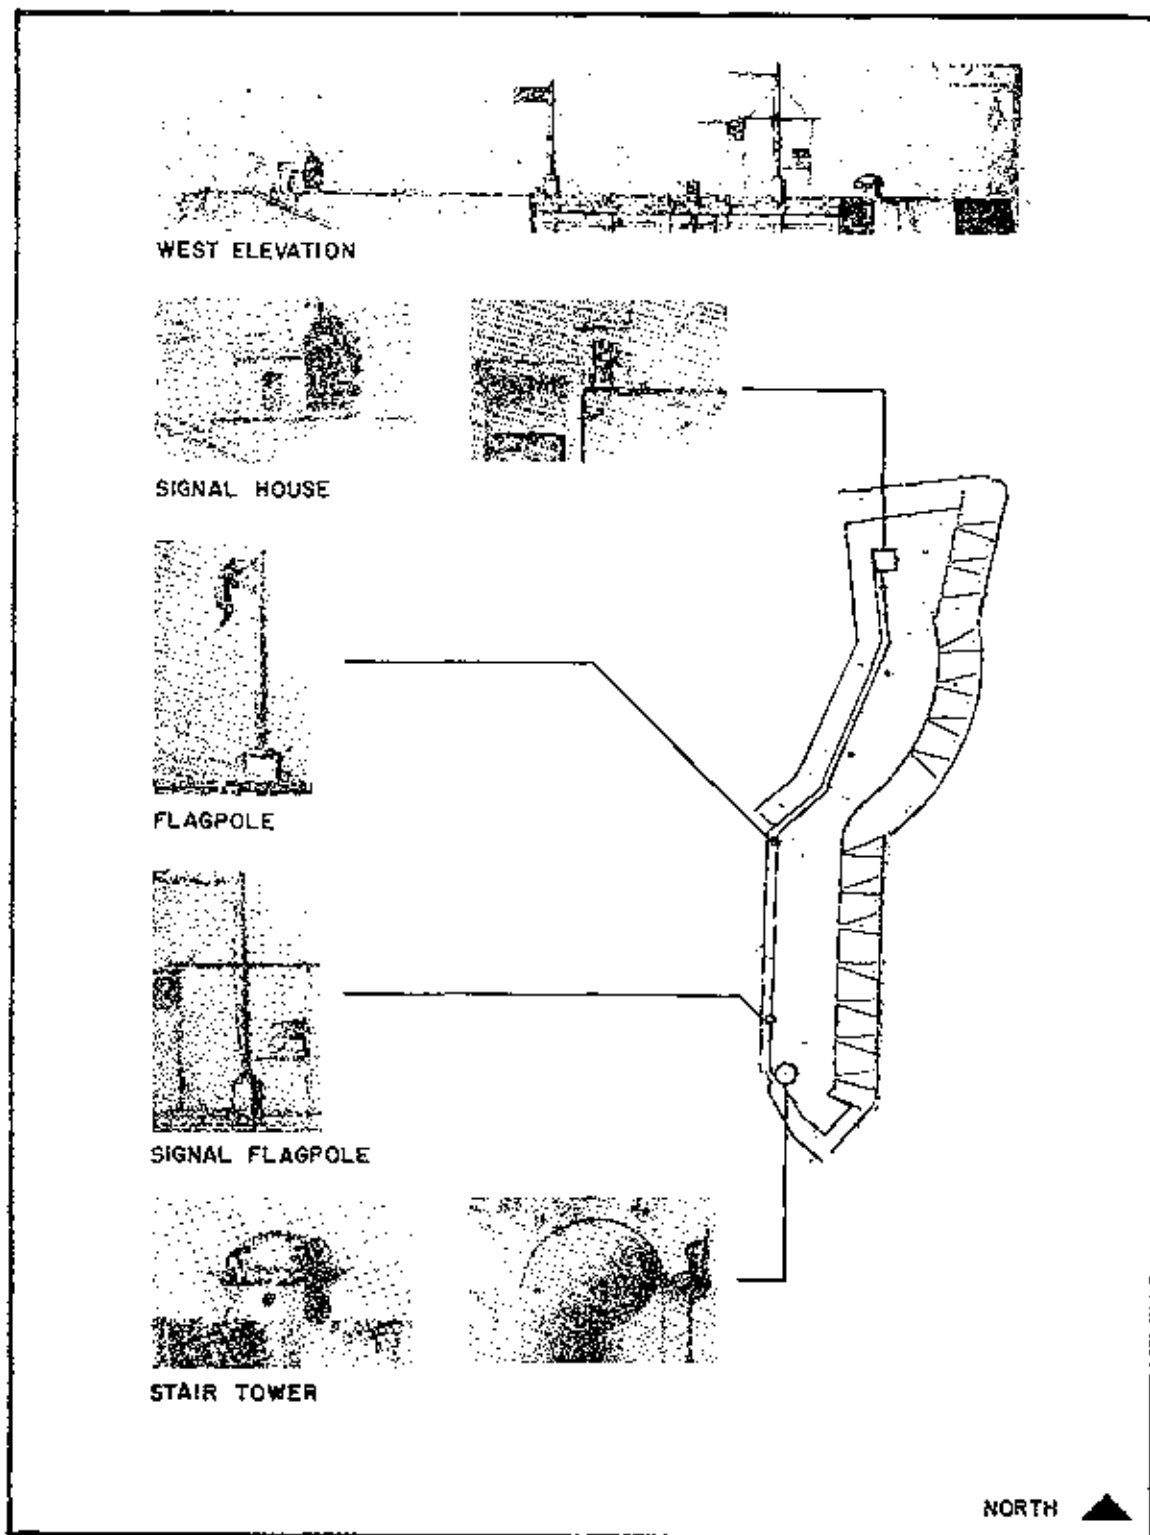
Figure 4.12. Detailed views of el Caballero from 1861 drawings by Manuel Castro. Compiled by Barbara Yokum, 1986.

Delineator Manuel Castro recorded San Cristóbal in color-washed drawings in 1861 (fig. 4.12). These provide the most detailed views of el Caballero to date. Unchanged in 1861 were the original eighteenth-century embrasures, the stair tower, and the two cistern heads. The intricate detailing shows for the first time; a small round window in the west facade of the stair tower, the octagonal shape of the cistern heads, and the long rectangular shape of the early cistern below. The cistern was located at the first floor level of the Plaza and oriented parallel to the ramp at the west wall. Horizontal access to the cistern today is through a small opening in the exterior west wall above the ramp. This same opening was clearly illustrated by Castro. Enclosing the cistern opening in the drawing was an open grille of basketweave design.

Also shown in their same locations were the later signal pole and signal house, both probably built after the plan of 1783 and before 1821. The signal house was colored yellow, white, and green in 1861. The body of the building was yellow, its simple cornice white, and the south door and west window shutters green. This was similar to the paint scheme for the buildings on the Plaza below. However, no verification of this color scheme for the signal house has been found. The one exterior paint sample removed from the body of the building has no evidence of an early yellow finish.

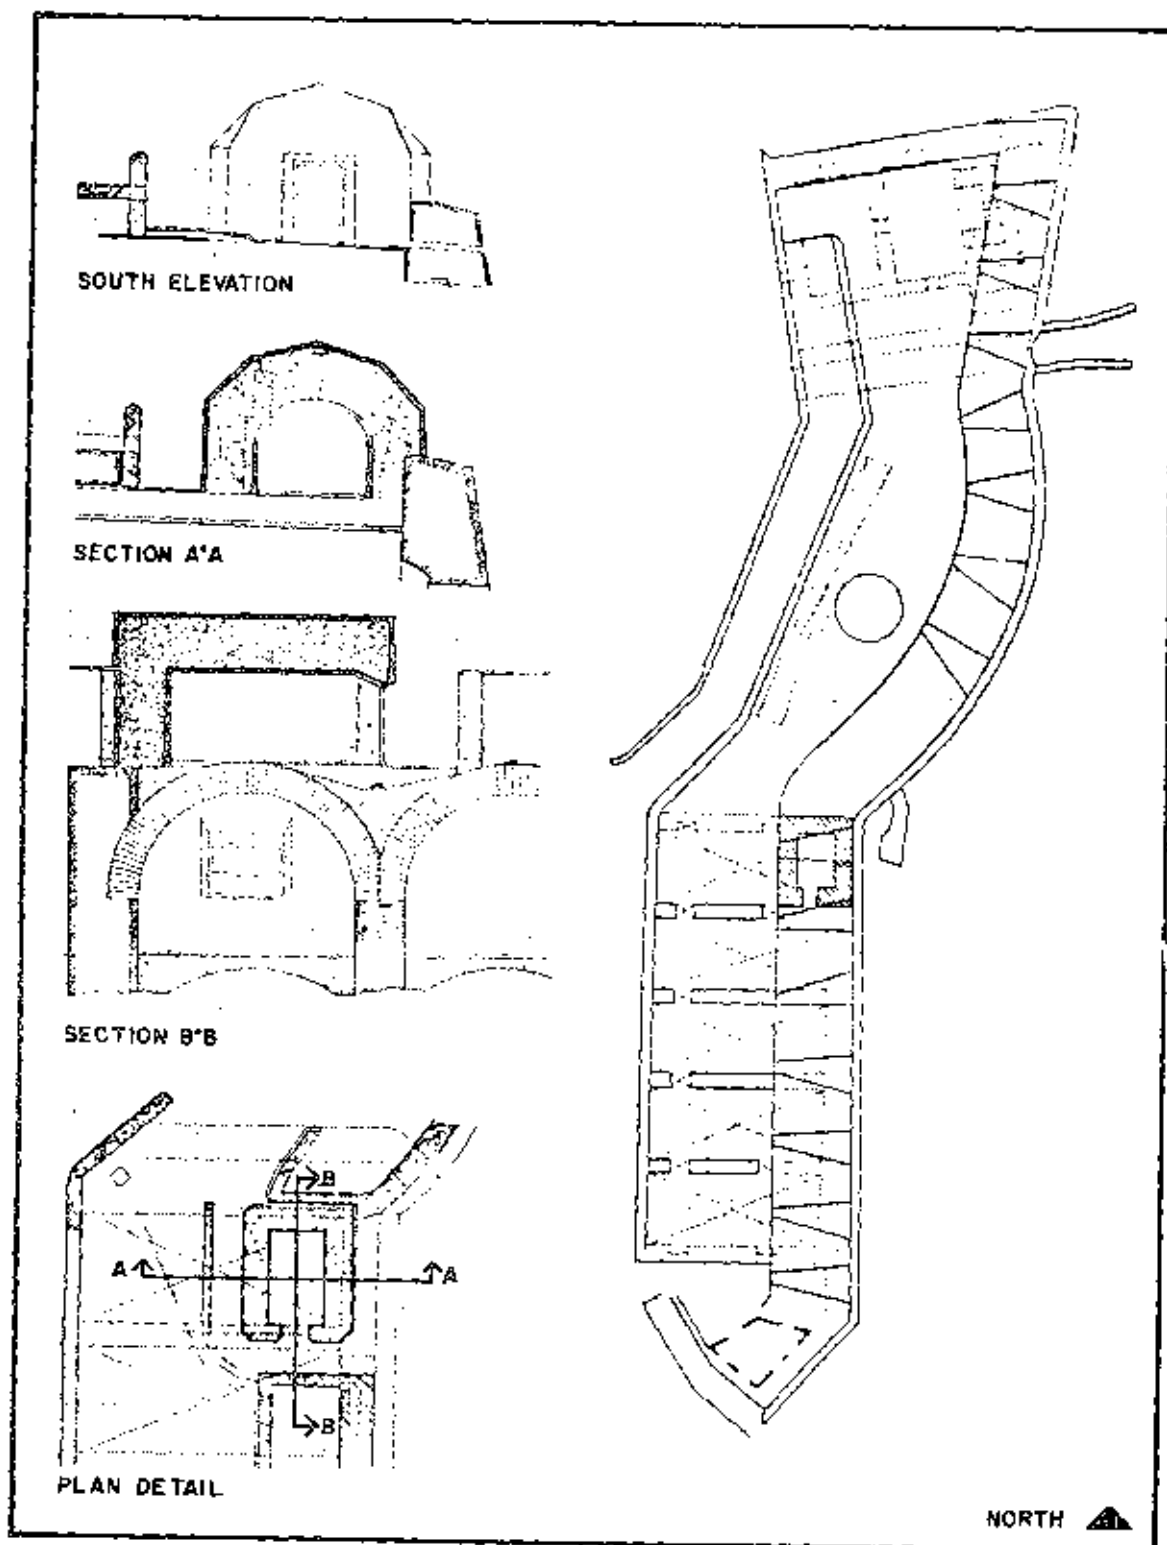
Figure 4.13. The new powder magazine, ca. 1897. From drawings obtained by Colonel Goethals in 1898. (San Juan NHS Archives.)

Two documented renovations were made in ca. 1897.¹³ A 24-cm. howitzer was emplaced at the west parapet adjacent to the ramp, and a powder magazine built to supply it. (See fig. 4.13.) Alterations made to accommodate the gun included building of a raised base and a mound of earth at the west wall for protective cover. The magazine was built behind and to the south of the gun within the east parapet wall of the south extension. Two embrasures, located immediately south of the

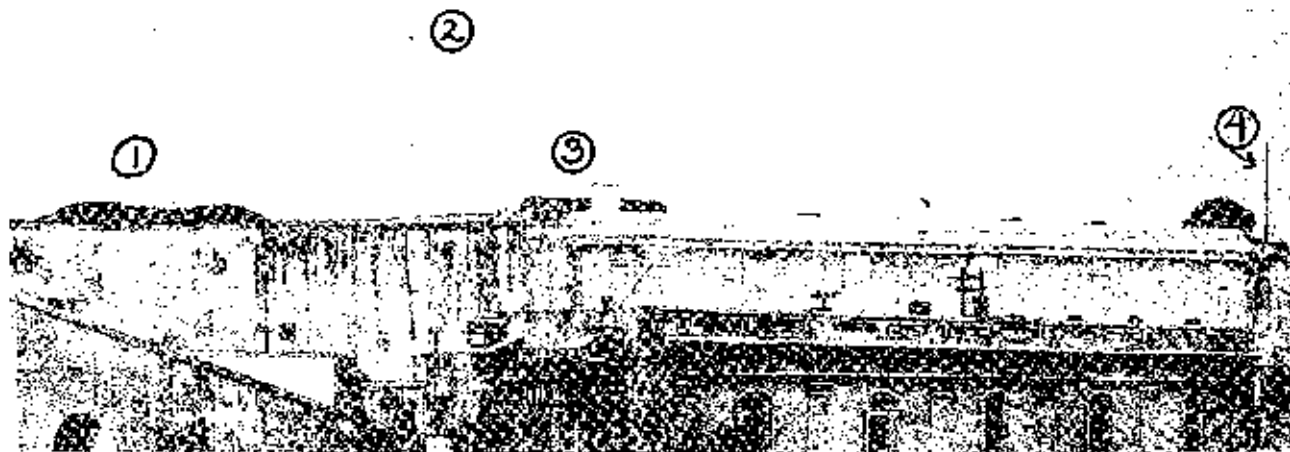
Figure 4.15. Detail of view dated 1912 (numbers added). Note following features: 1) earthen mound, ca. 1897; 2) iron flagstaff, ca. 1902; 3) powder magazine, ca. 1897; 4) possible derrick. (San Juan NHS Archives.)

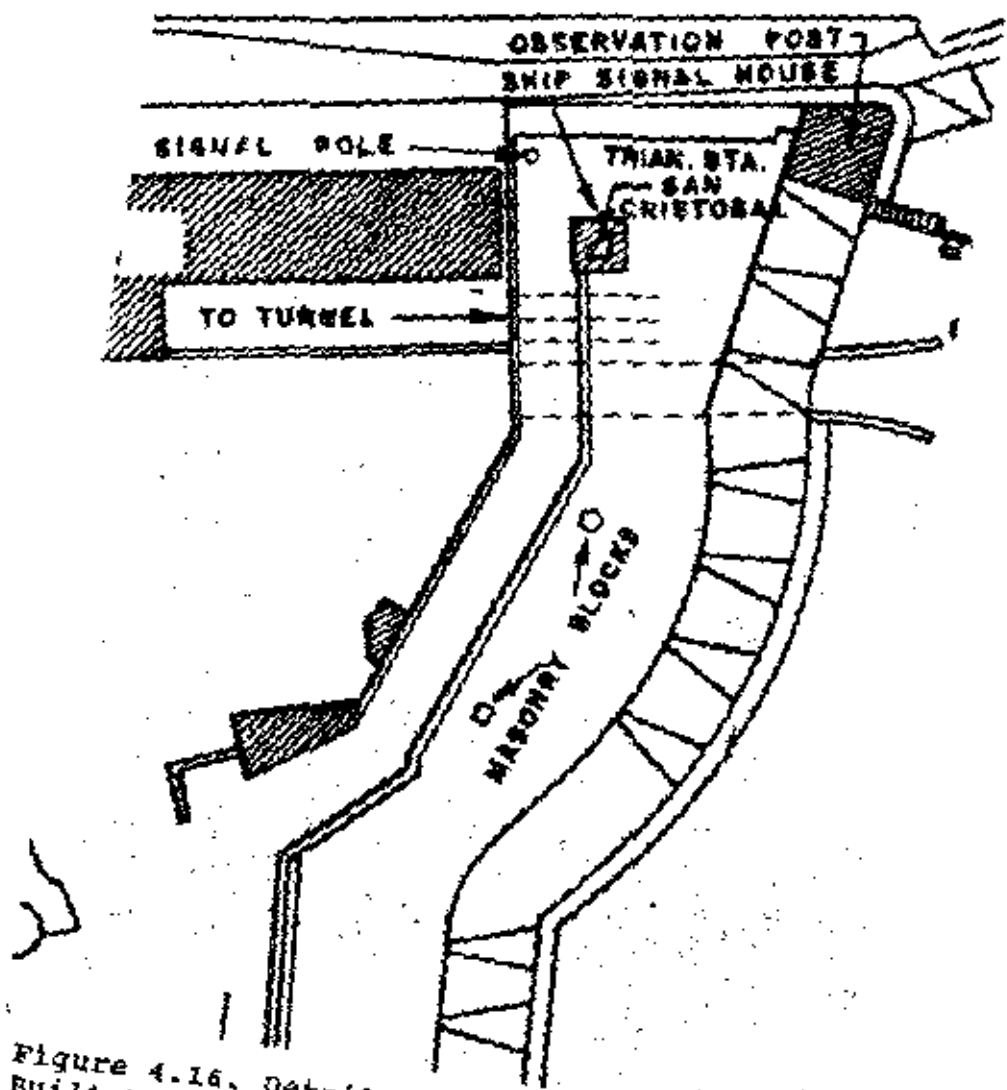
Figure 4.16. Detail of plan Fort Brooke as Built," Office of the Engineer, U. S. Army, ca. 1949, highlighting el Caballero. (San Juan NHS Archives.)

A plan (fig. 4.16) of San Cristóbal made in about the late 1940s records the use and terminology of the structure on the north end of el Caballero. At the northwest corner was the reinstalled "Signal Pole." Nearby, at the head of the ramp, was the "Ship Signal House." On top of the signal house was a triangular symbol labeled "Triang. Sta. San Cristóbal." The new World War II fire station was labeled the "Observation Post." The two historic cistern heads, no longer in use, were denoted "Masonry Blocks."²⁰

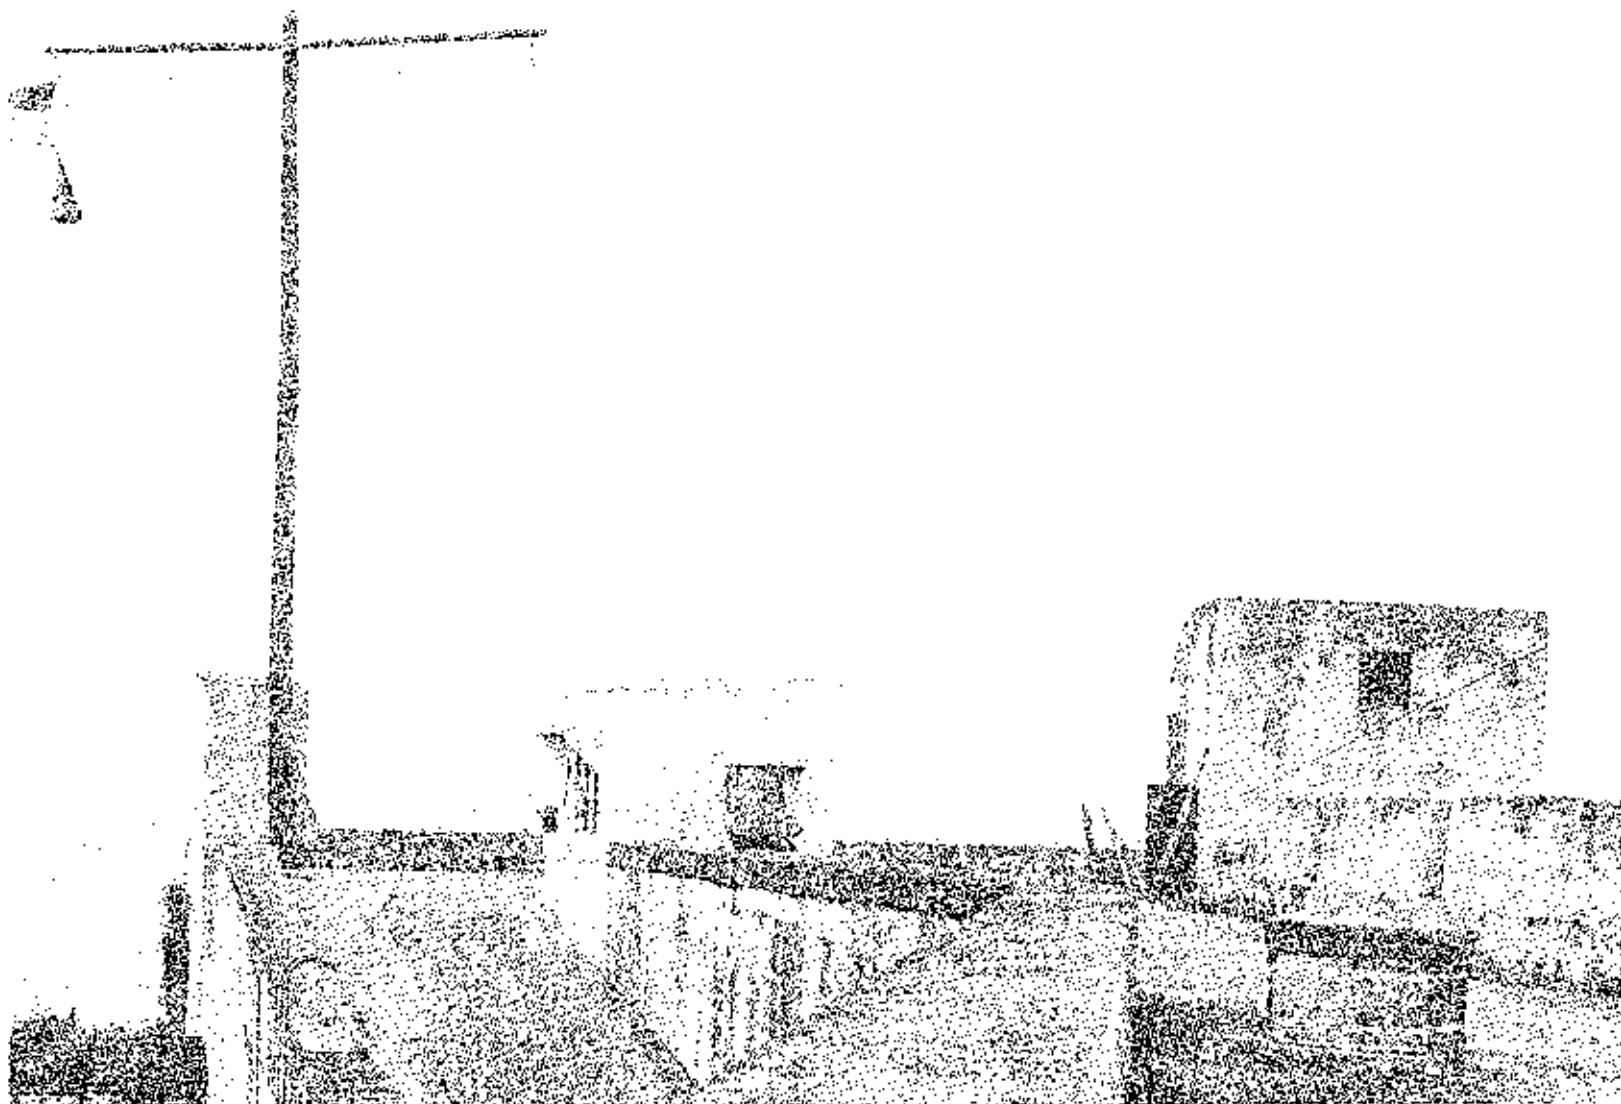
Figure 4.17. North end of el Caballero with signal house on left and fire control station on right. Ca. 1960. (San Juan NHS Archives.)

Photographs taken in the decade of the 1950s chronicle the repair and restoration work that was undertaken.²¹ The exterior of the signal house appeared lighter in color, perhaps due to repainting or restuccoing. Installed over the doorway and window openings were hoods to shield the sun and rain. At the stair tower, a comparison of photographs taken in 1953 and 1960 indicate that the exterior wooden door was replaced. The exterior side of the door in 1953 was composed of flush boards installed horizontally. By 1960, the boards in the new door were oriented vertically. (See figs. 4.17, 4.18.)

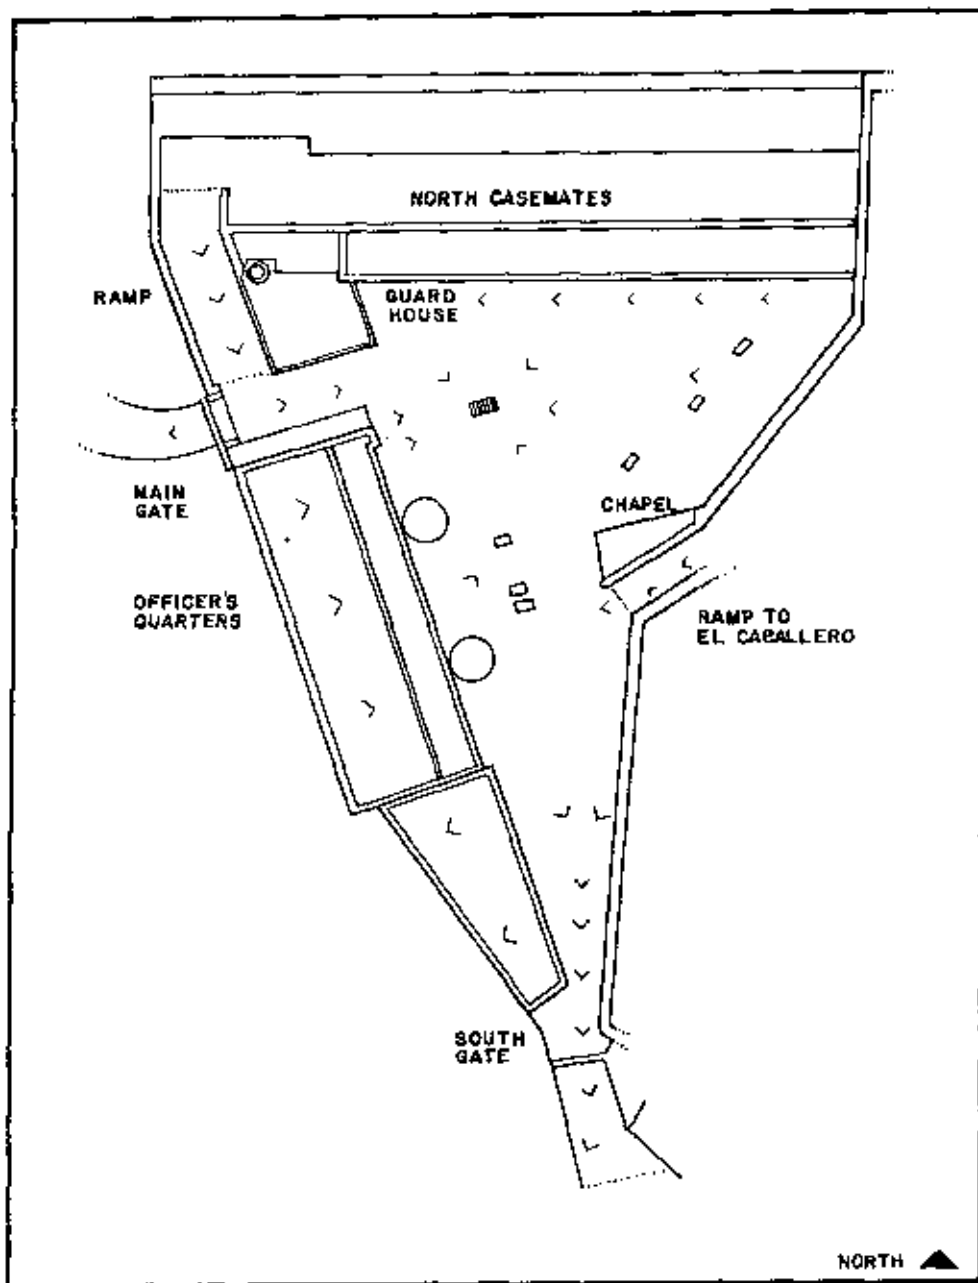
Figure 5.1. Drawing of Plaza de Armas and surrounds showing drainage patterns. Based on a 1939-39 Corps of Engineers drawing. Rendering by Jana Gross, 1989.

The Plaza de Armas (fig. 5.1, 5.2), historically known as the Plaza Baja (Lower Plaza), and the Patio Principal (Principal Patio), is the large open triangular area of San Cristóbal bounded on the north, west, and east by the North Casemates, Officers' Quarters, Main Gate, and the Troops' Quarters and ramp. The Plaza served as the primary place of assembly and parade for San Cristóbal and still functions as the center for the site's activities. External access to the Plaza was, and still is, through the Main and South Gates. Internal circulation was accessed through the various ramps and tunnels to the upper and lower levels and the outworks. The Plaza was also an essential element in the water drainage and retrieval system designed at San Cristóbal. Two additional elements in the water retrieval system closely related to the Plaza are; the cisterns beneath the Officers' Quarters, and the Well Houses located in front of the Officers' Quarters on the

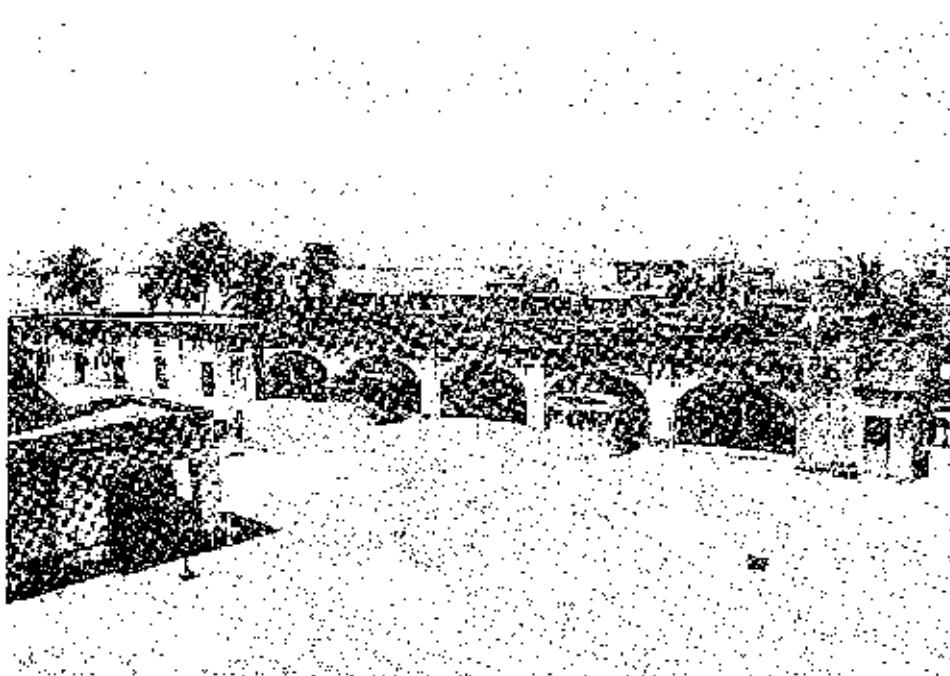
Figure 5.2. View from el Caballero showing the Plaza de Armas, Well Houses, and Officers' Quarters. Photo by CPR, 1986.

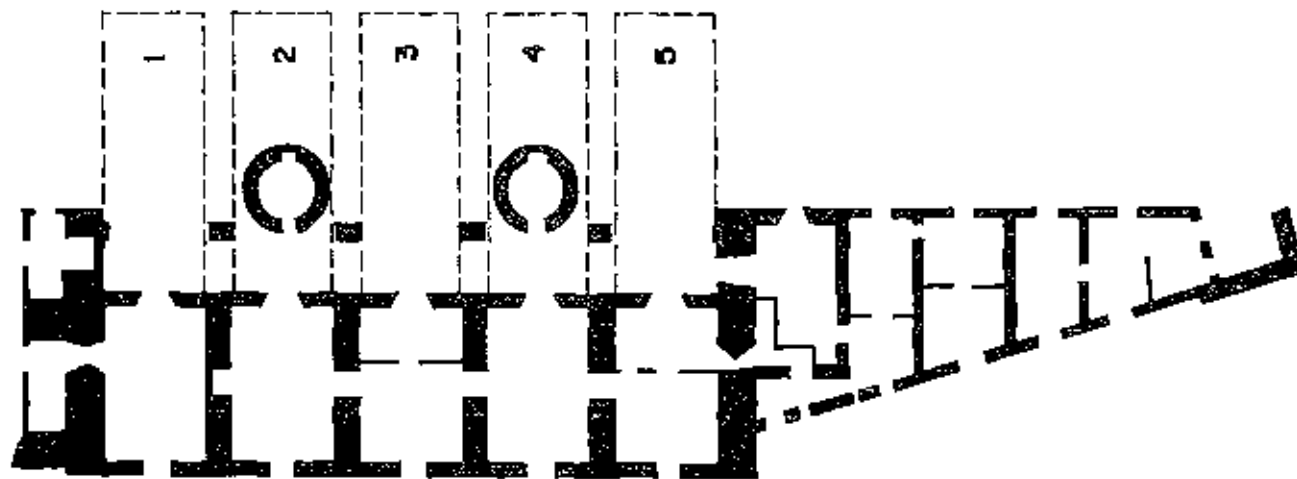
Figure 5.3. East elevation and plan of Officers' Quarters showing the Well Houses and their cisterns. Drawing by HABS (1961) annotated by Jana Gross (1989).

Below the casemates of the Officers' Quarters and extending eastward beneath the Plaza de Armas lie the principal cisterns of San Cristóbal. Construction of all five cistern vaults is generally the same, each being rectangular in plan, barrel vaulted, and positioned partially above grade on the west elevation. (See figs. 5.3, 5.4.) A shallow blind arcade extends along the west facade of the Officers' Quarters allowing direct access by means of a doorway, to the north and south cisterns or vaults. As originally constructed, the five vaults were designed to function as two independent cisterns composed of two connected vaults on the north side (1 and 2),

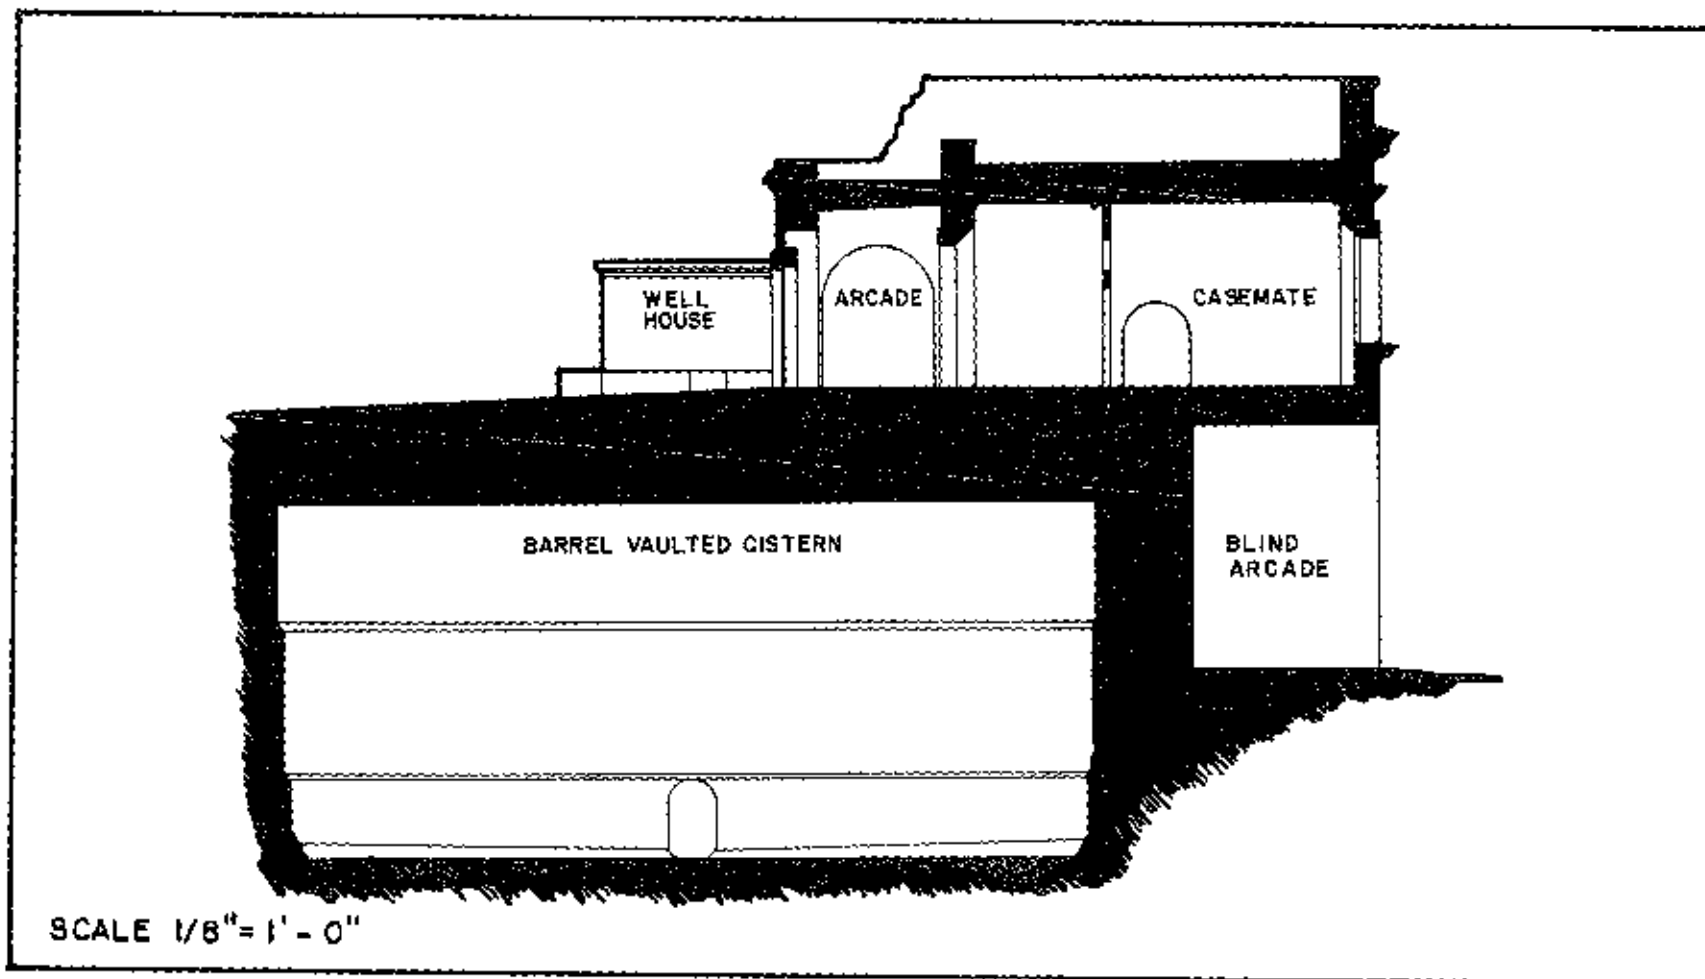
Figure 5.4. Section through cistern vault 3 looking south. Drawing based on 1961 HABS drawings. (Jana Gross, 1989.)

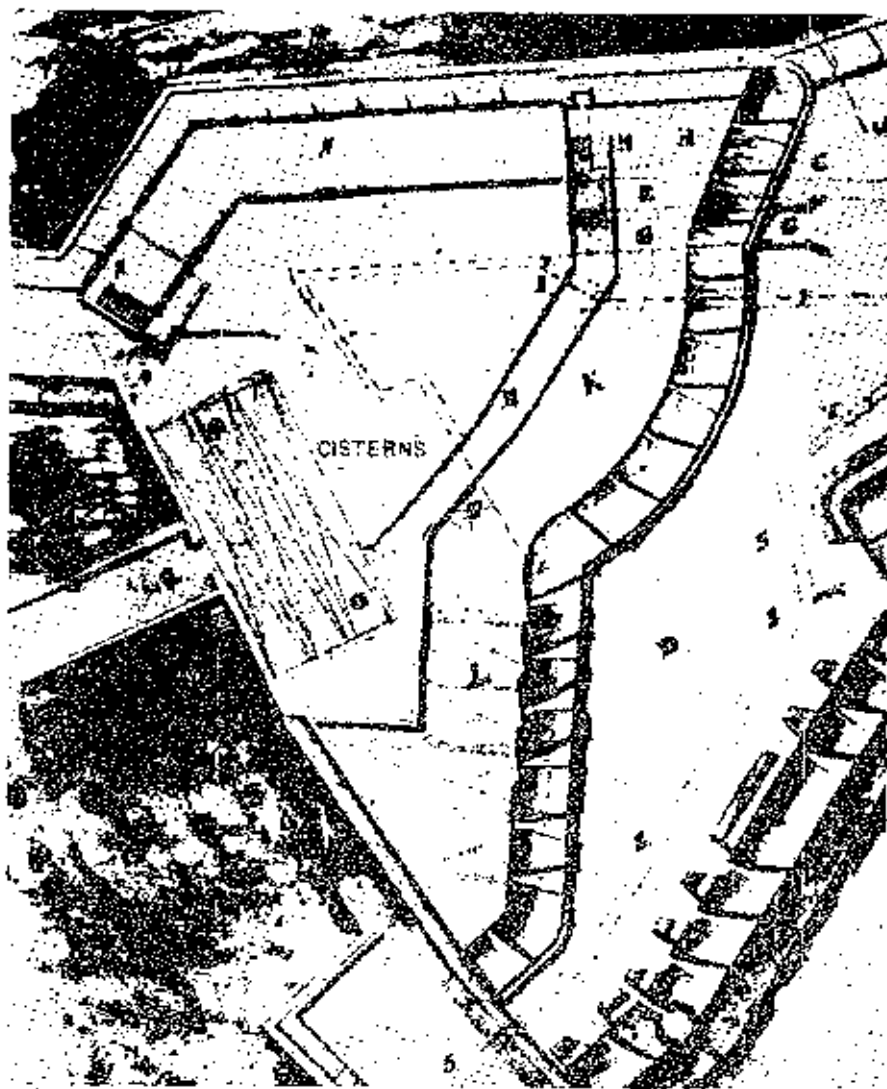
Figure 5.7. Detail of O'Daly's August 8, 1773 plan showing cisterns oriented east to west.

O'Daly's proposed plan for the modernization of San Cristóbal in 1765 was the first that showed the demi-bastion to the west of the cavalier and the old powder house removed, the south gorge infilled, and a plaza created. Several features of this proposal, such as the Rampa de Subida (main access ramp), were modified before construction. The plan of 1773 was a more accurate representation of the Plaza as it may have appeared prior to the enclosing of the north and west walls and the construction of the Officers' Quarters and North Casemates. During this time, prior to the erection of these structures, the Plaza probably remained unpaved (fig. 5.7).

This configuration was amended by 1773 (fig. 5.7) to include five large vaults arranged to form two independent cisterns of two and three vaults each now oriented east-west in approximately the same location. According to construction records, the cisterns were near completion by the end of June 1774 and were rendered on the interior with a parging of bitumen and red hydraulic mortar that still survives. It is likely that the interior devotional paintings (murales votivos) were also executed at this time. Also in these records was the first reference to the construction of the porticos above for guard rooms and lodging (Officers' Quarters). By March or April of 1775 the cisterns were in operation and the portico above ready for use.⁴

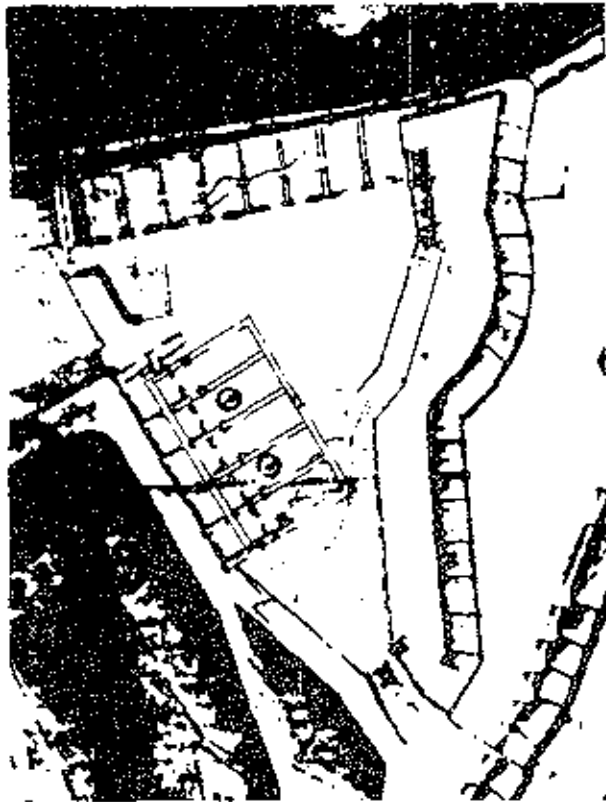
Figure 5.8. Detail of September 13, 1783 plan by Juan Mestre showing Plaza de Armas.

Mestre's drawings of 1783 (fig. 5.8) were the earliest showing the Plaza enclosed on the north by the North Casemates, on the west by the Officers' Quarters and on the southwest by the west wall. Also shown for the first time were the wellheads that pierce the Plaza above the cisterns, and the curved main entry ramp just north of the Officers' Quarters. A square feature, perhaps a pool to collect water, appeared on the drawings. Records of this period stressed the importance of the Plaza in water collection: "The waters of the plaza which were not directed to the cisterns, were carried to the latrine pits and then to the ocean through a master drain conduit".² These conduits ran under the Plaza as shown on the sketches of this period.
