THE FORTIFICATIONS OF SAN JUAN NATIONAL HISTORIC SITE

HISTORIC STRUCTURE REPORT

El Fuerte de San Cristóbal

1991

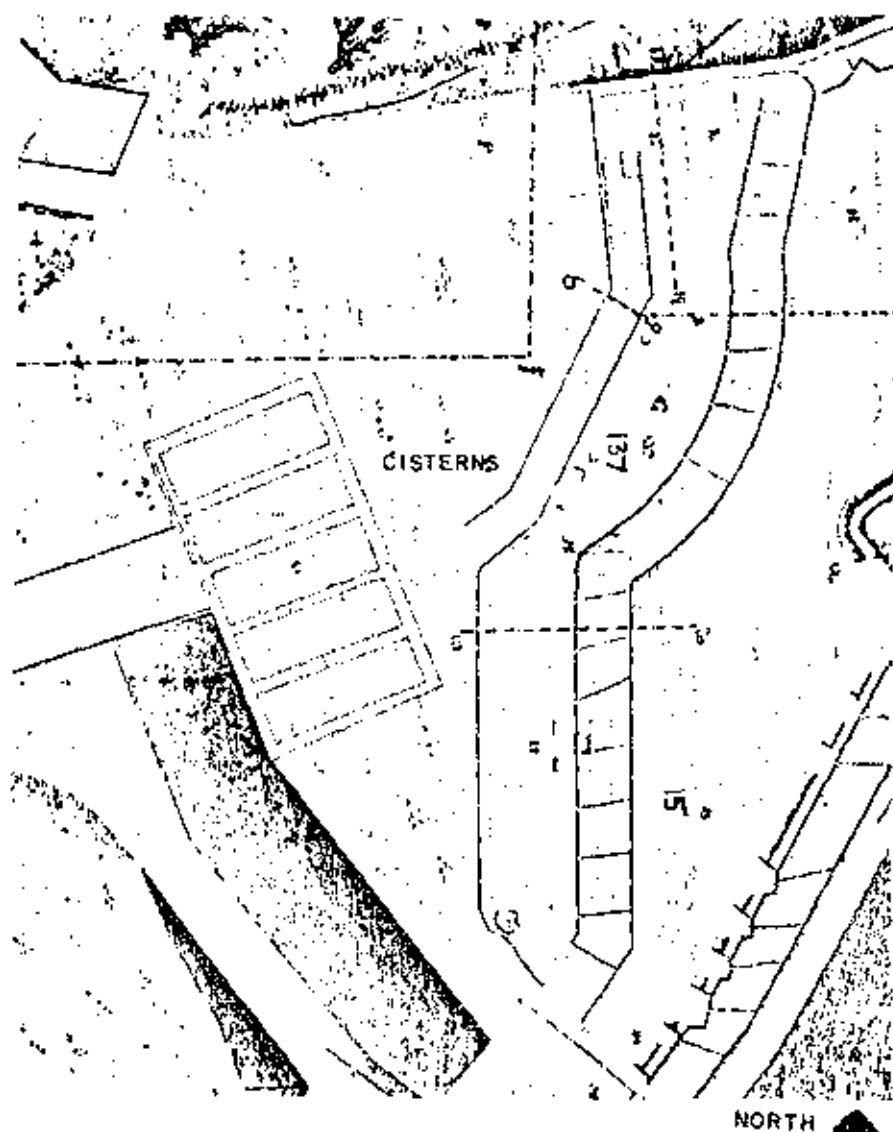
Figure 5.9. Detail of O'Daly's January 15, 1769 proposed plan showing cisterns oriented north to south.

The Cisterns were first seen on O'Daly's original designs of 1769 (fig. 5.9) proposed the construction of three large vaulted cisterns under the Plaza de Armas centered in front of the west Rampa de Subida and running north-south, parallel to the west wall. These were described on the plan as:

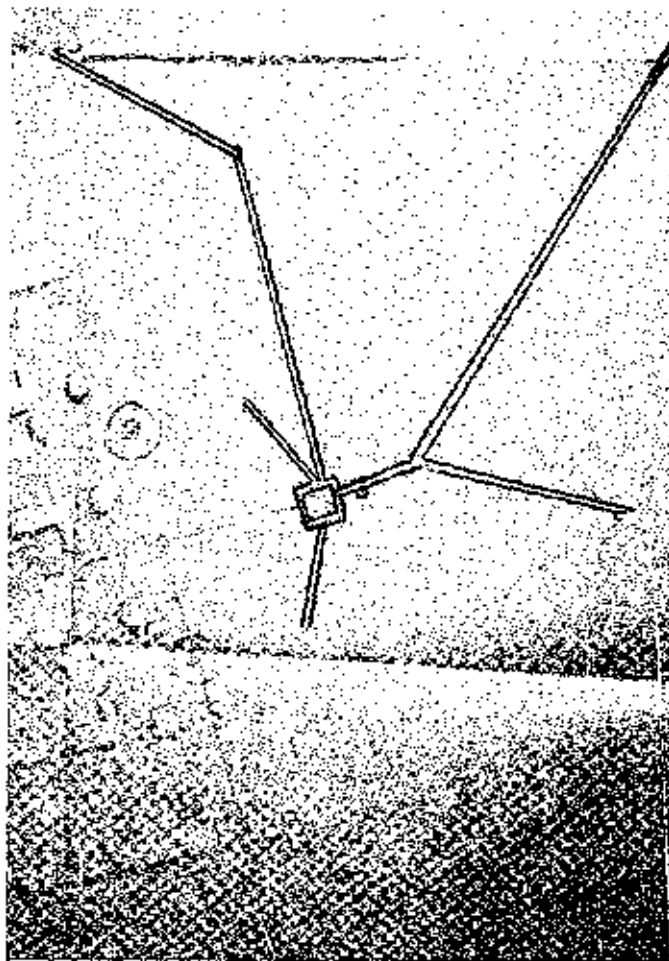
Figure 5.10. Plan by Mestre, 1783, showing water retrieval system beneath the Plaza de Armas. Drainage network highlighted. (San Juan NHS Archives.)

Mestre's plan of 1783 and related contemporaneous drawings confirmed the completion of O'Daly's work and depicted both the feed system for the cisterns and the Well Houses with heads for water retrieval. As substantiated by the physical evidence of the drainage system on the terreplein of el Caballero, these drawings indicated that the water was collected from the vicinity of the northeast and east tunnel ramps and was channelled under the Plaza de Armas to an open square conduit from which outtakes fed the two cisterns (see figs. 5.10). In addition to the cisterns, this conduit also supplied water to the latrines located in the extreme west casemate of the North Casemates. In plan, both well heads appear to be identical. The heads themselves were octagonal in shape and were surrounded by roofless circular walls open on the west to provide direct access from the Officers' Quarters.

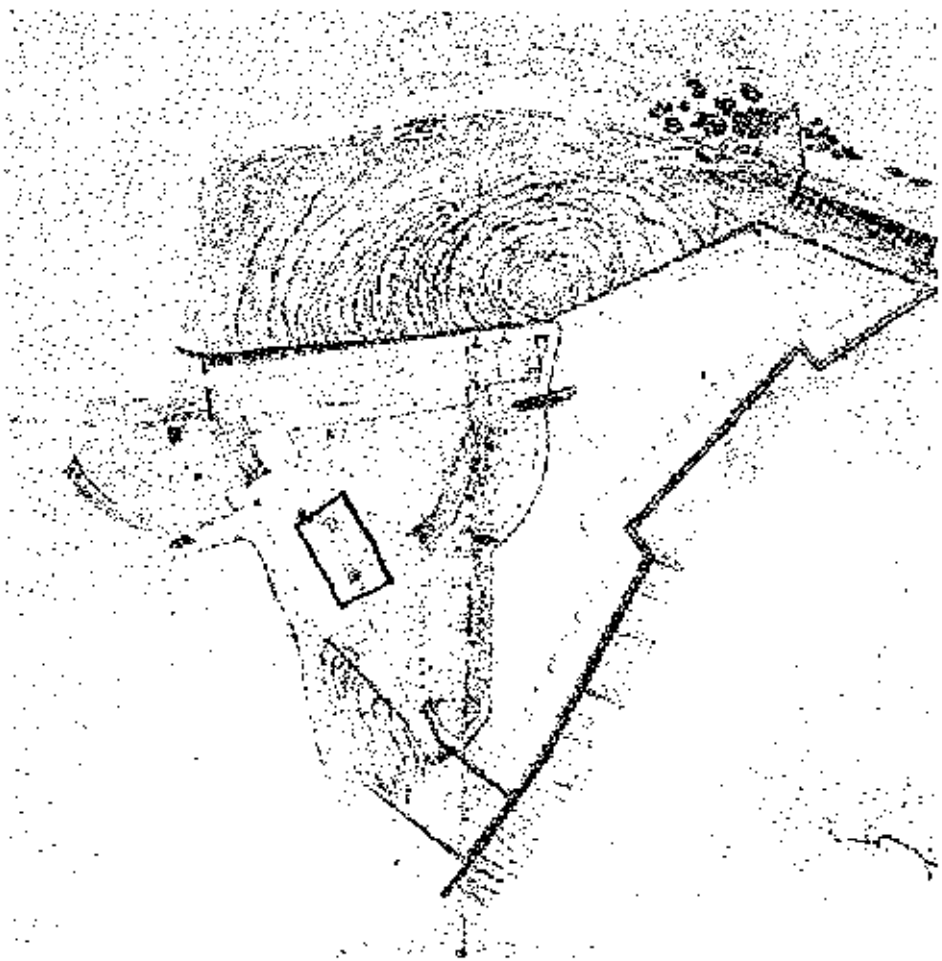
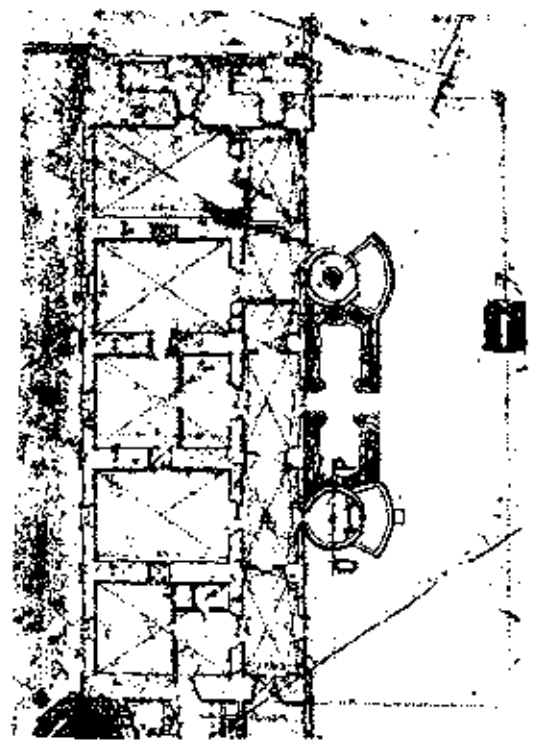
Figure 5.11. Manuel Castro's 1861 plan showing the Plaza de Armas with detail on right. (From NAHPC negative.)

According to the Castro plans the cisterns remained unchanged. However, the well houses underwent major alterations including the conversion of the south Well House to an officers' bath house and the insertion of a low walled garden (parterre) between the two structures. The bath house was created by removing the well head and inserting a small engaged oval pool (3 to 4 feet deep) and niche on the interior of the east wall. Low platforms flanked the pool on either side. The original circular wall was modified into an octagonal wall presumably to accommodate the glazed pyramidal roof illustrated in Castro's renderings. The walls must have been restuccoed at this time and pierced by dumbbell-shaped vents. Castro's drawings suggested an interior elaborately decorated with Islamic elements characteristic of Hispano-Moresque architecture perhaps including a marble pavement

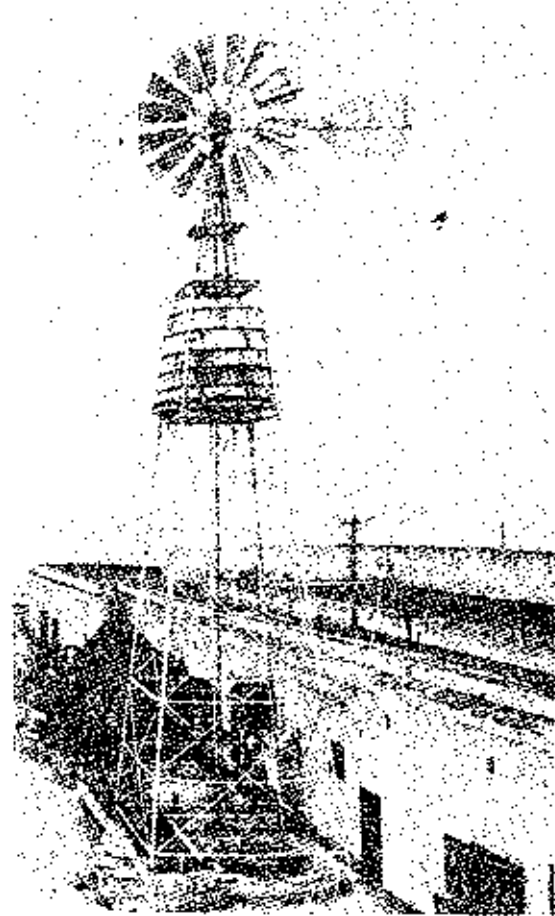
Figure 5.12. Detail or view of Plaza, ca. 1905, showing windmill in place on site of former Well House. (HABS negative 181.25.)

One of the first new elements to appear during this period was a small projecting structure of undefined function in the middle of the Plaza de Armas as well as a large windmill.¹¹ The latter consisted of a wind driven water pump and a wooden tank on a metal base installed in 1899 on the site of the former Well House (presumably demolished at that time). (See fig. 5.12.) The non-potable water in the tank was utilized for police purposes and for sanitary plumbing during periods when the city water supply might fail to supply sufficient water.¹²

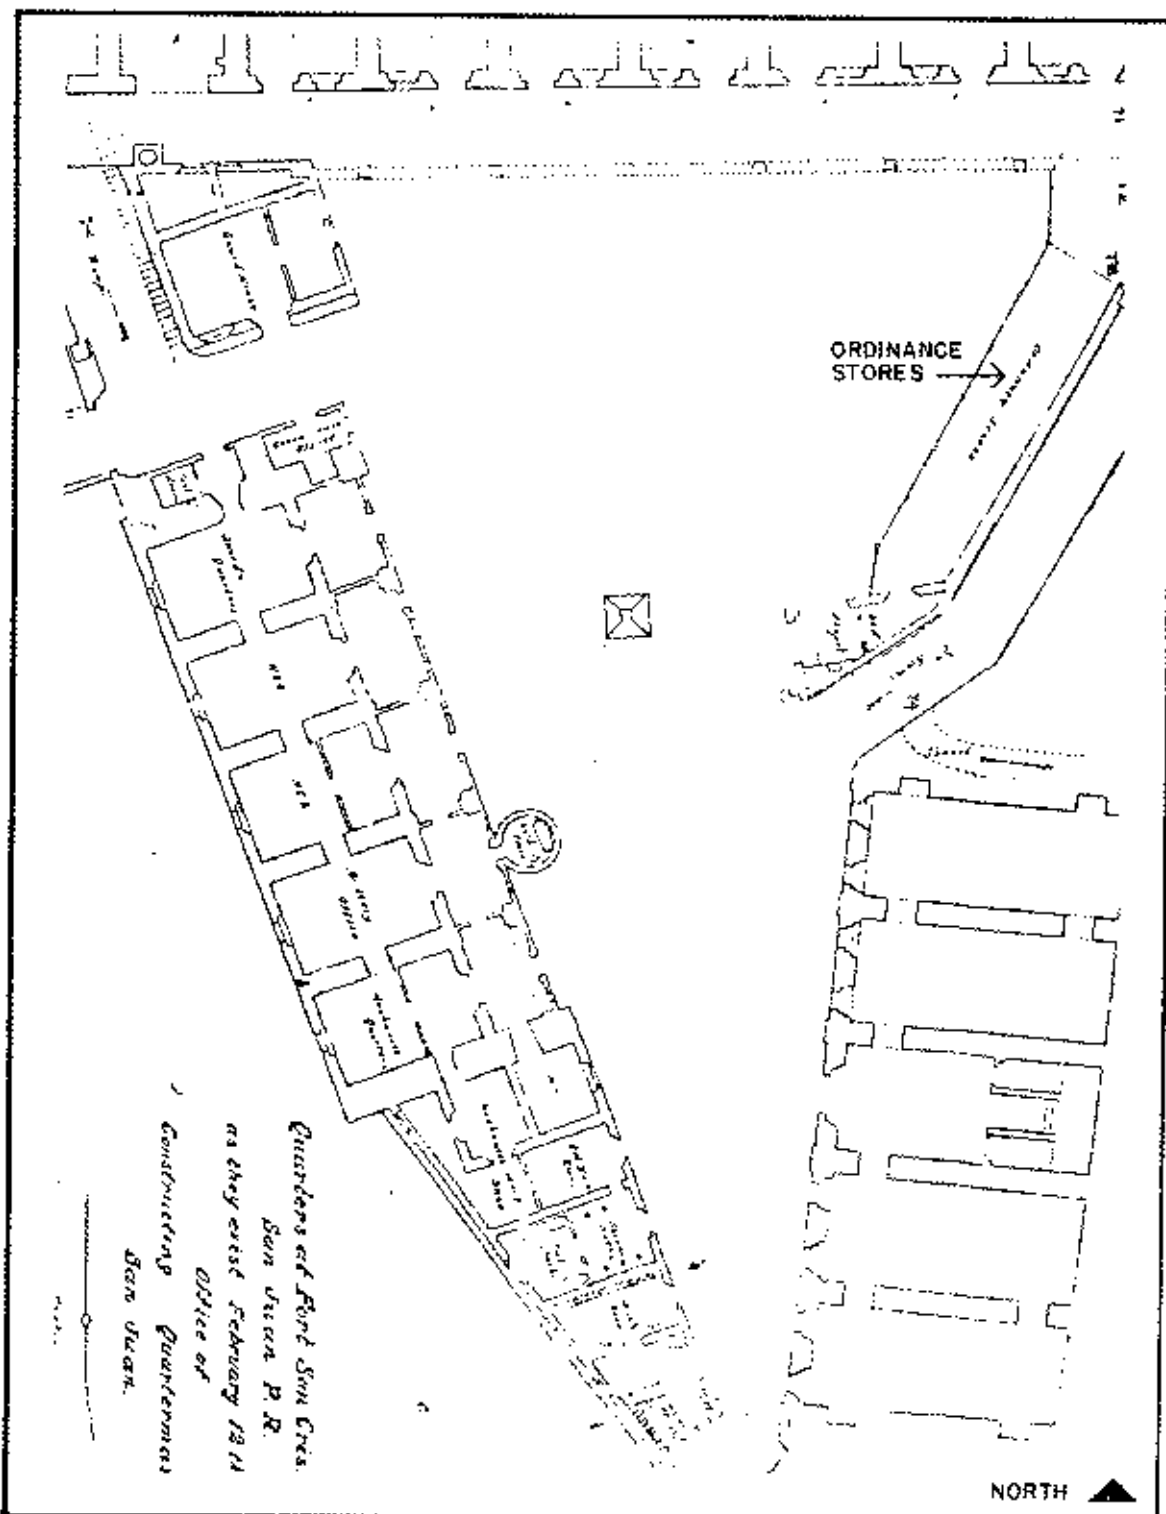
Figure 5.13. The Plaza de Armas as it appears in Guy S. Boyce's 1901 plan. (San Juan NHS Archives.)

In a 1901 plan (fig. 5.13) of the fort by the Constructing Quartermaster, a shed structure referred to as "Ordinance Stores," was indicated along the entire east wall of the plaza below the ramp to el Caballero.¹³

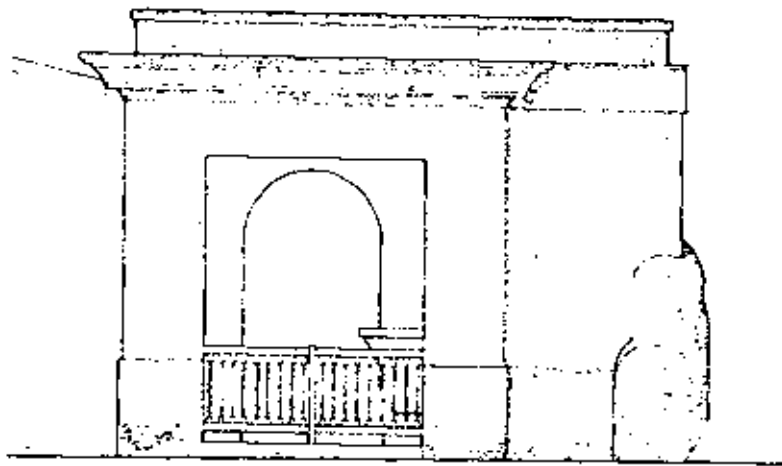
Figure 6.2. North elevation of the Chapel. Photo by Richard Crisson, 1986.

The Chapel (La Capilla) of San Cristóbal is a triangular-shaped structure on the Plaza de Armas (figs. 6.1, 6.2). Its undocumented name is la Capilla de Santa Barbara. Built in the mid-nineteenth century, this building is the only chapel noted at San Cristóbal in available documentary evidence. It is one story high, measuring almost 13 feet from its base to the top of the roof parapet. Architecturally, it represents a simplified expression of the nineteenth century's neoclassical style. Its most distinctive decorative feature is the gracefully-shaped interior altar.

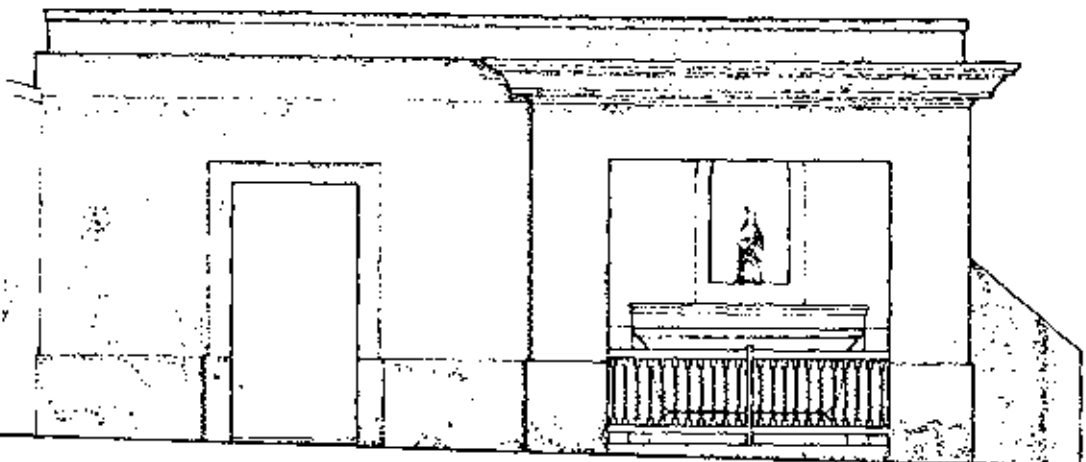
WEST ELEVATION

NORTH ELEVATION

Figure 6.3. North and west elevations. Drawings by HABS, 1989.

The structure was recorded by HABS during the summer of 1989. (See figs. 6.3 and 6.4.) There are two square doorways on the north facade ("A" and "B"). The easterly doorway ("A"), has a square architrave. There is no door nor evidence of previous hardware. There is a third doorway, "C", on the west facade. Neither doorway "B" or "C" have surrounds or hardware. These doorways, however, have a section of balustrade fixed within them. The balustrades were installed by the NPS sometime between 1963 and 1971 and consist of a handrail, lower rail, and turned balusters of various designs. The entire

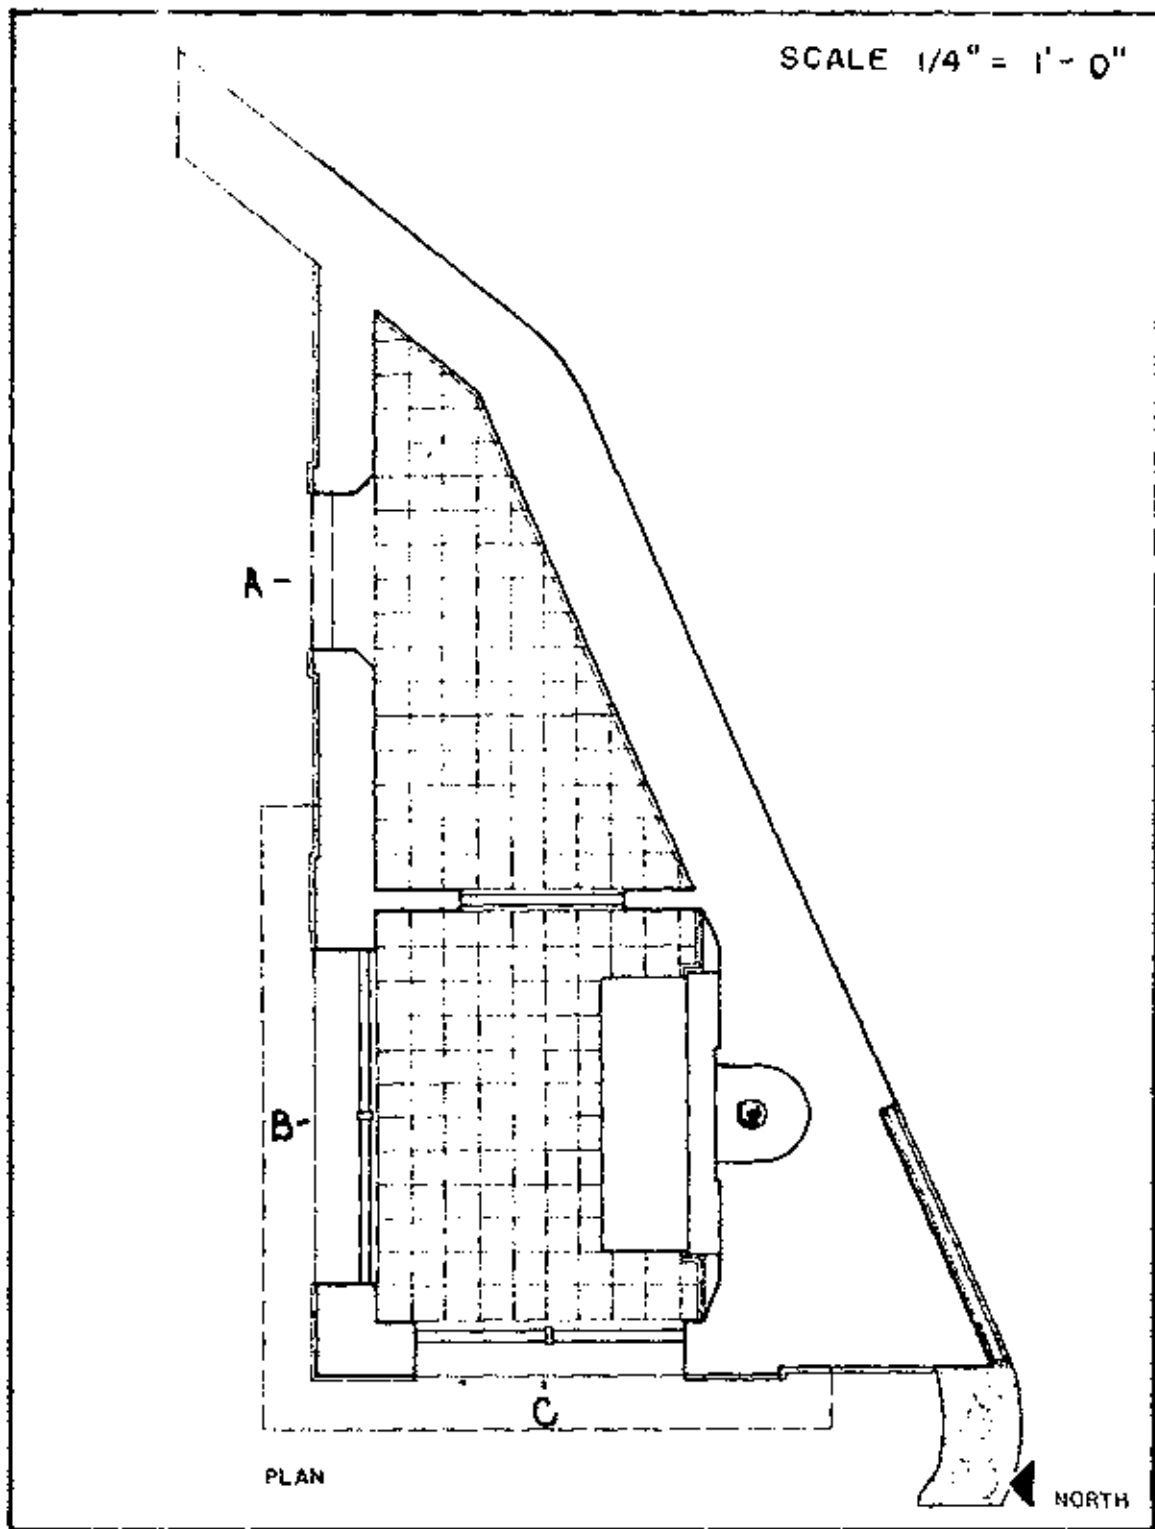
Figure 6.4. Plan of the Chapel. Drawing by KABS, 1989.

The interior of the Chapel is divided into two rooms. (See fig. 6.4.) The larger room on the west can be considered the sanctuary. It contains the altar and altarpiece. The smaller room to the east, considered the vestry, adjoins the first and is connected by a doorway.

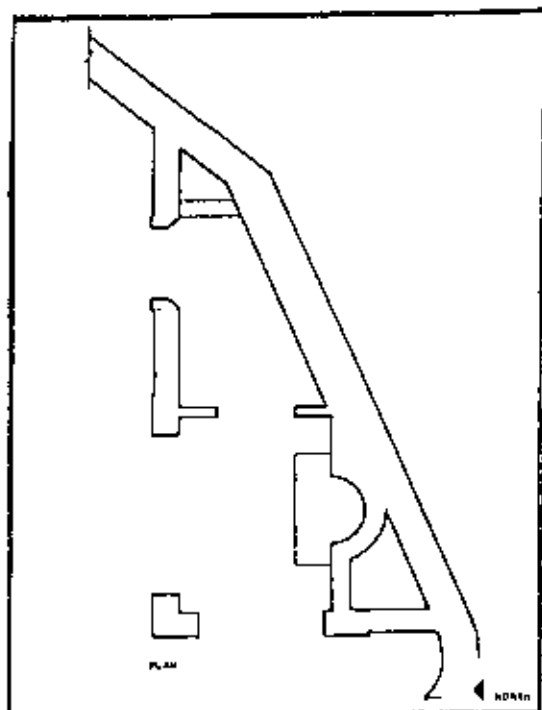
Figure. 6.6. Retracing of Castro's 1861 plan of the Chapel by Jana Gross, 1989.

In 1861, two rooms were shown to be interconnected by a wide doorway. The small room on the east side was trapezoidal, entered from the outside by a narrow doorway in the north facade. The function of this room was not indicated. The larger room on the west side was rectangular and open to the outside by the two previously described wide doorways: one in the north facade and one in the west facade.

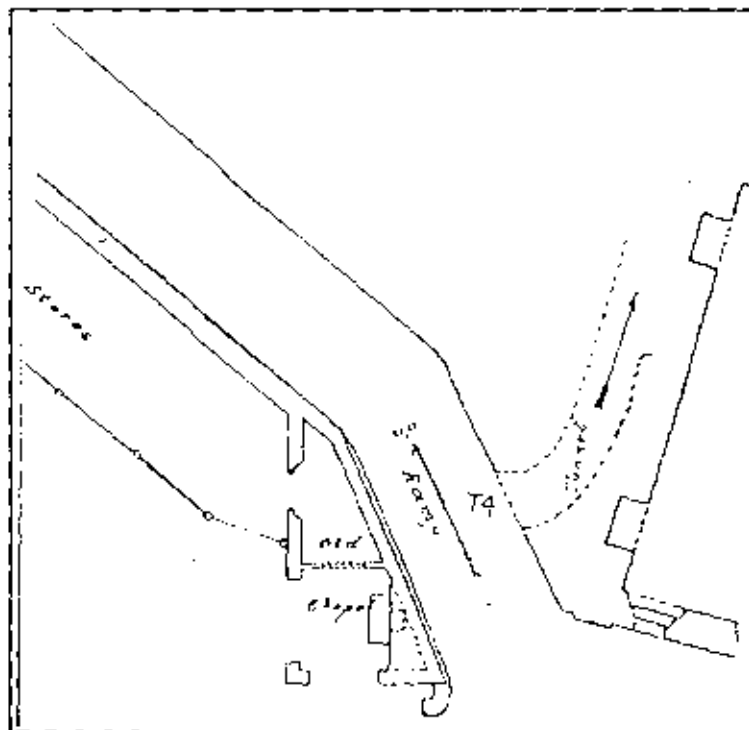
Figure 6.8. Detail of plan dated 1901 showing the "Old Chapel" and proximity of ca. 1890's "Ordnance Stores." (San Juan NHS Archives.)

During the invasion, the Chapel is said to have been "converted hurriedly into a storehouse for cartridges."⁴ This no doubt referred to the long "ordnance" stores building constructed at the base of the ramp to el Caballero abutting the Chapel at its north wall. This new structure is first seen in the 1901 drawings (fig. 6.8) entitled "Quarters at Fort San Cristóbal as They Exist February 12, 1901."⁵ Here, the east room of the Chapel was incorporated as the south end of the storage building and the west room remained independent and most likely remained in use as a chapel. During the invasion:

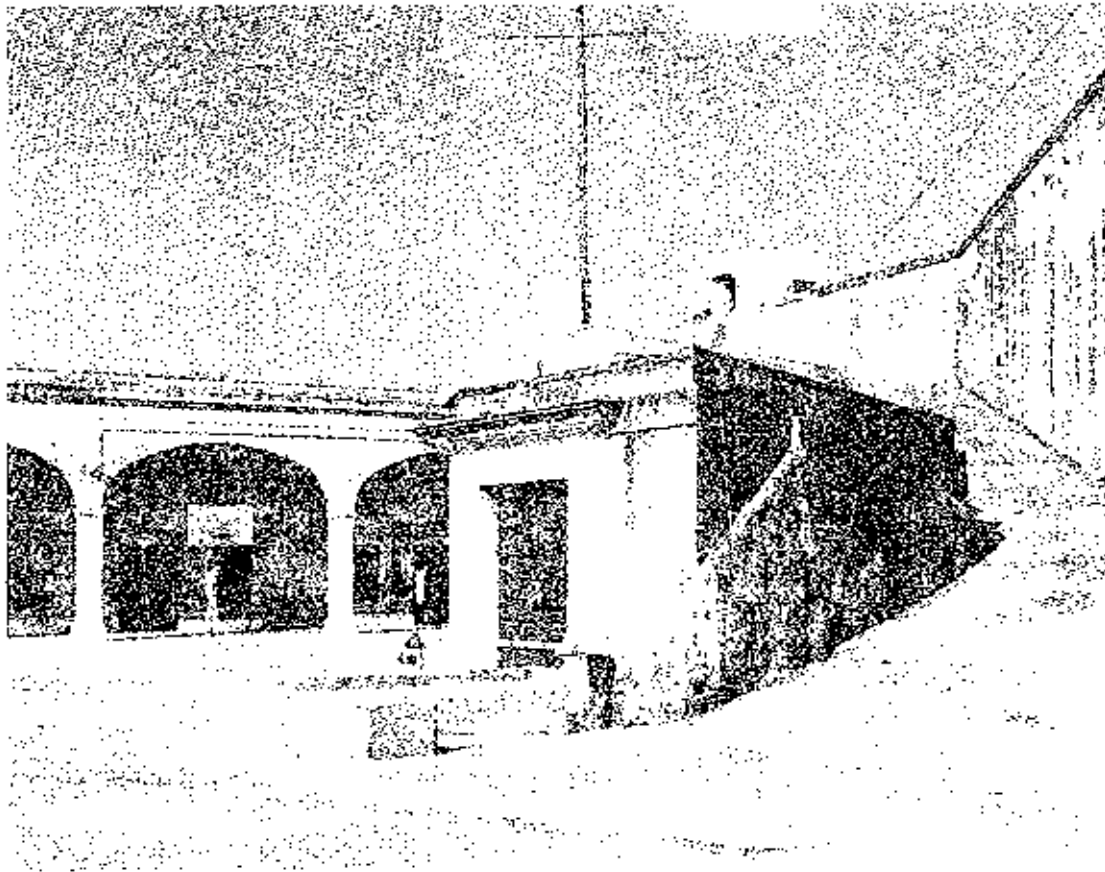
Figure 6.11. West and south elevations of the Chapel. HABS photo by Jack Boucher, 1960.

In January 1960, HABS photographed the building. (See fig. 6.11.)¹⁷ Comparison of this view with our earliest photograph reveals some changes. In 1960, the exterior doors were placed differently and were of a new design. The new doors hinged on the interior (vs. exterior of 1905) side of the doorjamb and had a multi-panel design (vs. flush surface of 1905) on the exterior side. In 1960 the basketball court was illuminated by an electric floodlight situated on the northwest corner of the roof. Water sources were close at hand, with a water spigot on the southwest side of a new fire hydrant at the northeast corner. One other photograph taken at this time documents another change.¹⁸ The north facade was used as a sign for a military parking lot and lettered with "MPCI" and "MCPI VEHICLES ONLY."

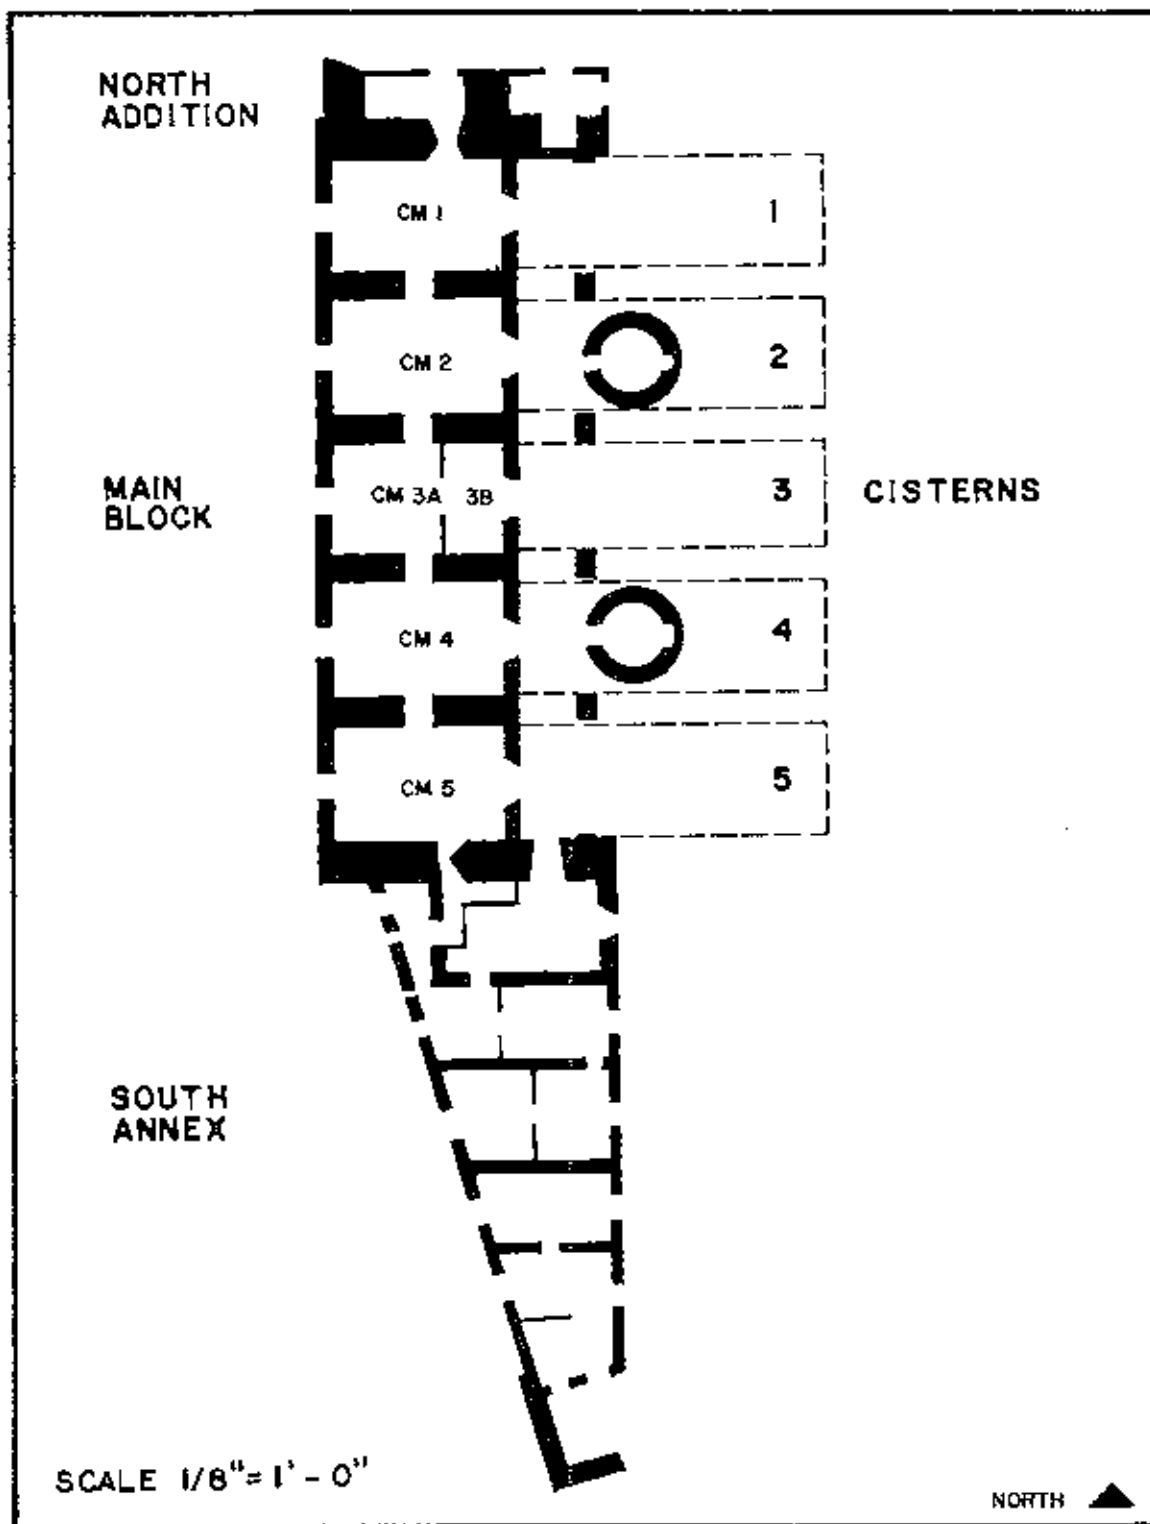
Figure 7.1. Plan of the Officers' quarters with casemates and cisterns labeled. HABS drawing (1961) annotated by Jana Gross (1989).

The Officers' Quarters, historically referred to as the Pabellón del Gobernador (Governor's Pavillion), is located along the western edge of the Plaza de Armas and forms the western wall of San Cristóbal between the Main and South Gates. It was built between 1773 and 1775. The present building is comprised of three distinct units: the original main block, the north addition, and the south annex. (See fig. 7.1.) The complex is presently used for park administration, public lavatories, and storage facilities.

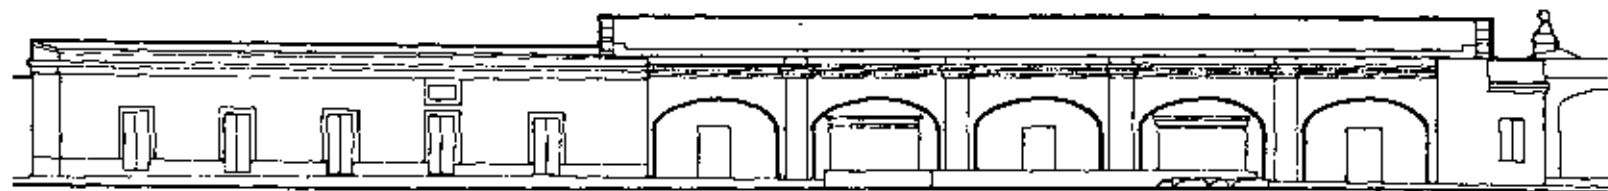
EAST ELEVATION

Figure 7.2a. East elevation of the Officers' Quarters. HABS drawings (1961) annotated by Jana Gross (1989).

The main block of the Officers' Quarters is five bays in length with a five-bay open loggia extending across the east elevation. The block is one story high on the east elevation and two stories on the west elevation. (See fig. 7.2, 7.3.) The latter is formed by the topography and the grade change accommodating a series of cisterns below.

The west, or city elevation, is similarly five bays wide, but two stories in height. Each bay is articulated by a colossal order pilaster that supports a complex entablature and parapet above. (See fig. 7.2.) This elevation is pierced by a loggia consisting of five barrel vaulted chambers lying on an east-west axis and extending east under the main block and plaza. The chambers are cisterns for water storage. The blind arcade on the west elevation articulating the cistern units are sealed with solid masonry walls and recessed approximately ten feet in from the plane of the facade.

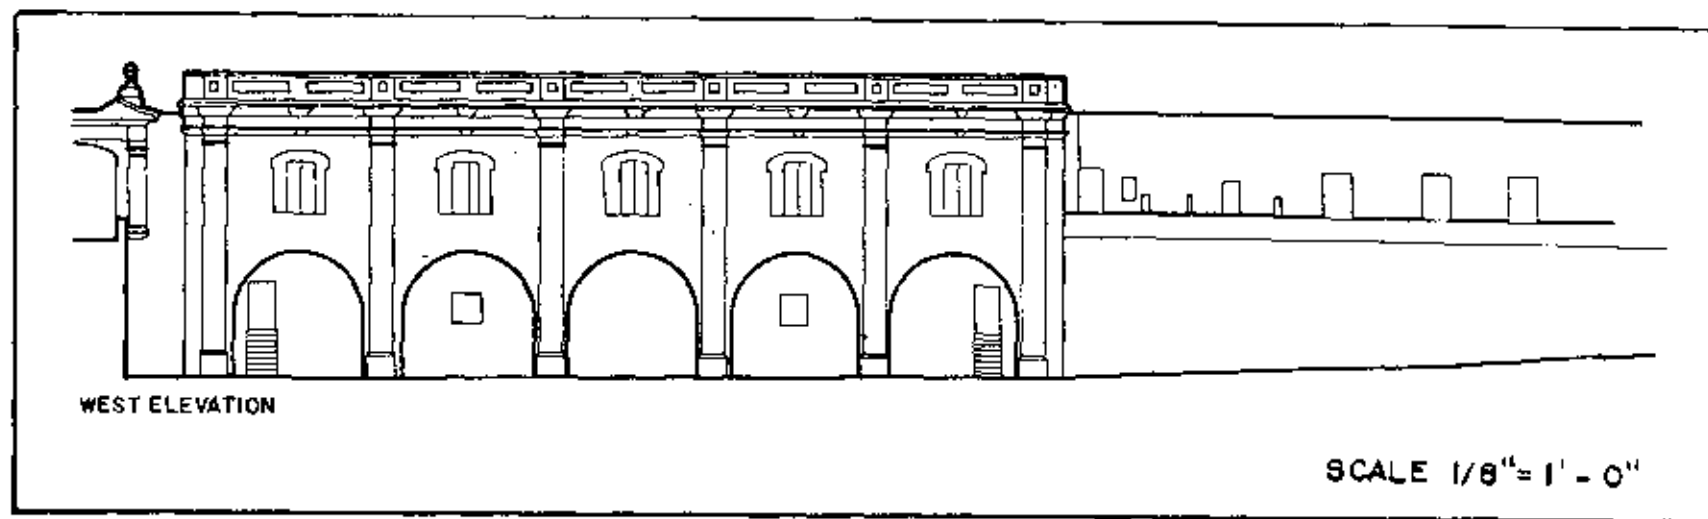
Figure 7.2b. West elevation of the Officers' Quarters. HABS drawing (1961) annotated by Jana Gross (1989).

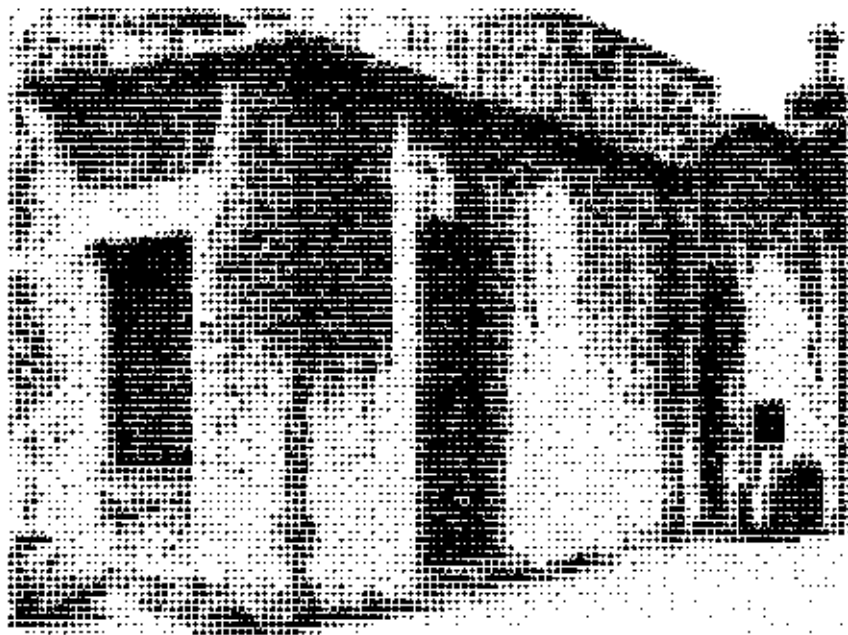
Figure 7.8. West and north elevations of north addition. Photo by CPR, 1986.

Of a later construction date (ca. 1783) than that of the main block and cisterns, is the single-story addition situated on the north end of the Officers' Quarters adjoining the east wall of the Main Gate. This small north addition (fig. 7.8, 7.9) served as an integral component of the security system surrounding

The walls of the north addition are topped by a simple projecting stucco cornice. Two segmental arched door openings pierce the north facade; each is fitted with modern reproduction wooden doors and transoms. The ghost of a window has been infilled and parged and is clearly seen on the west end of the north elevation below the vaulted portion of the roof. The east elevation has one rectangular window opening fitted with a wooden reproduction shutter made of vertical boards and horizontal battens.

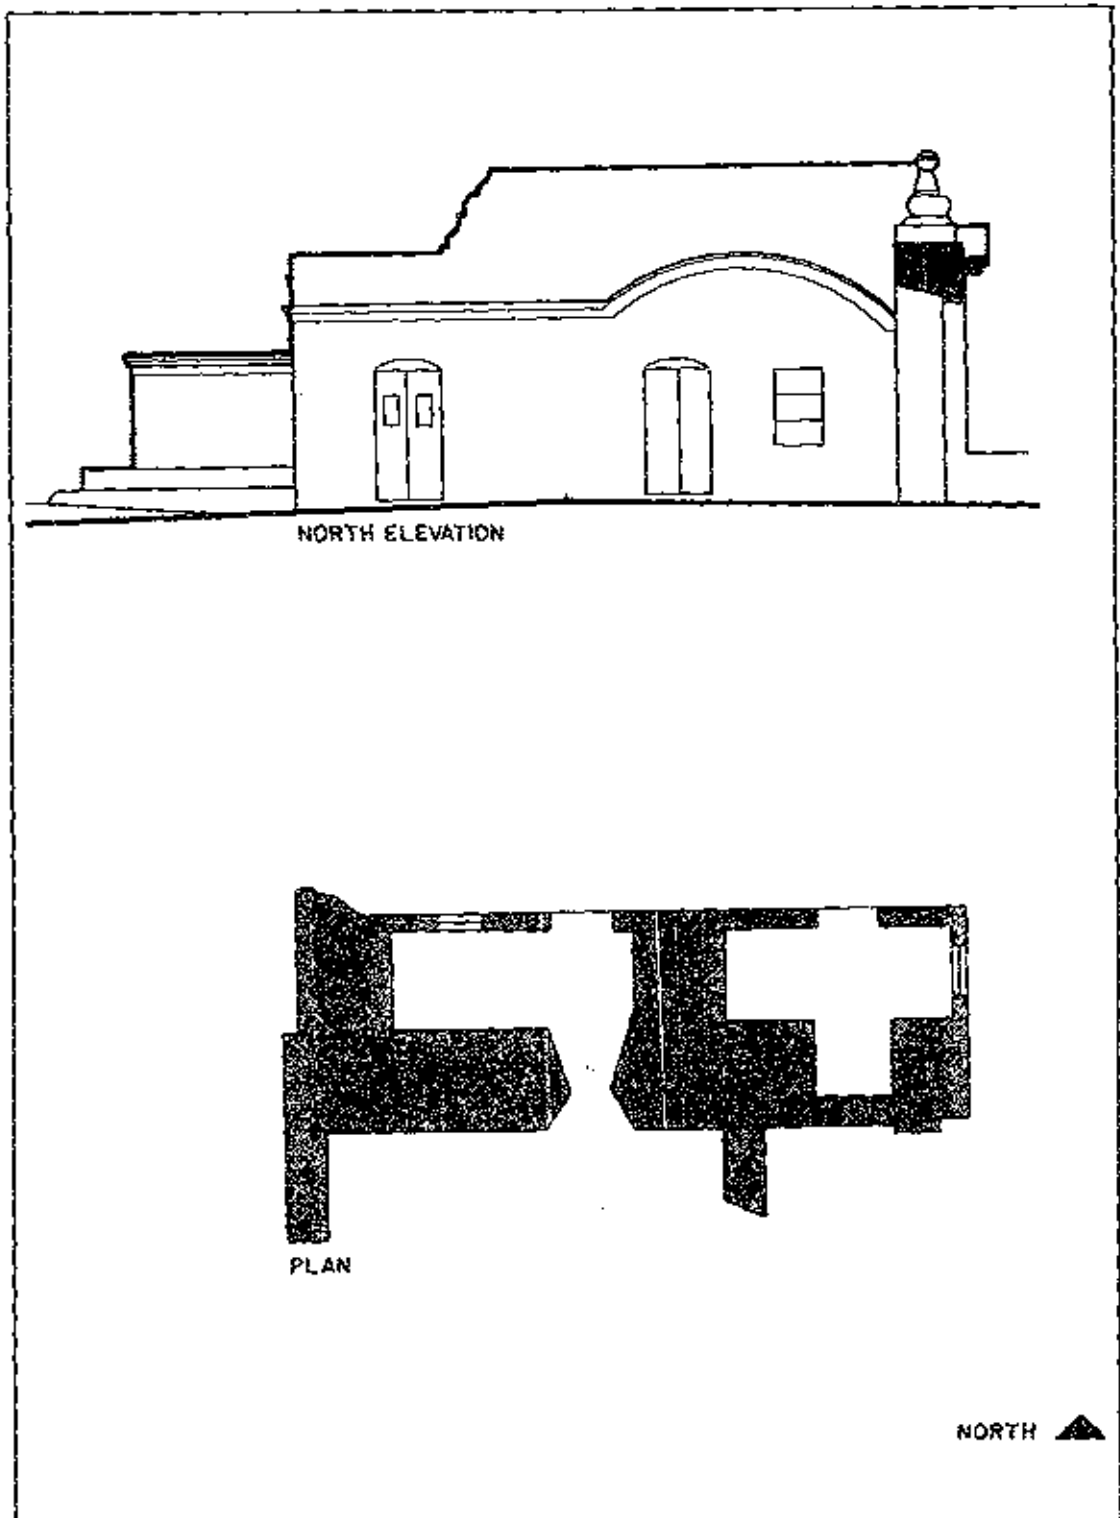
Figure 7.9. North elevation and plan of north addition to Officers' Quarters. By Jana Gross based on 1961 HABS drawings.

The roof of the north addition is flat on the east and humped on the west indicating the barrel vaulted room below. Both sections are laid in brick pavers. A low brick parapet surmounts the flat portion of the roof. Rain water runs eastward down the slope of the vault and is directed by a slight pitch of the flat section toward the northeast corner of the roof where it drains through a single outlet onto the Plaza de Armas.

The addition contains two narrow rectangular rooms. The east room is slightly smaller and has a small square alcove to the south (formerly a passage connecting it to the loggia of the main). The west room is barrel vaulted and accessed either through an opening from CM-1 or through a door facing north. The opening into CM-1 is segmentally arched with double-splayed jambs and chamfered edges. It is fitted with an original rectangular wooden door enframement of mortise and tenon construction (a modern door and enframement was installed in the opening after this investigation was conducted).

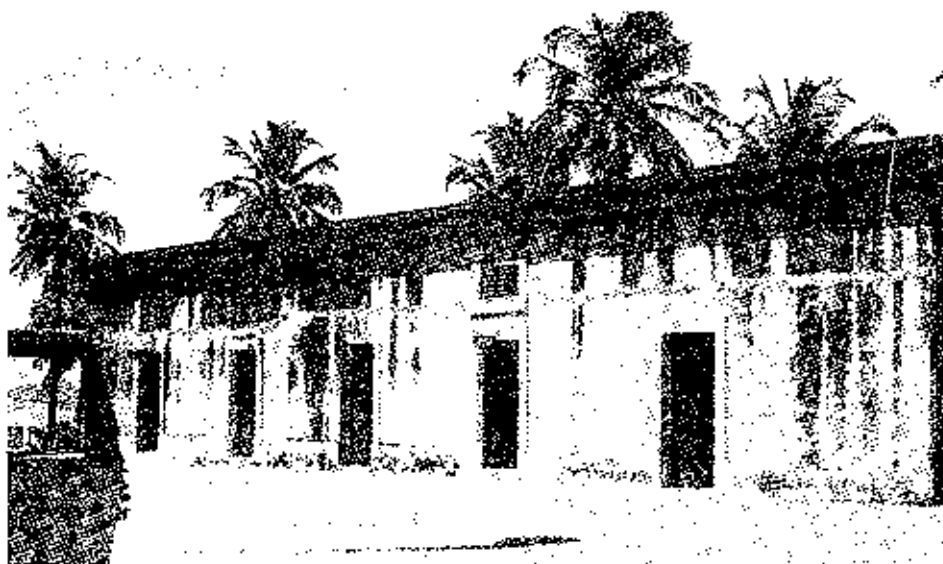
Figure 7.10. East elevation of the south annex of the Officers' Quarters. Photo by CPR, 1986.

At the opposite end of the building is the south annex (fig. 7.10), a single story addition to the Officers' Quarters. The wing is roughly triangular. This addition contains approximately ten varying-sized rooms that are used by the NPS for administration and to accommodate public restroom facilities, storage closets and changing rooms for park administration.

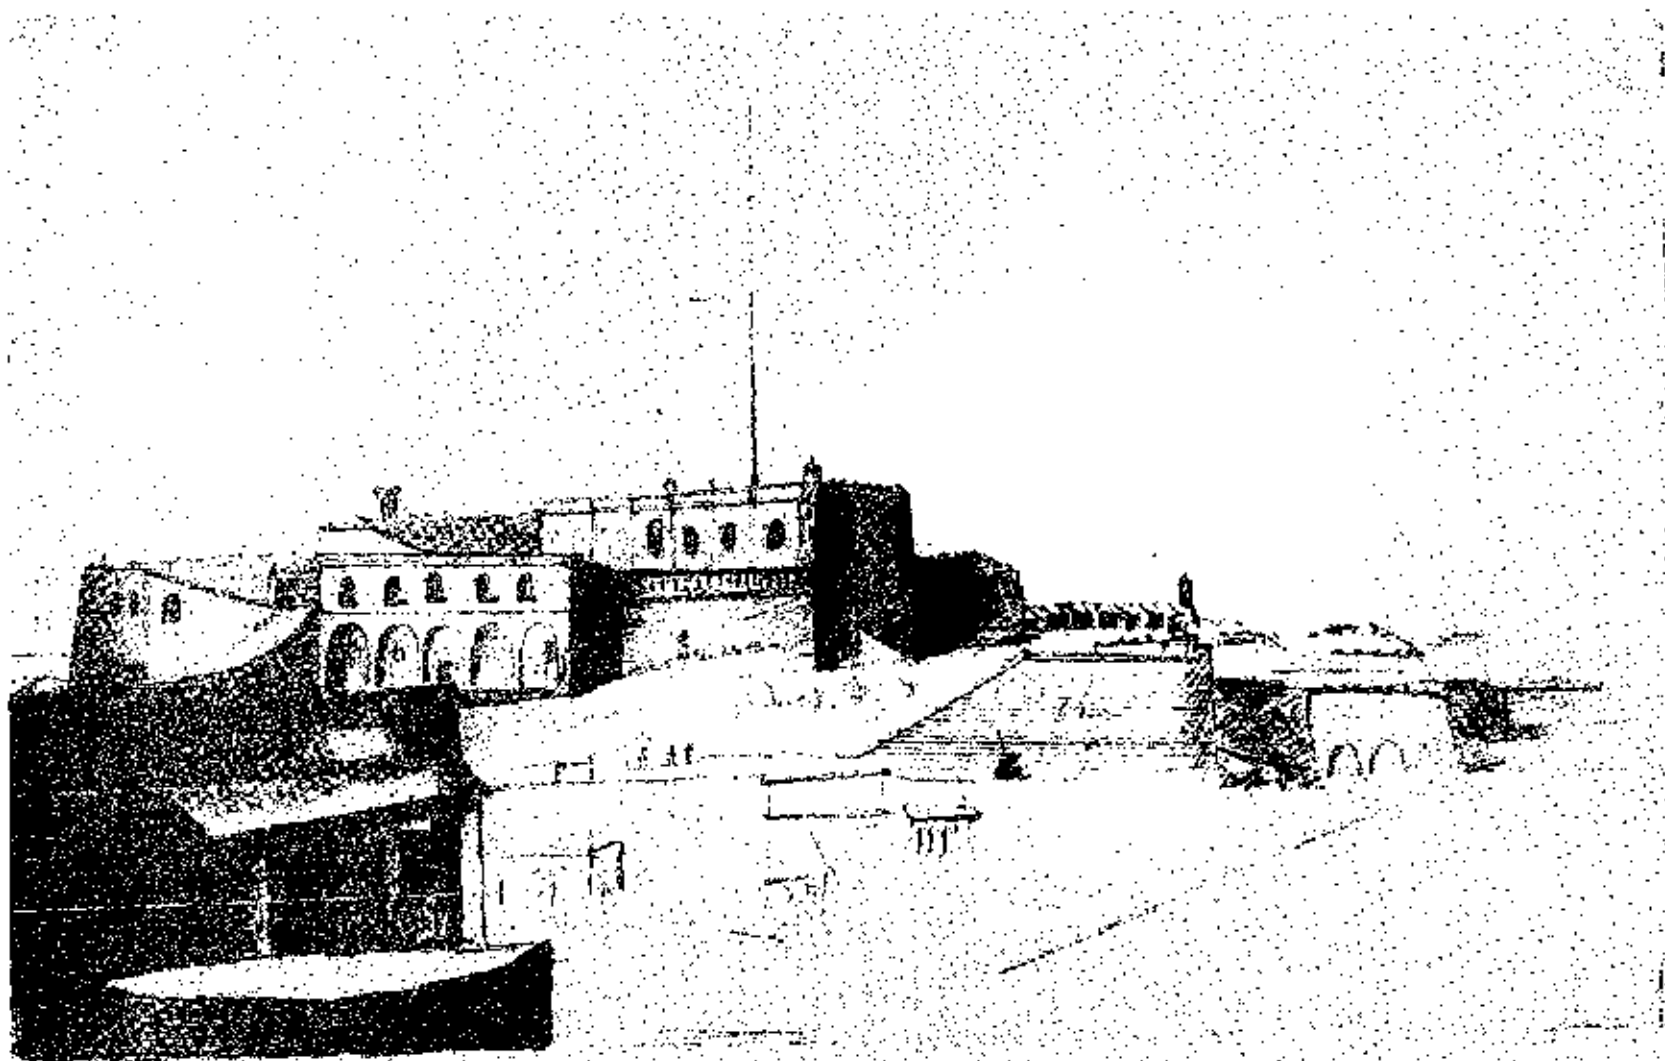
August Pleá
1821

Figure 7.13. Sketch by August Pleá, ca. 1821, showing the west elevation of San Cristóbal. (HABS negative 181.197.)

The earliest available view of the west elevation of the Officers' Quarters is found in an 1821-23 sketch (fig. 7.13) of the fortifications drawn by August Plee, a French artist and botanist, while touring Puerto Rico.⁵ As this view was only a rough sketch, the accuracy of details must be somewhat suspect. Nevertheless, some features of the city side elevation were of interest. Plee drew a simple facade pierced by five windows, each with a projecting sill, but with no enframements visible. The elevation was topped by a projecting cornice of different profile from that later seen and traversed by a secondary projecting cornice that runs across the facade below the windows and above the large arches of the blind arcade.

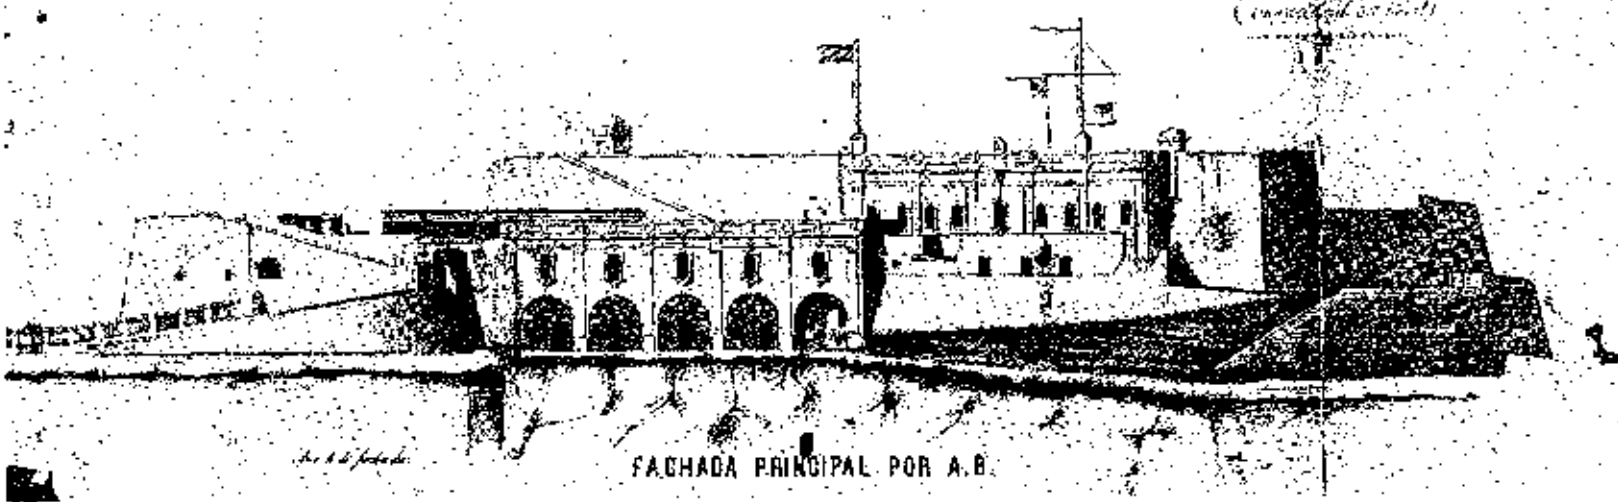
FACHADA Y CORTES DEL CASTILLO DE SAN CRISTOBAL

Figure 7.15. West elevation of the Officers' Quarters. Drawing by Manuel Castro, 1861. (HABS negative 181.22.)

Many changes made to the Officers' Quarters during this period were detailed in Manuel Castro's extensive set of plans and elevations of 1861. (See fig. 7.15 and Volume I.) For the first time the west elevation appeared in a measured drawing. The simple upper cornice depicted by Plee (ca. 1821) was now seen as an ornate cornice with a parapet. The intermediate cornice has been removed. The facade was articulated by six colossal pilasters with projecting bases and capitals. Cistern vaults 1 through 4 of the blind arcade were enclosed with wooden slat partitions, each pierced by a rectangular door opening, and vaults 1, 2, and 4 by a window or vent. Segmental arched window surrounds were seen in place at this time. The western elevations of the ca. 1832 and ca. 1850 additions to the south of the Officers' Quarters were also clearly depicted by Castro. The west elevations were varied in height and configuration.¹⁰ The configuration and height of these walls were later unified as evidenced in the irregular parging and differing window openings.

The earliest reliable depiction of the Officers' Quarters exterior color scheme is found in the Castro drawings. Most of the building's west elevation was shown as yellow except for the pilasters, window surrounds, cornices, and the fifth chamber of the blind arcade, all of which were white. Window transoms and louvers (presumably wooden) appeared dark green. The wooden slat partition walls were represented as dark brown. Analysis of paint samples from these areas may confirm the 1861 color scheme.
