THE FORTIFICATIONS OF SAN JUAN NATIONAL HISTORIC SITE

HISTORIC STRUCTURE REPORT

El Fuerte de San Cristóbal

1991

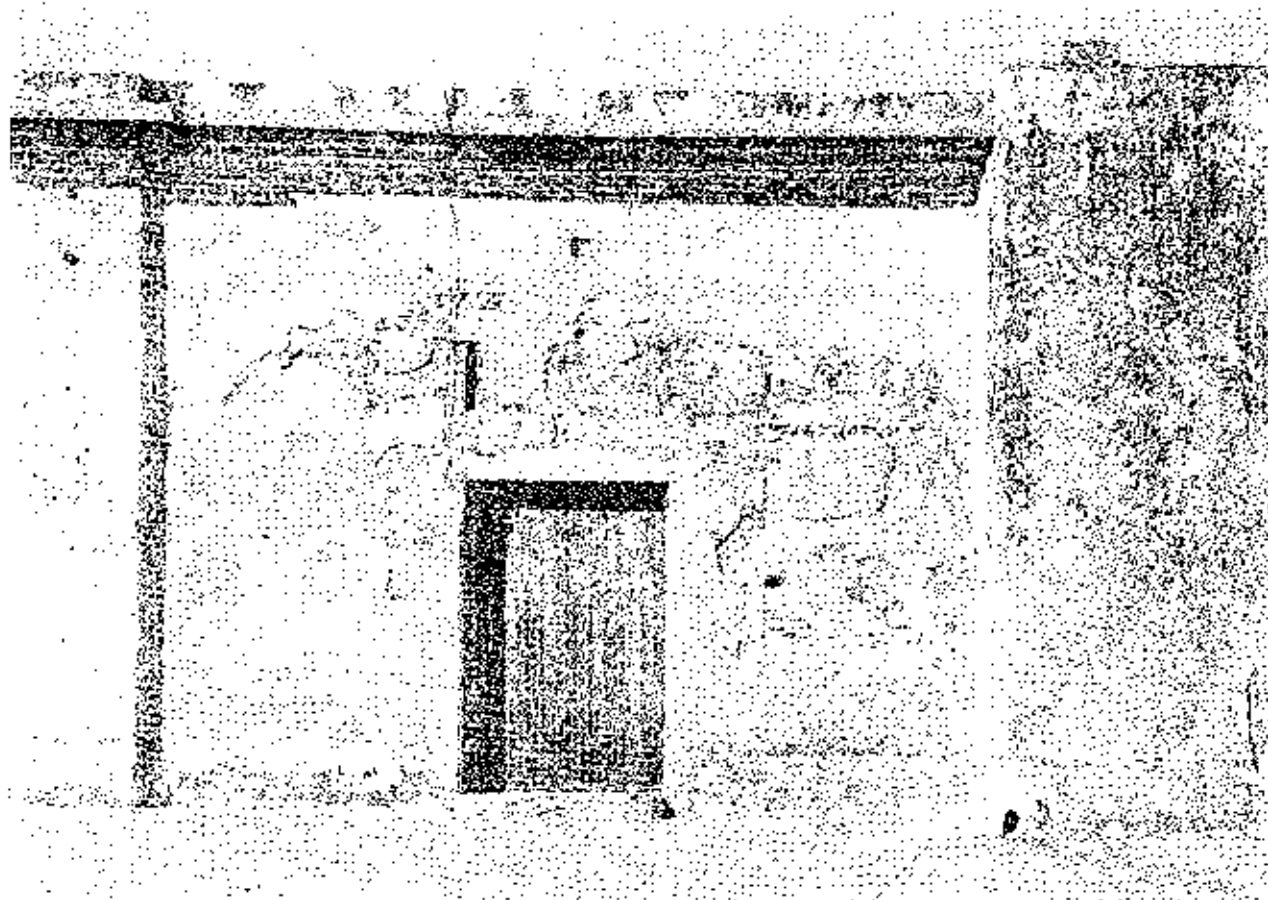
Figure 7.19. East elevation of CM-1 with loggia filled in and ventilation slits evident. HABS photo, ca. 1960. (Negative 181.167.)

Photographs from 1960 (fig. 7.18) illustrate many elements of the Officers' Quarters that have since been removed or altered.²² It is likely that many of the changes occurred during the conversion of the Quarters to offices between 1961-64. The loggia infill walls of CM-1, CM-3, and CM-5 retained rectangular raised-brick door enframements. Failing stucco reveals that other casemates retained original vertical ventilation slits. These, along with earlier window openings, were infilled with brick and stucco or plaster (fig. 7.19).

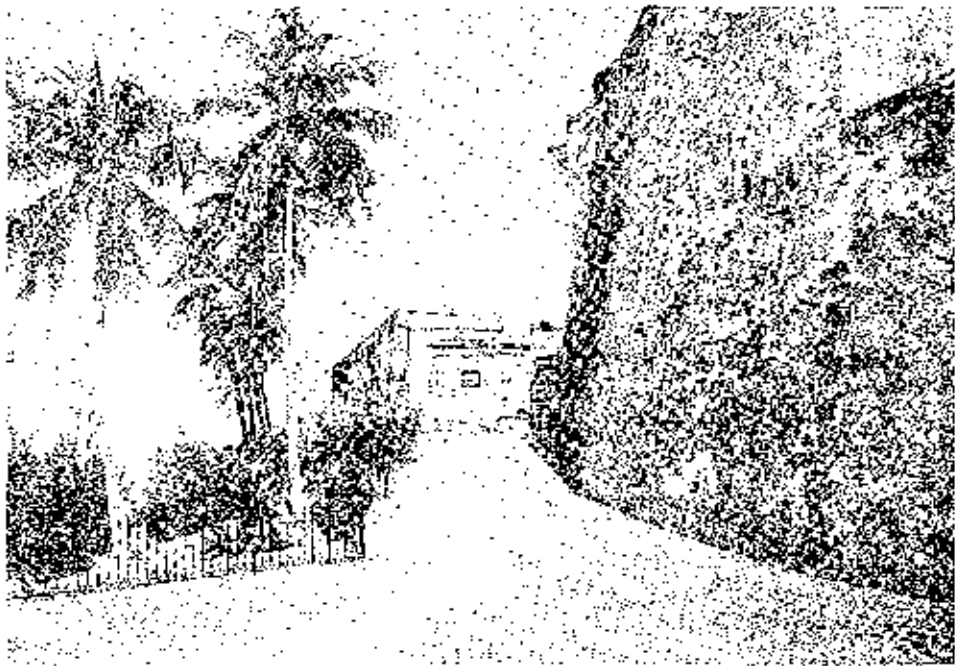
Figure 8.1. View of the South Gate looking north into the Plaza de Armas. Photo by CPR, 1986.

The South Gate is located at the southern tip of the Plaza de Armas giving access to the upper and lower batteries of the South Bastion and to the sloping terrain (pomerium) to the west of the fort. Originally, this gate also gave direct access to Santiago Gate, the main entrance to the city. The gate is engaged on the east to the battered wall of the southwest corner of the Troops' Quarters and on the west to a low ornamented parapet wall south of the ca. 1861 north addition to the Officers' Quarters. A gently sloping ramp leads away from the gate in a southwesterly direction terminating at the lower battery of the South Bastion. The gate was historically known as Puerta del Socorro (gate of back-up assistance). (See figs. 8.1, 8.2, 8.3.)

The South Gate is of simple design, characterized by two monumental stone posts (9 feet high) which support a brick and wood lintel. The posts are of ashlar stone (10-12 inches high, variable length) laid with brick spacers creating joints 1-2 inches wide and are topped by brick-supported, bell-shaped sandstone caps. Mortises, now filled at the apex of each molded stone cap, suggest that the posts were once finished with decorative finials. Surviving stucco evidence suggests

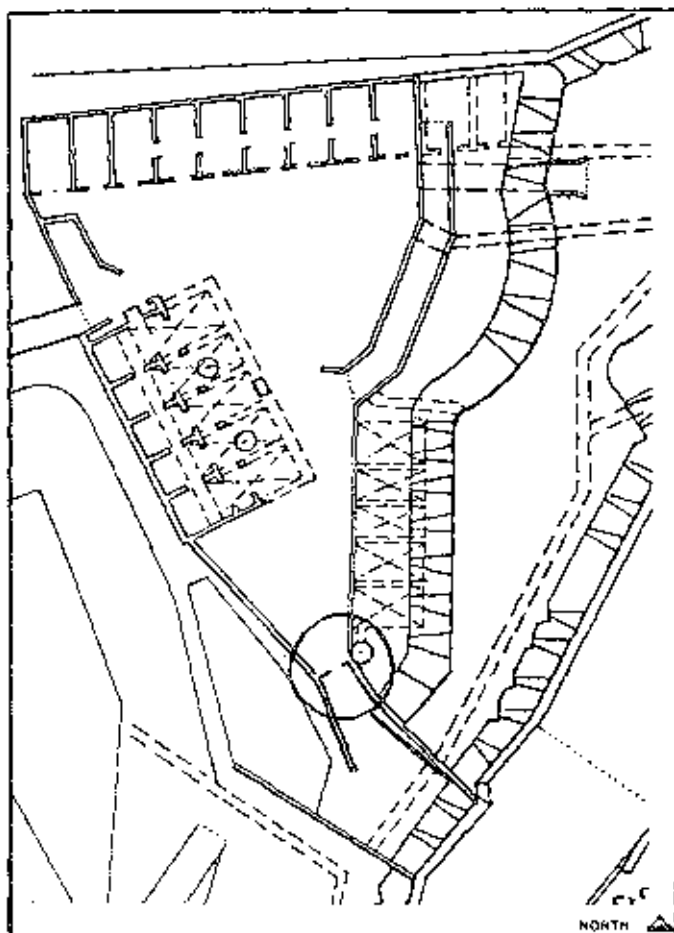
Figure 8.5. Mestre's 1783 plan with South Gate circled. Tracing by Jana Gross (1989) based on tracing by Torres-Reyes (1965).

In plans dating through 1766, internal access into the fort from the south was introduced as a series of temporary ramps leading up the slope from the pomerium below. Although the present ramp was established by 1773, no formal gate is depicted until Mestre's plans of 1783 (fig. 8.5). This gate marked the intersection of the newly established ramp and the end of a low parapet wall extending from the southwest corner of the original block of the Officers' Quarters (constructed at this time) to enclose and define the Plaza de Armas.

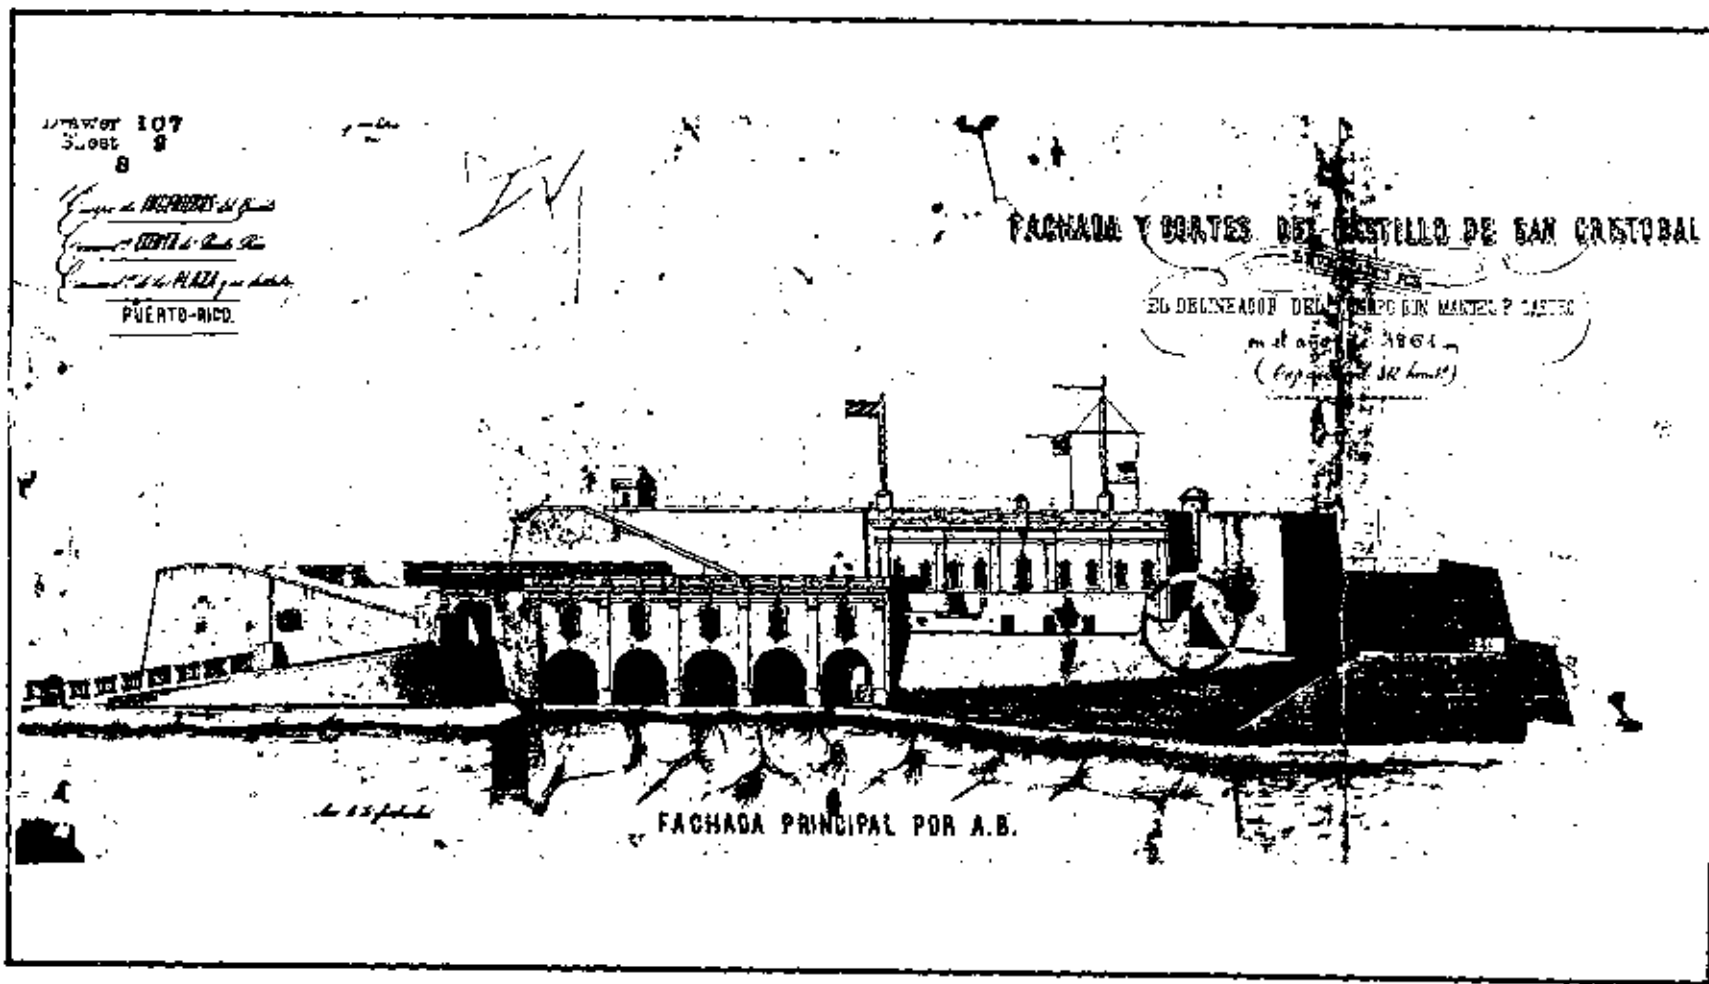
Figure 8.7. West elevation of San Cristóbal by Manuel Castro, 1861. South Gate circled. (NASS negative 181.22.)

The Castro plans and elevations of 1861 (fig. 8.7) contain many informative illustrations of the South Gate. Directly to the north of the gate, a decoratively scrolled projection of different profile than that of the western gate post appears with a slightly recessed masonry wall connecting the area between the scrolls and the west post of the gate. Although this is the first available representation of this decorative

element, it was probably constructed atop the parapet wall someyears prior to 1861, with the area between the decoratively-scrolled projection and the west gate post infilled by this time. No niche or rubble-filled arched opening is seen in the Castro elevations of the west facade of the fort, but it is extant and visible in 1986. A large wooden door fills the entire flat arched area between the two gate posts.

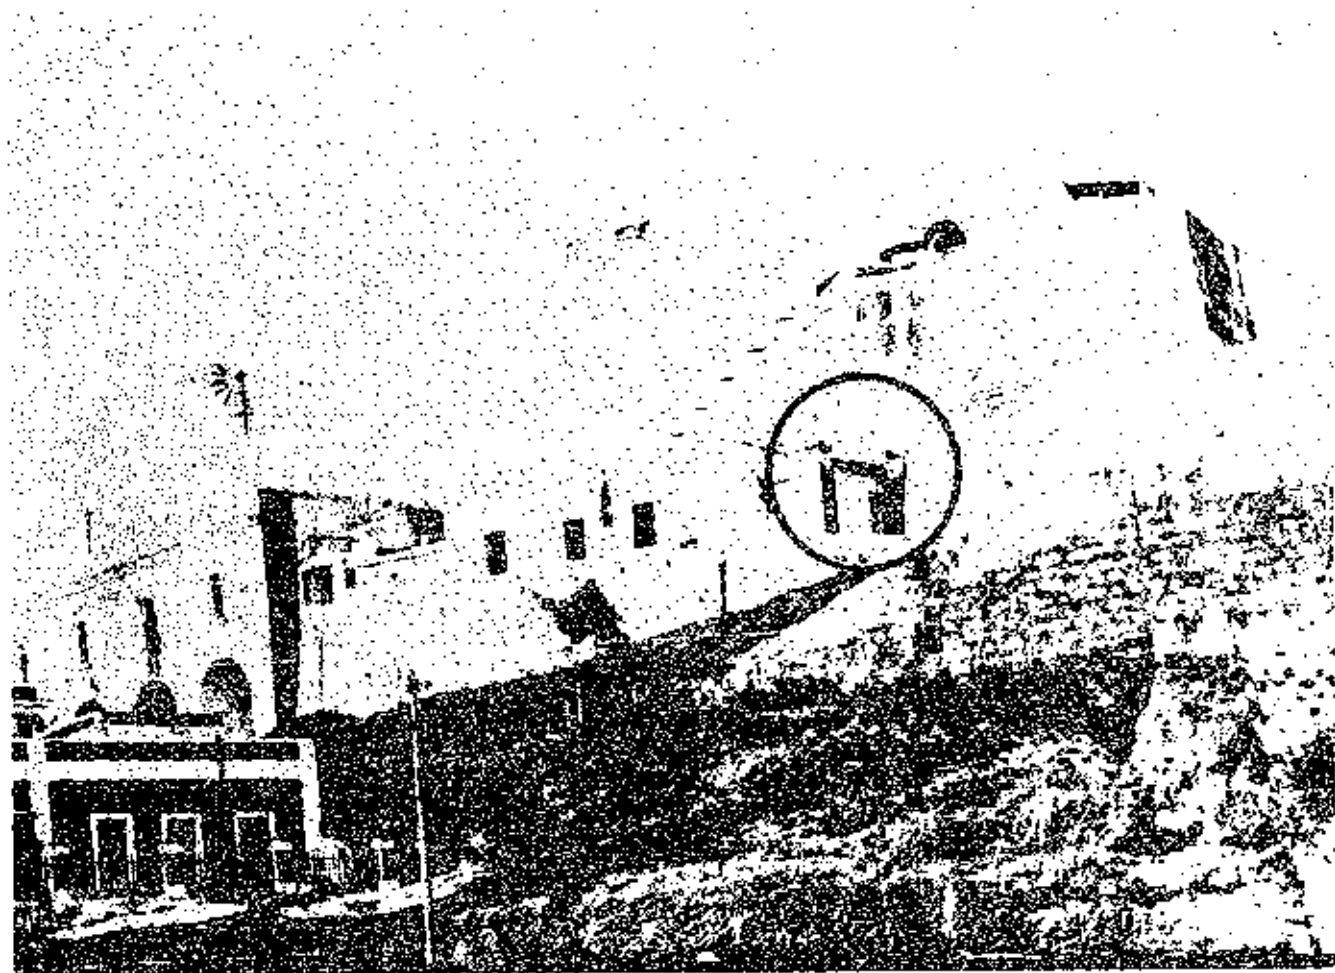
Figure 8.8. View of south west portion of San Cristóbal with South Gate circle. Note masonry infill of doorway, ca. 1898. (San Juan NHS Archives.)

A photograph (fig. 8.8) dated ca. 1898 shows a large portion of the gate opening to have been infilled with a masonry wall to accommodate a modern narrow wooden door set in a wooden frame on the eastern side of the opening. Fragments of broken glass, which most likely served as deterrents to climbing on the gate, covered the top of the lintel and the small masonry infill wall. A photograph dated 1899 indicates that a small rectangular opening or window was cut through the masonry infill between the decorative scroll and the west gate post.⁵

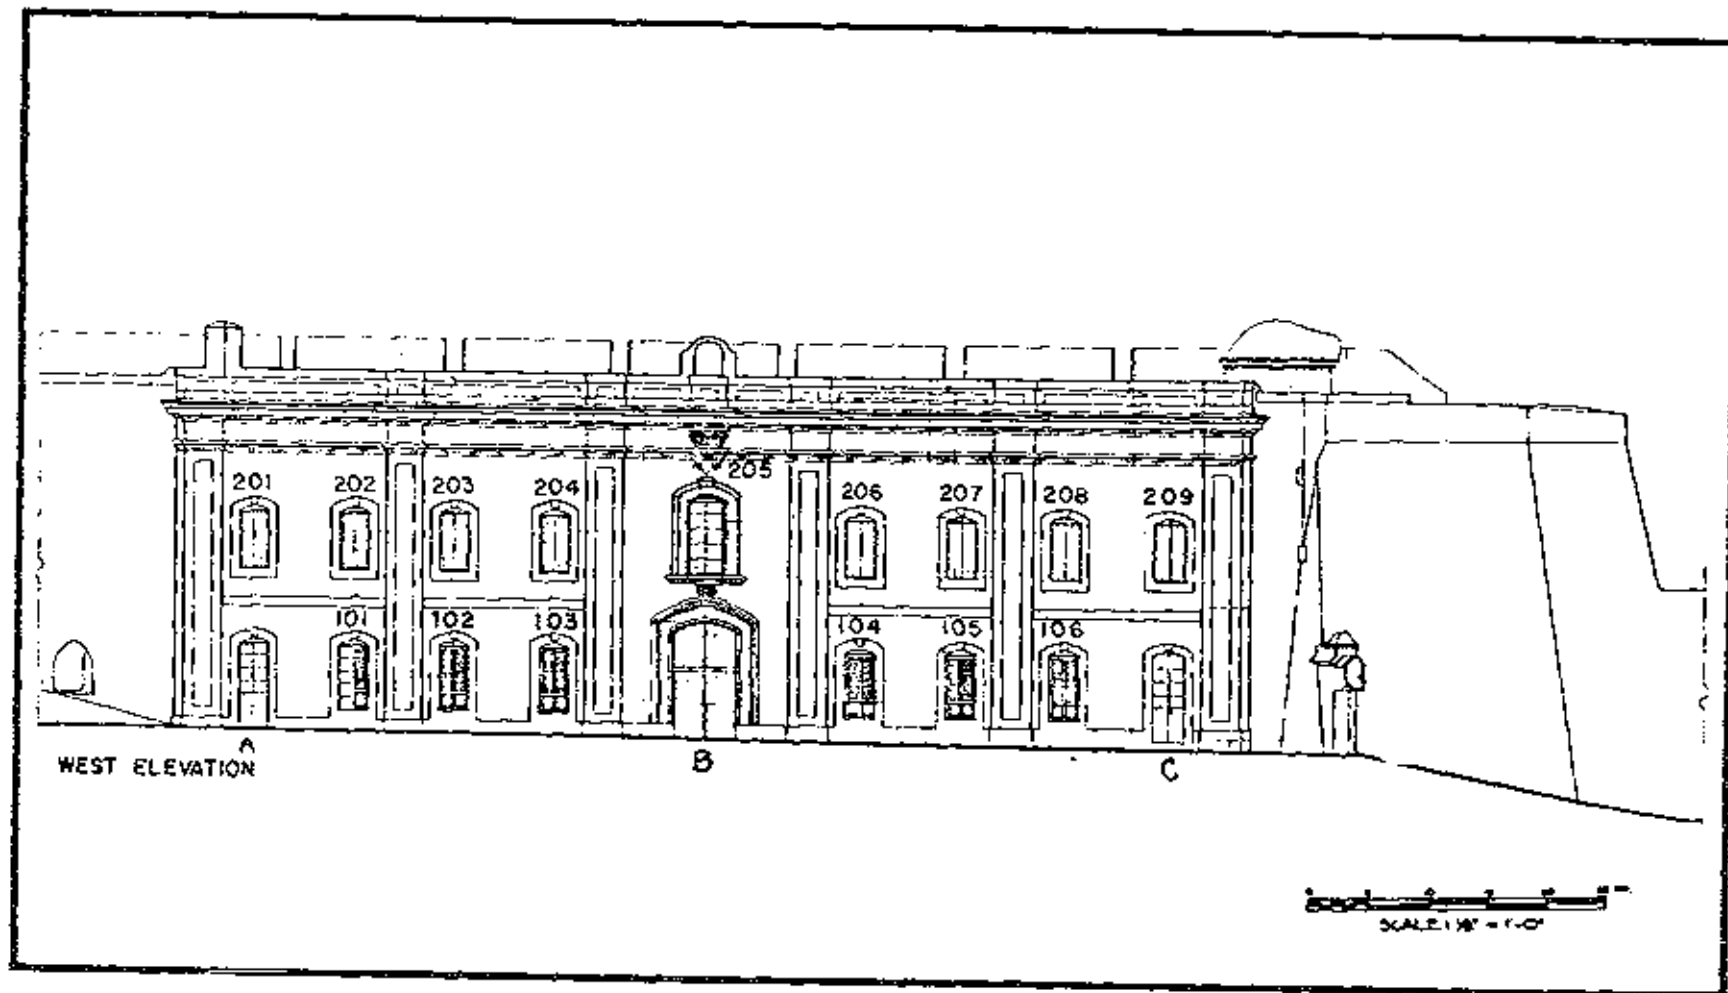
Figure 9.2. Troops' Quarters, west elevation with door and window openings labeled. HABS drawing (1962) annotated by Jana Gross (1989).

assigned to the doorways, numbers 101 through 106 to the first story windows, and 201 through 206 to the second story windows. On the east facade, numbers 107 through 110 were assigned to the first story windows and 210 through 214 to the second story windows. (See figs. 9.2, 9.3.)

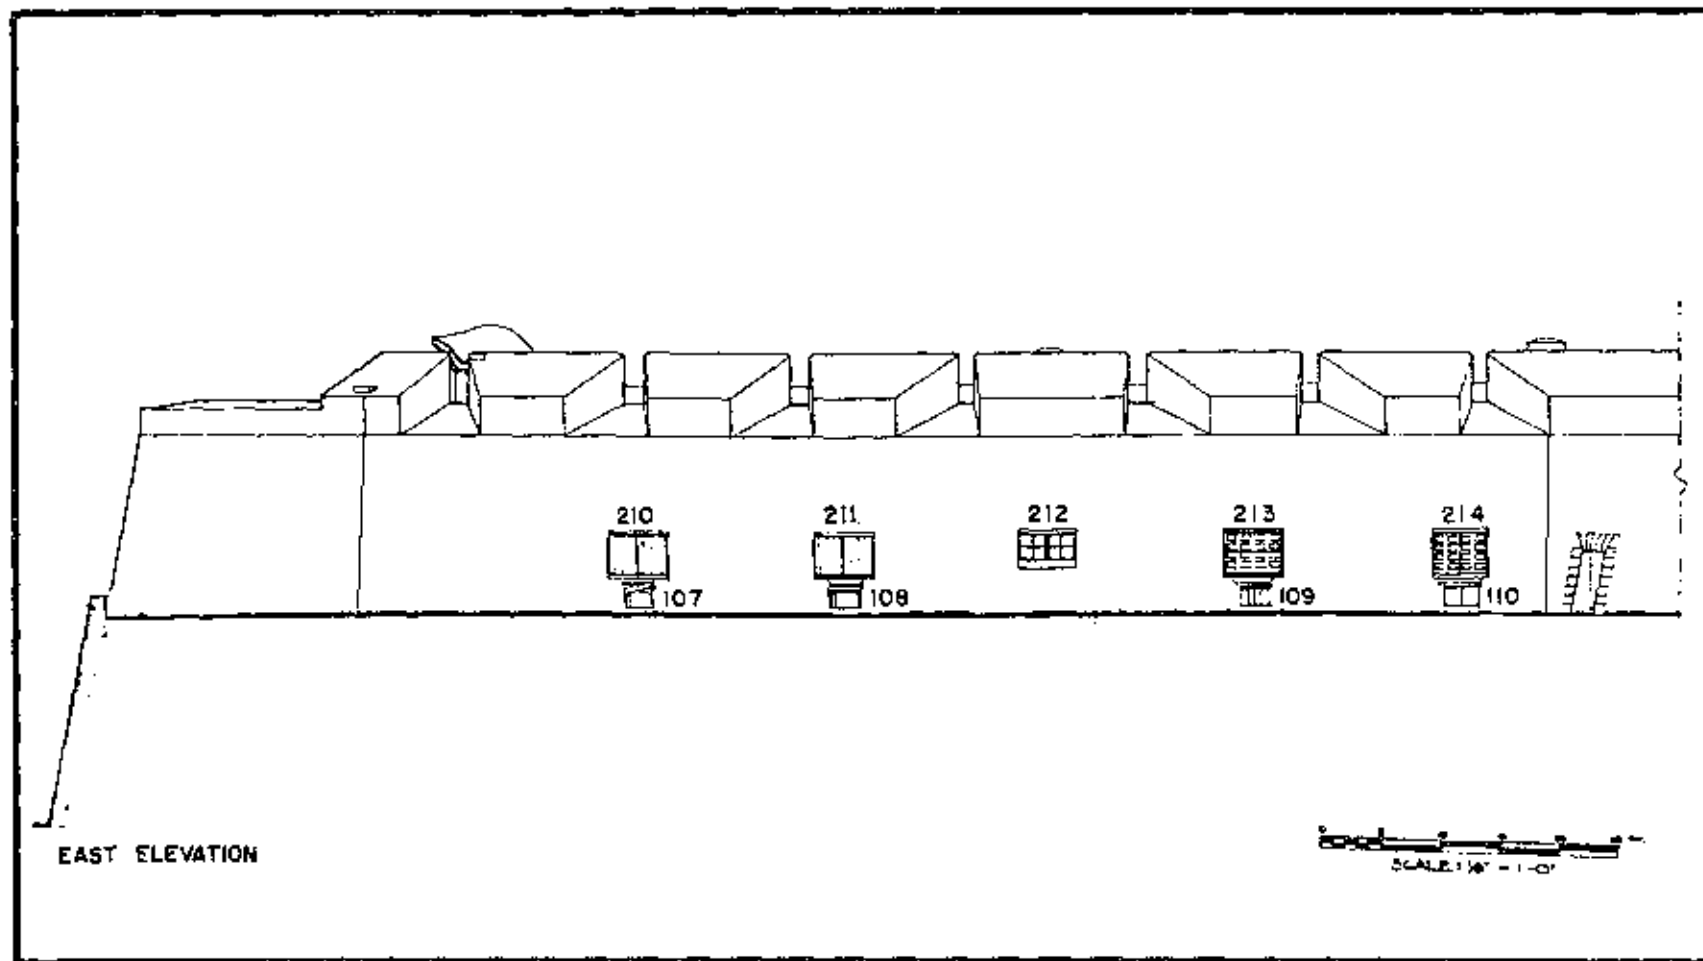
Figure 9.3. Troops' Quarters, east elevation with window openings labeled. HABS drawing (1962) annotated by Jana Gross (1989).

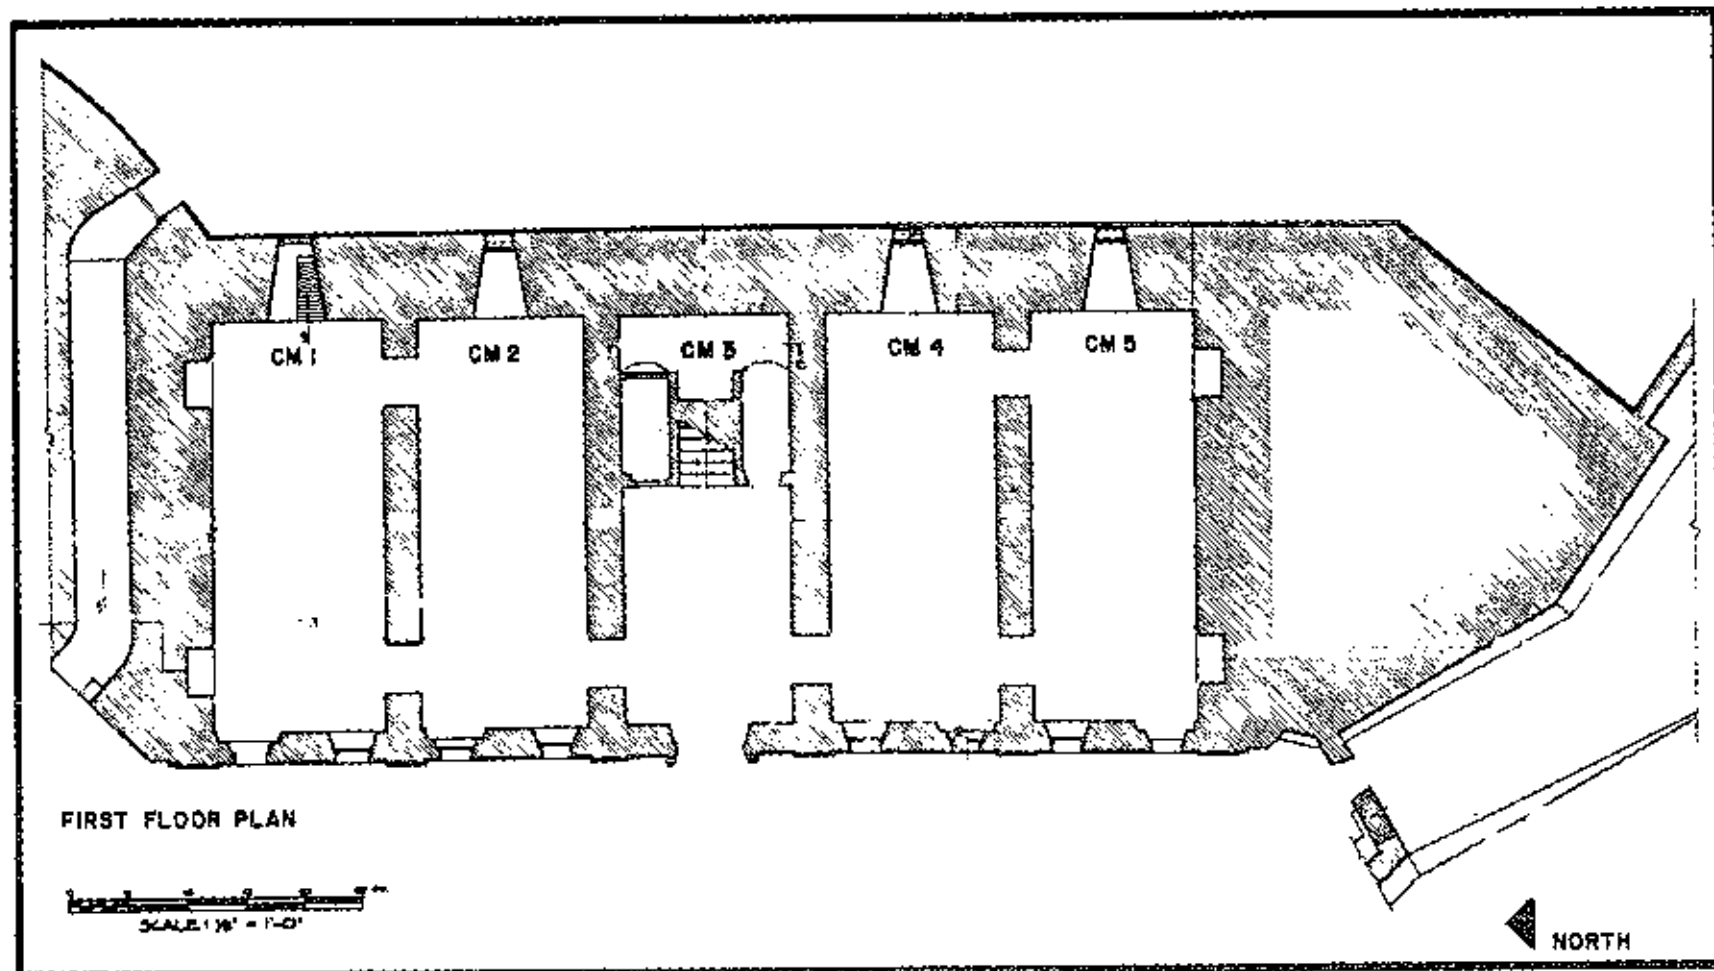
FIRST FLOOR PLAN

Figure 9.5. First floor plan of the Troops' Quarters. HABS drawing (1962) annotated by Jana Gross (1989).

The two-story structure is subdivided into interconnected casemates, or bombproofed vaults. For convenience, each of the ten interconnected casemates was numbered (south to north) and labeled CM-1 through CM-10 by HABS in 1962. The museum space is in CM-2 and CM-4. The audio-visual room is in CM-1. CM-3 serves as the entrance and location of the main staircase. CM-5 is unused. The second floor of the Troops' Quarters is almost on grade with the terreplein of the South Bastion. It is of the same dimensions as the first floor. The casemates are numbered CM-6 through CM-10 and are all connected by paired doors. With the exception of CM-5, the interior was restored in the 1970s. (See figs. 9.5 and 9.6.)

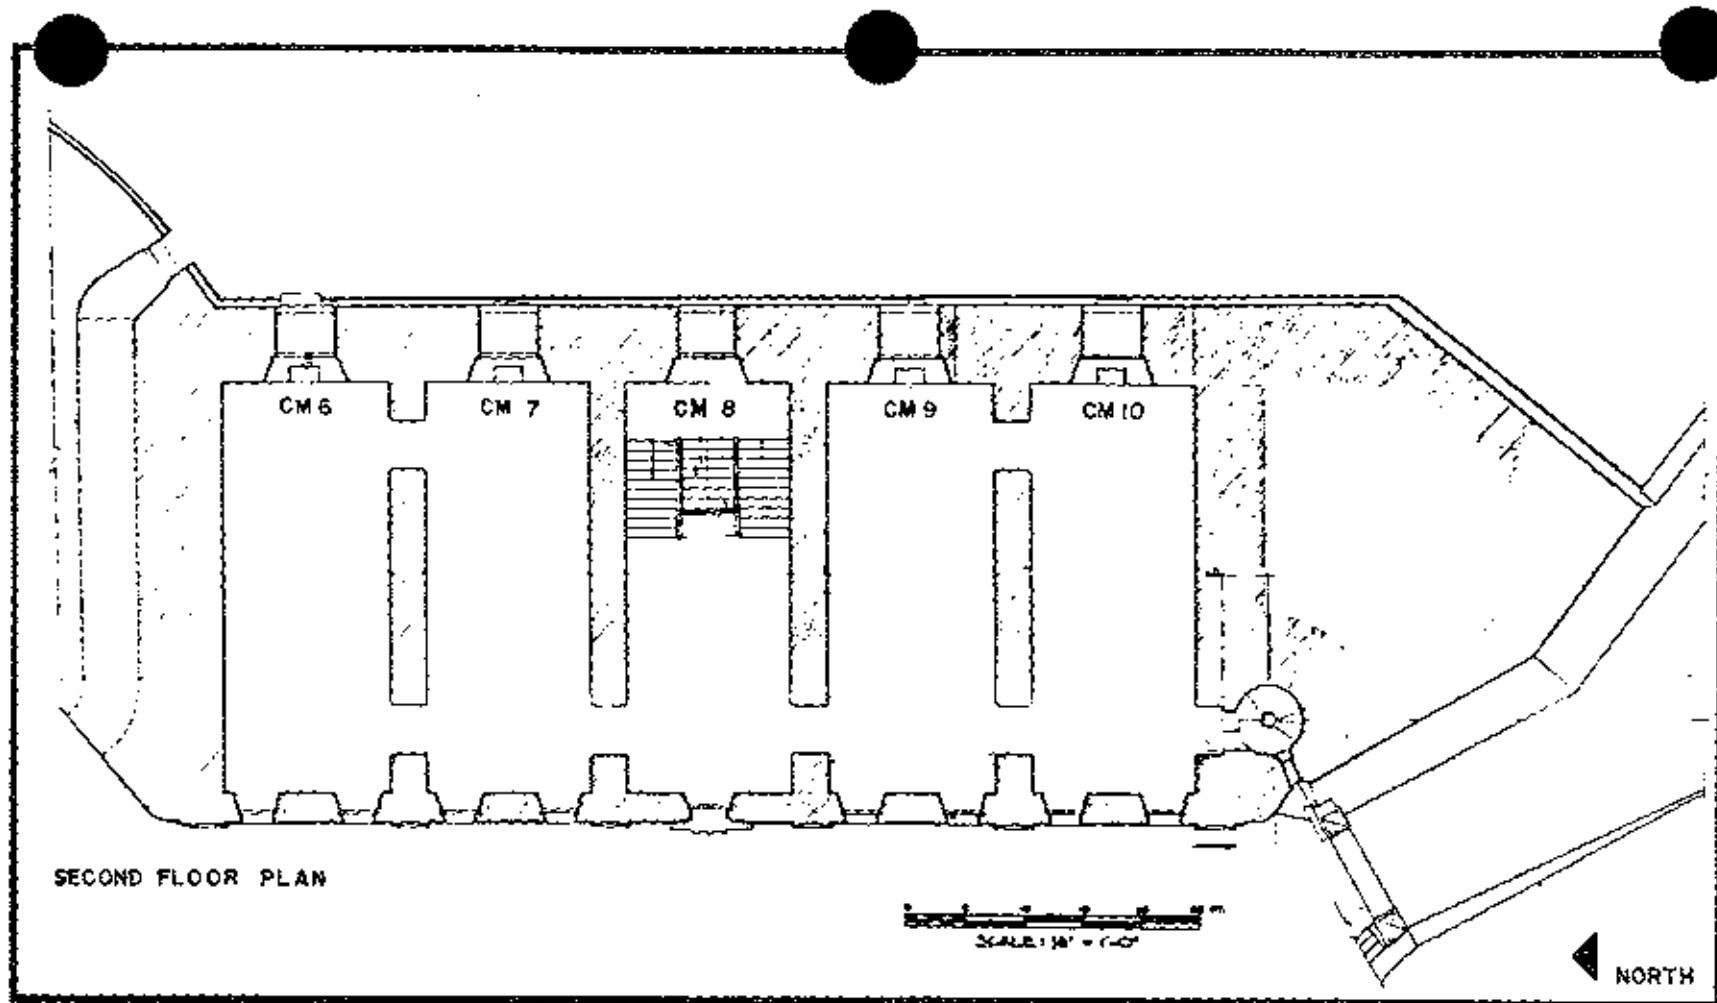
Figure 9.6. Second floor plan of the Troops' Quarters. HABS drawing (1965) annotated by Jana Gross (1989).

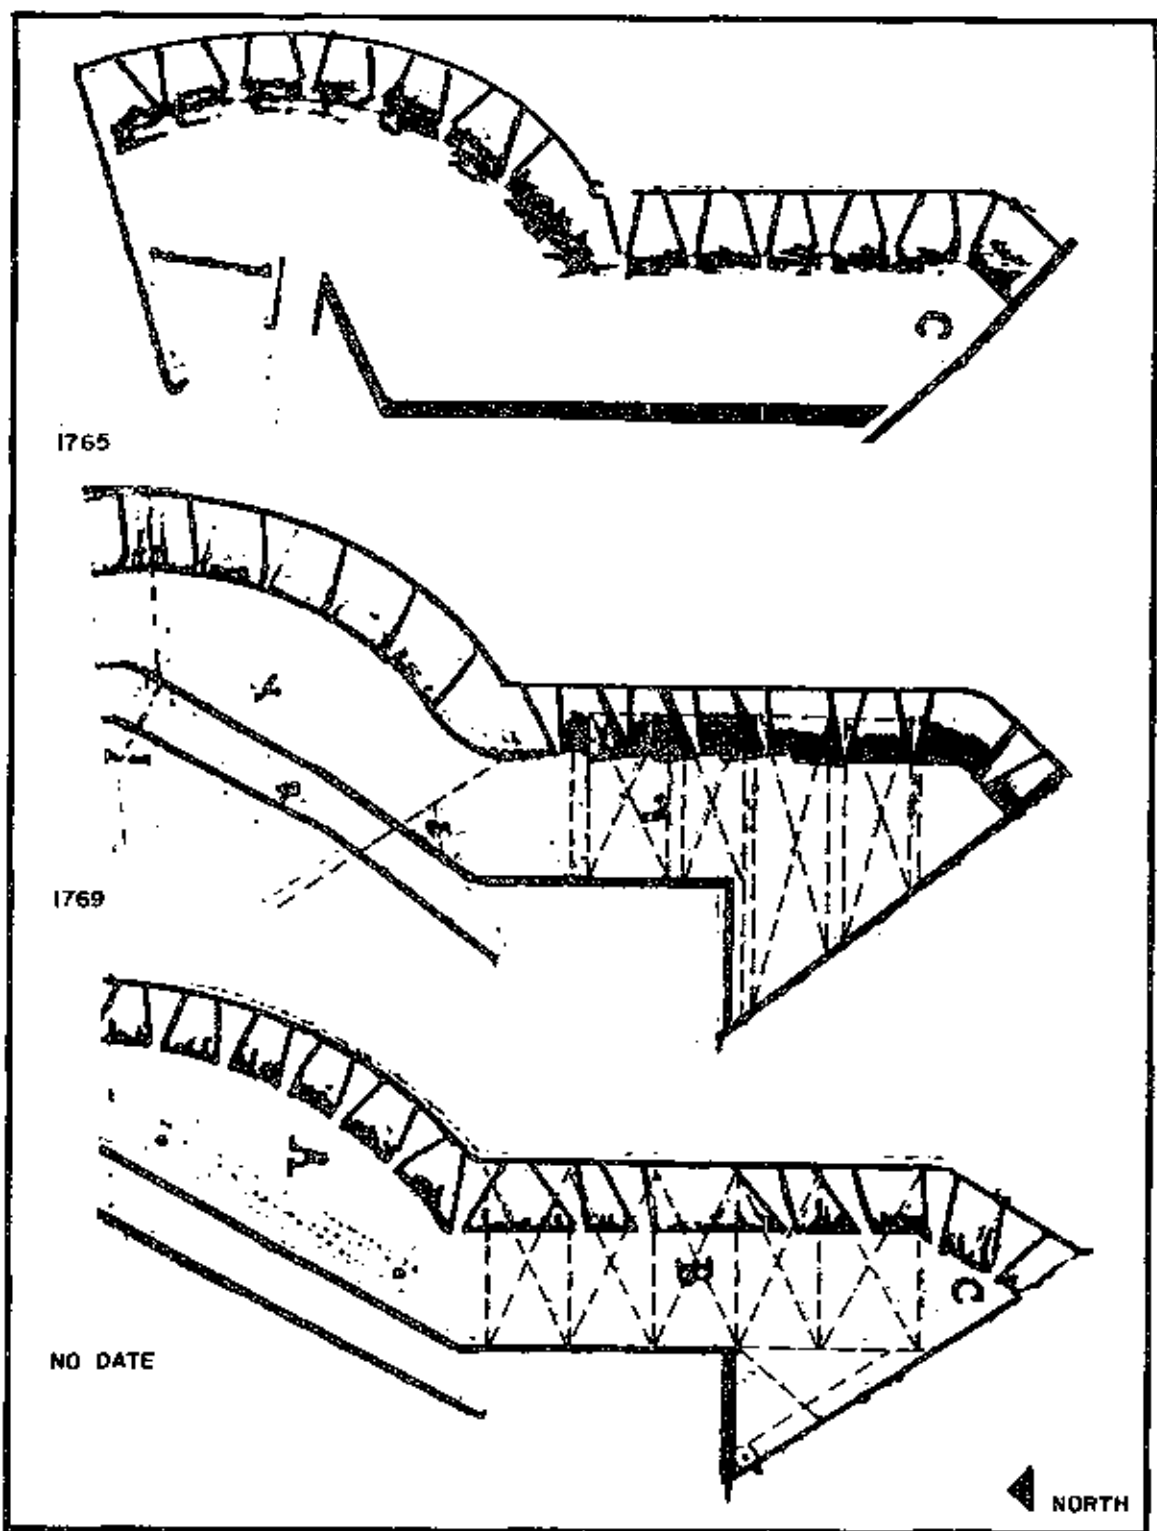
Figure 9.8. Three proposed plans for the Troops' Quarters. ("No Date" plan probably dates to 1769.)

Two drawings (fig. 9.8) by O'Daly, one dated 1765 and the other 1769, illustrated the proposed new structure. The 1765 plan showed a rectangular feature labeled "C", explained in the legend to be:

A third plan, undated and of unknown authorship, proposed an enlarged structure as in 1769 but with six instead of five vaults. Situated at the south end was what is assumed to be the stairs, labeled "C" and described: "Door for help when the enemy has breached and the main gate is barricaded."⁴

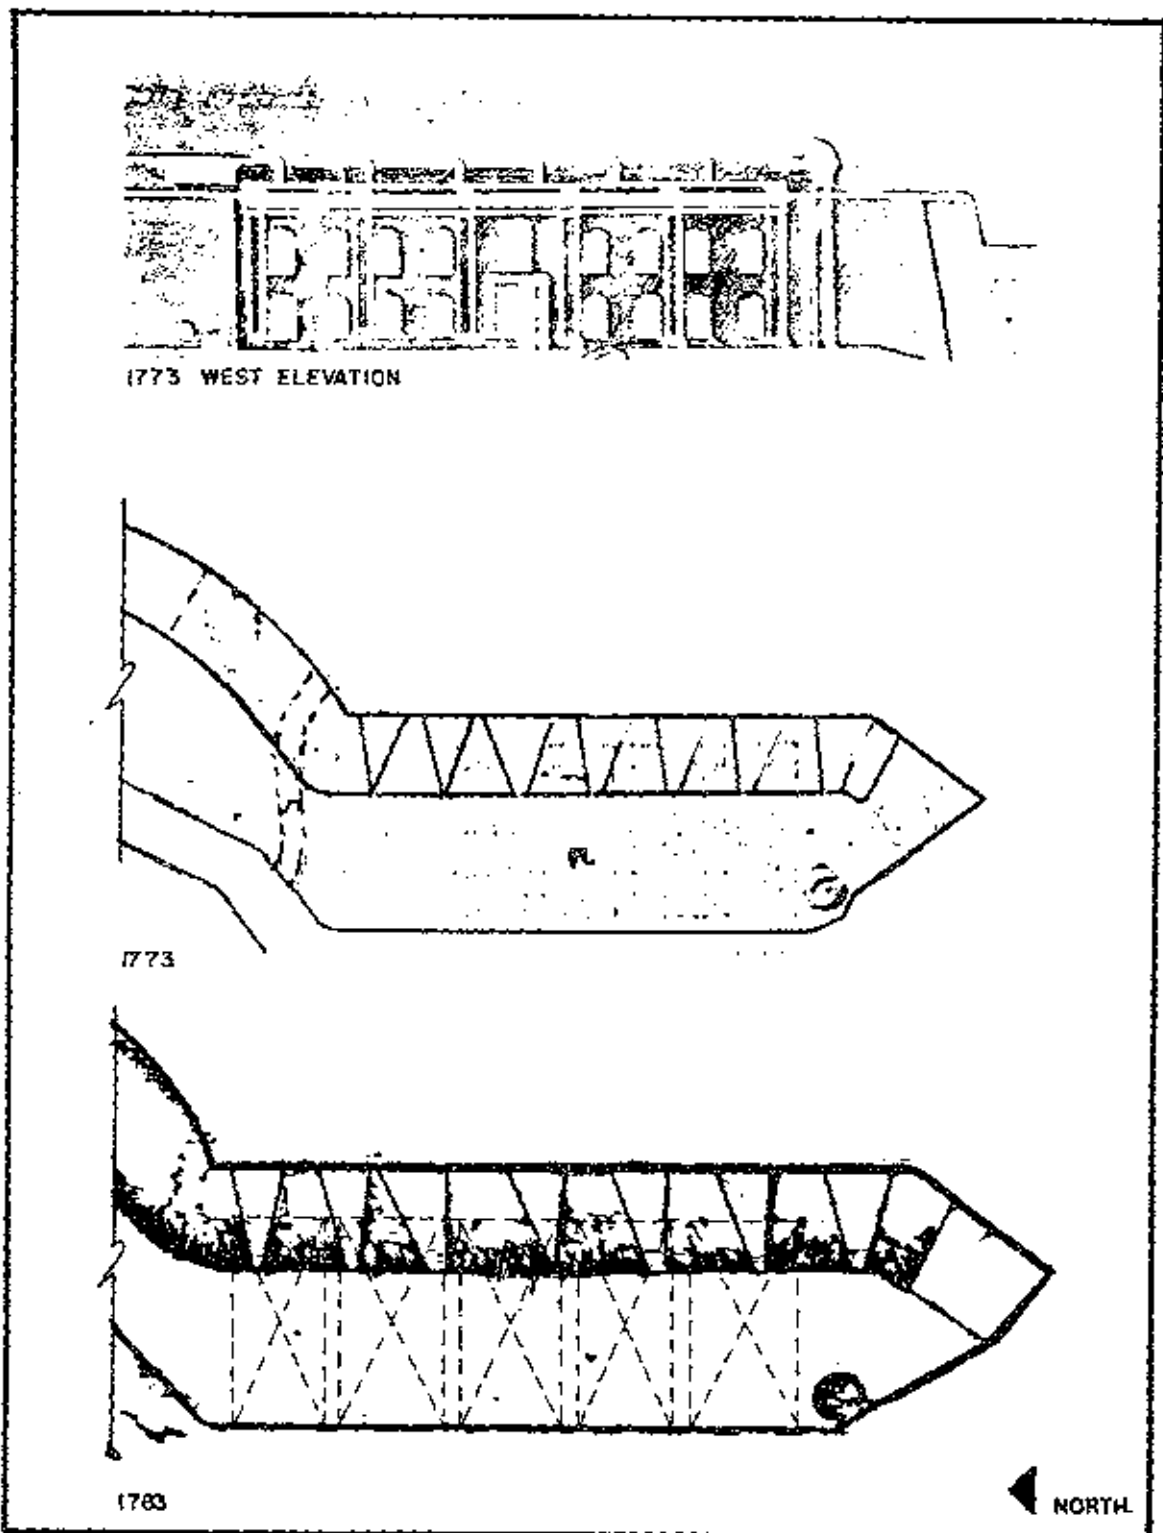
Figure 9.9. The Troops' Quarters as built, 1773 and 1783. Details of drawings by Engineers O'Daly and Mestre.

The first view of the new vaults as built is provided by O'Daly's plan and elevation drawings of 1773 (fig. 9.9). Here, the new wing was labeled "n" on the plan and described as:

The end note below the legend further specified that these were "newly constructed." The plan showed a structure almost identical in shape to that originally proposed in 1765, with five rectangular vaults of about equal size. An interior staircase was located at the east wall of the center vault and a spiral staircase at the far southwest corner. The west elevation drawing clearly showed a symmetrical front facade divided into five bays that correspond to the five vaults. Each of the bays was articulated by a full two-story pilaster. In the center bay was a wide doorway (first story), and above it a central window. The adjacent north and south bays had four windows each: two in the first story and two in the second story. There was a total of one doorway and seventeen windows. Not shown were window shutters and a bell support.

The 1773 drawings also showed a wing of triangular shape attached to the south facade. It is within this wing at the northwest corner that the spiral stair was contained. Other than this, the wing appeared to have no other function than to provide a protective thick wall to the vaults, and to increase the area of el Caballero above. Whether the interior was hollow or filled is not indicated.

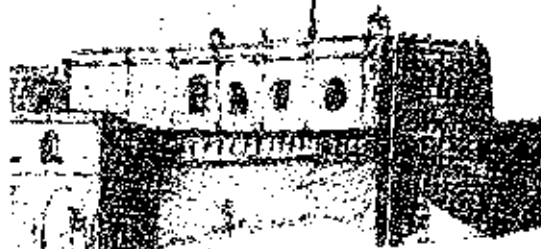
Figure 9.10. Sketch by August Plee, ca. 1821. (HABS negative 181.197.)

The only information found on the building for this period is a sketch dated ca. 1821 (fig. 9.10).⁸ While certain "artistic liberties" appear to have been taken with architectural details, the basic form of the building was shown little changed from the more exactly rendered elevation of 1773. Two new features were the arched bell housing and a signal pole, both located at the roof level of the west facade.

The sketch is a view looking northeast towards San Cristóbal. The second story west facade and the south facade are visible. Inaccuracies that are apparent include the number of bays and the number of windows. The west facade in this sketch was divided into six bays instead of five as shown in 1773, in later drawings, and as it exists today. The number of windows

was correct for the three bays on the north side but incorrect on the south side. The bell housing was located, as it is today, in the middle of the west facade on the roof. No bell was drawn in the arched enclosure. A large signal pole was located to the south of the bell housing.

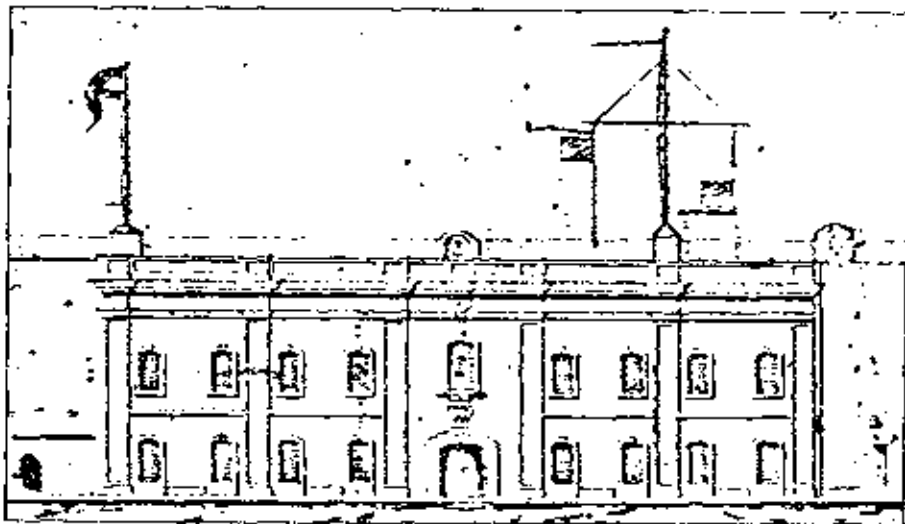
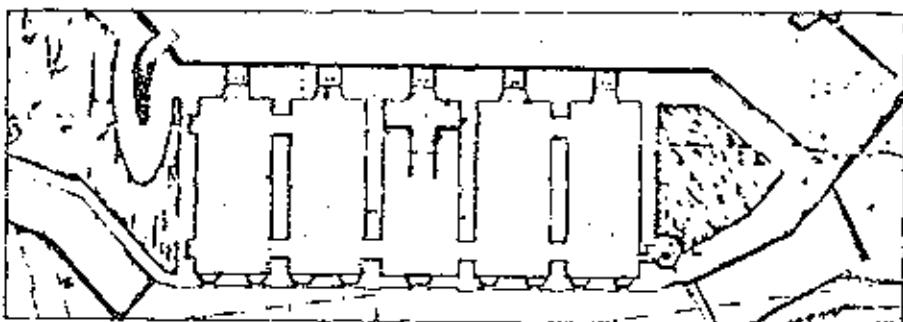
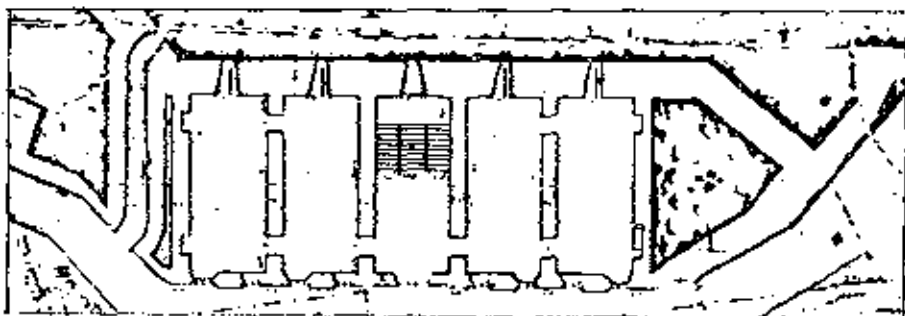
Figure 9.11. Details from Manuel Castro's 1861 drawings showing the west elevation and floor plans of the Troops' Quarters. (San Juan NHS Archives.)

In 1861, Manuel Castro recorded the Troops' Quarters in five drawings: a west elevation, first floor plan, a second floor plan, a roof plan, and a section (figs. 9.11 and 9.12). Although the intent of the drawings is not known (e.g., recording existing conditions or proposed work), the east portion appears to have changed little from its appearance as recorded in 1773, ca. 1821, and 1839. The several new features shown for the first time are confirmed to have existed by later photographs and written descriptions. The drawings are therefore thought to be an accurate recording of the building as it looked in ca. 1861.

In 1861, the exterior west facade was little changed from earlier descriptions with the exception of four new additions and slight differences in paint colors. First, the windows had louvered shutters. Although these are now missing, early photographs and remaining physical evidence of hinge pintles in the window jambs indicate that these were located on the exterior side of the window openings.¹² Second, a flagpole and base on the far north corner of the roof had joined the earlier pre-ca. 1821 signal pole on the south side. Third, a bell had been installed in its pre-ca. 1821 housing located on the roof between the two flag poles. Lastly, two decorative elements were located on the west facade: one above and one below the second story window in the middle bay.

The 1861 plans and section "K.L." provide a detailed view of the interior vaults. As originally built in the 1770s, these consisted of five vaults on each of the first and second floors, a communication stairway between the two floors in the middle vault, and a spiral stairway from the second floor to el Caballero in the southwest corner. This was unchanged in 1861. Further details were provided in these drawings. In three of the four end vaults were two wall niches (their function is unknown). These were located in the first story north vault (north wall), the first story south vault (south wall), and the second story north vault (north wall). Interior communication between all the vaults was via doorways in the interior partition walls. Direct access to the upper terreplein of the adjacent bastion to the east was provided from all first floor vaults through a small opening in the upper east wall reached by means of a ladder. The ladder located in the north end vault appears to have been built in. All other ladders were moveable. On the second floor, all vaults had one large window opening centered in the east wall;

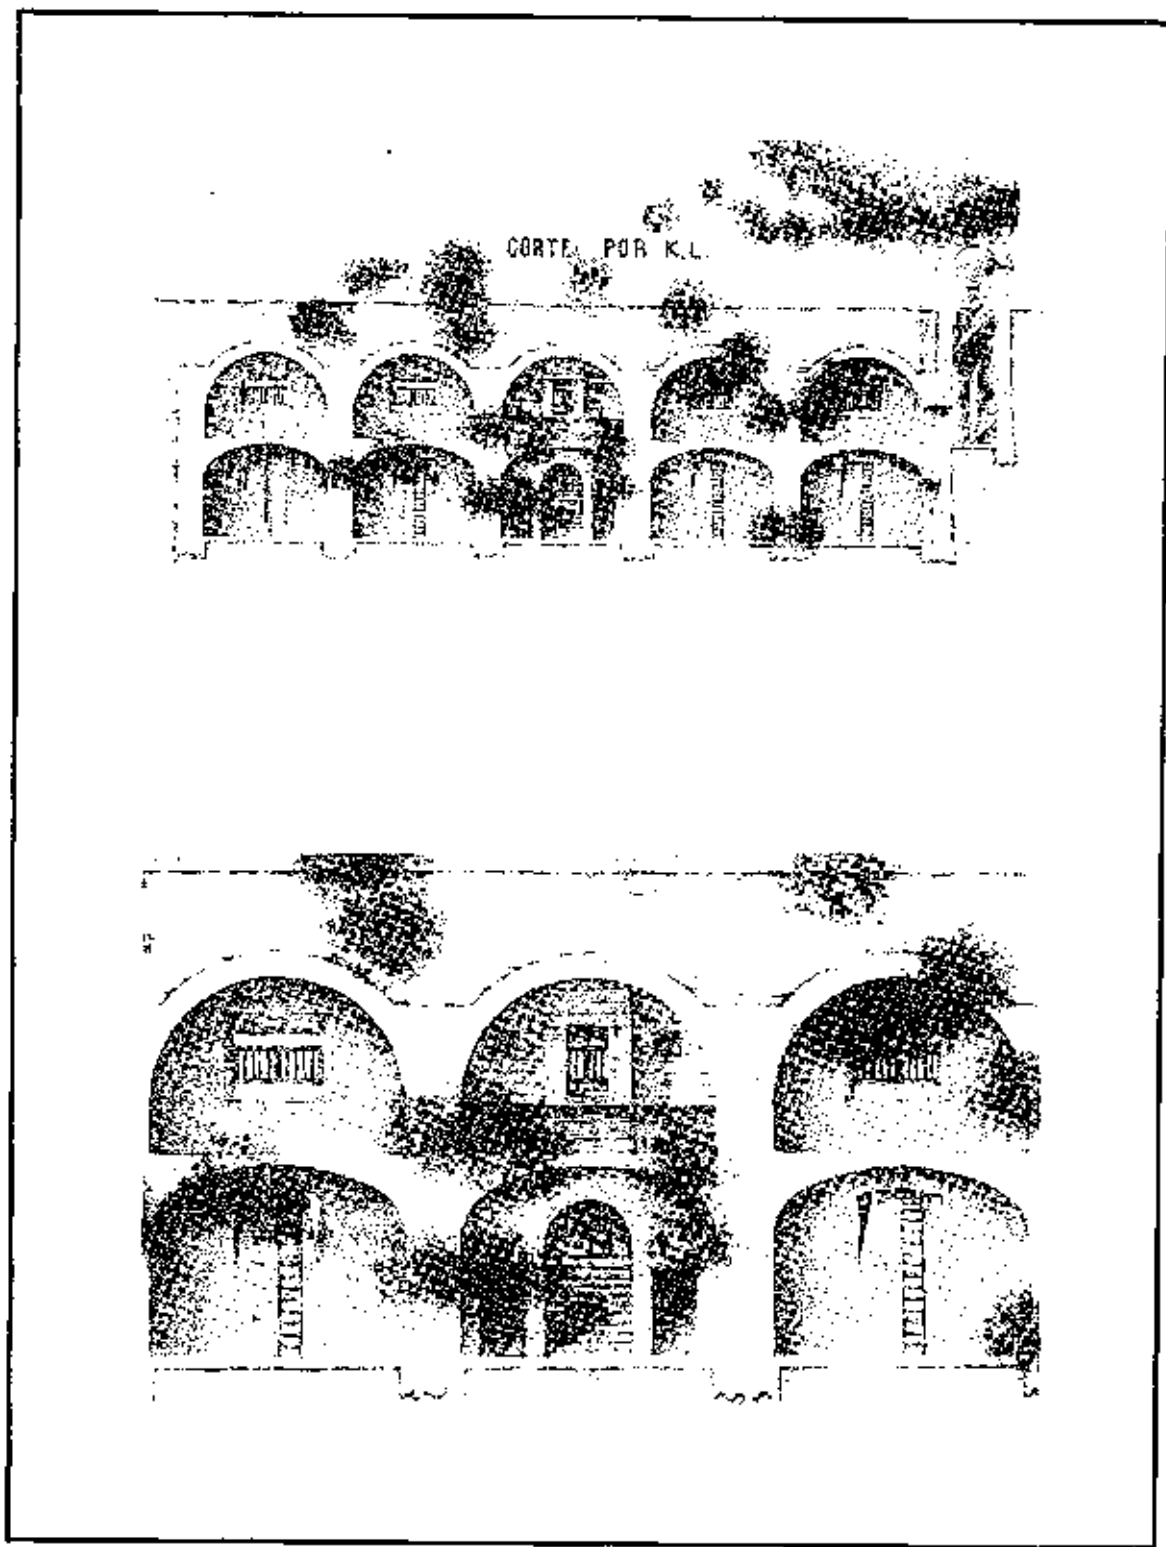
Figure 9.12. Manuel Castro's section of the Troops' Quarters, 1861. (San Juan NHS Archives.)
