THE FORTIFICATIONS OF SAN JUAN NATIONAL HISTORIC SITE

HISTORIC STRUCTURE REPORT

El Fuerte de San Cristóbal

1991

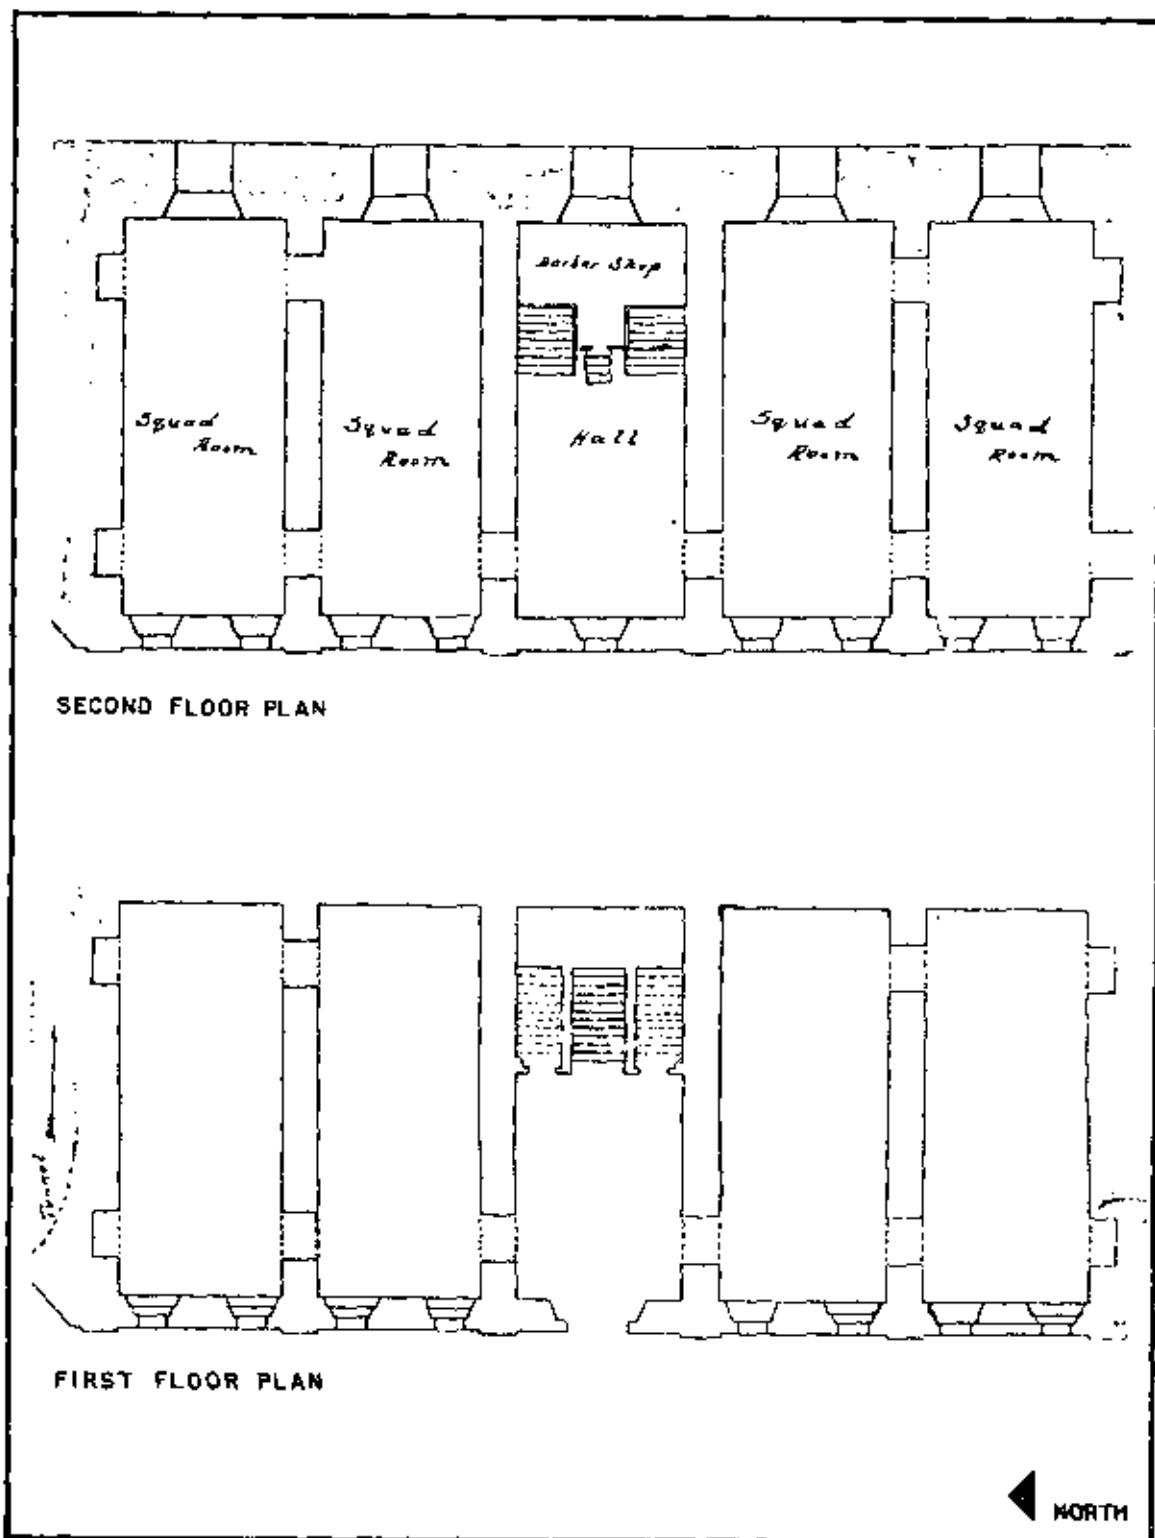
Figure 9.13. Detail of plan, "Quarters at Fort San Cristóbal," showing interior layout of the Troops' Quarters, 1901. (San Juan NHS Archives.)

and uses of the quarters at San Cristóbal were detailed in a plan dated February 12, 1901.¹⁷ This plan (fig. 9.13) showed the first floor vaults of the building unlabeled and apparently not used as quarters, and the second floor vaults labeled as "squad rooms", "hall", and "barber shop". Four squad rooms were present, two located to either side of the center stair hall. The barber shop was located in the east end of the hall in a small partitioned room over the stairs; this was the same room first illustrated by Castro in 1861 and believed to be a later addition to the original structure. Also in 1901, the coal oil and regulation lamps then in use were determined unsatisfactory because of the heat they gave off and their tendency to blow out.¹⁸ Therefore, wires were strung, fixtures positioned, and meter boxes installed for 16-candle power incandescent lights.¹⁹ The control room appears to have been the first floor north vault (CM-5) where several obsolete switches, meters, and fuse boxes were found affixed to the walls in 1986.

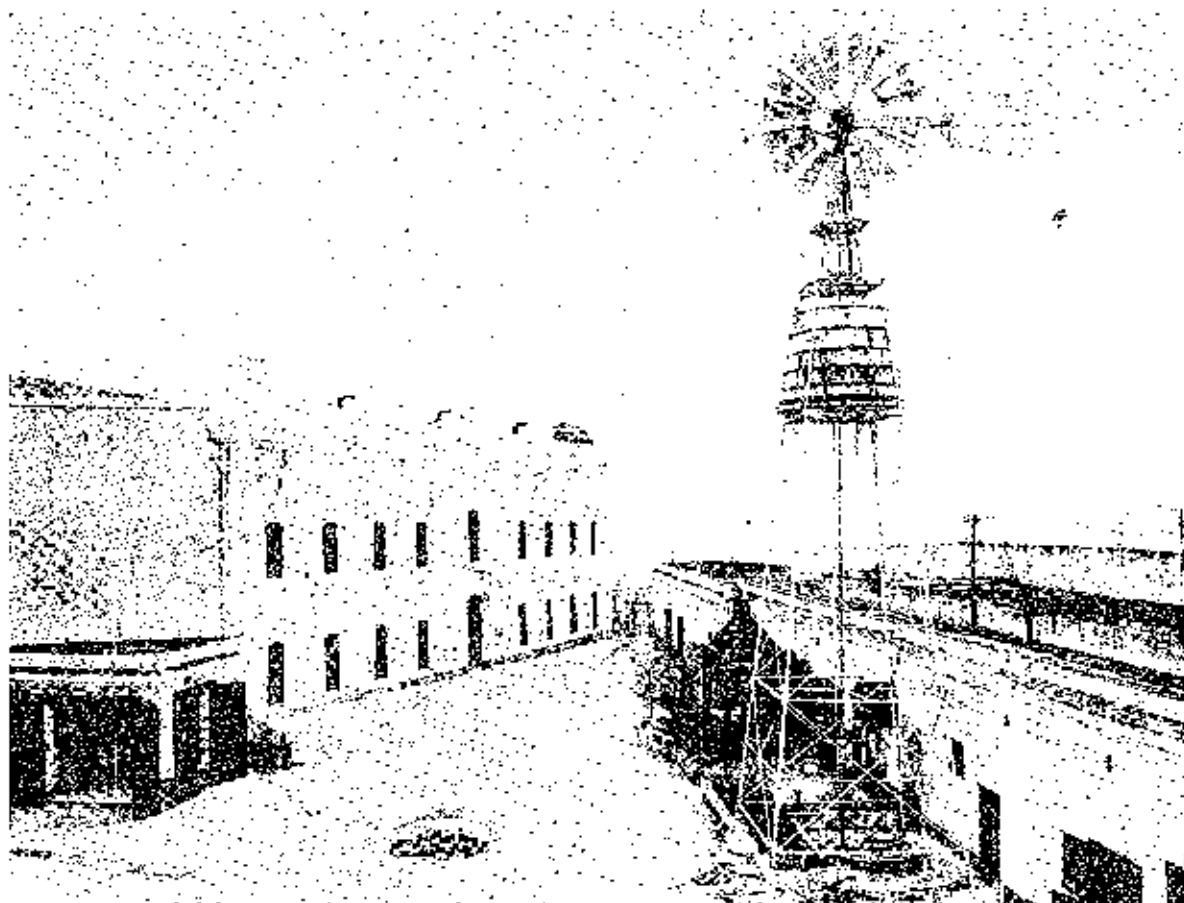
Figure 9.14. View dated ca. 1905 showing west and north elevations of the Troops' Quarters. (HABS negative 181.25.)

Whether or not the exterior was restuccoed within the next few years is not recorded, although a photograph (fig. 9.14) of the northwest facade dated ca. 1905 seems to show it in good repair except for a crack at the upper north corner, west facade.²¹ In fact, the west facade was virtually unchanged from the elevations of 1861. Coloration, although shaded in black and white, appears to have been similar. Louvered shutters, which differed only slightly by having a panel in their lower sections, were still in place in the windows. The flagpole formerly located at the northwest corner of the roof was missing. The base support was shown in place, but the pole itself was most likely taken down in 1902 when a new 75 foot flagpole was installed elsewhere on el Caballero.²² The four artillery pieces emplaced sometime after 1861 on the roof were still extant in the ca. 1905 photograph.

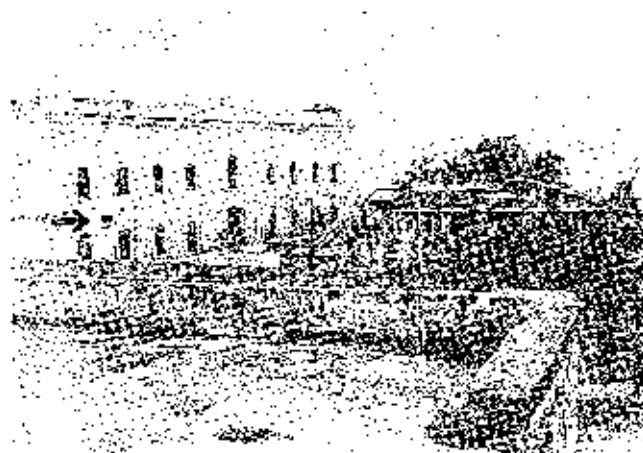
Figure 9.15. Detail of view showing west elevation, ca. 1950. Note remnant of former kitchen chimney. (San Juan NHS Archives.)

spring of 1942 as evidenced by a photograph of it attached to the west facade.²⁸ This chimney was located between the doorway and window of the kitchen in the first floor north vault. The hole made in the wall for the chimney flue was uncovered by the NPS in the 1970s during repairs to the west facade. Although its use was not then known, it was described as "uniform and rectangular (manmade)," measuring 31 inches wide by 6 inches high."²⁹ In 1943, a plan of San Cristóbal identified a kitchen and mess halls on the first floor, and squadrooms on the second floor. Four years later, in 1947, a general plan described the building succinctly as "number 22. Squad Room & Mess Hall."³⁰

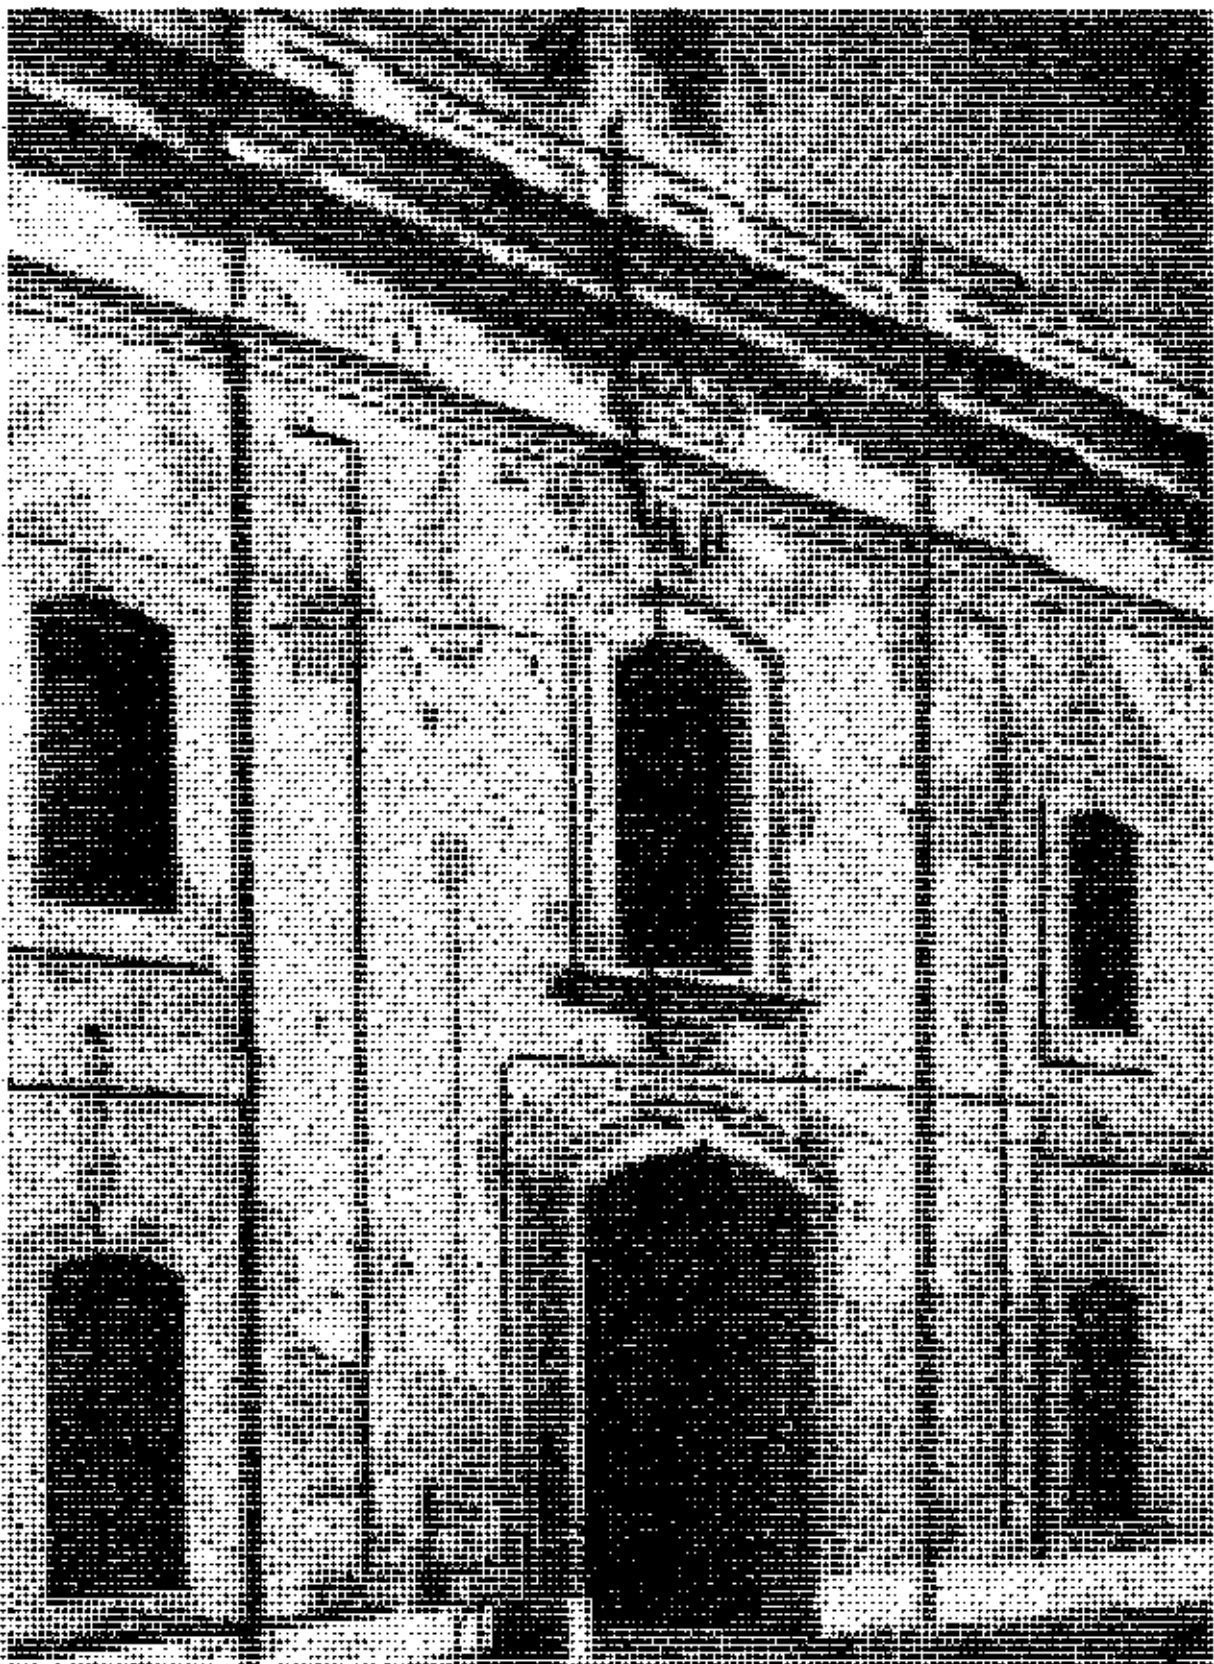
Figure 9.17. West elevation, main entrance. Photo by HABS,
January 1960.

In the 1960s, the building was recorded by HABS and renamed the "Troops' Quarters." The exterior west facade was photographed in January 1960 and measured drawings prepared during the summer of 1962.³² In addition, existing conditions of the electrical system were recorded by the NPS in September 1962.³³ Both the drawings and photographs illustrated a building basically unchanged from its eighteenth-century appearance, yet modernized and in need of repairs. (See fig. 9.17.)

In the HABS photographs, the west facade had a mottled/patched appearance and was crossed by electrical conduits. The doors of the two end doorways appeared to be old shutters that were lengthened using vertical boards. Window shutters were of mixed styles, including louvered, narrow vertical board, and wide vertical board. Exterior louvered shutters were in first story windows only. Only interior solid shutters survived in the second story windows, and of these only shutters in the middle and south vaults were of wide vertical board design and therefore probably of an early date. On the east facade, the small first story windows were boarded over. The small window in the middle stair vault illustrated in Castro's 1861 drawings is missing. The second story east windows were enclosed with two types of shutters: paneled on the north side and narrow vertical boards on the south side.

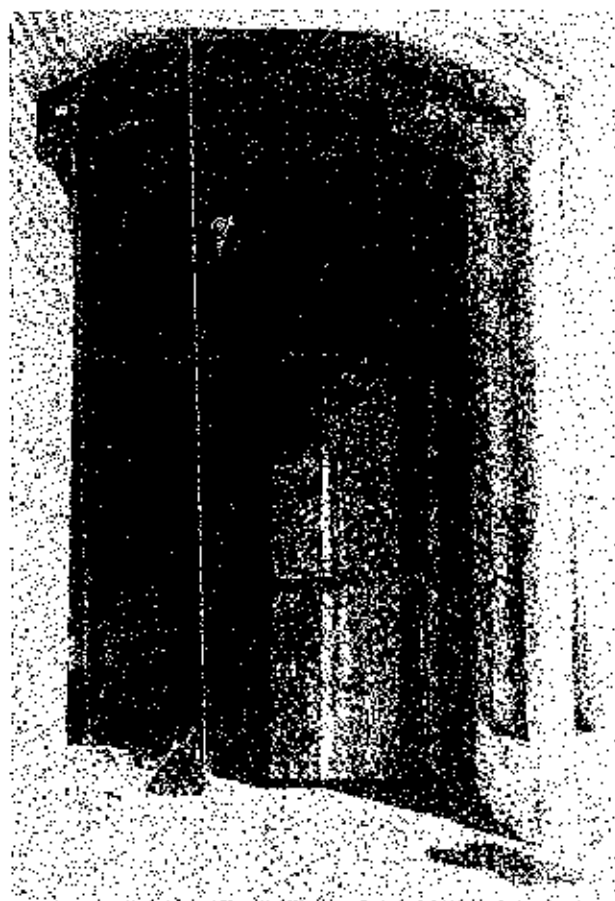
Figure 9.18. Main entrance during restoration, ca. 1874-75. (San Juan NHS Archives.)

It was estimated that of the original doors and window shutters, 50% had been retained in various stages of preservation varying from good to poor. Existing original doors and shutters were to be repaired and reinstalled and missing ones replaced by exact reconstructions.³⁵ The old hardware was to be removed and replaced by new reproduction hardware made by the Hartland Forge of Vermont.³⁶ The paint finishes on one shutter from the Troops' Quarters were examined by the NPS Museum Lab at Harpers Ferry, West Virginia who identified 22 layers of paint.³⁷ All paint, however, was subsequently stripped from the original doors, window frames,³⁸ and window shutters and the wood then treated with a mixture of kerosene and linseed oil.³⁹ No research or justification for this treatment has been found. (See fig. 9.18.)

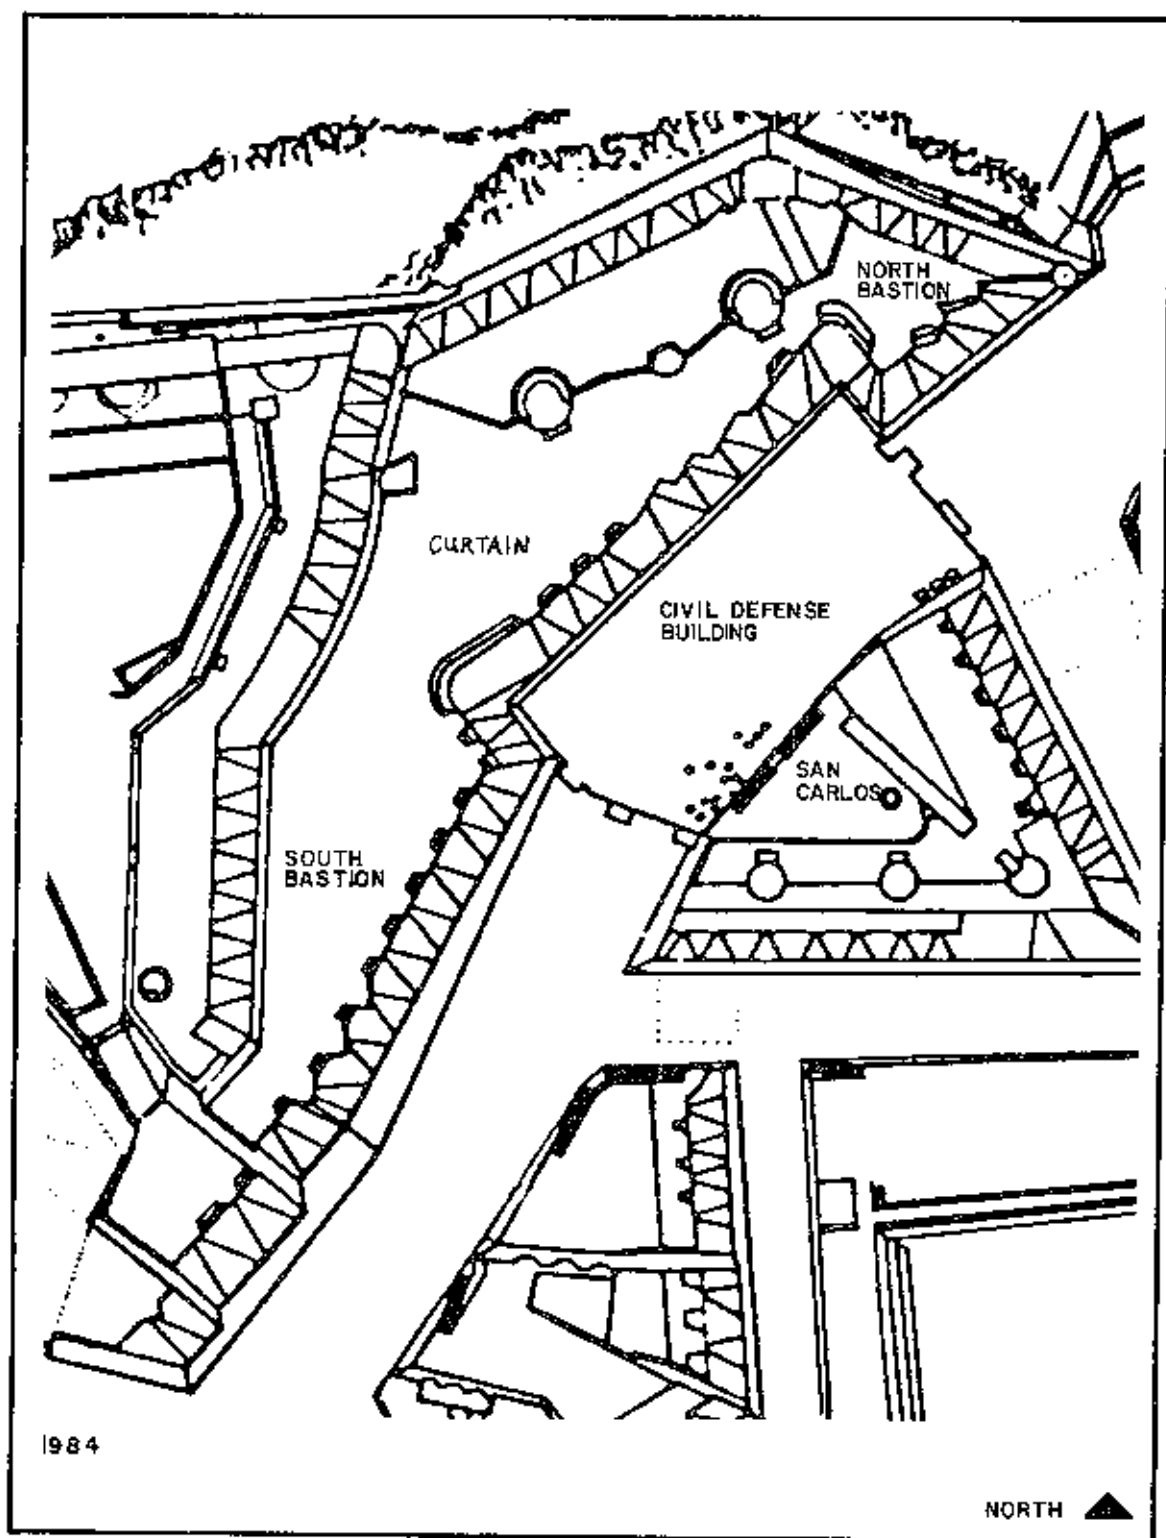
Figure 10.1. Detail of 1984 HABS site plan of San Cristóbal showing the North Bastion, the Curtain, and the South Bastion.

The eastern defense of San Cristóbal forms an irregular semi-circular configuration adjoining the west (curtain) wall of el Caballero and the Troops' Quarters. It is composed of the North Bastion, the Curtain, and the South Bastion. (See figs. 10.1, 10.2, 10.3.) The northern most section is the North Bastion, historically known as the Baluarte del norte (1765) and Baluarte plano del norte (1766). Adjoining the North Bastion on the south is the Curtain with its curtain wall and terreplein known historically as the Baluarte medio (1766), Baluarte plano (1766), and Cortina ("curtain"). The South Bastion forms the lower portion of the eastern defense. It also was known as the Baluarte plano (1765), and as the Baluarte plano del sur (1766). For the remainder of this chapter, and for references in related chapters, the terms North Bastion, South Bastion and Curtain will be used.

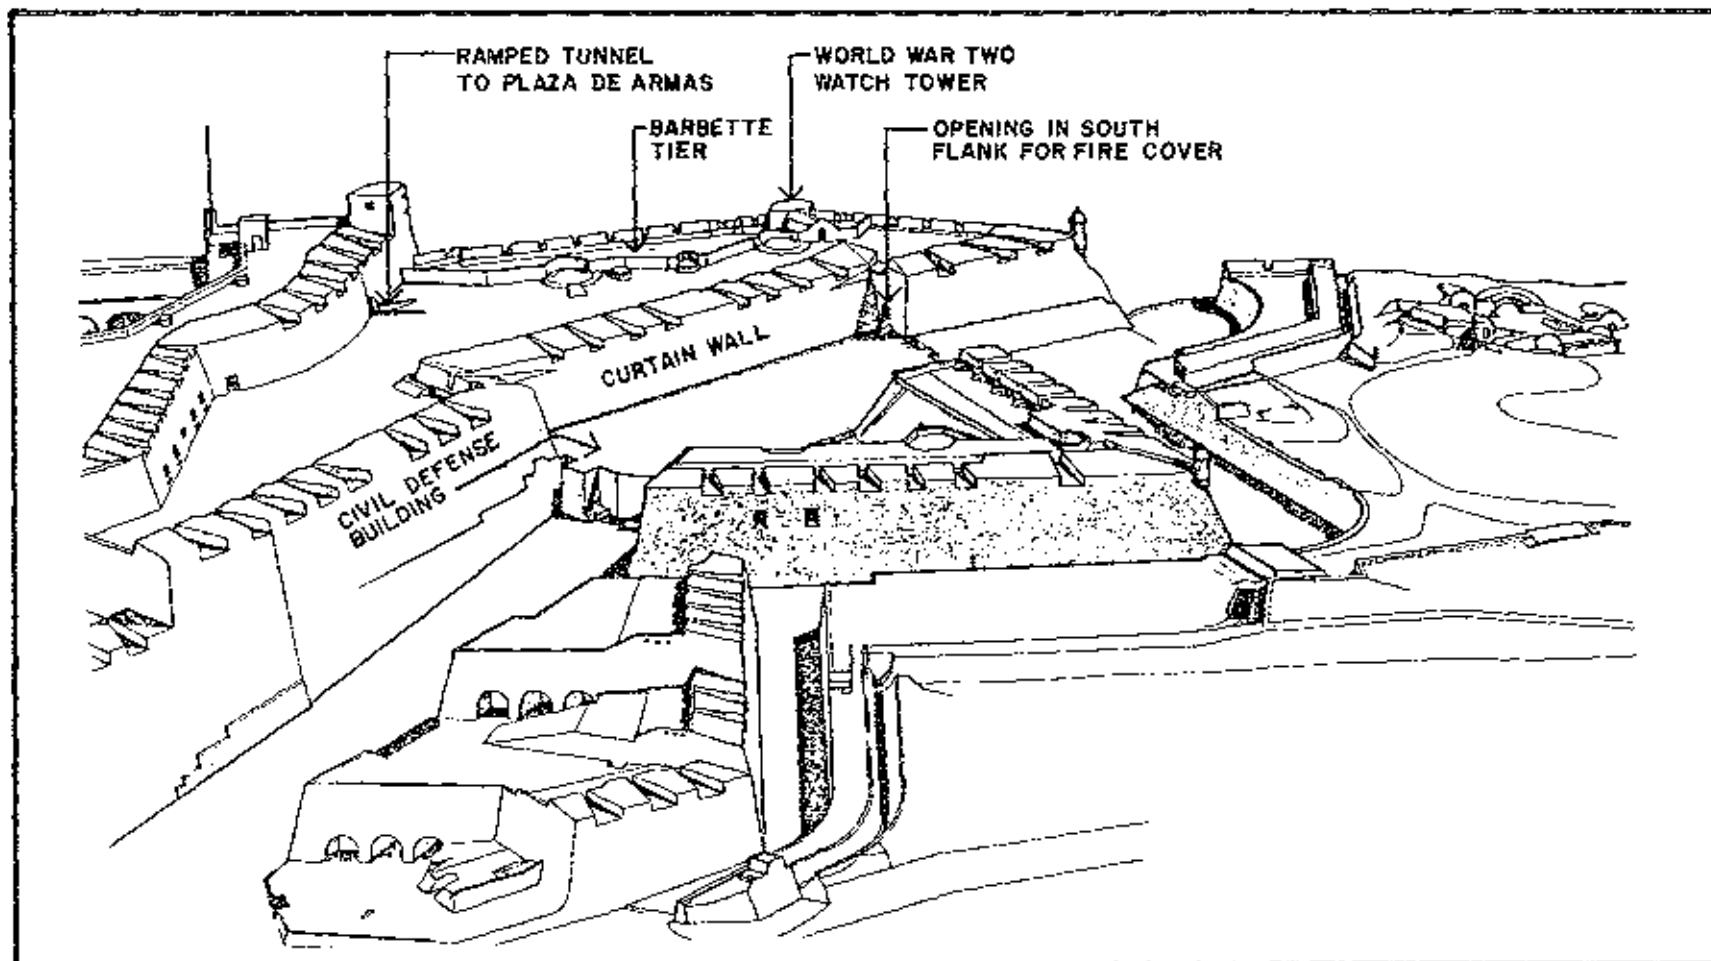
Figure 10.3. Perspective drawing by HABS, 1985. Annotated by Jana Gross, 1989.

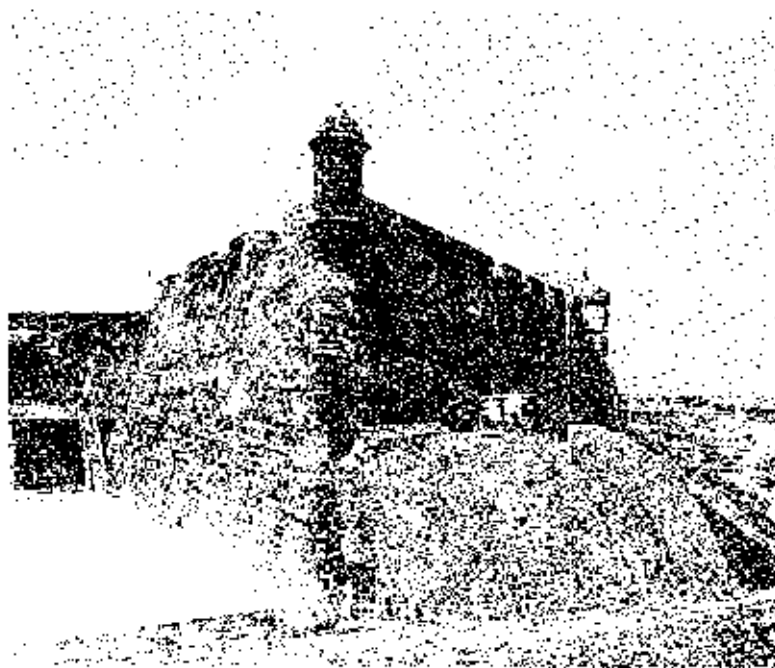
Figure 10.4. North and east walls of the North Bastion with sentry box. Photo by CPR, 1986.

The masonry of the North Bastion appears to exhibit two distinct systems that may relate to the raising of the earlier bastion in 1765. The sentry box (fig. 10.4) located at the northwest salient angle of the bastion is one of the few early echaugettes (sentry boxes) to survive. It is bonded to the upper wall. Like the salient angle, it is constructed of finely cut ashlar block set with brick spacers.

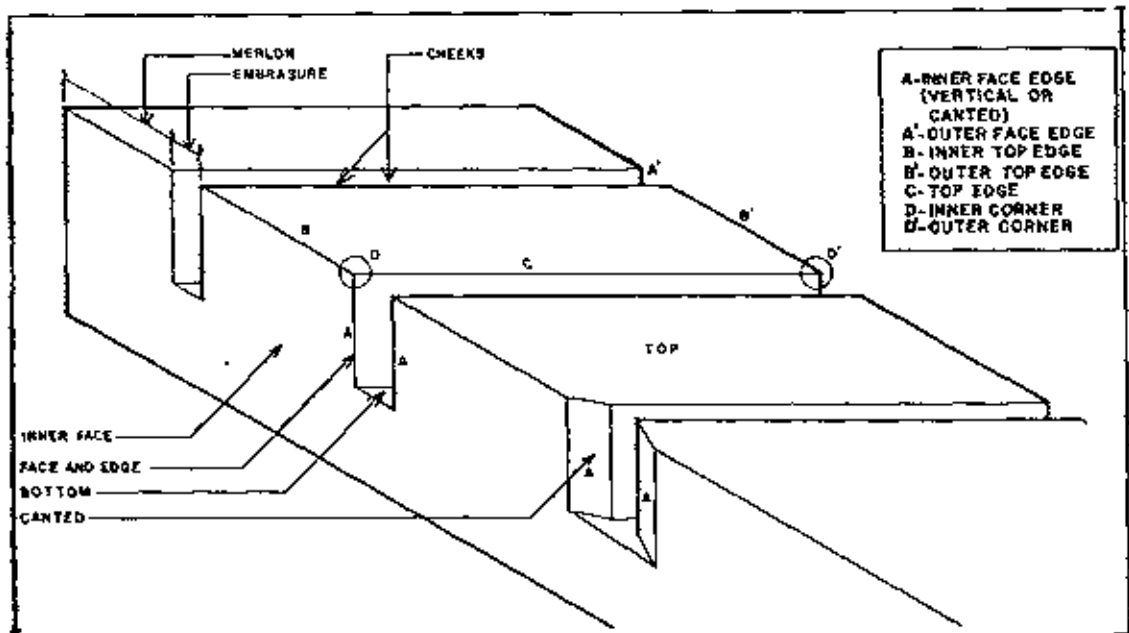
Figure 10.11. Schematic drawing of embrasures by CPR, 1986.

techniques. All embrasures are approximately the same height and are of rubble fill construction with numerous stucco coatings of various dates. Embrasure openings are trimmed with either ashlar or brick or a combination of both. Stone is generally used for the exterior edges and for interior corners. Subtle variations appear to relate to location, construction period, and repair/alteration. At least five distinct types can be observed. (See figs. 10.10, 10.11.) In general, Type I embrasures are found along the north battery and the north face of the North Bastion, while Type II embrasures are found only on the south face of the North Bastion. Type III embrasures extend along the entire length of the Curtain and flanks of the adjacent bastions. Type IV embrasures are located on both faces of the South Bastion and Type V on the lower batteries of this bastion.

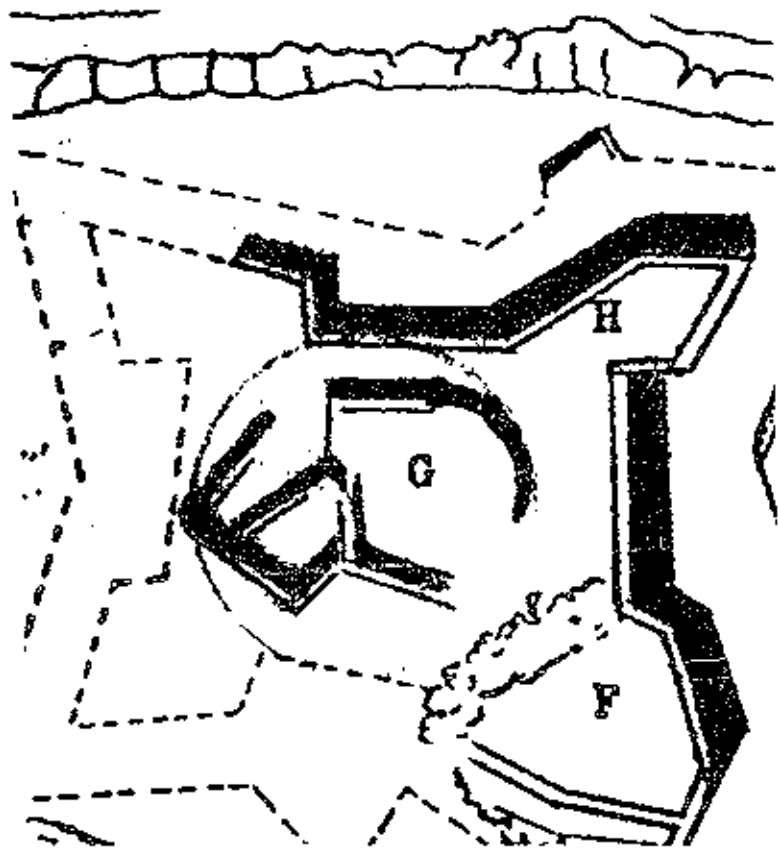
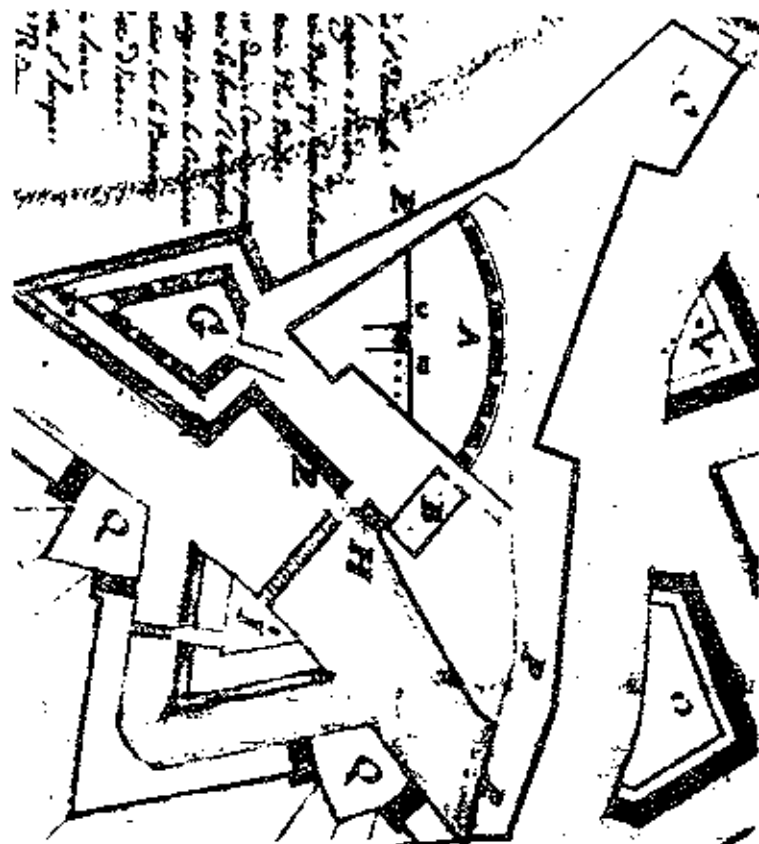
Figure 10.12. Left: Detail of Osorio Venegas' plan of San Cristóbal, 1678. Right: Detail of a 1702 plan showing North ("O") and South ("P") Bastions connected by a curtain.

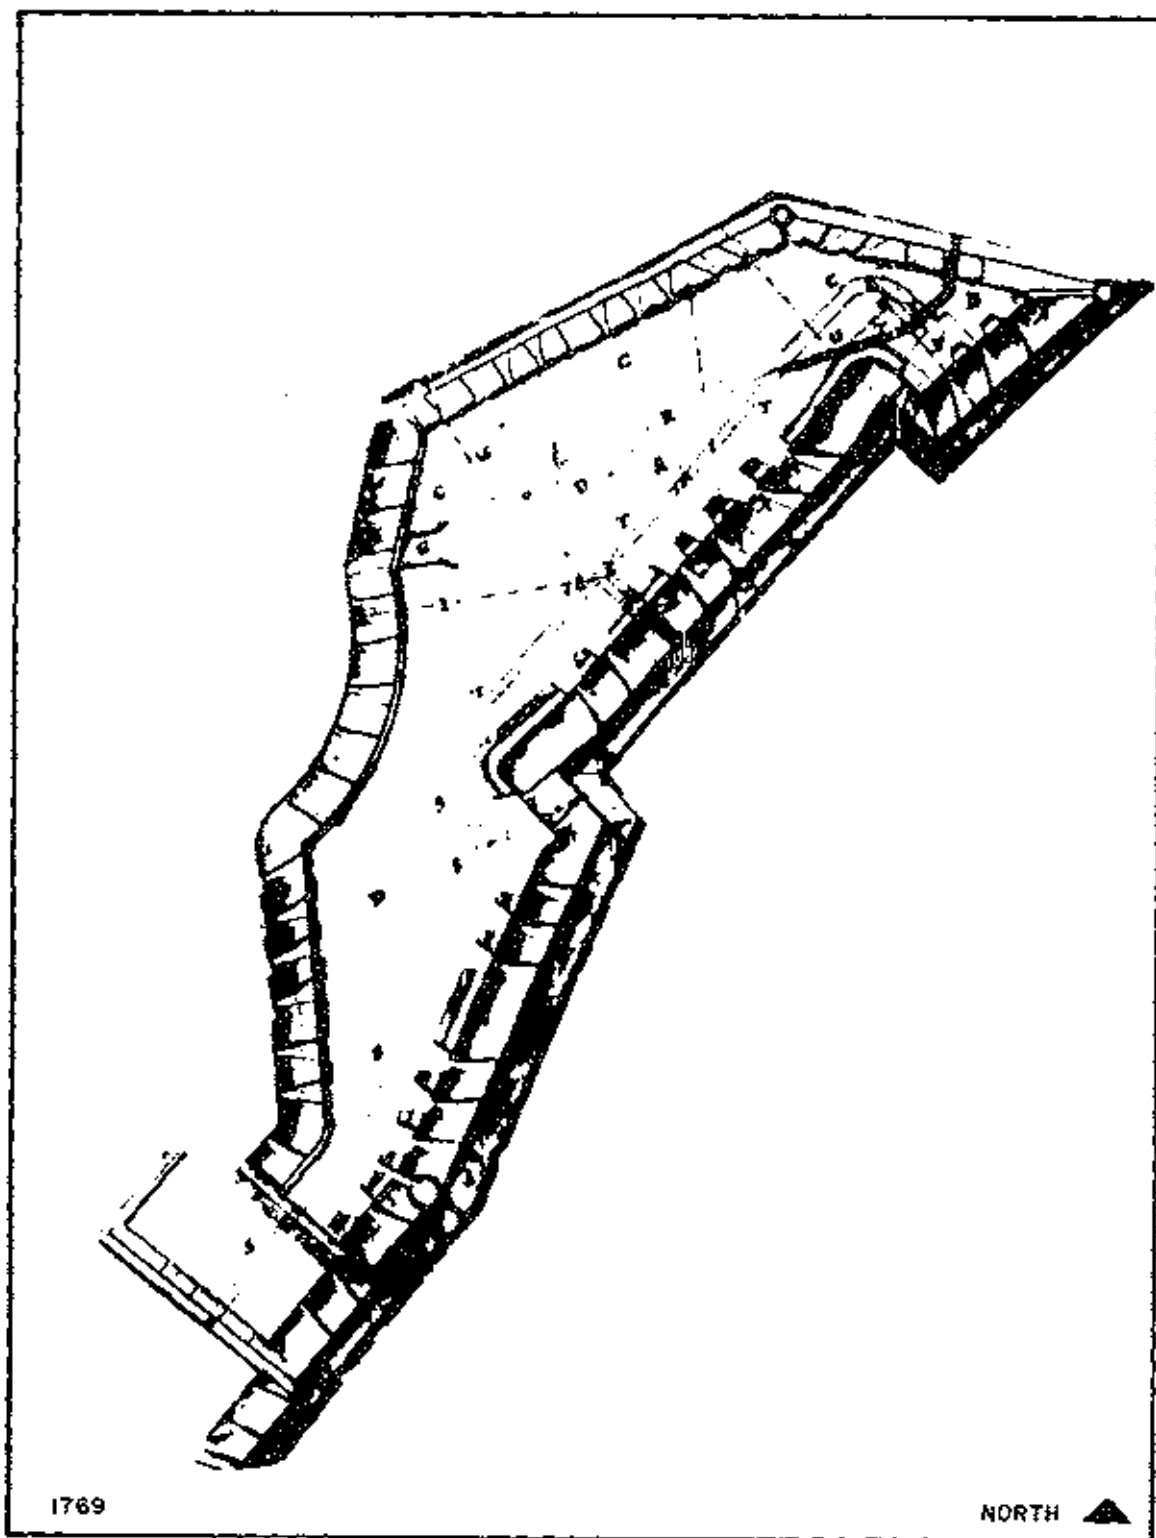
Figure 10.14. Detail of O'Daly's proposed construction plan showing North Bastion, Curtain, and South Bastion.

O'Daly's 1769 plan and profiles of the construction works (fig. 10.14) are the first available graphic representations of the work executed and planned between 1766-9. (Color plans from 1765 exist though they may not have actually been executed.) Extremely informative legends and explanations accompanied these documents. Items of particular interest included the new parapets with their embrasures comprising all of the front (west and north) of the fort; raising areas of the curtain walls and terreplein above the old work; raising the sentry box of the North Bastion northwest corner; reinforcing the terrains along the North Bastion; and excavating a deeper main moat.

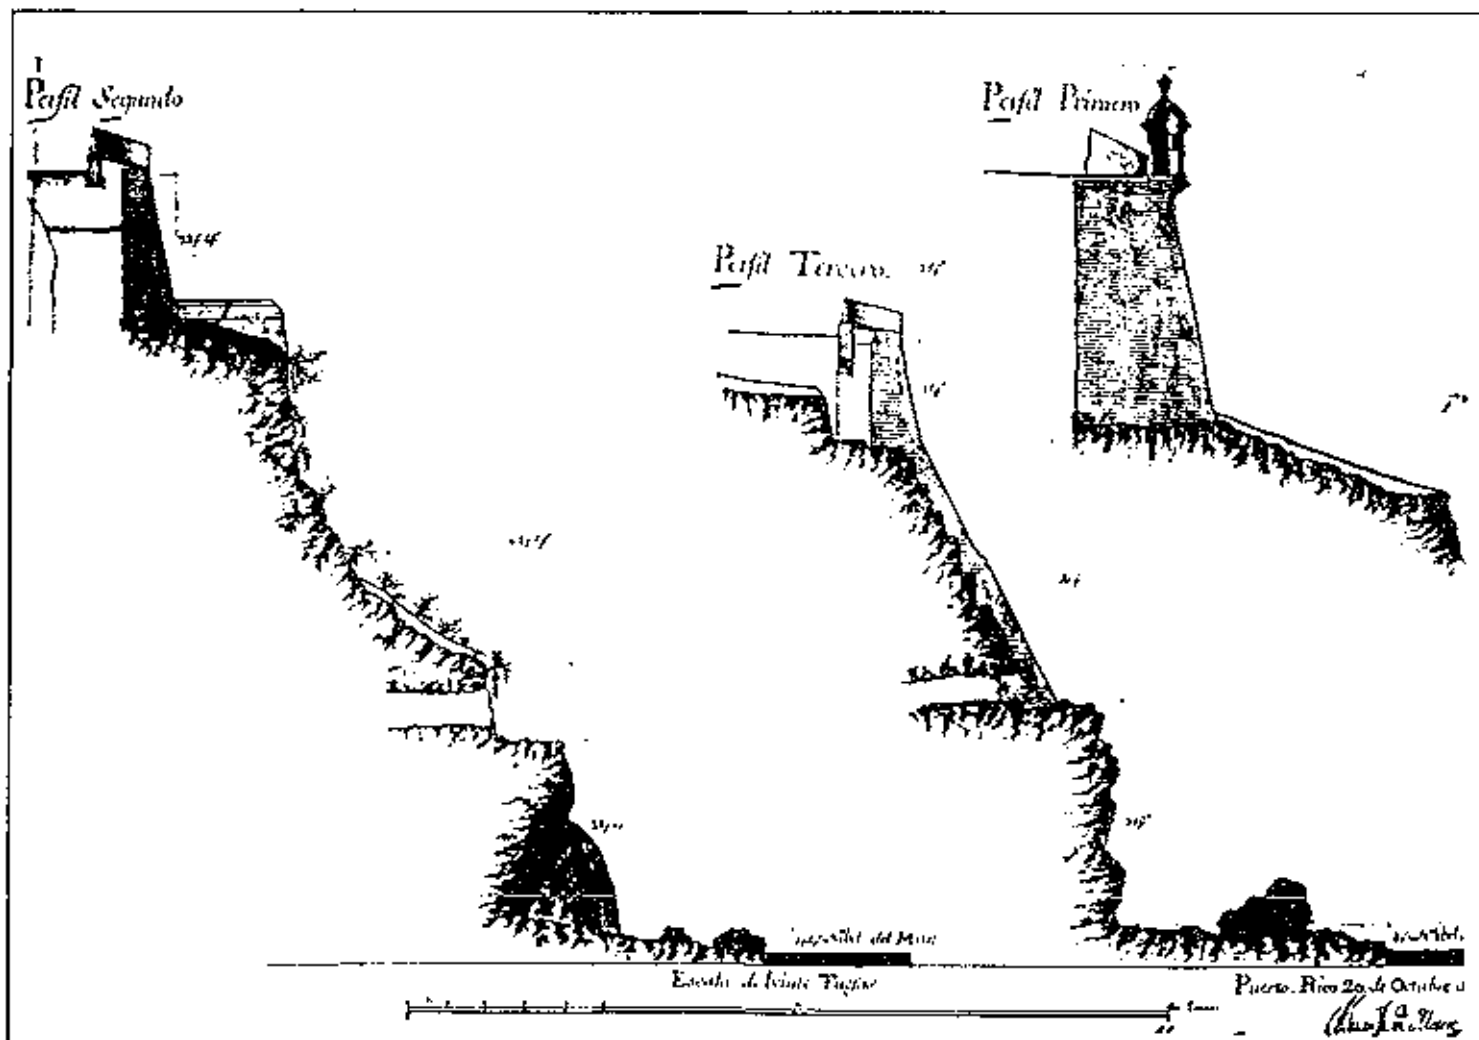
Figure 10.15. Profiles of north walls and terrain of San Cristóbal showing buttress reinforcement of North Bastion and north counterscarp area. Drawings by O'Daly and Mestre, 1769.

Sections of the north walls of San Cristóbal drawn by Mestre and O'Daly in 1769 showed the buttress reinforcement, and method of reinforcing terrain near the northern part of the shoulder and face of the North Bastion and north of the counterscarp area. (See fig. 10.15.) In September of 1769 the northern "part of the curtain between the North and South Bastions tumbled together with the temporary wooden bridge spanning the moat between the fort and San Carlos Ravelin."¹³ The bastions and their flanks were not affected, presumably because the North Bastion had been recently reinforced and the South Bastion's foundation was very stable. The moat in these undamaged areas had already reached its required depth; in other areas excavation had begun but was incomplete.

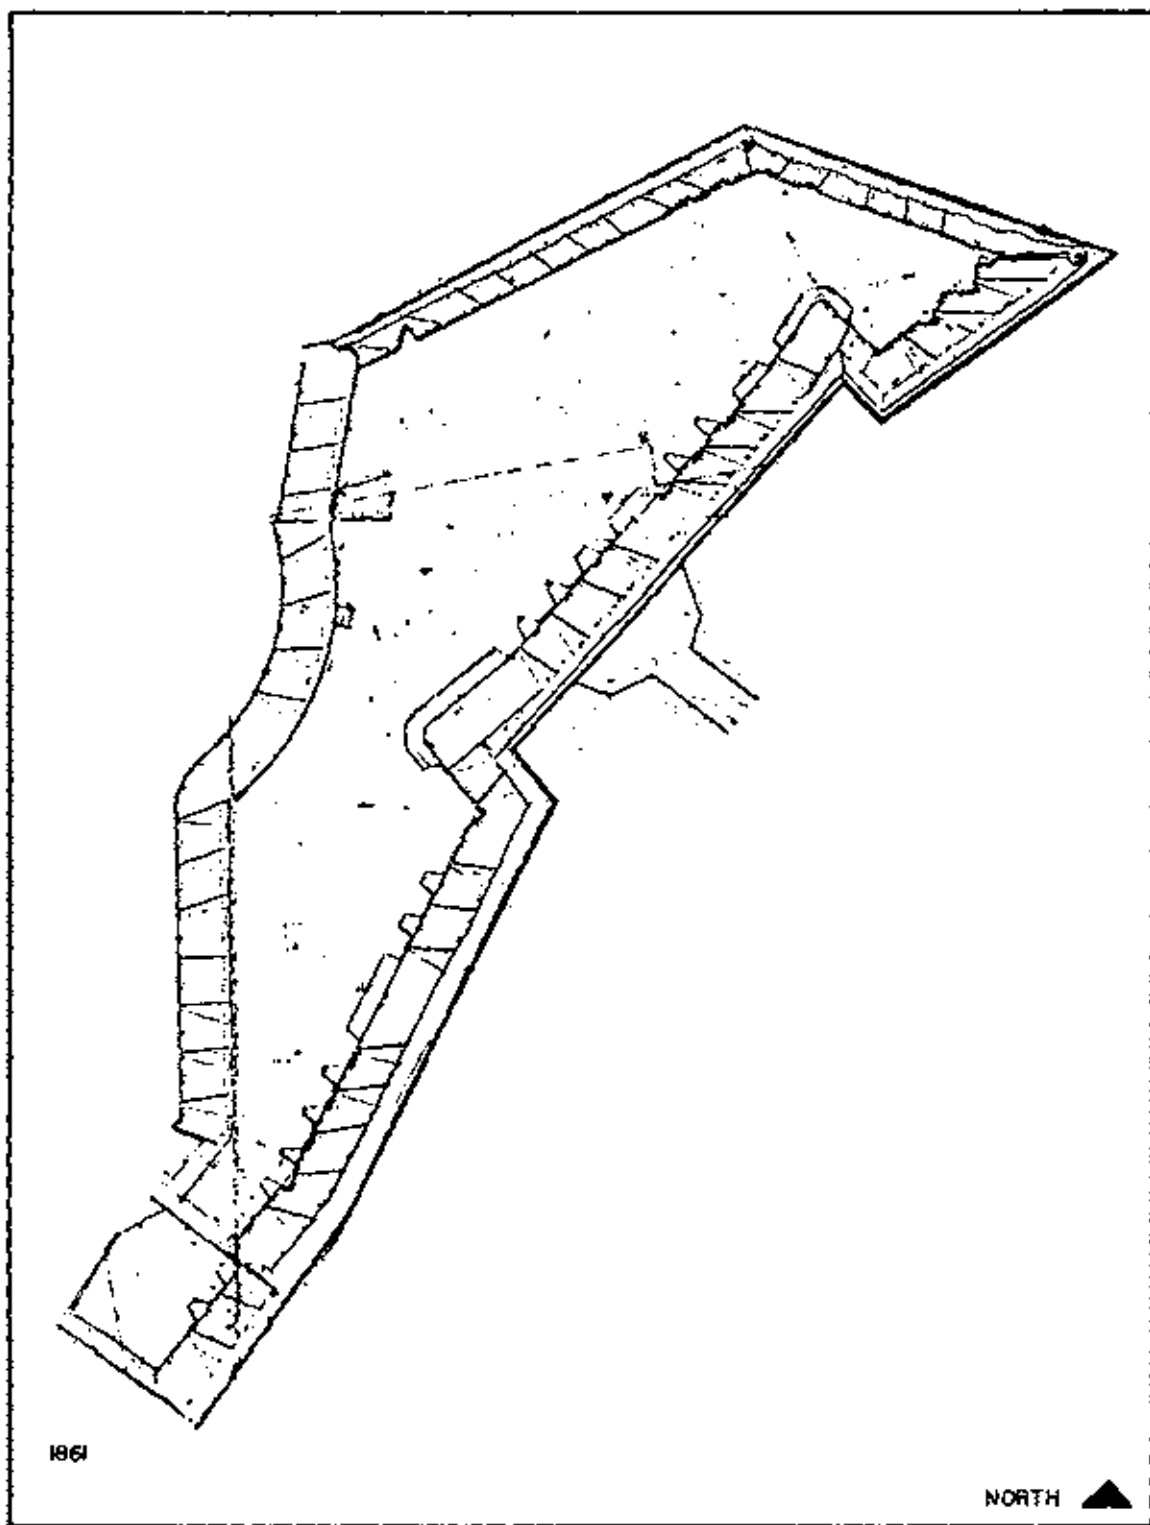
Figure 10.17. Detail of Manuel Castro's 1861 plan showing North Bastion, Curtain, and South Bastion. (San Juan NHS Archives.)

The Castro plans and elevations of 1861 (fig. 10.17) did not show major alterations to either the Curtain, North or South Bastions. Of interest however, was a small structure with a double-pitched roof, shown only on the topographic plan, that appears to coincide with an arched opening now filled (excavated and filled in 1963) in the wall of el Caballero. Located adjacent to the curved (and oldest) section of the wall, the small structure appeared to project a few feet from the plane of the wall onto the terreplein.

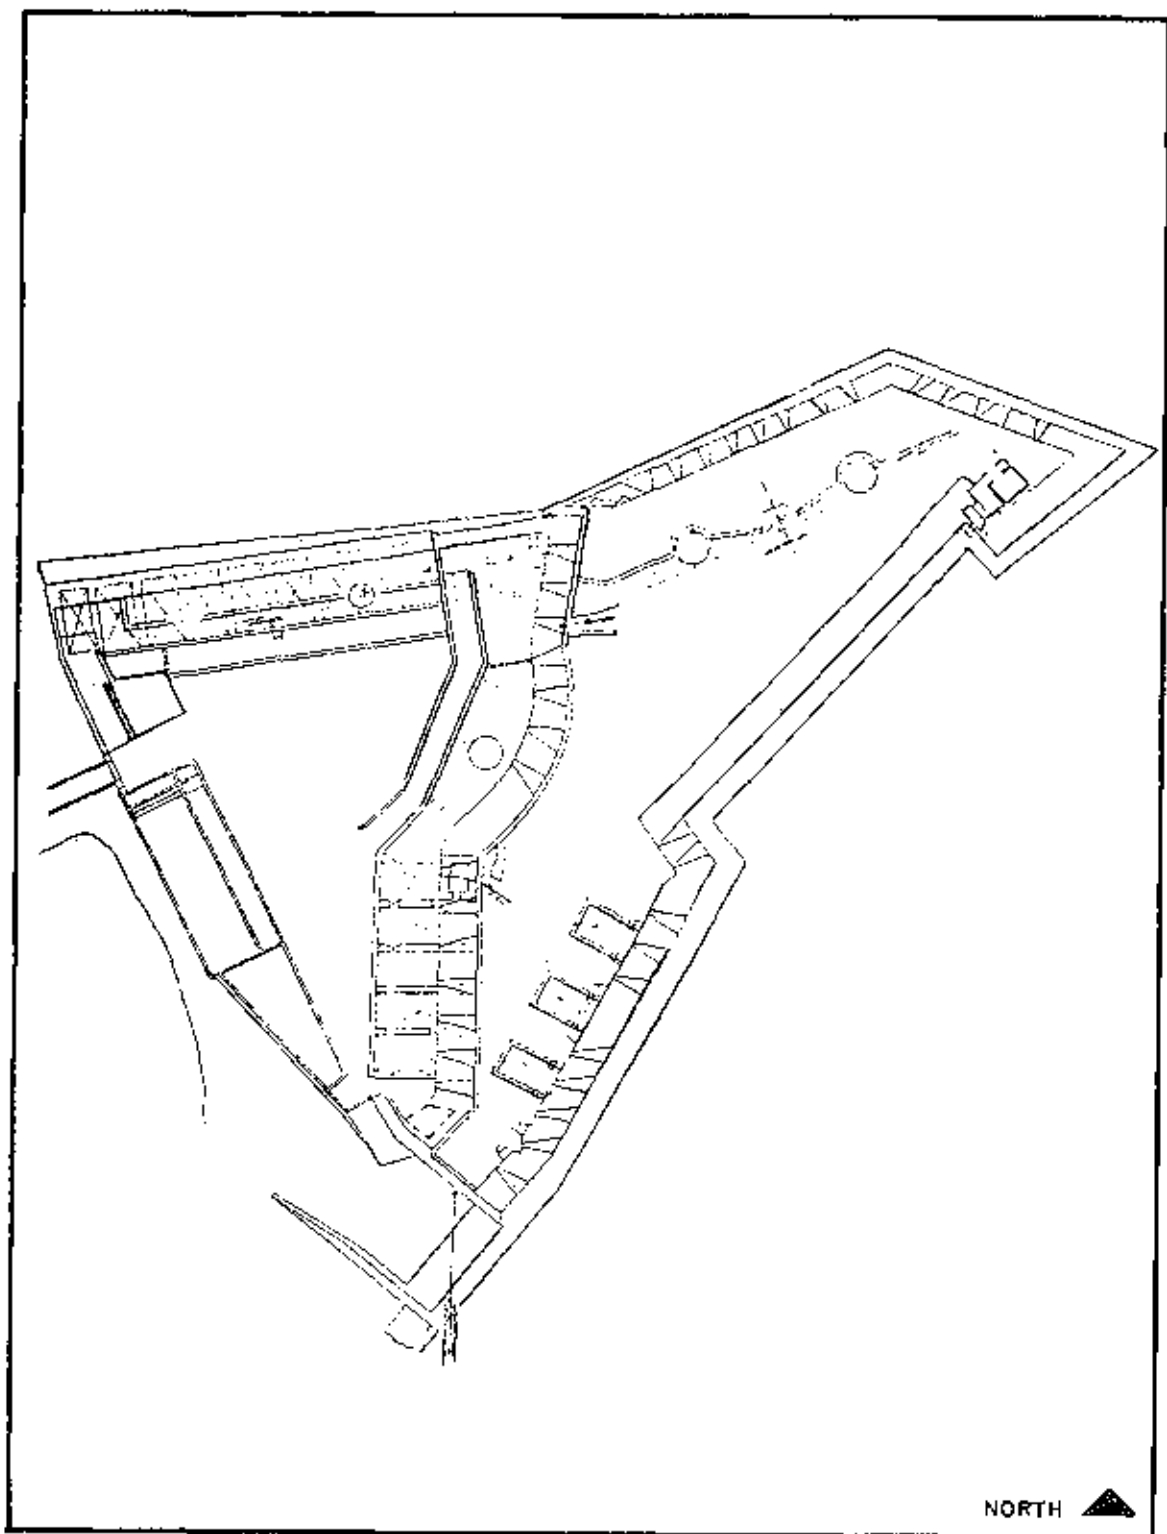
Figure 10.18. Drawings of Colonel Goethals showing modifications for modern guns and location of new magazine, ca. 1898. (San Juan NHS Archives.)

In the late-nineteenth century, physical modifications were made to San Cristóbal as part of the extensive preparations for the impending Spanish-American War. Many of these changes took the form of additions to the interior of the existing fort and were visible on an 1898 Plan of San Cristóbal.²⁰ The plan (fig. 10.18) showed three earthen traverses (running east/west) located along the inner face of the South Bastion. Rectangular traverses provided additional cover for gun crews and were constructed over eighteenth-century firing steps, obscuring them from view.

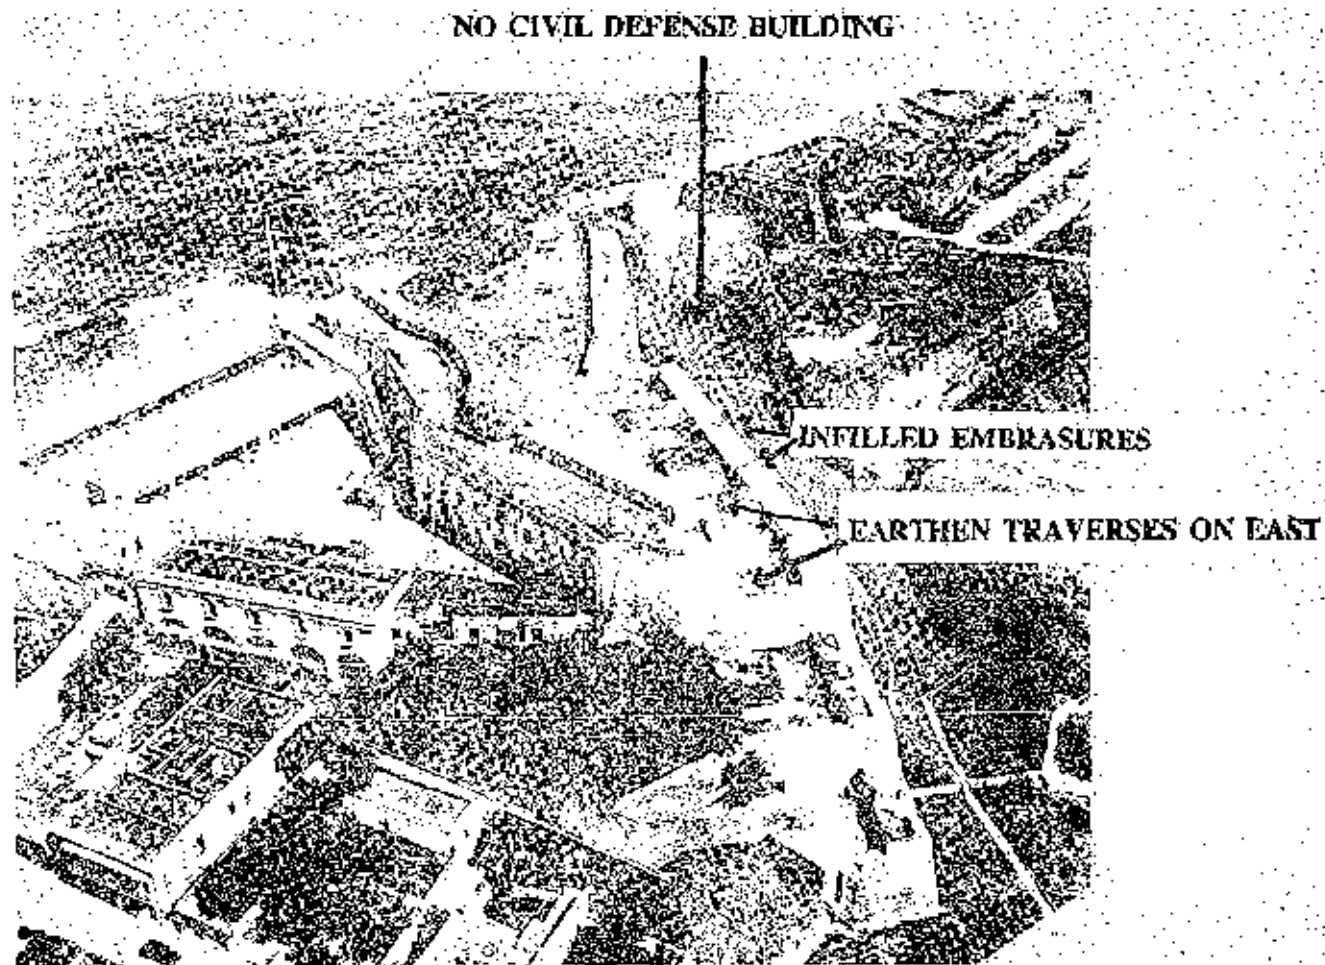
Figure 10.19. Aerial view of San Cristóbal ca. 1938-40. Note infilled embrasures and earthen traverses along the curtain wall. (San Juan NHS Archives.)

traverses on the east (fig. 10.19). Also called for in the specifications and carried out in 1940, were the repairs to the sentry box at the salient angle of the North Bastion. This project called for the pointing, patching and refacing of such portions of the old sentry box as needed and the placing of a new finial to replace one that had been destroyed.²⁷
