THE FORTIFICATIONS OF SAN JUAN NATIONAL HISTORIC SITE

HISTORIC STRUCTURE REPORT

El Fuerte de San Cristóbal

1991

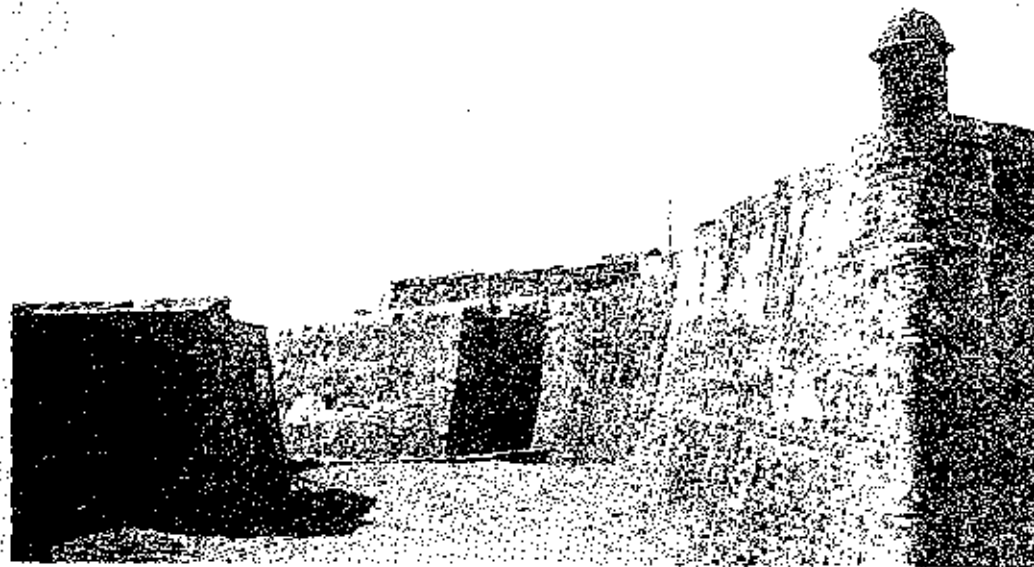
Figure 10.20. View of the main moat prior to construction of the Civil Defense Building, ca. 1938-40. (San Juan NHS Archives.)

Preconstruction photographs (1938-40) show the eighteenth-century covered way and moat to have been extant and predominantly intact (fig. 10.20). These early elements were totally obliterated by the military during construction of the bunker. Its construction dramatically altered the fort's eighteenth-century configuration.

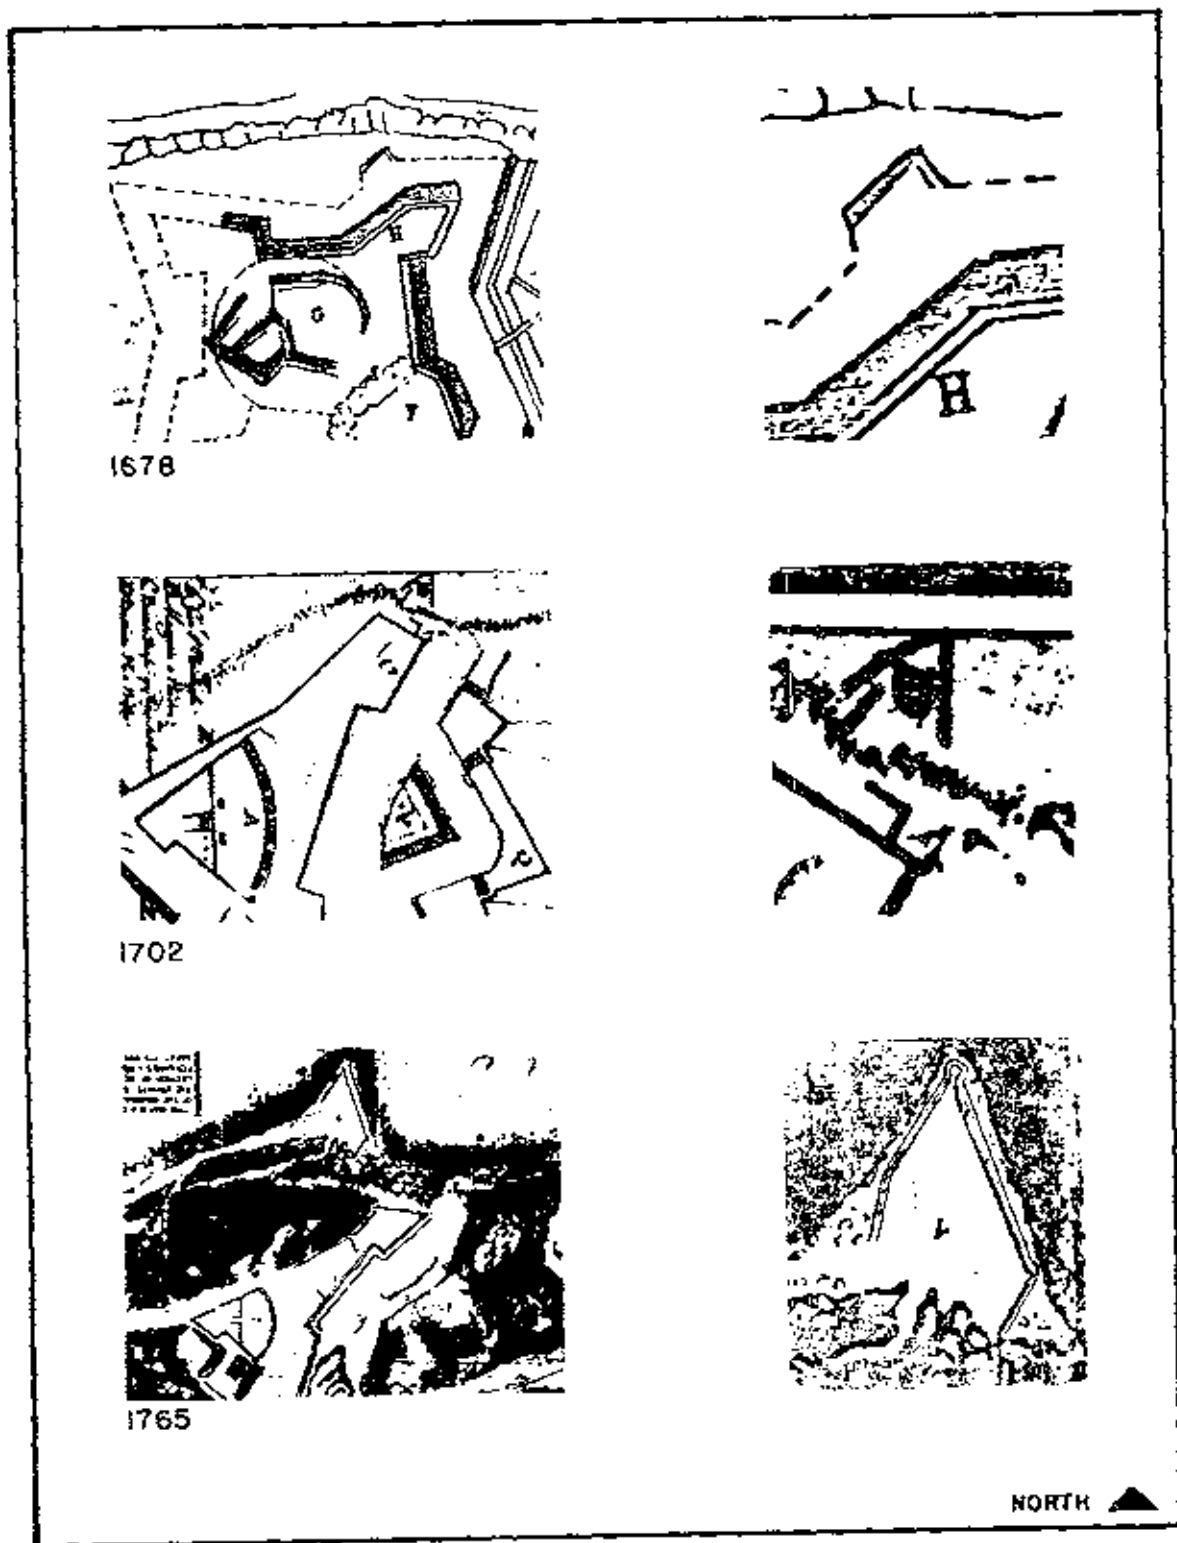
Figure 11.5. Early plans including el Espigón. Compiled by Barbara Yokum, NARO, NPS, 1986.

The outpost located on the north coast of San Cristóbal is one of the fortification's few remaining features dating from the seventeenth century. This outpost may have been constructed as early as ca. 1634-1644, at the same time as the original fort, and certainly before the map of 1678. Its east wall appears to have been extended up the north slope between 1678 and 1702. The only name associated with the outpost in this period is Bastión. A bastion is generally defined to be "a projecting part of a fortification." Early plans from this period are found in figure 11.5.¹

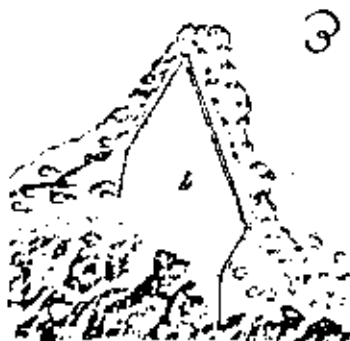
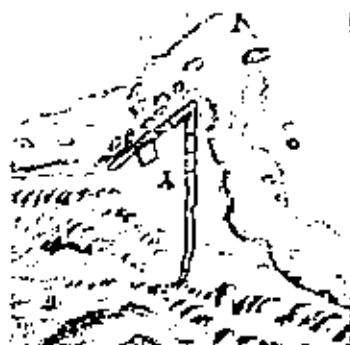
Figure 11.6. Details of eighteenth-century plans including el Espigón. Compiled by Barbara Yokum, NPS, NARO, 1986.

It was during this period that the north outpost acquired the name el Espigón meaning the point or breakwater.⁴ Work done in these years included the constructing a small structure at the inside west wall (ca. 1769-73) and installing of a retaining wall adjacent to the upper east wall (1771). Plans from this period are found in figure 11.6.

The last known eighteenth-century plan that included el Espigón is dated 1783 by Engineer Juan Francisco Mestre.¹¹ It once again showed the rounded sentry post to the north and the unidentified structure adjacent to the inside west wall. It also labeled the outpost "Espigón. (See fig. 11.6.)

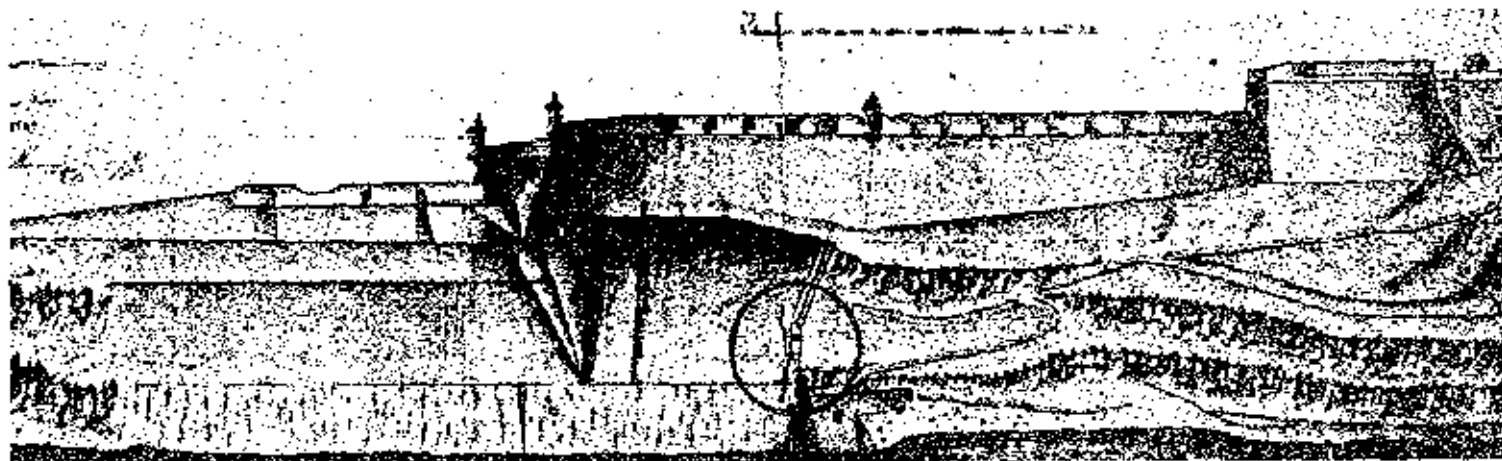
Figure 11.7. 1773 elevation drawings by O'Daly showing el Espigón. Note trails to west of el Espigón in north elevation drawing. (AGI-Santa Domingo, Seville, Spain.)

The earliest known elevations of el Espigón were executed by O'Daly in 1773.⁸ The north, east, and west elevations (fig. 11.7) clearly showed a round sentry box at the north tip with three small window openings and a domed roof topped with a finial. Today, the dome is flatter and lacks a finial. In the plan that accompanies the elevations was the previously mentioned small square structure with hipped-roof attached to the west wall. Since this structure was not shown in the elevations,⁹ it may be that its height fell below the height of the walls.

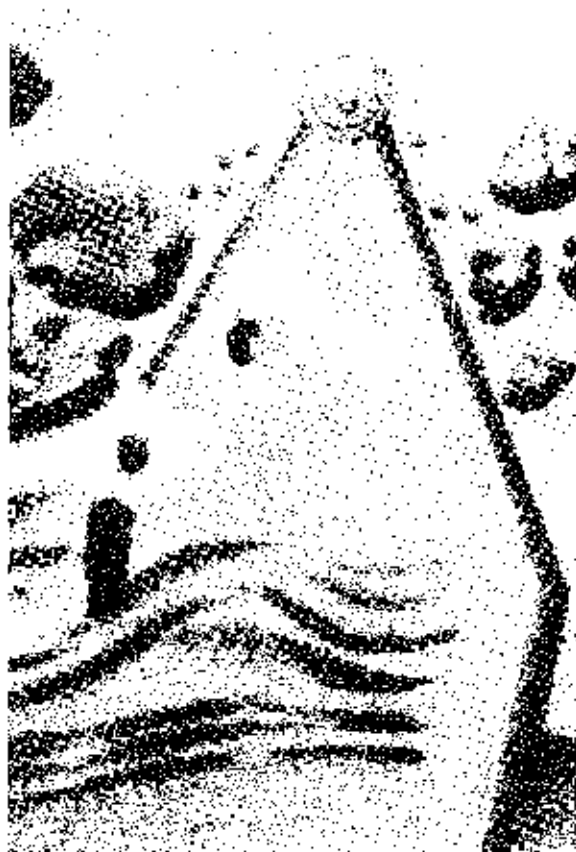
Figure 11.8. Detail of 1861 plan by Manuel Castro showing el Espigón. (San Juan NHS Archives.)

In both the model and Castro's plans,¹² el Espigón was shown with its east and west walls and sentry box. Not shown was the small square structure located inside the west wall (last seen in the 1783 plan). Considerable detailing was provided in the Castro plans, such as individual stones in the east and west walls and the round finial of the sentry's domed roof (fig. 11.8). In addition, the ocean appears to have encroached on the outpost making the northern tip completely surrounded by water.

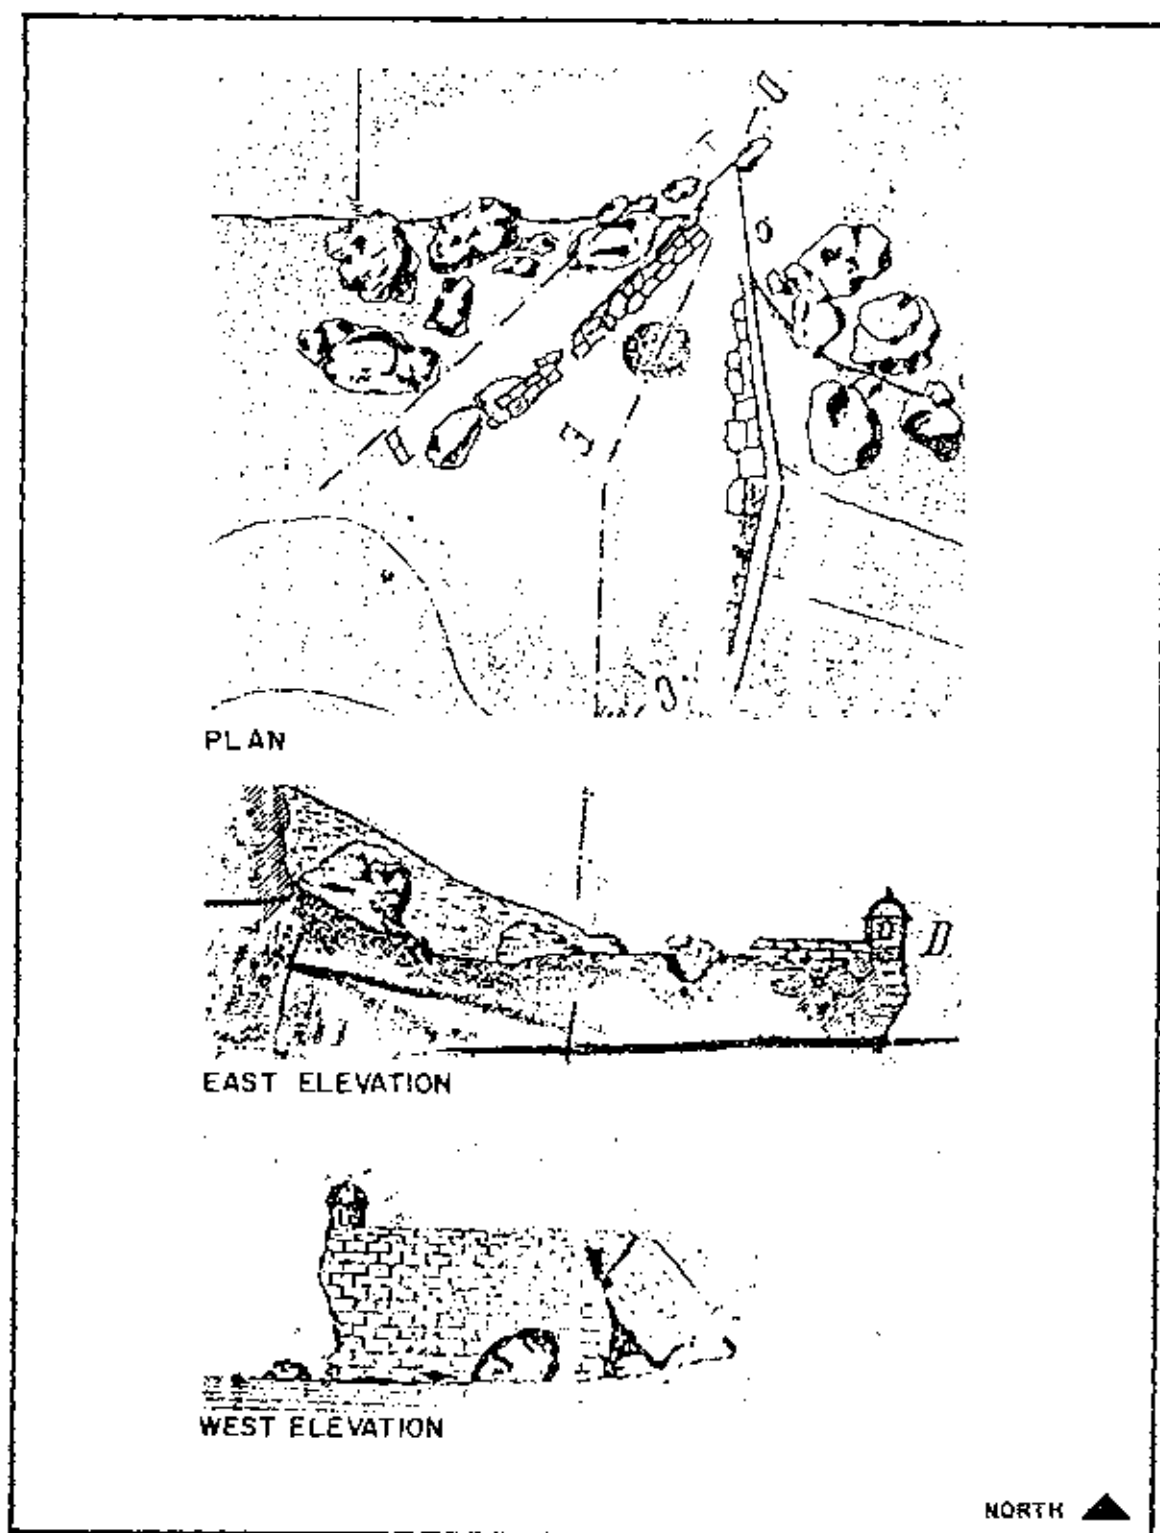
Figure 11.9. Details of drawing dated May 15, 1880, "Proyecto Modificado de Reparación y Conservación del Castillo de San Cristóbal." (San Juan NHS Archives.)

A more likely explanation, however, is provided by the proposal itself (fig. 11.9).

The proposal, dated 1880, is a drawing entitled "Modified Project for the Repairs and Conservation of the Castle of San Cristóbal".¹⁵ Shown on the sheet were three sketches of the north outpost. Figure 1 was a plan described as "emplacement which is projected to be abandoned;" Figure 2 was a section through the center of the sentry box and looking east; Figure 3 was an elevation of the west side. All three drawings recorded obvious signs of deterioration. The north front wall, directly beneath the sentry box, was eroded away, most likely by wave action. The west wall at both the top and south ends was in bad condition. Along the top, the stones have fallen away in several areas. At the south end, almost one-third of the entire wall shifted and was at an angle to the remaining wall, perhaps the result of an earthquake. Lastly, a large

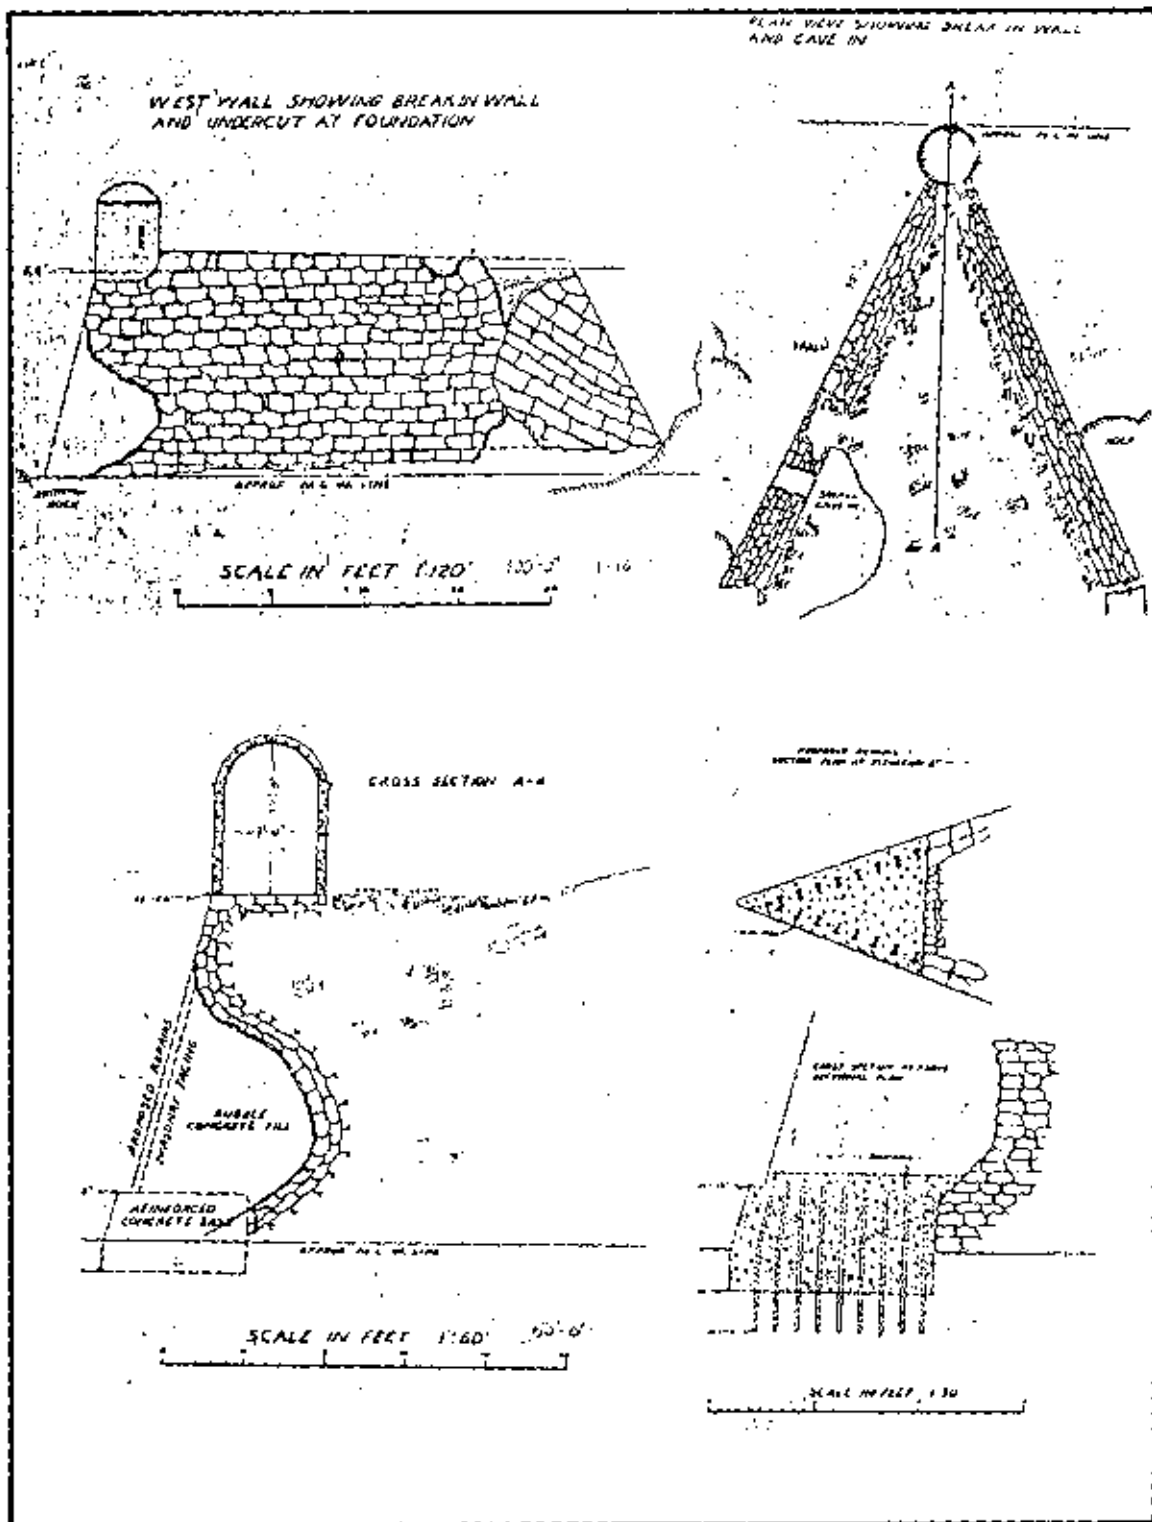
Figure 11.10. Proposed repairs to el Espigón, 1938-39. U. S. Engineer Office, War Department. (San Juan NHS Archives.)

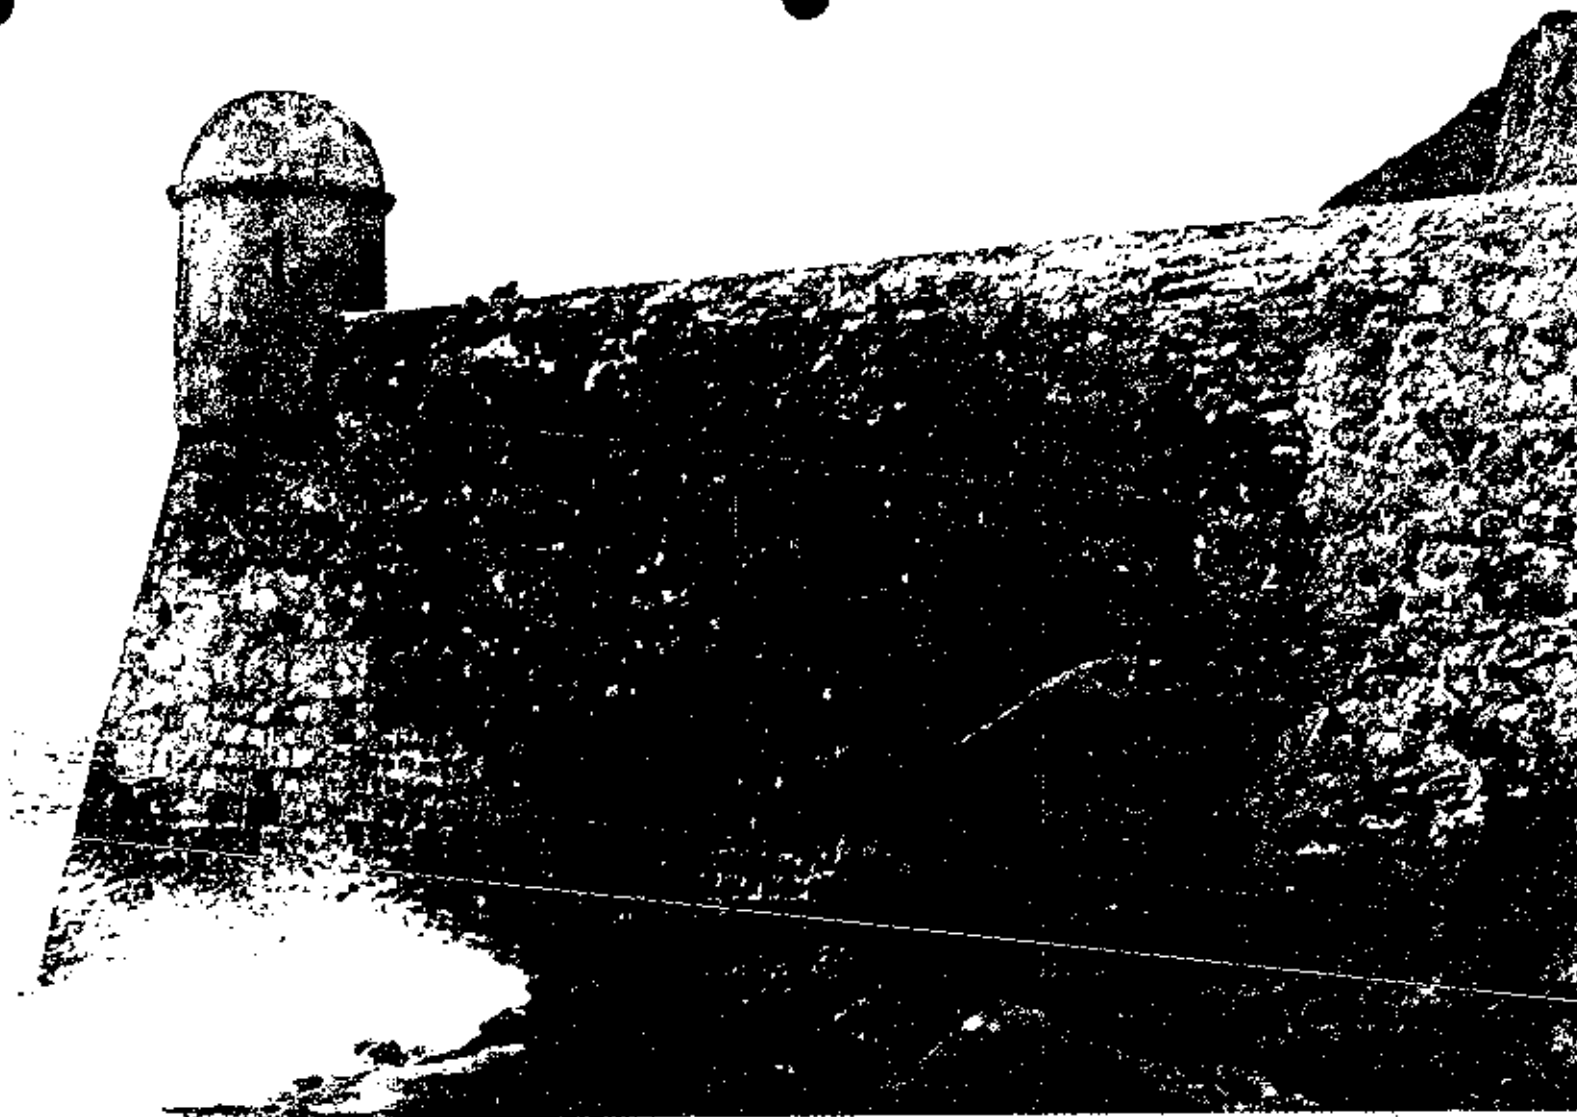
Figure 11.11. View showing the restored west elevation of el Espigón from the completion report dated August 16, 1939. (San Juan NHS Archives.)

Not until the late 1930s was the foundation repaired (W.P.A. funds were used). By this time, according to the completion report, the front "foundation had been undermined very badly so that the upper portion was a cantilever exposed to the full force of the Atlantic Ocean."¹⁹ This is shown both in a photograph taken at the commencement of work in April 1938 and a drawing entitled "Condition of 'Haunted Sentry Box' - Proposed Repairs."²⁰ Shown on the drawing (fig. 11.10) were conditions similar to those in 1880 including the shifted west wall at the south end and a "small cave-in" just inside the west wall. The work was carried out in April, May, and June of 1938. Sand bags were used to hold back the water. At the north tip, below the cantilever, a concrete base was poured and reinforced with short lengths of sharpened rail driven into the rock below. Above this, the large void was filled with rubble concrete fill and faced with natural sandstone rock quarried from the immediate vicinity. The sentry box itself was said to have "required only a minimum of pointing up."²¹ A photograph (fig. 11.11) included in the completion report and dated June 24, 1938, shows the entire west wall and north front wall repaired. The south end of the west wall appears to have been completely refaced with stone.

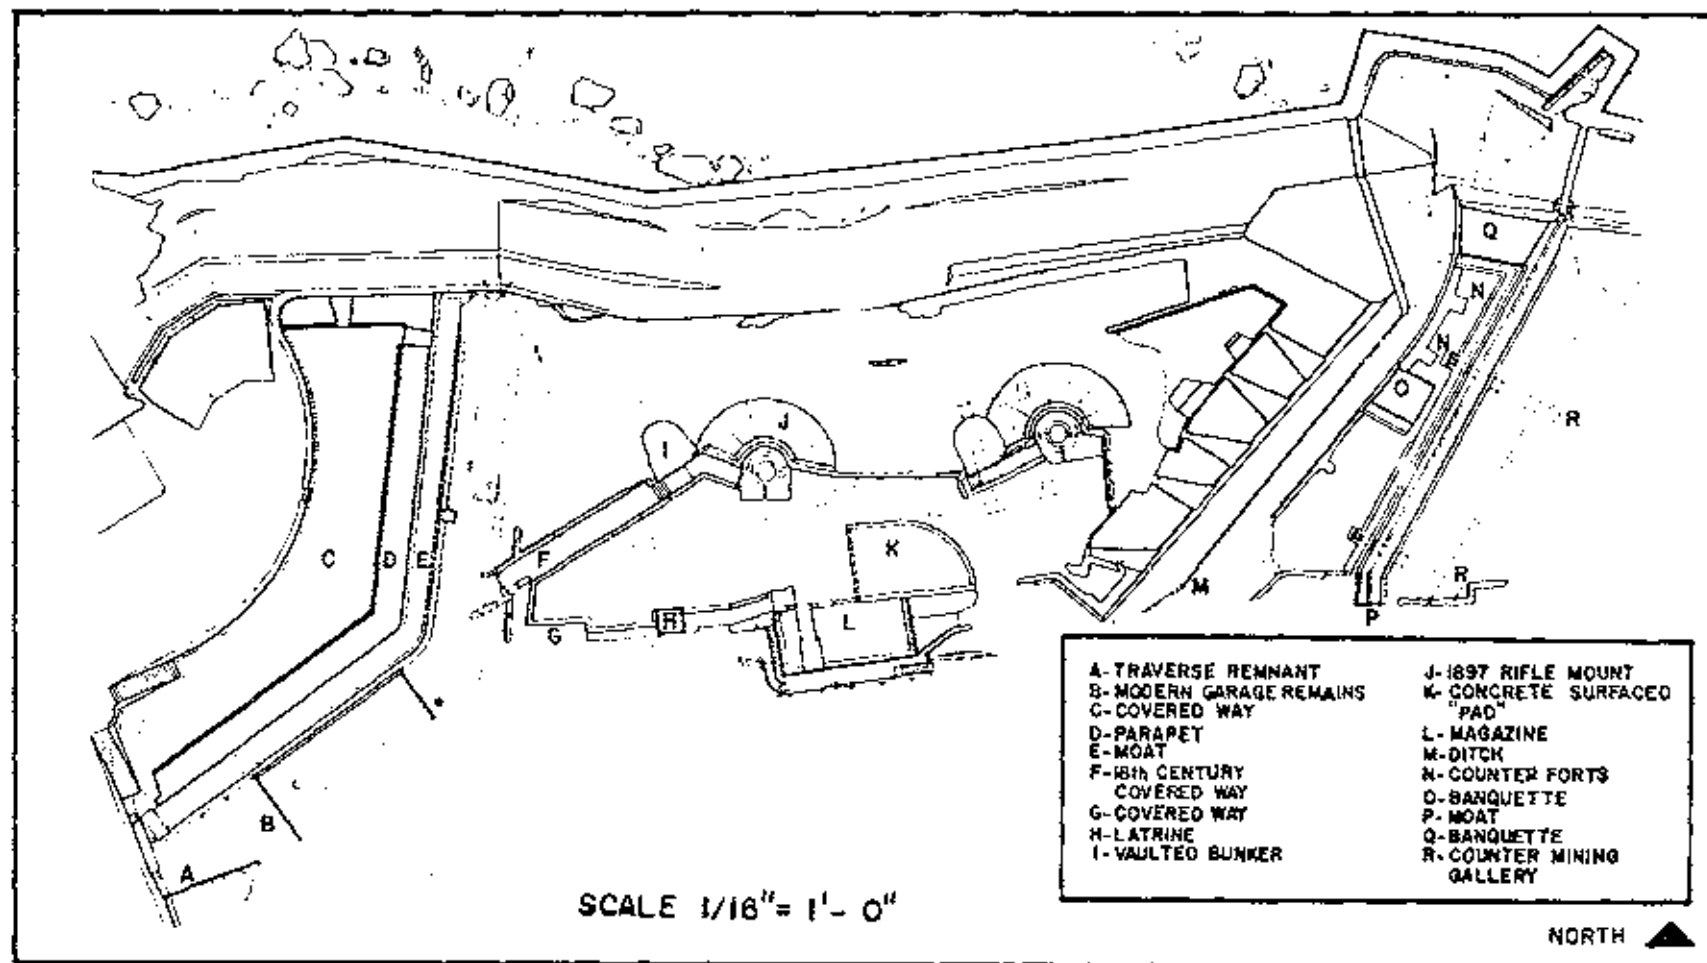
Figure 12.1. Overall plan of Santa Teresa Battery with individual features labeled. HABS drawing (1986) annotated by Jana Gross (1989).

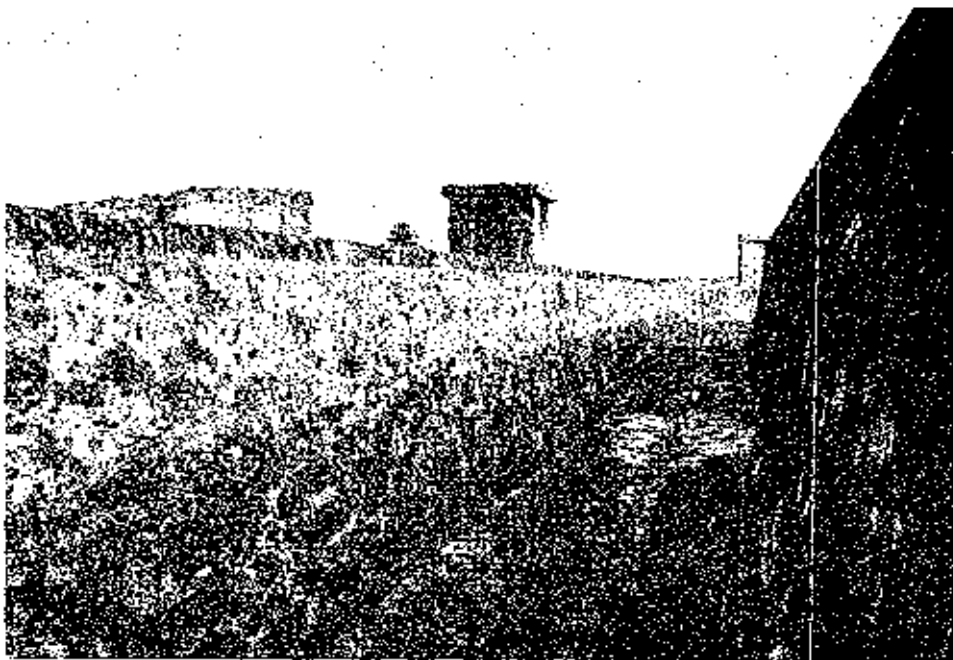
Figure 12.5. Shallow moat running beside the curved covered way. Photo by CPR, 1986.

To the east and the southeast is a parapet overlooking a moat that is banded on the right by a one-foot ditch (fig. 12.5). The parapet is of rubble construction with a brick rowlock course at the upper interior edge and cut sandstone blocks at the corners. The cut stone used at the corners of the parapet is chinked with brick. Specially molded bricks are used for coping to accommodate the slope of the merlon. The south portion of the exterior parapet wall has parging of cement up to the level of the moat wall to the east, with galletting above. The northern stretch of the parapet has galletting with sporadic areas of portland cement patching.

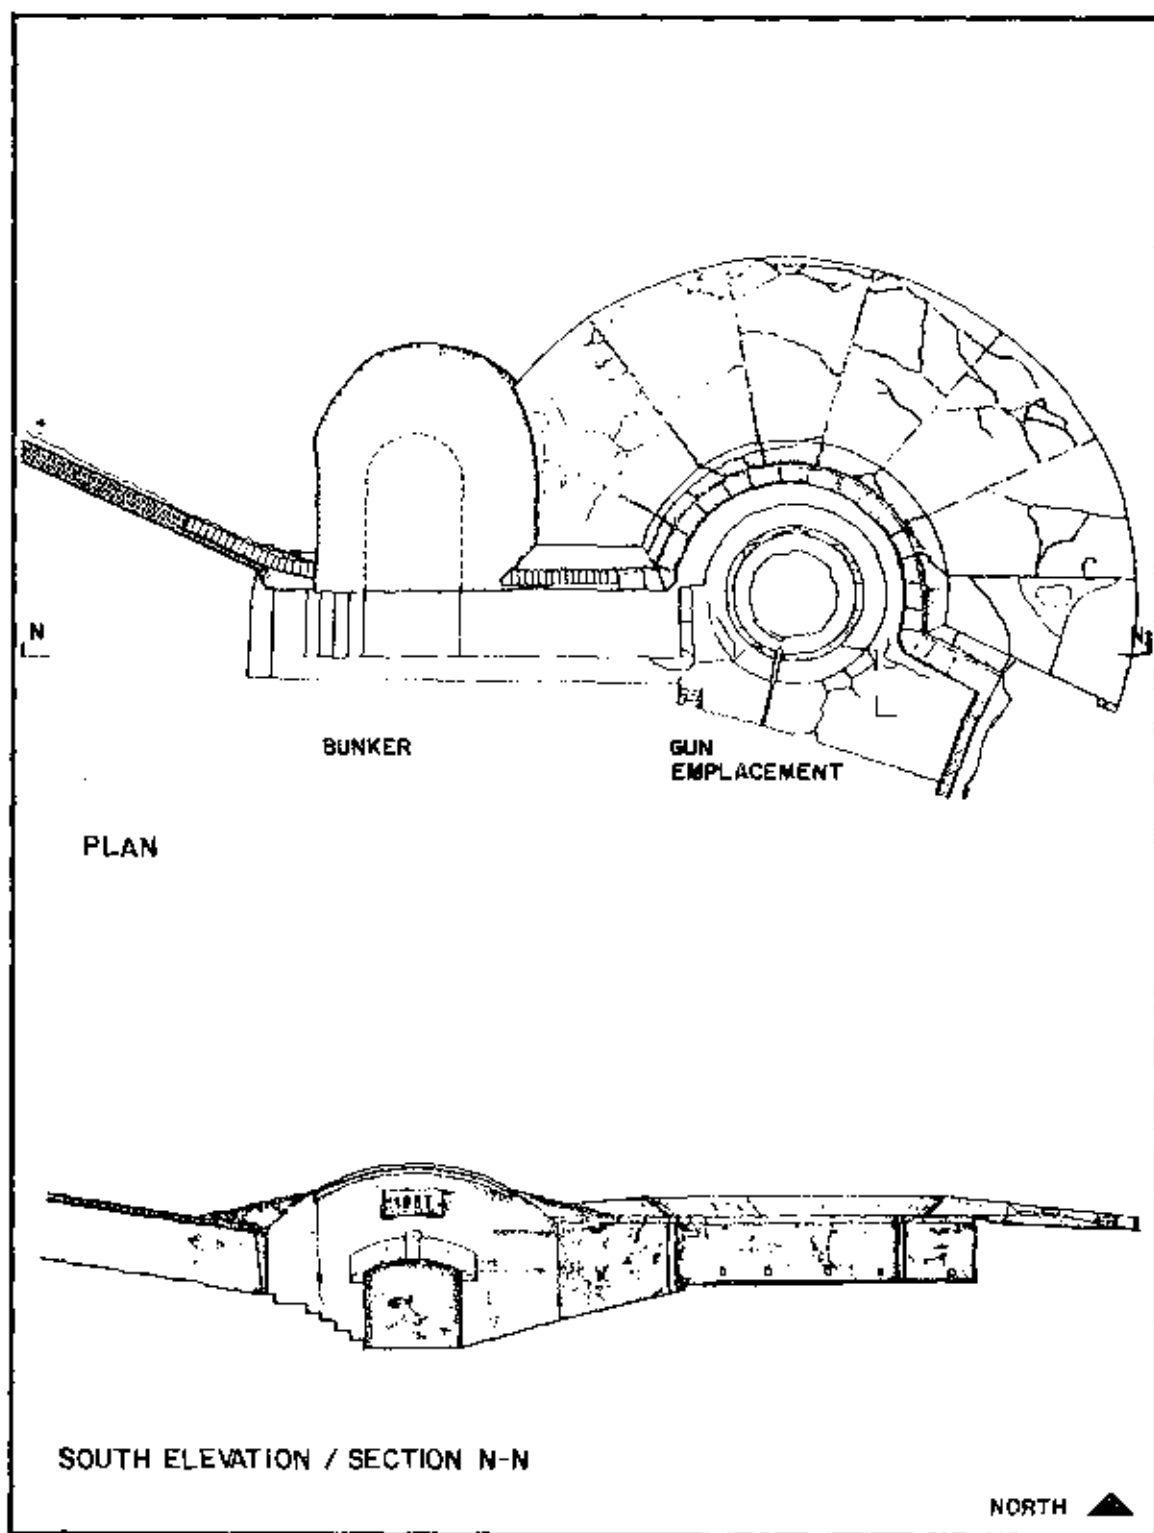
Figure 12.7. Plan and south elevation of 1897 gun emplacement and bunker. Detail of 1986 HABS drawing.

Just west of each gun mount is a vaulted recess constructed of formed concrete that was used for ammunition storage (I). (See fig. 12.7, 12.8, 12.9.) The south facade of these vaulted bunkers has

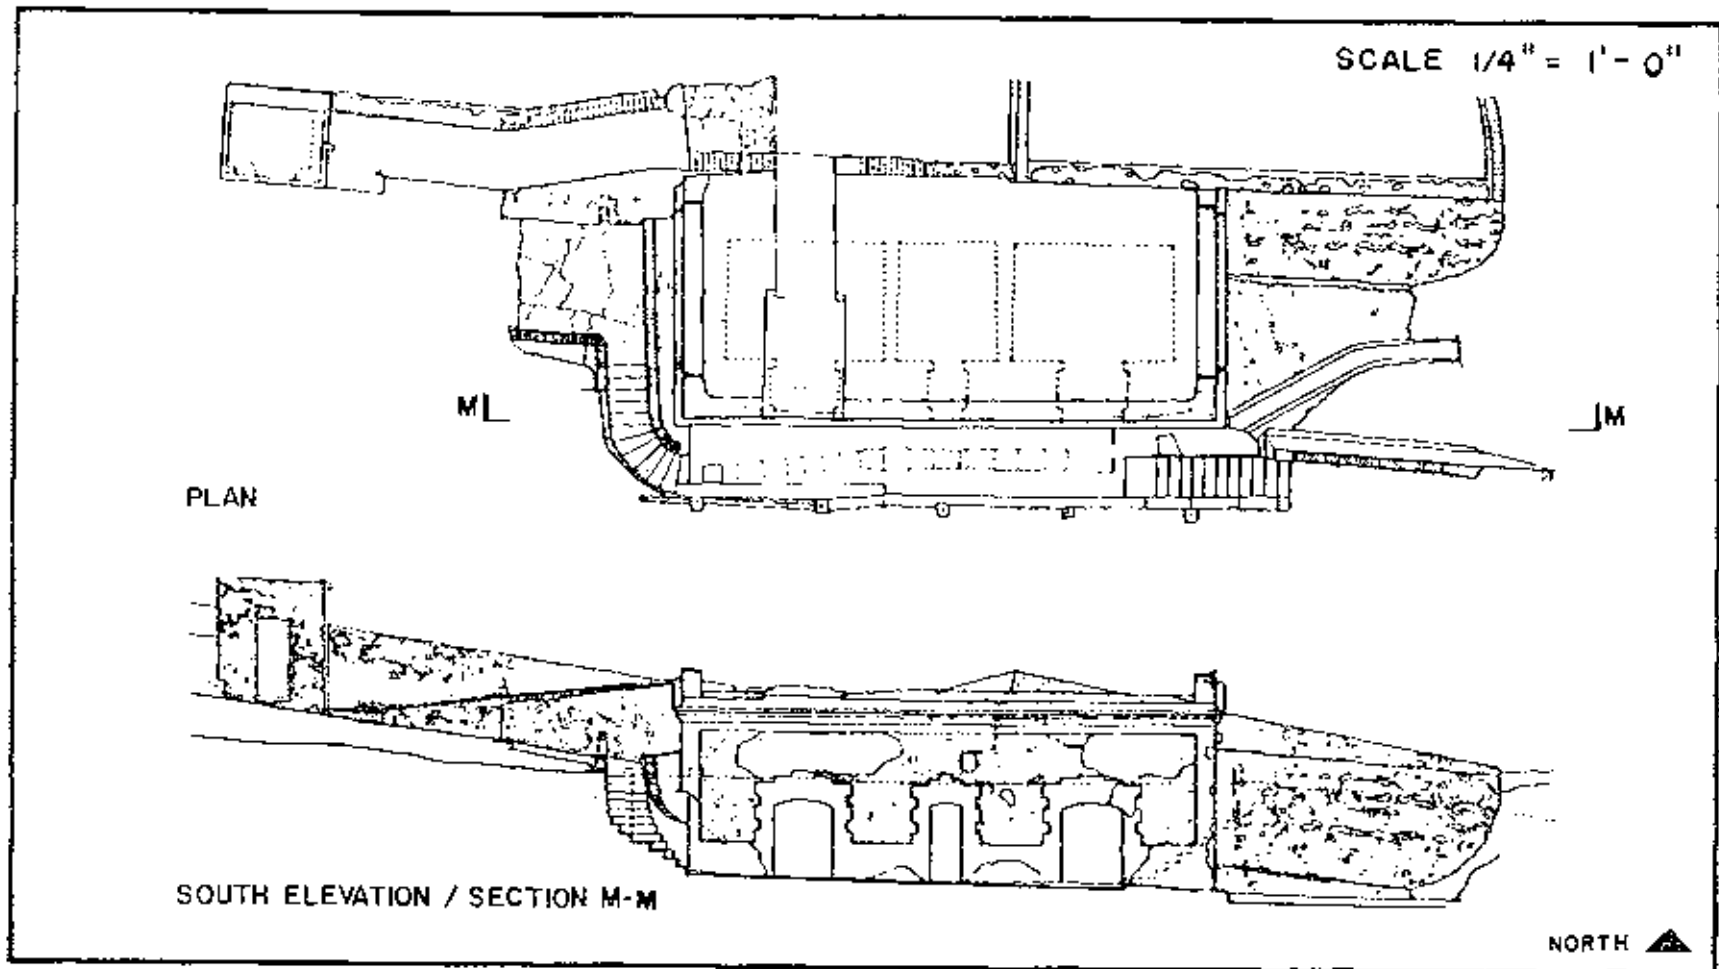
Figure 12.10. Plan and south elevation of 1897 magazine. Detail of drawing by HABS, 1986.

wall to the east, function as retaining walls. At grade level there are five concrete piers. The floor is surfaced with concrete with a series of drain covers. The wall of the magazine is constructed of rubble and has a simple molded cornice. The main facade faces south with three doors. The brick vault and door enframements with rubble walls are now surfaced with concrete (fig. 12.10).

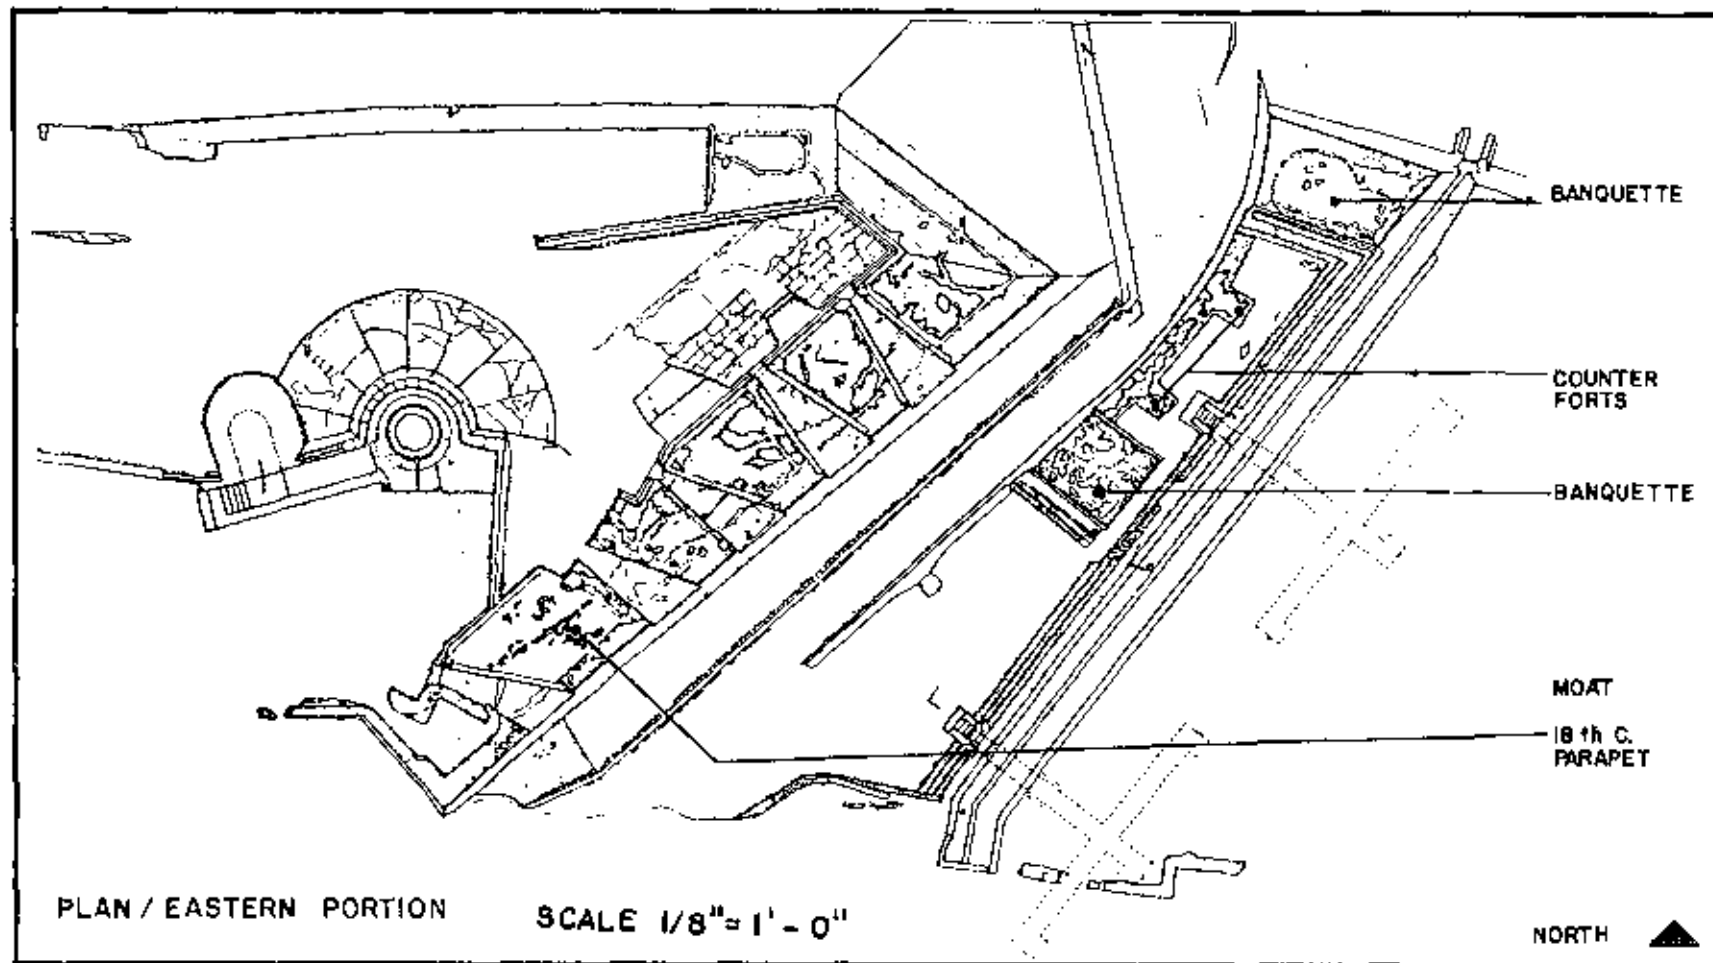
Figure 12.11. Plan of the eastern portion of Santa Teresa Battery showing the eastern embrasured parapet wall, moat and countermining tunnels. Drawing by HABS, 1986.

The eastern most portion (figs. 12.11, 12.12) of Santa Teresa consists of an eighteenth-century parapet that originally had five embrasure openings. The seawall to the north joins with the parapet that turns (from the seawall) and faces east. Four embrasures and two northern banquettes remain intact. The south portion of this parapet is only partially extant; the merlon is gone and the base of the parapet and embrasure cheek walls remain, exposing the rubble construction of the eighteenth-century walls. The embrasure openings are edged with chamfered stone blocks, and the parapet and cheek wall upper edges are brick. The embrasures, although altered and partially destroyed, exemplify typical eighteenth-century embrasure/parapet construction techniques.

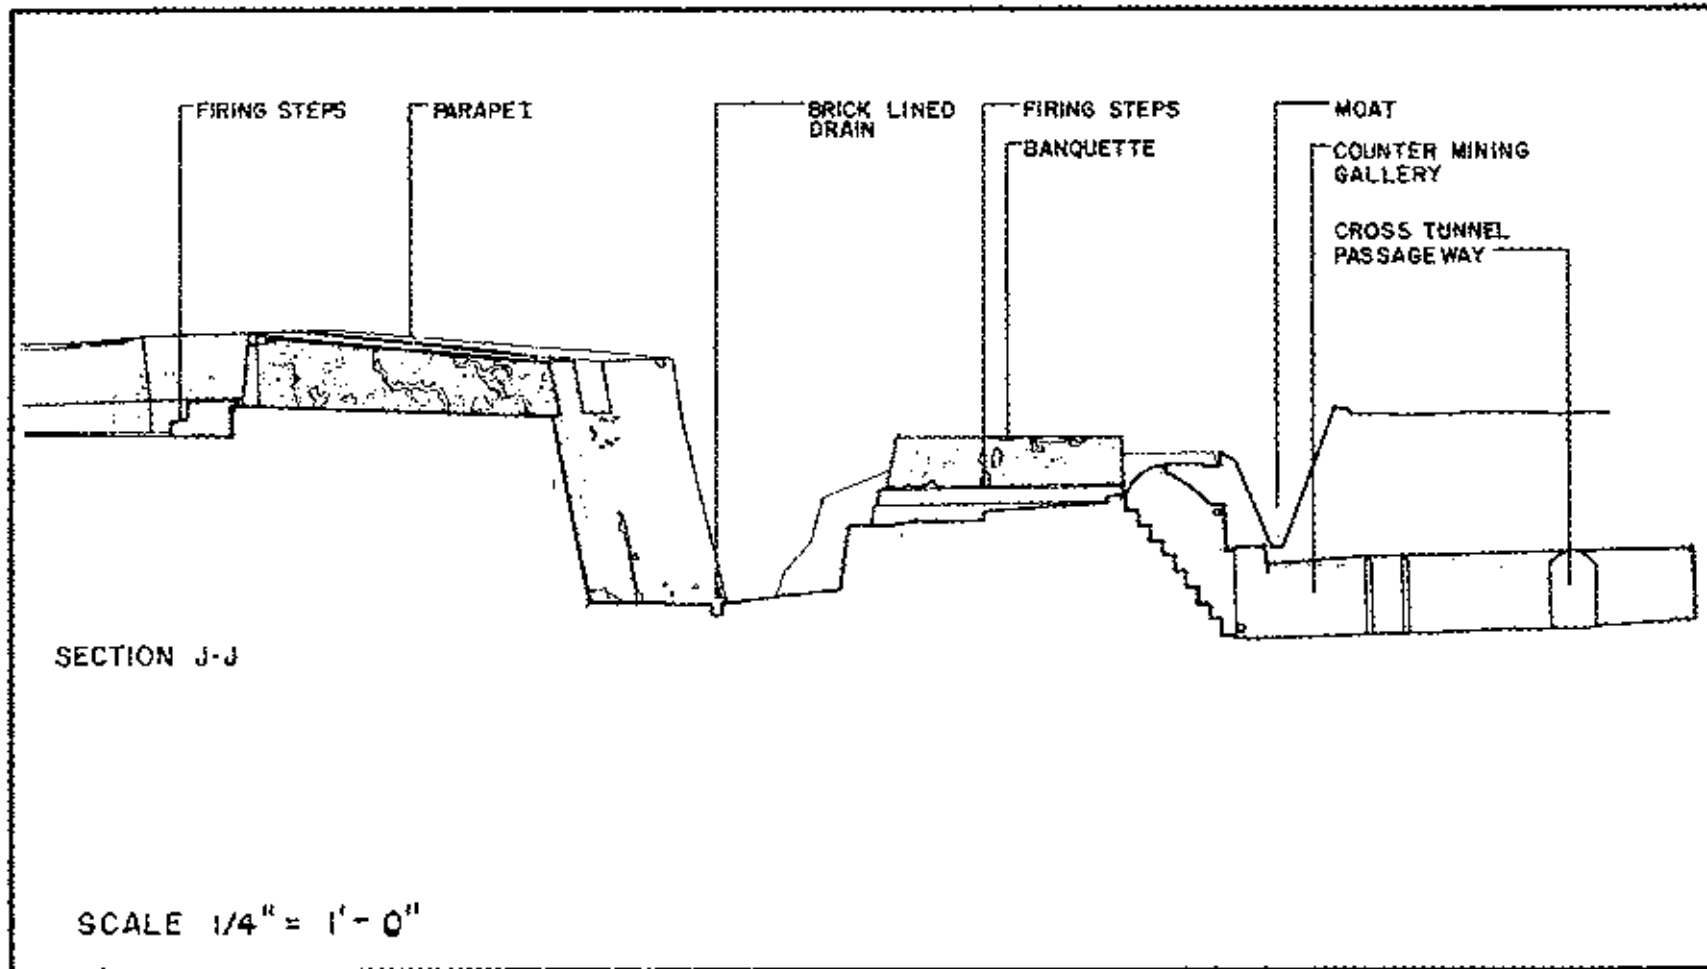
Figure 12.12. Section J-J from the eastern portion plan (fig. 12.11) showing defensive fortifications. Detail of drawing by HABS, 1986.

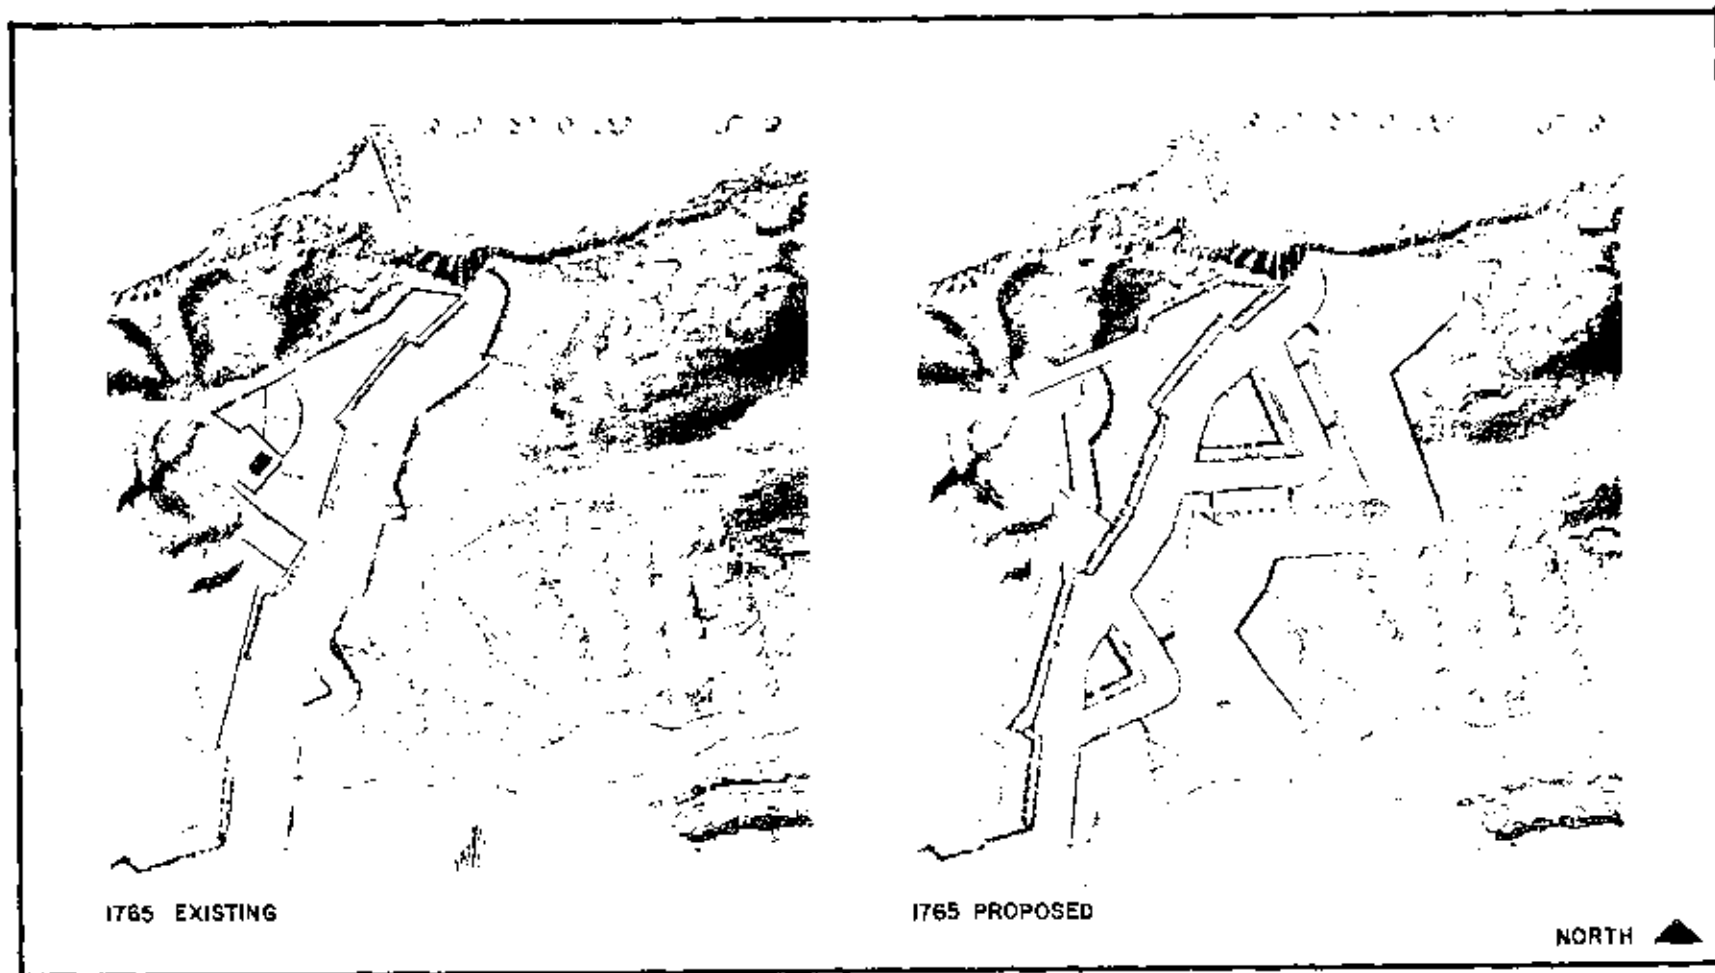
Figure 12.17. Left: May 17, 1765 existing conditions plan by O'Daly. Right: 1765 proposed modernization plan by O'Daly.

The structures identified as Santa Teresa date primarily to this period (excepting the construction associated with the 1897 gun mounts and magazine). The earliest reference appears in engineer Thomas O'Daly's 1765 existing conditions plan for San Cristóbal. This plan showed the curved wall of the North Bastion counterscarp with a sloping earth embankment to the east. In the 1765 O'Daly proposed work plan, this area evolved into a covered way that followed the line of the two ravelins fronting San Cristóbal. (See fig. 12.17.)
