THE FORTIFICATIONS OF SAN JUAN NATIONAL HISTORIC SITE

HISTORIC STRUCTURE REPORT

El Fuerte de San Cristóbal

1991

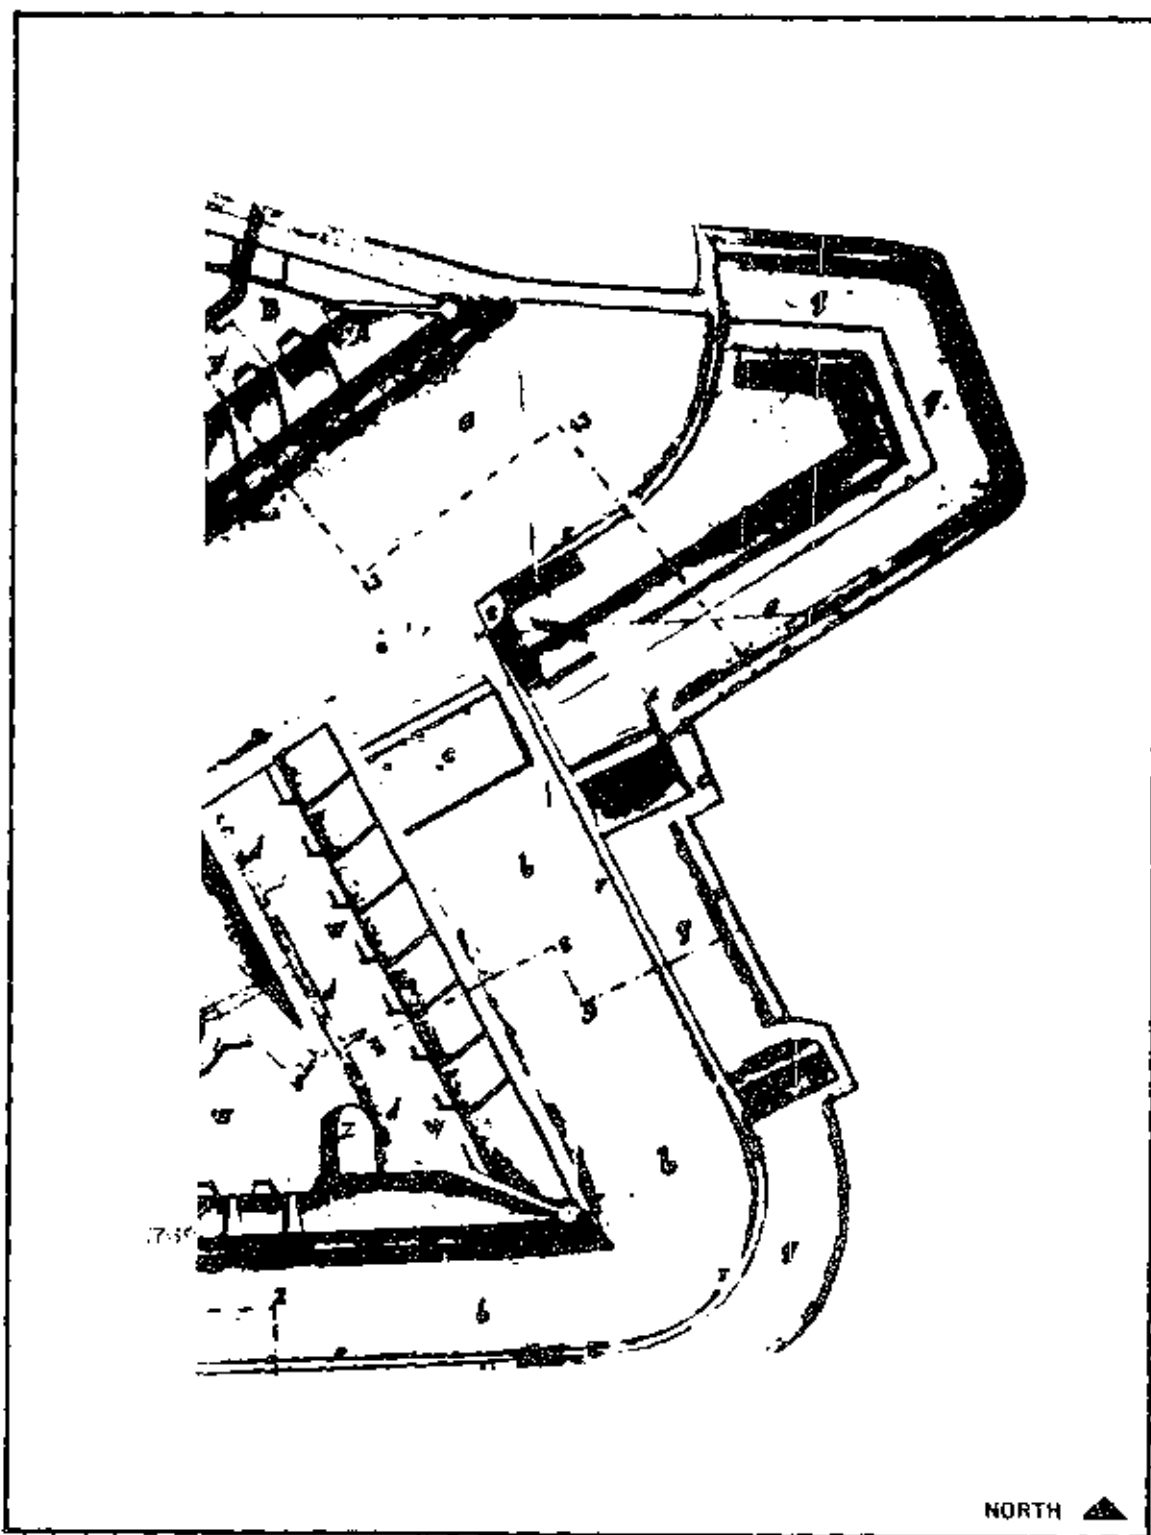
Figure 12.18. Detail of 1769 proposed construction plan by O'Daly showing ("q") covered way, and ("e") countermine tunnel.

Early in 1769, O'Daly produced a construction plan depicting works from 1766-69 (fig. 12.18). The plan showed a hook-shaped redoubt atop the North Bastion counterscarp wall. A profile for the plan showed posts on the west face of the eastern parapet wall forming a palisade. The tunnel leading from the corner stairs was shown, but the tunnel with entry in the curved counterscarp wall was not shown. The western part of the glacis was shown to slope east at the eastern wall of the redoubt.

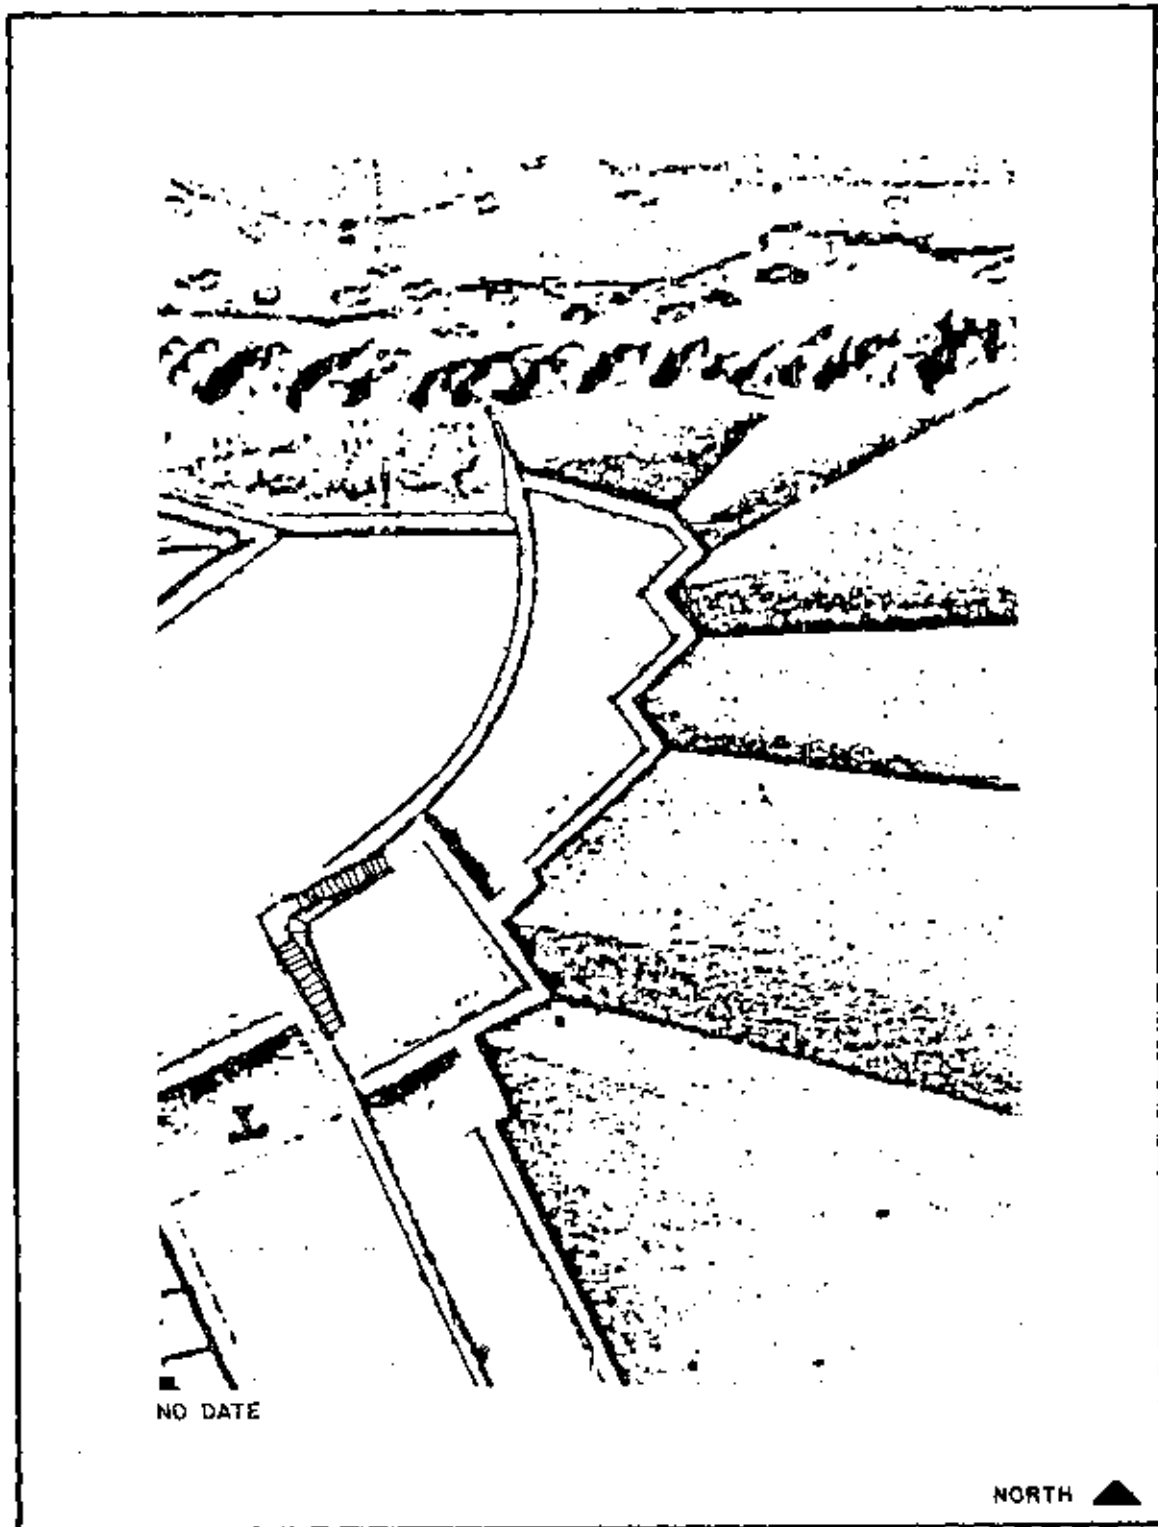
Figure 12.19. Detail of undated plan by O'Daly, ca. 1769, showing curved covered way and its eastern glaciis.

Apparently the redoubt underwent several design changes before the structure in its present configuration was built. The redoubt's function was altered in an undated plan of O'Daly's (fig. 12.19) that depicted a small ravelin-like structure in the covered way. O'Daly's August 31, 1772 existing plan (fig. 12.20) showed a parapet with deflective angle facing east overlooking a covered way with a second parapet wall in the same configuration. This plan used the Spanish drafting convention of depicting new construction in red, and work yet to be executed in yellow. Depicted in red at this point were the curved wall, stairs, north parapet, west parapet overlooking small moat, outer retaining wall of moat, and outer parapet wall.

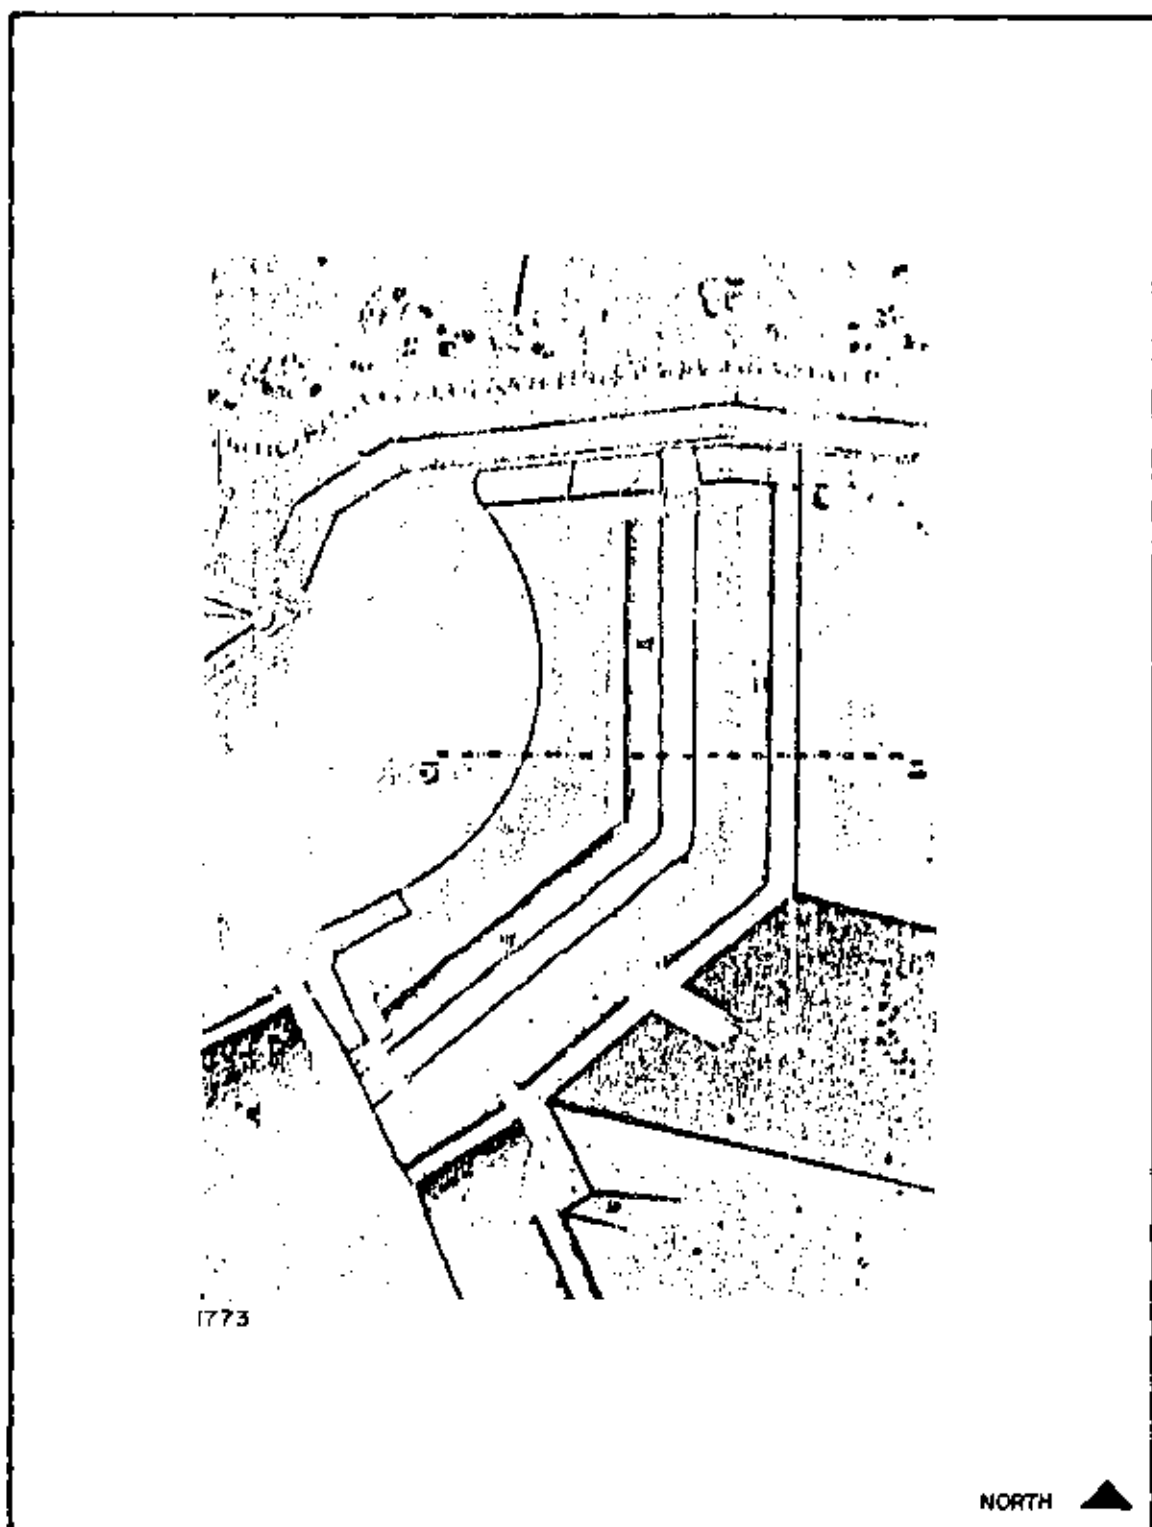
Figure 12.20. Detail of August 31, 1772 existing conditions plan by O'Daly showing curved covered way of Santa Teresa.

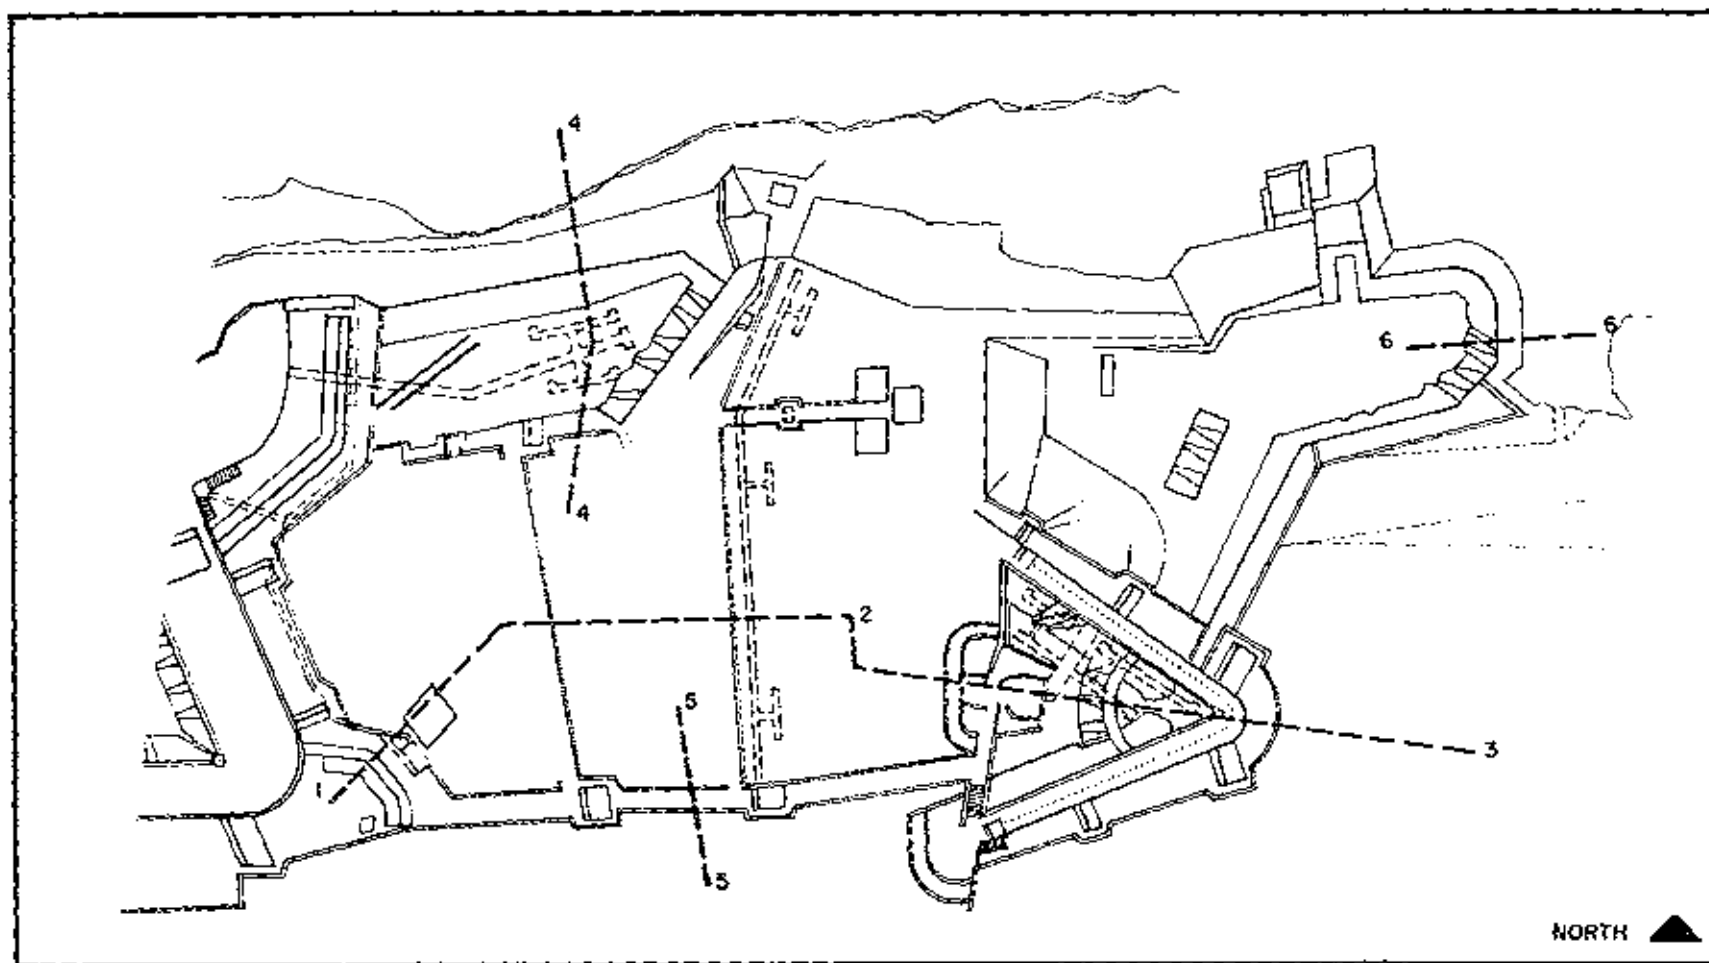
Figure 12.22. Modern tracing of Mestre's September 13, 1783 plan of the San Cristóbal outworks adapted from Torres-Reyes Construction History of San Cristóbal (1965).

Juan Mestre began extensive plans and sections of the San Cristóbal fortifications in September of 1783. It is in this 1783 plan that a fort (Santa Teresa) appeared to the east of the covered way with access to the fort by means of a diagonal covered way (fig. 12.22). The seawall ran from the counterscarp and continued into a parapet with embrasures for five cannons facing east. This overlooked a small ditch, two northward banquettes, and a continuation of the first line of defense moat with a parallel mining gallery. At this point there was a single entrance to the north that led into an easterly shallow-branched gallery. Linking the counterscarp and covered way with the first and second lines of defense was a covered way with tambours (see glossary). This constituted a fully developed land defense in conjunction with la Princesa, el Abanico, and the first and second lines of defense. Also, the second tunnel from the North Bastion's curved counterscarp appeared for the first time.

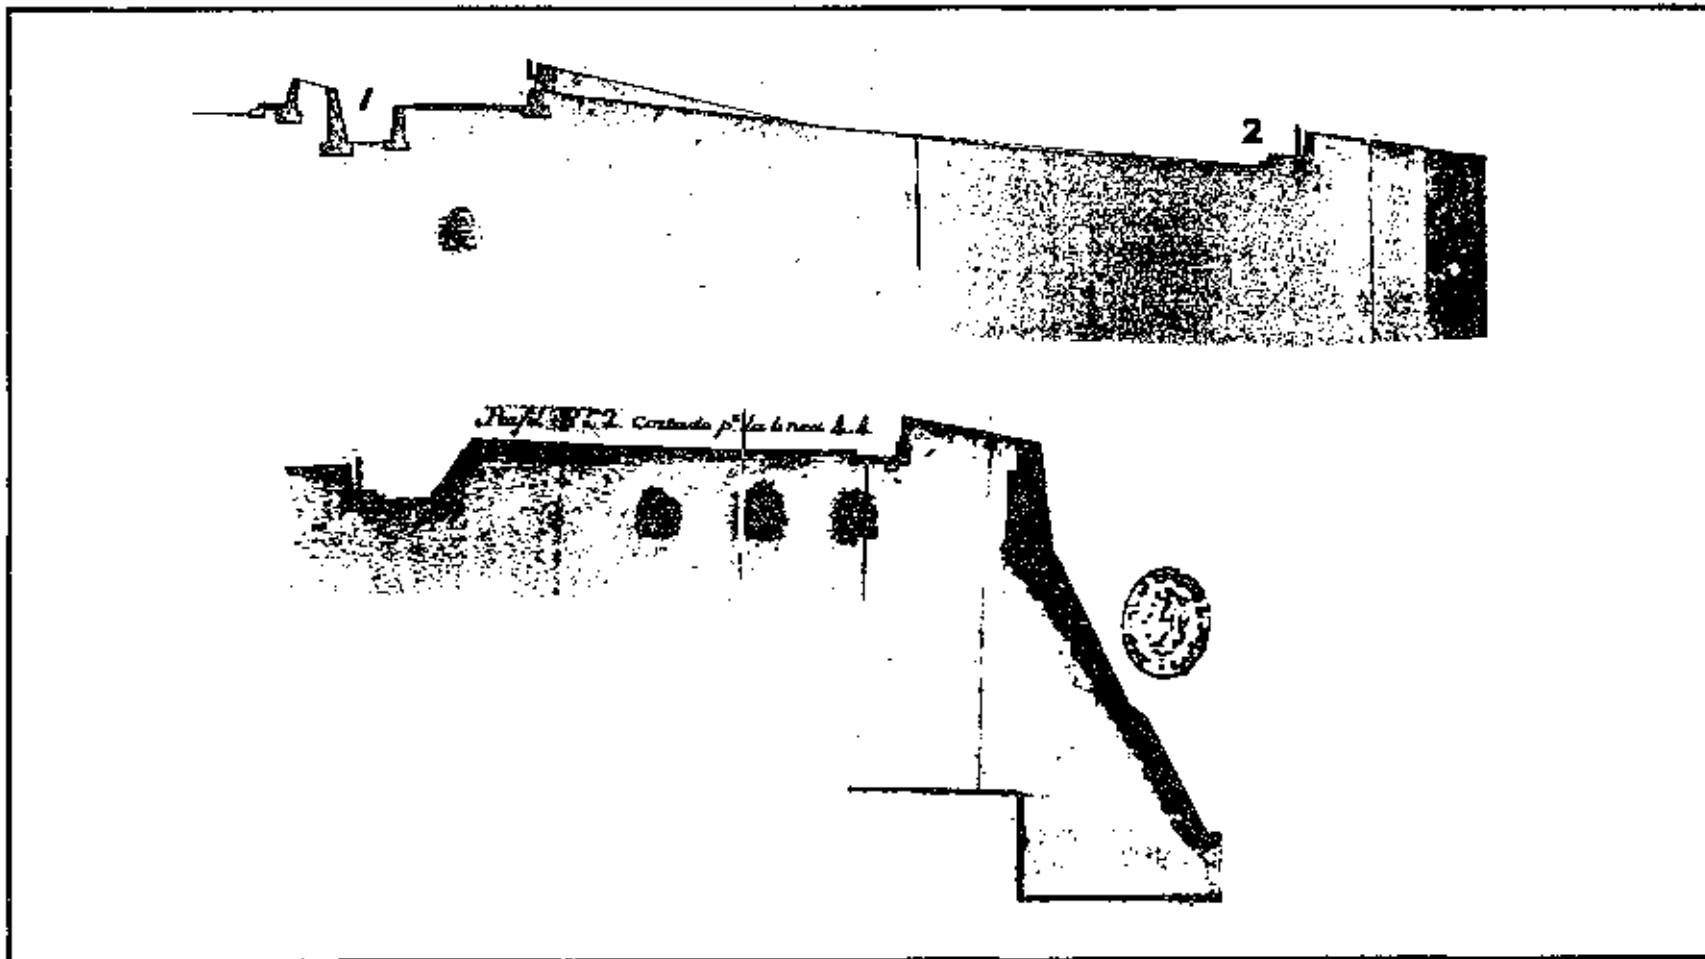
Figure 12.23. Top: Detail of Profile No. 1 by Mestre, 1783, showing the moat and palisade of the first retreat line.

Bottom: Profile No. 2 by Mestre, 1783, looking west at cut line 4.4 on fig. 12.22.

The sections of Mestre's September 1783 plan pertinent to Santa Teresa are Profiles Nos. 1 and 2. (See fig. 12.23.) Profile No. 1 represented a cut through the first defense line that appeared to be similar to the eastern moat and steps. Here wooden posts (perhaps palisades) were set along the western retaining wall of the moat at a height extending slightly above the height of the eastern retaining wall. A channel to receive wooden posts existed between the brick steps overlooking the eastern moat that is now overgrown with vegetation. Profile No. 1 also recorded the existence of a palisade along the first line of defense. In Profile No. 2 the construction of the covered way with the tambours included wooden posts (fagina) lining the interior of the southern retaining walls.

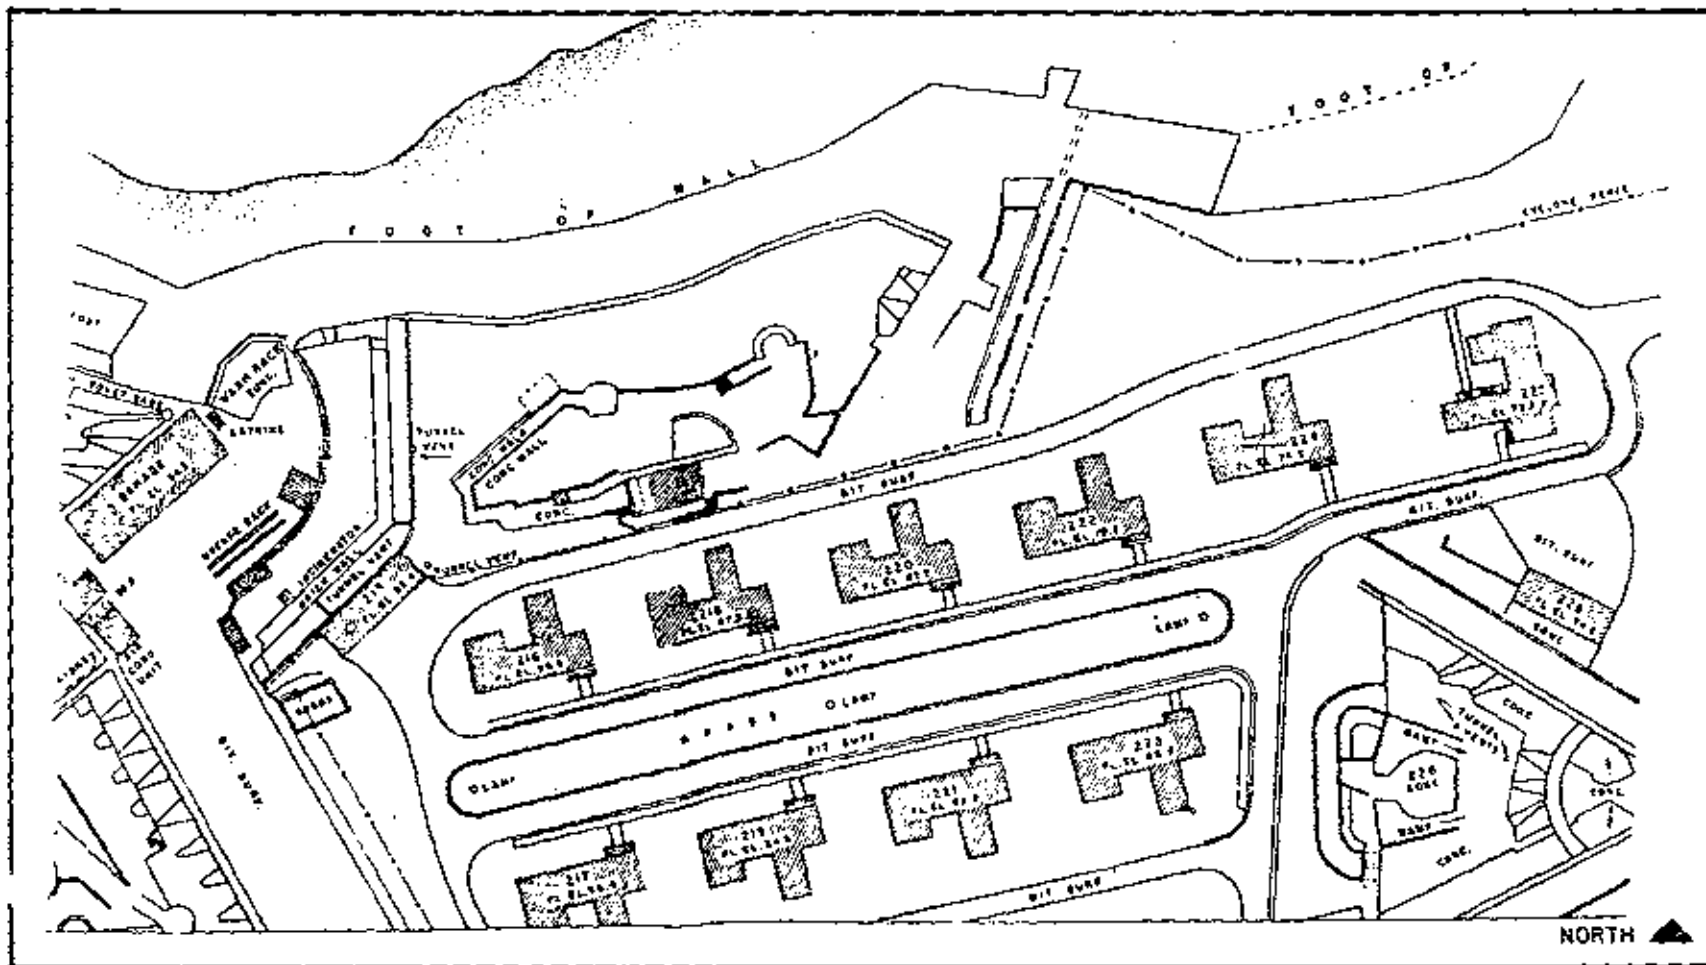
Figure 12.25. Plan "Fort Brooke As Built," Office of the Engineer, U. S. Army Forces Antilles, ca. 1949. Illustrates new army housing at Santa Teresa and La Princesa. (San Juan NHS Archives.)

The presence of the Army is clearly reflected in the "As-Built Survey of Fort Brooke" conducted in 1949.⁹ (See fig. 12.24, 12.25.) The la Princesa officers' quarters occupied the entire area of the glacis to the east of Santa Teresa. Several concrete structures associated with the motor pool included Building 214 (the garage) abutting the western moat, and in the main moat, the grease rack, and a square structure at the center of the curved counterscarp. At this time, the western moat had two

concrete buttressing slabs to the left and right of the deflection angle. Other structures indicated in the 1949 survey were: the latrine, a structure on the "roof" of the magazine, and an incinerator on the covered way against the southeast parapet (material unknown). The floor of the diagonal way and its south wall were described as made of concrete. Most of the eastern embrasures had earth fill covering all but the two northernmost embrasures and merlons. Indications of a drainage system appeared in the eastern brick-

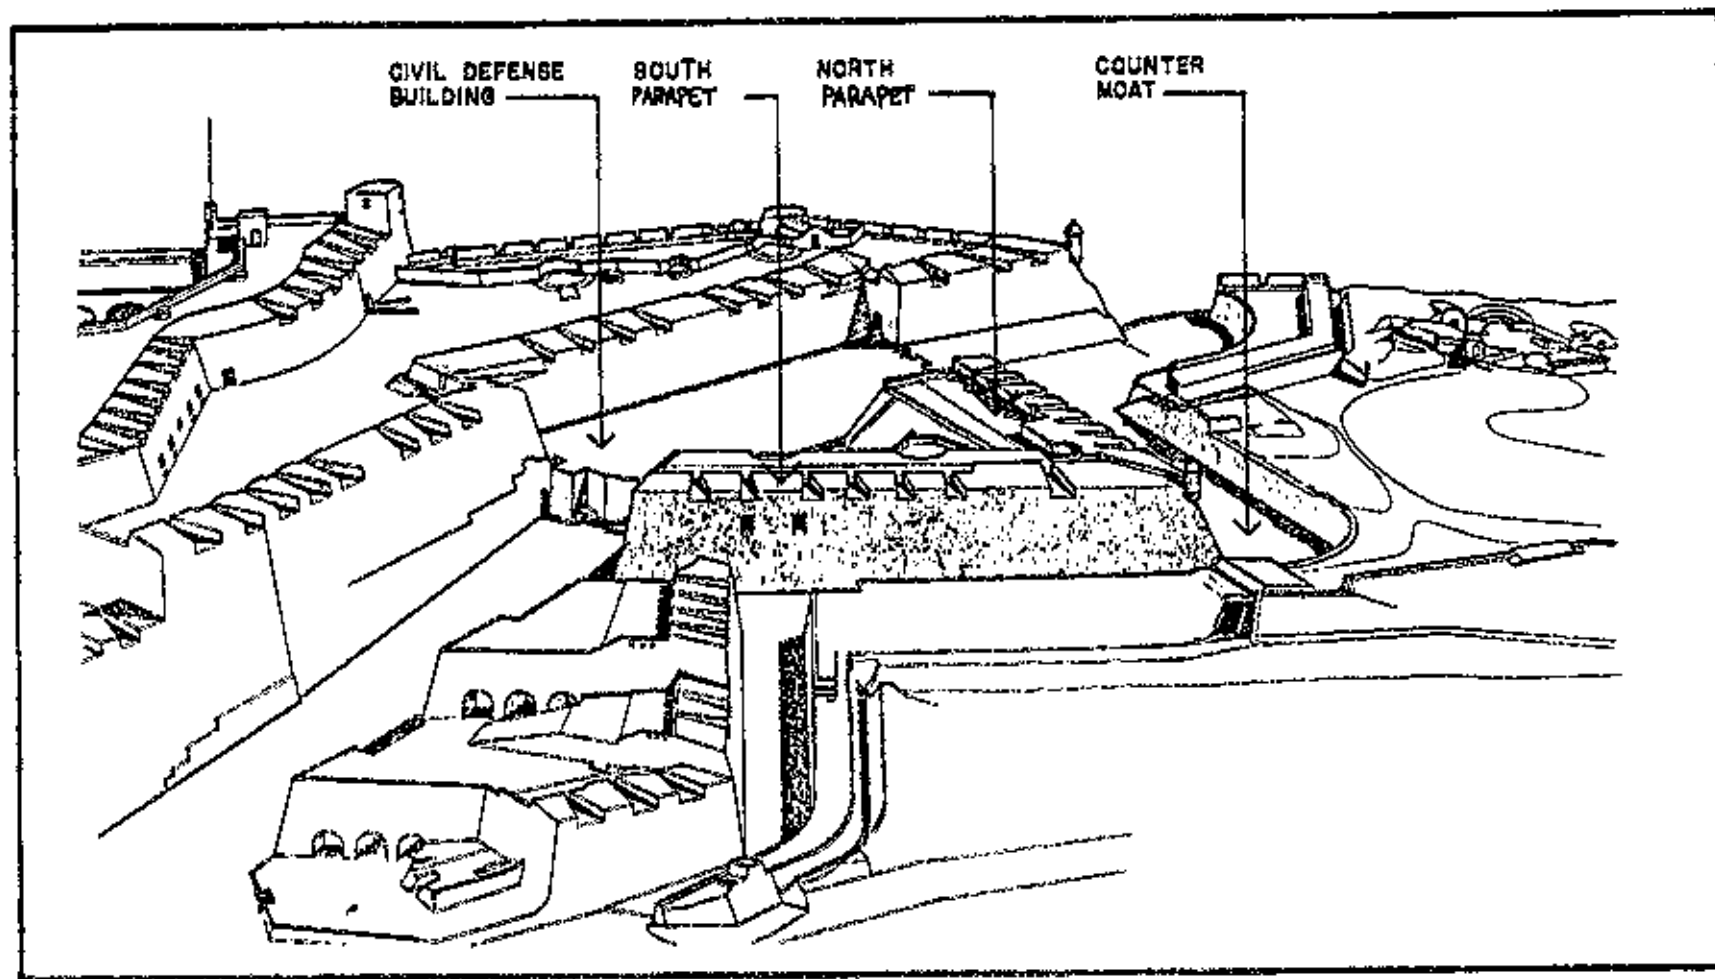
Figure 13.1. Aerial perspective of San Carlos Ravelin with features labeled. Based on a RASS site plan (1985), annotated by Jana Gross (1989).

Revellín de San Carlos, or San Carlos Ravelin as it will be referred to throughout the chapter, is constructed of coursed stone ashlar and rubble with a scored stucco finish. It lies to the east of the main curtain wall of San Cristóbal. (See fig. 13.1.) To the north of San Carlos the land slopes gently away until it reaches the sea cliffs. To the south, the rocky terrain drops off rapidly toward the city. The parapets of San Carlos overlook a countermoat beyond which lies Santa Teresa Battery to the north, la Trinidad Counterguard to the south, and a glacis to the east.

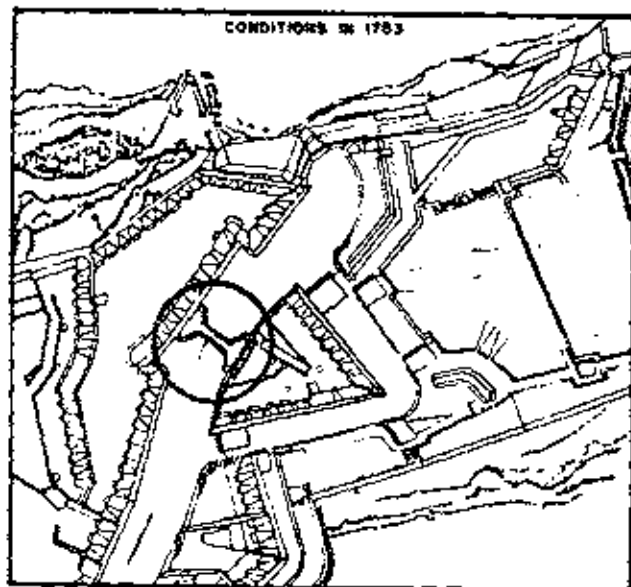
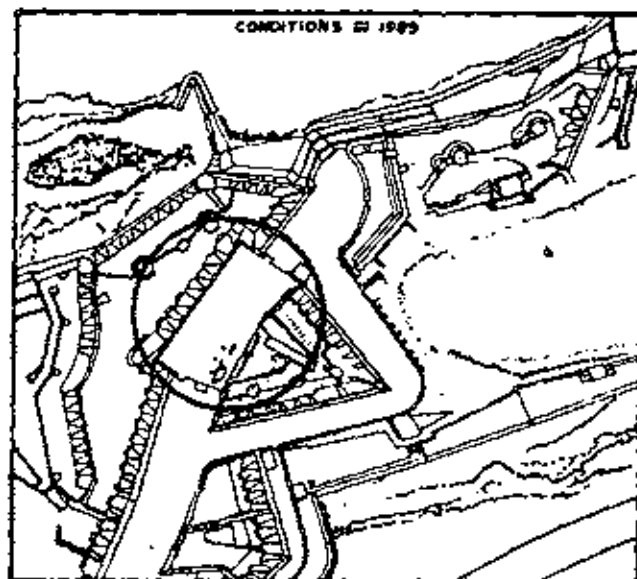
Figure 13.2. Conditions of San Carlos and surrounds in 1783 (left) and 1986 (right). Drawings from HABS cover sheet (1985).

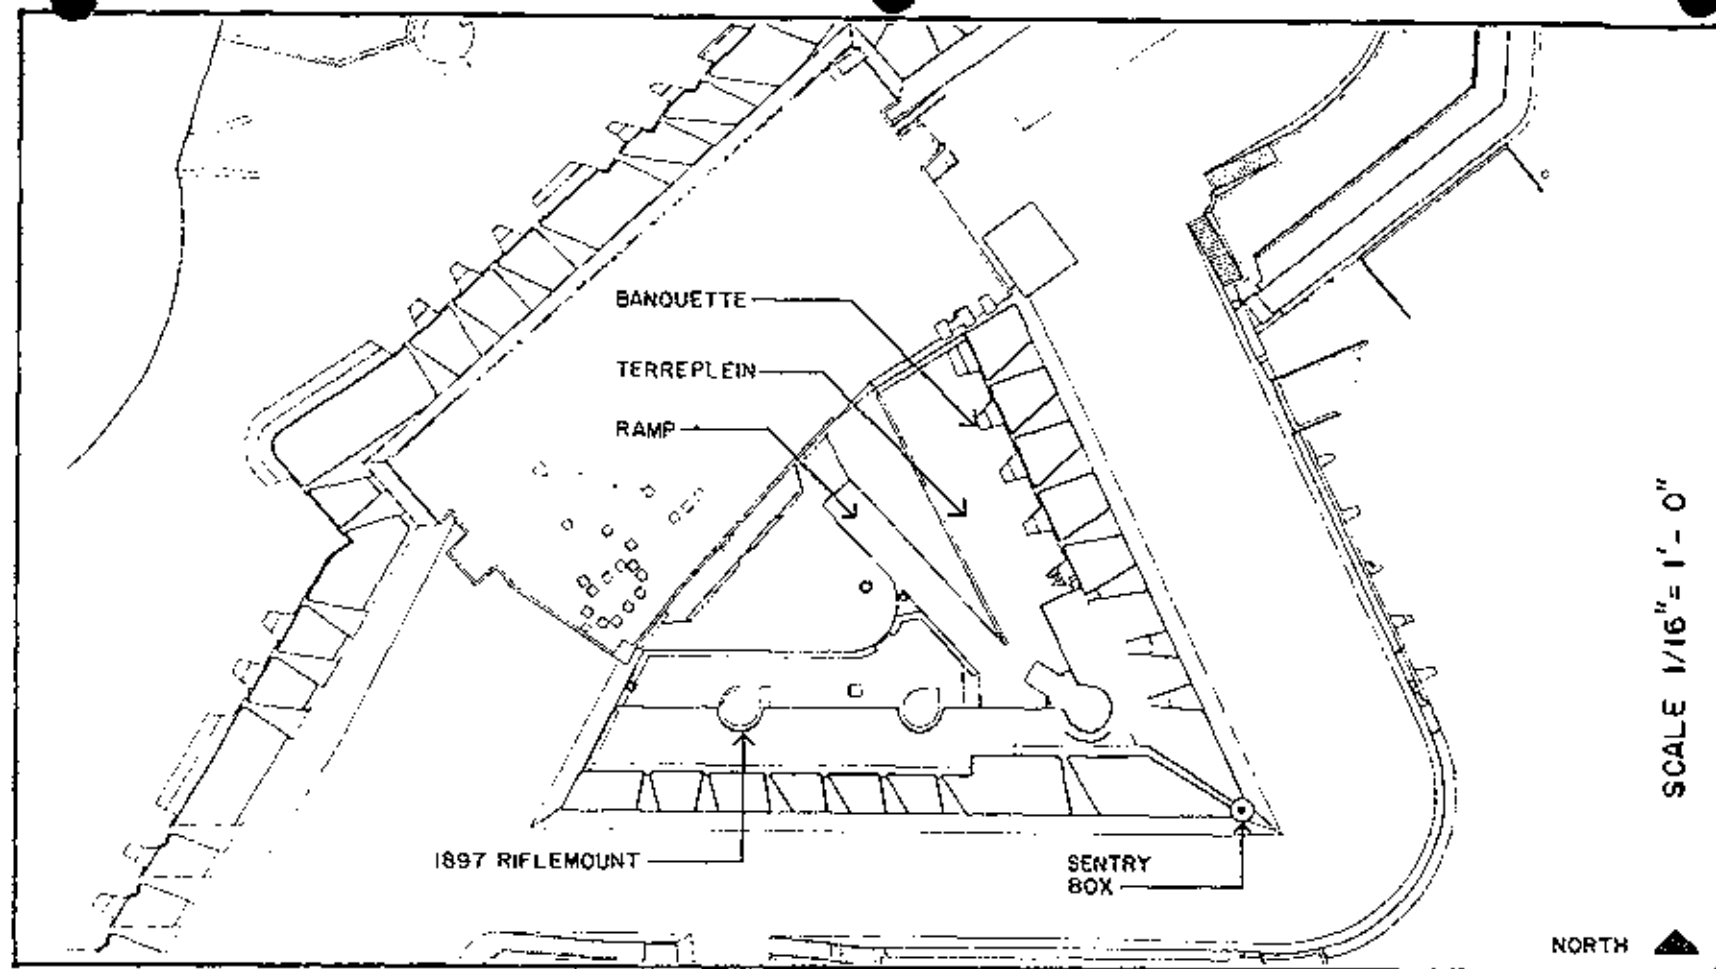
Figure 13.3. HABS site plan of San Carlos Ravelin, 1985.

A raking slope to the north of the lower terreplein buttresses the interior face of the north parapet. The upper levels of both the north and south parapets are accessible via a ramp ascending along, and parallel to, the north parapet (fig. 13.3).

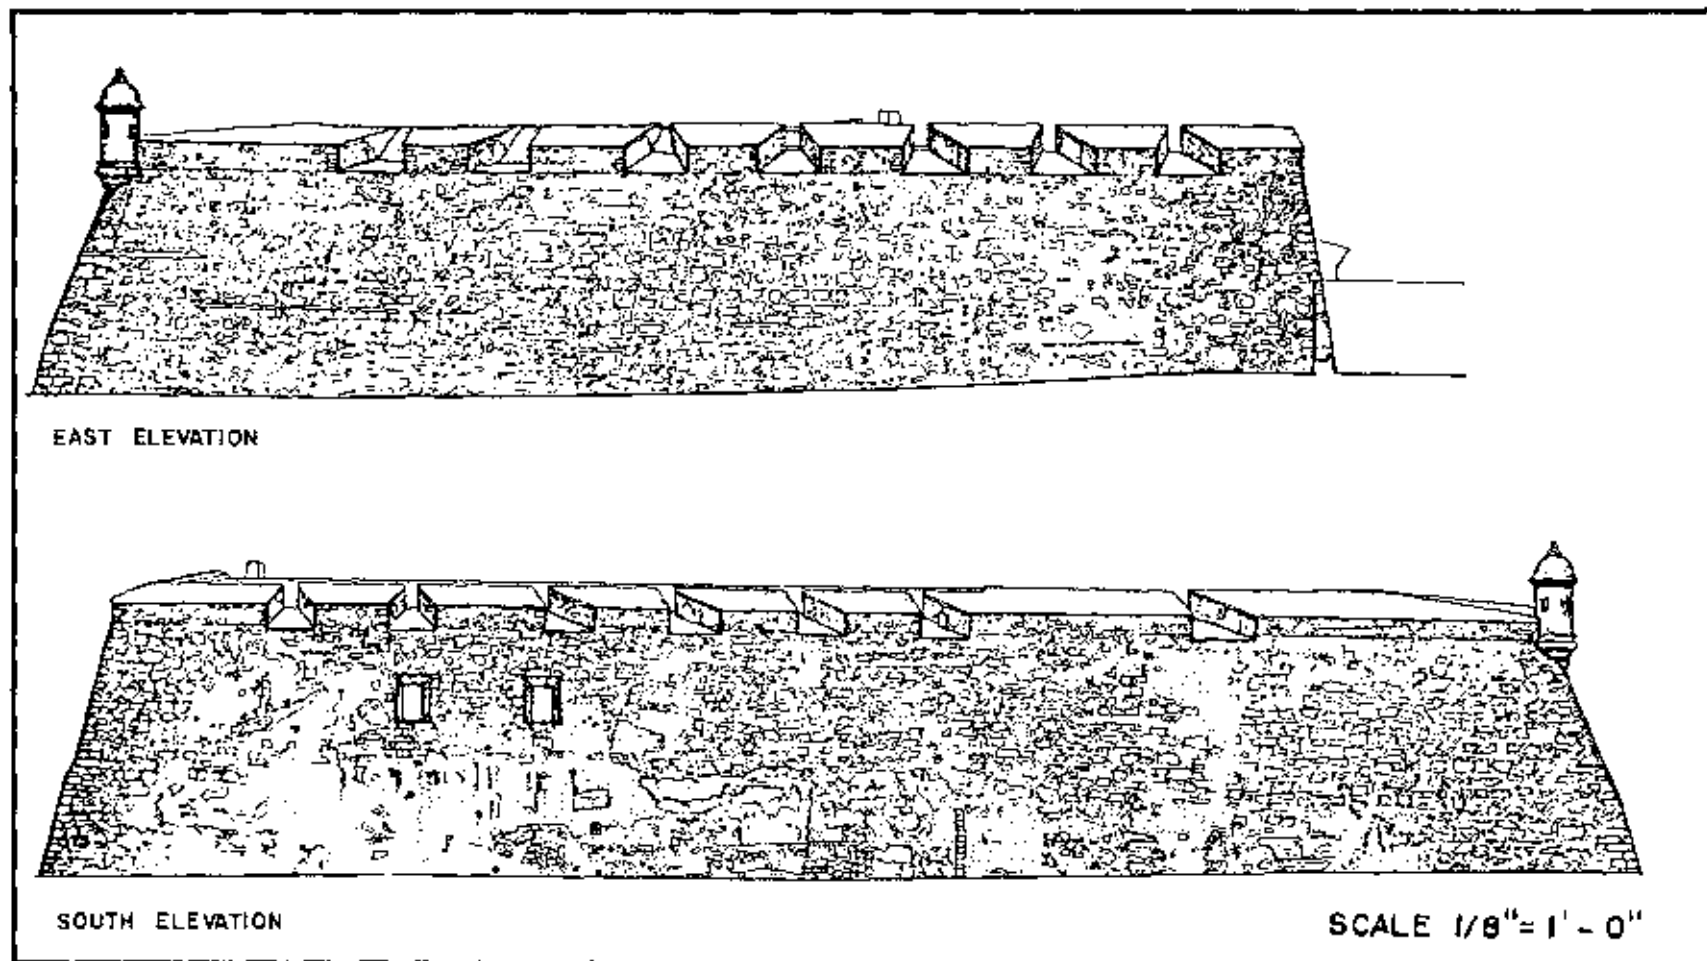
Figure 13.4. North and south elevations of San Carlos Ravelin. Drawing by HABS, 1985.

The lower walls of the north and south parapets of San Carlos Ravelin (figs. 13.4, 13.5) are essentially composed of outer and inner sandstone retaining walls with earth and/or rubble fill. The counterscarp facade is battered from the foot of the foundation wall to the embrasure level.

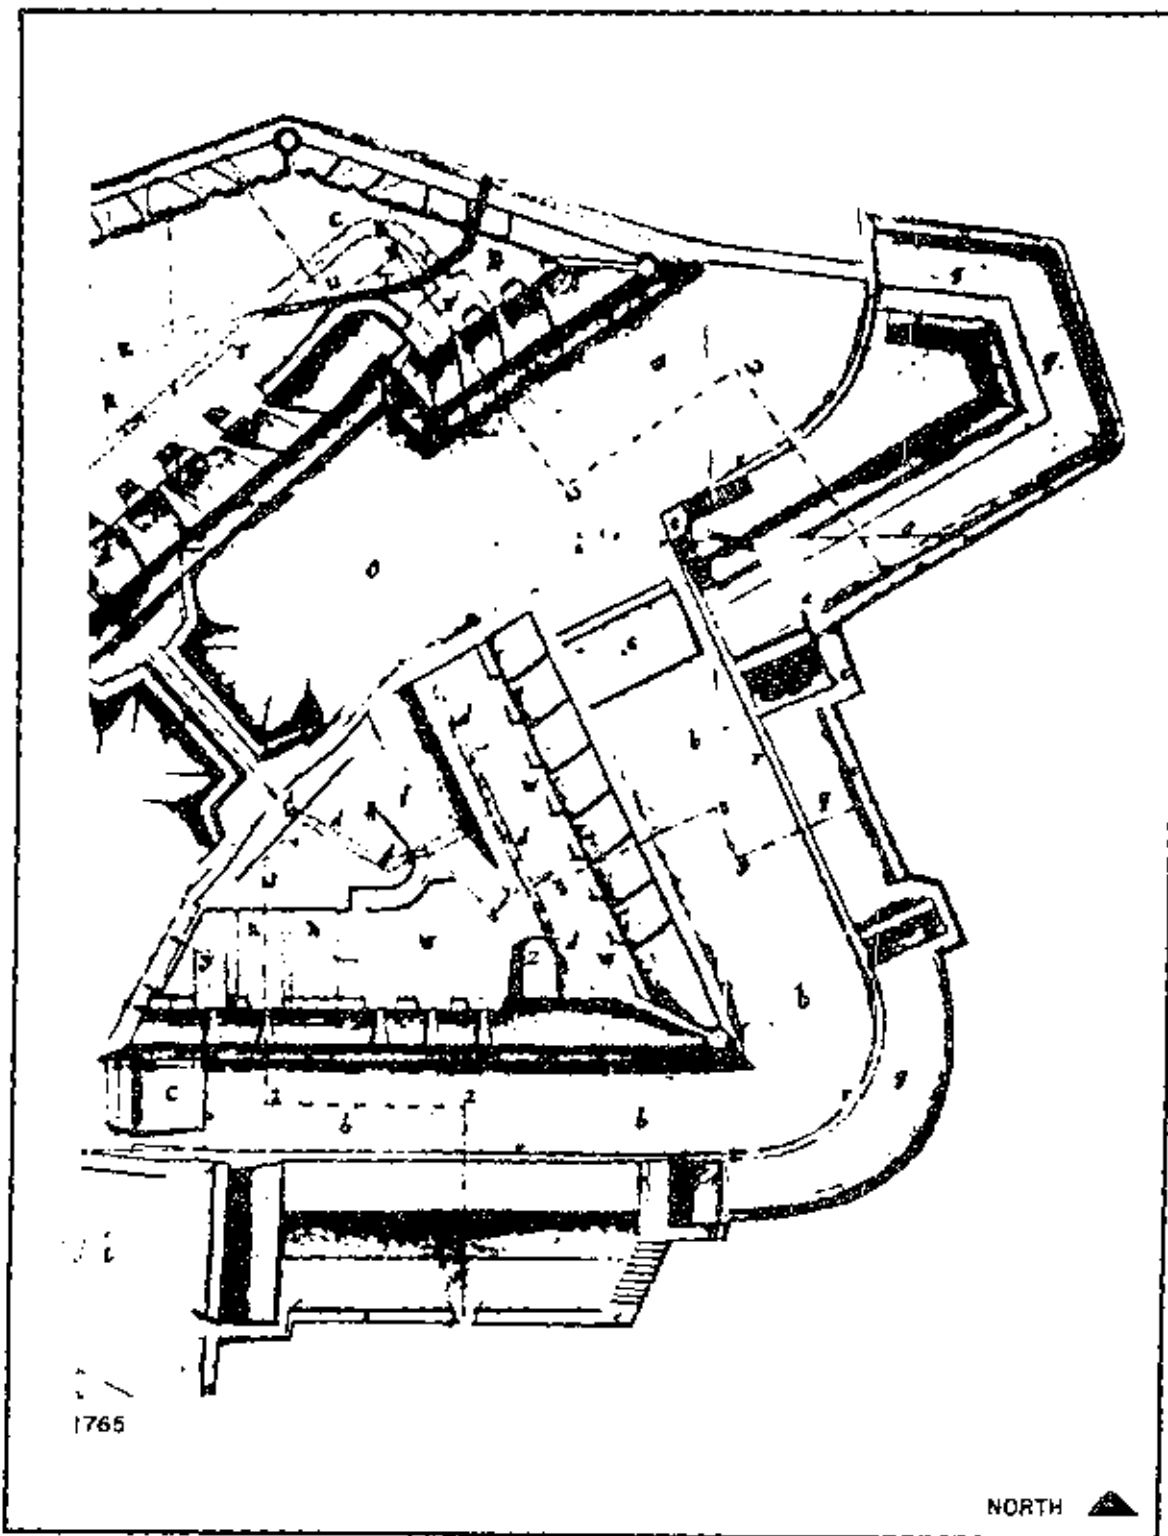
Figure 13.9. Detail of O'Daly's 1765 proposed construction plan showing San Carlos Ravelin.

The earliest reference regarding San Carlos Ravelin appeared in engineer Thomas O'Daly's 1765 proposed plan for San Cristóbal (fig. 13.9). In this plan, San Carlos was shown to the east of the curtain wall of San Cristóbal. The north parapet had five embrasure openings and the south had four. There was no covered way in the moat between the main fort and the ravelin.¹

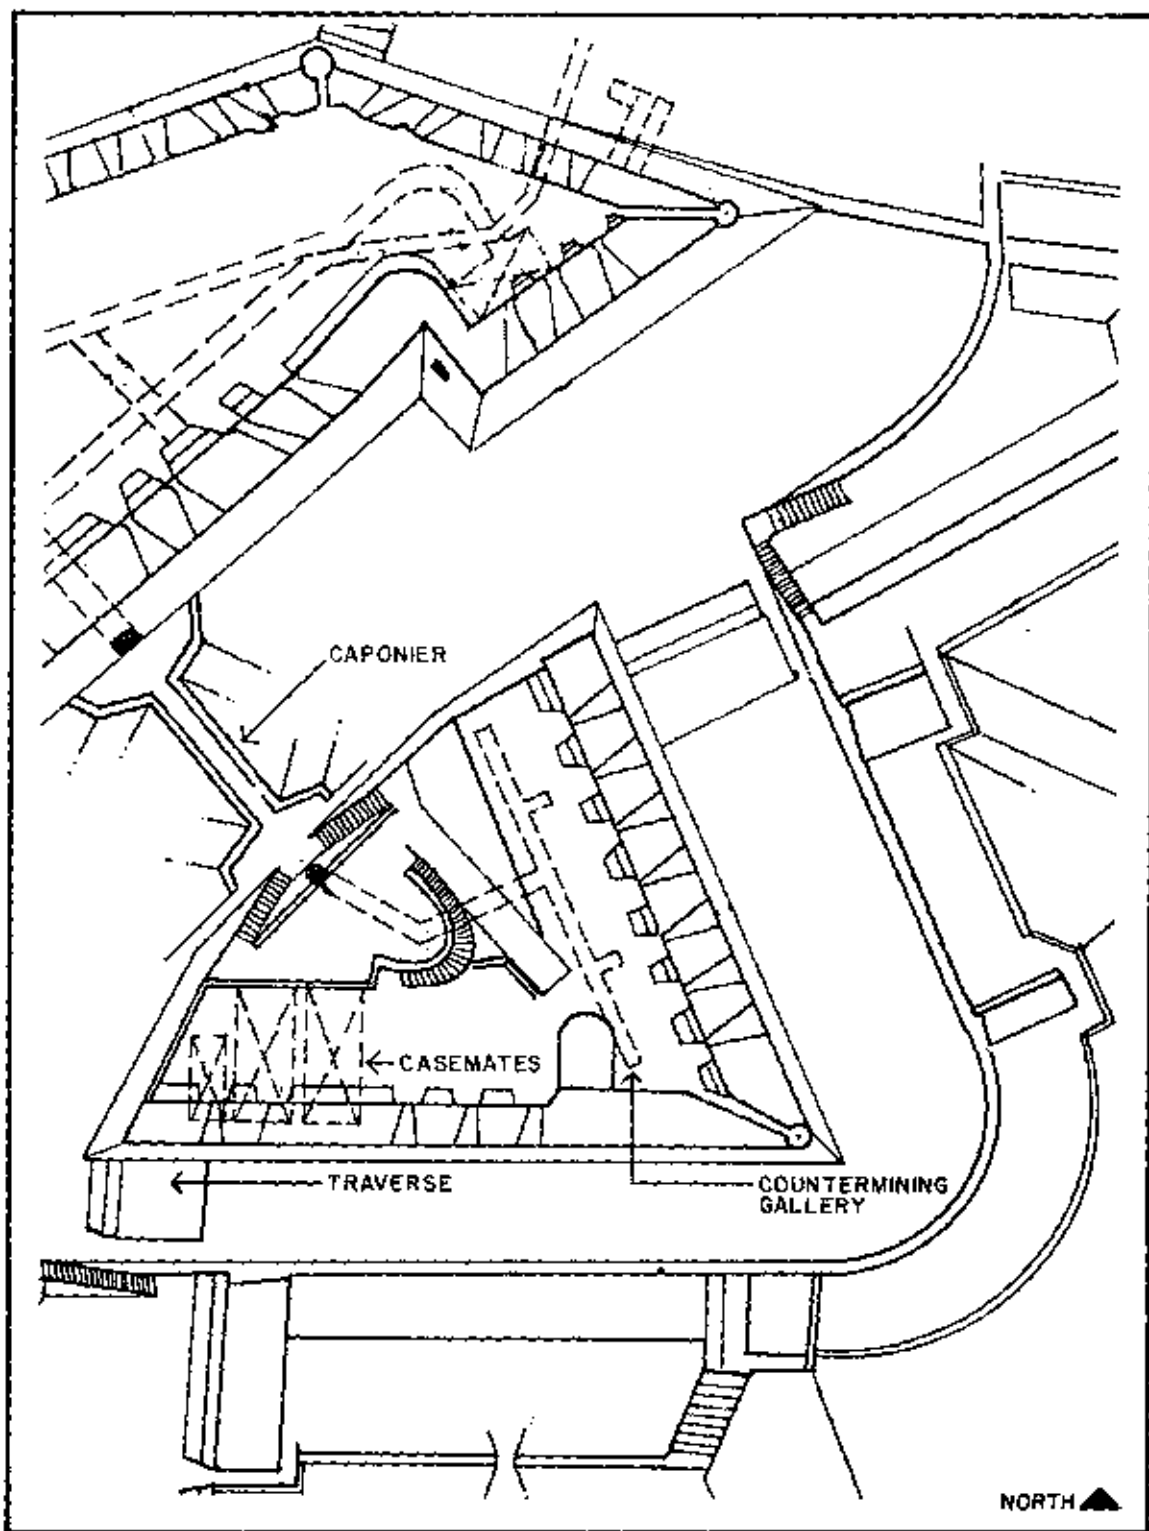
Figure 13.10. January 15, 1769 proposed conditions plan of O'Daly. Tracing by Torres-Reyes (1965), retraced and annotated by Jana Gross (1989).

In January of 1769, O'Daly produced a construction plan (fig. 13.10) depicting works from 1766-69. This plan showed the state of the projected work, the excavations, countermines, terrepleins, and the configuration of the fort after completion.³ The plans showed San Carlos fronted by a counter moat with traverses at the junctions with the main moat. The caponier linking the ravelin and the main fort was shown, as well as a covered way with traverses atop the counterscarp wall of the ravelin moat. The north parapet had seven equidistant embrasure openings; the south had five openings that were not uniformly spaced. A passageway led to a sentry box at the salient angle. The ramp leading from the lower terreplein was present as well as a curved stair adjacent to the ramp that leads to the upper level of the south parapet.² A rounded barrier against rebound batteries for the south parapet was depicted. In the south parapet,

two vaulted casemates and one vaulted powder storage chamber were shown. A projected countermining gallery was indicated along the length of the north parapet.
