THE FORTIFICATIONS OF SAN JUAN NATIONAL HISTORIC SITE

HISTORIC STRUCTURE REPORT

El Fuerte de San Cristóbal

1991

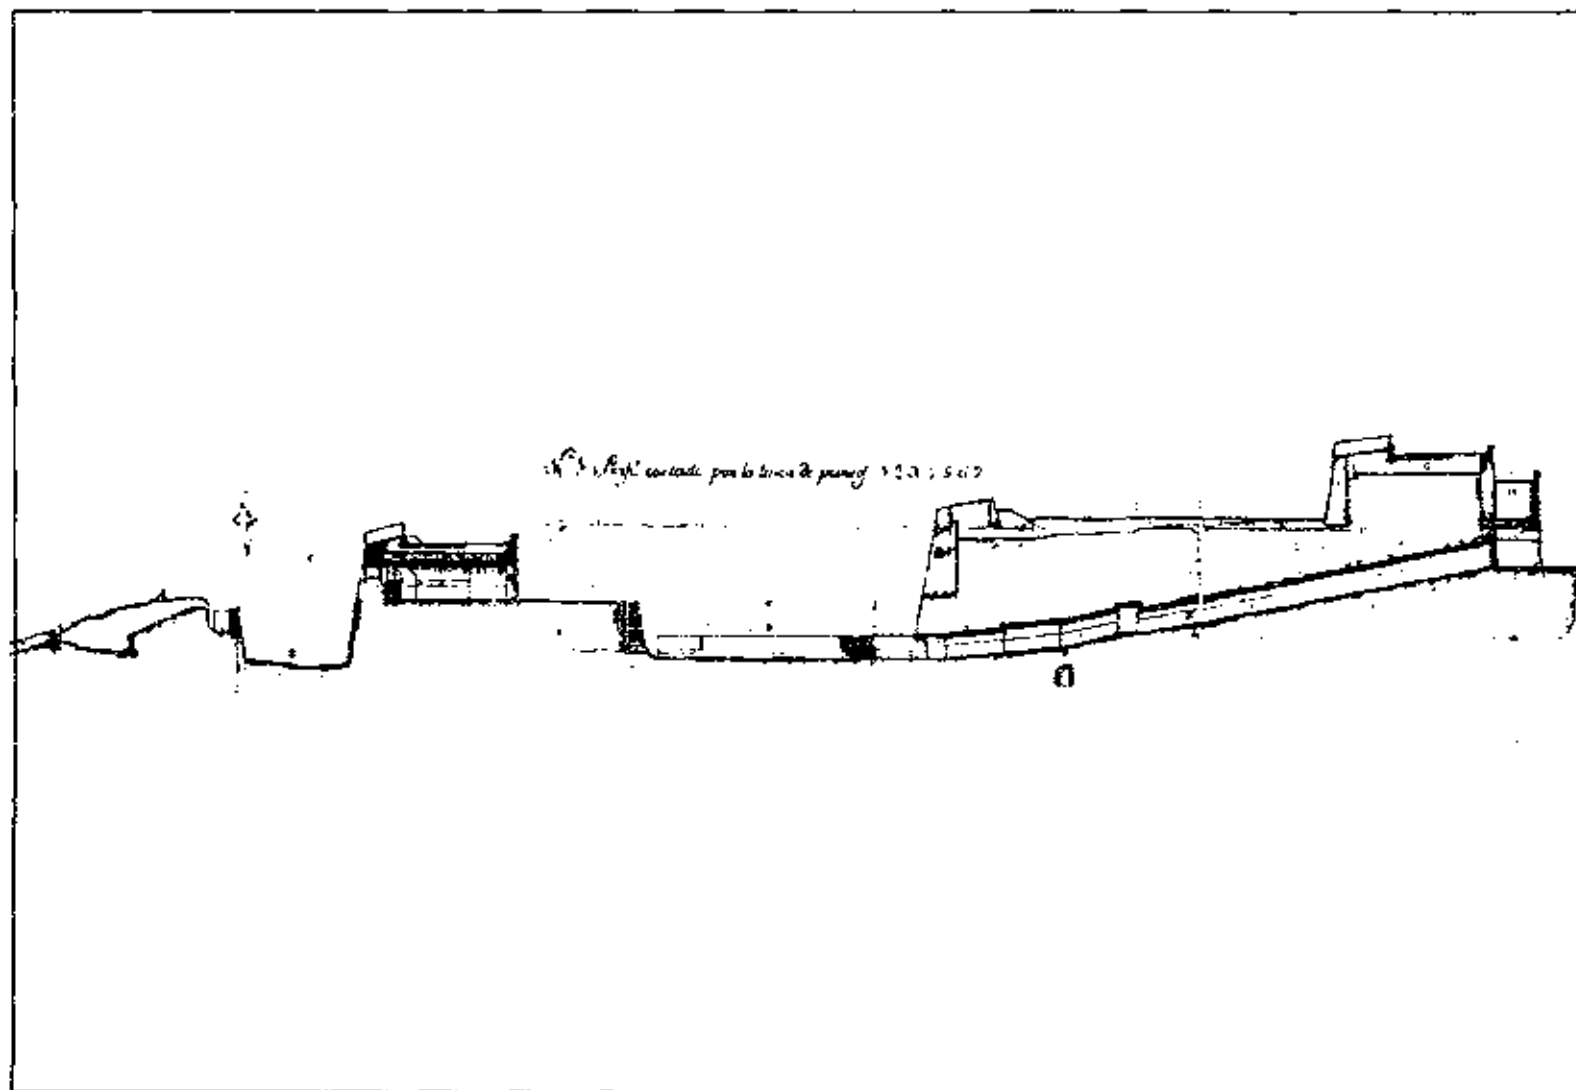
Figure 13.11. Profile No. 1 by O'Daly showing the moat, cavalier, terreplein, and stairs of San Carlos Ravelin. October 20, 1769.

Accompanying the plan of 1769 were profiles, one of which includes San Carlos (fig. 13.11). Profile Number 1 cut through the countermoat and the San Carlos south parapet center casemate. The interior section of the casemate showed the west wall with a doorway to the western chamber and a ventilation shaft above the door. There were indications of two square openings at mid-wall that do not relate to any physical evidence.

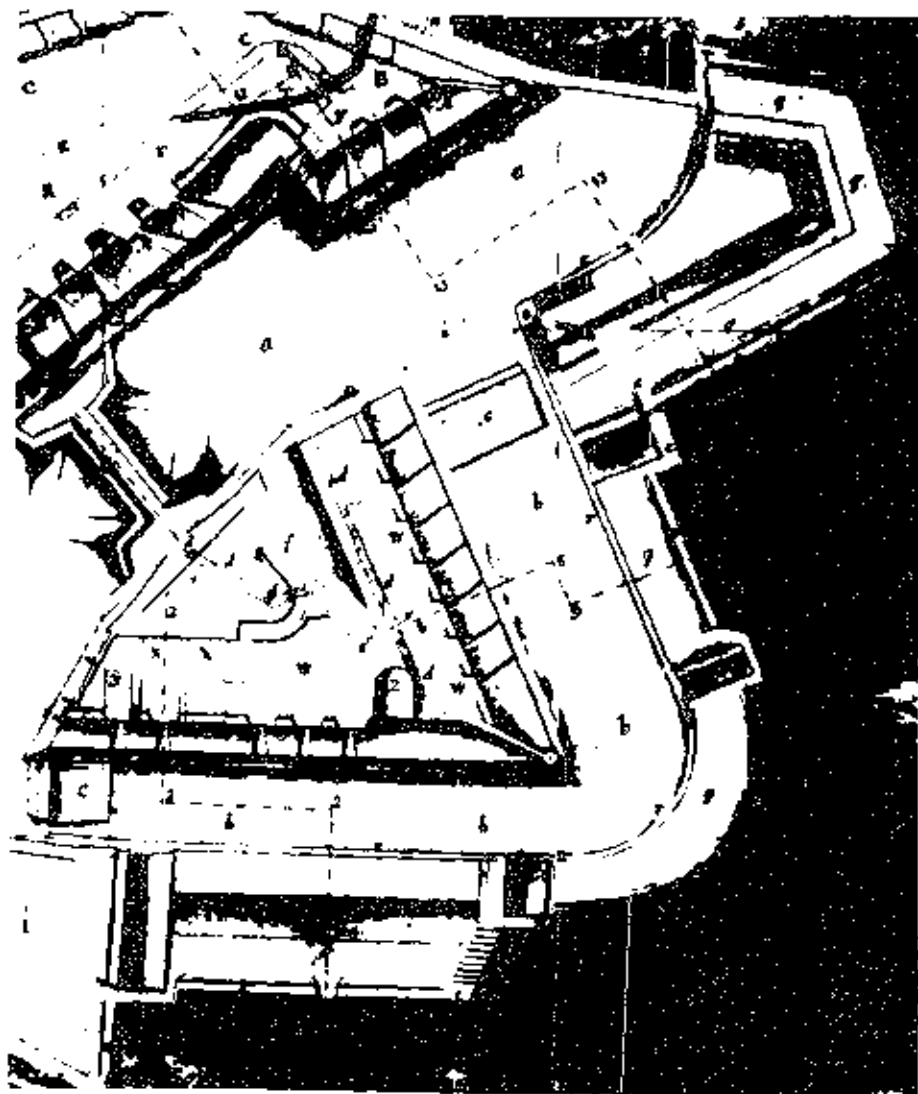
Figure 13.12. Detail of "As-built" plan by O'Daly, 1769, showing San Carlos Ravelin.

A later "as built" plan believed to date to ca. 1769 was also produced by O'Daly (fig. 13.12). On it, the most notable change was the deletion of the curved stairs for retreat from the south parapet. This resulted in a

continuous interior parapet wall for the south parapet. A section through the easternmost chamber showed a door communicating between the two

eastern casemates, a window in the south wall, and a coped interior parapet wall.

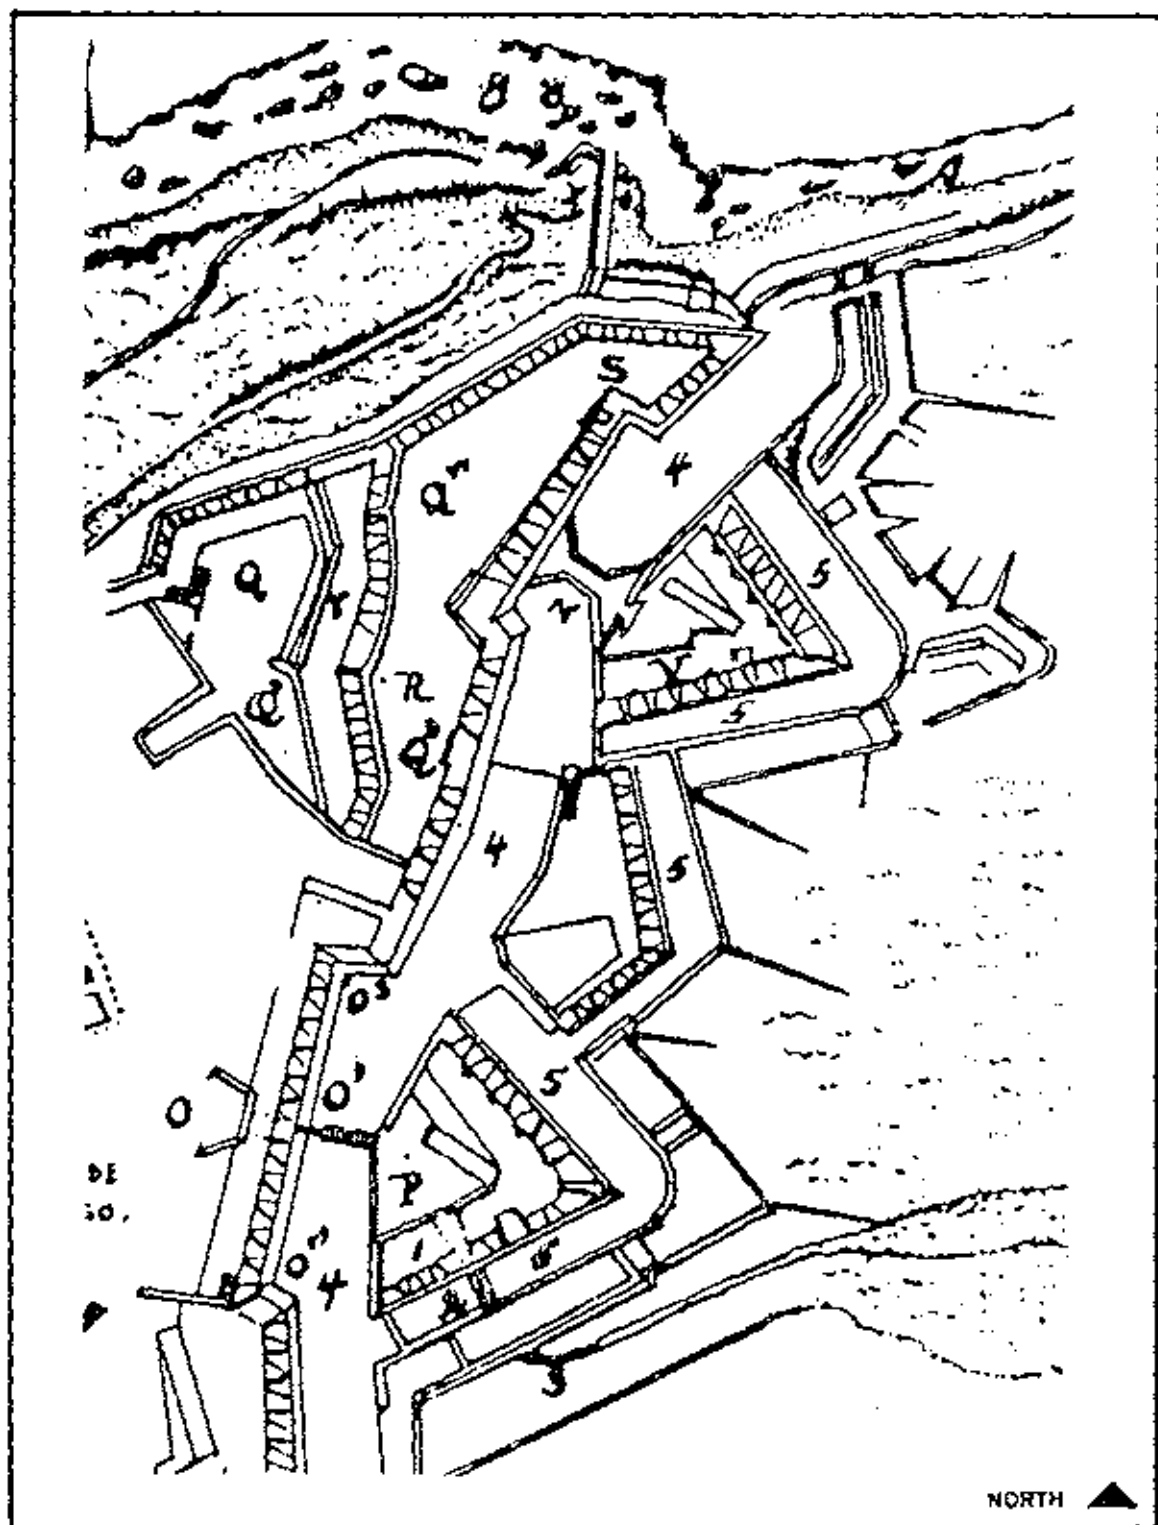
Figure 13.13. Detail of the 1772 plan of San Cristóbal by O'Daly. San Carlos is labeled "P" and its moat "5".

According to the construction reports, work was completed at San Carlos in February 1770 with the completion of two embrasures.⁵ By 1771 the heavy artillery was in place with five cannons in the north parapet and six cannons in the south. The 1772 O'Daly plan of work completed by 1771 showed the completed San Carlos with exterior elements depicted in red (fig. 13.13). The double stairs and caponier were shown in red as well.

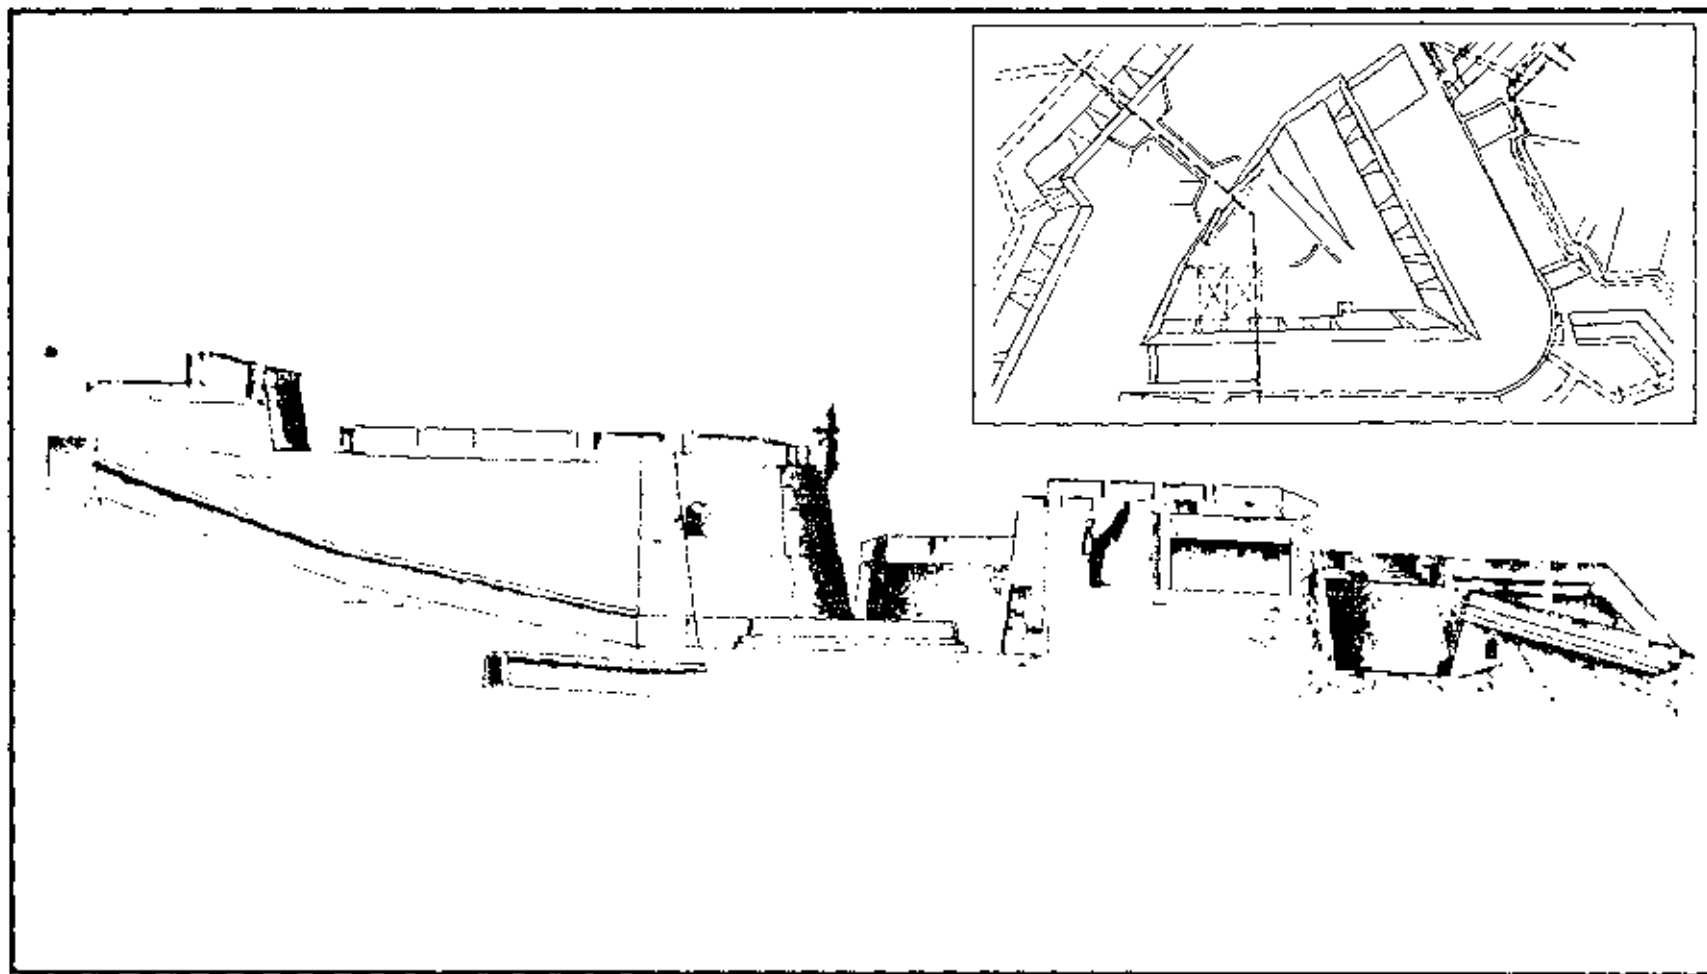
Figure 13.14. Section cutting through south flank of San Carlos, North Bastions, and Main Moat looking north. Section dated February 26, 1773, by O'Daly.

The 1773 section through the south flank of San Carlos (fig. 13.14) is helpful for illustrating the construction techniques of the casemates and south parapet. The south scarp of the parapet utilized the natural rock through which the countermoat is excavated. Thick masonry walls extended up from a natural rock base forming the exterior wall for the parapet and embrasures. Brick was used for the vaulted ceilings that were covered with earth fill. Cut stones were set into the pavement along the revetment wall and were the firing pads. The rest of the esplanade was shown as paved. Some details that did not appear in previous plans or drawings were delineated in the February 26, 1773 profile. The finial at the intersection of the ramp and curved parapet wall was shown in profile. The interior parapet of the south parapet was shown without a coping.

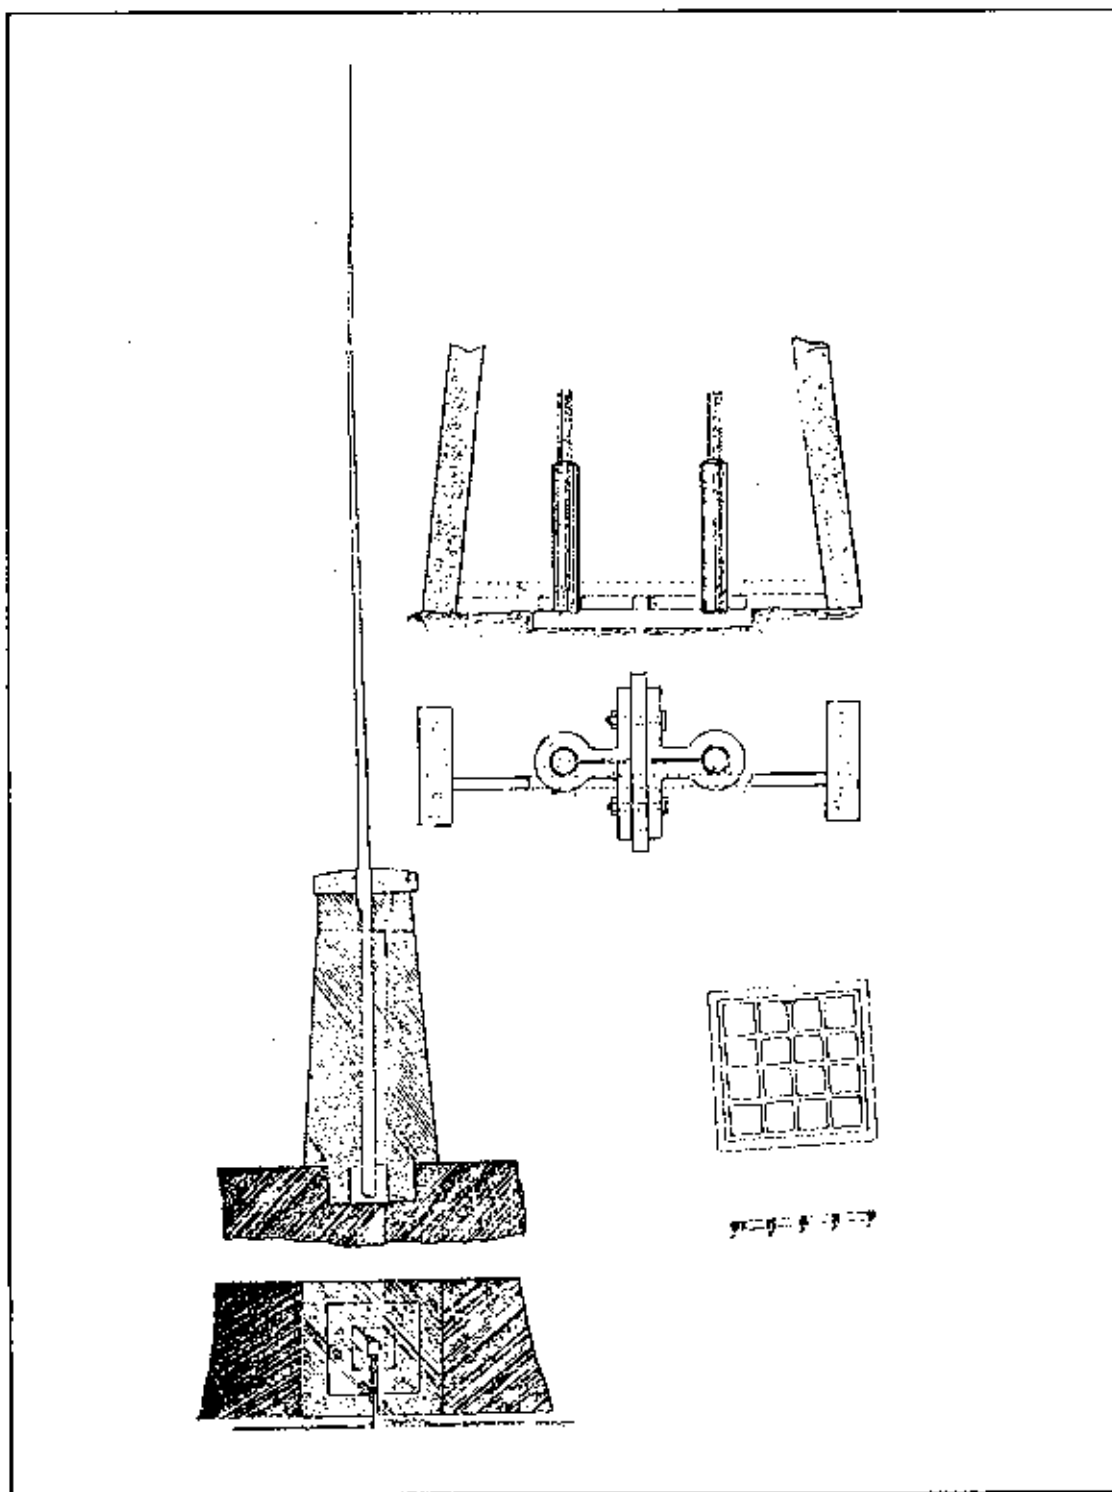
Figure 13.15. Detail of 1818 drawings of lightning rod installed at San Carlos Ravelin. (Servicio Histórico Militar-España, Madrid, Spain.)

In 1818, plans for two lightning rods were drawn (figs. 13.15, 13.16). One drawing showed construction details for lightning rods to be erected on masonry bases at San Carlos and la Trinidad; the other drawing showed San Carlos in plan with the two locations for the rods at the northern end of the west facade of the south parapet and at the midpoint of the south parapet⁴. In addition, the construction of the windows in the south wall of the casemates was illustrated in plan, section, and elevation. The outer opening in the scarp wall was splayed stone; pockets were indicated that probably held wooden members. The wide jamb was approximately the width of the wall with pockets for a wooden frame. The window in the south wall of the east casemate was now completely cemented over. The middle casemate's south window was still intact with the original tan lime bedding mortar. The lintel of the frame would have been a segmental, with projecting ears accommodated by pockets in the masonry. Two shutters would have folded into the space created by the jamb. Section A-B showed part of the lower terreplein and a cut through the middle casemate. The north door construction appeared to have two masonry semi-arches over the door. Currently the void is filled with brick. It is interesting to note that the section through the south parapet showed a solid masonry wall, whereas toward the western end, as depicted previously, natural rock was incorporated into the wall. The presence of natural rock is apparent when viewing the western facade of the south parapet.

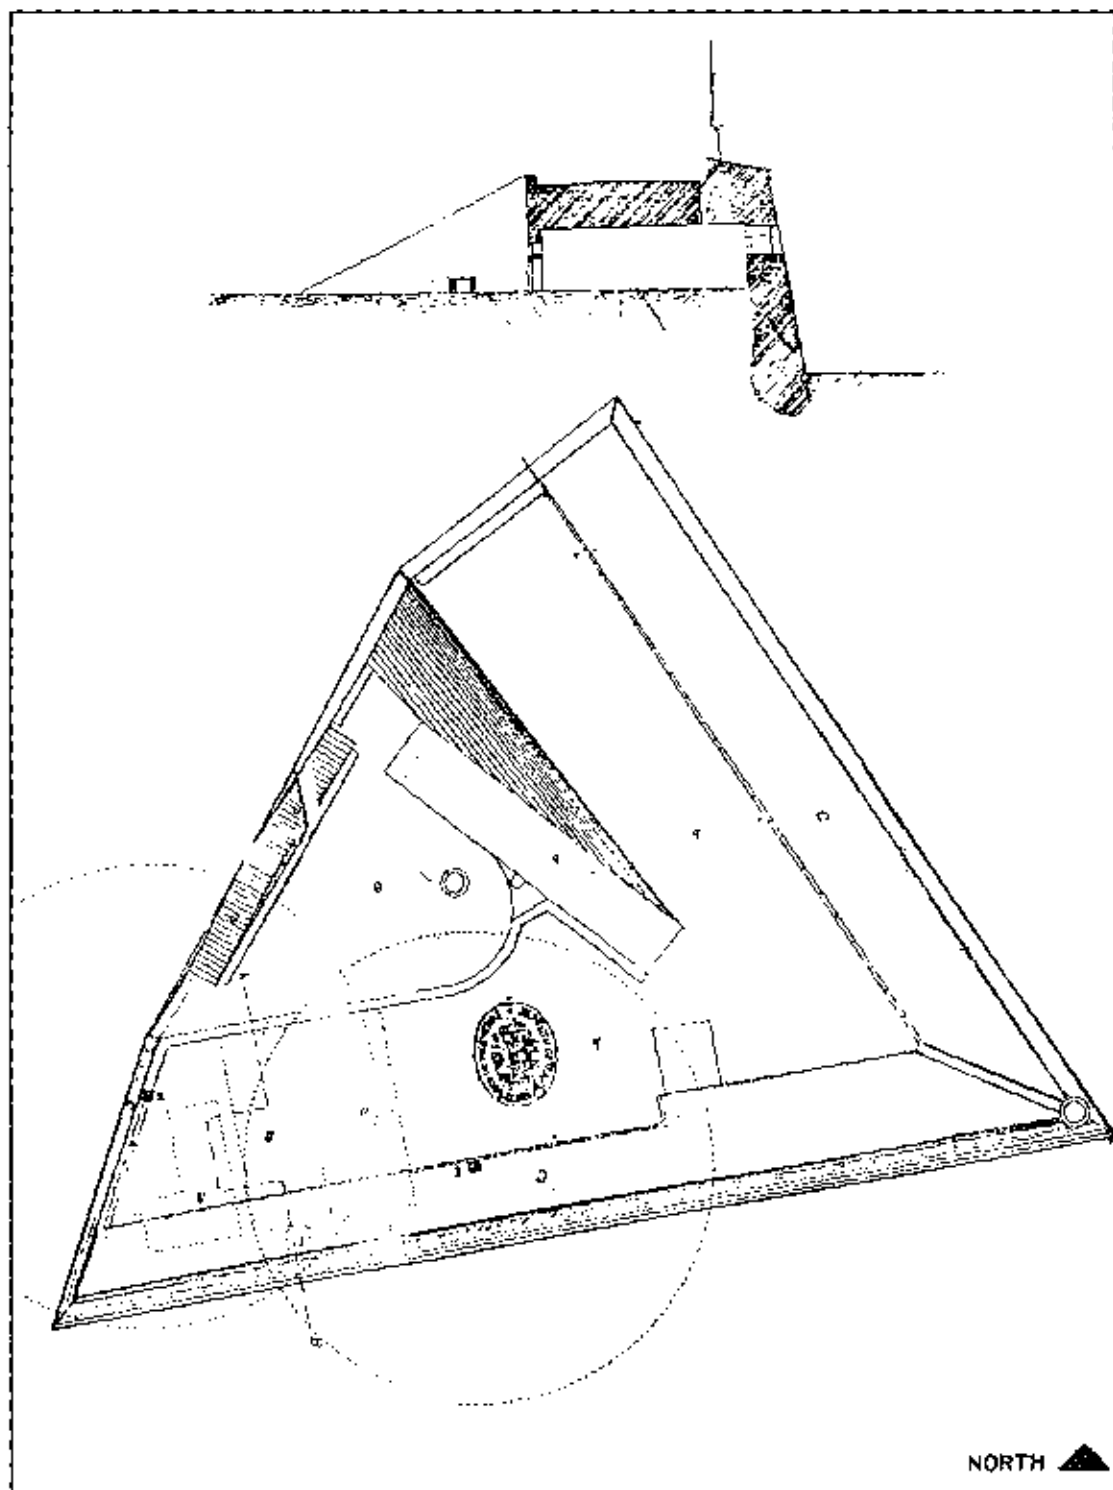
Figure 13.16. Detail from 1818 drawing "Proyecto de Habilitación de las Bovedas de S. Carlos para Polvorin" showing lightning rod at San Carlos. (Servicio Histórico Militar-España, Madrid, Spain.)

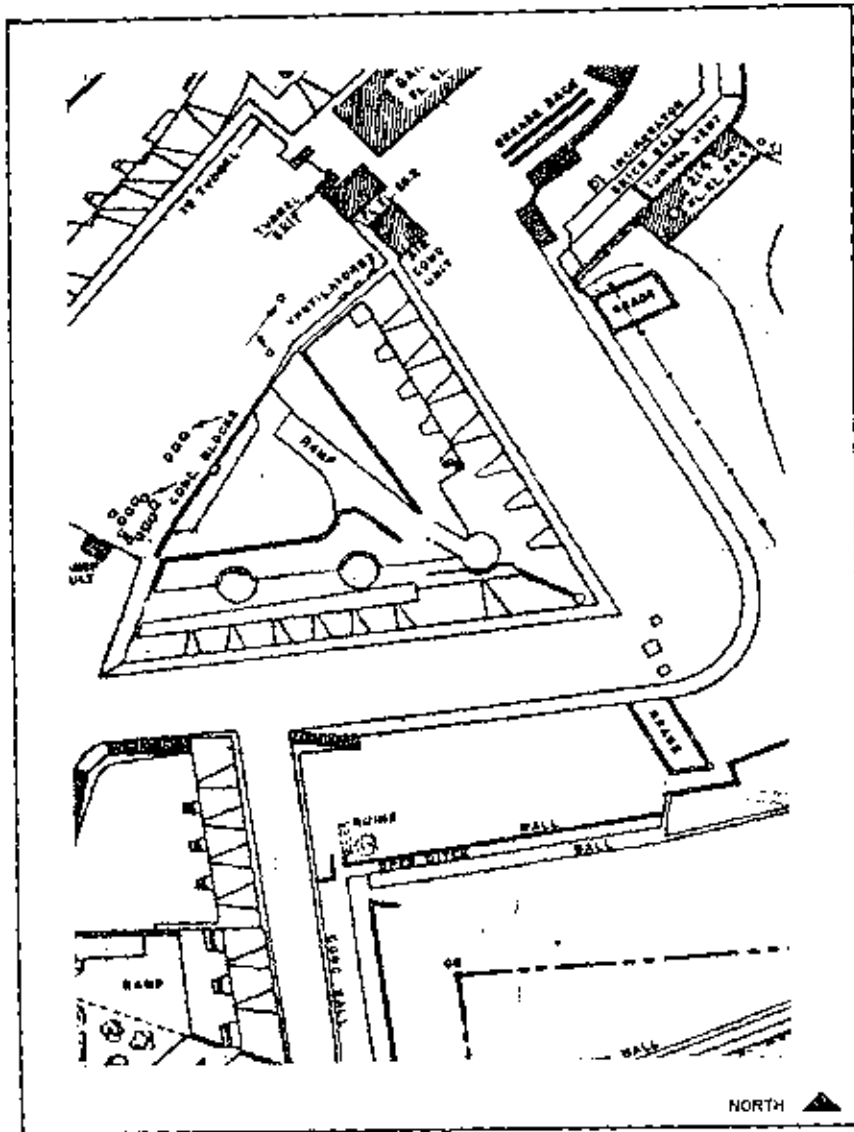
Figure 13.18. Detail of "As Built Survey, Ft. Brooke" plan showing locations for radio antennae, 1949. (San Juan NHS Archives.)

The 1949 "As Built Survey, Ft. Brooke" indicated the locations for radio antennae and electrical distribution.¹¹ The existing concrete step was shown replacing the original double stairs. (See fig. 13.18.)

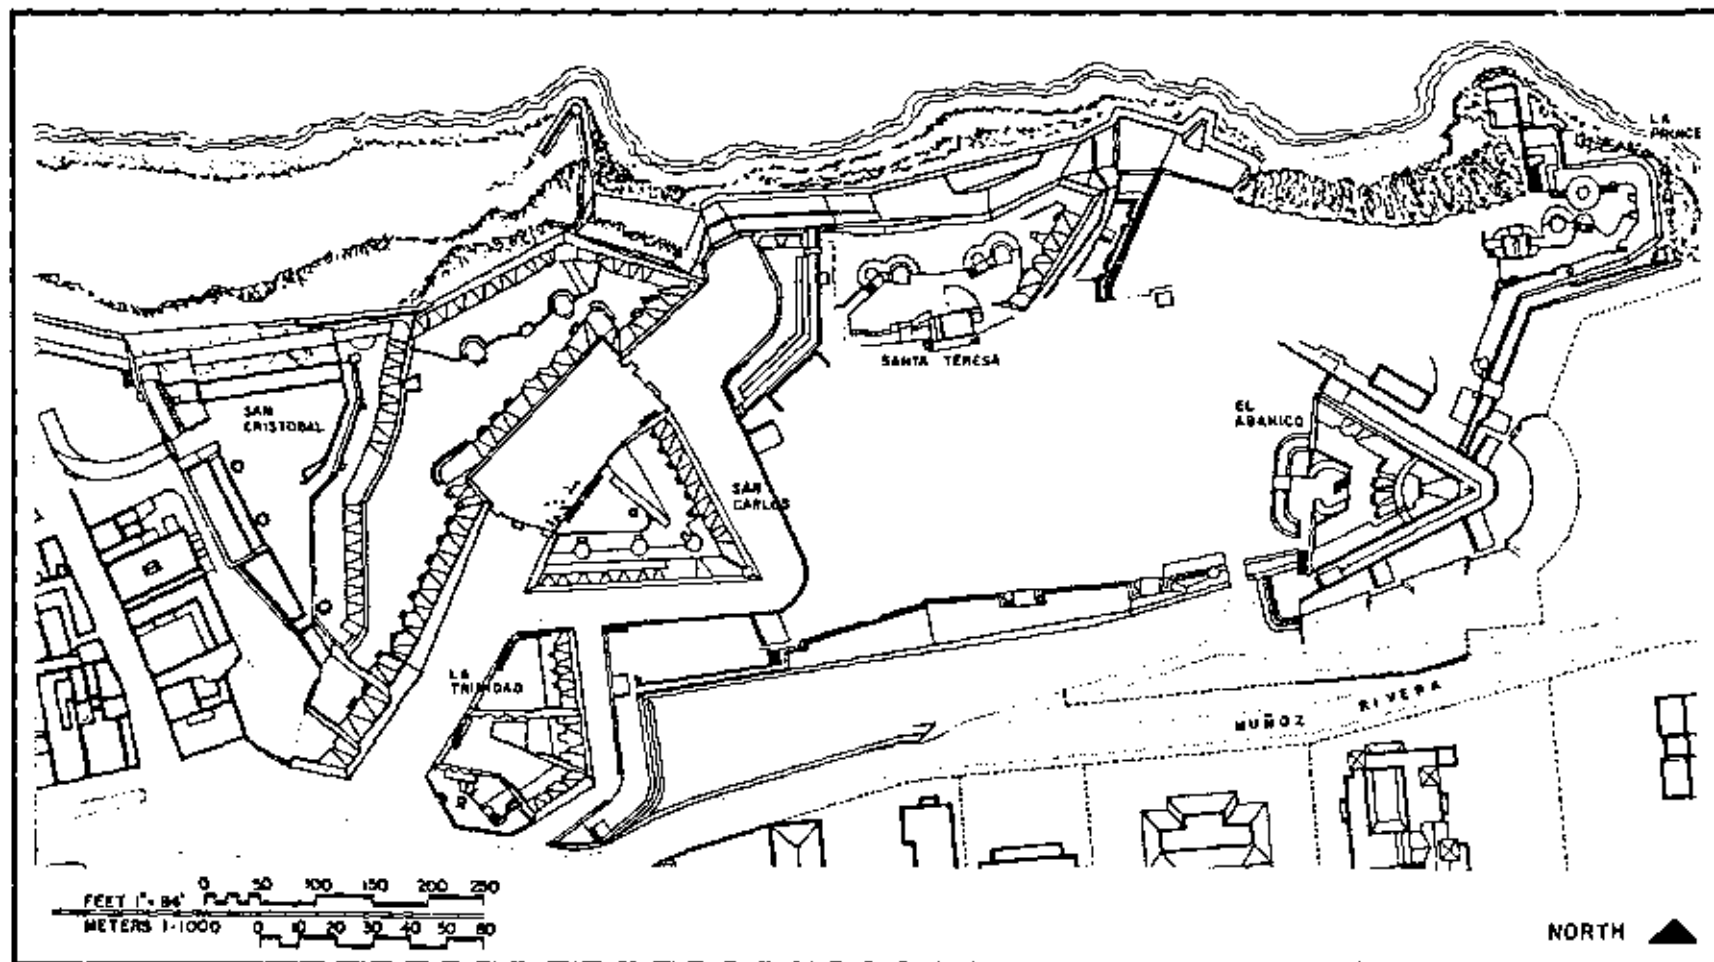
Figure 14.1. Site plan of San Cristóbal showing location of la Trinidad. Drawing by HABS, 1984.

La Counterguardia de la Trinidad, or la Trinidad as it will be referred to throughout the chapter, lies to the south of San Carlos Ravelin and to the east of the South Bastion of San Cristóbal and functioned as a counterguard protecting these structures from breaching fire. There is a 55 foot elevation drop in the topography from north to south accommodated by stepping down the slope in multiple levels. Four major levels were formed; upper, intermediate, lower, and base. The unit is bounded by the main moat of San Cristóbal on the west, San Carlos' countermoat on the north, and by its own countermoat on the east. On the south is the Munoz Rivera roadway. (See figs. 14.1 and 14.2)

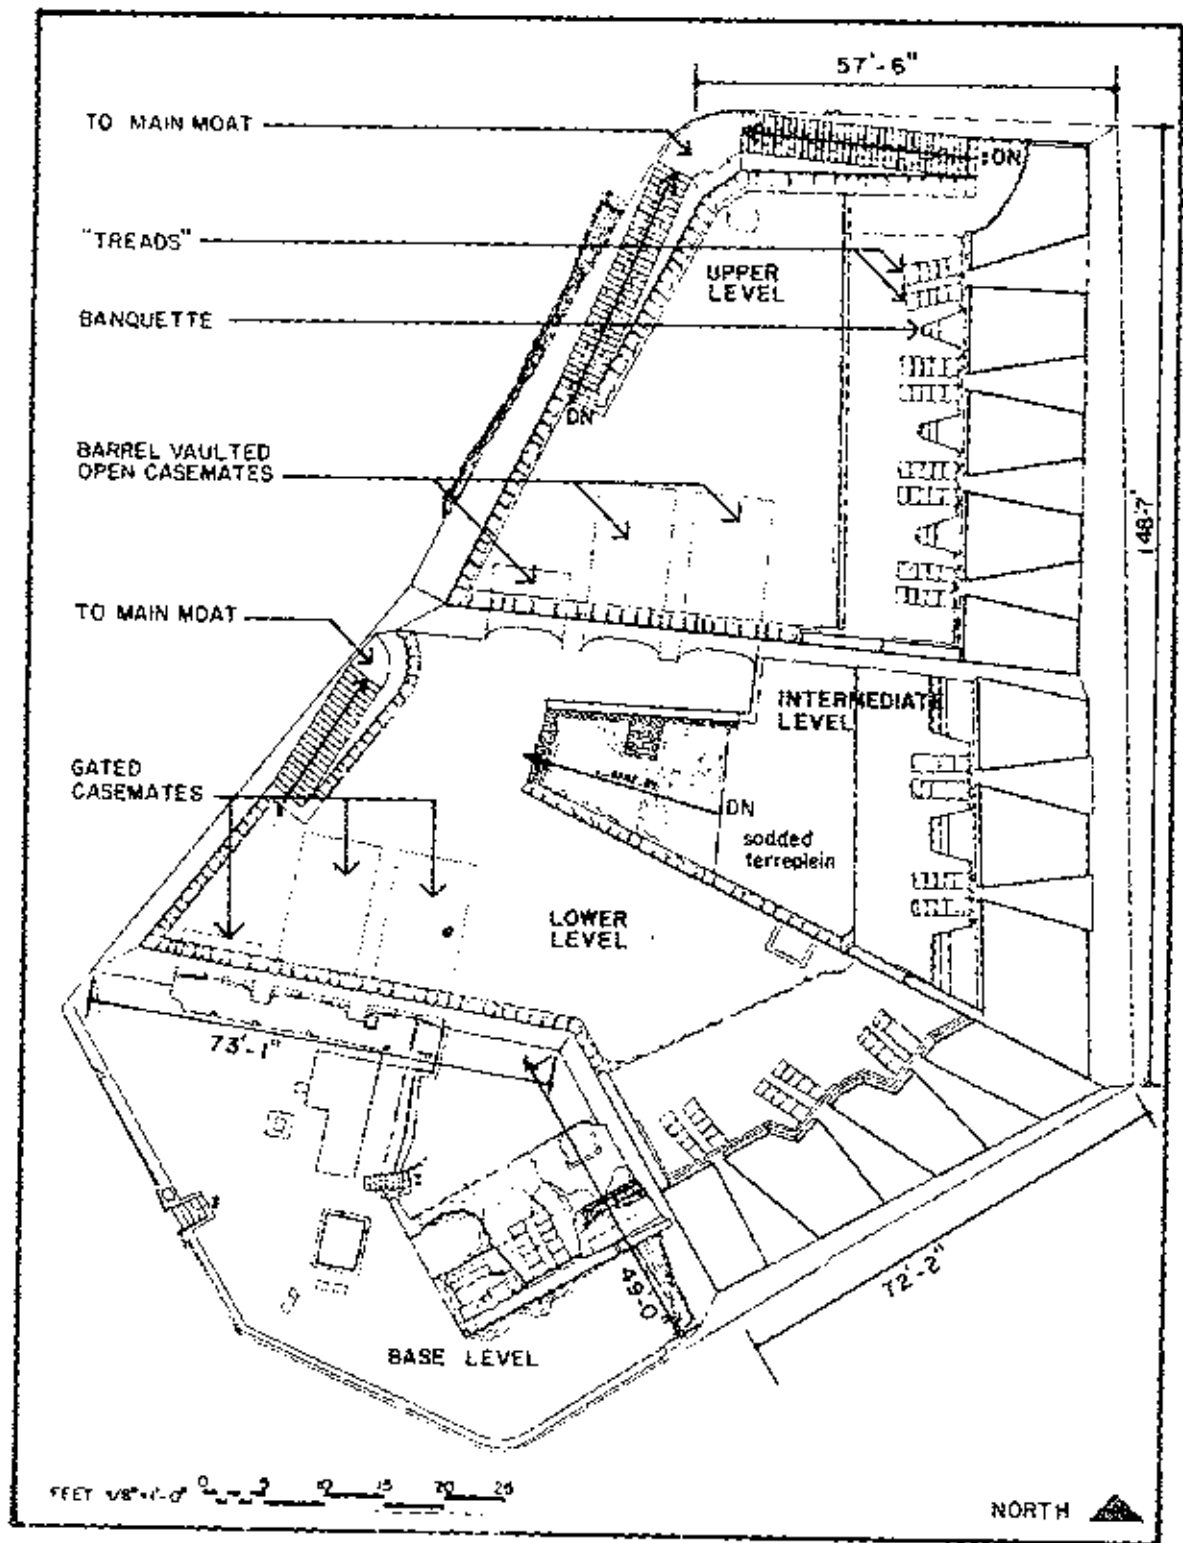
Figure 14.2. La Trinidad Counterguard with levels and elements labeled. HABS drawing (1984) annotated by Jana Gross (1989).

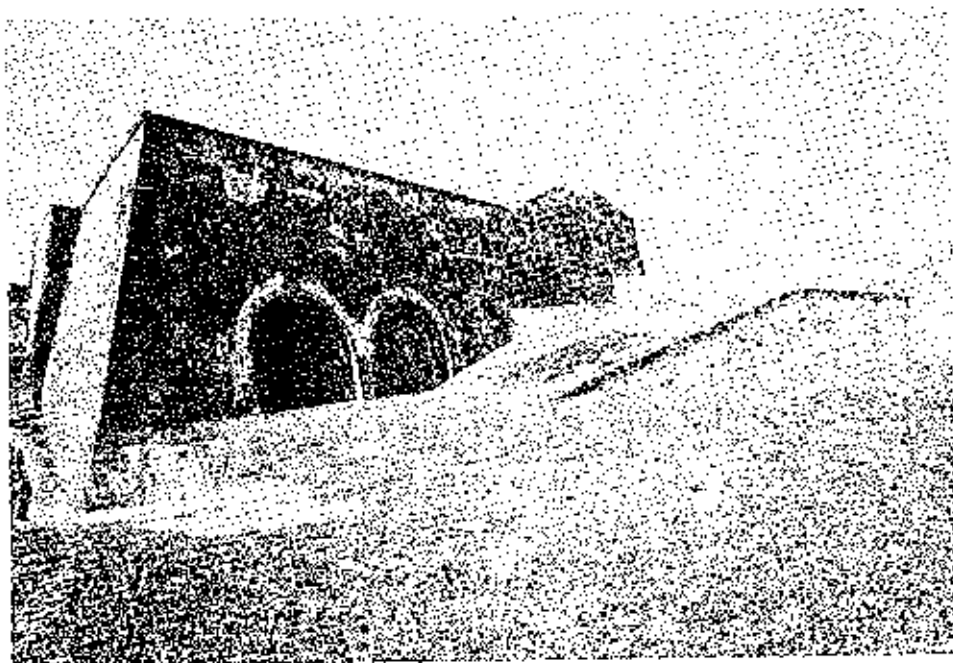
Figure 14.6. Arched openings to casemates extending beneath terreplein of upper level. Photo by CPR, 1986.

On the lower level to the north of the ramp lie the openings to casemates that extend beneath the terreplein of the upper level (fig. 14.6). The two eastern casemates measure about 12 feet by 27 feet. The western casemate about 12 feet square. All three are barrel vaulted chambers. The western and center casemates are linked by a small arched passage.

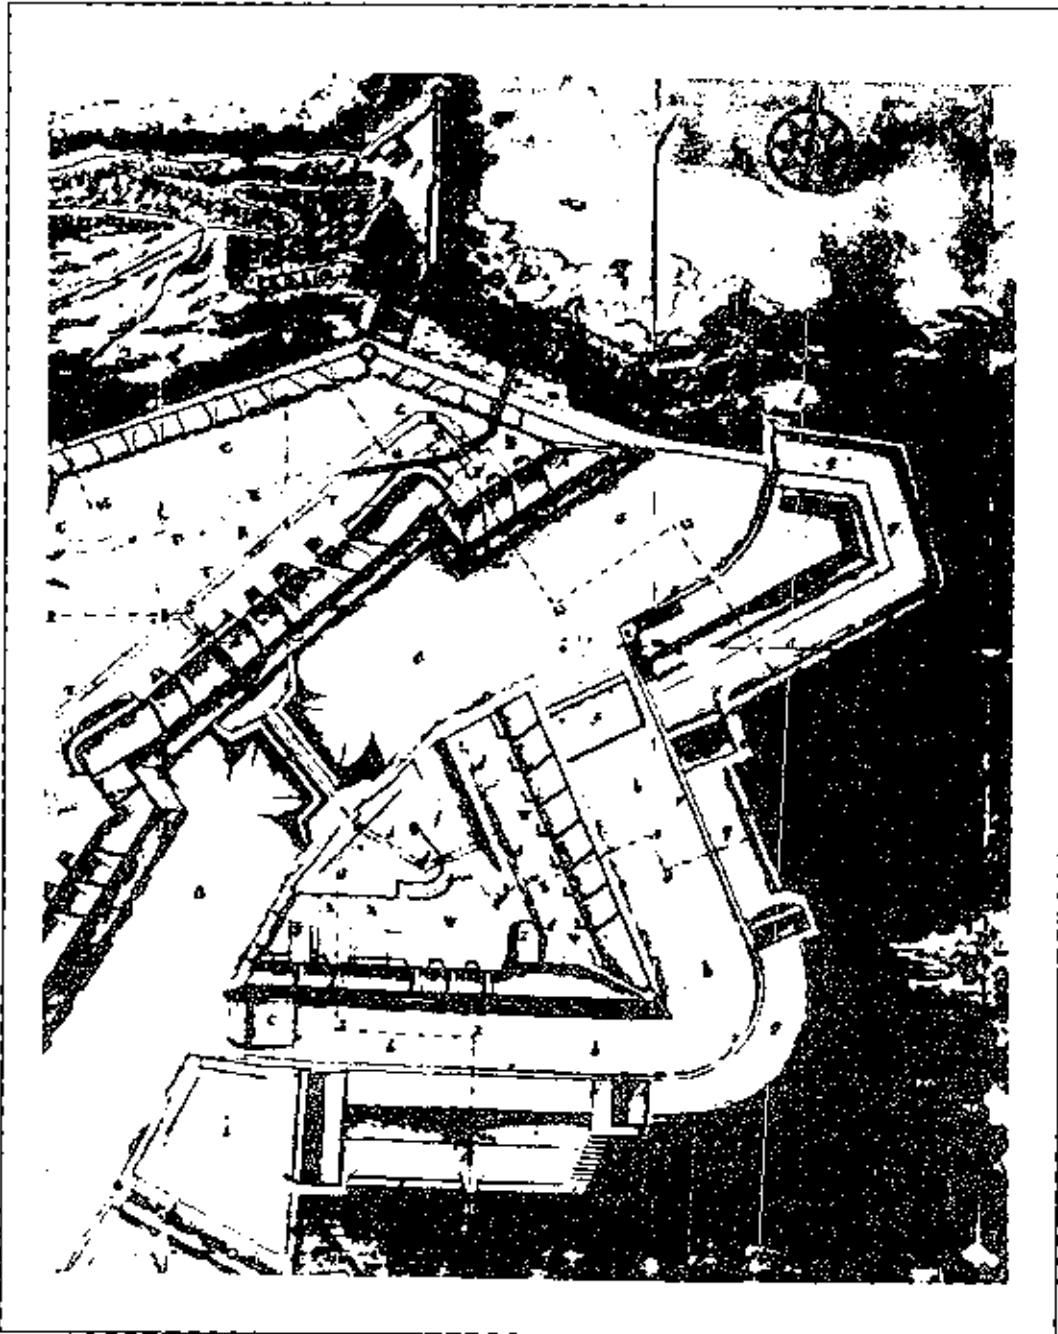
Figure 14.7. Detail of O'Daly proposed plan, January 15, 1769.

In January of 1769, Thomas O'Daly produced a construction plan (fig. 14.7) depicting works from 1766-69. He also documented this work in a report.

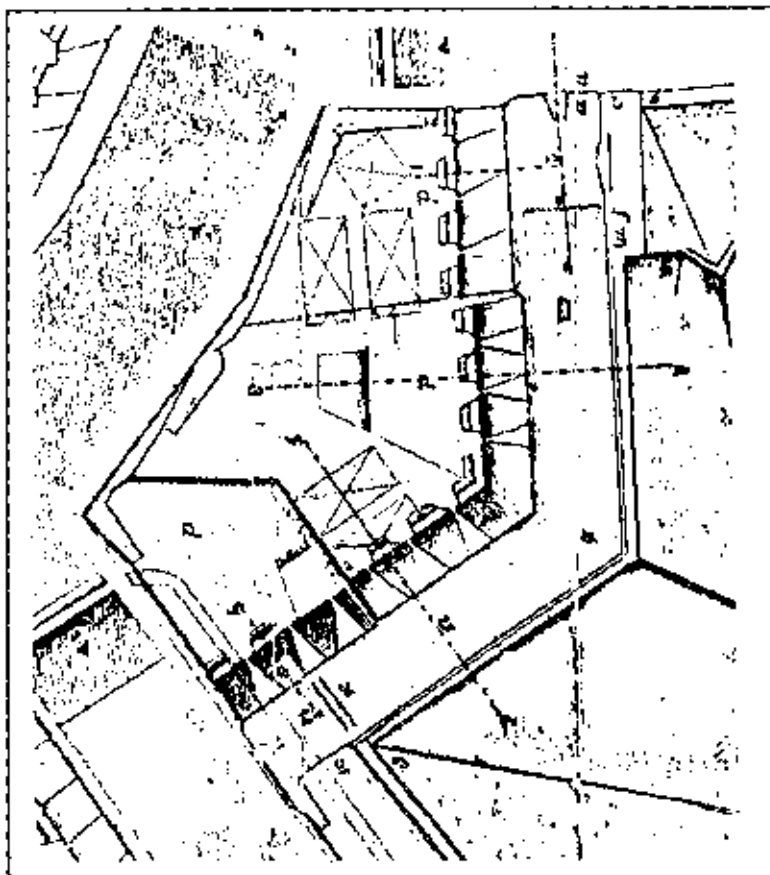
Figure 14.8. Detail of O'Daly plan, August 8, 1773.

On August 8, 1773, O'Daly issued another plan (fig. 14.8) showing la Trinidad with some alterations to the February plan. Again, three embrasures were shown at each level with three banquettes in black; a fourth banquette in red was

shown on the upper level. A small rectangular chamber was shown between the double stairs leading to the upper level. Two casemates were shown at the lower and base levels. A ramp provided access from the lower level to the intermediate level; another ramp allowed access from the base level to the northern esplanade of the base level.

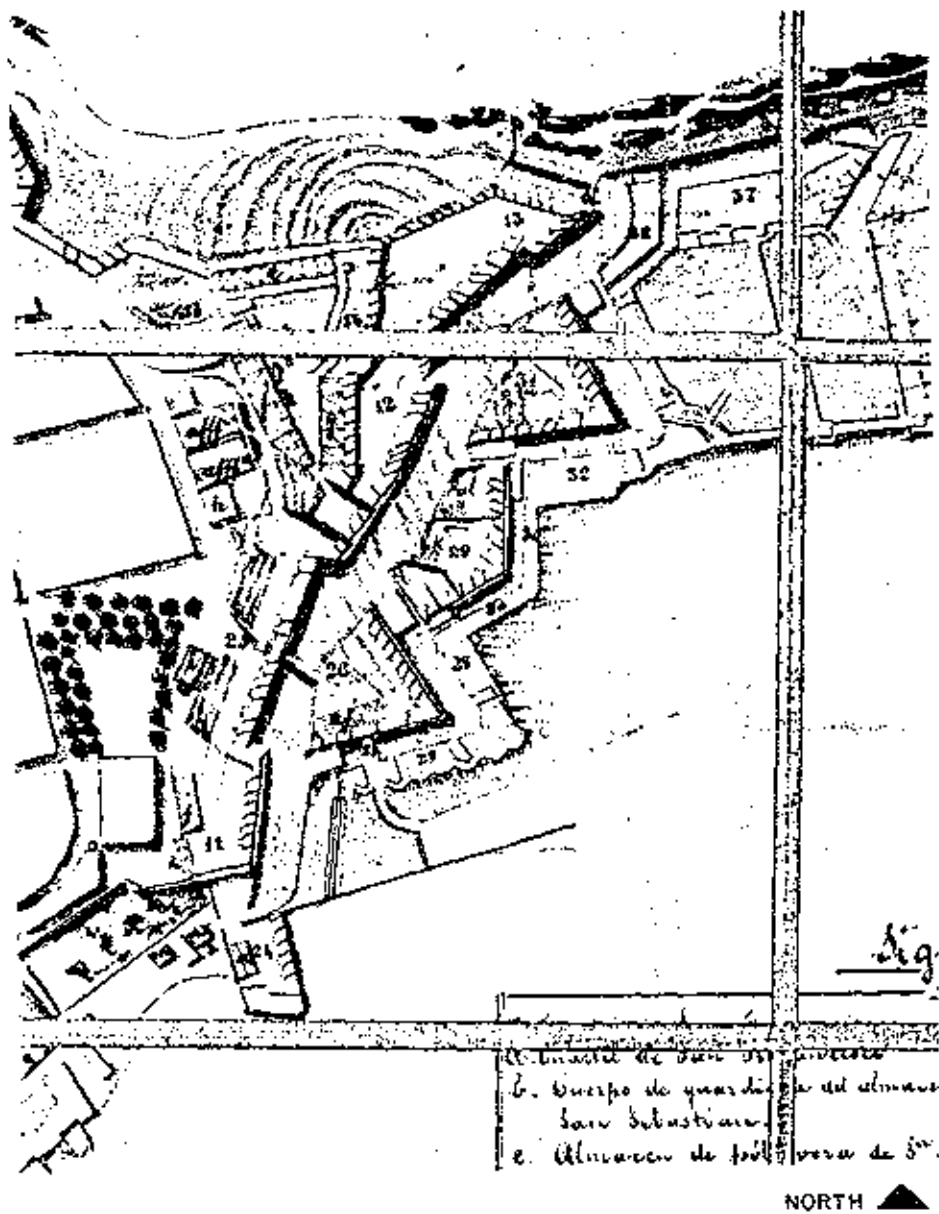
Figure 14.10. Detail of plan dated August 1864 by Manuel de Castro showing la Trinidad labeled "29". (San Juan NHS Collection.)

The De Castro plan of 1861 (dated August 1864) is a small scale plan that does not show a great deal of detail (fig. 14.10). However, it is notable that for the first time the fourth embrasure of the upper level was shown. All of the casemates appeared in blue.

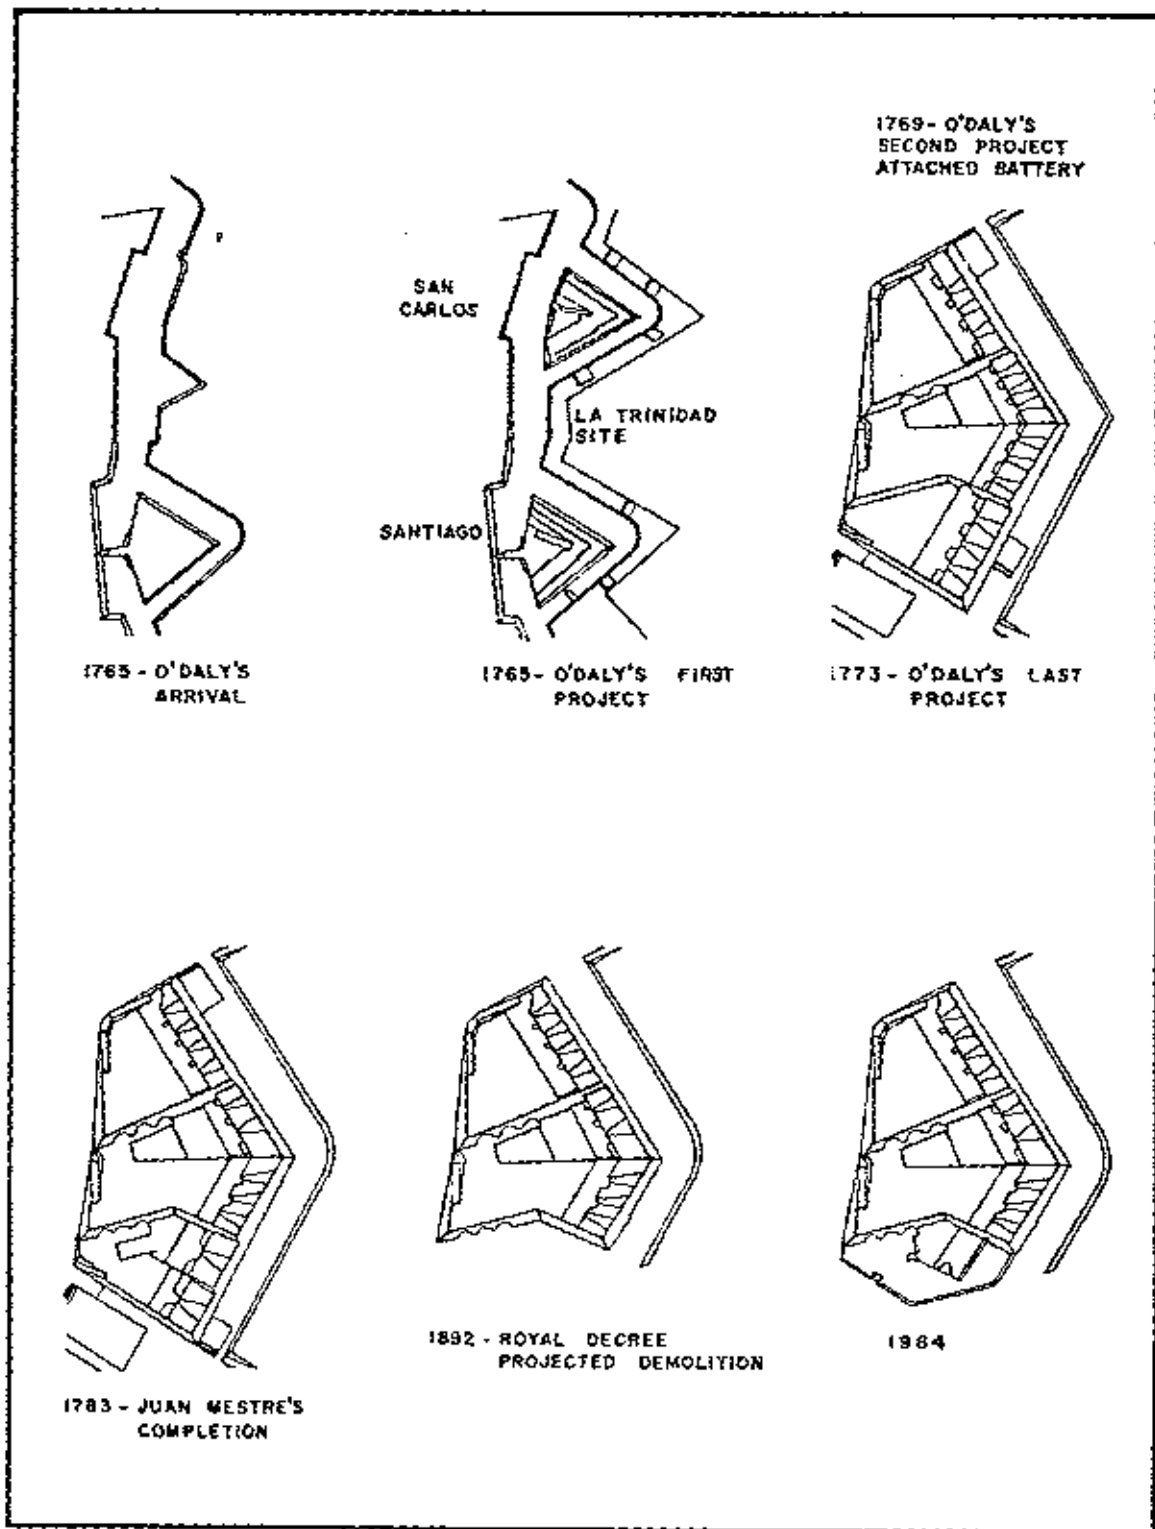
Figure 14.13. The evolution of la Trinidad Counterguard as indicated on KABS cover sheet, 1984.

For a visual overview of the structural evolution of la Trinidad Counterguard see figure 14.13.
