THE FORTIFICATIONS OF SAN JUAN NATIONAL HISTORIC SITE

HISTORIC STRUCTURE REPORT

El Fuerte de San Cristóbal

1991

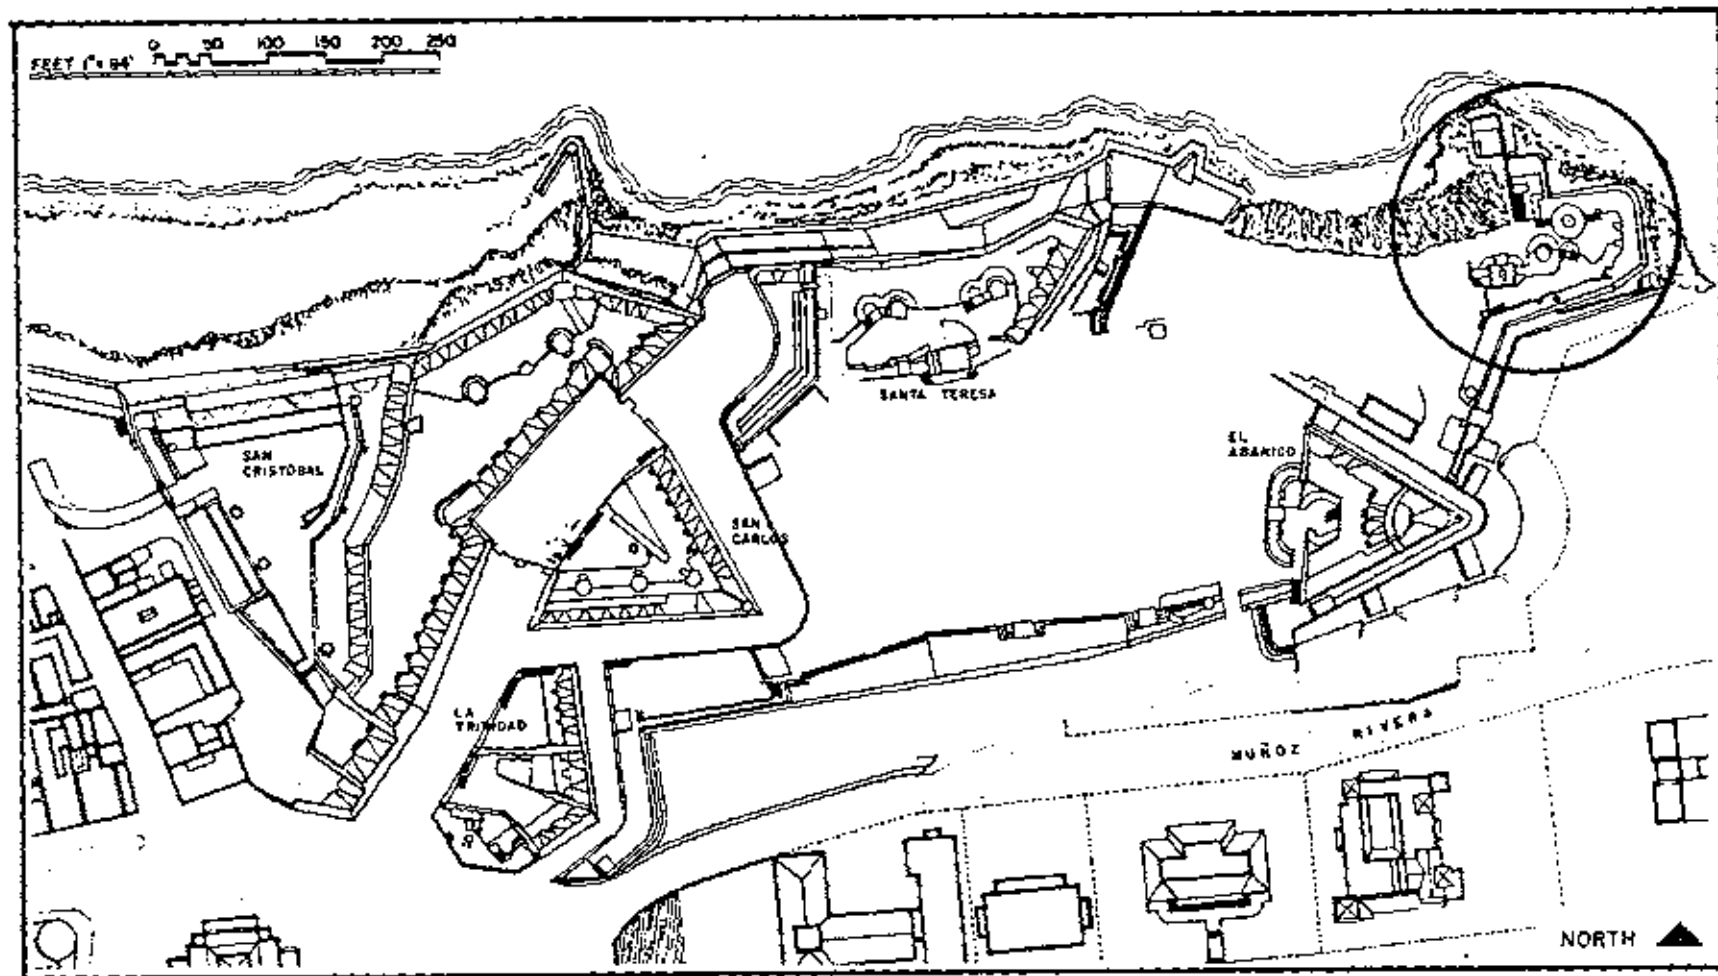
Figure 15.1. Site plan of San Cristóbal with the fort of la Princesa circled. Drawing by HABS, 1984.

The outwork now commonly referred to as la Princesa (fig. 15.1) was originally known as Fuerte de la Princesa (Port of the Princess). It derives much of its architectural interest from surviving features dating to its initial construction between 1779-1783, as well as to subsequent modification projects dating to ca. 1896 and ca. 1940. Its location, adjacent to the Atlantic Ocean, east of San Cristóbal, and north of el Abanico, is emphasized by massive cliff-like walls facing north and east.

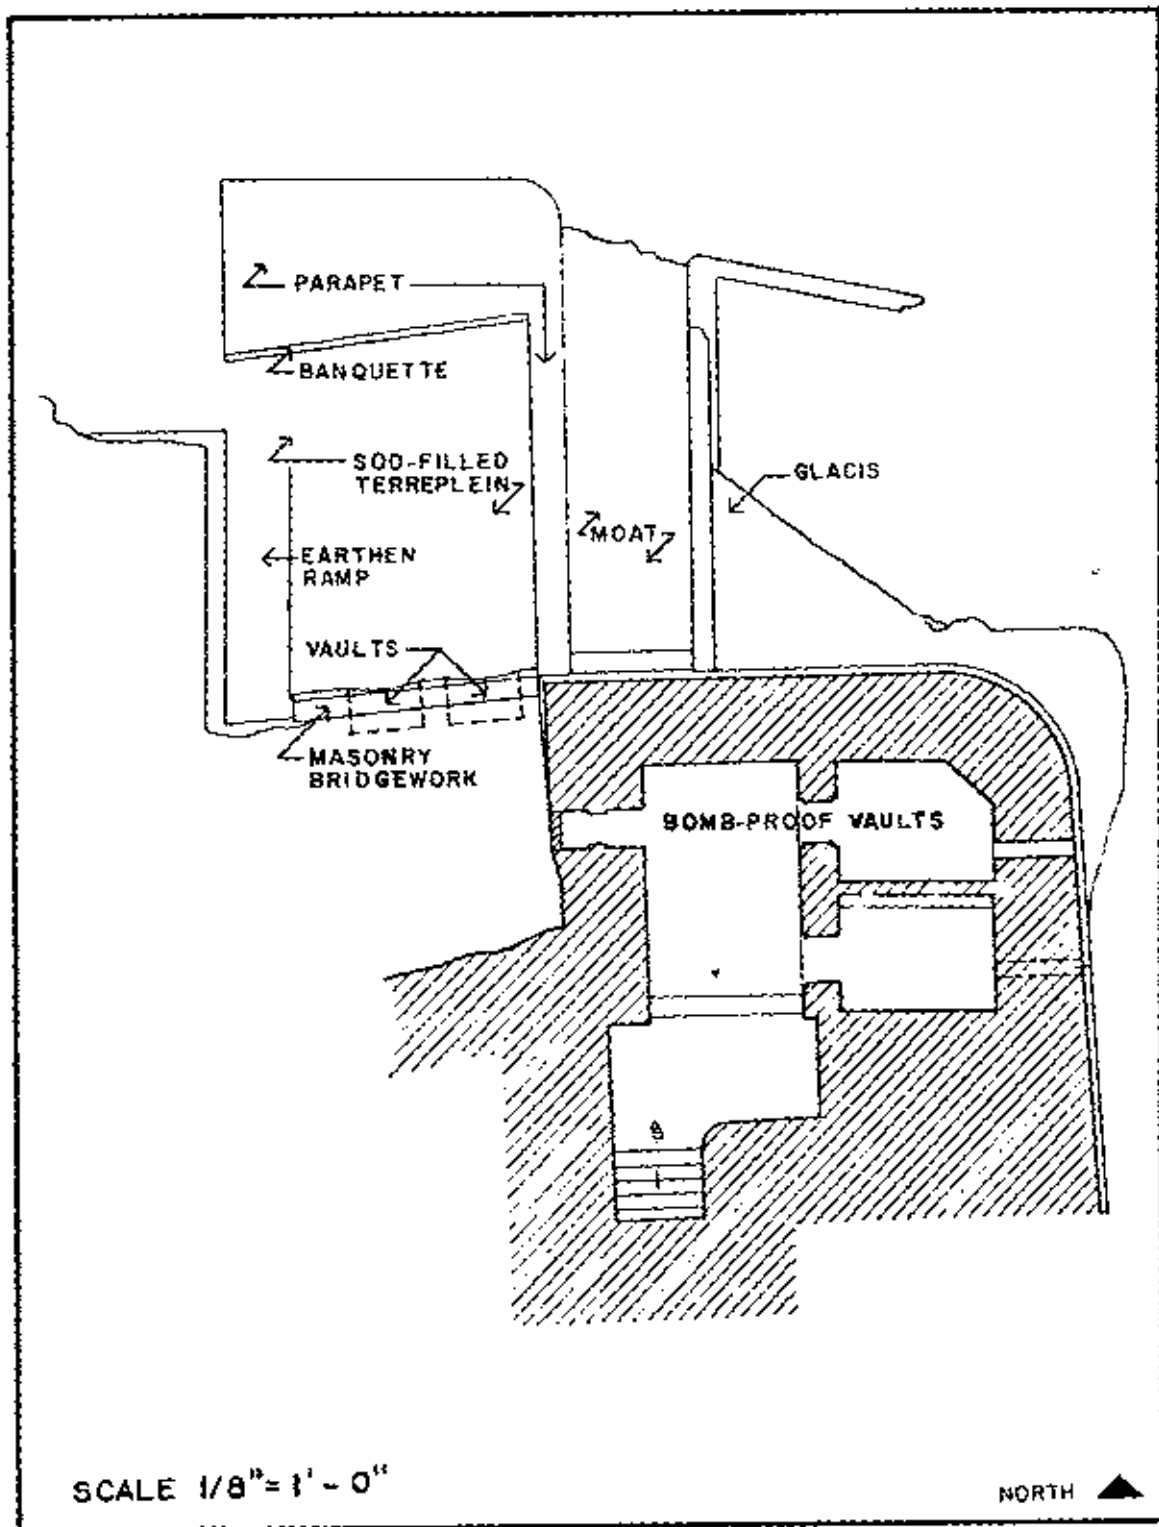
Figure 15.2. Plan of la Princesa detailing the north moat with individual elements labeled. HABS drawing (1963) annotated by Jana Gross (1989).

The north moat is a small section of dry moat projecting from the north face of la Princesa. It slopes down almost to sea level and has vertical walls varying in height. Adjacent to the east side of the north moat is a fragment of a sloping glacis consisting of stucco over stone. The west wall of the moat bends at a right angle towards the west to form a broad sloping parapet. Fragments of a banquette for artillery firing seaward run along the parapet. A sod-filled terreplein (referred to by HABS as North Covered Way) is effectively enclosed on the west and north by this wall and parapet. On the east side of the terreplein/covered way is a small steep earthen ramp leading up to a rubble masonry bridge supported by two elliptical brick vaults. The vaults open onto the south side of the terreplein below and may have served as temporary shelters. (See figs. 15.2 - 15.5.)

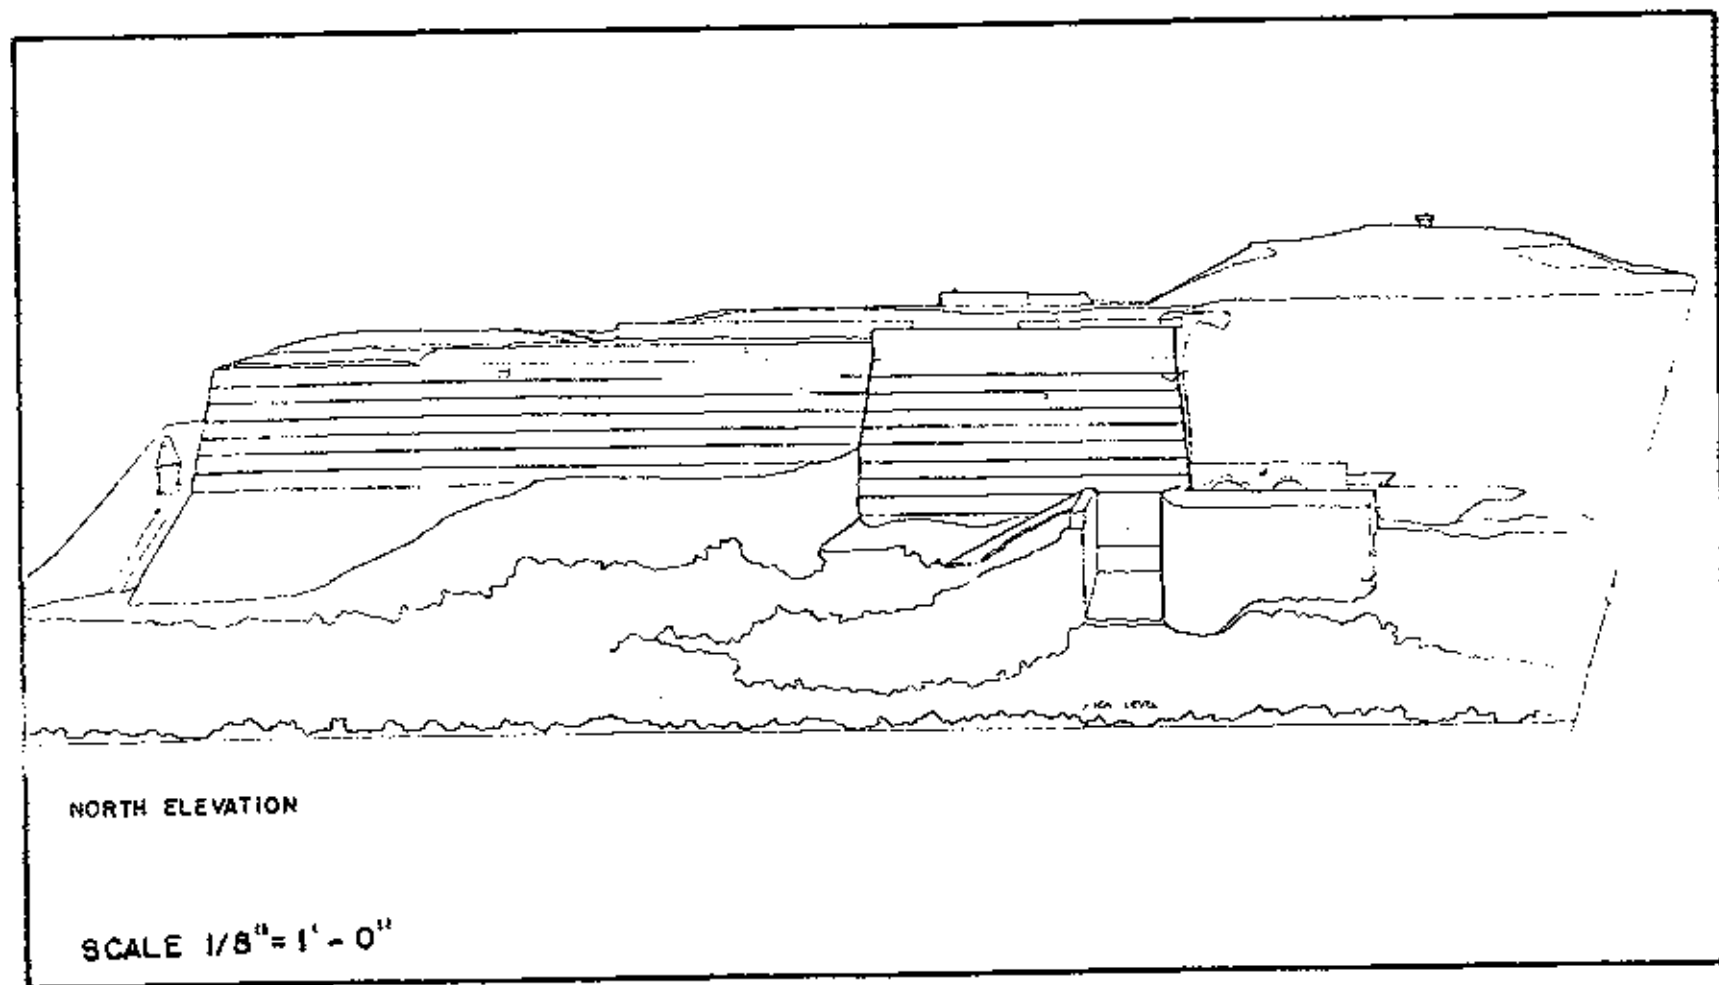
Figure 15.5. North elevation of la Princesa. Drawing by HABS, 1963.

The main parapet walls of la Princesa are steeply-battered, and rise between 50 and 60 feet above sea level. The north and east walls follow the geography of the terrain and jog in roughly two sections adjoining each other at a 90 degree angle in the northeast corner.⁷ (See fig. 15.5.)

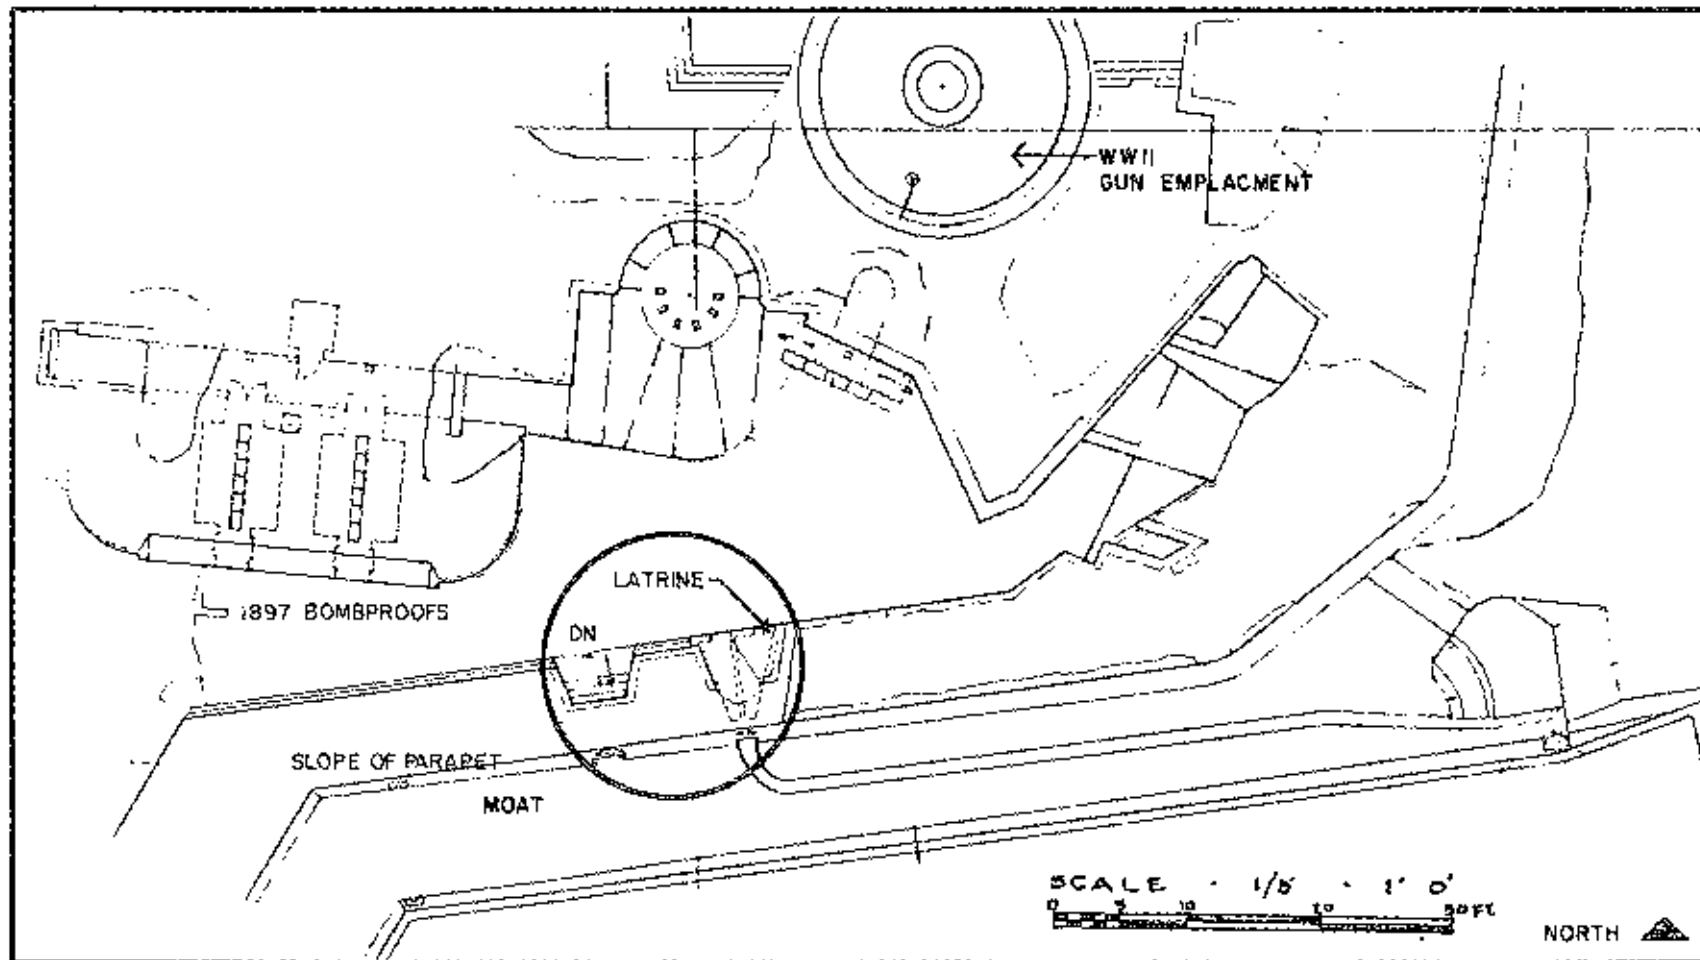
Figure 15.7. Detail of plan of la Princesa with converted embrasures circled. NABS drawing (1963) annotated by Jana Gross (1989).

The sloping south parapet is constructed of rubble and still contains the two surviving eighteenth-century embrasures facing southeast (fig. 15.7). However, both embrasures were modified in the late nineteenth century by constructing a pair of latrines in one and a stairway and doorway in the other.

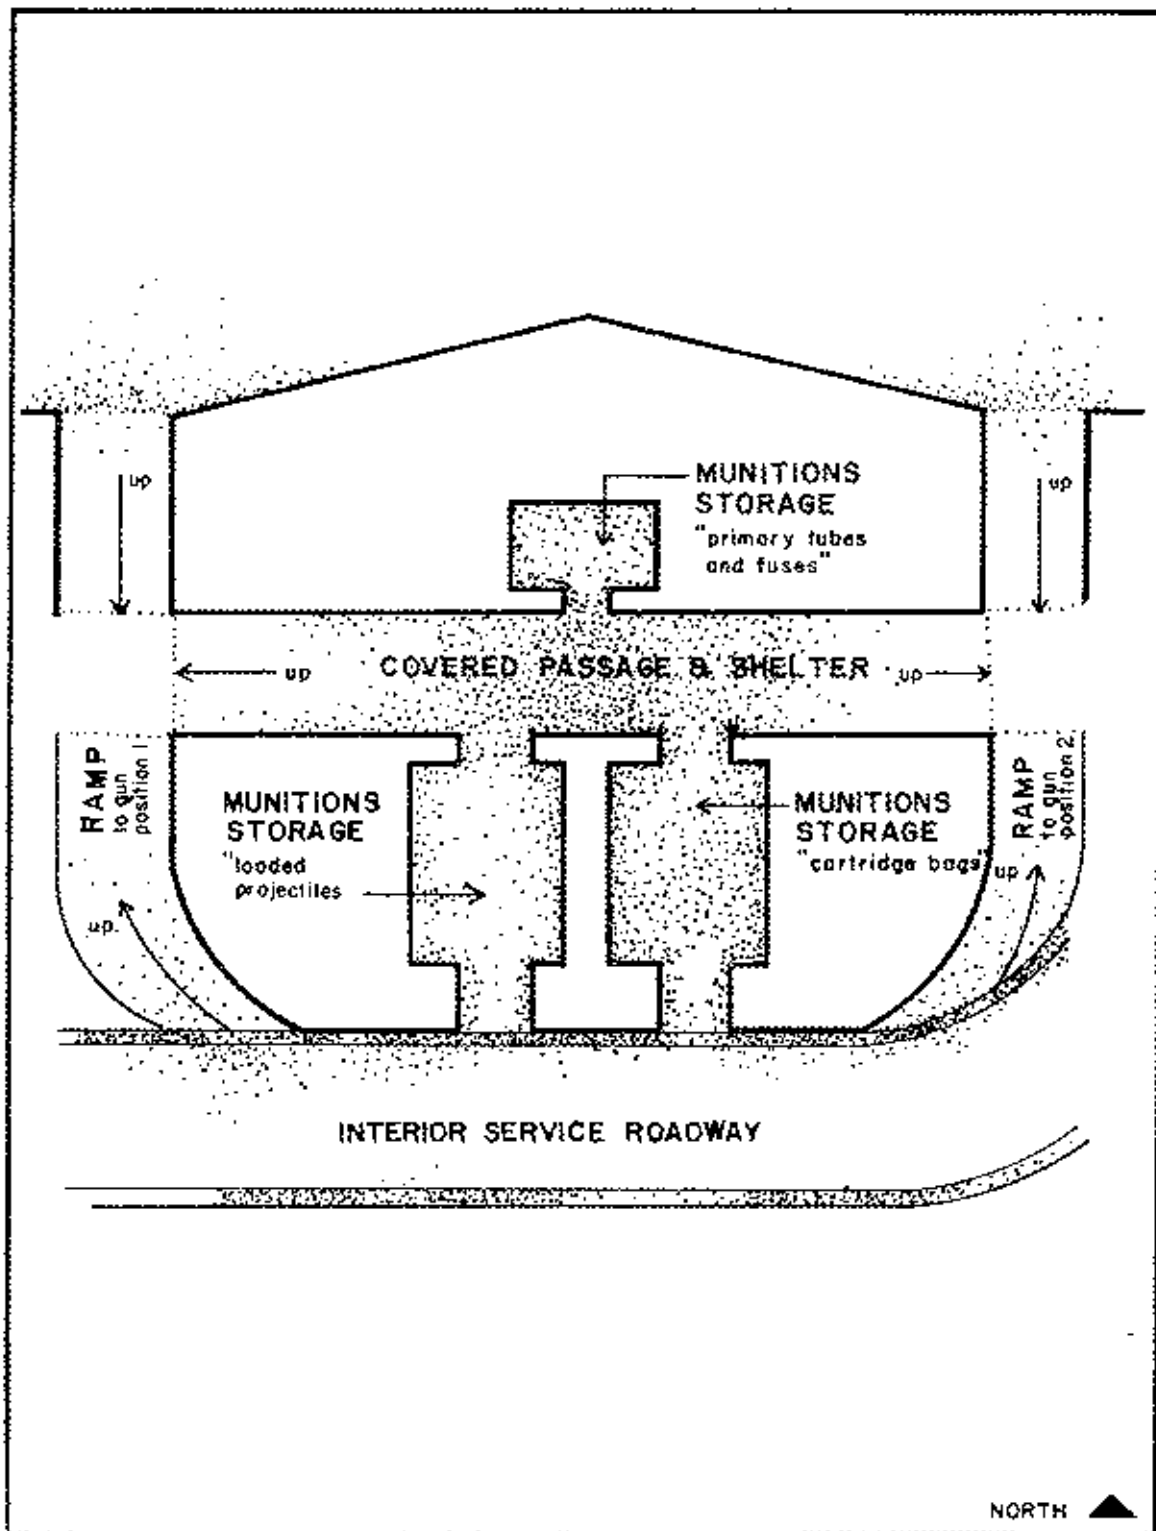
Figure 15.10. Detail of east bombproof located between gun positions 1 and 2. Sketch by Barbara Yokum (1989) is based on the drawing obtained by Colonel Goethals in 1898. (San Juan NHS Archives.)

Each bombproof is vaulted. They were designed to store munitions (projectiles and cartridge bags). The extant east bombproof consists of three chambers: two chambers on the south and one chamber to the north separated by a six-foot wide covered passage (fig. 15.10). Two arched doorways access the southern chambers and have a slightly projecting stylized quoin and vousoirs. North doorways of the same chamber are of black welded steel with deep reveals. The interior walls of the vaulted chambers are plain, with whitewashed or painted plaster surfaces. The floor is concrete with a center drain. The vaulted rooms are unused. No visible evidence remains of the 1903-04 electric lighting, nor of any other mechanical system.

traverses to be 39 feet wide by 33 feet deep and the centraltraverse to be 6 feet 6 inches wider. The south elevation (dated ca. 1897) showed the eastern and middle traverses with ramps, and the western traverse with steps that led to the gun positions. The traverses were to serve as a protected shelter for the gunmen, and in the case of the east and west traverses, as a safe passage between gun positions. Within each of the three traverses is one or more bombproof vaults, generally referred to as "bombproofs." (See fig. 15.10.)

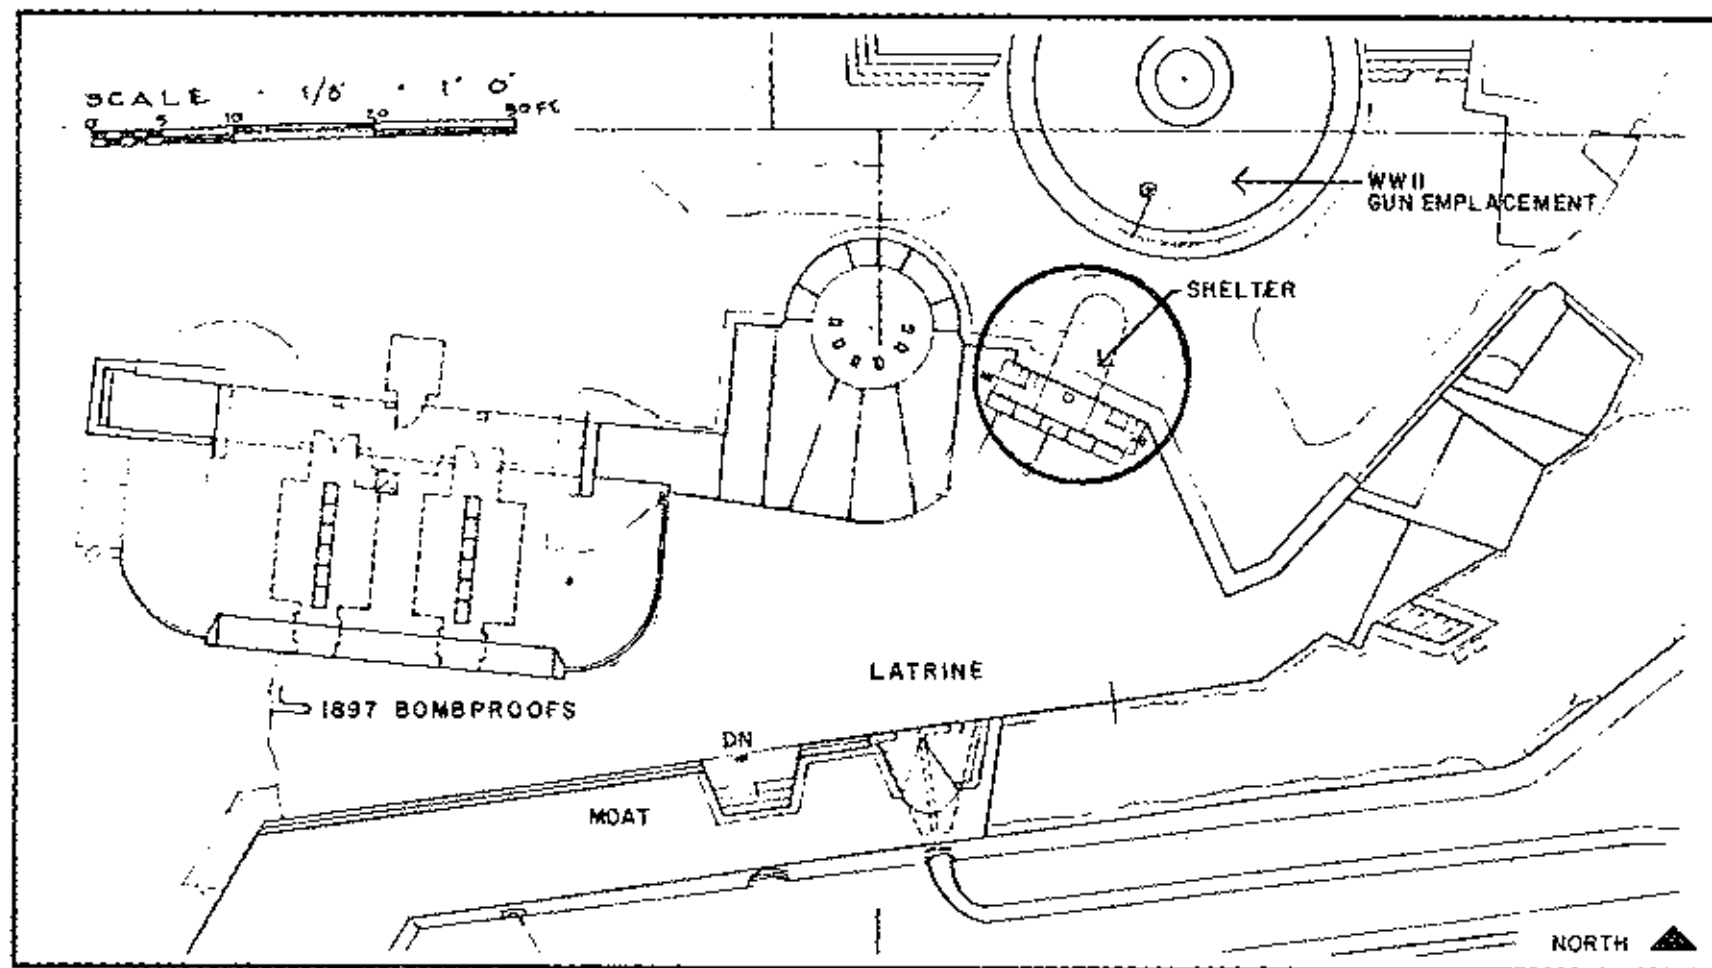
Figure 15.11. Detail of la Princesa plan with u-shaped shelter for soldiers stationed at gun position 1 circled. Drawing by HABS, 1963.

On the east side of the gun position within the north parapet is a small u-shaped recess (fig. 15.11). The recess is accessed by two small concrete stairways: one leading east and the other west. This feature would have provided cover for soldiers stationed at gun position no. 1. One of four circular gun blocks installed in 1940-41 remains extant at the far east of the parapet, northeast of the 1897 gun emplacements and bombproof. It is constructed of concrete and has an iron cog track within its outer edge.

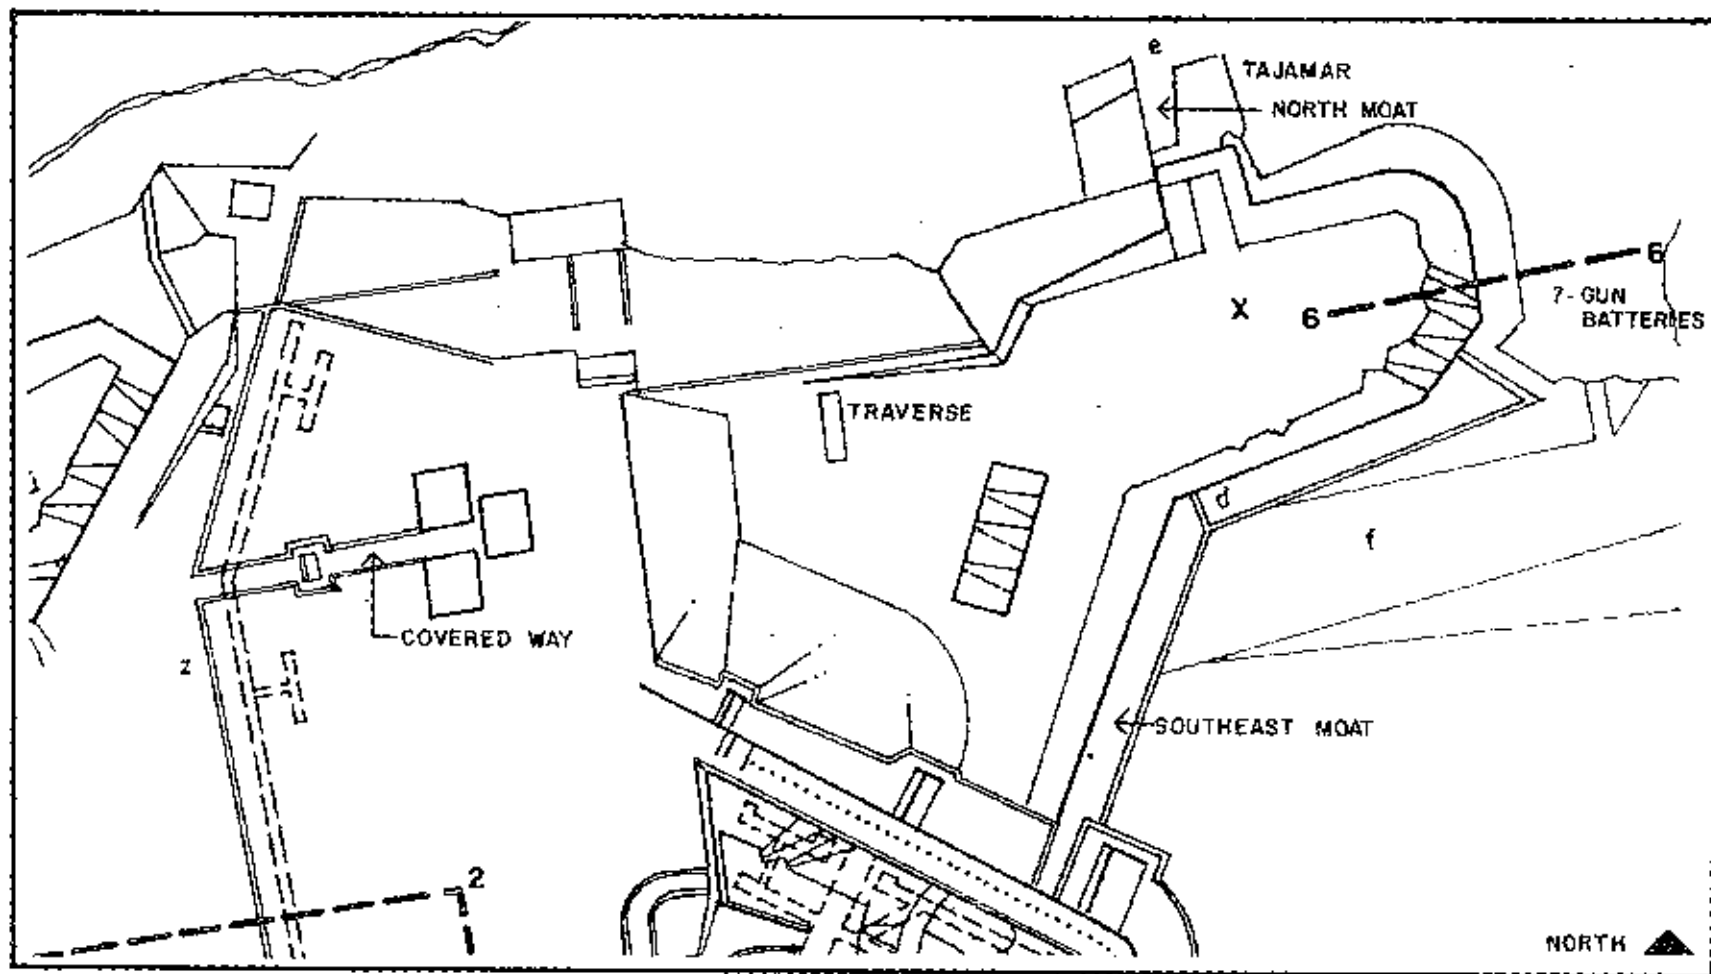
Figure 15.12. Detail of Mestre's 1783 plan showing la Princesa. Tracing of original by Torres-Reyes in Construction History of San Cristóbal, 1965.

To the south of the moat, on the east side, earth was removed and a ramp to the beach formed. According to Mestre in 1783, the ramp was covered with sod to prevent erosion. This feature was labeled "f" on the plan of 1783 and "R" on the plan of 1795. (See figs. 15.12 and 15.13.)

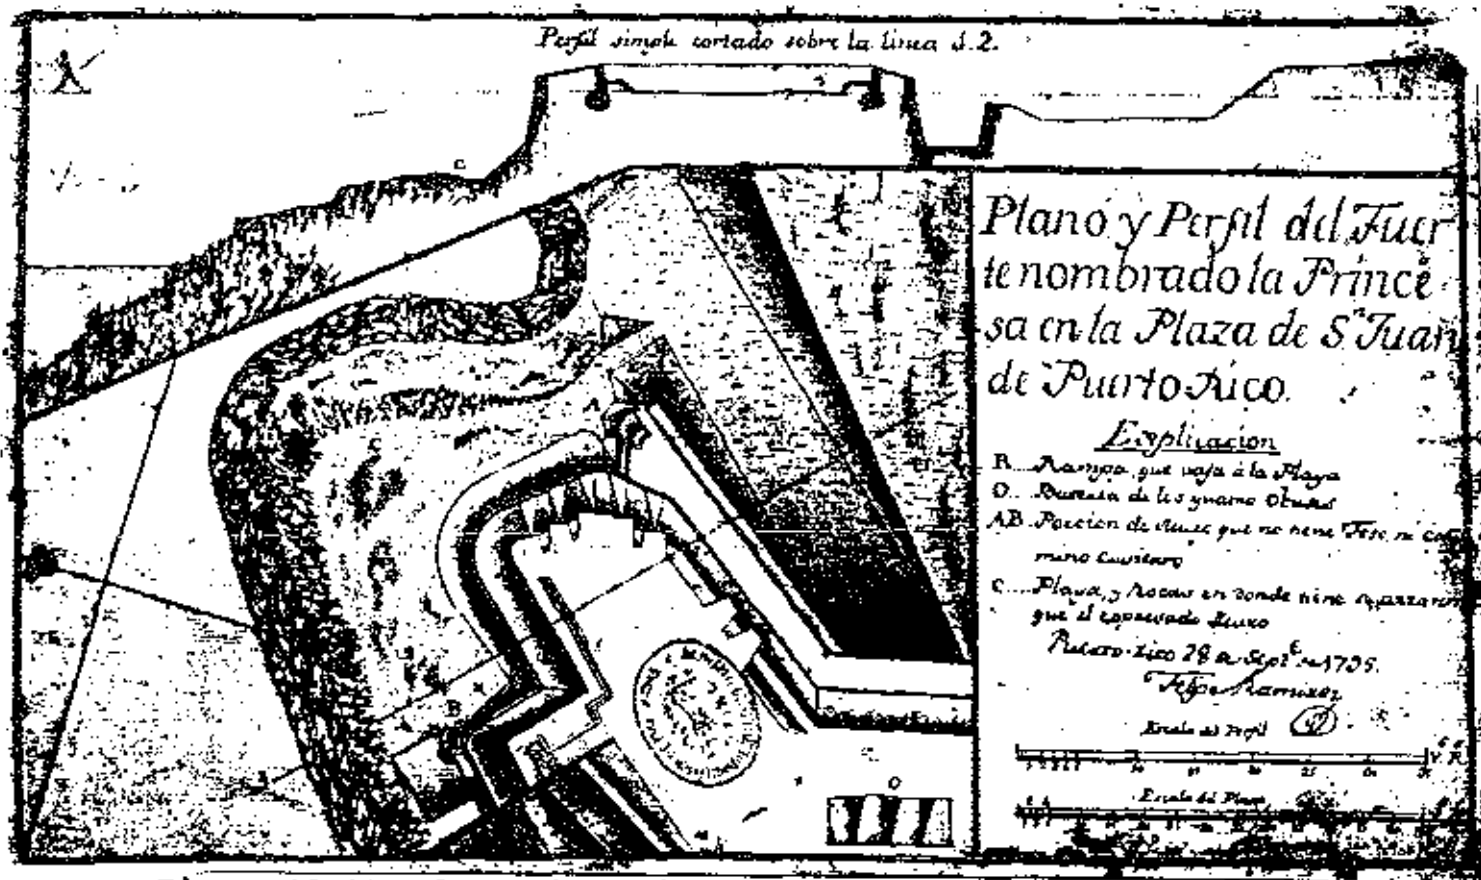
Figure 15.13. Plan and profile of la Princesa by Felipe Ramirez, September 28, 1795. (San Juan NHS Archives.)

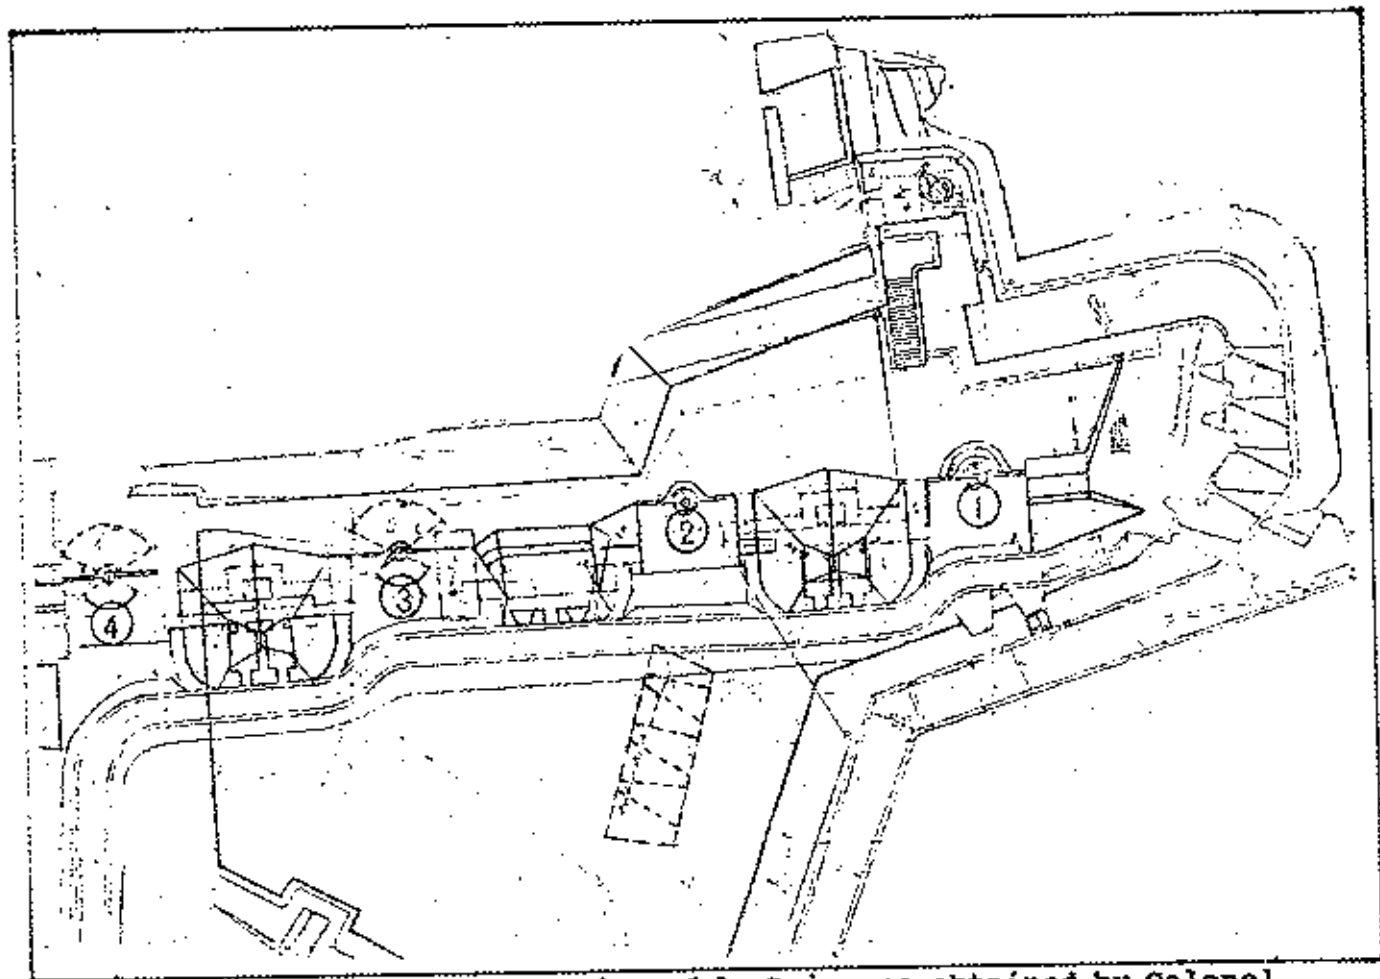
Figure 15.14. Spanish drawing of la Princesa obtained by Colonel Goethals in 1898 showing the new battery. (San Juan NHS Archives.)

Exterior communication between gun positions was by means of a new road located on the south side of the new gun positions. (See fig. 15.14.) This road ran in a westerly direction from gun position 1 to gun position 4 where it then turned south towards el Abanico. The bombproof chambers and the gun esplanades were both accessible from the roadway. The esplanades were accessed by means of ramps directly connected to the road. The road was paved with concrete, as was the area between gun position 1 and the east parapet wall. Draining the roadway were gutters located on either side.

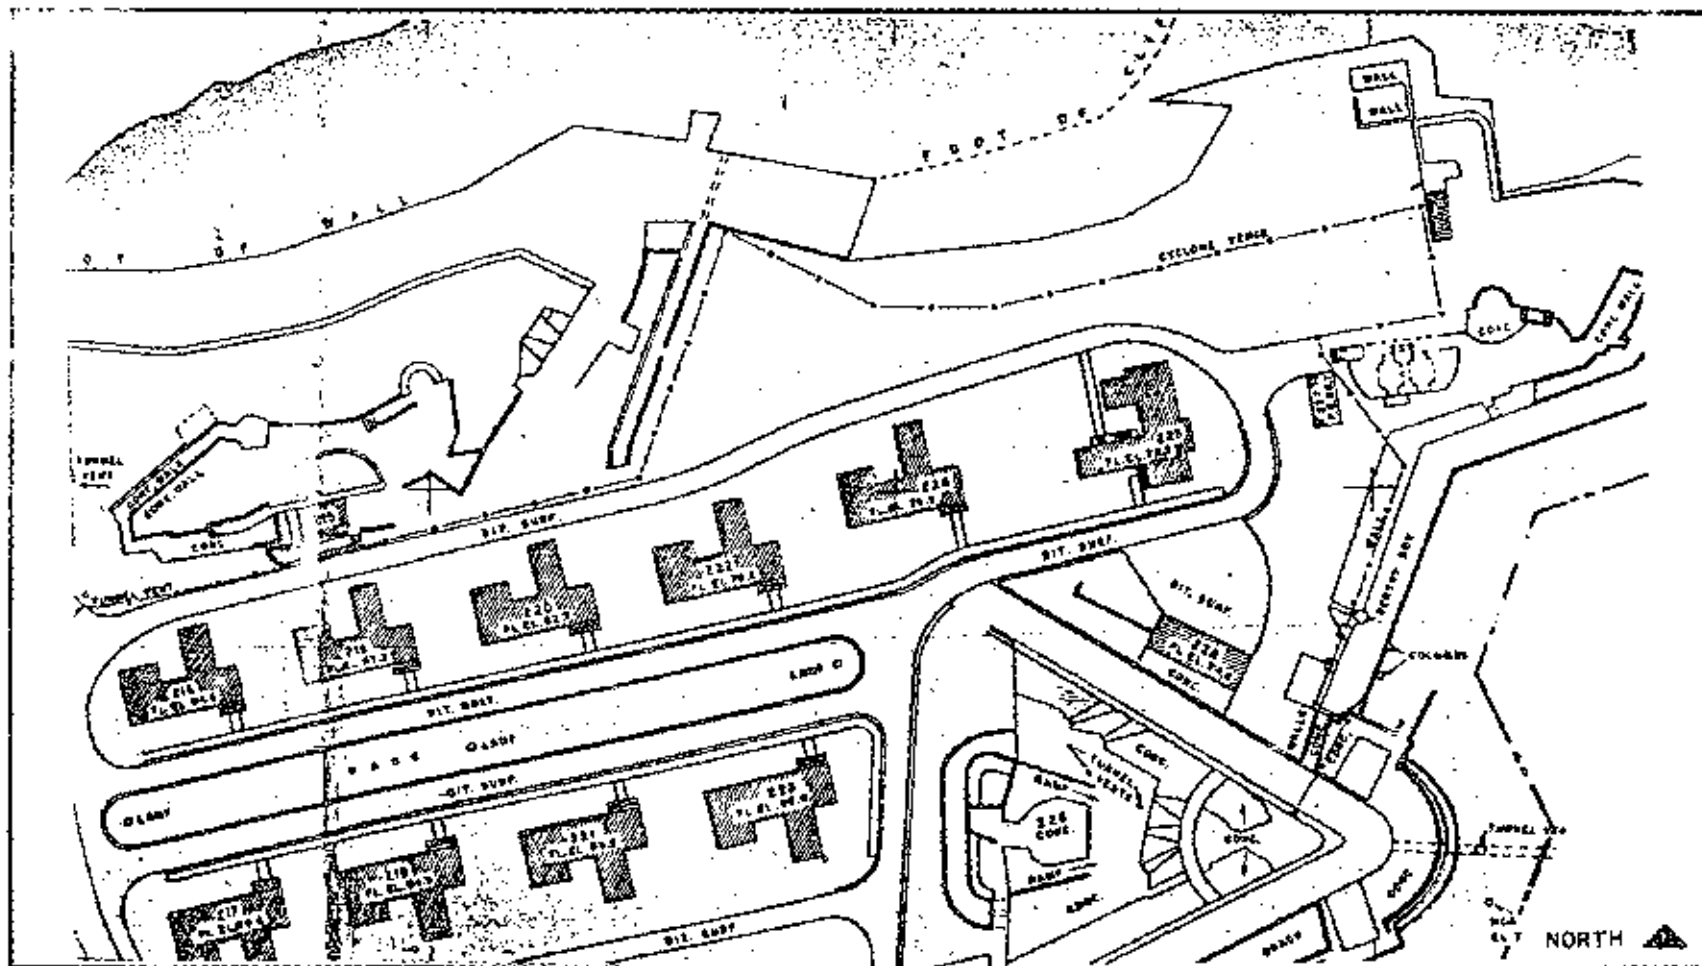
Figure 15.16. Plan showing new army housing on portions of La Princesa, 1949. (San Juan NHS Archives.)

The most significant alteration occurred in January of 1930 when construction of ten reinforced concrete structures to house military personnel commenced. Preparatory work involved destroying most of the 1895-97 battery with dynamite and hauling away the debris. Removed at this time were gun positions 2, 3, and 4; the center traverse and center bombproof that had housed the infirmary; the west traverse and west end bombproof that had stored munitions for the cannon emplaced at positions 3 and 4; and the shelter on the far west side of gun position 4. Left standing were gun position 1, the east traverse and east end bombproof, and the small shelter on the far east side of gun position one. New buildings constructed in the immediate vicinity of la Princesa battery were building no. 227 (garage) at former gun position 2, no. 225 (house) at former gun position 3, and no. 224 (house) at former gun position 4. Four additional houses were constructed along the north parapet and four were built just west of the entrance to el Abanico. Houses were built in two rows along a new road providing vehicular access. (See figs. 15.15 and 15.16.) Installed beneath the pavement were water lines, electrical conduit, and pipe drains.²¹

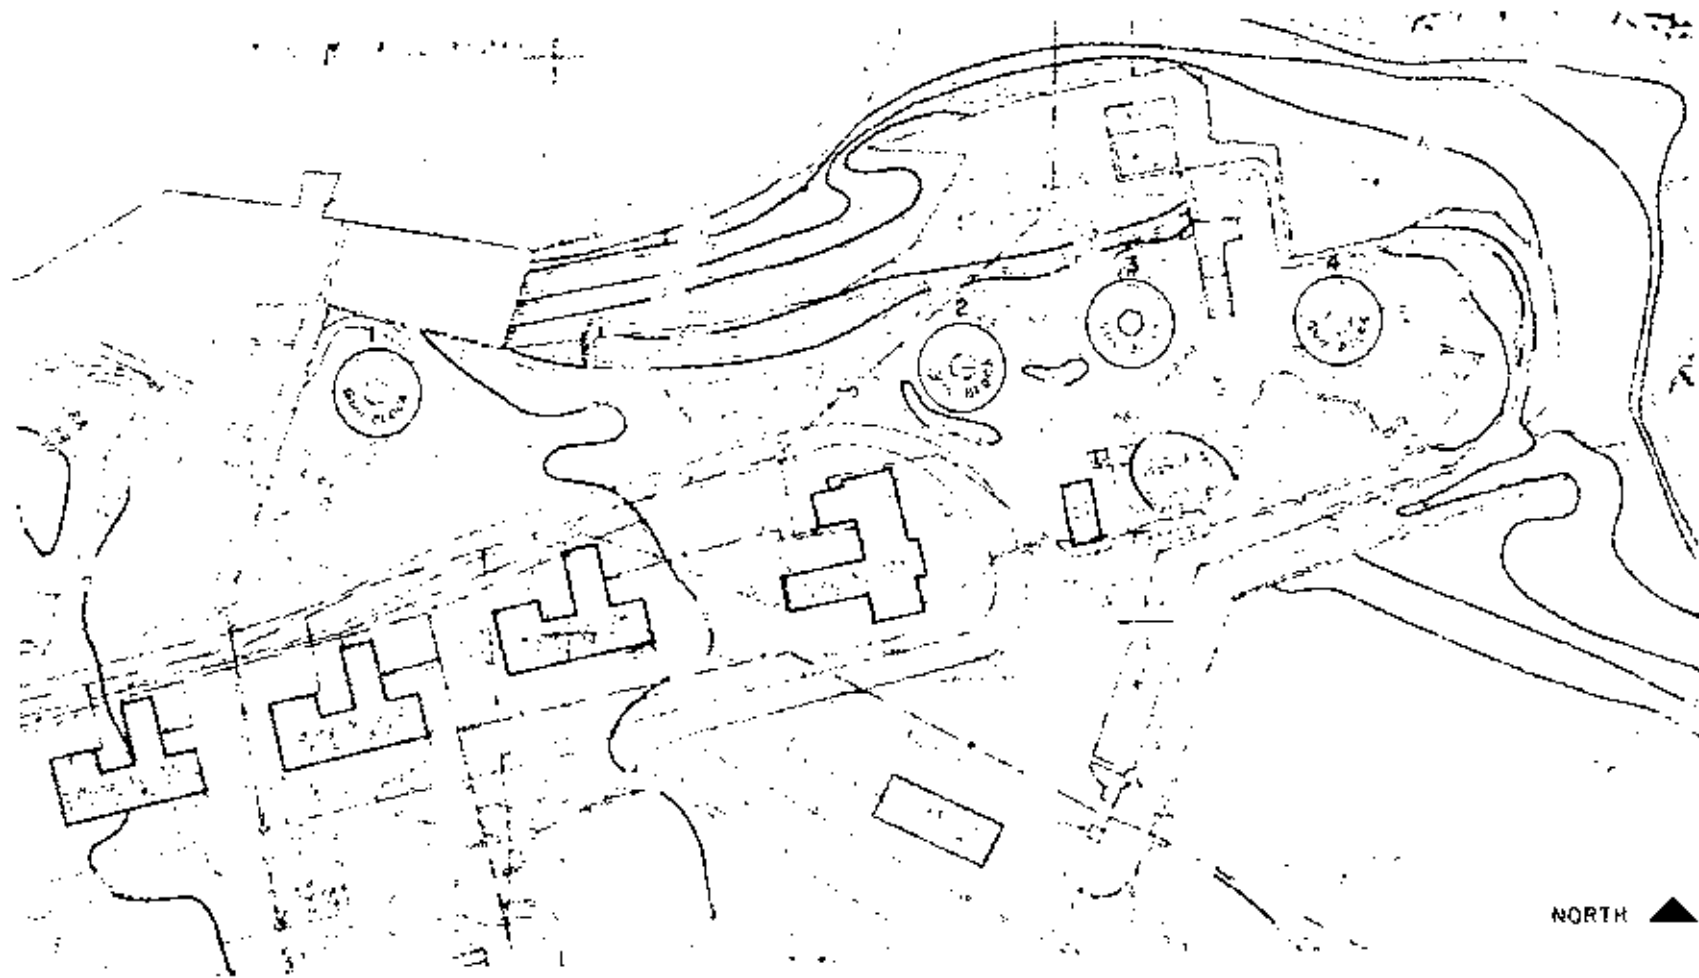
Figure 15.17. Detail of plan showing impact of 1930's housing and World War II gun blocks on la Princesa, 1949. (San Juan NHS Archives.)

La Princesa was rehabilitated again during 1940-41 in preparation for World War II. Four modern emplacements for 155-mm guns were constructed along the north coast. The exact locations of these gunblocks were illustrated in a later "as built" plan dated 1949 (fig. 15.17). Three emplacements were

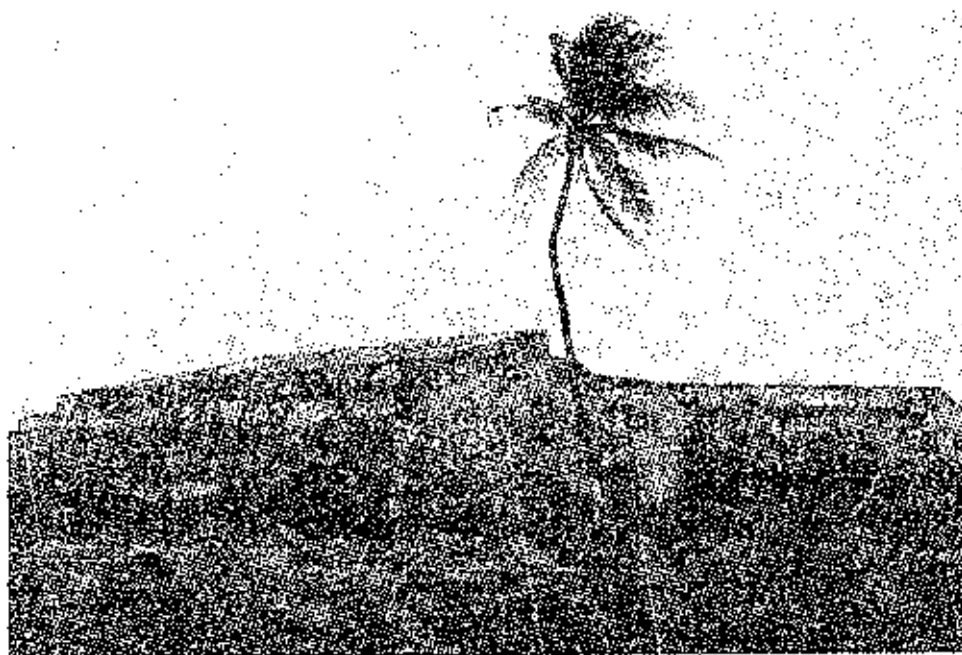
Figure 16.2. North and west elevations of el Abanico. Photo by Richard Crisson, 1986.

The outwork of el Abanico is located due east of San Cristóbal and south of la Princesa, on a low hill overlooking the north coast and the modern city of San Juan. It was designed to be a natural extension of the terrain and is oriented to face the original land front. Historically known as Fuerte del Abanico (Fort of the Fan), it was built between 1779-1783. The design of el Abanico was dictated by a crossfire pattern for the three gun emplacements in the "fan battery." Although it is similar in design to a ravelin, (a projecting outwork forming a salient angle), it is actually a small fort detached from the principal fortification and can be considered a redoubt. (Fig. 16.1, 16.2, 16.3.)

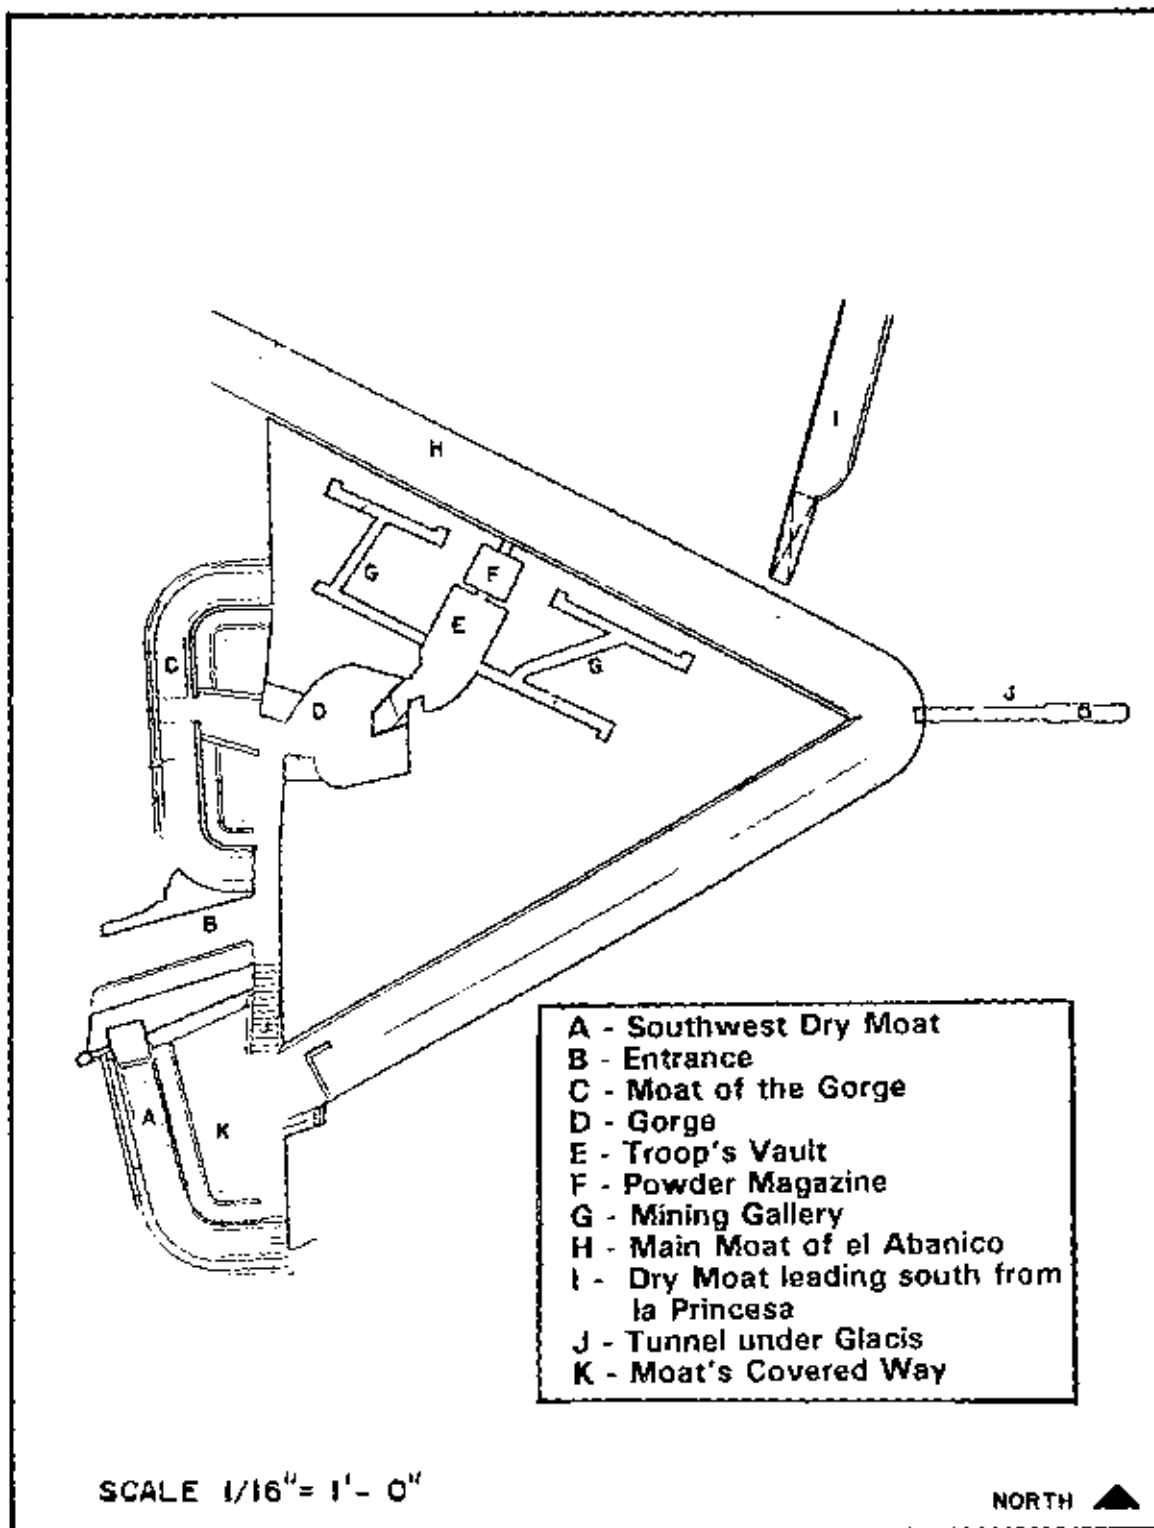
Figure 16.4. Plan of el Abanico with selected elements labeled. Detail of KABS plan (1963) as annotated by Jana Gross (1989).

In plan, el Abanico is an equilateral triangle located on a natural rise of strategic importance. El Abanico completed the north to south boundary of San Cristóbal: the third line of defense. For purposes of this study, discussion of el Abanico will be arranged in a roughly west to east direction. The features to be discussed include the covered way at the entrance (B), the gorge (entrance area) with its moat (D, C), the north and south ramps, the "fan battery", the north and south terrepleins, the main moat (H), the dry moat at the southwest (A), the moat's covered way (K), and the glacis. (See fig. 16.4, 16.5.)
