THE FORTIFICATIONS OF SAN JUAN NATIONAL HISTORIC SITE

HISTORIC STRUCTURE REPORT

El Fuerte de San Cristóbal

1991

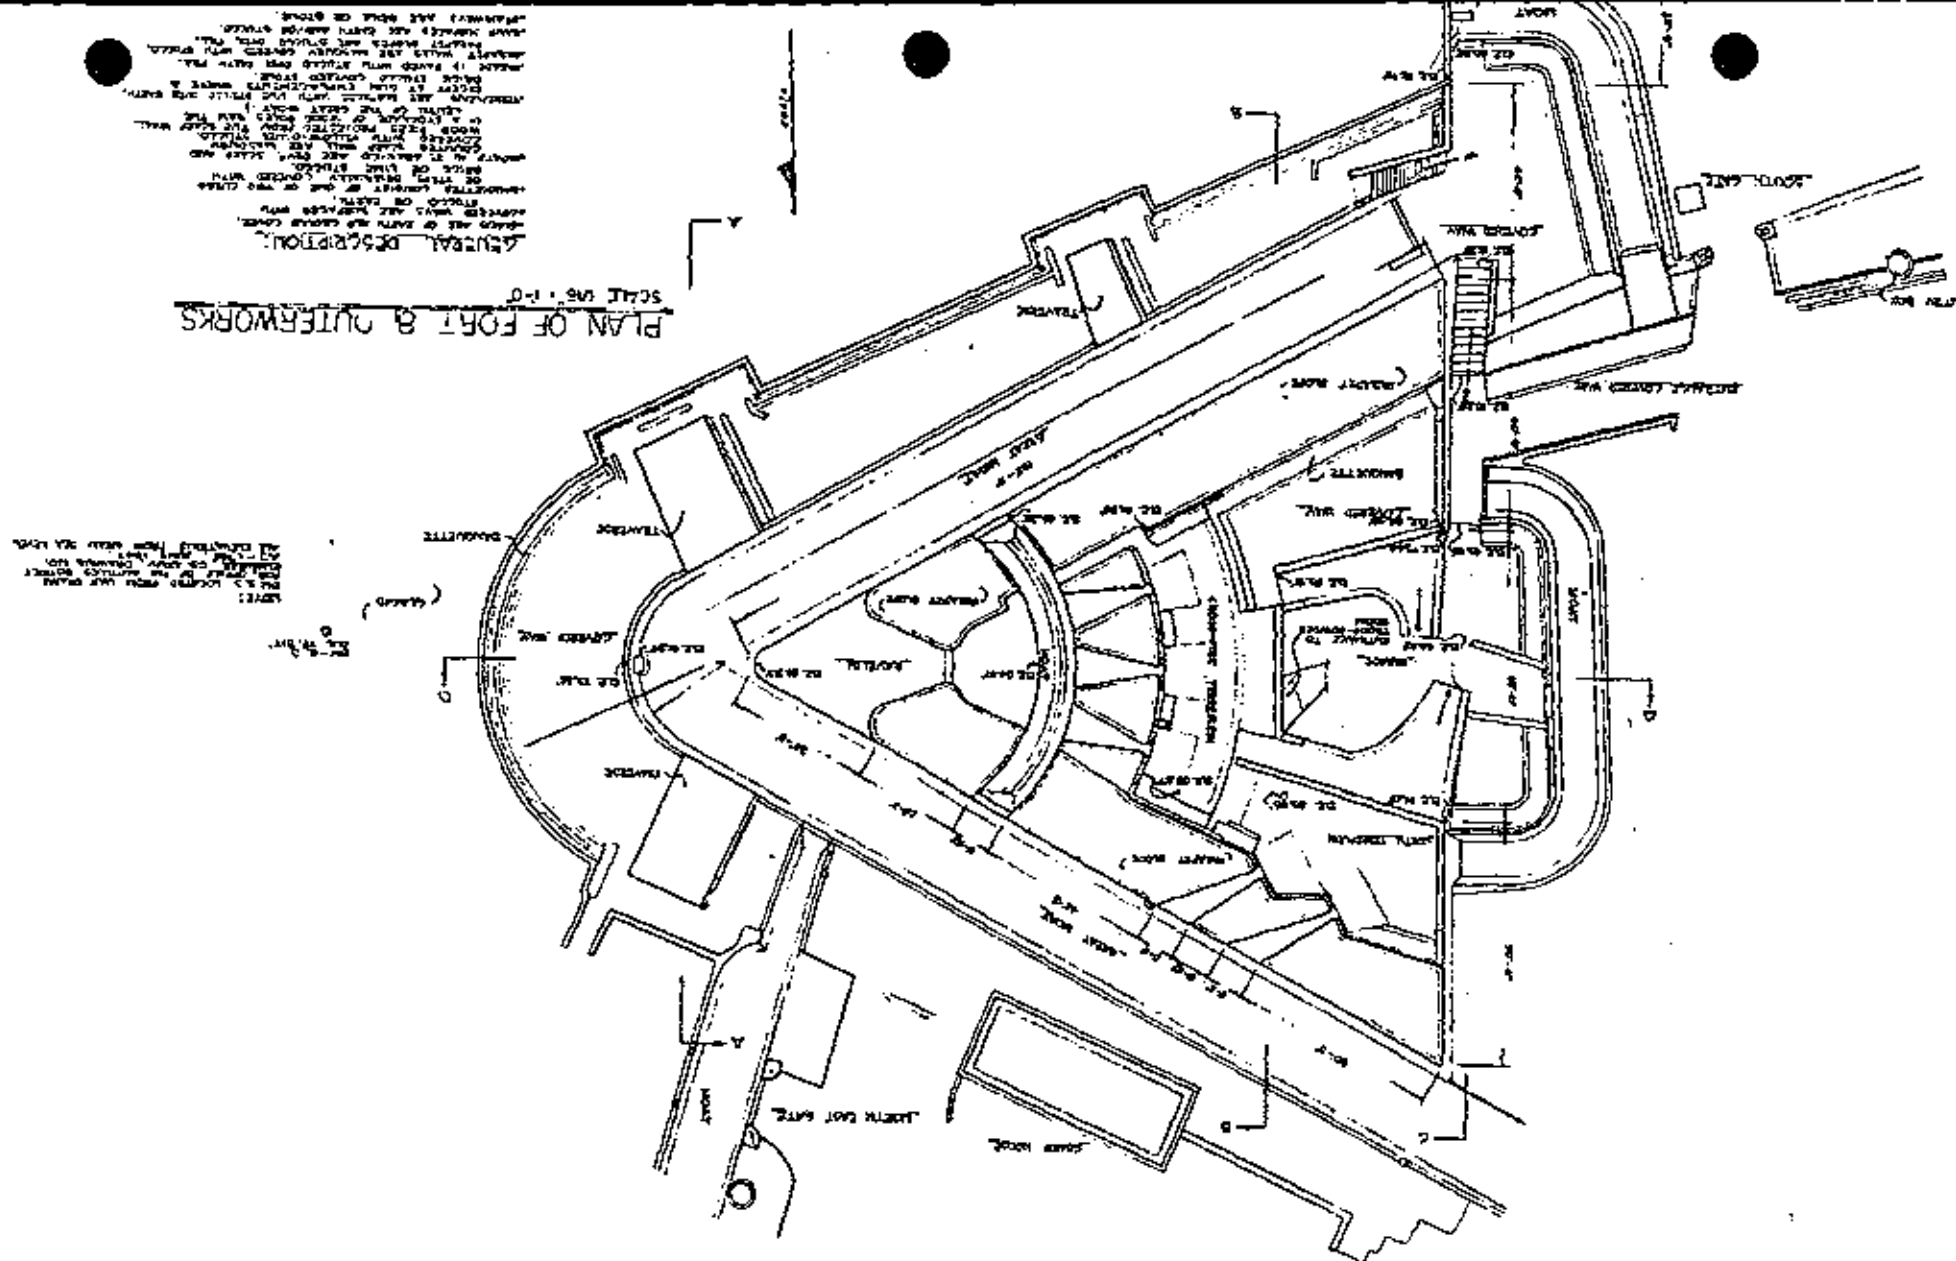
Figure 16.5. Plan of el Abanico by HABS, 1963.

In plan, el Abanico is an equilateral triangle located on a natural rise of strategic importance. El Abanico completed the north to south boundary of San Cristóbal: the third line of defense. For purposes of this study, discussion of el Abanico will be arranged in a roughly west to east direction. The features to be discussed include the covered way at the entrance (B), the gorge (entrance area) with its moat (D, C), the north and south ramps, the "fan battery", the north and south terrepleins, the main moat (H), the dry moat at the southwest (A), the moat's covered way (K), and the glacis. (See fig. 16.4, 16.5.)

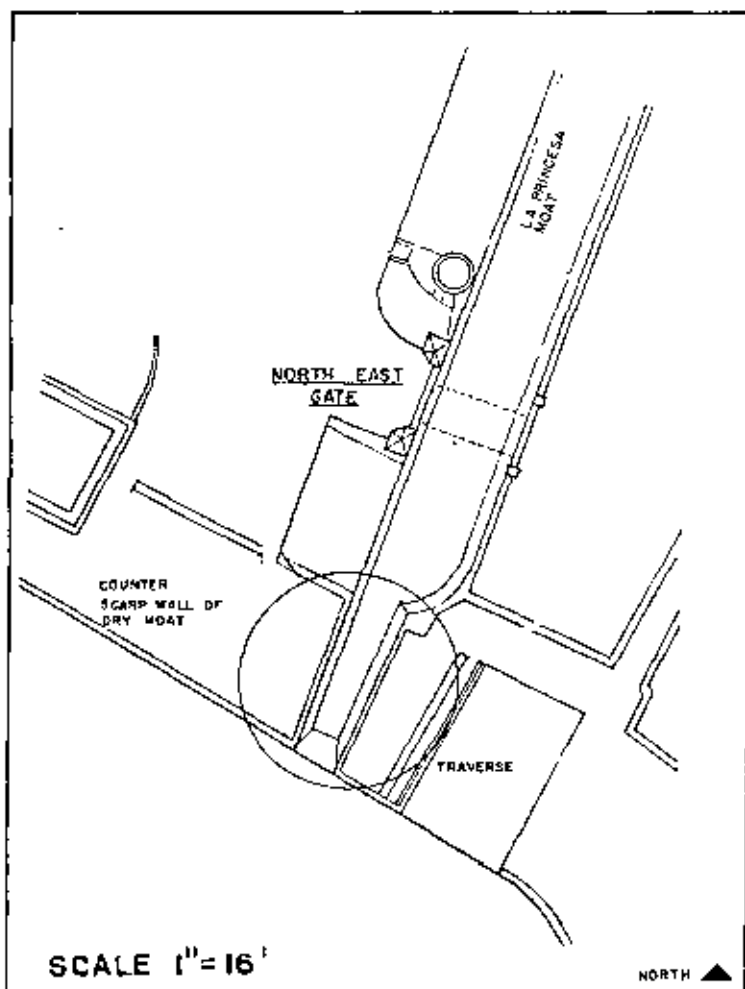
Figure 16.8. Northeast corner of el Abanico's moat showing how a portion of la Princesa's moat was enclosed at this point to form a cistern. Detail of HABS drawing, 1963.

The covered way is the most altered feature at el Abanico. The north section is interrupted by a narrow portion of moat extending from la Princesa (fig. 16.8). This part of la Princesa's moat was turned into a cistern by enclosing the walls with hydraulic cement in ca. 1896. Three of the sides survive. A bridge once spanned the moat and its location at the southern end is still easily discerned. To the east of this bridge was the original exit to the glacis.

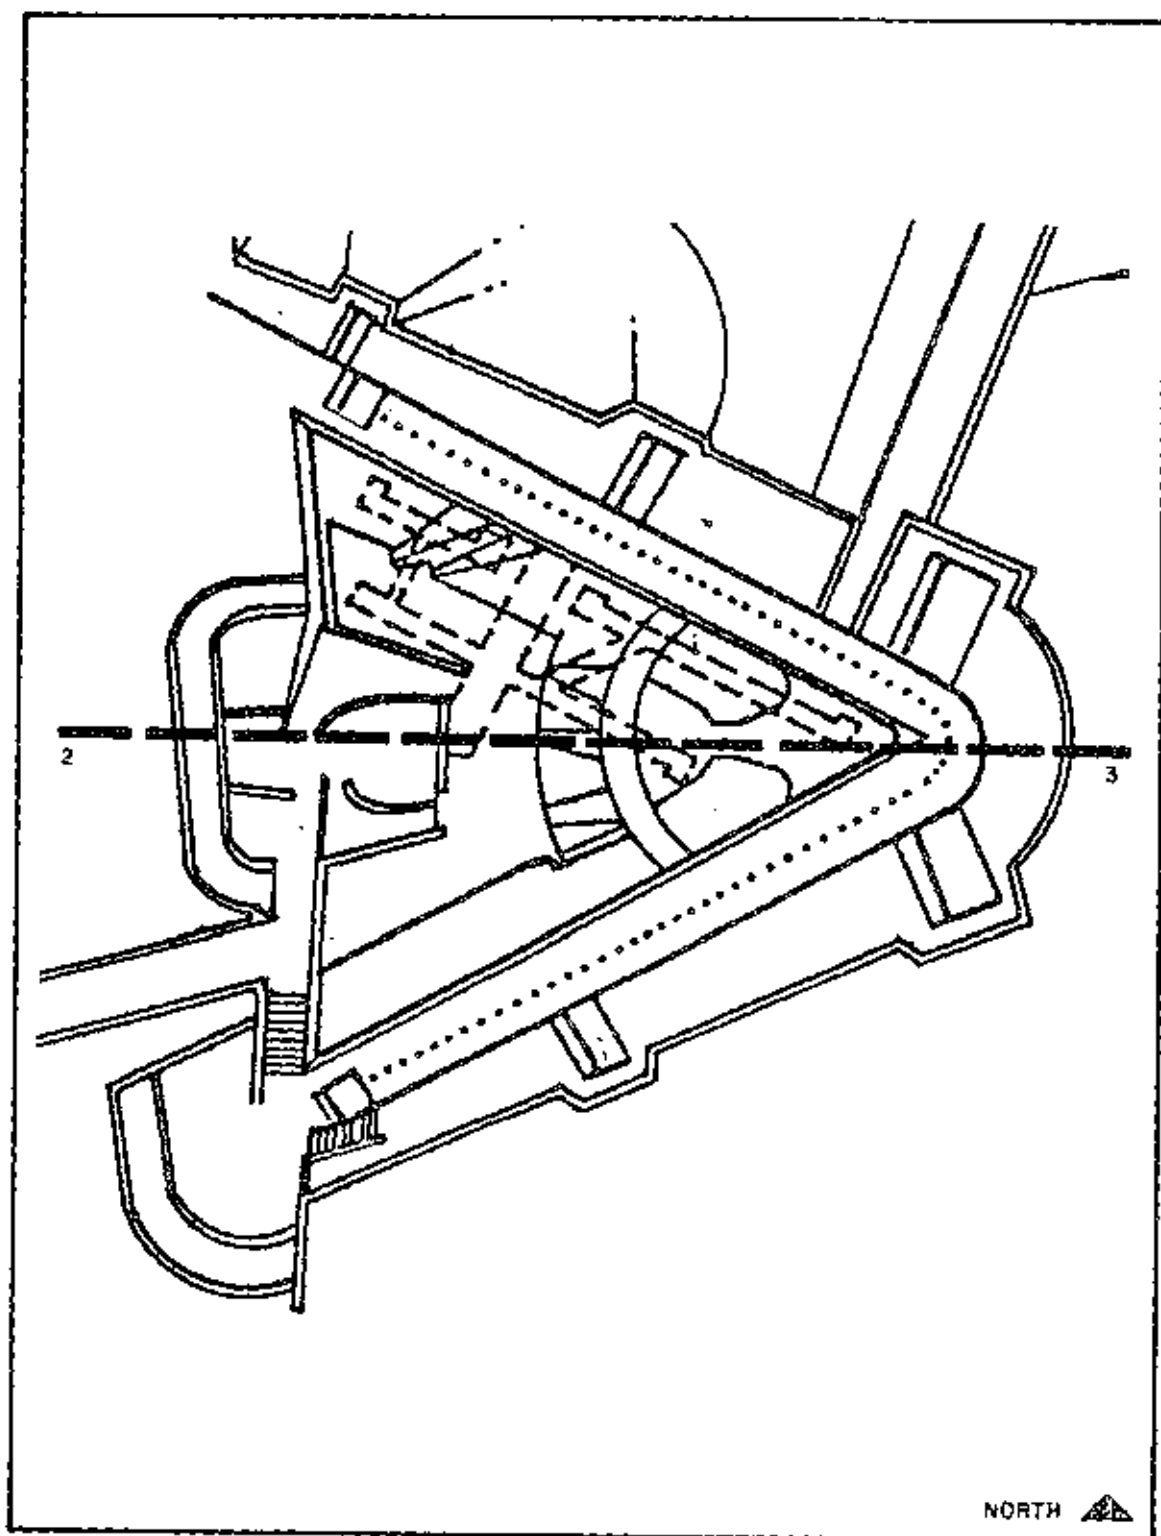
Figure 16.9. Detail of Juan Mestre's plan, September 13, 1783. Drawing by Jana Gross (1989) based on a tracing of the original by Ricardo Torres-Reyes (1965).

The appearance of el Abanico in 1783 was documented by Mestre's 1783 report, plan, and two sections: Profiles No. 1 and No. 3 (figs. 16.9, 16.10, 16.11). The fort has survived virtually unchanged over the years.⁷

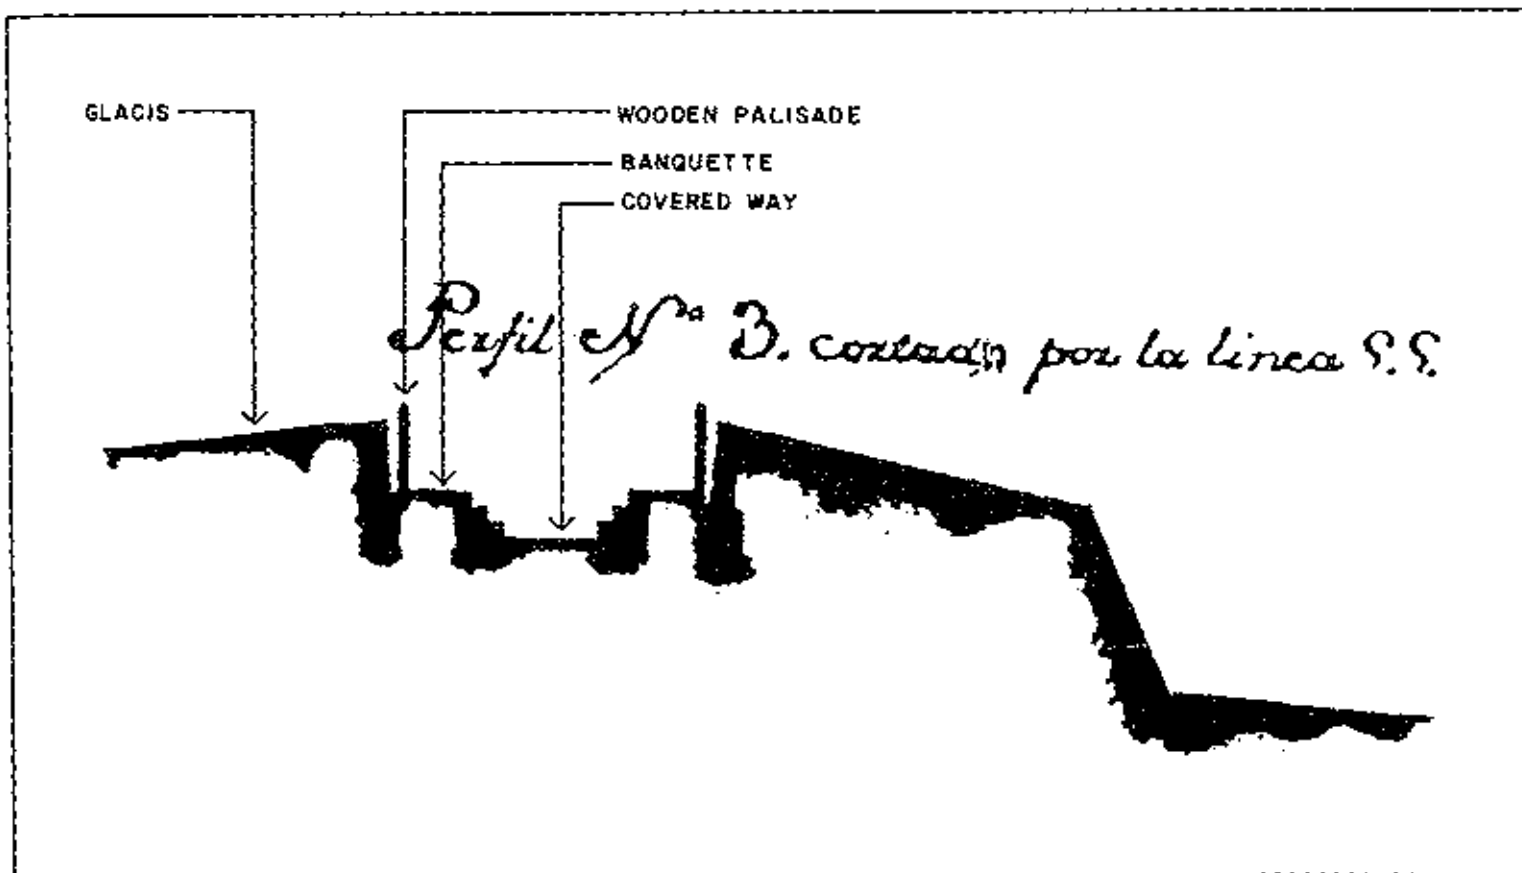
Figure 16.10. Profile No. 3 looking east through el Abanico's covered way. Drawing by Juan Mestre, September 13, 1783.

El Abanico was approached from the west by means by a covered way. Mestre indicated in his report of 1783 that this feature was constructed by excavating in the terrain that was composed of tufa, a soft porous rock. Profile No. 3, a section of the covered way, showed the following details: on either side of the protected passageway was a banquette three steps in height, upon each banquette and adjacent to the interior wall was a row of vertical

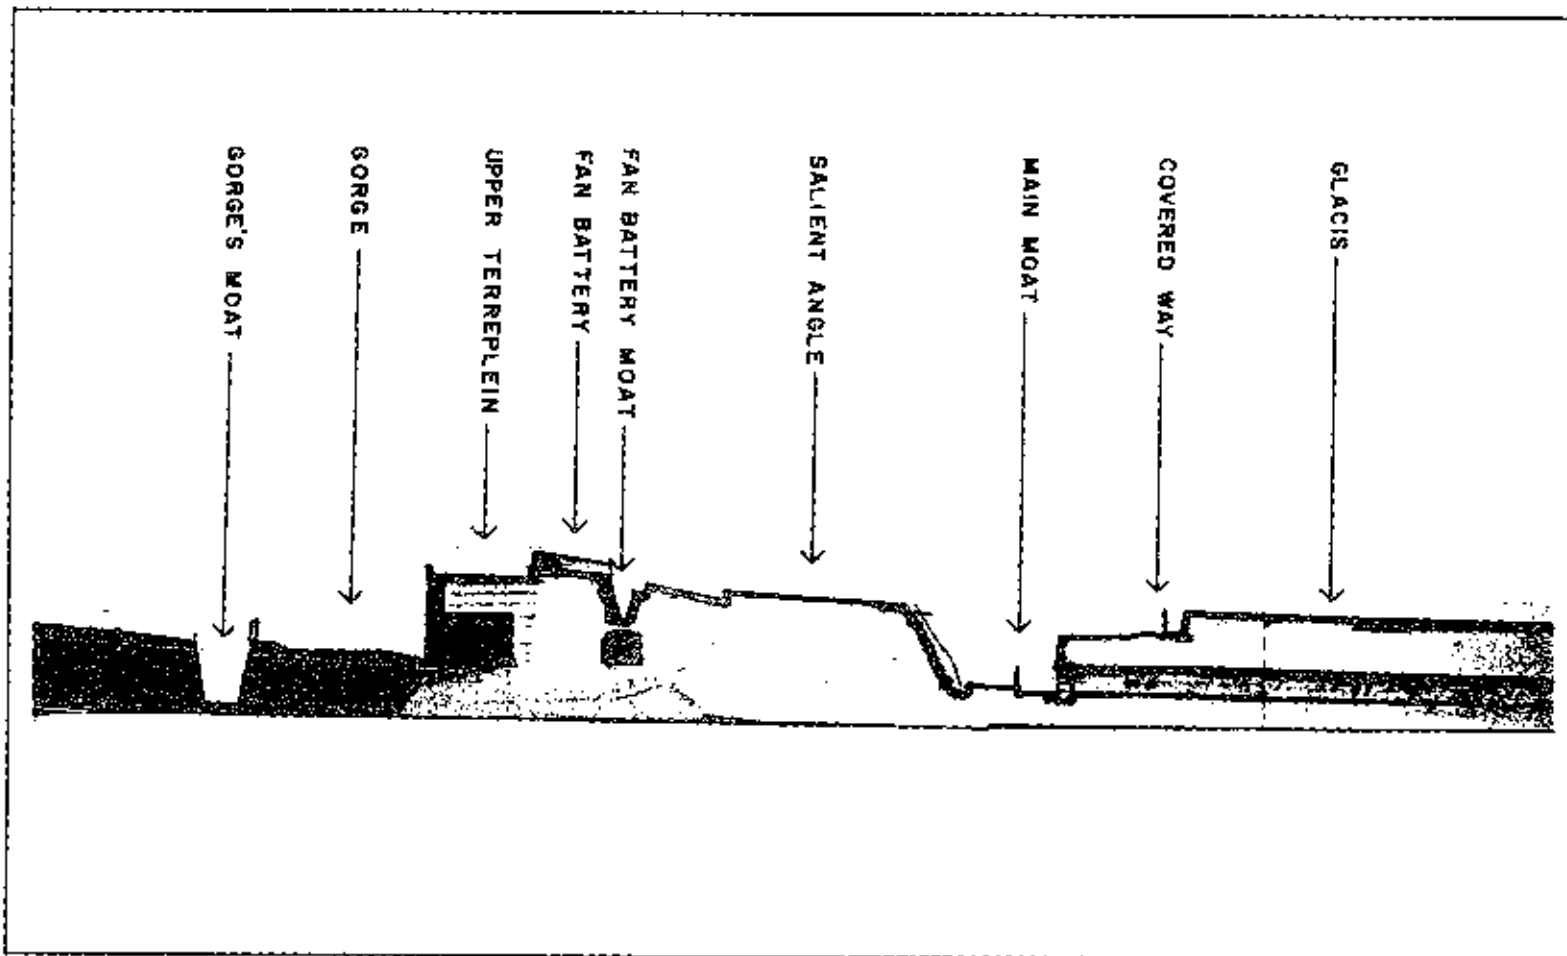
Figure 16.11. Profile No. 1 looking north through el Abanico. Drawing by Juan Mestre, September 13, 1783. Labeled by Jana Gross, 1989.

Profile No. 1, a section looking north, also illustrated the large vault and the southeast branch of the east mining gallery. (See fig. 16.11.) The interior chambers today are

On the exterior side of the moat's covered way was the glacis. This glacis was the terrain beyond the covered way and served as its parapet. (See fig. 16.11.) Profile No. 1 showed the terrain as flat, lacking the usual slope characteristic of a typical glacis.¹⁵

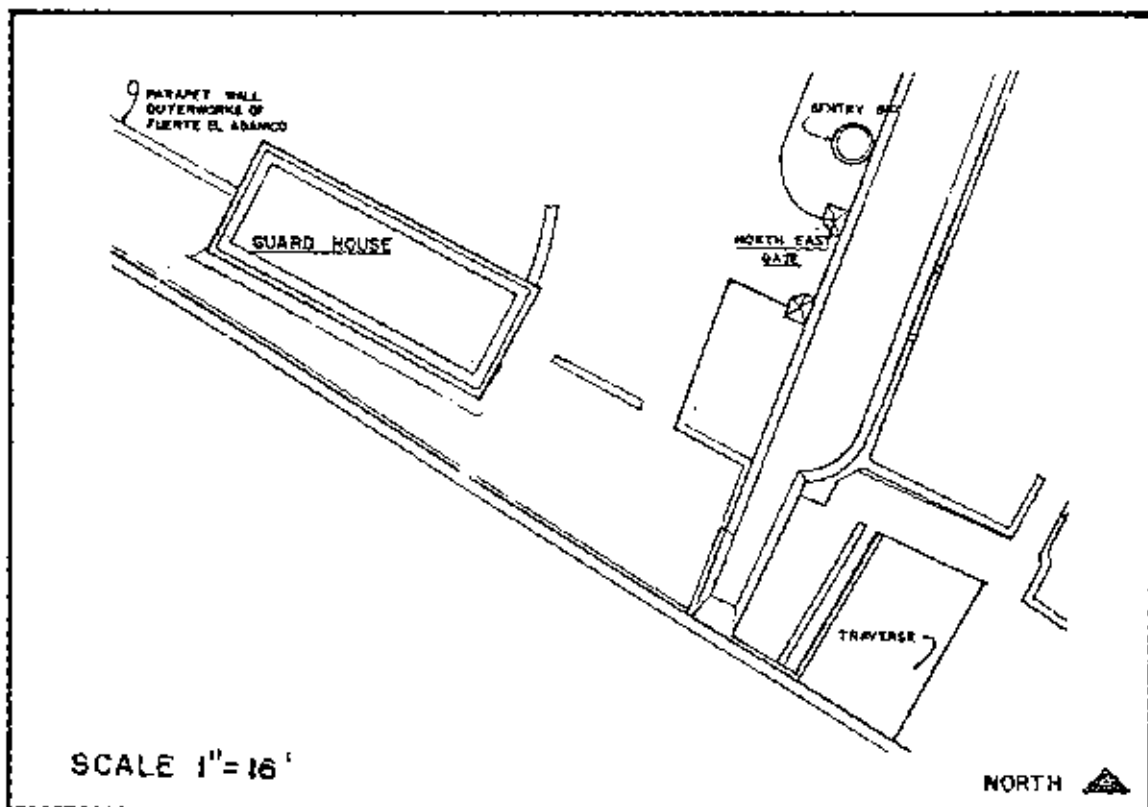
Figure 17.1. Top: South and east elevations of Guardhouse at el Abanico. Photo by Richard Crisson, 1986.

Bottom: MAB site plan showing location of Guardhouse at el Abanico, 1963.

Stylistically the building is similar to other garrison structures, with elements of nineteenth-century neoclassical architecture. It has articulated window and door openings, and a projecting cornice with parapet. The building sits on a shallow base and the corners project slightly. The construction materials and the building's intended uses were thoroughly described by Spanish military engineers in 1896. (See figs. 17.1 - 17.3.)

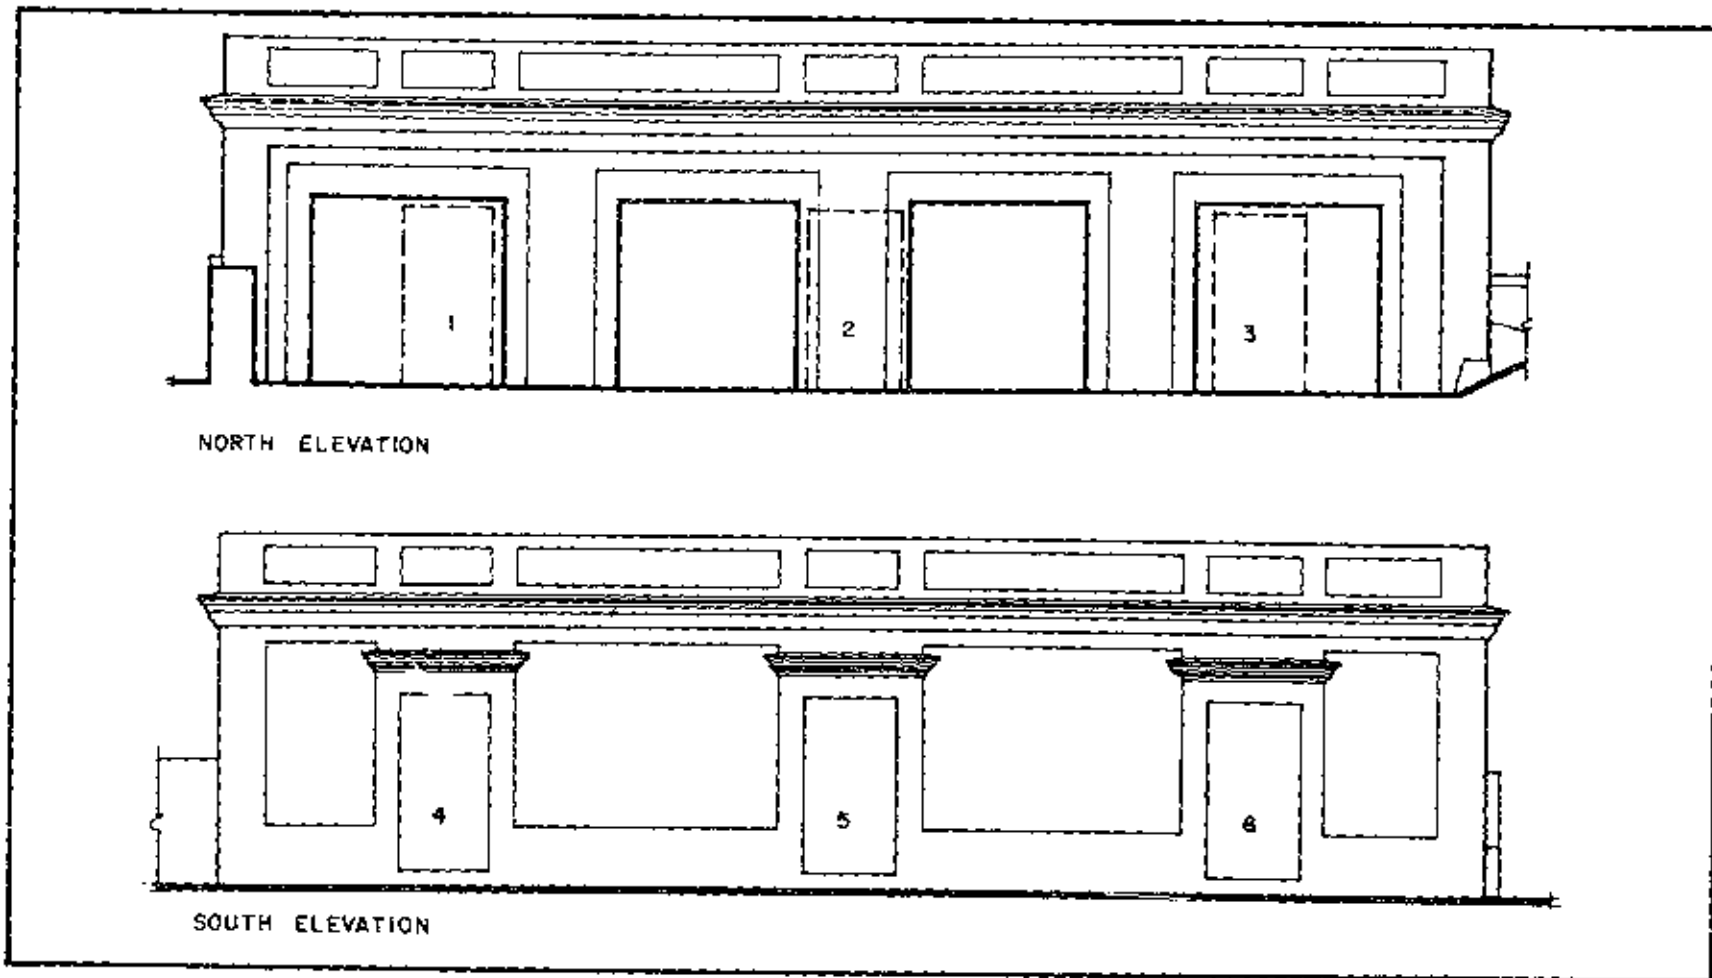
Figure 17.4. North and south elevations with openings numbered. HABS drawing (1963) annotated by Jana Gross (1989). Dotted lines indicate current openings.

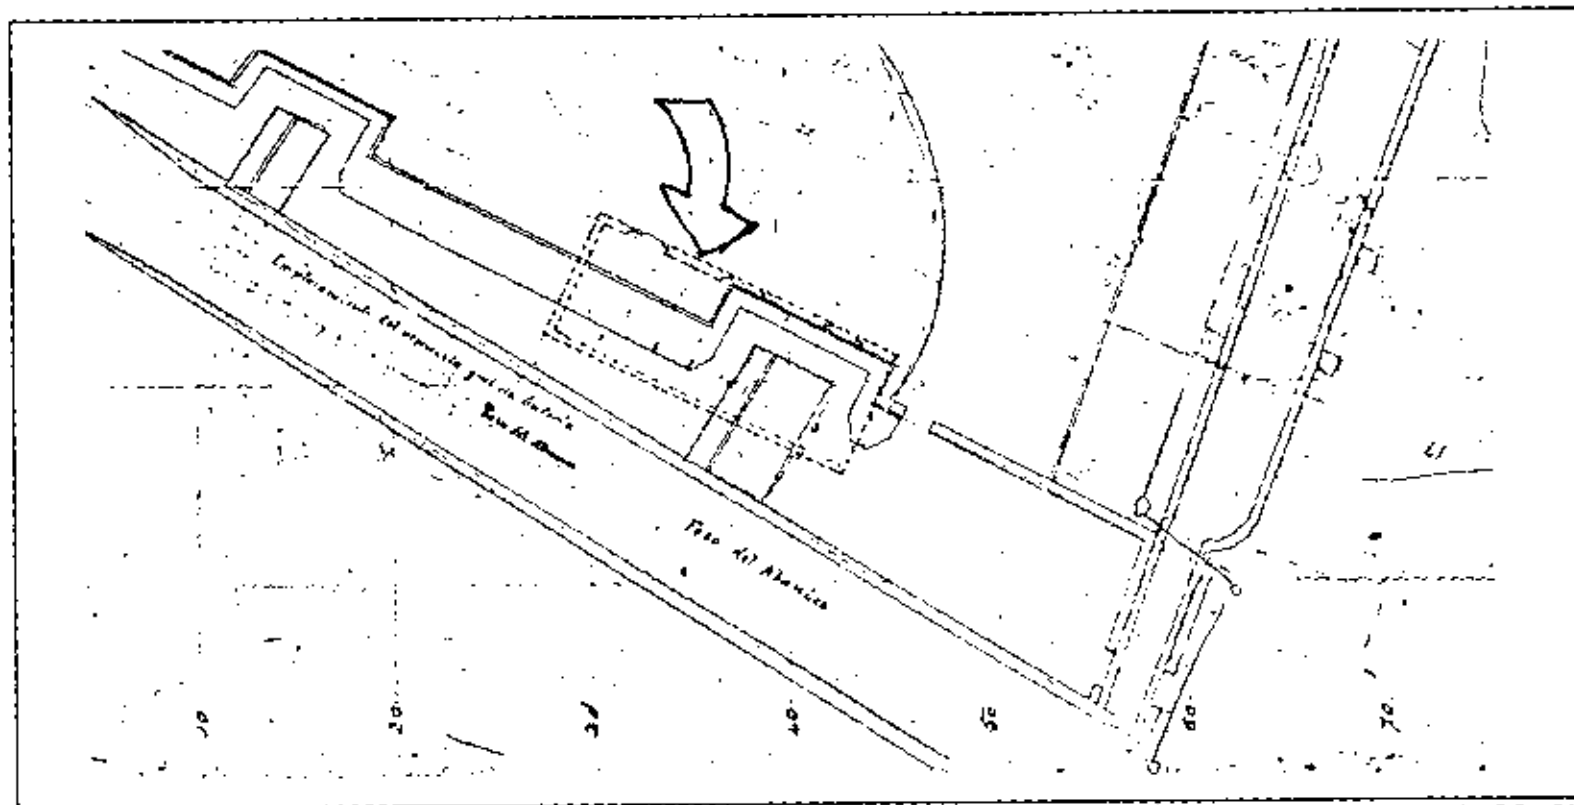
Figure 17.5. Detail of plan obtained by Colonel Goethals in 1898. Arrow (added) points to location of new Guardhouse. (San Juan NHS Archives.)

The building first appears in the plan of la Princesa dated 1897 (fig. 17.5). Its outline was superimposed over the earlier covered way and one traverse of el Abanico. The outline was not revealing. Discernable features included the rectangular shape of the structure, three openings in the north wall, and a north-south partition wall positioned equidistant between the west and middle openings of the north wall. No openings were drawn in the west wall. Features that cannot be distinguished due to the light rendering of the drawing were: openings at the east and south walls, and the second interior partition wall.⁷

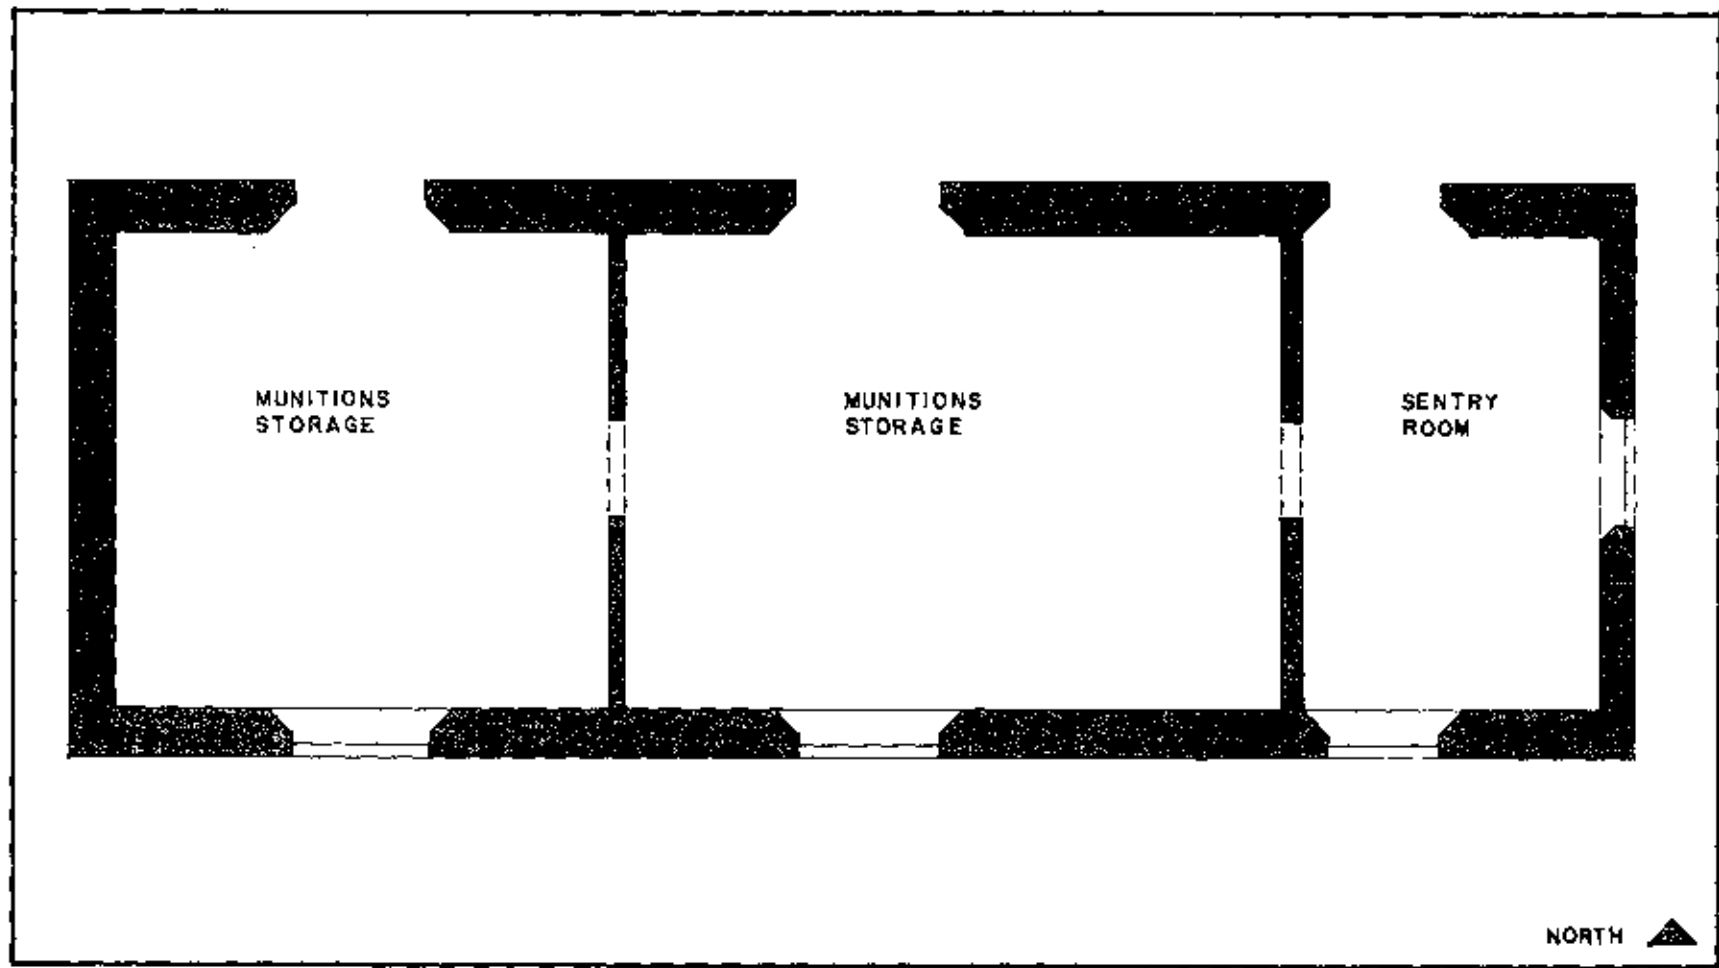
Figure 17.6. Conjectured original floor plan of the Guardhouse at el Abanico, ca. 1898. Drawing by Barbara Yokum, 1967.

The structure as originally built was a rectangular one-story masonry building (fig. 17.6). The walls were composed of brick, and brick and rubble stone. Brick was used at the base of the building, at the four corners, at the door and window openings, as leveling courses within the walls, and at the cornice and roof parapet. Rubble infilled the remaining spaces. The exterior was covered with stucco and the interior with plaster. The roof was supported by vigas of blue-black color. Spanning the beams were purlins covered with three layers of roofing tiles laid with lime mortar. Each tile measured 11 1/2 inches long by 5 1/2 inches wide by 7/8 inches thick. Drainage off the roof was through exterior iron downspouts located on the south facade. Water drained to a cistern located in the moat between el Abanico and la Princesa.

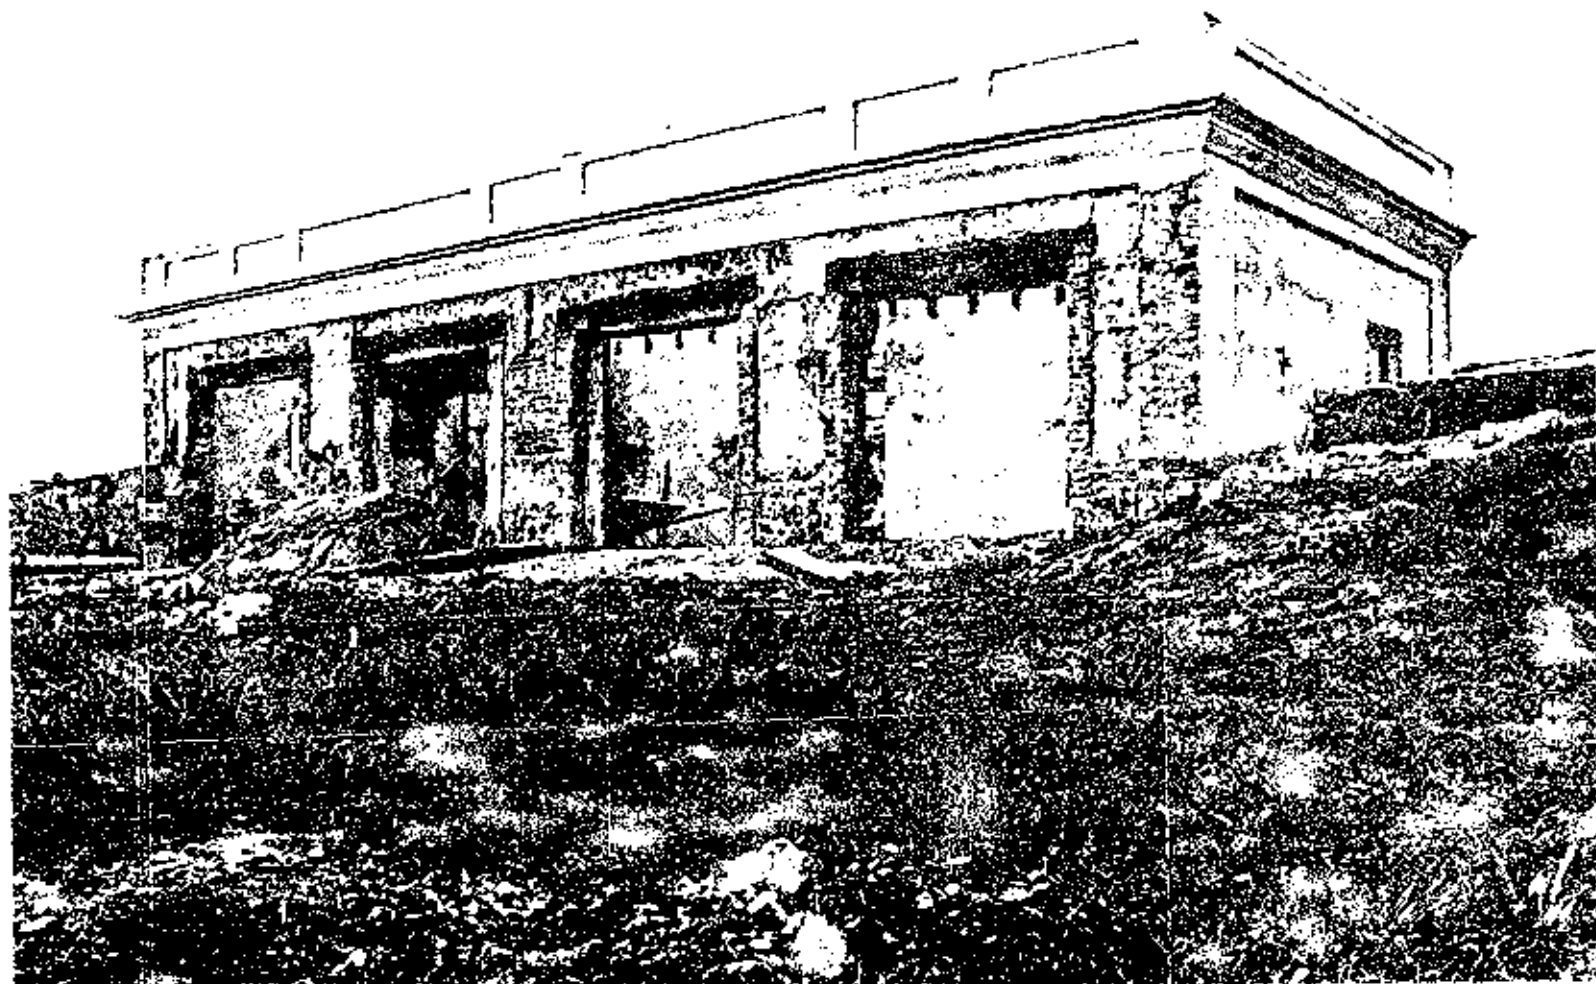
Figure 17.8. North and west elevations of the Guardhouse in the process of restoration, October 29, 1981. (San Juan NHS Archives.)

The first phase of the project was to remove post-historic and deteriorated building fabric. Modern materials that were taken out were the masonry infill at the south doorways and west window and later cement stucco. Deteriorated portions of the building that were removed were about 1,253 square feet of loose plaster and stucco, the entire roof including the beams, and the east interior partition wall. The demolition phase of the work was recorded by two photographs taken on October 29th, 1981 (figs. 17.8, 17.9) doorways and windows are open, the roof is off, and the east partition is wall gone.²²

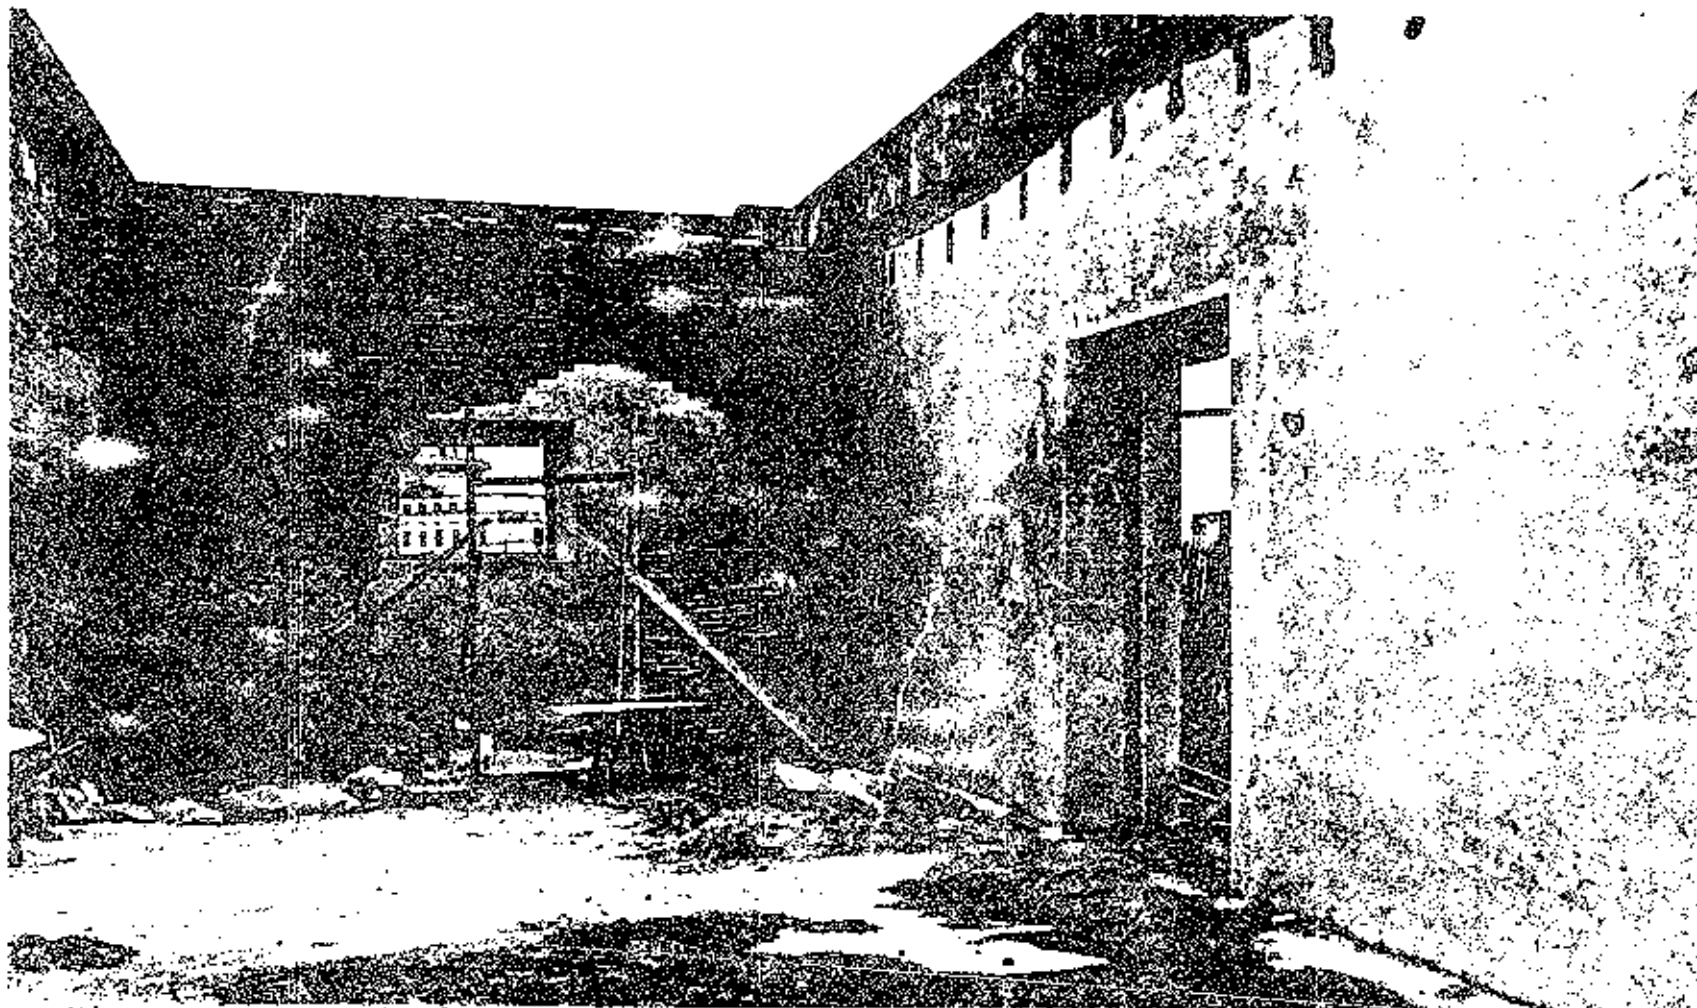
Figure 17.9. Interior of the Guardhouse looking southeast in the process of restoration, October 29, 1981. (San Juan NHS Archives.)

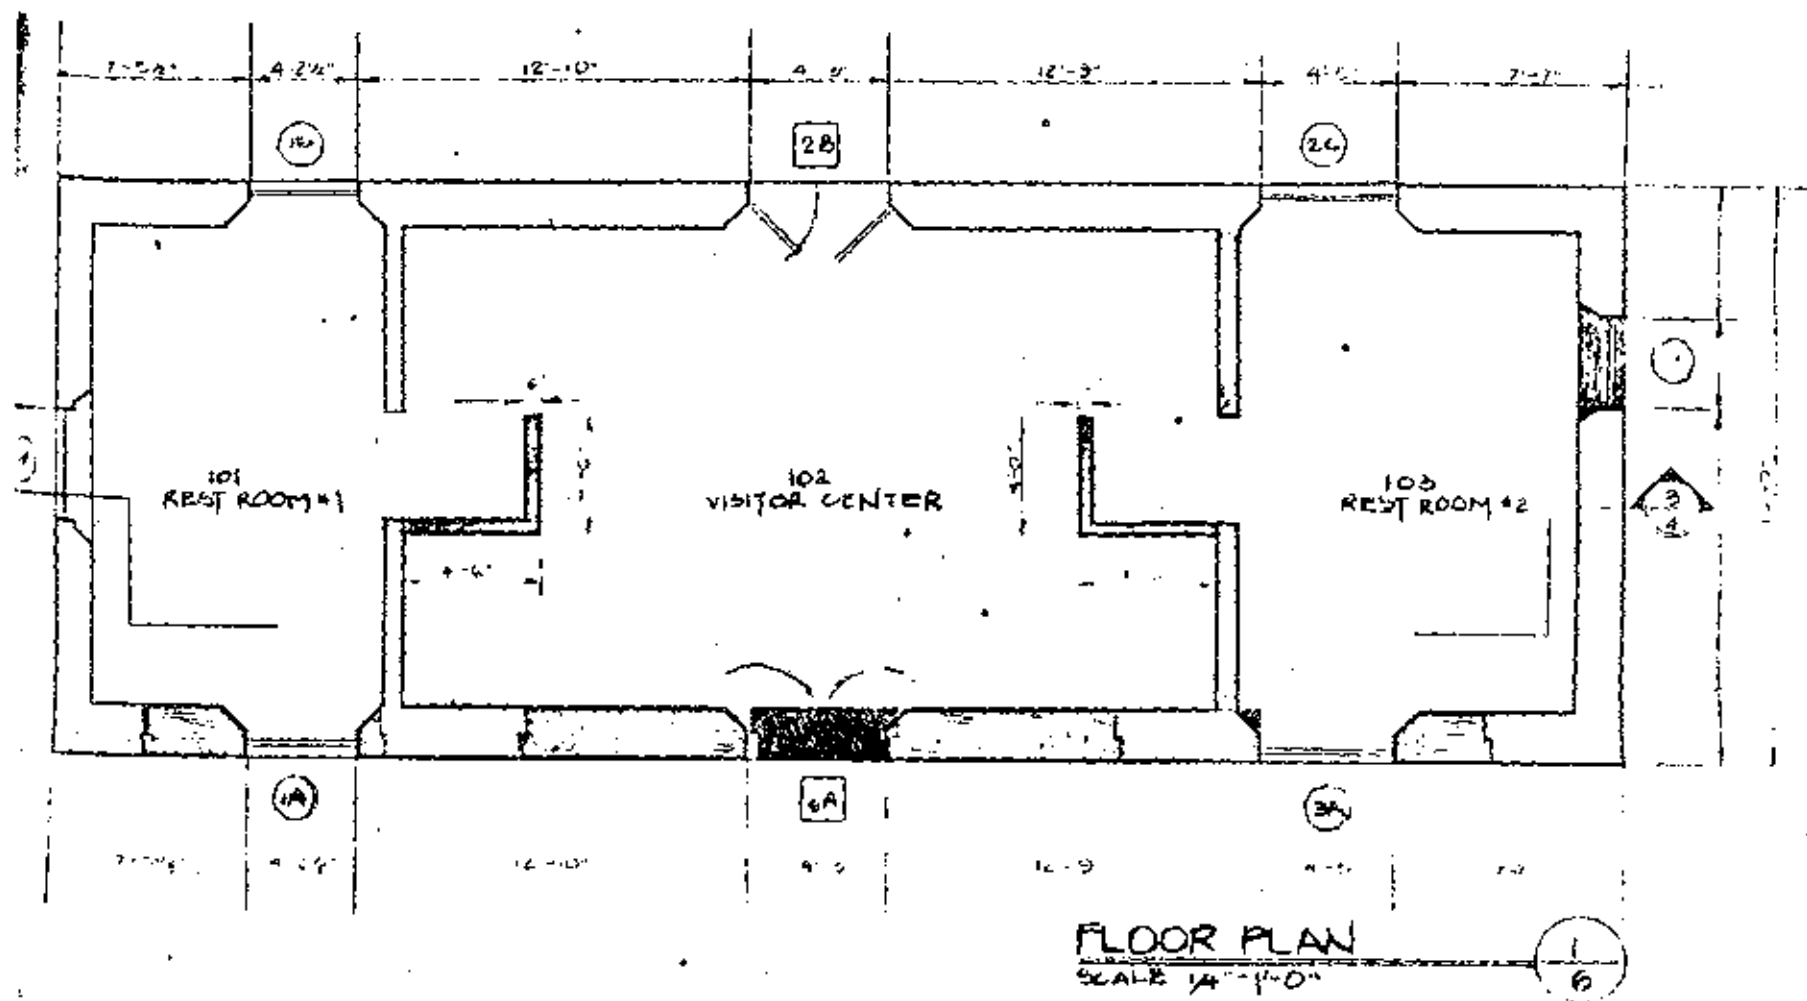
Figure 17.10. Floor plan of the adaptively redesigned interior of the Guardhouse, ca. 1981-83. (San Juan NHS Archives, Contract File.)

records (1896 report, ca. 1897 plan) were unknown to researchers. Reconstruction of the roof called for reusing all bricks (i.e., roof tiles) and beams in good condition. However, it was later discovered that no modern bricks could be found to match the old bricks and half or more of the roof beams were rotted at their abutments. Therefore, all new bricks were installed on the roof. Also new were the purlins and the upper cellular concrete deck. How many of the original vigas, if any, were reinstalled was not noted. The 900 roof bricks previously salvaged from the roof by the contractor were recommended by the contracting officer to be removed from the site and discarded. The contractor, however, reused these bricks in the reconstruction of the east interior partition wall. The west interior partition wall was also reconstructed although its placement conjectural (fig. 17.10).²⁴

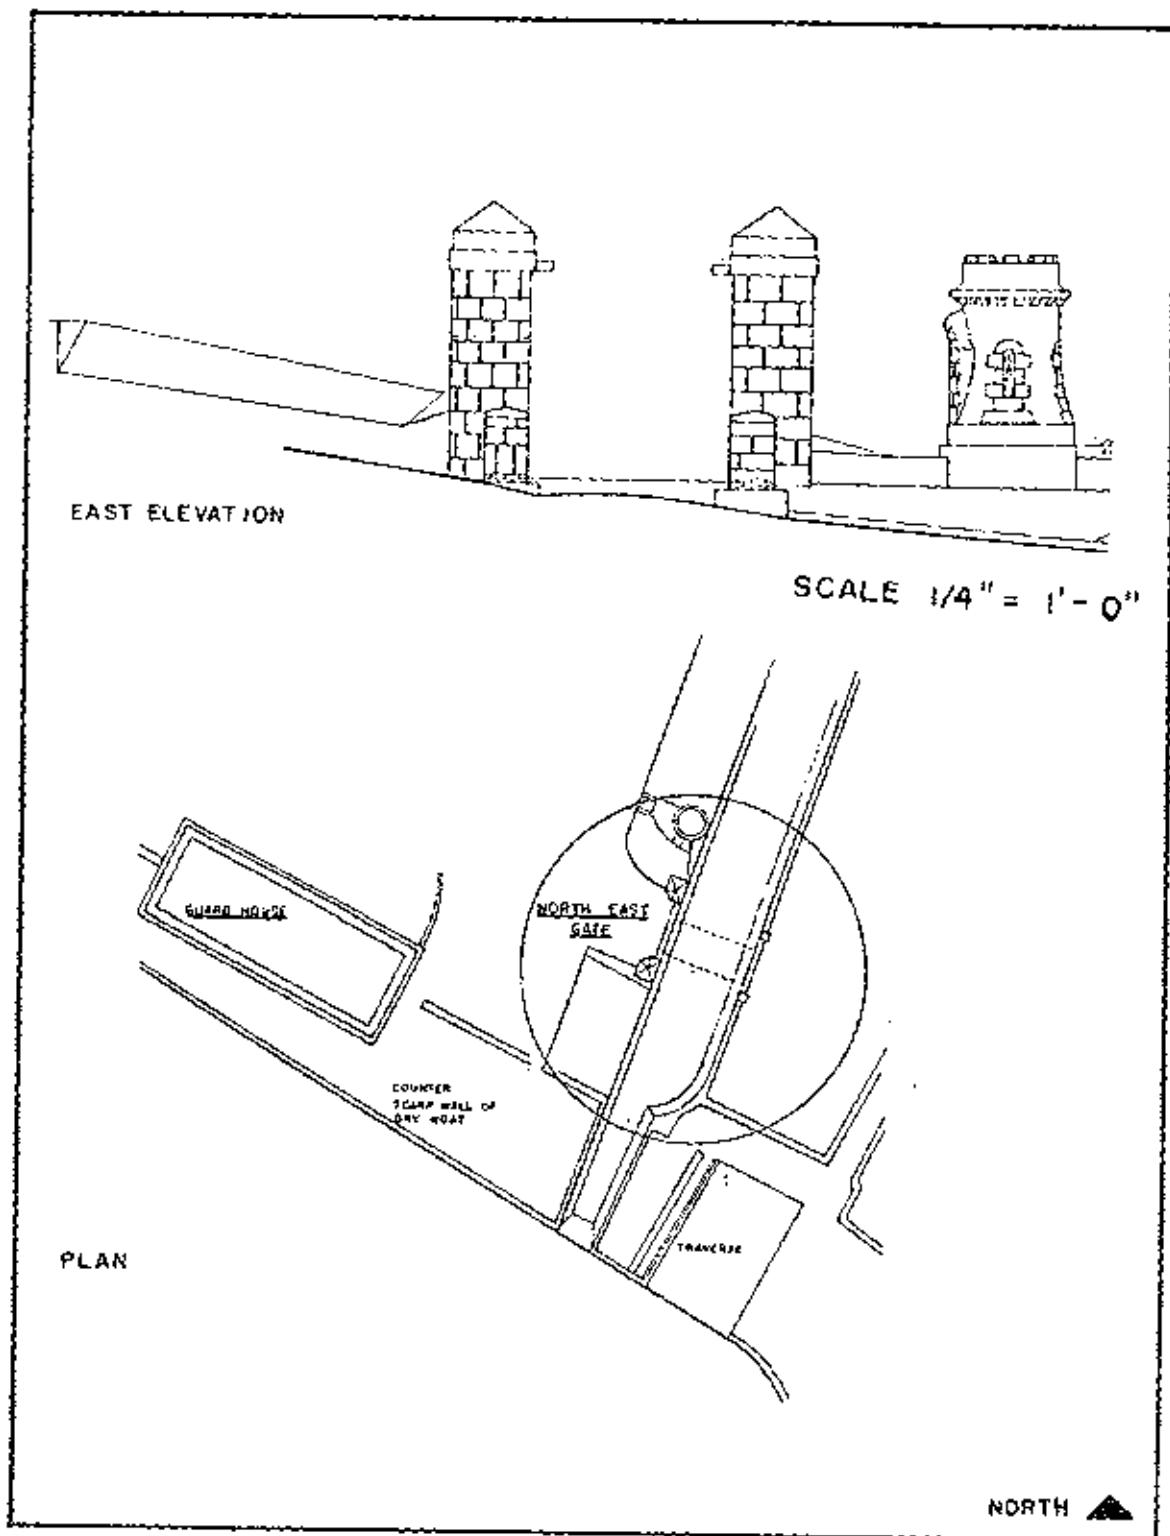
Figure 18.3. HABS drawings of east elevation and site plan of el Abanico's Northeast Gate, 1963.

The Northeast Gate of el Abanico is comprised of the following elements: a pair of five-sided masonry gateposts, a modern wooden bridge spanning the dry moat, a pair of secondary gateposts, and a sentry box. It is located at the southern end of the moat between el Abanico and la Princesa (figs. 18.1 - 18.3).
