THE FORTIFICATIONS OF SAN JUAN NATIONAL HISTORIC SITE

HISTORIC STRUCTURE REPORT

El Fuerte de San Cristóbal

1991

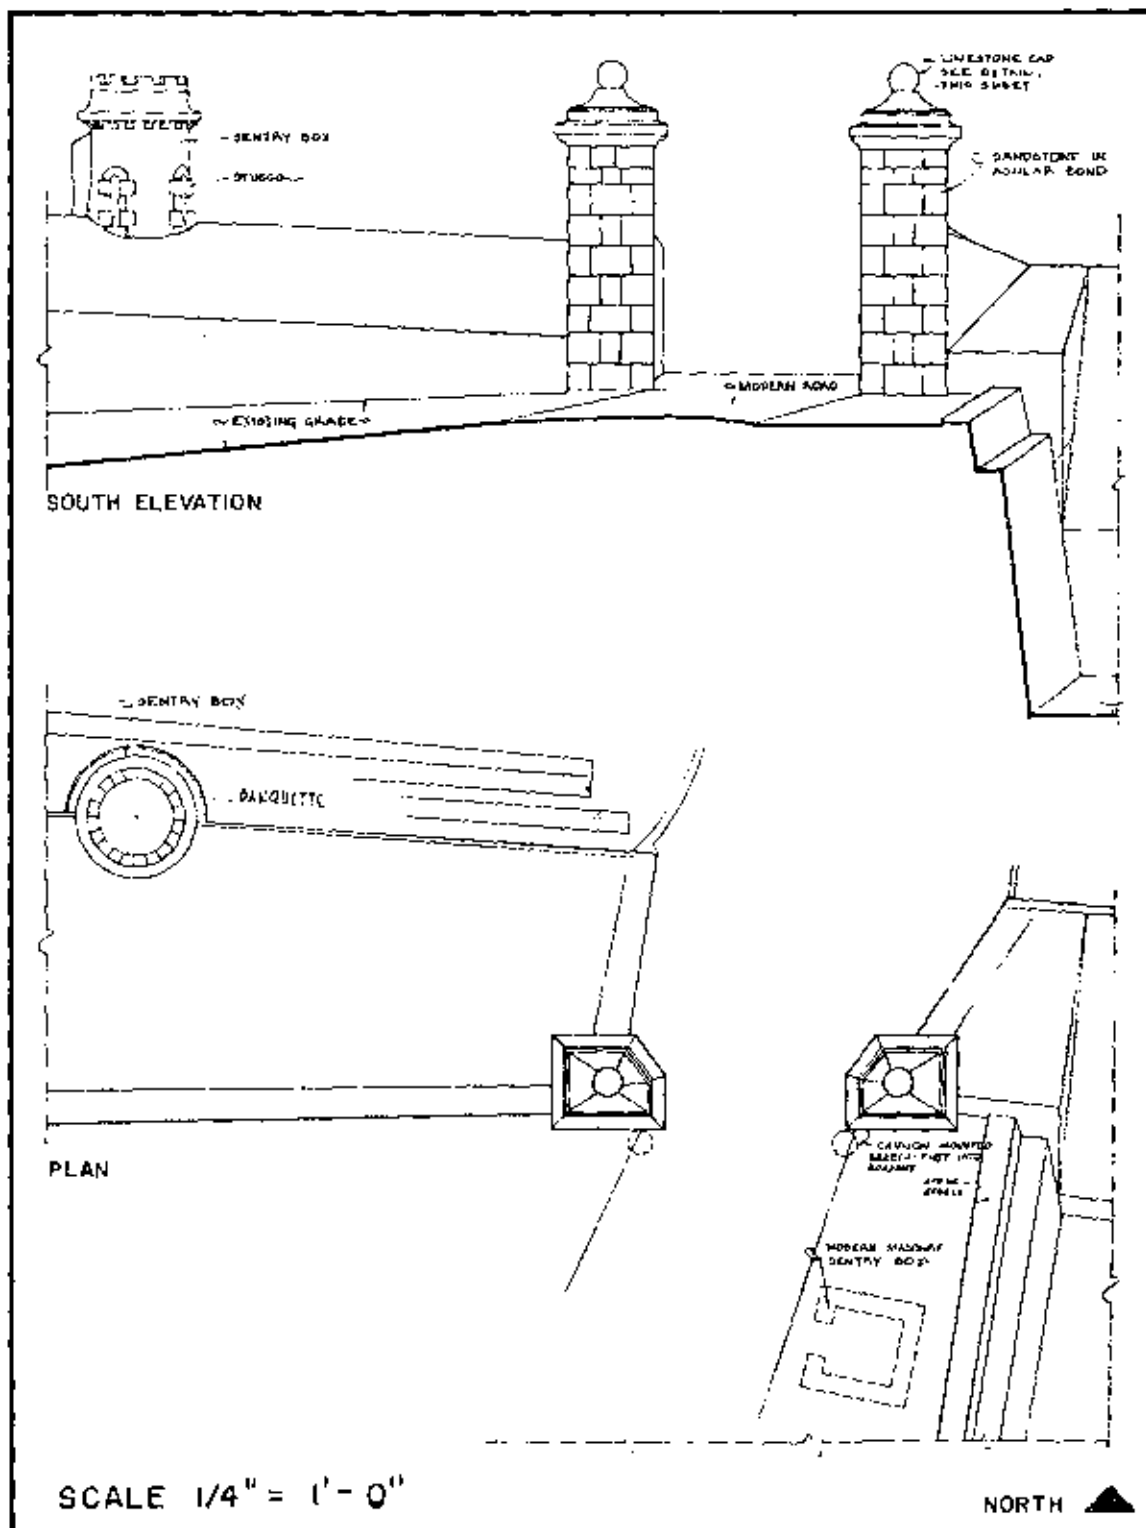
Figure 19.1. South elevation and plan of el Abanico's South Gate. Drawing by HABS, 1963.

The South Gate of el Abanico consists of two five-sided masonry gateposts and a detached cylindrical masonry sentry box. It was built around 1896 as a new and permanent entrance to la Princesa and el Abanico (ca. 1779-1783). The structure is located within the south parapet of the entrance covered way of el Abanico (fig. 19.1, 19.2).

The sentry box is located west of the gateposts and is approximately 11 feet tall. Distinctively shaped and topped by a parapet, the sentry box is built of bricks and covered with cement stucco. It is identical in design to the sentry box at the Northeast Gate (Chapter 18). The 12 inch side walls flare out to meet a slightly projecting round base. An overhanging modillioned cornice surmounts the walls. A flattened ovolo molding and fascia support the crenelated parapet top. This conceals the flat dome roof that contains the easterly roof drain.

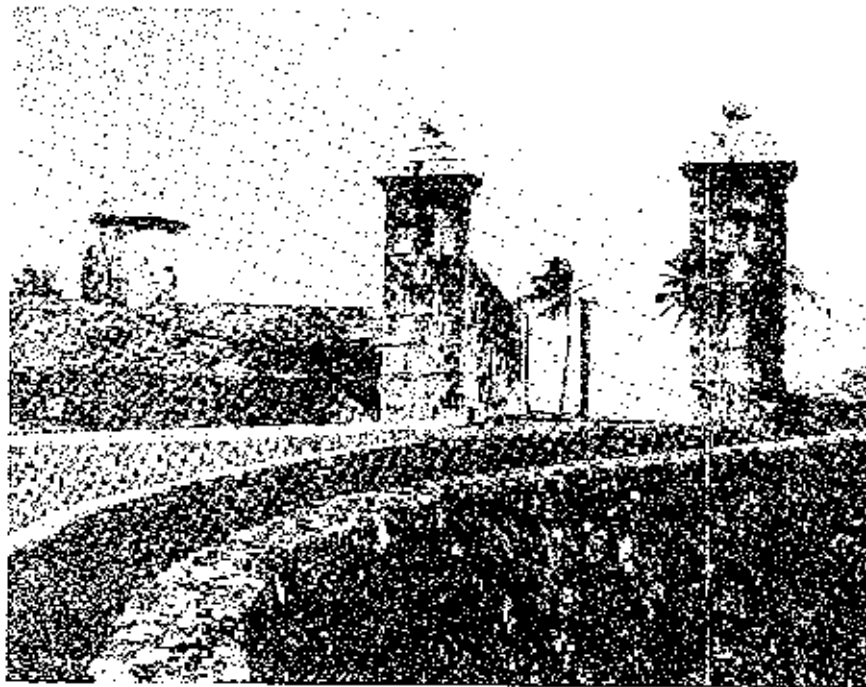
Figure 19.2. South elevation of the South Gate and sentry box of el Abanico. Photo by Richard Crisson, 1986.

Two samples of original mortar were

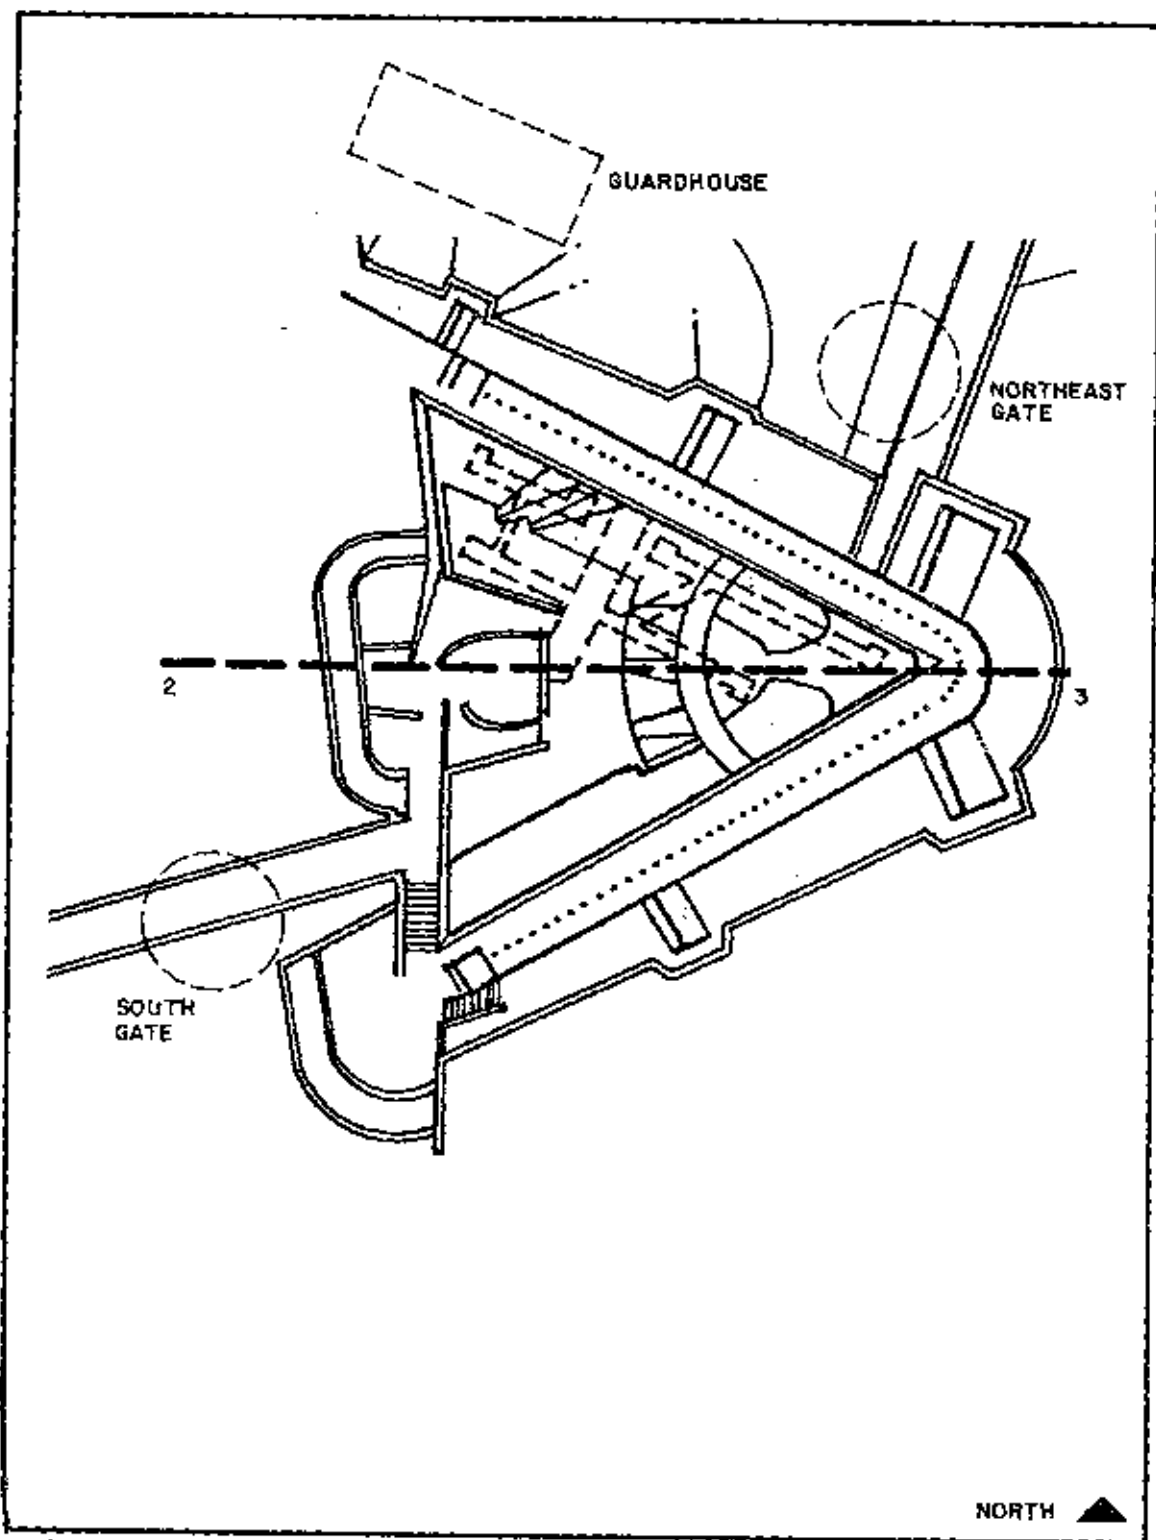
Figure 19.3. Detail of Juan Mestre's September 13, 1783 plan showing site of future South Gate, Northeast Gate, and Guardhouse. Tracing of original by Torres-Reyes (1965) annotated by Jana Gross (1989).

El Abanico was constructed sometime between 1779 and 1783. One feature of el Abanico was a covered way that enabled direct communication with the main moat of San Cristóbal. This was located on the south side of el Abanico as illustrated in Mestre's plan of 1783 (fig. 19.3). It was in the south parapet wall of this covered way that the South Gate would eventually be located. During this period, the gate did not exist.³

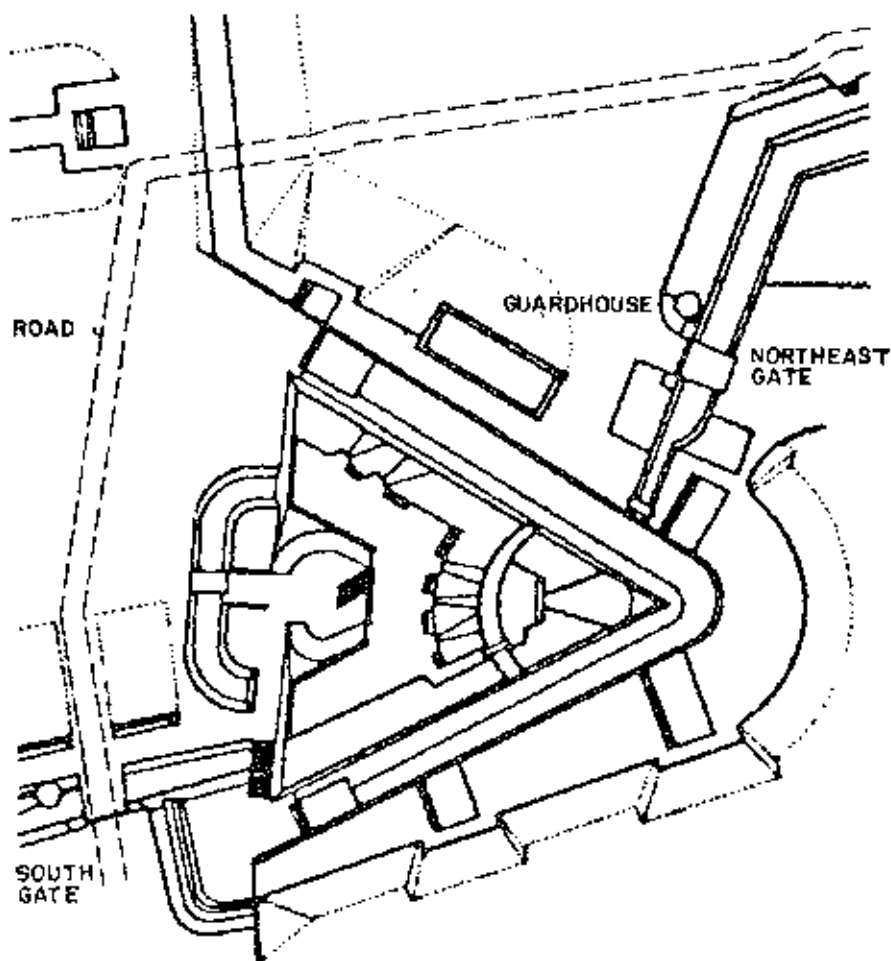
Figure 19.5. Detail of new service road illustrated on 1896 plan transferred to modern plan of fort. (Original unavailable.)

Documentation on the actual construction of the gateposts and sentry box has been located. Presumably this gate provided access to the newly modernized battery of la Princesa by means of a new interior service road illustrated in a plan of la Princesa dated ca. 1896 (fig. 19.5). This road was oriented behind the new gun positions and along the east-west axis of the battery. At the west end of the battery, the road turned towards the

south in the direction of the South Gate. Unfortunately, the plan does not continue as far south as the gate, but it seems likely that the road may have passed through it. Unlike the provisional road that passed through the Northeast Gate and was used to construct the battery, the service road was a permanent feature. It was probably used to transport munitions, supplies and troops.⁷

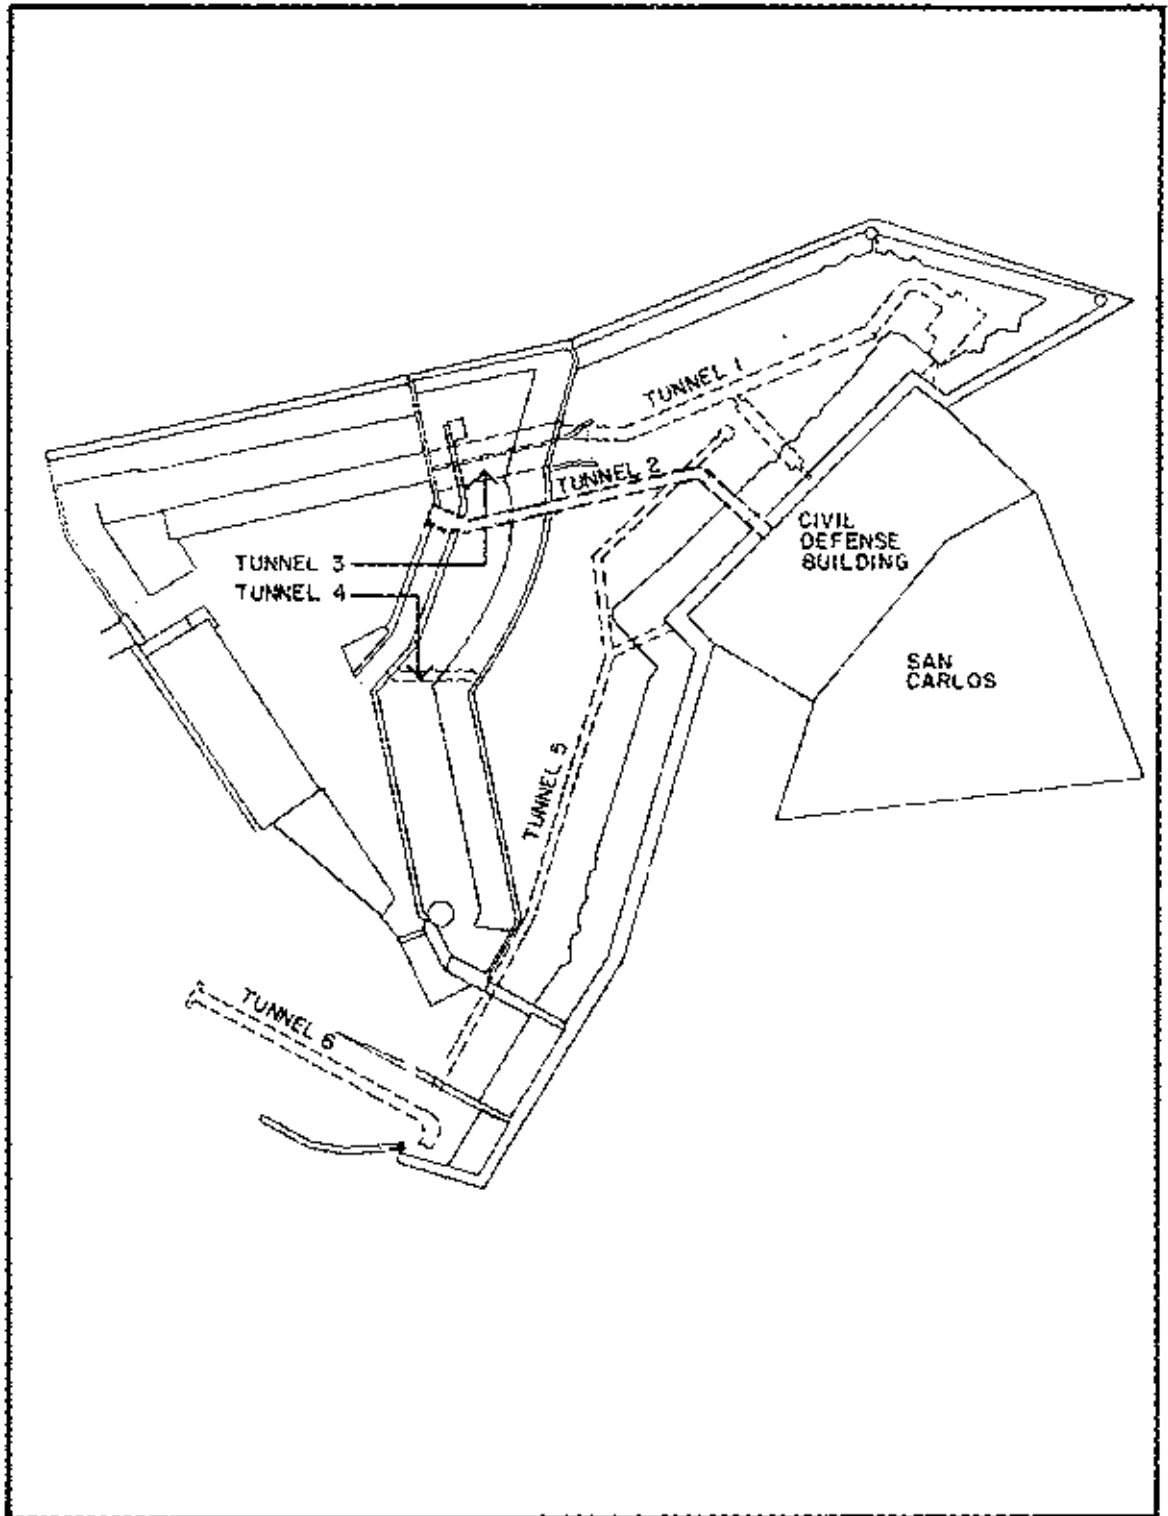
Figure 20.1. Plan of San Cristóbal with location of Tunnels 1-5 highlighted. Drawing by Jana Gross, 1989.

Tunnel 2 runs parallel, east to west, with Tunnels 1 and 3 and is entered from the west, off of the eastern side of the Plaza de Armas. Approximately half the size of Tunnel 1, it runs beneath the ramp to el Caballero, and under el Caballero and the North Bastion extending to the main moat of San Cristóbal. (See fig. 20.1.) Tunnel 2 was the principal entrance to San Cristóbal from the outworks on the east and could be used defensively as a countermining gallery to block access by an enemy invader.

The ramped underground passage, Tunnel 3, is located between Tunnels 1 and 2. (See fig. 20.1.) It is the widest of the tunnels and had the significant function of providing access from the Plaza de Armas to the North Bastion. Artillery and supplies were carried up this ramp to the numerous embrasures of this key defensive bastion.

Tunnel 4 is also a covered ramp entered from the base of the ramp to el Caballero at the west side of the Plaza de Armas. Parallel with Tunnels 1, 2, and 3, it is the southernmost of these features. It lies just north of the Troops' Quarters and directly beneath el Caballero. (See fig. 20.1.) The interior plan of Tunnel 4 is in the shape of an elongated "S". It was designed to enable troops quick access from the Plaza de Armas to the multi-embrasured San Cristóbal Rampart and South Bastion.

Tunnel 5 (see fig. 20.1) is a countermining gallery located directly beneath the eastern defense of San Cristóbal. It runs in a northeasterly direction below the level of the principal moat with a bifurcation south of the

Tunnel 6 (see fig. 20.1, 20.8) was designed as a sortie gate that allowed troops stationed in the main moat to make covert entrances and exits. The tunnel is located south of the lower batteries of the South Bastion and runs in a northwest-southeast direction. Access is gained through an entrance adjoining the Superintendent's residence (Building 210-211), to the west of San Cristóbal off Calle Norzagaray. It is a straight-run tunnel approximately 171 feet in length and is terminated by a sharp, right-angled bend to the southwest that presently exits onto Calle Norzagaray.

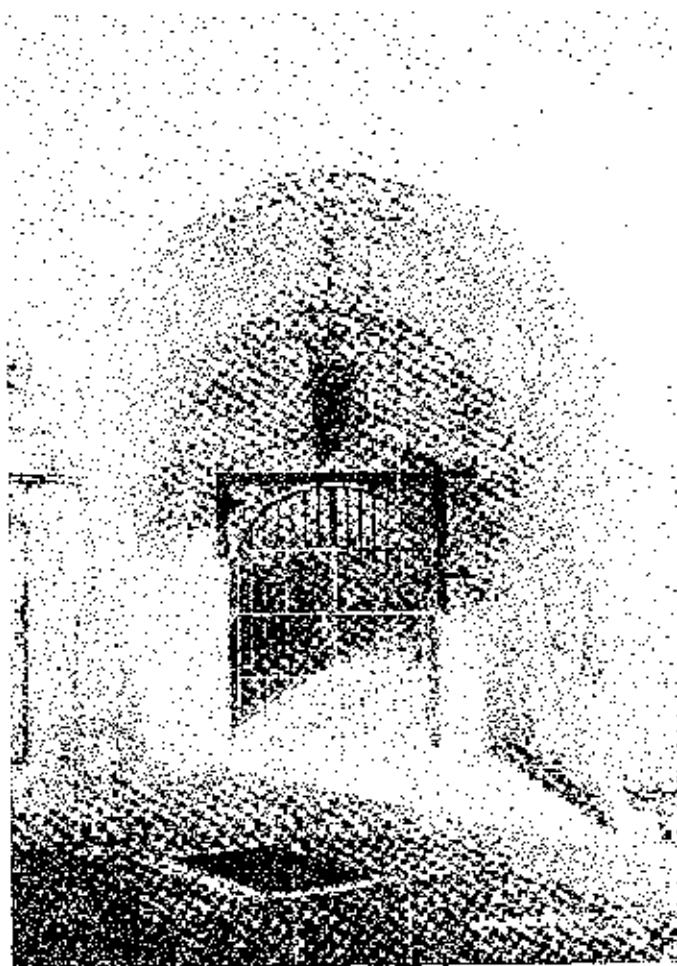
Figure 20.2. West opening to Tunnel. Photo by Richard Crisson, 1986.

Because the tunnel is an underground element, its only exterior feature is the entry vault and doorway facing west under the ramp to el Caballero (fig. 20.2). A flat pilaster, broken at the springing line, supports a flat arch surround with a keystone that frames the tunnel opening. It is covered with cement stucco and whitewash. A long centered patch indicates where an electric conduit has been removed. The entrance way to the tunnel is denoted by a smaller archway with

an iron grille recessed several feet in the opening. It is similar to other grilles installed by the NPS in the 1960s. Of greater interest is the heavy square wooden frame fixed immediately outside of the arched opening, probably dating to the eighteenth century.

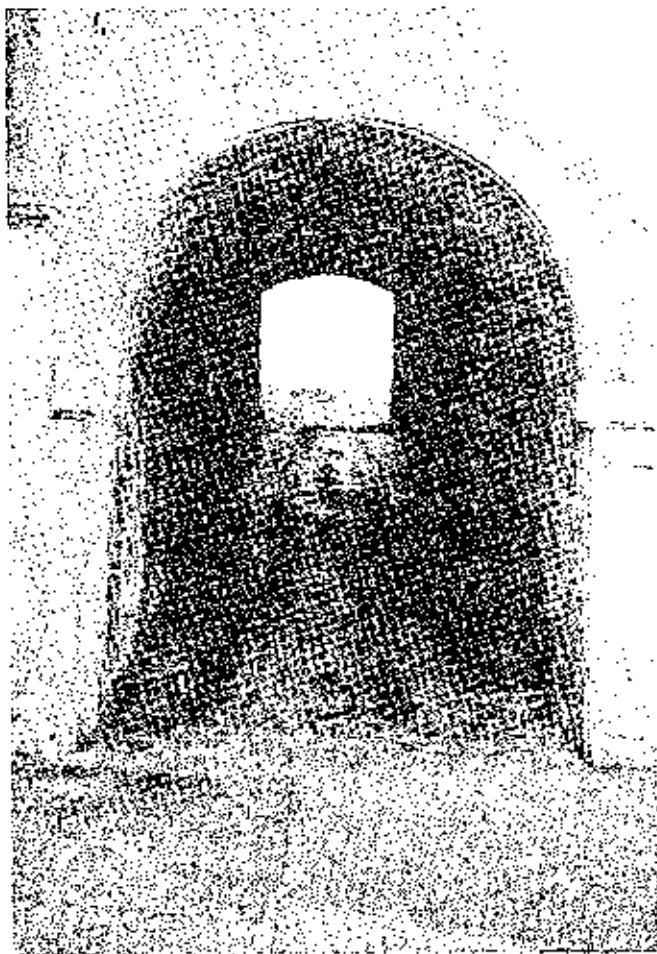
Figure 20.3. Left: West entrance to Tunnel 3.
Right: Upper east entrance to Tunnel.
Photos by Richard Crisson, 1906.

Tunnel 3 has only two exterior features (fig. 20.3): a large arched opening facing west and a lower segmental arched gateway opening to the east. The entrance to Tunnel 3 is located under the ramp up to el Caballero. The arched opening corresponds to the interior barrel vault. The architrave consists of a wide flat band, broken by a projecting band at

the springline and by a small keystone at its apex. A small modern wall-mounted plaque assists in the interpretation of the ramp.

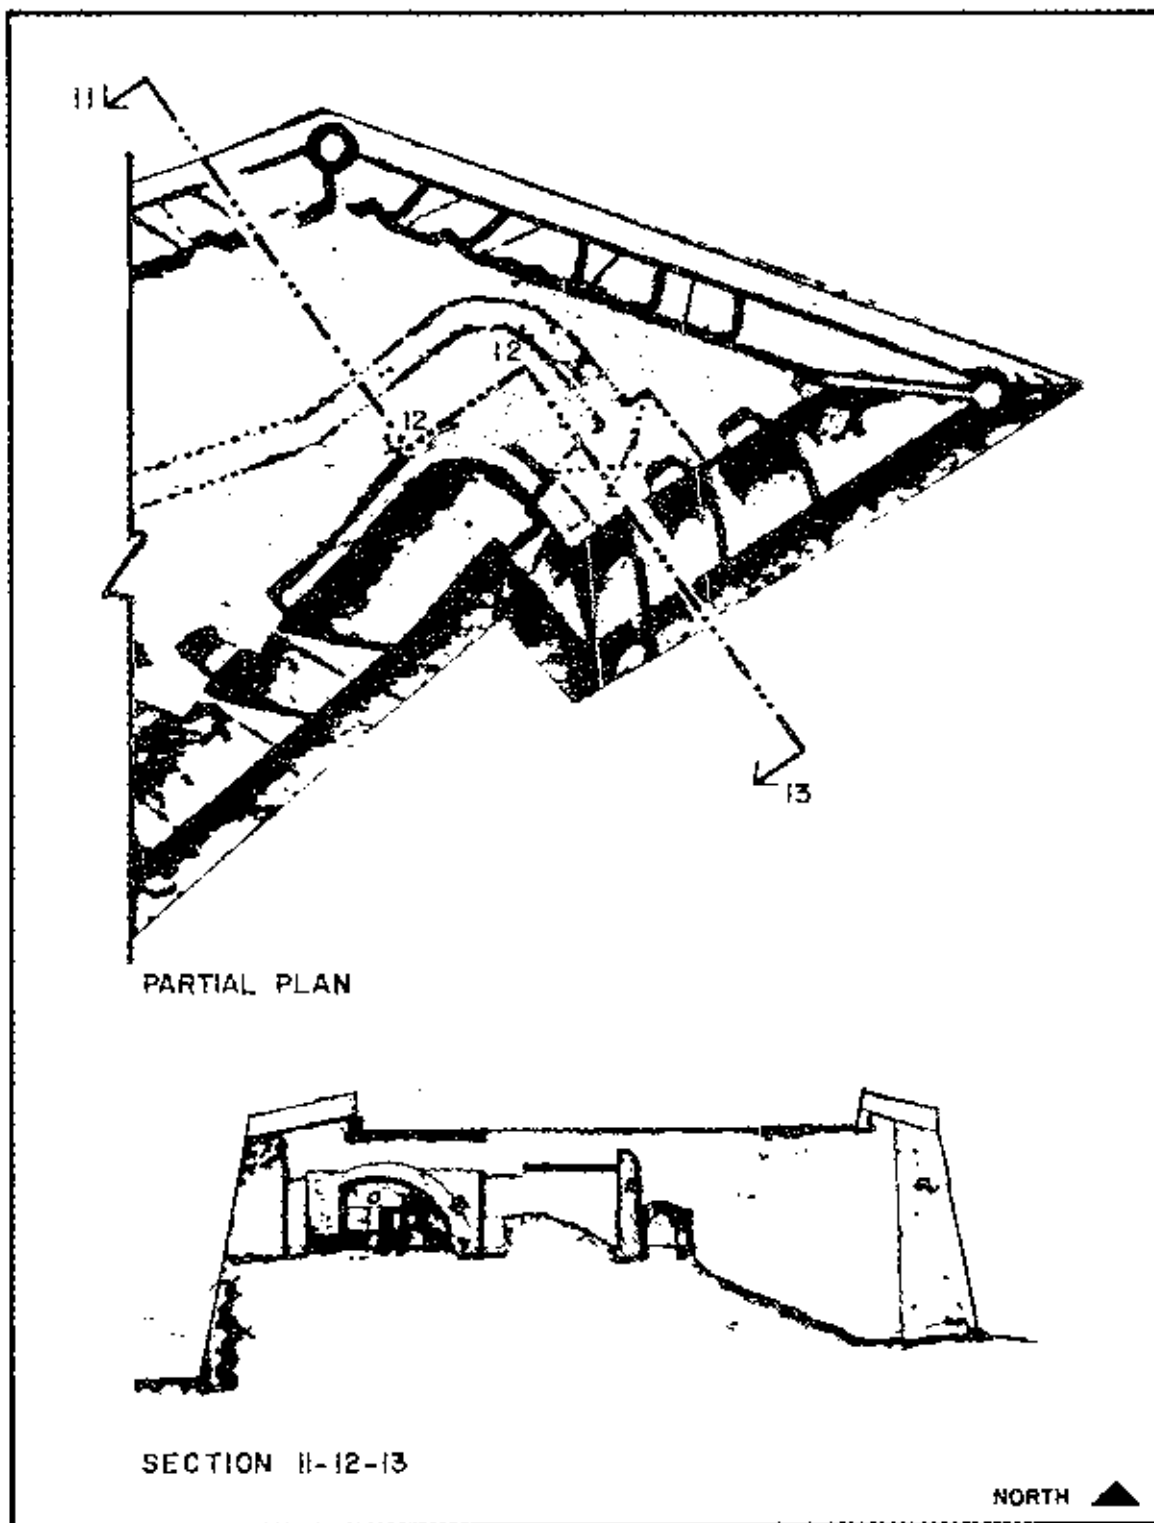
Figure 20.9. Profile No. 2 looking west at cut line 11, 12, 13, on the 1769 plan by Thomas O'Daly. Shaded areas added to illustrate existing works.

Approximately 180 feet of the tunnel's south wall comprise what was originally the north wall of the fort, known today as the North Bastion. This is illustrated graphically in a 1769 section (fig. 20.9) by Engineer Thomas O'Daly. Here, in Profile No. 2, the new tunnel was joined to feature "P" described as the "old wall of the northern part of the Castle . . ."³ This wall was built using a lime mortar containing brick dust.

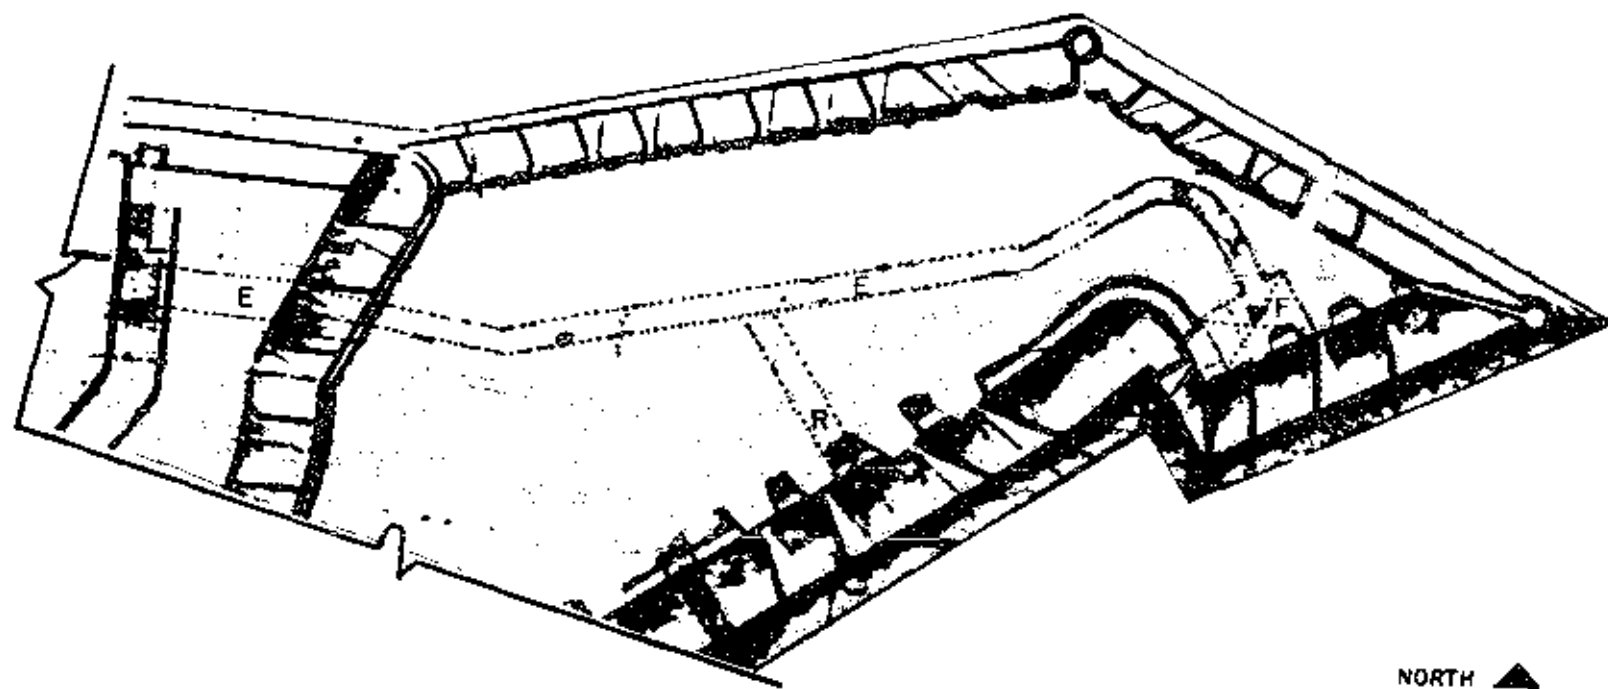
Figure 20.10. Detail of 1769 plan by O'Daly showing Tunnel 1. Shaded area added to illustrate existing works in 1765.

The gallery is documented for the first time in Thomas O'Daly's plan of 1769 (fig. 20.10). Here, it is labeled "E" and described as:

Construction of the gallery was complex, incorporating both new and existing works. An understanding of their construction may be achieved by close study of the 1769 plan as it compares with the earlier 1765 plan and existing conditions today. The west end of the gallery at the Plaza level was new construction in 1769, located in the base of the north extension to el Caballero. Opening off it in the north wall were two doorways to the new powder magazines still under construction. Another doorway in the east wall led to the gallery. (The mortar bomb located above this doorway no doubt signified its use as a countermining tunnel.) The portion of the gallery that continued on the east side of the doorway for approximately 18 feet was still located beneath the new north extension to el Caballero. For the next 220 feet, the gallery continued beneath the newly widened terreplein of the North Bastion. The first 35 feet under the North Bastion comprised all new construction. The mortar used in these walls was a beige color lime mix containing a small amount of sea shells.* Farther on, beginning at a slight bend, the gallery followed along the outside of the old north wall of the fort. This wall was then utilized as the new gallery's interior south wall as illustrated in the 1769 elevation labeled "Profile No. 2." This continued for about 185 feet. Towards the east end, the gallery veered sharply to the south. At this location an opening was broken in the old fort wall and construction continued by excavating beneath the old North Bastion. After a short distance, the gallery opened into a new casemate.¹⁰

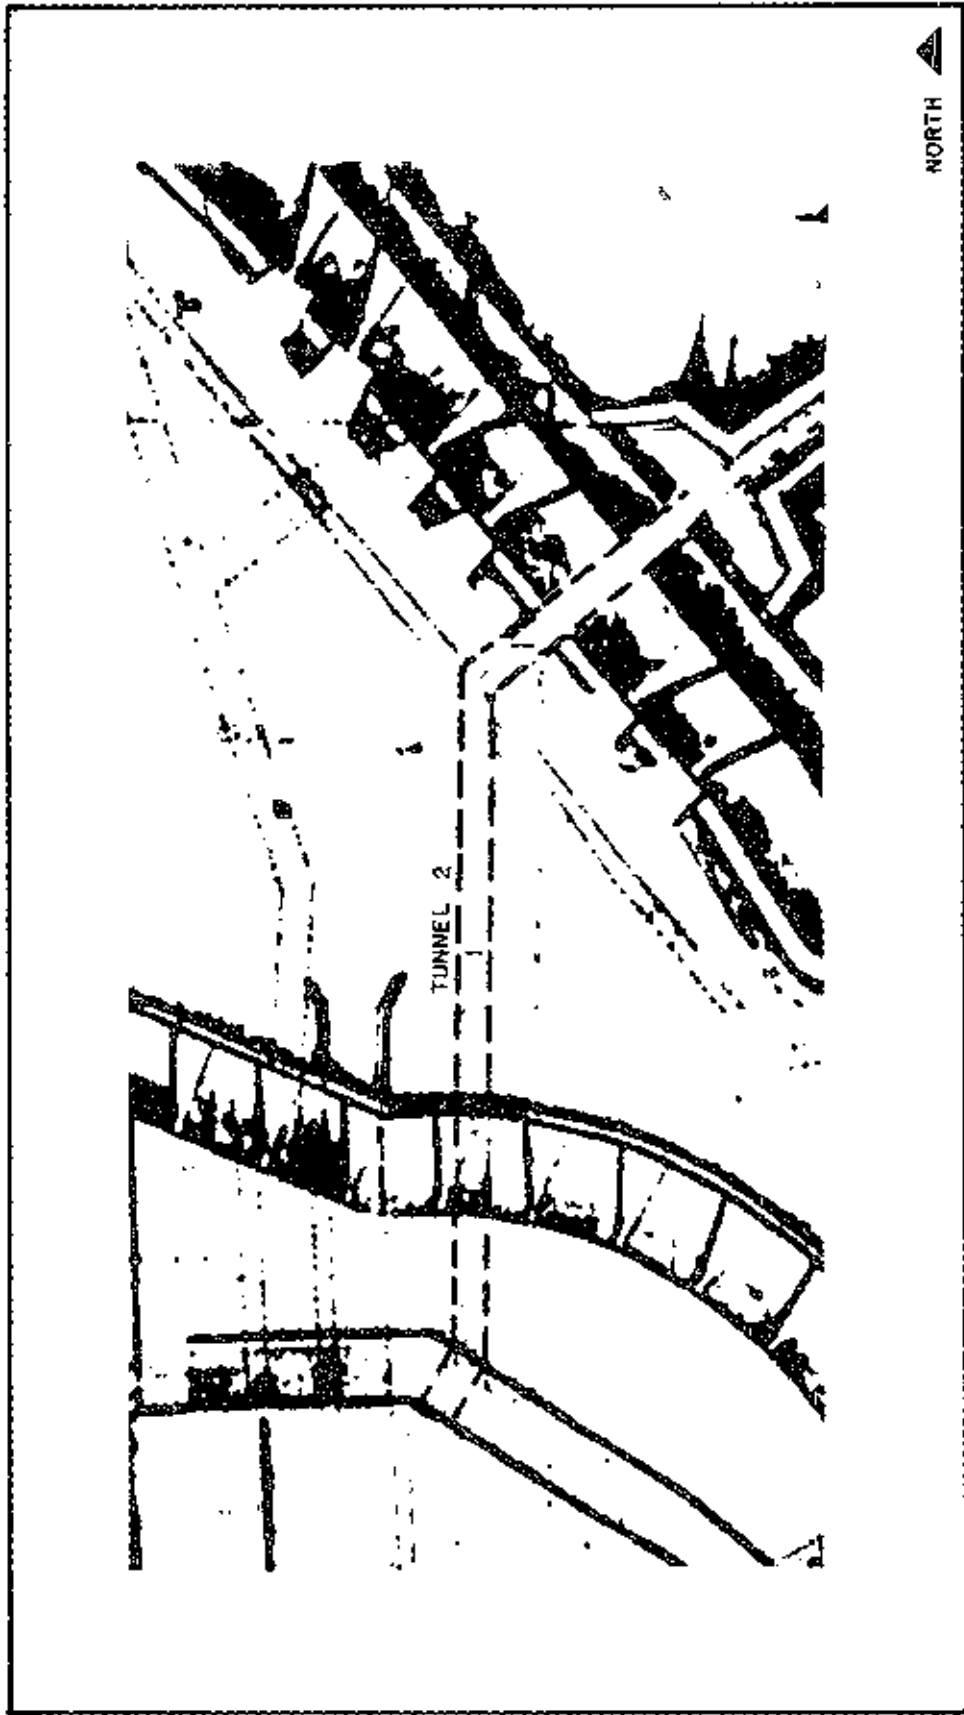
Figure 20.11. Detail of O'Daly plan showing Tunnel 2, January 15, 1769.

Tunnel 2 was documented for the first time in Engineer Thomas O'Daly's drawings dated 1769 (fig. 20.11, 20.12). In plan it was labeled feature "I" and described as:

The plan of 1769 and accompanying section (labeled Profile No. 1) provided a picture of the project as envisioned and eventually built. Three basic areas were apparent. First was an entrance vault off the Plaza located beneath the ramp to el Caballero. The vault was rectangular with a floor on the same level as the Plaza. It was undoubtedly an integral part of the ramp construction completed in 1771. Second, was a long tunnel located beneath the old Caballero and the San Cristóbal rampart. It ran in a straight easterly direction until its intersection with tunnel "T" that runs below it. Here the tunnel turned to the south and continued in a southeasterly direction. Its entire length was sloped downward towards the east. At the far east end, it terminated in the third area; the postern. This postern was the exterior opening in the curtain wall that gave access to the moat. Although not yet completed at this time, based on the section, passage across the moat would eventually be through a caponier.²⁰ The floor of the caponier would be at a lower level than the moat, thus providing protection from enemy fire. Directly on the other side of the moat was San Carlos Ravelin.

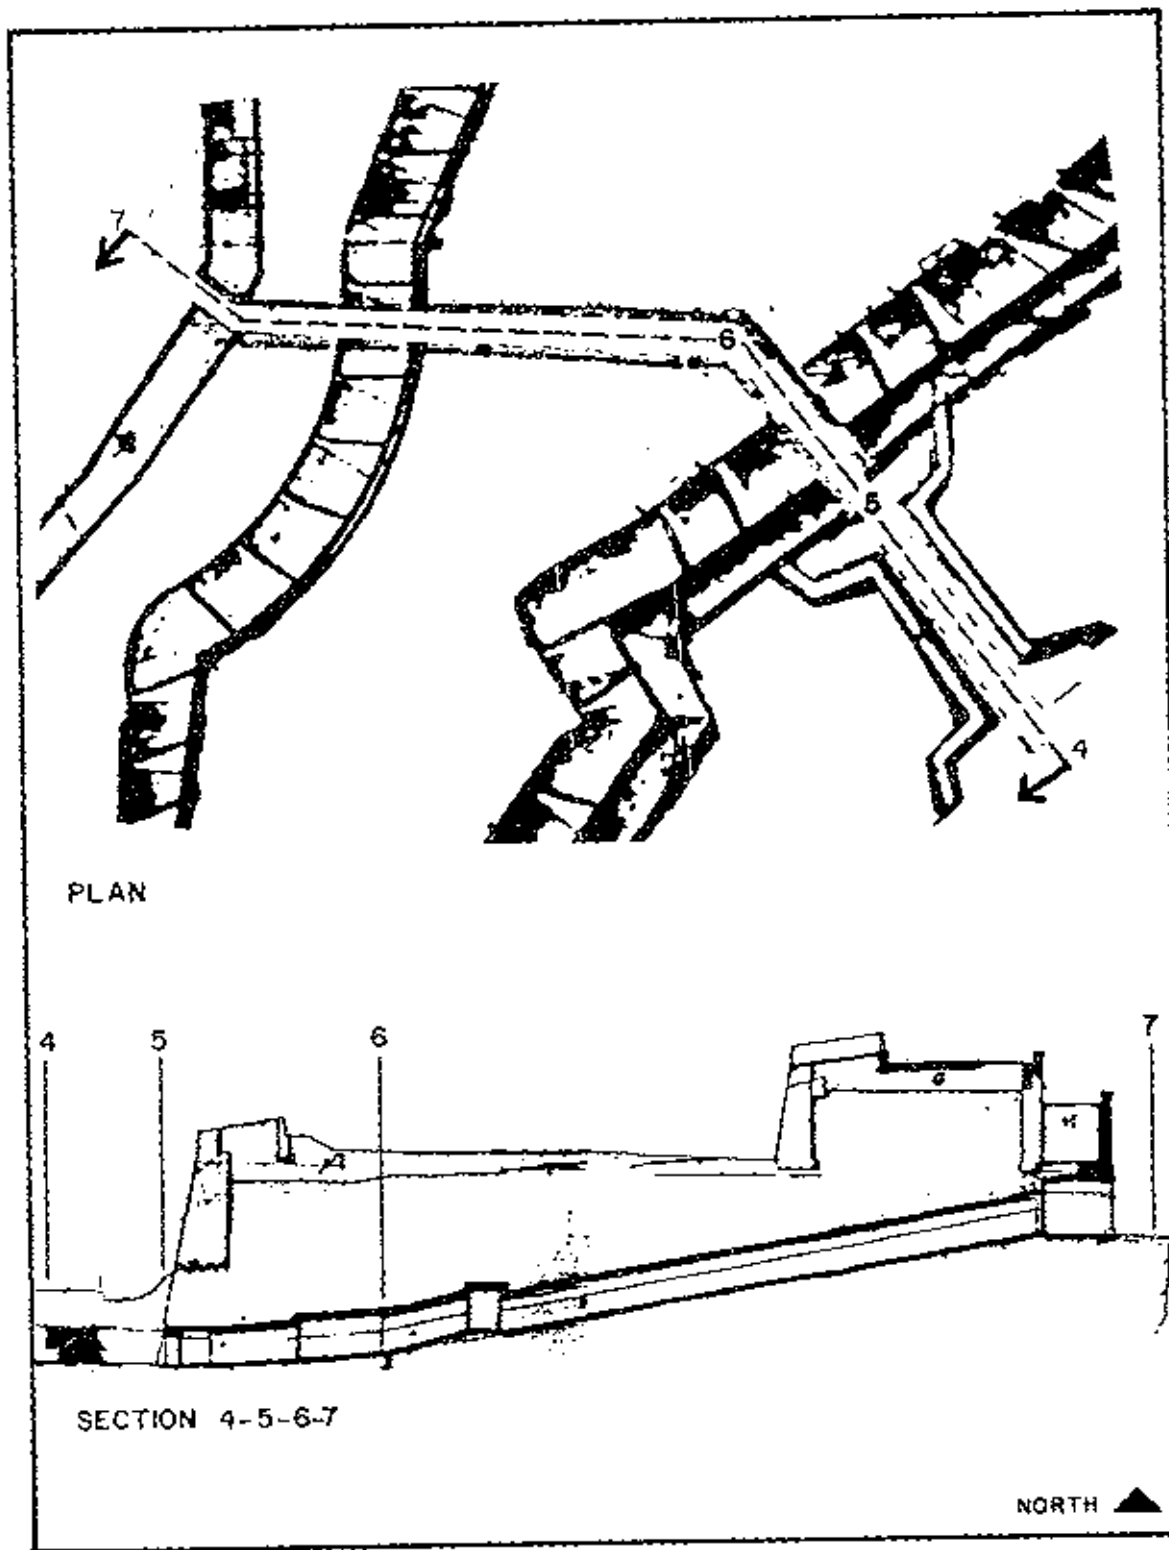
Figure 20.12. Profile No. 1 looking south at cut line 4, 5, 6, 7, on 1769 plan by O'Daly.

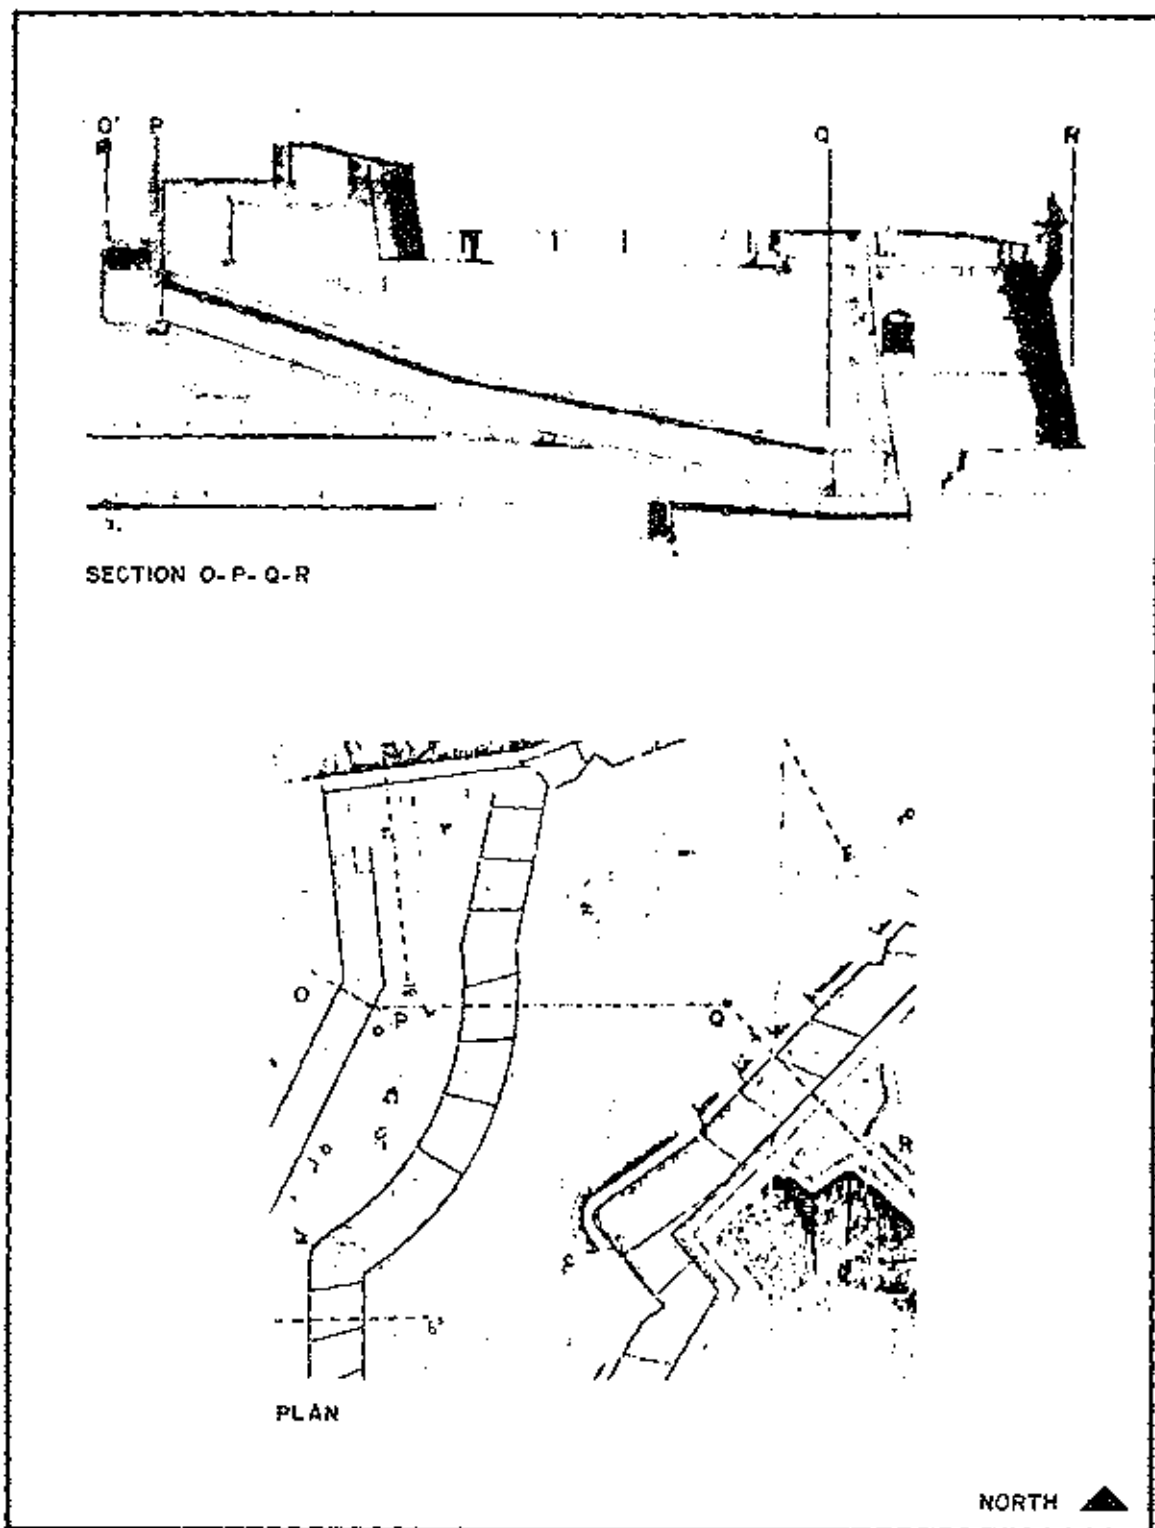
Figure 20.13. Section looking north through cut line o, p, q, r, s and showing Tunnel 2. Drawing by O'Daly, 1773.

The appearance of the completed postern tunnel was included in O'Daly's 1773 plan, west elevation, and section (fig. 20.13). The feature was labeled "K.K." and described as, "Postern whose gallery can also be used for countermining."²² In plan, the layout was unchanged from that illustrated in 1769. The west elevation showed the entrance to the vault off the Plaza de Armas as a large arched opening located in the ramp wall to el Caballero. The section (looking north) showed a small room of rectangular shape at the east end of the tunnel. This room, located within the moat curtain wall, was the postern.

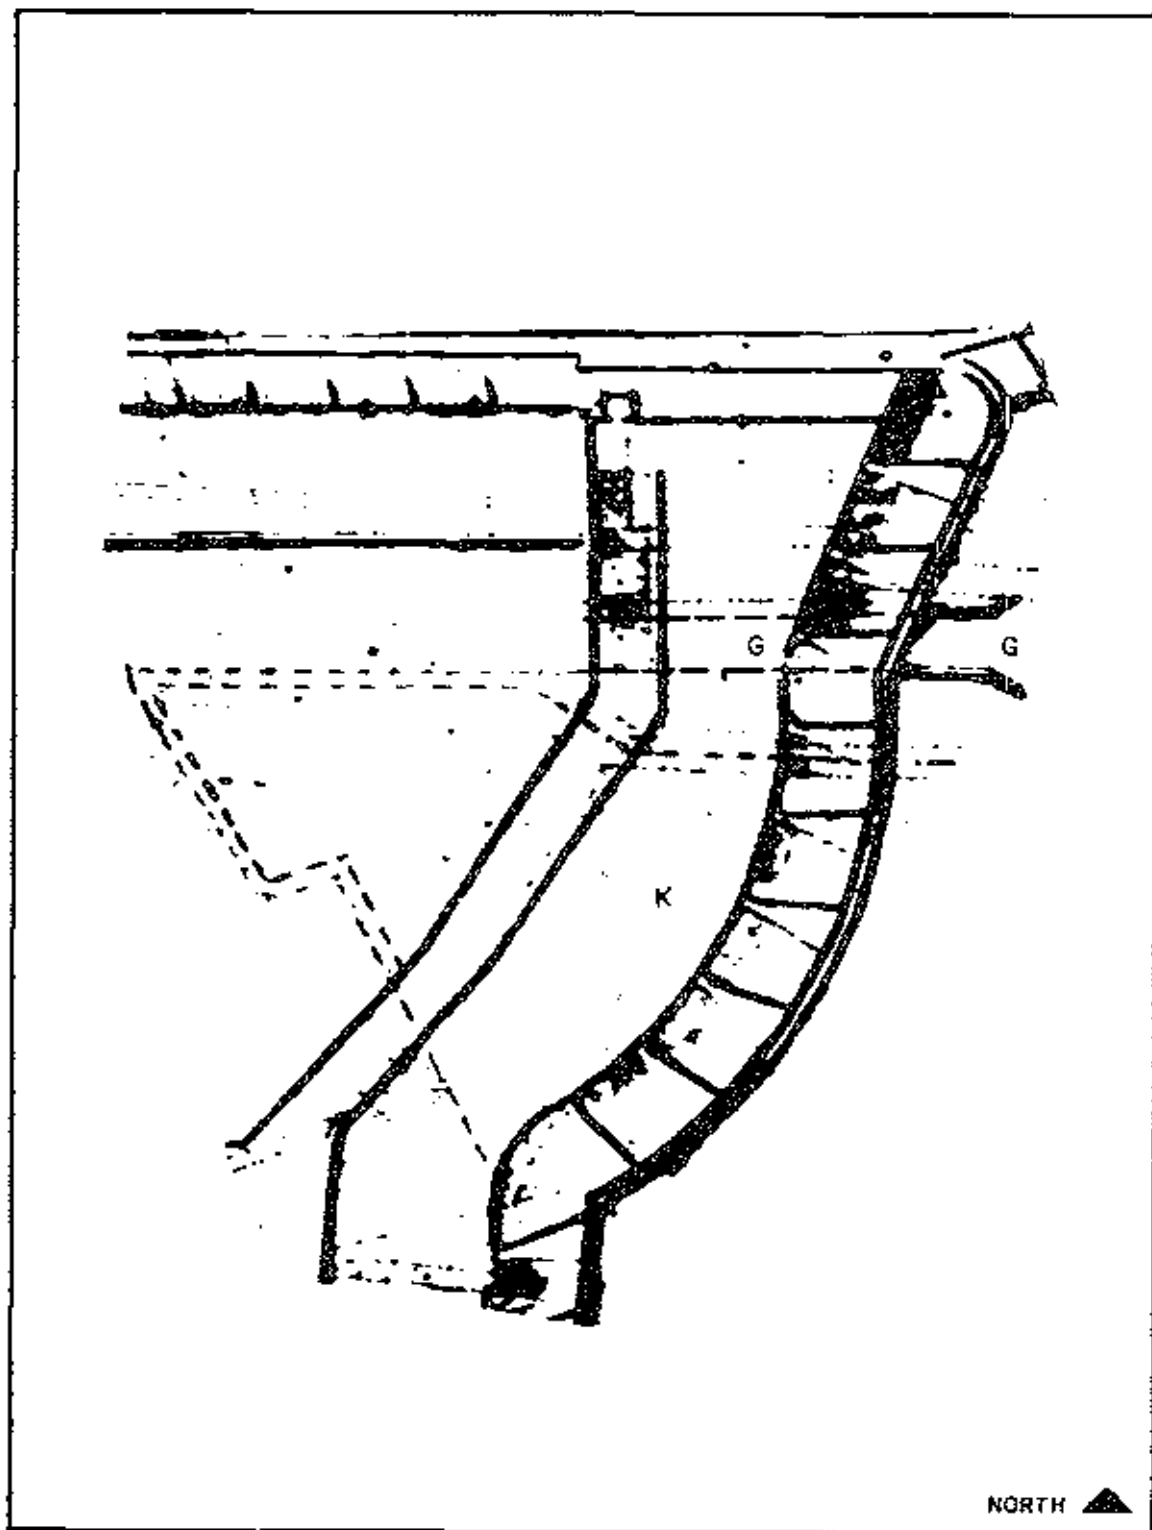
Figure 20.14. Detail of 1769 plan by O'Daly showing relationship of Tunnel 3 ("G") to original Caballero ("X").

The building of Tunnel 3 was part of the modernization project for San Cristóbal first proposed in 1765. It was not included in the original 1765 proposal but it did appear in the plan dated 1769 (fig. 20.14). It was known during this period as Puebla (gate) or Puebla del Castillo (gate of the Castle).

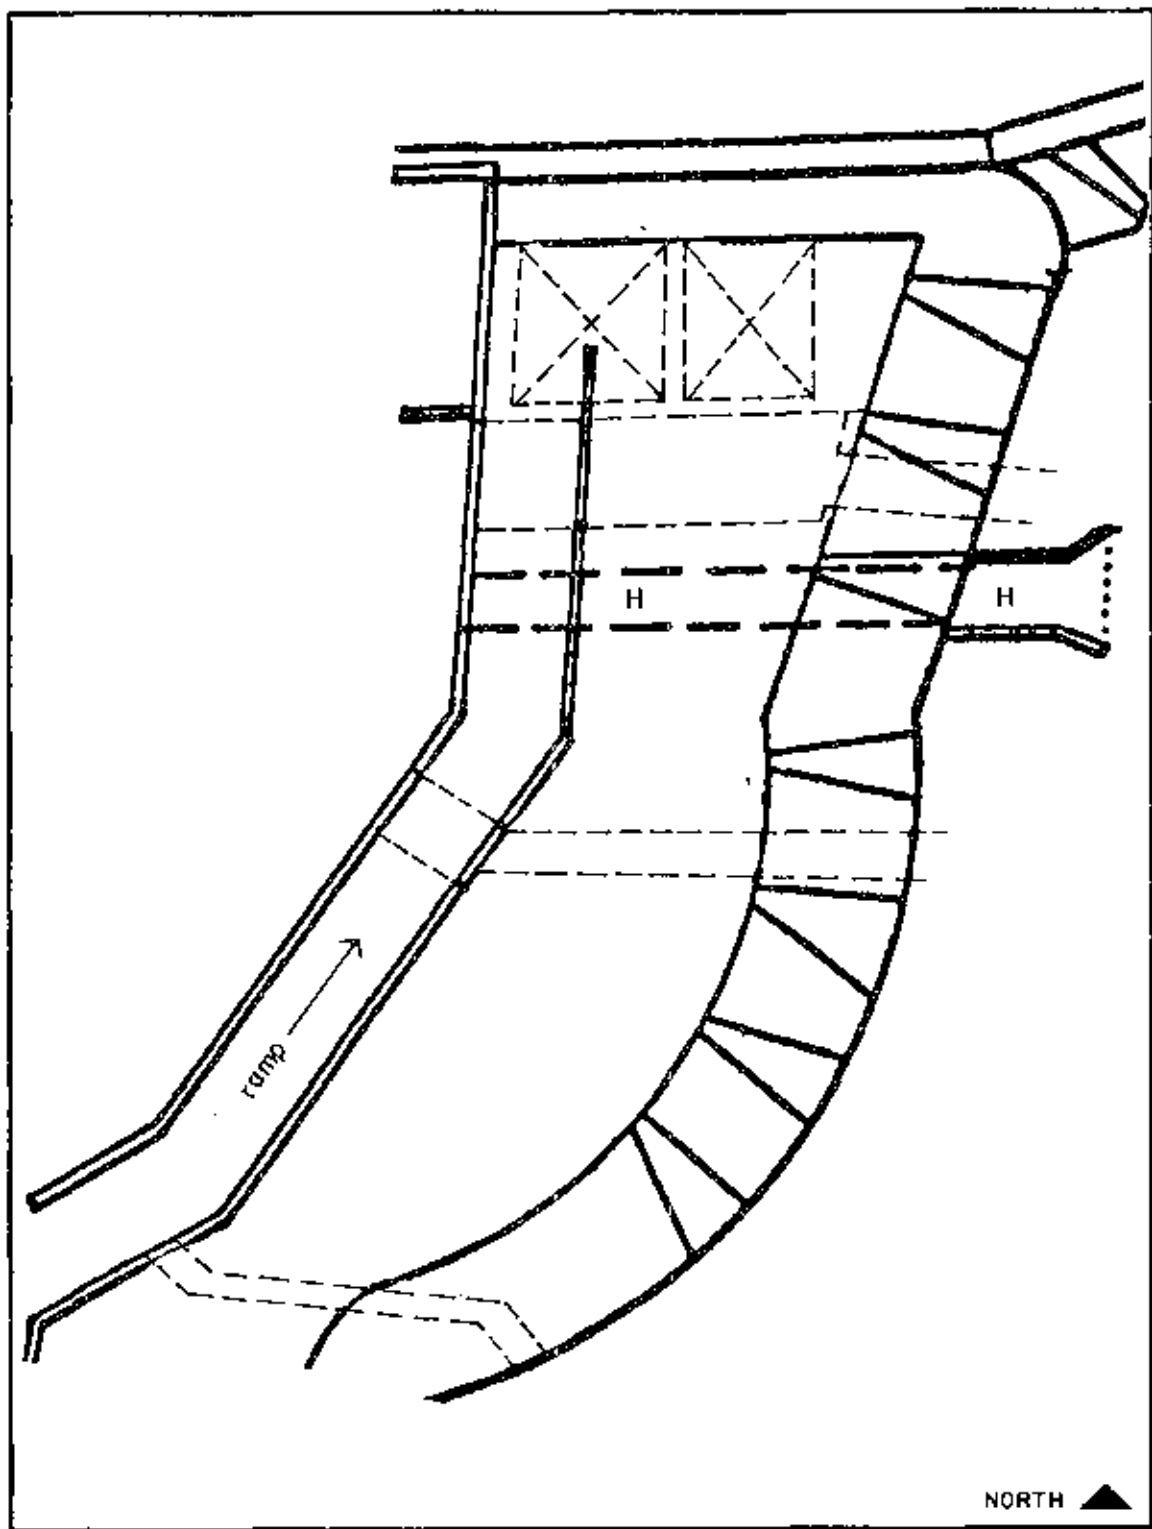
Figure 20.15. Detail of August 8, 1773 plan by O'Daly with Tunnel 3 labeled "H". Tracing of original drawing by Torres-Reyes (1965) annotated by Jana Gross (1989).

These conditions were unchanged four years later when O'Daly drew another plan (fig. 20.15) of San Cristóbal in 1773. Tunnel 3 was then labeled feature "H" and described as the "Gate of the Castle." The notes further explained that the Gate was "newly constructed."²⁵ An elevation of the same date illustrated the west entrance off of the Plaza. This was shown as a large arched opening in the wall beneath the ramp to el Caballero.
