THE FORTIFICATIONS OF SAN JUAN NATIONAL HISTORIC SITE

HISTORIC STRUCTURE REPORT

El Fuerte de San Cristóbal

1991

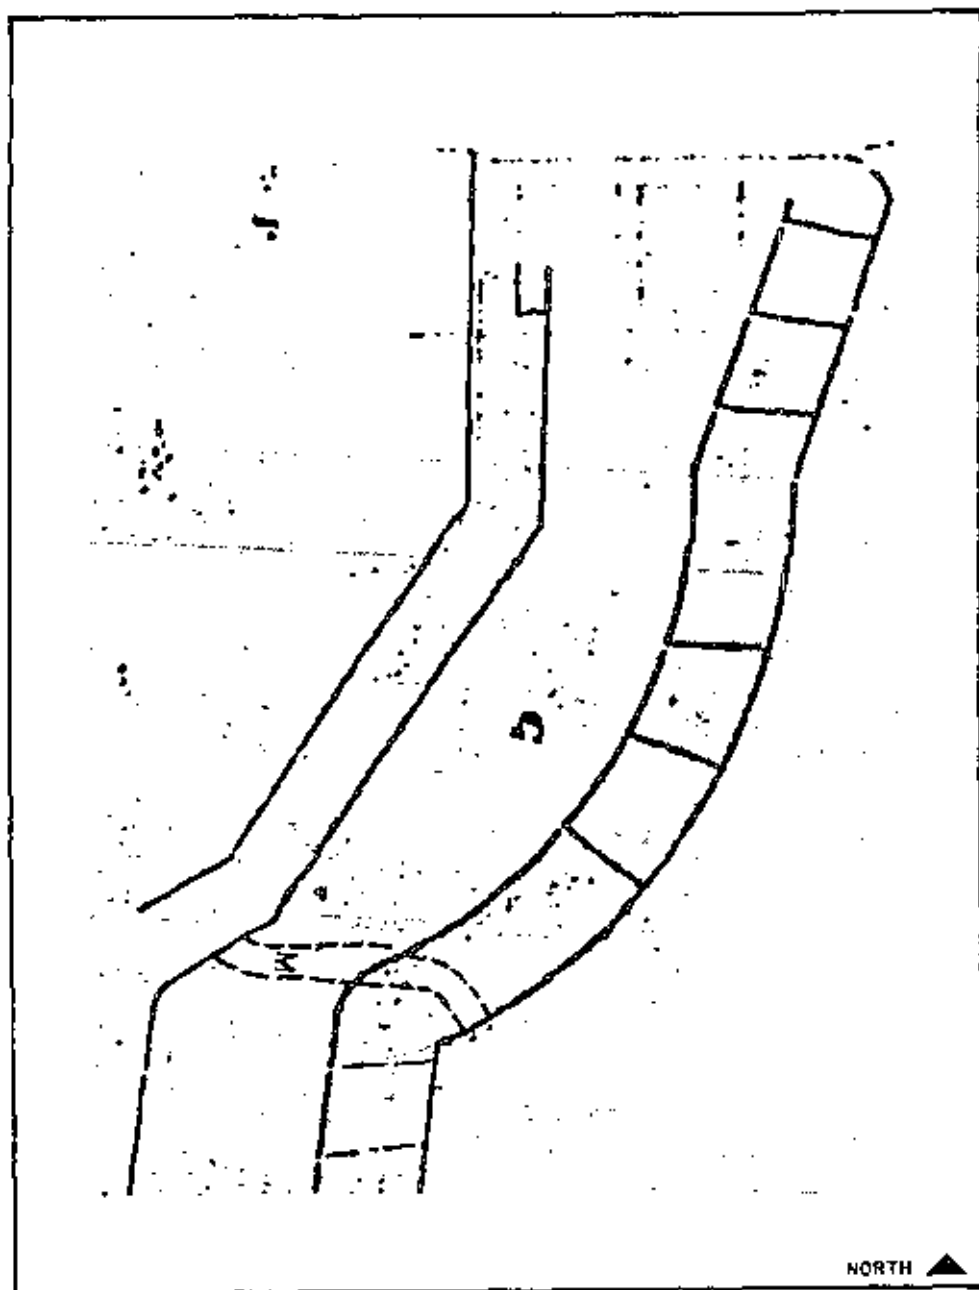
Figure 20.16. Detail of August 8, 1773 plan by O'Daly showing Tunnel 4 ("M") and its relationship to the original Caballero ("G").

The first known documented reference to Tunnel 4 is O'Daly's plan of 1773 (fig. 20.16); it was labeled feature "M" and described as the Poterna del Caballero (postern under the Cavalier). Like Tunnel 3, Tunnel 4 was shown as a passageway connecting the Plaza de Armas with the east terreplein of the fort. The elevation, also dated 1773, showed the west entrance

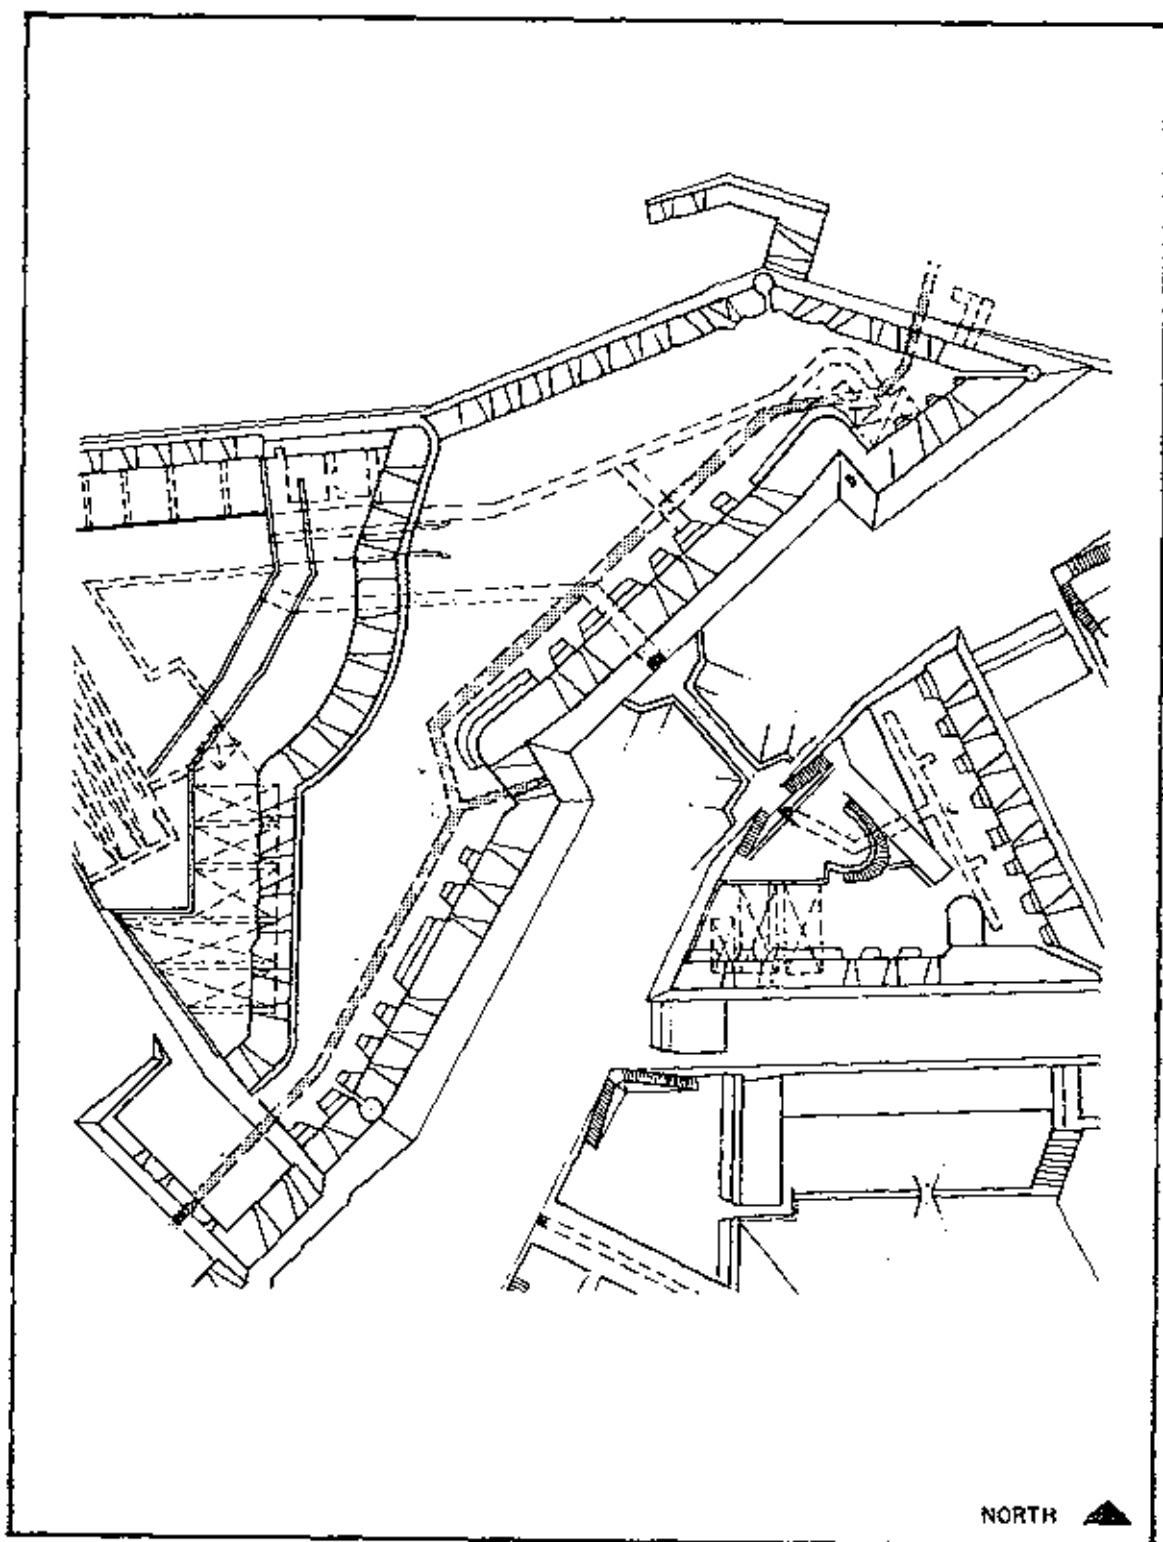
Figure 20.17. Detail of proposed plan by O'Daly, January 15, 1769 with Tunnels 5 and 6 highlighted. Tracing of original drawing by Torres-Reyes (1965) annotated by Jana Gross (1989).

O'Daly's Plan of 1769 (fig. 20.17) showed the tunnels in the works with "S", the executed portion of the countermining gallery, running only to the meeting of the curtain and the north flank of the South Bastion. The letter "T" on the same plan represented:

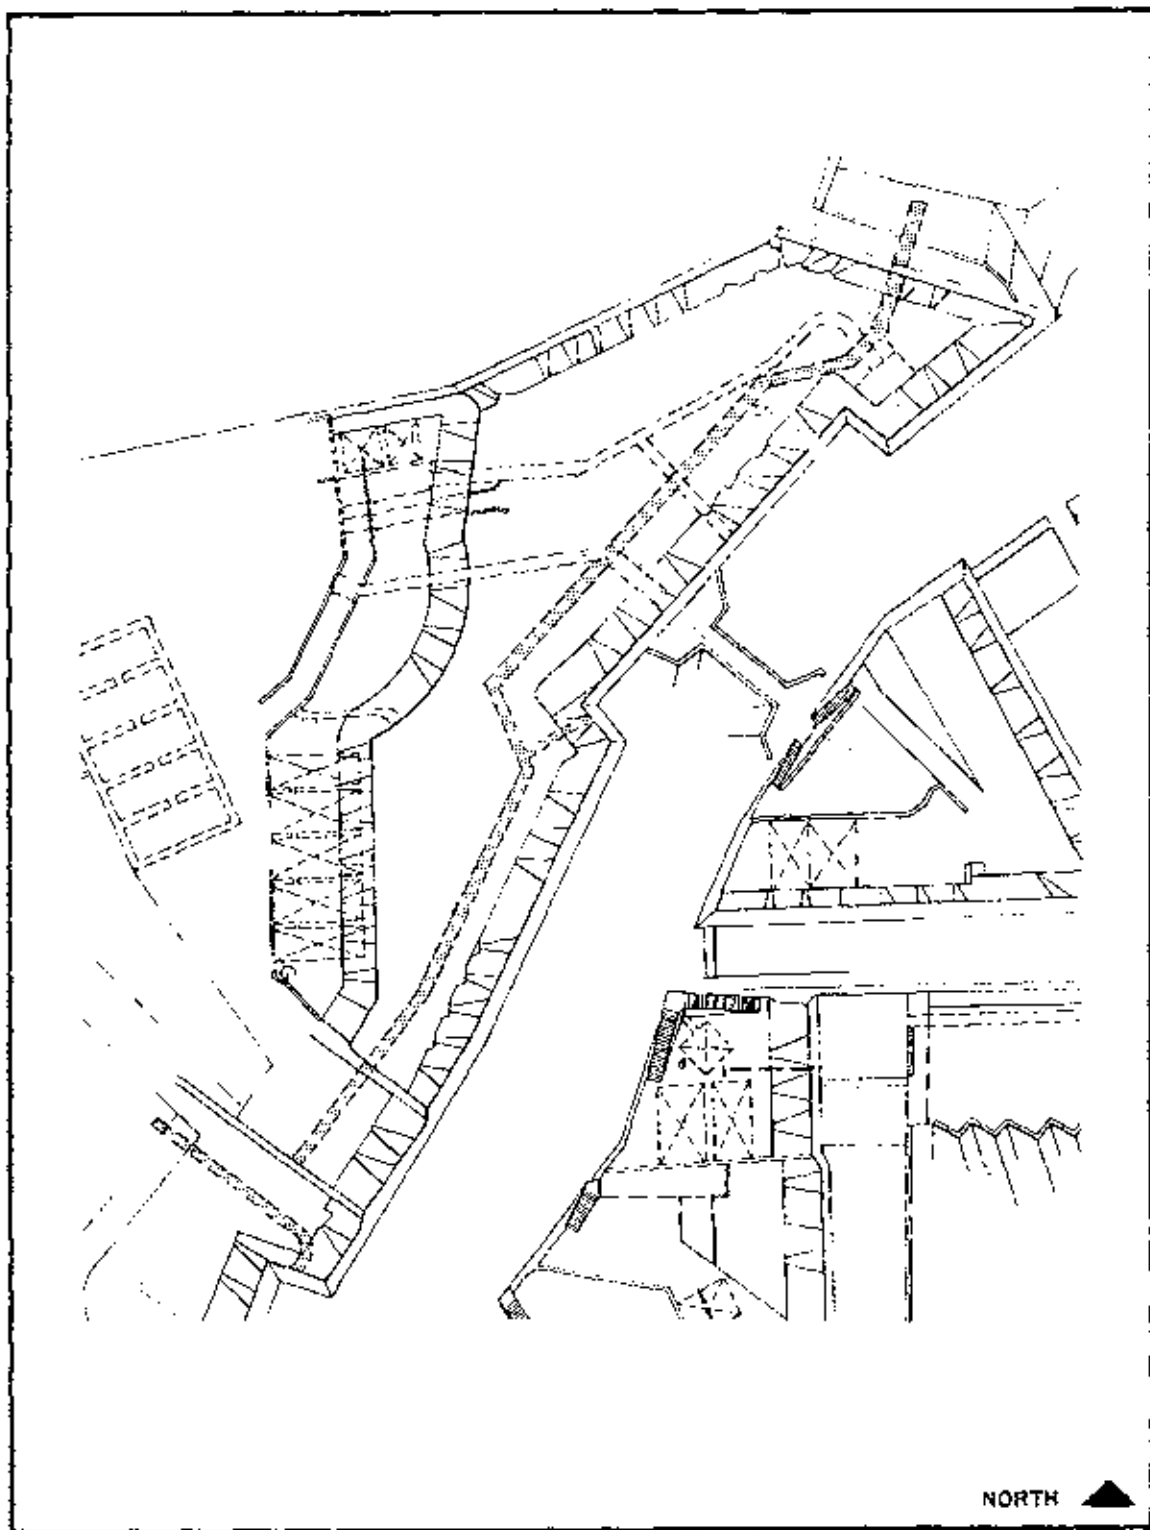
Figure 20.18. Detail of O'Daly plan, August 8, 1773 with Tunnels 5 and 6 highlighted. Tracing of original drawing by Torres-Reyes (1965) annotated by Jana Gross (1989).

O'Daly's plan of 1773 (fig. 20.18) showed Tunnel 5 in its completed form and labeled letter "QQ", "a countermining gallery that ran along the front of the castle and that ends in the north face of the North Bastion". (See Appendix A-10 for complete legend and plan.)

The tunnel appeared for the first time on O'Daly's plan of 1773. (See fig. 20.18.) Although indicated in dotted lines, this plan clearly illustrated the tunnel's location, orientation, and relationship to the entire defense system.

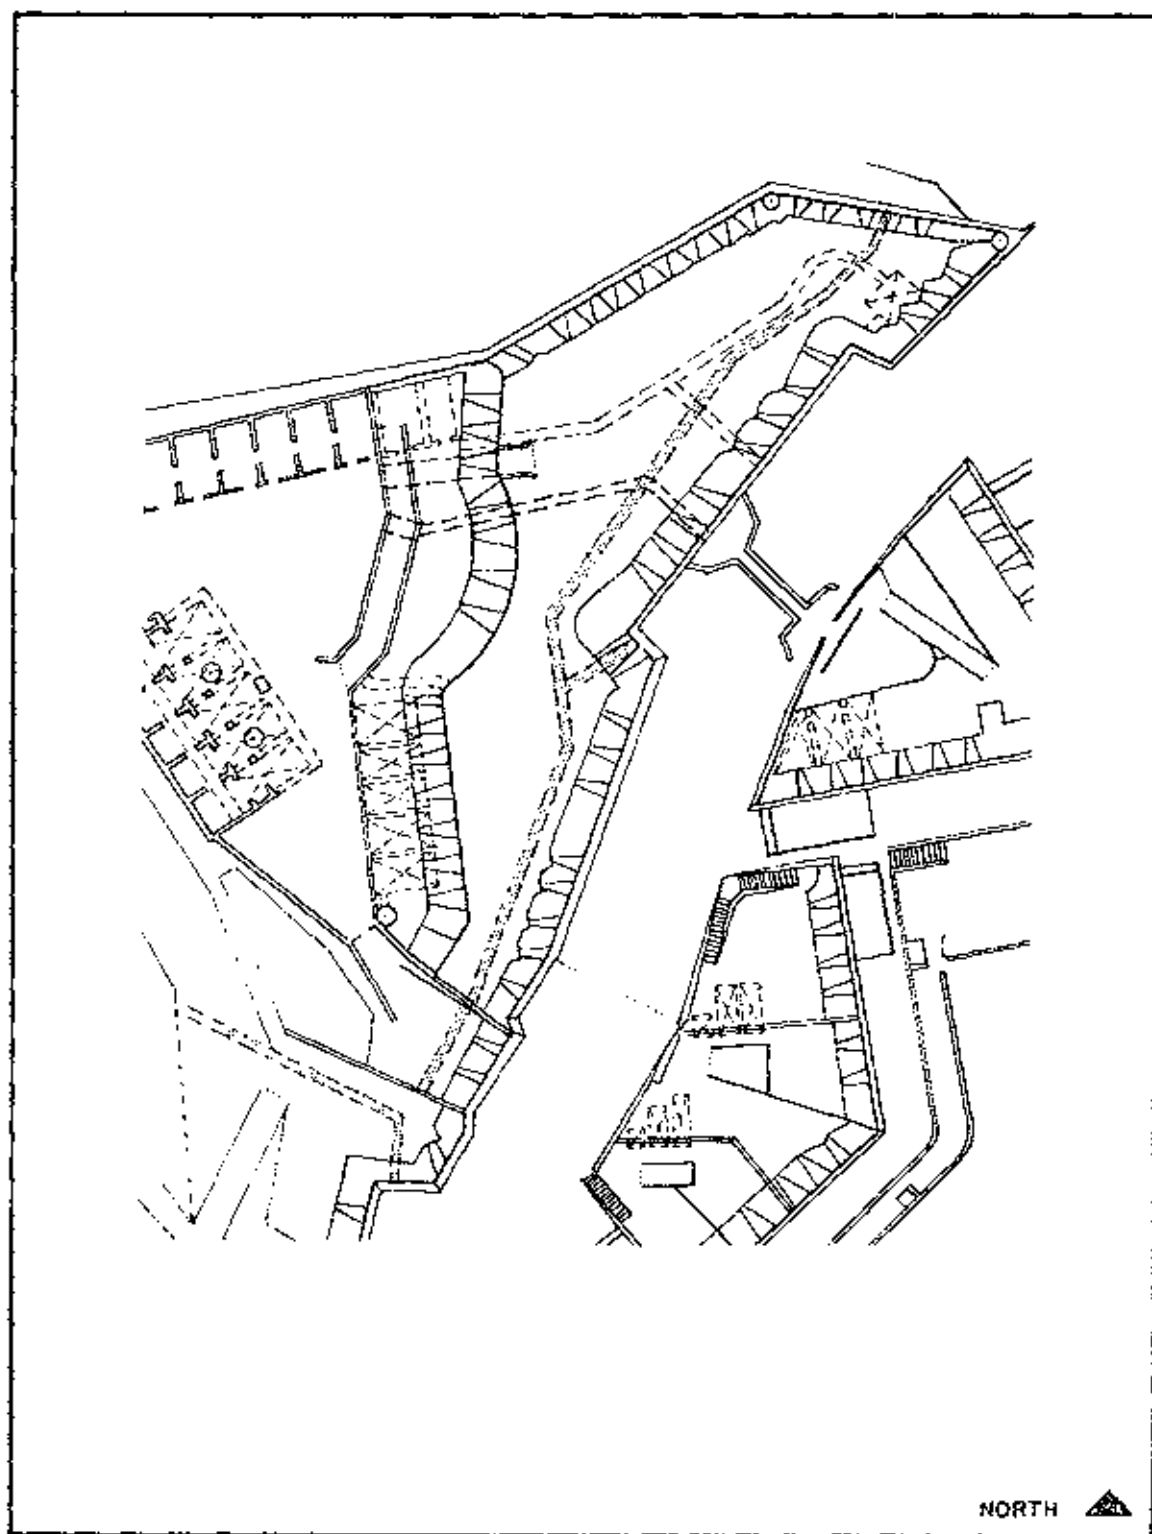
Figure 20.19. Detail of Mestre plan, September 13, 1783 with Tunnels 5 and 6 highlighted. Tracing of original drawing by Torres-Reyes (1965) annotated by Jana Gross (1989).

Although the tunnel as shown in Mestre's plan of 1783 (fig. 20.19) appeared unmodified, the plan is of interest as it clearly showed the location of the tunnel's emergence into the sloping pomerium to the west of the fort, and did not indicate that any buildings were constructed in this area.

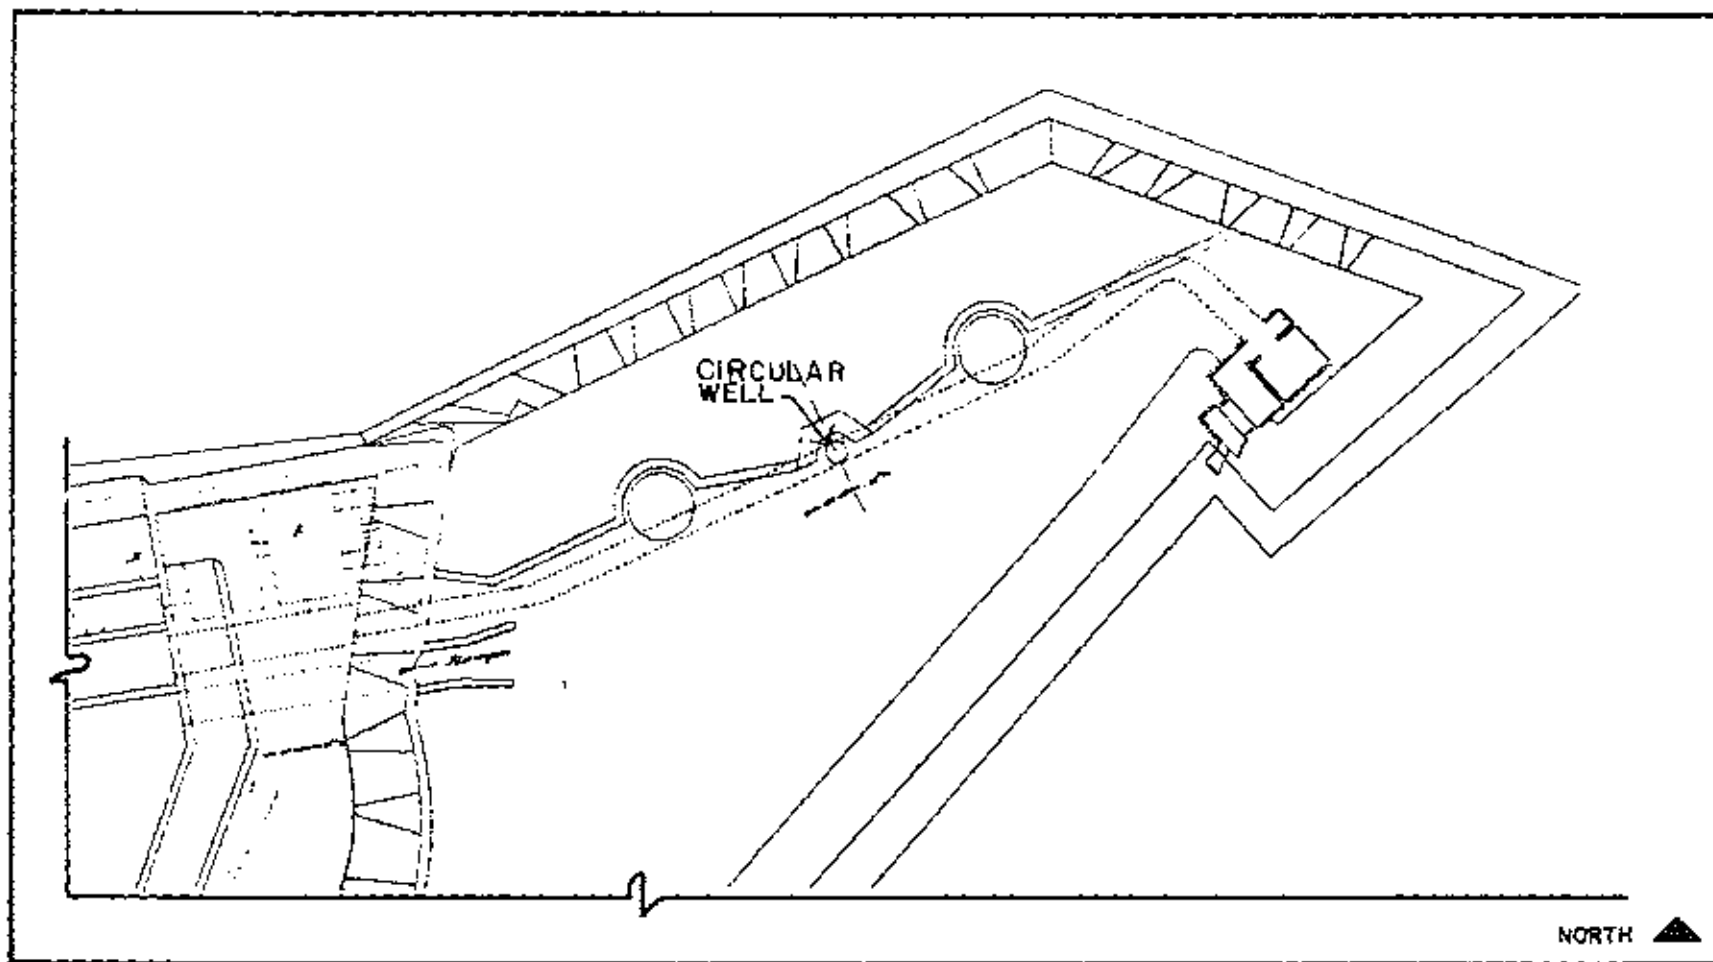
Figure 20.24. Detail of ca. 1897 plan obtained by Colonel Goethals in 1898 showing "circular well" at Tunnel 1. (San Juan NHS Archives.)

During the invasion by the United States in 1898, the gallery was used by the Spanish as a magazine. Ammunition for two guns emplaced on the North Bastion above was passed through "a circular well" situated between the guns.³⁹ While this brick-lined well may have been an early ventilation shaft, no documentation on its existence before 1898 exists. Therefore, it has been dated ca. 1897. The well was illustrated in a plan (fig. 20.24) obtained by a Colonel Goethals in 1898.

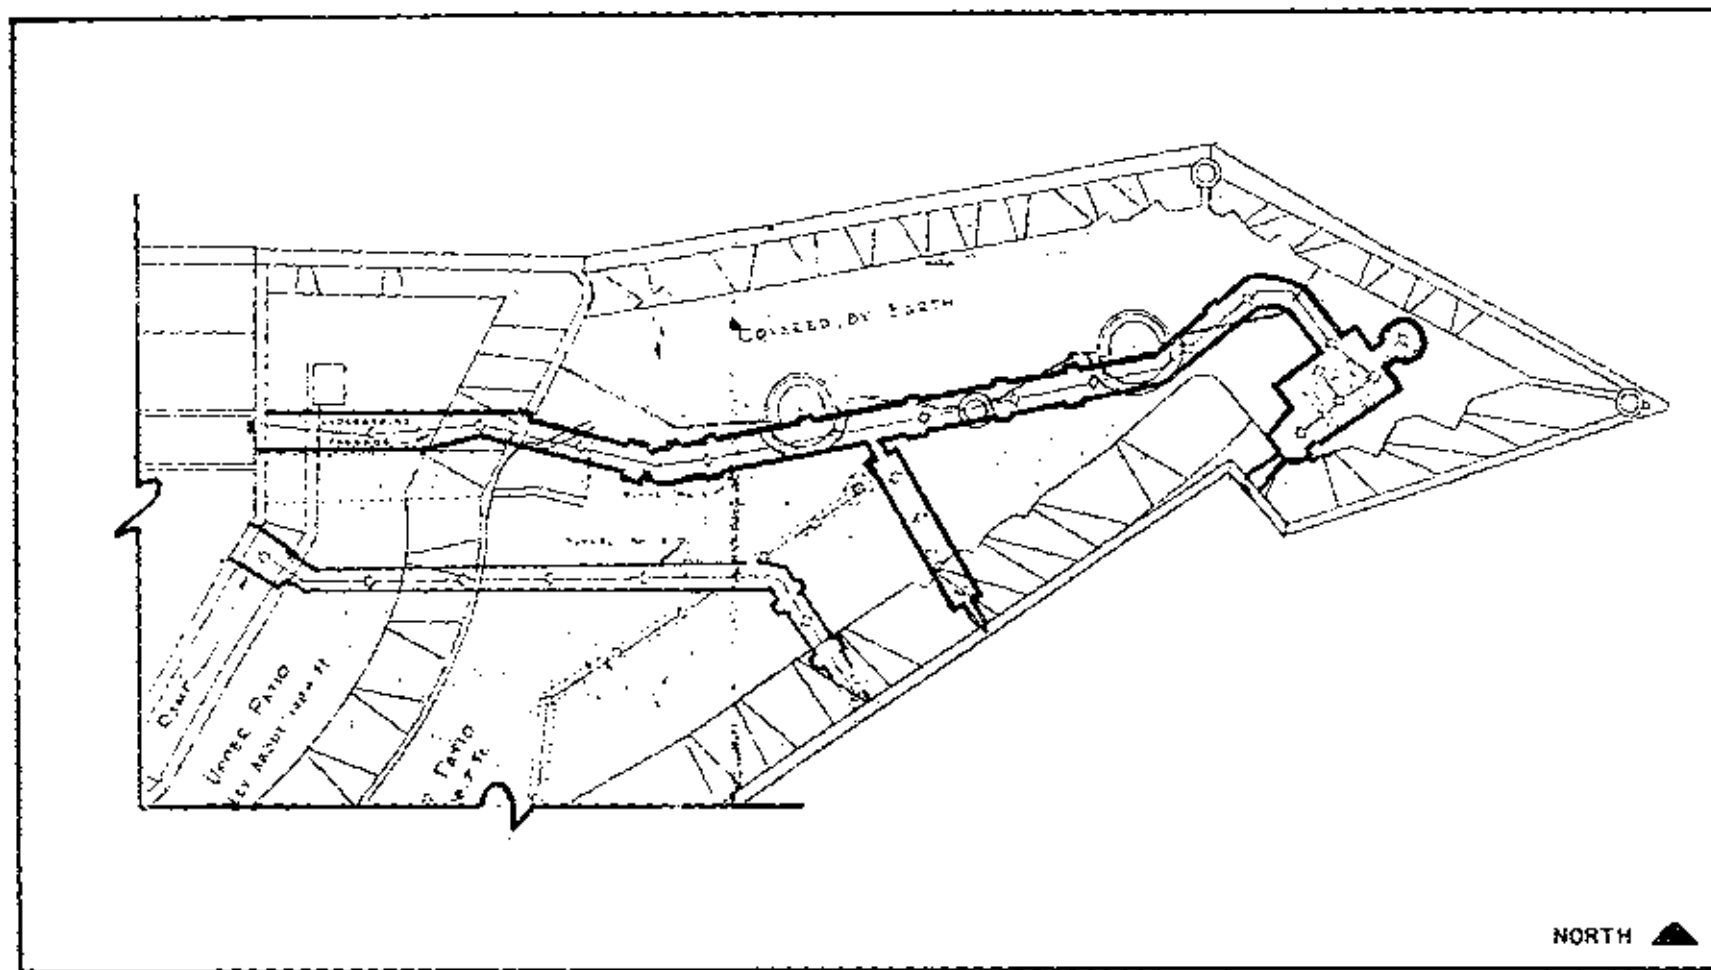
Figure 20.25. Detail of plan dated 1938-39 entitled "Electrical System for Tunnels Illumination." (San Juan NHS collection.)

In 1938-39, work was done as part of Job SW-8, "Exploration and Restoration of Subterranean Passages," and Specification No. F-28-5". Job SW-8 involved general cleaning of "the postern gate tunnel" and breaking through of the outside entrance, presumably at the east end. A temporary gate was installed and brick and masonry steps constructed to prevent water from entering. The brick lining was repaired and electrical lighting installed in "tunnel no. 2" as part of Specification No. F-28-5. The remains of this lighting system and the plan that accompanied the specification (fig. 20.25) indicate that both the conduit for the wiring and the lights were located in the ceiling.⁴⁶

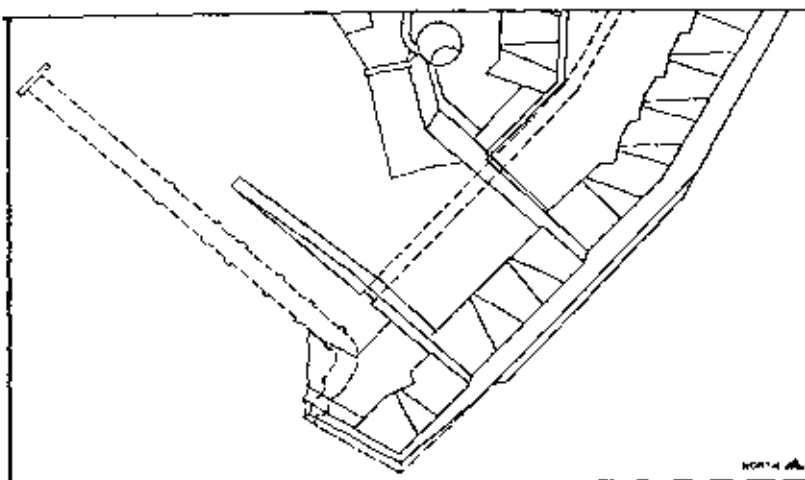
Figure 20.27. Detail of plan, May 1, 1938, showing mining slots in Tunnel 6. (San Juan NHS Archives.)

Army Corps 1938-39 plans of the fortifications (fig. 20.28) illustrated mining slots cut in the walls of Tunnel 6.⁵⁷ Although not previously indicated on available plans, these slots probably date to the original construction of the tunnel as there would be no logical reason for their modern installation.

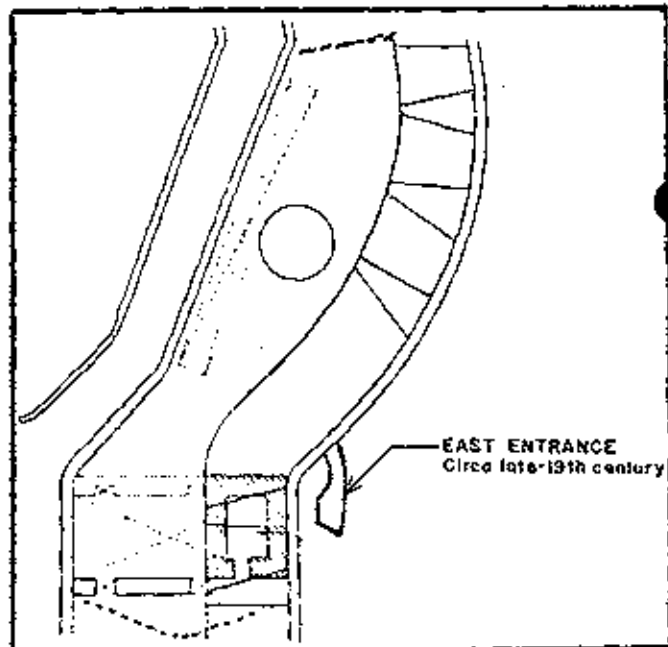
Figure 20.28. Late-19th century wall at east entrance to Tunnel 4. Plan, ca. 1897. (San Juan NHS Archives.)

In this period, a wall was built on the terreplein to the east. This new wall (fig. 20.27) functioned to protect the east exit. It was curvelinear in shape and was attached to the exterior wall of el Caballero on the north side of the opening. The wall was first recorded in a plan of ca. 1897 and may have been built in that year in preparation for the invasion by the United States. It was still extant in 1940 when it was included in a perspective drawing facing northwest. By 1949, and in plans of subsequent dates, the wall had disappeared. It was demolished sometime after World War II.⁵⁴
