# THE FORTIFICATIONS OF SAN JUAN NATIONAL HISTORIC SITE

## HISTORIC STRUCTURE REPORT

Castillo de San Felipe del Morro  
The City Walls  
An Investigation of the Materials Used  
Cultural Landscape Report

Castillo de San Felipe del Morro

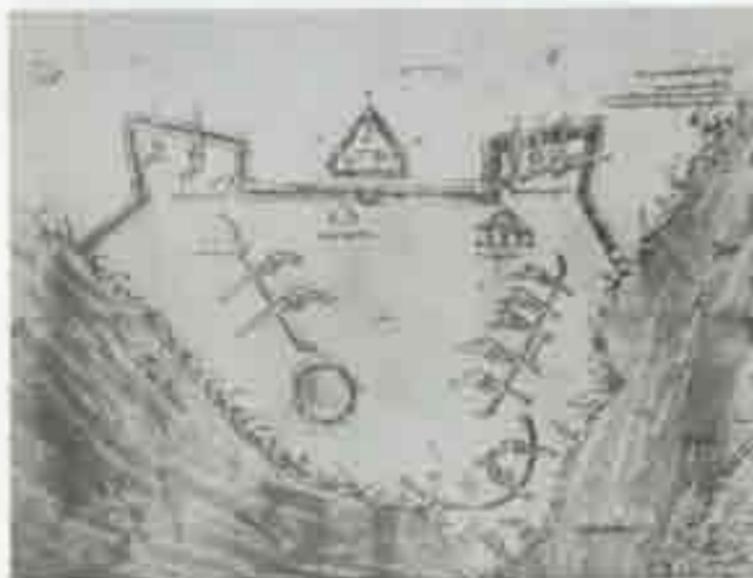
Figure 3. Ca. 1534 sketch of el Morro. (AGI-SU-10, 11, Seville.)

Visible on the interior are filled openings, or embrasures, for four cannons. Figure 3 (ca. 1881), essentially shows four cannons at the harbor entrance, behind a curved wall, with three cannons on a platform below; this presumably depicts the site before the bastion known as Santa Barbara had been built.<sup>4</sup> (It is not certain whether the curved wall represents the tower, or a later expanded upper platform.) At a later date, when Santa Barbara Bastion first took form, one of the three embrasures was converted to a doorway for access to the "Low Battery", as will be discussed below. Today, the first opening on the left accesses a stair leading to the so called "Water" or "Floating Battery", and is a more recent change, dating from ca. 1970, when the present Water Battery was constructed.<sup>4</sup> The present masonry dome over this space also dates from a later period when much of the fortress was rebuilt and many of its levels increased in height (details of this period will be discussed below). From the little evidence that remains for us to scrutinize, this earliest structure stood about 12.5 meters (60 feet) above sea level, with an interior height of about 3.8 meters (12 feet). The interior dimension is shown on a reconstruction from the NASS drawings (figs. 3 and 4), and the later increase in height is based on the physical evidence of existing elevations and an early (1742) drawing of the fort.

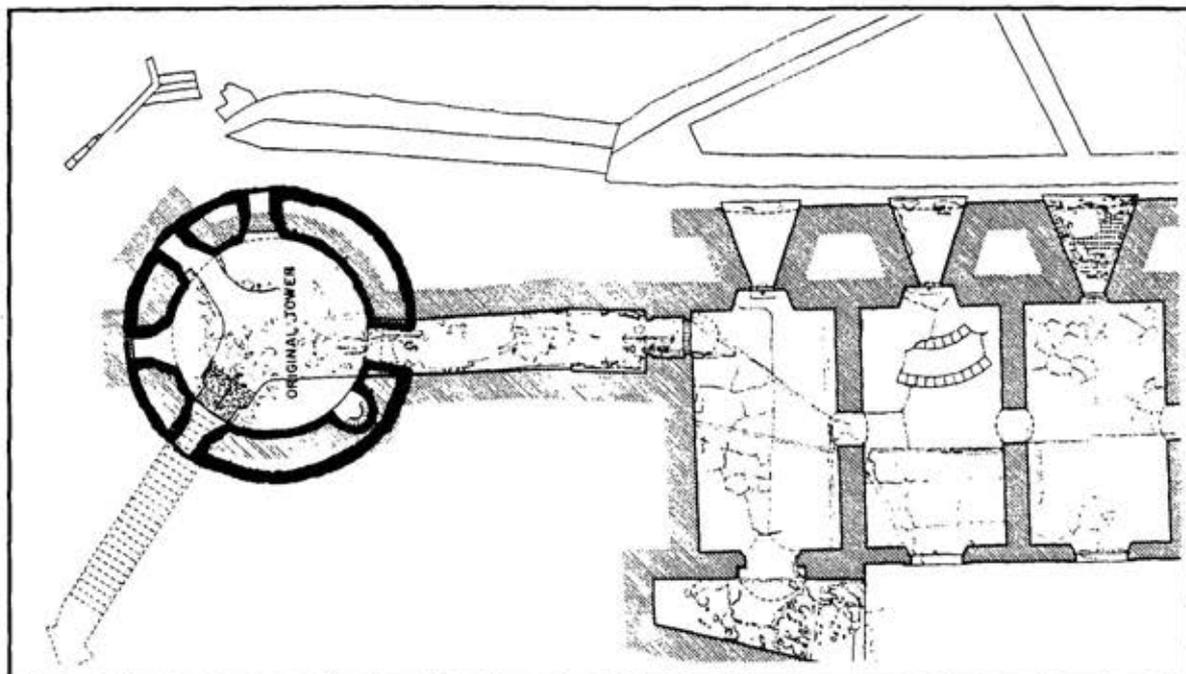
Figure 3. Location of ca. 1540 Tower in plan. (Annotated HABS drawings.)

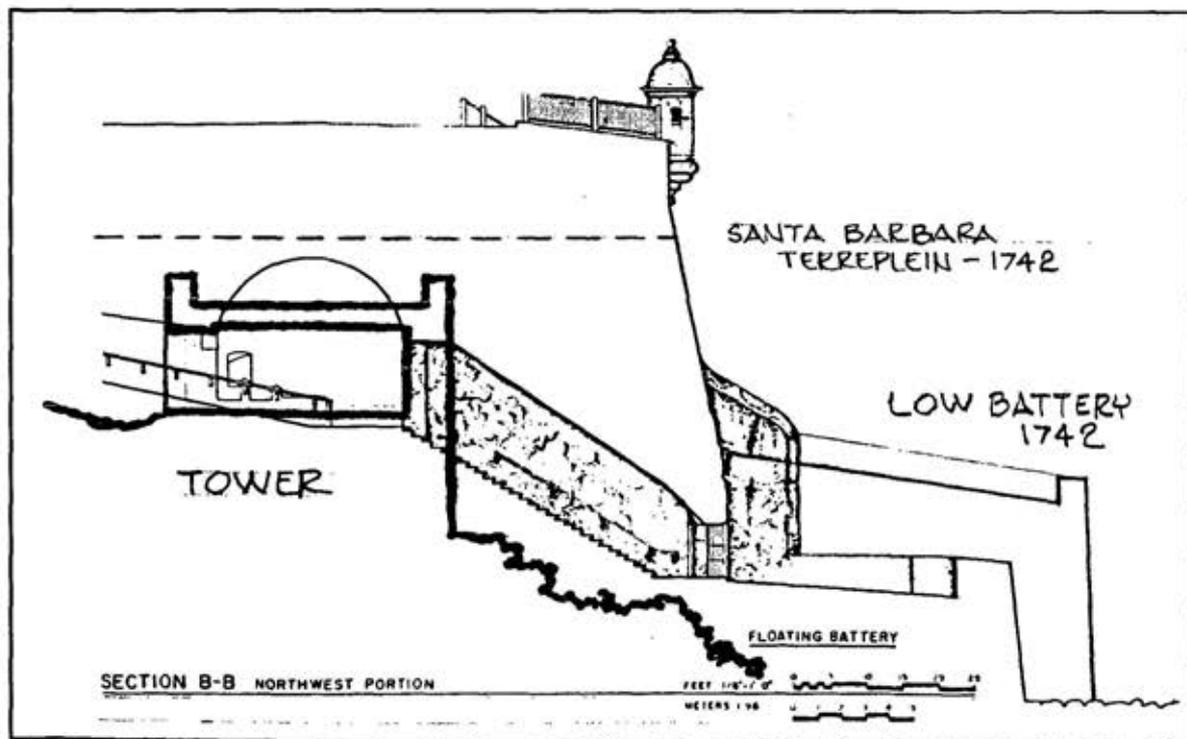
Figure 4. Location of ca. 1540 Tower in section. (Annotated HABS drawings.)

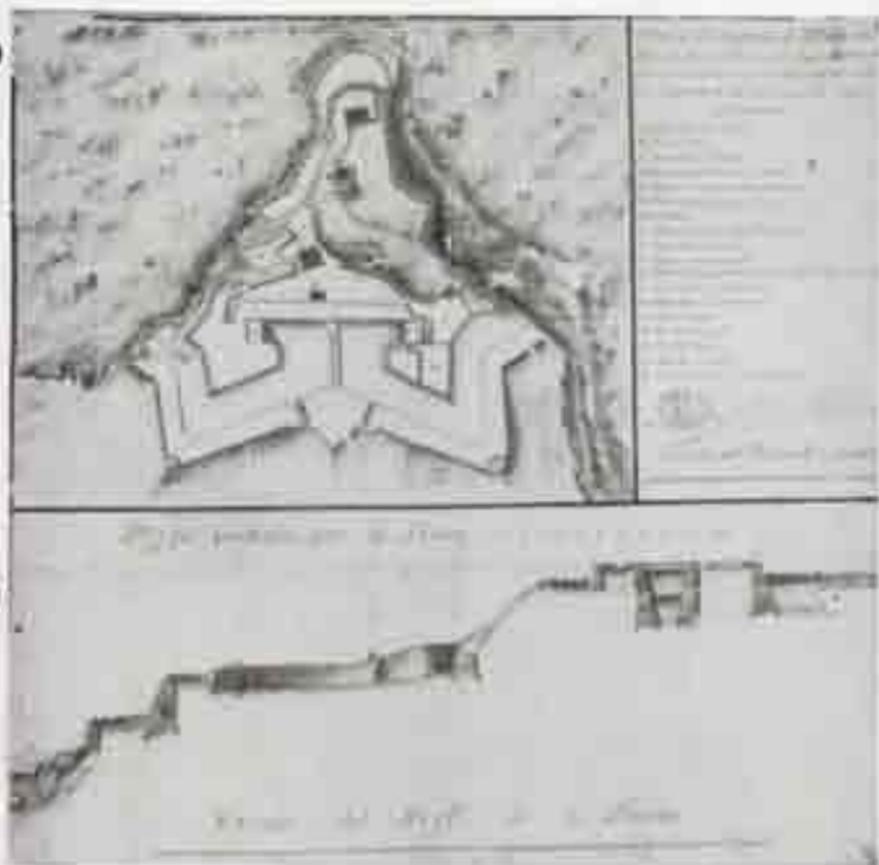
Figure 8. 1741 Drawing of El Morro. (HNM-Madrid; sign: S.750; K-  
b-2-58.)

The early years of the site remain vague and no physical remains, with the exception of the "Tower", have been identified as dating prior to ca. 1600. What is evident from the 1742 drawing, is that the defenses at the site consisted primarily of two separate fortifications; one guarding the harbor entrance and one providing protection from a land attack. It should be noted that at this early date there is little concern, judging from the layout of defenses and lack of cannons with a seaward orientation, for attack from the sea, including naval bombardment. Such considerations were based, on the size of cannon carried by naval vessels and their ability to fire at elevated targets.<sup>11</sup> As the capacity of ships to carry larger cannon increased, an increase in

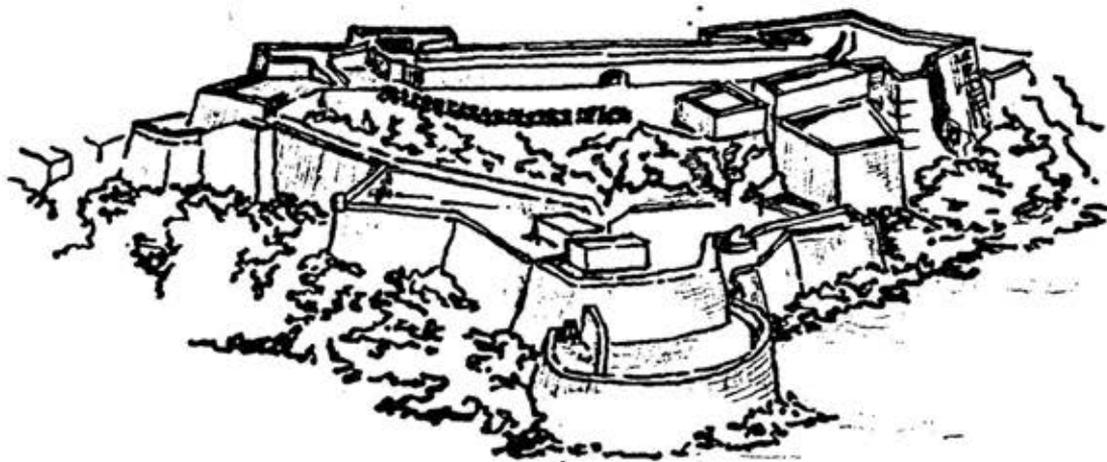
EL MORRO 1742

Figure 11. Conjectured view of el Morro, 1742.

(20 feet), and projected out into the harbor entrance a greater distance than at present (the elevation found in the chart, using the 4:3 ratio, is inaccurate; see explanation below). In 1742, the intersection of the curved outer wall of the Low Battery with the harbor side wall of the fort was farther past (to the southeast) the present intersection of the Water Battery wall. O'Reilly speaks of the battery as "already built" and not worth changing. In fact, the 1765<sup>18</sup> plan accompanying the description shows a similar configuration to the 1742 plan. A 1772<sup>19</sup> plan of O'Daly shows the present configuration for this battery. Therefore the present battery was constructed sometime between 1765 and 1772. At that time, access to this battery was provided by the construction of the present stair, using the embrasure farthest to the left (south) as the stair entrance, and descending through the wall to the battery floor level.

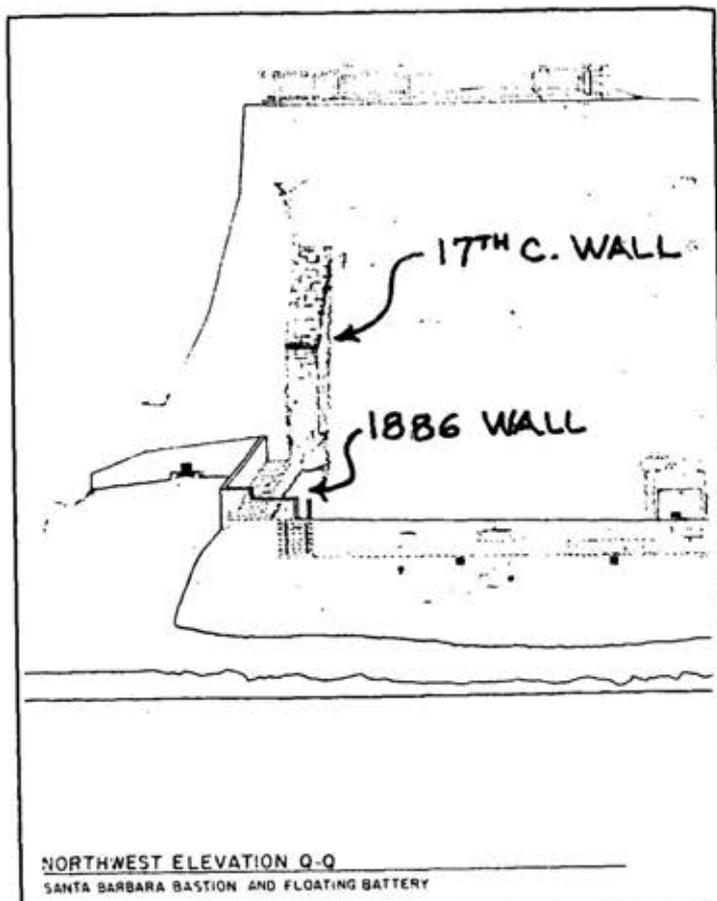
Figure 12. The extension of the old wall is seen going up the scarp; at the base is the 1886 rubble wall.

Battery (see the 1776 plan). On the 1742 plan there is a curved wall within the battery that extends out from the scarp wall of the higher battery screening the passage entrance from the harbor. It is the remnant of this wall that extends up the exterior of the Santa Barbara wall (see HABS drawing 33, and figs. 5 and 12). Presumably, the earlier height of the Santa Barbara Bastion, or high platform, cannot have been lower than the top of this wall remnant; that is approximately 3 meters (10 feet) below the present terreplein. There also is a change in angle of the wall slope, and in the character of the stucco at this point. These changes place the height of the earlier level of the Santa Barbara terreplein at about 20.3 meters (66 feet) above sea level; higher than the dimension found by scaling off the 1742 section using the 4:3 correction (see chart above). A reason for this difference would seem to be an inaccuracy in the 1742 section. The elevation of 16 meters (51 feet), scaled off the 1742 section using the 4:3 correction, cannot be correct; it would place the terreplein height below the elevation of the door lintel leading into the tower chamber, which is 16.3 meters (53 feet). Since the tower chamber, and the Santa Barbara terreplein existed together, the terreplein could not have been at that low a level and still allowed entrance to the chamber. If the height is scaled without using the 4:3 correction, an elevation of 20.8 meters (67.5 feet) above sea level is achieved, approximating the height of the wall fragment; it also appears that the height of the Low Battery is accurately scaled without the 4:3 correction. The elevation of the Santa Barbara terreplein, scaled from the 1742 plan, is close to the figure based on the height of the curved wall remnant found above. Without further documents, or partial demolition of the wall, it is difficult to be certain of the exact seventeenth, or late-sixteenth century elevation of this level.

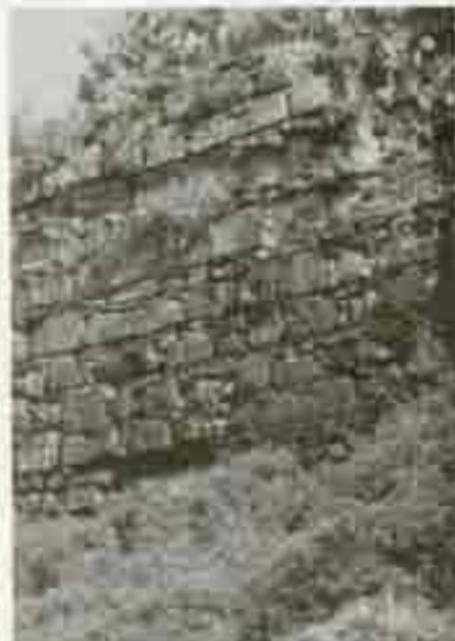
Figure 15. Remains of seventeenth c. retaining wall at the sea end of the counterscarp. (E.S. Cliver, 1890.)

Other areas that appear to date from the pre-1770 period are the outer bay of the entrance portal (not the vaulting), possibly the west facing wall of the Austria Bastion, and the lower portion of the tunnel to the tower room. In addition, walls by the sea that formed part of the land defense on the 1742 plan and seem to have been abandoned in the late-eighteenth century, still have sections remaining, albeit in poor condition (Fig. 15). These walls are found on the far side of the moat outside Ochoa and Carmen bastions.

A portion of a retaining wall remains seaward of the moat. Based on construction and the early plans, it is believed that these walls are from the first quarter of the seventeenth century with some rebuilding during the twentieth century using rubble, and limestone slabs.

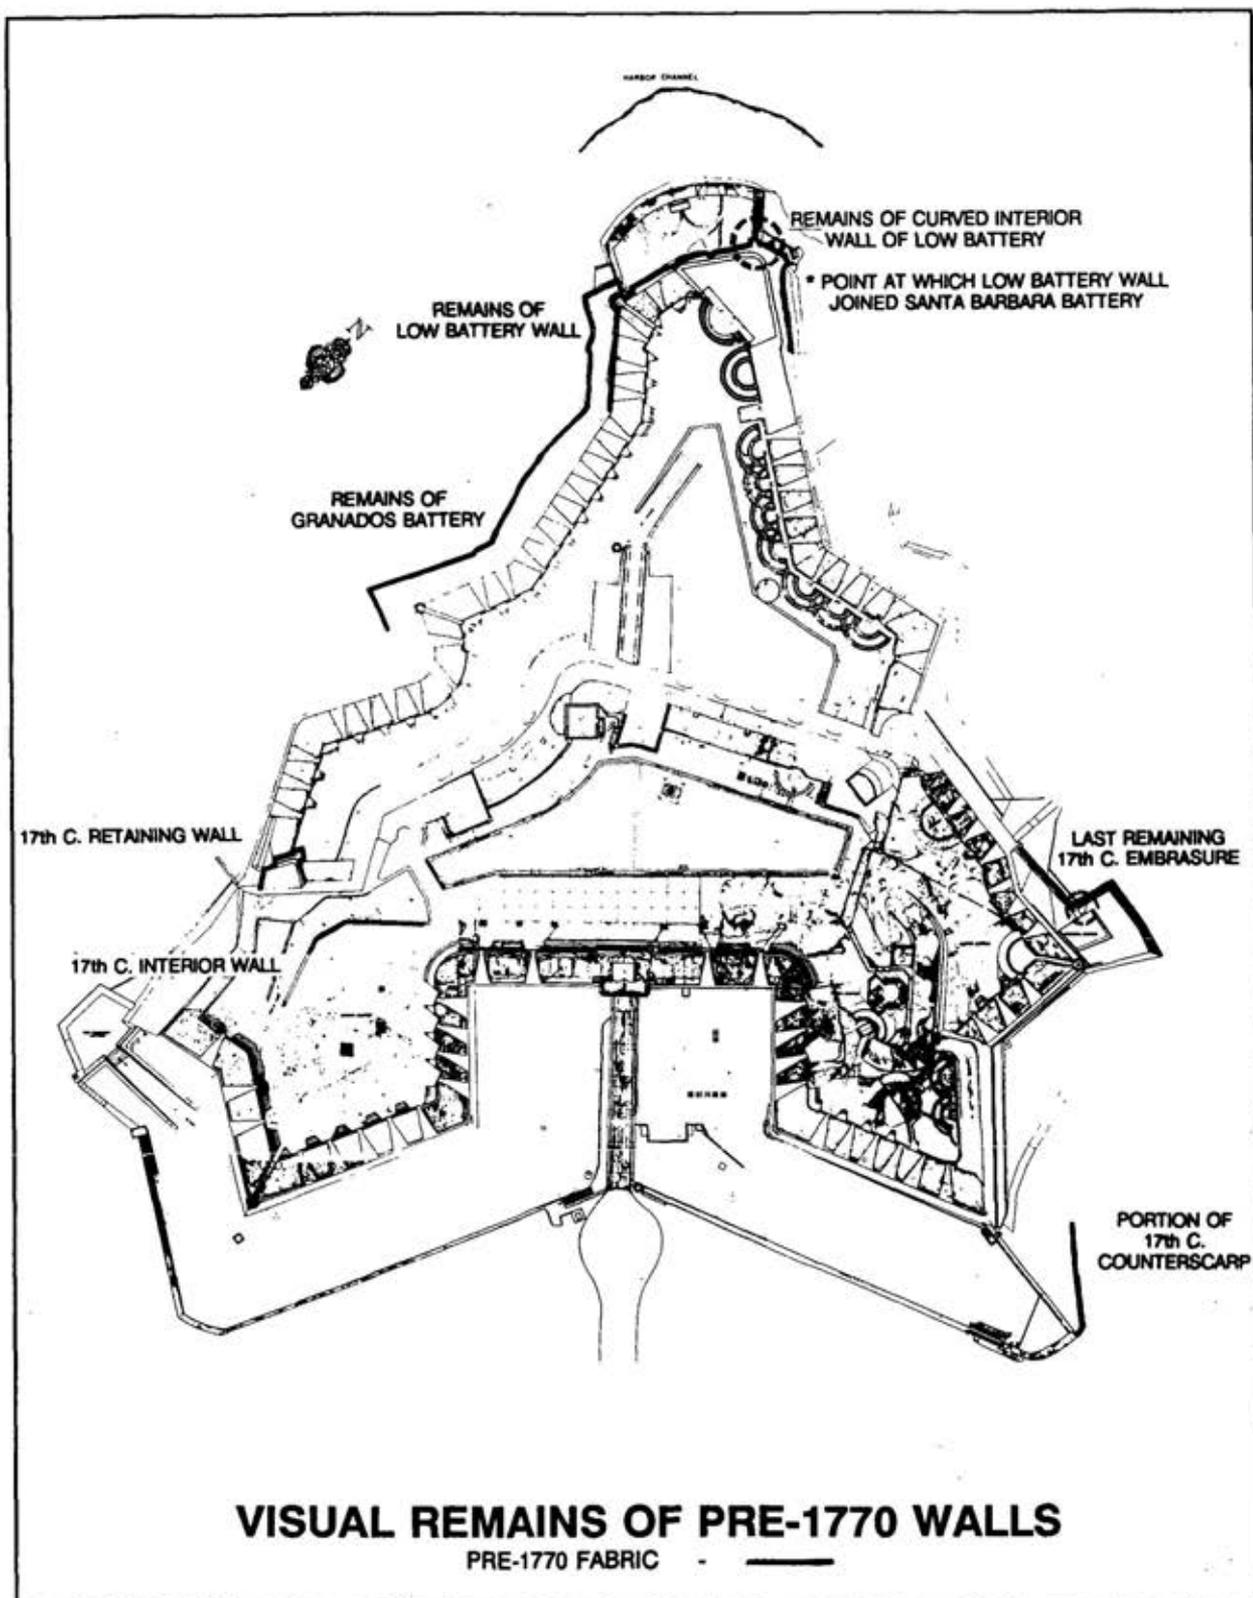
Figure 17. Plan showing the location of the remaining pre-1765 historic fabric at the fortress. (HABS, ca. 1960.)

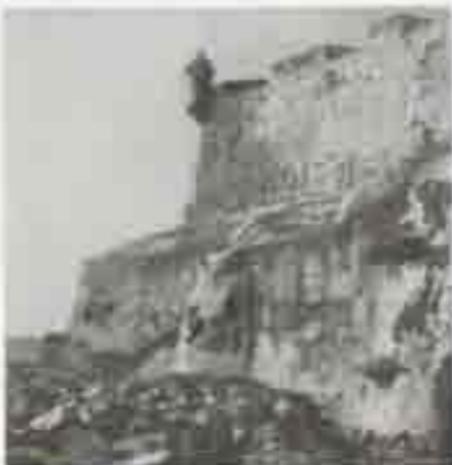
Figure 18. Harbor side of Santa Barbara B. showing the line of Granada B., the triangular entry post and the fragment that was the beginning of the Low Battery. (Photo by E.S. Cliver, 1990.)

As part of the construction of the wall, a large cistern was built, filling the void under the main plaza. On the surface of the plaza was a cistern head (similar to that of a well) from which water could be drawn. (The present cistern head is a reconstruction by the NHC after 1860.) For the great wall to have been built by 1774, the terreplein of Santa Barbara already would have to have been raised, or its elevation determined, so the ramp could end at the correct level. In raising the elevation of the Santa Barbara terreplein, the old Granada Battery, of which O'Reilly was critical in his 1765 description, was filled and used as a foundation for the harbor side of the extended Santa Barbara terreplein. Evidence for this can be seen on the 1743 plan. A small triangular projection (a guard post) exists at the transition point to the Low Battery, just below the wall of the then smaller Santa Barbara Bastion. The configuration of the present foundation wall supporting the Santa Barbara harbor wall, follows that of Granada Battery as depicted on the 1743 plan, including the small triangular projection (fig. 5). If one follows the outer wall of the foundation (the old Granada Battery) westward, the height drops down, as the Granada wall does on the 1743 plan, to the remaining fragment of the Low Battery (fig. 18) leaving no doubt that the Granada Battery exists under the later fill that

ventilators on the curtain terreplein. Also, during this period, a wall located in the lower plate, running north to south, was removed leaving evidence of its existence as patches in the corner of the Santa Barbara crenate wall (Fig. 18).

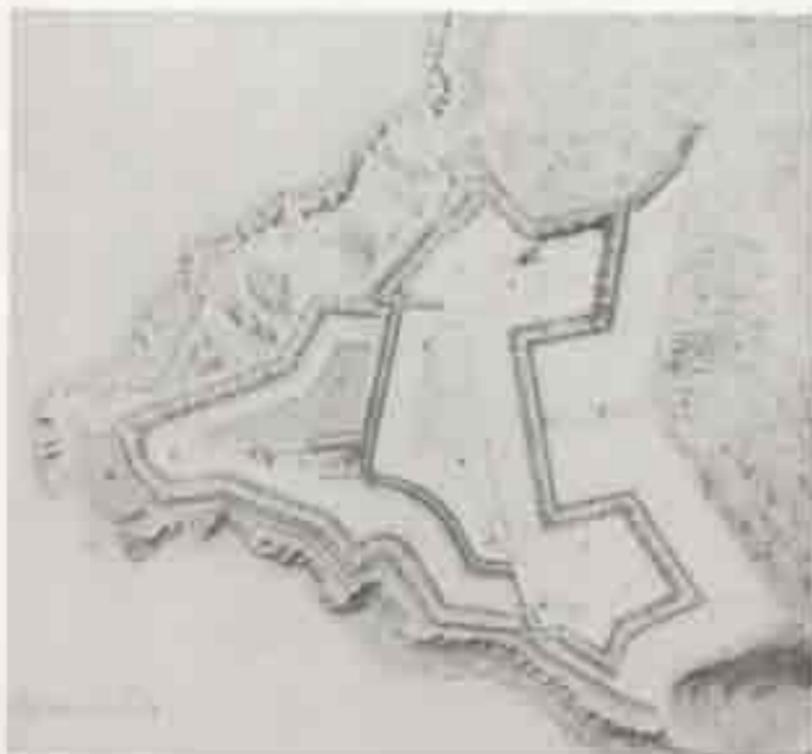
Figure 19. Detail of 1784, Mestre plan. (Servicio Histórico Militar No. 3795, Madrid.)

Ochoa Bastion was raised in height beginning in 1773, as was Austria Bastion,<sup>45</sup> but not as recommended by O'Hallilly. Prior to 1765, Ochoa Bastion was of two tiers, with an upper and a lower level (see the 1747 plan). The reason for the two levels was the rapid drop in elevation toward the sea from the level of the hornwork wall. In order to avoid the construction of massive foundations and a high retaining wall on the sea side, the Spanish, in raising the levels of Ochoa Bastion during the 1770s, maintained the two tier configuration. Later, a 1784 Mestre Drawing (Fig.

19) proposed the increase in elevation of the seaward side of Ochoa Bastion. In 1786, before a 1787 earthquake that caused some damage to this bastion, the seaward side of Ochoa was raised to the existing elevation, and the Ochoa terreplein became one continuous level, equal in height to Austria Bastion and the curtain wall terreplein.<sup>41</sup> It is curious that prior to the seaward level being raised, the upper level is shown in the 1784 drawing with three embrasures on the southeast wall facing the moat (fig. 19). This same drawing proposes three embrasures on the northeast (seaward) side of the raised wall. A May 12, 1787, Mestre drawing, after the terreplein elevation has been increased, shows three embrasures on the northeast side, and five embrasures on the southeast wall (see historic drawing 21 in Volume I). From this document, it would appear that after the increase in elevation, the southeast wall had five embrasures. However, today there are six embrasures. Either the drawing is incorrect, or when the two en barbette guns were installed on Ochoa in the 1850s (discussed below), an additional embrasure was added at the corner; this seems unlikely if the Spanish were going to a different gun arrangement, one that did not require embrasures. It is possible that the wall was rebuilt after being damaged in the earthquake. However, a 1793 drawing (Historic Drawing 24, Volume I) proposing a ravelin, shows four embrasures on the southeast wall. This seems impossible. The simplest assumption is that after the terreplein was raised, the southeast wall had six embrasures, as it does now, and that what we see in the drawings are inaccuracies that may be attributed to focus, due to the fact that the drawings are either a plan of the city as a whole, or one depicting a proposed ravelin; the number of embrasures may have been irrelevant.

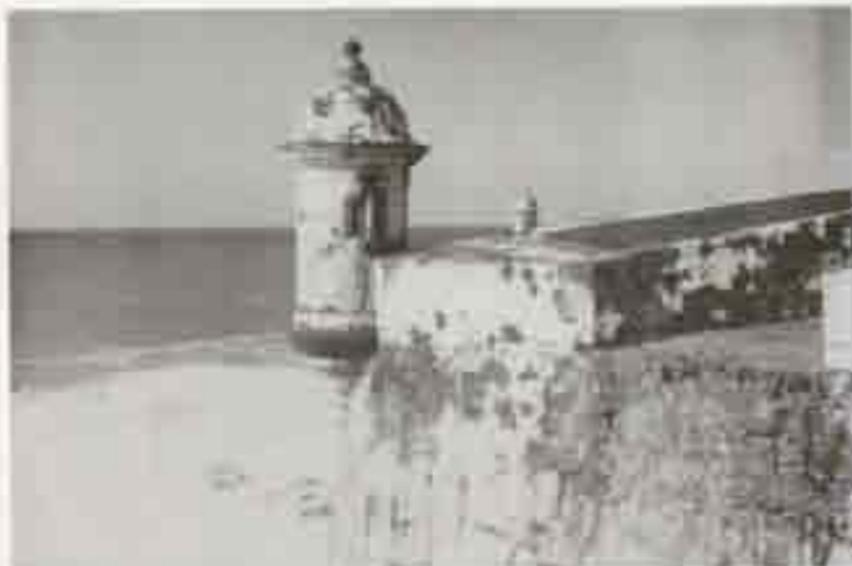
Figure 21. Only remaining unaltered el Morro seventeenth c. sentry box, on Santa Barbara St. (J. Bowsher, WAMS, 1960.)

Another feature that is typical of the post-1770 work is the sentry boxes (these have become a symbol of San Juan, and are found on automobile license plates). Almost decorative in character (fig. 21), they are located at the corners of walls (city and fortress) where the most opportune views for detecting intrusion existed. The present type of sentry boxes, from the post-1770 period, are characterized by their open curved domes with finials, and the corbelled rings, resting on a ball, supporting the boxes at the bastion corners. The earlier sentry boxes from the seventeenth century were simple in appearance, having only a semi-spherical dome over the cylinder of the guard space. Rather than being corbelled out from the corner, as are the later sentry boxes, they merely sat on a circular slab built into the curved corner of the wall. Only two of these seventeenth-century sentry boxes remain; one at el Cañonc (ca. 1665)<sup>41</sup> seen in fig. 22, and the other on el Funicón (mid-seventeenth century), below San Cristóbal. Evidence remains of the circular supporting slab for the earlier sentry box of the North Bastion at San Cristóbal; this is now part

(1) The sentry boxes (one on Carmen and one on Santa Barbara), that had the upper portions removed by the Spanish in the nineteenth century, were restored to their present appearance (fig. 34); a second sentry box on Santa Barbara Bastion at the salient, was intended to be reconstructed, but was eliminated from the work. (The sentry box on Austria Bastion had been reconstructed as part of an earlier project, but is not listed by Hearns.) The restoration used a nest-stone block for the wall and cap (the drawings for the solids are found in the park archives) that was set in place with mortar but left without stucco. The original post-1765 sentry boxes were made of brick with stuccoed surfaces. One of these eighteenth-century sentry boxes remains, unaltered, on the harbor side of Santa Barbara Bastion (fig. 21).

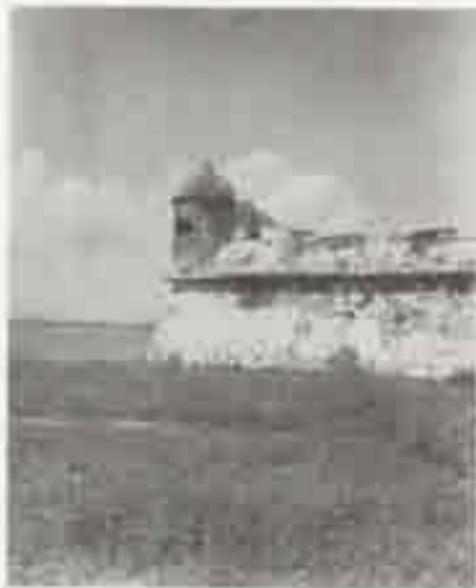
Figure 22. A seventeenth c. sentry box on el Cañuelo, 1937. (SAJU MNM Archives.)

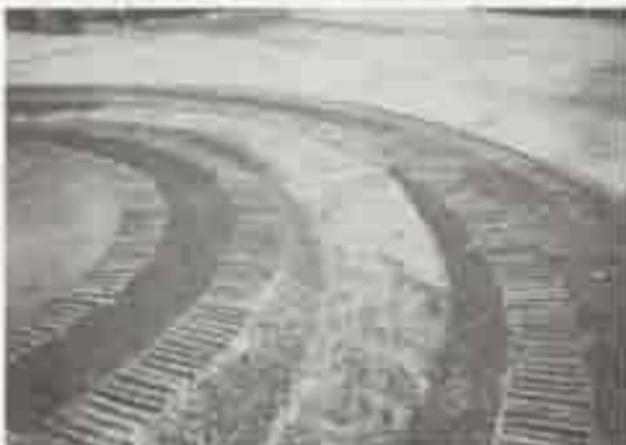
Figure 24. Tracks for an 1850's gun emplacement; note groove in dark stone from the iron rail. (Photo by S.R. Clivar, 1988.)

Primarily, the nineteenth century saw alterations for incorporating new types of gun emplacements, and included the addition of a lighthouse and signal tower. The addition of the first type of modern gun emplacement can be seen in Santa Barbara Bastion at its eastern end. Between 1831 and 1835,<sup>44</sup> four embrasures were eliminated (filled in) and positions for two newer guns (possibly mortars, or columbs) on barbette were built. This work is characterized by an iron pintle with three arcs (the inner arc is missing on what visibly remains) of dark basalt on the

terraplain surface, to which iron tracks once were fastened (Fig. 24). A raised wooden platform, on which the gun was placed to fire above the sea level, pivoted around the pintle supported by wheels running on the tracks. (Eventually the U.S. Army built a large emplacement in this area covering most of the left-hand

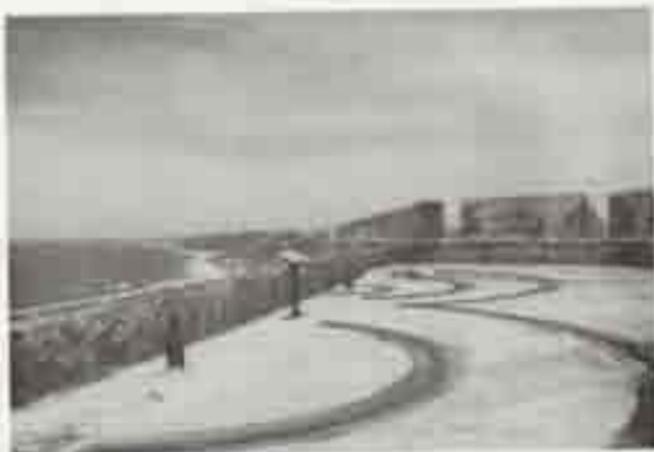
Figure 25. Two 1850's gun emplacements on Ochoa Bastion. (Photo by E.B. Oliver, 1990.)

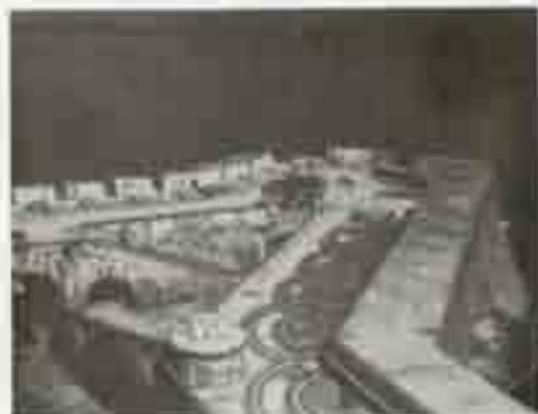
Figure 24. Santa Barbara Bastion with filled masonry, 1918-19. (RAJU WMS files.)

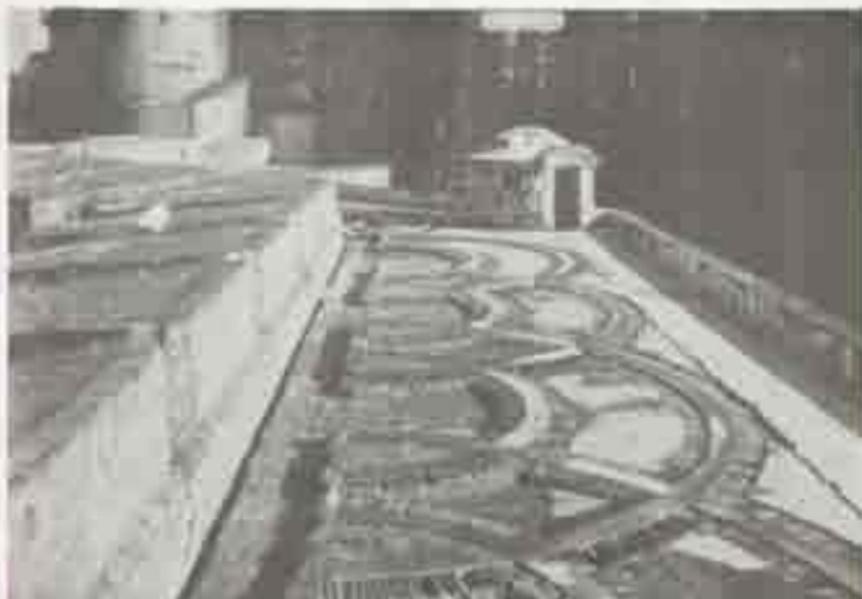
Figure 27. Tracks for 1860's gun emplacements on Santa Barbara Bastion. (J. Soucher, N332, 1960.)

The 1860's emplacements (fig. 27) are characterized by having two tracks of a lighter colored limestone without evidence of iron rails and with a different type of pintle using four wooden posts as part of the support (not such remains of this material). Although not such evidence remains, it appears that four emplacements in the Water Battery were installed as part of this work since they also exhibit the four wooden post pintle support.

(3) In its efforts to restore el Morro the Americans opened the embrasures that had been filled by the Spanish as part of the 22 barbette artillery modernization of the 1860's (fig. 27). This was part of the restoration of nine embrasures as well as the rebuilding of two embrasures on the north side of the Santa Barbara terraplain, and the restoration of all the embrasures and firing steps (banquettes) along the west side of Santa Barbara. Other embrasures also were restored or repaired on Carmen Battery, where the incinerator had been, and in the casemates off the plaza, judging by the number of embrasures cited on this level.

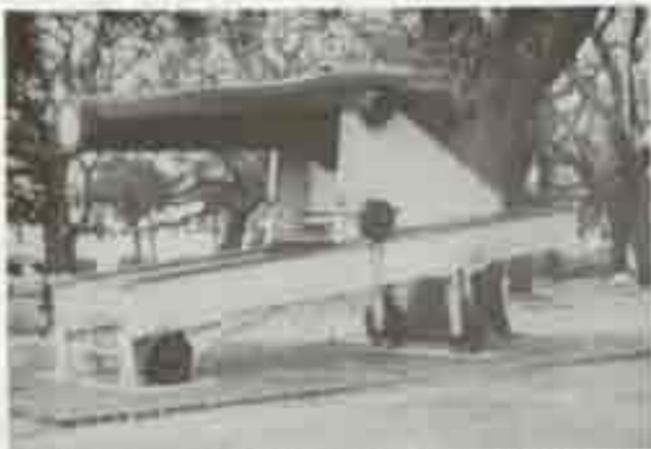
Figure 28. Iron carriage for an 80-barbette gun emplacement, Battery Park, Charleston, S.C. (Photo by E.N. Cliver, 1923.)

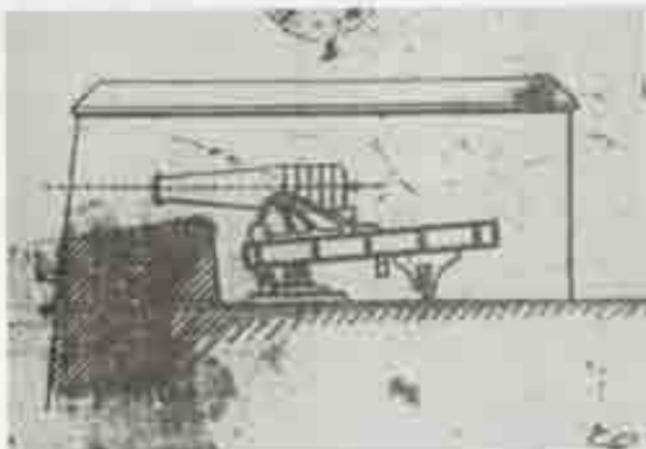
Figure 29. An 1876 drawing for a gun emplacement in Havana, Cuba. (Servicio Histórico Militar-España, Madrid, Drawing # 031-098.)

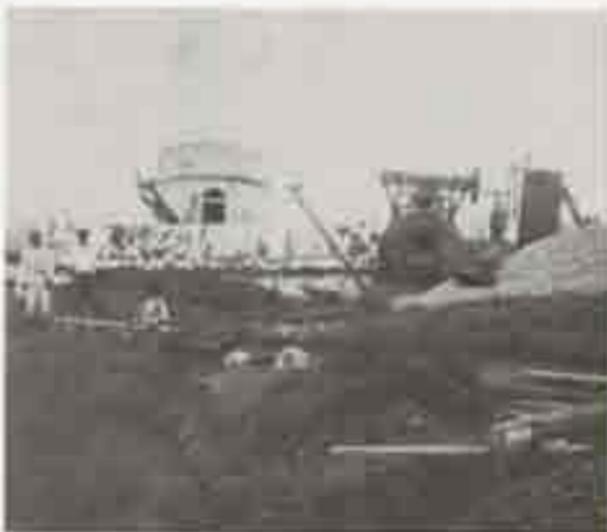
Figure 31. Sentry tower on Austria Station, after the 1902 alteration. Ca. 1912. (SAJU NMS files.)

semaphore tower demolished by the U. S. Army in 1940 and shown in figure 31. The foot print of this structure remains on the Austria terreplein as a patch on the surface.<sup>101</sup> One side of this patch projects beyond the circular shape on the base, indicating the location of the stairs that went up on the outside of the structure to the level of the tower base. A similar base was duplicated, with the exterior stair, on the Ochoa terreplein.

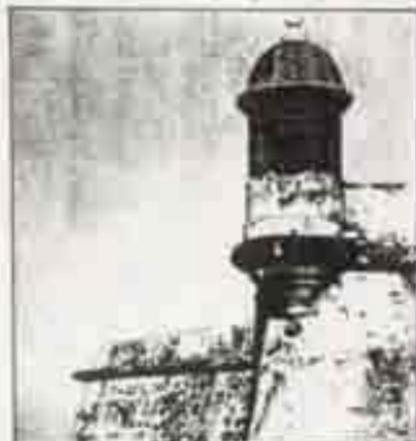
Figure 34. Rebuilt sentry box on Austria Bastion. (J. Boucher, NABD, 1940.)

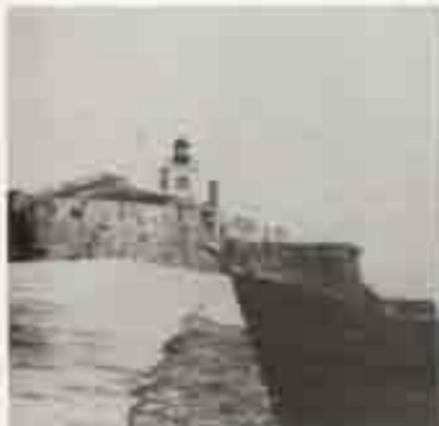
Figure 16. Osboe and Carmen Bastions with stack from incinerator at center. (SAJU WHS files).

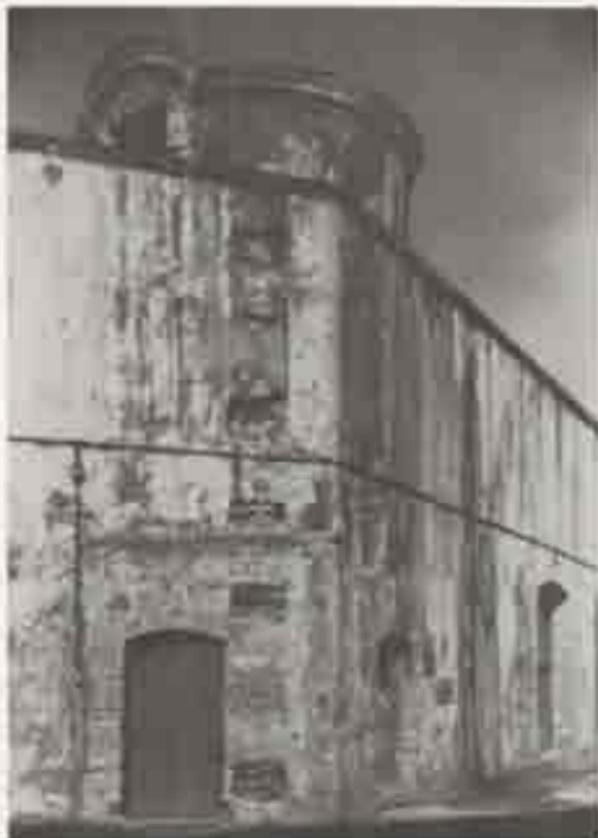
Figure 38. Inside corner of the Santa Barbara terraplain where earlier masonry wall had been. (J. Soucher, MADS, 1940.)

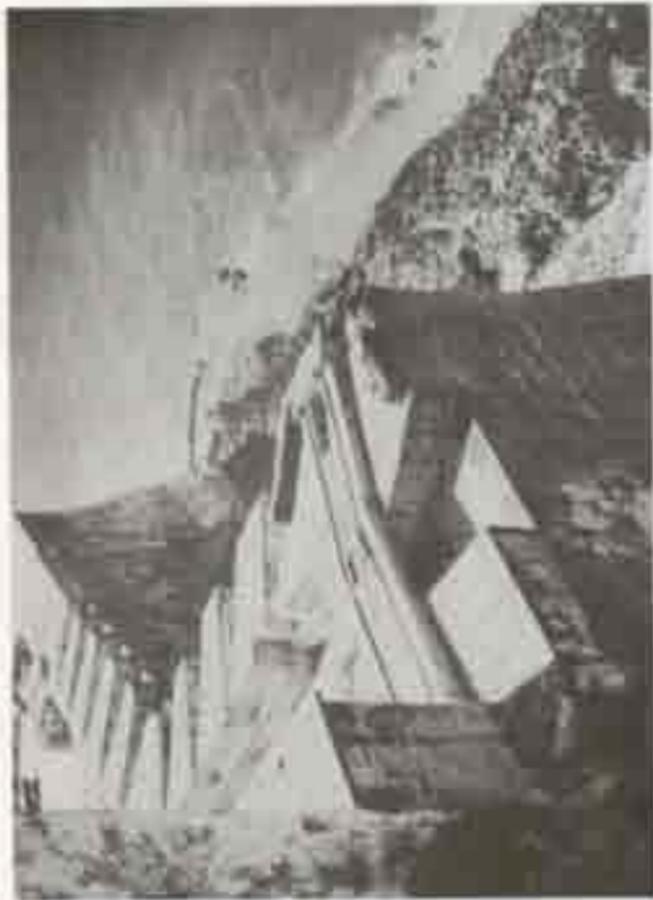
Figure 19. World War II search light trunk at the east end of Santa Barbara Station demolished. (P.O. Gjessing, 1957, pack files.)

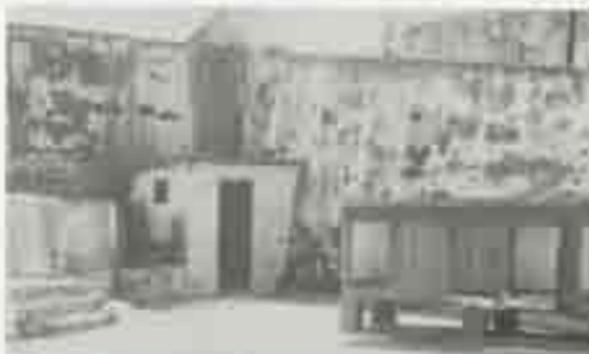
Figure 41. World War II latrine, demolished. (J. Boucher, NARS, 1960.)

This structure was built on the *C a r a e n* terrace between the ramp and the parapet wall (Fig. 41) and has since been demolished. The erosion of the rock cliffs on the channel side of Santa Barbara bastion continued to present problems.<sup>45</sup> Work again was done in this area by

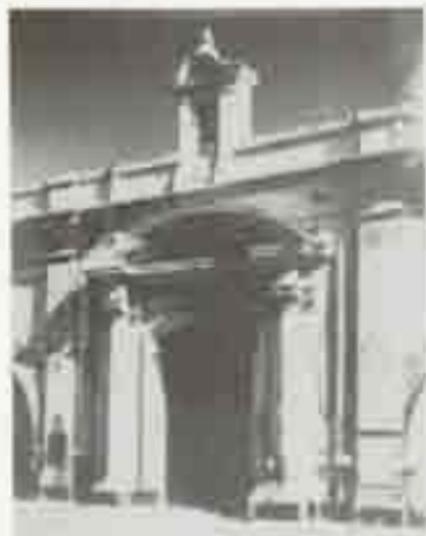
Figure 47. Elevation of the Chapel. (J. Raucher, NABP, 1965.)

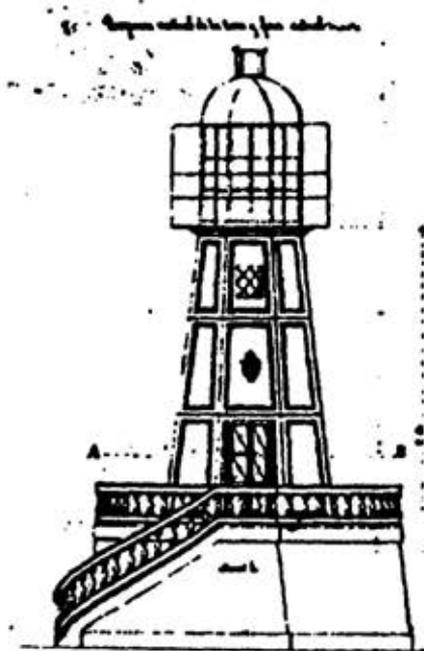
Figure 44. 1868 - Drawing of the lighthouse on its first base located on the Austria terreplein. (AHN)

The earliest view of the lighthouse is in the elevations of the Castro drawings of 1861. These drawings show little detail. However, a drawing of September 10, 1867, shows the lighthouse, in detail, on its Austria terreplein base (fig. 44).<sup>92</sup> The British Sailing Directions for 1859, give the elevation of the light as 174 feet above sea level.<sup>93</sup> Considering that the terreplein has an

elevation of 140 feet and that the tower was to be 18 feet high and, scaling from the drawing in figure 44, the height of the stone base was approximately 7 feet and the focal plane of the light was about 4 feet above the tower top, the light would have been 29 feet above the terreplein or, 169 feet in elevation.\*

In 1876, the lighthouse was relocated to the terreplein of Ochoa Bastion<sup>94</sup> where the present lighthouse now stands. Plans for this move were begun in 1868. A drawing dated July 27, 1868 shows the proposed base for the lighthouse as it was to be relocated on Ochoa Bastion.<sup>95</sup> Another drawing, dated March 22, 1878, shows the lighthouse in its new location (fig. 45). Here, the tower appears very much as it does in the photo in figure 43. By scaling the height of the tower in figure 45 a dimension of 18 feet is obtained, the same as that found in figure 44. The U. S. Hydrographic Office's Sailing

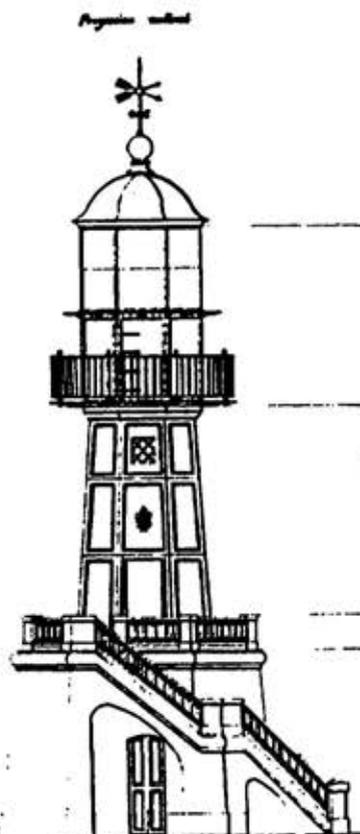
Figure 45. 1877 - Drawing of the lighthouse on its Ochoa terreplein base. (AHN)

The difference between the lighthouses is in the width of the platform at the top of the octagonal tower and in the solid crenelated parapet replacing the balustrade on the stairs and at top of the base. The structural pattern seen on the tower of the older lighthouse is gone from the tower of the American structure. A drawing prepared by the U.S. Army in 1905, shows this 1899 lighthouse on a sheet with the proposed new lighthouse.<sup>104</sup> A note on the earlier lighthouse states, "Present Tower as rebuilt [emphases added] in 1899 by the Navy Dept." The drawing shows the old tower having a crack just below the lower platform with the notation, "cracked entirely through and around tower." The height of the focal plane of the light, as measured on this drawing, is 42.5 feet above the terreplein (182.5 feet in elevation).

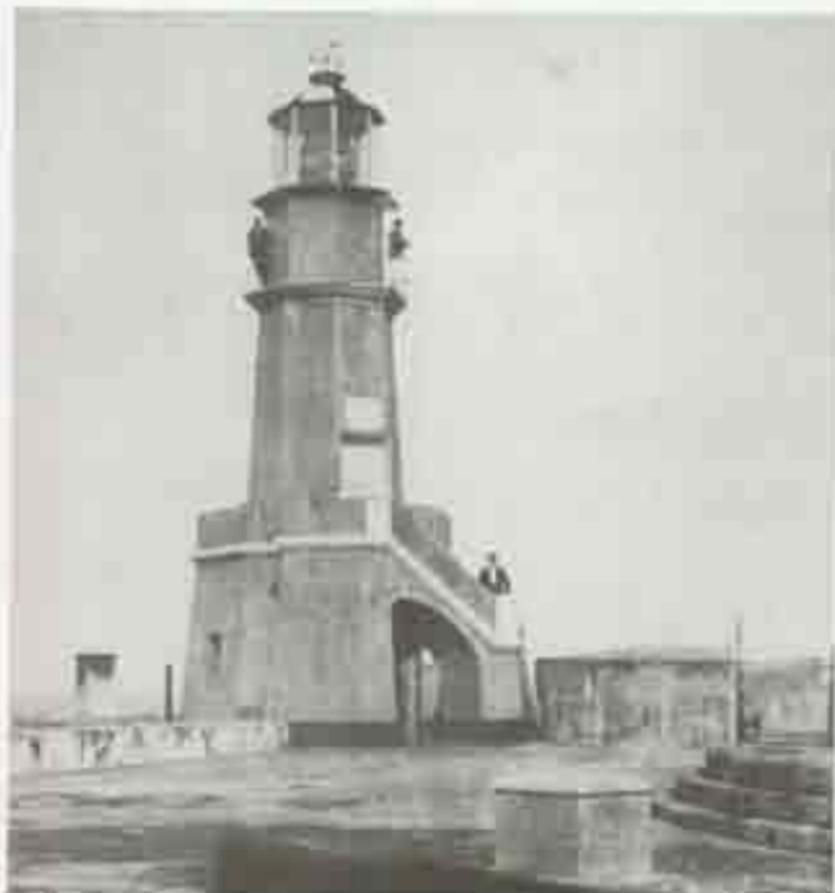
Figure 46. First American lighthouse, built on the base of the Sanagó Spanish lighthouse. (National Archives, 24-10-42-13B.1)

During the bombardment by the American ships in 1898, damage was done to the Spanish lighthouse, necessitating its removal by the U. S. Army.<sup>102</sup> In its place a "56-foot octagonal brick tower" was constructed in 1899, having a light elevation of 171 feet.<sup>103</sup> (The 56 feet must have been to the top of the lightning rod as explained below.)

A photograph of this tower exists (fig. 46). A 56-foot high tower, if built directly on the terreplein (140-foot elevation), placed the light at least 196 feet above sea level; even higher considering the light would be positioned 4 to 6 feet above the top of the tower. The lighthouse in figure 46 looks very similar, in height and detail, to the lighthouse in figure 43.

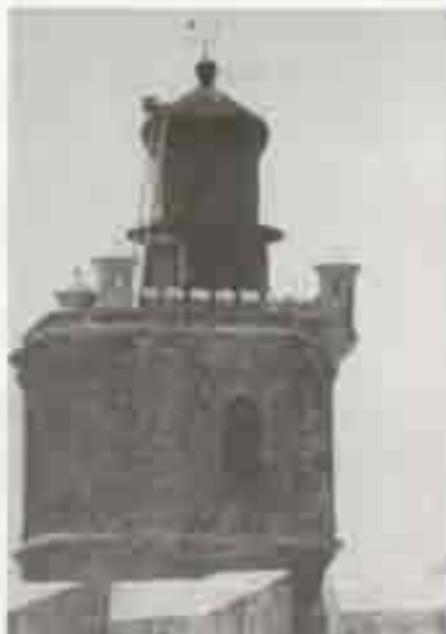
Figure 48. Present el Morro Lighthouse. (Photo by F.S. Cliver, 1990.)

Today, the deterioration of the brick is extensive. In addition, rust jacking occurs where steel beams are inserted into the masonry. This jacking is exhibited by horizontal cracks that run along the joints below the parapet and near the bottom cordon of the square portion of the tower. This type of deterioration will occur at an accelerated rate because the cracks allow the entry of salts. As the width of the cracks increases, more salt-moisture can enter, resulting in an increase in oxidation. When oxidation occurs, the rust expands with great force (similar to ice formation or salt crystallization), causing stress cracking in the brick masonry unit. The alternatives for correcting these problems are dealt with in the section on RECOMMENDATIONS found in Volume I of this HSR.

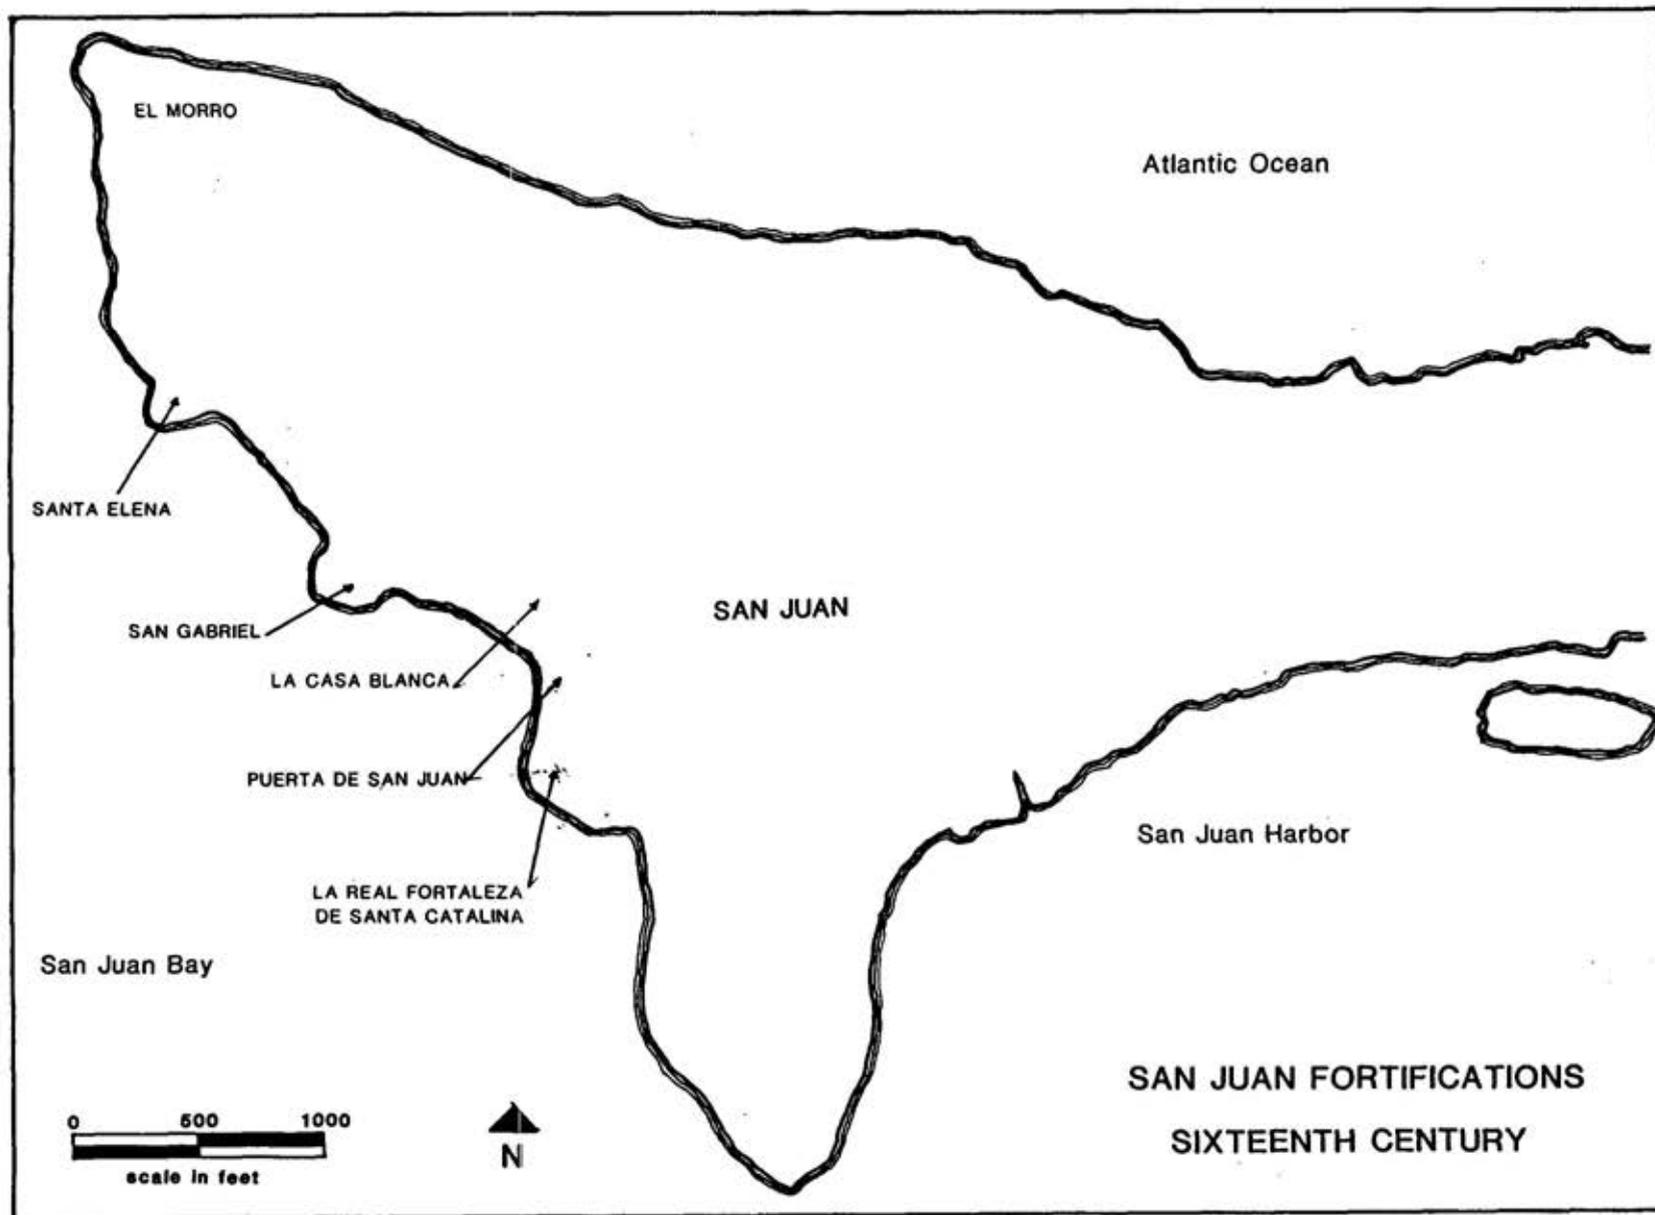
Figure 1. San Juan Fortifications in the sixteenth century. (Plan drawn by K. Faust and annotated by R. Crisson, 1991.)

The earliest fortifications in Puerto Rico were those defensive buildings constructed as casa fuerte (fortified houses) for the early colonizers. The best surviving example in San Juan is la Casa Blanca (the White House), built by the family of Juan Ponce de Leon shortly after the founding of San Juan in ca. 1520.\* When constructed, the main defensive purpose of Casa Blanca was to protect its inhabitants from Carib Indian raids.<sup>3</sup> Casa Blanca was conveniently situated on a bluff that was eventually integrated with the city wall defensive system (the building today overlooks the curtain wall of San Agustín). More importantly, Casa Blanca overlooked the entrance to the harbor. San Juan harbor, measuring 3 miles long by less than 2 miles wide, was always considered a "safe harbor," because many ships could be anchored and protected from the rough seas. It was the only harbor on the north coast of Puerto Rico that afforded protection in all weather, since it was shielded on the north by the relatively high land mass of the Islet of San Juan, and on the south, east, and west by the mainland of Puerto Rico. (See figures 1, 2 and 3.)
