# THE FORTIFICATIONS OF SAN JUAN NATIONAL HISTORIC SITE

## HISTORIC STRUCTURE REPORT

Castillo de San Felipe del Morro  
The City Walls  
An Investigation of the Materials Used  
Cultural Landscape Report

Castillo de San Felipe del Morro

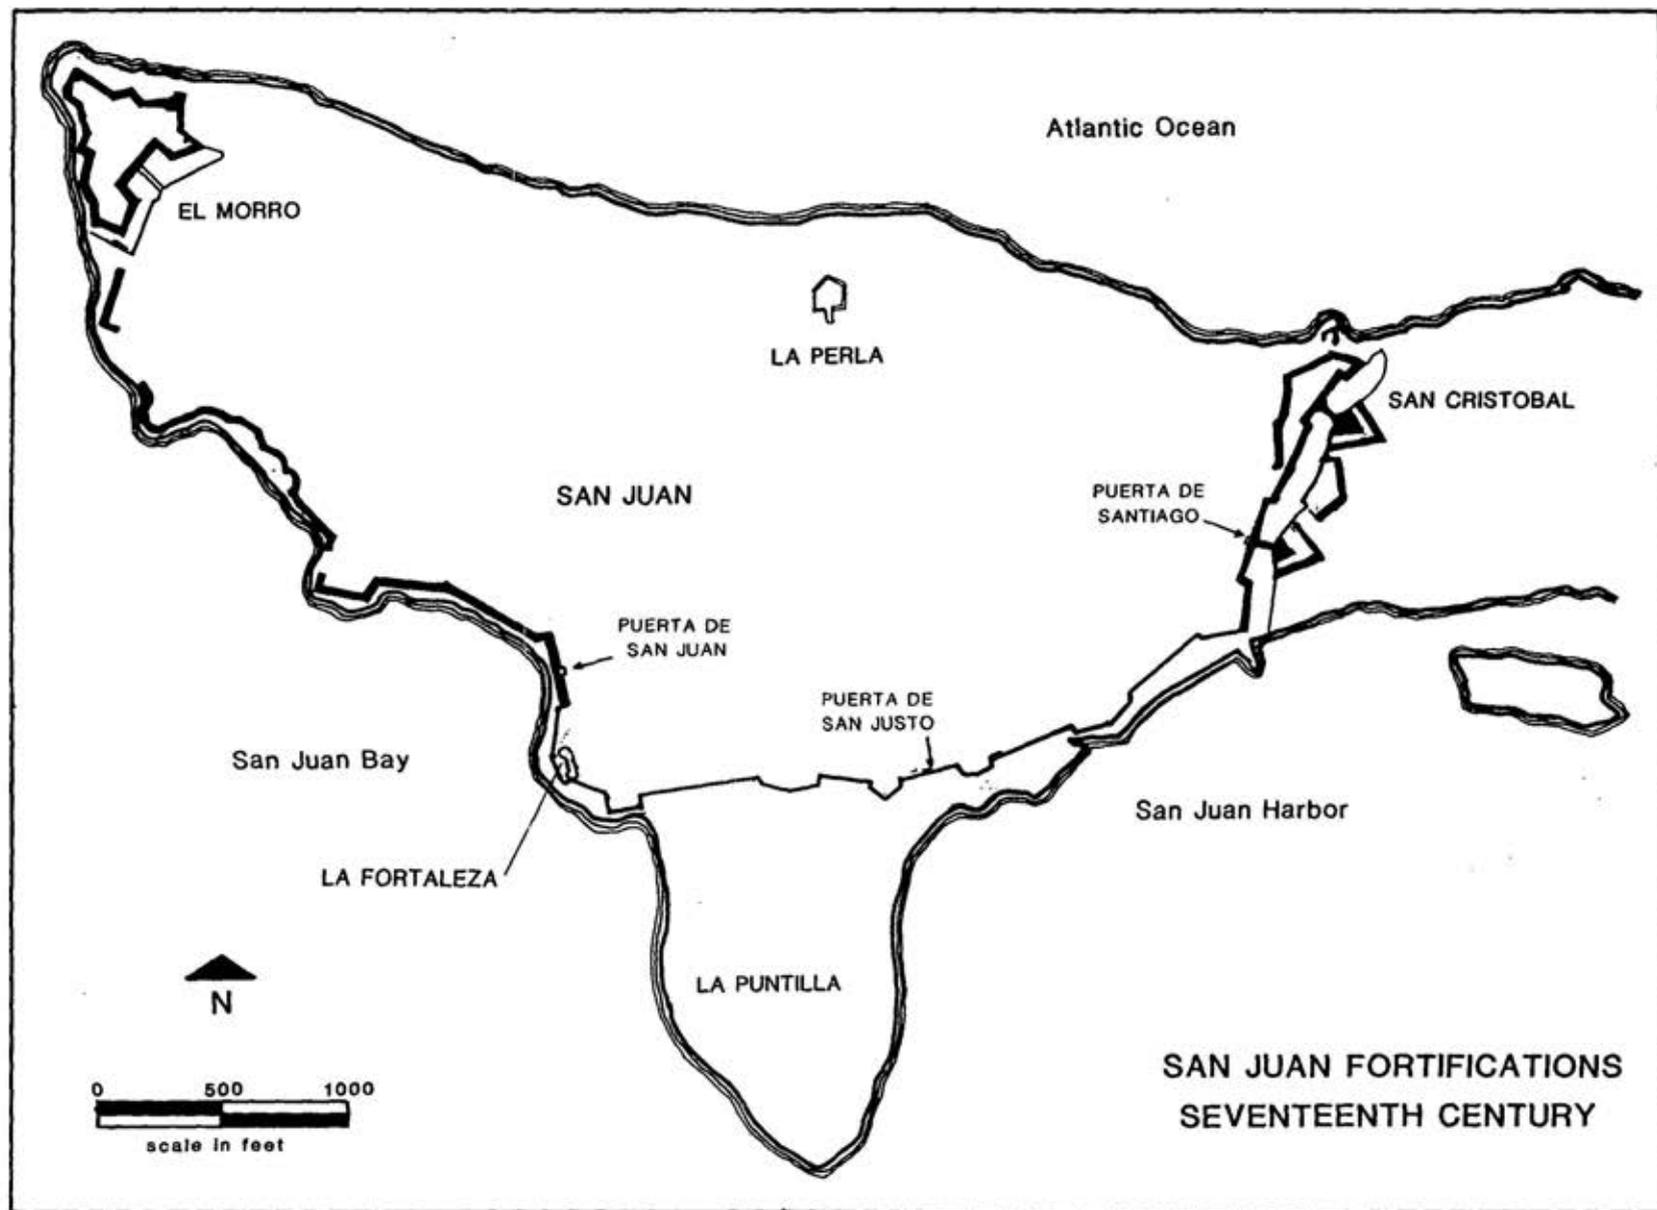
Figure 5. San Juan Fortifications in the seventeenth century. (Plan drawn by K. Faust and annotated by R. Crisson, NPS, NARO, 1991.)

Between 1630-60, the Spanish builders continued executing extensive repairs, reconstructions, and new construction (fig. 5). Both la Fortaleza and el Morro were rebuilt; city walls facing west, south, and east were either built or reconstructed; and el Cañuelo was rebuilt in its present square form as a masonry redoubt. San Cristóbal was begun in 1634 to serve as the bulwark of the easterly defenses.

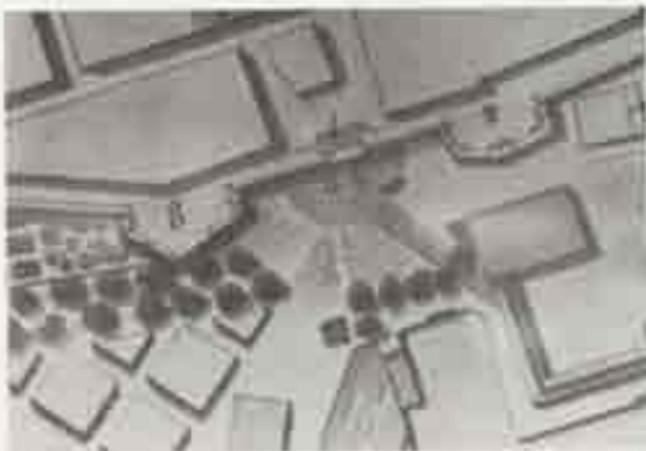
Figure 8. Area of Puerta de San Justo in 1882, detail of plan by M.J. Castro and J. López Maqó. (Servicio Geográfico del Ejército, no. 40, Madrid)

The remaining features of the south wall included la Puerta de San Justo (the Gate of Saint Just), ca. 1630-39. Based on nineteenth-century photographs, this was an imposing gate with a pedimented gable supported by large engaged columns (figs. 8 and 9). It stood at the foot of the present-day Calle San Justo. Like the other two original gates, it also was embellished with a motto above the doors. Here it said in Latin: Dominus mihi adjutor quem timebo? (If God is my helper, who should I fear?).<sup>15</sup> Farther east was the other bastion that defended this gate, el Baluarte del Muelle (the Bastion of the Wharf), dating from the same period. The final portion of the south wall was a curtain wall of ca. 1630-39, extending eastward; it may have been called la Cortina de San Rafael (the Curtain Wall of Saint Raphael). At the southeast corner of the south wall was el Baluarte de San Pedro Martir (the Bastion of Saint Peter the Martyr), but most often called San Pedro; it was constructed between 1634-50.

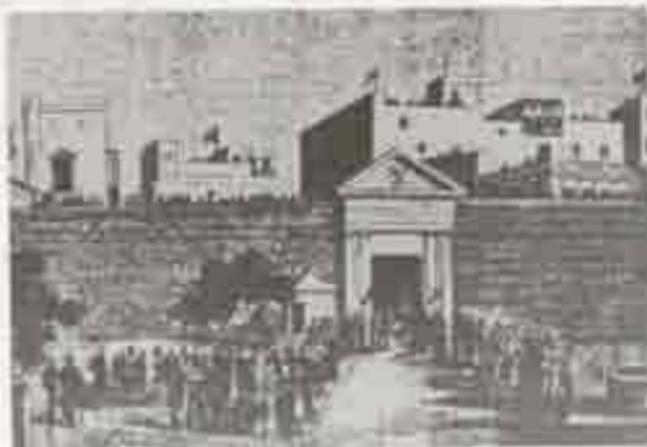
Figure 9. Puerta de San Justo in 1884. Engraving in *La Ilustración Española y Americana*. (Repro. in A.S. Rivera's *San Justo*, 1989.)

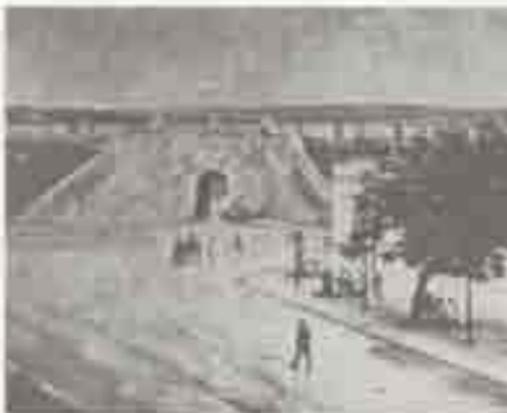
Figure 10. West elevation of Puerta de Santiago, ca. 1890. Photo by Feliciano Alonso. (Repro. in A.M. Rivera, 1989.)

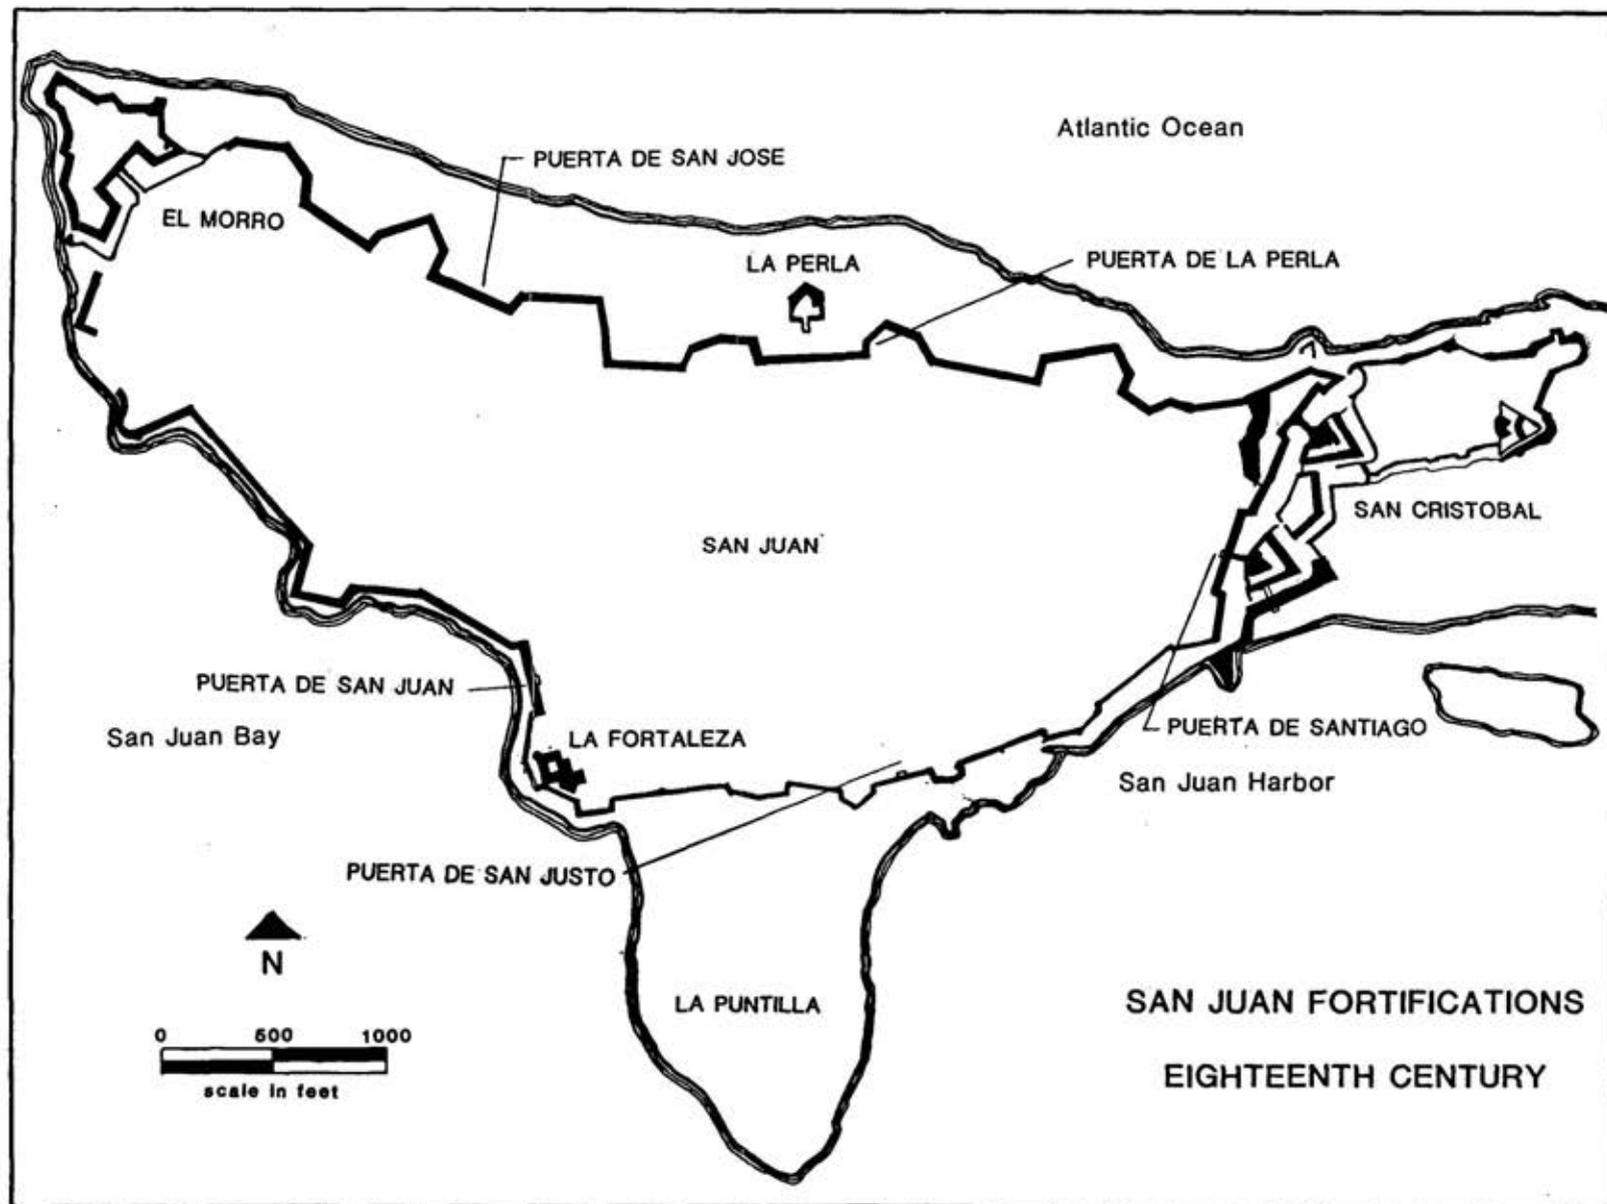
Figure 11. San Juan Fortifications in the eighteenth century. (Plan drawn by K. Faust and annotated by R. Crisson, NPS, NARO, 1991.)

The first half of the eighteenth century was politically calm for San Juan, particularly from 1701 on when the French Bourbons and the Spanish kings were politically aligned. Puerto Rico remained an almost forgotten colony. Correspondingly, little work except for a few improvements made around 1740, can be documented for this period. Complacency ended, however, with the conclusion in 1763 of the Seven Years' War and the reforms inaugurated by Charles III in 1759 when he became King of Spain. Impending conflict between Spain and England signaled that improvements had to be made to the fortifications of San Juan. (See figure 11.)

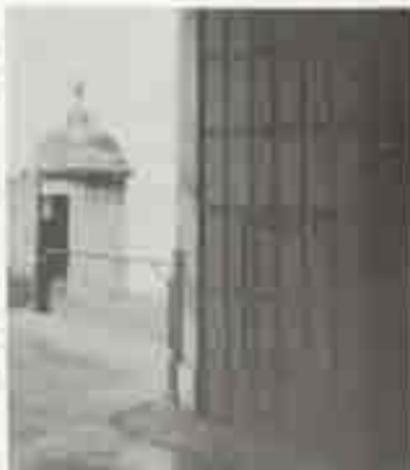
Figure 17. San Juan Gate looking west. (Photo by W. Crissien, 1996.)

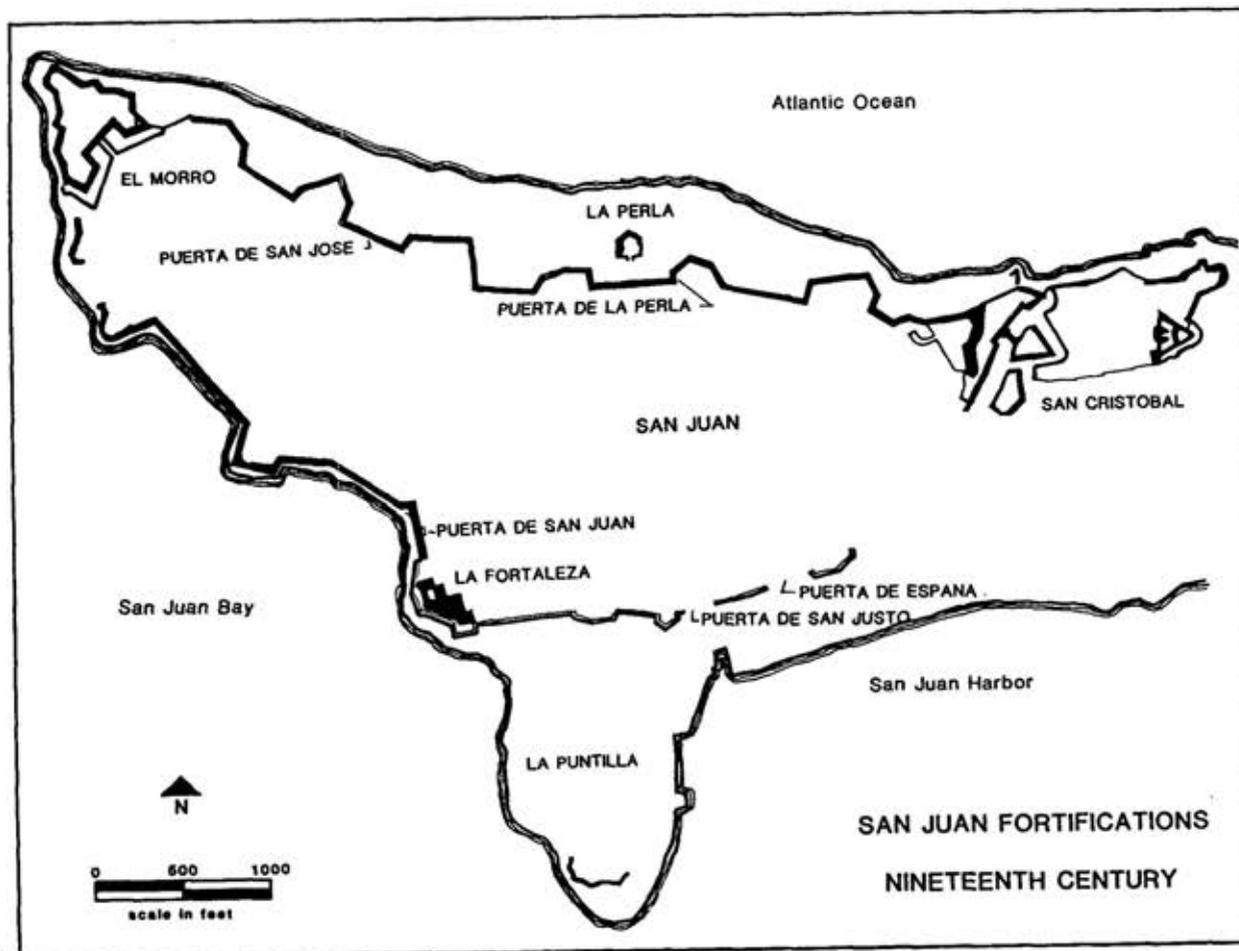
Figure 13. San Juan Fortifications in the nineteenth century. (Plan drawn by K. Faust and annotated by R. Crisson, 1991.)

Even though warfare and political forces changed considerably during the nineteenth century, neither of these changes affected the fortifications of San Juan as much as the socio-economic forces (fig. 13). The threat of war had diminished, and by 1830 only Cuba and Puerto Rico remained under Spanish dominion in the Caribbean. This century is best described as a period of repair and maintenance at the fortifications; many of these repairs may have been needed as part of regular maintenance, but others may have been to correct damage caused by the 1797 British attack. Records allude to repairs and replastering of many fortification walls in the period 1824-35. Artillery and gun emplacements were routinely upgraded during the century. Military engineers continued to depict the city and its defensive features in overall city plans from mid-century onward. (See Historical Drawings, Volume I.)

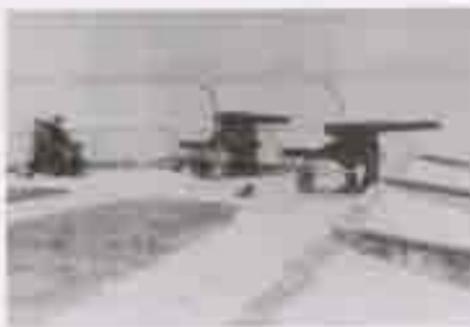
Figure 14. Santa Elena Bastion with Spanish cannons, ca. 1898. (IAJU NMR Archives.)

Santa Elena lay south of San Fernando and according to Navarro was deployed with 20 infantry soldiers in 1818. By 1819, Dávila indicated that Santa Elena had two 24-cm cannon, one bronze and one iron. Santa Elena remained strategically important, being close to the shipping channel, and was subsequently modified in ca. 1887 (fig. 15). By 1898, Colonel Goethals and Major Crosby described Santa Elena with:

three 11-cm breech-loading rifles, mounted on obsolete center-pintle carriages . . . these pieces were serviced from a small concrete magazine with a thin earthen cover . . . the parapet fronting the guns was ten feet across the superior slope.<sup>55</sup>

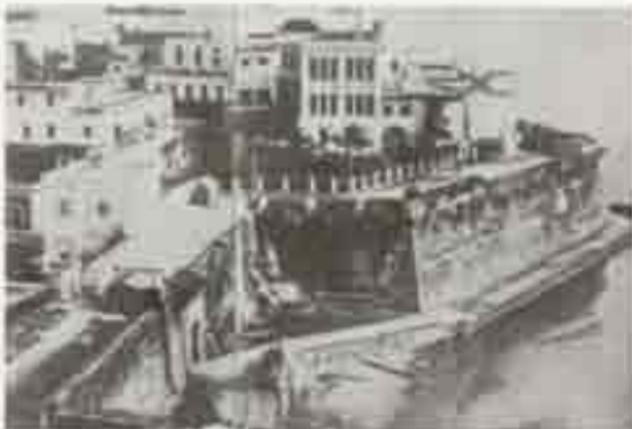
Figure 16. La Fortaleza and Santa Catalina Bastion, ca. 1898. (Repro. in A. Sepúlveda Rivera, 1989.)

Goethals and Crosby indicated in 1898 that the Spanish had modernized "la Fortaleza Battery" with a 19-cm Ordóñez rifle and the parapet had been reinforced by constructing a parallel wall 10 or 15 feet away and [by] filling the space in between with earth.<sup>41</sup> It is clear that the west wall had taken a renewed defensive role in preparation for the war with the United States; however, none of these positions were used during the 1898 conflict. (See Figure 16.)

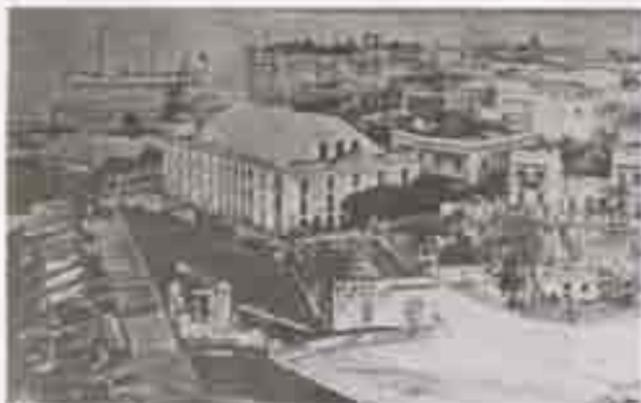
Figure 19. View prior to demolition of East Wall, 1897. Puerta de Santiago on left. (Repro. in A. Sepúlveda Rivera, 1988.)

The most significant easterly defenses were those comprising San Cristóbal and its outworks. Unfortunately, every structure south of la Trinidad (at San Cristóbal) was demolished in 1897, including el Revellín del Principe and la Puerta de Tierra, the curtain wall of Santiago and Santiago Gate and Santiago Bastion.<sup>50</sup> (See figures 19 and 20.)

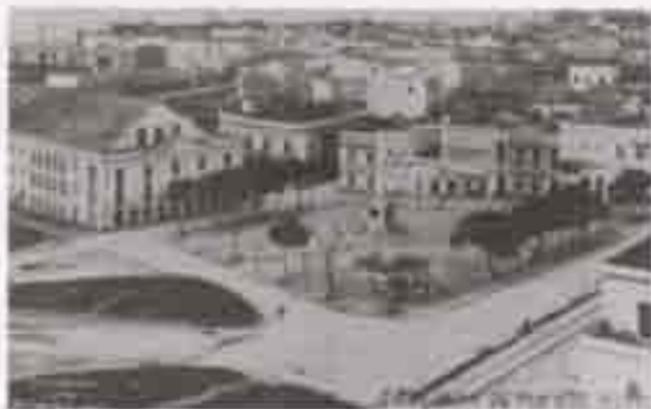
Figure 20. View soon after demolition of East Wall, ca. 1900. (Photo archives, UPQ, Rio Piedras.)

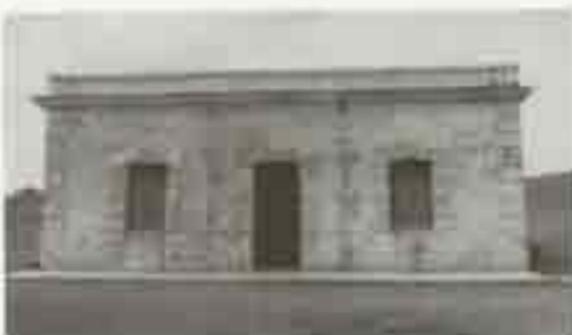
Figure 23. San Antonio Guardhouse at San Antonio Bastion. (Photo by E. Crisson, 1980.)

As part of the various changes and improvements made by the Spanish just prior to the Spanish-American War in 1898 was the construction of the San Antonio Guardhouse ca. 1897 in the Bastion of San Antonio, and adjoining el Morro (fig. 23).<sup>44</sup> Evidently, the defensive role of the north wall was reduced in the nineteenth century, while el Morro and San Cristóbal were strengthened with far-reaching artillery. This was confirmed in the description of 1898 by Goethals and Crosby in which San Antonio bastion was the only reinforced element of the north wall. This battery, immediately east of el Morro, was close enough to the fort to be considered a defensive extension of el Morro. The 1898 report described it as having:

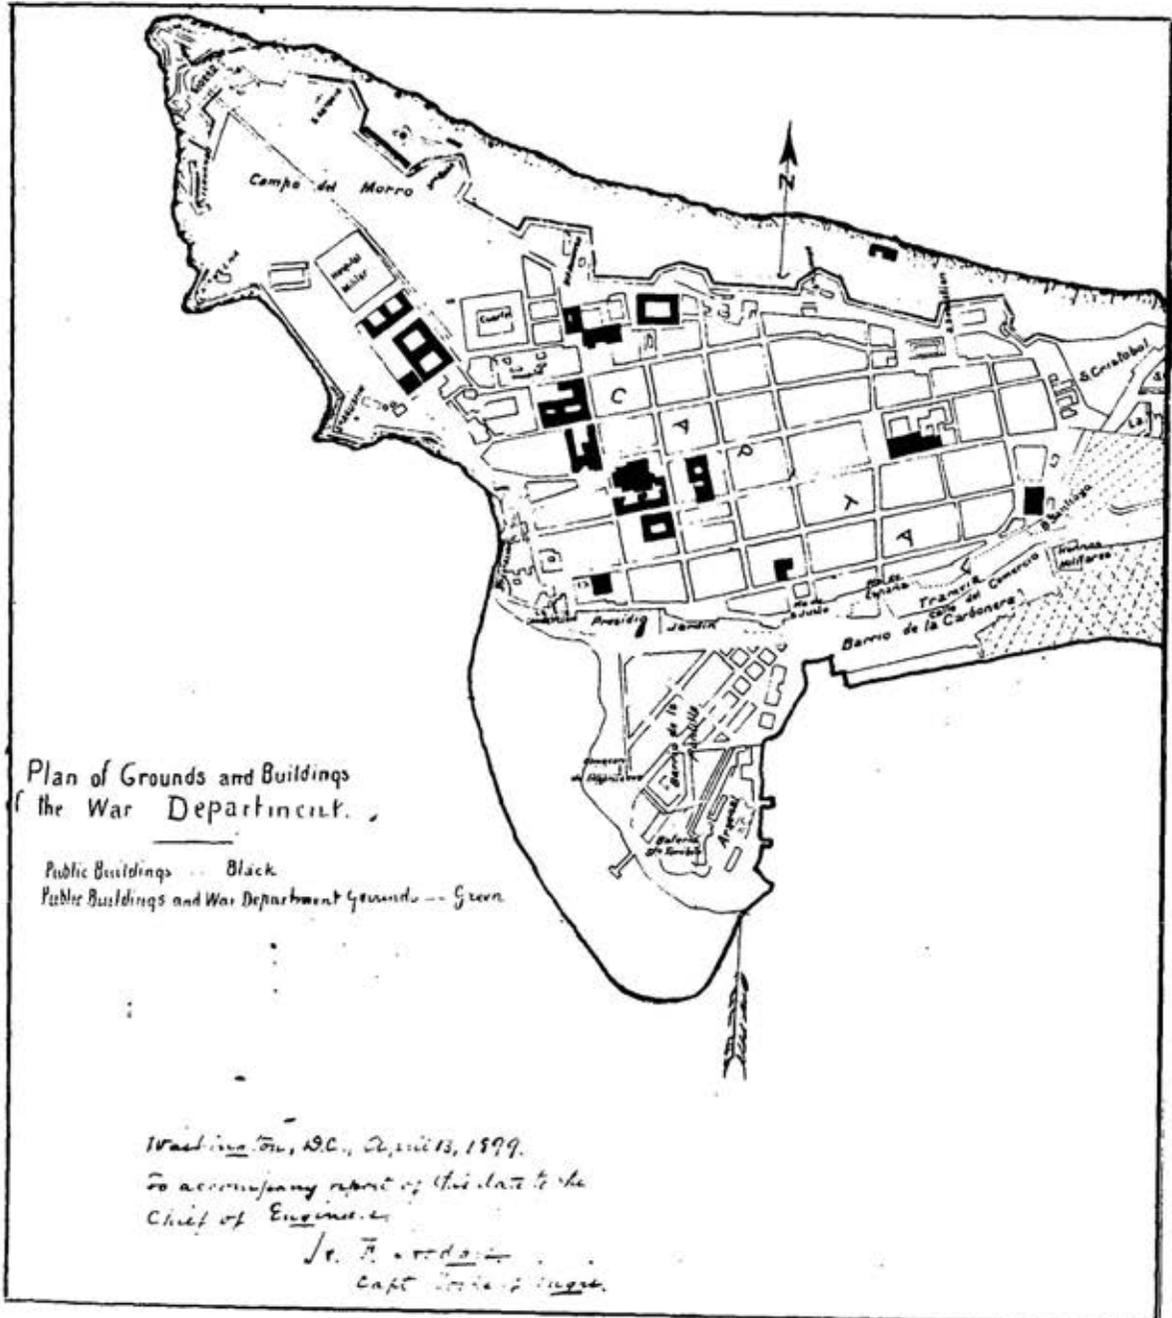
Figure 24. Plan of grounds and buildings of the War Department, 1899. (SAJU NHS 0543-1864.)

In preparation for the work that would be needed in the twentieth century, U.S. Army engineers soon began to document the extent and conditions of the defensive walls. The first of many plans prepared in the twentieth century was dated 1900 (fig. 24).<sup>60</sup> In five short months the aggressor became the

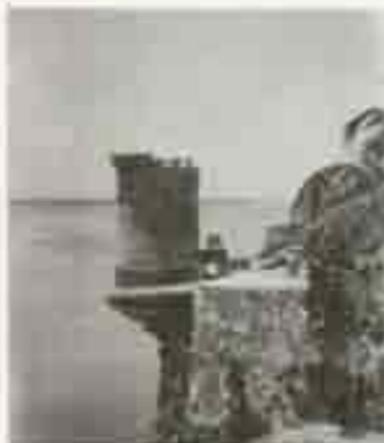
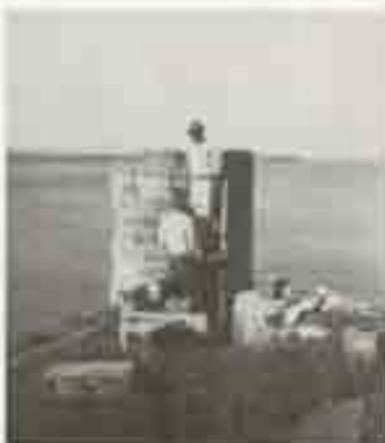
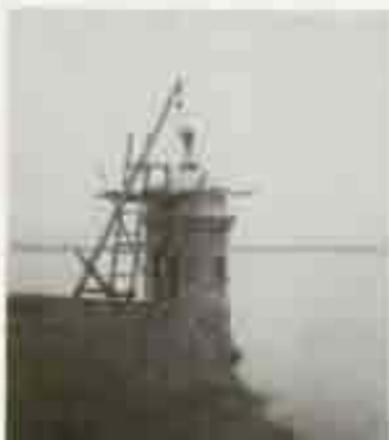
Figure 24. San Agustin sentry box, August 1933. (SAJU MMS Archives.)

Specification F 28-2 included reconstructing eight sentry boxes that were removed by the Spanish in locations interfering with the line of fire. The Army engineers utilized the same cast concrete block system developed in 1932. The mixture had

a colored admixture and the blocks were laid with mortar. The ogee dome was built of separately cast pieces, laid with mortar, and topped with a new cast concrete finial.<sup>99</sup> Among the reconstructed sentry boxes were several in city wall locations. They were as follows: "San Juan Gate" (actually at la Fortaleza), at San Sebastián bastion, at Santa Rosa bastion, and at San Antonio bastion. It was unclear which of the two historic sentry boxes noted in the 1932 project were used to replicate the new ones.

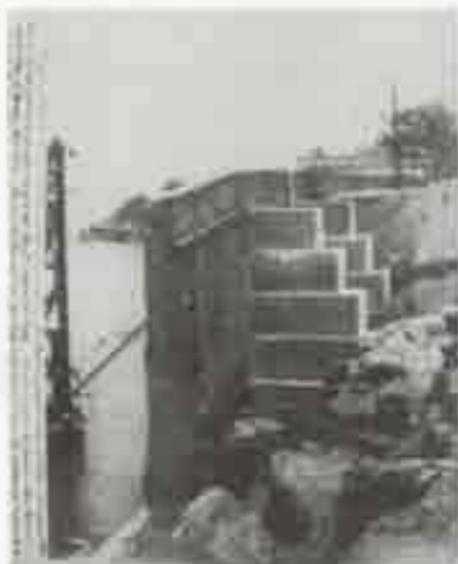
Figure 31. New concrete counterforts for the curtain wall between Santa Elena and San Agustín Bastions, 1938. (SAJU NMS Archives.)

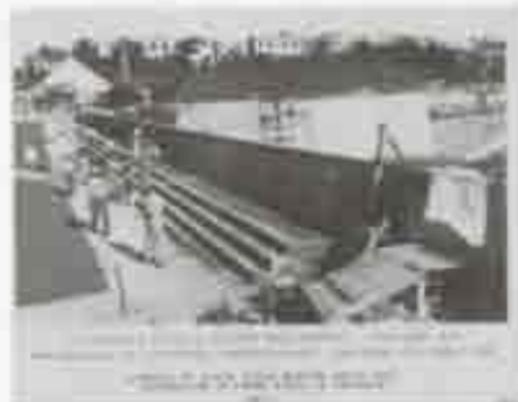
Figure 34. Santa Elena Bastion, reconstruction of firing steps, 1839. (Completion Report, SAJU MHS Archives.)

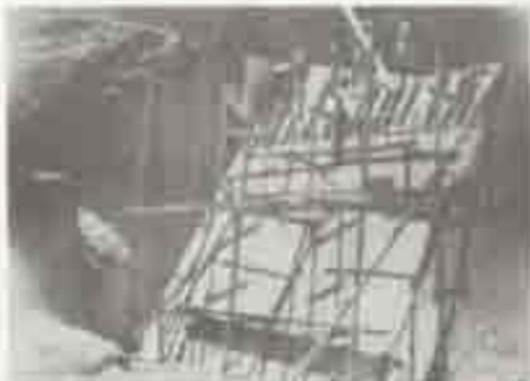
Figure 35. Reconstructed scarp wall, Santo Domingo Bastion, May 1936. (SAZU HNS Archives.)

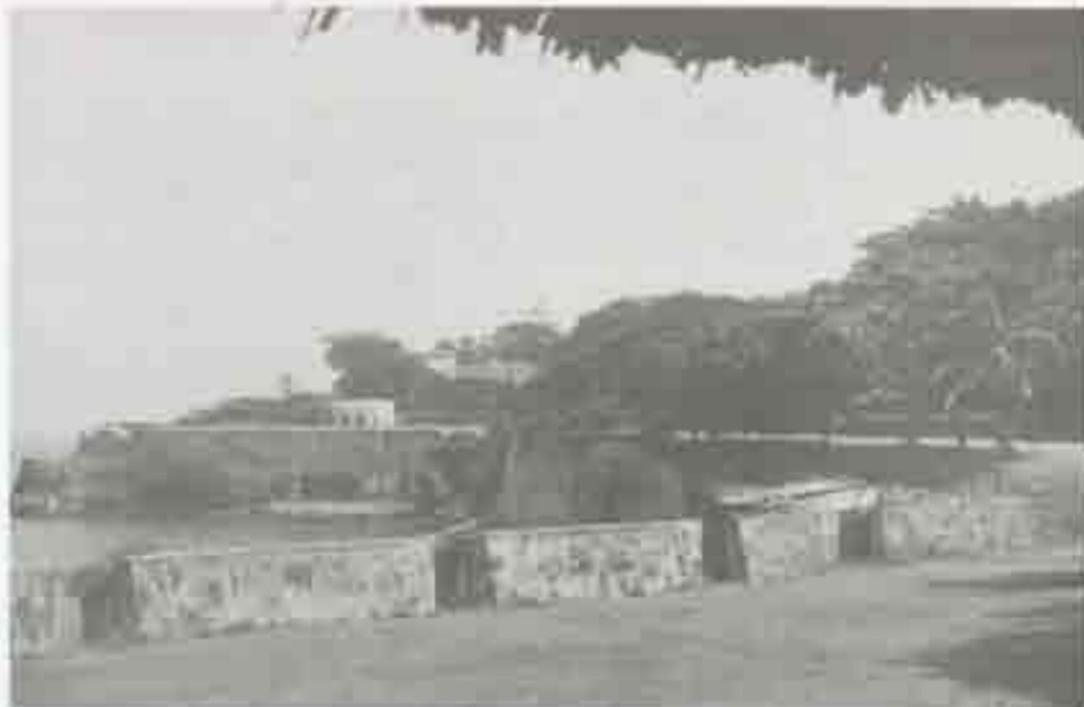
Figure 27. Condition of the west city wall in vicinity of the San Agustín (foreground) and Santa Elena (background) Sections, ca. 1960. (KAJN VHS Archive.)

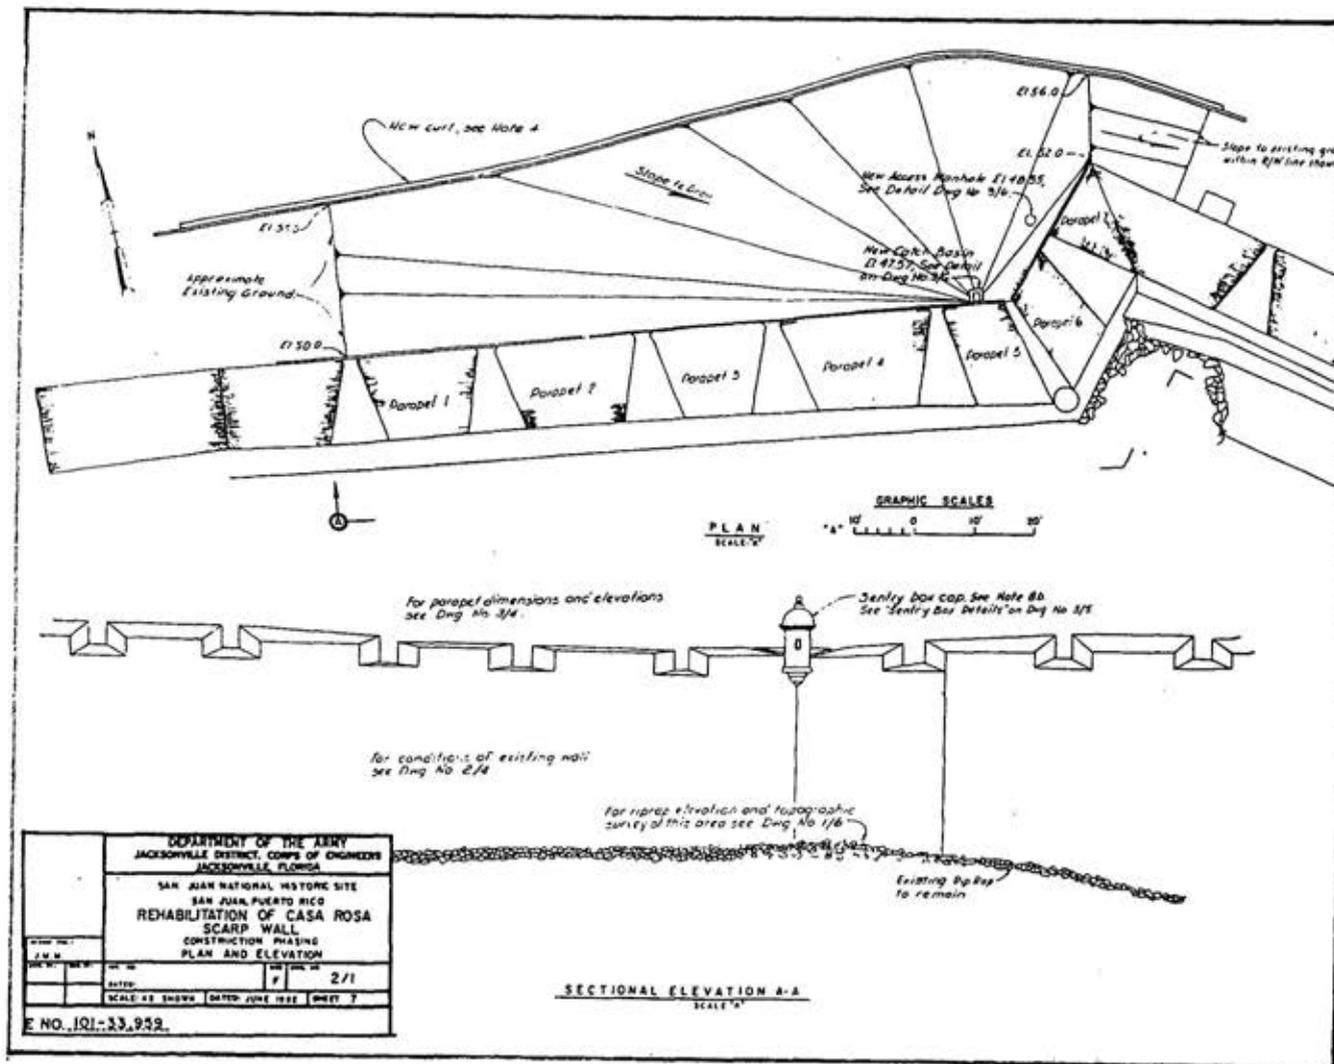
Figure 39. Elevation and plan of reconstructed wall, 1982, at San Agustín Bastion, U.S. Army Corps of Engineers. (Copies of drawing at SAJU NHS Archives.)

A number of contracts executed by the Corps of Engineers have been centered on projects located in the west wall between el Morro and San Agustín and in the north wall between el Morro and San Cristóbal. Although some drawings were located for this study, the complete project file for each specification was not found. Various projects directly affecting the city walls are of interest for this study. "Emergency Protective Works" at Santa Elena, dated 1977, was apparently the first of these projects.<sup>121</sup> The drawings show the placement of a rip rap revetment in front of Santa Elena, as well as doing borings along a stretch of this wall. This was followed in 1978 by a project titled "Foundation Treatment (and Access Trail)," in the area from San Juan Gate to Santa Elena. The drawings portray what is commonly known as the "jeep trail," extending northward from San Juan Gate to the base of Santa Elena. The jeep trail is situated above a rip rap revetment and allows access for maintenance of the west wall. The project titled "Stone Revetment from Santa Elena Bastion to South End of El Morro West Wall" was dated 1980, and included the continuation of the earlier revetment at the base of Santa Elena. A subsequent project "Subsurface and Structural Exploration at Casa Rosa Scarp" was dated 1981 (fig. 38). The drawings denote severe vertical cracks within the scarp wall and horizontal cracks along the merlons. The work of the project included removing the upper half of the scarp wall and its five embrasures flanking the sentry box. The sentry box was also removed and reconstructed. The final project of this series was titled the "Rehabilitation of Casa Rosa Scarp Wall." The drawings, dated 1983, included subsurface work and the installation of parapets, sentry box, stone facing, utilities and landscaping (figs. 39 and 40). The idea behind this project was to form a totally new "hollow" parapet, using a reinforced concrete wall faced with "2 inch sawed stone facing" and trimmed along the perimeter with brick. The interior of the parapet contained reinforced concrete counterforts behind

the face wall and a new reinforced concrete retaining wall was built parallel to the wall. Both walls supported a new "roof slab" terreplein consisting of precast concrete slabs topped with backfill and sod. The entire parapet was to be regraded and drained by means of new drain outlets.<sup>122</sup>

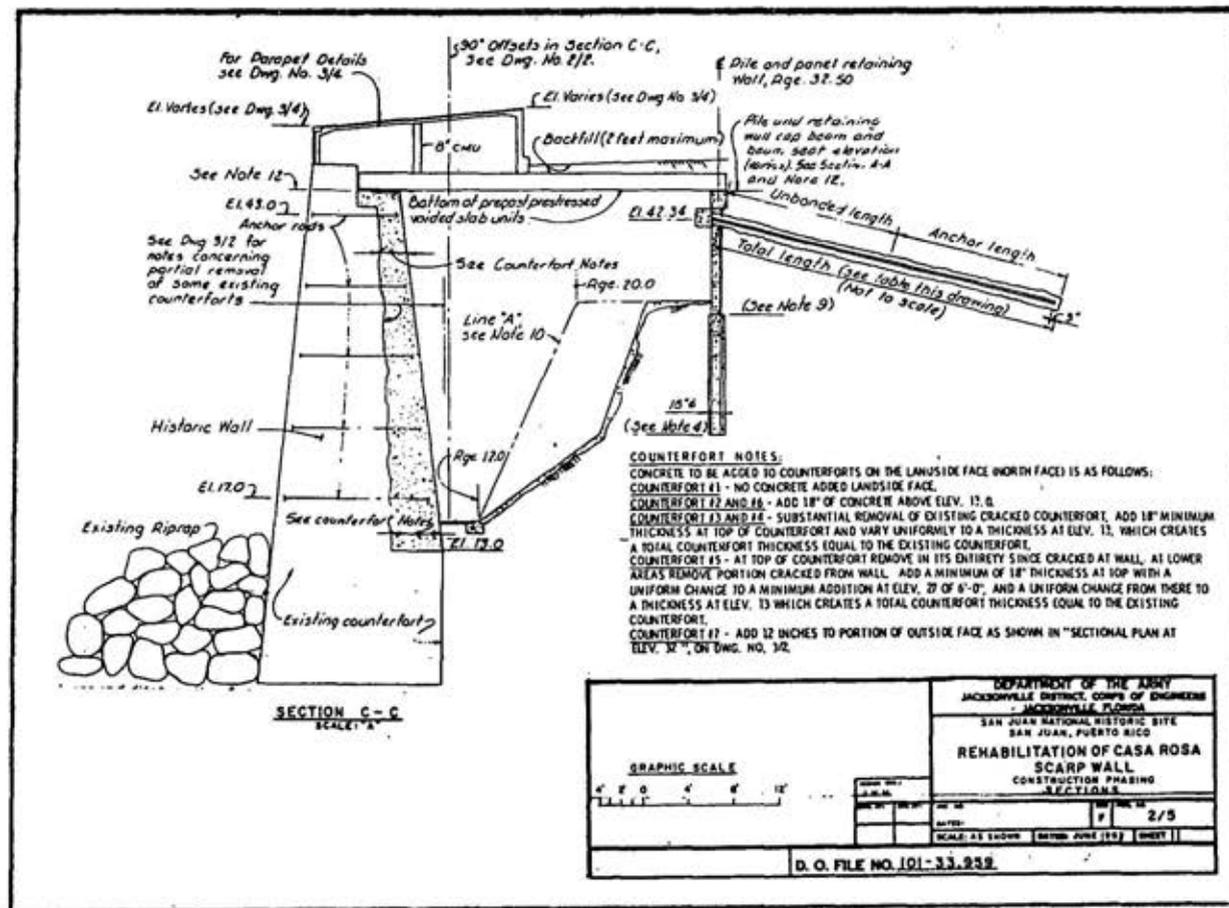
Figure 40. Section through reconstructed wall at San Agustín Bastion, 1982. Corps of Engineers. (Copies of drawing at SAJU NHS Archives.)

Wall (Fig. 44). It has 10 embrasures and two sentry boxes that were both reconstructed in 1932. The southeasterly sentry was rebuilt a second time in 1982 (Fig. 40). The conditions of the parapet walls include differential weathering, biological growth, and patching. Six of the southernmost embrasures were reconstructed since 1981. San Agustín is identified with a bronze marker on the wall.

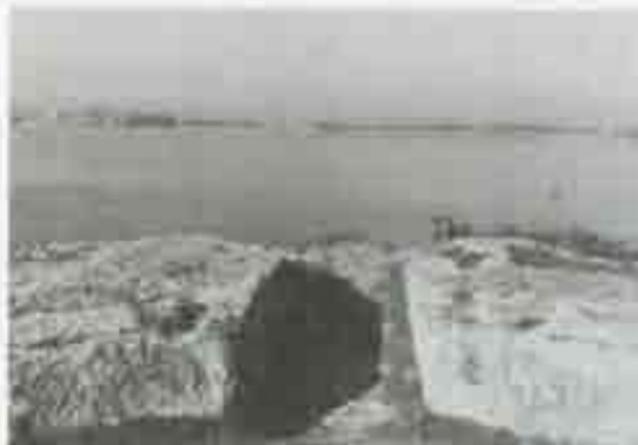
Figure 43. Embrasure at San Fernando Bastion,  
(Photo by E. Crisson, 1990.)

San Fernando Bastion is situated south of el Morro (fig. 42). It has been greatly modified over the years and contains neither a sentry box, however, what may survive from a former embrasure is still evident (fig. 43). A modern chain-link fence separates San Fernando from the edge of the cliff. Further south is Santa Elena Bastion. Santa Elena is the only rounded bastion. It has no sentry box but contains 11 embrasures. The exterior walls are constructed of coursed, face-dressed sandstone rubble; the openings of the embrasures are of chamfered dressed stone. Horizontal surfaces of the merlons are brick-edged concrete, probably installed as part of the 1977 Corps of Engineers project. The embrasures exhibit various conditions of deterioration, including differential weathering and biological growth. Most of the flat wall surfaces are patched and have a number of surface cracks. All of the embrasures have iron fences placed approximately one foot away from the exterior face. Santa Elena is identified with a bronze marker on the wall.

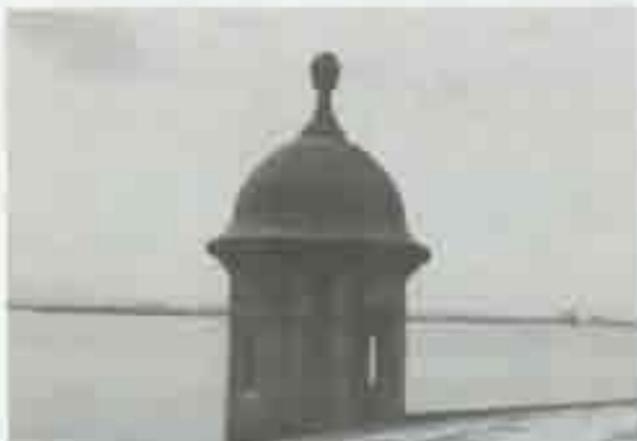
Figure 45. Reconstructed sentry box of San Agustín curtain wall. (Photo by H. Crissan, 1990.)

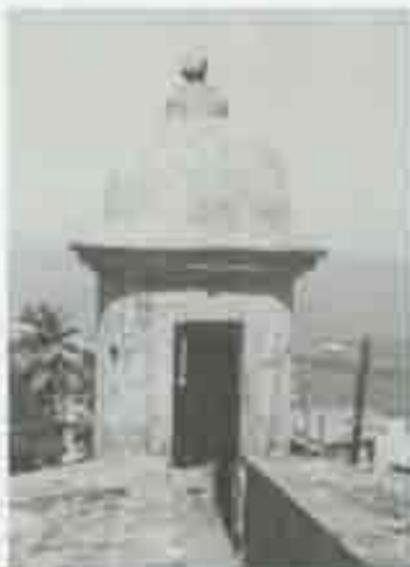
Figure 54. San Sebastián, original sentry box. (Photo by S. Crissan, 1996.)

brick rubble, covered with stucco. This sentry box has severe cavity erosion below the cornice and at the base, and has exposed brick and stucco patches (fig. 54).

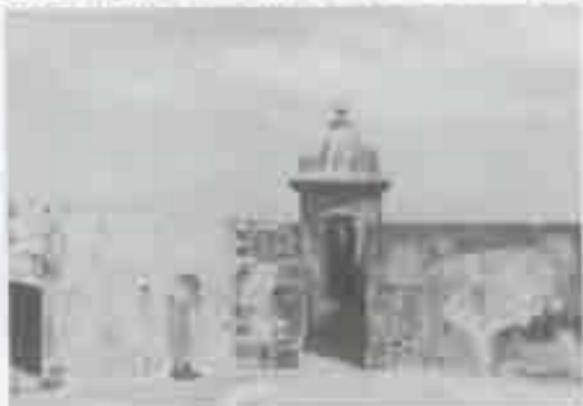
Figure 81. Sentry Box at San Antonio Bastion. (Photo by S. Crissan, 1990.)

(Fig. 81). The bastion consists of coursed, face-dressed sandstone rubble with rubble joints, dressed stone corners, and brick-edged embrasures. A large stone scupper is located near the salient angle and has a large cast iron pipe leading down to the base of the scarp wall. The embrasures have cavity erosion and differential weathering. Most have been patched and have areas of mortar loss, while others have cracks and biological growth. San Antonio is identified with a bronze marker on the wall.

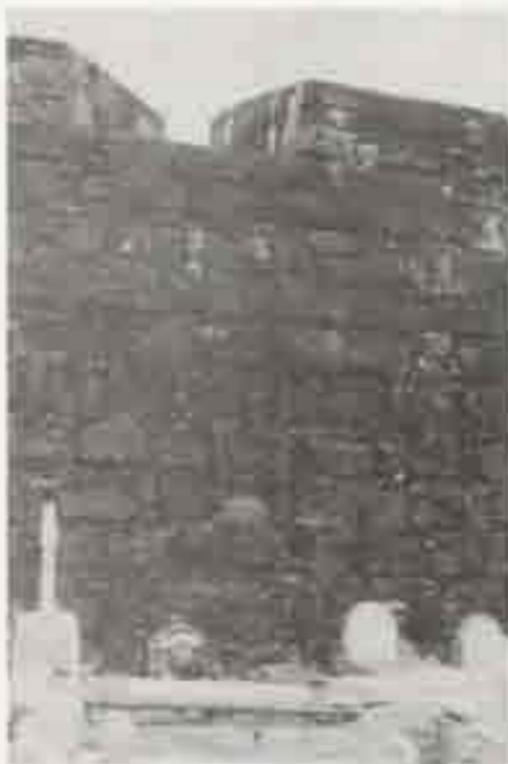
Figure 1. North wall of San Juan, backing cemetery. Note use of ashlar with stone chinking (this wall has more chinking than other walls); brick chinking and brick of merlons may be repairs. Photo by J. Jacob, 1949.

Identifying size, tooling, and bedding patterns of stone blocks is difficult and often impossible to determine due to the stucco covering. However, much of the deteriorated stucco has weathered and formed to the contour of the blocks beneath (especially at el Morro), revealing these characteristics. (See figures 1 and 2.) Almost all of the fortified walls are constructed with a slight batter. Rock-face blocks are generally 18 inches to 24 inches in height and 30 to 36 inches in length, with length varying more than height. Their depth cannot be determined without further investigation.

Black and white marble pavers are found in the chapel at el Morro, in the vestry of the chapel at San Cristóbal, and outside the northern-most casemate of the Officers' Quarters under the arcade. These are 11 inches square and laid in a checker-board fashion. Marble grave stones are embedded at the base of the north wall adjacent to the San Juan Cemetery (fig. 1).

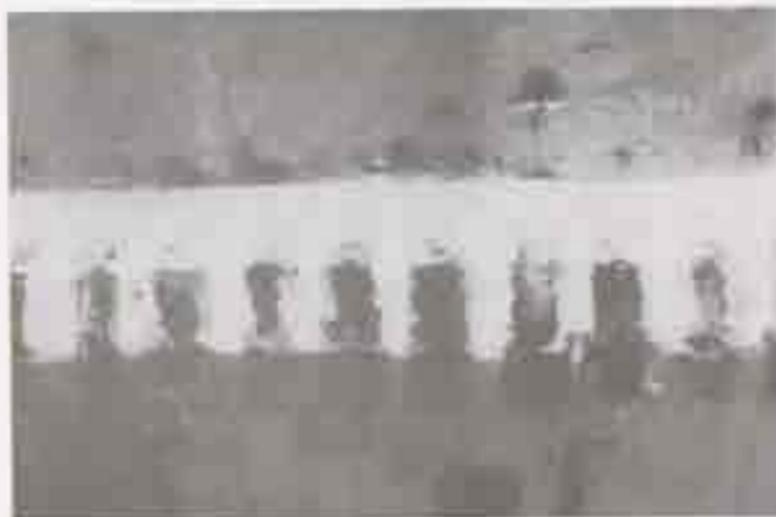
Figure 3. Casted hollow brick along banquetta on south side of Santa Barbara Battery. 3. Decorative brick-dust stucco partially remains, covering brick faces. Photo by J. Jacob, 1989.

A document from the Real Maestranza de Ingenieros (date unknown, but probably around 1832) notes the use of a soldier or rowlock course of brick along sidewalls in San Cristóbal (the exact location is not clear).<sup>24</sup> Whether all brick edging dates to this period or to the late-eighteenth century is not known. Edges of banquettes are faced with canted bullnose brick. Where a bullnose brick has one rounded corner, these have one corner cut off on a 45 degree angle (fig. 3).

At Santa Barbara Battery, traces of brick-dust stucco remain on the top edge of the banquettes facing the bay. The brick in this location are canted on the top corner and covered with white stucco. It appears that indentations were made in the stucco on top of each brick and then filled with the brick-dust stucco to the same plane of the adjacent white stucco. This would have given a toothed appearance to the banquettes (fig. 3).

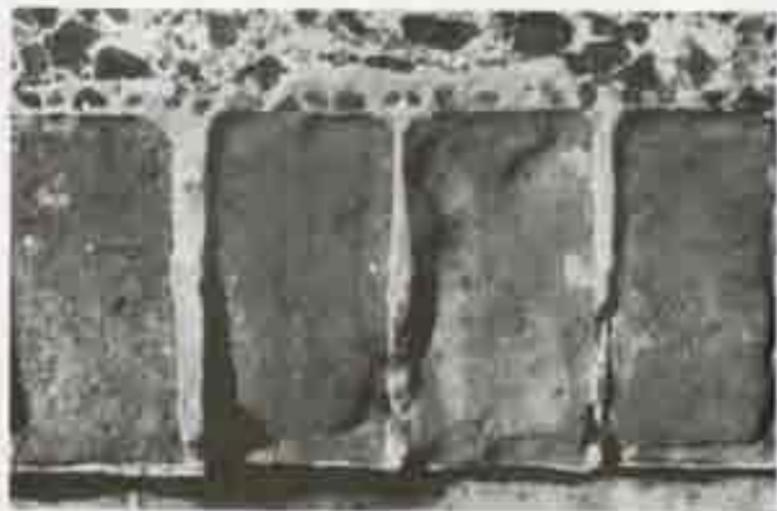
Figure 4. Northwest edge of ramp connecting the Plaza de Armas and Santa Barbara Battery. Brick galling is located between brick and corncob. Photo by J. Jacob, 1989.

Small gravel-sized chunks of brick are used in galleting.<sup>27</sup> The very edge of the ramp leading from the Plaza des Armas to Santa Barbara Battery is faced with paving brick. Imbedded in the strip of mortar running between the inside edge of these brick and the adjacent hormigón of the ramp are small brick chunks set 1 to 2 inches apart (fig. 4).

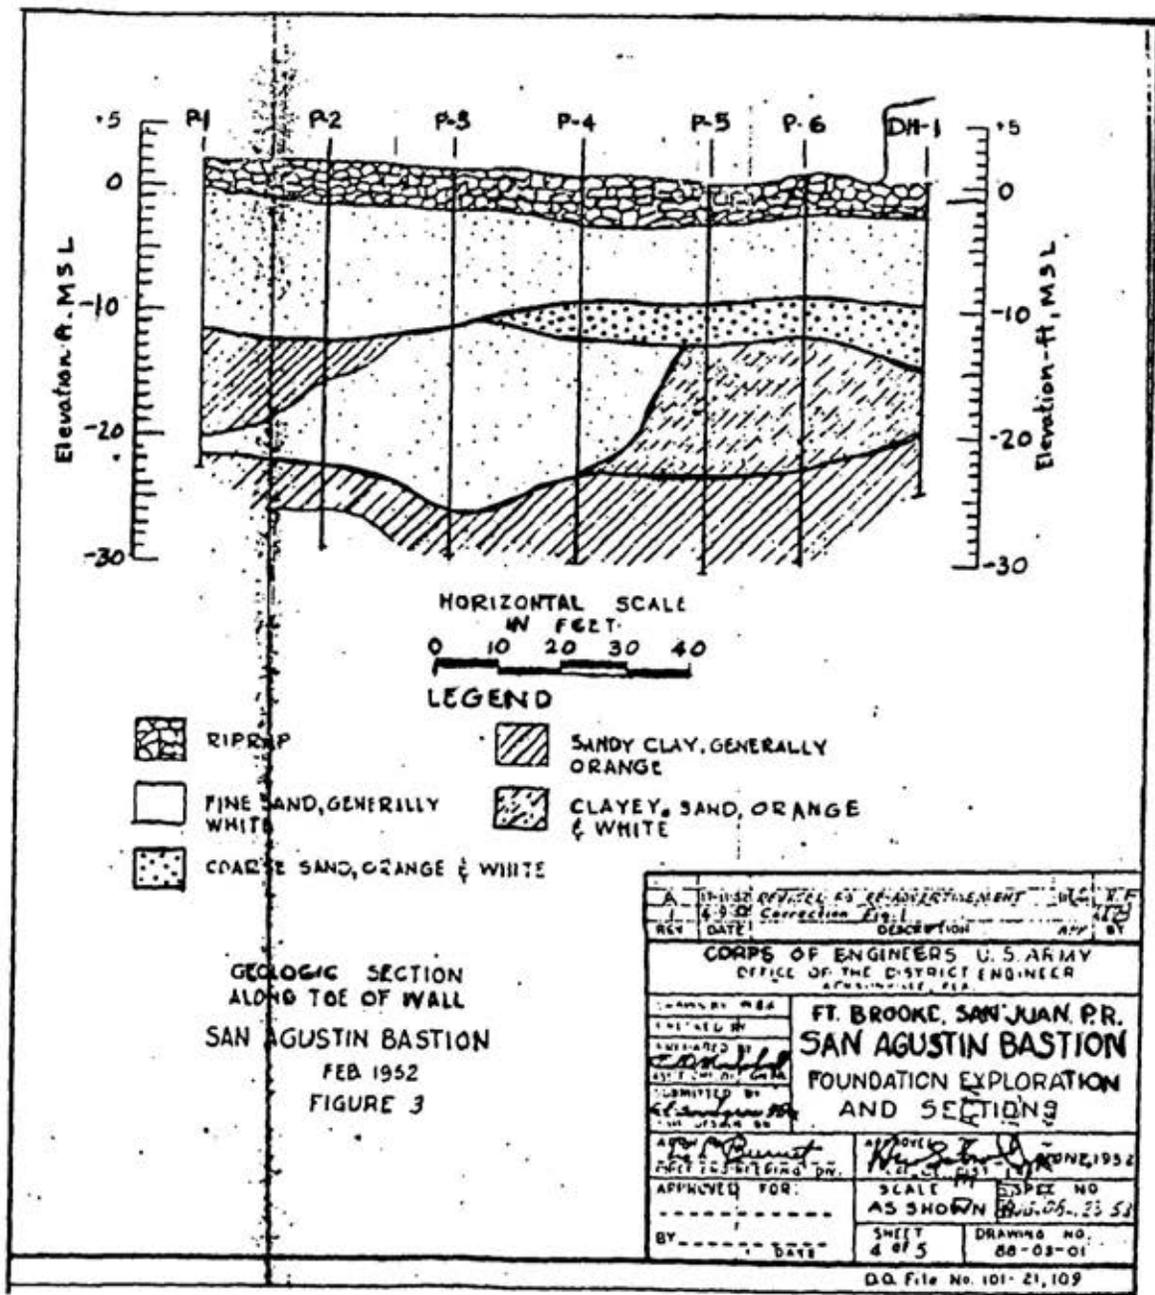
Figure 5. U.S. Army Corps of Engineers drawing, 1952. Wall section along toe of San Agustín Bastion. (San Juan NHS Archives.)

A U.S. Army drawing from 1952 shows a wall section along the toe of San Agustín Bastion depicting different layers of sand and soil (fig. 5). The layers are labeled: "fine sand, generally white"; "coarse sand, orange and white"; "sandy clay, generally orange"; and "clayey sand, orange and white." These descriptions are not unlike sands found in mortar samples collected on the site.

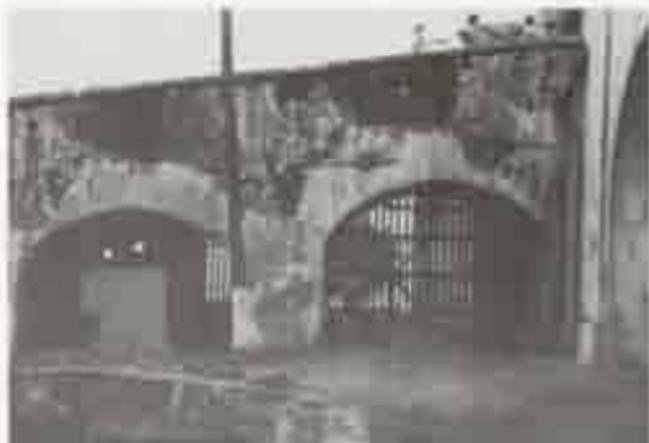
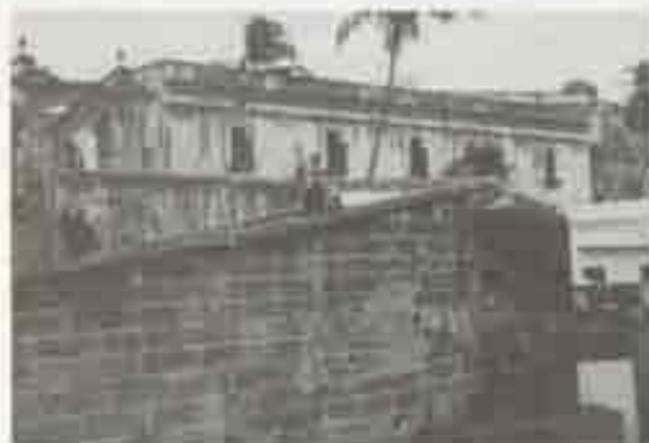
Figure 8. South face of ramp wall leading to the Main Gate of San Cristóbal. Photos by J. Berkowitz, 1967.

result of the yellow from the blocks streaking down the wall face.) A scribed line pencilled black outlines each faux block (fig. 7). Above the segmental arches of the ramp, faux voussoirs are depicted in a like manner (fig. 8).

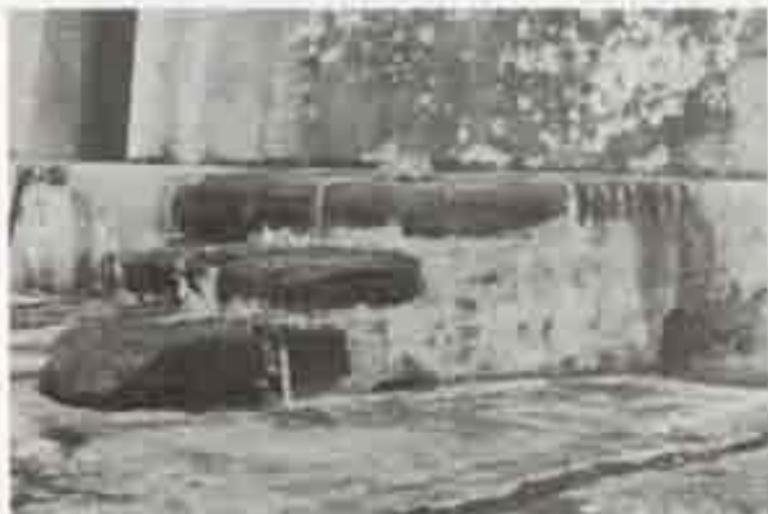
Figure 9. Banquette on top level of la Trinidad. Photo by J. Jacob, 1949.
