# THE FORTIFICATIONS OF SAN JUAN NATIONAL HISTORIC SITE

## HISTORIC STRUCTURE REPORT

Castillo de San Felipe del Morro  
The City Walls  
An Investigation of the Materials Used  
Cultural Landscape Report

Castillo de San Felipe del Morro

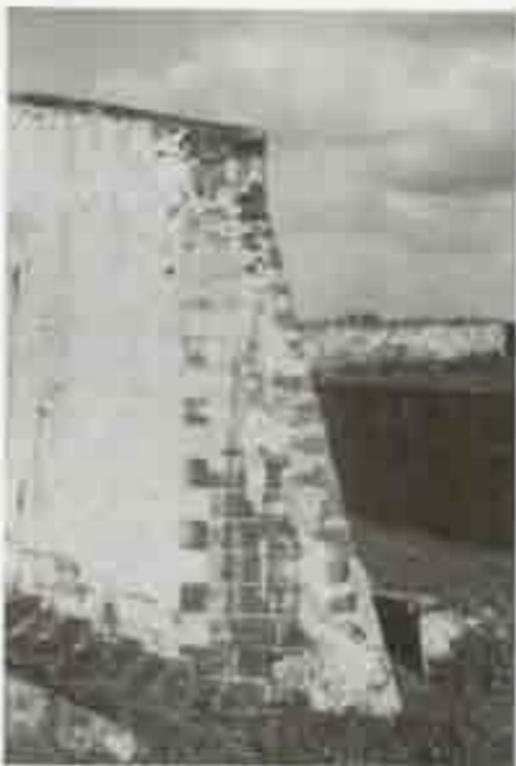
Figure 10. South salient angle of el Kbanico. Photo by J. Jacob, 1969.

Faux quoins are located on the north and south salient angles of el Abanico (fig. 10). These are yellow in color and have a rough surface texture. Faux joints are painted black.

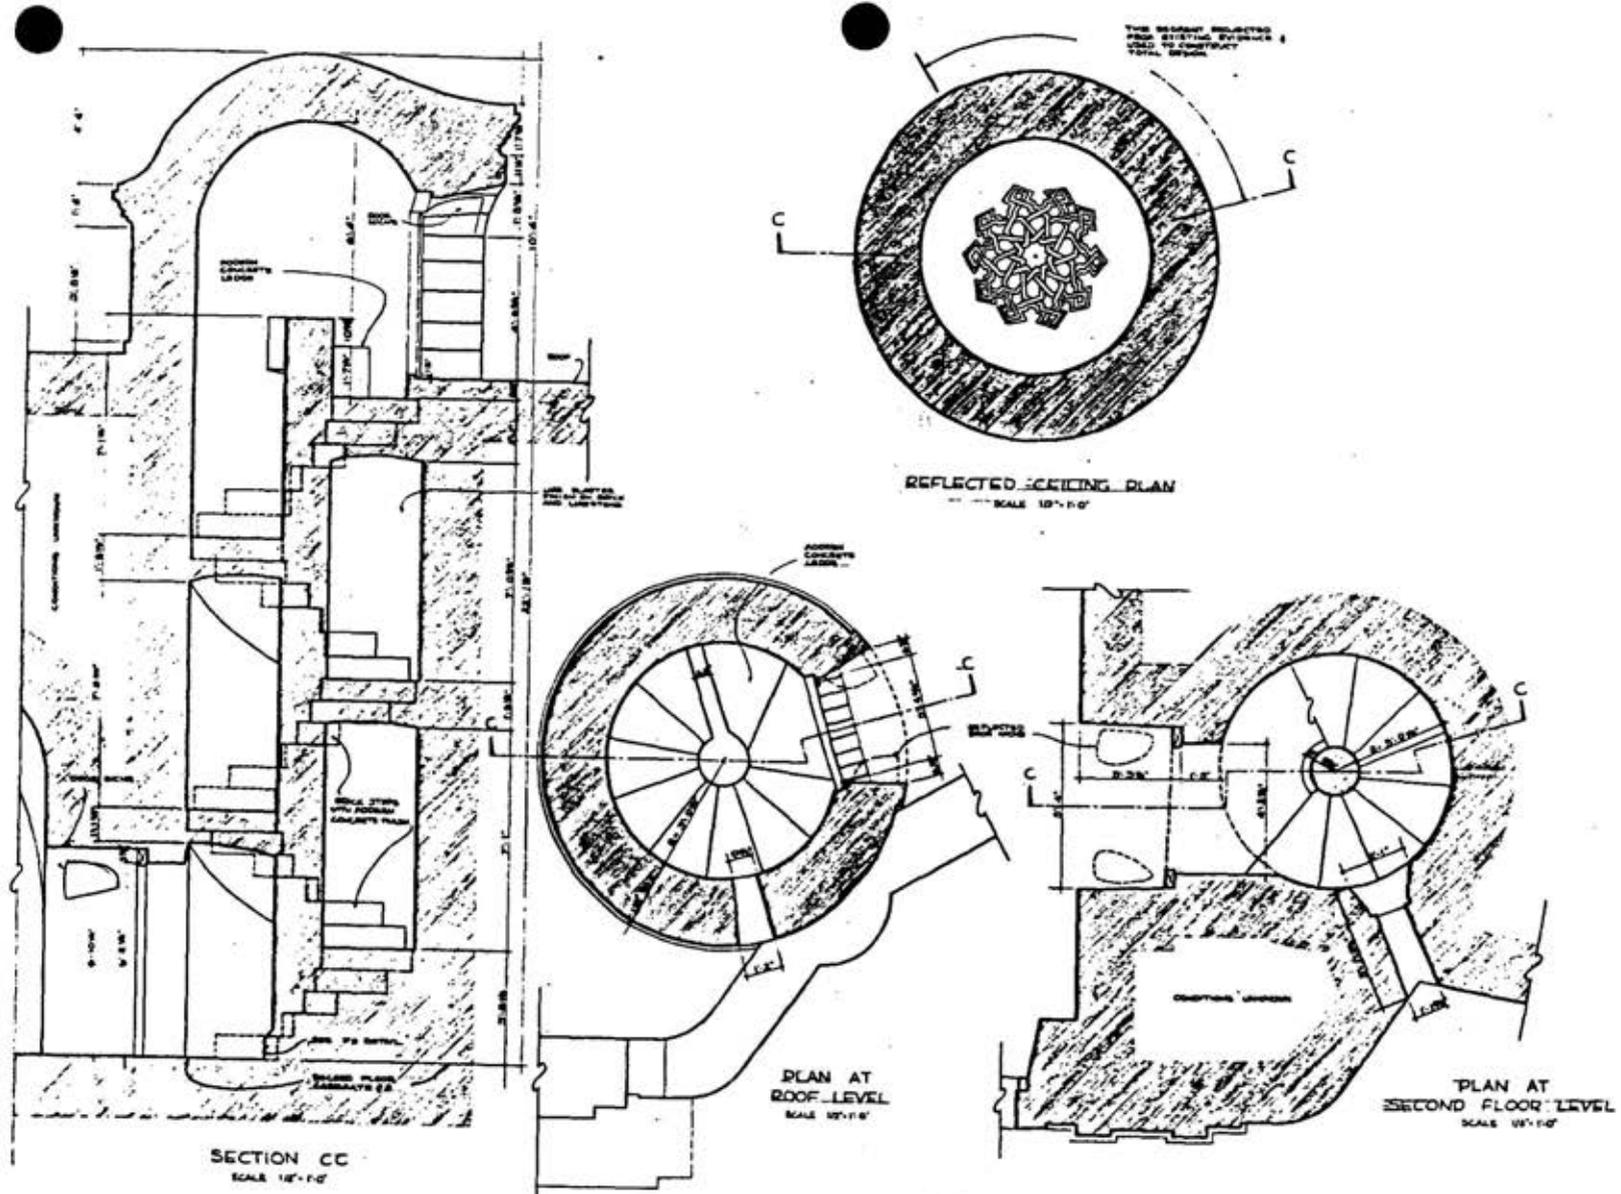
Figure 13. El Caballero, detail of spiral stairs. Drawing by HABS, 1962.

On the interior side of the dome of the stair tower at San Cristóbal are the remains of a decorative finish scheme. A geometric design is outlined in scribed lines pencilled black. A hypothetical view of the dome and its finish as it appeared in the nineteenth century is illustrated in a HABS drawing (fig. 13).

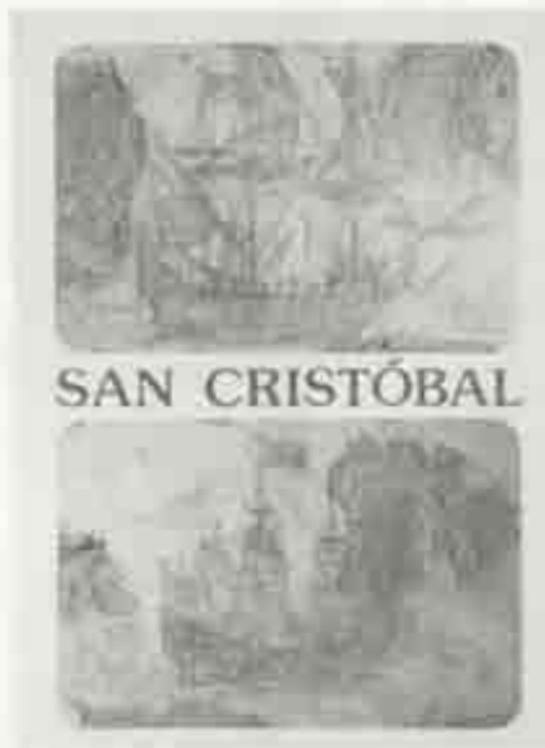
Figure 14. Drawings of ships found in the "Dungeon" at San Cristóbal. Date unknown. (Postcard, San Juan HNS.)

Sailing ships are a common image on the walls of the fortifications. Those documented by HABS are carefully executed in black and found in the tower at el Morro and the dungeon at San Cristóbal (fig. 14). Black ships are also found in Tunnel 6 and on a merlon (facing the embrasure) on Santo Domingo Bastion. Other black line drawings are found in el Morro. In addition to the drawing of the ship in the tower is the remains of a drawing of a pediment. A drawing of a serpent is on the wall in the circular stair.

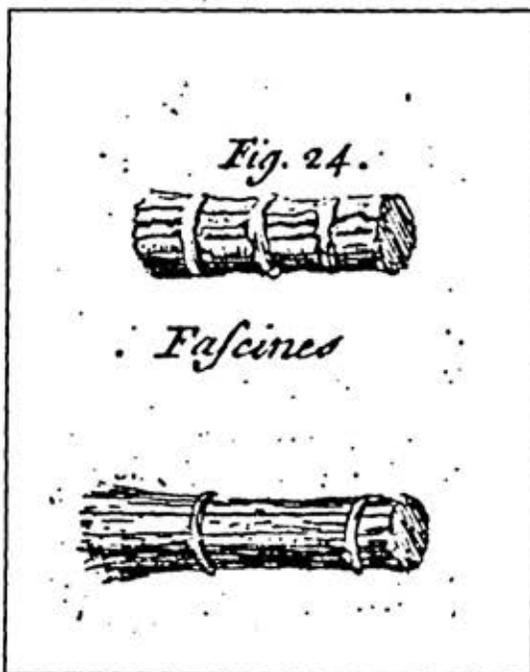
Figure 16. Fascines. Illustrated in E. Chambers, Cyclopedia of Arts and Sciences, 1752.

In E. Chambers Cyclopedia of Arts and Sciences (London, 1752), an illustration of fascines is given.<sup>84</sup> Two bundles of sticks are depicted: one with both ends cut off evenly, one with one end cut off evenly and the other left uncut with its tapered ends protruding (fig. 16). George Ripley and Charles A. Dana also mention fascines in The American Cyclopaedia (1874): "The interior slope [of a ditch in temporary works] is revetted by sods, or some material hastily gathered for the purpose, as logs, boards, fascines, gabions, &c."<sup>85</sup> Although the exact configurations of fagina described in the Spanish definitions are unclear, the illustration provided by Chambers appears to be a close match. It may be that fagina were used for facing earthworks, both to prevent (or retard) erosion from weathering and enemy access.

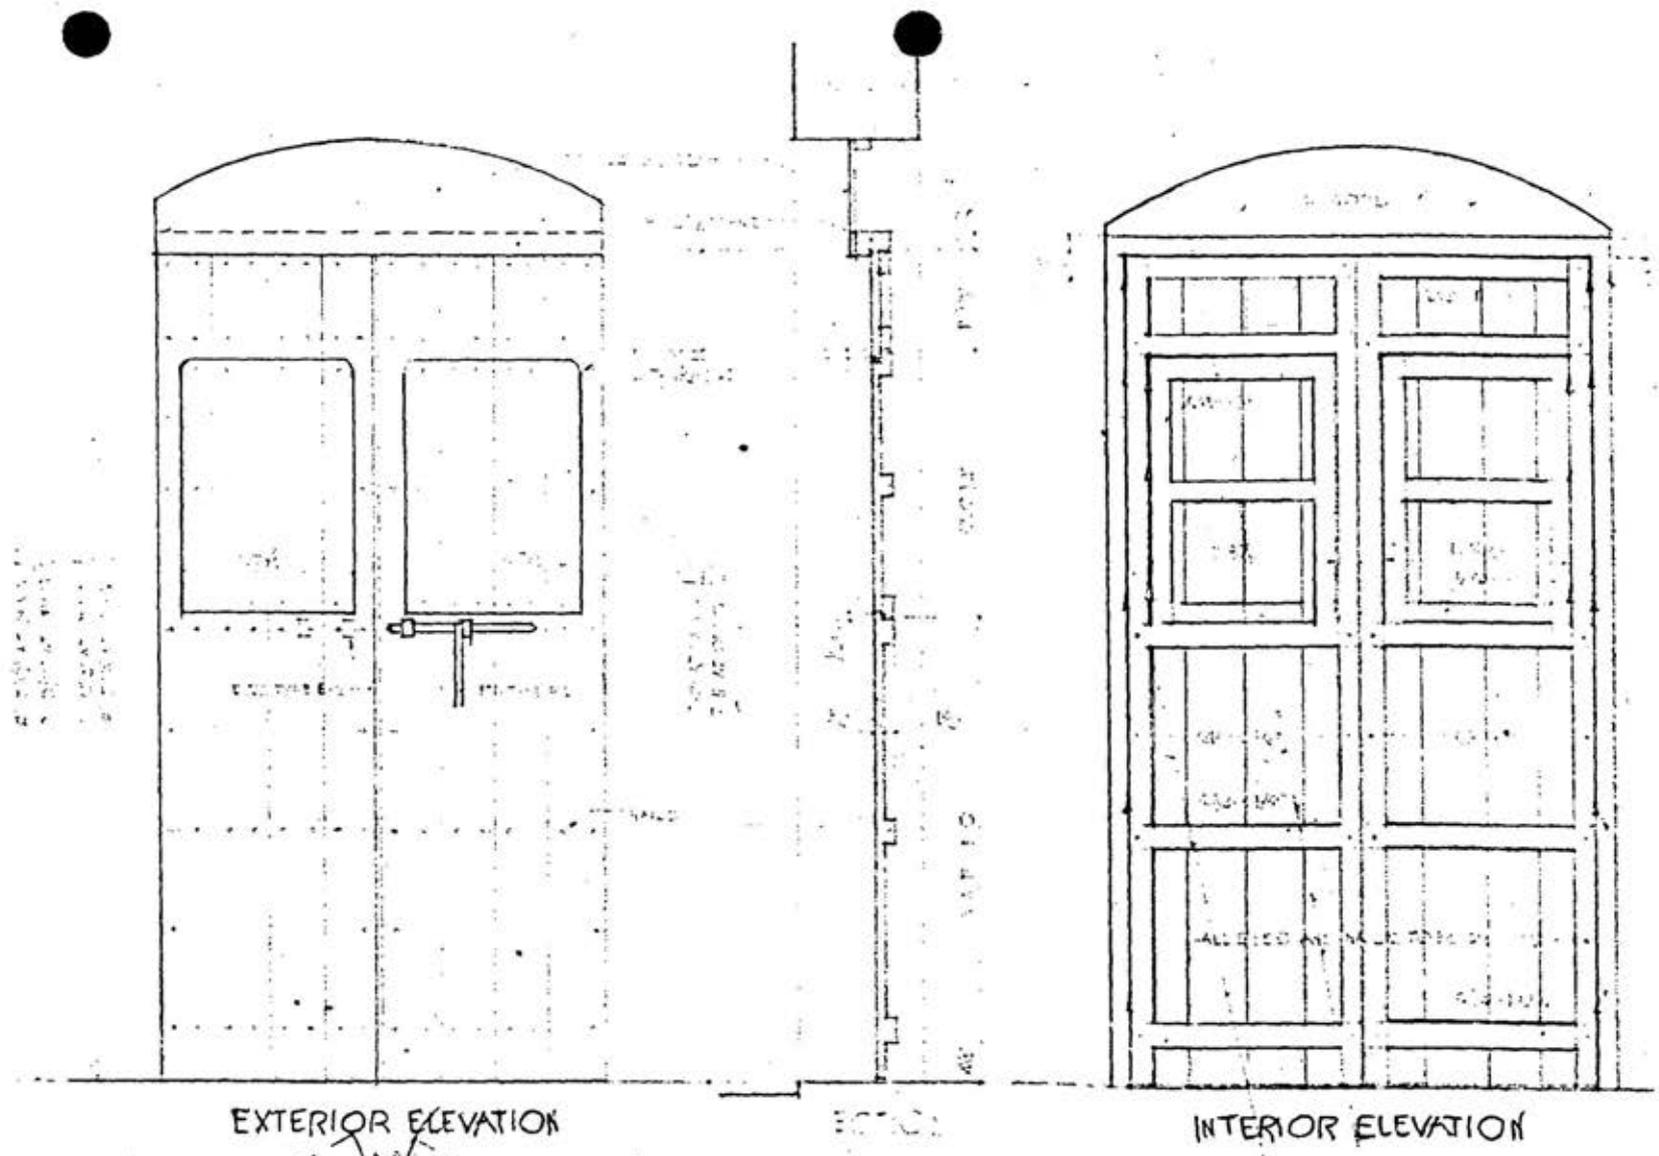
Figure 17a. Door type "A", San Cristóbal. (Dept. of Interior, Division of Design and Construction. Drawing no. NHS: SJ/3062, 1962.)

In the early 1960s, HABS documented extant doors, gates and shutters in the fortifications (figs. 17-22 and 28); some of these may date to the late-eighteenth century, others to the early-twentieth century. It is presumed that an attempt was made to replicate these accurately (from what was either being replaced or what was extant), and that the HABS illustrations can be considered to portray doors, gates and shutters as they appeared in the late-eighteenth century.

Doors are typically of vertical planks braced on the back (interior side) by both vertical and horizontal members. Doors to casemates are double, hinged on either side with both sides opening to the exterior. Some doors have a small opening in the top third; this opening has a hinged cover opening to the interior with a grille on the exterior side.

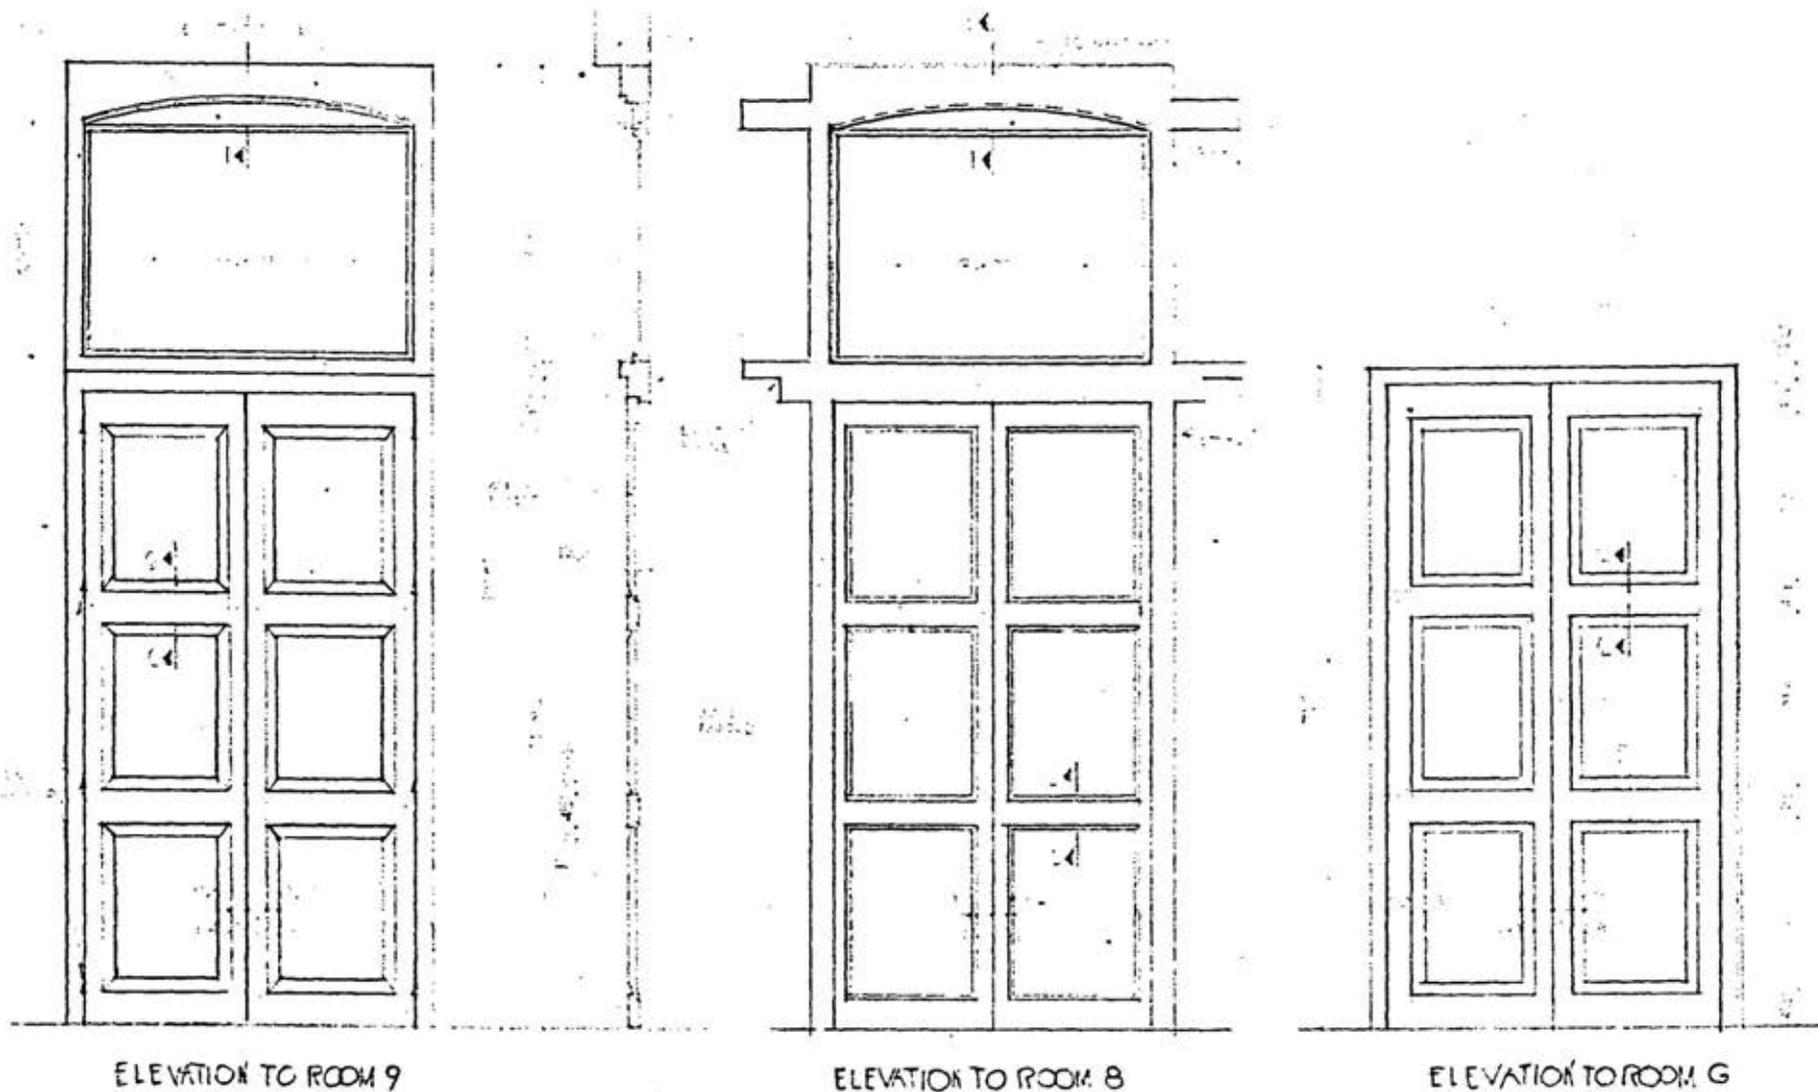
Figure 17b. Door type "D", San Cristóbal. (Dept. of Interior, Division of Design and Construction. Drawing no. NHS:SJ/3062, 1962.)

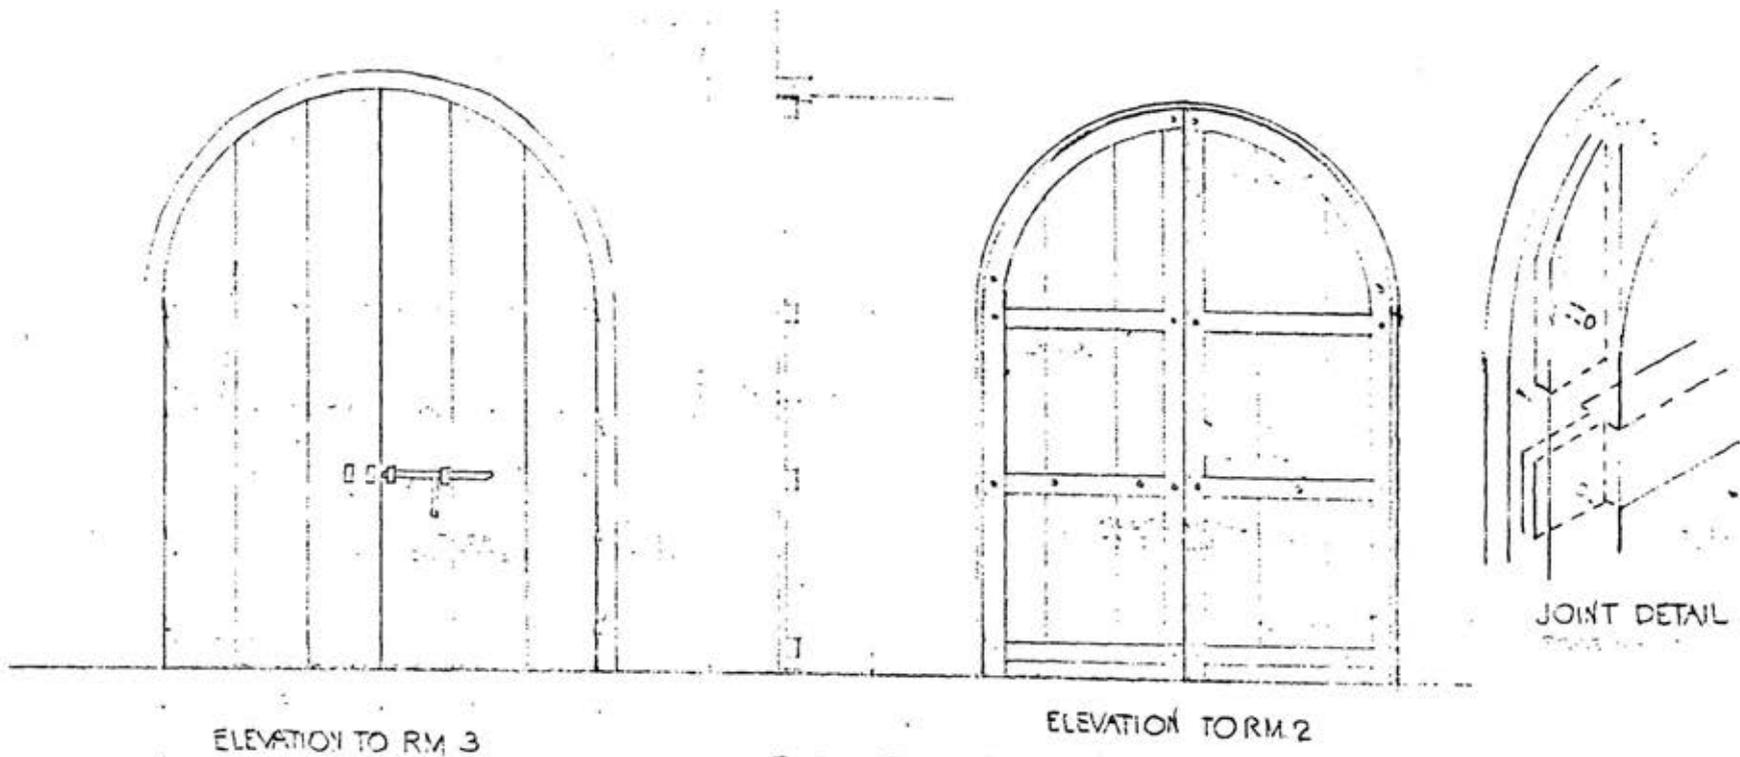
Figure 17c. Door type "E", San Cristóbal. (Dept. of Interior, Division of Design and Construction. Drawing no. NHS:SJ/3062, 1962.)

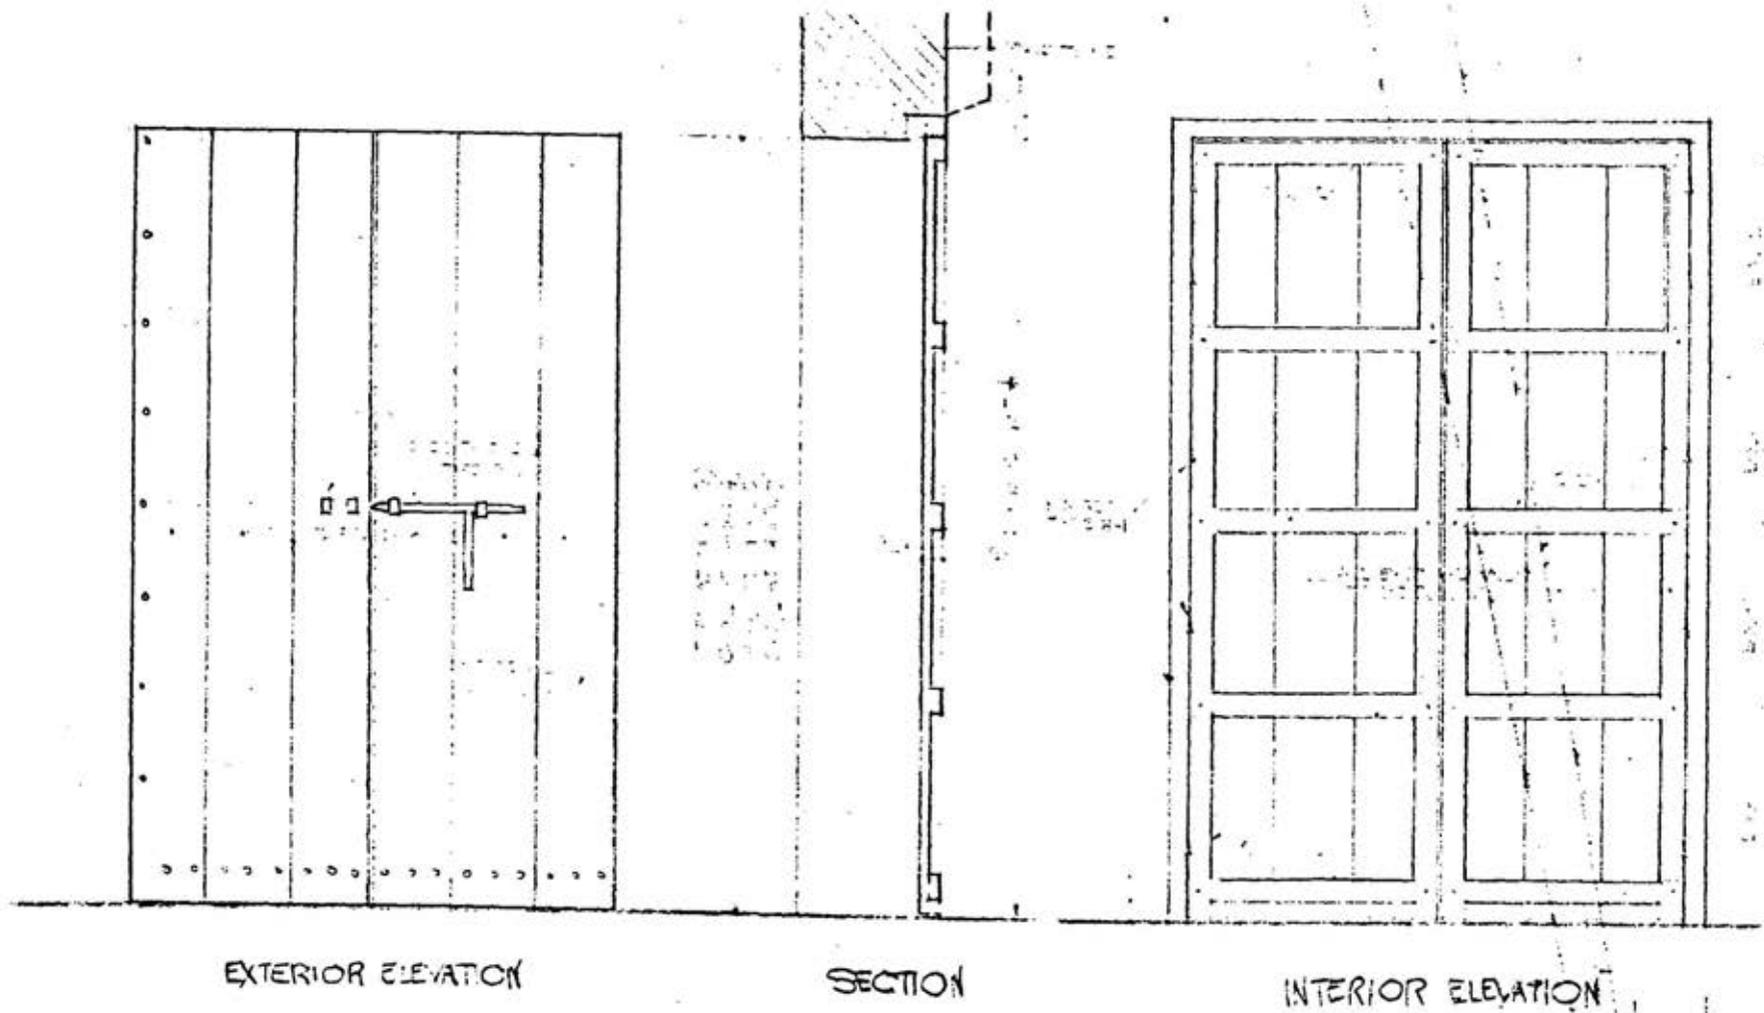
Figure 17d. Door type "F", San Cristóbal. (Dept. of Interior, Division of Design and Construction. Drawing no. NHS:8J/3062, 1962.)

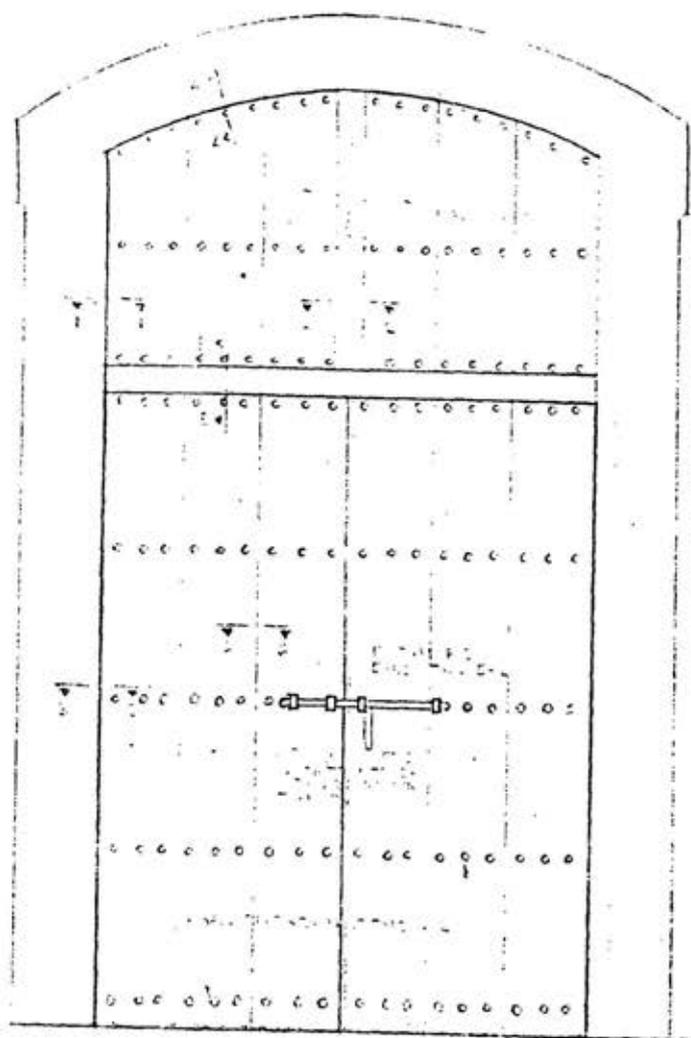
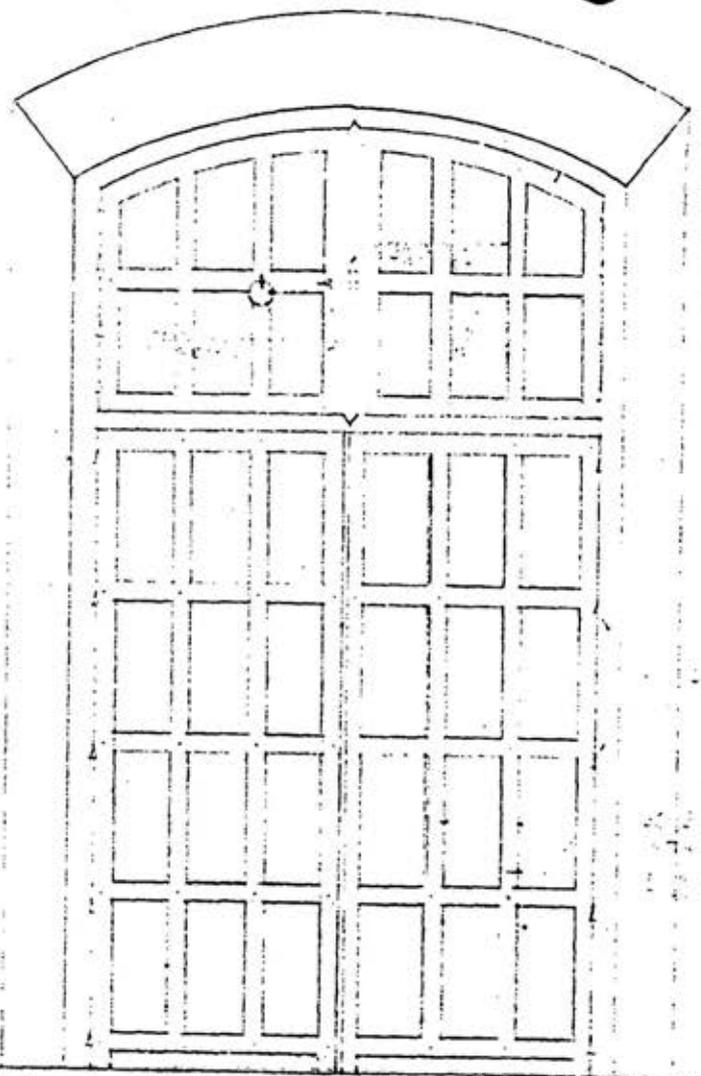
Figure 18a. Door type "A", San Cristóbal. (Dept. of Interior, Division of Design and Construction. Drawing no. NHS:8J/3062, 1962.)

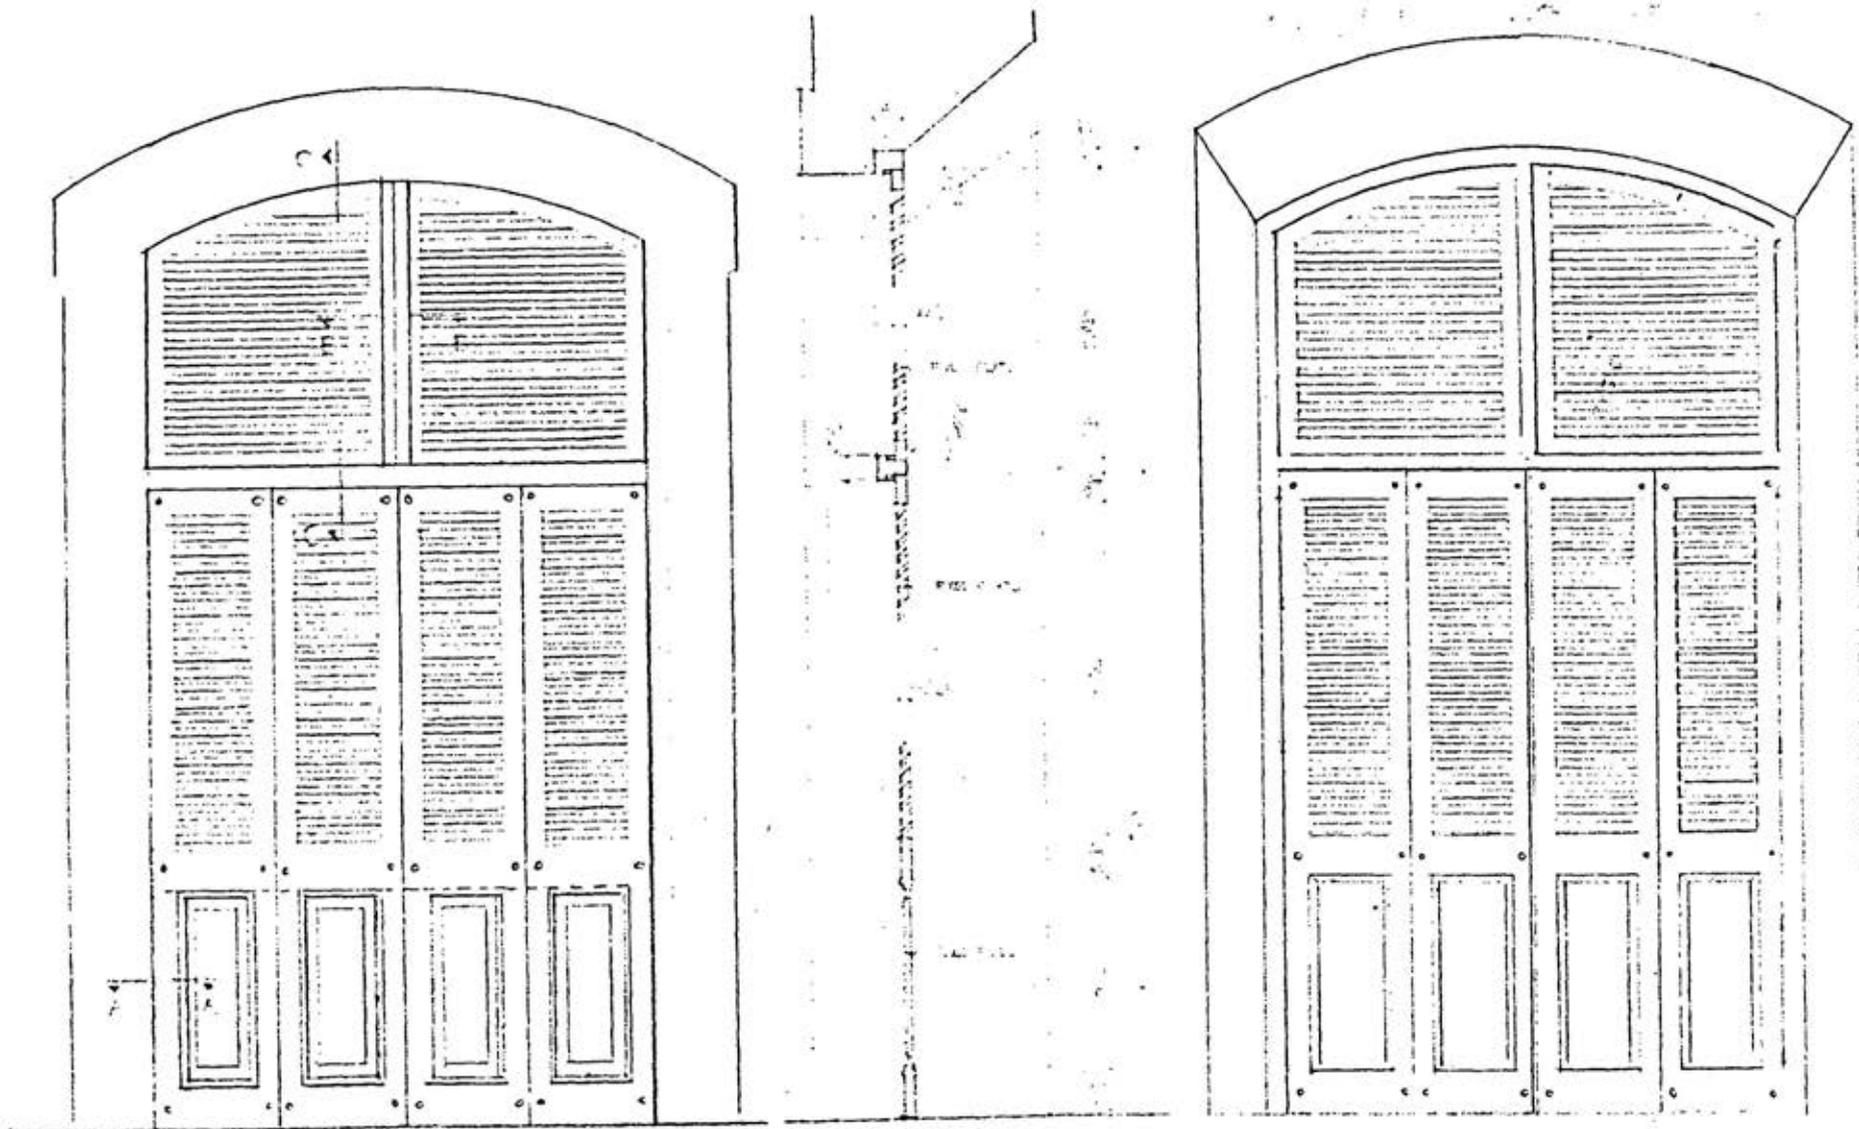
Figure 18b. Door type "B", San Cristóbal. (Dept. of Interior, Division of Design and Construction. Drawing no. NHS:8J/3062, 1962.)

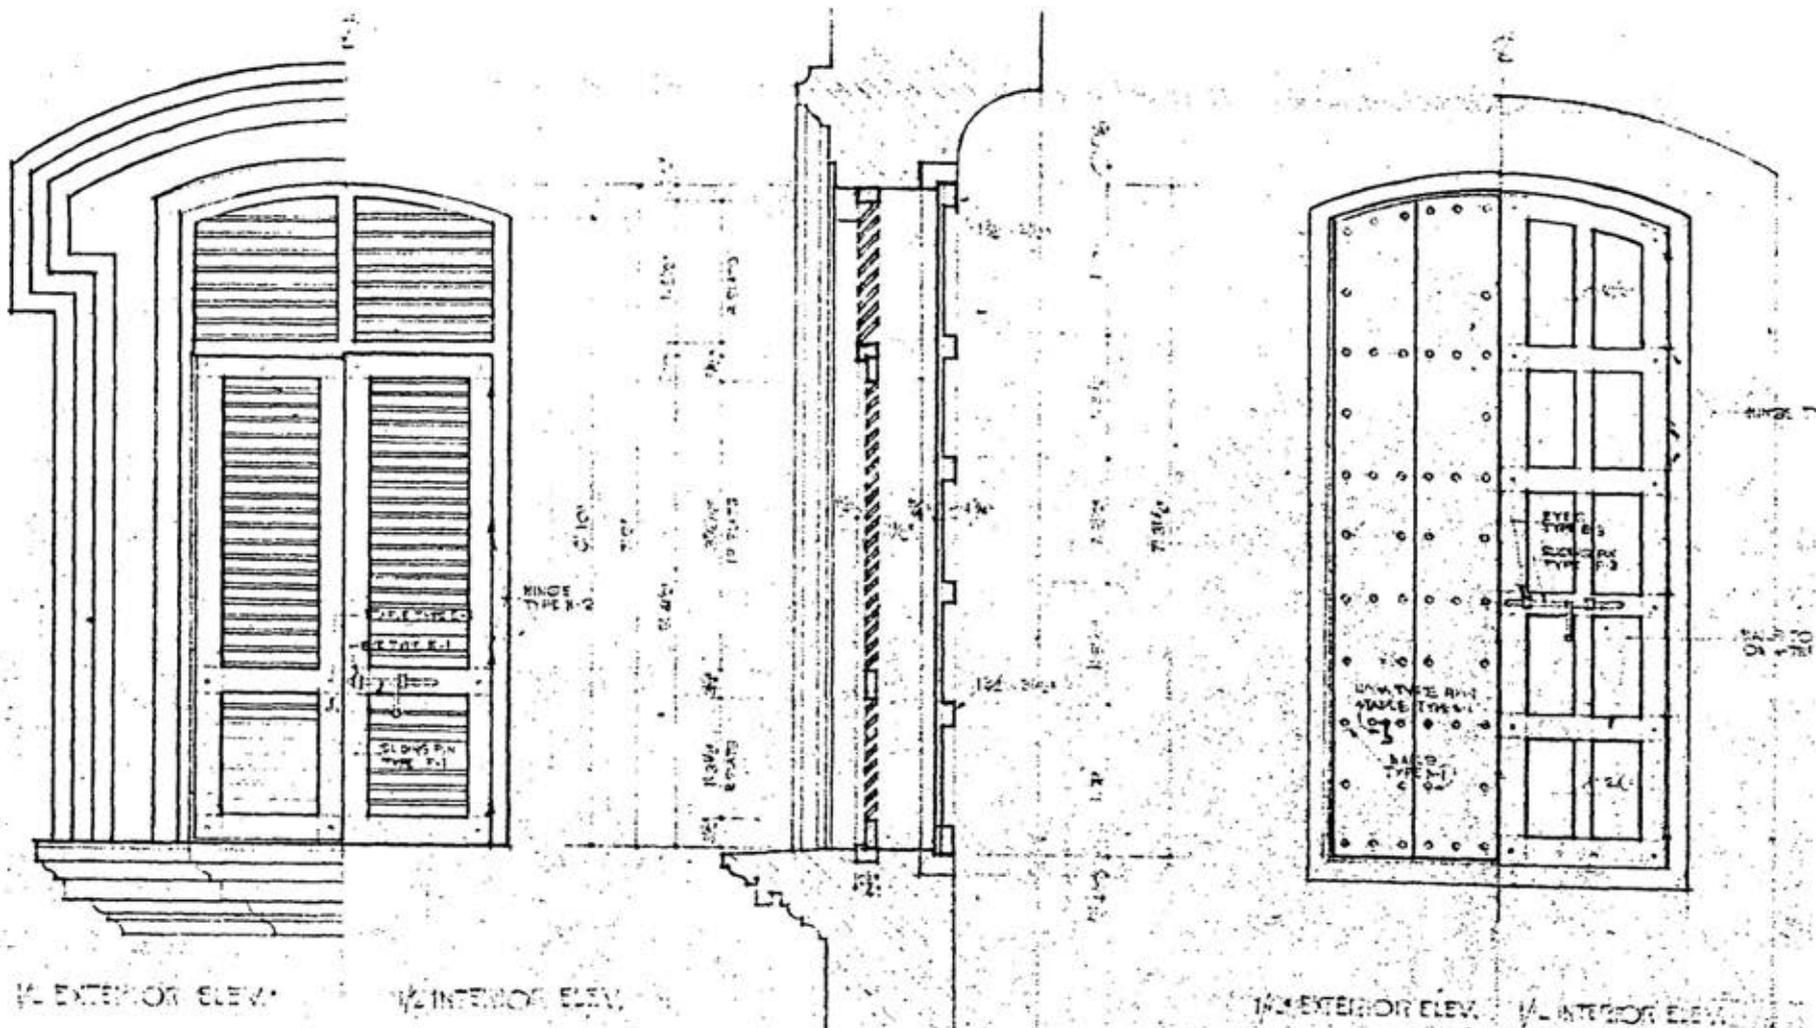
Figure 19. Shutter types, San Cristóbal. (Dept. of Interior, Division of Design and Construction. Drawing no. NHS:8J/3062, 1962.)

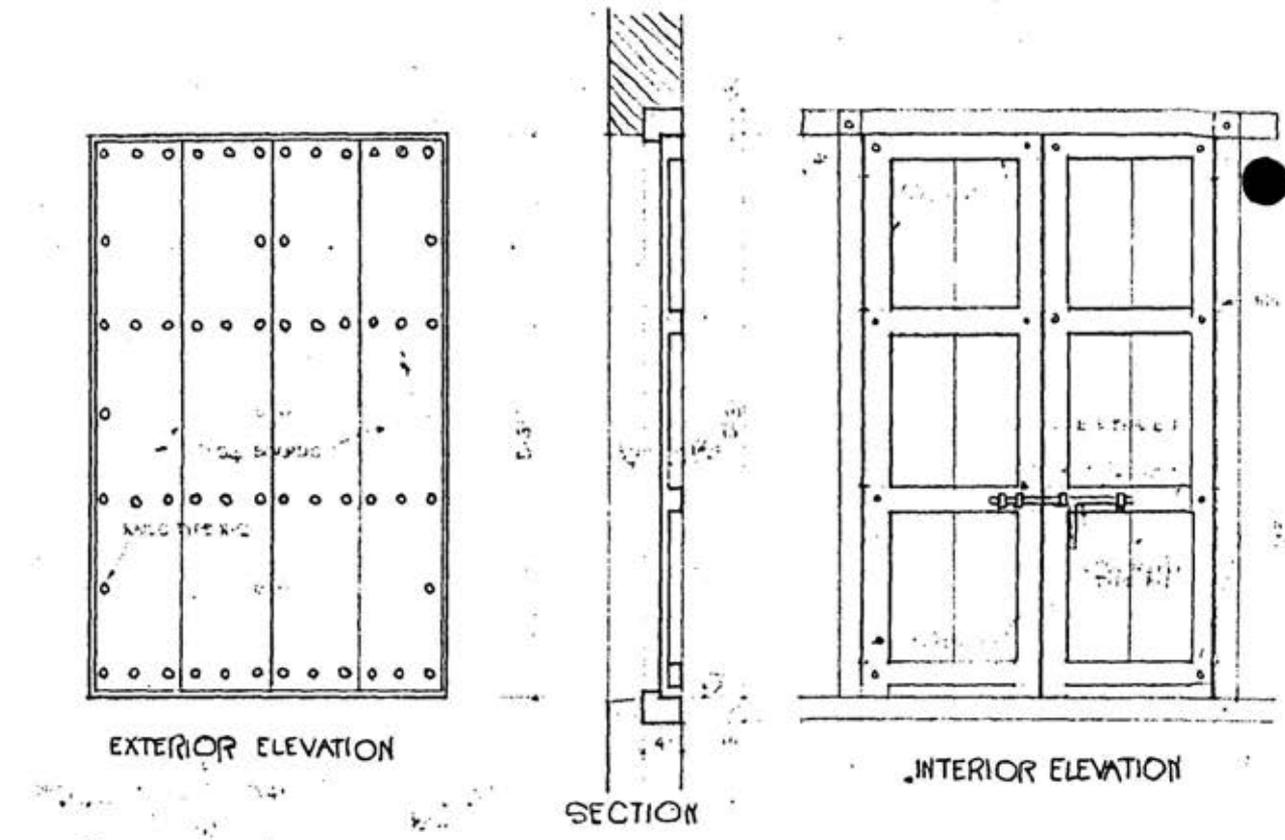
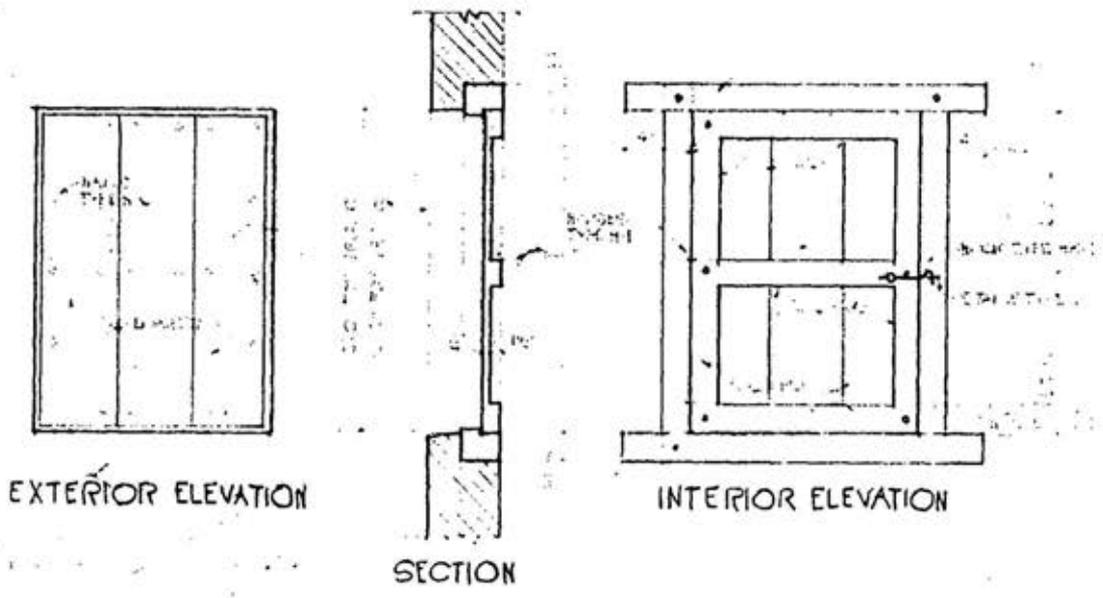
Figure 20a. Shutter types, San Cristóbal. (Dept. of Interior, Division of Design and Construction. Drawing no. NBS:8J/3062, 1962.)

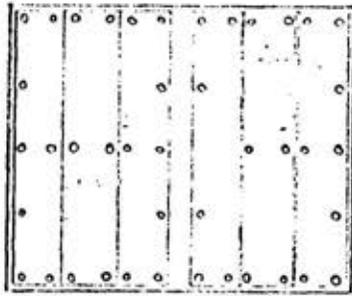
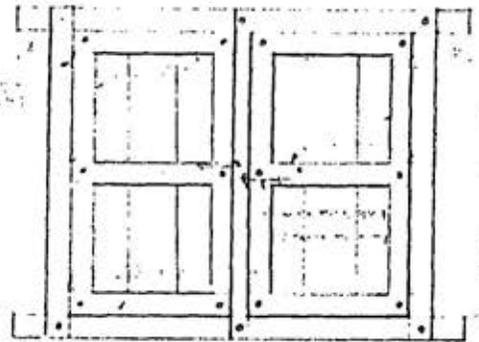
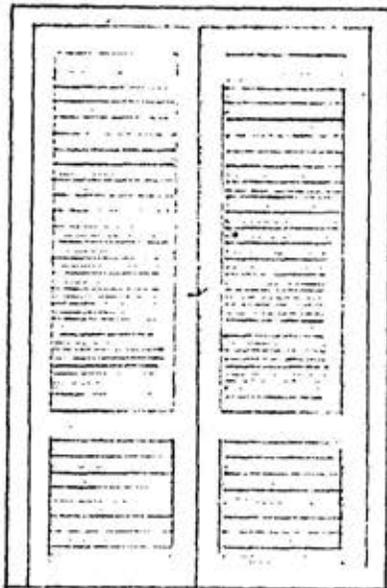
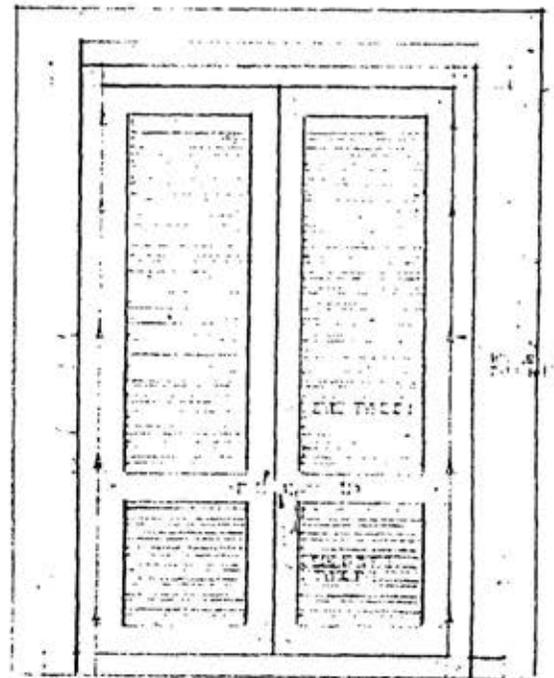
WINDOW 18G1 b

Figure 20b. Shutter types, San Cristóbal. (Dept. of Interior, Division of Design and Construction. Drawing no. NHS:SJ/3062, 1962.)

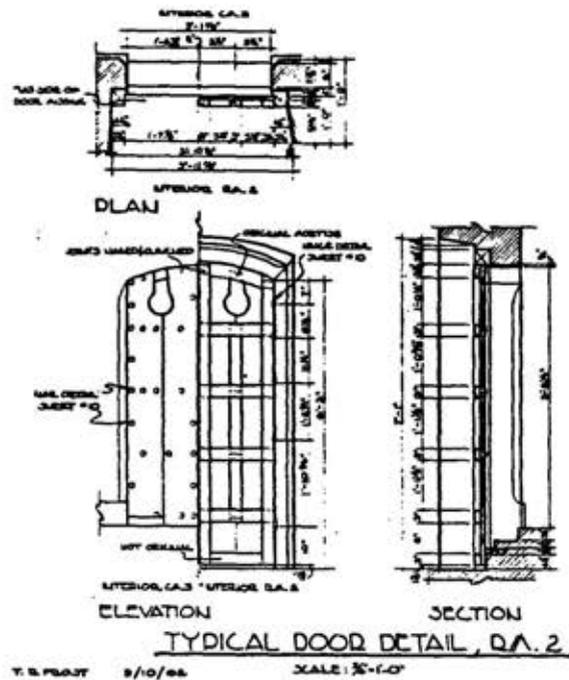
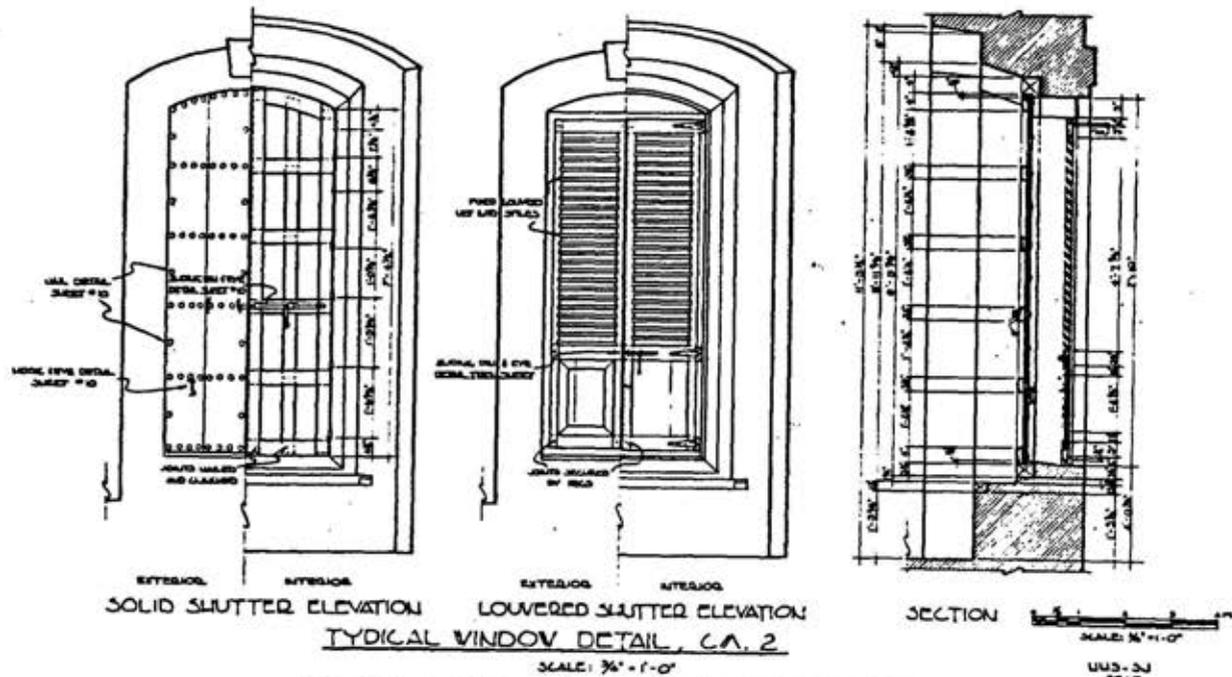
Figure 21. Door and shutter types, San Cristóbal. (Drawing by HABS, 1962.)

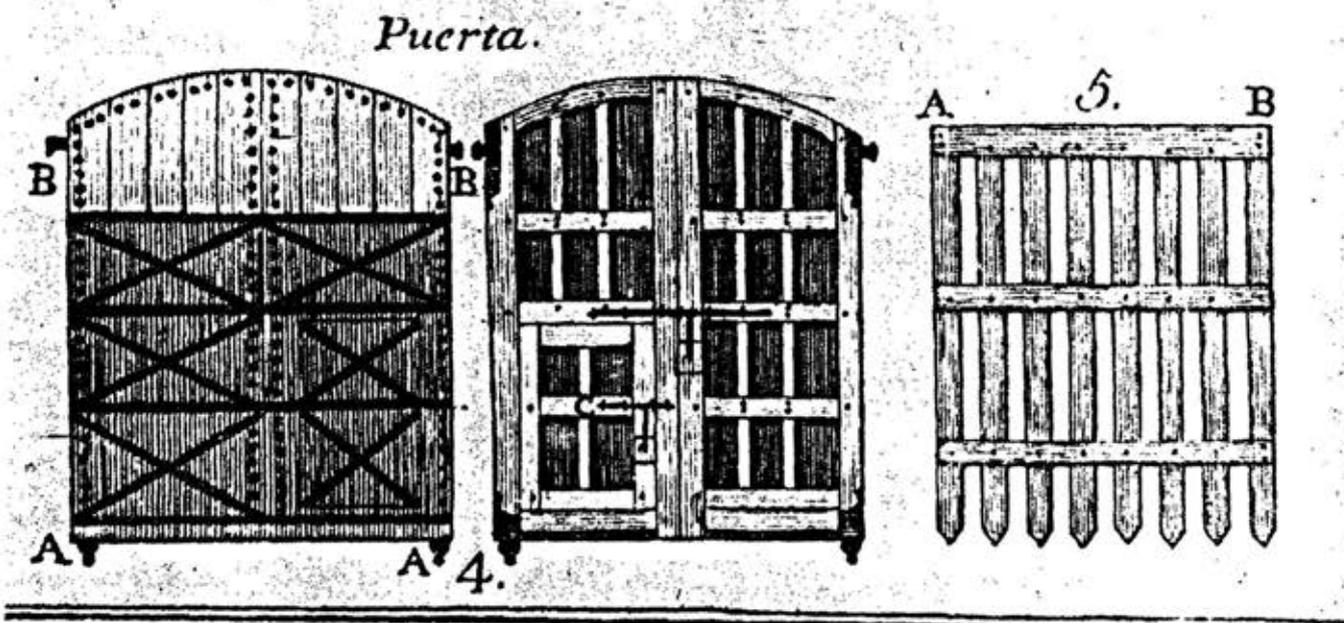
Figure 23. A harrow gate is illustrated on the right. The gates currently found at the fortifications are similar to that illustrated in the center. (From Richard Torres-Reyes "San Cristóbal Gates," 1964.)

The main gates of el Morro and San Cristóbal, and those at el Morro's chapel, the Troops' Quarters, and the San Juan Gate are constructed of vertical boards braced on the back by horizontal and vertical members. Wickets (a small hinged door in the lower part of a larger door) were placed in these gates to enable easy pedestrian access (fig. 23).

The harrow gates referred to in 1770-1771 are described by Torres-Reyes as "made of timbers whose dimensions were commonly 6 by 4 inches, and 6 inches distant from each other, well fastened to three or four crossed bars, and secured with iron."<sup>95</sup> A harrow gate is illustrated in a late-eighteenth-century document (fig. 23) and appears just outside of the Main Gate of San Cristóbal in Castro's drawing. This type of gate is no longer extant in the fortifications.
