# THE FORTIFICATIONS OF SAN JUAN NATIONAL HISTORIC SITE

## HISTORIC STRUCTURE REPORT

Castillo de San Felipe del Morro  
The City Walls  
An Investigation of the Materials Used  
Cultural Landscape Report

Castillo de San Felipe del Morro

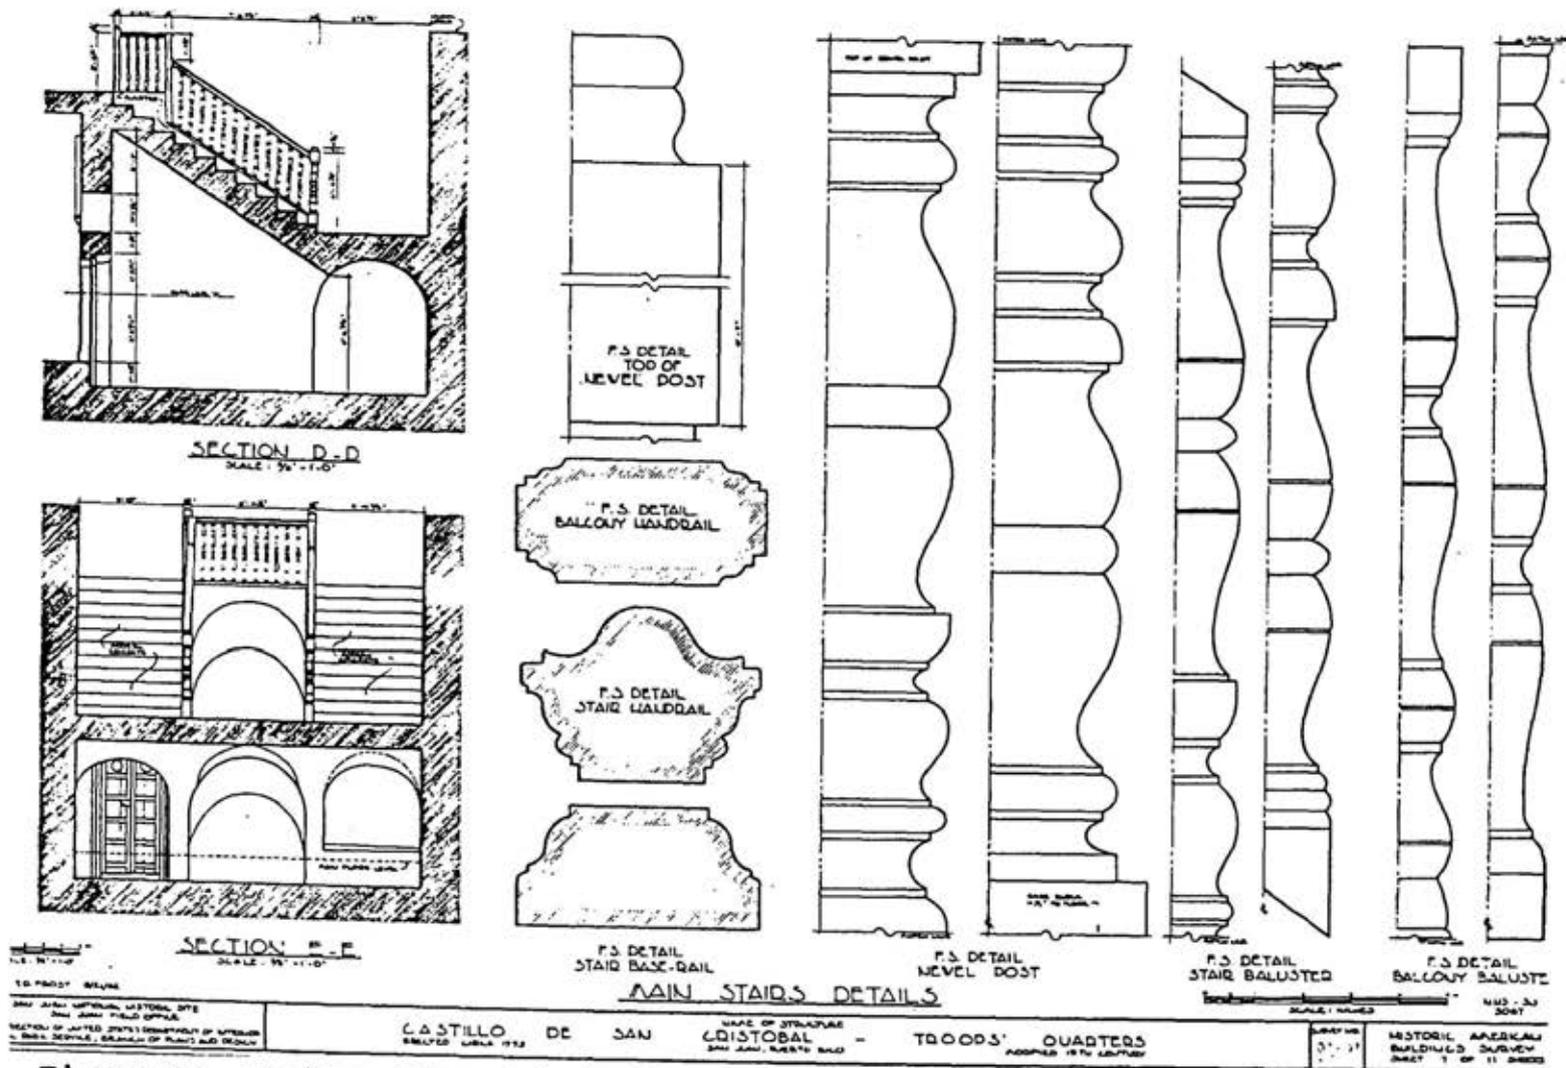
Figure 24. Stair railing details from the Troops' Quarters, San Cristóbal. (Drawing by HABS, 1962.)

The balustrade of the main stairway in the Troops' Quarters is presumed to be original to the building's construction in 1771. The newel posts and balusters are turned. There are two types of balusters: one on the stair and one on the balcony; the balcony and stair handrail have different profiles as well (fig. 24). The balustrade is now painted a dark green.

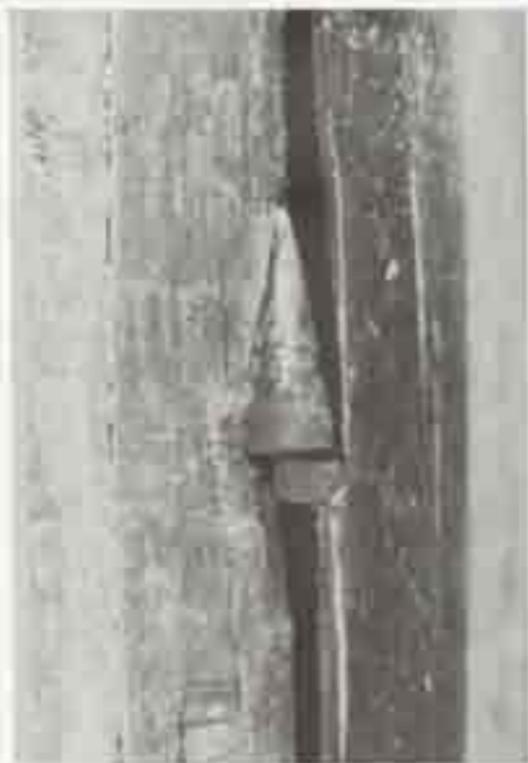
Figure 19. Cabañase hinge from shutter on Troops' Quarters, San Cristóbal. Photo by J. Jacob, 1989.

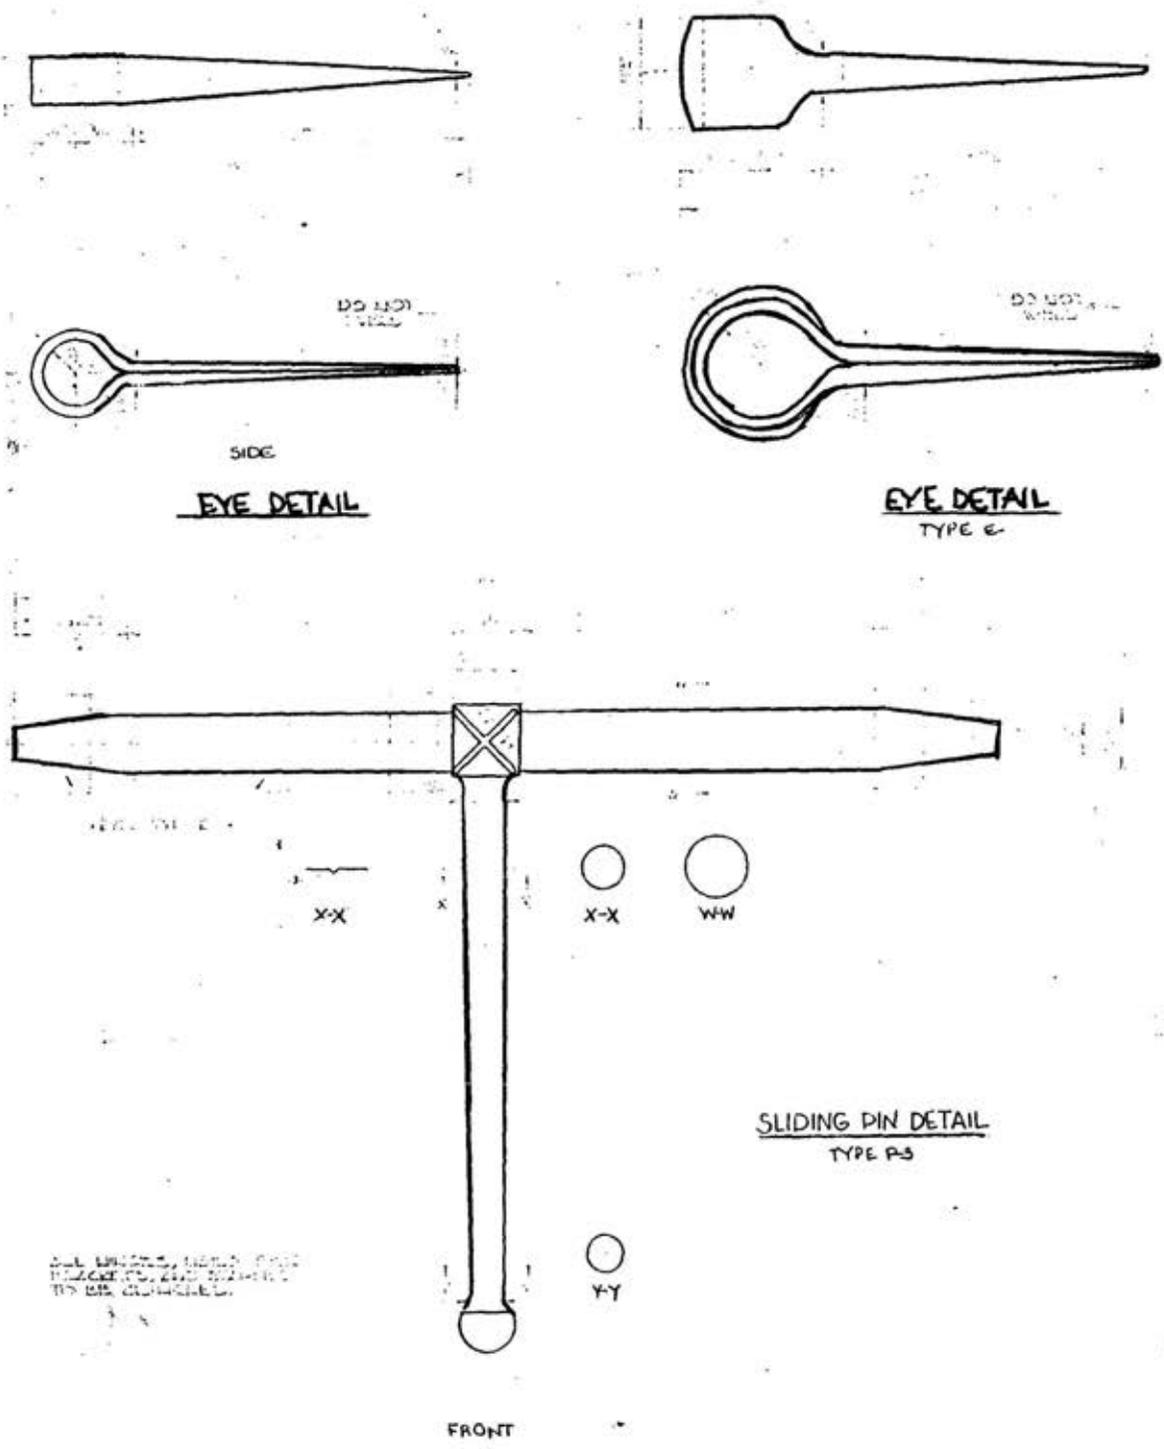
**Figure 26b. Hardware details from the Troops' Quarters, San Cristóbal. (Dept. of Interior, Division of Design and Construction. Drawing no. NHS:SJ/3062, 1962.)**

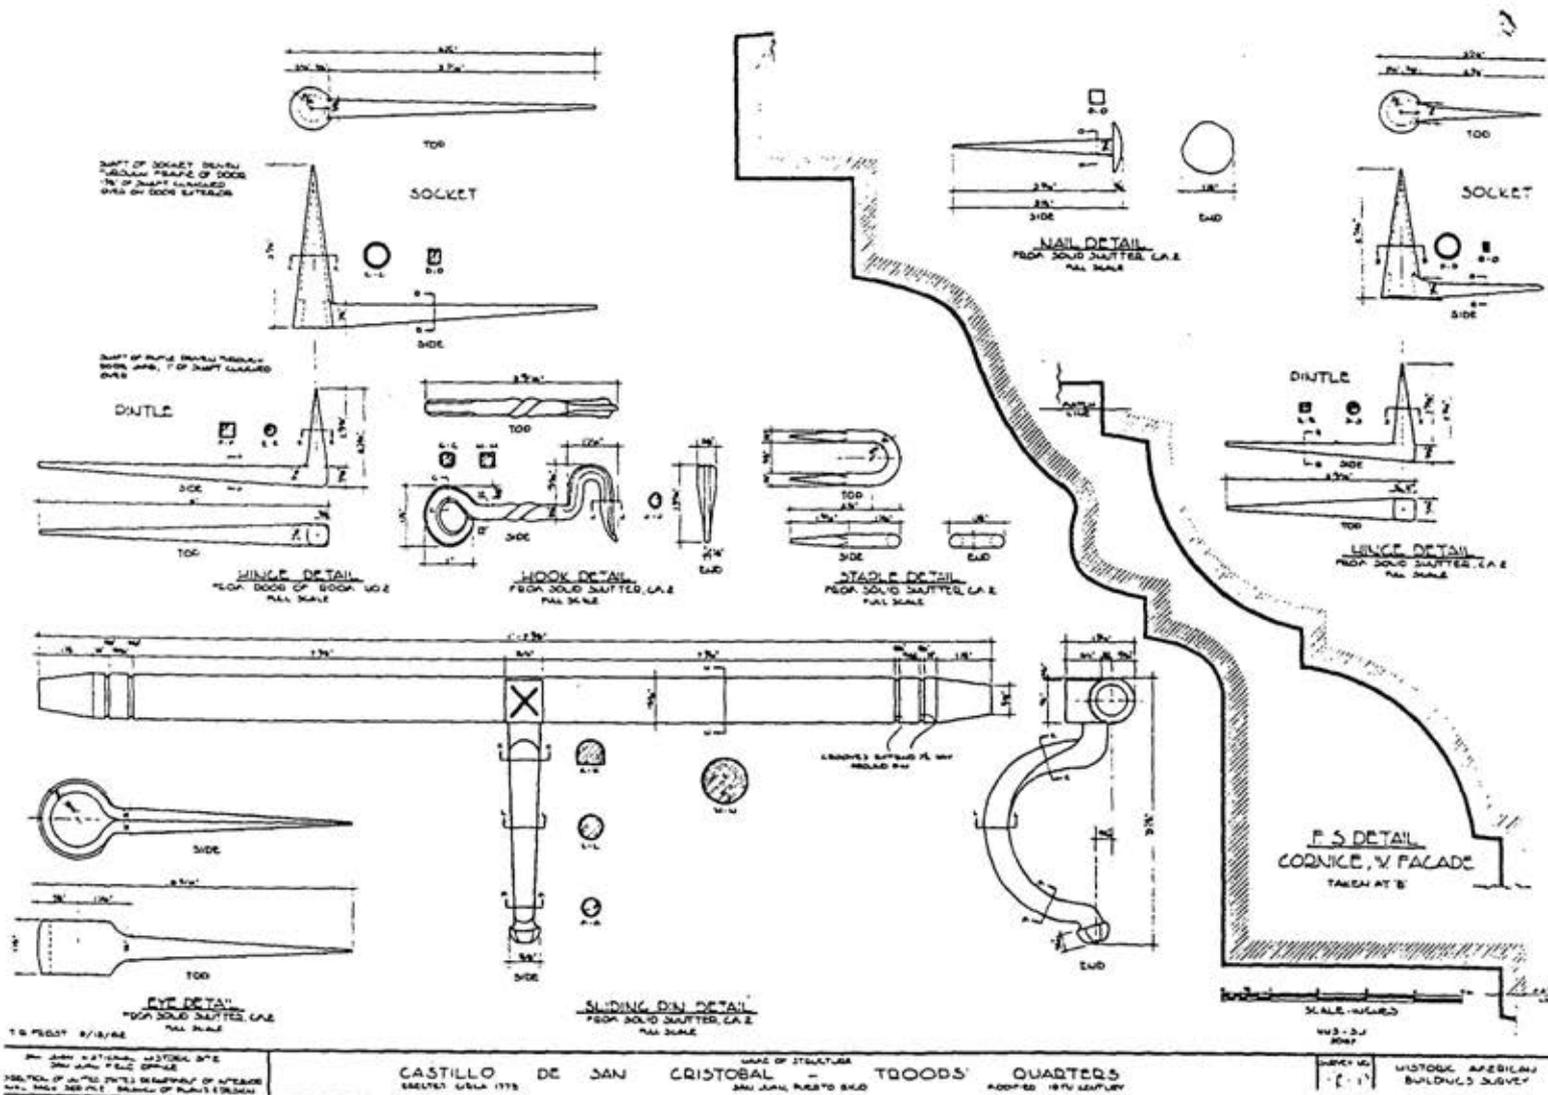
Figure 27. Hardware details from San Cristóbal. (Drawing by HABS, 1962.)

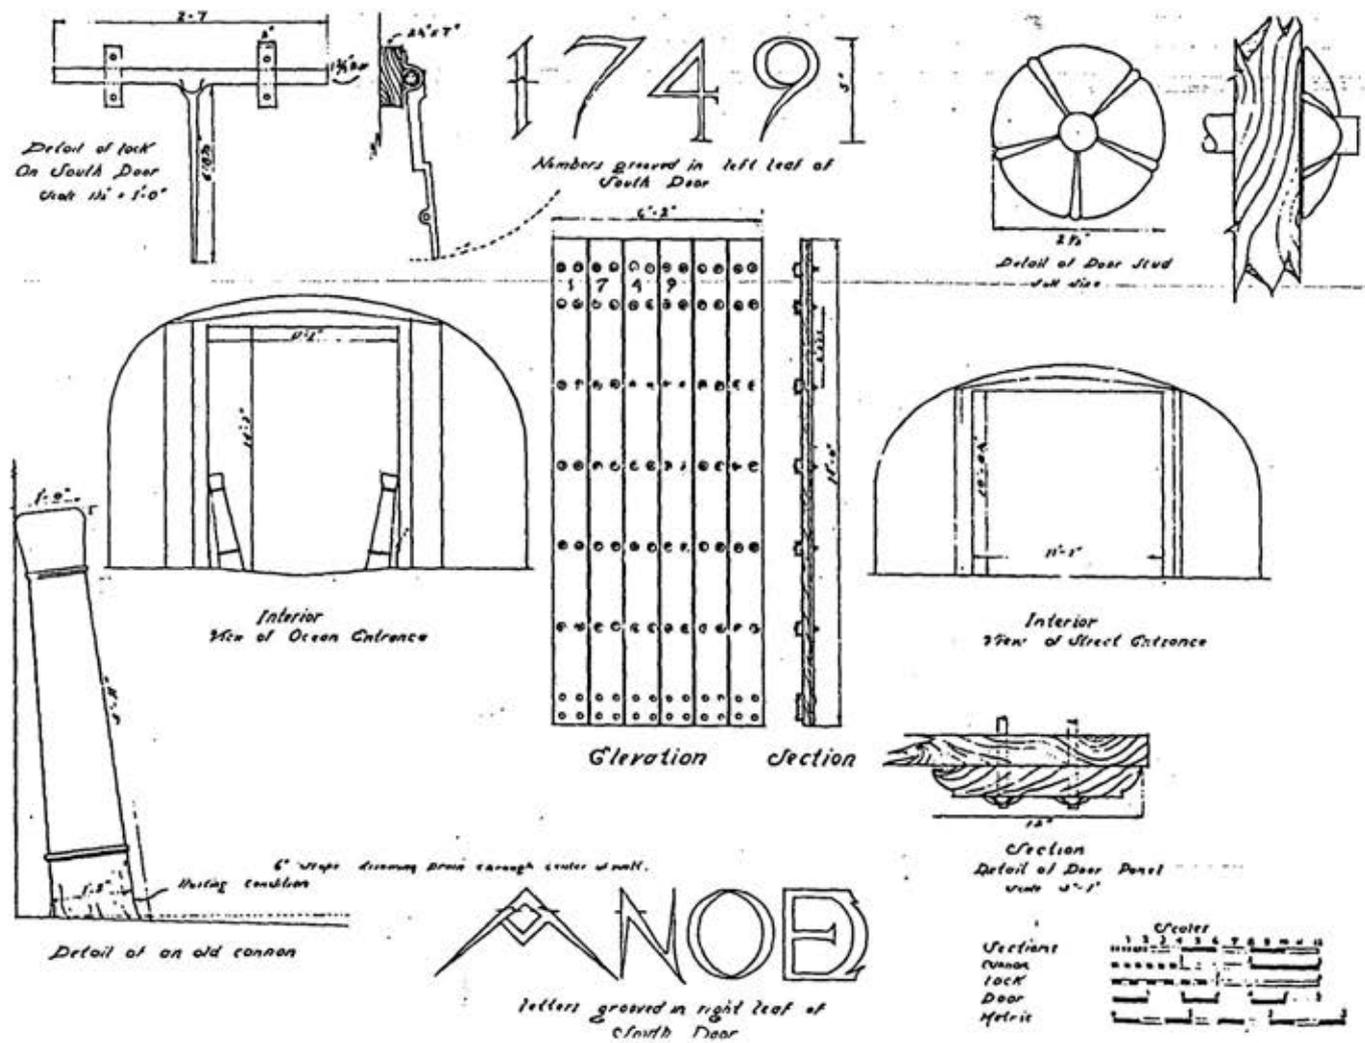
Figure 28. Old cannon and hardware details of Old San Juan Door. (Drawing by HABS, ca. 1960.)

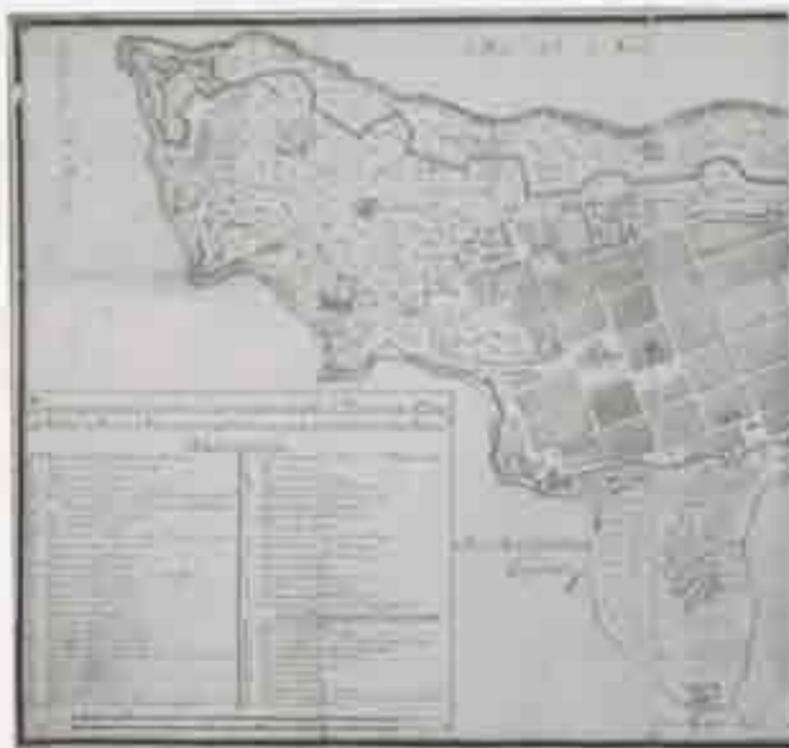
Figure 2. 1776 Map, San Juan, Juan de Villalonga, under the direction of Thomas O'Daly, Museo Naval, XIII-A-9, Madrid. Reproduced in Anibal Sepúlveda Rivera, SAN JUAN, HISTORIA ILUSTRADA DE SU DESARROLLO URBANO, 1800-1898.

This section of the report describes landscape conditions during Period I. Figures 2 and 3 illustrate the various landscape elements during this period. These elements include: circulation, structures, land form, vegetation, small-scale features, utilities, and views. Figure 4 further illustrates the character of the Esplanade during Period I.

Maps from 1776 (fig. 2) and 1792<sup>17</sup> show not only the three older routes but also a network of paths on the Esplanade. Both maps suggest that the southern route was the major means of accessing el Morro from 1540 to 1860. It would have been used to transport supplies and artillery from the harbor to the fort. This old route is approximated by the present-day Casa Rosa Road and the portion of el Morro Road leading from Casa Rosa Road to the fort.

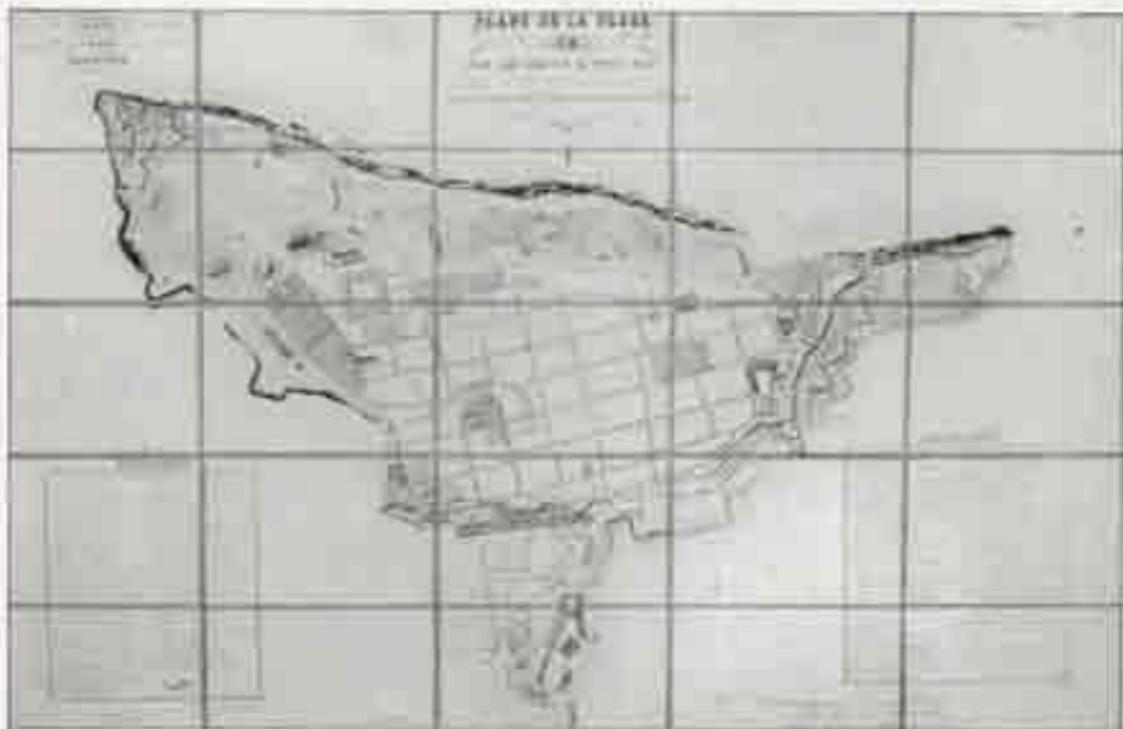
Figure 3. 1841 Map, Plano de la Plaza de San Juan Bautista de Puerto Rico. Rafael Clavijo y Piá, 1841, S.G.E. Cart. X (CAT. 40). Reproduced in Anibal Sepúlveda Rivera, San Juan, Historia Ilustrada de su Desarrollo Urbano, 1968-1988.

A map from 1861 (fig. 3) suggests that the route from the center of the city became the more prominent means of accessing el Morro at about this time.<sup>18</sup> The section of the road known as Norzagaray and at the eastern end of the Esplanade was

The original purpose of the old northern route is unclear. It resembled a road on the 1625 map, and did in fact connect the city with el Morro. However, its out-of-the-way location suggests that it was not a major route to the fort. It later gained in importance. After San Cristóbal was built, the northern route was extended to form a link between it and el Morro. In the late eighteenth century it provided access to defensive bastions built along the north shore. After the north bastions became obsolete due to improvements in artillery during the nineteenth century, the segment of the path connecting to the main route to the fort disappeared (see fig. 3).

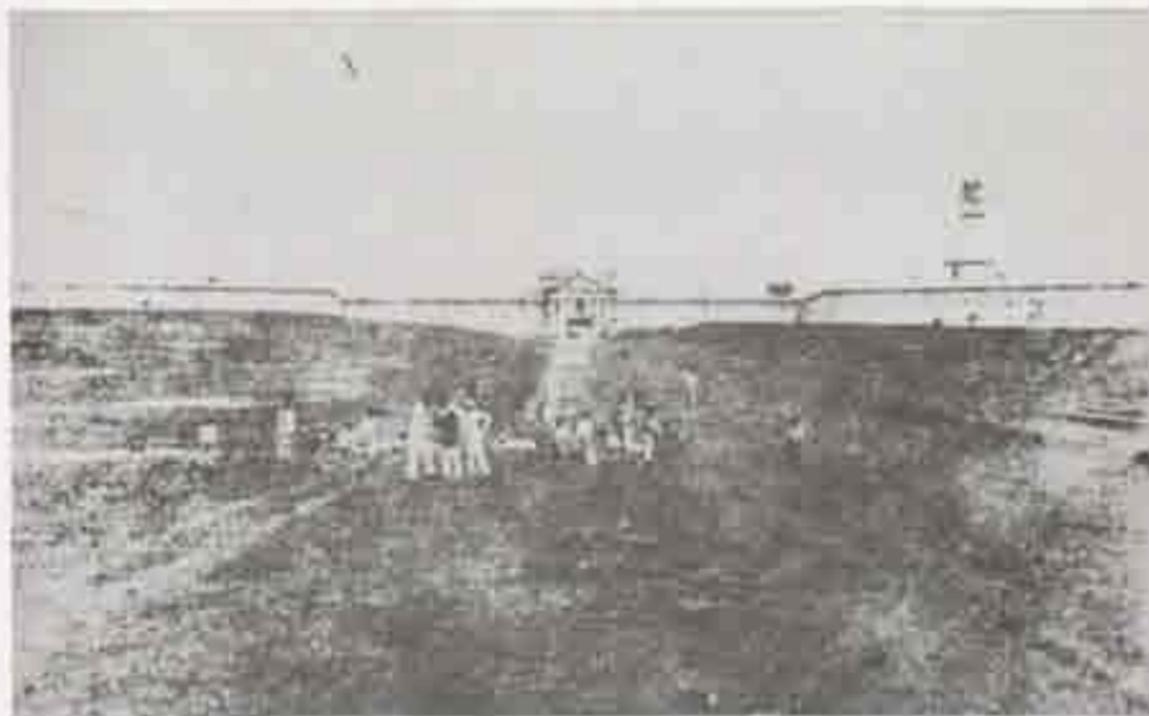
Figure 4. The Esplanada; ca. 1890. This view of the Fort from el Morro Road illustrates the open character of the Esplanada, its lansform and the road treatment. SAJN Archives, San Juan, PR.

Between 1873 and 1887, then, the present configuration of the Esplanade was established. The condition of the relatively smooth-surfaced Esplanade was shown in a ca.-1890 photograph (fig. 4). The 1898 bombardment left numerous holes in the Esplanade, however. "The dark hillside was dotted with the geyser-like earth clouds of exploding shells, most of them rising around el Morro and the barracks."<sup>45</sup> In 1899, work was approved to regrade and fill in the holes on the Esplanade.<sup>46</sup>

The lack of vegetation on the Esplanade was also confirmed by a Dutch map of 1625 showing the Esplanade barren of trees, while other areas of the islet were heavily vegetated.<sup>49</sup> The lack of vegetation was also apparent in the previously cited sketch map by A. Vingboons of the same year.<sup>50</sup> The sketch map of el Morro and San Cristóbal by Luis Venegas Ossorio in 1678 did not show trees on the Esplanade, but did indicate vegetation in other outlying areas of the city.<sup>51</sup> By 1797, French naturalist André Pierre Ledrú reported that vegetation was limited on the entire islet. He explained that "it was necessary to travel three miles from the city to find habitat in which to gather specimens."<sup>52</sup> An 1821 sketch of the Esplanade by another French naturalist, Auguste Plée, illustrated one single palm tree growing near the moat and sallyport of el Morro.<sup>53</sup> Figure 4 shows the Esplanade still barren of trees ca. 1890.<sup>54</sup>

The views across the Esplanade were largely unobstructed throughout Period I, as illustrated in fig. 4. The San Antonio Bastion, Casa Rosa, the Insane Asylum, Ballajá Barracks, and Santo Domingo Bastion were all clearly visible from el Morro. During the early part of Period I (ca. 1540-1780), views from the fort also would have included Calvary Hill, the adjacent ravine, and the road to the San Juan Gate. Juan de Villalonga's plan of 1776 (fig. 2), documented in plan the features discussed above. The open views were maintained during the quarrying of the hill and the filling of the ravine, and they persisted up to the end of Period I.

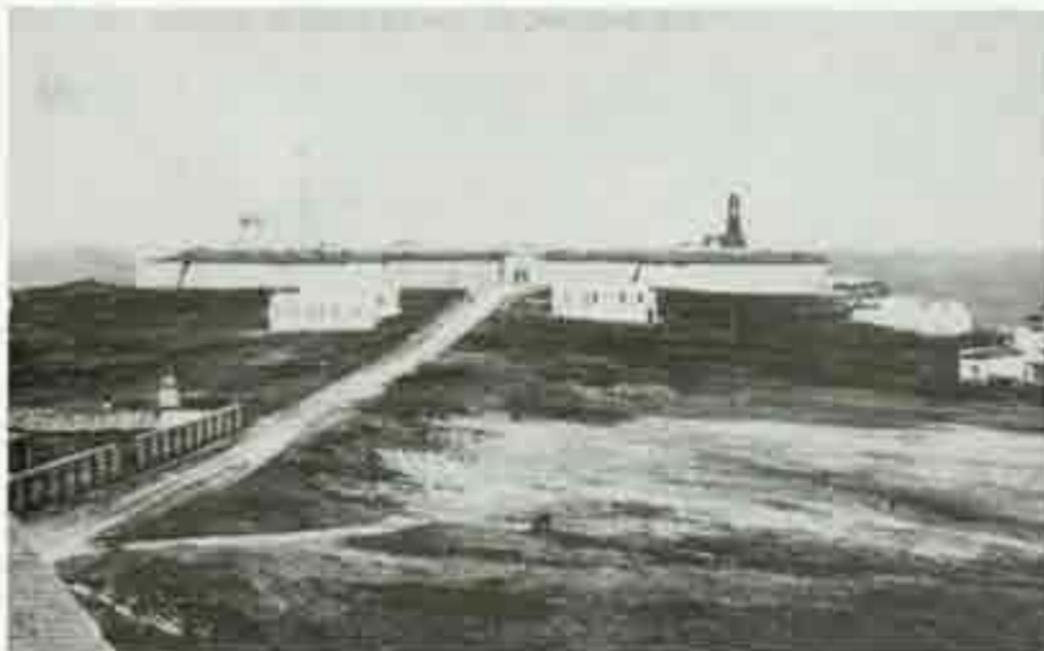
Figure 5. The Esplanade: ca. 1905. This view of el Morro from the east shows three Officers' Quarters, masonry wall of the Yellow Fever Hospital, and the Dutch Monument. The open character of the Esplanade, areas denuded of grass due to intensive use, projectiles along road, early utilities and road treatment are illustrated. Captain Ralph E. Gambell Collection, SAJU Archives, San Juan, PR.

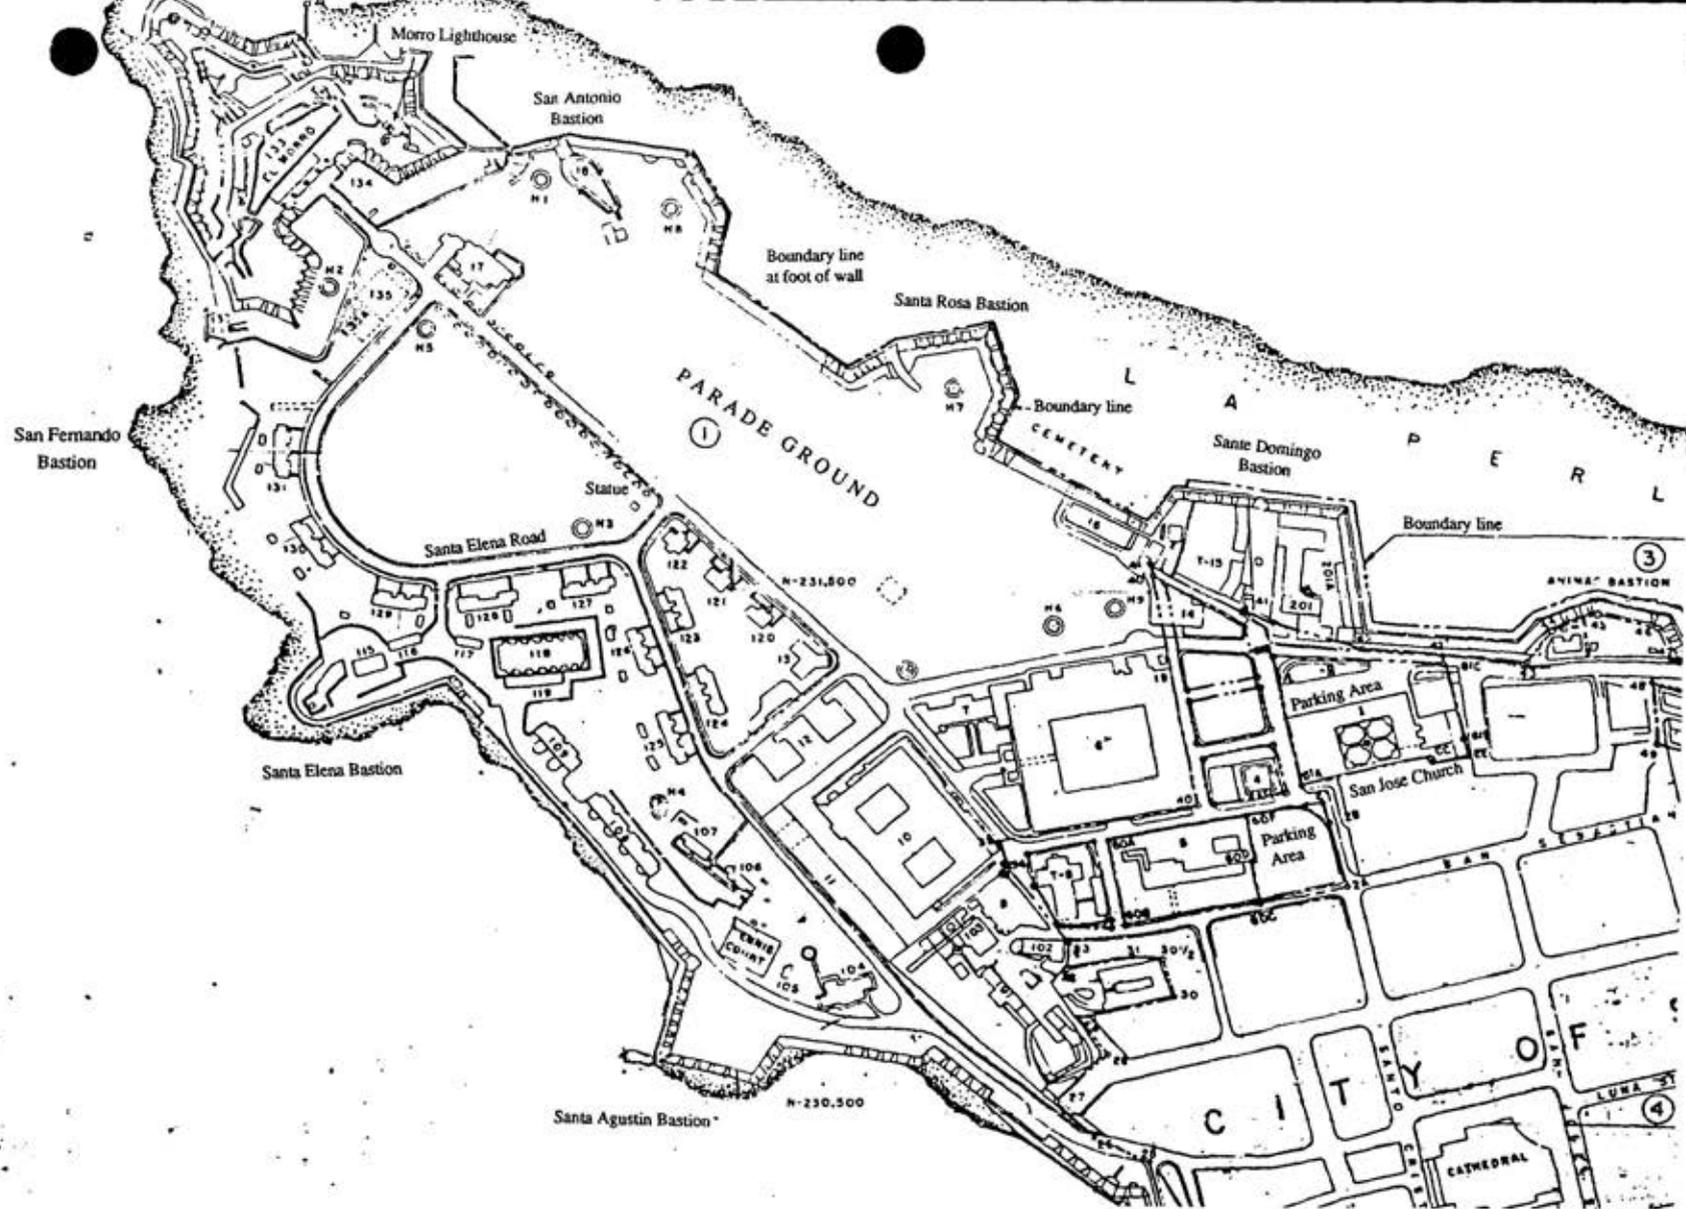
Figure 7. Map of ca. 1960, el Morro and surroundings. Based on 1886 survey showing U.S. Army development, ca. 1930-1961. Sheet 1 of 1, SAJU 0550. SAJU Archives.

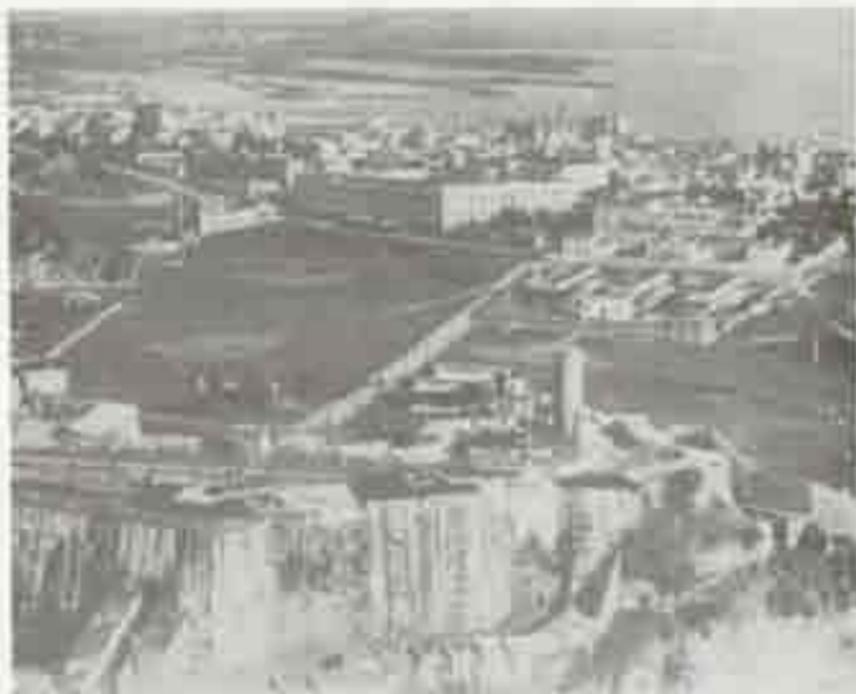
Figure 8. East view of Esplanade, 1933. Aerial view showing the open character of the site, the condition of the Esplanade, city in background, and the three Officers' Quarters and the Yellow Fever Hospital in the foreground. Projectiles and utility poles are seen along the paved El Morro Road. USIU Archives, San Juan, PR.

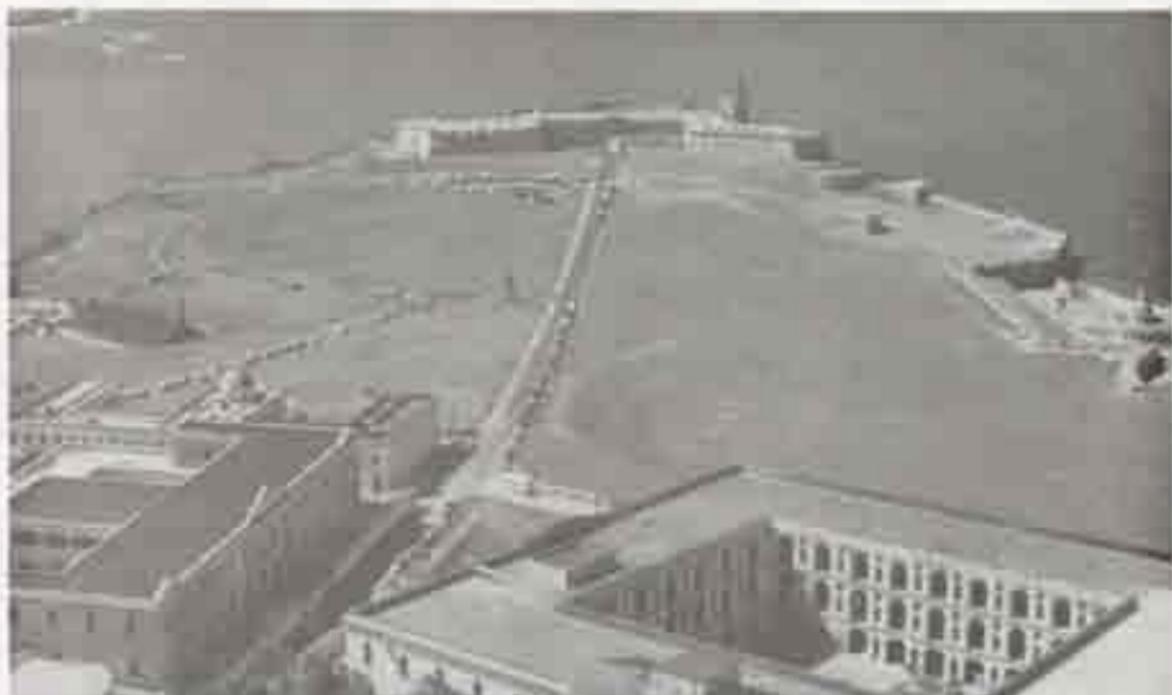
Figure 11. West view, 1966. Aerial view towards el Morro showing paved road system, 40-car parking lot, parallel parking, and the Dutch Monument. ERSPO, San Juan, PR.

Figure 11 is an aerial view looking towards el Morro from the entrance to the Esplanade. This photograph shows el Morro Road, the sloped area in the foreground, and the fort in the background. The Dutch Monument, the 40-car parking lot, and the Powder Magazine are included in this view. Figure 12 is an aerial view looking east showing the parking lot, and the roads and trees in Parcel B. The defensive walls on the north side of the Esplanade and the Ballajá Barracks on the south clearly limit this view of the Esplanade. Figure 13 is an aerial view looking towards Parcel B, showing the pattern of vegetation near the Casa Rosa and illustrating the open character of the Esplanade.

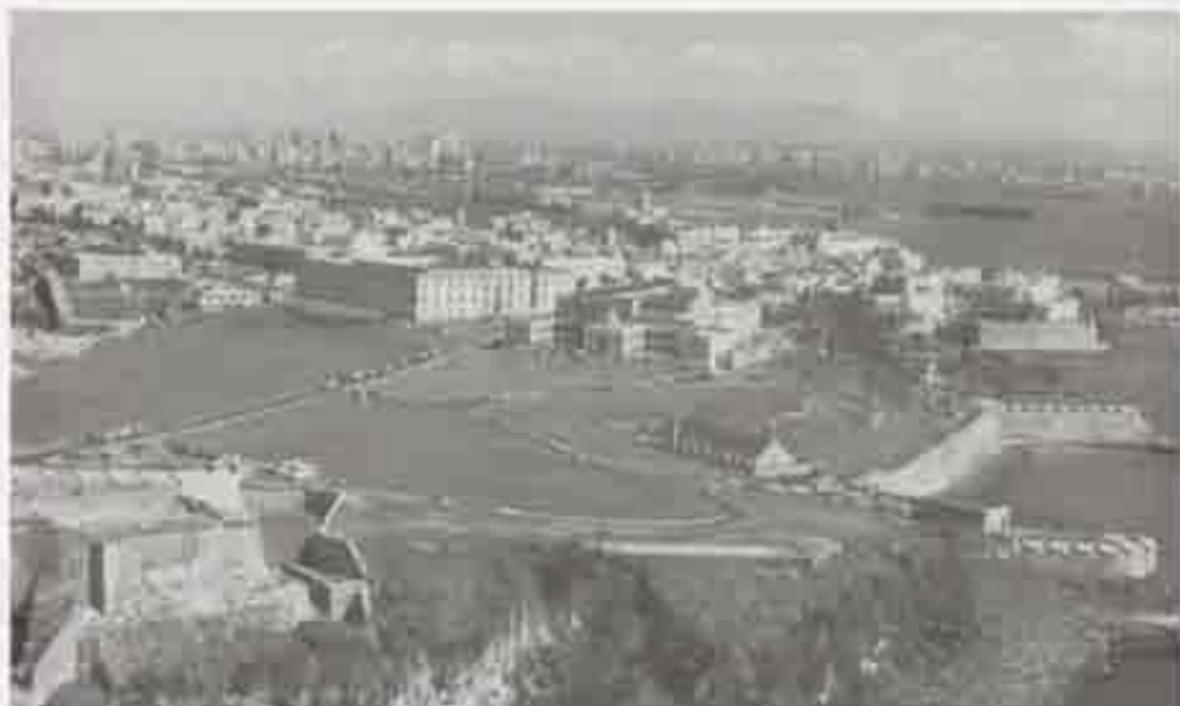
Figure 12. East view, 1988. Aerial view from el Morro toward the city showing the paved road system, 40-car parking lot; parallel parking, the Dutch Monument, tennis courts, the chain-link fence, and the play area in Parcel 9. PRMPO, San Juan, PR.

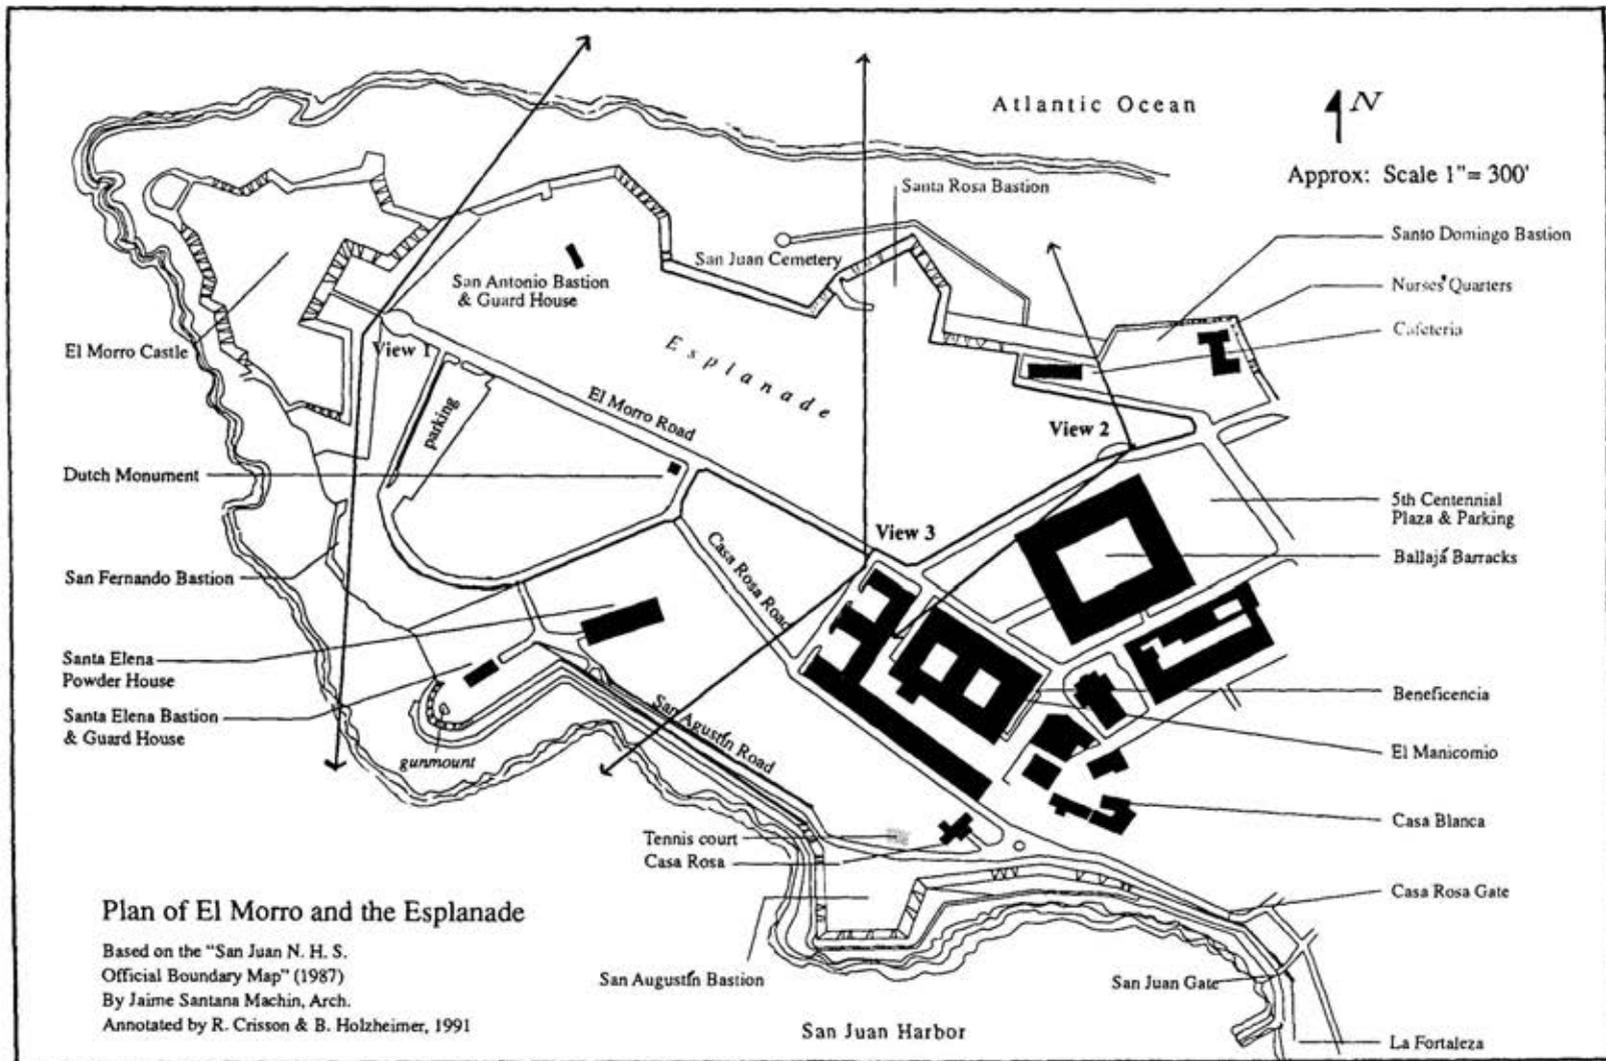
Figure 14. Existing Conditions. Site plan indicates locations of existing buildings, roads, vegetation, and primary views. The primary views (Views 1, 2, and 3) are keyed to composite photographs depicted in Figures 15, 16, and 17.

Figure 14 shows the locations from which the composite photographs, figs. 15-17, were taken. The composite photographs illustrate the primary site views. Figure 15 shows the view from the fort looking east toward the city. Figure 16 shows the view from Ballajá Barracks looking west to the fort. Figure 17 shows the view from the intersection of Manicomio and el Morro Roads looking west towards the fort.

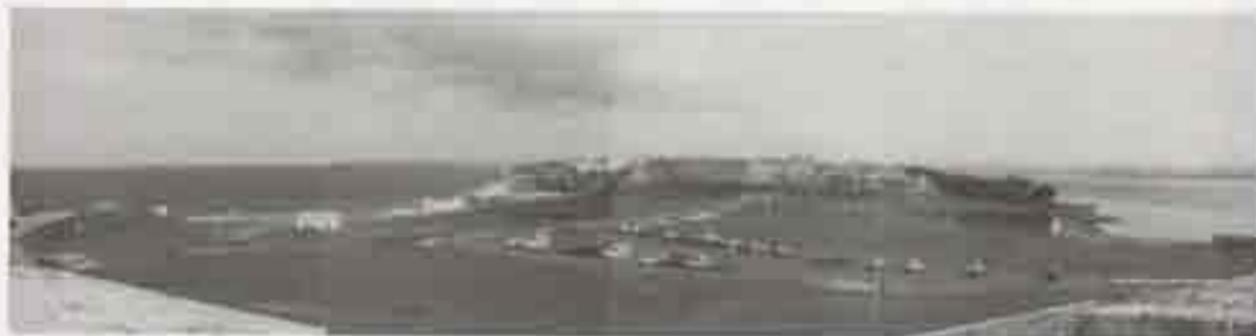
Figure 15. Composite photograph, East View, 1971 (View 1). Vista from el Morro showing parking lot, parallel parking along the roads, trees in Parcel B, and the general open character of the site. Photography by Richard C. Crieson.

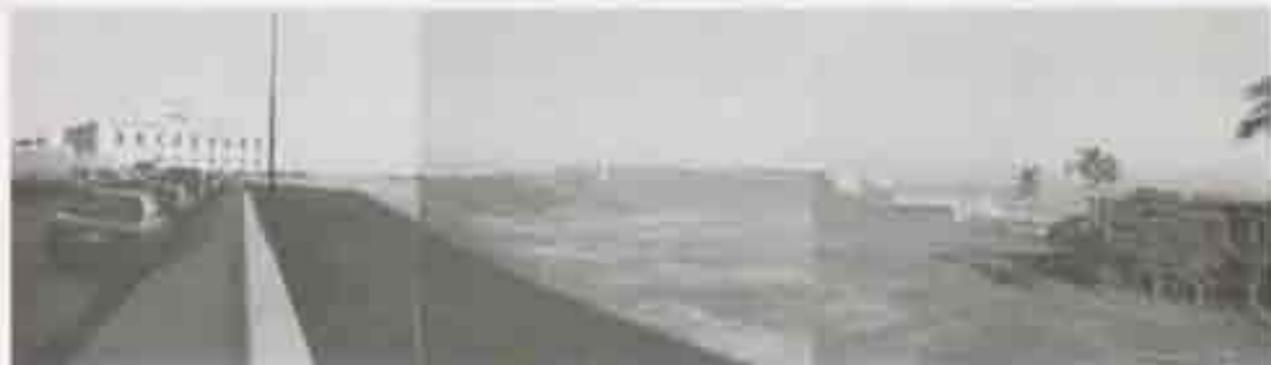
Figure 18. Composite photograph, West View, 1991 (View 2). Vista from Ballajá Barracks shows el Morro, Dutch Monument, parallel parking along roads and sloped area in front of Ballajá Barracks. View is limited to the south by el Manicomio (School of Plastic Arts). Photography by Richard C. Grissen.

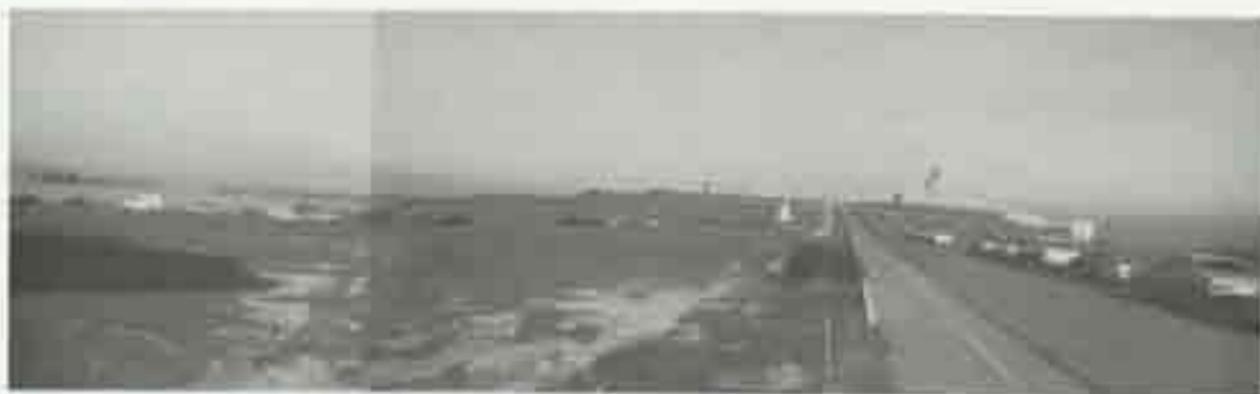
Figure 19. Composite photograph, West View, 1991 (View 3). Vista from intersection of Mahlonie and el Morro Roads shows el Morro, Dutch Monument, parking, and Powder Magazine area. Photography by Richard C. Crismon.

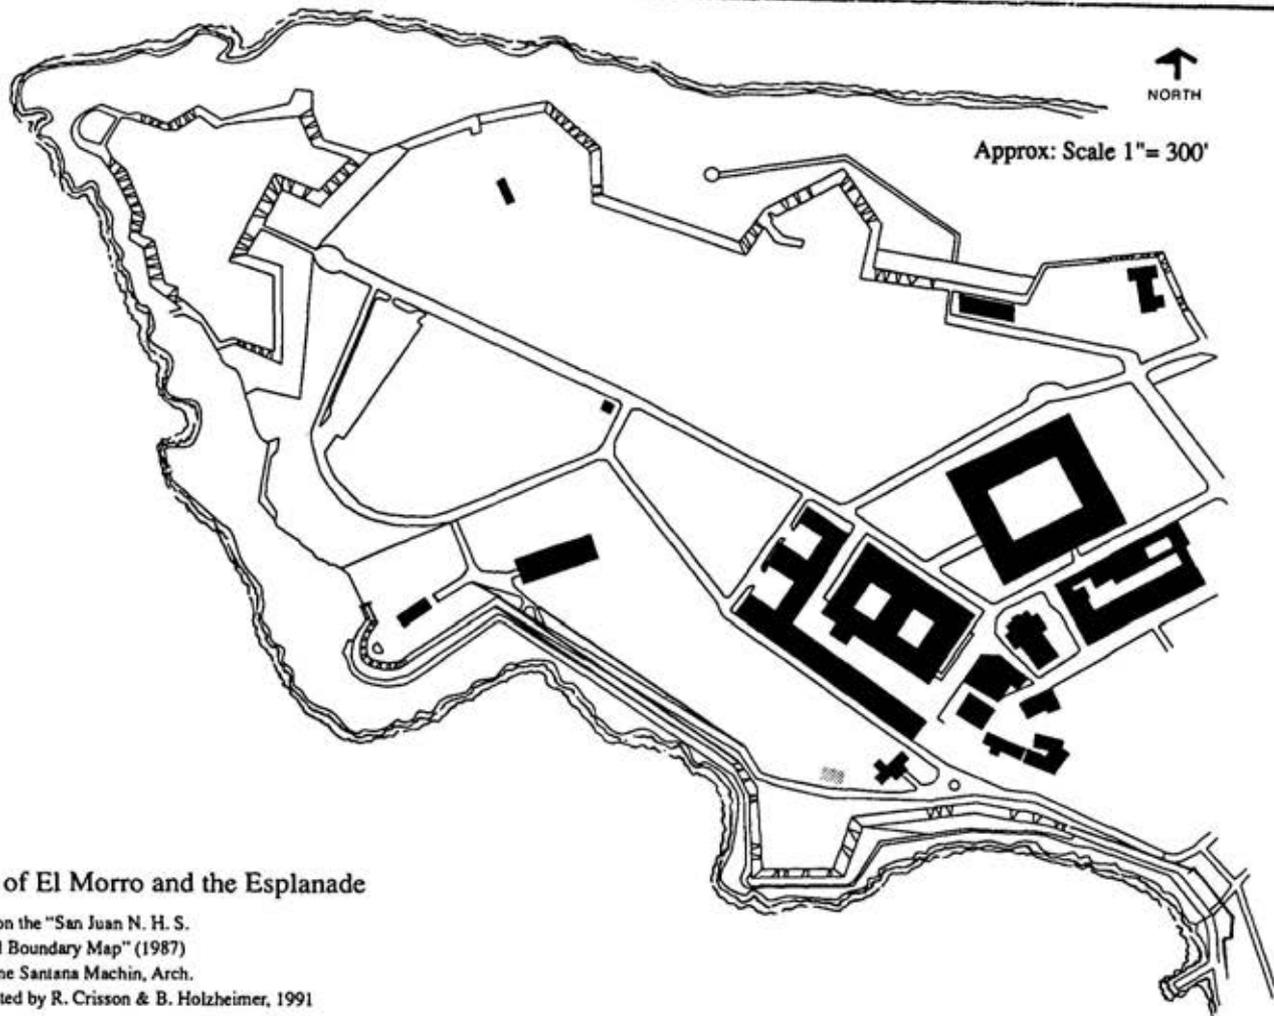
### Plan of El Morro and the Esplanade

National Park Service: Official Boundary Map  
San Juan National Historic Site  
Composite of Partial Set  
1987, edited in 1991

Based on the "San Juan N. H. S.  
Official Boundary Map" (1987)
