Subject: Water Features – Proposed Chuckwalla National Monument Chuckwalla National Monument, California

This Water Feature Report (WFR) was prepared by Roux Associates, Inc. (Roux) to identify springs and other water features in the proposed Chuckwalla National Monument. Although geologically the area is considered part of the Mojave Desert Geomorphic Province (California Geologic Survey, 2002), ecologically the proposed monument is in a transitional zone between the Mojave and Sonoran Deserts (Figure 1). The author has 36 years of hydrogeological and water resources experience and is a California-licensed Professional Geologist, California Certified Hydrogeologist and California Certified Engineering Geologist with extensive experience relating to desert springs and the environmental forensics associated with sourcing spring discharges.

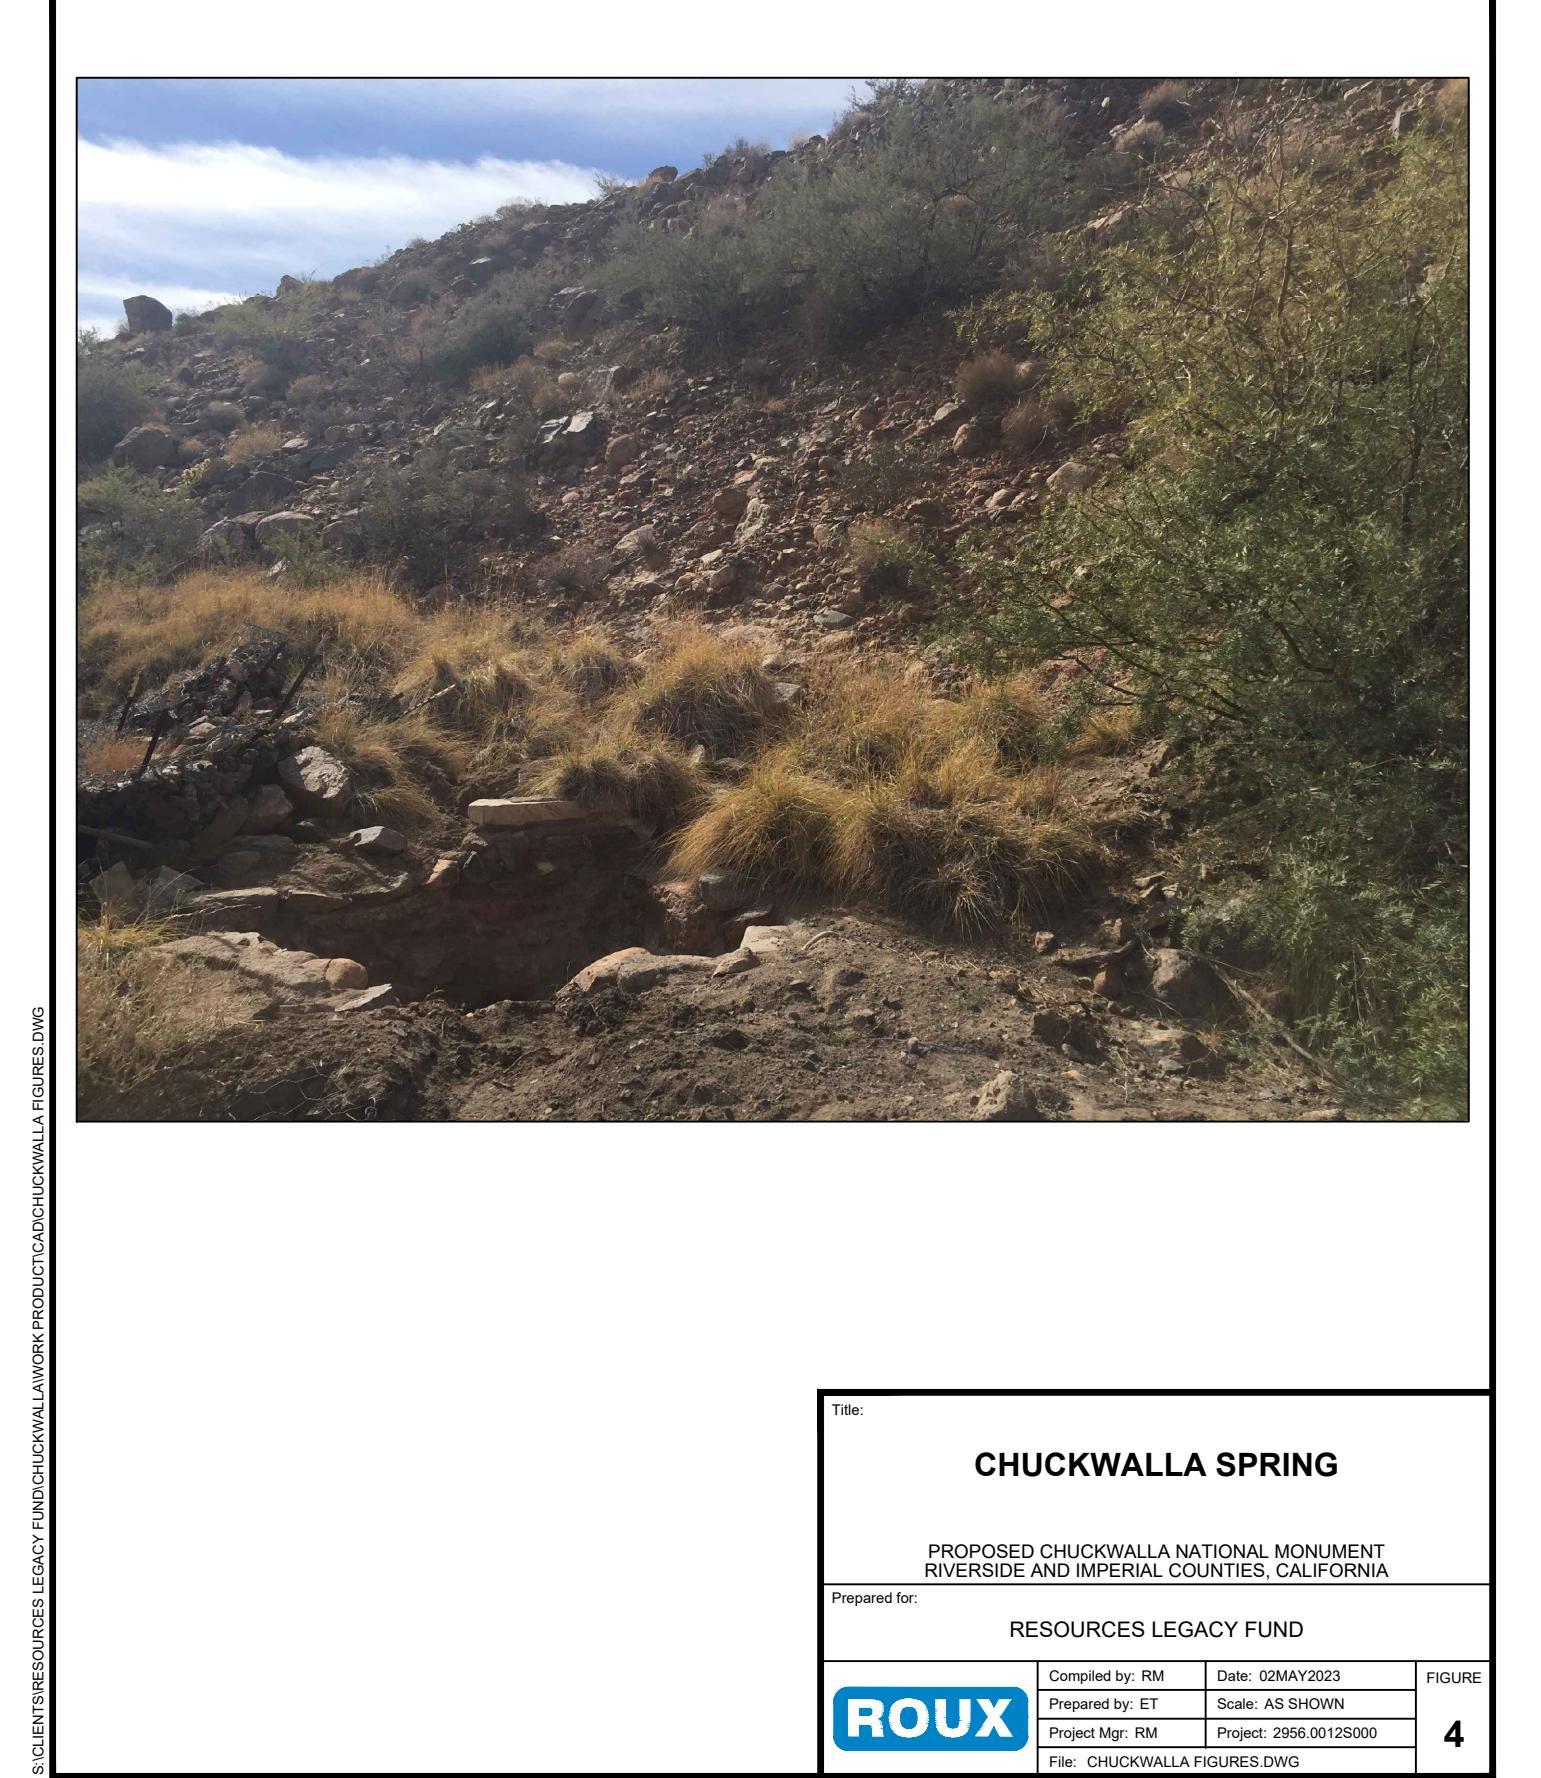
CHUCKWALLA SPRING PROPOSED CHUCKWALLA NATIONAL MONUMENT RIVERSIDE AND IMPERIAL COUNTIES, CALIFORNIA Prepared for: RESOURCES LEGACY FUND Compiled by: RM Date: 02MAY2023 FIGURE Scale: AS SHOWN Prepared by: ET Project: 2956.0012S000 Project Mgr: RM 4

The spring consists of a hand-dug hole lined with rock with groundwater at about 4 feet below ground surfaces (in 2018) in granitic terrain (Partner, 2018). A gabion wall was constructed up-wash to mitigate sedimentation. It appears difficult for wildlife to reach spring in the configuration described, and there were no noticeable signs of wildlife use when the site was visited. There was sparse riparian vegetation, consisting only of mesquite, catclaw acacia and bunchgrass.

When the site was inspected, there was no odor to the water present, and discharge was through evaporation only. The water was high in dissolved solids content (greater than 2,000 parts per million) and with a pH of 7.81 when measured. The spring is on public lands managed by the U.S. Bureau of Land Management, and there are no water-right filings with the State of California for this spring.

Chuckwalla Spring (Figure 4) lies high on the north slope of the Chuckwalla Mountains in the SE1/4 of Section 17, T8S, R17E. This spring is in the watershed, but not within the boundary of, the Chuckwalla Valley groundwater basin (7-05) in Riverside County, California. The spring is accessible from the

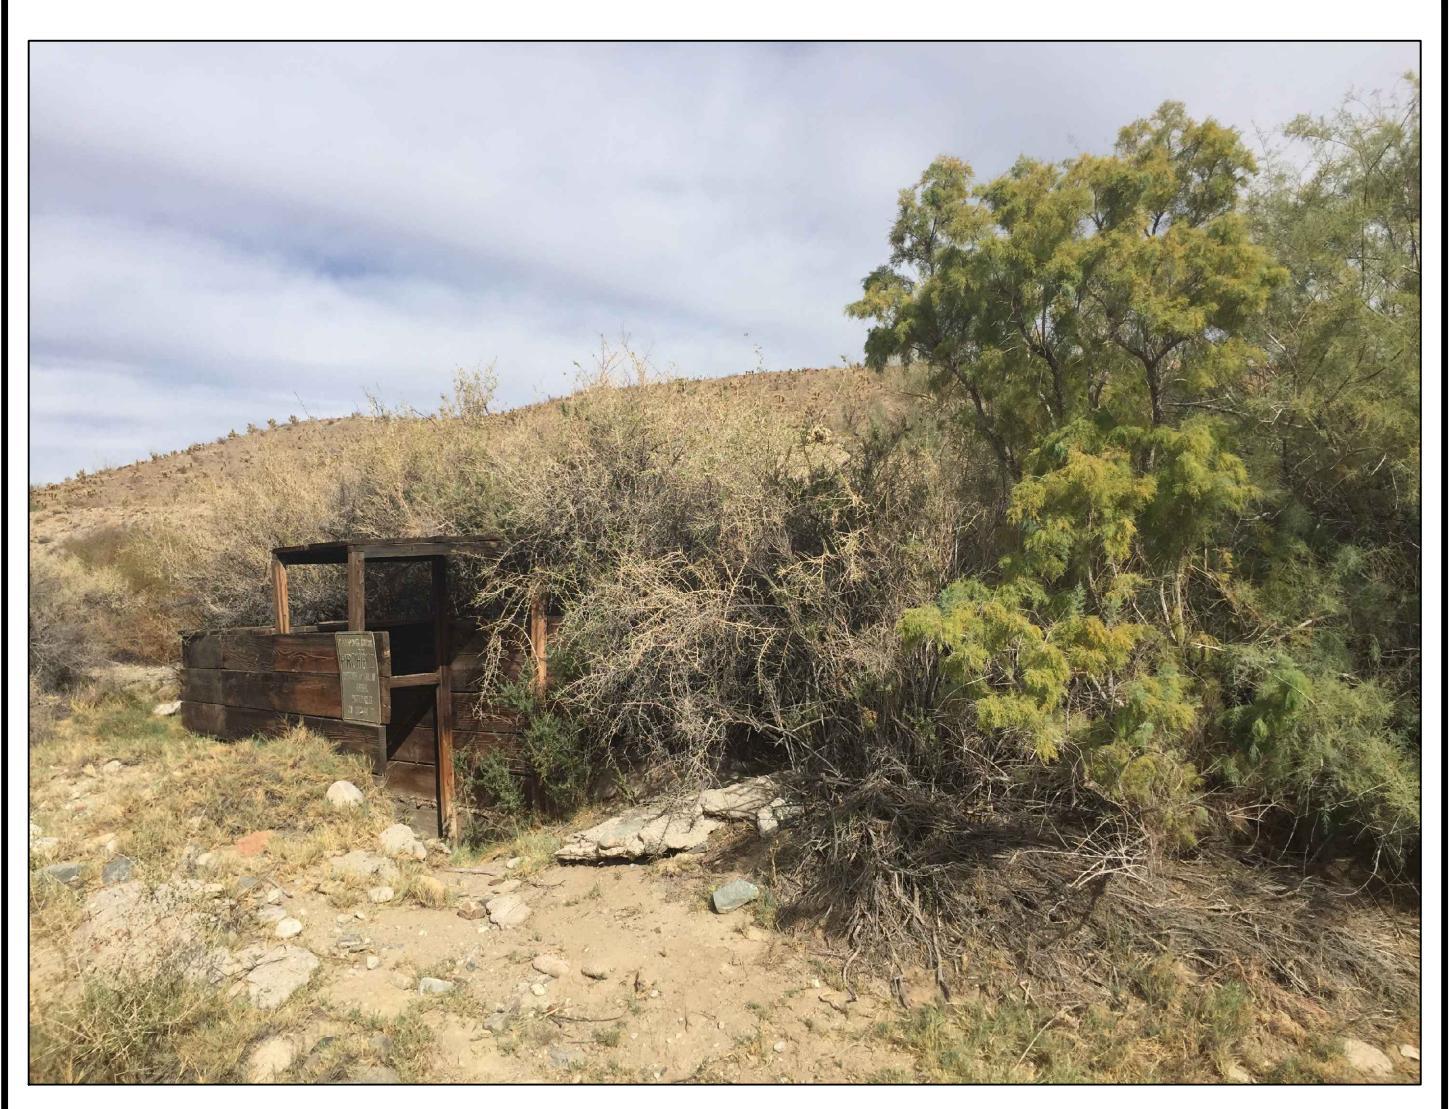
CHUCKWALLA WELL SPRING PROPOSED CHUCKWALLA NATIONAL MONUMENT RIVERSIDE AND IMPERIAL COUNTIES, CALIFORNIA Prepared for: RESOURCES LEGACY FUND Compiled by: RM Date: 02MAY2023 FIGURE Scale: AS SHOWN Prepared by: ET

As described above in 2017, although a well may be (or was formerly) present, this feature is more of a spring with a spring box with water and seeps surfacing in channel downslope of spring box. The spring is in igneous and metamorphic-rock terrain (intrusive silicic). Although not observed at the spring, deer and/or Desert Bighorn Sheep tracks were observed nearby, and it is likely that this water source is used by them. There were many Phainopepla present at the time of the inspection. Vegetation at the spring consists of mesquite, grasses, boxthorn, and tamarisk. One palm tree is present nearby but not at the spring.

Chuckwalla Well Spring (Figure 5) lies at the base of the south slope of the Chuckwalla Mountains in T8S, R17E. Sections have not been defined in this area. This spring is in the watershed, but not within the boundary of, the Arroyo Seco groundwater basin (7-37) in Riverside County, California. This spring is within the Chuckwalla Bench Area of Critical Environmental Concern. The spring is accessible from the Bradshaw Trail Road (two-wheel drive accessible), while a high-clearance two-wheel drive can access the dirt road to the site.

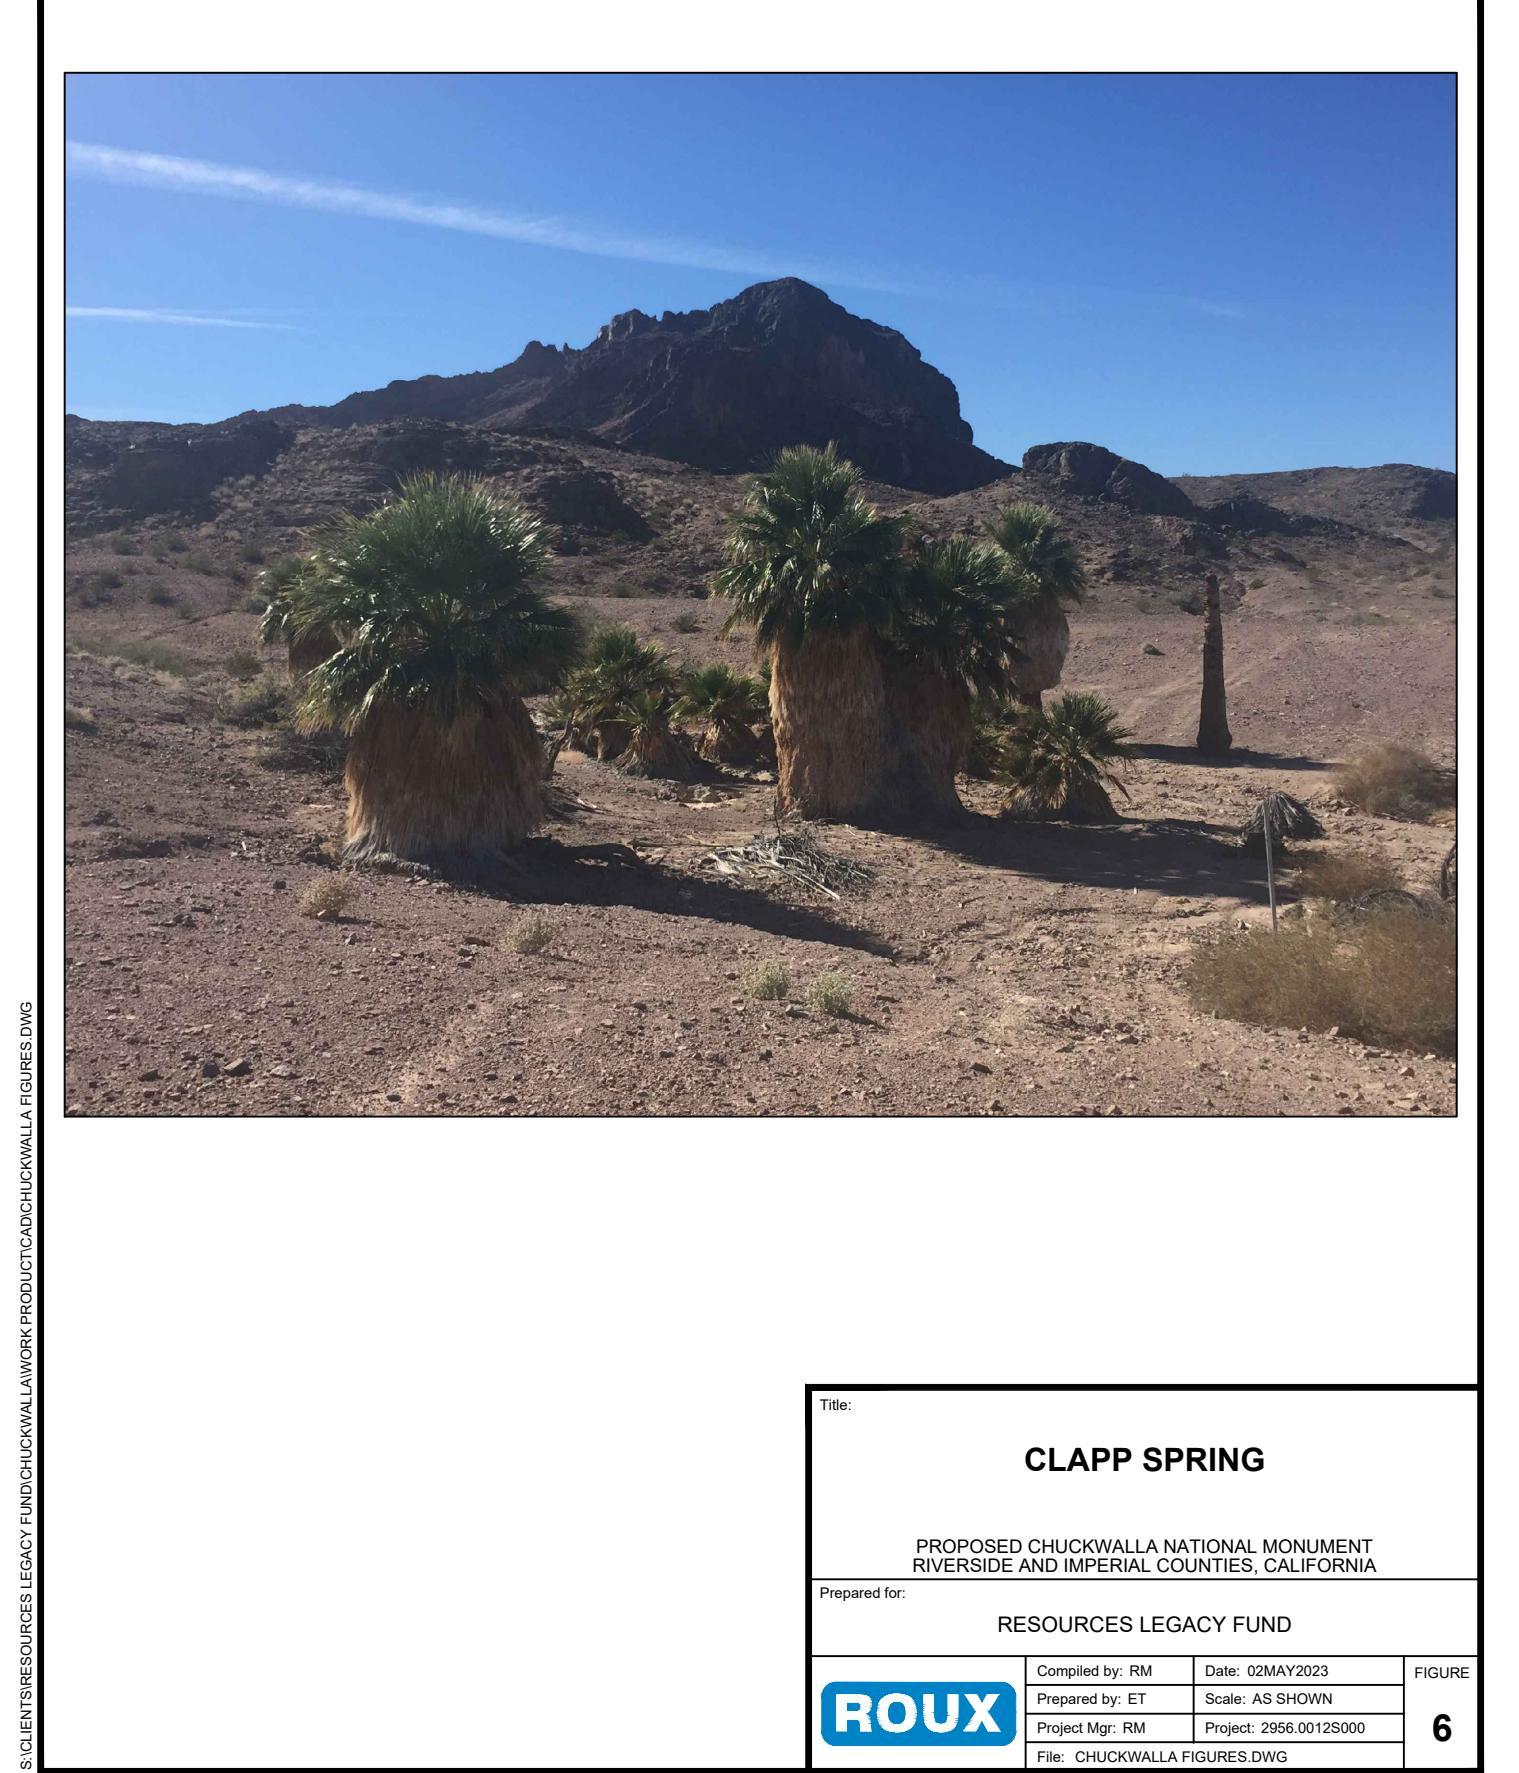
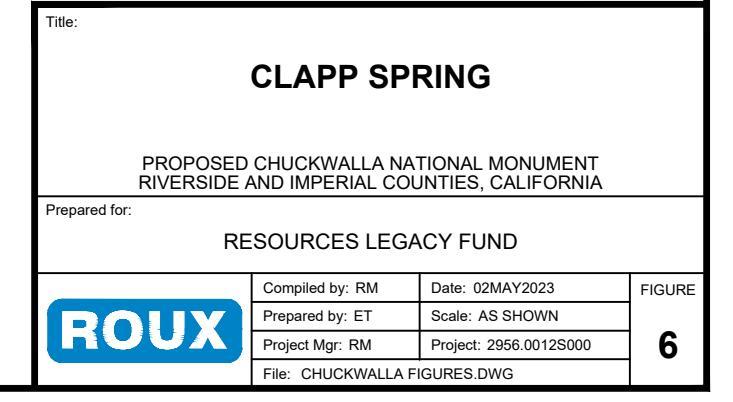
At the time of inspection in 2017 (Partner, 2018), this spring in volcanic terrain consisted of a dry spring vent area that had been human-altered. There were signs of deer or Desert Bighorn Sheep (tracks and scat) present. A Cactus Wren was observed at the spring. Vegetation consisted primarily of mesquite, ironwood, and saltbush although approximately 10 palm trees are also present. Of note is that this spring has been noted as being perennial in the past (noted on BLM wilderness site) but is currently dry and may be affected by regional groundwater pumping. There are no water-right filings with the State of California for this spring.

Clapp Spring (Figure 6) is on the northeast slope of the Palo Verde Mountains in the NE1/4 of Section 10, T9S, R20E. This spring is in the watershed, but not within the boundary of, the Palo Verde Mesa groundwater basin (7-39) in Riverside County, California. Clapp Spring is within the Palo Verde Mountains Wilderness. The spring is accessible from the Bradshaw Trail east of the Mule Mountains, following a powerline road south to a reasonable dirt road heading west. This route becomes a four-wheel-drive accessible only dirt track and arrives at the spring from the north.

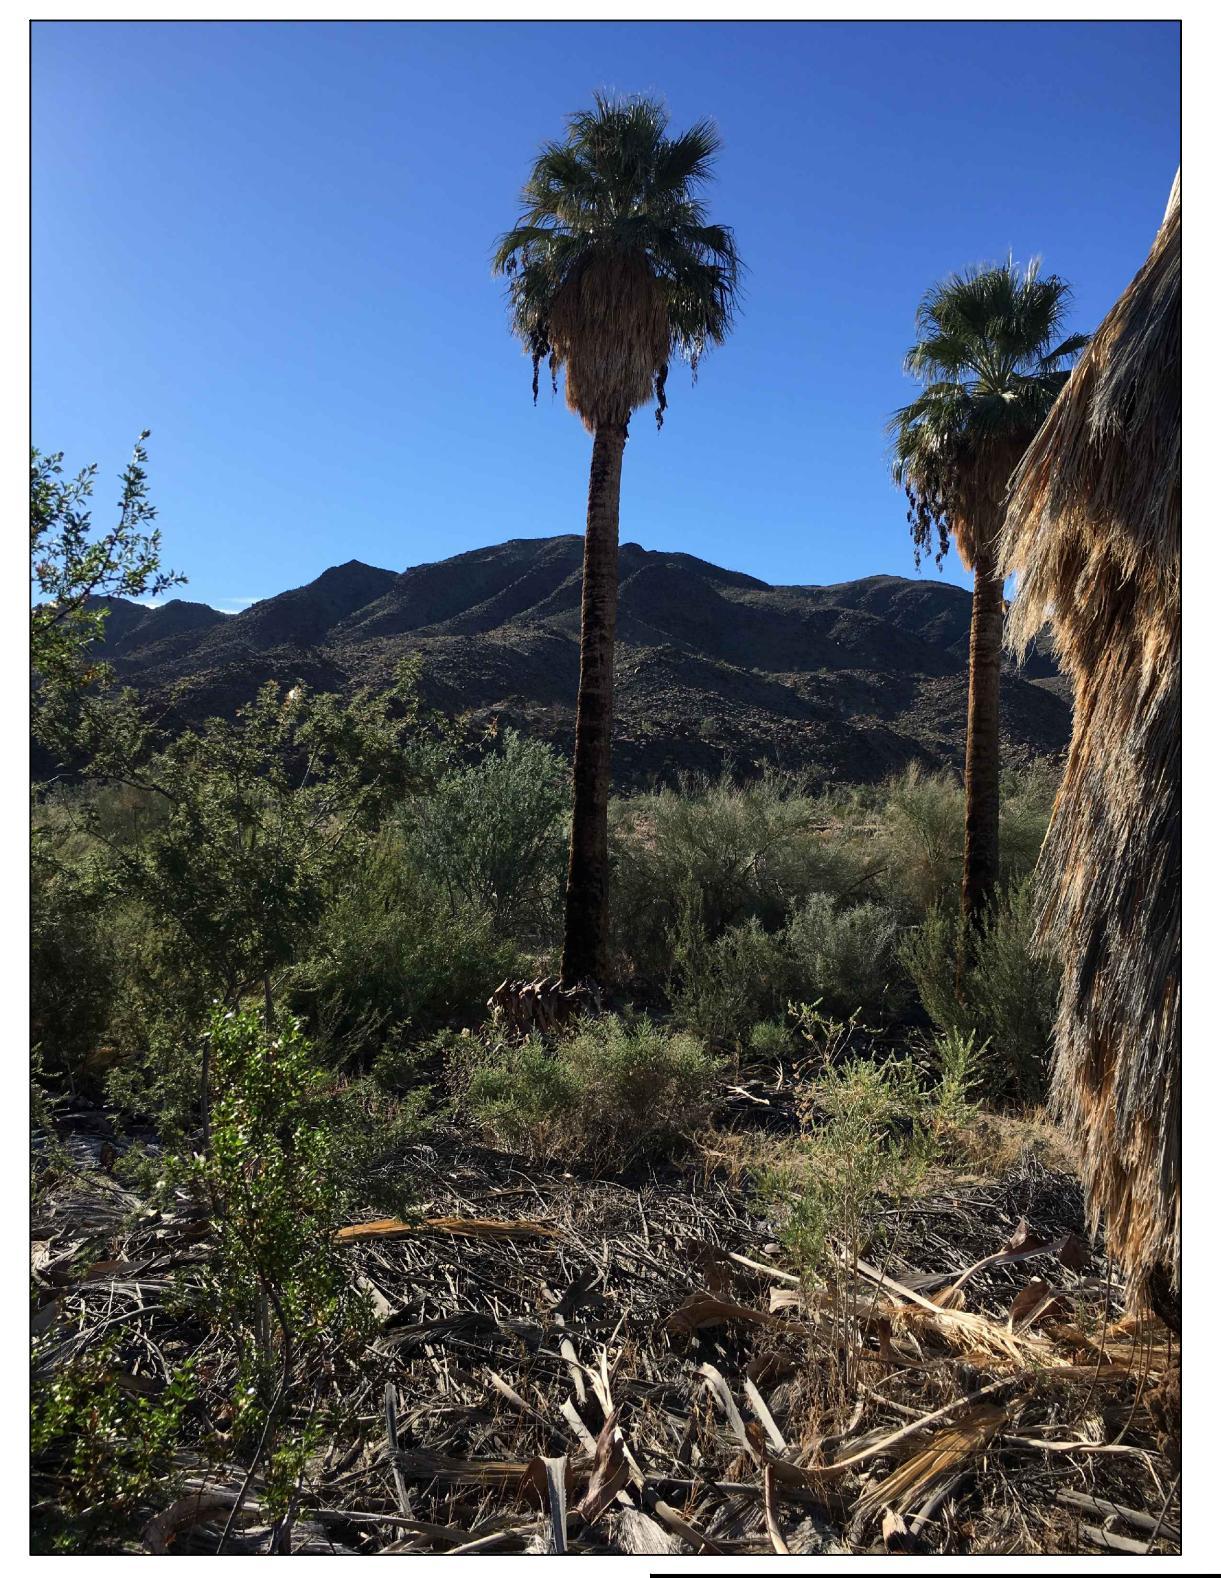
CORN SPRING

The spring field/cienega is in granitic terrain where there is no longer surface expression of flow. Spring discharge is through evapotranspiration only. Groundwater-dependent vegetation appears stressed and palm trees present are stressed/dying. This may be the result of up-gradient pumping near Aztec Well and water use by the existing recreational area at the spring. Birds observed during a site visit in 2017 included Phainopepla and Gilded Flicker along with un-speciated hummingbirds. Vegetation consisted of the aforementioned palm trees, along with mesquite, catclaw acacia, palo verde, creosote, arrowweed, boxthorn, brittlebush, and desert mallow. Continued decline of the riparian could lead to non-functional status in the future.

Water quality parameters were measured from the water system at the BLM campground during a site inspection in 2017. There was no odor to the water, and the water appeared to be generally of good field quality (dissolved solids content less than 500 parts per million) although laboratory analysis for general water quality was not conducted. There is a federal water right claim filed by BLM with the State of California for this spring. Brown (1923) noted Corn Spring as a Public Water Reserve.

Corn Spring (Figure 7) lies on the north slope of the Chuckwalla Mountains in the NW1/4 of Section 28, T6S, R16E. This spring is in the watershed, but not within the boundary of, the Chuckwalla Valley groundwater basin (7-05) in Riverside County, California. Corn Spring is in the Corn Springs Area of Critical Environmental Concern. Corn Spring is reached by following the Corn Spring Road from I-10 to Corn Spring Campground (good dirt road, 2-wheel drive accessible).

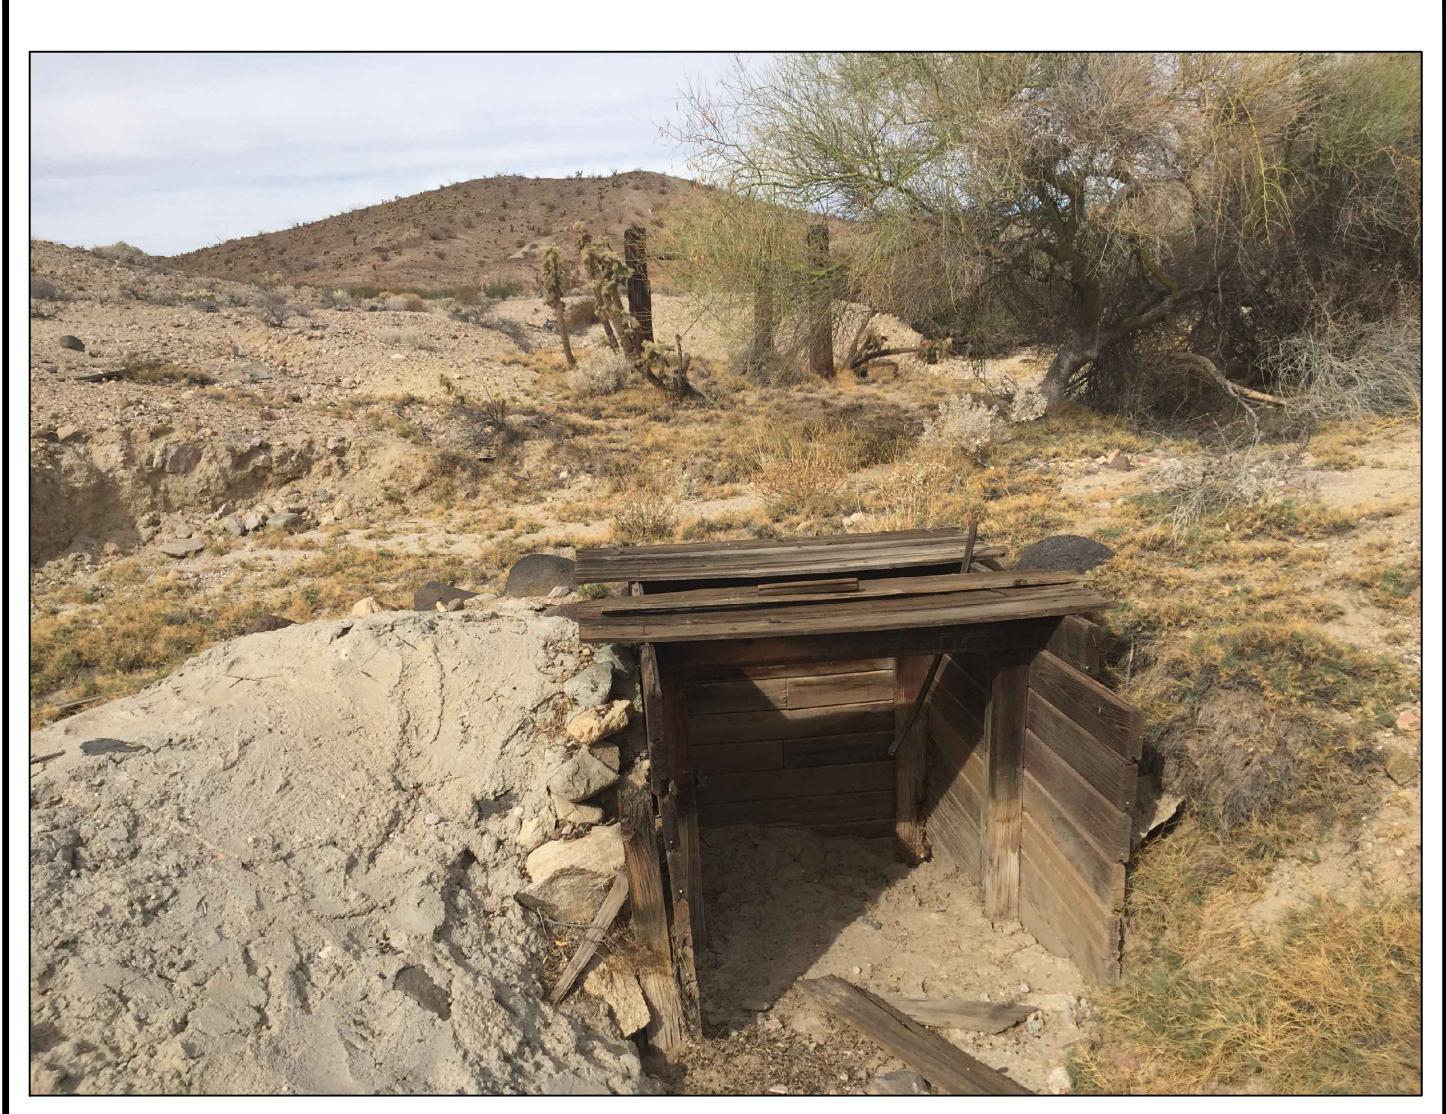
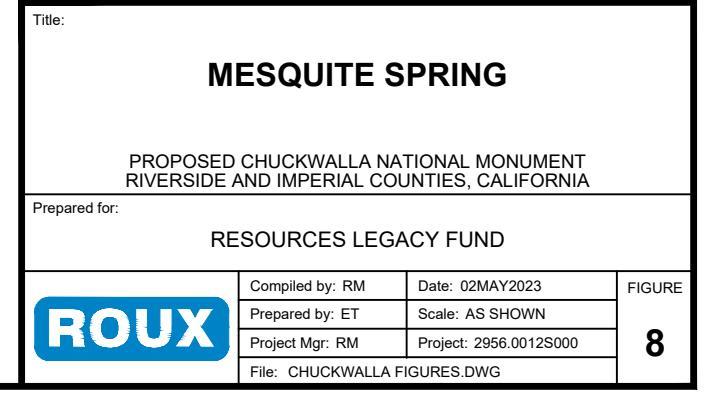
At the time of inspection in 2017 (Partner, 2018), a spring-box was present but dry. Other infrastructure present appeared in disrepair and generally no longer in use. It is possible that this spring was overused in the past. There were deer and/or Desert Bighorn Sheep tracks and scat present, with plentiful Phainopepla. Vegetation consisted primarily of mesquite and grasses including bunchgrass. There are no water right filings with the State of California for this spring.

Mesquite Spring (Figure 8) is on the south slope of the Chuckwalla Mountains in the SE1/4 of Section 29, T8S, R17E. This spring is in the watershed, but not within the boundary of, the Arroyo Seco Valley groundwater basin (7-37) in Riverside County, California. Mesquite Spring is within the Chuckwalla Bench Area of Critical Environmental Concern. The spring is reached from the Bradshaw Trail (two-wheel drive). A short hike along a dirt track leads to the spring.

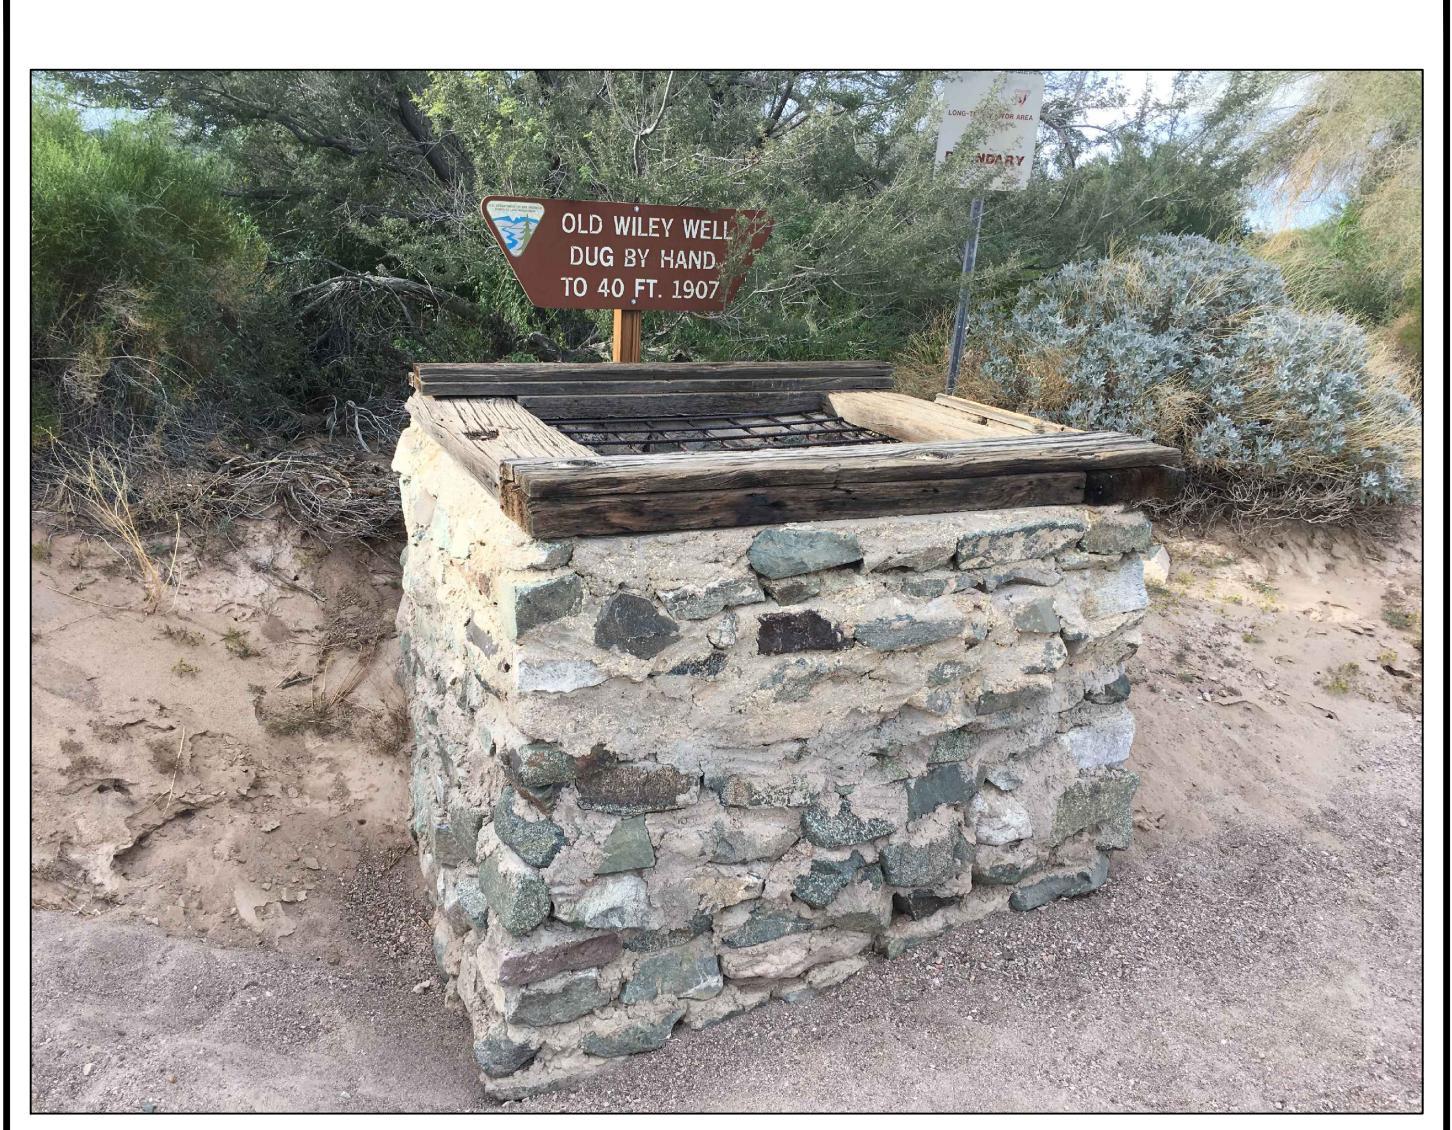
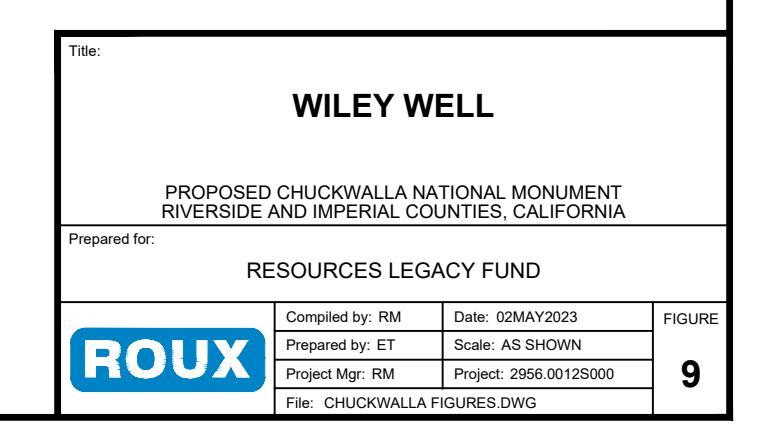
Wiley Well (Figure 9) is within the alluvial valley separating the Little Chuckwalla Mountains and the Mule Mountain and is within the Chuckwalla Valley Groundwater Basin (7-05) in Riverside County, California. The historic well is within a campground accessed by a good dirt road (Wiley Well Road) from Interstate 10. There is a handpump for the campground water system, and water from the pump was used to collect water sample that indicated the water had a high mineral content (greater than 1,000 parts per million dissolved solids). Birds observed during the site inspection included Verdin and Phainopepla. Vegetation present included palo verde, and various shrubs. The feature is used for recreation and the BLM has a water right (S006240) filed with the State of California for this source. The well was dug in 1907 by A.P. Wiley, a shopkeeper from Palo Verde, deepening a shallower well that was previously dug here in 1876 by a stage company. Water from the well was extracted by a bucket attached to a rope and it is only about 22 feet deep (Ross, 1992).
