Tabby

Construction Methods

Tabby Today: Preservation

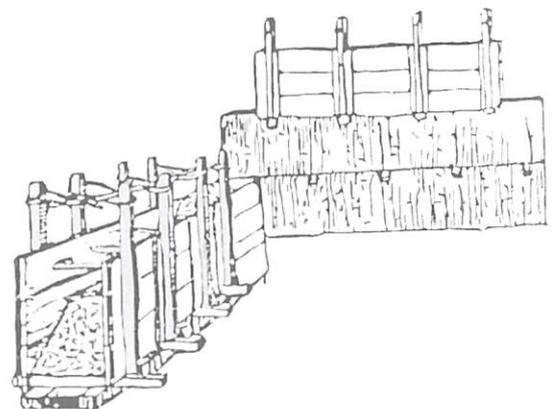
Tabby was poured one layer at a time into a wooden mold held in place with spreader pins.

Whole shell tabby was pourable and used much like today's concrete. This type of construction was used for the slave cabins, kitchen house, and the walls of the barn. Tabby, without the whole shells, could also be made into bricks, which were used in the barn and the first floor of the kitchen house, as well as the

There are holes in the walls of the slave cabins because wooden spreader pins were used to hold the frame parallel during construction. Once the pins were removed, the holes were filled in, but the filler has since deteriorated.

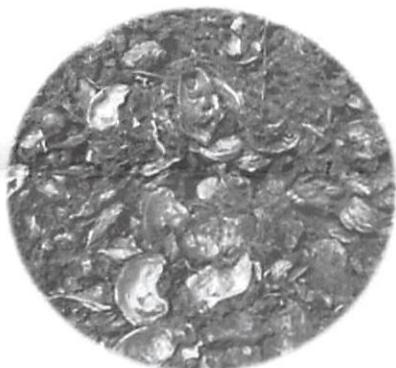
A close-up photograph of tabby (NPS)

Tabby was created entirely from locally available materials. Oyster shells piled into middens by the Timucua were burned and ground for lime. Sand and water were mixed in, and often whole shells were added to speed the hardening of the tabby and to increase volume and durability.

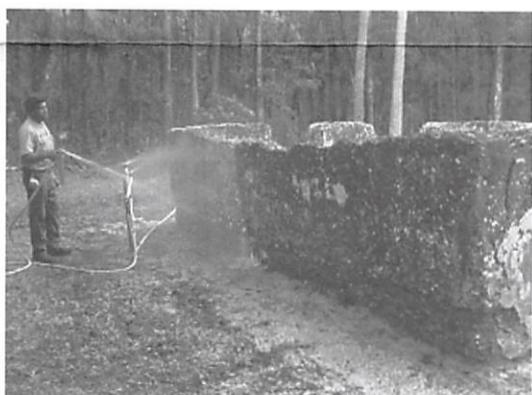
Tabby preservation in progress (NPS)

The tabby preservation project protects the historical craftsmanship and prevents further erosion due to environmental processes by cleaning the buildings and replacing the lime putty coating that the structures had originally.
