HEMLOCK BRIDGE  
Acadia National Park Roads & Bridges  
Spanning Maple Spring Brook on West Sargent Mountain Road  
Northeast Harbor Vicinity  
Hancock County  
Maine

HAER NO. ME-34

WRITTEN HISTORICAL AND DESCRIPTIVE DATA  
PHOTOGRAPHS  
XEROGRAPHIC COPIES OF COLOR TRANSPARENCIES

STRUCTURE: Stone-faced reinforced concrete filled spandrel arch bridge

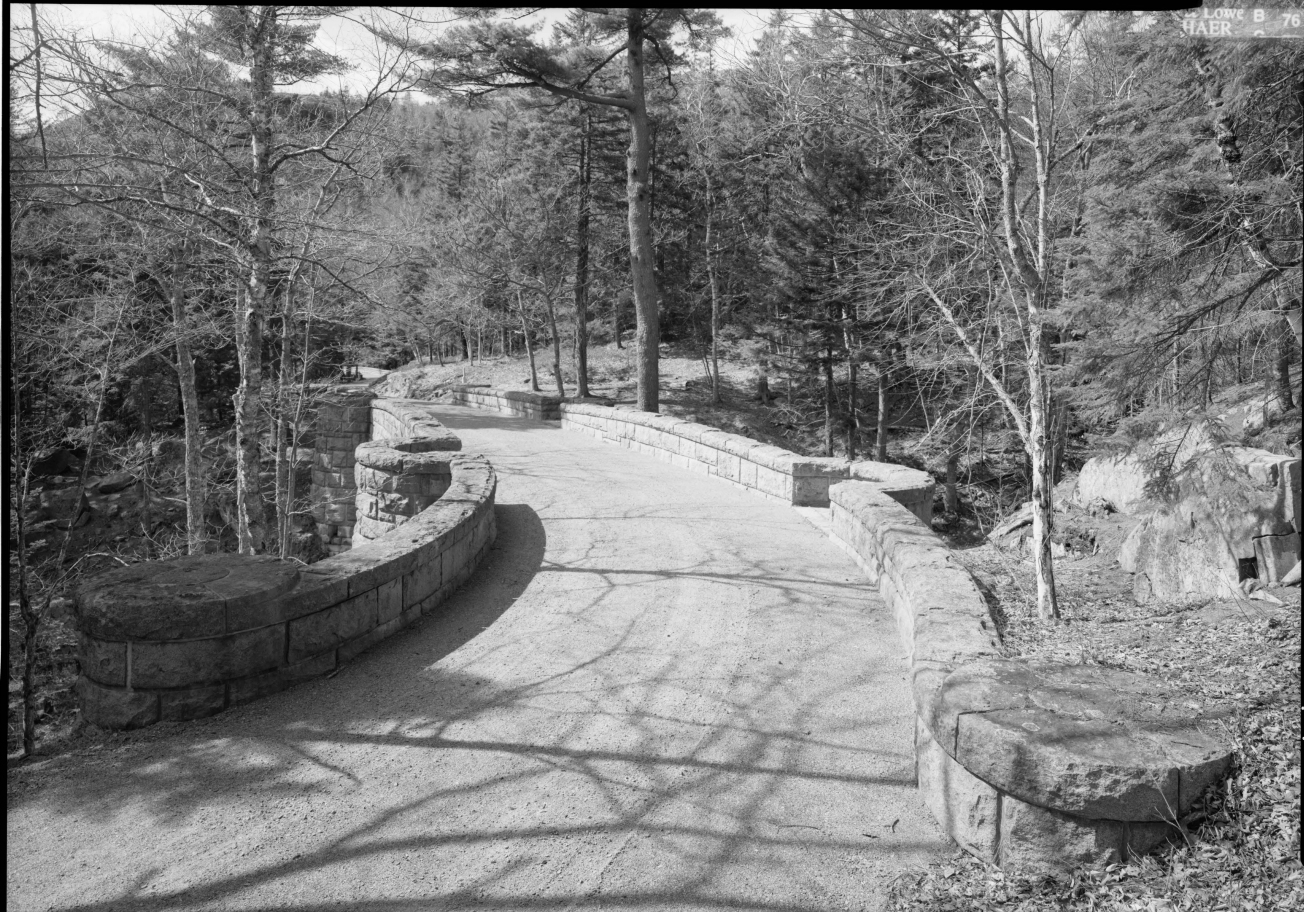
HAER No. ME. 34.1

- ME-34-1 HEMLOCK BRIDGE, SOUTH VIEW FACING NORTH BY 340 DEGREES.
- ME-34-2 NORTH HEMLOCK BRIDGE, VIEW SW BY 220 DEGREES.
- ME-34-3 DETAIL OF WEST PORTAL OF HEMLOCK BRIDGE.
- ME-34-4 HEMLOCK BRIDGE IN ELEVATION, NE BY 30 DEGREES.
- ME-34-5 PERSPECTIVE VIEW OF MAIN SPAN FACING DEAD NORTH.
- ME-34-6 NORTH HEMLOCK BRIDGE SW BY 220 DEGREES.
- ME-34-7 ATLAS' STAIRWAY AT HEMLOCK BRIDGE.
