DUCK BROOK BRIDGE

HAER NO. ME-40

Acadia National Park Roads & Bridges

WRITTEN HISTORICAL AND DESCRIPTIVE DATA

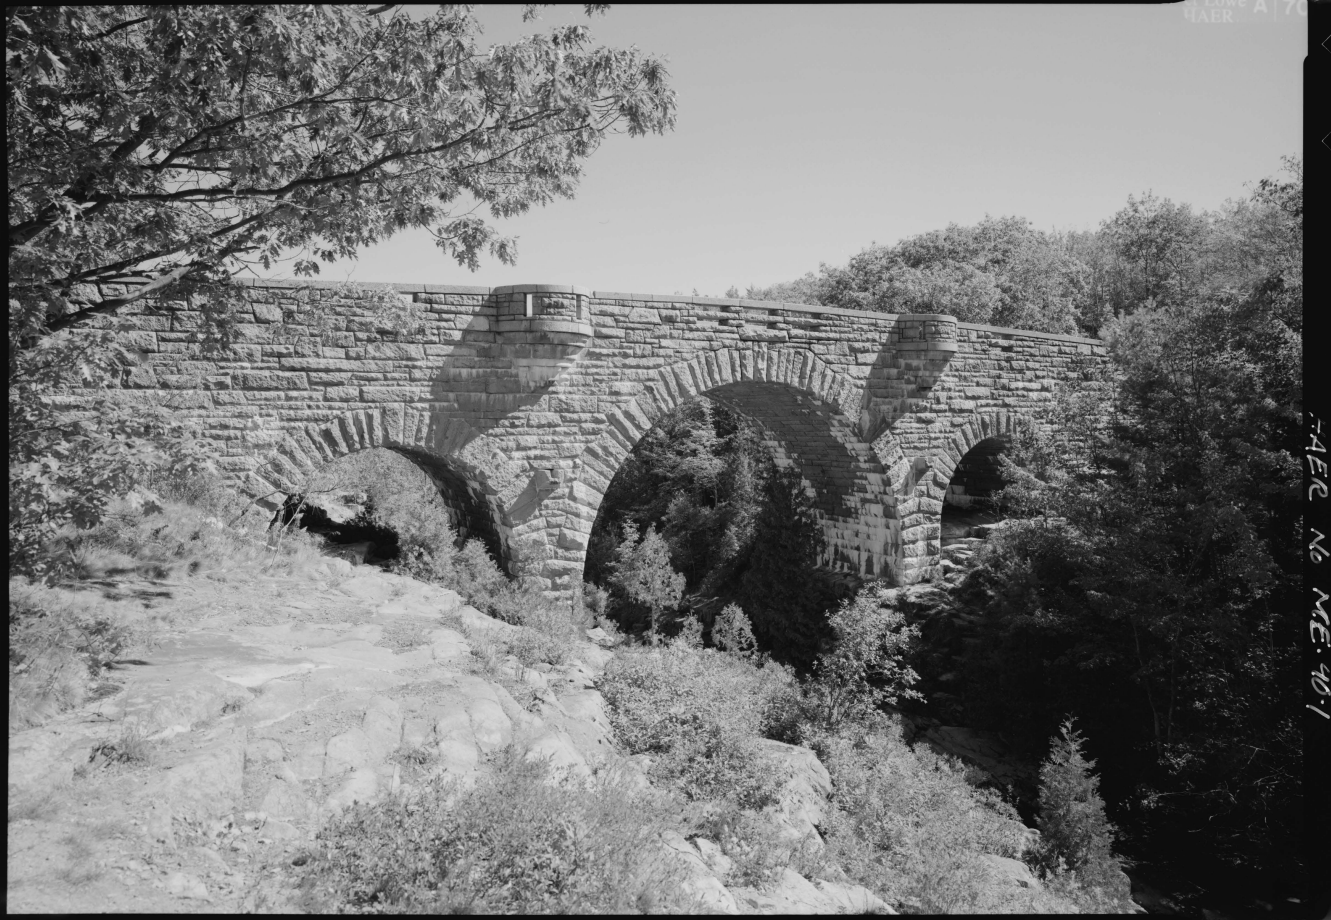
HAER No. ME. 40.1

| ME-40-1 | GENERAL PERSPECTIVE LOOKING N |

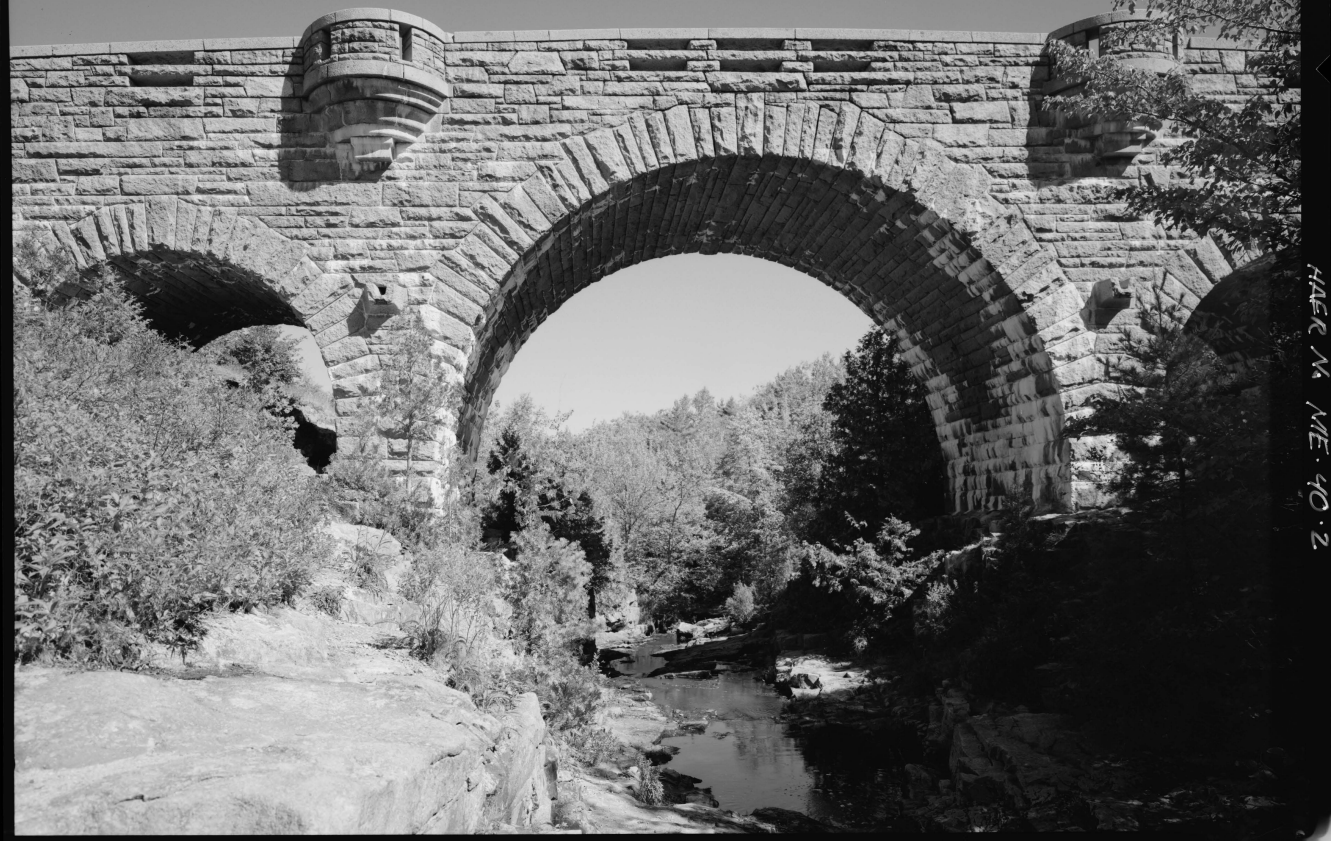
HARR M. ME. 40.2

| ME-40-2 | ELEVATION FACING NORTH CLOSE TO BROOK LEVEL |

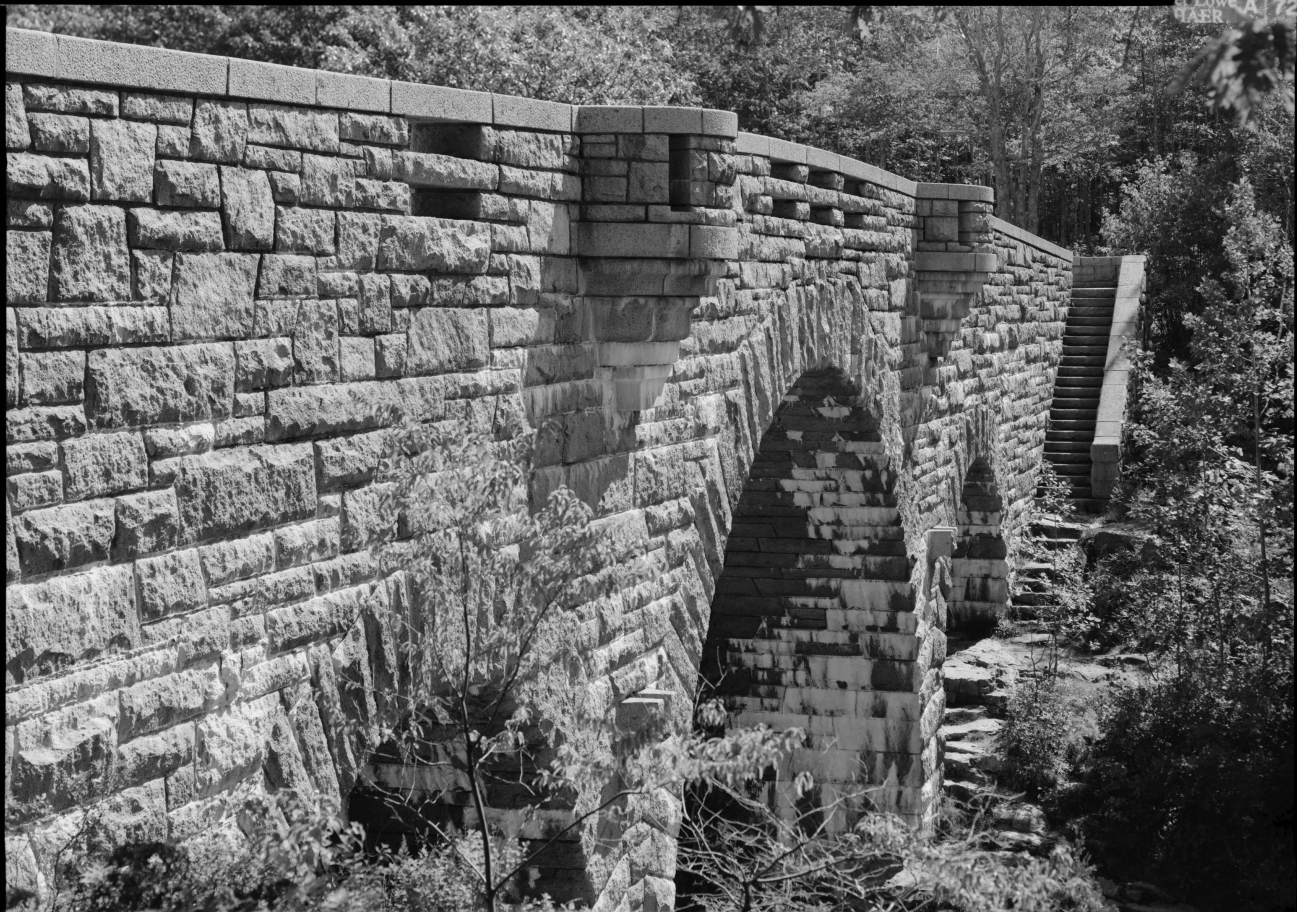
HAER N. ME. 40.3

| ME-40-3 | OBLIQUE PERSPECTIVE LOOKING NE AND SHOWING STAIRS OPPOSITE |

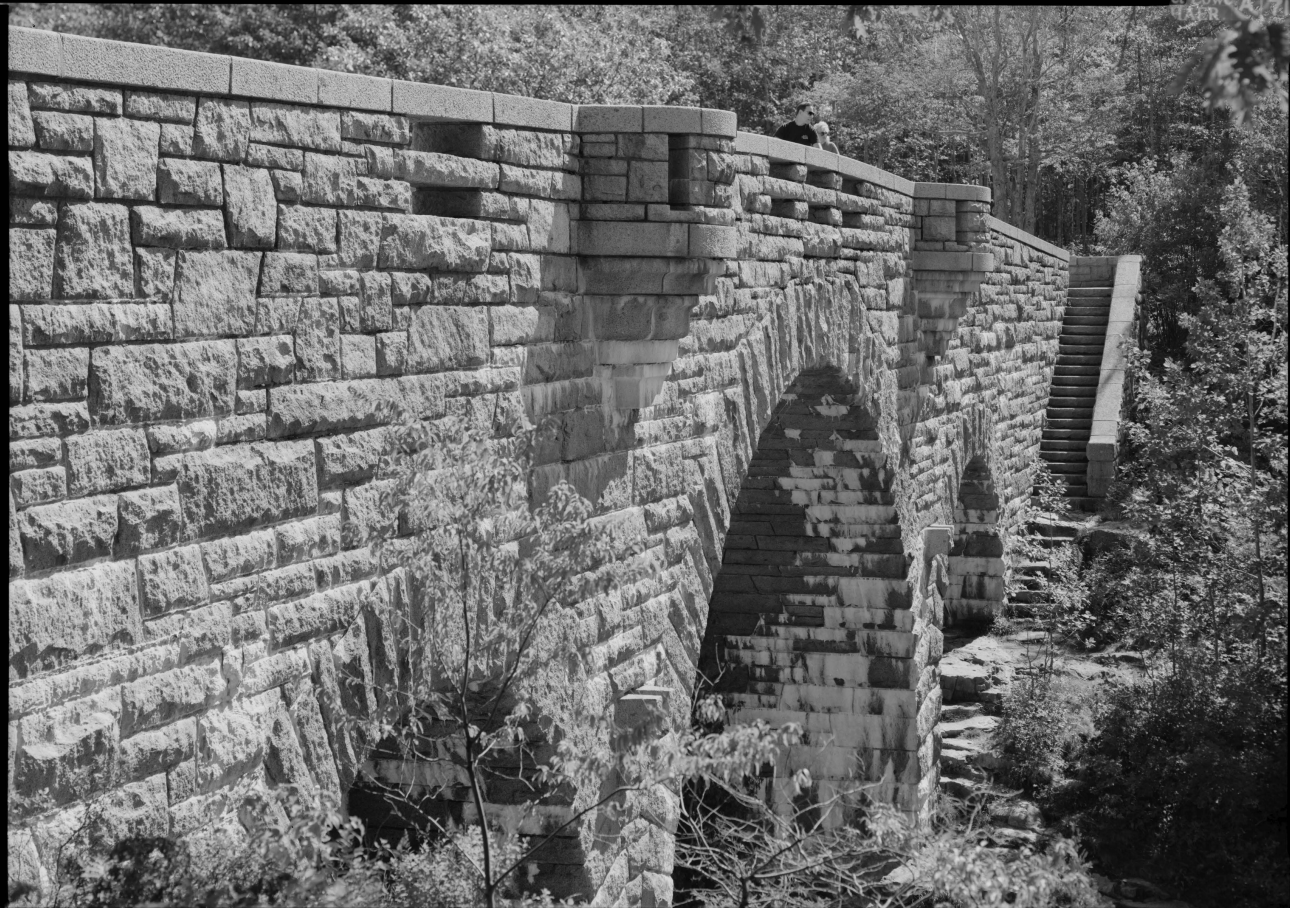
HAER No. M.F. 42.4

| ME-40-4 | SAME VIEW WITH TOURISTS FOR SCALE |

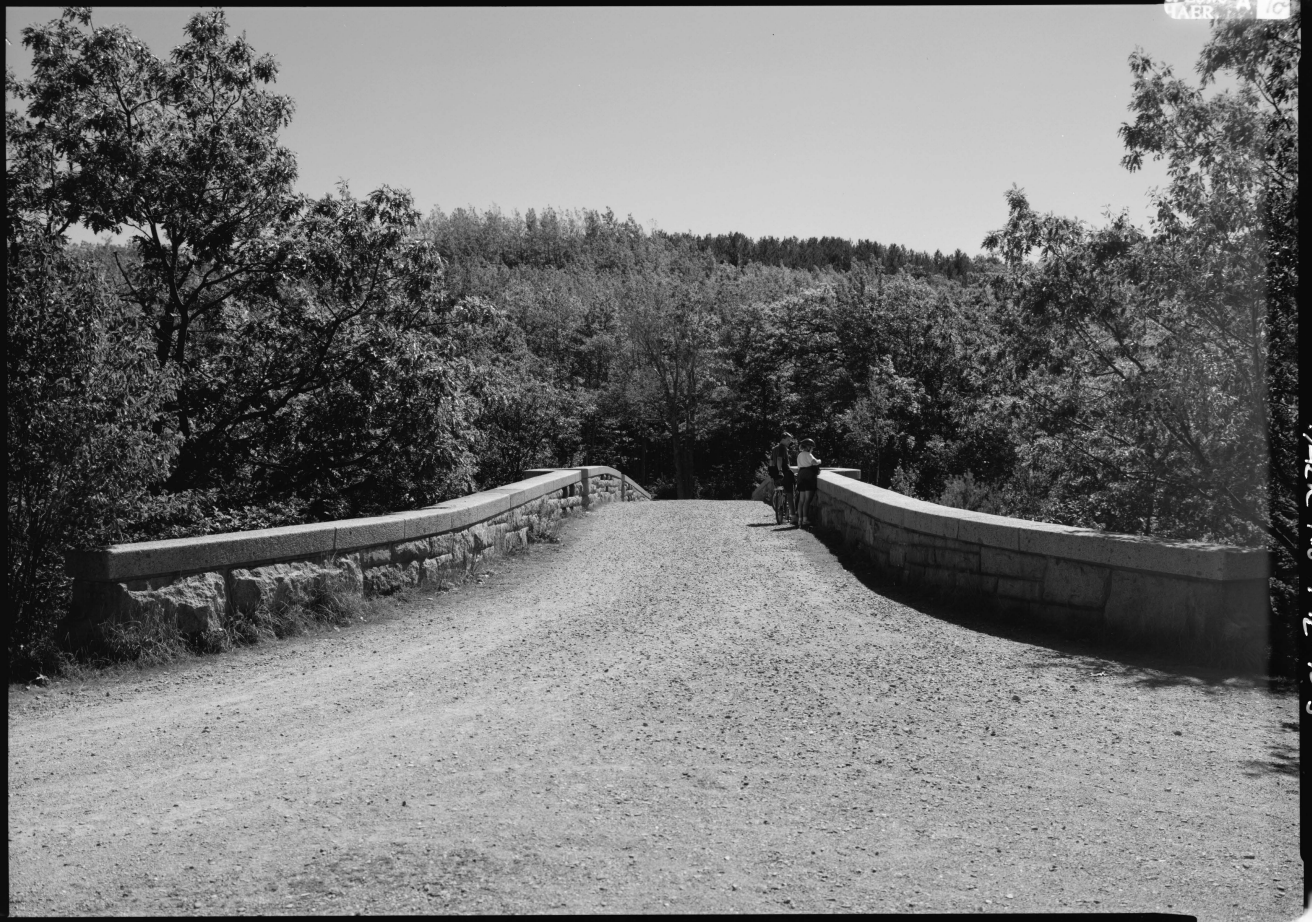
74EC No ME. 40.5

| ME-40-5 | WESTERN PORTAL AND CARRIAGEWAY LOOKING EAST |

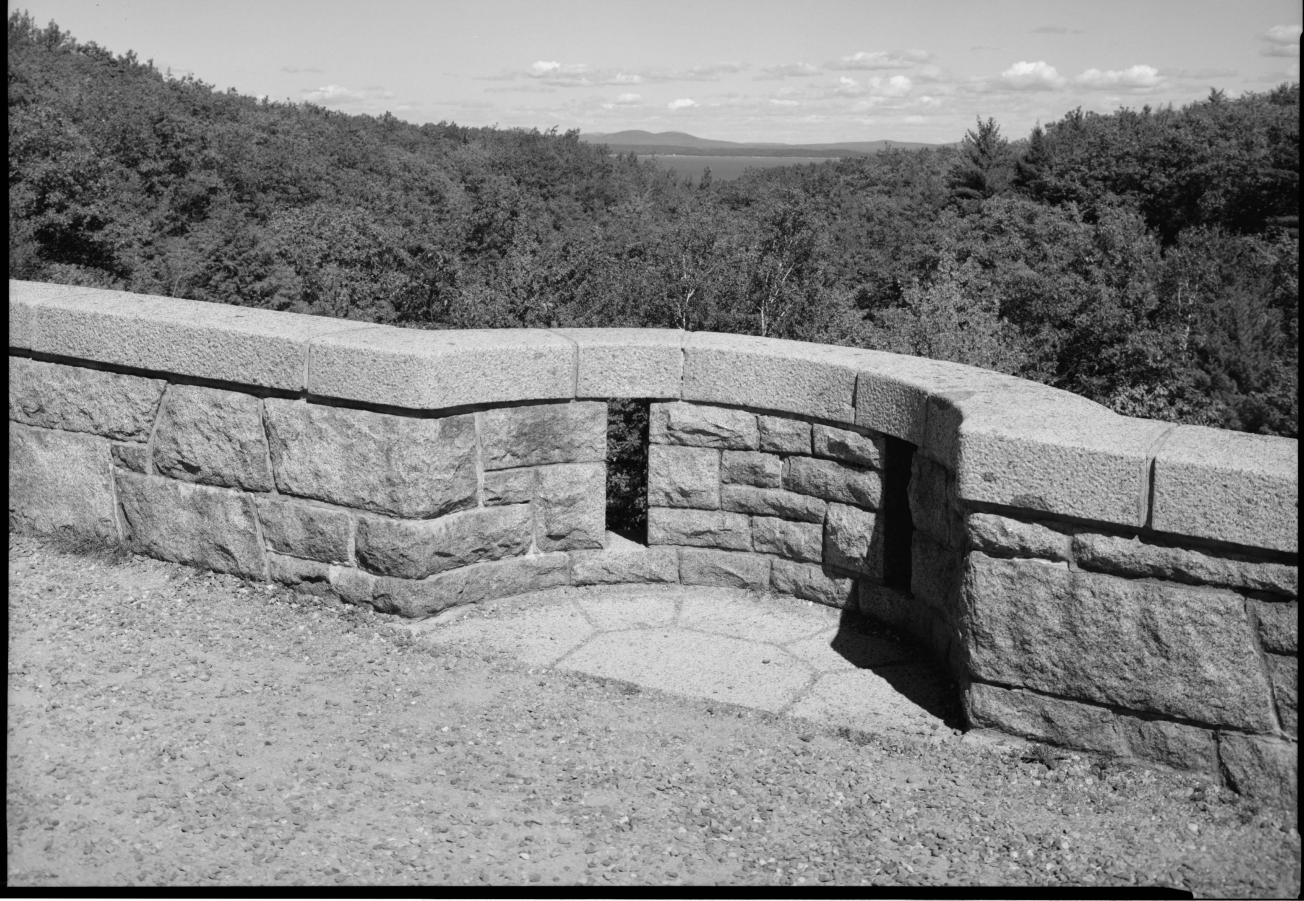
| ME-40-6 | LOOKING NORTH TO FRENCHMANS BAY AND PARAPET DETAIL |
