## Archeology Program

National Park Service  
U.S. Department of the Interior

### Chaco Culture NHP Intentional Site Reburial Program

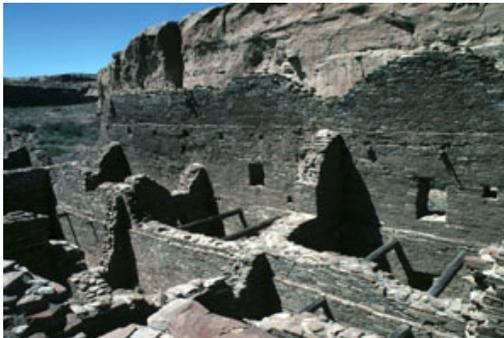
Chaco Canyon's Chetro Kettl, with subterranean levels exposed through archaeological excavation (photo by Robert Blanchette, 2006)

From the 1920s through the early 1980s preservation methods impacted fabrics of the ruins in a variety of ways. Deeply excavated rooms next to unexcavated ones resulted in drainage problems, severe horizontal loading on the walls, and accelerated loss of mortar and stone on the exposed surface. Moisture infiltration into walls, in combination with freeze-thaw cycles and salt crystallization, accelerated stone and mortar erosion, particularly at wall bases and tops of walls. To counteract these trends, harder and more durable mortars replaced the mud mortars in an attempt to extend the period between repair cycles. But under many conditions, particularly in wall bases, these cement-based hard mortars, incompatible with the soft sandstone and original mud mortars, led to severe consequences in the long-run. Large sections of the structural sandstone elements began to fail, and entire sections of walls eroded and collapsed. The repetitive fabric treatments were significantly affecting the authenticity and integrity of structures.

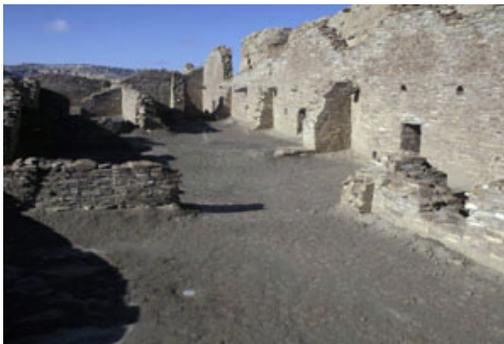
Chetro Kettl reburied to protect masonry walls and wooden beams (photo by Robert Blanchette, 2006)

Intentional site reburial is an effective, practical, and economical treatment for the most threatened structures with the greatest visitation and is a sustainable and relatively low-tech solution to some of the more complex structural problems (for example, see Thorne 1989, 1990, 1991; Burch 2004). Although difficult to calculate cost comparisons, the one-time costs for reburying an average room in an ancient Puebloan site like the ones in Chaco Canyon as part of developing the intentional site reburial program are estimated to be up to 5 times the cost of a single routine in-kind fabric treatment. However, the more fragile sections need repair treatment on average every 2 to 5 years. Without considering inflation or other factors such as rising labor and equipment costs, savings are realized within 10 to 20 years, and 'fabric savings' are immediate.

Intentional site reburial design has been fairly simple in concept and premised on two basic principles. The first is to equalize fill levels within the structures wherever possible; this alleviates problems associated with lateral pressure and moisture infiltration. The second is to design drainage systems that effectively remove surface moisture and keep the site reburial fill as dry as possible. Geotextiles are used as horizon markers to indicate where the intentional site reburial fill begins, and bulk fills are locally available soils.
