PREPARED	DATE	DRAWING NO.	550
DESIGNED			28,000
CHECKED		PCIP PKG.	
DRAWN		SHEET	2
DATE			OF 13

**PLAN - BASEMENT**  
SCALE: 1/8" = 1'-0"

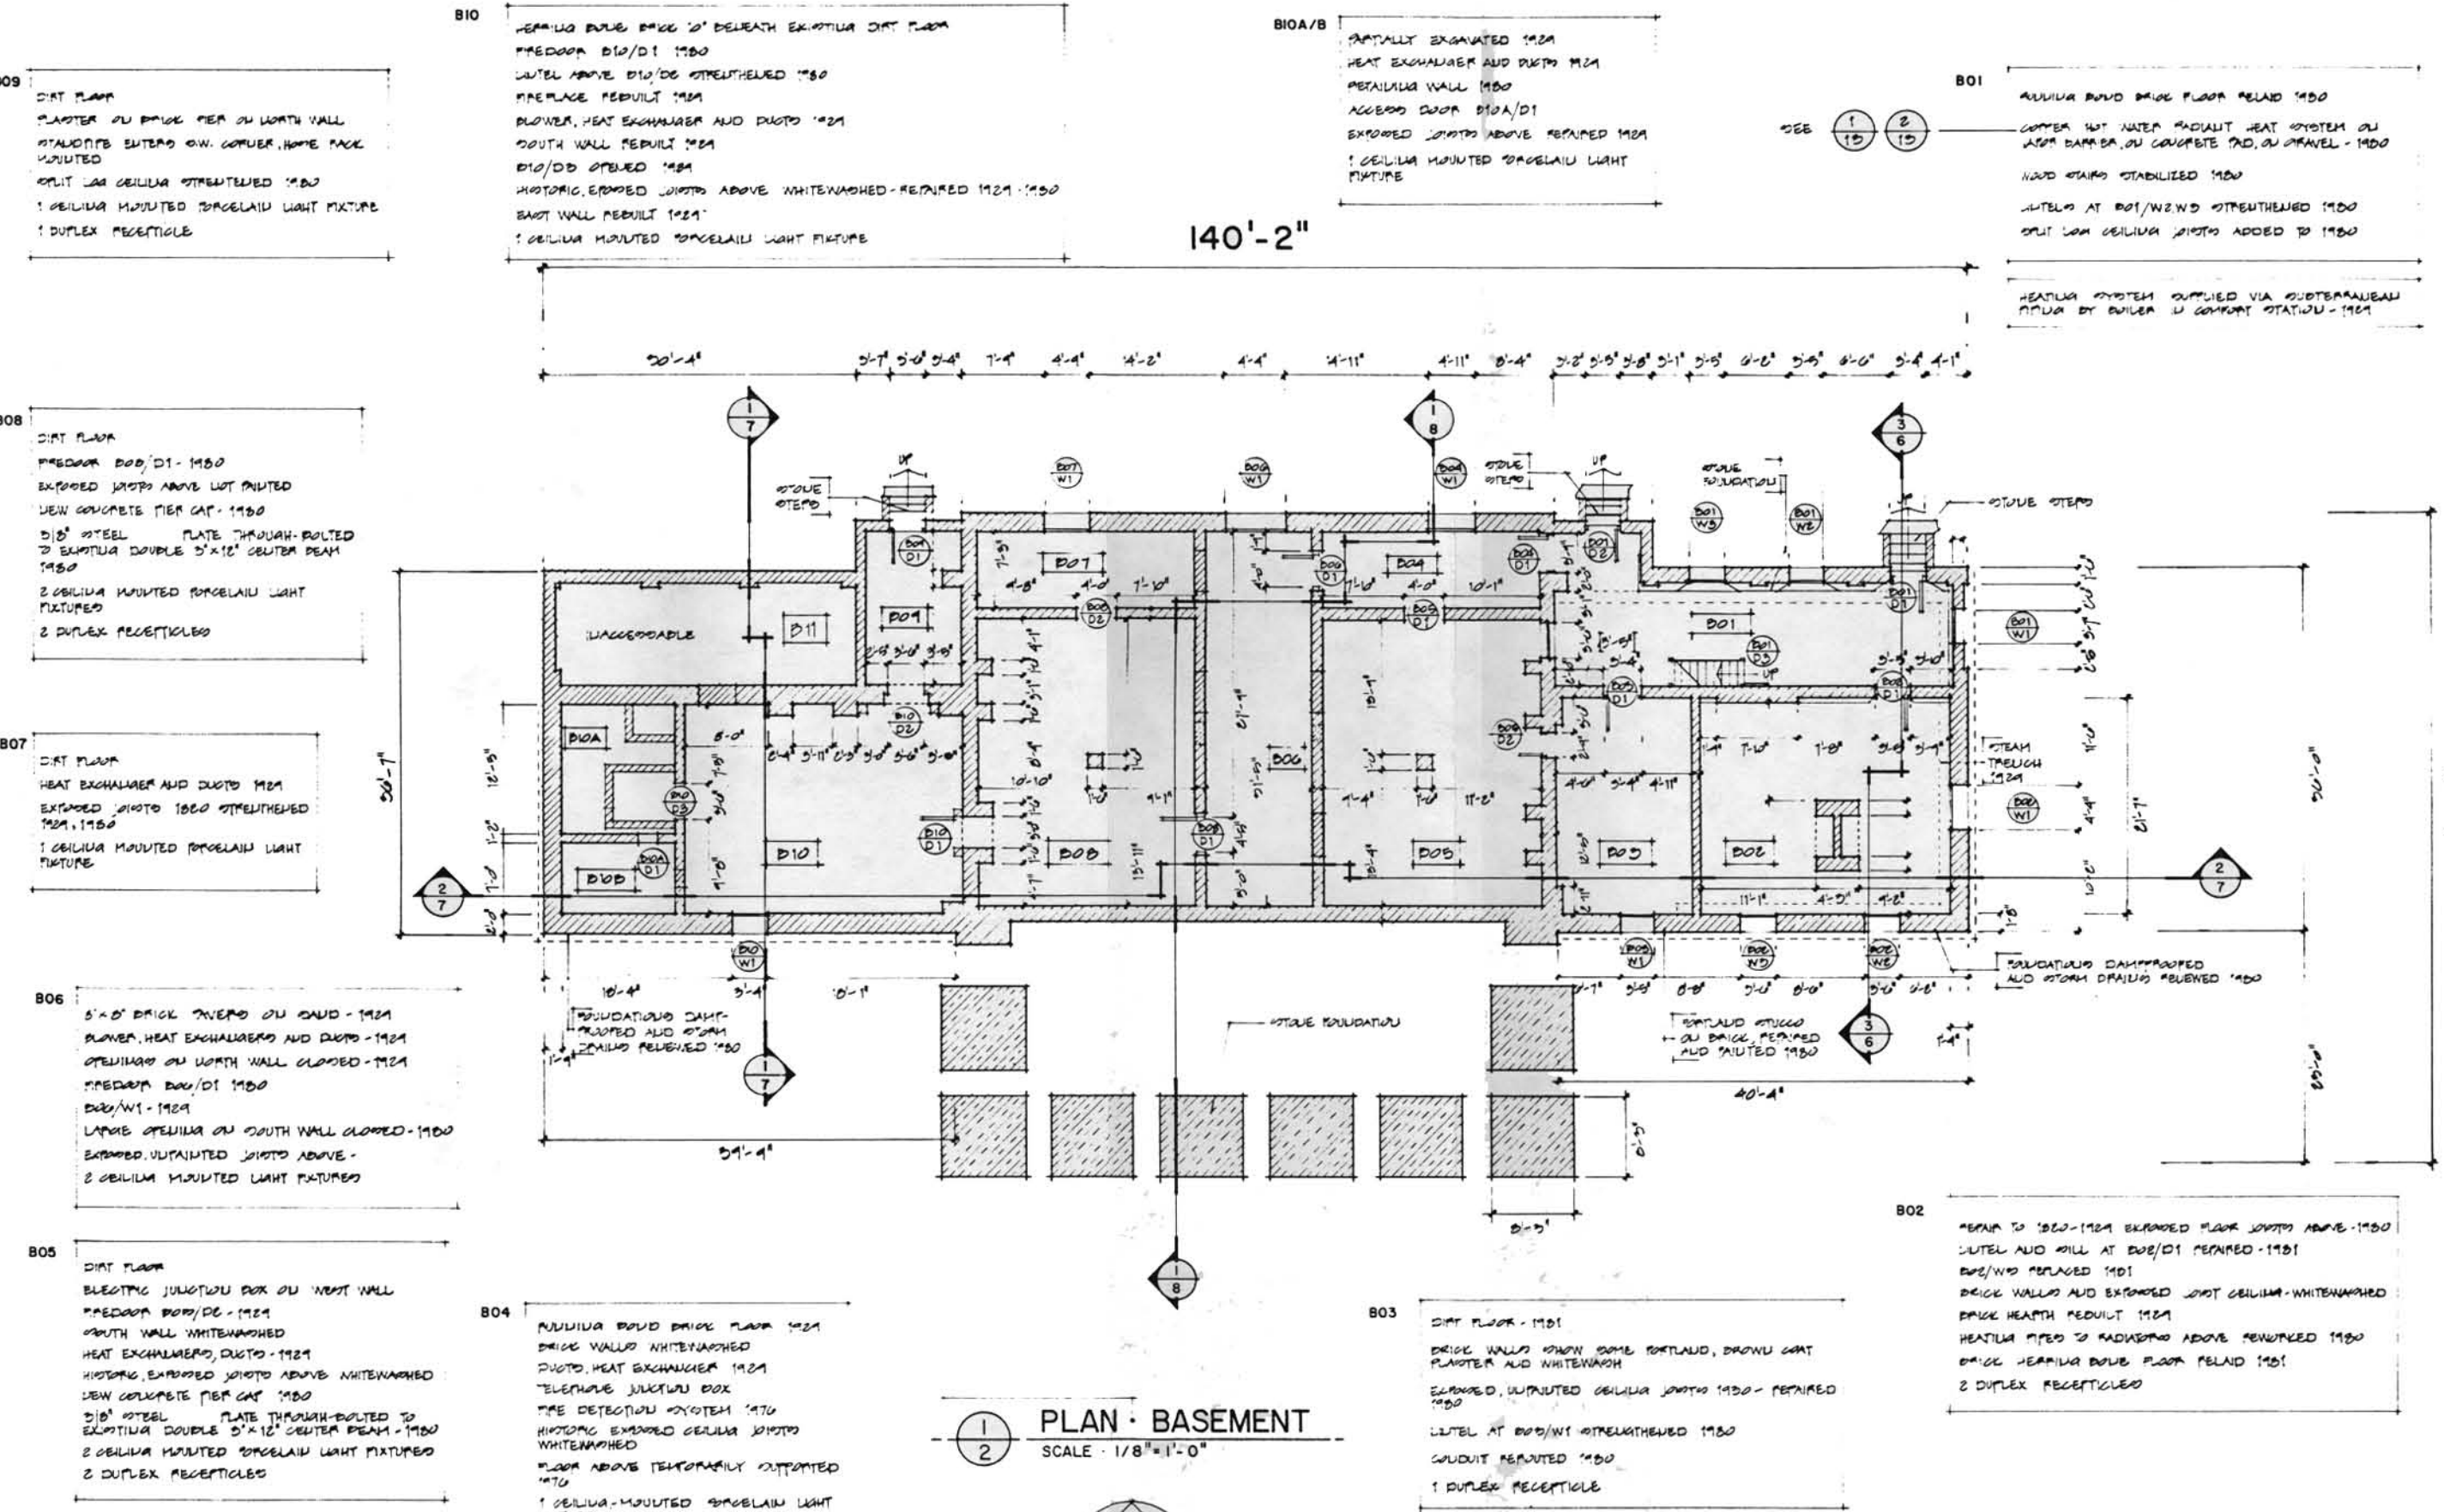
**B09**  
DIRT FLOOR  
PLASTER ON BRICK TIE ON NORTH WALL  
STANDARD ENTERED SW. CORNER, HOME PLACE  
MOUNTED  
SPLIT LAM. CEILING STRENGTHENED 1950  
1 CEILING MOUNTED PORCELAIN LIGHT FIXTURE  
1 DUPLEX RECEPTICLE

**B10**  
HEATING BOILER BRICK 12" DEPTH EXISTING DIRT FLOOR  
FIREDOOR B10/D1 1950  
LITEL ABOVE B10/D2 STRENGTHENED 1950  
FIREPLACE RESULT 1924  
BLOWER, HEAT EXCHANGER AND DUCTS 1924  
SOUTH WALL RESULT 1924  
B10/D3 OPENED 1954  
HISTORIC, EXPOSED JOISTS ABOVE WHITENASHED - RETAINED 1924 - 1950  
EAST WALL RESULT 1924  
1 CEILING MOUNTED PORCELAIN LIGHT FIXTURE

**B10A/B**  
PARTIALLY EXCAVATED 1924  
HEAT EXCHANGER AND DUCTS 1924  
METALLIC WALL 1950  
ACCESS DOOR B10A/D1  
EXPOSED JOISTS ABOVE RETAINED 1924  
1 CEILING MOUNTED PORCELAIN LIGHT  
FIXTURE

**B01**  
MULLION BRICK BRICK FLOOR FELLAD 1950  
COPPER HOT WATER RADIANT HEAT SYSTEM ON  
LARGE BRICK, ON CONCRETE PAD, ON GRAVEL - 1950  
WOOD STAIRS STABILIZED 1950  
LITELS AT B01/W2, W3 STRENGTHENED 1950  
SPLIT LAM CEILING JOISTS ADDED TO 1950

HEATING SYSTEM SUPPLIED VIA SUBTERRANEAN  
PIPING BY BOILER IN GARAGE STATION - 1924

**B08**  
DIRT FLOOR  
FIREDOOR B08/D1 - 1950  
EXPOSED JOISTS ABOVE NOT PAINTED  
NEW CONCRETE TIE CAP - 1950  
510" STEEL PLATE THROUGH-BOLTED  
TO EXISTING DOUBLE 5"x12" CENTER BEAM  
1950  
2 CEILING MOUNTED PORCELAIN LIGHT  
FIXTURES  
2 DUPLEX RECEPTICLES

**B07**  
DIRT FLOOR  
HEAT EXCHANGER AND DUCTS 1924  
EXPOSED JOISTS 1950 STRENGTHENED  
1924, 1950  
1 CEILING MOUNTED PORCELAIN LIGHT  
FIXTURE

**B06**  
5'x5' BRICK TIE ON SAND - 1924  
BLOWER, HEAT EXCHANGER AND DUCTS - 1924  
OPENINGS ON NORTH WALL CLOSED - 1924  
FIREDOOR B06/D1 1950  
B06/W1 - 1924  
LARGE OPENING ON SOUTH WALL CLOSED - 1950  
EXPOSED, UNPAINTED JOISTS ABOVE -  
2 CEILING MOUNTED LIGHT FIXTURES

**B05**  
DIRT FLOOR  
ELECTRIC JUNCTION BOX ON WEST WALL  
FIREDOOR B05/D2 - 1924  
SOUTH WALL WHITENASHED  
HEAT EXCHANGER, DUCTS - 1924  
HISTORIC, EXPOSED JOISTS ABOVE WHITENASHED  
NEW CONCRETE TIE CAP 1950  
510" STEEL PLATE THROUGH-BOLTED TO  
EXISTING DOUBLE 5"x12" CENTER BEAM - 1950  
2 CEILING MOUNTED PORCELAIN LIGHT FIXTURES  
2 DUPLEX RECEPTICLES

**B04**  
MULLION BRICK BRICK FLOOR 1924  
BRICK WALLS WHITENASHED  
DUCTS, HEAT EXCHANGER 1924  
TELEPHONE JUNCTION BOX  
FIRE DETECTION SYSTEM 1970  
HISTORIC EXPOSED CEILING JOISTS  
WHITENASHED  
FLOOR ABOVE TEMPORARILY SUPPORTED  
1970  
1 CEILING MOUNTED PORCELAIN LIGHT  
FIXTURE

**B03**  
DIRT FLOOR - 1951  
BRICK WALLS SHOW SOME PORTLAND, BROWN GRAY  
PLASTER AND WHITENASH  
EXPOSED, UNPAINTED CEILING JOISTS 1950 - RETAINED  
1950  
LITEL AT B03/W1 STRENGTHENED 1950  
CONDUIT RESULT 1950  
1 DUPLEX RECEPTICLE

**B02**  
REPAIR TO 1950 - 1924 EXPOSED FLOOR JOISTS ABOVE - 1950  
LITEL AND MILL AT B02/D1 REPAIRED - 1951  
B02/W3 REPLACED 1951  
BRICK WALLS AND EXPOSED JOIST CEILING - WHITENASHED  
BRICK HEARTH RESULT 1924  
HEATING PIPES TO RADIATORS ABOVE REWORKED 1950  
BRICK HEATING BOILER FELLAD 1951  
2 DUPLEX RECEPTICLES
