**NATIONAL REGISTER OF HISTORIC PLACES  
 INVENTORY -- NOMINATION FORM**

Faneuil Hall

Dock Square (Faneuil Hall Square)

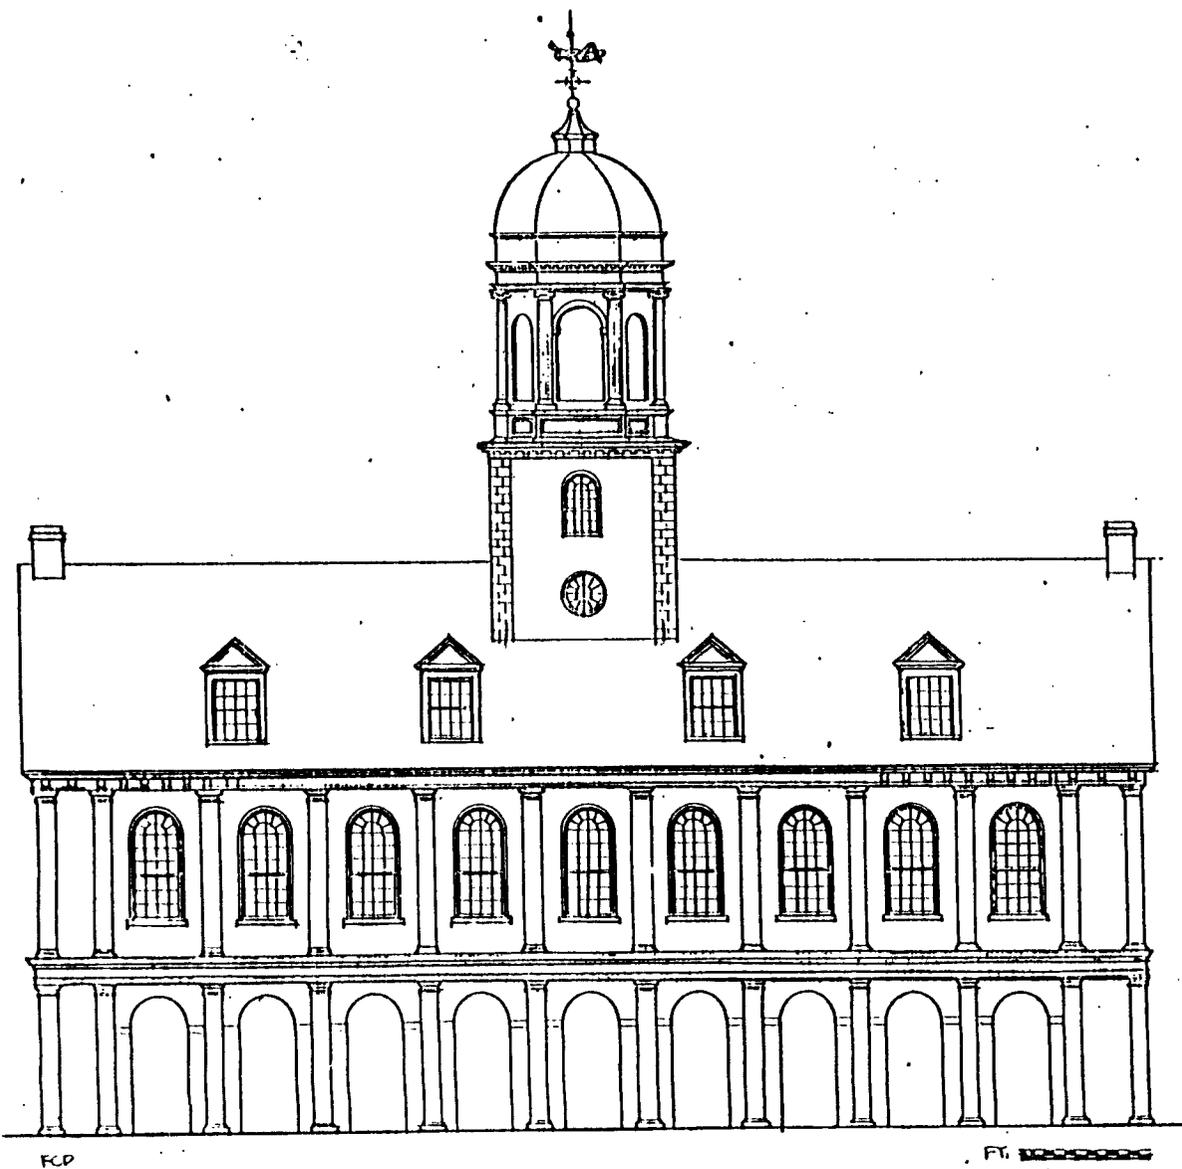
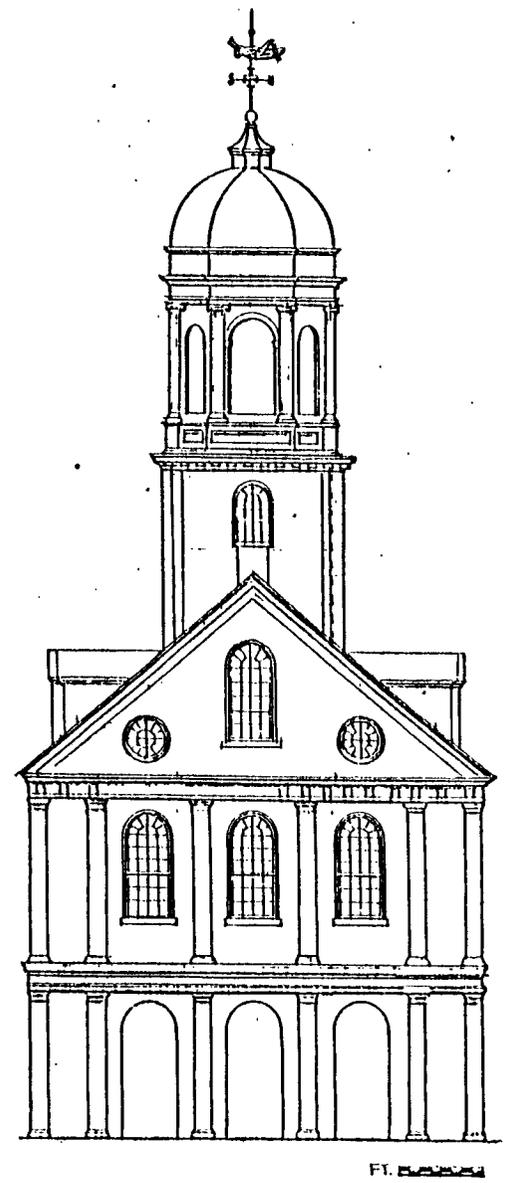
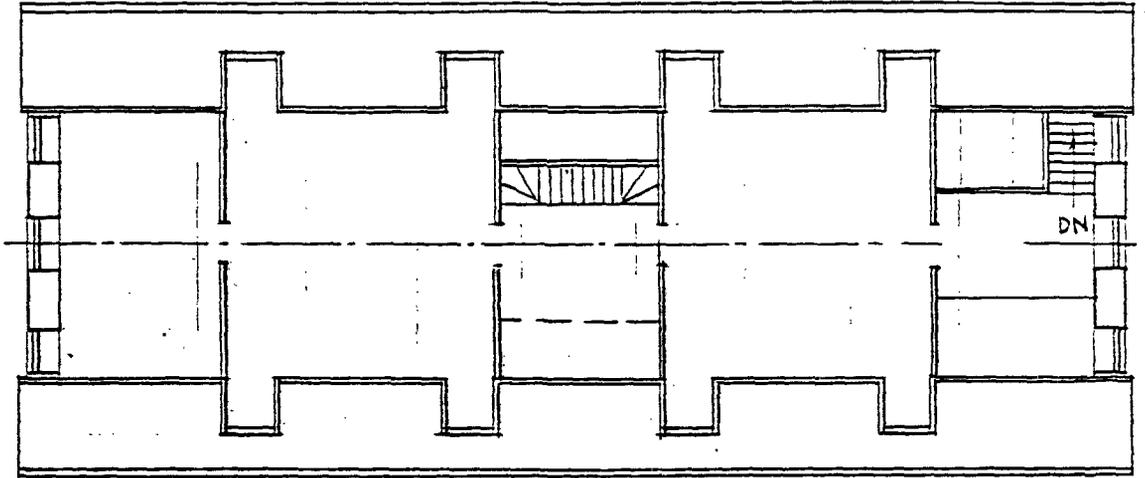
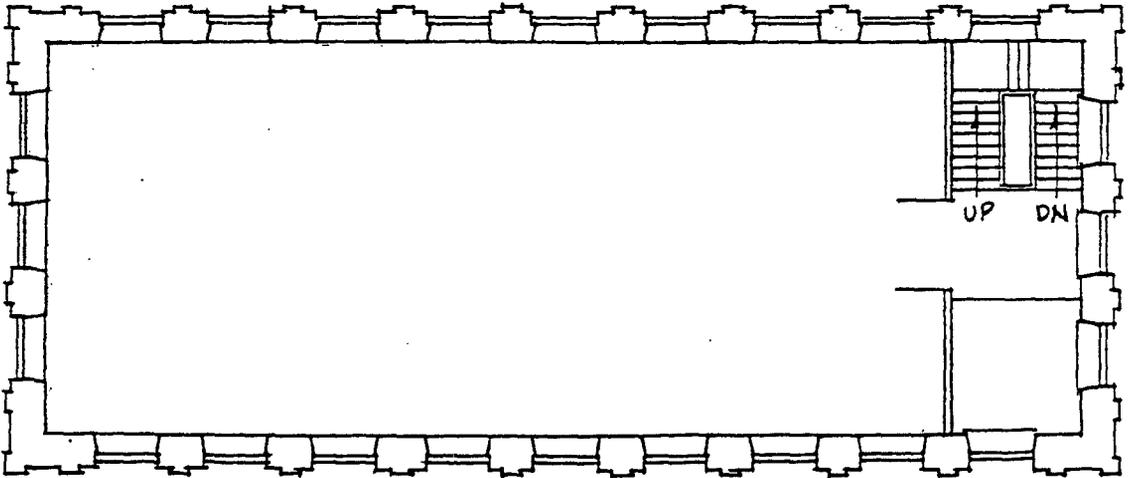
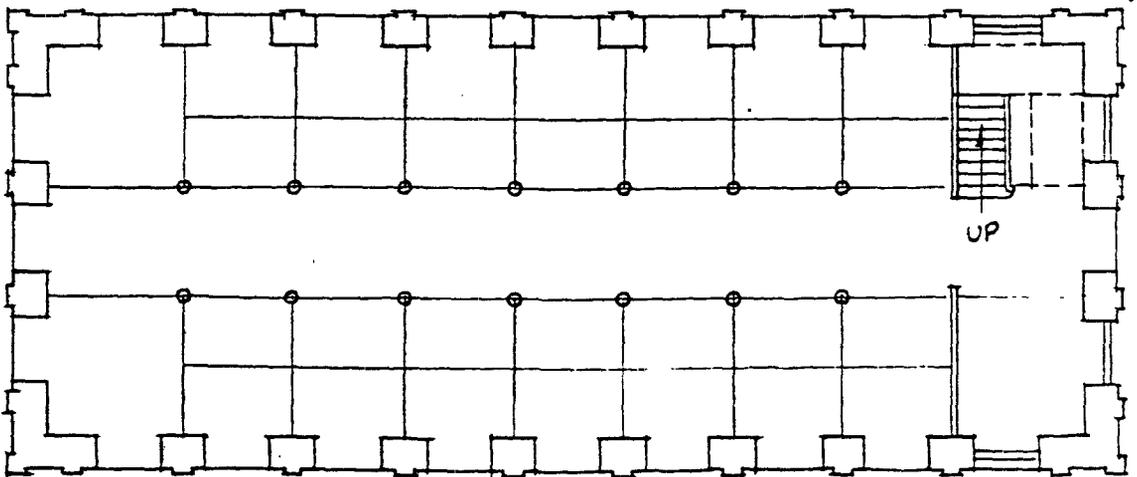
Illustration 14. Reconstructed Elevations of Faneuil Hall (c. 1761-1805).

CHAMBERS

HALL

MARKET

Appearance and Use c. 1768-1805. Necessary improvements and repairs continued to be made in the area around the building as well as to the building itself (Ill. 14, 15). In 1770 the town decided "that the Passage Way leading from the North part of Faneuil Hall Market into Ann Street and Union Street, is so narrow as often times to obstruct the passing of Carts, Trucks, and other Carriages thereby endangering the Limbs and Lives of the Inhabitants and is a public Nuisance." They thus voted "that the Selectmen be impower'd to fill up the Dock from the South East Corner of the Town's Land to the Warehouse occupied by the Heirs of the late John Fayerweather...for the present accomodation of Faneuil Hall Market" (Ill. 6).

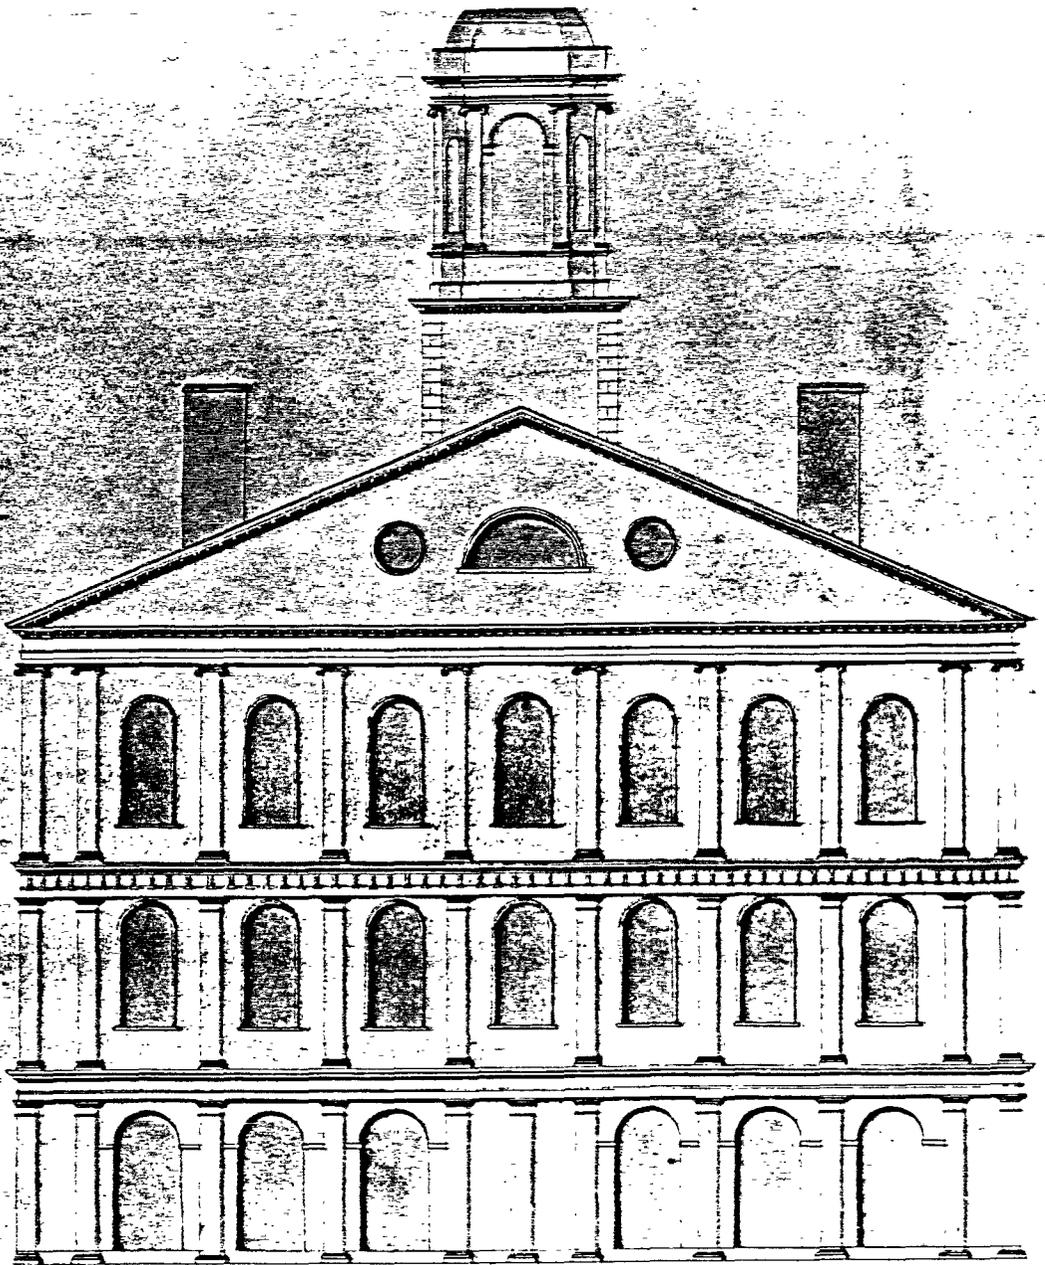
Illustration 17. Faneuil Hall -- "East End" (c. 1805).

*East End*

From early descriptions, views, Bulfinch's architectural drawings, and other sources, we may glean a fairly clear impression of the appearance and use of the newly enlarged Faneuil Hall. It is clear that the Hall as expanded in 1806 was nearly four times larger than the original structure. Its width was doubled via an addition of equal size to the north, and its height was doubled. This form differs little from what we know today. As shown in his architectural drawings (Ill. 17-20), Bulfinch extended the same freestone Tuscan and Doric entablatures with their pilasters and capitals around the new portions of the building, and continued the hierarchy of the orders by adding Ionic pilaster capitals to the third story. Two chimneys appear at the roof level, with the ridge crowned with what appears to be the original cupola, simply relocated from the middle to the east end. At the east and west ends, the arched windows of the old hall are duplicated at the third-floor level. However, on the north and south sides, square-headed openings light the gallery level; a row of lunettes lights the armory floor.

Comparison of the Bulfinch drawings with early views and with the existing building reveals that certain variances from the original design occurred, in addition to later documented changes. On the exterior, Bulfinch's "East End" elevation shows that he originally intended no center entrance on this main facade — a fact explained by the stair configuration shown in his ground-floor plan. The retention of the north wall of the building precluded a central opening at the west end as well. There is no certain evidence that the building was constructed in this manner. The earliest view, by Abel Bowen in Shaw's 1817 History of Boston (Ill. 21), shows the east facade of the building essentially as Bulfinch designed it.

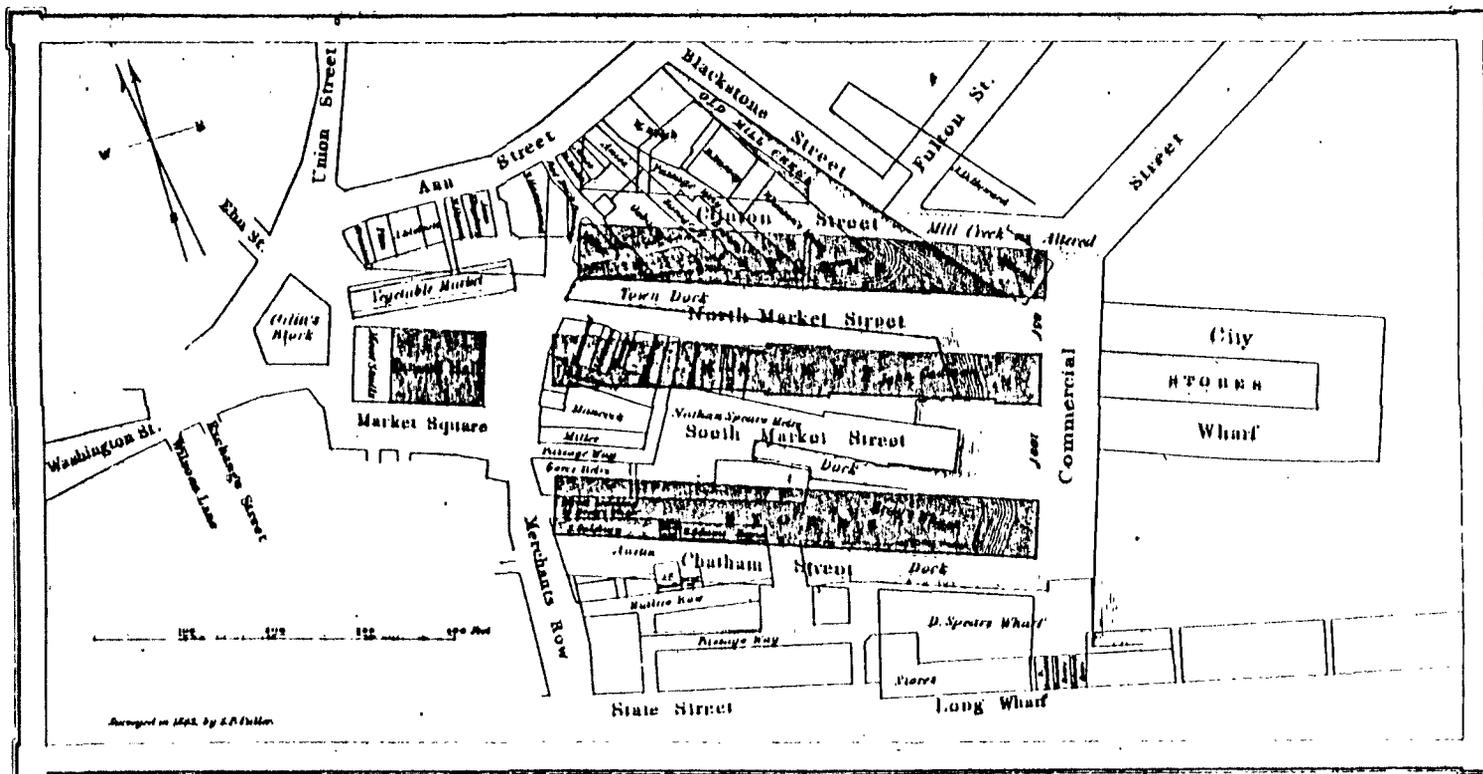
Illustration 25. Plan of Quincy Market and Faneuil Hall (1823).

GROUND PLAN OF THE MARKET HOUSE, ERECTED IN 1823, AND OF THE SPACE INCLUDED IN THE IMPROVEMENT.

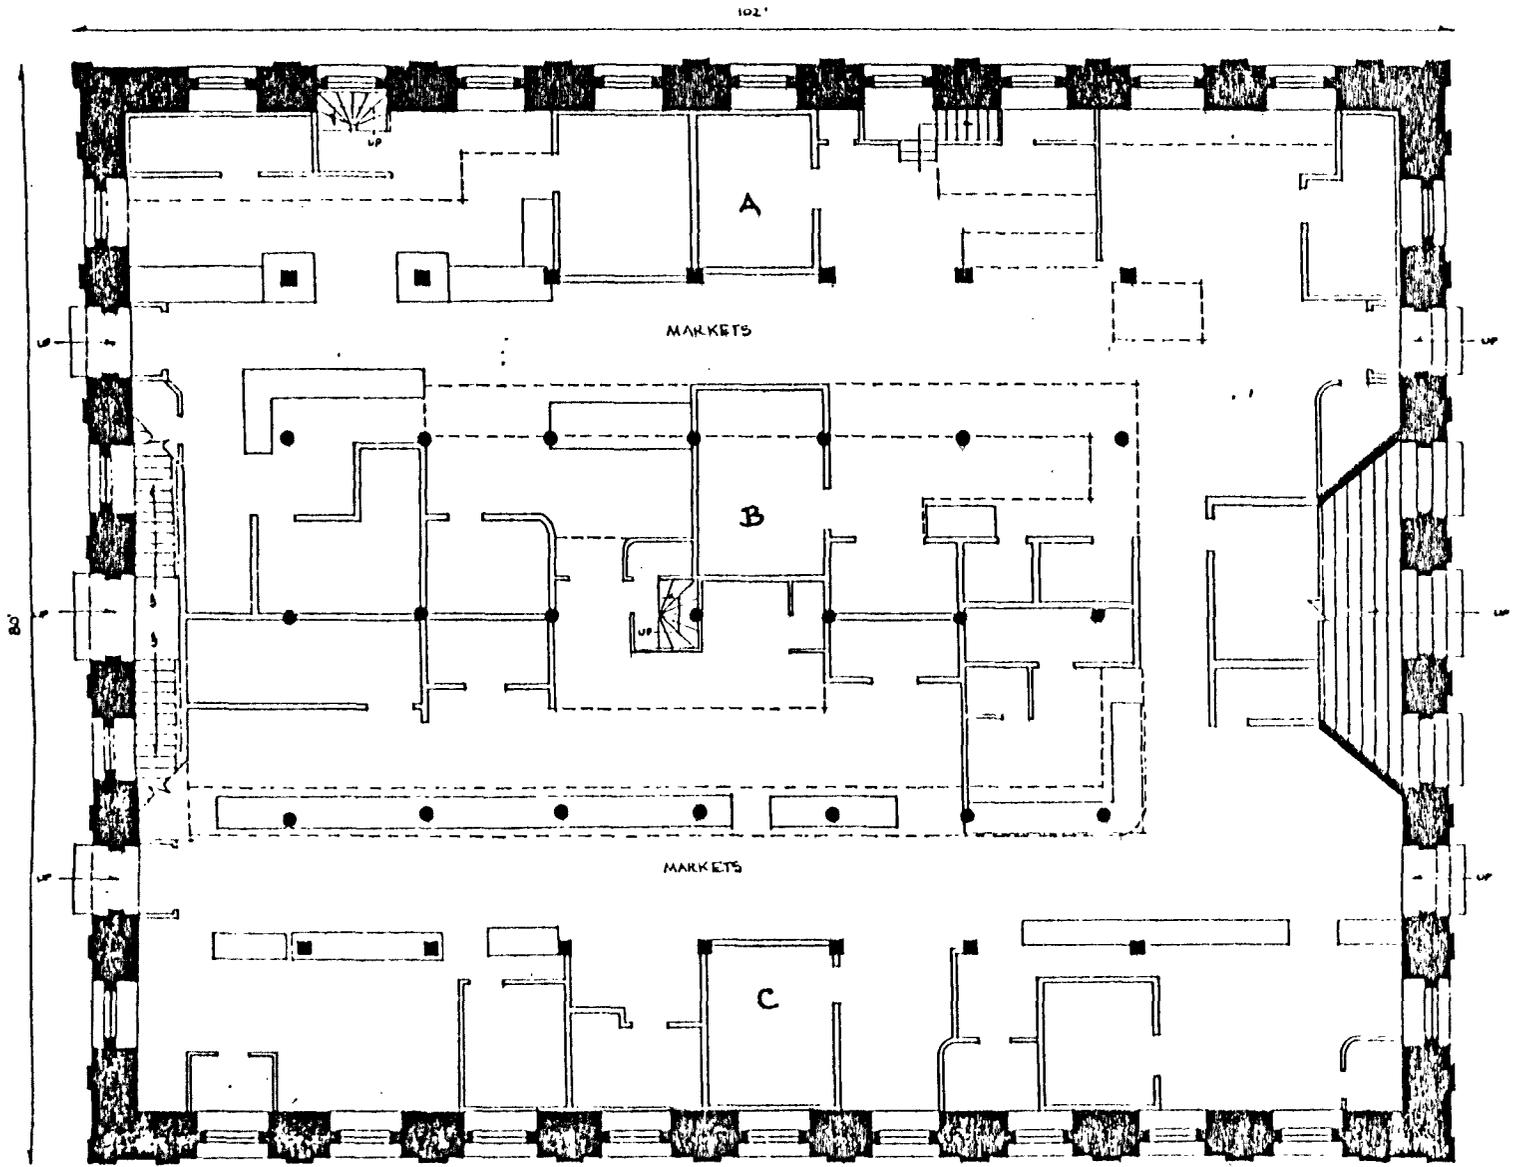
FANEUIL HALL  
FIRST FLOOR

DIAGRAM ONLY  
DIMENSIONS APPROXIMATE

Schematic plans (Ill. 78-82) made c. 1970 by Architectural Heritage, Inc., show the layout of the tenant areas on the ground floor and basement levels, as described above. However, the covered canopy, as well as half of the market stalls, would disappear during renovations made to the building in the 1970's. Waterfront Renewal proposals being made at that time included the restoration of Faneuil Hall Market ("Quincy Hall"), the North and South Market buildings, and Faneuil Hall (Ill. 83). Work on the latter was implemented in 1975-76. The project was funded partially by the City of Boston and partially by an historic preservation grant from the National Park Service through the Massachusetts Historical Commission. This work was carried out by Stahl/Bennett, Inc. It is described in their architectural drawings dated November 4, 1975, as well as in a "Completion Report" filed by them with the National Park Service shortly after the work was finished, under the firm's new title: Perry, Dean, Stahl, and Rogers. The work was performed under contract to the City of Boston's Public Facilities Department. It consisted primarily of an exterior renovation and an updating of interior fireproofing, with Cousins Company of Medford, Massachusetts, being the general contractor. (15)

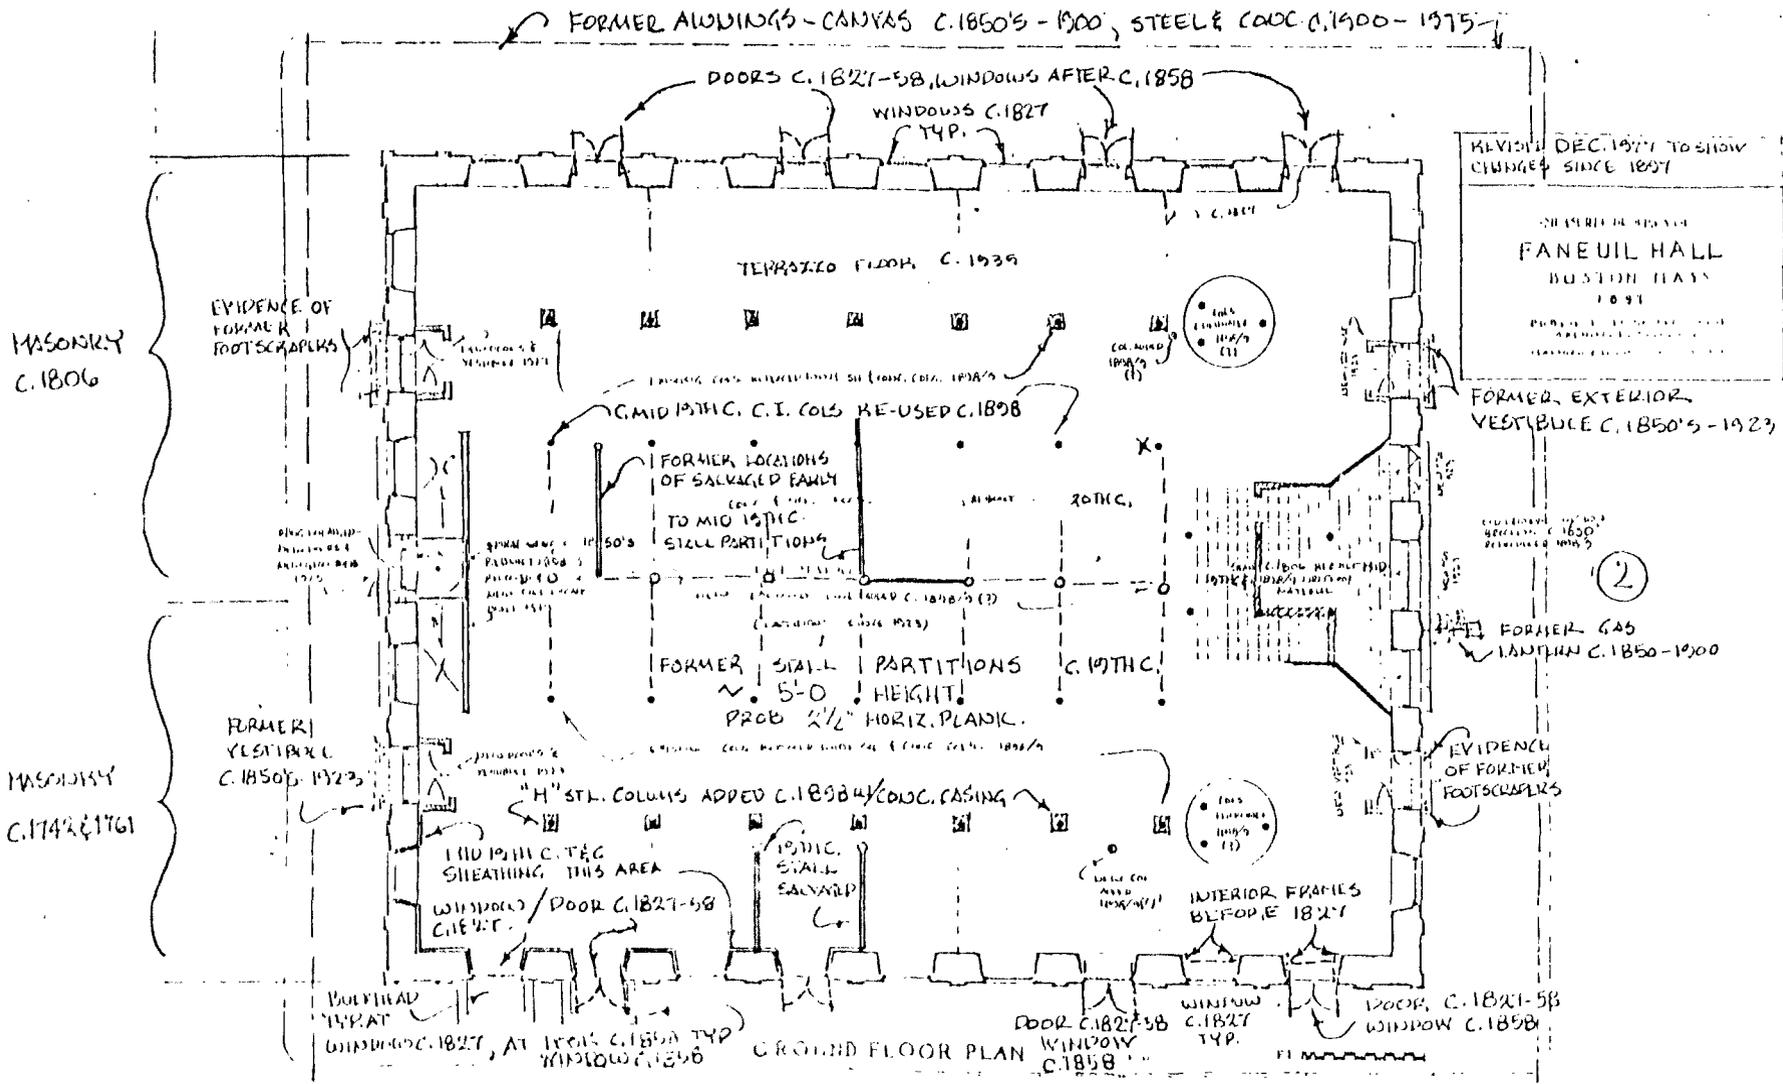
Illustration 98. Architectural Changes, Market Floor (1897/1977).

FANEUIL HALL - MARKET FLOOR, PLAN DATING MATERIAL COMPONENTS

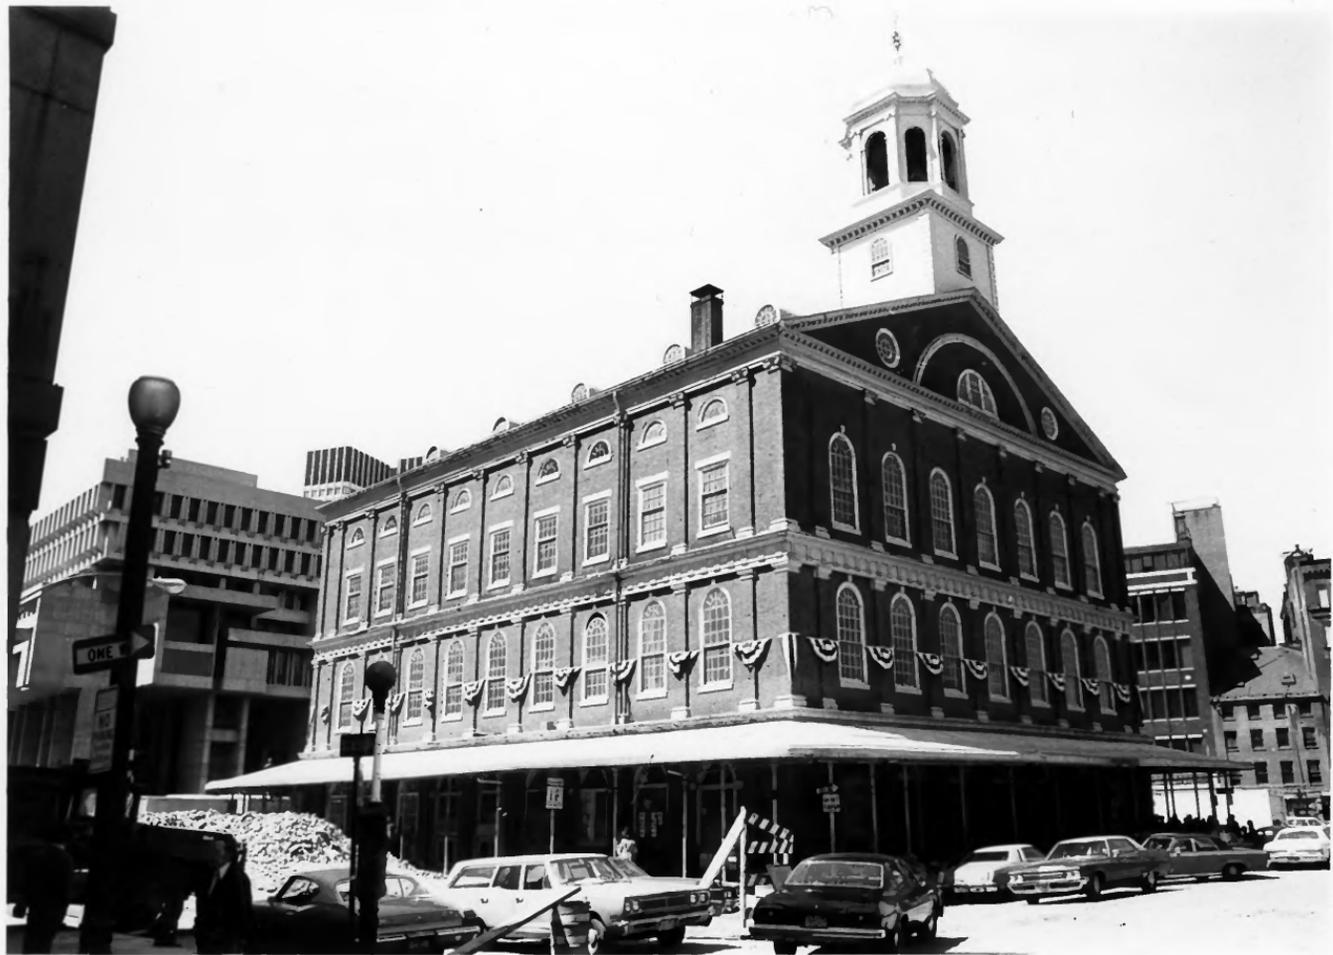
PHOTO NO. 1

south and east (left and right) elevations

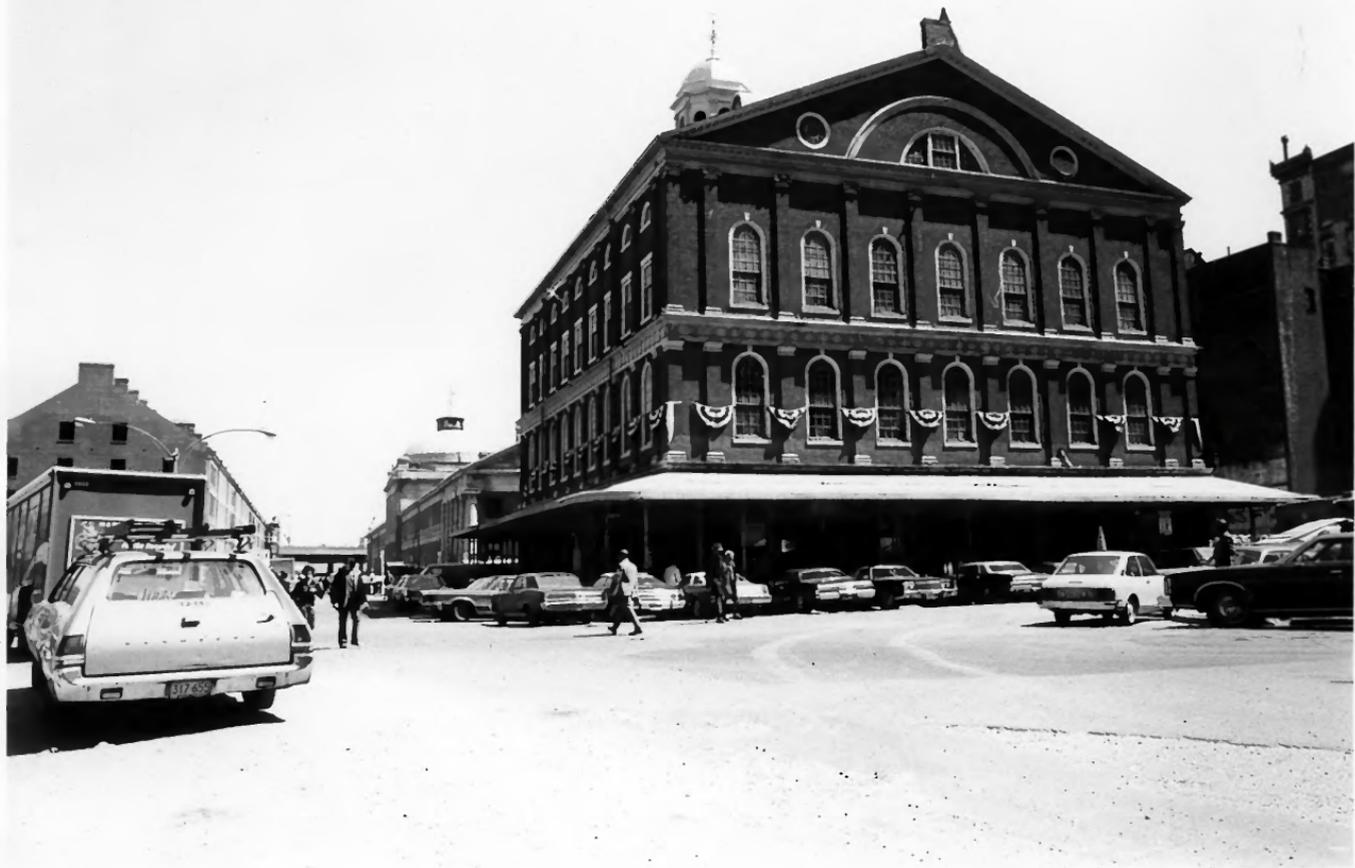
PHOTO NO. 2

north and west (left and right) elevations
