NATIONAL REGISTER OF HISTORIC PLACES
REGISTRATION FORM

historic name Moulton-Wells House

other names/site number Eldora State House

**United States Department of the Interior
National Park Service****National Register of Historic Places
Continuation Sheet**Moulton-Wells House, Volusia
County, Florida
Narrative DescriptionSection number 7 Page 1

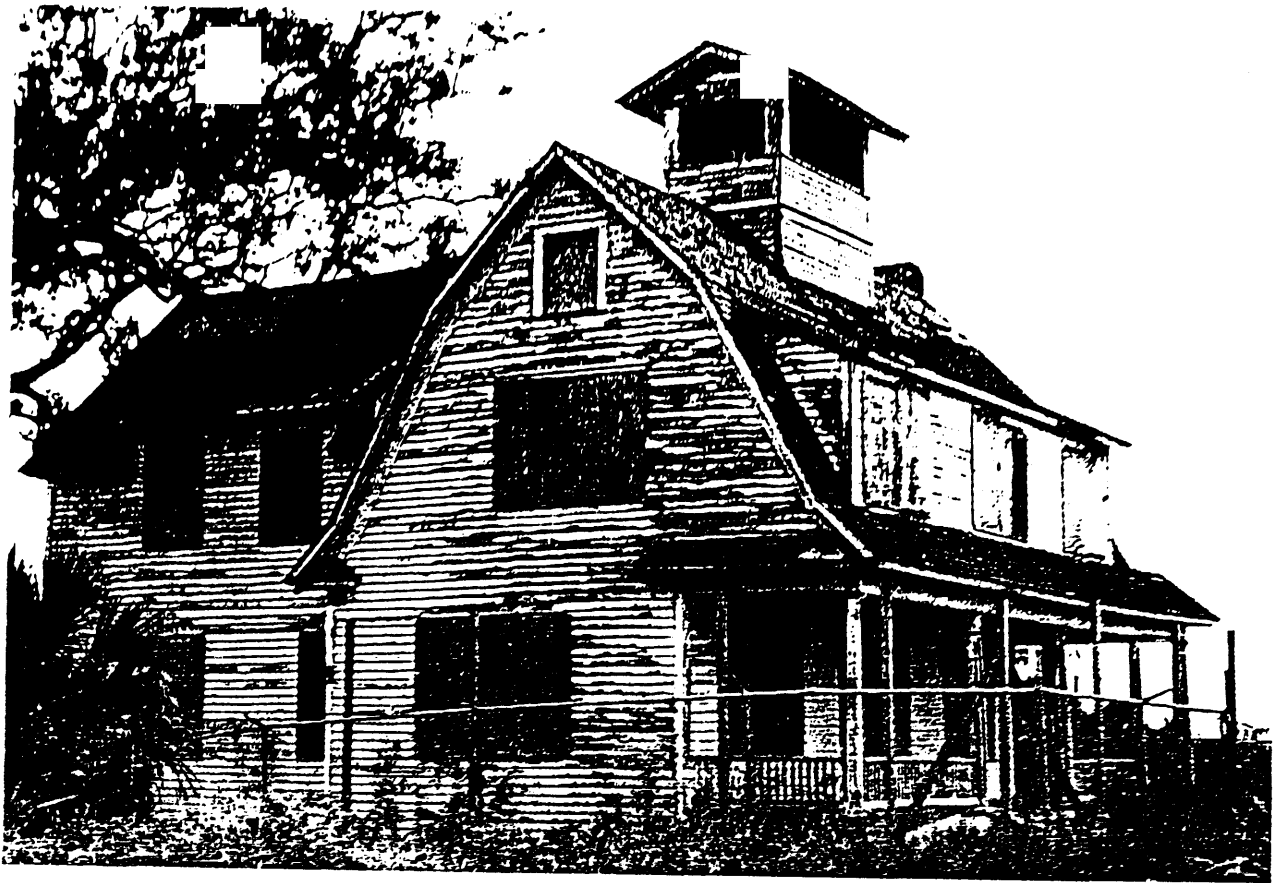
P 1. Northwest corner of house (camera faces southeast) Jan. 1989

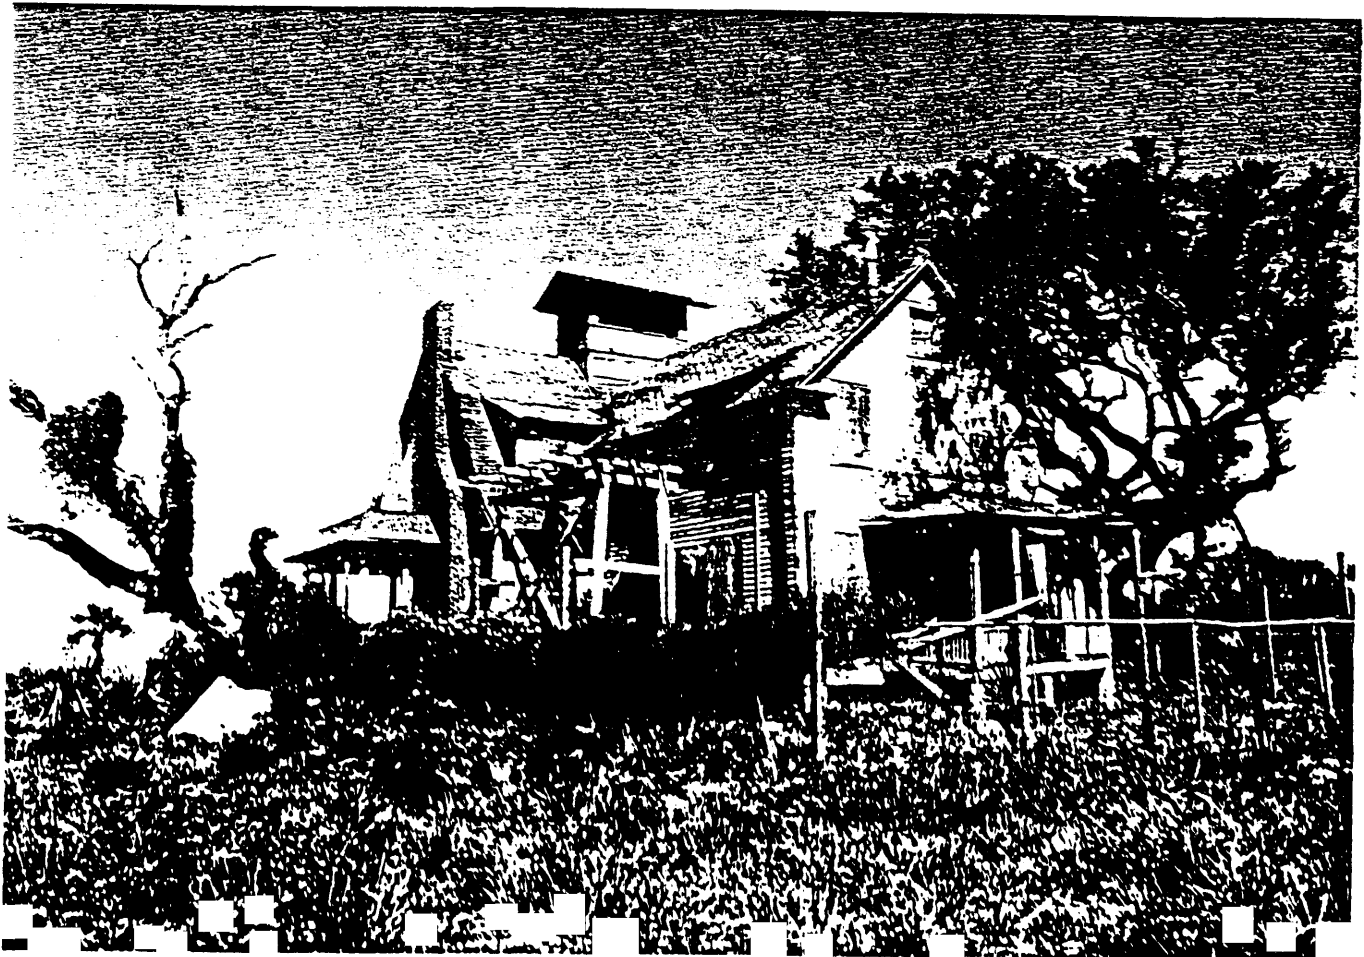
P 4. Southeast corner of house (camera faces northwest) Jan. 1989

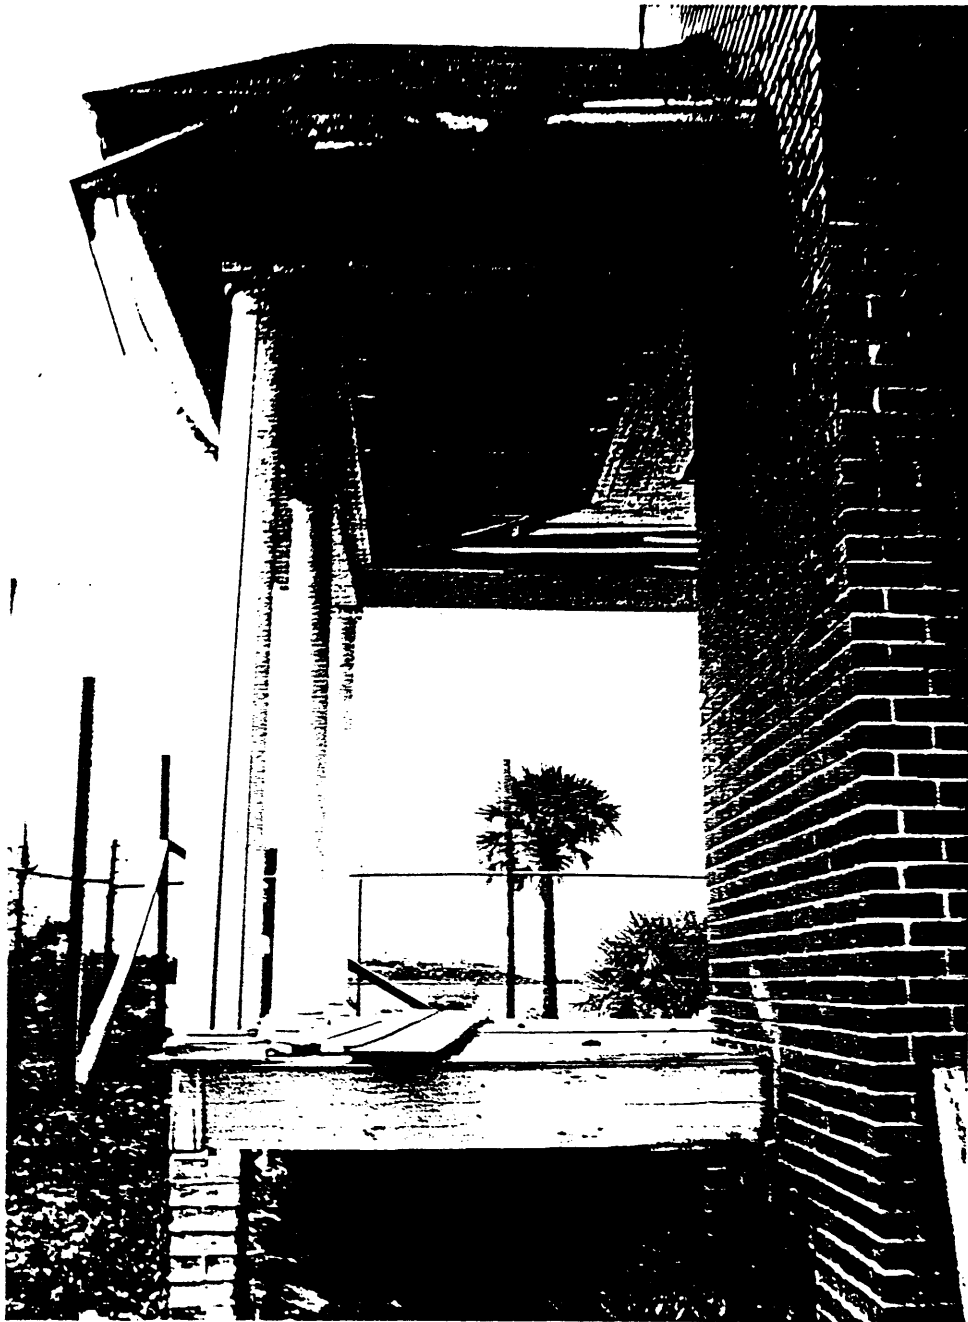
P 5. Front porch; note deteriorated condition of piers, columns, ceiling and gutter (camera faces west)
March 1990

Substantial stabilization work has been performed on the Moulton-Wells House since 1989, when the roof then present was replaced with a temporary rolled composition roof, and necessary structural repairs were performed to slow the effects of decay resulting from the damage noted above. Between 1991 and 1997, three monetary grants from the State Of Florida Bureau of Historic Preservation, donated funds and materials solicited by the non-profit group Friends Of Canaveral, and extensive matching funds from the National Park Service, resulted in a thoughtful, comprehensive approach to stabilization of the Moulton-Wells House. The installation of a new composition shingle roof, acquisition of as-built architectural drawings, and the professional research, definition, and printing of rehabilitation contract specifications were achieved during this period; the first major work accomplished as a result was a thorough and faithful replacement of both front and rear porches under a carefully specified contract in 1997.

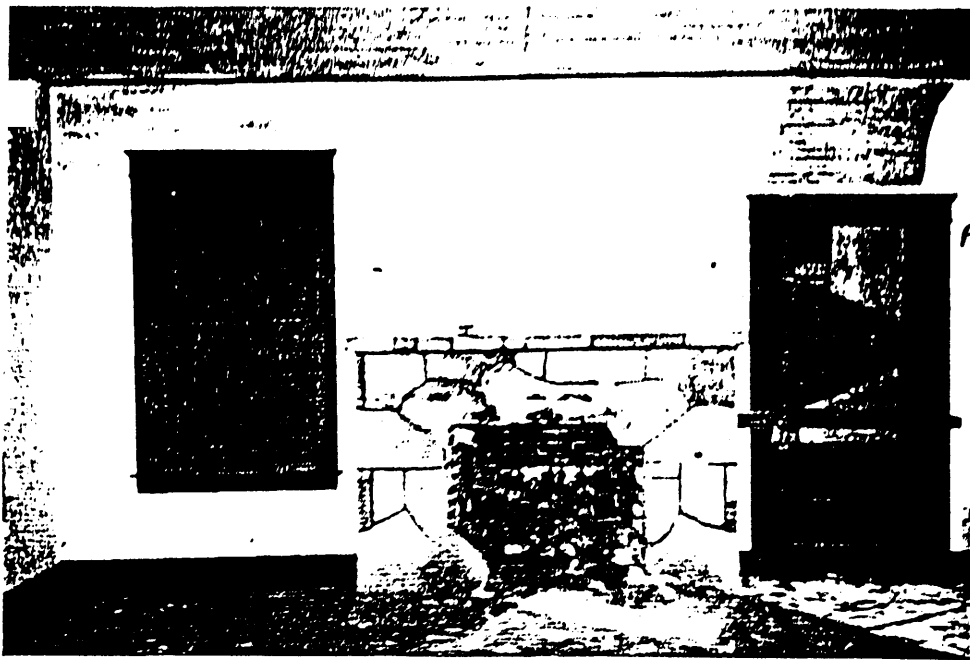
P 6. Living Room; note deteriorated condition of window, door, plaster, fireplace & barbed wire across window opening to deter break-ins (camera faces south) March 1990

A second, more ambitious contract from October, 1998 through May, 1999 rehabilitated the interior and exterior of the house to specifications defined by National Park Service Historic Architects from the Southeast Regional Office in Atlanta and consulting architects under contract to the Friends Of Canaveral, in coordination with grant provisions of the State of Florida Bureau of Historic Preservation. Major improvements made at that time include the installation of code-compliant electrical wiring, lighting, fresh water and sewer system plumbing, a state-of-the-art (high groundwater level) septic system, central heating and cooling systems, and installation of a wheelchair ramp external to the southwest aspect of the front porch. Incoming electrical service to the house was relocated to an underground configuration. The severely deteriorated interior wall and ceiling surfaces were removed and replaced with sheetrock (drywall) faced with unfinished plaster. All original door and window trim, baseboard, and cornice trim wood was carefully removed, refinished, and replaced in its original configuration within the house. The condition of all flooring (yellow pine throughout the house) was evaluated, with the result that some individual boards were replaced with like material, while the entire kitchen room floor was removed and replaced with new similar materials.

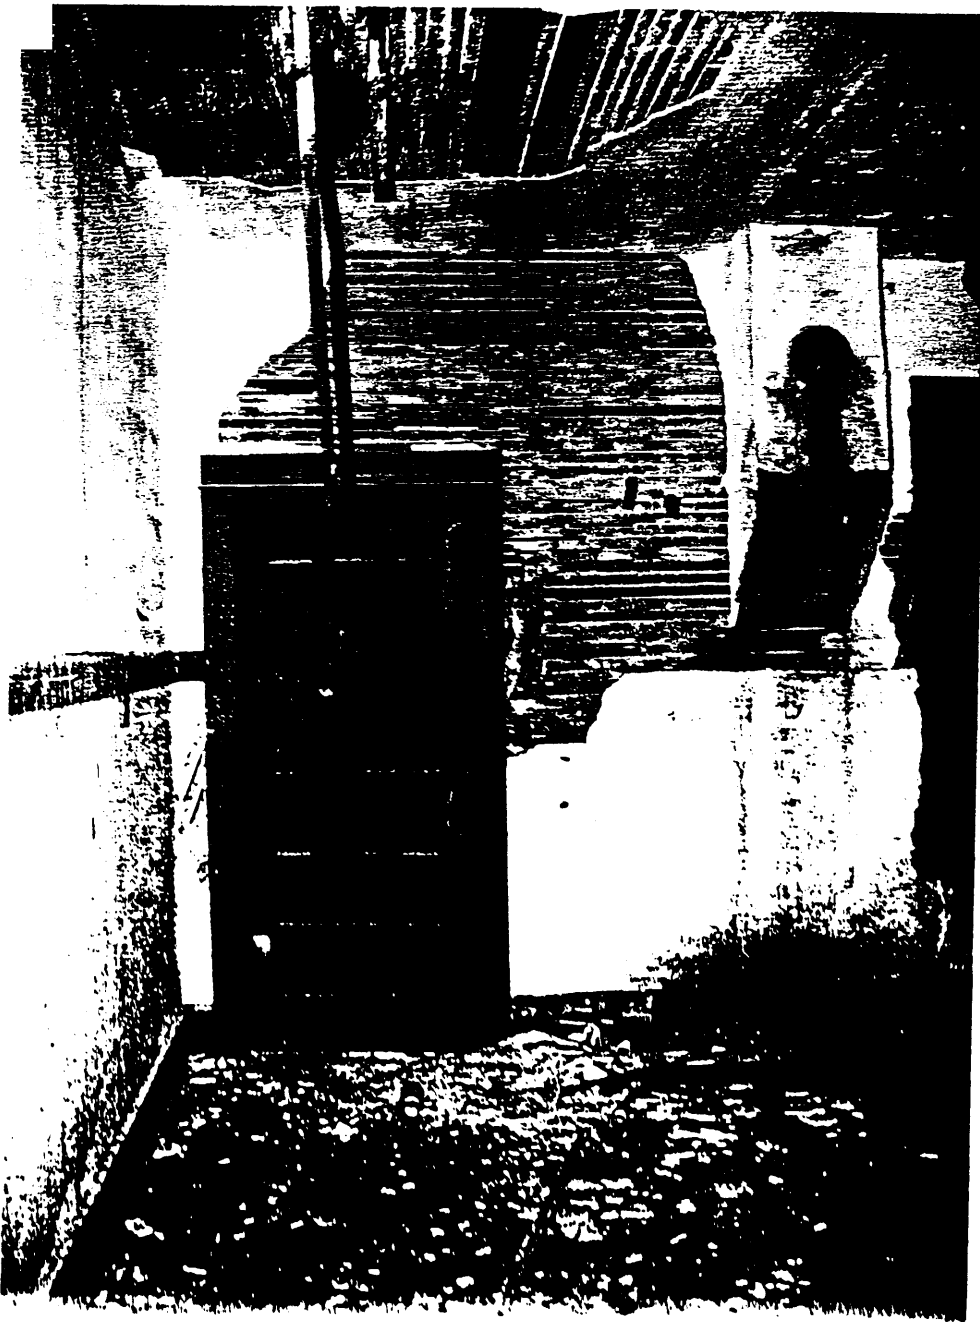
P7. Kitchen; note deteriorated condition of ceiling, wall and door. Also note physical damage caused by fallen limb and moisture damage from rain entering the house. (camera faces east) March 1990

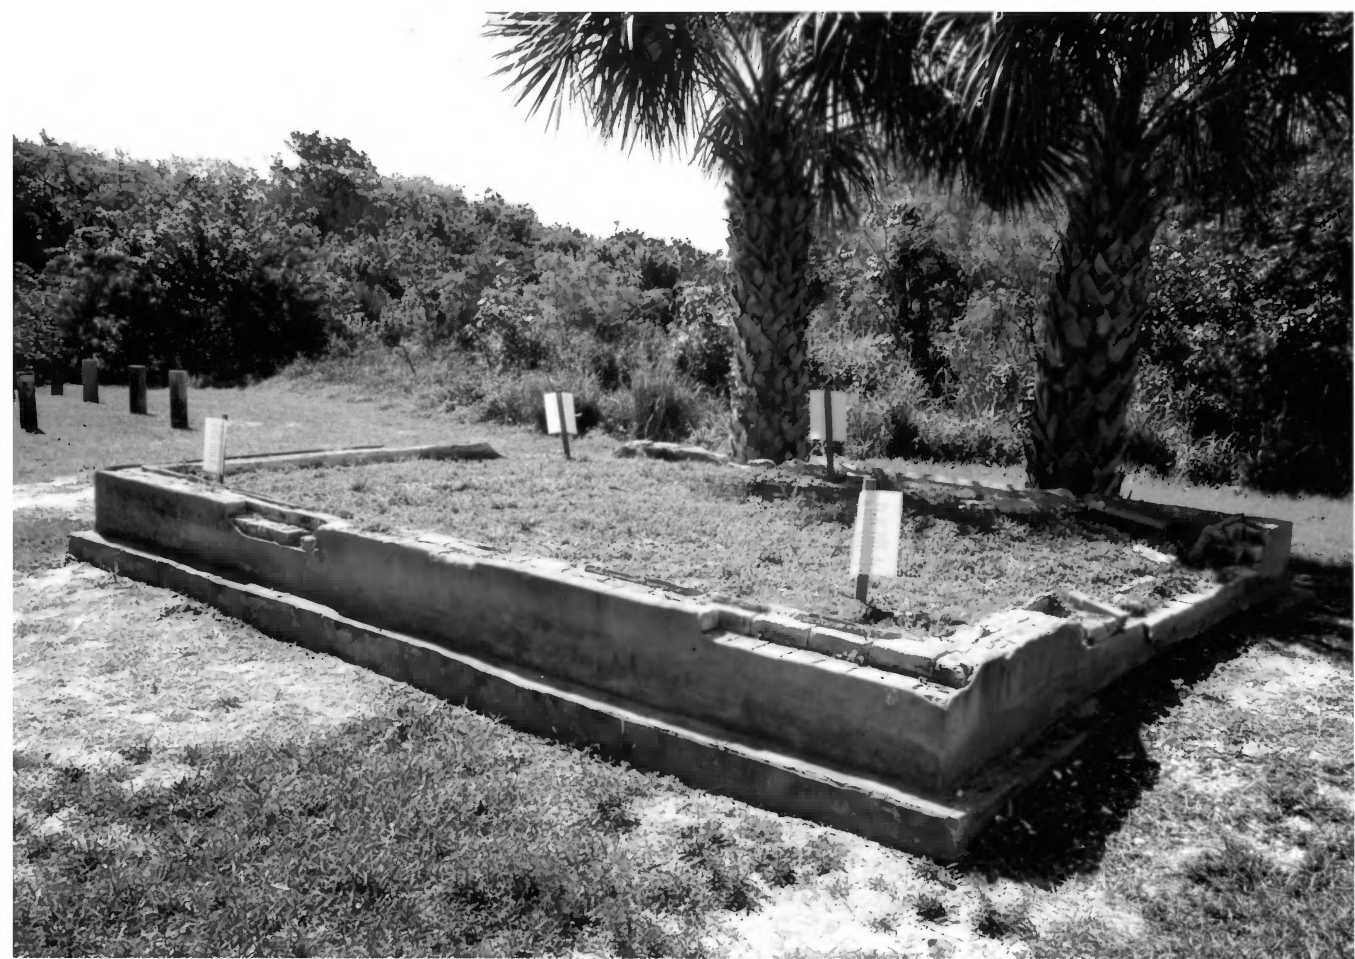
⑧ Moulton-Wells House, Volusia Co., FL

Cistern #1 (photographs 7-8): Situated 30 feet southeast of the Moulton-Wells House, this bricks-and-mortar structure is rectangular in shape, with internally-sloping walls and outside dimensions of 12 feet wide by 17 feet long. Faced inside and out with a Portland cement mortar veneer, its overall condition is good. Cistern #1 is shown in photos dating to circa 1930, fitted with gutter pipe extending from the southwest aspect of the State House roof to the east end of the cistern. Historically covered with a low-pitched front gabled shingle roof, the cistern has been open to the elements since the 1980s. This open condition has resulted in the disappearance of all wood roof support members, deterioration of exposed mortar, and dislocation of some of the soft, coarse-textured brick comprising its uppermost tier. Woody plants have established roots in the east end wall, hastening its disintegration.

1. Eldora
2. Volusia County, Florida
3. Reid Miller
4. April, 2001
5. Moulton-Wells House
6. View of cistern #1 from north, looking south
7. Photograph number 01-08

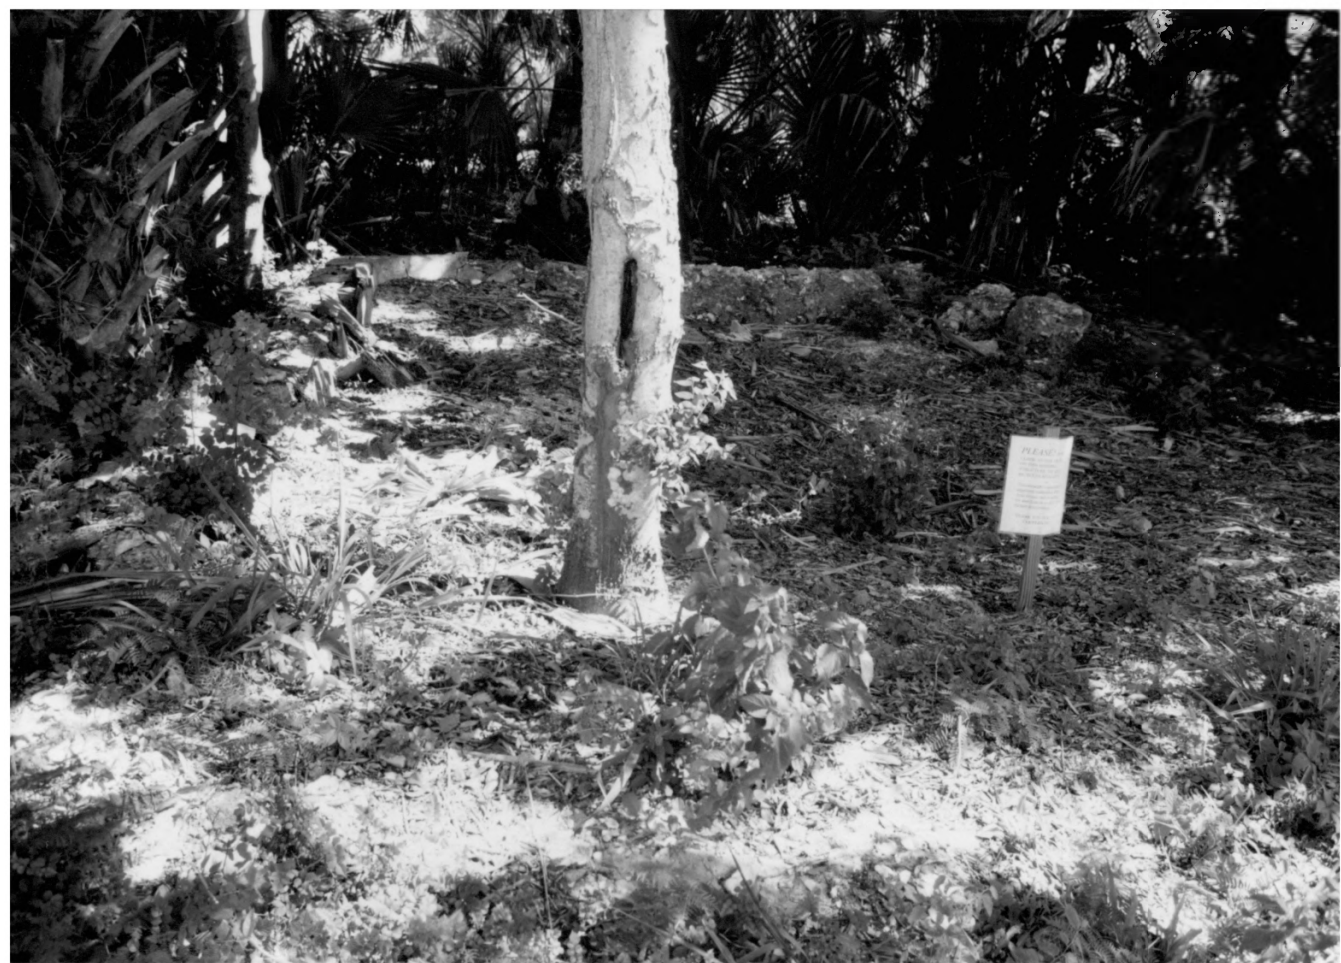
⑨ Moulton - Wallis House, Volusia Co., FL

Cistern #2 (photograph 9): Possibly the oldest of the three cisterns, this structure lies 42 feet northeast of the Moulton-Wells House. It was roofed similarly to cistern #1, as depicted in photographs taken circa 1927-1930; its roof is now completely missing. Like cistern #1, cistern #2 was supplied with rainwater collected from the State House roof, which was channeled to the south end of the cistern through an elevated, sloping gutter. This structure is constructed of tabby, a coarse oyster shell conglomerate bonded with reconstituted lime (produced by mixing burned, powdered oyster shell and fresh water). It is faced with a Portland cement veneer. Its roof having been gone for decades, the walls of this cistern are severely disintegrated, although its apparent original outline is still discernible, with overall dimensions of 14 feet wide by 18 feet long.

1. Eldora
2. Volusia County, Florida
3. Reid Miller
4. April, 2001
5. Moulton-Wells House
6. View of ruins of cistern #2 from southwest, looking northeast
7. Photograph number 01-09
