**United States Department of the Interior**  
**National Park Service**  
**National Register of Historic Places**  
**Registration Form**

historic name Colorado National Monument Visitor Center Complex

other names/site number 5ME.11658

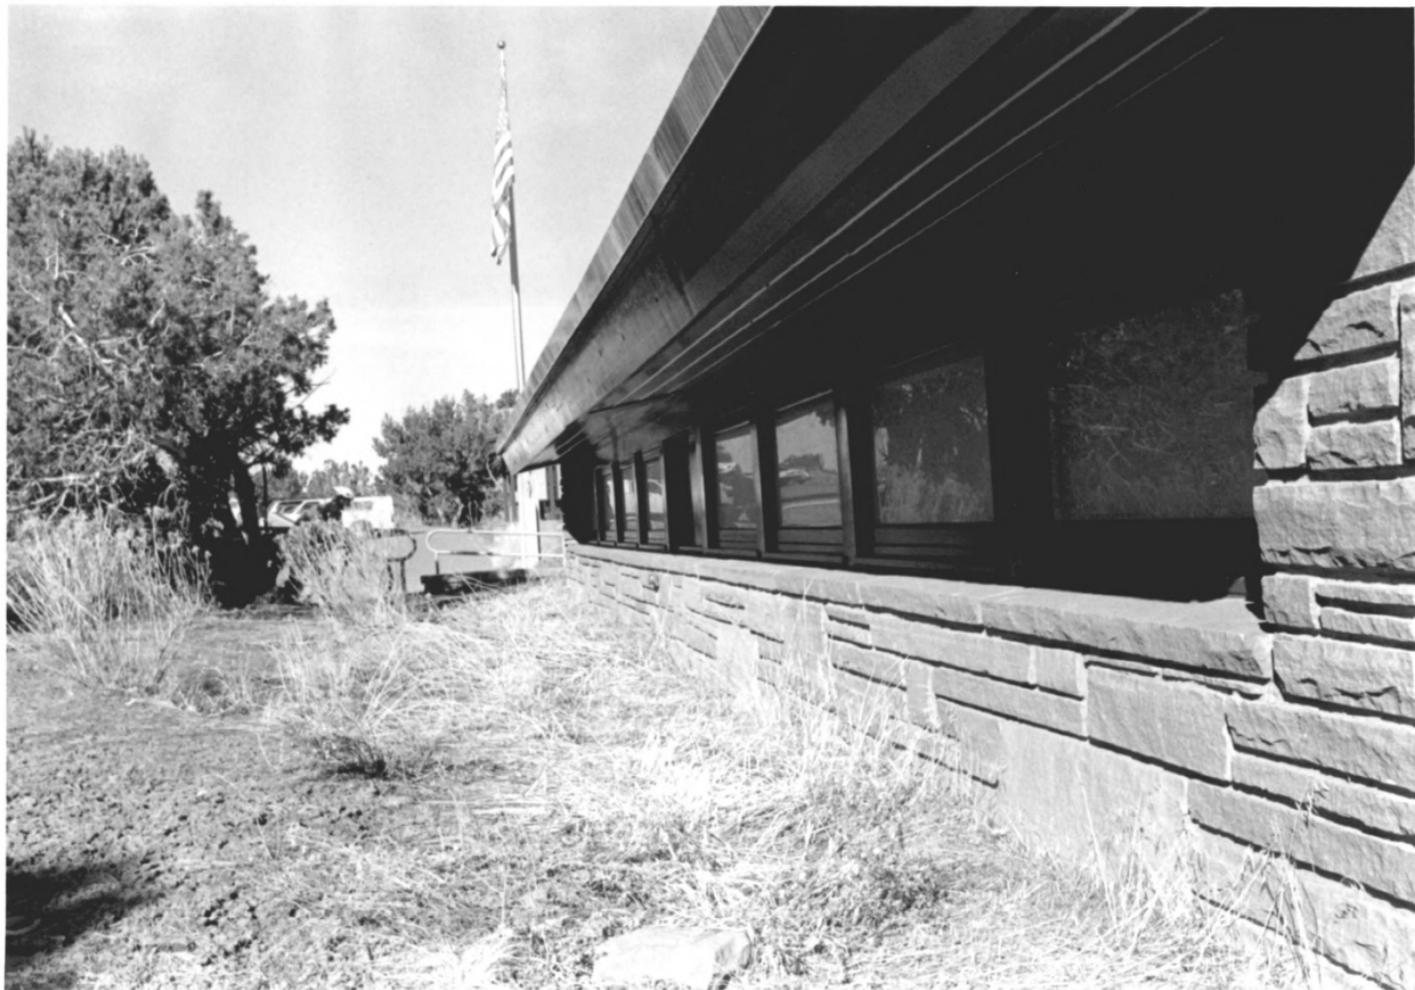
1. COLORADO NATIONAL MONUMENT VISITOR CENTER COMPLEX
2. MESA COUNTY, COLORADO
3. PHOTOGRAPHER: SETH ROBERTS
4. DATE: MARCH 2002
5. NEGATIVE NO. 4-14 COLORADO NATIONAL MONUMENT
6. FRONT (SIDE OF VISITORS CENTER), LOOKING  
SOUTHWEST
7. PHOTO NO. 4

The 3,000-square-foot Visitor Center is a one-story rectangular building with a basement; it is faced with stone masonry on a poured concrete foundation. The facade is sandstone in a random ashlar pattern. The building is comprised of two wings; a central lobby separates the exhibition wing on the west end and the office wing on the east end. The building, which faces north, is side-gabled; the gables meet near the middle of the roof and are offset at different top heights; the roof over the exhibition wing is higher than the roof over the office wing.<sup>4</sup> The sandstone chimney from the

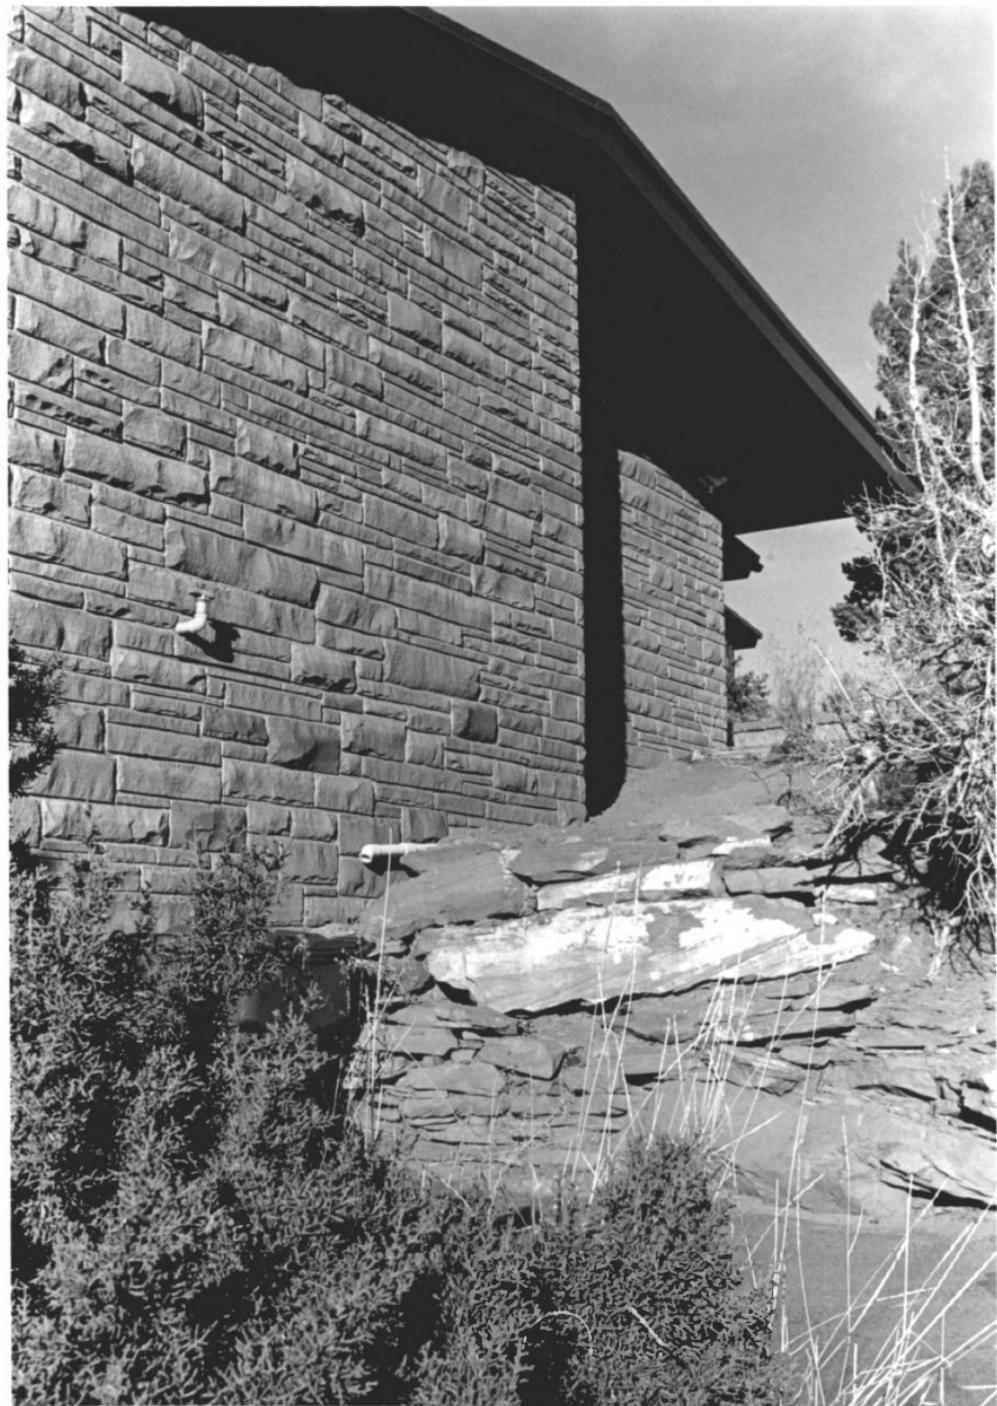
1. COLORADO NATIONAL MONUMENT VISITOR CENTER COMPLEX
2. MESA COUNTY, COLORADO
3. PHOTOGRAPHER: SETH ROBERTS
4. DATE: MARCH 2002
5. NEGATIVE NO. 1-18 COLORADO NATIONAL MONUMENT
6. FRONT SIDE OF VISITORS CENTER, LOOKING  
NORTHEAST
7. PHOTO NO. 5  
5ME.11658

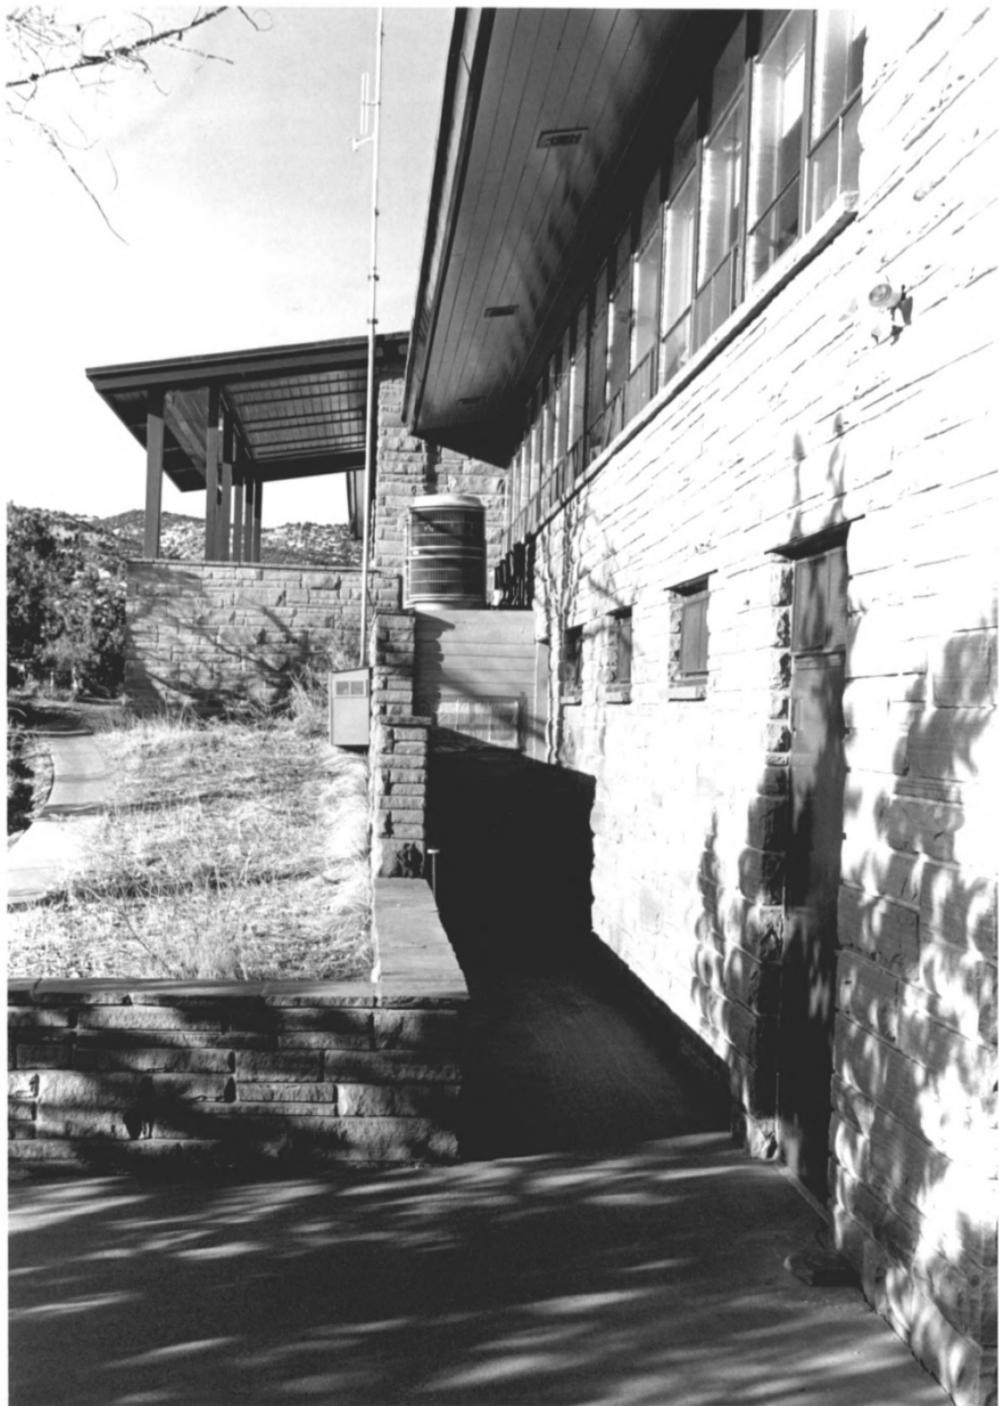
1. COLORADO NATIONAL MONUMENT VISITOR CENTER COMPLEX
2. MESA COUNTY, COLORADO
3. PHOTOGRAPHER: SETH ROBERTS
4. DATE: MARCH, 2002
5. NEGATIVE NO. 3-7 COLORADO NATIONAL MONUMENT
6. EAST SIDE OF VISITORS CENTER, LOOKING NORTHWEST
7. PHOTO NO. 6

As previously noted, the eastern wing of the Visitor Center encompasses the park's headquarter operations. A 4'0"-wide corridor runs down the middle of the office wing for 57'6", flanked by offices, a restroom, and a copy room.<sup>7</sup> The four offices on the south side of the corridor are approximately 11' x 14', although each varies slightly in size. These offices, which face the canyon, feature a row of continuous casement and stationary windows that are 5'4" high and extend up to the ceiling. The northern side of the office wing has a restroom, a copy room, and three offices. Two of the offices were the building's original public restrooms, accessed through entry doors on the northern exterior of the building. New public restrooms were built c. 1980 on the western end of the building front, at which time the restrooms were converted into offices. Along the north side of the office wing, a clerestory band of casement windows runs just below the roofline. The basement can be entered from the stairs at the end of the office corridor, or from an outside entrance that also acts as the air intake for the mechanical room in the basement. The basement has four small, rectangular, horizontal, casement

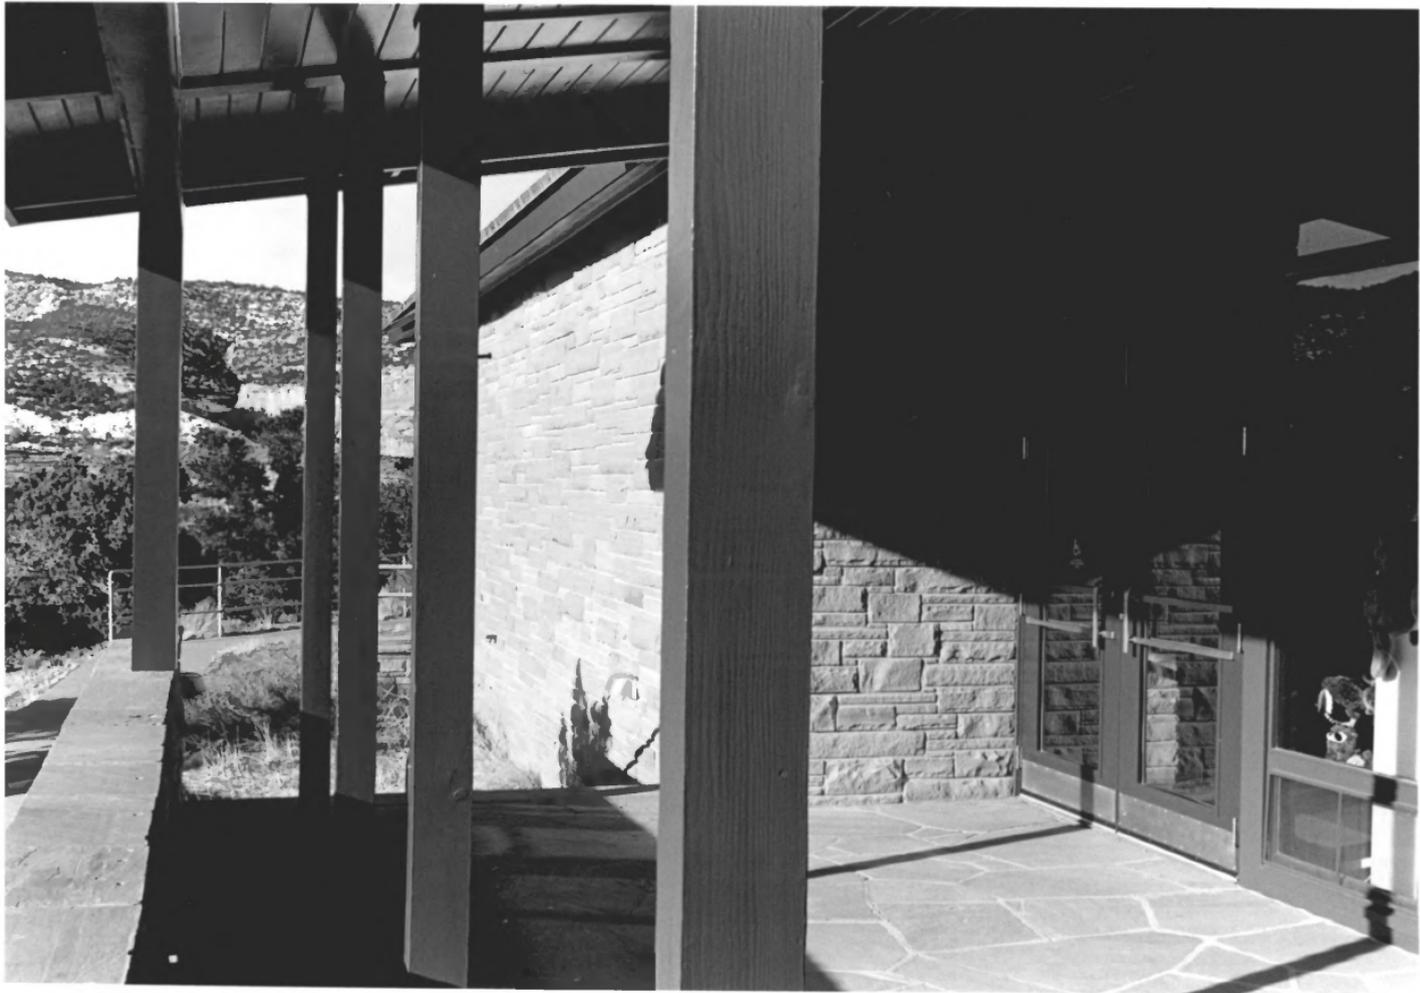
1. COLORADO NATIONAL MONUMENT VISITOR CENTER COMPLEX
2. MESA COUNTY, COLORADO
3. PHOTOGRAPHER; SETH ROBERTS
4. DATE; MARCH 2002
5. NEGATIVE NO. 3-8 COLORADO NATIONAL MONUMENT
6. BACK SIDE OF VISITORS CENTER, LOOKING SOUTHWEST
7. PHOTO NO. 7

Other major work to the building exterior included enclosing the rear porch with storefront glass to create a solarium, which has since been removed. Volunteers, including monument staff and members of the Grand Junction Solar Energy Society, built the solarium c. 1979. The project was part of an energy conservation effort by Colorado National Monument, which was one of six parks chosen by the Department of the Interior to experiment with solar energy. The project included adding a skylight in the roof of the porch and a wood-burning stove.<sup>12</sup> The sun and the wood-burning stove were to heat the enclosed porch and transfer the air to the lobby to defray heating costs. Although the enclosure did, indeed, defray heating costs, it was removed c. 1994 because it also increased cooling costs in the summer. At the same time, the skylights were removed and replaced with decking and roofing materials.<sup>13</sup>

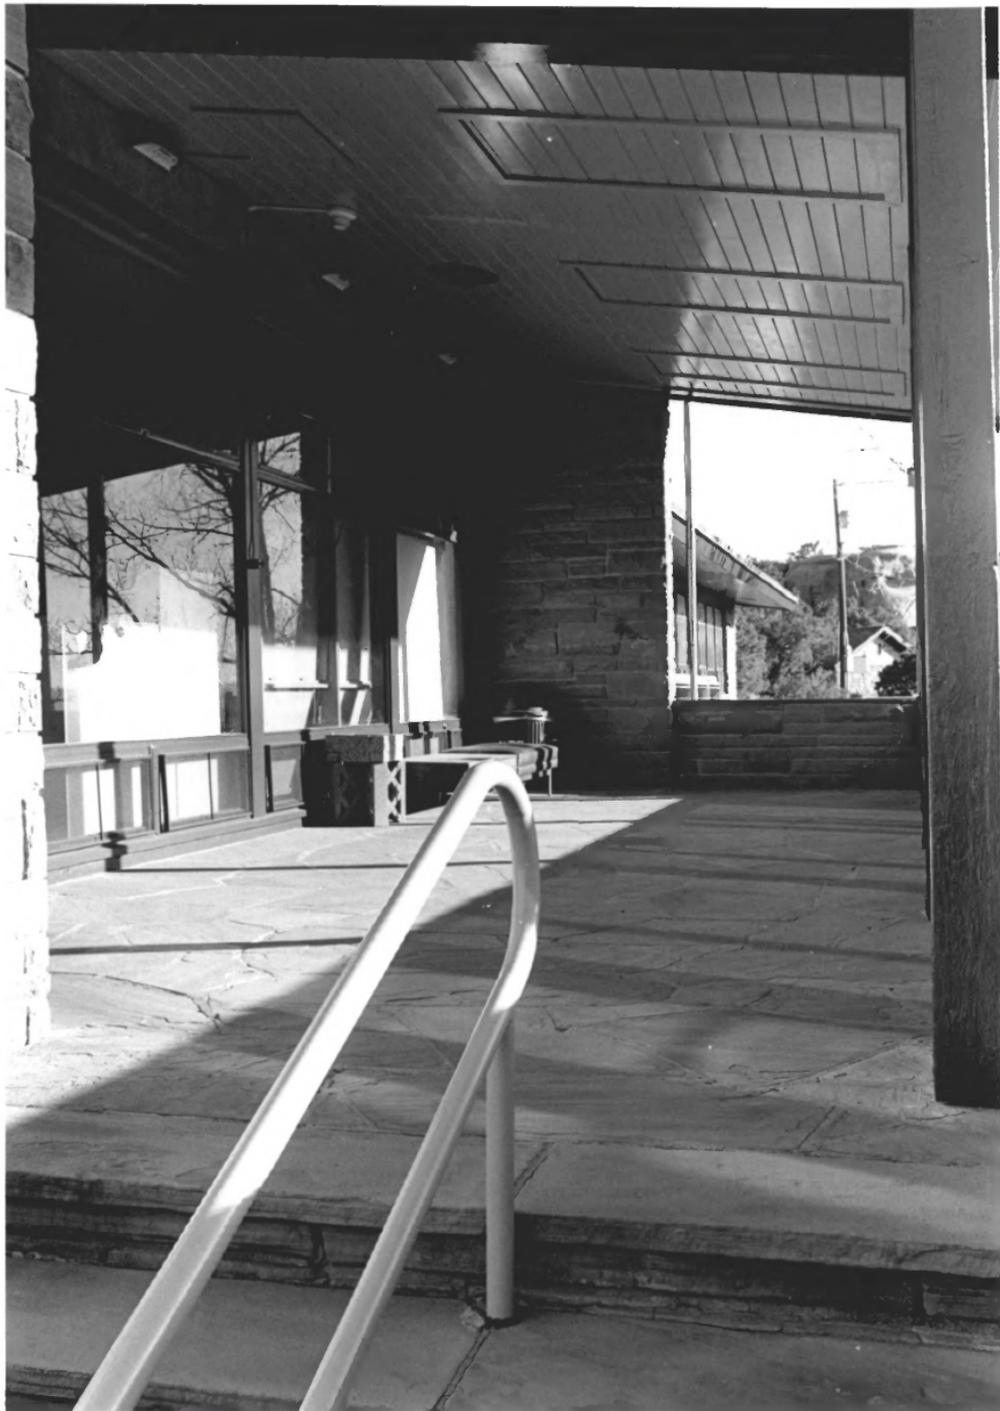
1. COLORADO NATIONAL MONUMENT VISITOR CENTER COMPLEX
2. MESA COUNTY, COLORADO
3. PHOTOGRAPHER: SETH ROBERTS
4. DATE: MARCH 2002
5. NEGATIVE NO. 3-12, COLORADO NATIONAL MONUMENT
6. BACK PORCH OF VISITORS CENTER, LOOKING SOUTHWEST
7. PHOTO NO. 8

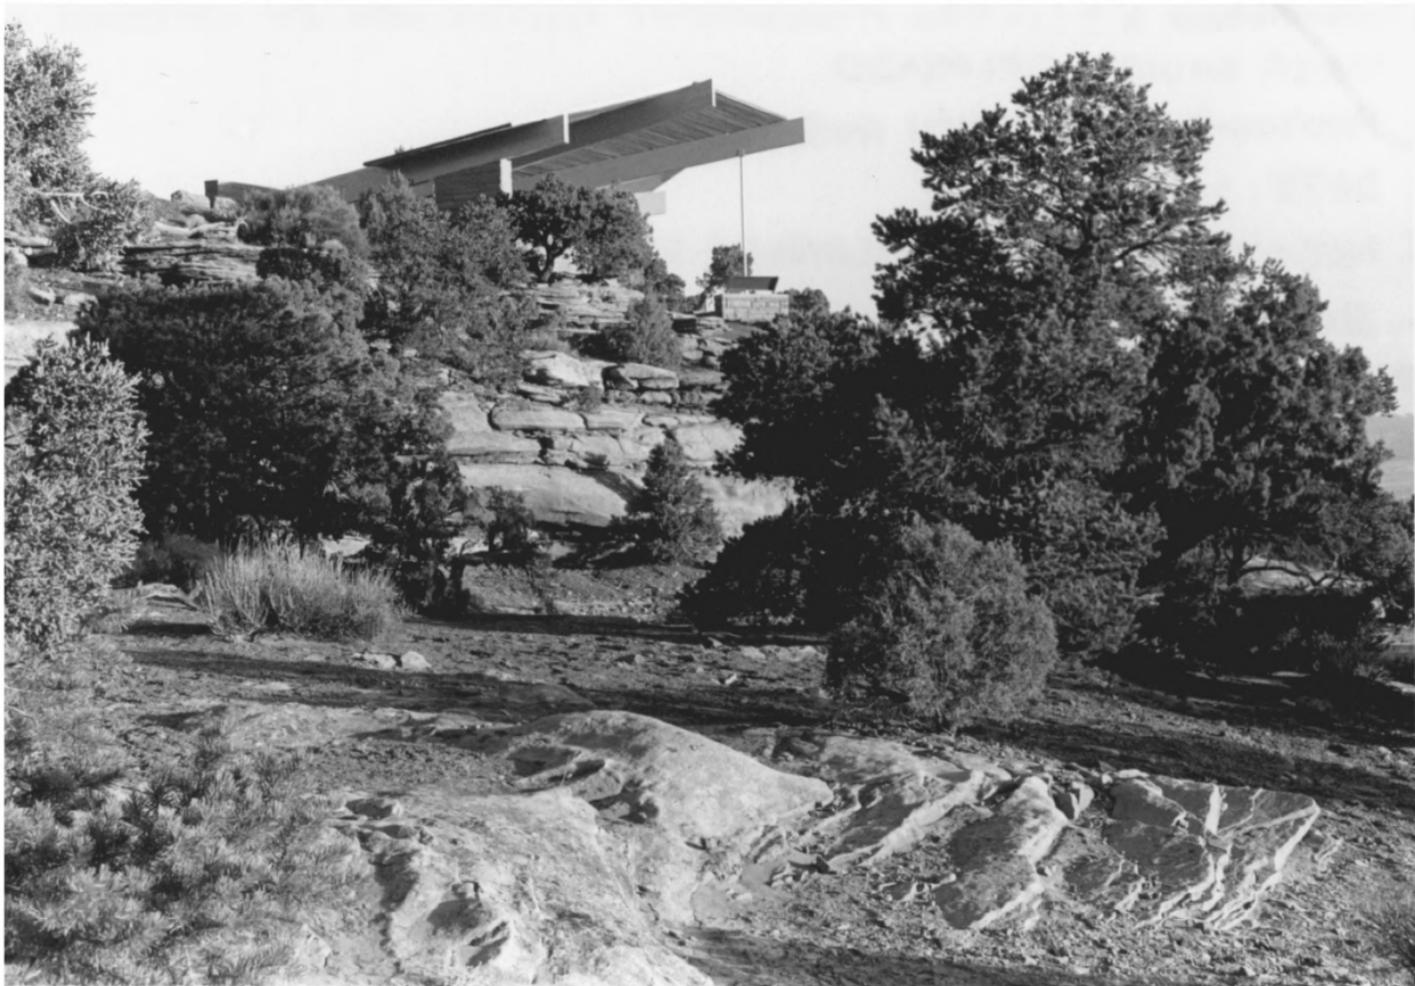
1. COLORADO NATIONAL MONUMENT VISITOR CENTER COMPLEX
2. MESA COUNTY, COLORADO
3. PHOTOGRAPHER: SETH ROBERTS
4. DATE: MARCH 2002
5. NEGATIVE NO. 2-21 COLORADO NATIONAL MONUMENT
6. BOOKCLIFF SHELTER, LOOKING NORTHEAST
7. PHOTO NO. 16

The most significant change to Bookcliff Shelter is that a pole now supports the canyon side of the middle beam, obstructing views of the canyon. The pole was placed in the shelter approximately 15 years ago, when the end of the middle beam that is anchored into the east wall rotted out. The rot seems to be caused by faulty flashing on top of the beam. The other beams are in excellent shape. Although most of the masonry is in good shape, some settlement cracks have occurred and a few stones have loosened on both the anchor and back walls of the shelter.

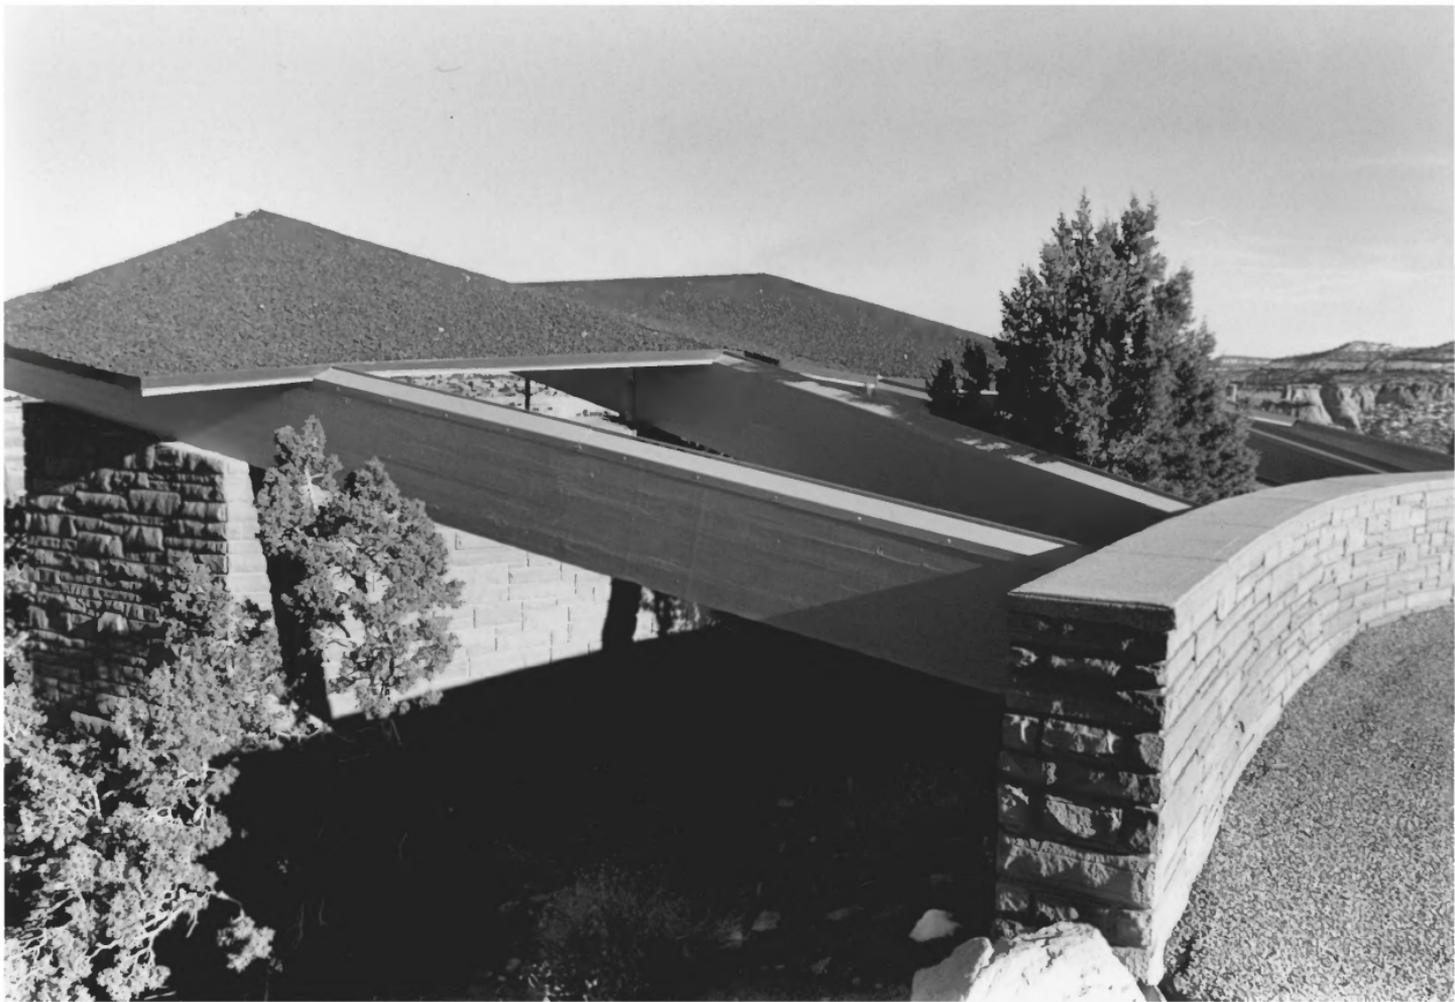
1. COLORADO NATIONAL MONUMENT VISITOR CENTER COMPLEX
2. MESA COUNTY, COLORADO
3. PHOTOGRAPHER: SETH ROBERTS
4. DATE: MARCH 2002
5. NEGATIVE NO. 2-11 COLORADO NATIONAL MONUMENT
6. BOOKCLIFF SHELTER, LOOKING EAST
7. PHOTO NO. 18

Bookcliff Shelter has undergone some changes that deviate from its original design by NPS architect Phil Romigh. Romigh called for the glulam beams and the underside of the roof decking to be stained with Olympic Heavy Bodied Stain "Mesa Gray."<sup>25</sup> However, that wood is now painted, not stained. Another change is that Romigh's plans called for steps and 16"-high stone walls along the walks that lead to the shelter from the parking area and Canyon Rim Trail, but these steps and walls were never built. Although drawn on the plan, this work was not included in the contract of E.C. Huff of Grand Junction. The steps and stone walls would have helped with crowd control and helped guide visitors to

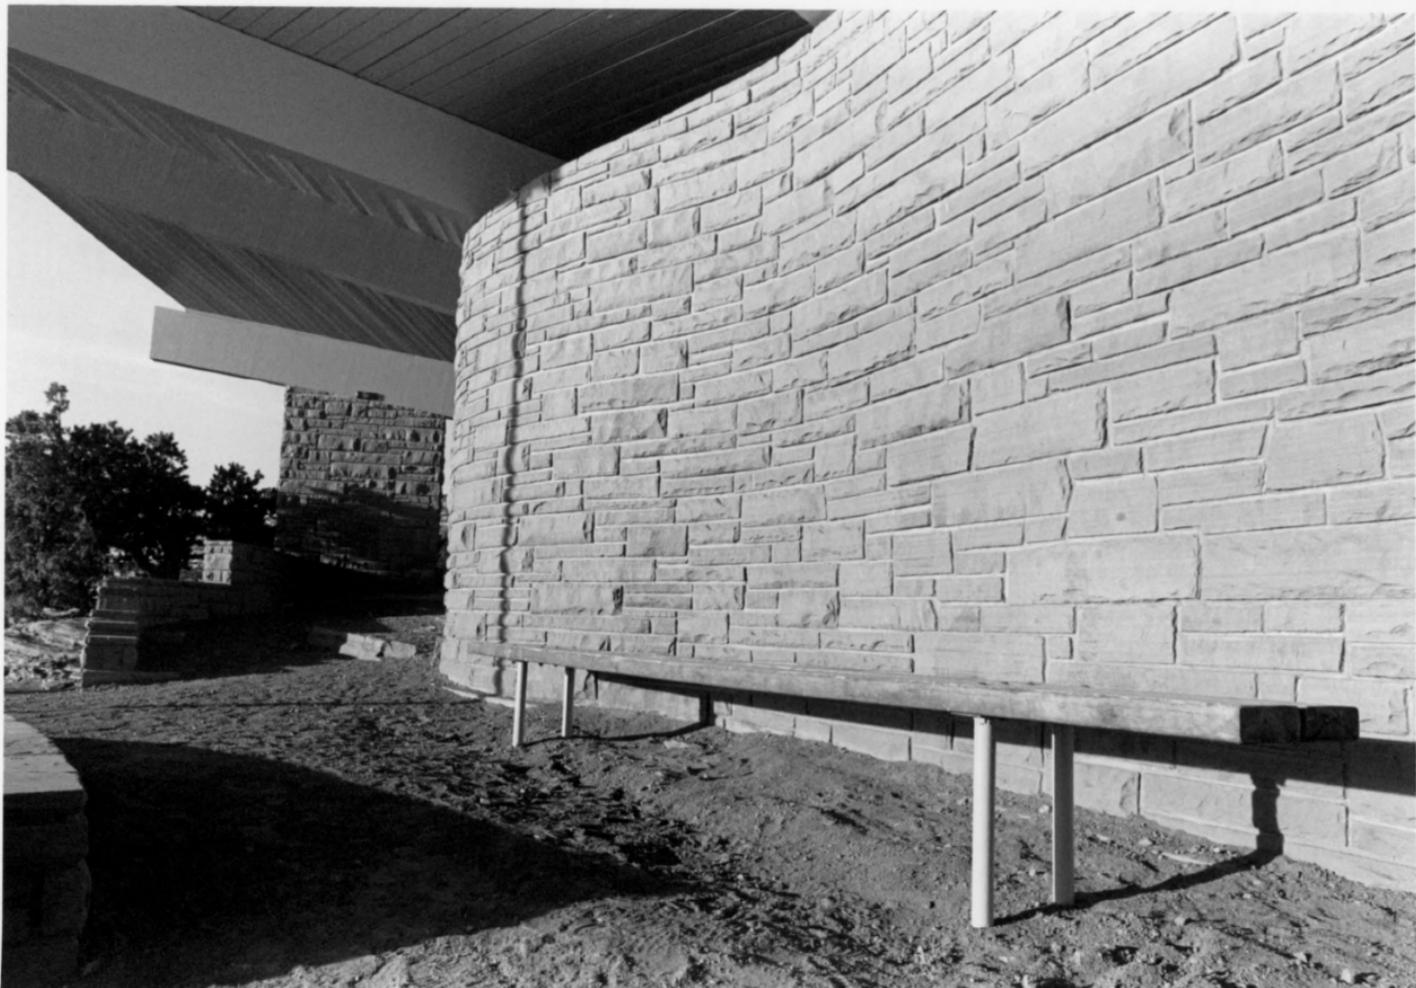
1. COLORADO NATIONAL MONUMENT VISITOR CENTER COMPLEX
2. MESA COUNTY, COLORADO
3. PHOTOGRAPHER: SETH ROBERTS
4. DATE: MARCH 2002
5. NEGATIVE NO. 2-8 COLORADO NATIONAL MONUMENT
6. BOOKCLIFF SHELTER, LOOKING SOUTHWEST
7. PHOTO NO. 19

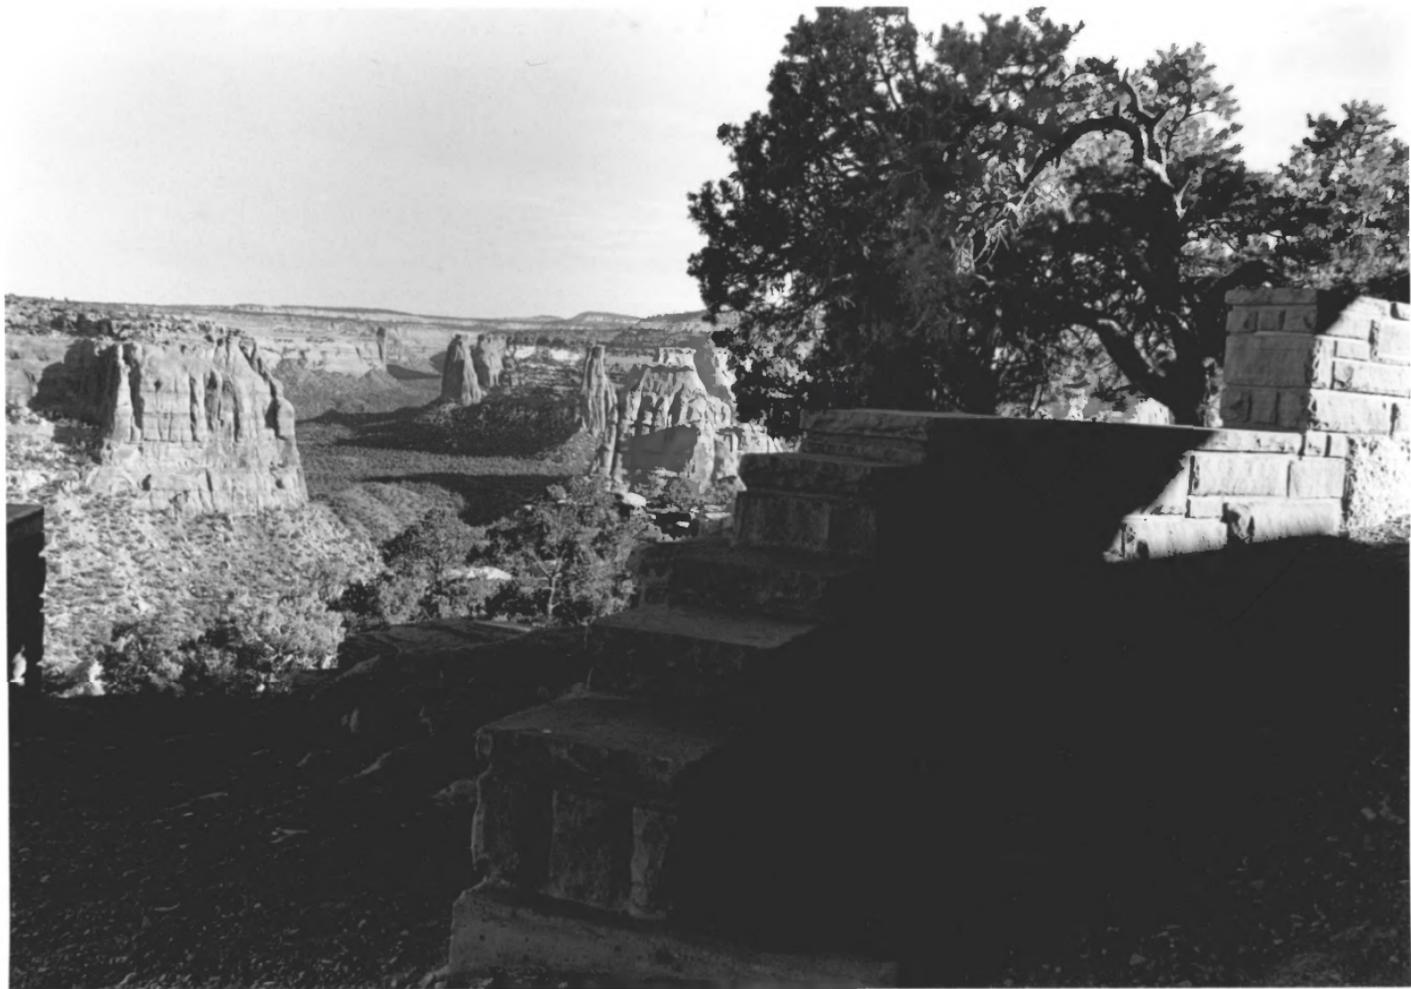
1. COLORADO NATIONAL MONUMENT VISITOR CENTER COMPLEX
2. MESA COUNTY, COLORADO
3. PHOTOGRAPHER: SETH ROBERTS
4. DATE: MARCH 2002
5. NEGATIVE NO. 2-23 COLORADO NATIONAL MONUMENT
6. BOOKCLIFF SHELTER, VIEW FROM INSIDE, LOOKING  
SOUTHWEST
7. PHOTO NO. 20
