National Park Service
Cultural Landscapes Inventory
2012

Nelson House
Colonial National Historical Park

Inventory Unit Summary & Site Plan

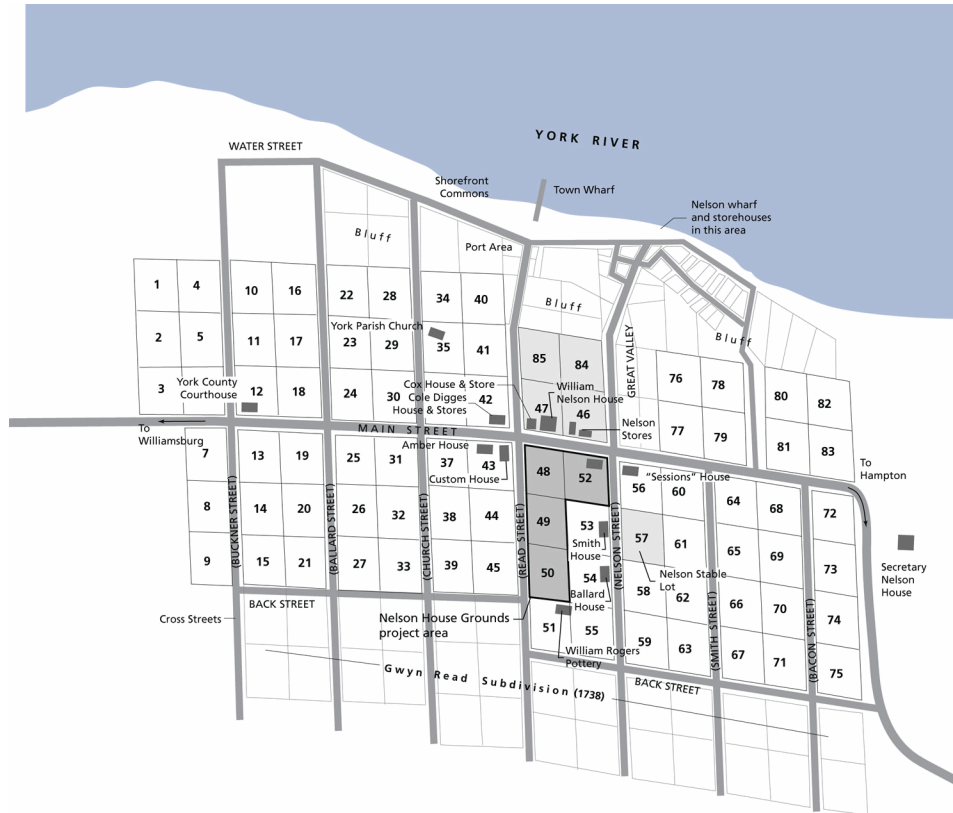
Figure 2. Map of Yorktown during the early Nelson period showing the expansion of village lots in the Gwyn Read Subdivision, and development neighboring the Nelson House grounds (SUNY ESF).

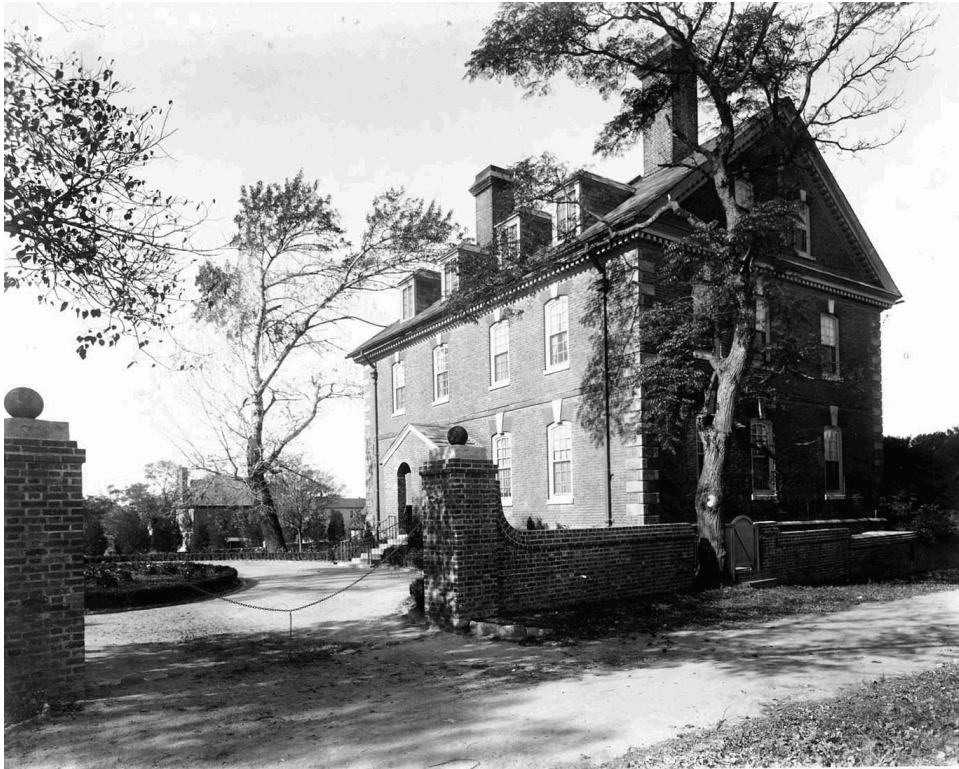
Figure 6. The redesigned forecourt (back court) looking west from Pearl (Nelson) Street across the marl-surfaced circular entrance drive, ca. 1918 (Colonial National Historical Park archives, Blow Family Photographs, album #13).

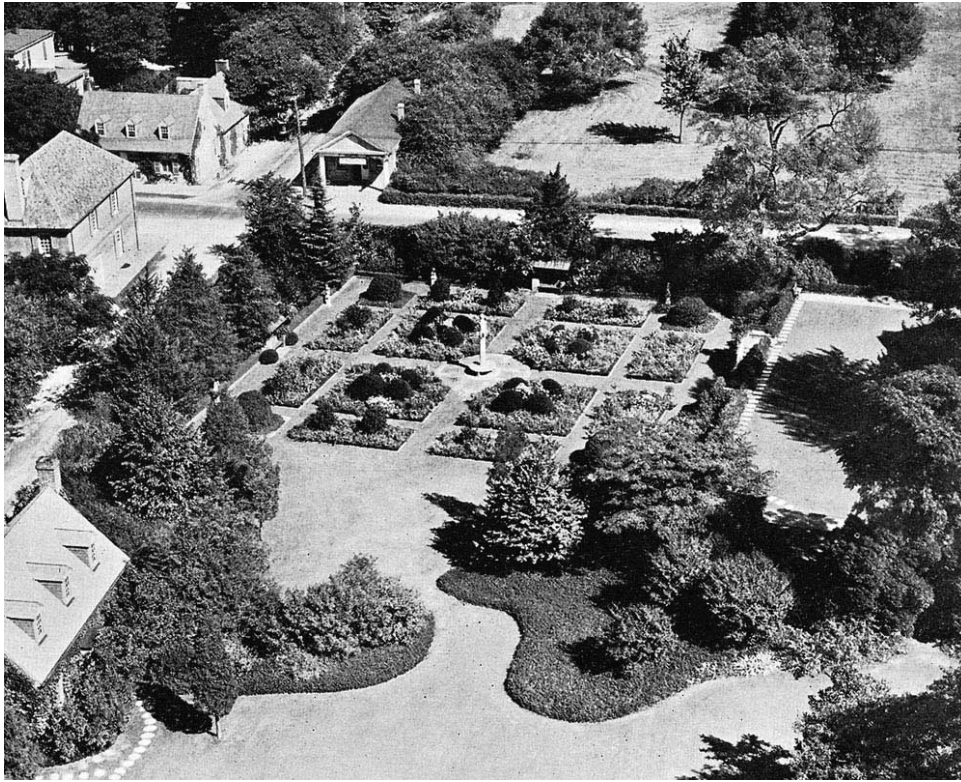
Figure 8. The York Hall formal garden, built in 1922, looking north, ca. 1930 (Yorktown Sesquicentennial Commission, "The Yorktown Sesquicentennial," 1932).

On the lower terrace, Gillette's design for the large formal garden used a classical quincunx plan consisting of symmetrically placed beds divided by two central intersecting walks and parallel secondary walks (Figure 8). Gillette based his design on the formal garden at Groombridge Place in Tonbridge, Kent, England that was the ancestral home of Mrs. Blow's family. The design required the addition of low brick retaining walls around the north and west sides to retain the pre-existing grade around the perimeter trees and shrubs that had been planted during the initial development of the landscape. The main east-west axis of the garden was aligned with the steps to the upper terrace and west entrance of the house (Figure 9). Plantings in the beds were an informal, old-fashioned mixture of flowering perennials and roses contained by borders of clipped dwarf boxwood and brick edging. The Blows obtained an extensive assortment of plants from historic places across Virginia, including Monticello, Westover and Tuckahoe Plantations, Mount Vernon, Bruton Parish Church, the President's House at the College of William and Mary, and Evelyn Byrd's Garden. The beds were also planted with a profusion of flowering spring bulbs. In the middle of the center beds were groups of four yews, and the outer corner beds each contained a single specimen tree boxwood. The other beds contained one or two deciduous shrubs in the center. (Groombridge Place Gardens and Enchanted Forest website; Gillette Papers, George P. Blow Correspondence)

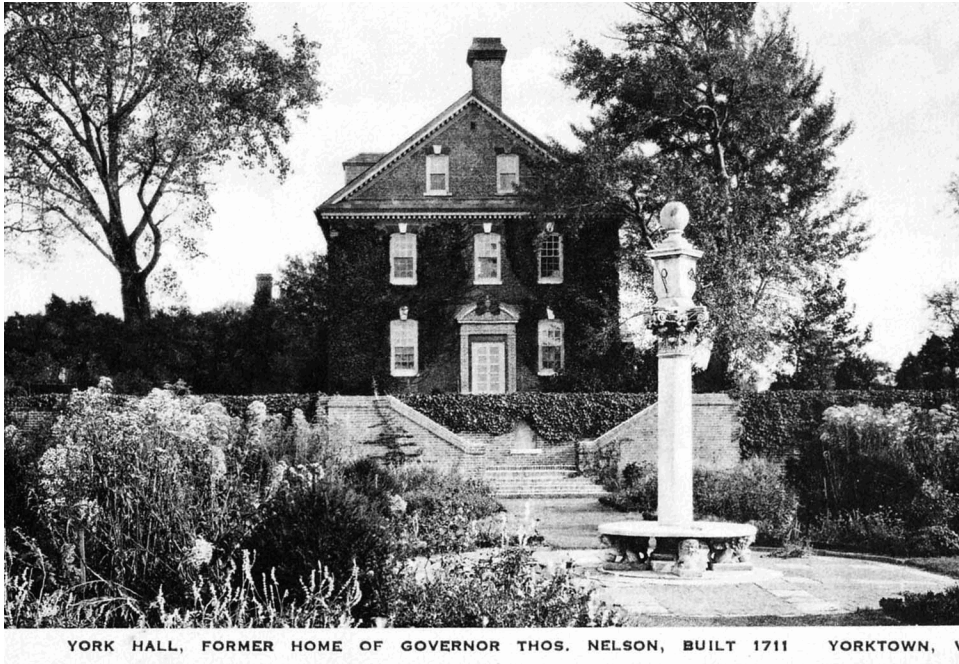
Figure 9. A ca. 1927 postcard of the formal garden showing the axial relationship with the stairs to the terrace (Courtesy of Jane Sundberg).

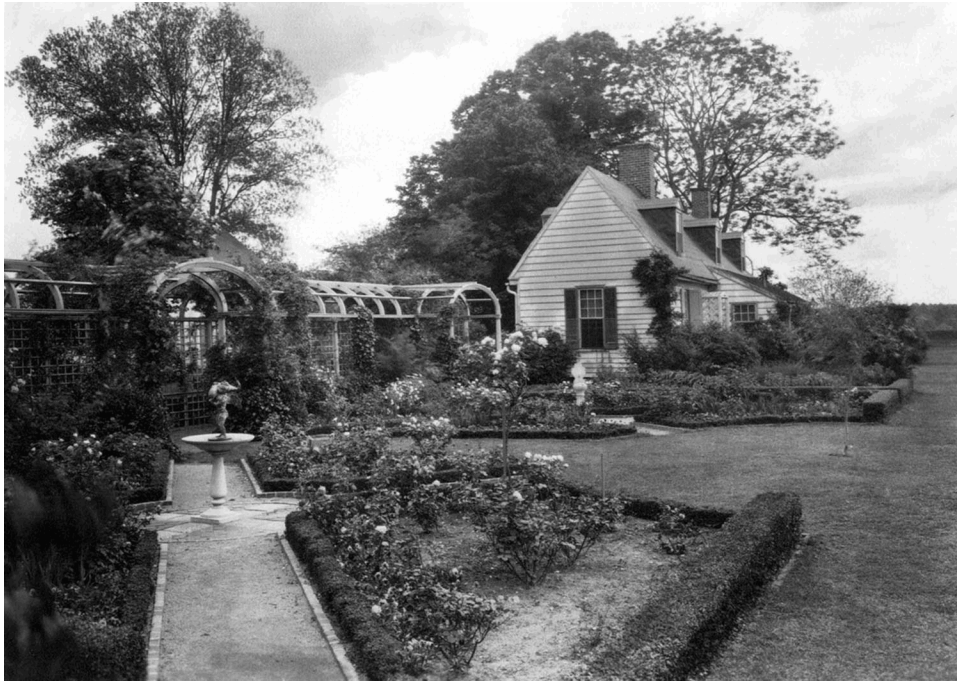
Figure 10. The rose garden and arbor between the Smith and Ballard houses, built in 1923, looking southeast toward the Ballard House, ca. 1925 (Colonial National Historical Park archives, YOR 10.6).

George P. Blow's death, included a parterre rose garden that was modeled after another garden at Groombridge Place (Figure 10). On the south side of the rose garden adjoining the Ballard House, Gillette designed a small, hedge-enclosed garden called the Garden of Pleasant Associations. (Harper, 1989: 20; Gillette Papers, George P. Blow Correspondence)

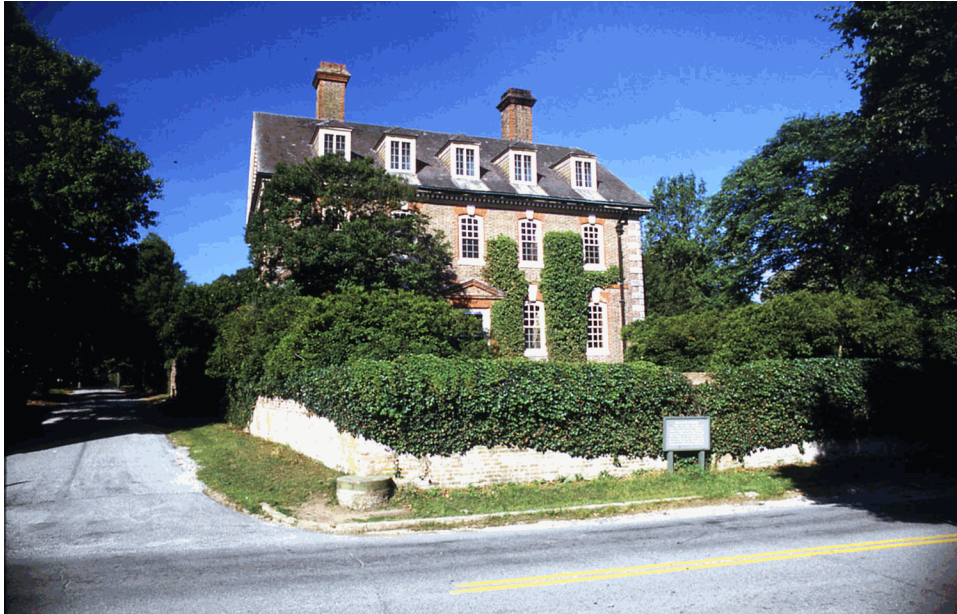
Figure 11. The Nelson House and lowered boxwood hedge, looking south across Main Street, June 1972 (Richard Freer, National Park Service, Harpers Ferry Center).

the apron, and installation of a steel fire escape on the south side of the building. During this time, the park maintained the landscape and made some minor changes, such as removing or pruning portions of the old boxwood hedge in the front court to open views of the house from Main Street (Figure 11). Between 1972 and 1974, the park completed several studies for the property that documented the history and existing conditions of the buildings and determined a treatment strategy to restore them to their colonial appearance. In 1974, the park completed an archeological study of the terrace to understand the colonial service yard. This study uncovered several historic building foundations, wall fragments, and traces of marl drives. No testing was undertaken in the front court, where the garden pool and walks were to be removed, or in the back court, which was designated as a contractor staging area for the restoration of the house. (Wenger, 2003: 124; National Park Service, plan of archeological research area, 1974)

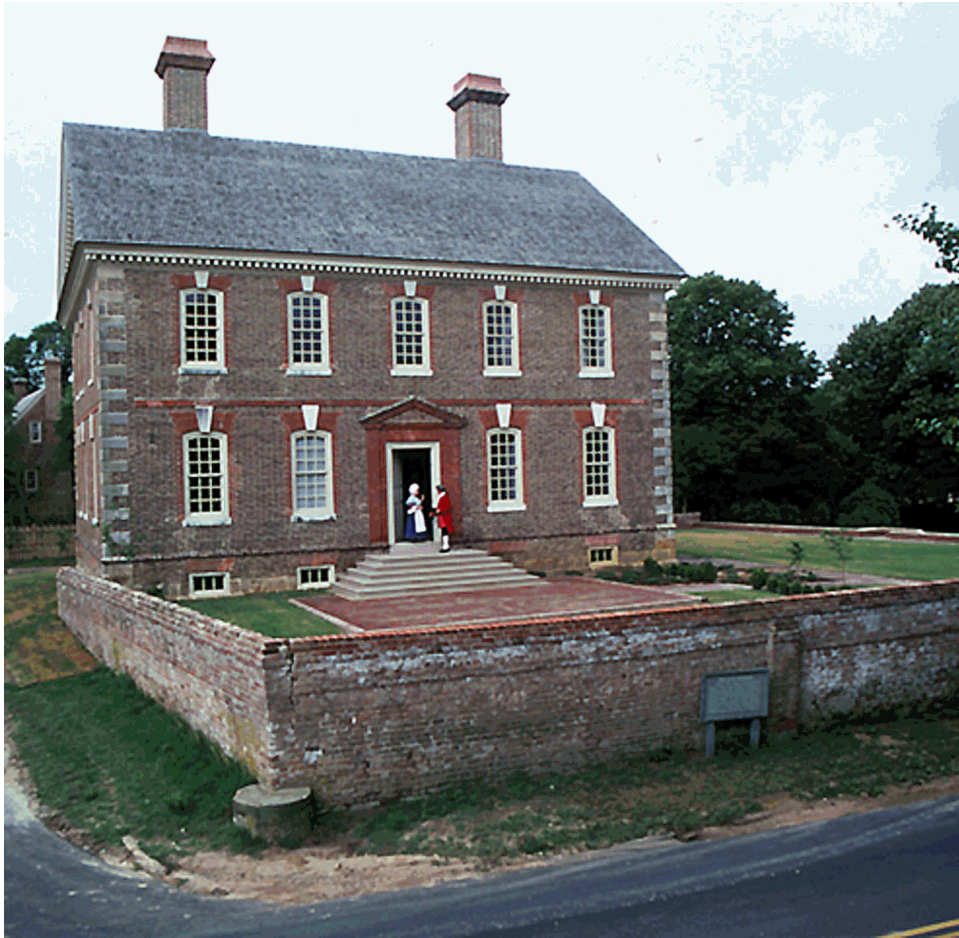
Figure 12. The recently restored Nelson House with its front court showing the new steps, walks, and boxwood hedge, ca. 1976. The perimeter brick wall had not yet been lowered (Richard Freer, National Park Service, Harpers Ferry Center).

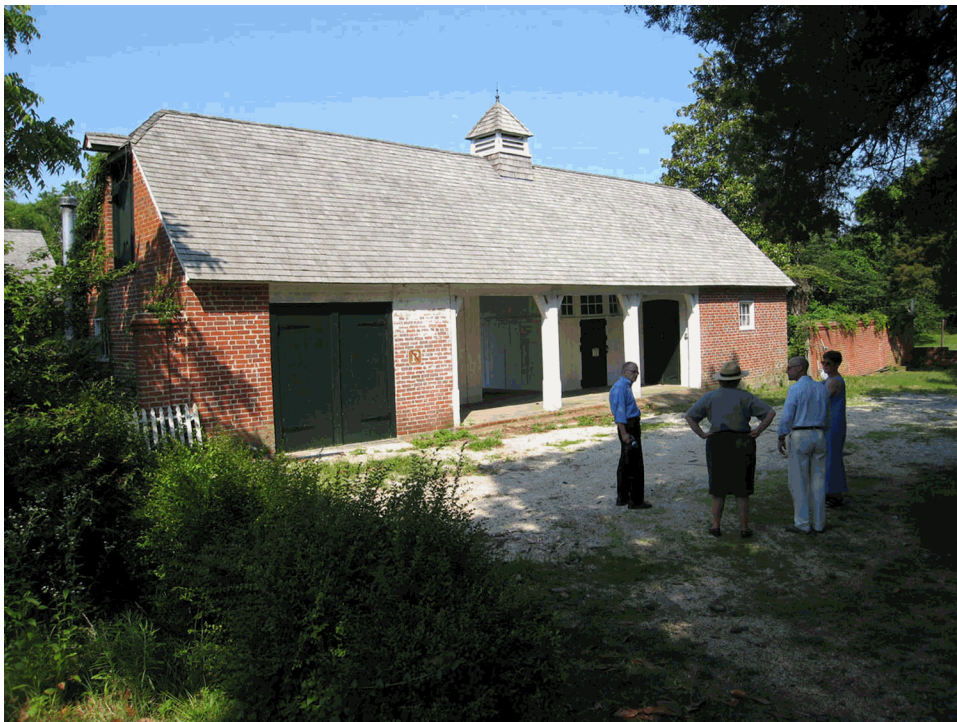
Figure 14. The service drive and stable looking west, June 2007 (SUNY ESF).

The service yard, used by the park for maintenance storage, has a utilitarian function similar to its historic use, as does the carriage house (garage), which serves as a park ranger station (Figure 14). Despite the contemporary changes, the existing land use is generally compatible with the historic character of the landscape. An exception is at the carriage house (garage), where an exterior steel staircase, antennae, and park service vehicles along Read Street related to the building's use as a ranger station detract from the landscape's historic domestic use.

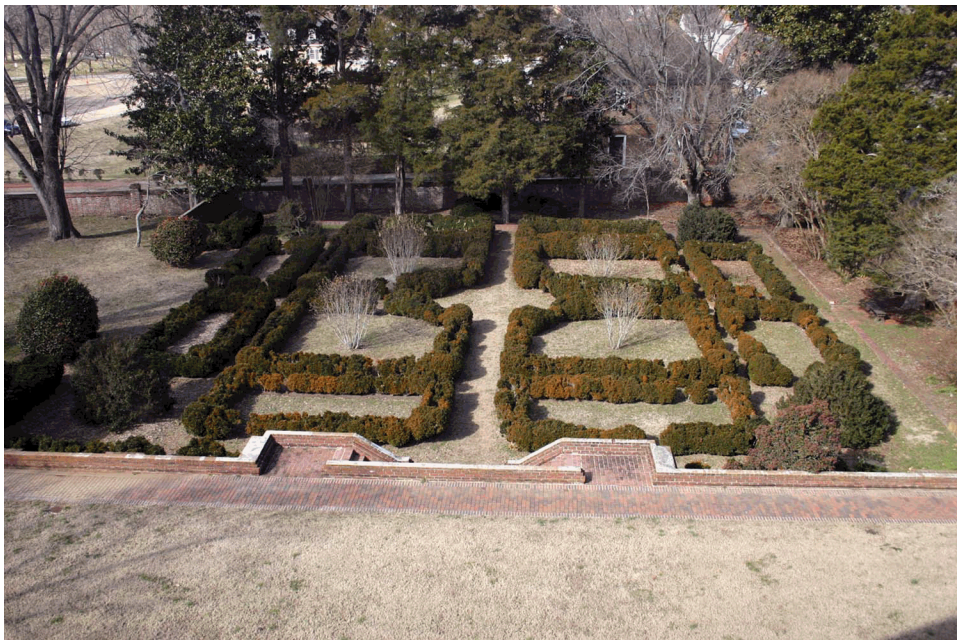
Figure 15. Looking west across the formal garden from the second floor of the Nelson House, January 2010. The terrace is in the foreground (SUNY ESF).

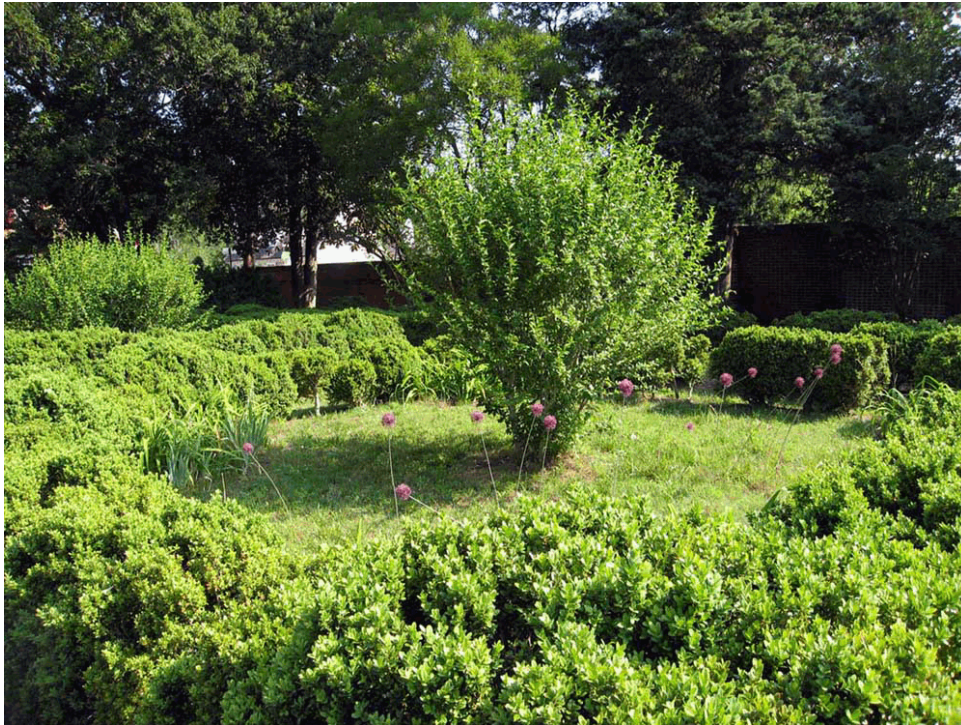
Figure 16. One of the main formal garden beds looking southwest showing center rose of Sharon, perennials, and mown cover, June 2007 (SUNY ESF).

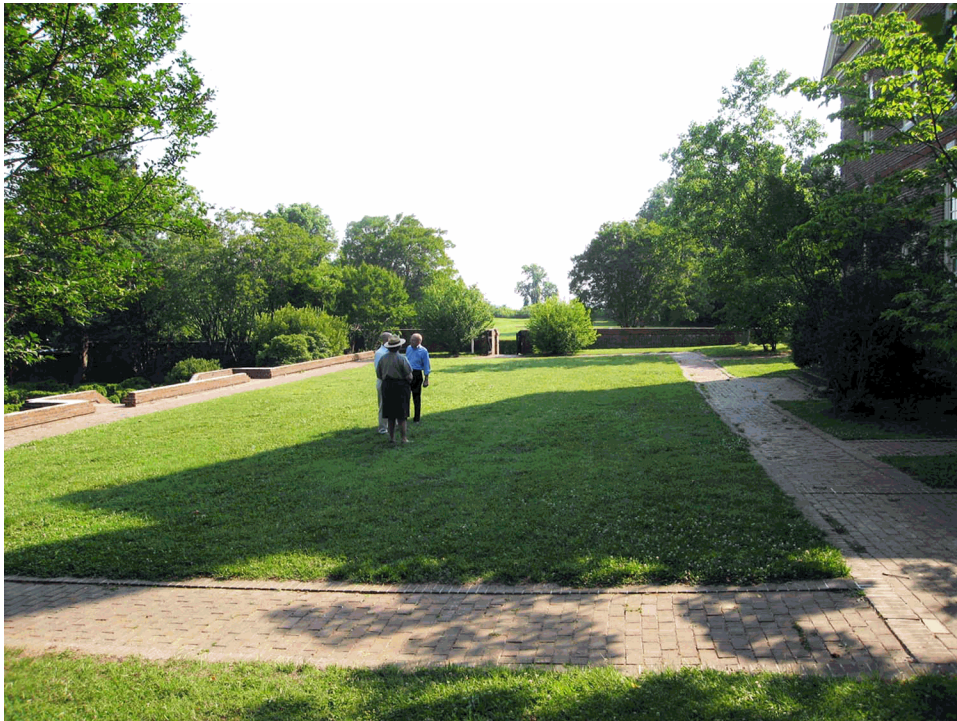
Figure 17. The terrace looking north with the Nelson House at right and steps to the formal garden at left, June 2007 (SUNY ESF).

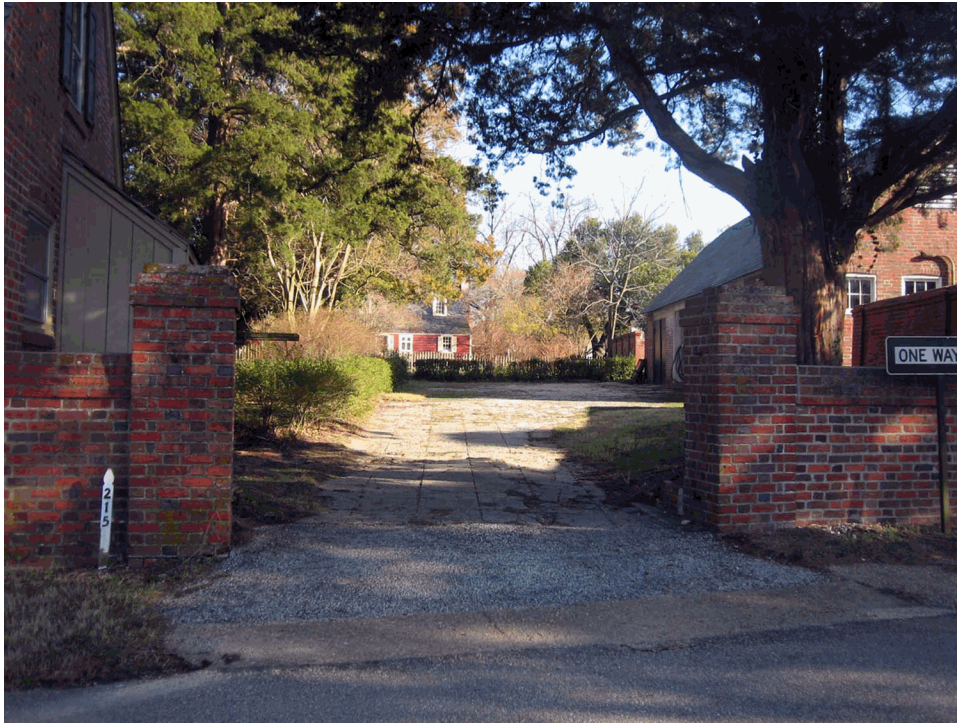
Figure 18. The entrance to the service area looking east from Read Street with the stable at right and Wisteria Cottage at left, March 2008 (SUNY ESF).

garden and service drive were retained, but the stepping-stone paths were removed (Figure 18). Existing circulation thus reflects the York Hall estate only in the formal garden and service area. There is no trace of circulation from the Revolutionary War and Civil War periods.

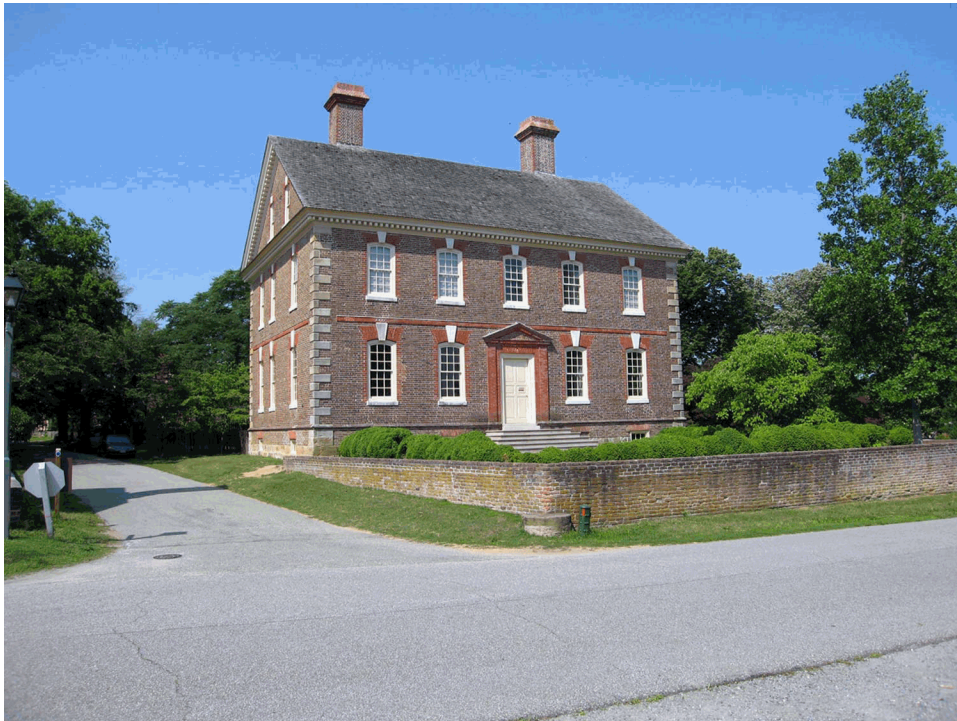
Figure 19. The front court of the Nelson House looking southwest from Main Street, showing the perimeter wall and boxwood hedge, June 2007 (SUNY ESF).

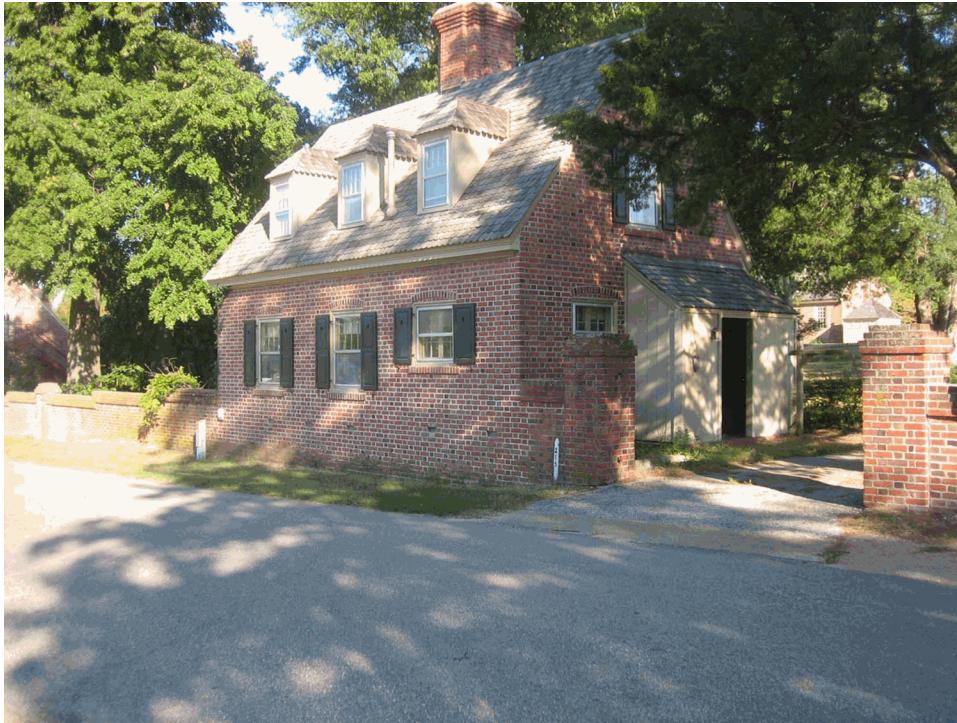
Figure 20. The front of Wisteria Cottage looking southwest from the lawn, June 2007. The large tree is a willow oak, dating to the York hall estate period (SUNY ESF).

At the beginning of the York Hall estate period in 1914, only the Nelson House and brick retaining wall remained, along with the ruins of the kitchen–wash house. By ca.1916, three new outbuildings had been completed: the garage (carriage house), Wisteria Cottage (gardener's cottage, Figure 20), and the stable (Figure 21), along with a brick perimeter wall. Improvements in the 1920s resulted in the addition of another brick wall in the garden.

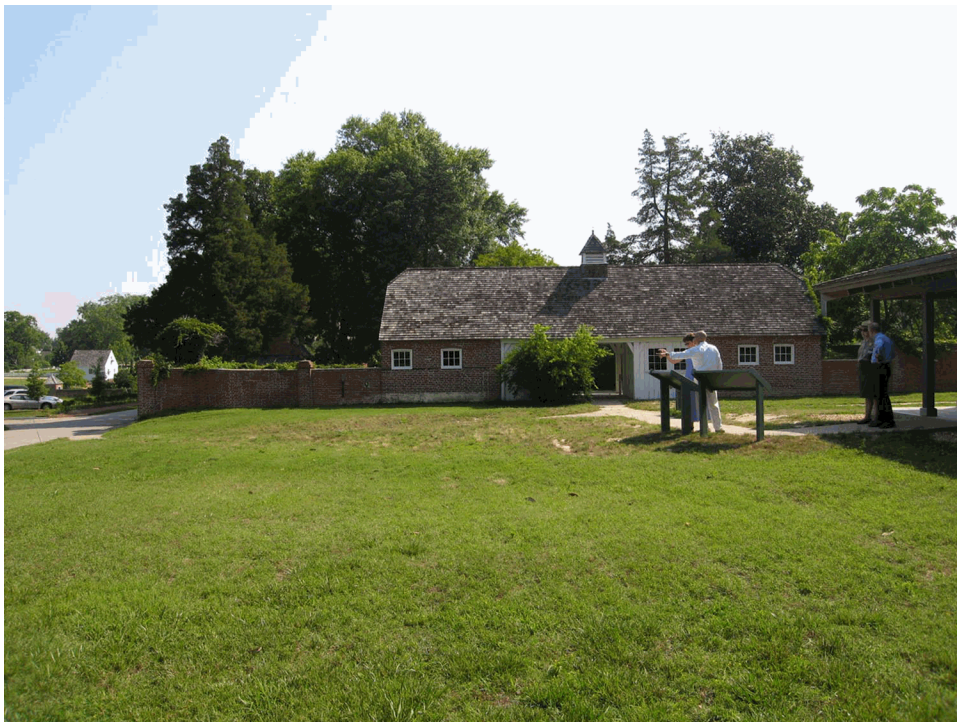
Figure 21. The stable looking north from the Poor Potter Site, June 2007 (SUNY ESF).

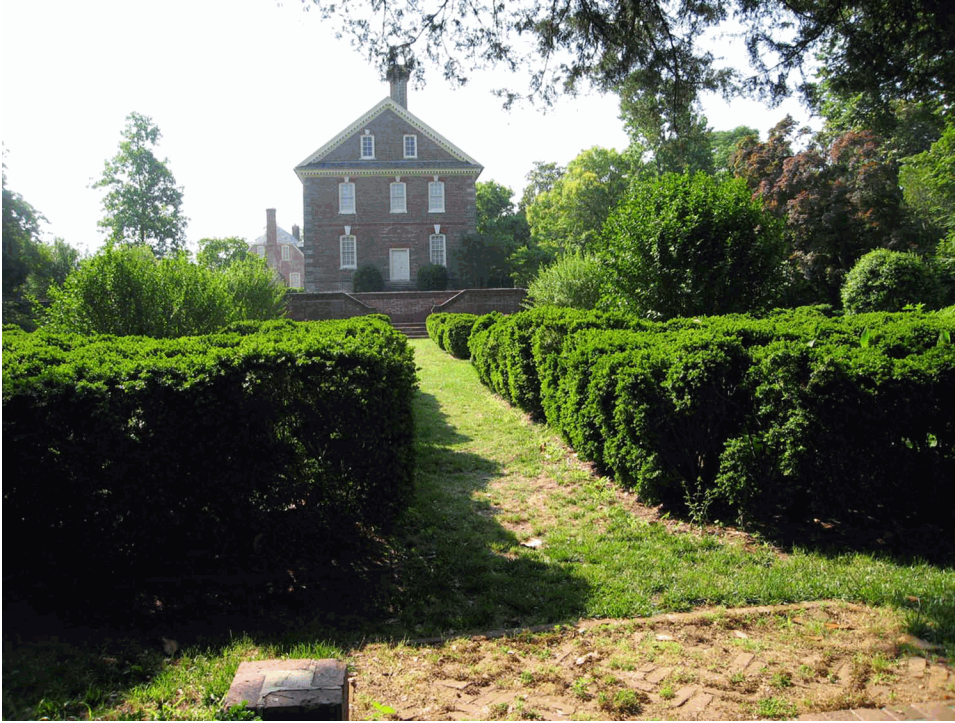
In the park service rehabilitation of the grounds during the 1970s, the boxwood hedge around the front court was replaced with small plants that reopened the view to the outside. However, the growth of woods and specimen trees in the Great Valley and on lots 46 and 47 north of Main Street blocked most of the York River view. The view of the formal garden was retained, but the view across the lawn was blocked by shrubs planted during late Blow ownership. The internal garden vistas along the axial walks were lost due to removal of the focal point, the sundial column (Figure 22).

Figure 22. The formal garden looking east showing axis with the terrace steps and entrance to the Nelson House, June 2007 (SUNY ESF).
