**NATIONAL REGISTER OF HISTORIC PLACES
INVENTORY -- NOMINATION FORM**

Jonas Coonrad House

10340 Riverview Road

Brecksville *vic* VICINITY OF

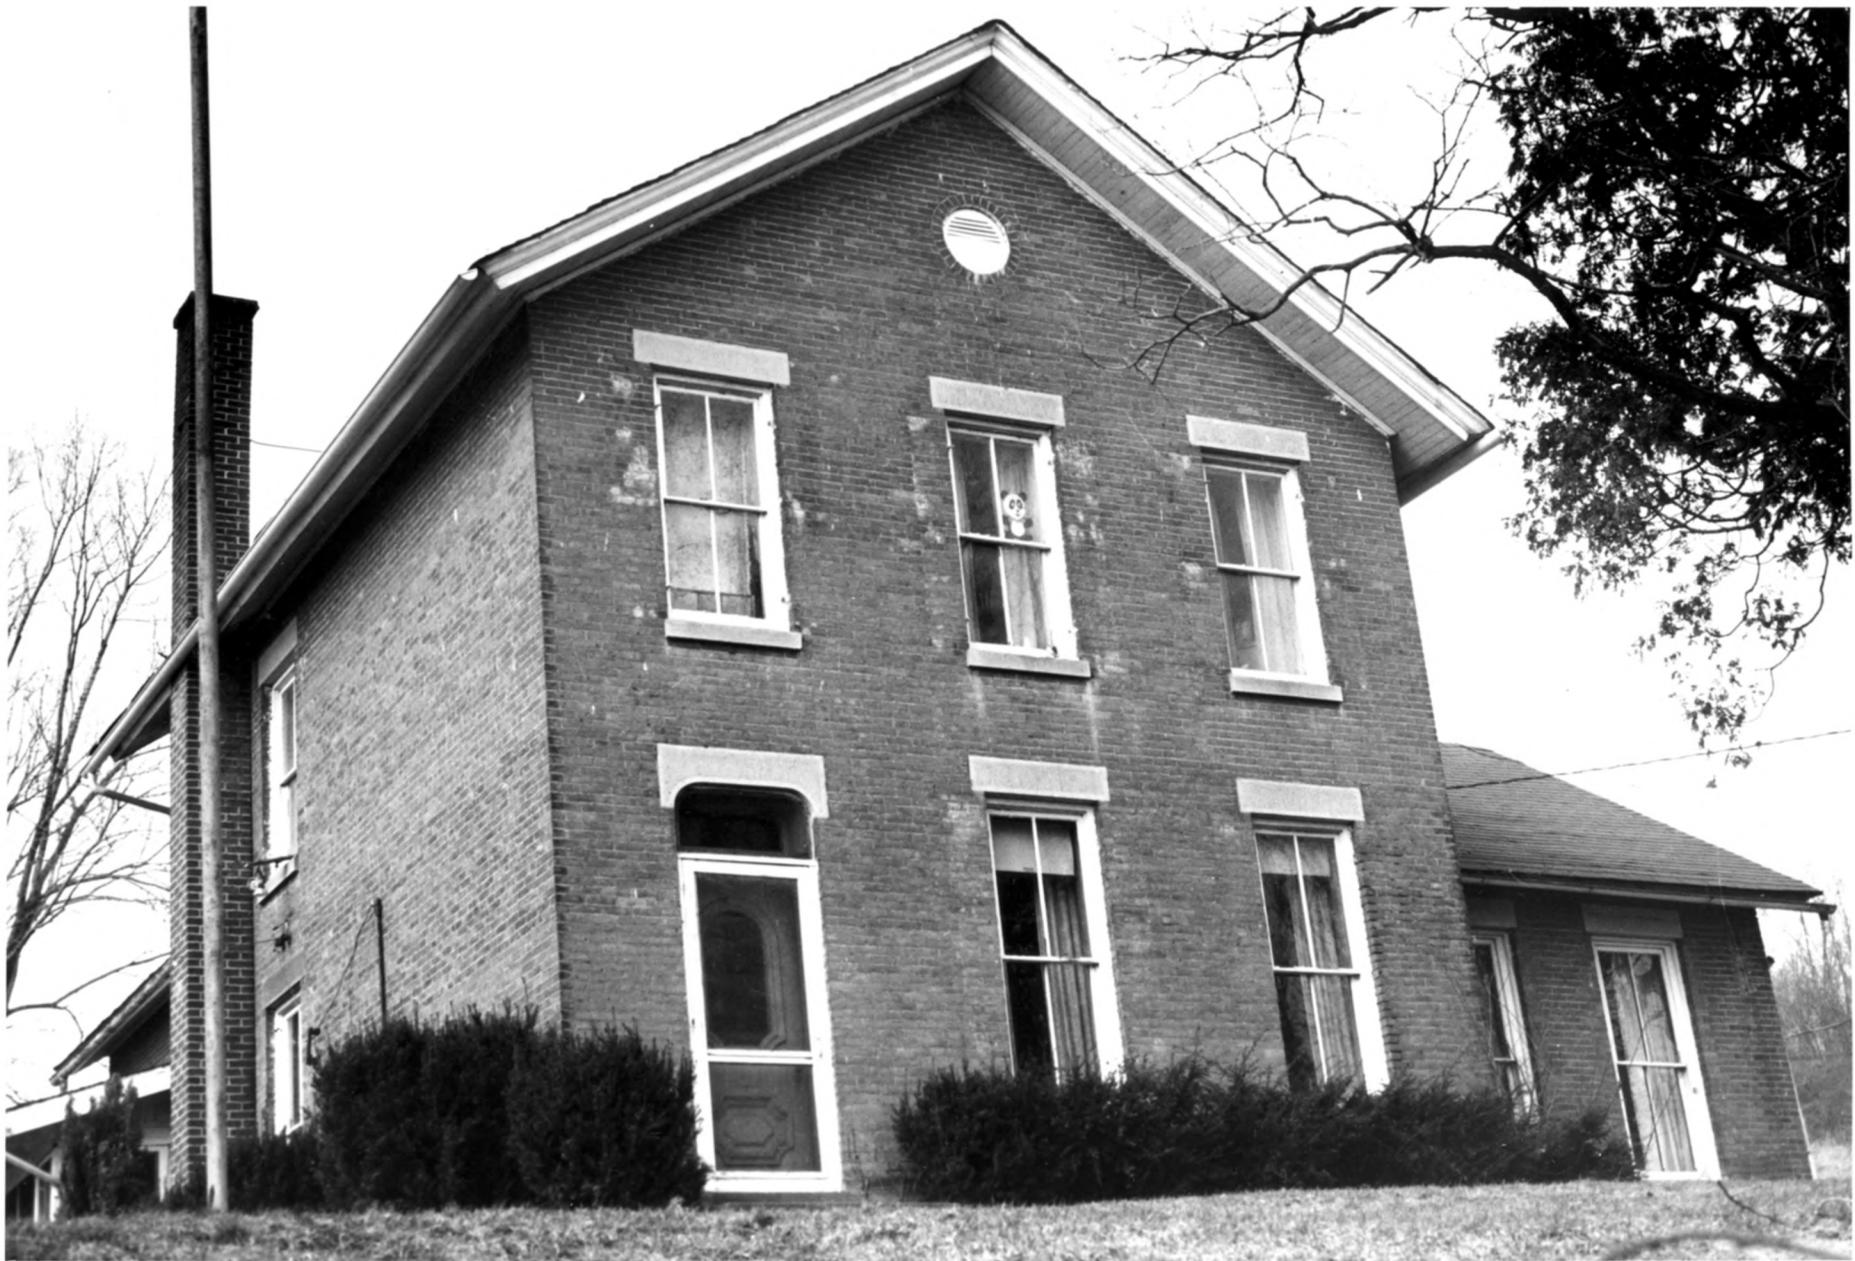
Coonrad House photo #1 of 3

East facade looking northwest

Situated on the western rim of the Cuyahoga Valley, the Jonas Coonrad House is a traditional brick farmhouse built in 1875. The house has a plain ashlar sandstone foundation with a cut stone water table, and there is a basement. The two-story main block is three bays wide with gable end facing the road. The front entrance is on the left side. A lower two-story wing projects from the rear of the main block, and there is a one-story ell on the north side. The red brick is laid in stretcher bond, and the house features tooled stone sills and lintels. The front entrance features a stilted rectangular lintel over a transom light. The paneled front door has a single round-arch light and is reminiscent of the Second Empire style. The house has large double-hung windows, with 2/2 lights, and there is an oculus window in the gable.

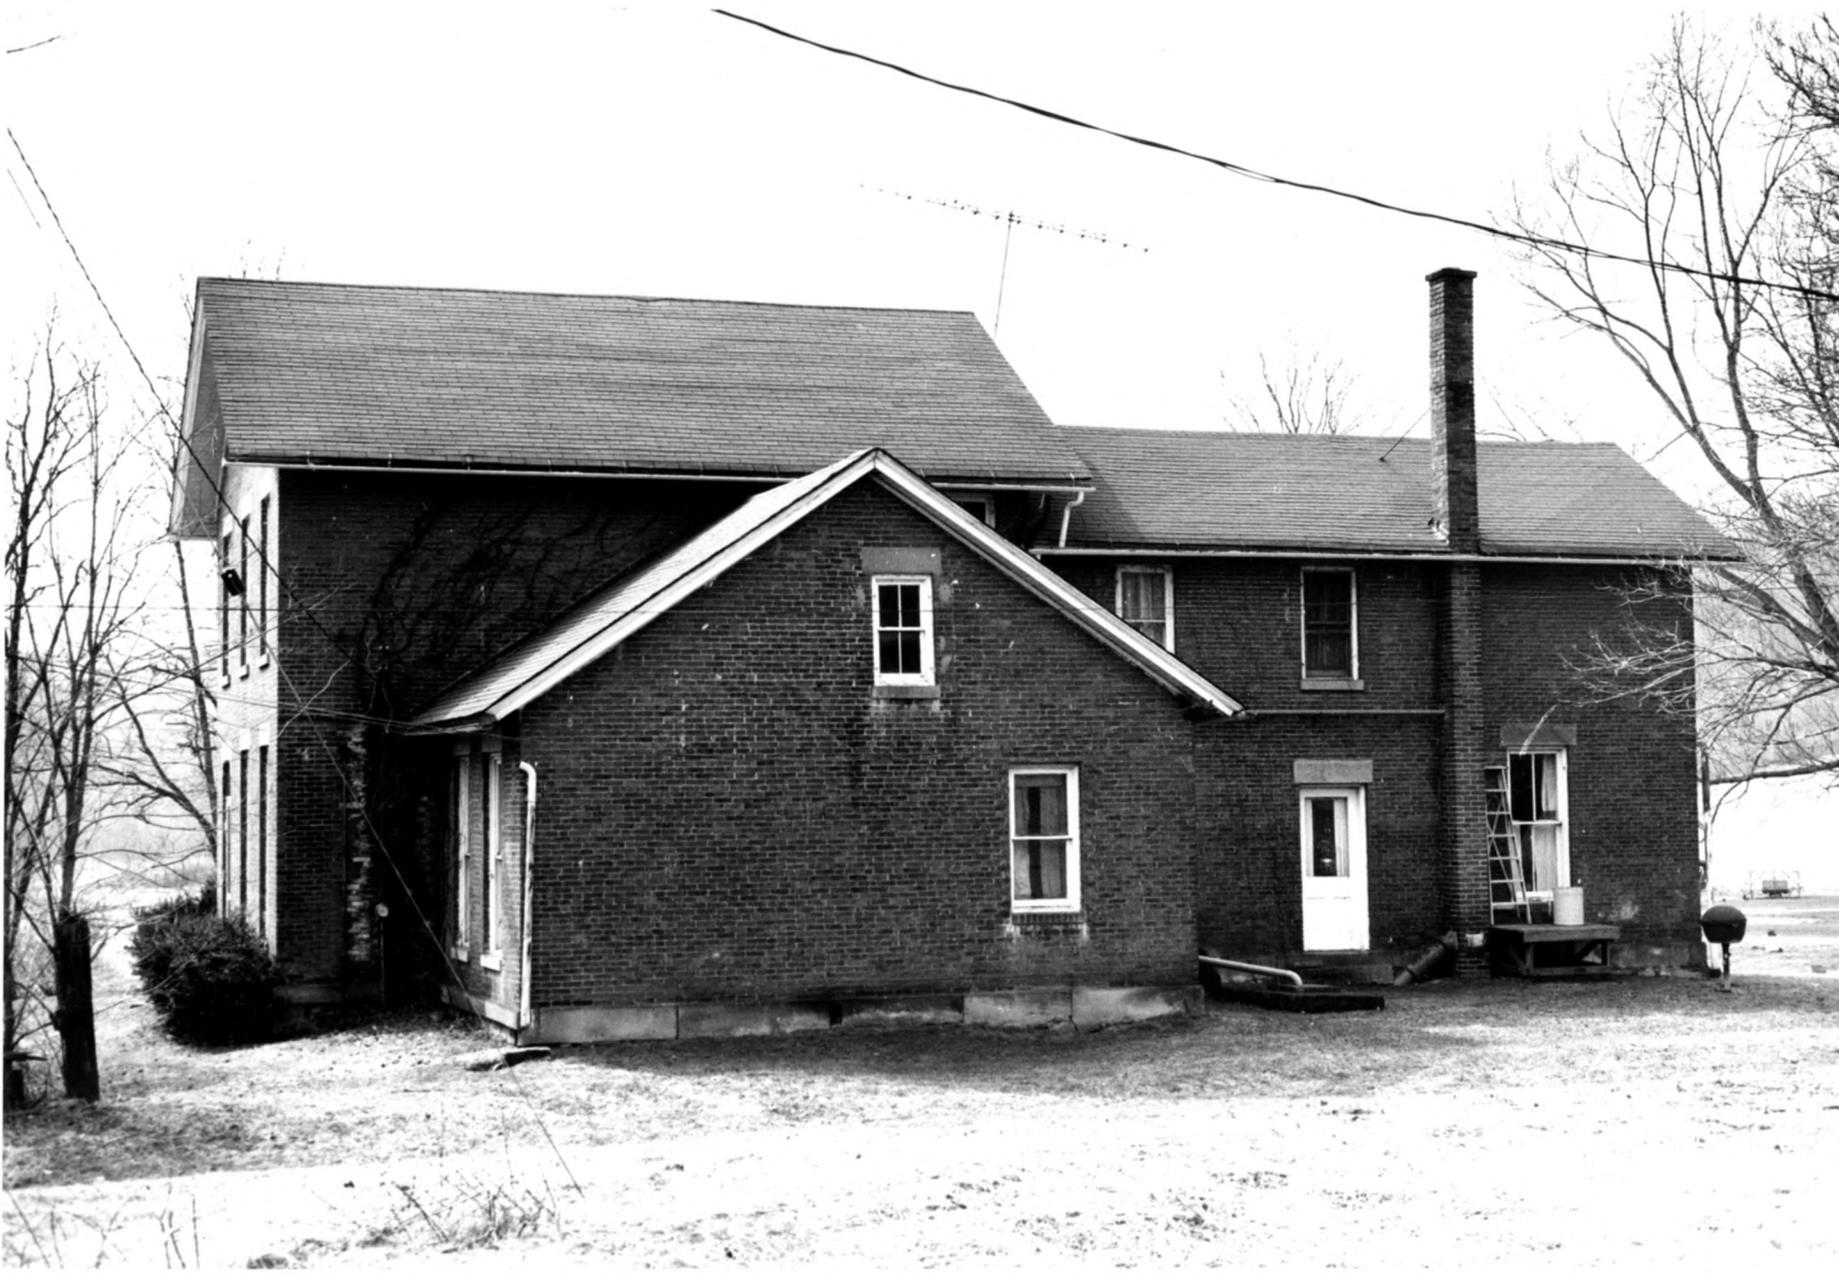
Coonrad House photo #2 of 3

North elevation looking south

A screened porch has been added on the south side, and the outside end chimneys on the north and south walls probably were added when the house was made into two apartments in 1954. Although the original eleven-room house has been divided, an inspection of the first-floor apartment shows that much of what appears to be the original moldings are still intact.

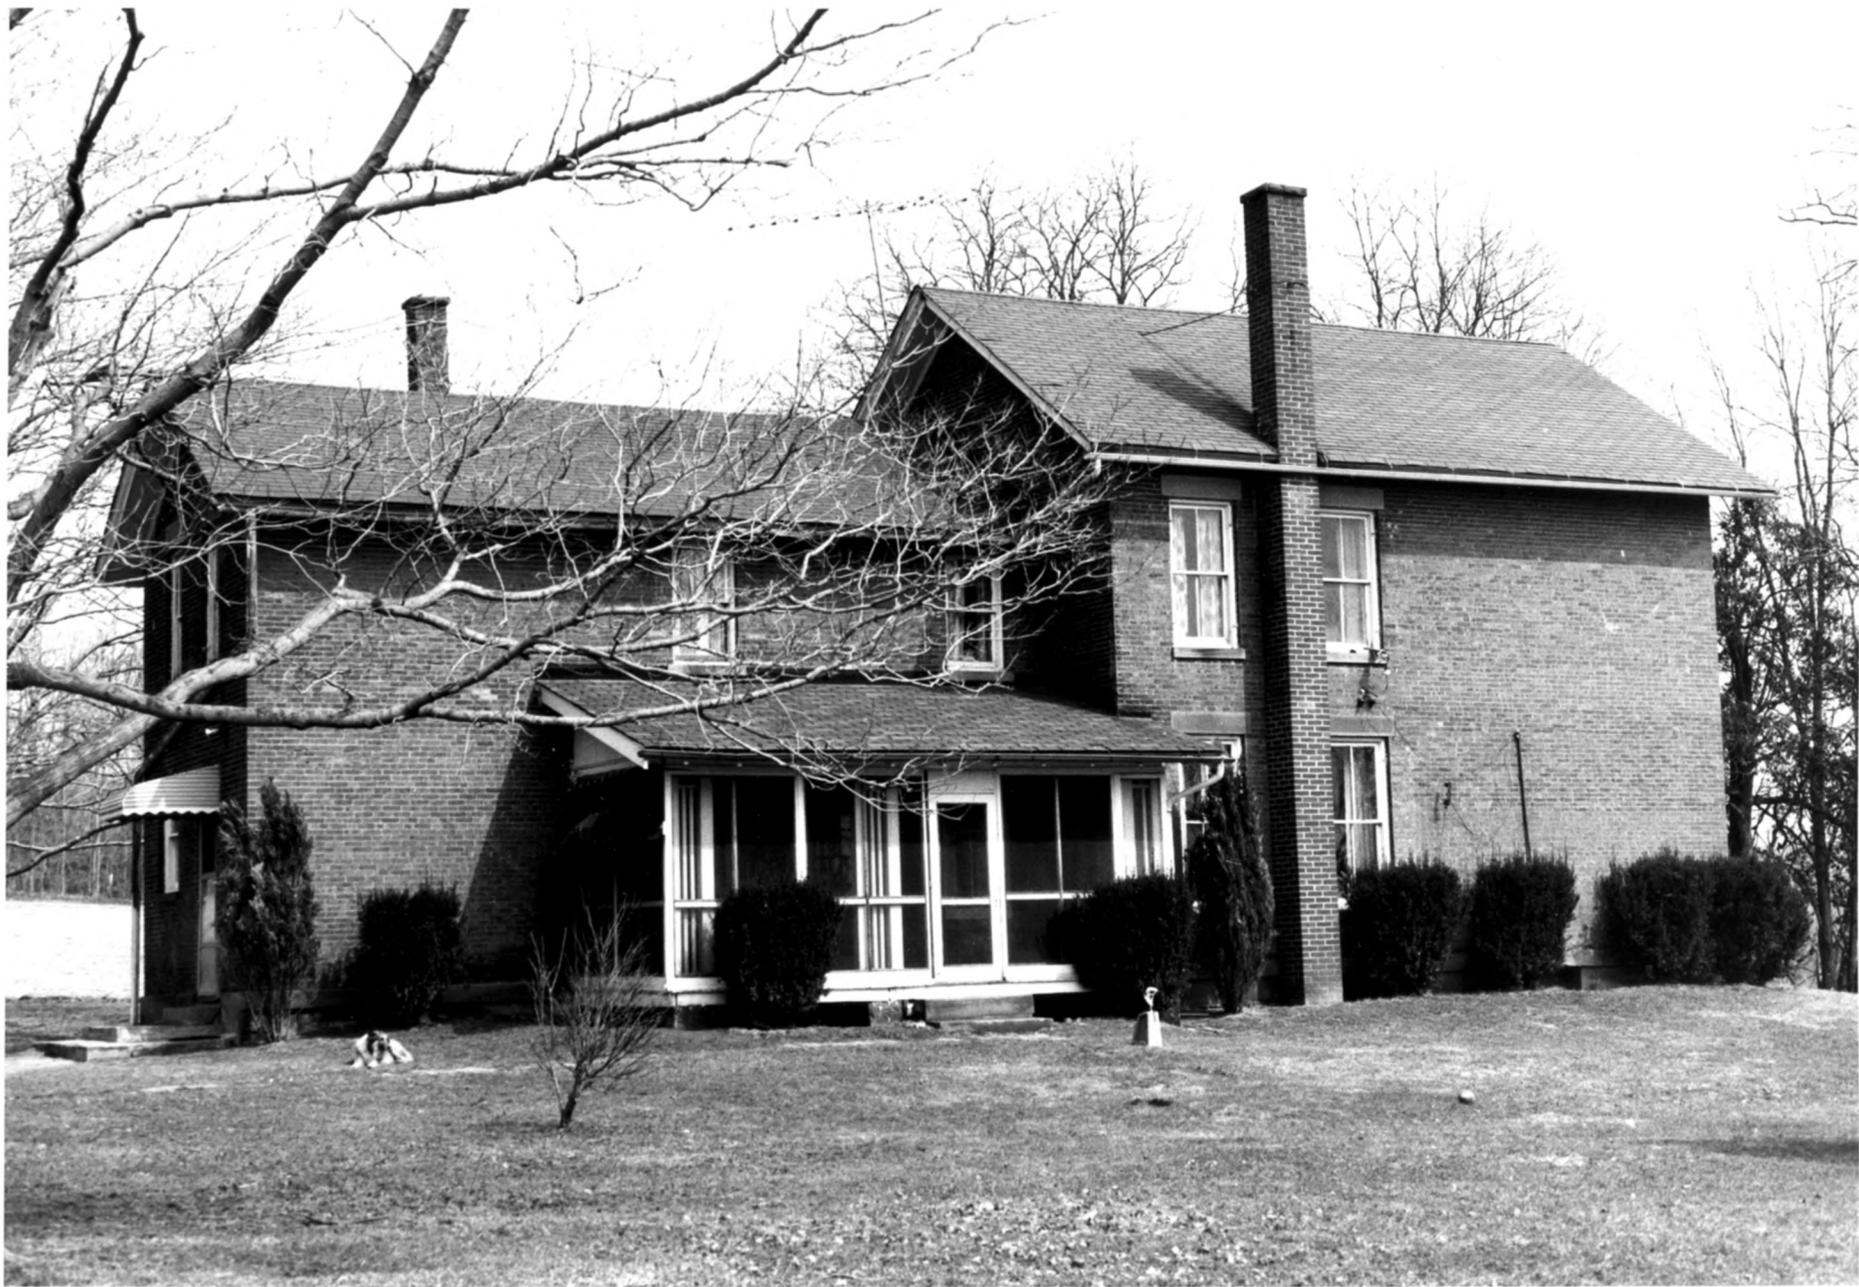
Coonrad House photo #3 of 3

South facade looking northeast

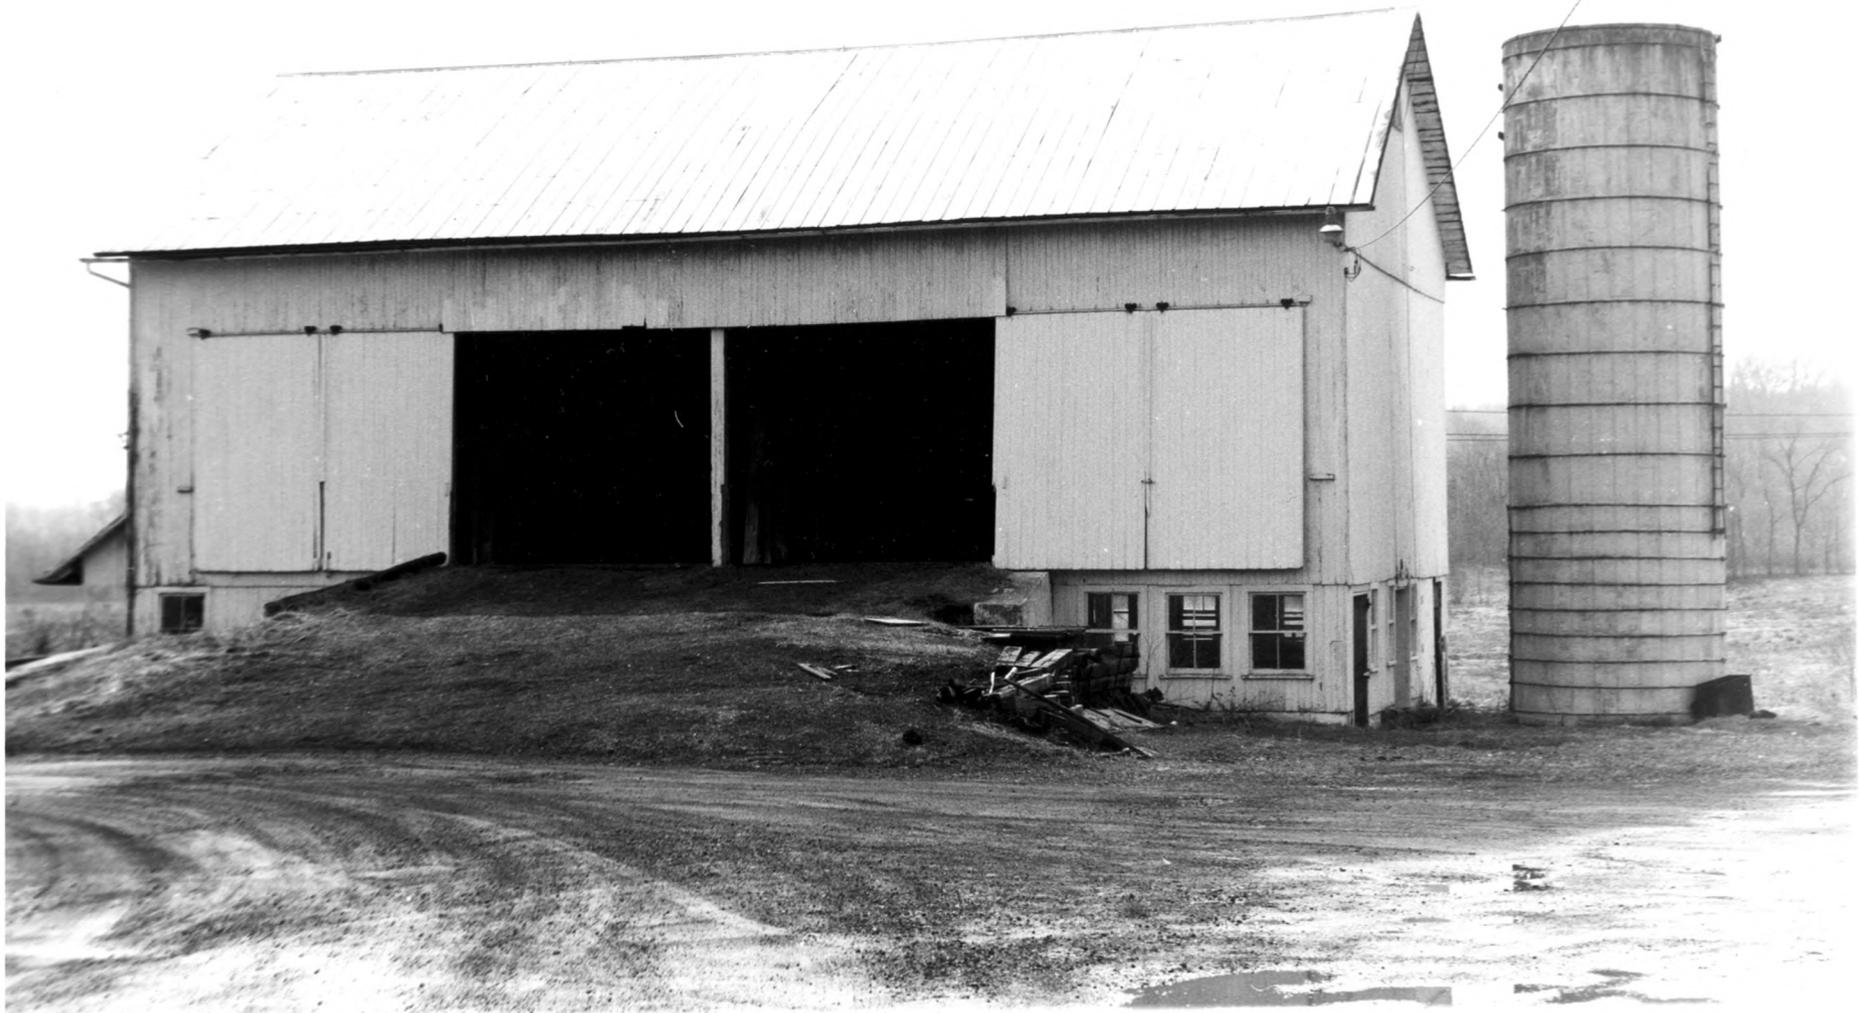
View showing northern elevation of barn.

There is a large gable-roofed bank barn with vertical siding on the south side of the house. It was built in 1913, after the original Coonrad barn, located near the road, burned down. A spring-fed pond created during the 1960s is situated at the foot of the hill between the house and the road.
