**NATIONAL REGISTER OF HISTORIC PLACES
INVENTORY - NOMINATION FORM**

COMMON: **Peninsula Village Historic District**

STREET AND NUMBER: *both sides of*
OH State Route 303 (see continuation sheet)

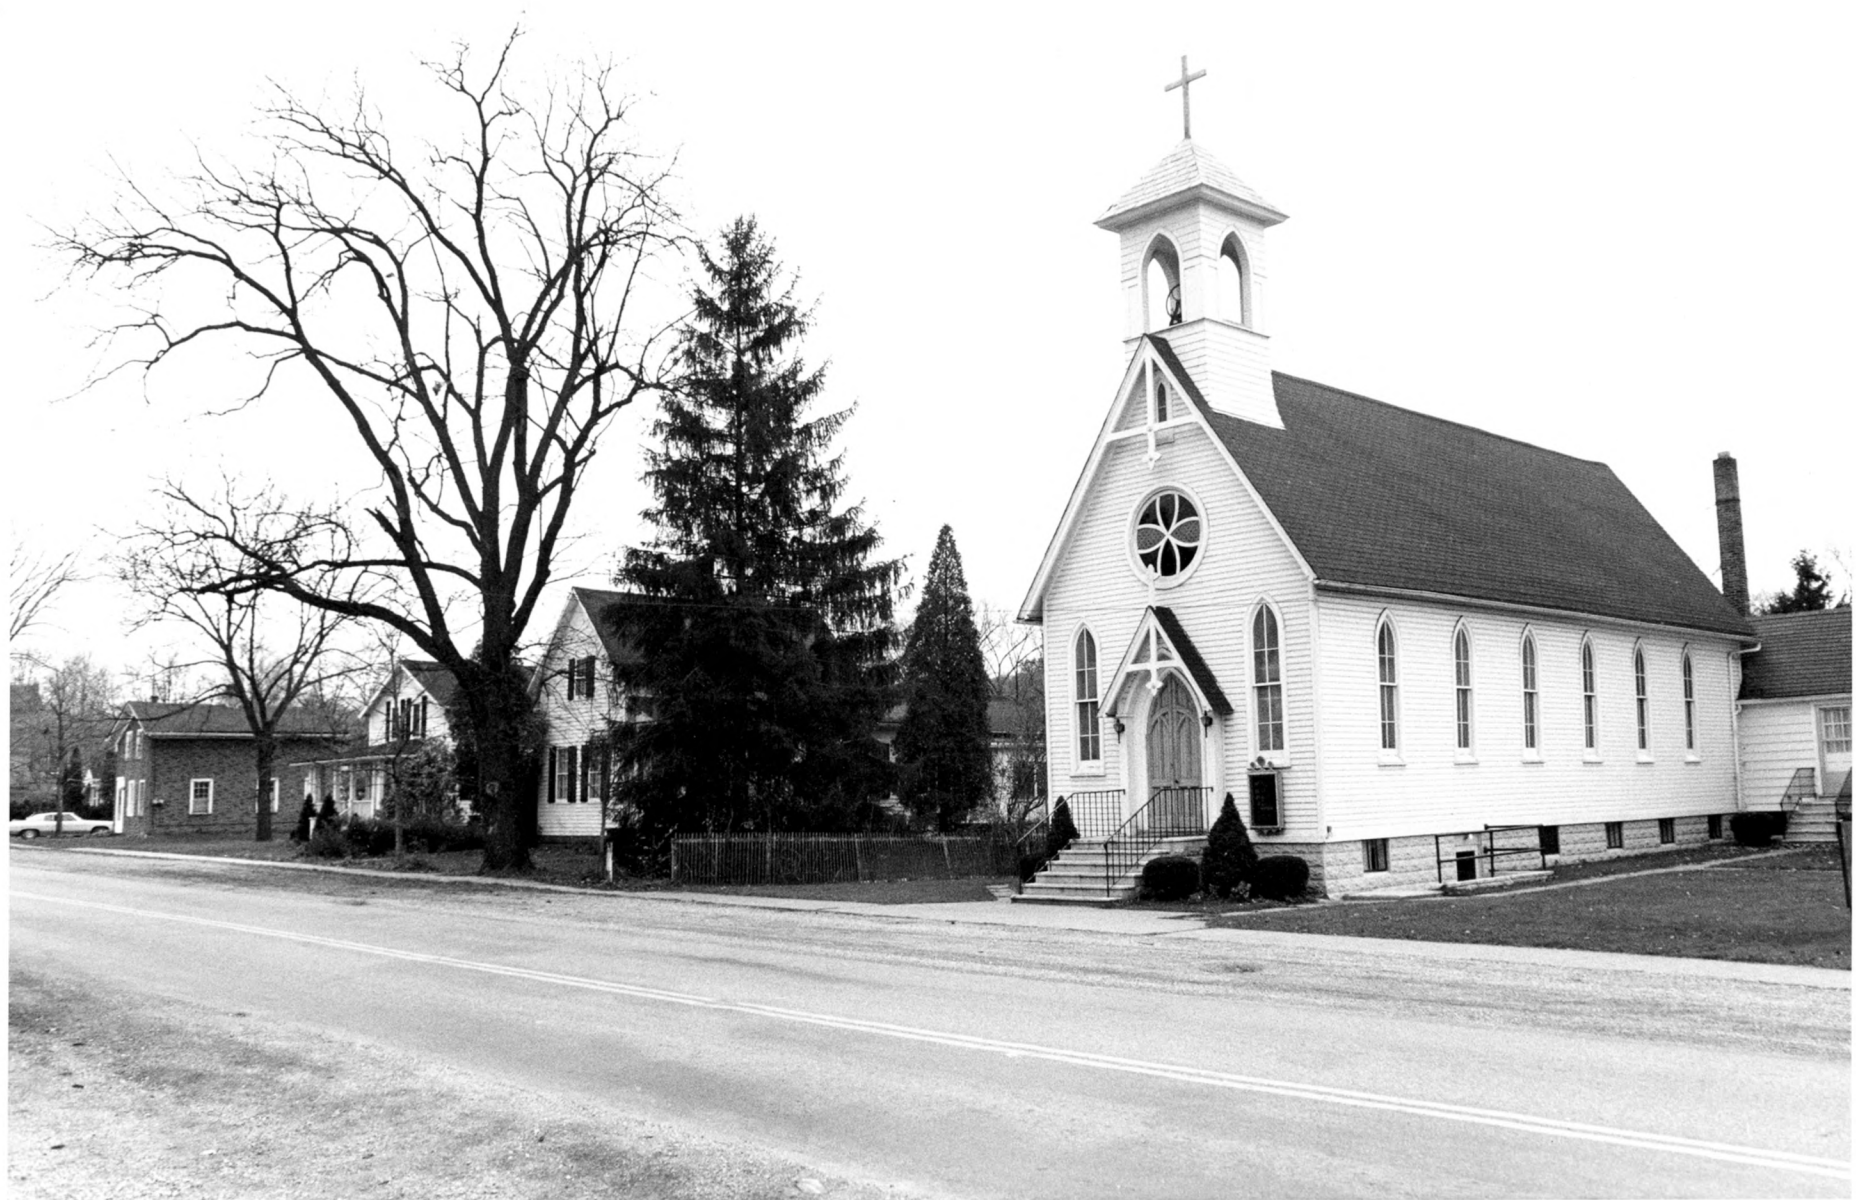
#1 of 14

Mother of Sorrows Catholic Church, Akron-Peninsula Road, looking South.

③ Mother of Sorrows Catholic Church, 6034 Akron-Peninsula Road. This is another frame church building, in the Gothic Revival Style. In 1935 it was expanded by adding a section in the center, and a basement hall was constructed underneath.

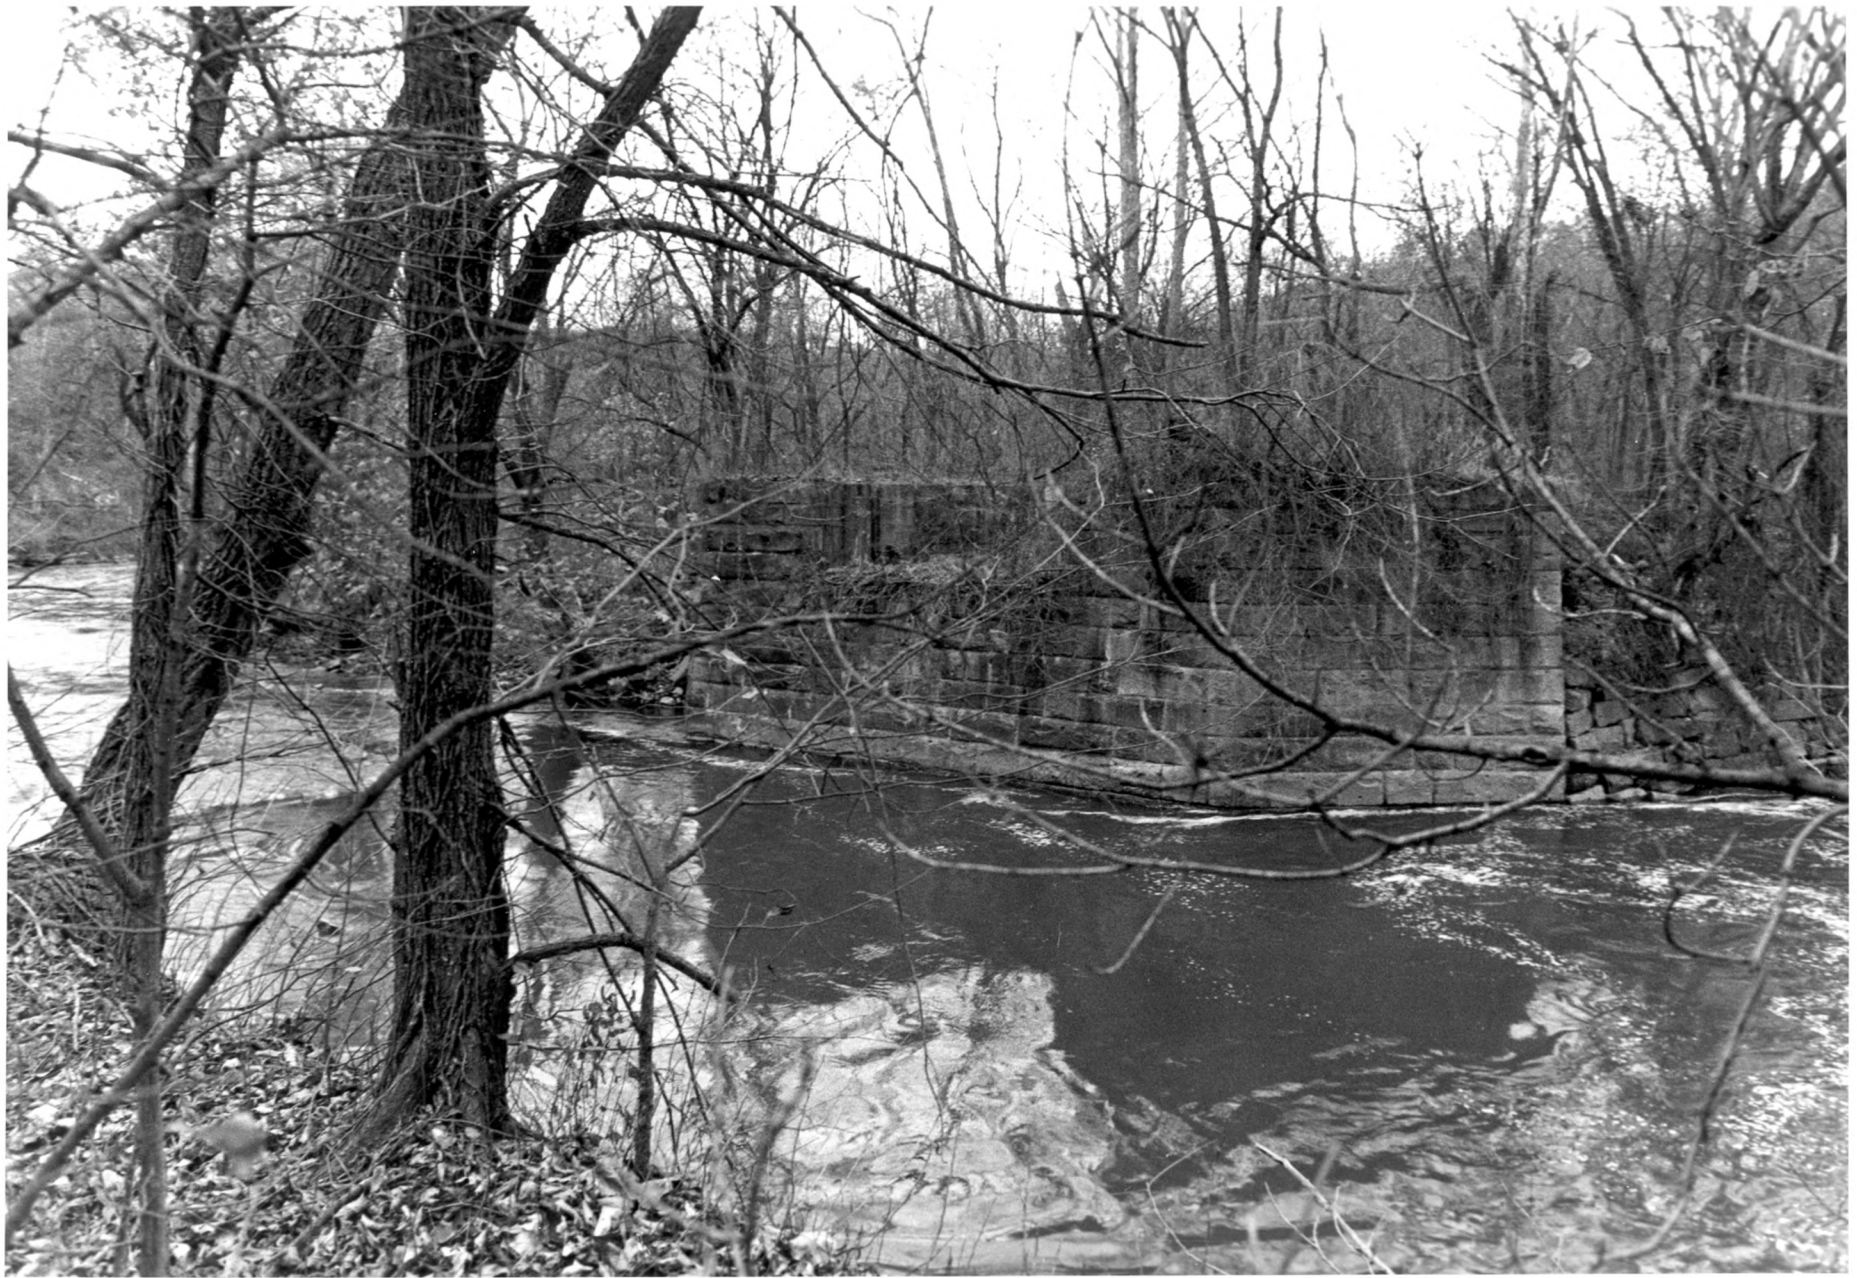
2 of 14
0470
PROPERTY OF THE NATIONAL REGISTER

Northern abutment of the canal aqueduct, looking north across the Cuyahoga River.

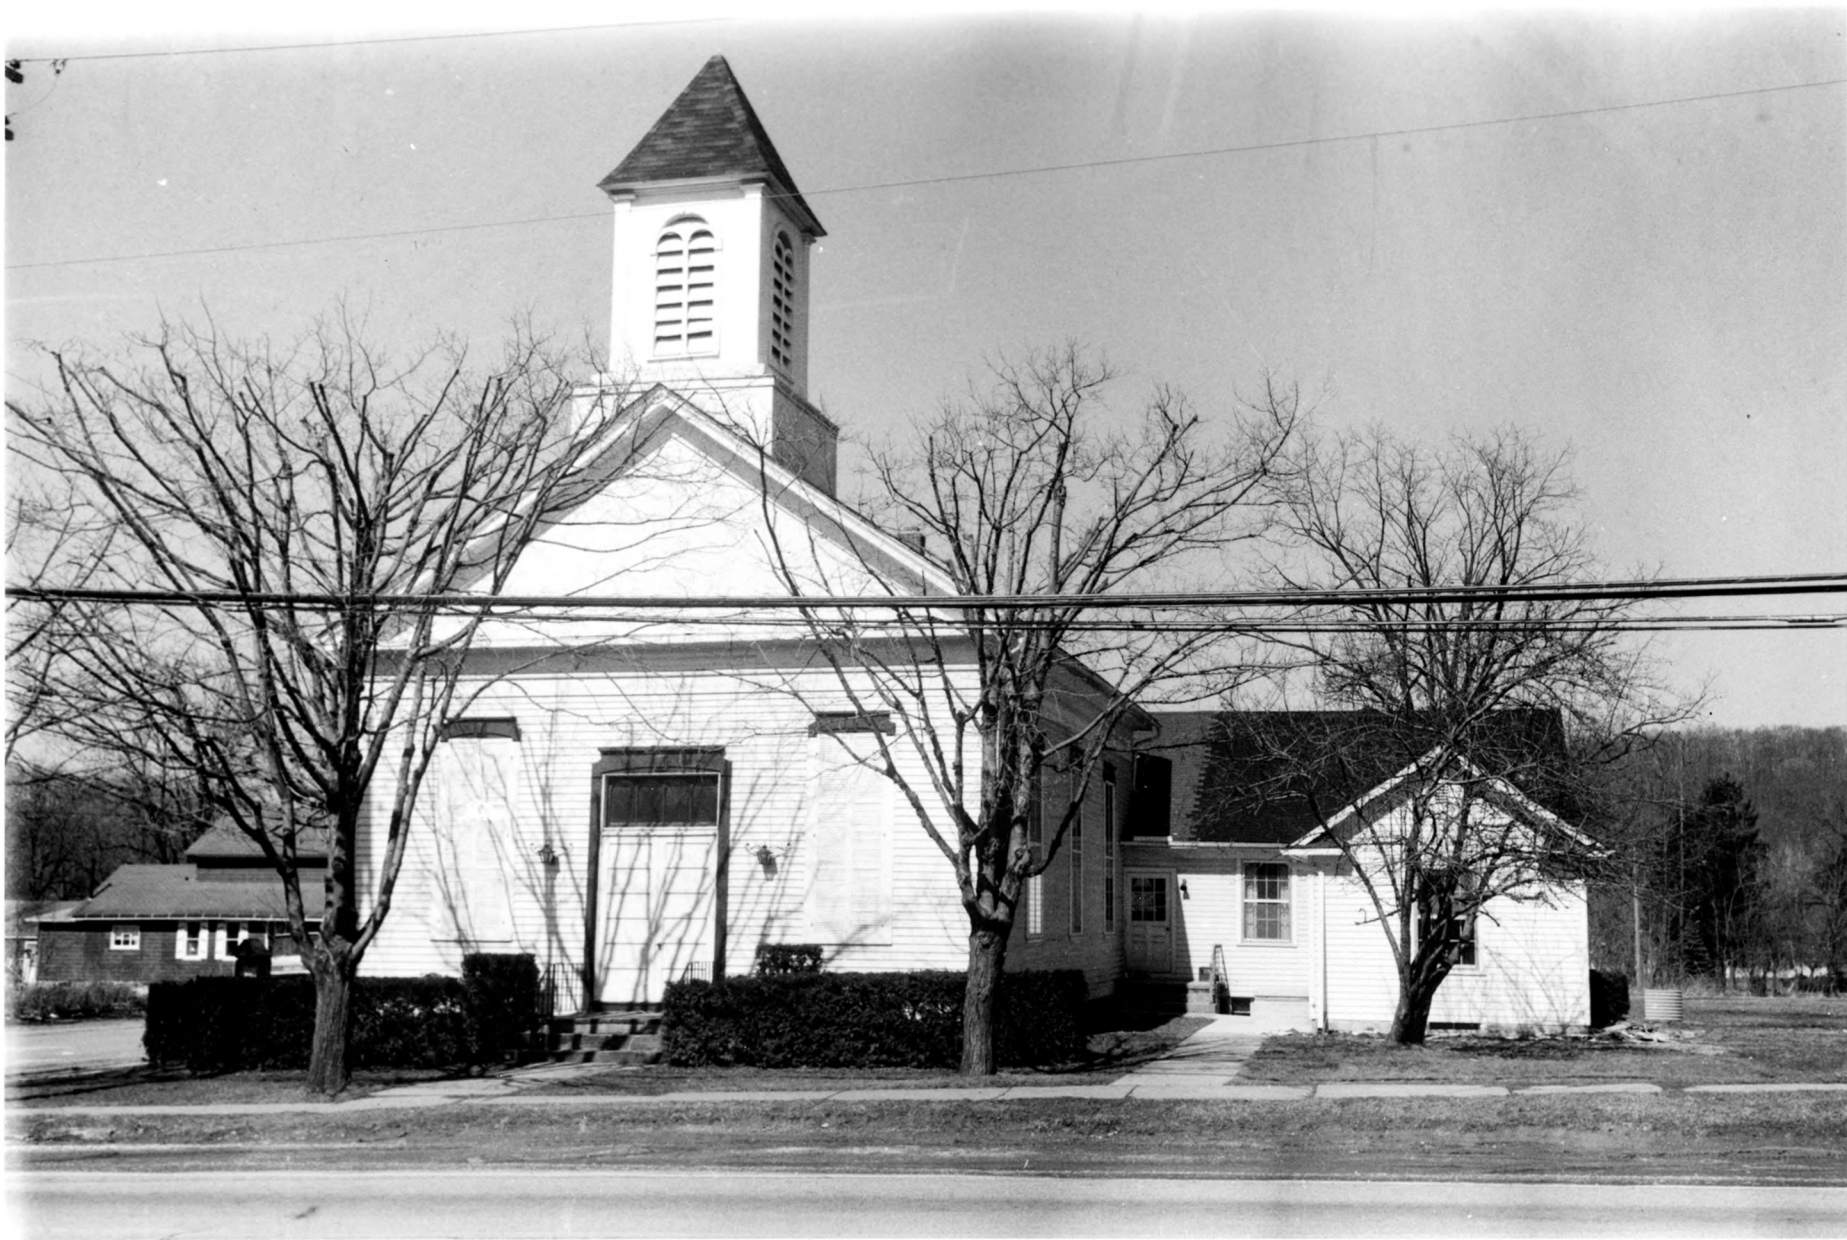
3 of 14

Peninsula United Methodist Church, northeast corner East Main and Akron-Peninsula Road, looking north.

② Peninsula United Methodist Church, northeast corner Main Street and Akron-Peninsula Road. Facing the Town Hall, this frame building has the basic simple lines of a Greek Revival church building. The tower has louvered openings in the Romanesque Revival Style. A modern wing was added to the north side in 1919. The interior was seriously remodeled in 1940.

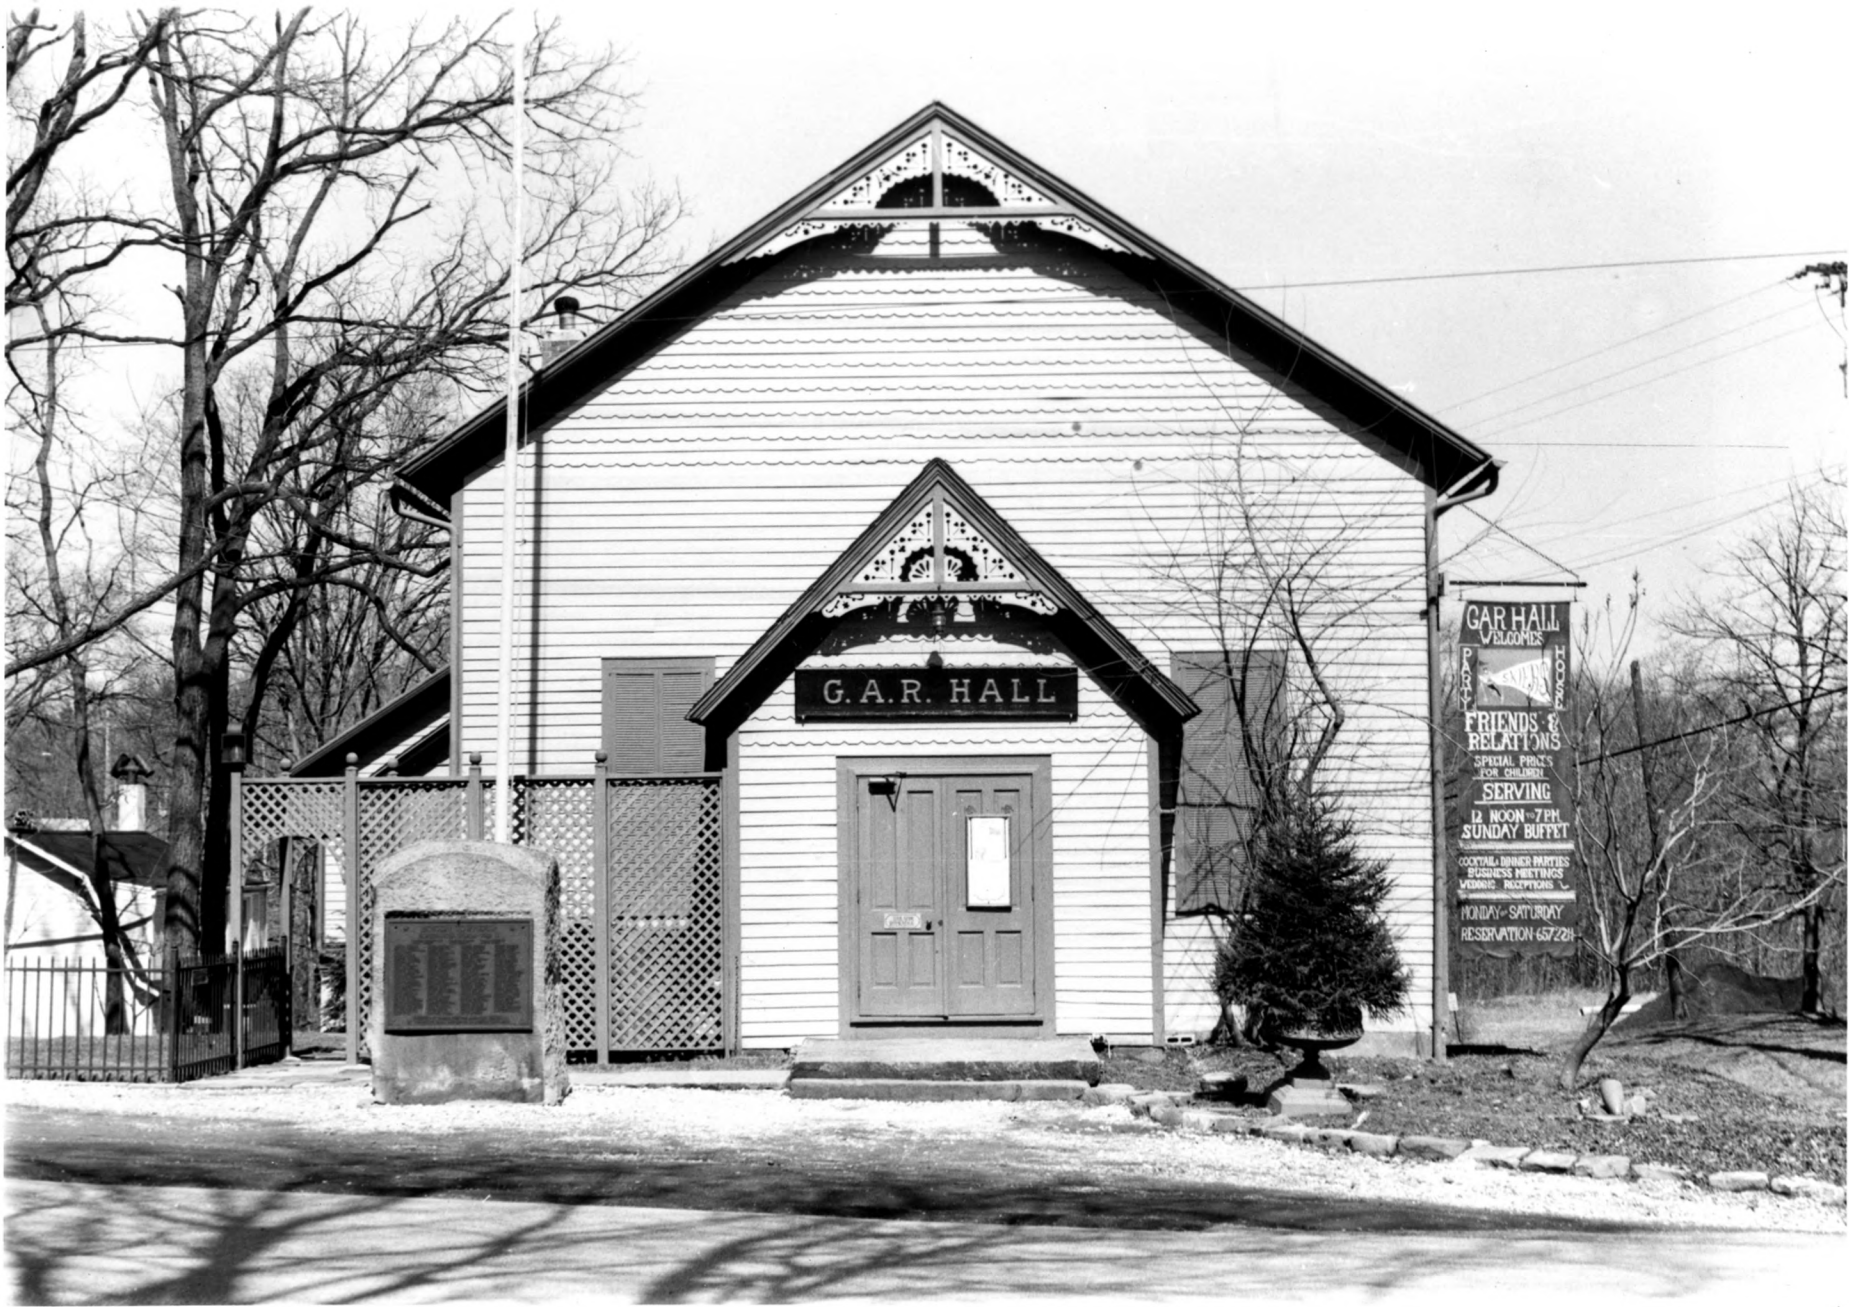
#4 of 14

4. IDENTIFICATION
DESCRIBE VIEW, DIRECTION, ETC.
G.A.R. Hall, northwest corner West Main and Riverview Road, looking north.

① G. A. R. Hall, northwest corner West Main and Riverview Road. This is a frame building with Eastlake Style ornament. It contains a large hall and stage on the street level. Being on a hillside to the rear, the building had a basement opening to the grade level, which served as a dining room. Later a basement kitchen and a street level anteroom and cloakroom were added to the west. Since 1963, the building has been renovated. The hall and stage have been restored, with oil chandeliers of the original type in the hall. The basement areas have been modernized for public use.

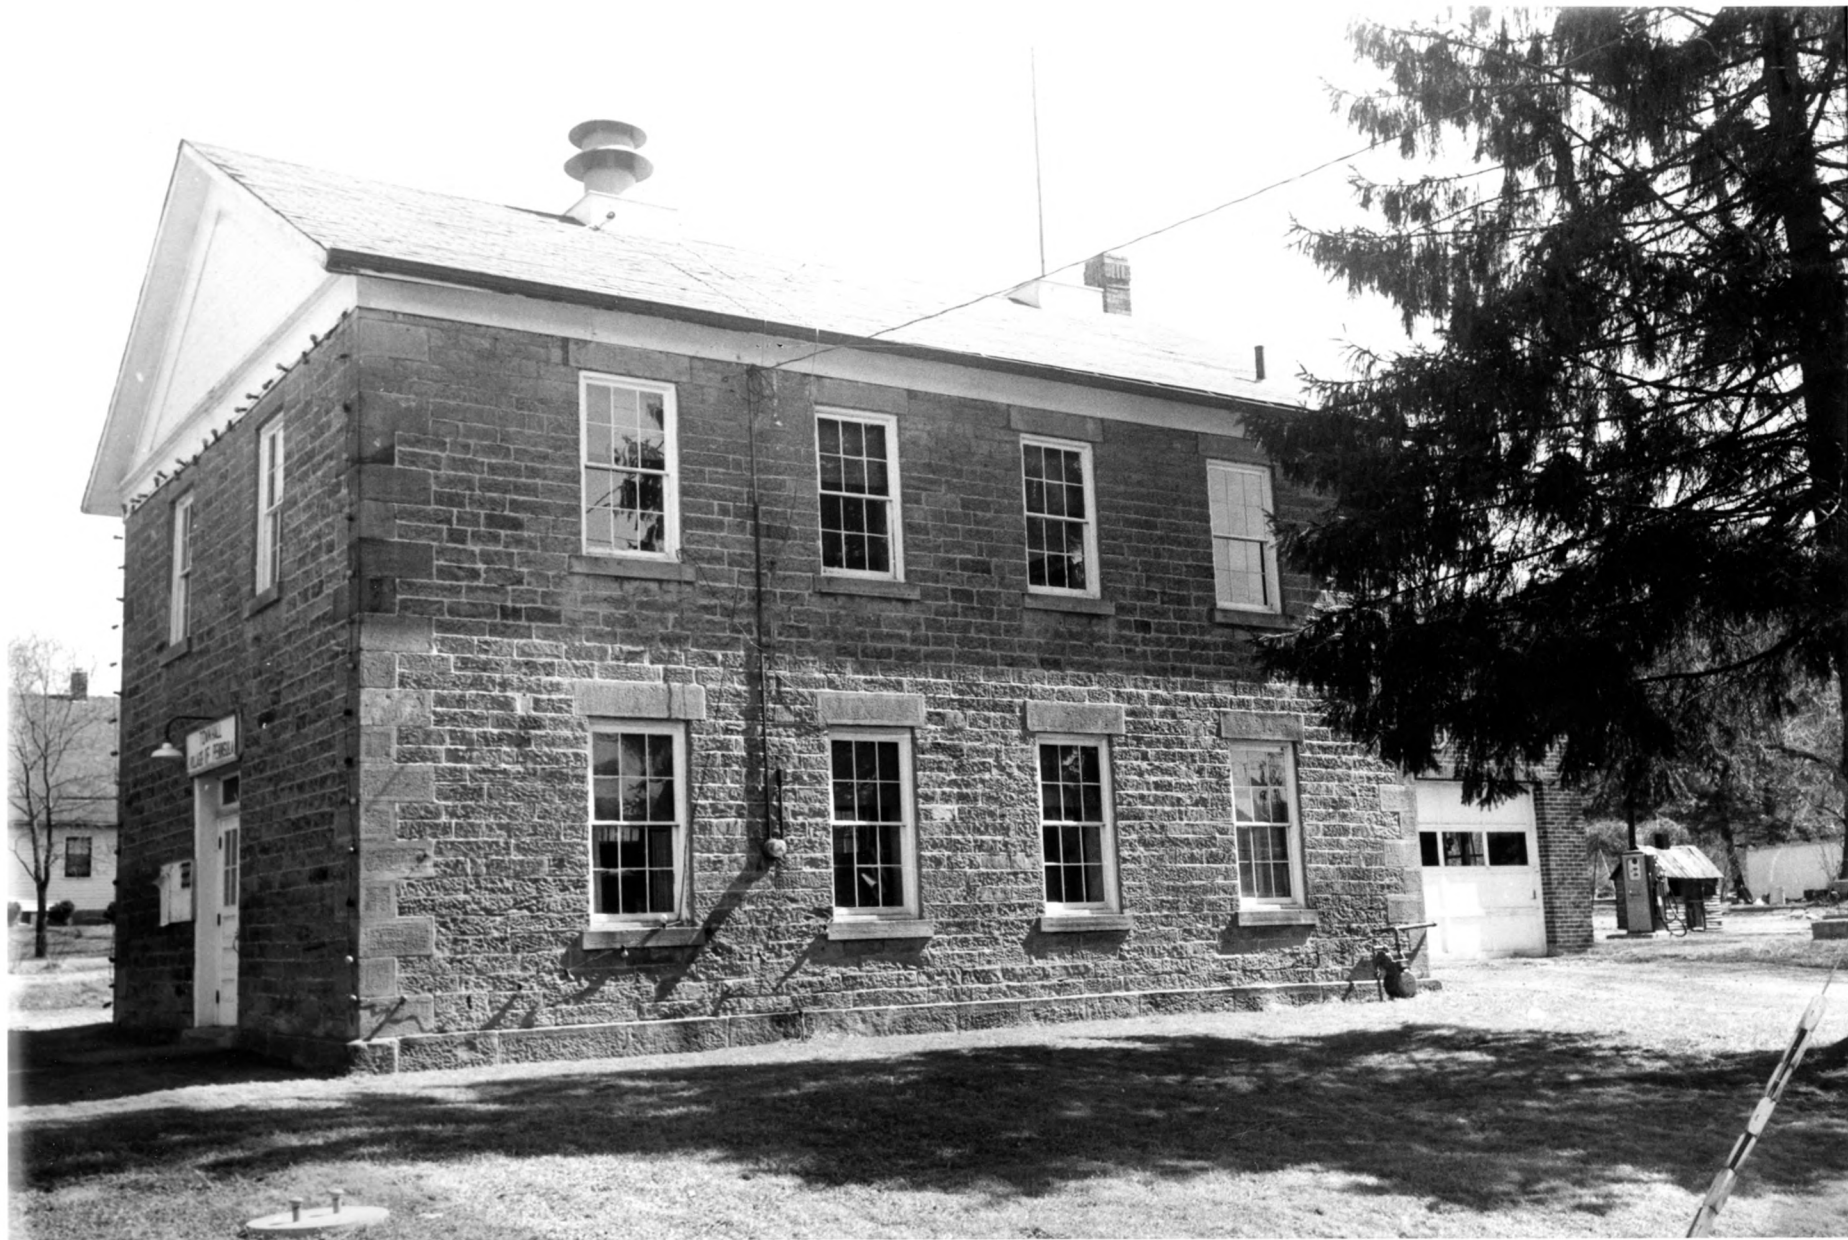
#5 of 14

Town Hall, southeast corner, East Main and Akron-Peninsula Road, looking east.

① Town Hall, southeast corner Main Street and Akron-Peninsula Road. This is a rectangular two-story building of sandstone ashlar construction, with large quoins at the corners. The window arrangement is symmetrical, with horizontal stone lintels over all openings. The roof is a simple gable with a wooden pediment, but there is no Greek detail. On the interior, one iron-barred jail cell remains on the ground floor.

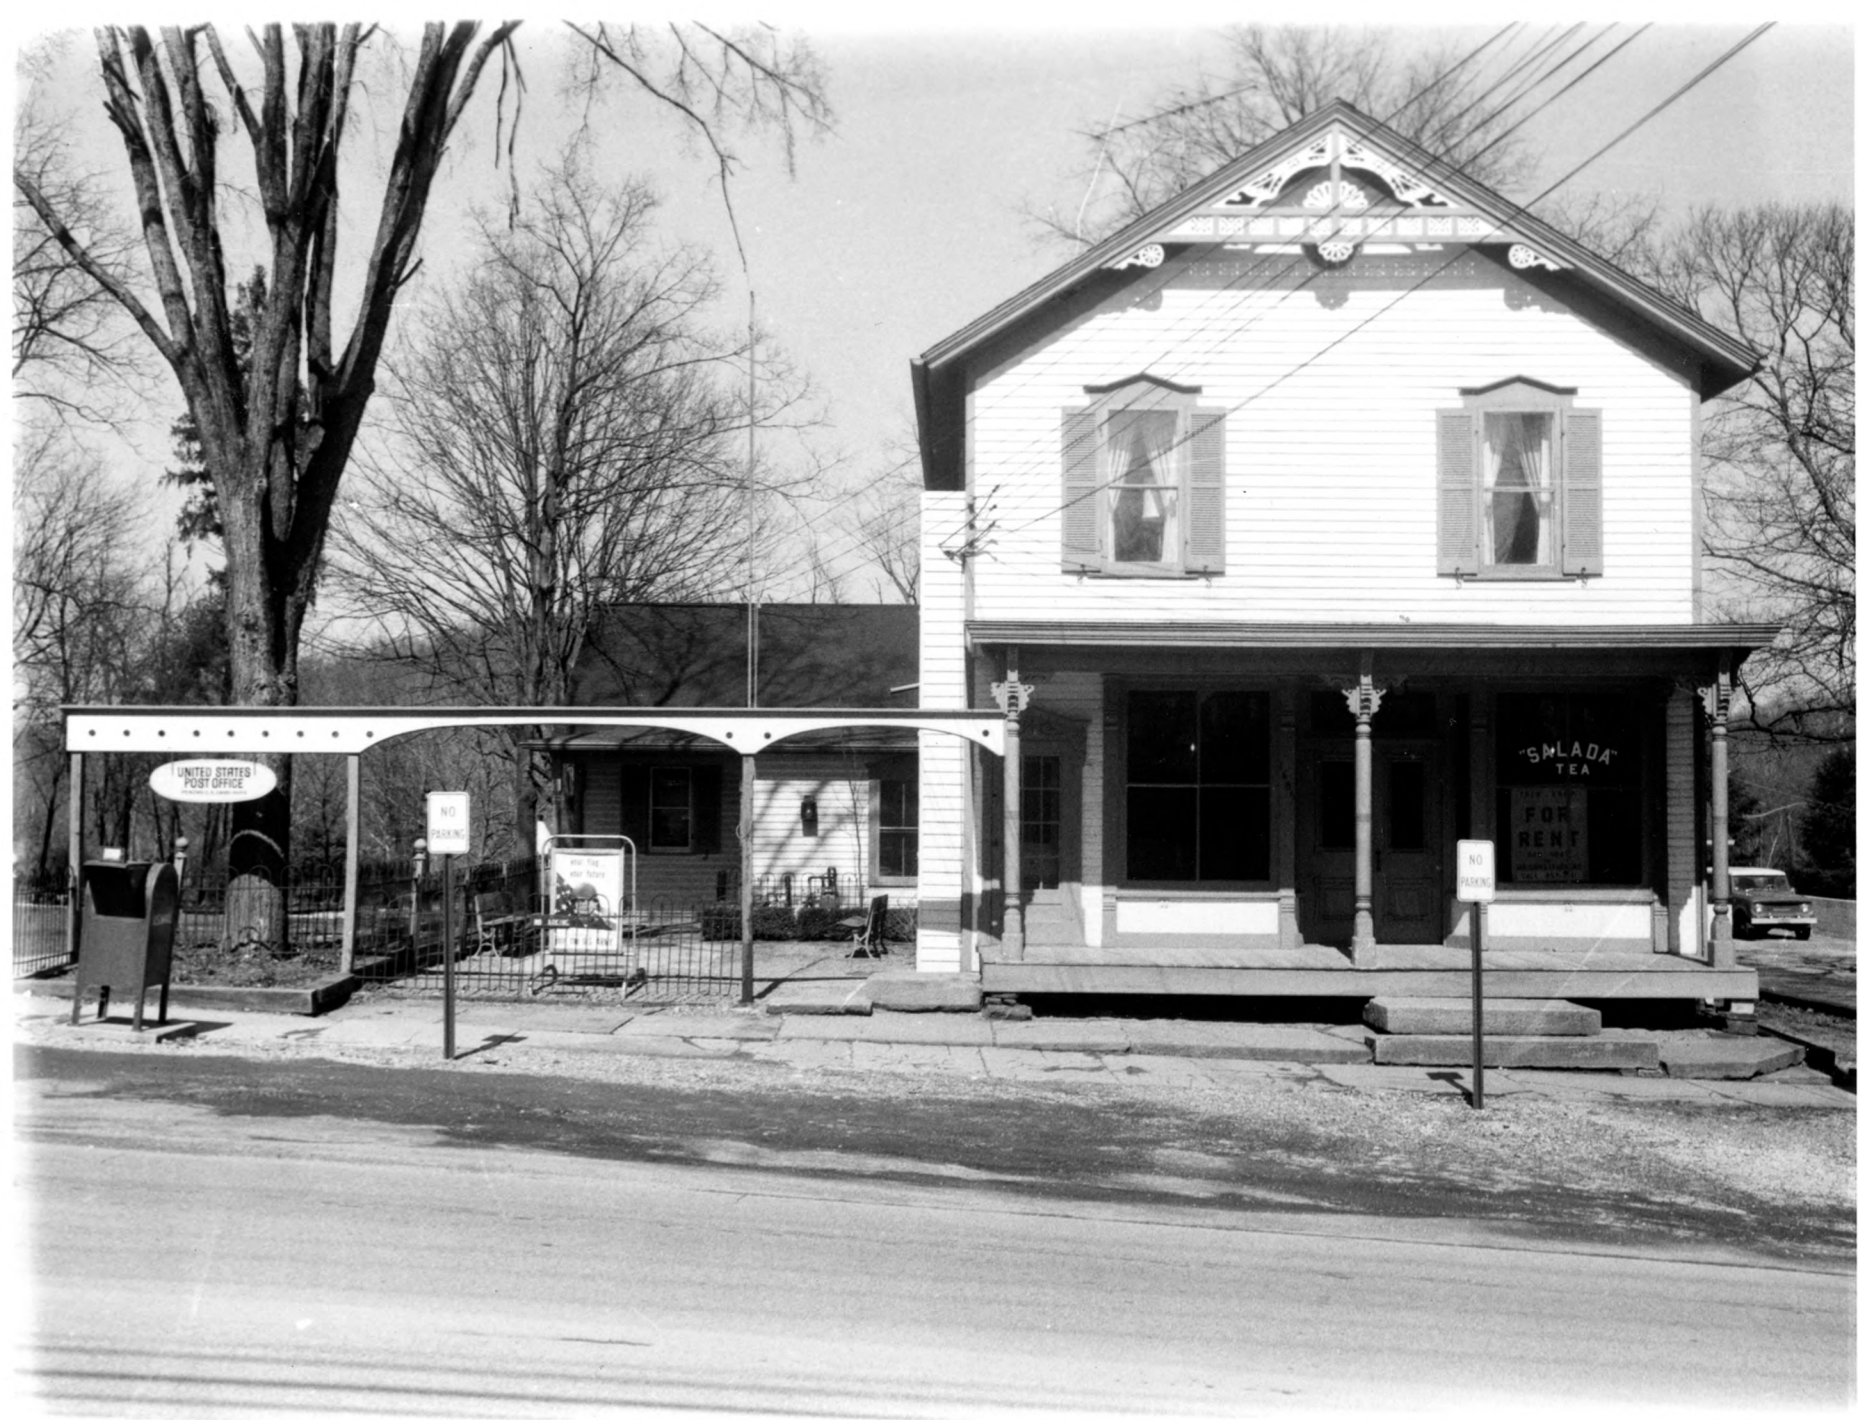
#6 of 14

1. NAME		
COMMON Peninsula Village Historic District	AND/OR HISTORIC	NUMERIC CODE (Assigned by NPS) AUG 23 1974
2. LOCATION		
STATE Ohio	COUNTY Summit	TOWN Peninsula
STREET AND NUMBER State Route 303 (see continuation sheet)		
3. PHOTO REFERENCE		
PHOTO CREDIT	DATE 1972	NEGATIVE FILED AT Cuyahoga Valley Assn. Box 222, Peninsula
4. IDENTIFICATION		
DESCRIBE VIEW, DIRECTION, ETC. General Store, 1685 West Main, looking north.

① General Store, 1685 West Main Street. This is a frame building in the Eastlake Style with the narrow end facing the road, and a porch across the front. Like the previous store, it had a residence on the second floor.

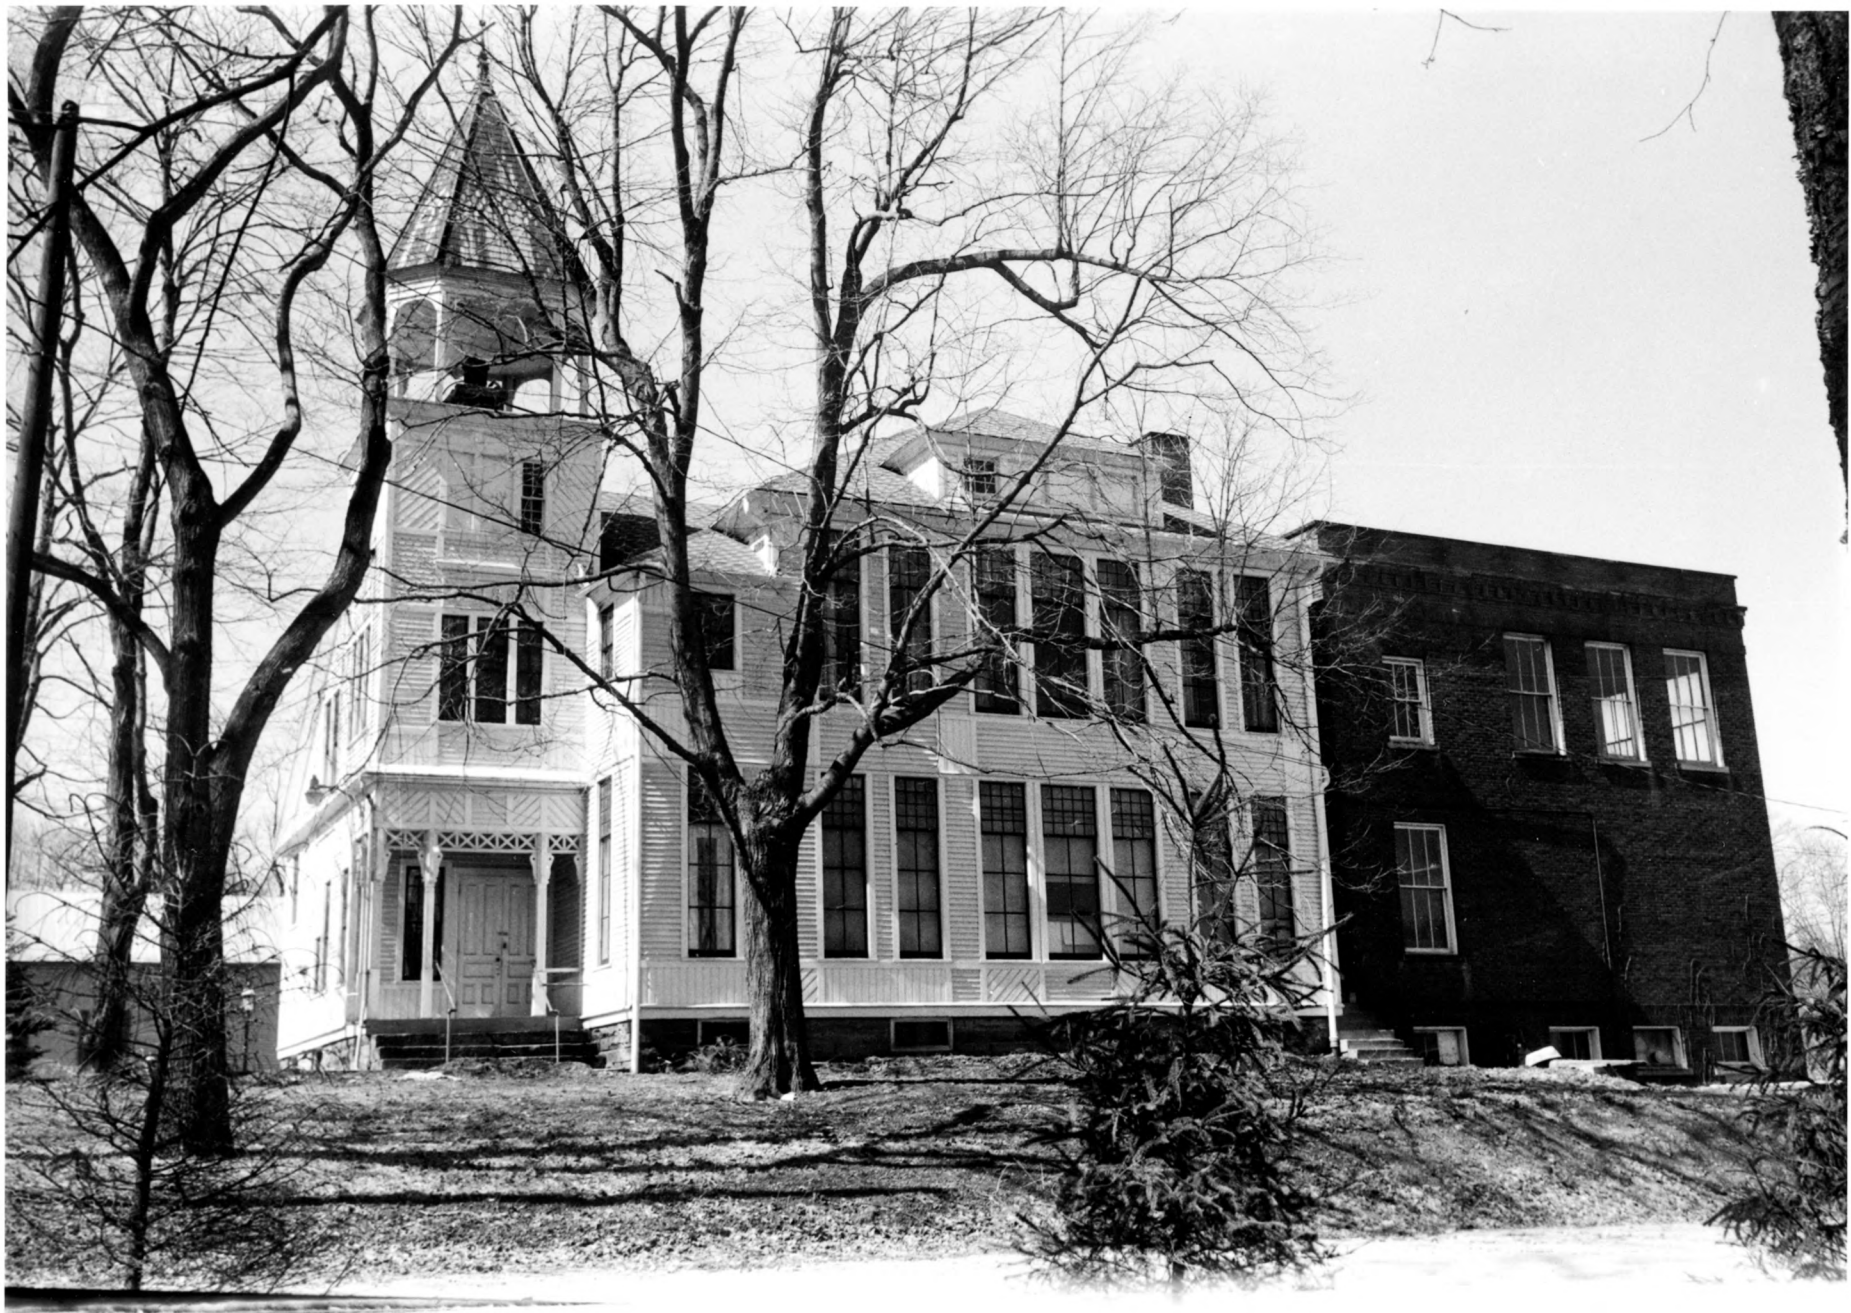
8 of 14

Old Peninsula High School, Northeast corner West Main and Riverview Road, looking west.

① Peninsula High School, northeast corner West Main and Riverview Road. This 1889 two-story school building is an excellent example of the Stick Style. The wall surface is divided by horizontal and vertical posts to symbolize the internal framing structure, and faced with horizontal and diagonal siding between these members. The corner tower has an open octagonal belfry with a steep pyramidal roof. A two-story brick addition was built to the rear in the 1920's, but it has a completely different character from the older part.

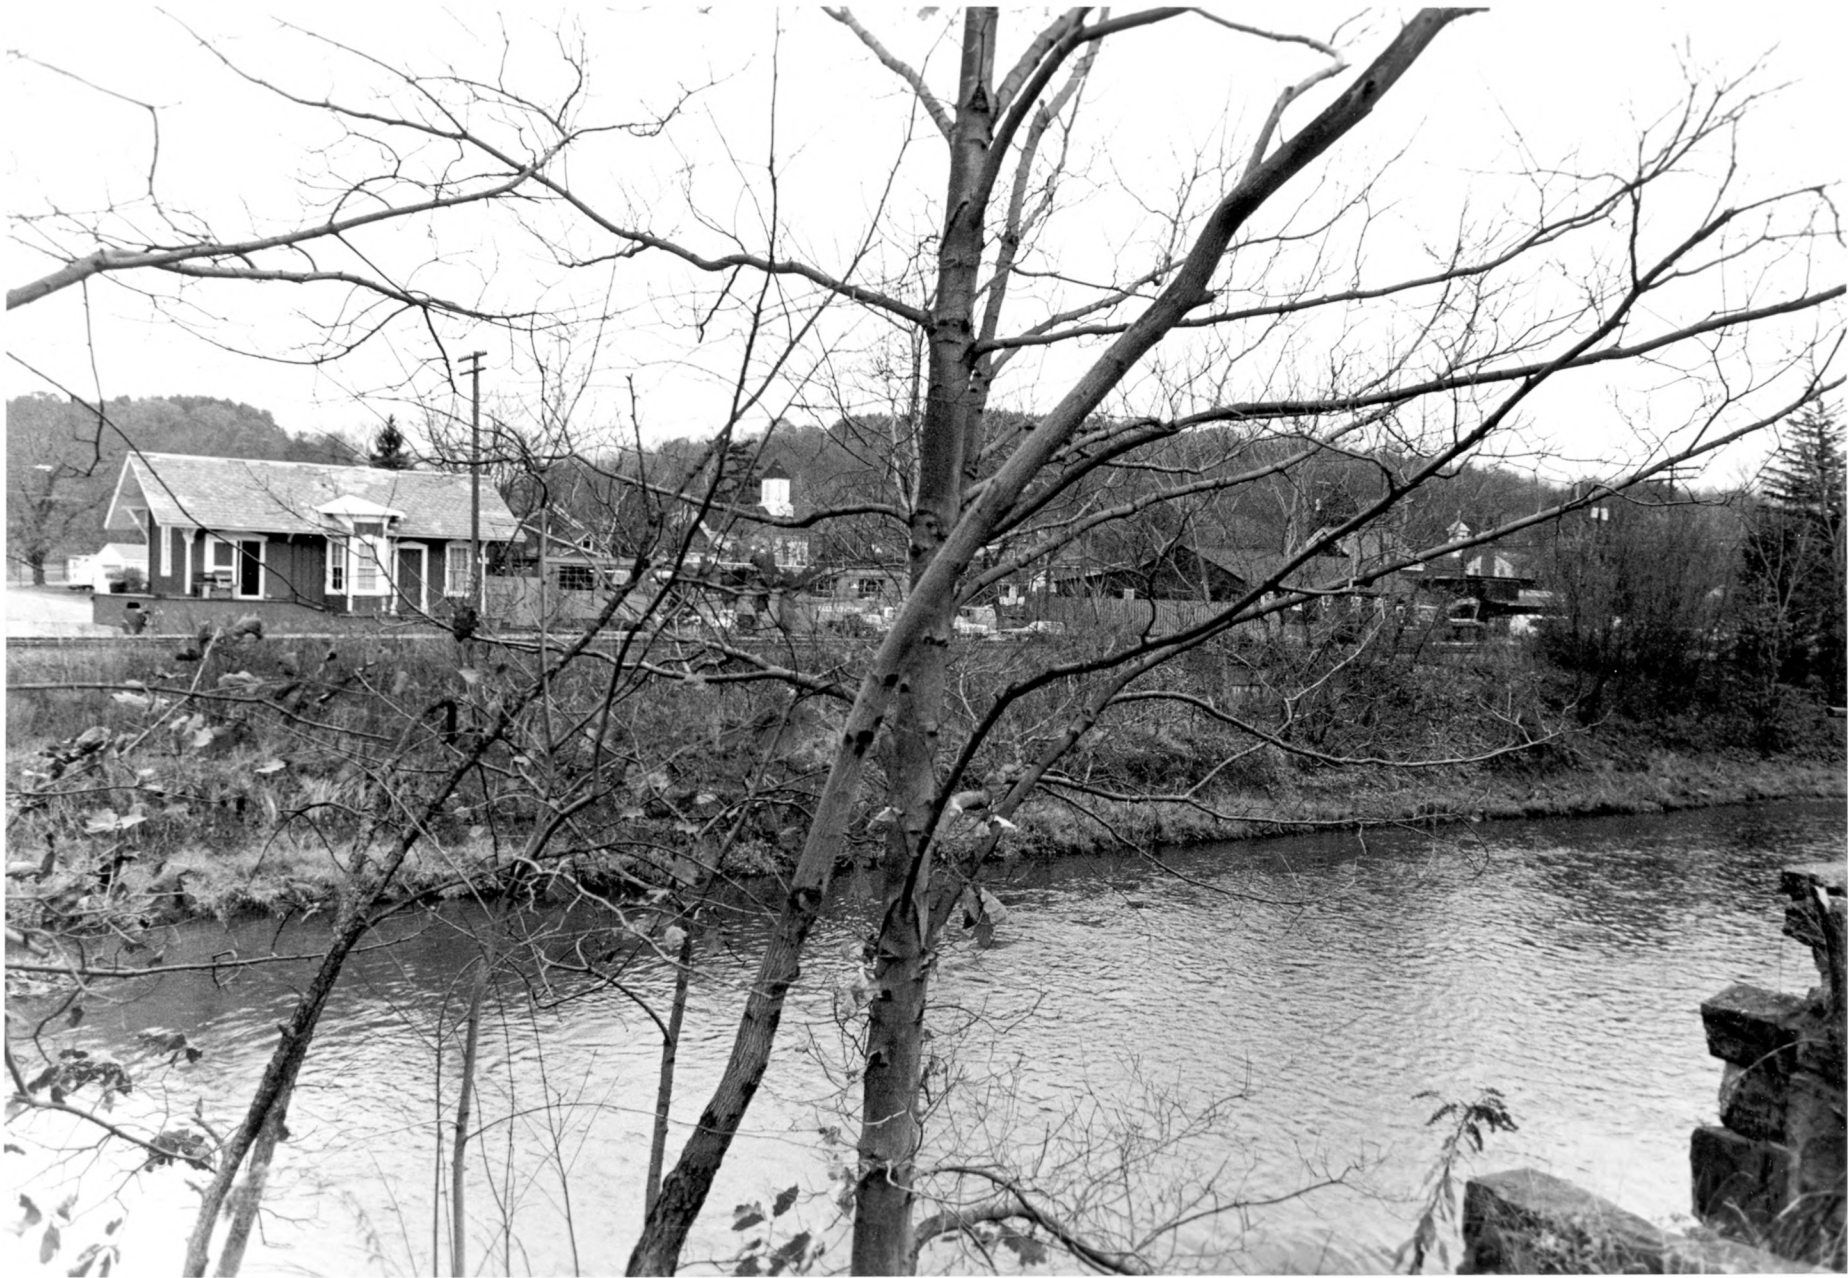
#10 of 14

Foot of Mill Street, looking East across the Cuyahoga River.
Railway depot at left. Methodist Church tower in the distance.

④ On the railroad right-of-way at the foot of Mill Street is a frame depot building. This was recently moved to Peninsula from the village of Boston, one-and-a-half miles north, to replace one that had been razed. It is a typical rural station with wide overhanging eaves and hints of High Victorian Italianate Style in the window frames.

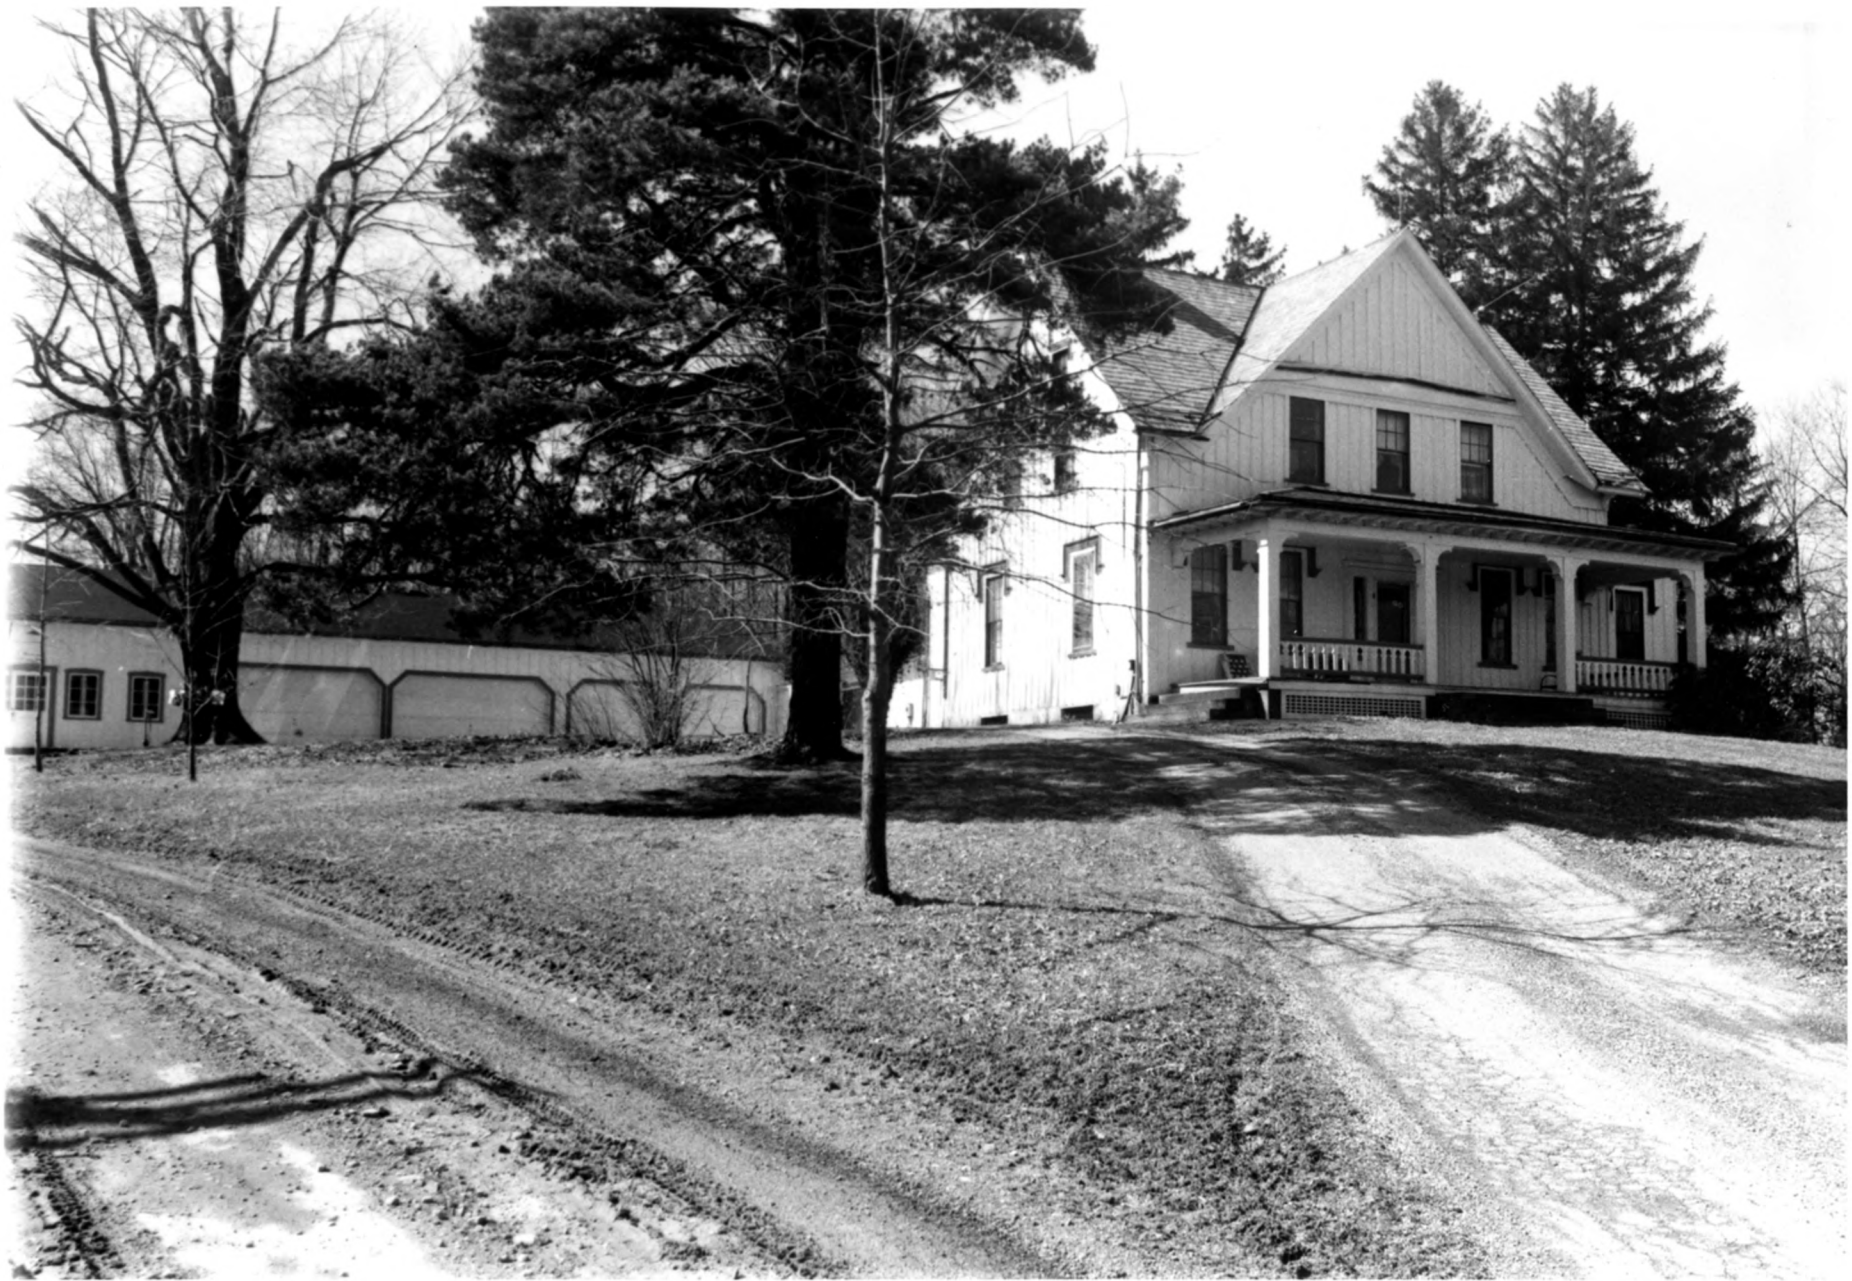
11 of 14

Lawson Waterman House, 6050 Riverview Road, looking west.

(10) Waterman House, 6050 Riverview Road, south of Route 303. This was originally a Greek Revival frame farmhouse, with a typical five-bay facade and central entrance with sidelights. In the second half of the century it was remodeled with a tall front gable, higher roof, drop molding on the windows, and vertical siding.
