**NATIONAL REGISTER OF HISTORIC PLACES
INVENTORY - NOMINATION FORM**

COMMON: **Peninsula Village Historic District**

STREET AND NUMBER: *both sides of*
OH State Route 303 (see continuation sheet)

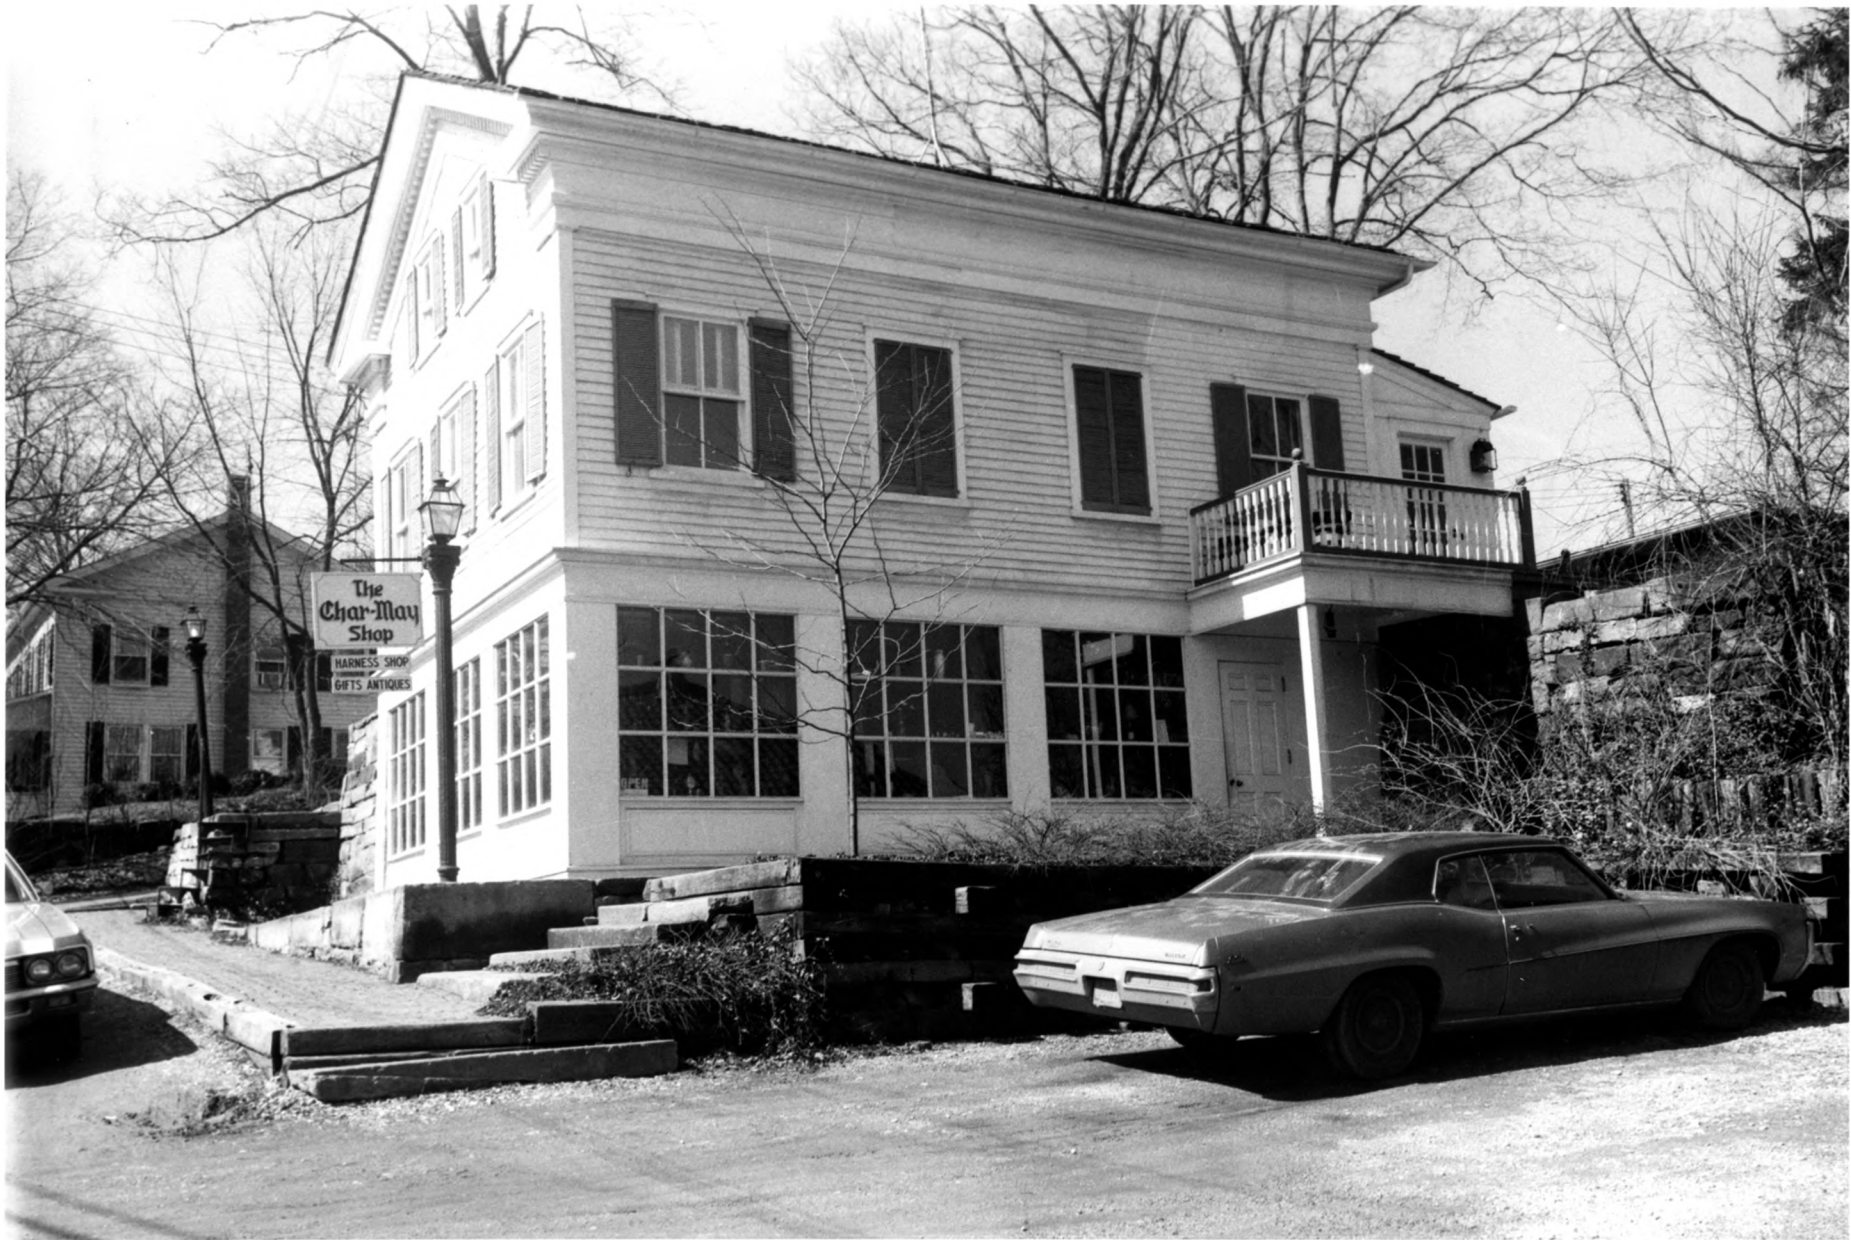
#12 of 14

Wood's Store, 1663 West Main, looking west.

⑤ West of the Cuyahoga River. Store at 1663 West Main Street. This is a two-story frame building with a store on the lower level and a residence on the upper level. The entablature is a fully-developed Greek Revival feature, with frieze and cornice returns on the end facing the road. An unusual detail is the two closed and

shuttered windows on the east elevation. They were designed to maintain the symmetry of the exterior, but actually cover framing members behind them. The building has been extensively restored since 1963, and wings which were added to the north and west in 1854 have been removed.

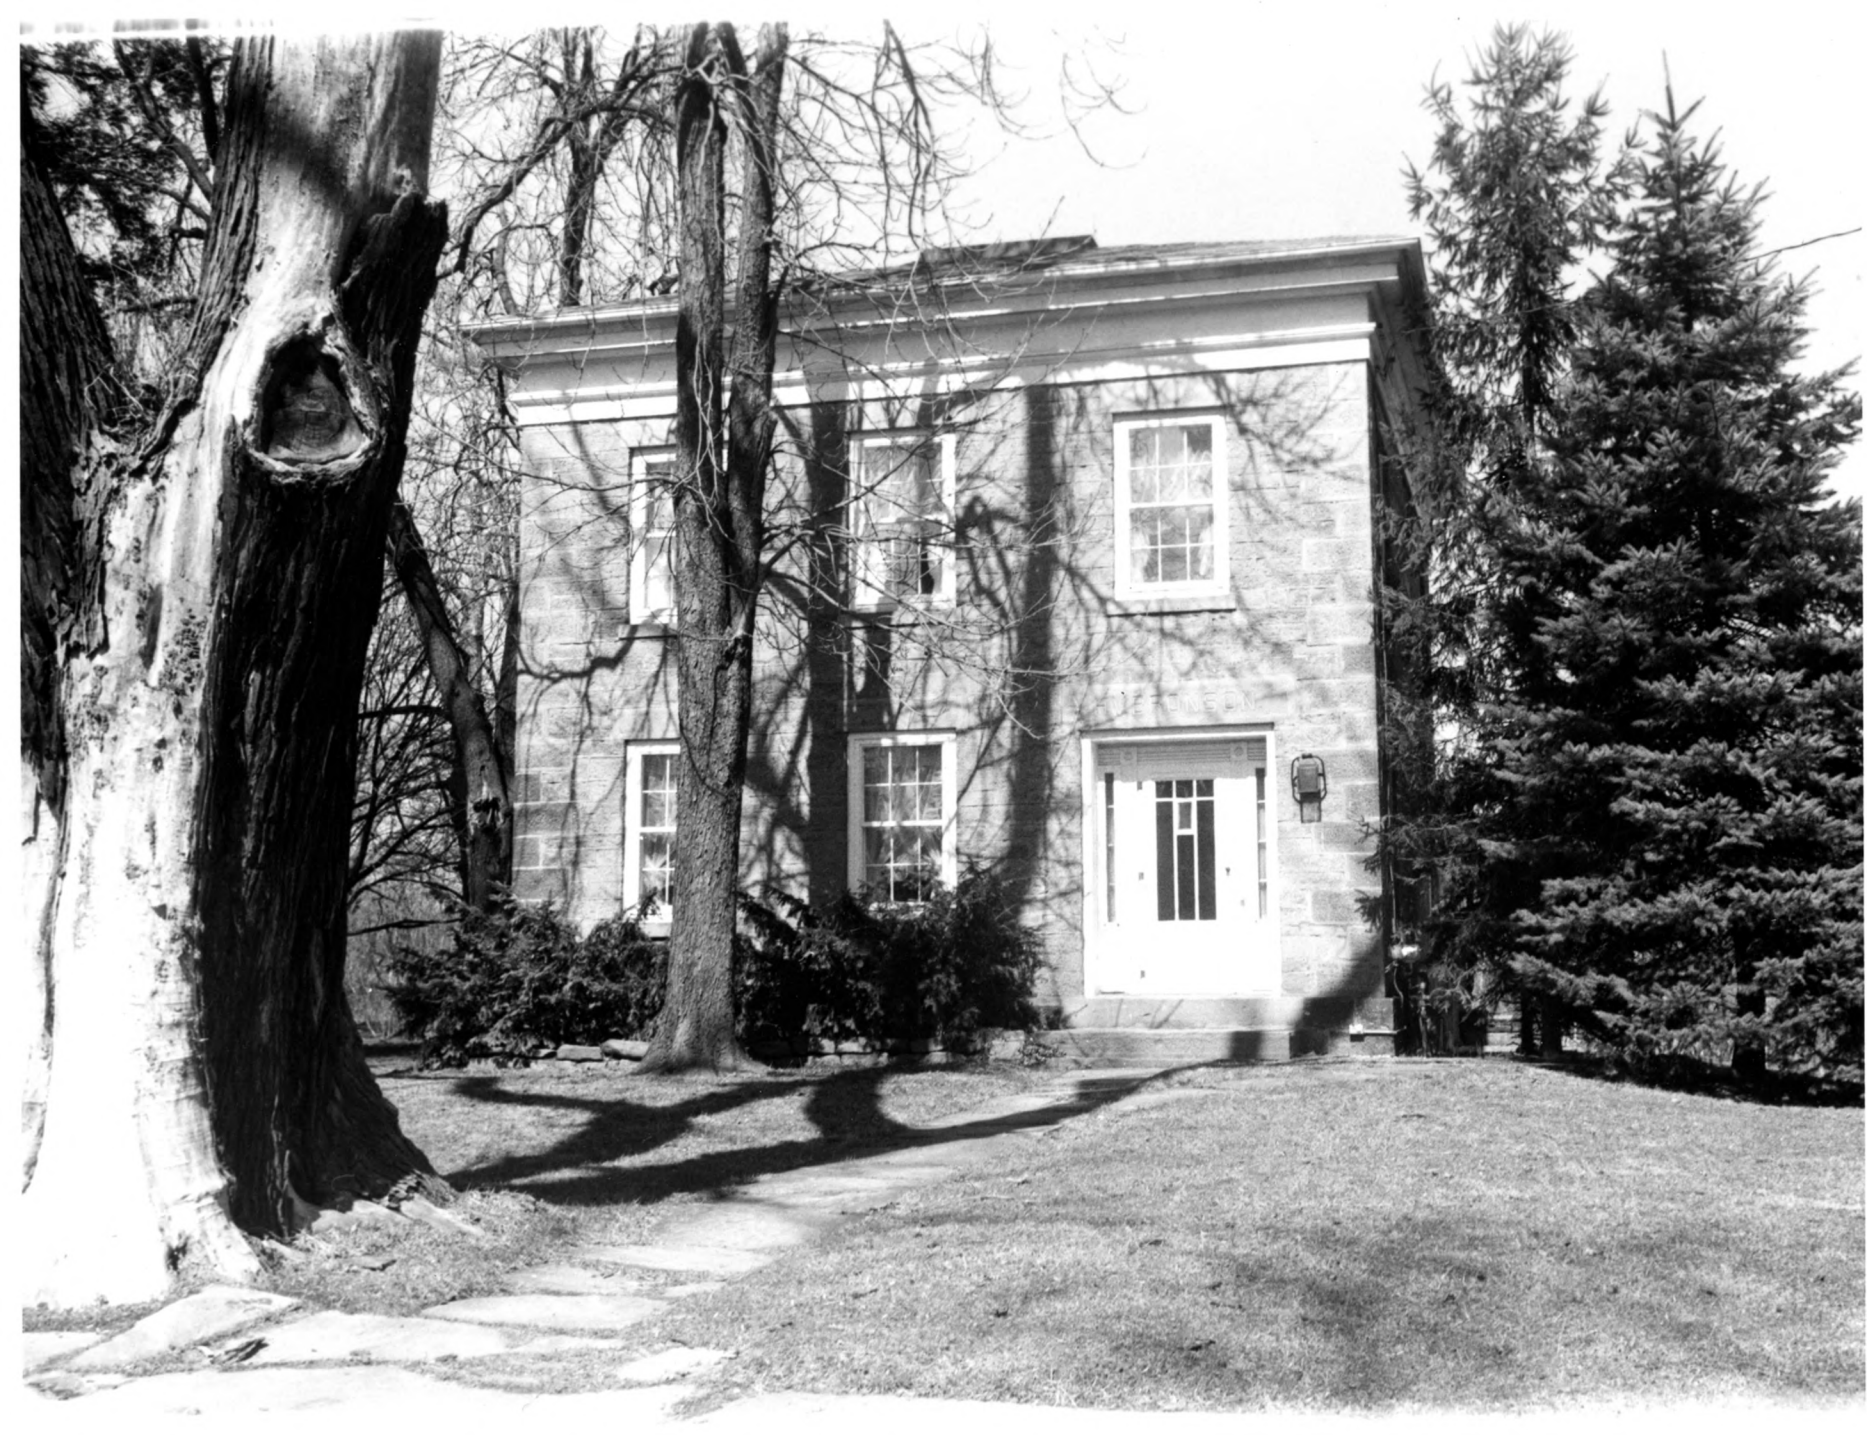
#13 of 14

Harmon Bronson House, 1715 West Main, looking north.

① Bronson House, 1715 West Main Street. This is a squarish two-story sandstone residence with a three-bay facade and the entrance door to one side. It is very similar in construction to the Town Hall. The roof is hipped.

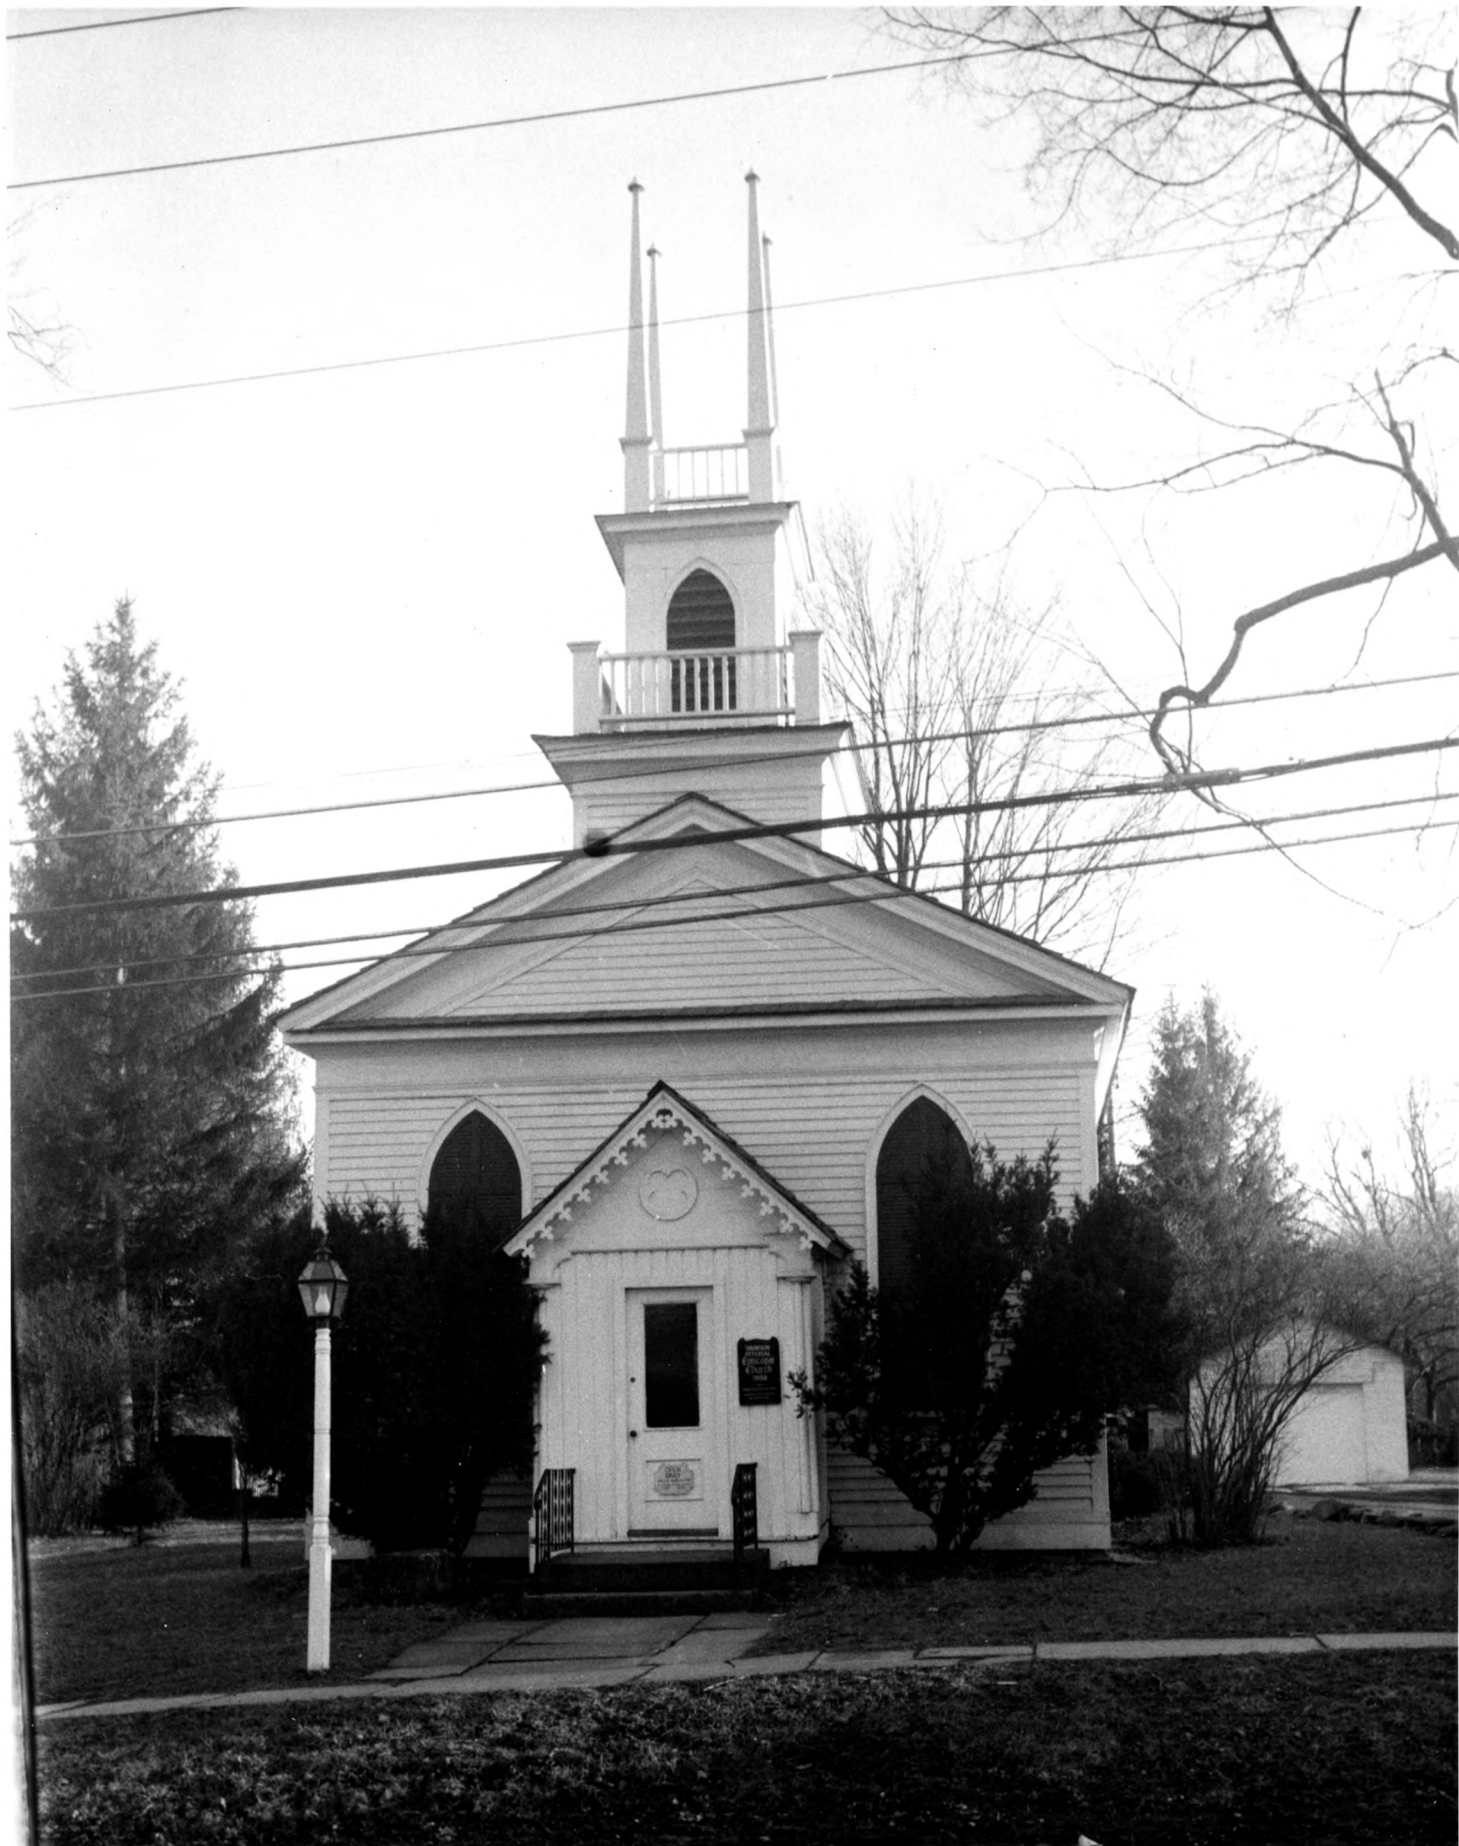
#14 of 14

Bronson Memorial Church, West Main and Church Streets, looking south.

① Bronson Memorial Church, West Main and Church Streets. The basic form and original style of this frame building were Greek Revival. The pediment, cornice and frieze are excellently proportioned. In 1889 the building was remodeled in the Gothic Revival Style. The pointed arches are simply permanent shutters above the original windows. The four spires and the small entry porch with its trefoil "gingerbread" are other additions. In 1965 the building was restored, a new basement constructed, and heating and lighting added. However, it still retains its basic nineteenth century character.
