OHIO HISTORIC INVENTORY

1. No. 7	4. Present Name(s) Lock No. 35
2. County Summit	5. Other Name(s)
3. Location of Negatives OHS

Lock No. 35, Ohio and Erie Canal
District, Cuyahoga and Summit
Counties, Ohio

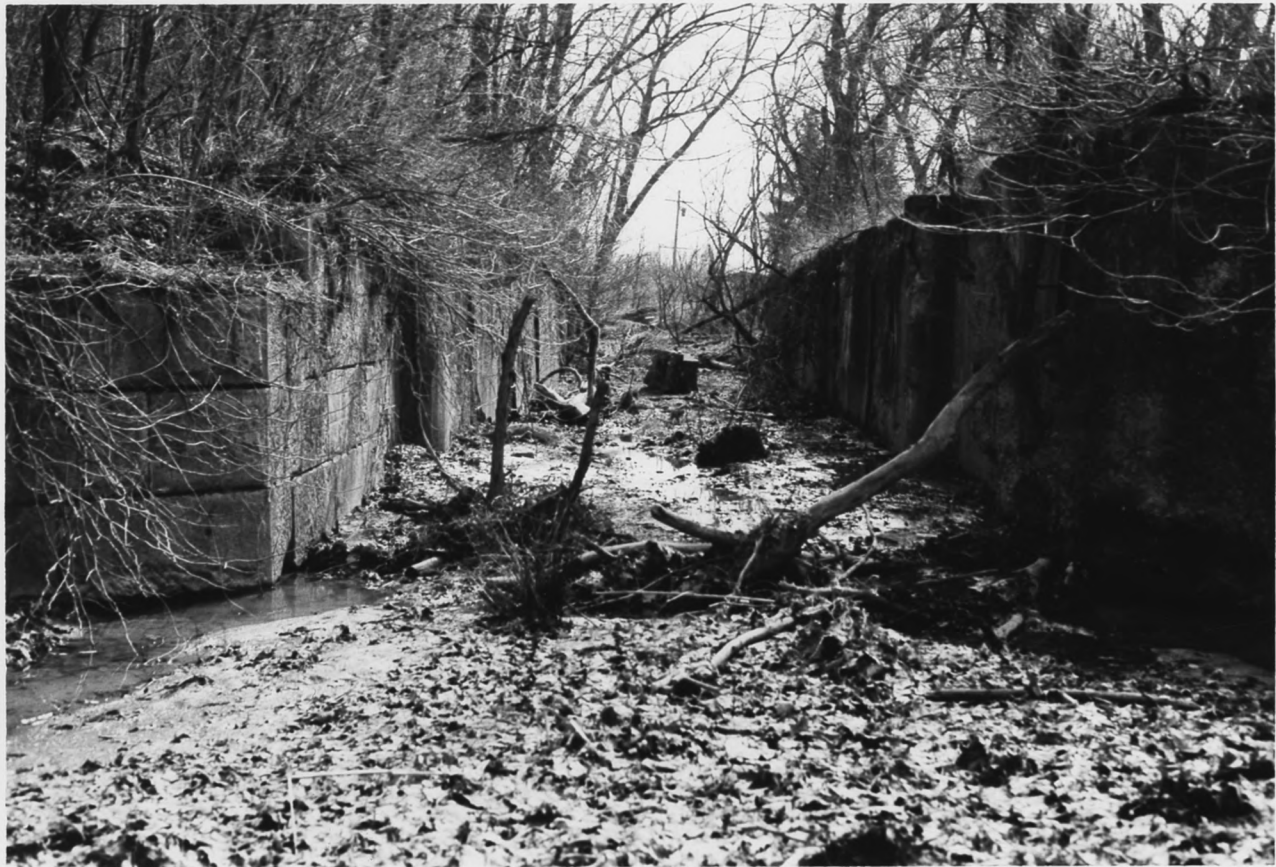
Summit Lock No. 35

42. Further Description of Important Features
Lock is standard mitered gate type. The lock chamber is 90 feet long by 15 feet wide. The cut stone construction is partially faced with concrete, applied c. 1905 as a stop-gap repair measure. Both gates are missing. The canal is dry at this point.

View looking south.
