UNITED STATES DEPARTMENT OF THE INTERIOR  
NATIONAL PARK SERVICENATIONAL REGISTER OF HISTORIC PLACES  
INVENTORY -- NOMINATION FORM

Death Valley Scotty Historic District (Preferred)  
AND/OR COMMON

Scotty's Castle and Ranch, Death Valley Ranch

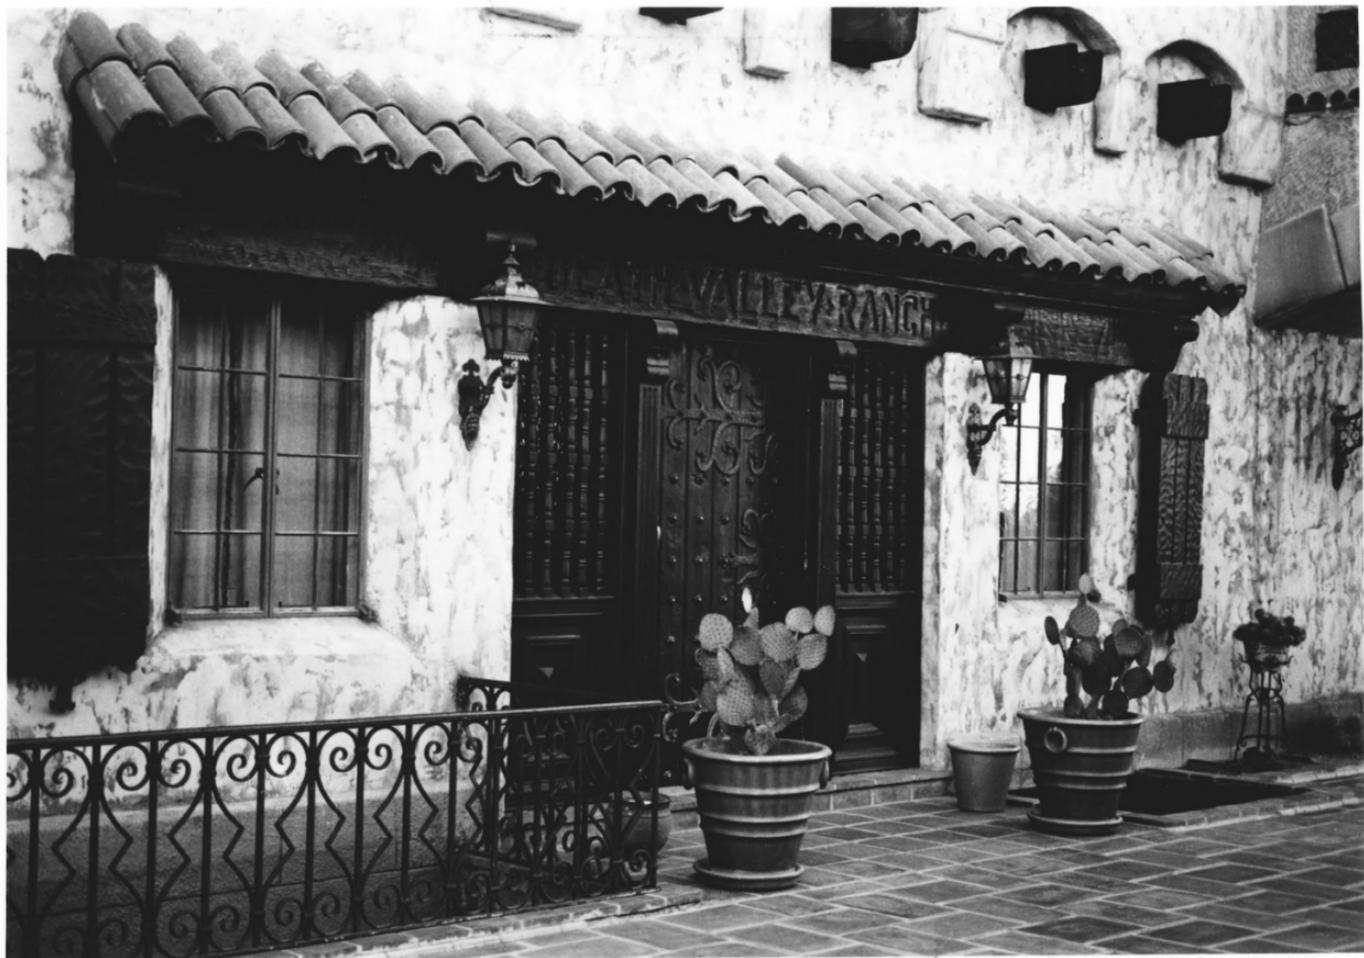
PHOTO NO. 5 <sup>15</sup> 7-116

Hacienda (SC-1), from Southeast.

The Hacienda is a frame, hollow tile and stucco building. The structure has a concrete foundation with a full basement which was never completed. The basement, divided into rooms by wooden partitions, is in use today as a storage area and employee recreation room. The Hacienda is being used as employee quarters. The first floor is divided at the center in two apartments, with lofts at the east and west ends. The floors are finished with red quarry tile, with a decorative tile baseboard edging throughout most of the structure. The interior woodwork, including shutters and exposed beams, is hand-finished redwood, with decorative hand-wrought iron fittings made specifically for this building. On the exterior, the red mission tile gable roof parallels the main axis of the structure and is flanked by several tile-covered shed roofs over smaller sections of the building. The structure is in good condition, and seems to be structurally sound, although major work needs to be done on the environmental control systems.
